INVESTIGATION OF DRILLING INDUCED DAMAGE
IN PPS/GLASS FIBER REINFORCED
COMPOSITES

Submitted to the Faculty of the
Graduate College of the
Oklahoma State University
in partial fulfillment of
the requirements for
the Degree of
MASTER OF SCIENCE
July, 1995

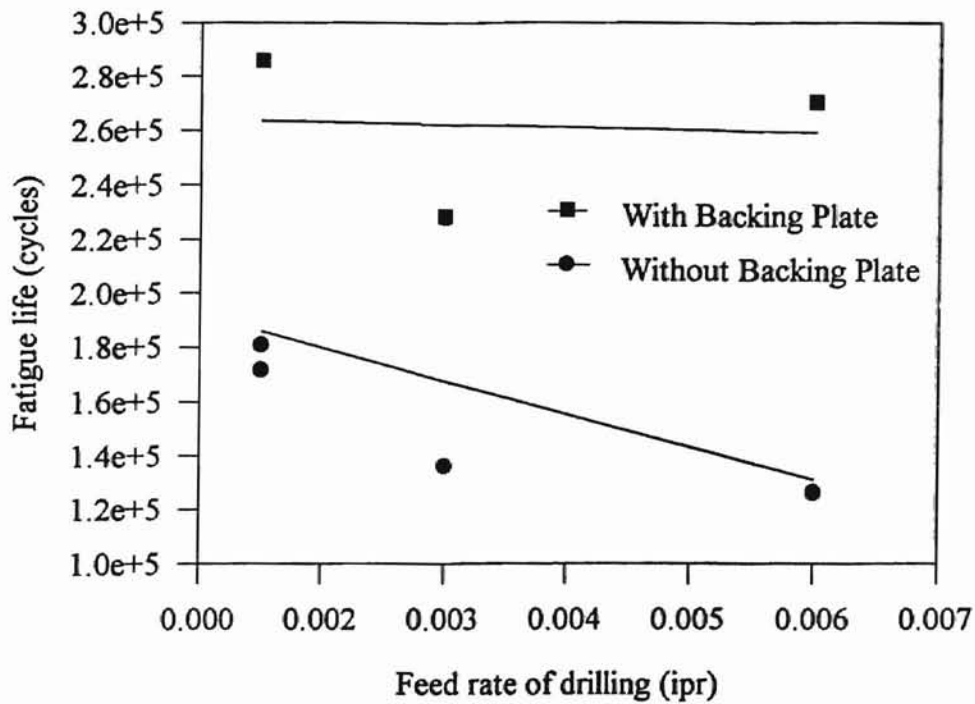
Figure 10 : Comparison between fatigue lives of specimens loaded between 3.4 KN. and 0.4 with and without a backing plate.

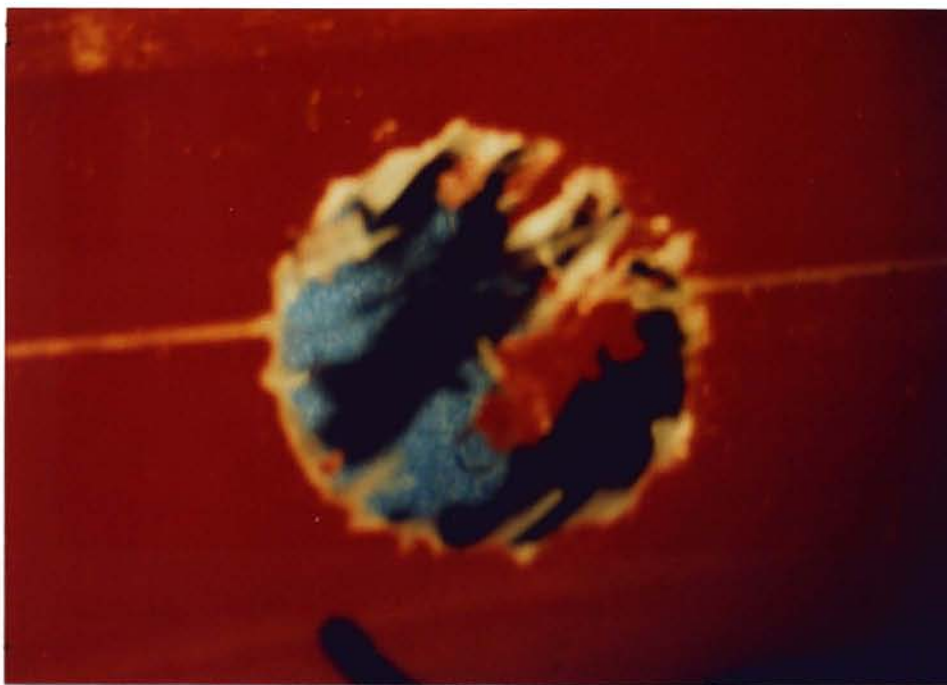
Figure 15: The exit face of a hole drilled at a feed rate of 0.0015 ipr, without a backing plate. x 8

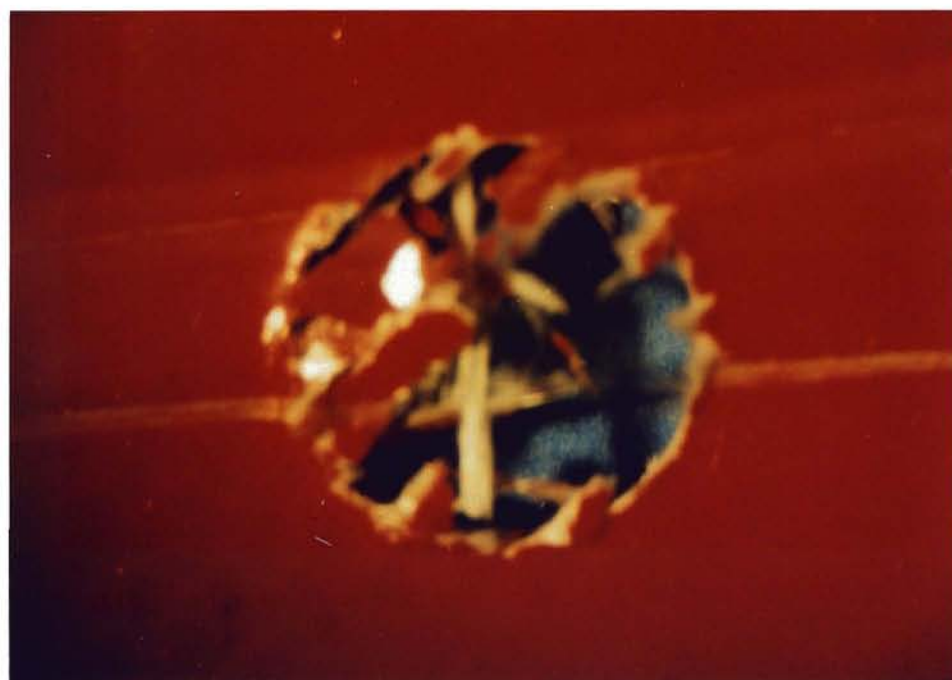
Figure 17: The exit face of a hole drilled at a feed rate of 0.006 ipr, without a backing plate. x 8

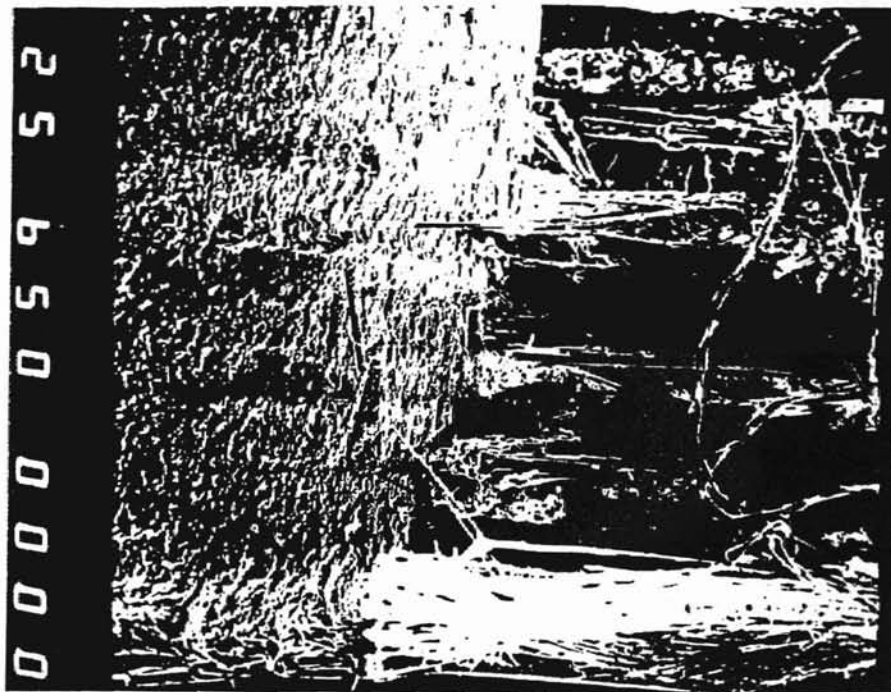
Figure 28 : Section showing the hole surface to the left and fractured surface. The hole quality is poor and the fractured surface is very uneven. This is specimen no 25, was drilled with no backing plate at 0.003 ipr and failed at 136090 cycles. x 65

The fractured and drilled surfaces were also observed under the scanning electron microscope. Figure 28 shows the fractured surface and a part of the drilled surface. It can be observed that the fractured surface is uneven and has regions that are delaminated. Also, observe the extensive damage of the top layer of the specimen. Figure 29 shows a section of the hole surface shown in Figure 28, that indicates inter laminar delamination. Crazeing can be observed on the matrix surface at the fatigue initiation zone in Figure 30. Also, note the matrix adhering to the broken fibers. Figure 31 shows the increase in irregularity in the overload zone as compared to the fatigue zone that starts from the edge of the hole(Figure 28). The top and bottom surface seen in Figure 32 and 33, show extensive damage. Note that since this specimen was drilled without a backing plate the bottom layer is damaged more than the top layer. Also, note that the bottom layers look more smeared, with the matrix layer almost not visible.

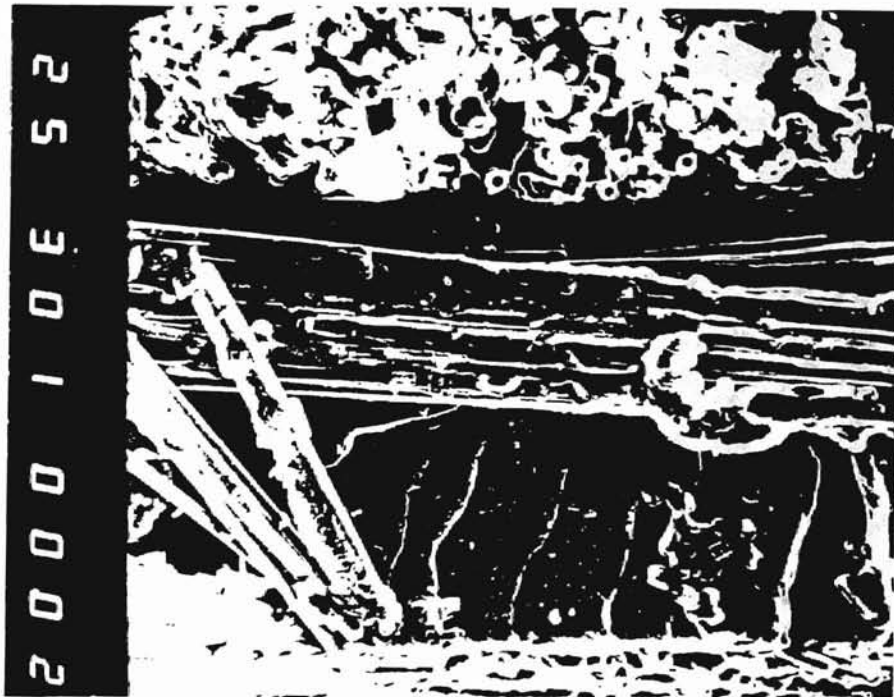
Figure 30 : Crazing of the matrix near the fatigue initiation zone for specimen no. 25. Observe too, the matrix adhering to the broken glass fibers. x 300

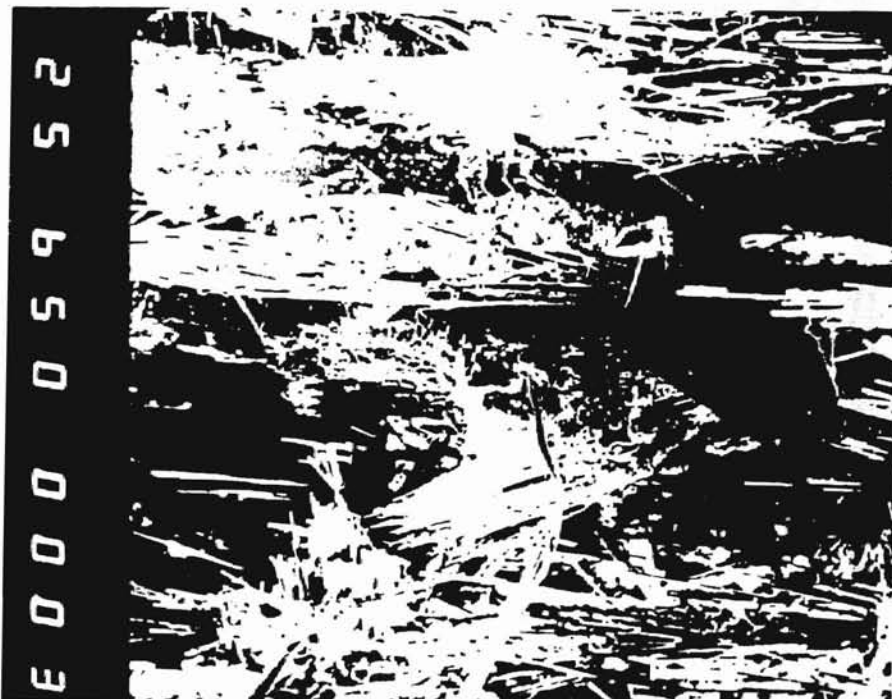
Figure 31 : The fractured area near the edge (overload zone) of the specimen no. 25. Extensive fiber pull out can be observed. x 65

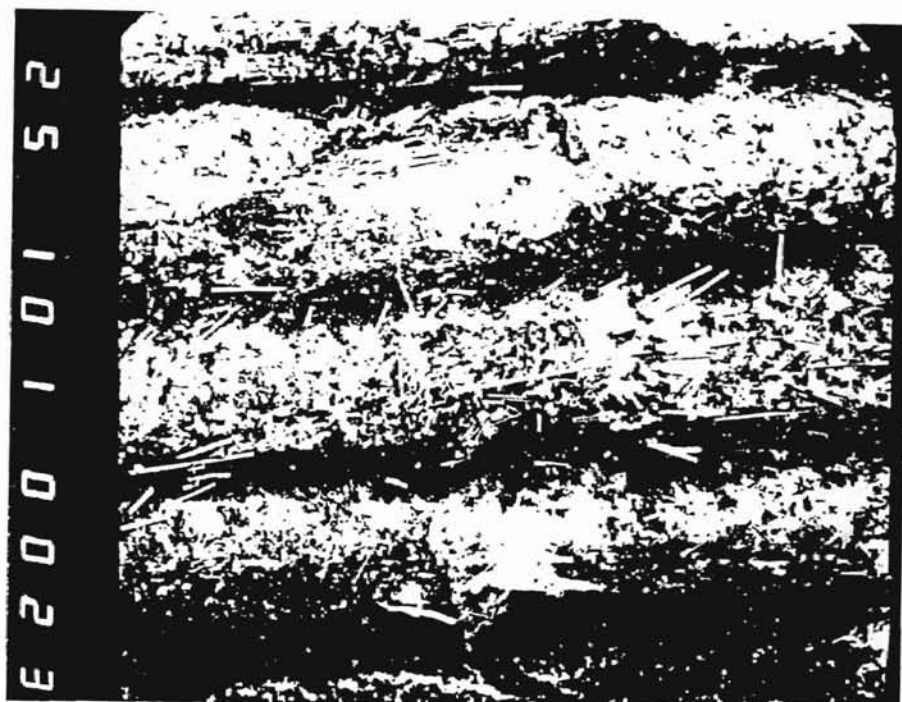
Figure 42 : Sectional view of the hole surface drilled at 0.003 ipr without a backing plate.

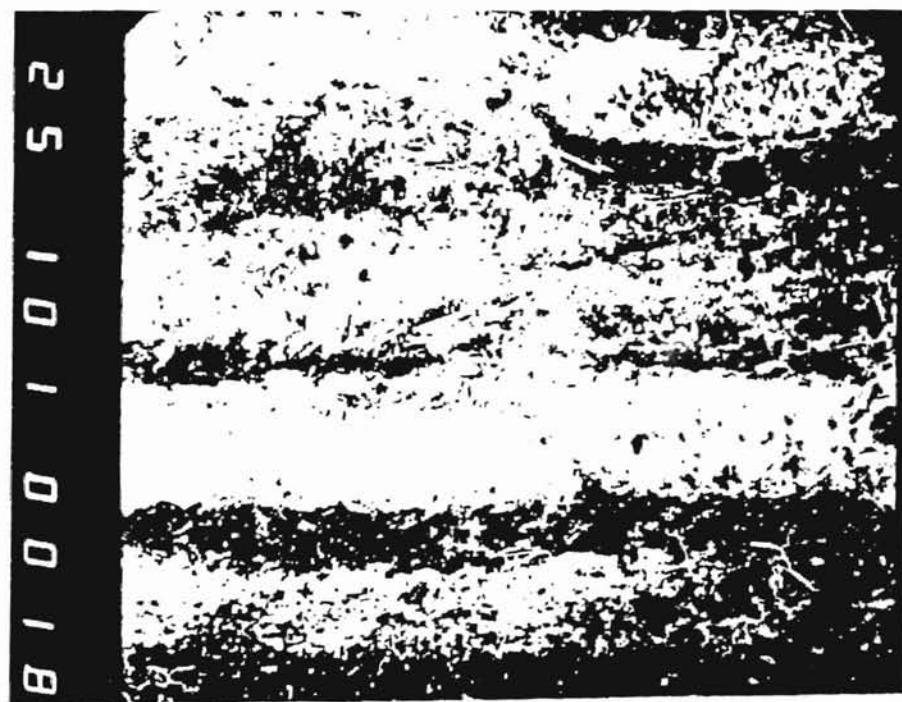
Figure 43 : Sectional view of the hole surface drilled at 0.006 ipr without a backing plate.

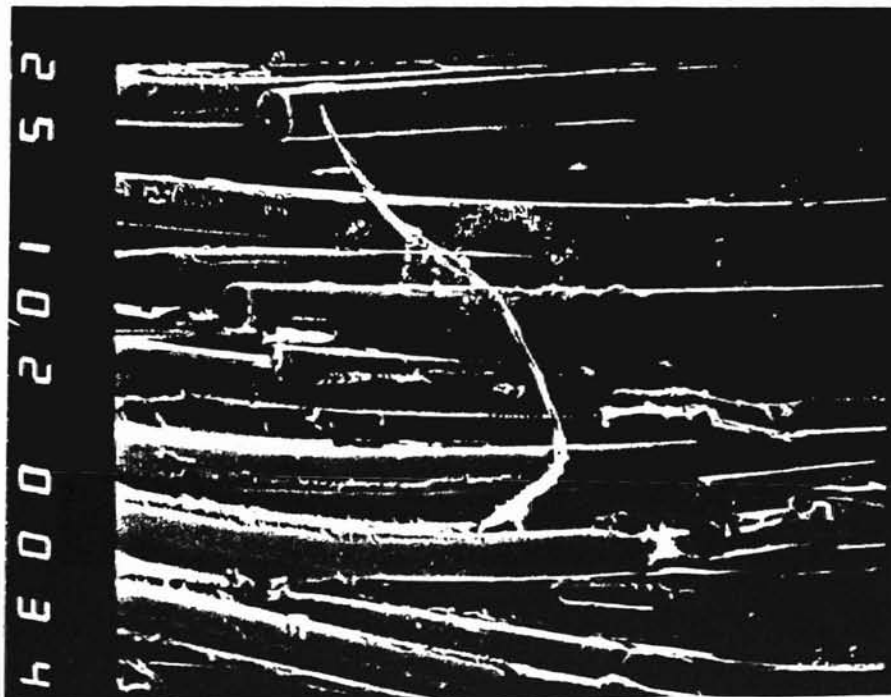
Figure 45 : Fracture surface of a tensile specimen tested at 0.1524 mm/sec. Section shown is near the edge of the specimen. x 200

The SEM was also used to observe the differences in the fractured surfaces of tensile specimens. In Figure 44 and 45 we can observe that almost all the fibers have traces of matrix on them. This indicates relatively good fiber matrix adhesion. Both the figures show almost the same amount of matrix adhering to the broken glass fibers. Although the photos show only a small portion of the fractured surface, almost all the fibers had matrix adhering to it. Hence no definite conclusion could be made regarding the variation of fiber matrix adhesion with respect to the strain rate of the tensile test.
