**THE FATIGUE STRENGTH OF STIFFENER DETAILS
FABRICATED WITH SUBSTANDARD WELDS**

**Submitted to the Faculty of the
Graduate College of the
Oklahoma State University
in partial fulfillment of
the requirements for
the Degree of
MASTER OF SCIENCE
May, 1995**

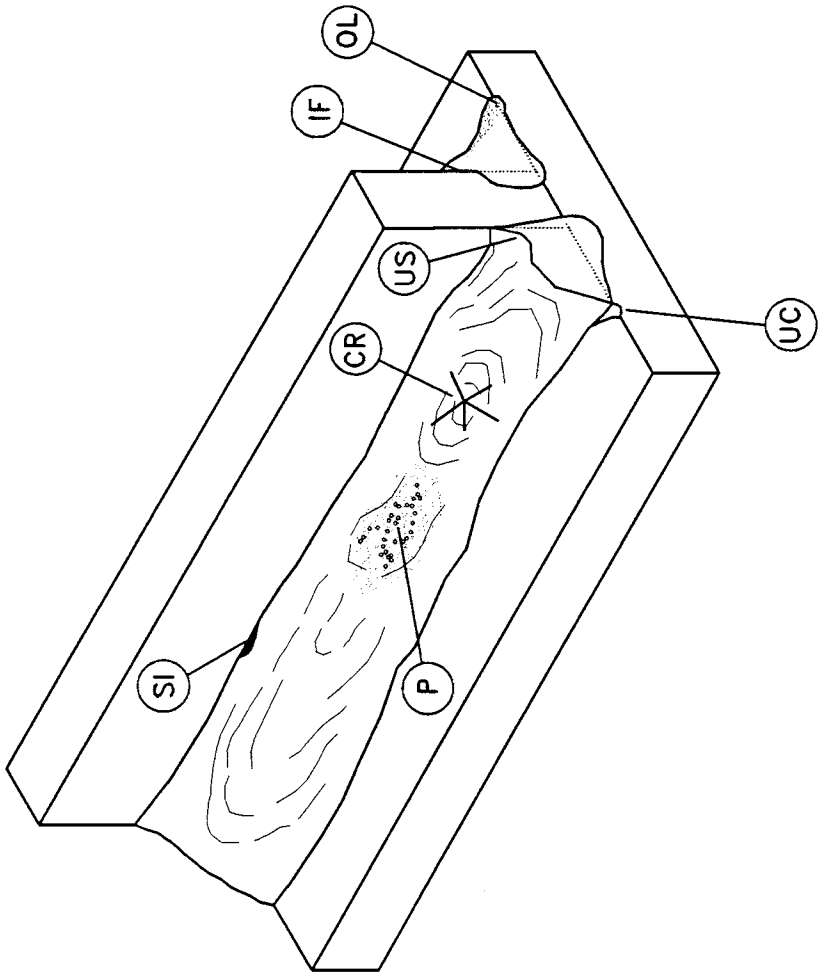
Figure 1. Fillet Weld Discontinuities in a T-Joint

Various types and sizes of weld discontinuities exist; Table 1 presents the most common. The weld discontinuities are categorized as either procedure related or metallurgical. Both categories adversely affect the weld by introducing stress concentrations. In addition, metallurgical discontinuities may affect chemical properties such as corrosion resistance. The weld discontinuities may be found in the weld metal, the base metal, or the weld heat-affected zone [2]. The T-joint shown in Figure 1 depicts the weld discontinuities listed in Table 1.

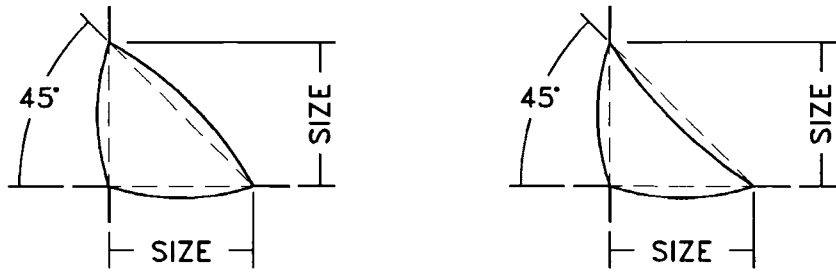
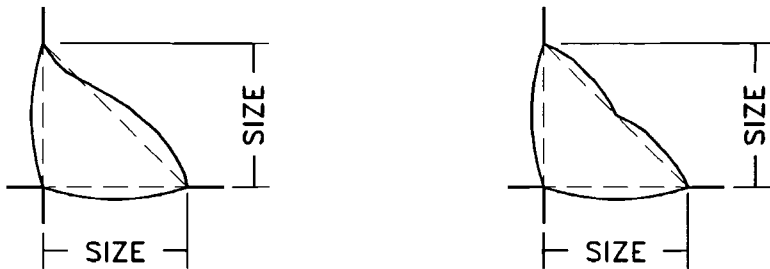
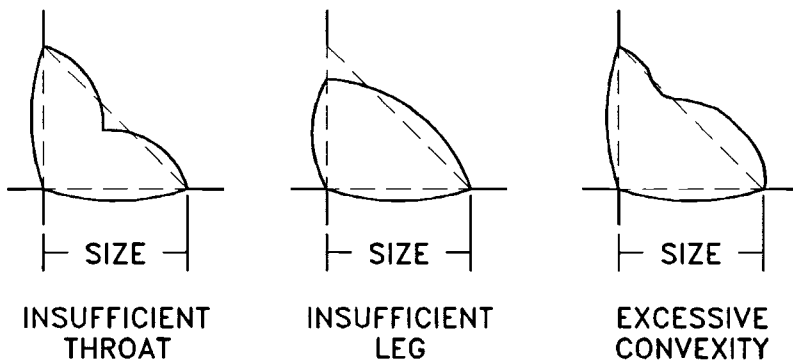
Figure 2. Fillet Weld Profiles

In addition to the discontinuities discussed, the finished profile of a weld may also adversely affect the service performance of a joint. Poor profile may cause stress concentrations as well as contribute to the formation of incomplete fusion or slag inclusions [2]. Figure 2 shows desirable, acceptable, and unacceptable fillet weld profiles.

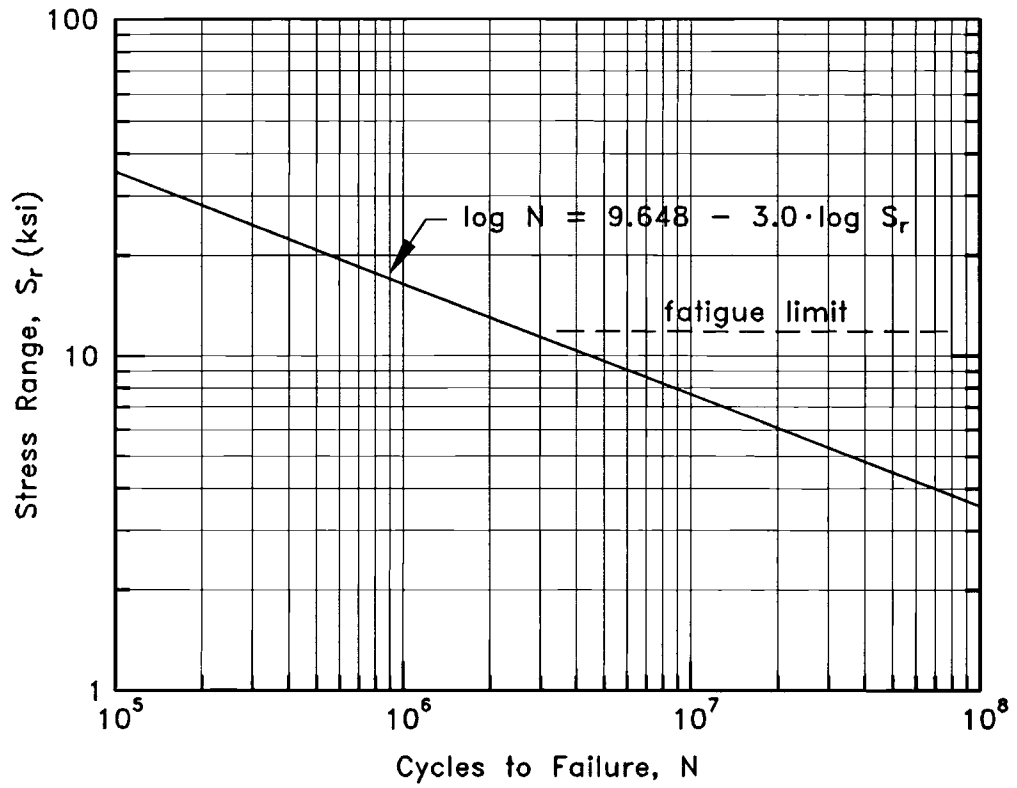
Figure 3. AASHTO Fatigue Resistance Curve for a Category C Detail

from the NCHRP fatigue study on transverse stiffeners. The curve is presented in Figure 3. As previously noted, the fabrication techniques, workmanship, and inspection procedures employed in the NCHRP fatigue study complied with the ANSI/AASHTO/ AWS D1.5 Bridge Welding Code. This document places specific limits on cracking, convexity, undercut, lack of fusion, porosity, and undersizing. Such weld discontinuities are not considered weld defects until their size and frequency exceed the specified limits. The data obtained in the NCHRP fatigue study on transverse stiffeners applies to quality welds free of defects. Consequently, the AASHTO fatigue resistance curve for a Category C detail makes no allowance for substandard welding.

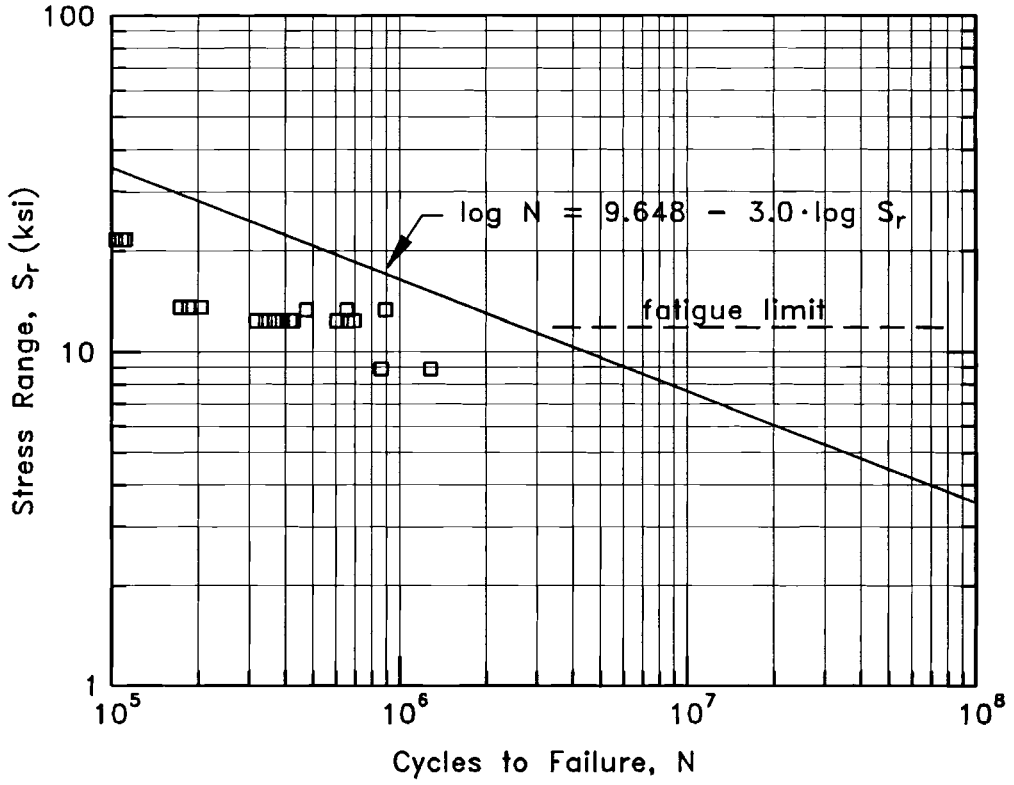
Figure 4. West German Test Data

Information available on the fatigue strength of welded stiffeners containing weld defects is limited. In tests performed on beams with fillet welded stiffeners, Gurney [10, 14] attributed three early failures to undercut at the toe of the weld. Although the undercutting was slight, its presence reduced the fatigue life of the detail to below a Category C. In a West Germany study [12, 17], fatigue tests performed on welded stiffeners consistently yielded results that were significantly below the predicted strength. The reduced fatigue strength was reportedly due to unintended weld defects, namely hydrogen-induced cold cracking and weld undercutting. All the test data obtained in the West German study fell below the fatigue resistance curve for a Category C detail. A comparison of the test data obtained in the West German study to the AASHTO Category C fatigue resistance curve is shown in Figure 4.

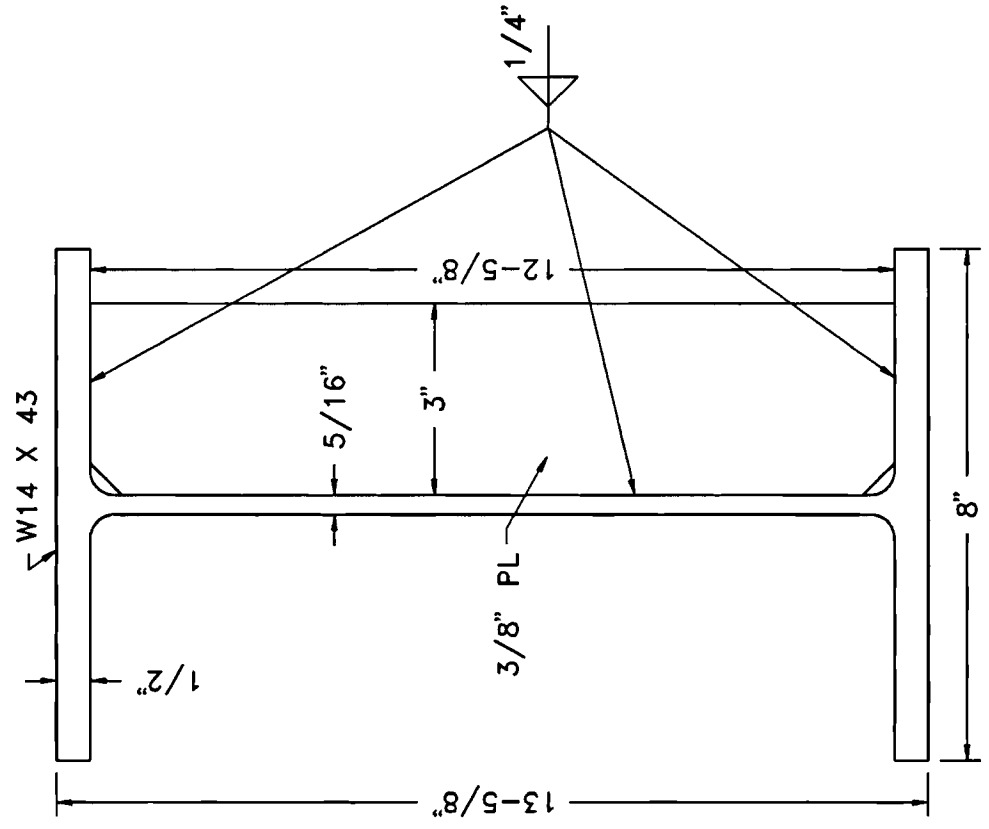
Figure 7. Cross Section of a Typical Test Specimen

fabrication shop. The fabricator was sent the plans and specifications for a typical test specimen. Taking a 20 foot length of a W14 X 43 rolled steel beam, the fabricator attached the one-sided transverse stiffeners by welding to the web and both flanges. The fabricator attached the stiffeners with 1/4 inch fillet welds using the flux cored arc welding (FCAW) process. Because the test data obtained from the control specimen would be compared to the test data obtained from previous tests on stiffener details fabricated with quality welds, it was important for the control specimen to be fabricated with quality welds. Hence, the fabricator was instructed to use normal fabrication techniques, workmanship, and inspection procedure conforming to the requirements of the ANSI/AASHTO/ AWS D1.5 Bridge Welding Code. A typical welded joint made on the control specimen is shown in Figure 8.

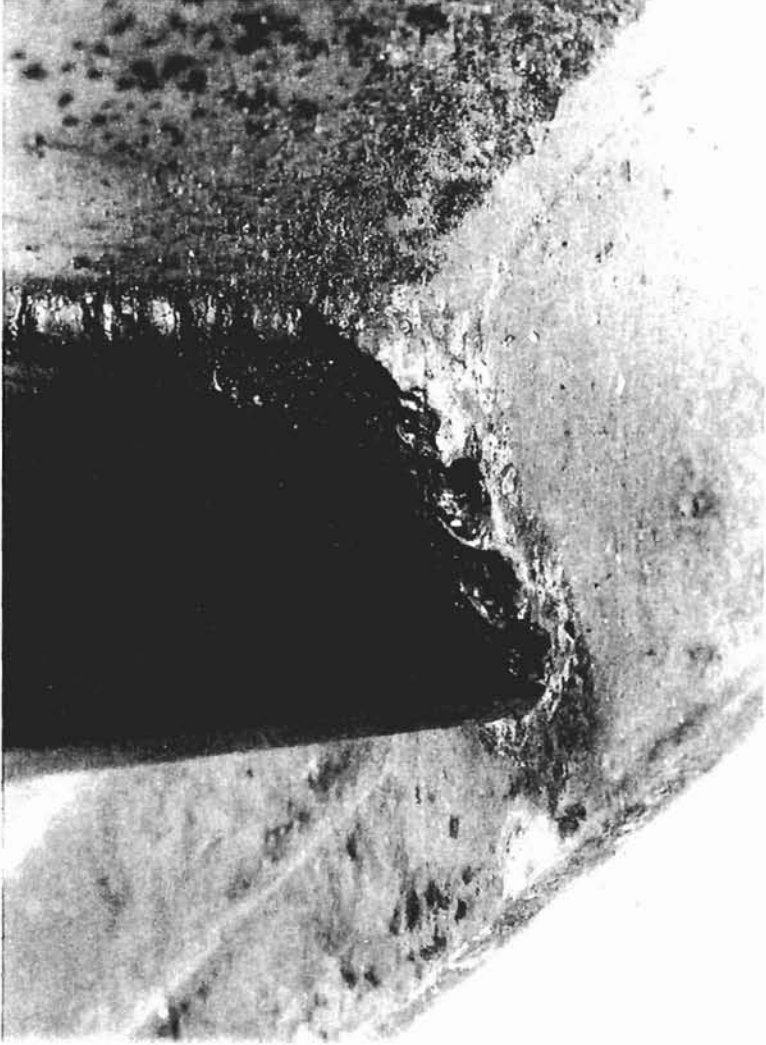
Figure 10. A Typical Welded Joint with Substandard Welds

welds. The failure to preheat also encouraged welds with poor quality. Furthermore, the laboratory technician responsible for welding the details was instructed to produce poor quality welds by moving the electrode in and out at several locations. Manipulating the electrode in this manner was intended to simulate the movement that would occur while welding to a bridge with traffic present. The combination of the poor welding techniques employed resulted in welds with excessive discontinuities. A typical welded joint made on one of the test specimens fabricated in the laboratory is shown in Figure 10.

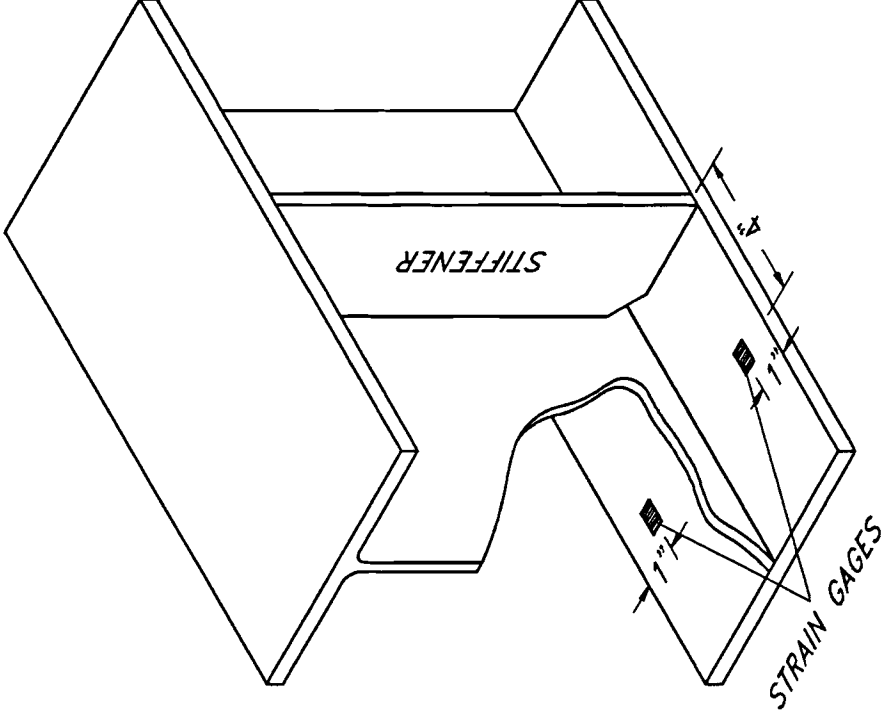
Figure 12. Strain Gage Configuration

Before testing, the three specimens were fitted with strain gages so that actual stress ranges could be determined. Both 350 ohm and 120 ohm strain gages were used. Strain gages were placed along the inside of the tension flange of each beam. More specifically, the strain gages were placed approximately 4 inches away from the stiffener details and approximately 1 inch from the edges of the tension flange. The strain gages were placed on each side of the tension flange. The diagram in Figure 12 shows the strain gage configuration at a stiffener detail.

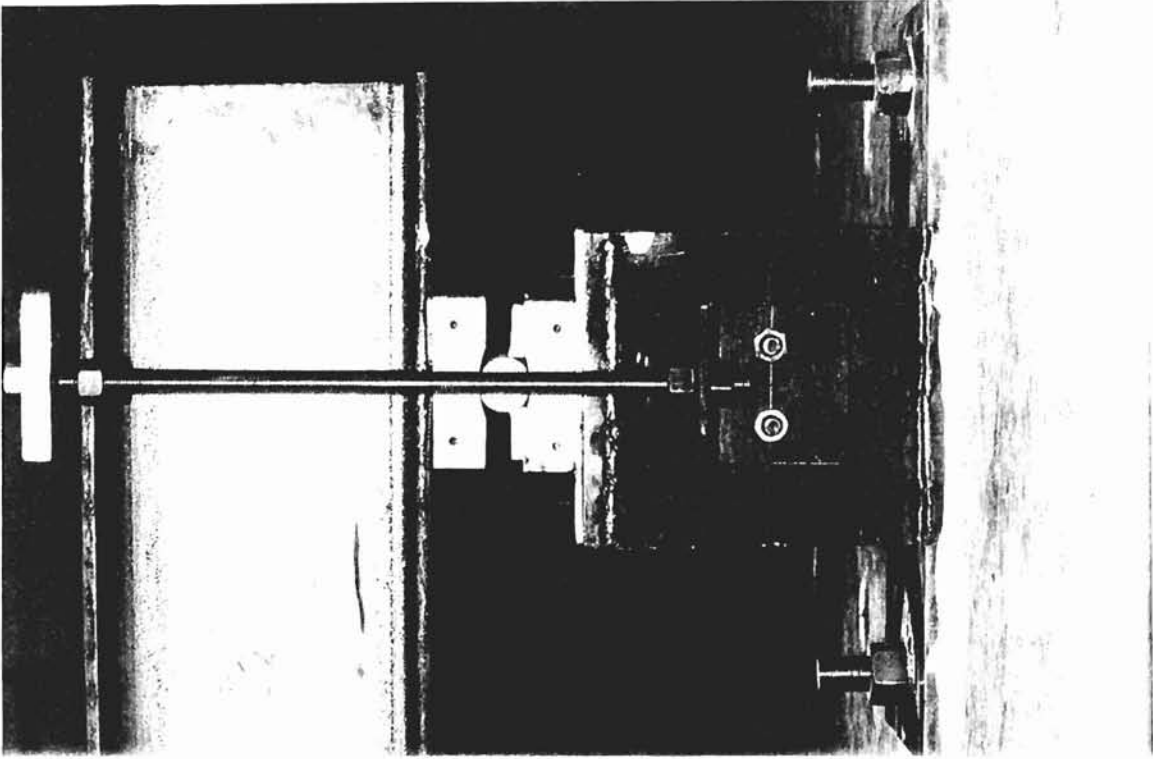
Figure 13. Simple Support

All specimens were tested on simple supports. The rotational freedom of the simple supports was provided by a cylindrical roller trapped between two thick plates. The plates were rounded to accommodate the cylindrical roller. The rounded plates and the cylindrical roller were thoroughly coated with grease to reduce friction. To prevent unwanted movement of the test specimen, threaded fasteners held the test specimen firmly against the simple supports. Figure 13 shows a side view of the simple supports. All specimens were tested on an 18 foot span with two-point loading where the distance between the load points was 5 feet. The load configuration is shown in Figure 14. At the load points, rotational freedom was allowed by a rotational mechanism similar to that used on the simple supports. Loads were applied by a hydraulic actuator and were distributed to the two locations on the test specimens through a spreader beam. The servo-controlled hydraulic actuator operated between 0.6 and 2.7 cycles of load application per second with a maximum capacity of 50 kips. The servos were commanded by an electronic control unit near the test site, and the

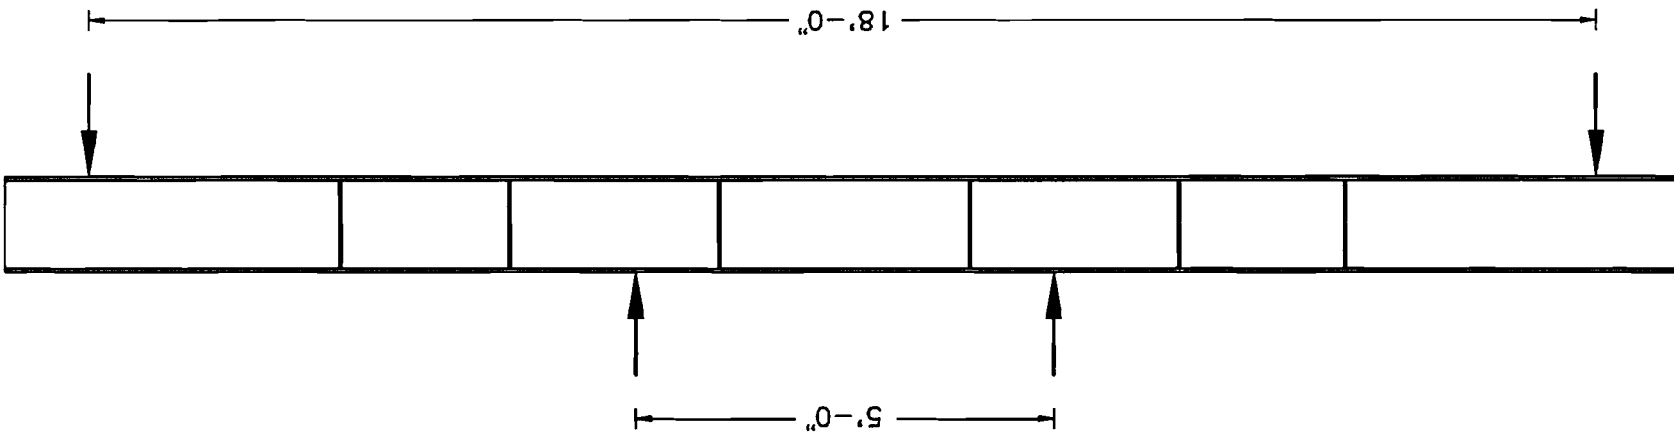
Figure 14. Load Configuration on Test Specimen

actuator was activated by a hydraulic pump located beyond the test site. The hydraulic actuator was supported above by a steel test frame. The test frame and the simple supports were securely fastened to a reinforced concrete reaction floor. For safety, side rollers attached to the columns of the test frame were positioned against the web of the spreader beam to prevent possible bucking. The test setup is shown in Figure 15. All components of the test setup such as the test frame, the simple supports, and the spreader beam were designed to withstand the numerous load cycles required to fatigue test the three specimens.

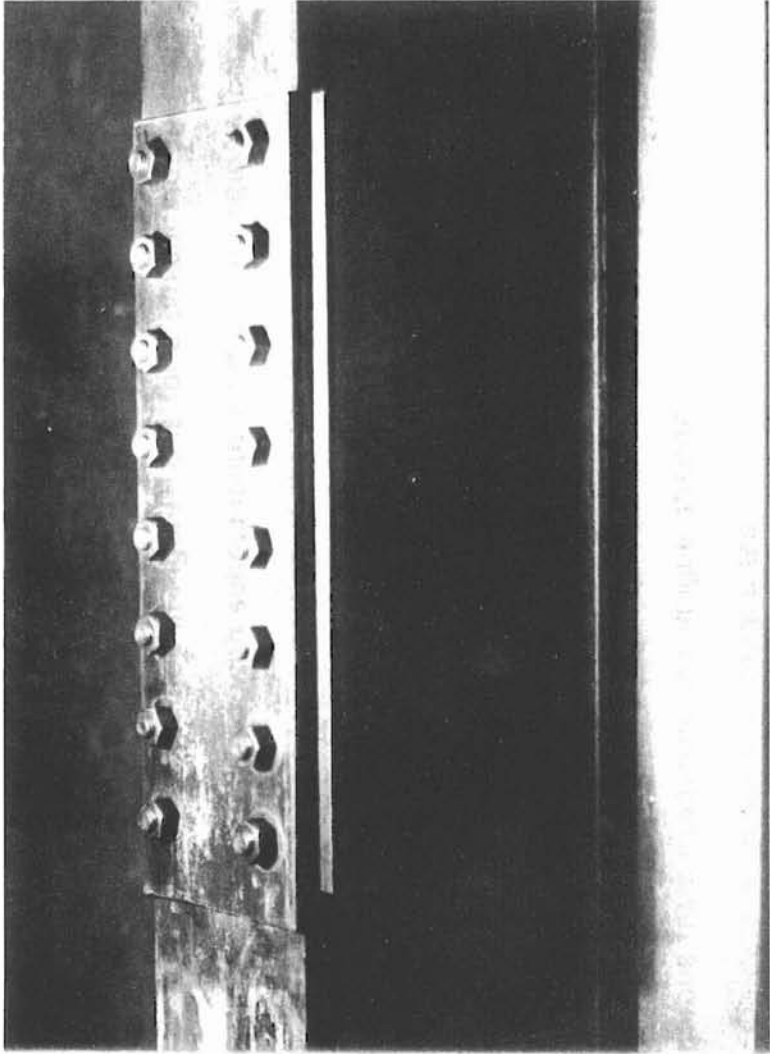
Figure 16. Splice Plate Detail

repairs were accomplished by splicing across the cracked region. Splice plates with a thickness of 3/8-in. were bolted above and below the tension flange with 3/4-in. diameter A325 bolts. The bolts were accommodated by drilling holes through the tension flange and splice plates. Because of the nature of the fatigue loading, the splice plate details were designed as slip-critical connections requiring several bolts on each side of a crack. A typical splice plate detail is shown in Figure 16.

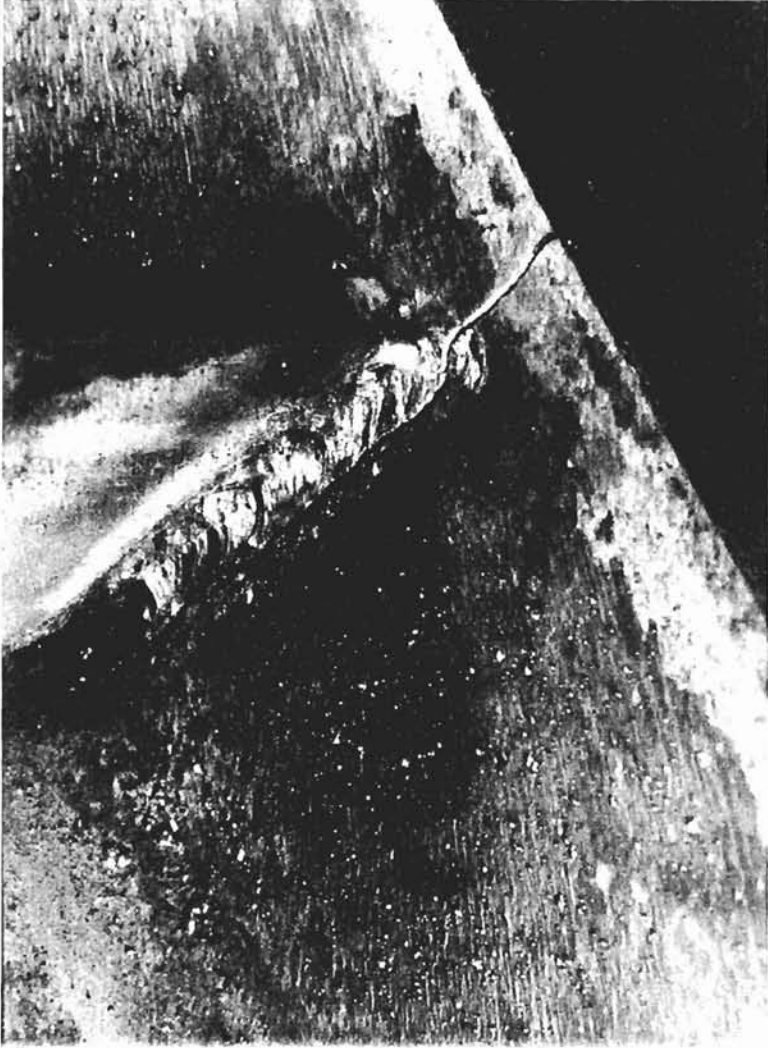
Figure 17. A Typical Crack at a Stiffener Detail

All failures occurring in the fatigue tests were the result of a crack initiating and growing adjacent to the fillet weld joining the stiffener to the tension flange. A typical failure is shown in Figure 17. Beams reached the end of their fatigue life when the crack had destroyed most of the tension flange and deflections had become large. Some of the cracks propagated up into the web of the test specimens. A typical crack starting from a surface discontinuity at the toe of the fillet weld is shown in Figure 18. The cross-sectional view presented in Figure 18 is for a typical stiffener detail on a test specimen fabricated with substandard welds. The region where slow growth prevailed over a large portion of the life is apparent from the smooth fracture appearance [10].

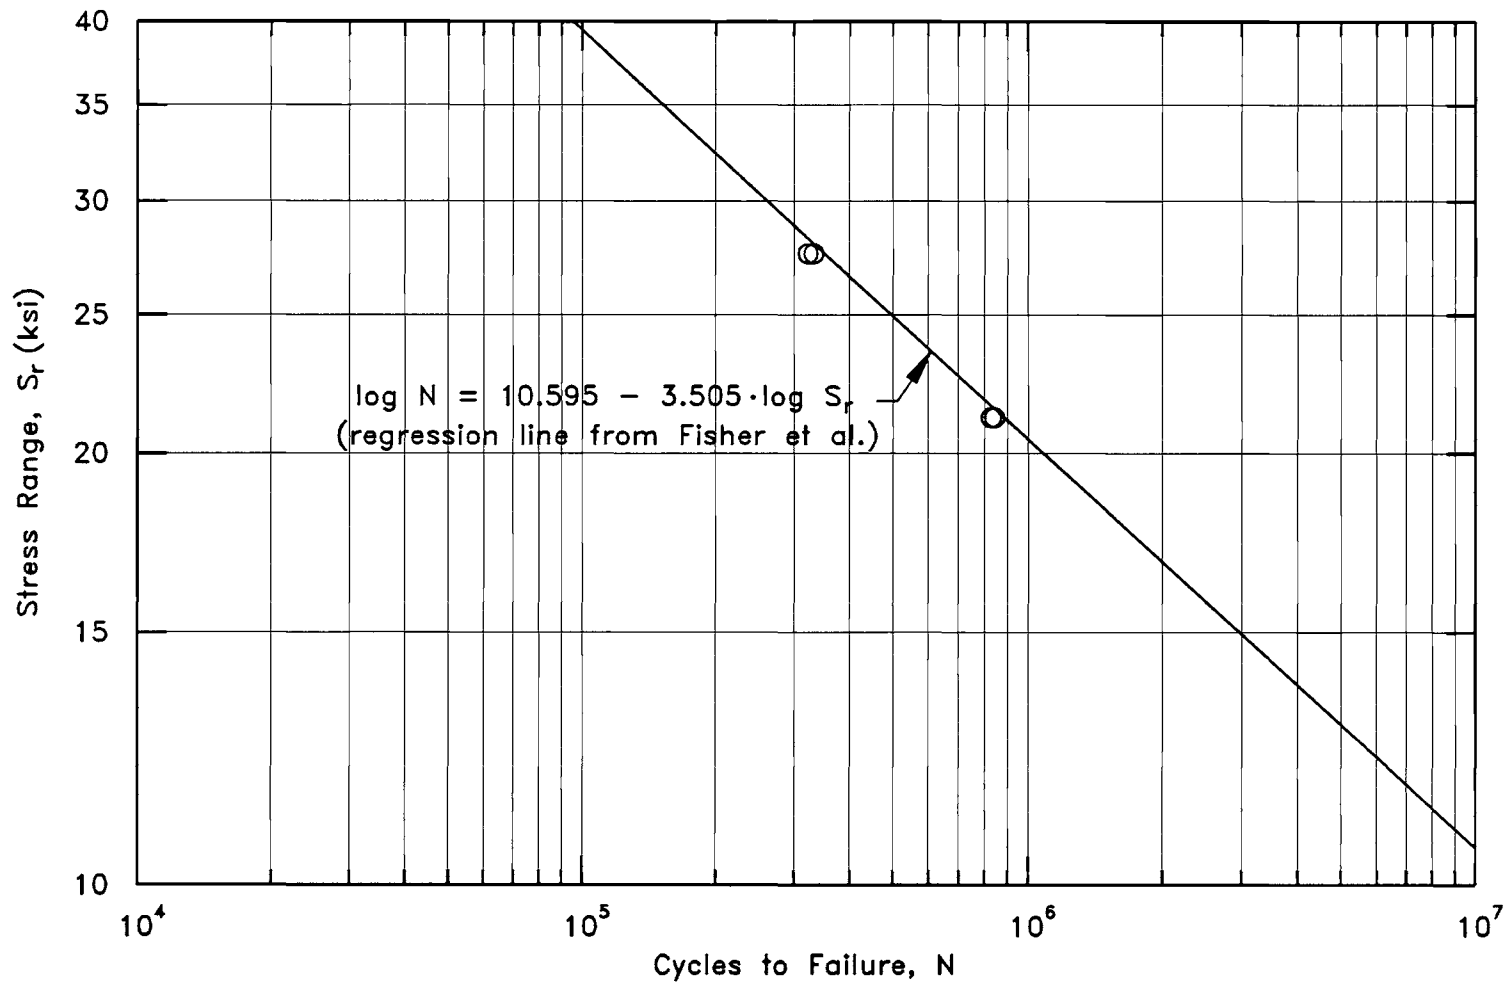
Figure 19. Comparison of the Control Specimen Test Data and the Fatigue Curve Generated by Fisher et al.

The load cycles to failure and the stress range data obtained from each test specimen are shown in Table 4. The results for the control specimen are in close agreement with those presented by Fisher et al. [10]. Recalling from an earlier discussion, data were accumulated by Fisher et al. in numerous tests examining the fatigue strength of stiffener details. In Figure 19, the data obtained from fatigue testing the control specimen is compared to the curve generated from a linear regression analysis of Fisher's data. The close agreement between the results for the control specimen and Fisher's results indicates the reliability of the test setup and the test procedures followed in this study.

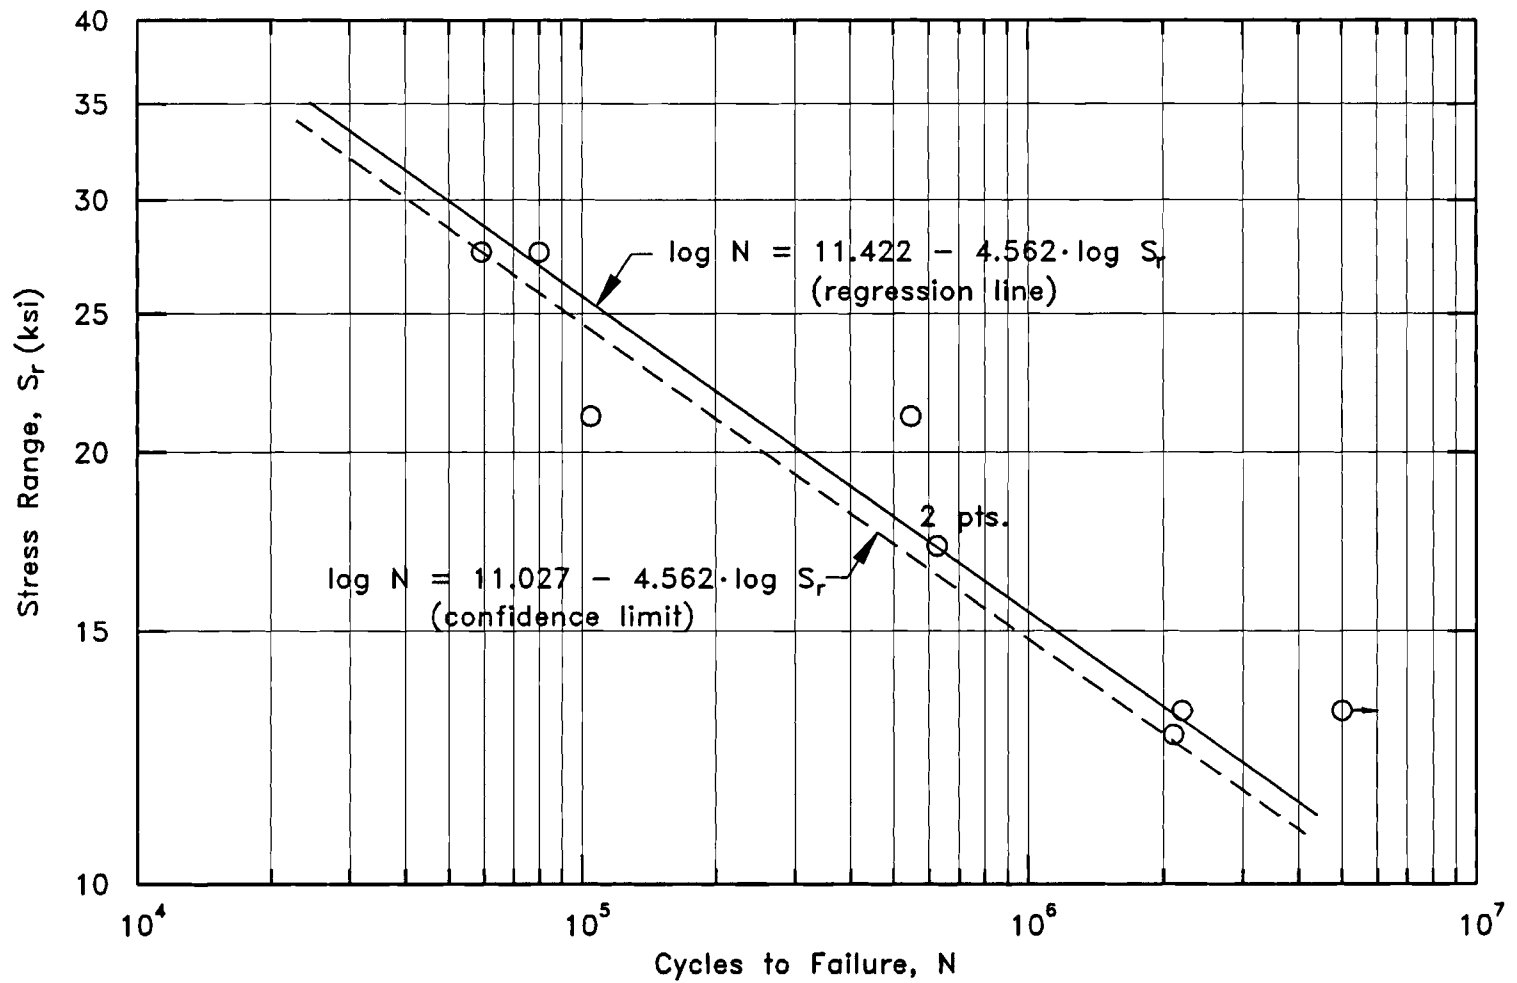
Figure 20. Plot of the Test Data for the Stiffener Details with Substandard Welds

The results obtained from fatigue testing the stiffener details fabricated with poor quality welds are presented in Figure 20. Included in Figure 20 are the data points, the curve generated from a linear regression analysis of the data, and the lower bound curve derived from the approximate 95 percent confidence limit for the data. The fatigue limit for the stiffener

details with substandard welds was not clearly defined; however, one stiffener detail sustained over 4.9 million load cycles at a stress range of 13.2 ksi without failure or visible crack growth. Fatigue testing of the specimen containing this stiffener detail was stopped as a result of fatigue cracks occurring elsewhere along the span.

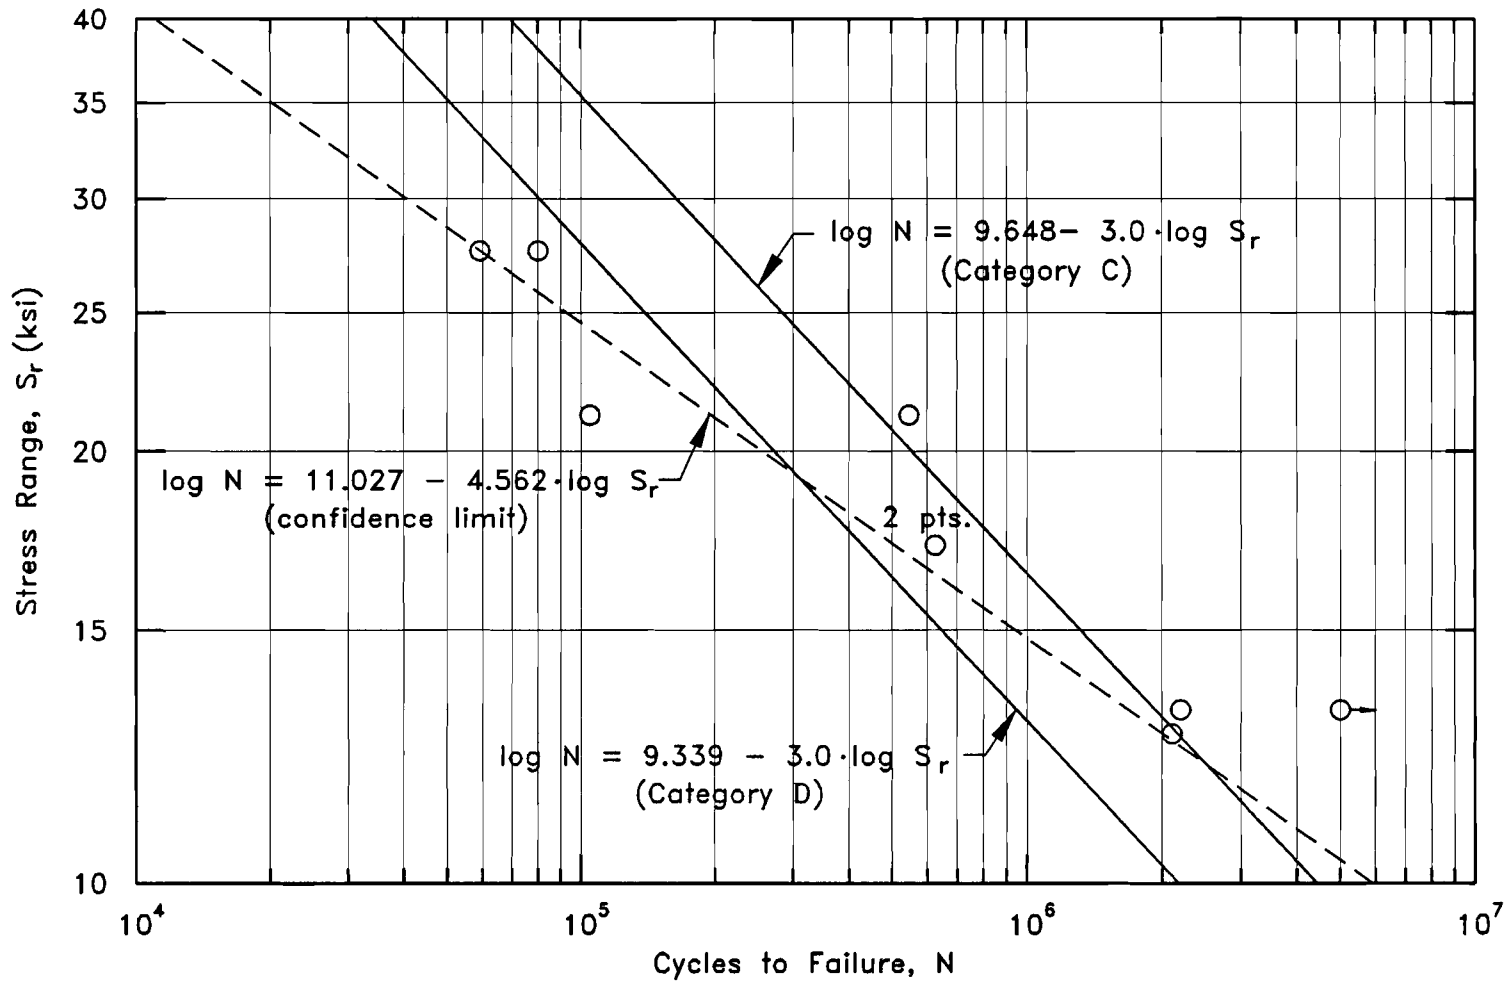
Figure 21. Comparison of the Test Data to AASHTO Fatigue Curves for Category C and D Details

In Figure 21, the data for the stiffener details having poor weld quality are plotted along with the AASHTO fatigue curves for Category C and D details. Also shown in Figure 21 is the lower bound fatigue curve derived from the approximate 95 percent confidence limit for the test data. Most of the test data for the stiffener details having poor weld quality fall below the fatigue curve for an AASHTO Category C detail. In further comparison, the slope of the fatigue curve for the stiffener details with poor weld quality is 4.562 whereas the slope of the fatigue curve for an AASHTO Category C detail is 3.0. The lower bound fatigue curve derived from the approximate 95 percent confidence limit for the test data intersects the fatigue curve for an AASHTO Category C detail at approximately 12.0 ksi. Thus, the fatigue strength of stiffener details fabricated with substandard welds is lower than the fatigue strength of AASHTO Category C details at stress ranges greater than 12.0 ksi. Recalling that the lowest stress range examined in the fatigue tests was 12.7 ksi indicates further testing at lower stress ranges may be needed.
