MACHINING EFFECTS ON TENSILE AND FATIGUE  
BEHAVIOR IN A  $[(\pm 45/0/90/0)_2 / \overline{0}]_s$  GRAPHITE  
EPOXY LAMINATE

Submitted to the Faculty of the  
Graduate College of the  
Oklahoma State University  
in partial fulfillment of  
the requirements for  
the Degree of  
MASTER OF SCIENCE  
December, 1995

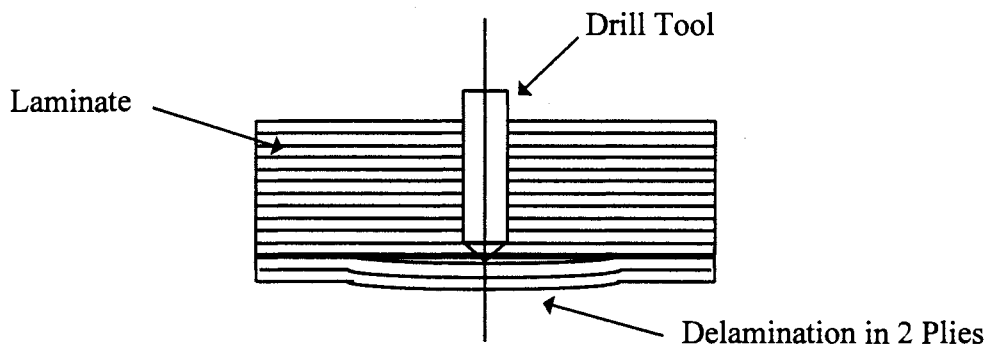
Figure 1: A schematic depiction of delamination in laminate composites.

Although not shown in Fig. 1, similar but less severe delamination also occurs at drill entry due to drill tool pullout. When subjected to compressive, shear or cyclic loads, delamination can be a limiting factor [4].

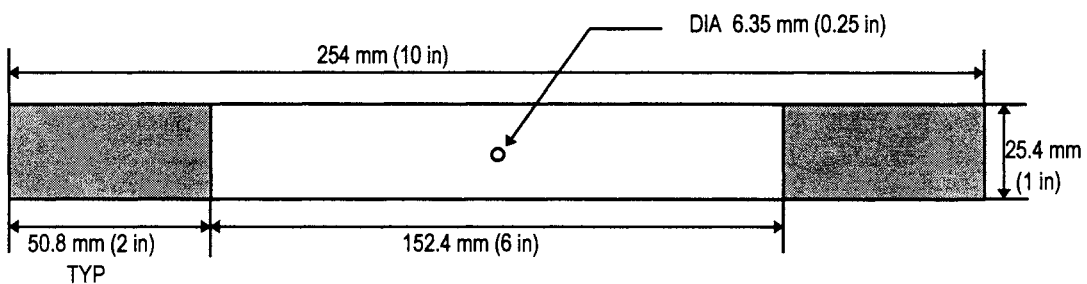
Figure 3: Dimensions of tensile and fatigue specimens. (Scale 1 mm = 1/2 mm)

The dimensions and geometry are in accordance with ASTM 3039/D 3039M-93.

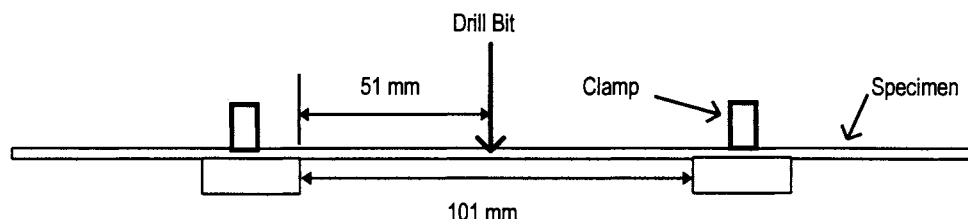
Figure 5: Drilling fixture. (Scale 1 mm = 2 mm)

The drill speed was maintained at 2000 rpm for all holes and no coolant was used. At this speed, no coolant was needed since epoxy melting did not occur [29]. During drilling, a fixture was used to hold each specimen (see Fig. 5).

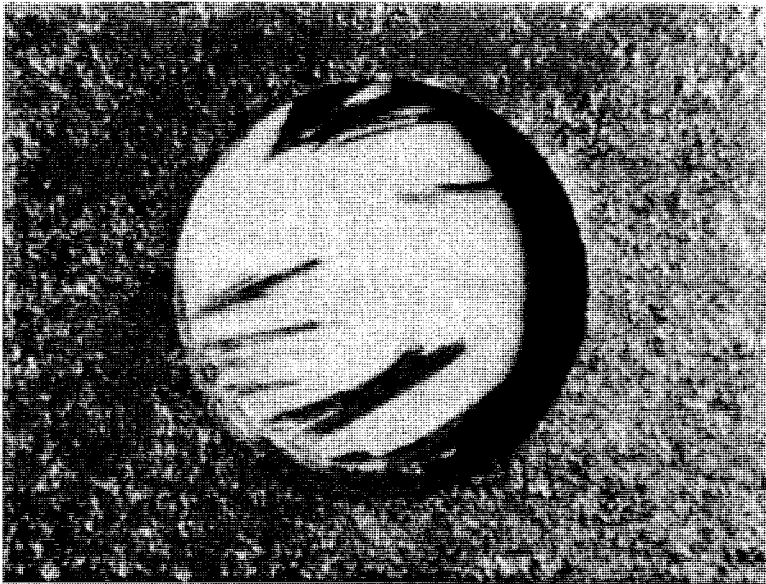
Figure 6: Entry face of H1-A-1 drilled at .0178 m/min feed with HSS bit. Note that the major damage seen is from the exit face. {X 8.5}

Machining was documented by taking Polaroid pictures through the zoom microscope. The first group of 10 pictures (Figs. 6 ~ 15) shows the resulting damage from using a HSS bit at the five feed rates. As stated earlier, no backing plate was used for any of the holes. The results of using a carbide bit are shown in Figs. 16 to 21. The HSS bits were examined under the zoom microscope and some minor pitting was recorded (see Figs. 22 and 23).

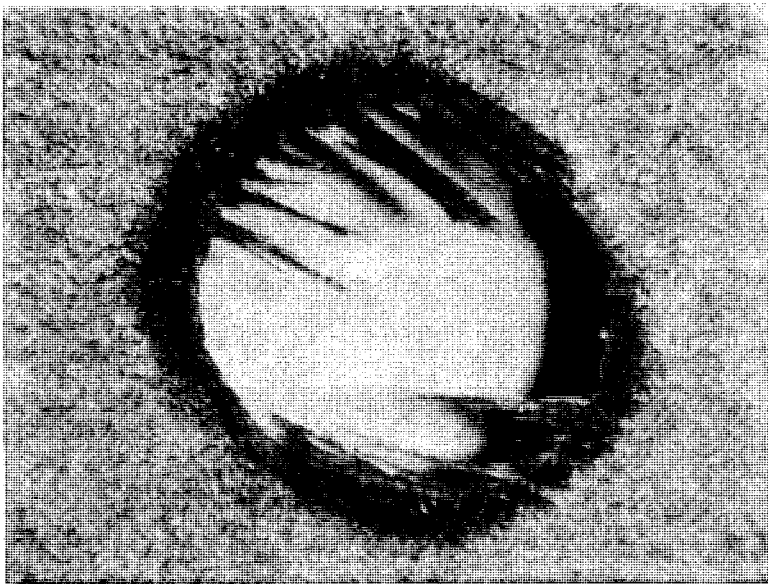
Figure 7: Exit face of H1-A-1 drilled at .0178 m/min feed with HSS bit. {X 8.5}

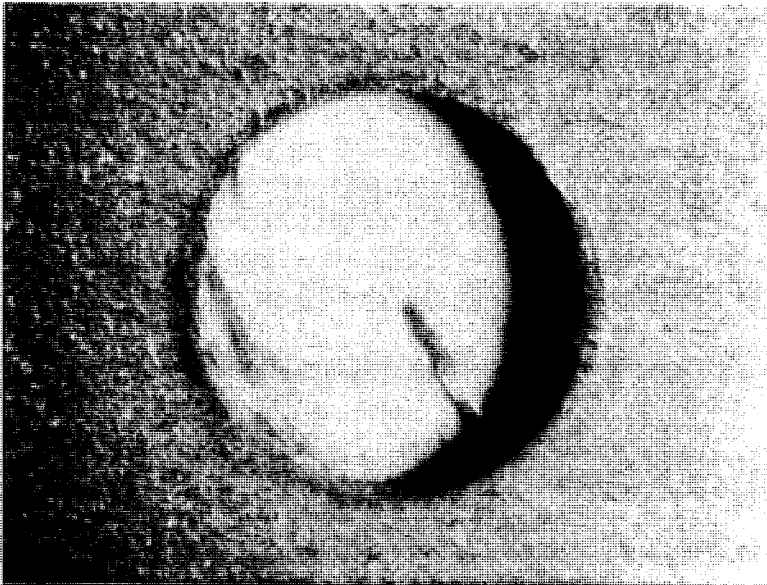
Figure 8: Entry face of H2-B-6 drilled at .0508 m/min feed with HSS bit. Note that major damage seen is from the exit face. {X 8.5}

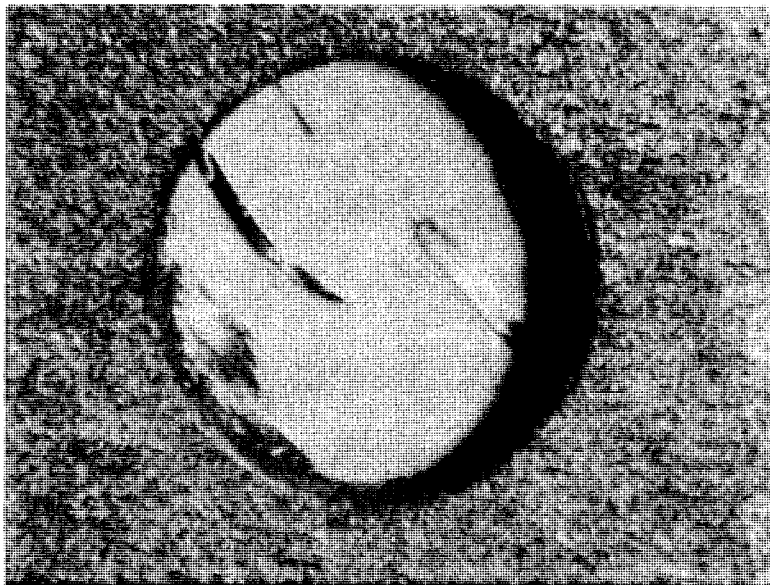
Figure 10: Entry face of H3-C-9 drilled at .153 m/min feed with HSS bit. Note that major damage seen is from the exit face. {X 8.5}

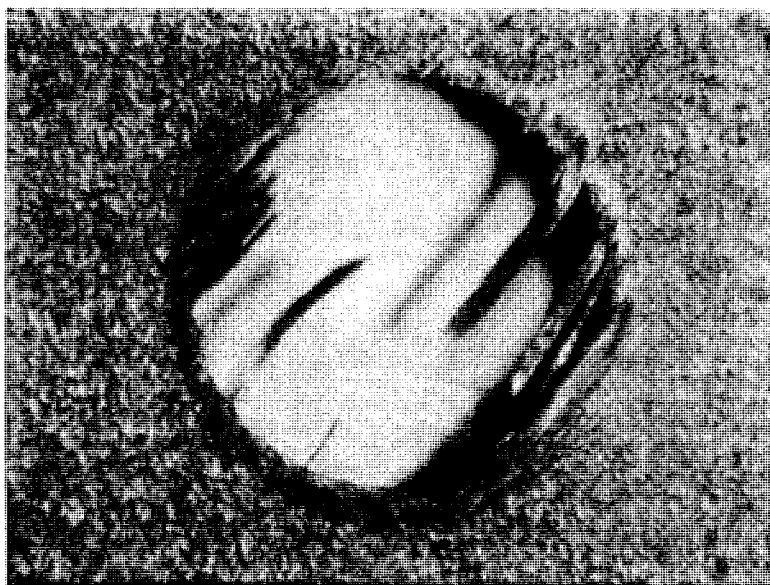
Figure 11: Exit face of H3-C-9 drilled at .153 m/min feed with HSS bit. {X 8.5}

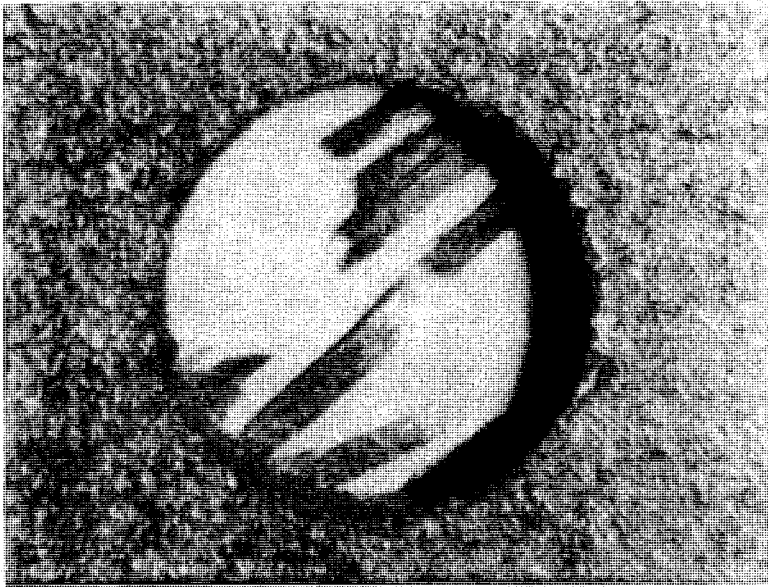
Figure 12: Entry face of H4-D-13 drilled at .457 m/min feed with HSS bit. Note that major damage seen is from the exit face. {X 8.5}

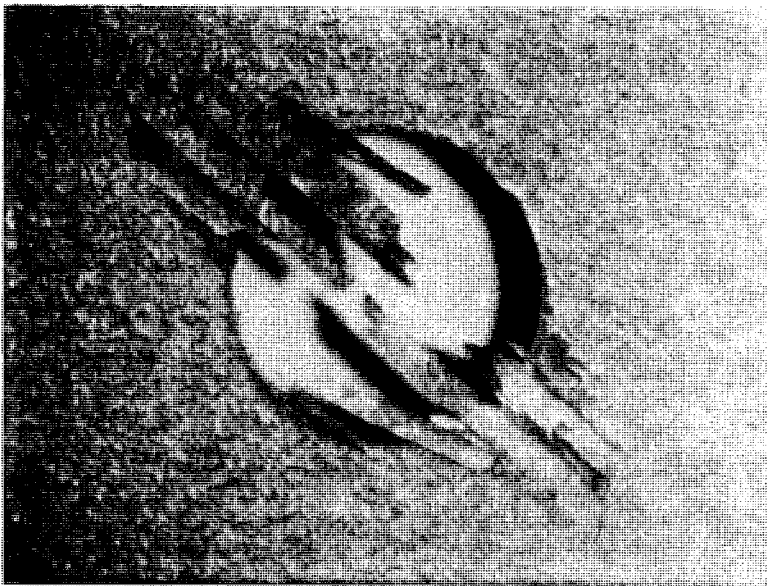
Figure 13: Exit face of H4-D-13 drilled at .457 m/min feed with HSS bit. {X 6.5}

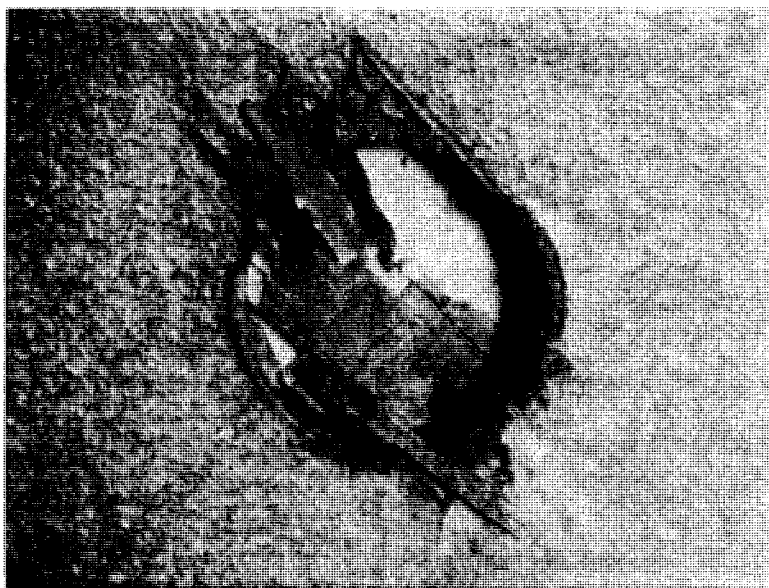
Figure 14: Entry face of H5-E-18 drilled at 1.37 m/min feed with HSS bit. {X 6.5}

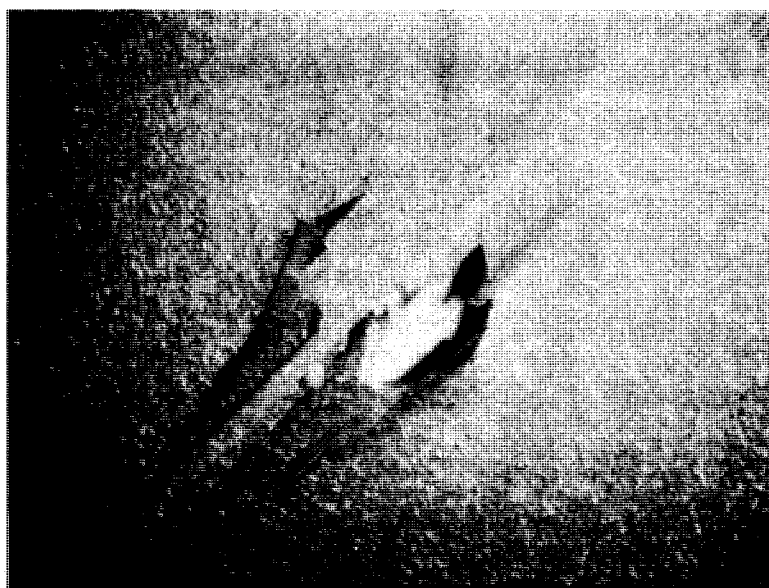
Figure 15: Exit face of H5-E-18 drilled at 1.37 m/min feed with HSS bit. {X 4}

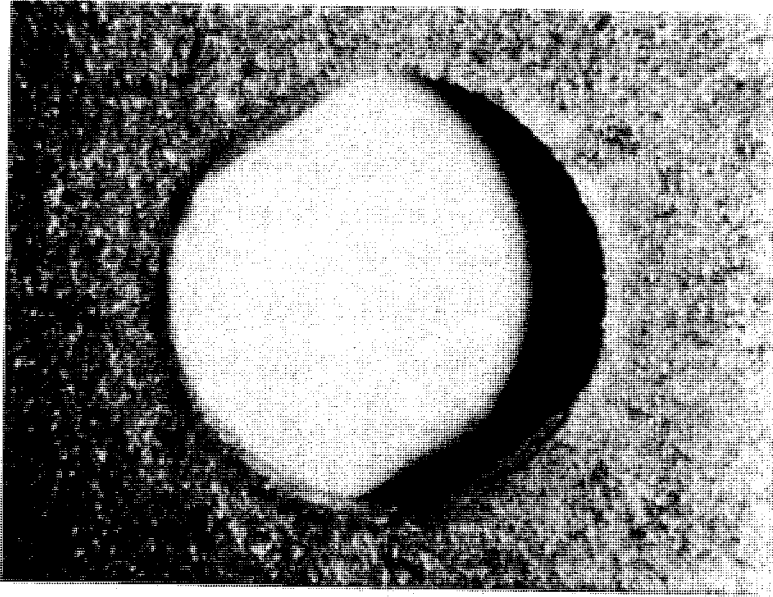
Figure 16: Exit face of C1-A-19 drilled at .0178 m/min feed with carbide bit. {X 9}

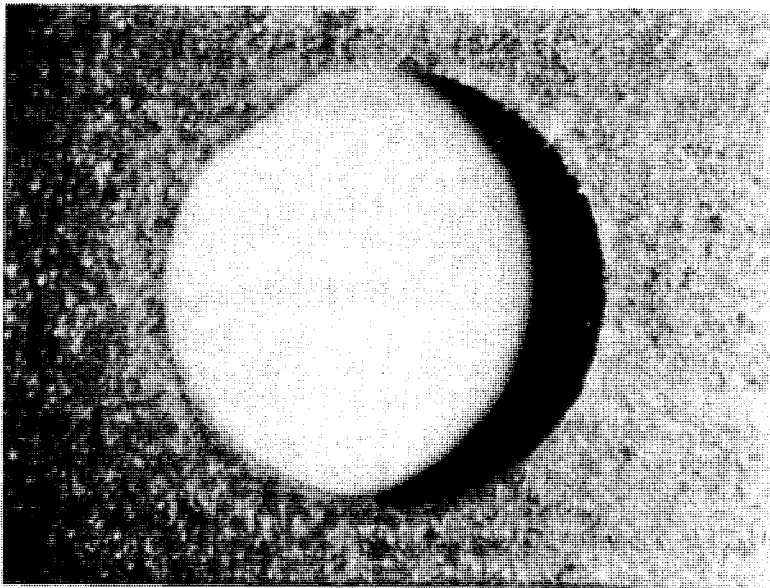
Figure 17: Exit face of C1-B-20 drilled at .0508 m/min feed with carbide bit. {X 9}

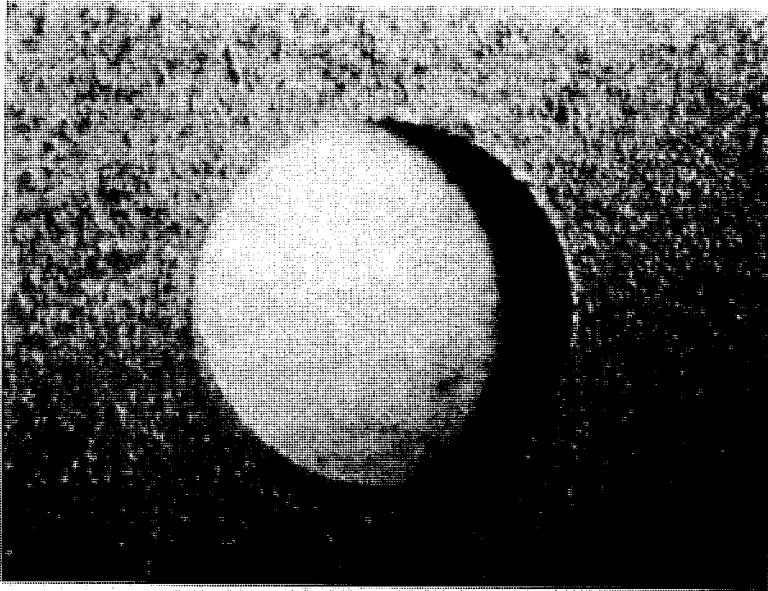
Figure 18: Exit face of C1-C-21 drilled at .153 m/min feed with carbide bit. {X 8}

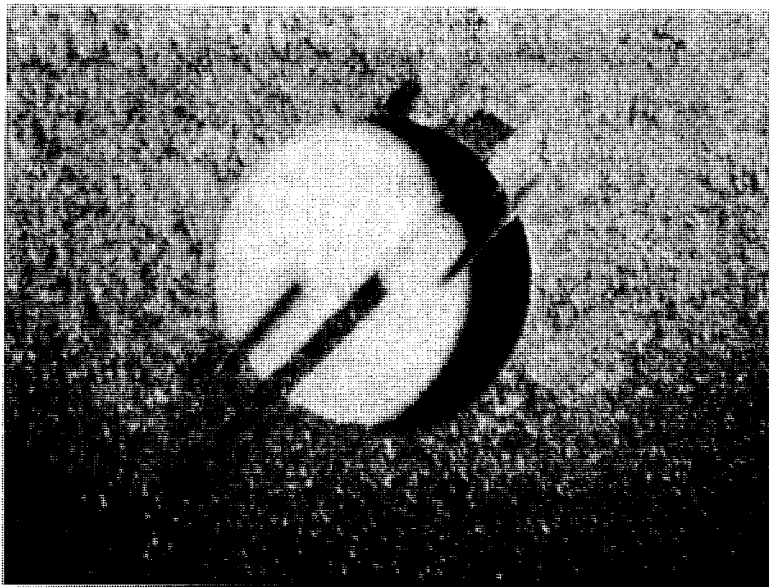
Figure 19: Exit face of C1-D-22 drilled at .457 m/min feed with carbide bit. {X 6.5}

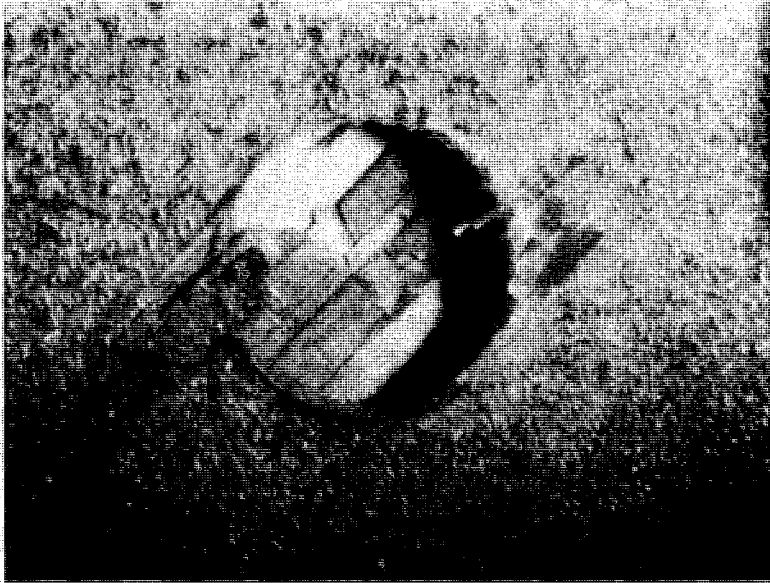
Figure 20: Entry face of C1-E-23 drilled at 1.37 m/min feed with carbide bit. {X 6}

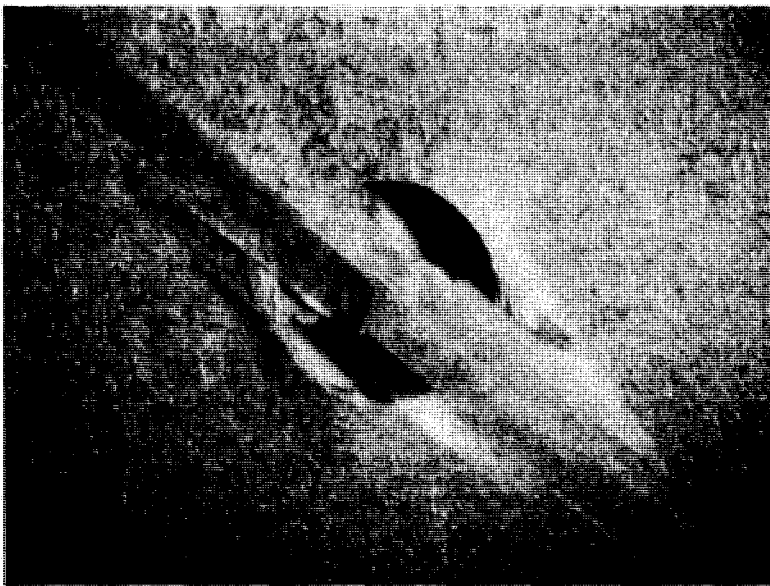
Figure 21: Exit face of C1-E-23 drilled at 1.37 m/min feed with carbide bit. {X 4.5}

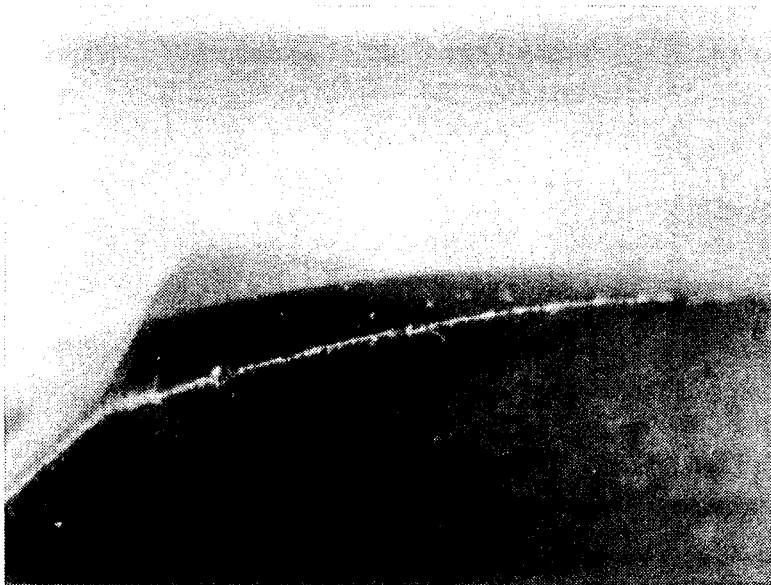
Figure 23: Edge view of cutting edge on used HSS bit. Note minor pitting when compared with Fig. 22. {X 25}

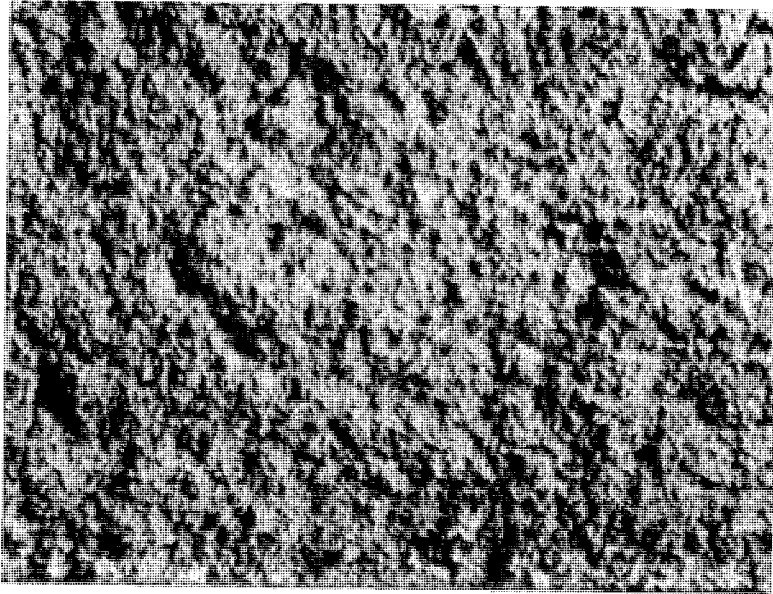
Figure 24: Lowest feed (.0178 m/min) chips which are a fine powder. {X 10}

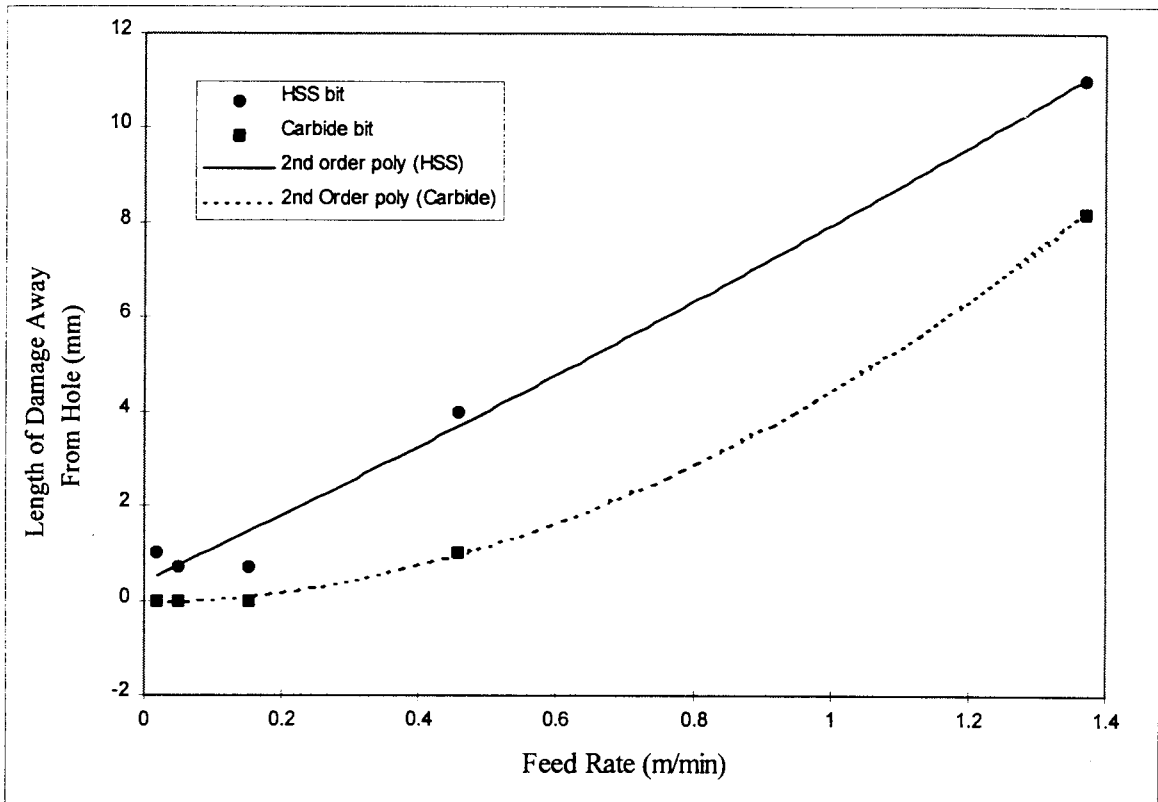
Figure 26: Damage comparison between HSS and carbide bits based upon the length of damage away from hole.

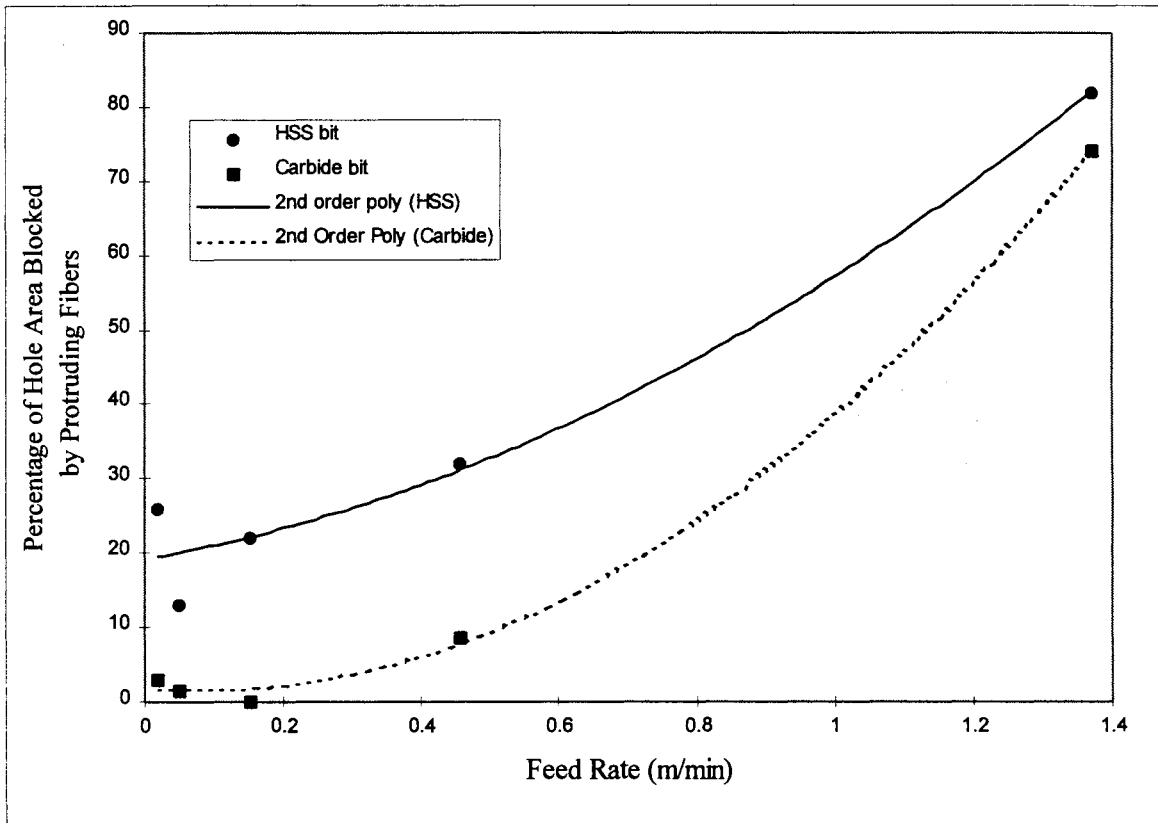
Figure 27: Damage comparison between HSS and carbide bits based upon percentage of hole area blocked by protruding fibers.

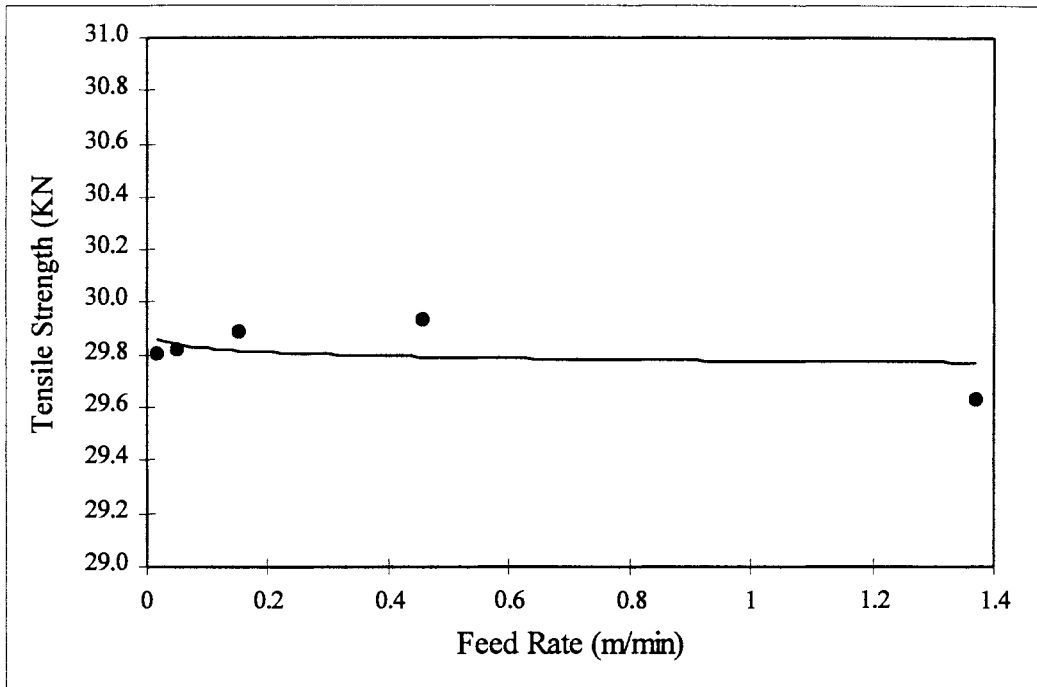
Figure 28: Effect of feed rate on tensile strength. All tensile tests performed at .051 mm/s head rate.

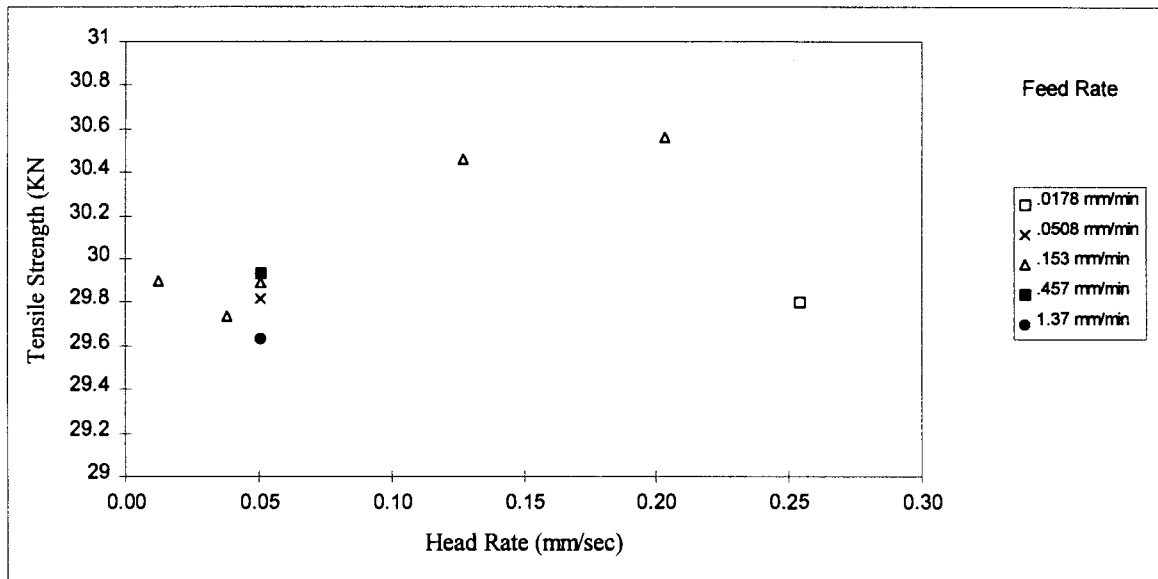
Figure 29: Tensile test results at various head rates and feed rates.

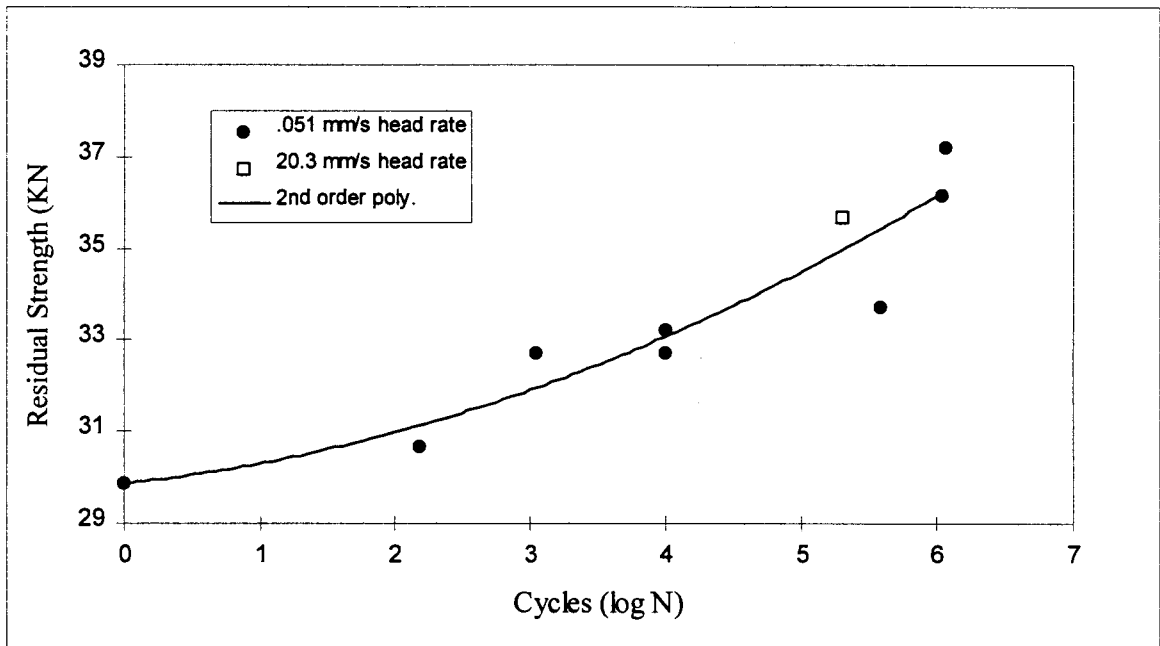
Figure 30: Residual strength testing at a constant feed rate of .153 m/min and a constant head rate of .051 mm/s which corresponds to a strain rate of  $3.33 \times 10^{-4}$  mm/mm/s.

Each of the points from Fig. 30 were used to determine the percent increase in residual strength. Fig. 31 is a graphic portrayal of the increase in residual strength.

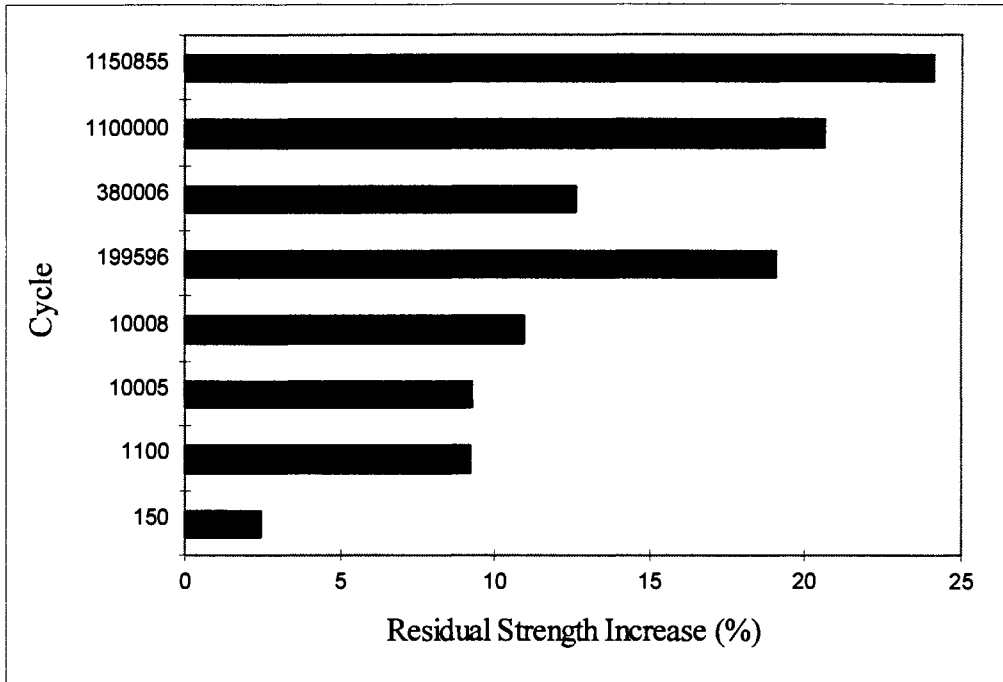
Figure 31: Percent increase in residual strength.

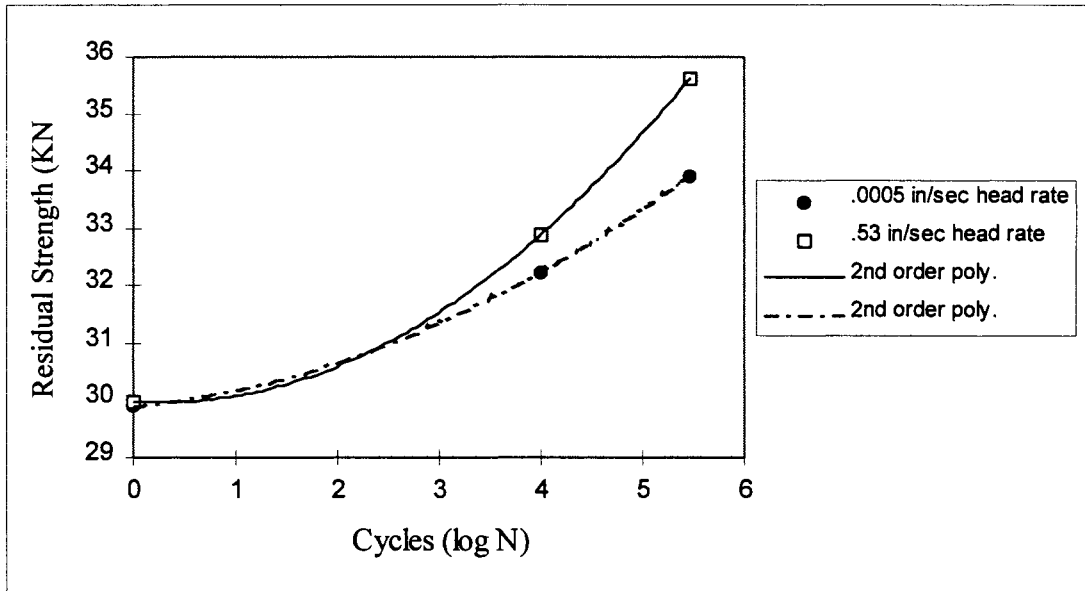
Figure 32: Effect of head rate on residual strength.

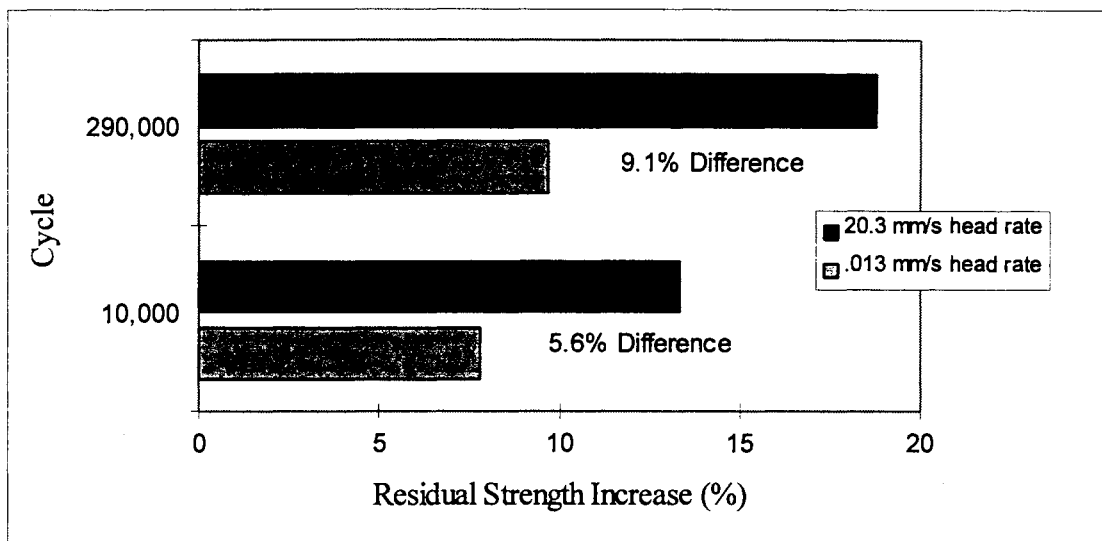
Figure 33: Comparison of residual strength increase at different head rates.

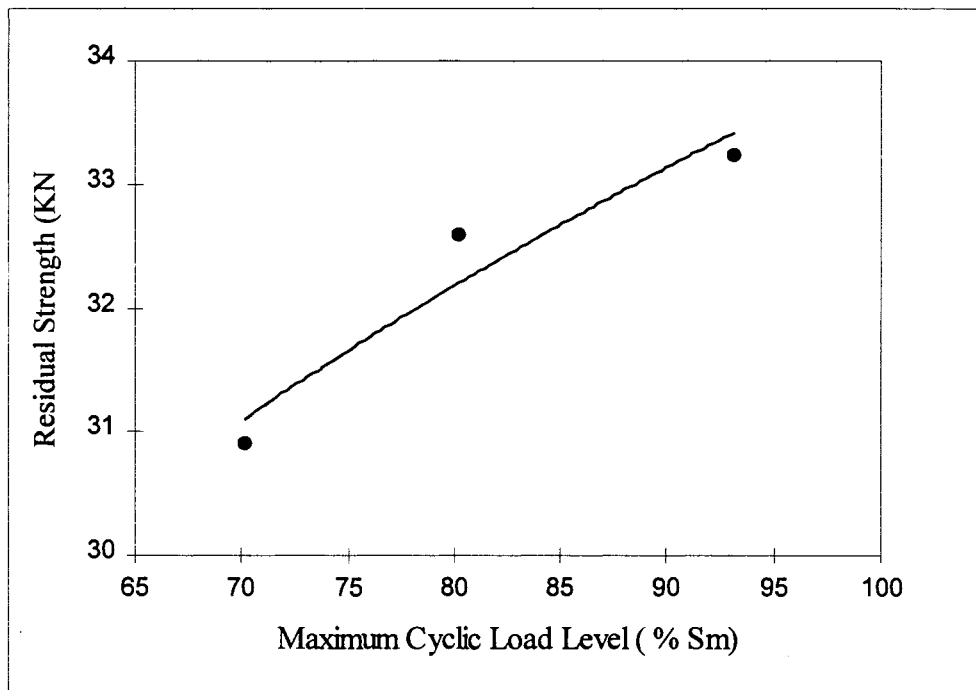
Figure 34: Effect of cyclic load level on residual strength.

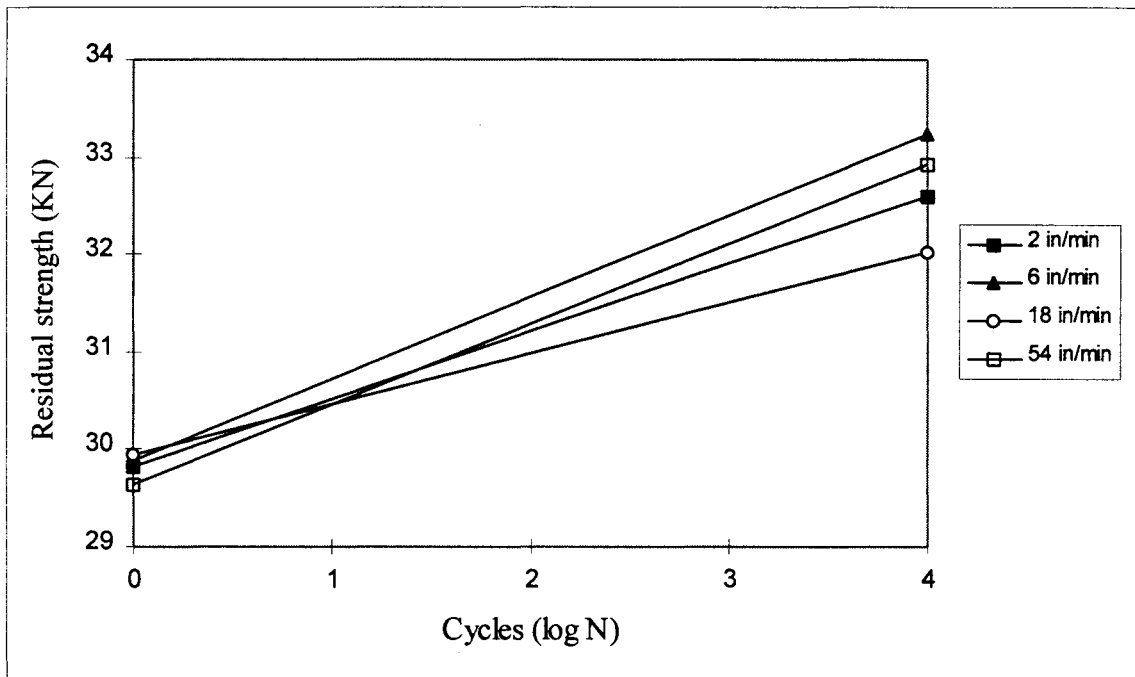
Figure 35: Effect of feed rate on residual strength.

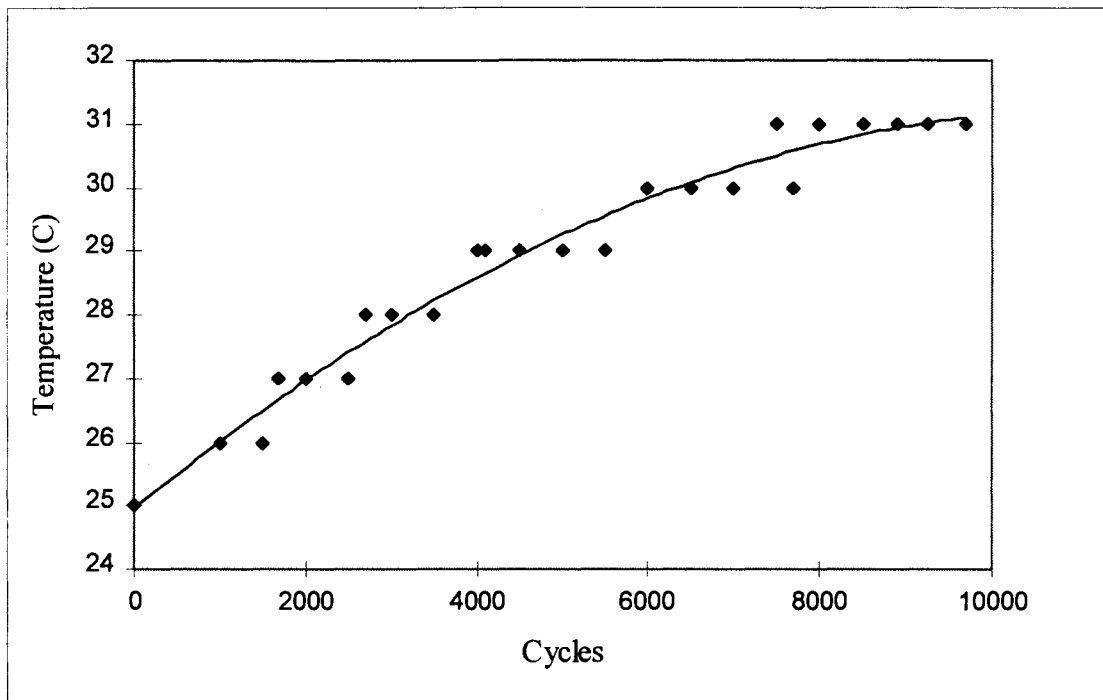
Figure 36: Temperature Profile for 10,000 cycles at 9 Hz. Data taken from specimens H9-C-36 and H9-C-37.

During a 1 million cycle test, a temperature increase was felt by hand. This temperature rise, which occurred during testing, was then documented. Fig. 36 presents the temperature profile for a typical 10,000 cycle test, while Fig. 37 shows the profile for a longer 400,000 cycle test. Both profiles were obtained at  $0.93 S_m$  load level using a frequency of 9 Hz (Note that one hour at 9 Hz corresponds to 32,400 cycles).

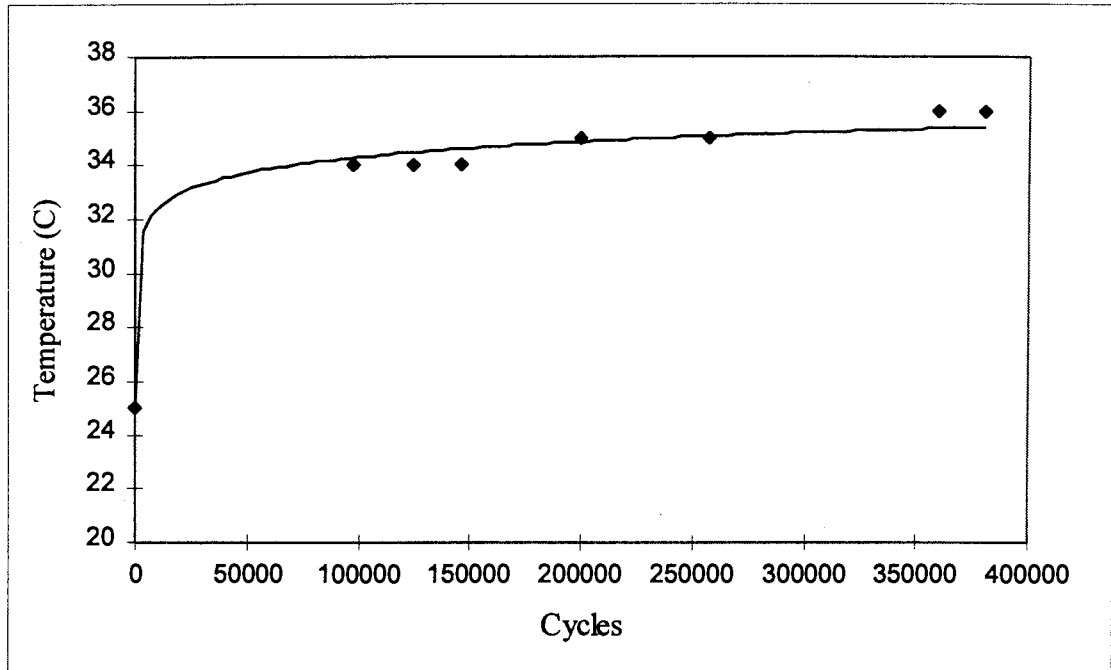
Figure 37: Temperature Profile of 380,000 cycles at 9 Hz (93% load level). Data taken from specimen H8-C-35.

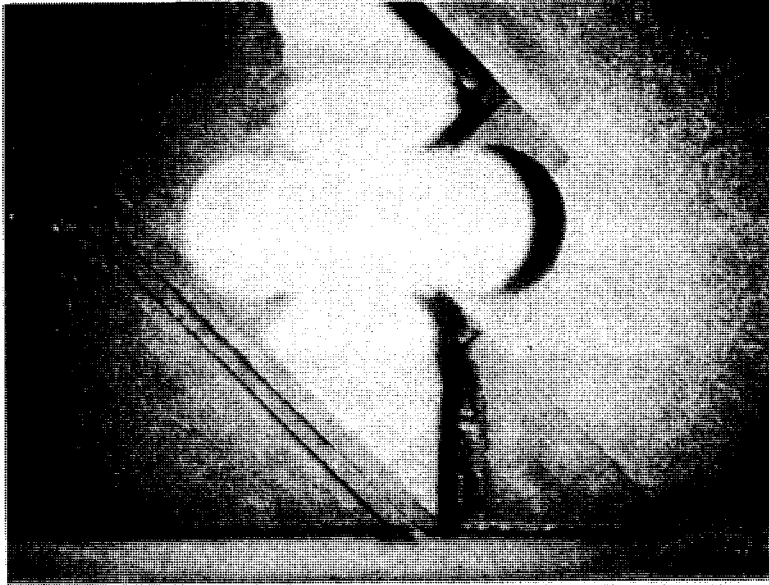
Figure 38: H6-C-27 tensile tested at .004 mm/s head rate (29.7 KN strength). Note uniform and even fracture surface except for 45° ply which did not fracture {X 3.5}

Several pictures were taken through a zoom microscope to document specimen fracture. Figs. 38 and 39 contrast the different fractures at the slowest and fastest head rates. The next figures (Figs. 40 and 41) show the fracture surface of specimens which experienced the highest number of cycles before being residual strength tested. Fig. 42 shows the brooming effect which occurred during high cycle testing. The split between the layers in Fig. 42 is typical of all tests which received 500,000 cycles or more.

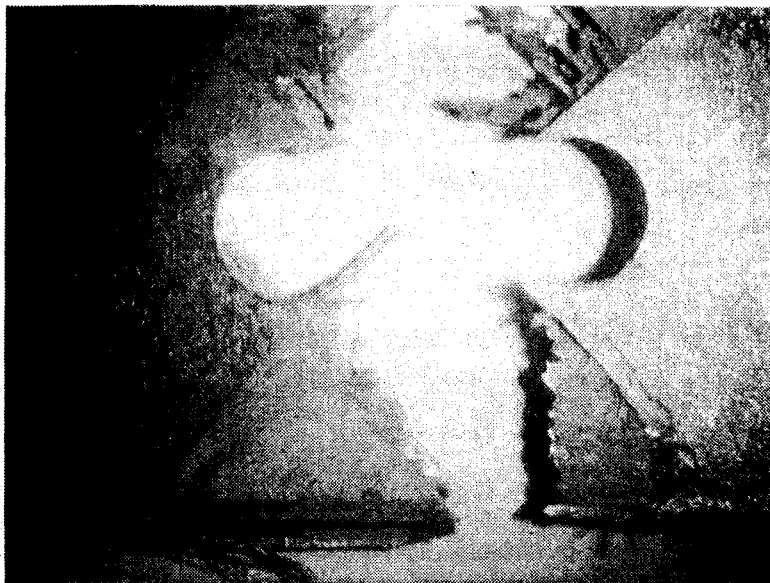
Figure 40: H3-C-10 fatigued at 27.9 KN (93% initial tensile strength) for 1,150,855 cycles. Residual strength was 32.2 KN. View is looking down on bit entry. Note rough and uneven fracture surface. {X 3.5}

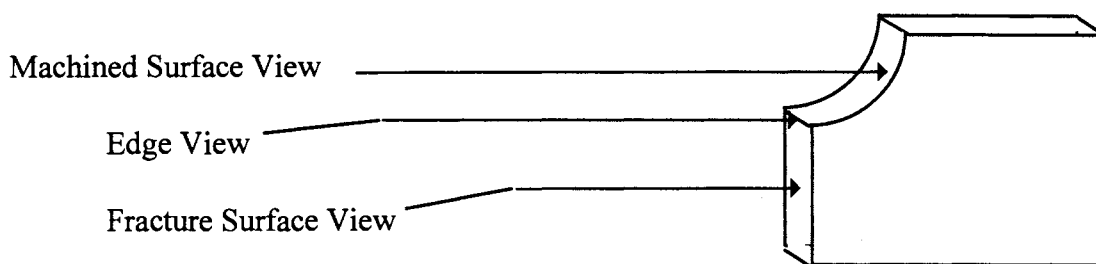
Figure 43: SEM view description.

A scanning electron microscope was used to get a more detailed look at the fractured and machined specimen surfaces. All of the SEM pictures are one of three views, as shown specifically in Fig. 43.

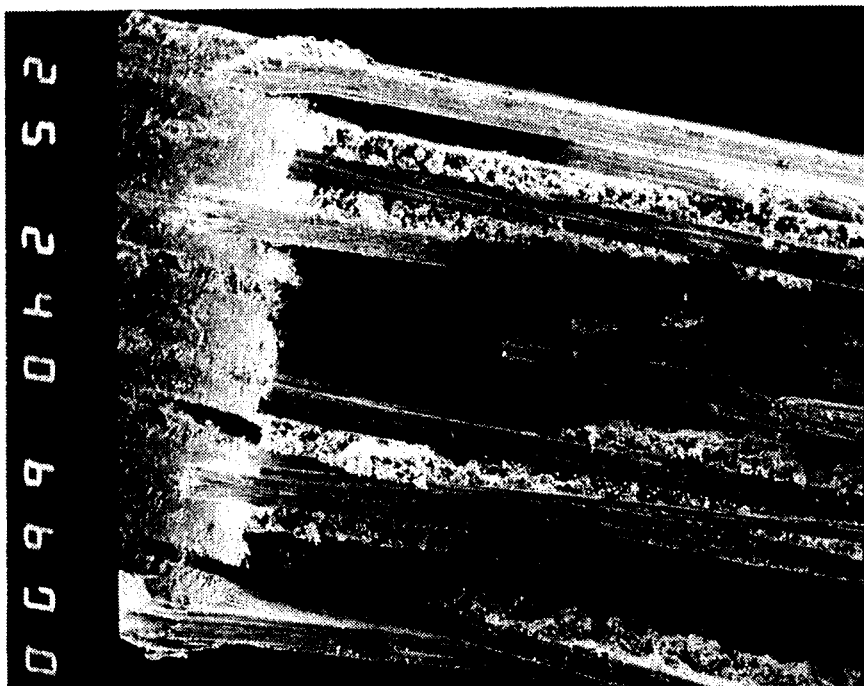
Figure 44: Edge view taken from H3-C-28 which was drilled at .153 m/min feed (bit entry at top of picture). Specimen was tensile tested at 20.3 mm/s head rate which corresponds to head rate during a 9 Hz fatigue test. {X 24}

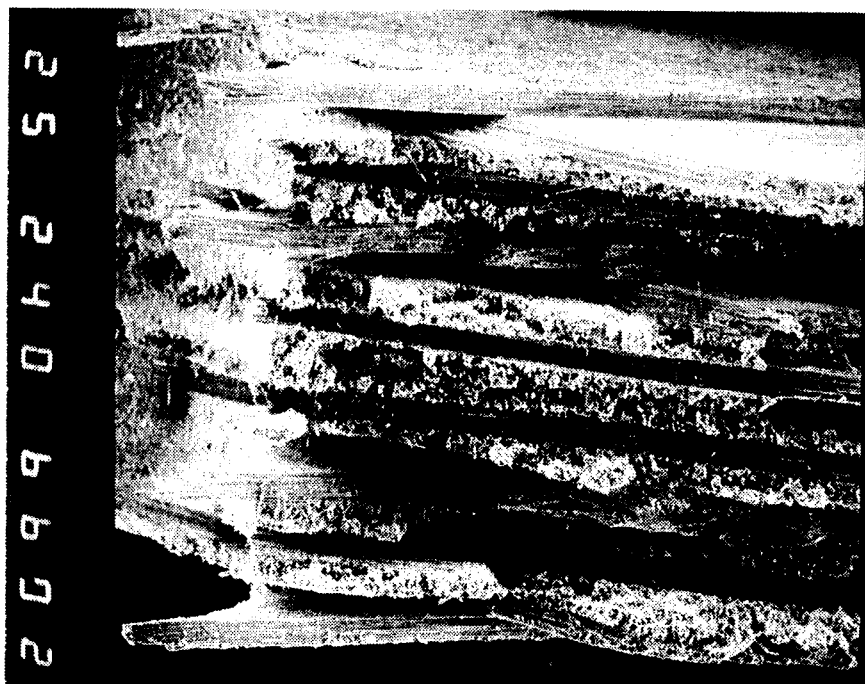
Figure 45: Edge view taken from H6-C-27 which was drilled at .153 m/min feed (bit entry at bottom of picture). Specimen was tensile tested at slow head rate of .004 mm/s. {X 24}

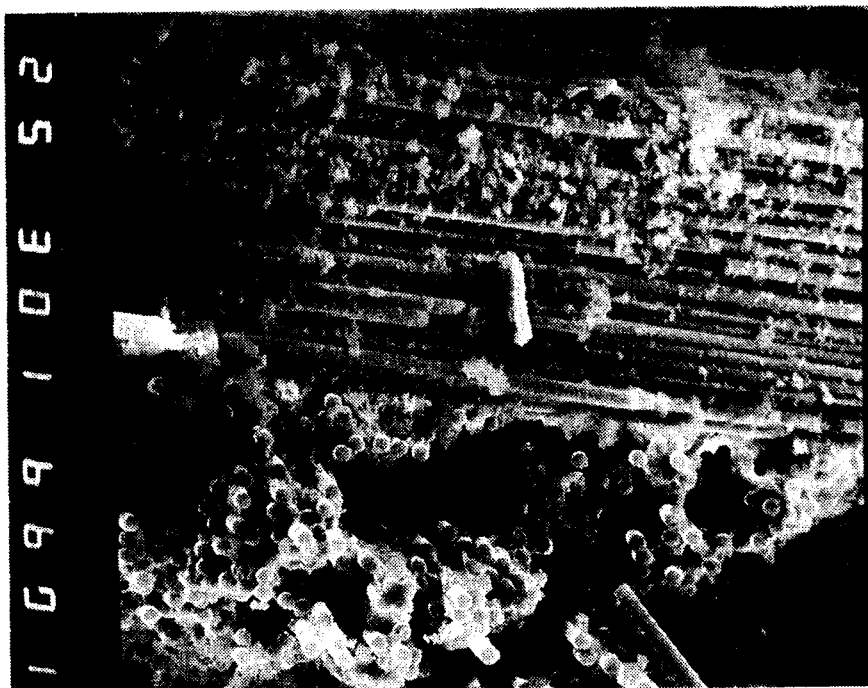
Figure 46: Fracture surface view of H3-C-28. Upper half of picture is 90° fibers while lower half is 0° fibers. Specimen experienced fast strain rate tensile test. {X 300}

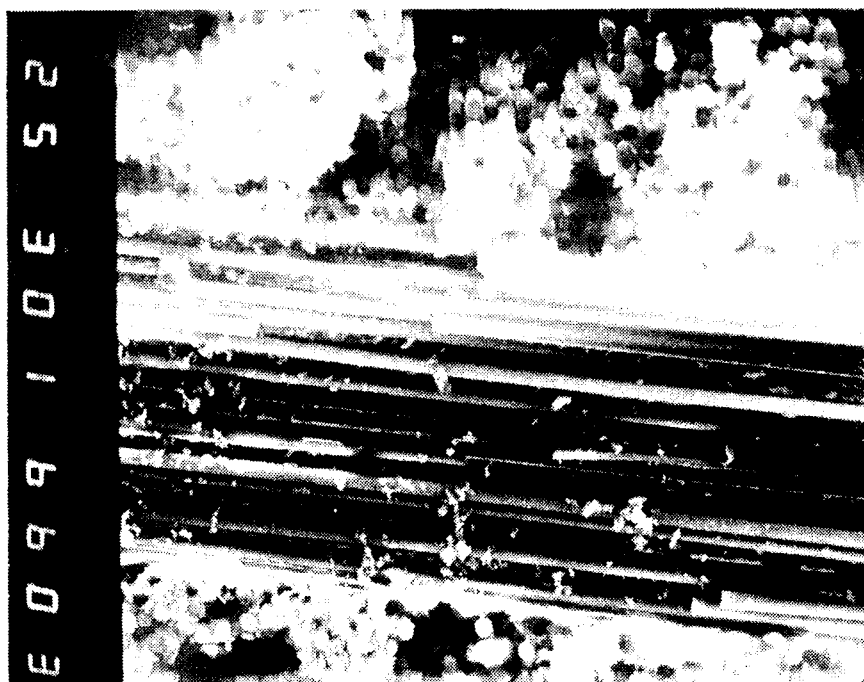
Figure 47: Fracture surface view of H6-C-27. Upper half is 0° fibers while lower portion is 90° fibers. Specimen experienced slow head rate tensile test. {X 300}
