MACHINING EFFECTS ON TENSILE AND FATIGUE  
BEHAVIOR IN A  $[(\pm 45/0/90/0)_2 / \overline{0}]_s$  GRAPHITE  
EPOXY LAMINATE

Submitted to the Faculty of the  
Graduate College of the  
Oklahoma State University  
in partial fulfillment of  
the requirements for  
the Degree of  
MASTER OF SCIENCE  
December, 1995

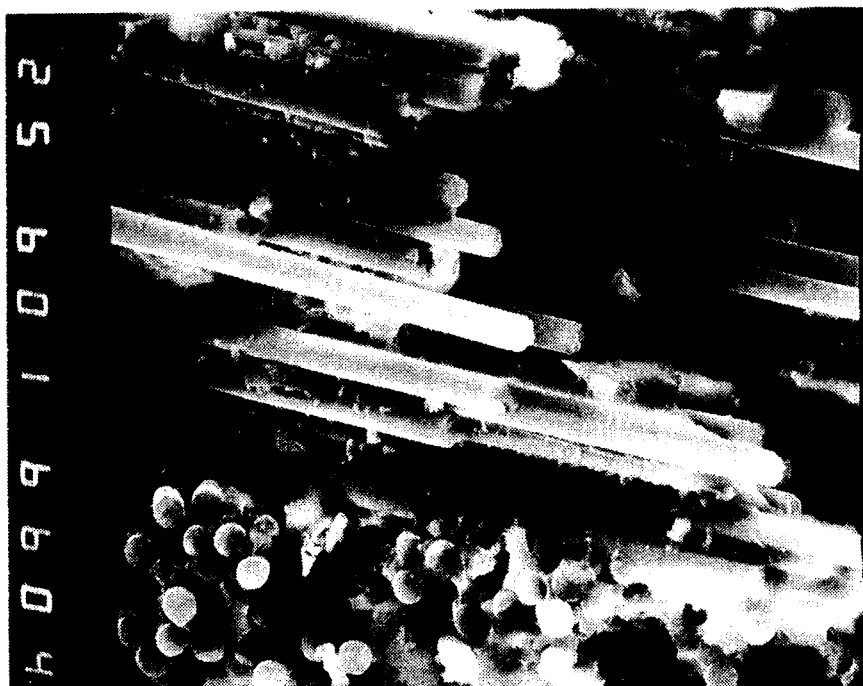
Figure 48: Fiber detail taken from fracture view of specimen H6-C-27. Specimen was tensile tested at slow head rate. {X 600}

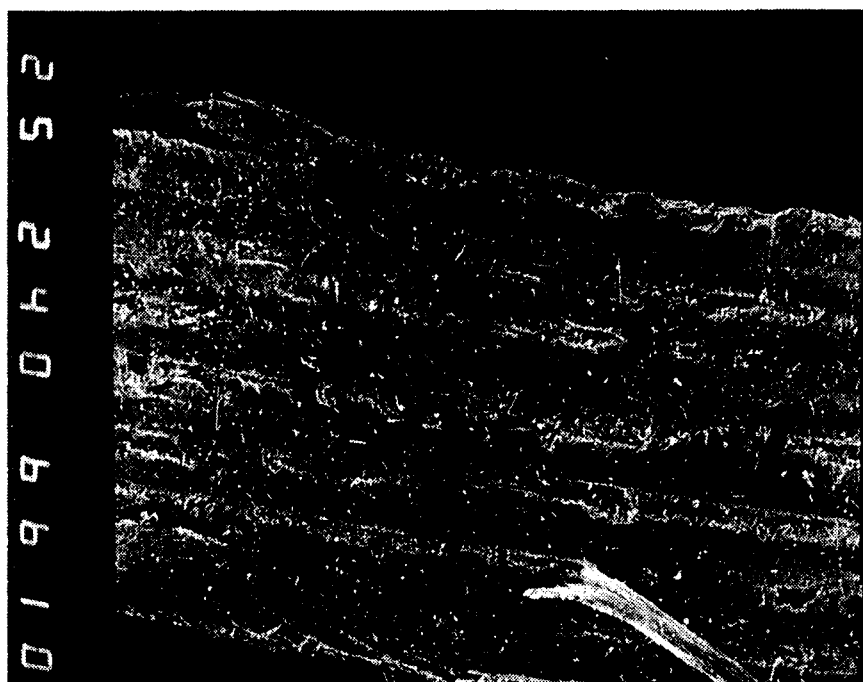
Figure 49: Machined surface view of specimen H3-C-28. Specimen drilled at .153 m/min feed (bit entry at top of picture). Specimen experienced fast strain rate tensile test. {X 24}

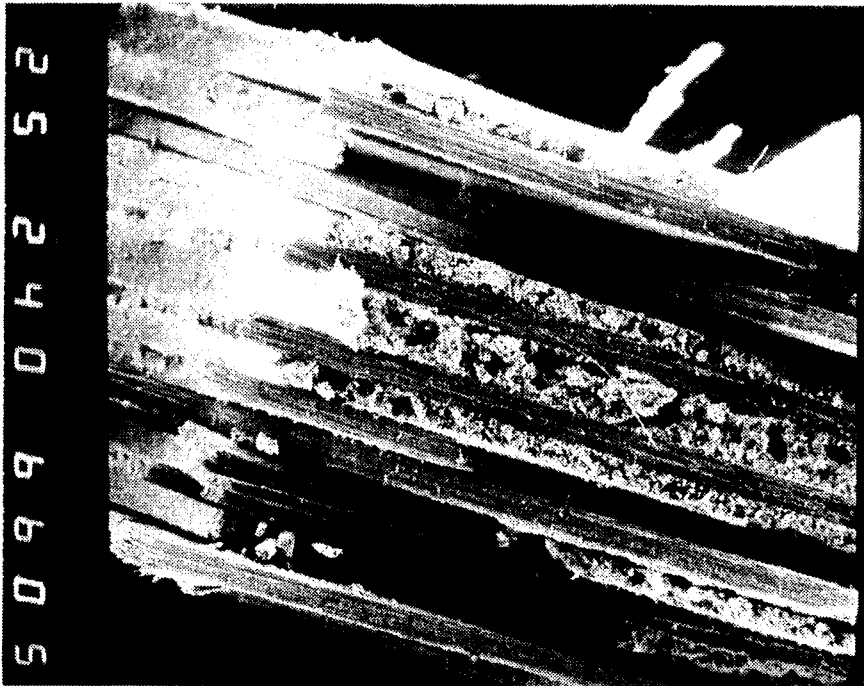
Figure 50: Edge view taken from H7-C-29 which was drilled at .153 m/min feed (bit entry at top of picture). Specimen experienced 1,100,000 cycles at 27.9 KN (93% initial tensile strength). Residual strength was 36.1 KN. {X 24}

6. Larger dark gaps around 45° plies in Fig 50 then seen in Figs. 51 and 54.
7. Ply separations around 45° plies in Fig. 52, while separations are not seen in Fig 53.
8. Machined area in Fig. 53 is not as well defined and appears smeared when compared with similar machine area shown in Fig 52.

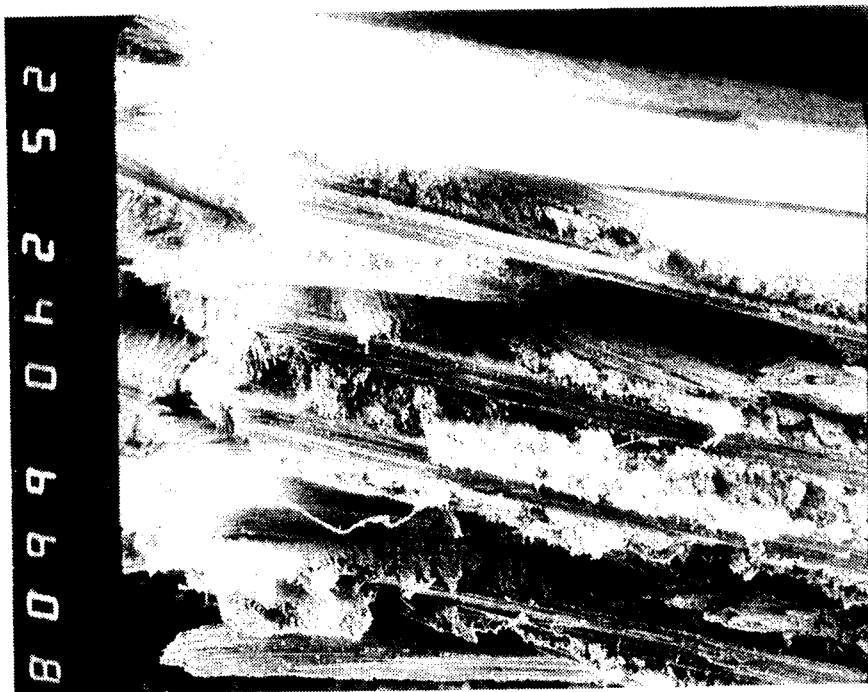
Figure 51: Edge view taken from H5-E-15 which was drilled at 1.37 m/min feed (bit entry at bottom of picture). Specimen experienced 10,010 cycles at 27.9 KN (93% initial tensile strength). Residual strength was 32.9 KN. {X 24}

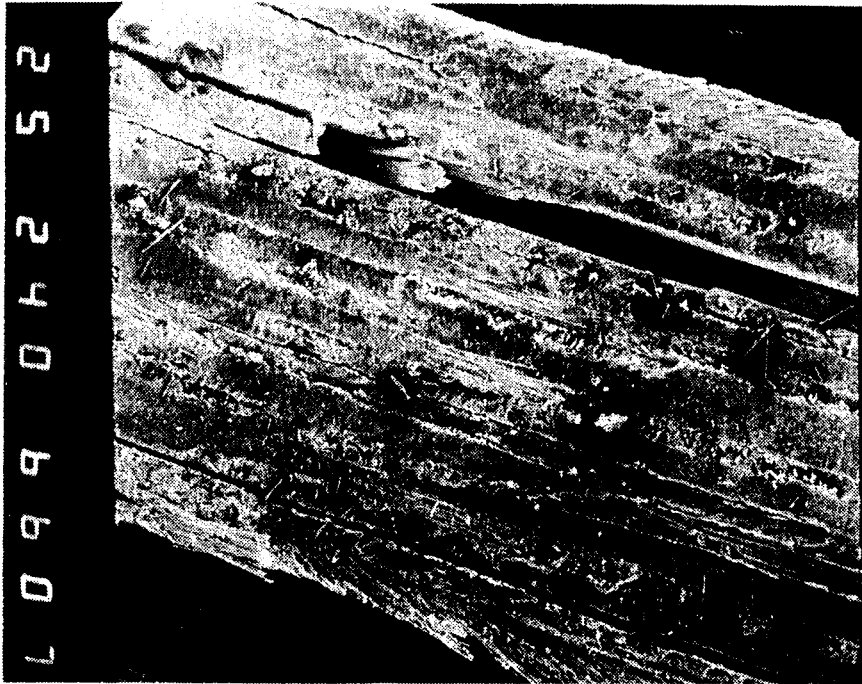
Figure 52: Machine surface detail from H7-C-29 (same sample as Fig. 50). Top bit entry at .153 m/min feed. 1,100,000 cycles at 27.9 KN resulted in a residual strength of 36.1 KN. {X 24}

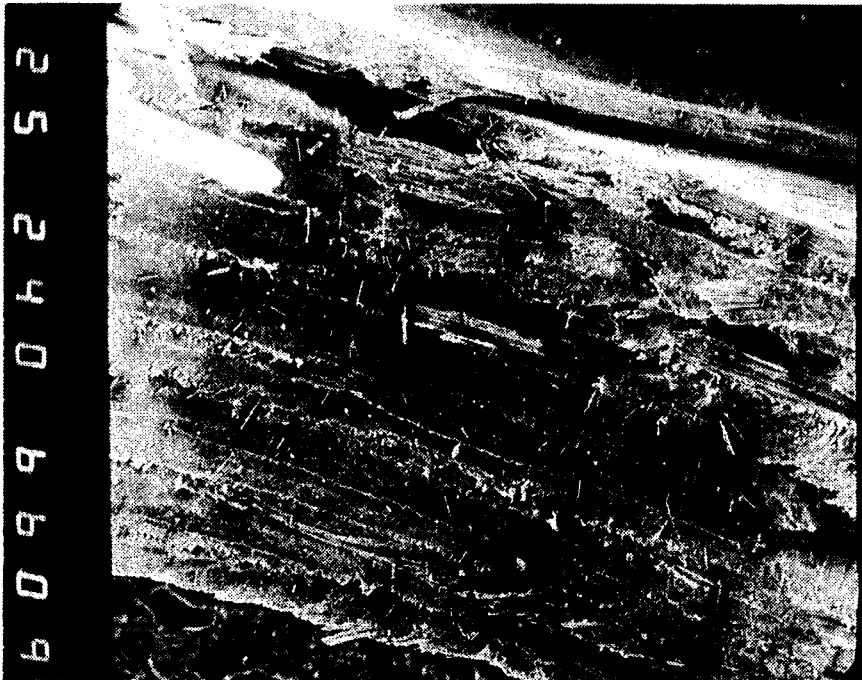
Figure 53: Machined surface view from H5-E-15 (same sample as Fig. 51). Bottom bit entry at 1.37 m/min feed. 10,010 cycles at 27.9 KN resulted in a 32.9 KN residual strength. {X 24}

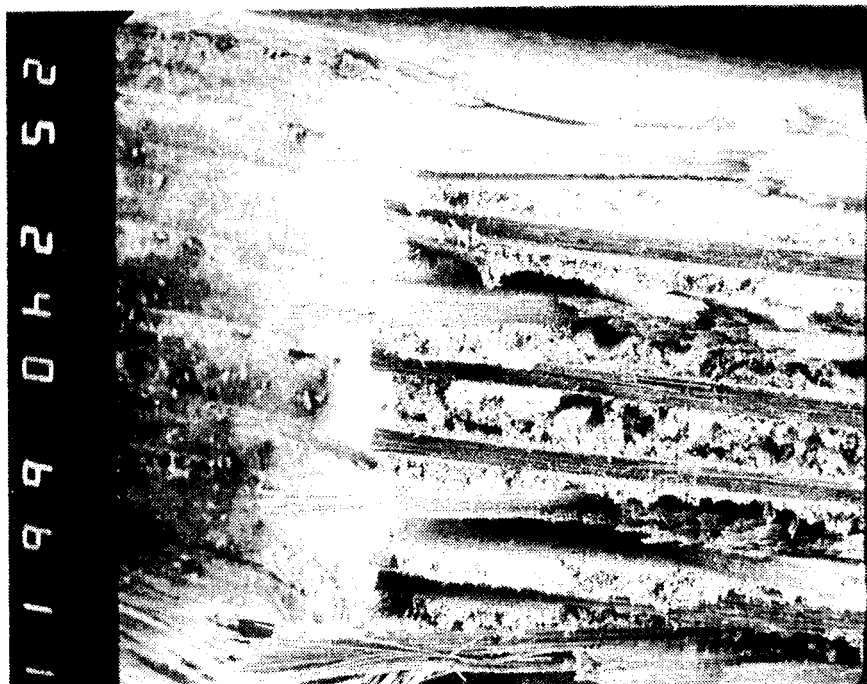
Figure 54: Edge view taken from H2-B-7 which was drilled at .0508 m/min feed (bit entry at top of picture). Specimen was tensile tested at .051 mm/s head rate with a strength of 29.8 KN. {X 24}

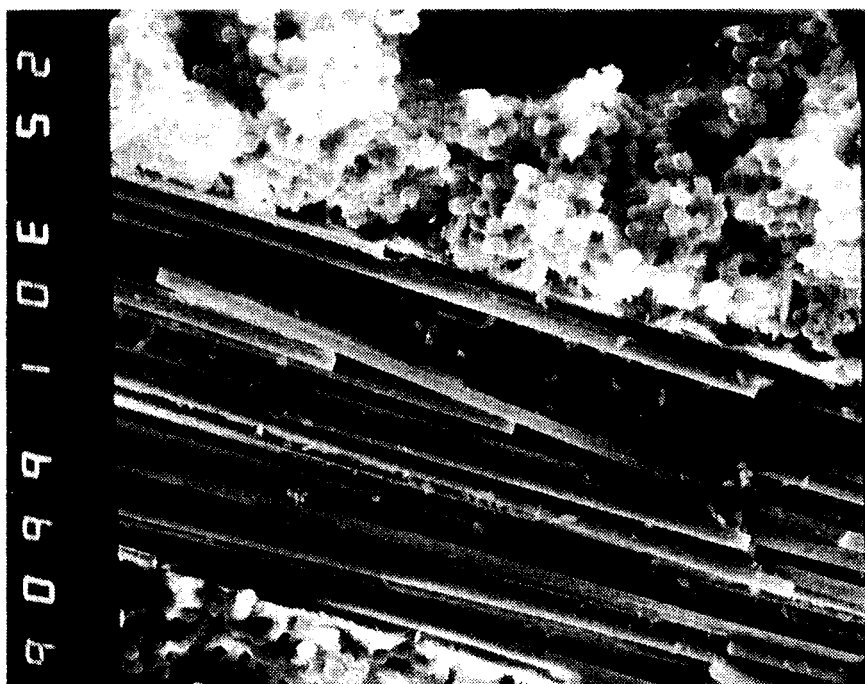
Figure 55: Fracture surface detail of H7-C-29. Upper half is 0° fibers while lower portion is 90° fibers. 1,100,000 cycles at 27.9 KN resulted in a 36.1 KN residual strength. {X 300}
