CORROSION ASPECTS OF ALLOY 600

Submitted to the Faculty of the
Graduate College of the
Oklahoma State University
in partial fulfillment of
the requirements for
the degree of
MASTER OF SCIENCE
May, 1991

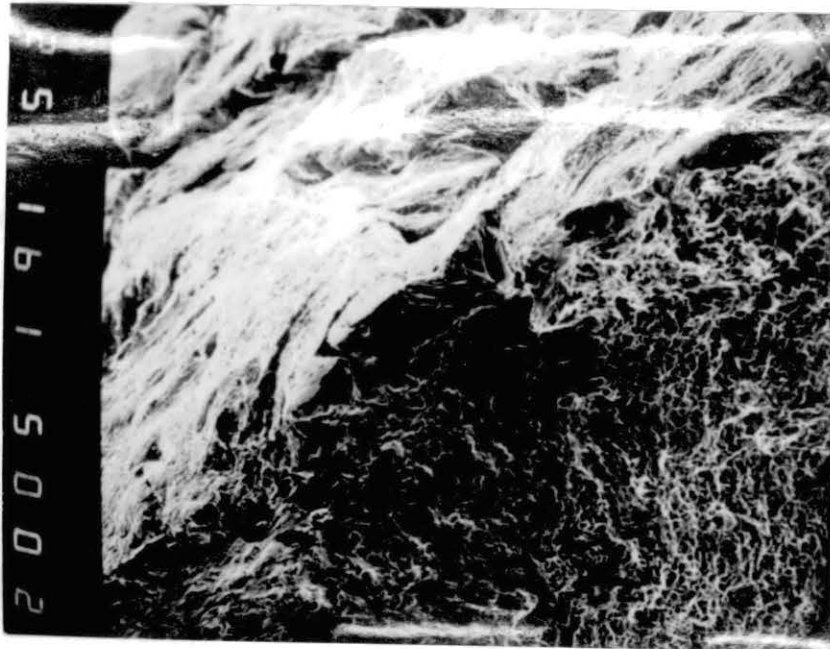
Figure 23. The TG Microstructure in Figure 22 in One
Side of The Surface (160X)

In 0.1 M ferric chloride solution, the unsensitized specimen showed two kinds of microstructures, these are side cracking which is similar to TG cracking on one side of the specimen and microvoids on the rest of the sample (figure 22). Consequently, the fracture is assumed to start by the penetration of the solution from one side and created the TG cracking (figure 23) and ended in the rest of the specimen which created the microvoids (figure 24). There was not any pitting on the specimen.

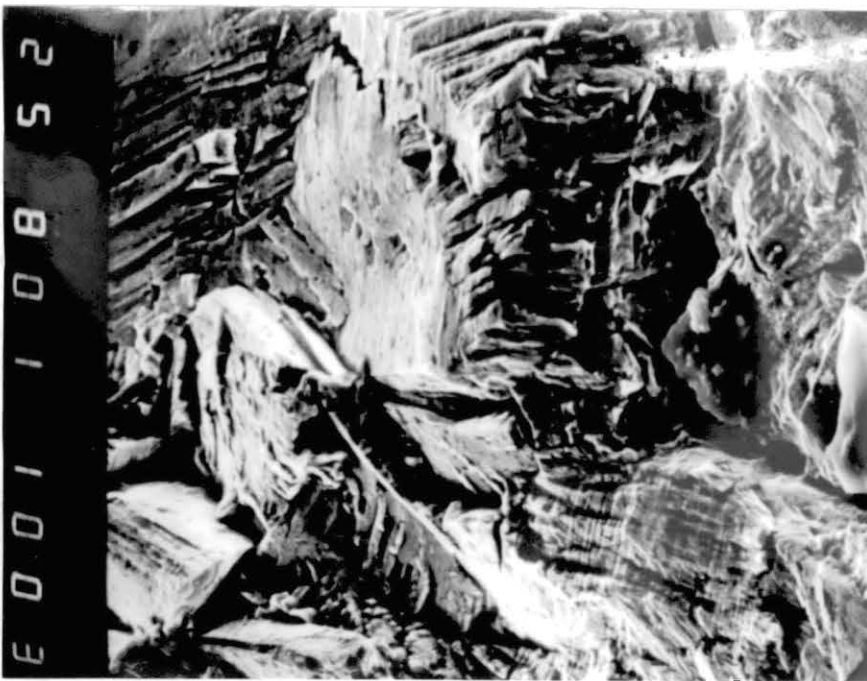
Figure 29. The TG Microstructure in Figure 28 in The
Whole Fracture Surface (800X)

In liquid mercury, the unsensitized specimen showed a full TG cracking microstructure (figure 28) which again suggests the aggressive effect of the mercury environment on Alloy 600 (figure 29). The microstructure indicates also that mercury penetrated across the whole cross section which
