STRESS CORROSION CRACKING

IN MONEL 400

Submitted to the Faculty of the Graduate College
of the Oklahoma State University
in partial fulfillment of the requirements
for the Degree of
MASTER OF SCIENCE
May, 1989

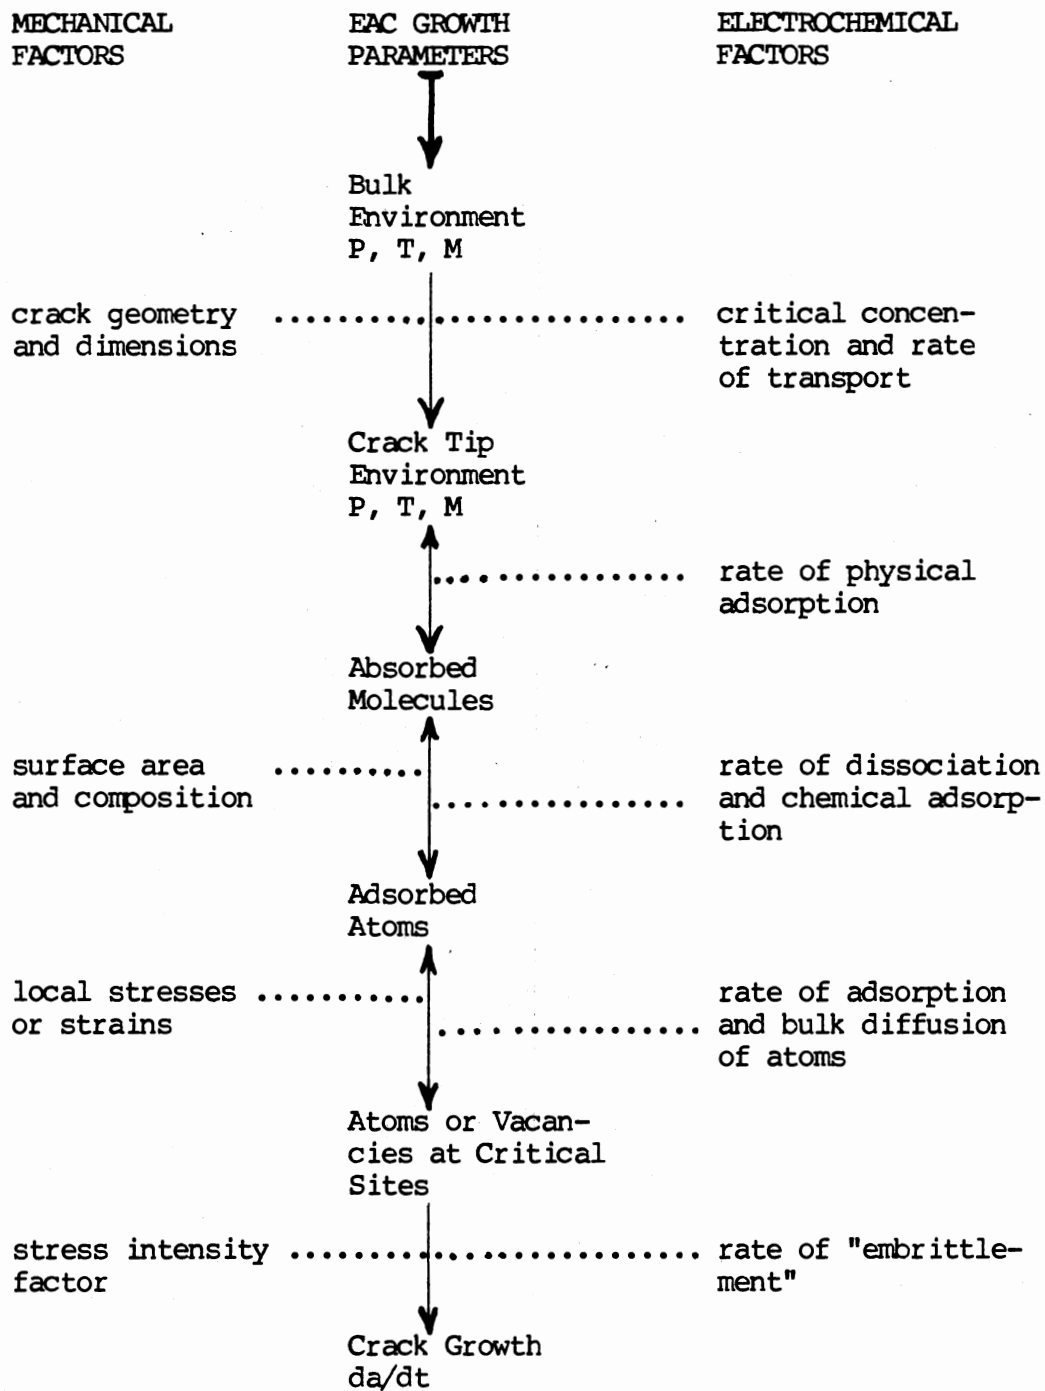
Figure 1. Schematic Illustration of Process and Parameters

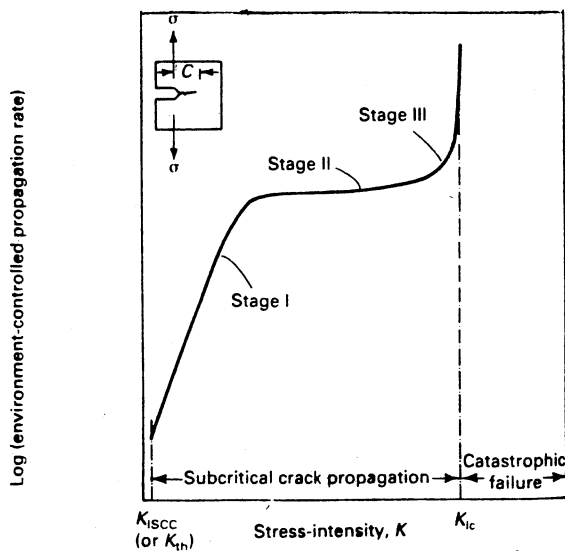
Figure 5. Typical, subcritical crack propagation rate versus stress intensity relationship. Stress intensity, K , is defined as $L = A\sigma\sqrt{\pi C/B}$, where σ is the total tensile stress, C is the crack length, and A and B geometrical constants. (From Craig¹⁸)

The stress concentration governs the stage of growth rate for a system. As Figure 5 demonstrates, stage III will result in catastrophic failure. The stress is dependent upon the strain. The strain rate can

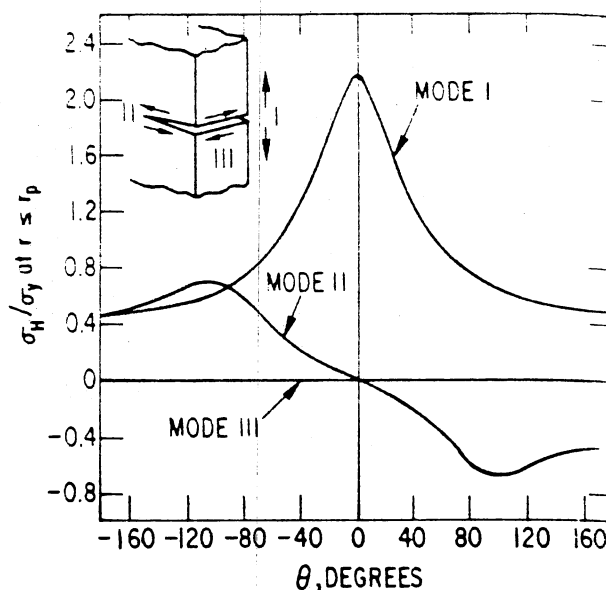
Figure 8. Hydrostatic stress gradients for crack loaded in Modes I and II. (From Nichols⁶¹)

Figure 8 demonstrates the hydrostatic stress gradient occurring around the crack front. The loading mode can determine the type and degree of stress in the area, thereby determining the propensity to failure.

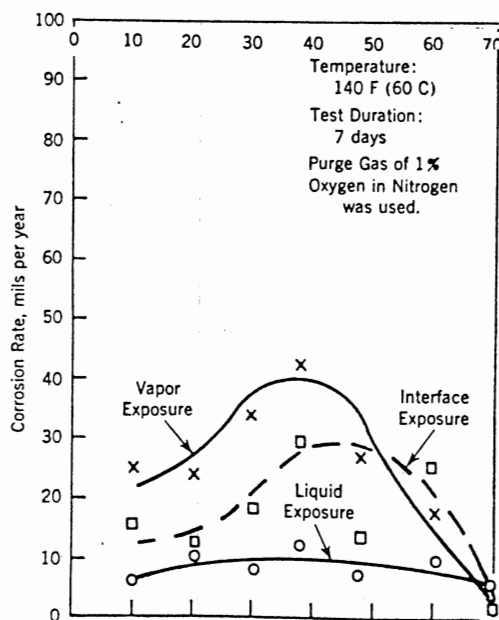
Figure 13. Effect of hydrofluoric acid concentration on corrosion of Monel alloy 400. (From Comley and Evans¹³)

As illustrated by the table listing of Appendix A, several cases of SCC of Monel involve a hydrogen fluoride environment. Figure 13 demonstrates the corrosion rate of Monel 400 exposed to HF acid. The diagram indicates a dependency upon the acid concentration. The diagram in Figure 14 is the isocorrosion chart of Monel 400 in HF. The lowest corrosion rate, independent of acid concentration, occurs near room temperature. This could imply that, contrary to common assumption, Monel 400 will demonstrate its greatest tendency towards SCC at room temperature, as it does for LME and HE.

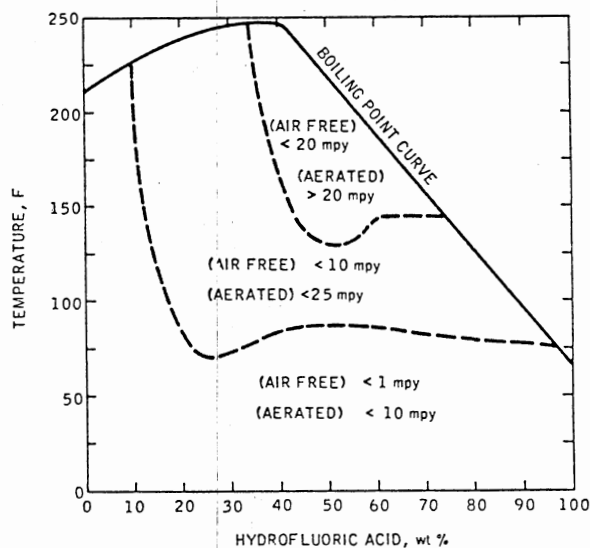
Figure 14. Isocorrosion chart indicating corrosion of Monel alloy 400 in hydrofluoric acid solutions. (From Comley & Evans¹³)

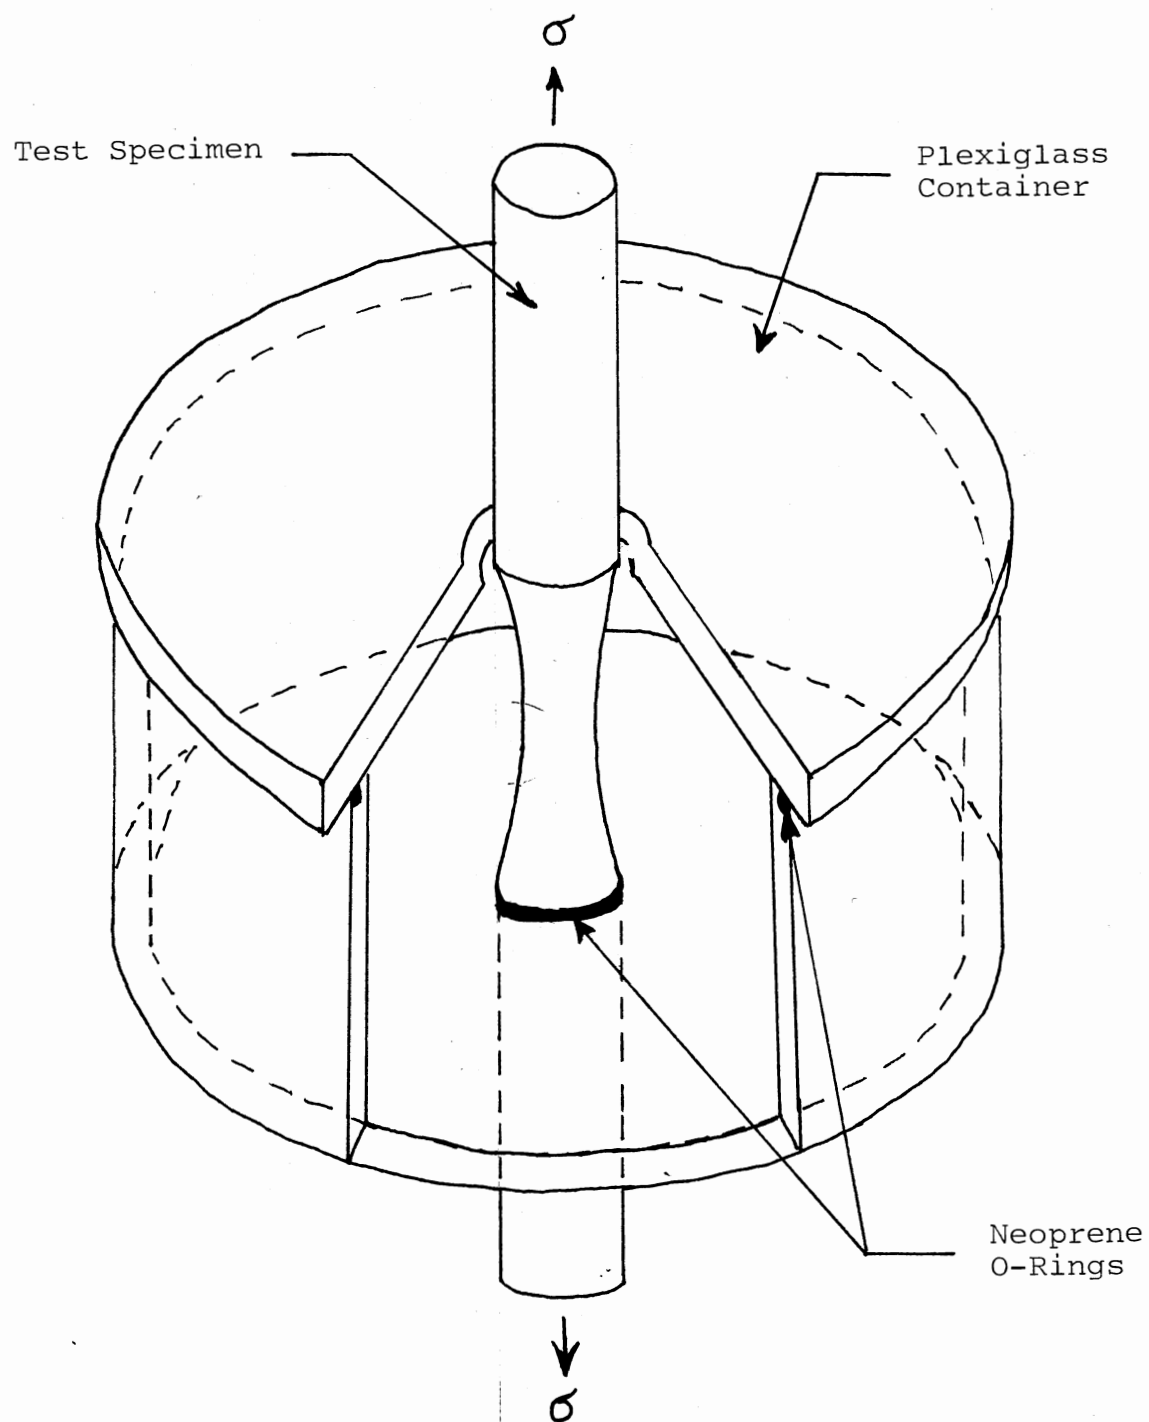
Figure 18. Environmental Chamber Used in Stress Corrosion Cracking Tests (After Fredell²⁹)

Subsequent tests will be conducted in active environments. The environments will be confined to the waisted portion of the sample. A diagram⁴⁵ of the environment chamber is supplied in Figure 18. The chamber is constructed with a resistant plexiglass body. A neoprene O-ring

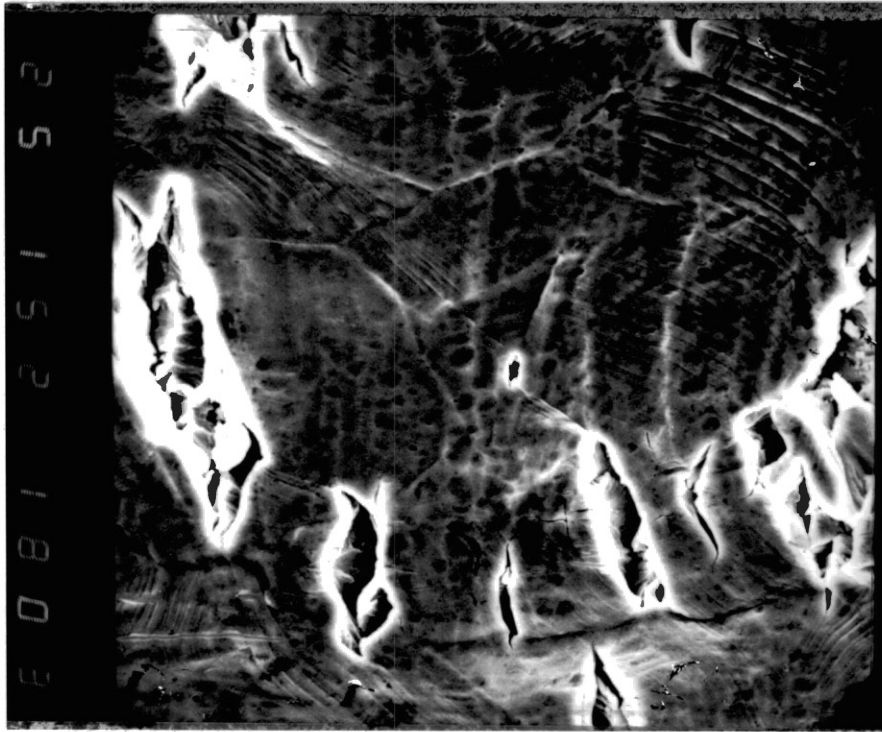
Figure 32. Fast rate test details near the fracture. Smaller cracks, slip bands, and pronounced grain boundaries are revealed; X 1500.

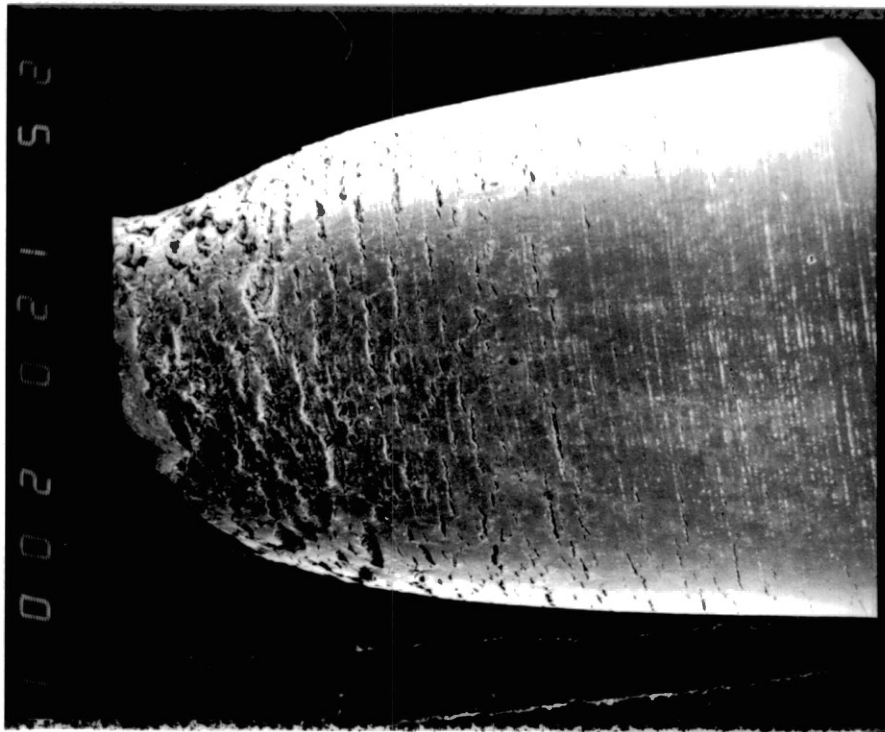
Figure 33. As received Monel 400 specimen, side view of the fracture. Compared to Figure 25, the cracking is less extensive; X 12.

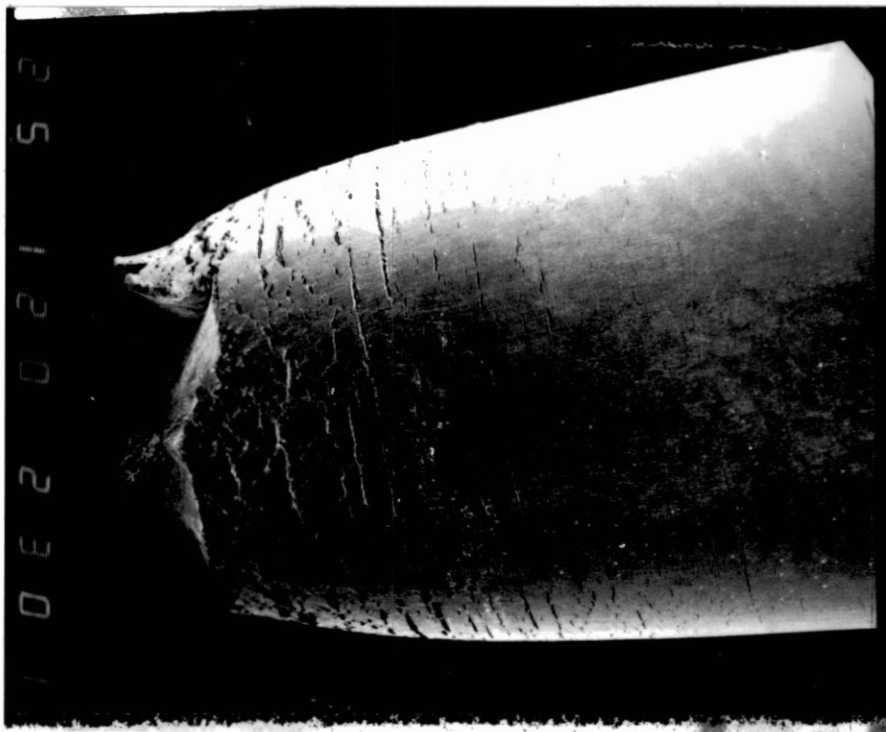
Figure 34. As received Monel K500 specimen, side view of the fracture. The sample is similar to Figure 33 and illustrates less extensive cracking than Figure 25; X 12.

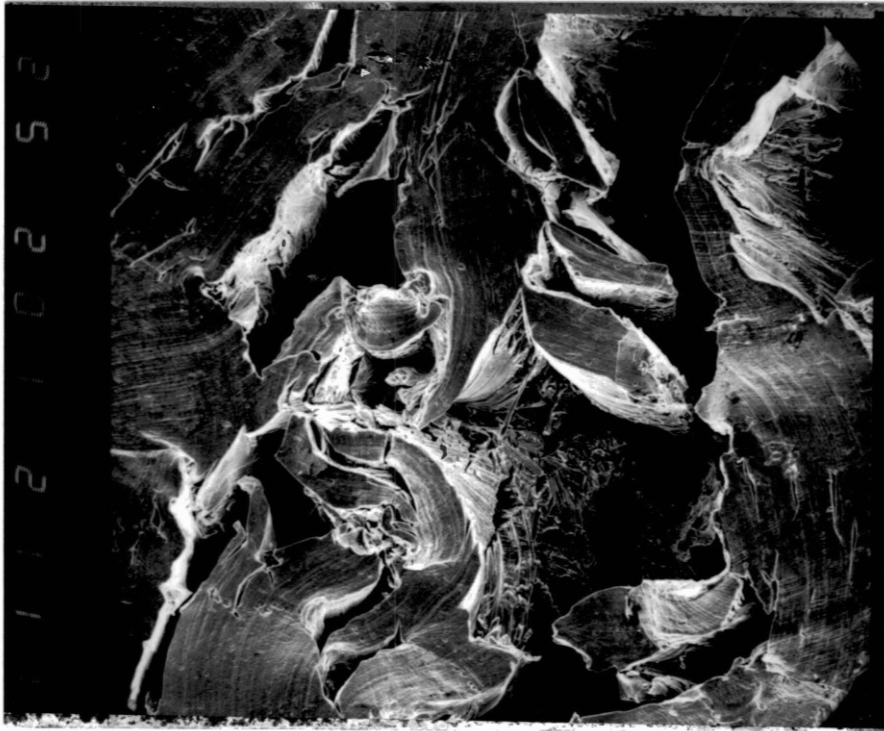
Figure 38. Coarse grain test details of Figure 36, near the fracture. The cracks are gaping under extensive plastic deformation; X 200.

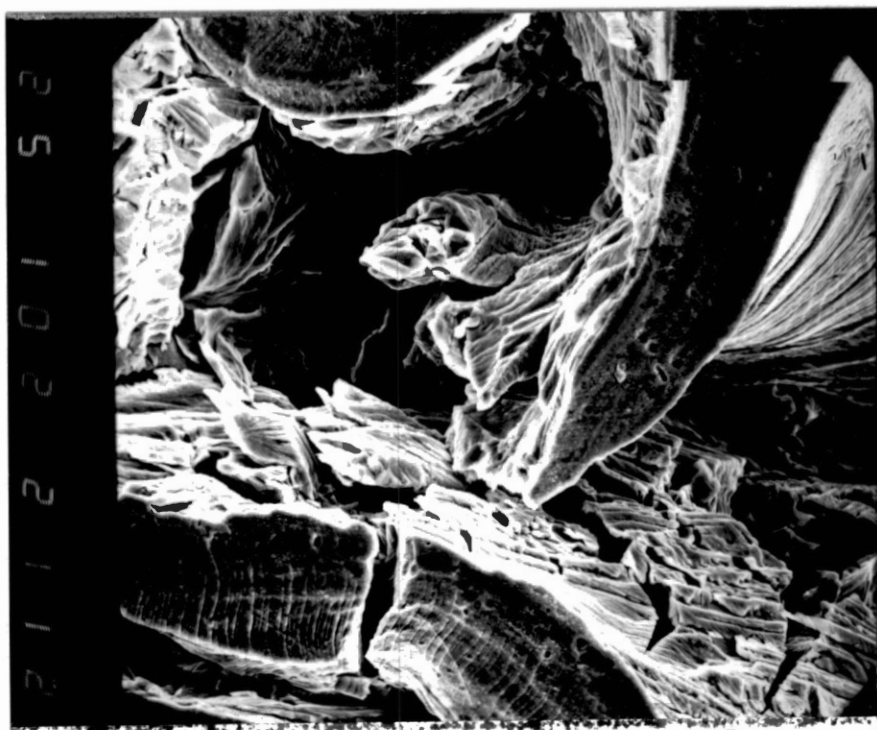
Figure 39. Coarse grain test details of Figure 38. The slip bands, pitting, and diverse nature of TG cracking within gaping cracks are illustrated; X 1000.
