MODIFICATION OF FATIGUE DAMAGED
STEEL BRIDGE DIAPHRAGMS

Submitted to the faculty of the
Graduate College of
Oklahoma State University
in partial fulfillment of
the requirements for
the Degree of
MASTER OF SCIENCE
July, 1989

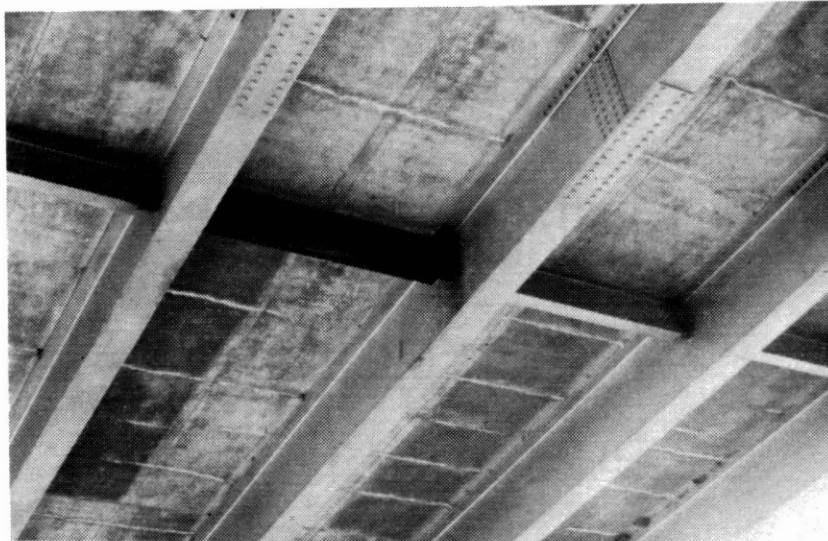
Figure 2. Placement of Diaphragms

A picture showing several diaphragms is displayed in Figure 2, and two examples of fatigue damage are shown in Figure 3. All cracks initiate at the lower cope, as can be seen in Figure 3, and propagate up through the member. It was found that 40% of the diaphragms have experienced some fatigue damage and five diaphragms have experienced a total section loss. These findings influenced ODOT to initiate research to determine the cause of the cracking and develop solutions for the problem.

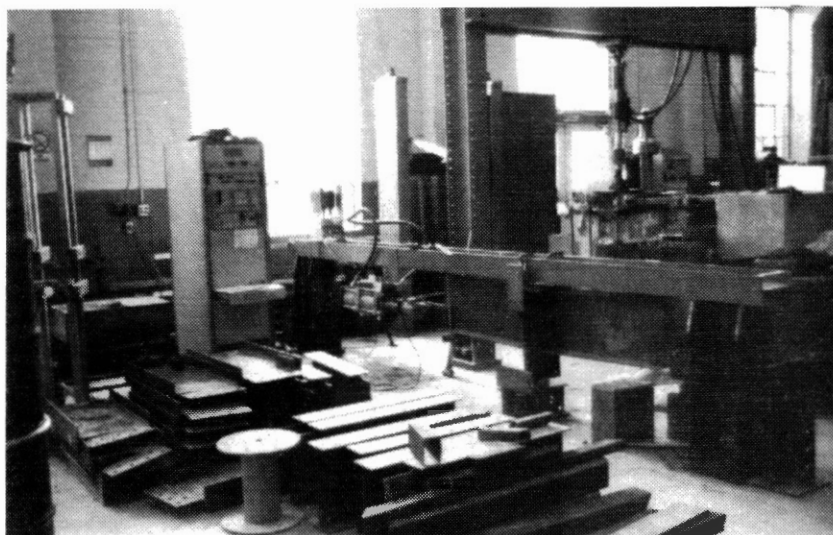
Figure 9. Testing Equipment

The testing equipment is composed of three main components: structural, hydraulic, and electronic. The structural system supports the test specimen and the hydraulic ram as well as transferring the test loads into the floor system. The hydraulic system supplies the pressure to the ram which applies the load to the specimen. The electronic system controls the application of the loads and monitors the displacements. The testing equipment is shown in Figure 9.

The structural system is composed of two vertical sections and a wide flange connecting the vertical members. The vertical members provide support for the ram and specimen as well as transferring the test load into the floor system. The horizontal member adds rigidity to the system, provides upward support for the ram and specimen, and is used to help prevent lateral displacements of the specimen. The role of preventing lateral displacements will be discussed in more detail in the next section.

The electronics and hydraulics function as a closed loop servo-controlled system. The electronics system includes a function generator to produce a sinusoidally

varying load time history and a peak detector to monitor the applied load. Load is applied through a 50 kip capacity hydraulic ram.

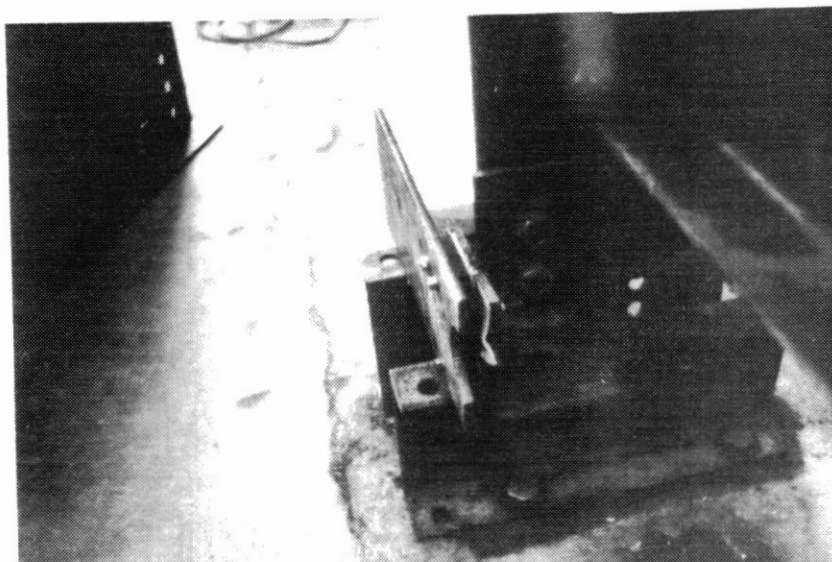
Figure 12. Lateral Restraints

One problem that arose during the initial test was a large lateral displacement which occurred when load was applied to the specimen. During cyclic loading, the specimen became laterally unstable. This problem was solved by attaching restraints to the simulated girder which do not allow lateral motion but do allow vertical and longitudinal motion. The restraints, which are shown in Figure 12, bolt

to the girder in three locations: the upper web on both ends of the girder and the lower web on one end of the girder. Each restraint uses two Teflon pads which are able to slide freely against one another in the desired direction of motion. Each restraint uses one pad connected to the girder and a second pad attached to a stable surface. The stable surface for the top two restraints is the structural wide flange, and the stable surface for the lower restraint is a floor attachment. The restraints perform adequately to resist the undesirable motion. It should be noted that the problem with lateral motion does not occur on the bridge because the diaphragms are connected to a stiff longitudinal girder.

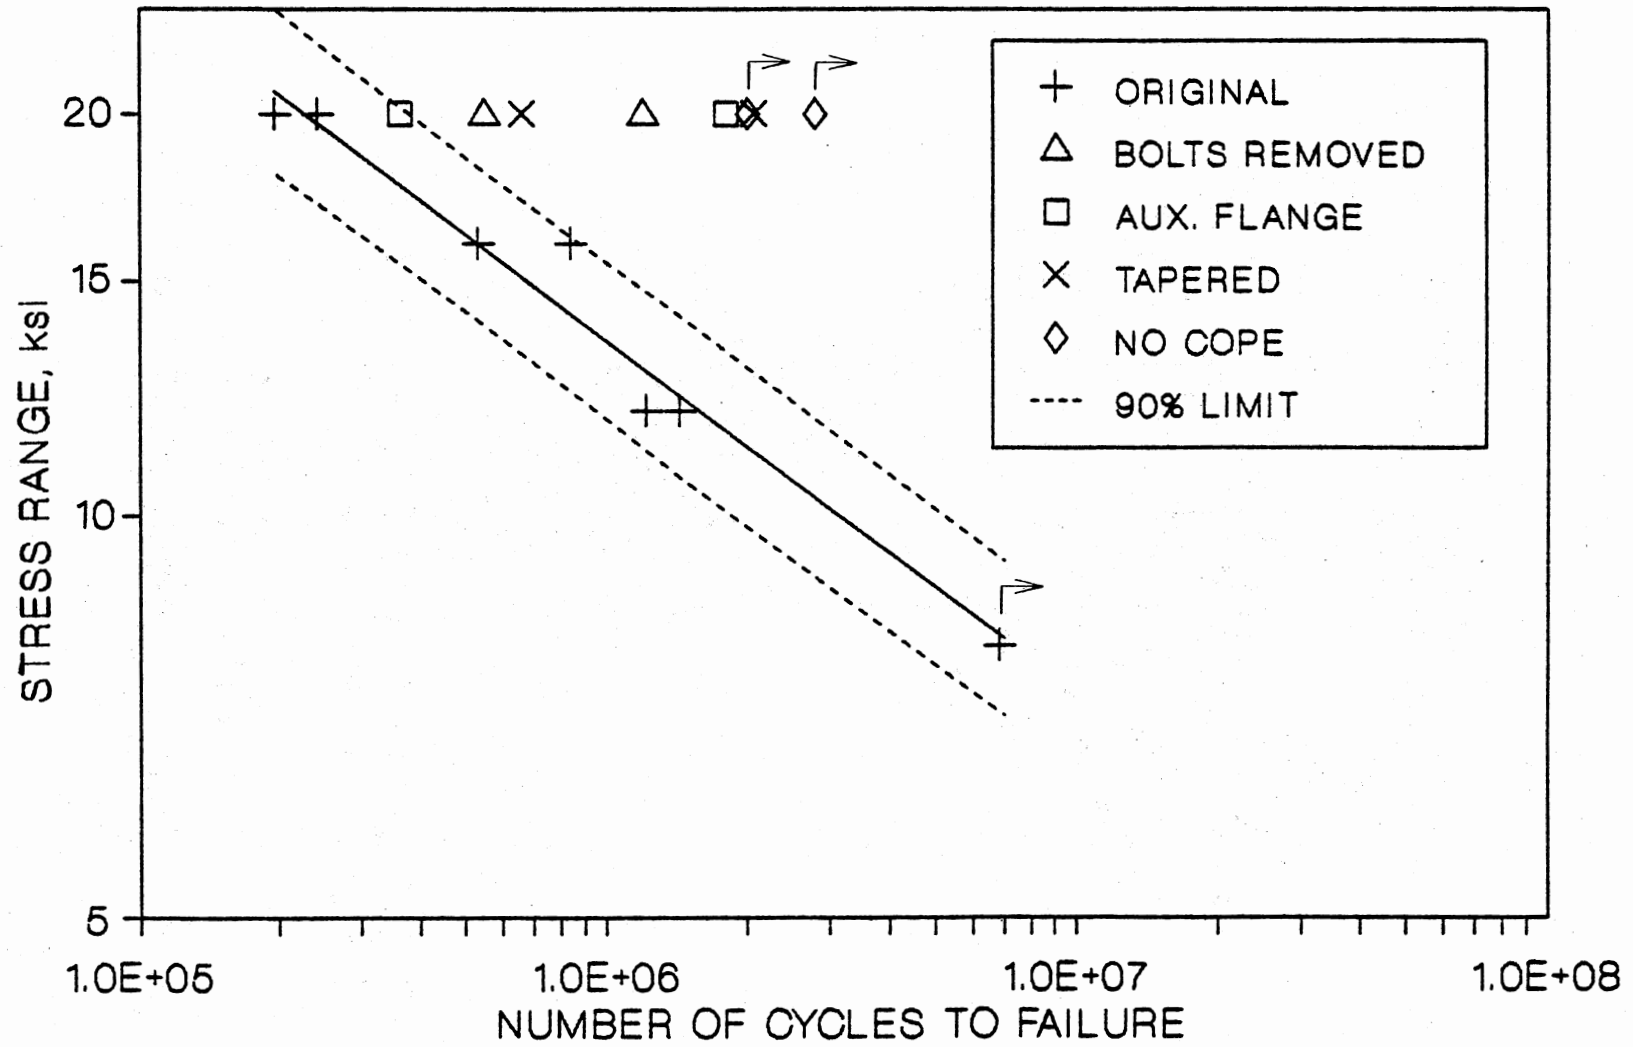
Figure 22. Fatigue Life of All Specimens

is increased. The experimental values for fatigue life are shown in Table 3 and are plotted against the original detail life in Figure 22.

The uncoped detail was tested to establish that an uncoped member will not have the problems associated with the coped members. All of the specimens underwent approximately 2 million cycles and never failed in any way. The data is shown in Table 3 and in Figure 22.
