INVESTIGATION OF THE HYDROLOGY, FLUVIAL GEOMORPHOLOGY, AND  
SEDIMENT TRANSPORT IN THE LAKE THUNDERBIRD WATERSHED IN  
CENTRAL OKLAHOMA

A DISSERTATION

RUSSELL C. DUTNELL

2015

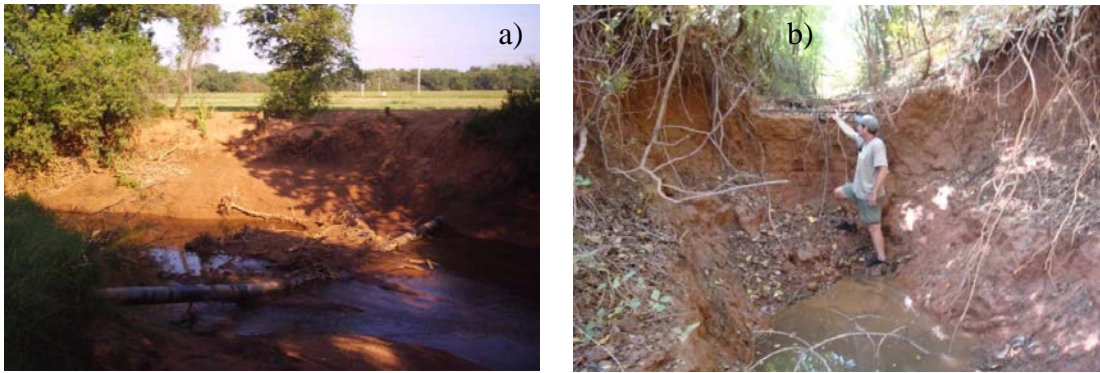
*Figure 4: Indications of the Little River channel incision and widening including a) exposed high pressure gas lines and b) tributary head cuts.*

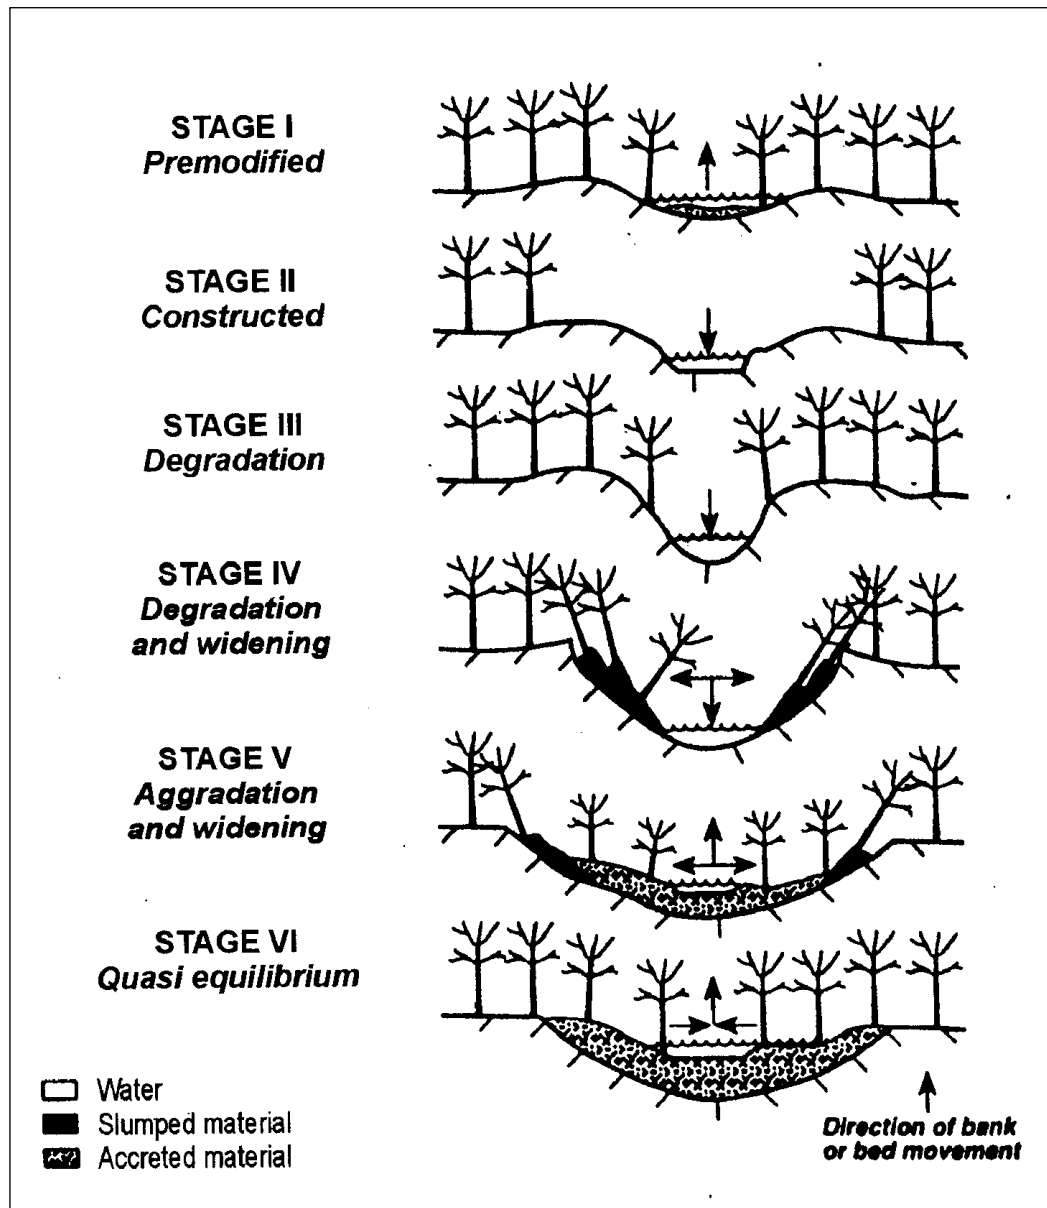
Figure 5: Channel Evolution Model – The Little River is currently at Stage IV, the degradation and widening stage. (Simon (1989))

Schumm et al. (1984), and later Simon (Simon, 1989, 1994) developed a process-based classification scheme that describes a natural channel's adaptation to straightening. As shown in Figure 5, the Channel Evolution Model, describes a complete “cycle” of bank-slope development from the pre-modified conditions through stages of adjustment to the eventual reestablishment of stable bank conditions. The Little River channel bed, in the reach reconnoitered in the vicinity of 12th Avenue NE, appears to have just entered Stage IV of the evolutionary cycle, the degradation and widening phase, and appears to have incised at least 6-8 feet at the time.

were completed. Wildhorse Creek appeared to be at Stage V (see Figure 5), the aggradation and widening phase, in 1999, as there was evidence of deposition on inside bends and point bars were beginning to form.

The FGM survey data were used to determine the morphological parameters required to classify the stream reach using the “classification of natural rivers” scheme developed by Rosgen (1994, 1996), as shown in Figure 14. These parameters include the entrenchment ratio, the bankfull width to bankfull depth ratio, the channel sinuosity, and the slope. Methodologies for conducting the geomorphic surveys proposed for use in this study may be found in Rosgen (1996) and in Harrelson et al (1996). Each FGM site was also classified using Simon’s Channel Evolution Model (Figure 5).

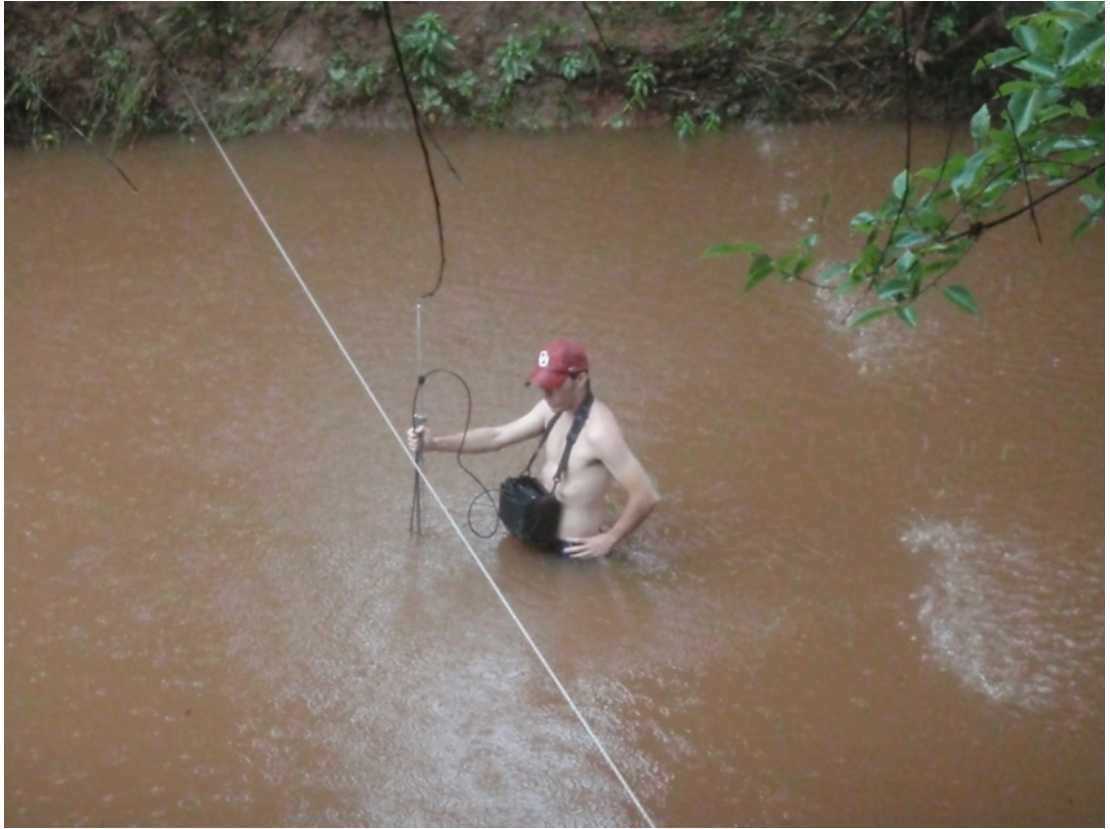
*Figure 10: Discharge measurement using Marsh McBirney flow meter at the Little River at 60<sup>th</sup> site.*

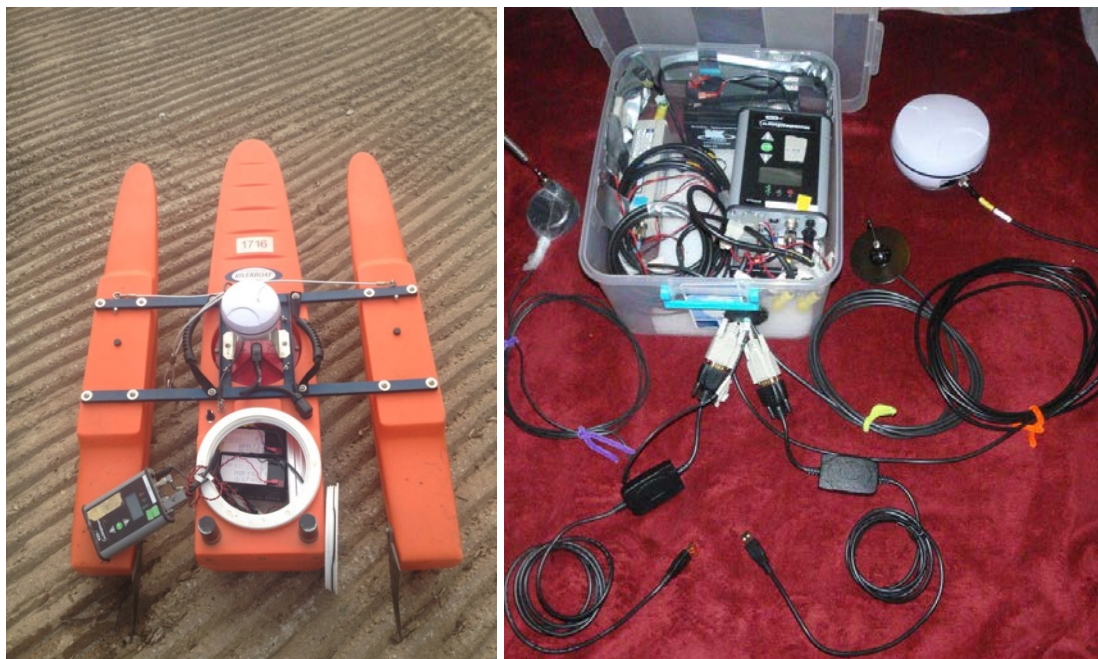
*Figure 11: ADCP measurement instrument setup. Left) Trimaran setup; Right) Base station setup.*

Taking discharge measurements with the ADCP required first setting up the system. The mobile GPS station, two radios, and two batteries had to be carefully, and properly, arranged in the aft cavity of the trimaran. The various components were connected to provide communication and power to the trimaran. Next, the base station, including the base GPS station, GPS antenna, two radios, two antennas, and a battery had to be set up and connected to a laptop computer. Figure 11 shows all of the components except the mobile GPS station positioned in the trimaran (left) and the various components of the base station (right). A detailed step-by step procedure for setting up and operating the ADCP is provided in Appendix B. A condensed version of the procedure is presented below.

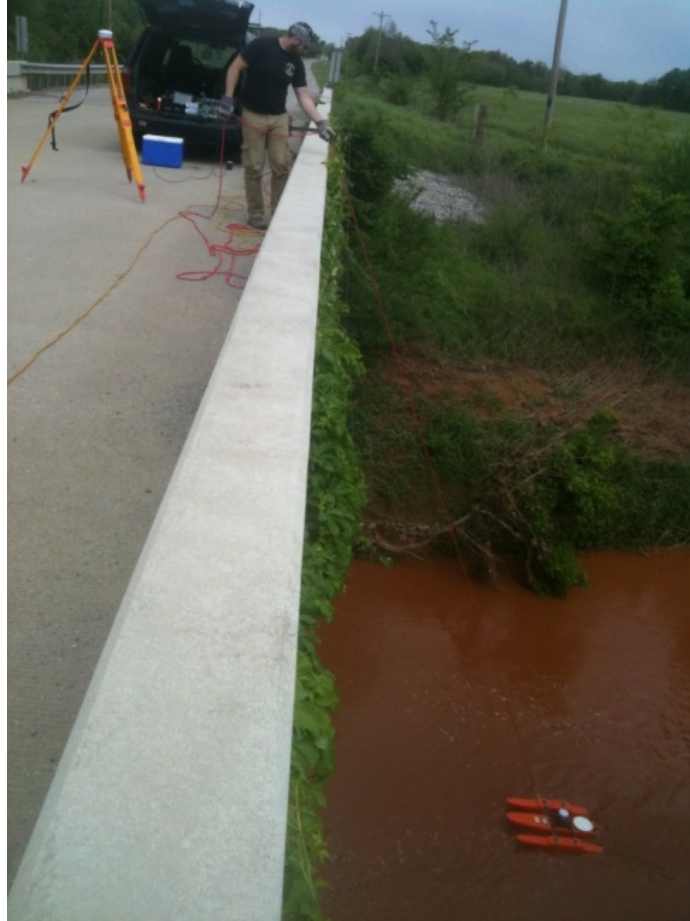
*Figure 12: Discharge measurement using Acoustic Doppler Current Profiler (ADCP) at the Little River at 60<sup>th</sup> site.*

After the measurements were completed, the boat was pulled back up, and the system was disassembled sufficient for transport. Figure 12 shows the ADCP being used to collect discharge data at the Little River at 60<sup>th</sup> Ave NE site. Note the boat winch “crane” attached to the guard rail, and base station setup behind the researcher.

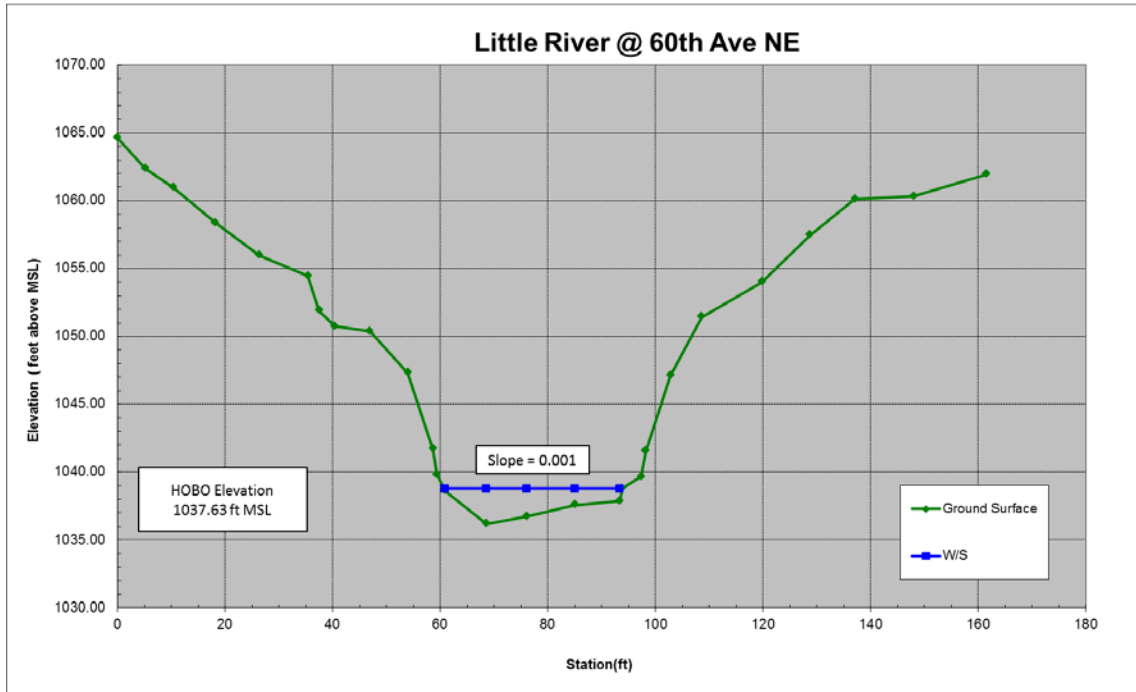
Figure 15: Cross-section plot for the Little River at 60<sup>th</sup> Ave NE monitoring site.

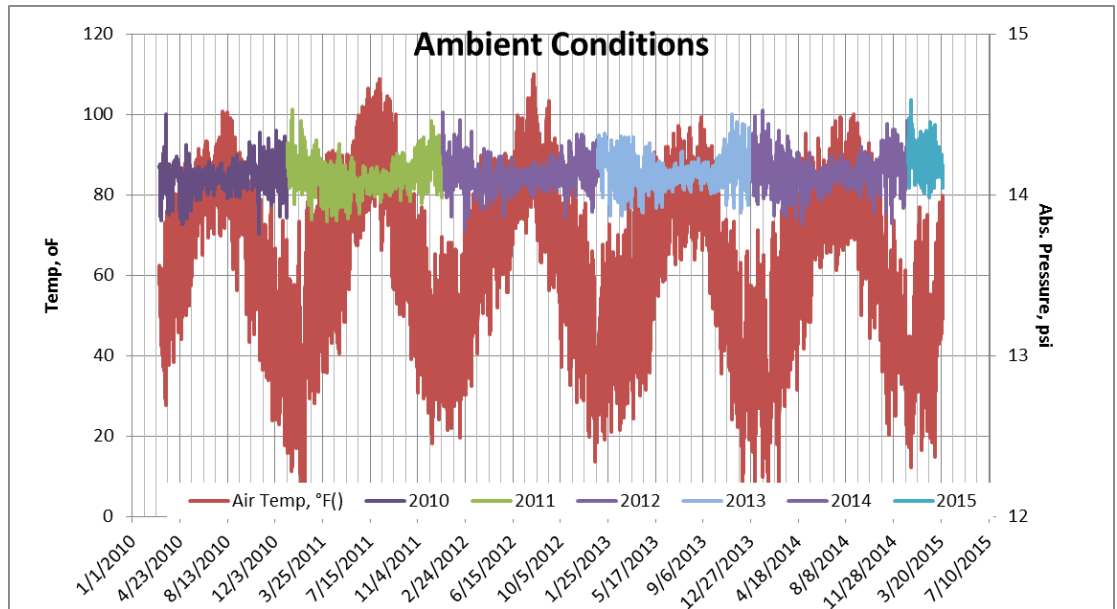
Figure 16: HOBO temperature and pressure plots for the Ambient Conditions site.

Figure 16 shows the temperature and pressure plots for the Ambient Conditions site for the period of record beginning on March 6, 2010 through the last data download on March 24, 2015. As expected, there is a wide swing in temperature, both diurnally and seasonally. The diurnal variation is evident by the wide “band width” of the plot, and the seasonal variation is seen in the sinusoidal pattern. Smaller variation may also be seen in the pressure plot with the variation being only slightly variable from season to season and less variable diurnally.

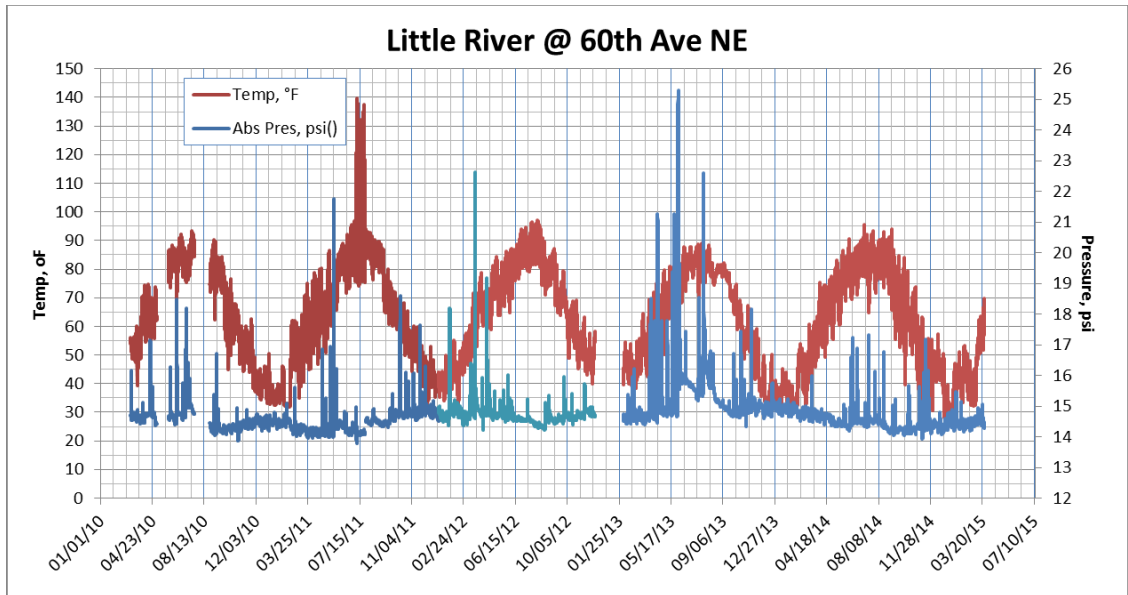
Figure 17: Temperature and pressure plots for the Little River at 60<sup>th</sup> Ave NE site.

The pressure plot for the Little River at 60th Ave NE site, unlike in the Ambient Conditions site plot, shows large spikes. These spikes are the result of deeper water associated with high flow events. Plots for all of the sites show similar trends in pressure.

Figure 17 for the Little River at 60<sup>th</sup> NE site, indicating exposure to the air. At the Rock Creek site, the exposure did not occur because the HOBO was moved. It occurred because the creek went dry.

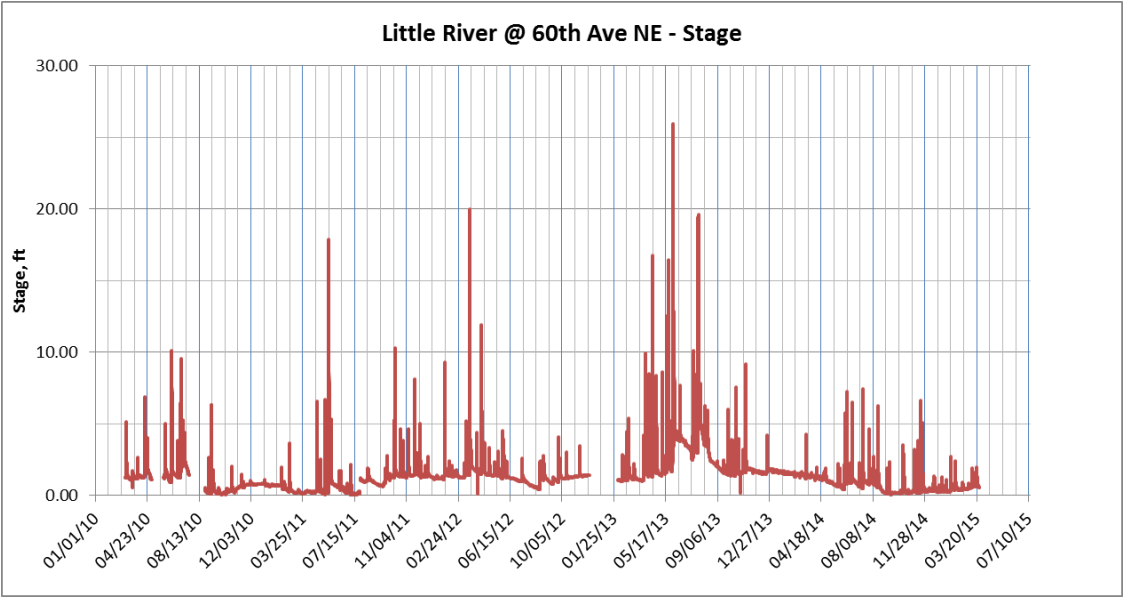
Figure 18: Stage plot for the Little River at 60<sup>th</sup> Ave NE site.

and from July 22, 2010 to August 25, 2010. Incidents such as this are the primary reason data downloading is conducted every 30 to 60 days, because it minimizes the amount of lost data should unforeseen events such as this occur.

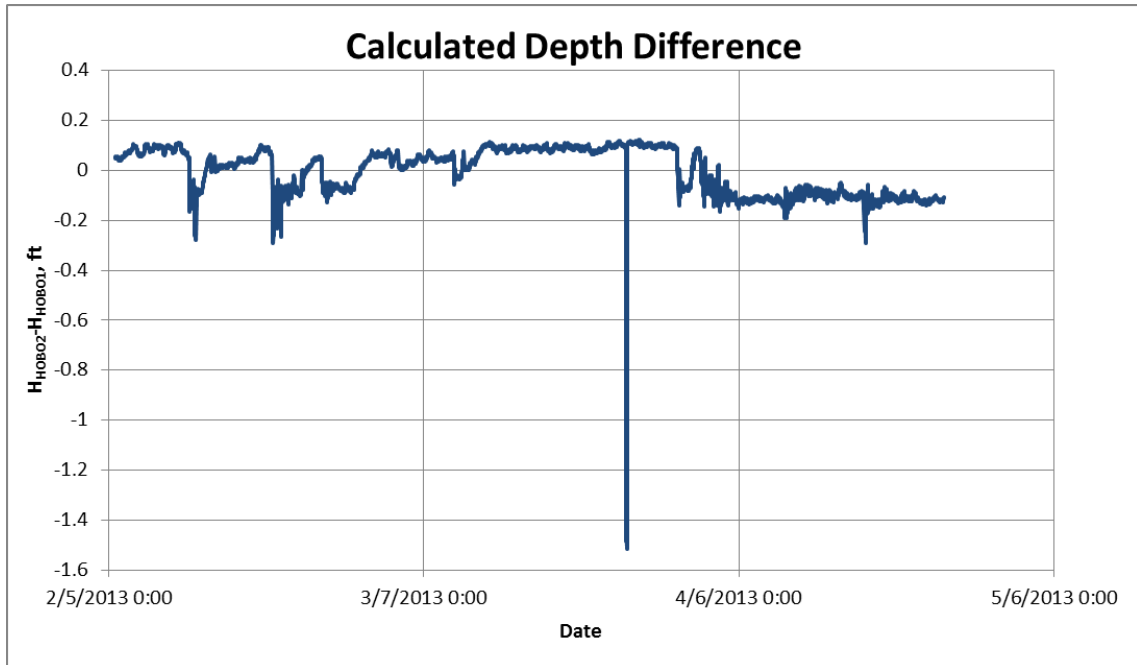
Figure 24: HOBO Side-By-Side Depth (stage) Measurement Difference Plot.

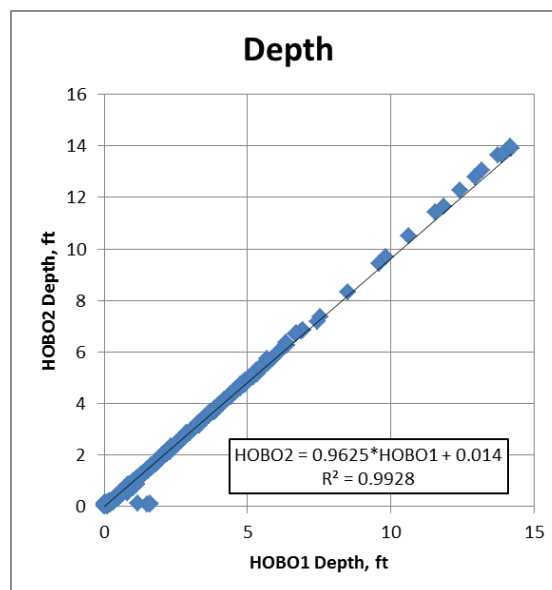
Figure 26: HOBOS Side-By-Side Measurement Depth Plot.

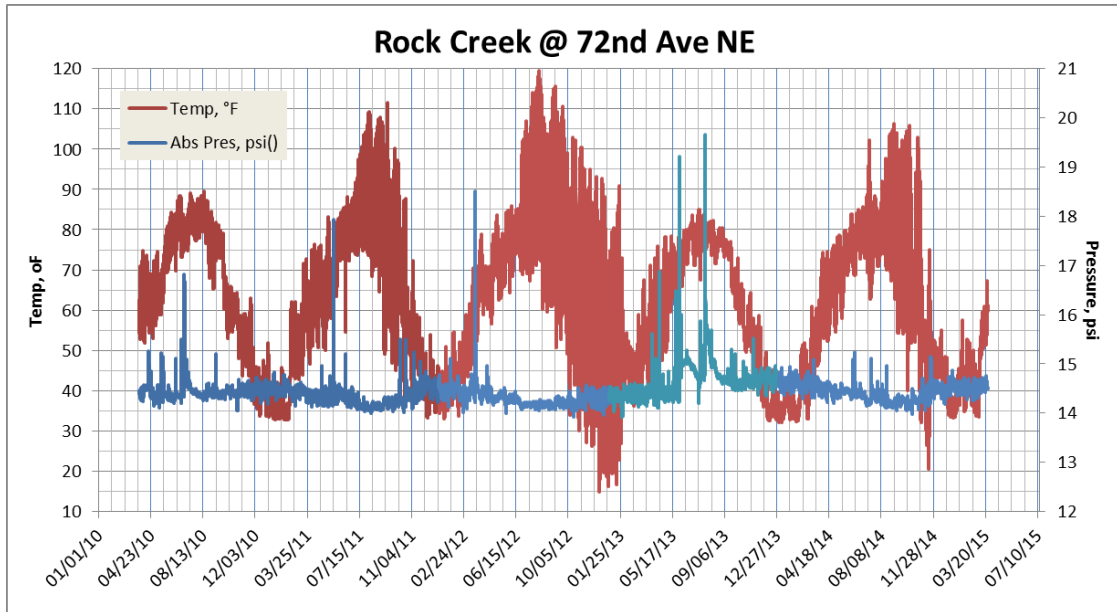
Figure 27: Temperature and pressure plots for the Rock Creek at 72<sup>nd</sup> Ave NE site.

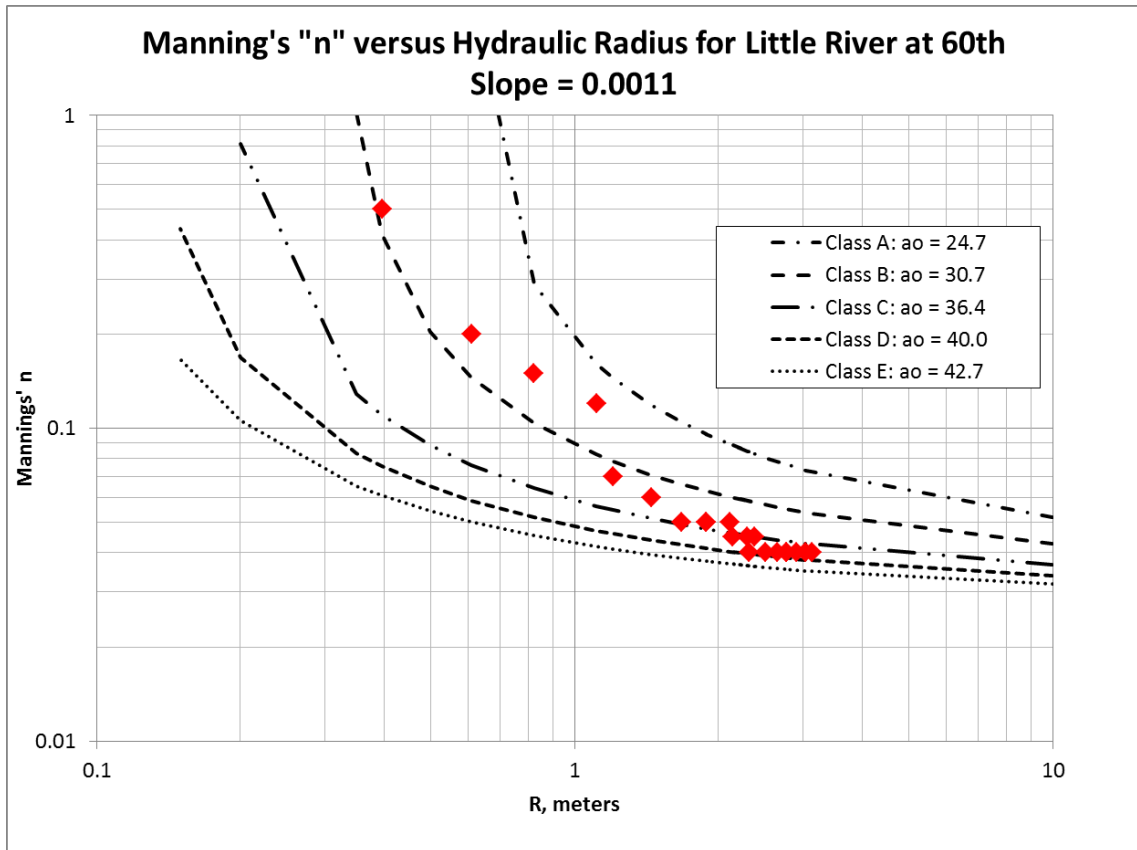
Figure 29: Manning's "n" versus hydraulic radius at Little River at 60<sup>th</sup> Ave NE.

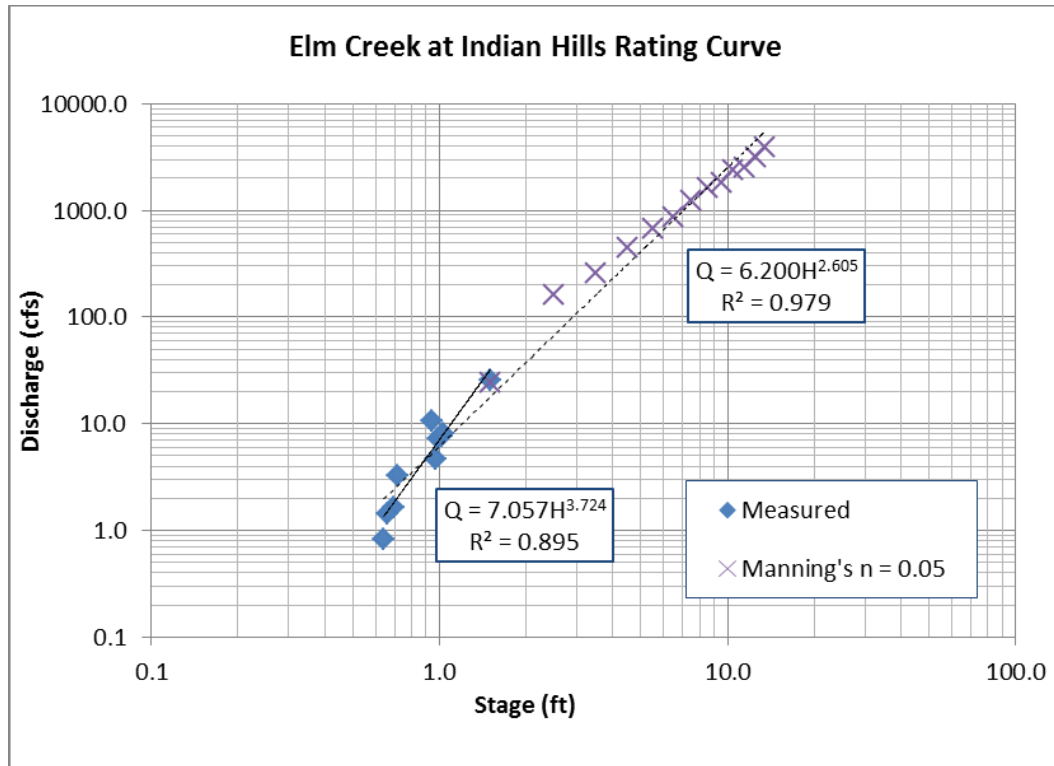
Figure 34: Elm Creek at Indian Hills stage-discharge rating curve.

Figure 34 shows the stage-discharge rating curve for the Elm Creek at Indian Hills site, the second site at which the ADCP was not used to measure high stage discharges. Again, the measured data are shown as blue diamonds. Discharge measurements ranged from 1.44 cfs to 25.64 cfs. The  $R^2$  value of the regression line from the measured data (solid line) is 0.8945, showing a fairly good relationship of the data. However, when calibration of “n” to the regression line was attempted, the “n” values required to match the extrapolated line dropped rapidly to less than 0.01, which is unrealistic, so that the extrapolated regression line of the data was deemed insufficient for use as a rating curve.

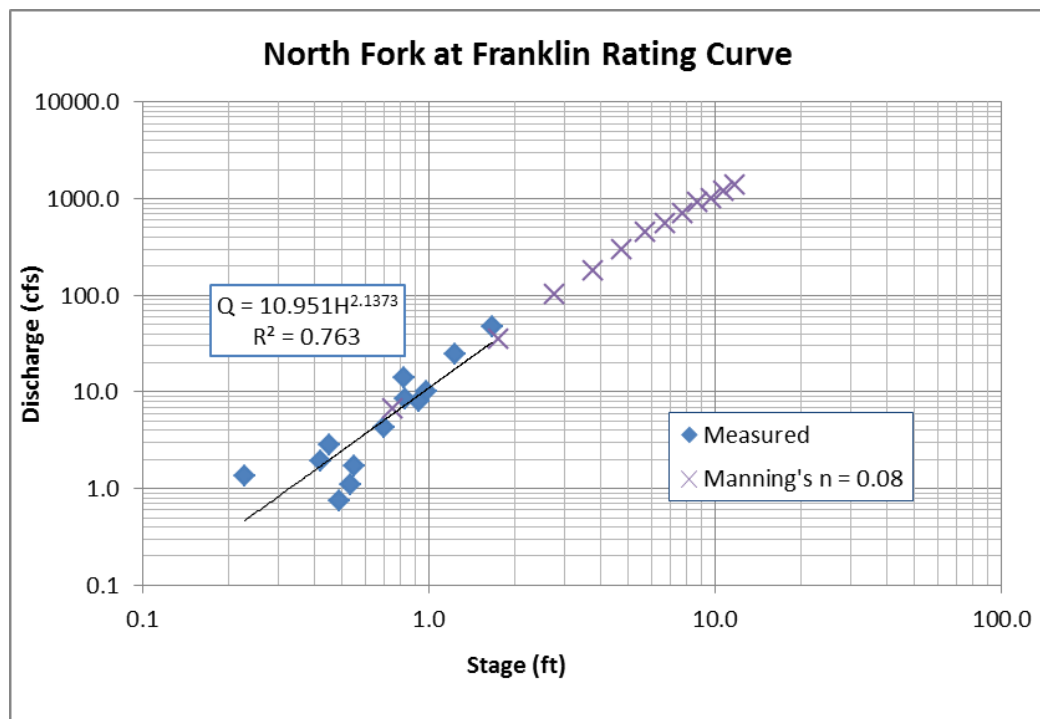
Figure 35: North Fork at Franklin stage-discharge rating curve.

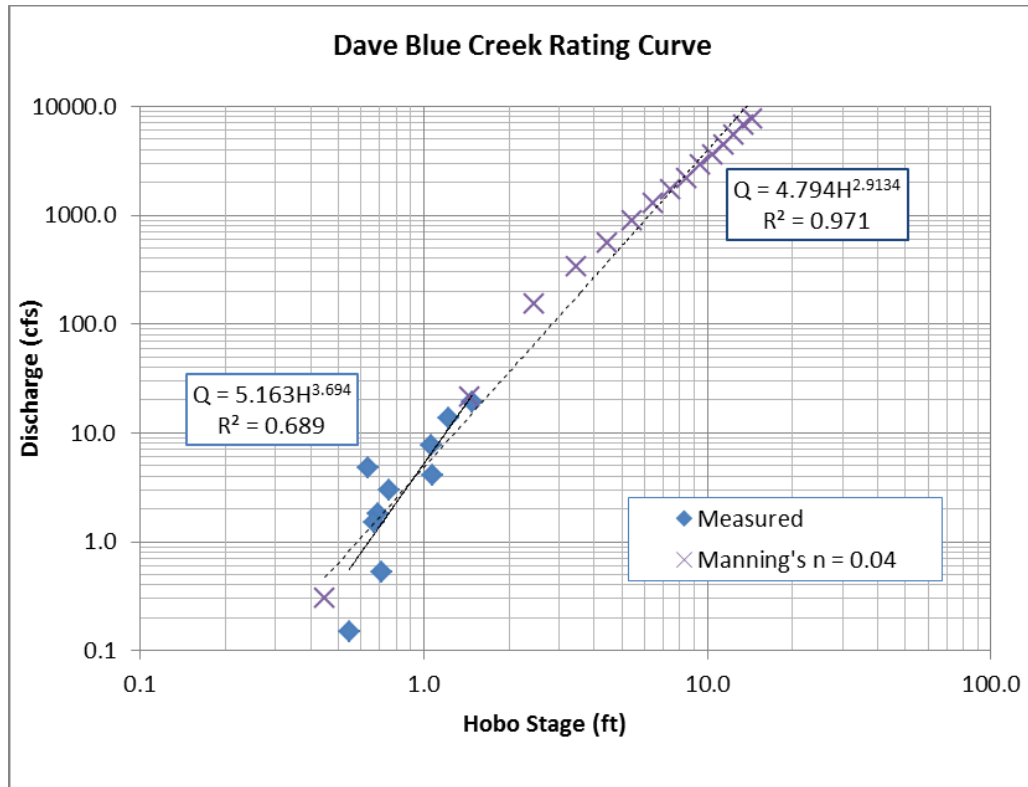
Figure 36: Dave Blue Creek at 72nd stage-discharge rating curve.

The final site where the ADCP was not used to measure high stage discharges was the Dave Blue Creek at 72<sup>nd</sup> Ave SE site. The stage-discharge rating curve for the site is shown in Figure 36. Measured discharges, shown as blue diamonds, range from 0.15 cfs to 19 cfs. The R<sup>2</sup> of the regression line of the measured data, at 0.6886, is the lowest observed in the study. This may be due to the extremely low discharges measured and possible error in measurement.

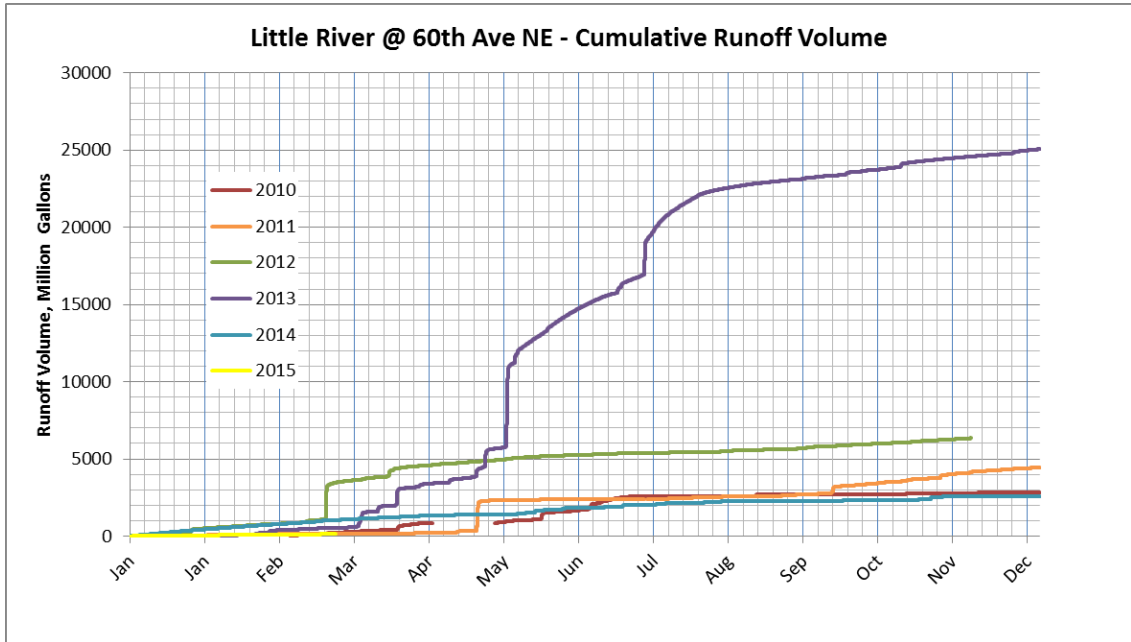
Figure 44: Cumulative Runoff Volume - Little River at 60<sup>th</sup> Ave, 2010-2014.

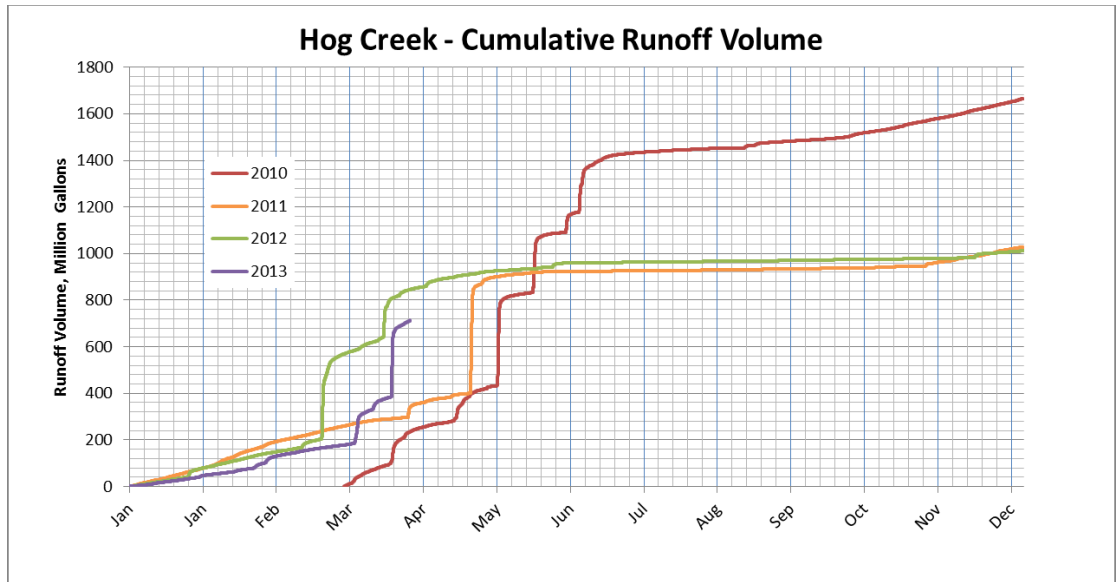
Figure 50: Cumulative Runoff Volume – Hog Creek, 2010-2013.

Creek (Figure 50) disappeared in March 2013, and was not replaced, it was not possible to estimate the cumulative runoff in 2013 or 2014.

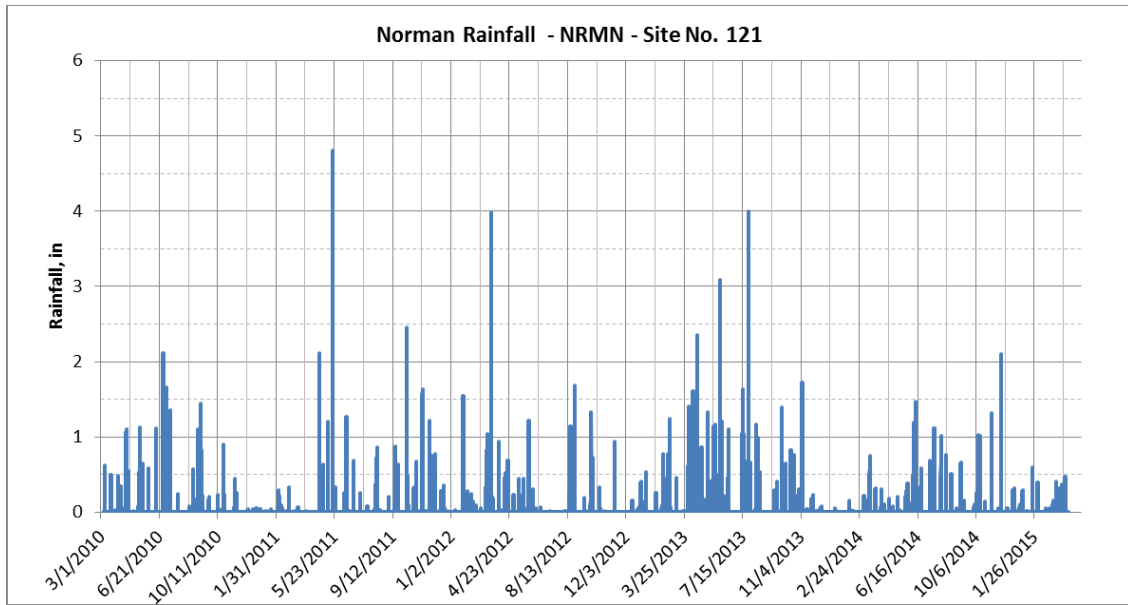
Figure 51: 30-Minute Rainfall Data for Norman, Oklahoma; Mar 2010 - Mar 2015.

Figure 51 shows the 30 minute rainfall data recorded at the Norman Mesonet station (NRMN – Site No. 121) for the period of the study. It may be seen that the largest rainfall event during the study was nearly 5”, 9 events exceeded 2”, 15 exceeded 1.5”, 43 exceeded 1”, and 89 exceeded 0.5”. Only storms producing 1.5” or more were considered for this assessment.

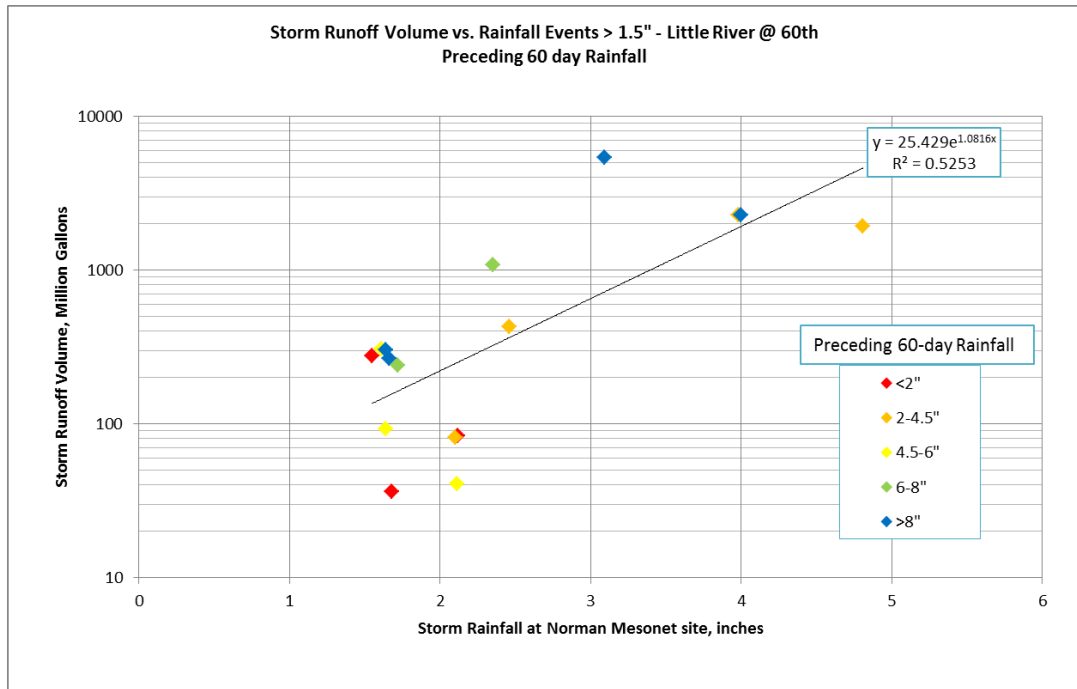
Figure 54: Storm Runoff Volume at Little River @ 60th vs. Rainfall Events > 1.5";  
Preceding 60-day rainfall.

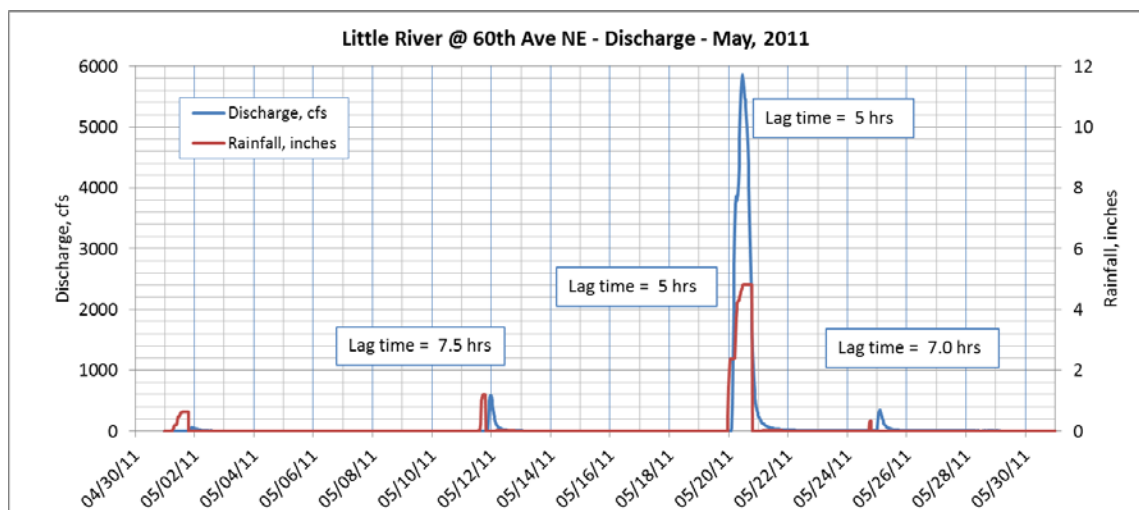
Figure 56: Discharge at Little River at 60<sup>th</sup> and rainfall at the Norman Mesonet station for May, 2011.

Figure 56 shows a plot of the discharge at the Little River at 60<sup>th</sup> site and the rainfall recorded at the Norman Mesonet site for May, 2011. It may be seen that four rainfall events were recorded at the Mesonet station during the month, three of which produced noticeable runoff events as recorded at the Little River at 60<sup>th</sup> site. The fact that no significant runoff was recorded following the rain event observed on May 2 could be an example of the rainfall recorded at the Mesonet station not always being representative of the rain actually falling on the watershed.

Figure 56 also shows the peak water surface elevation that was recorded during the study period (1,063.56 feet) and the highest measured water surface elevation (1054.06 feet). The largest discharge measured was 3,600 cfs, but the estimate from the rating curve at this stage is 4,200 cfs. Note that the channel was overflowing the right bank at the peak stage observed during the study, which had an estimated discharge of 12,500 cfs.

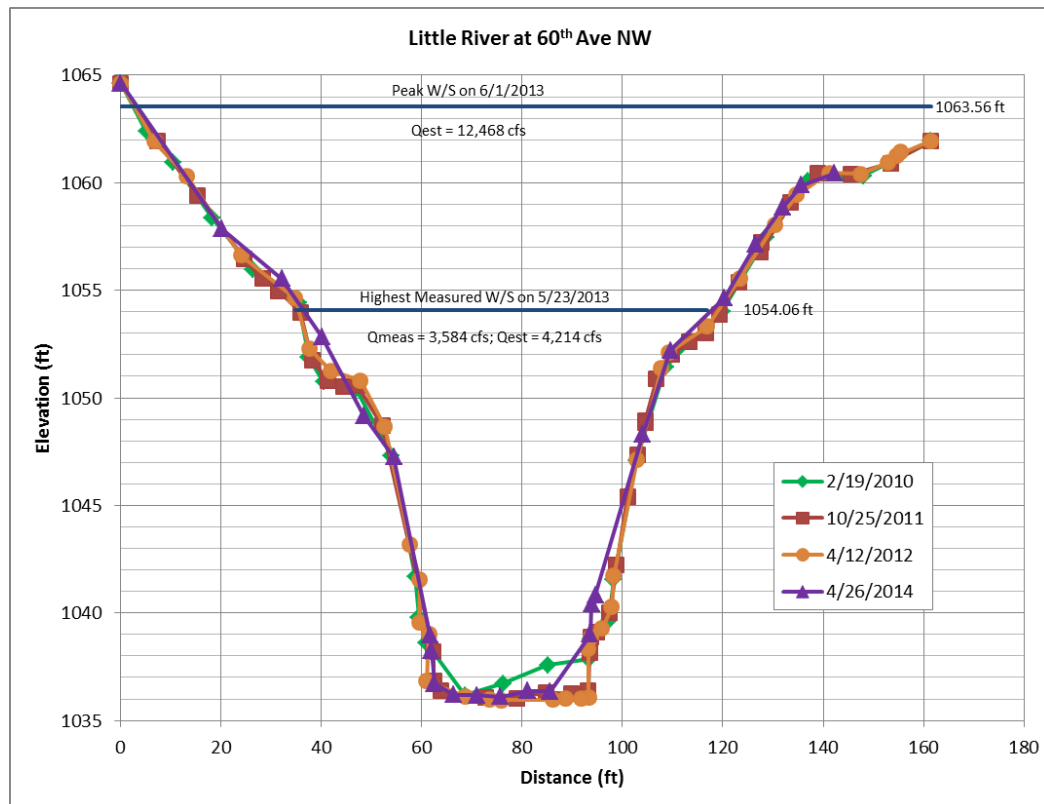
Figure 57: Cross-section Change at the Little River at 60<sup>th</sup> site.

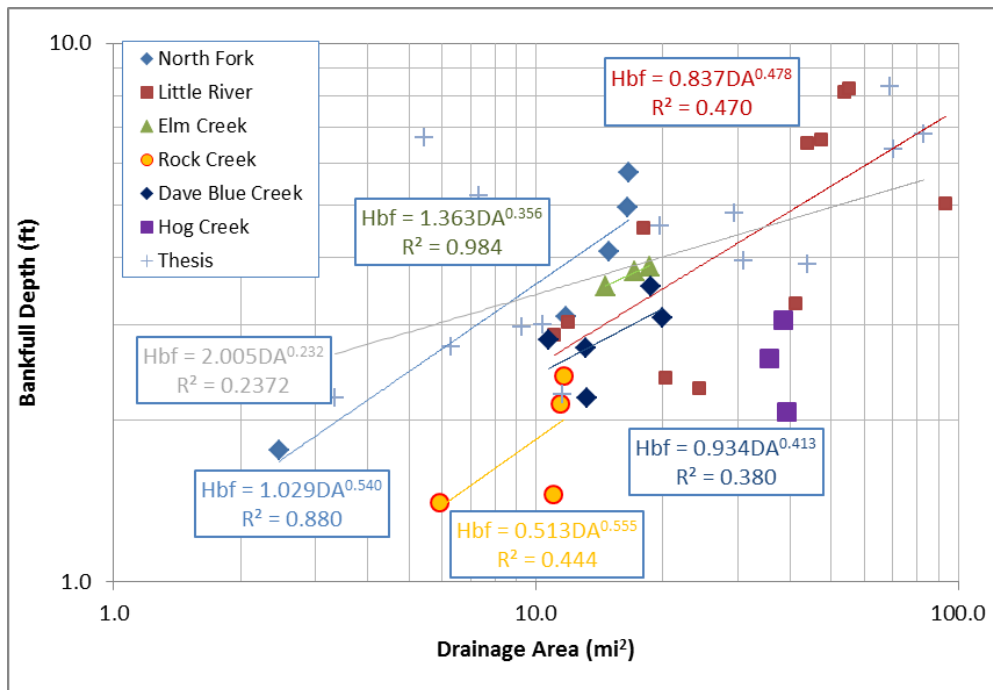
Figure 60: Bankfull Depth (ft) versus Drainage Area (mi<sup>2</sup>) Regional Curve for Lake Thunderbird watershed.

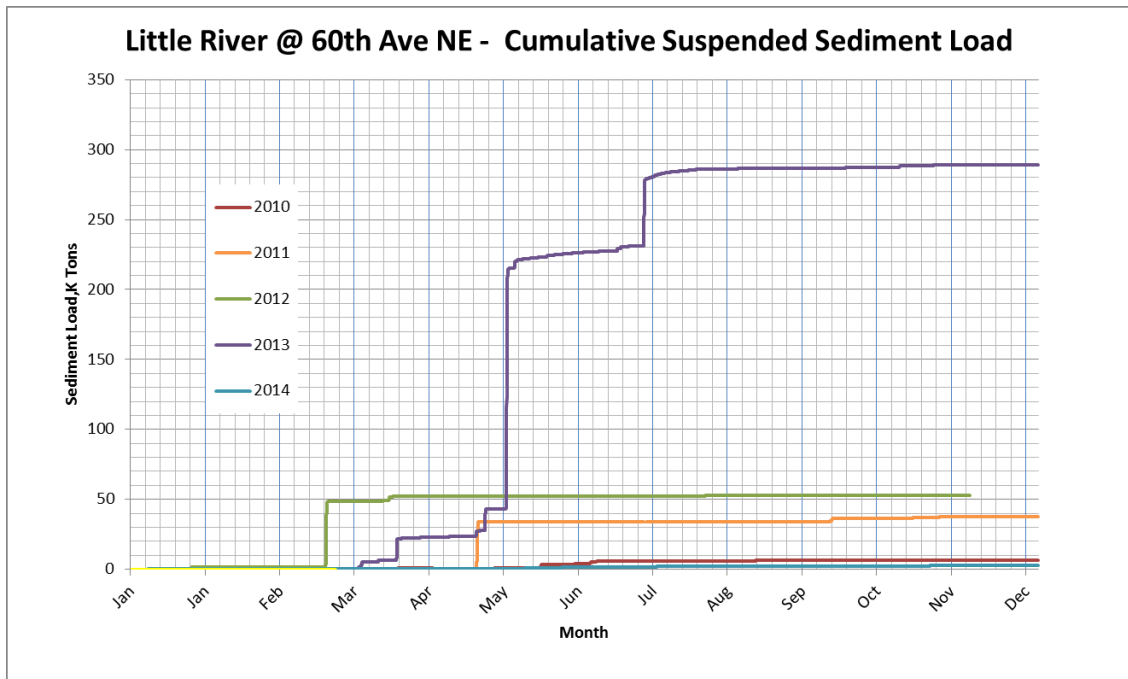
Figure 83: Annual Cumulative Sediment Loads to Lake Thunderbird from the Little River Watershed; 2010-2014.

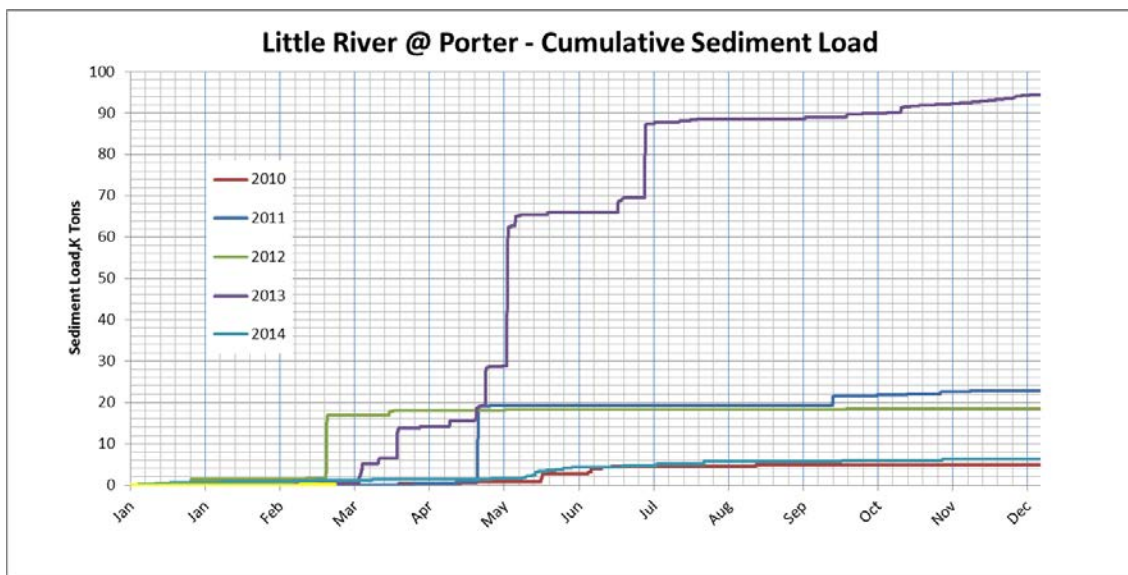
Figure 84: Annual Cumulative Sediment Loads at the Little River at Porter site; 2010-2014.

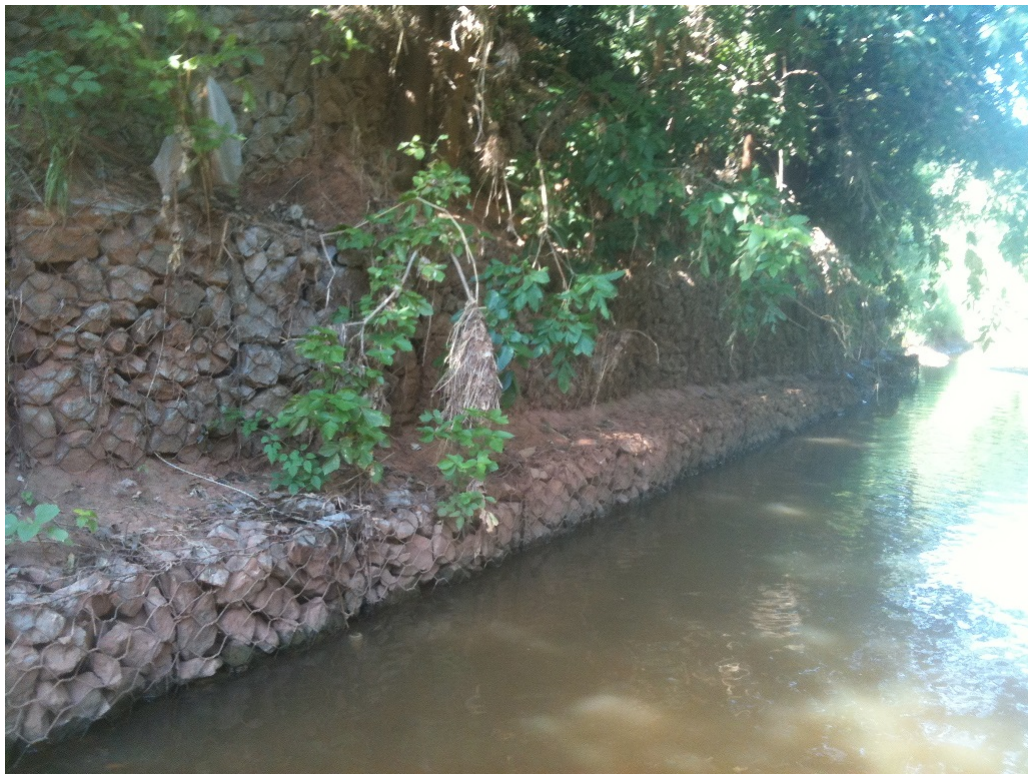
*Figure A.1.3: Little River at 60<sup>th</sup> Ave NE HOBOT replaced installation.*

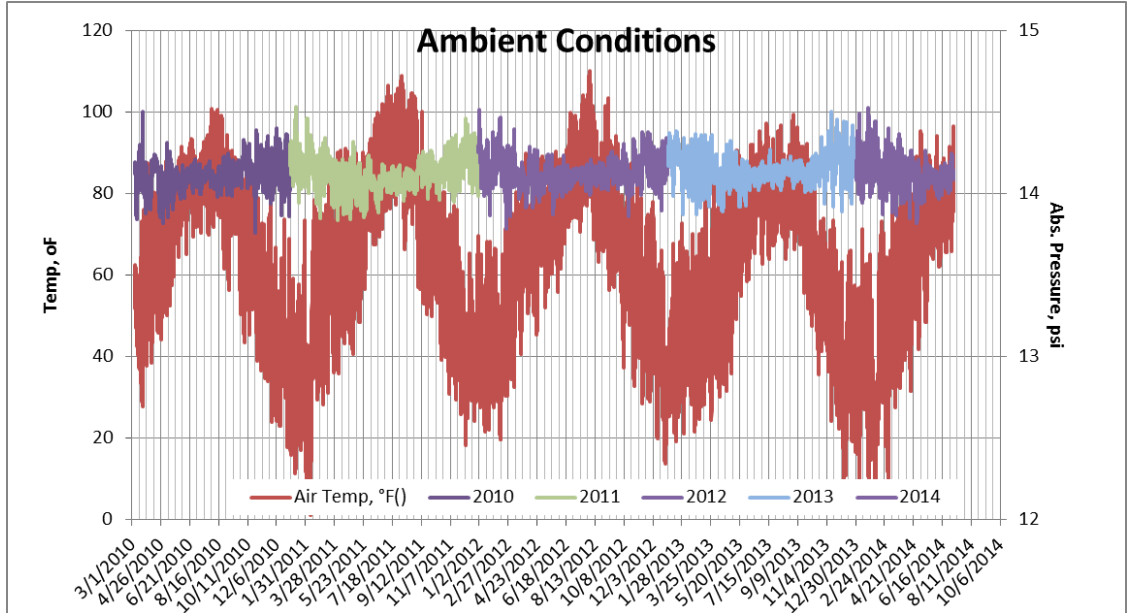
Figure C.1.1: Ambient Conditions site HOBO data plot.

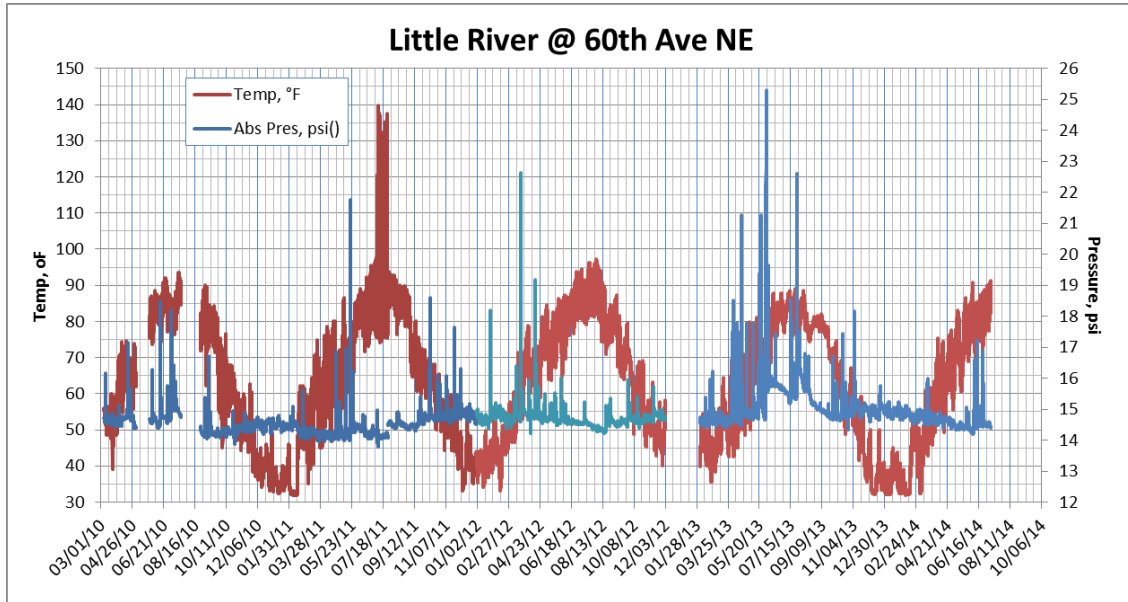
Figure C.2.1: Little River at 60<sup>th</sup> Ave NE site HOBO data plot.
