ANALYSIS OF LOAD PATHS IN RESIDENTIAL
HOUSES

Submitted to the Faculty of the
Graduate College of the
Oklahoma State University
in partial fulfillment of
the requirements for
the Degree of
MASTER OF SCIENCE
May, 2014

Abstract: The Moore tornado on May 20th 2013 caused severe damage to numerous residential homes. A research team was sent to rate the damage and collect information about load paths during tornadic events. The team found that the load paths of the houses were insufficient and that failure was occurring in the connections. Using the information they collected a relationship between the centerline of the tornado path and EF rating could be seen. This could be used to see how and where the failure occurs. In addition to a statistical analysis a theoretical analysis was also done to support the information from the research team. This analysis also included the comparison of nailed and metal connection to see the benefit they provide.

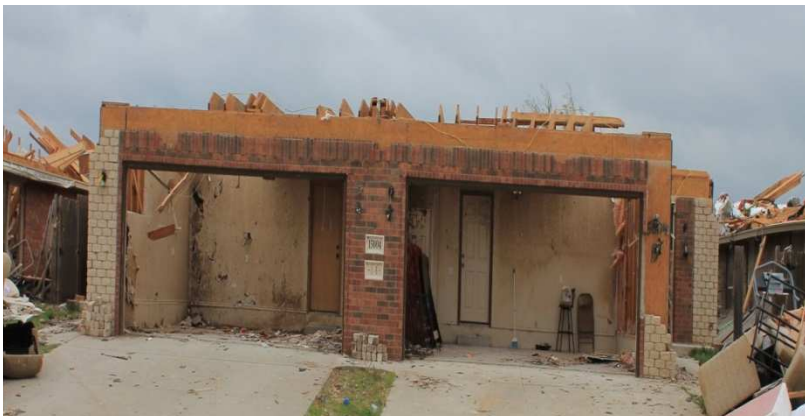
Figure 2: Roof Failure

The roof to top plate connection is where the load path begins. This connection has to transfer the uplift load from the roof to the top of the stud walls. This connection is one of the most important because of two reasons. One the dead load of the roof is obviously smaller than the rest of the house. Since this helps resist the uplift forces it requires better connections. Secondly if these connections fail the house loses its ability to behave as a diaphragm, greatly lowering the capacity. Figure 2 below shows this failure mode.

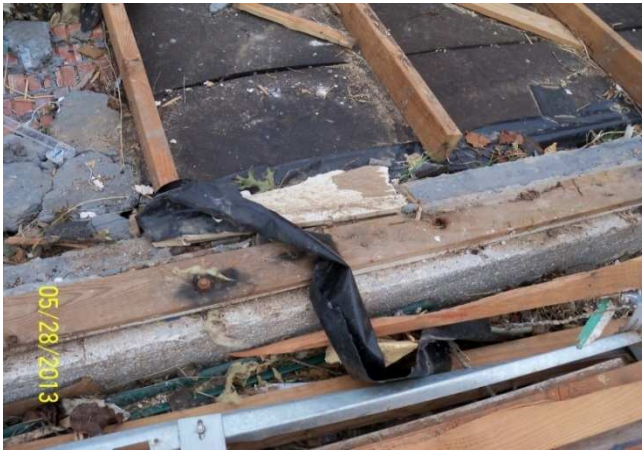
Figure 3: Failure of Stud to Bottom Plate Connection

When the connection between the studs and the bottom plate fail, the wall and roof systems are removed leaving the bottom plate anchored to the foundation as seen in Figure 3. Typically for this connection you will see the used on end nails. This is done for ease of construction. However since these nails are parallel to the grain they provide no withdrawal design capacity. Sheathing helps transfer the load from top to bottom plate as well if it is adequate. The sheathing is loaded in shear so the connection is much stronger .

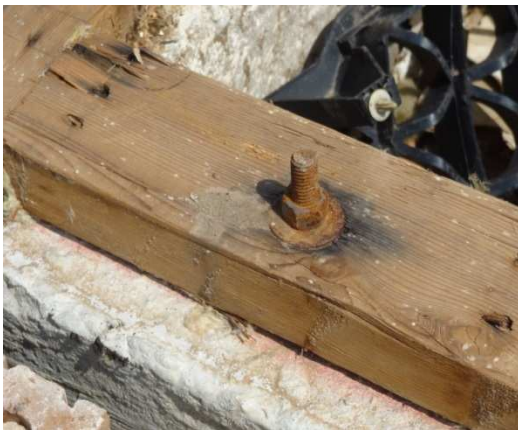
Figure 4: Bottom Plate Anchored to Foundation

The bottom plate would fail if the connections above it are adequate and the wood fails before the bolt reaches capacity. This type of failure leaves the anchor bolt in the foundation but removes the bottom plate. The difference between the stud connection failure and bottom plate failure can be seen in Figures 4 and 5. Notice in Figure 5 the bolts are bent but still have the nuts attached. This type of failures could be prevented several different ways such as decreasing anchor spacing, using larger pieces of lumber for the bottom plate, larger washers. All of these solutions increase the amount of surface area being loaded thus lowering the stress. This type of failure could also

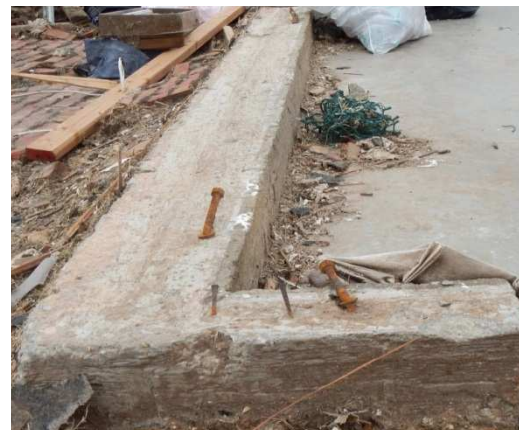
Figure 5: Failure of Bottom Plate

occur if the roof system is removed and the walls began to act as a moment arm about the bottom plate. This would put pressure perpendicular to the grain and could cause the wood to fail. This would explain the bending of the anchor bolts.

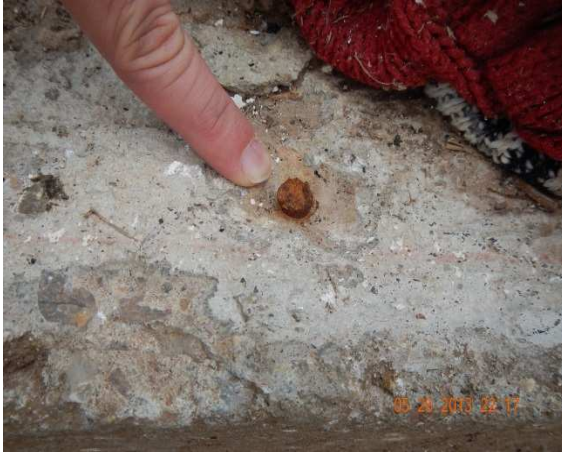
Figure 6: Shearing of Anchor Bolt

The second type of failure that occurs at the bottom plate is a bolt failure. Instead of the plate failing the bolt is the failure mechanism. The two failure types in this case were shear failure and thread failure or slippage. Shear can be observed in Figure 6. The two ways to resolve this issue is to either increase the size of the bolt or decrease bolt spacing. The problem with increasing the bolt size is that it would require a larger hole to be drilled in the bottom plate thus reducing the cross sectional area of the wood member increasing the probability of failure. In Figure 7 the anchor bolt is still attached but the nut has slipped. Again this could be prevented by decreasing bolt spacing. Also this could have occurred due to inadequate bolt length and not enough extra thread was provided for the nut.

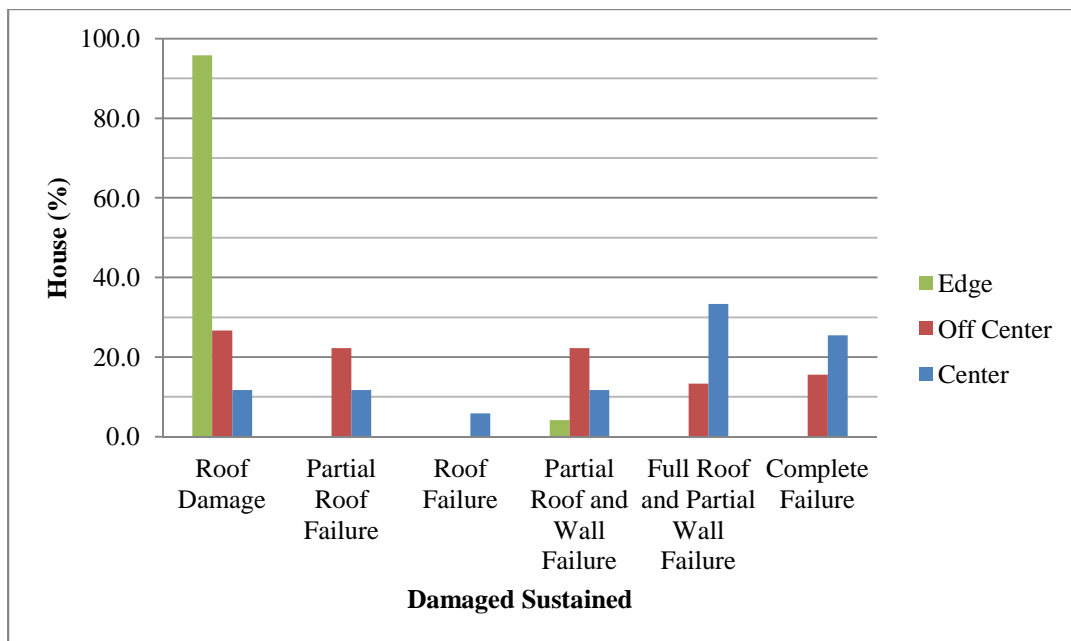
Figure 13: Percent of Houses vs. Damaged Sustained Based on Location

Below Table 5 shows that there is a relationship between the distance to the centerline of the tornado and the severity of the damage sustained. Figure 13 shows the same information in a bar graph.

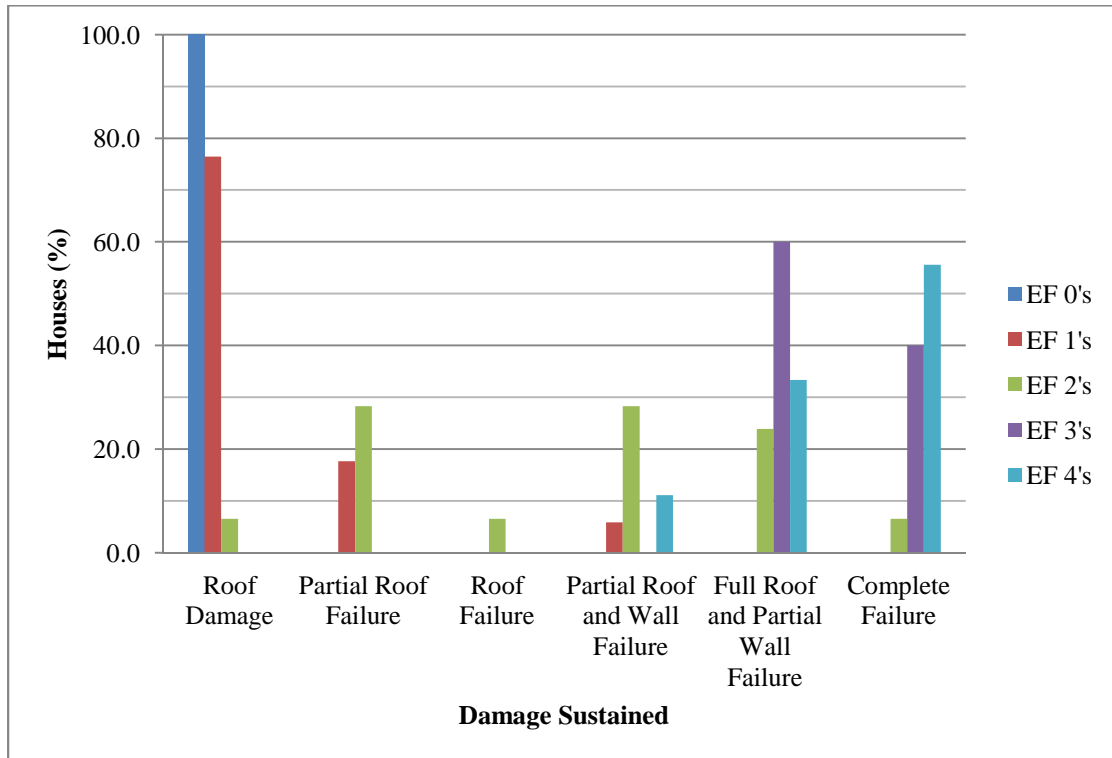
Figure 14: Percent of Houses vs. Damage Sustained Based on EF Rating

Table 6 shows the relationship between the EF rating a particular house was given and the damage that it sustained. Figure 14 shows this same information in graph form.
