A COMPARISON OF HYDROGEN AND MERCURY  
EMBRITTELEMENT OF NICKEL BASED  
ALLOYS

Submitted to the Faculty of the Graduate College  
of the Oklahoma State University  
in partial fulfillment of the requirements  
for the Degree of  
MASTER OF SCIENCE  
July, 1983

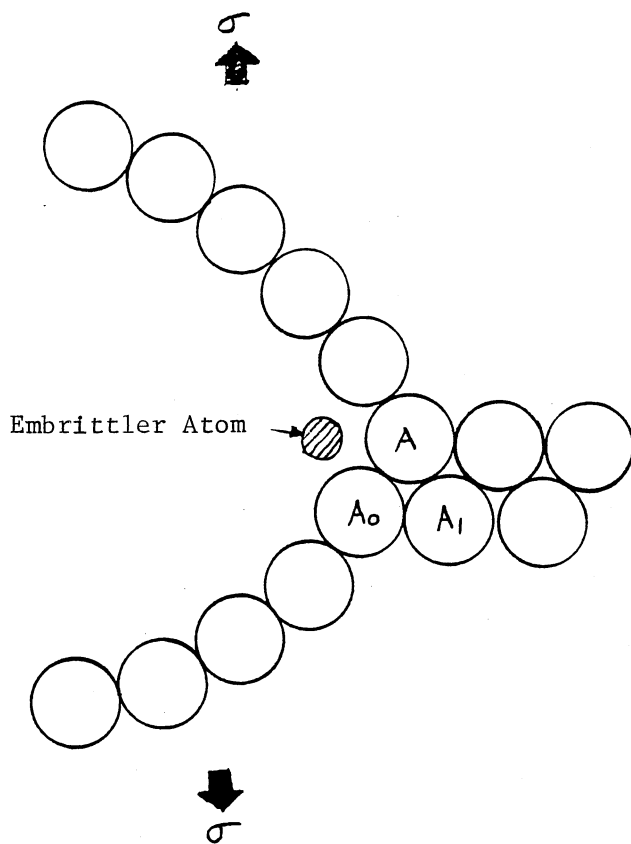
Figure 1. A proposed model of crack propagation through a metal lattice in which the embrittler atom interacts with the surface.

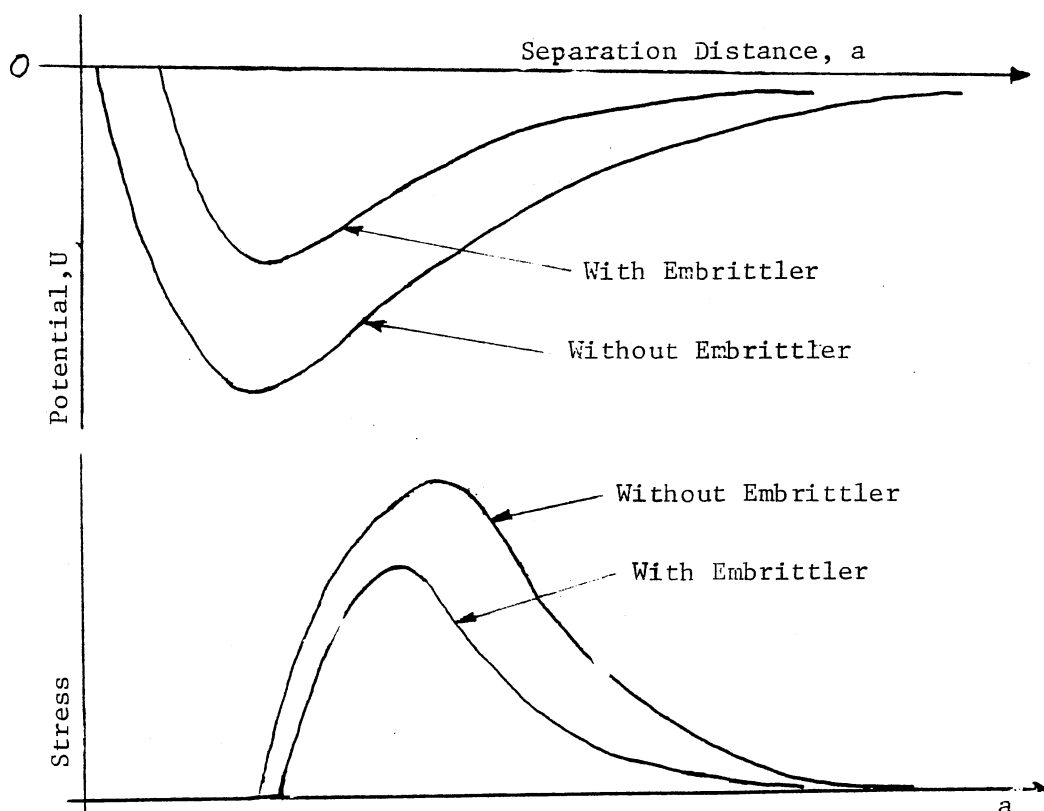
Figure 2. Potential energy and stress separation curves for bonds of the type A-A<sub>0</sub> with and without chemisorption.

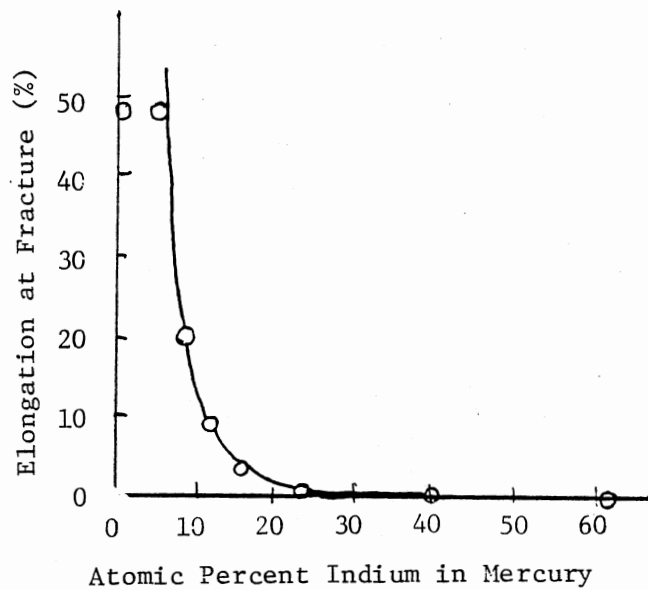
Figure 3. Variation in ductility of polycrystalline cadmium with the indium content of a mercury-indium surface coating.

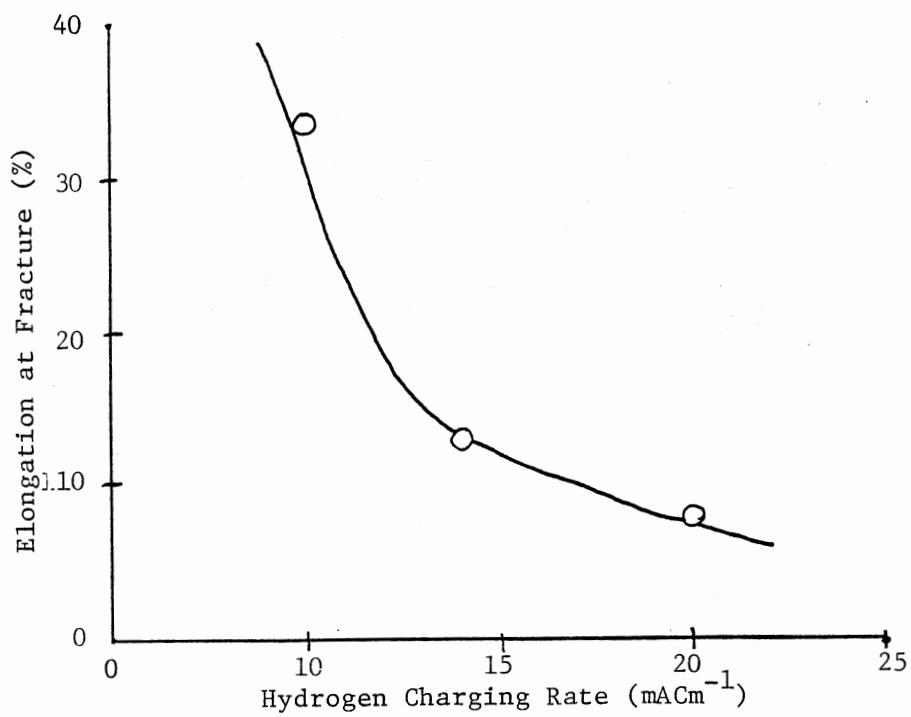
Figure 4. Variation of ductility with hydrogen charging rate for Monel 400.

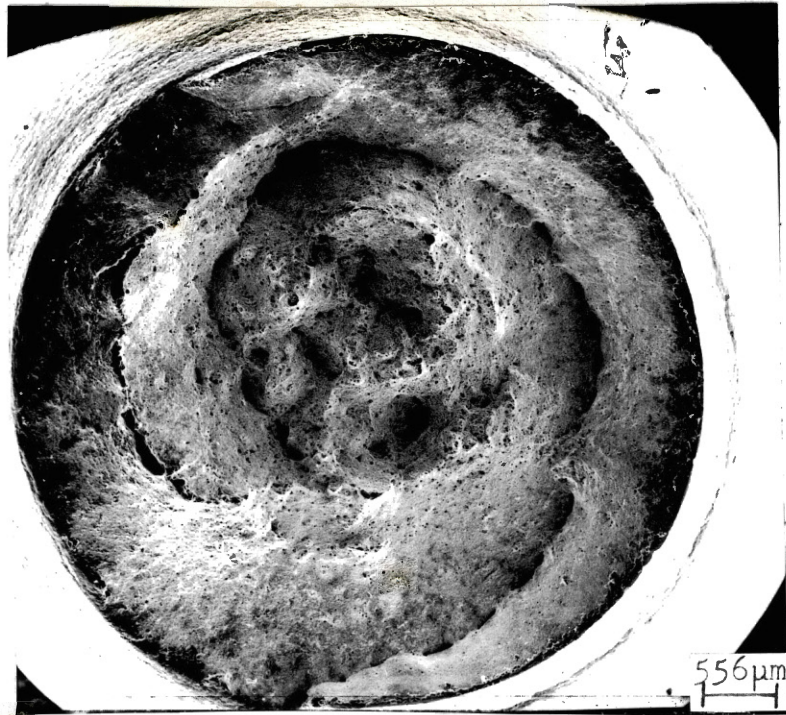
a. A typical cup and cone fracture of Incoloy 800 tested in mercury.

b. A typical slant fracture. Monel R405 tested in mercury.

Figure 7. The two types of fractures that occur in the mercury environment for the SSR tensile test.

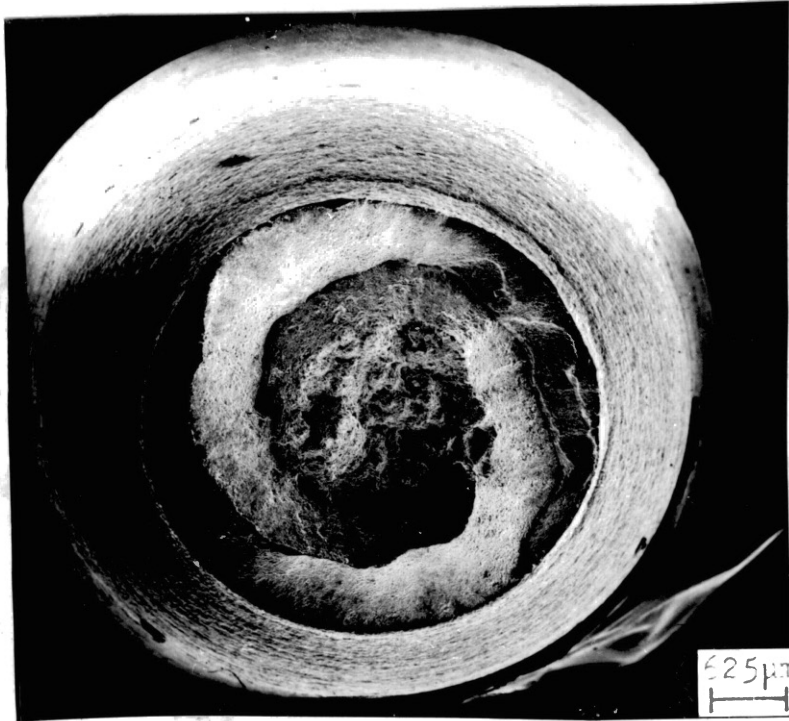
Figure 8. A Monel 400 fractured in air. This is a cup and cone fracture, which is the normal mode for SSR tensile tests in air.

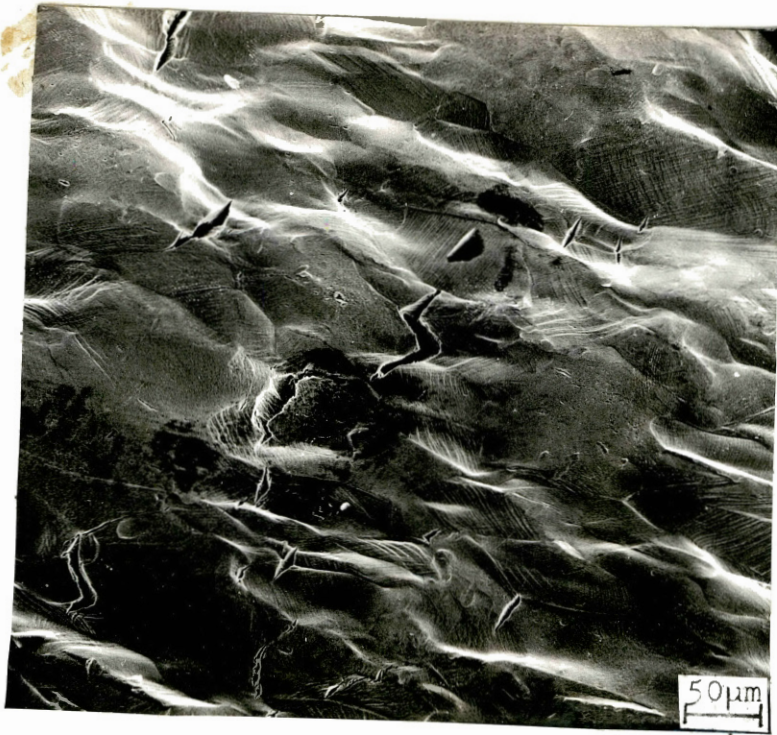
b. A closeup of Figure 27a showing that cracks do not tear across slip traces on grain boundaries.

Figure 27. Cracks that occur on the outside surface of a Nickel 200 specimen fractured in hydrogen.

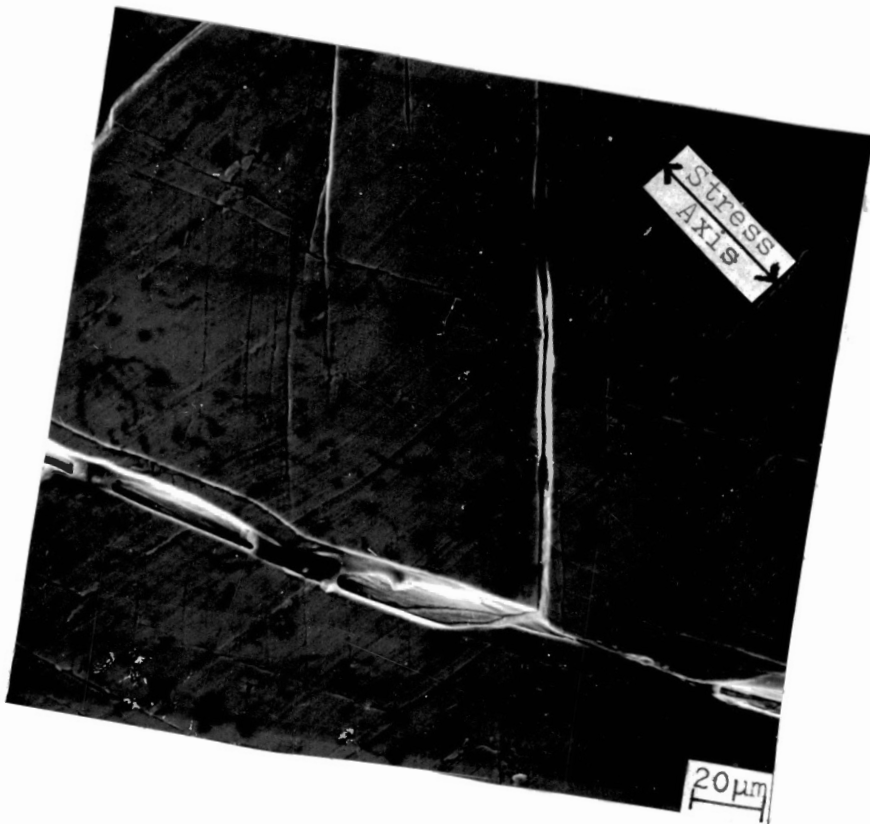
Figure 29. The outside surface of a Hastelloy C-276  
fractured in air showing  $45^\circ$  to the  
stress axis cracks.
