A STUDY OF ROLLER COMPACTED CONCRETE
AS A PAVING MATERIAL

Submitted to the Faculty of the Graduate College
of the Oklahoma State University
in partial fulfillment of the requirements
for the Degree of
MASTER OF SCIENCE
July, 1985

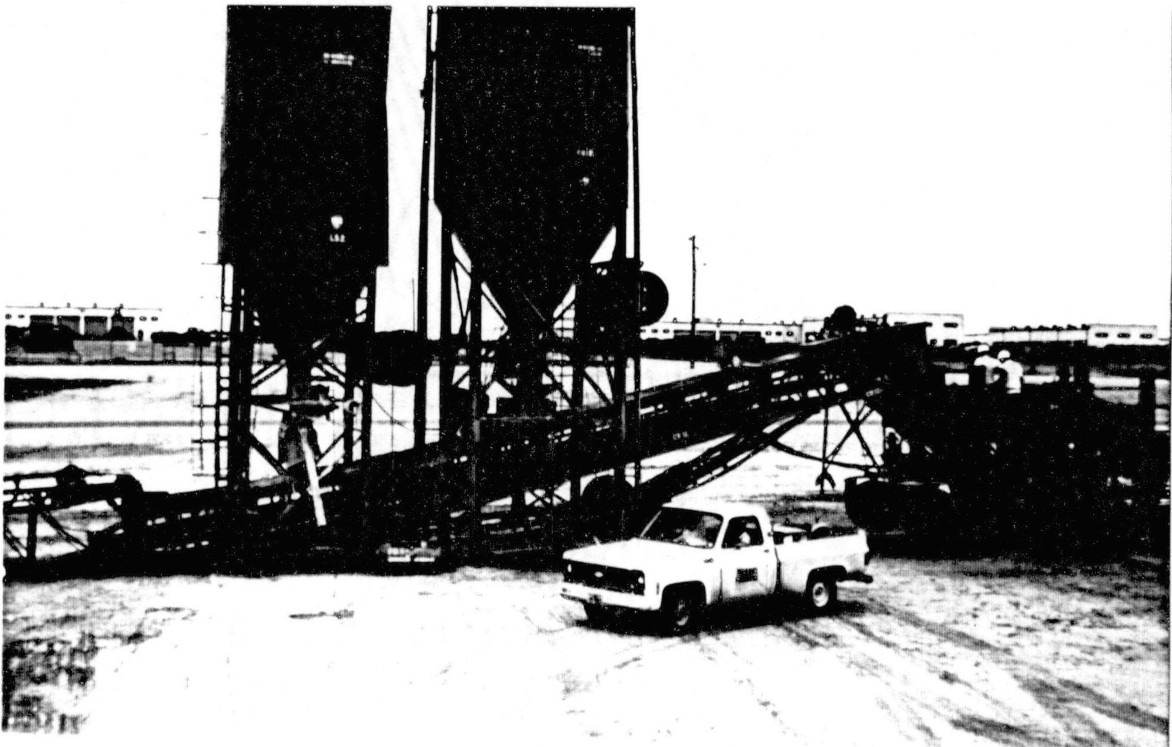
Figure 1. Photographs of Aggregate Bins, Silos, and Pugmill

(a) Aggregate Bins

(b) Silos and Pugmill

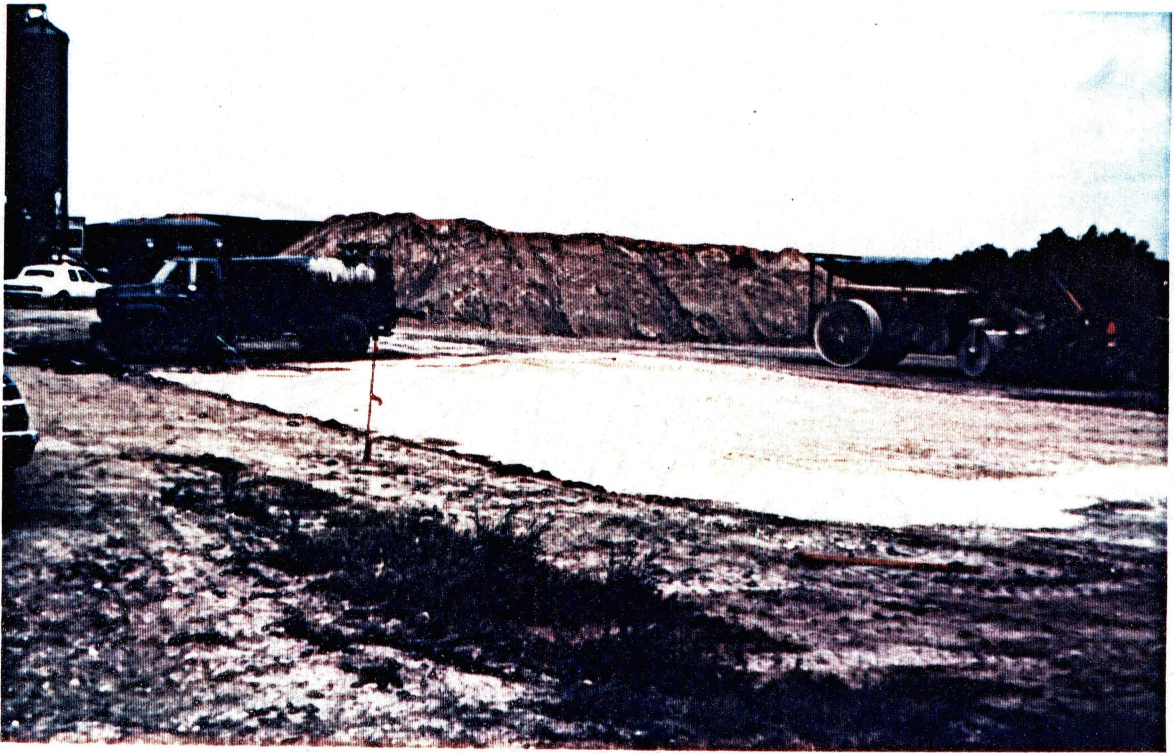
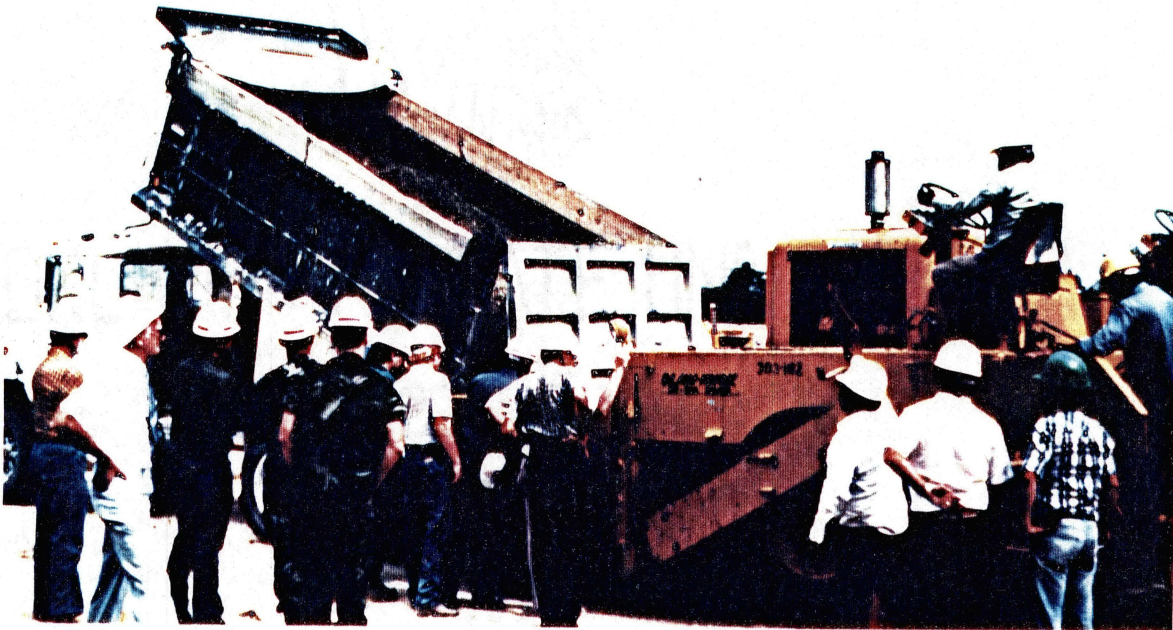
Figure 2. Photographs of Foundation and First Load of RCC

(a) Prepared Foundation for Test Section

(b) Dumping of First Load of RCC

The first test section, consisting of two 70-foot adjacent lanes, was constructed on June 4, 1984. A foundation was prepared similar to what would be used on the actual hardstand. The plant mix was trucked the short distance to the foundation and dumped into the laydown machine hopper (see Figure 2). An attempt to place a single 13- to 14-inch loose lift of RCC with a Blaw-Knox model PF 220 asphalt laydown machine met with little success. The lift thickness was too great for the machine to place without tearing the surface of the mix, as is shown in Figure 3. The surface defects were hand-filled with a shovel prior to the rolling operation. The contractor elected to construct the second lane in two lifts (also shown in Figure 3), first by dumping the mix directly on the foundation, then by spreading with a motor patrol to about 8 to 10 inches

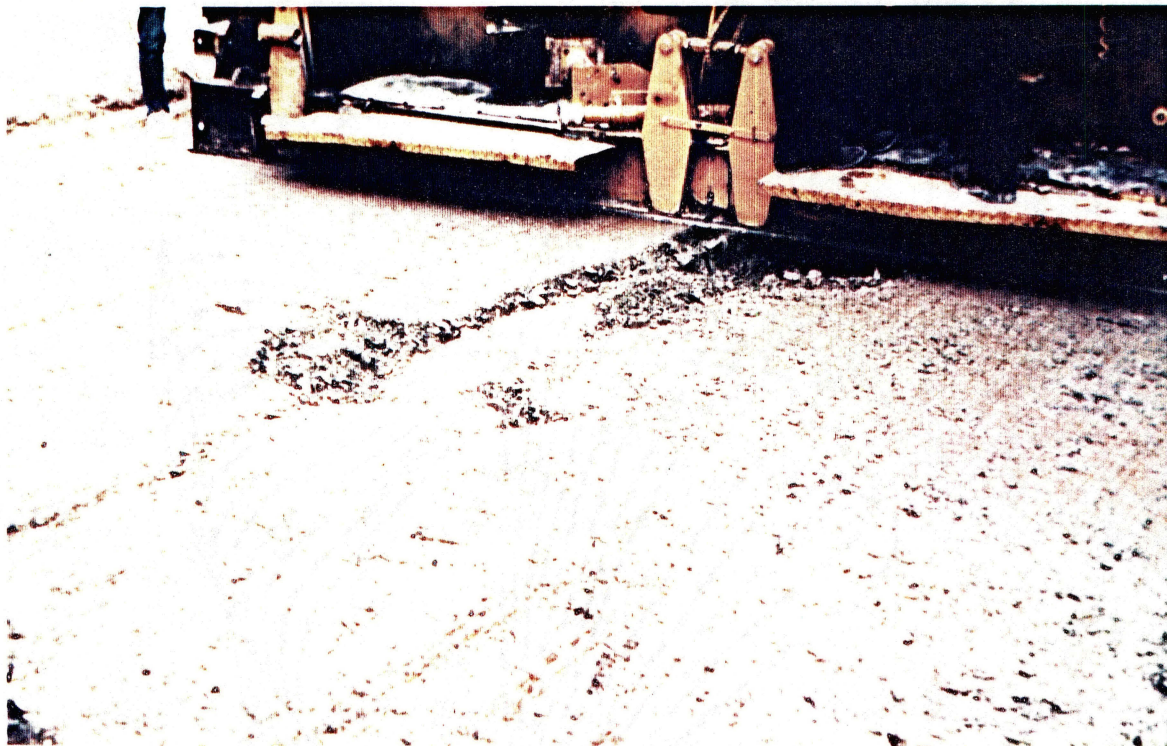
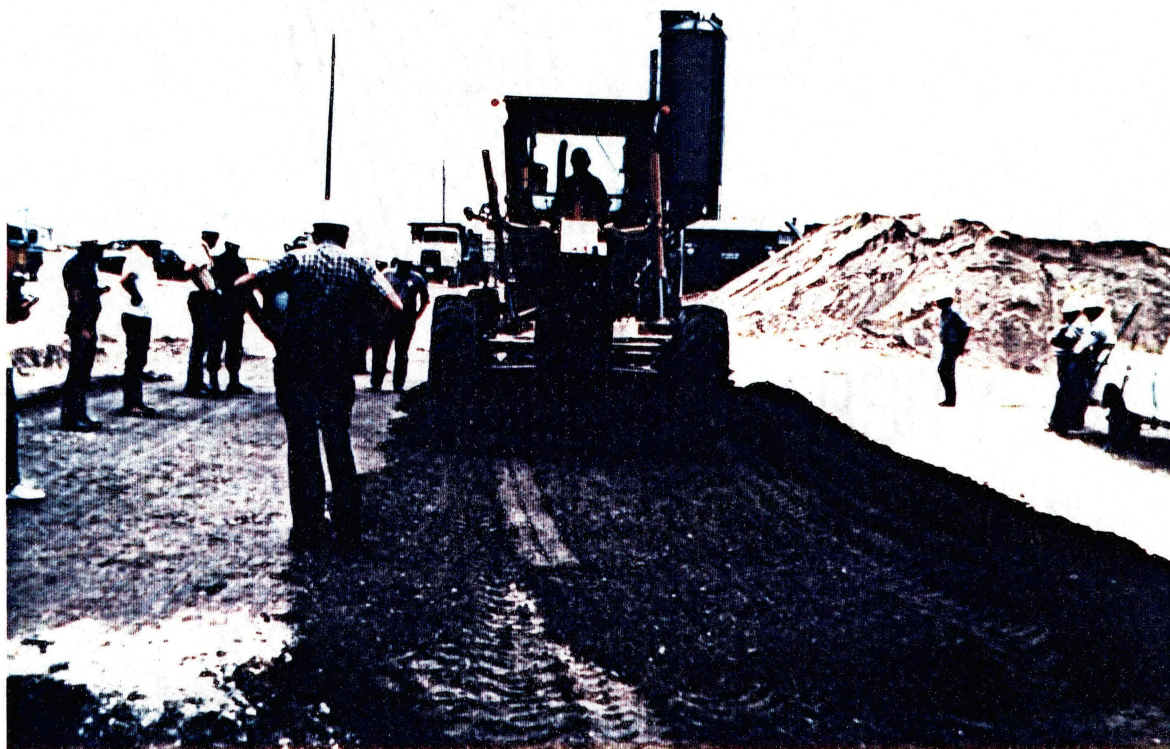
Figure 3. Tears in Surface and Two-Lift Construction

(a) Surface Tears Caused by Augers

(b) Second Lane, Two-Lift Construction

On June 8, 1984, the contractor began construction of a second test section, a single lane 12 feet wide and 100 feet long. During the interim between test sections, the contractor modified the augers on the laydown machine on the assumption the augers would distribute the RCC better and prevent the tearing that occurred the first time. Placement of the second test section consisted of a single loose lift between 11 and 12 inches thick with the laydown machine and compaction with the vibratory roller. Half of the section, longitudinally, was moist cured and the remaining half was cured with curing compound applied directly to the surface. Rolling patterns were experimented with and moisture-density measurements were made with a Troxler Road Reader nuclear gage, Model No. 3411-B, with a 12-inch probe.

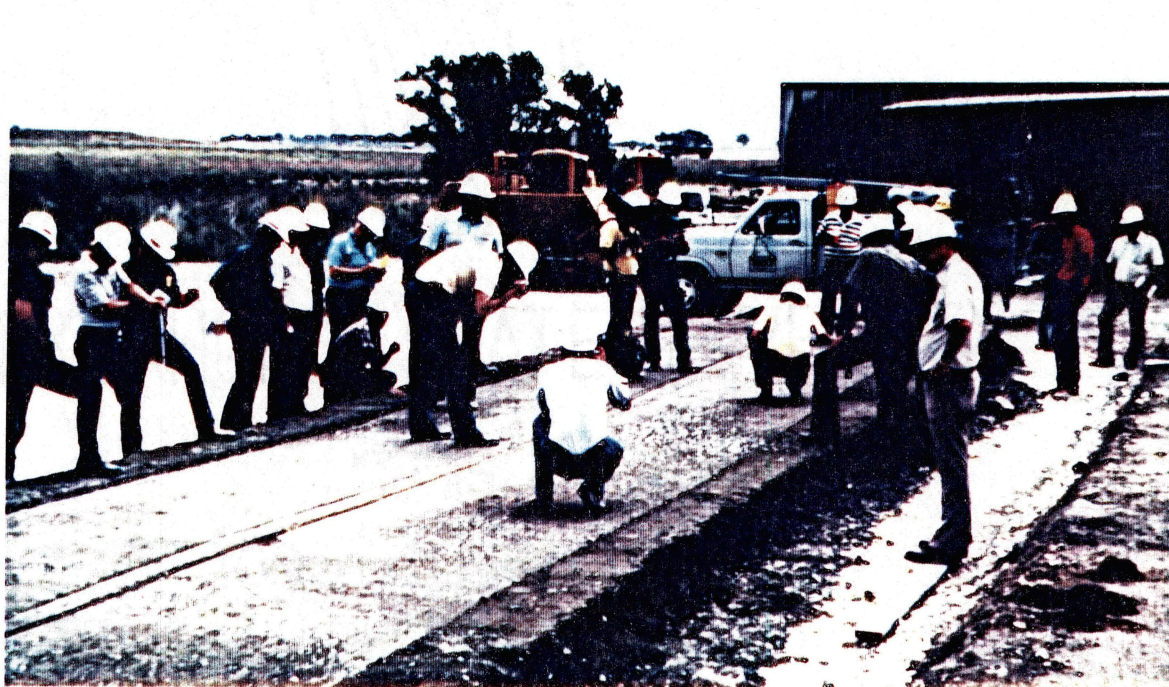
Figure 4. Initial Rolling of Test Section

(a) Initial Rolling of First Lane of Test Section

(b) Results of First Pass of Roller

Compaction was accomplished by rolling with a self-propelled tandem 10 ton, Tambo, smooth steel wheel vibratory roller (see Figure 4). An attempt to seal the surface with a 10 ton static pneumatic tired roller resulted in rutting of the surface. The steel wheeled roller was able to remove most of the ruts but not satisfactorily. During placement of the second lane, a thunderstorm with intense rainfall and lightning stopped all operations. No density-moisture measurements were taken as a result of the storm.

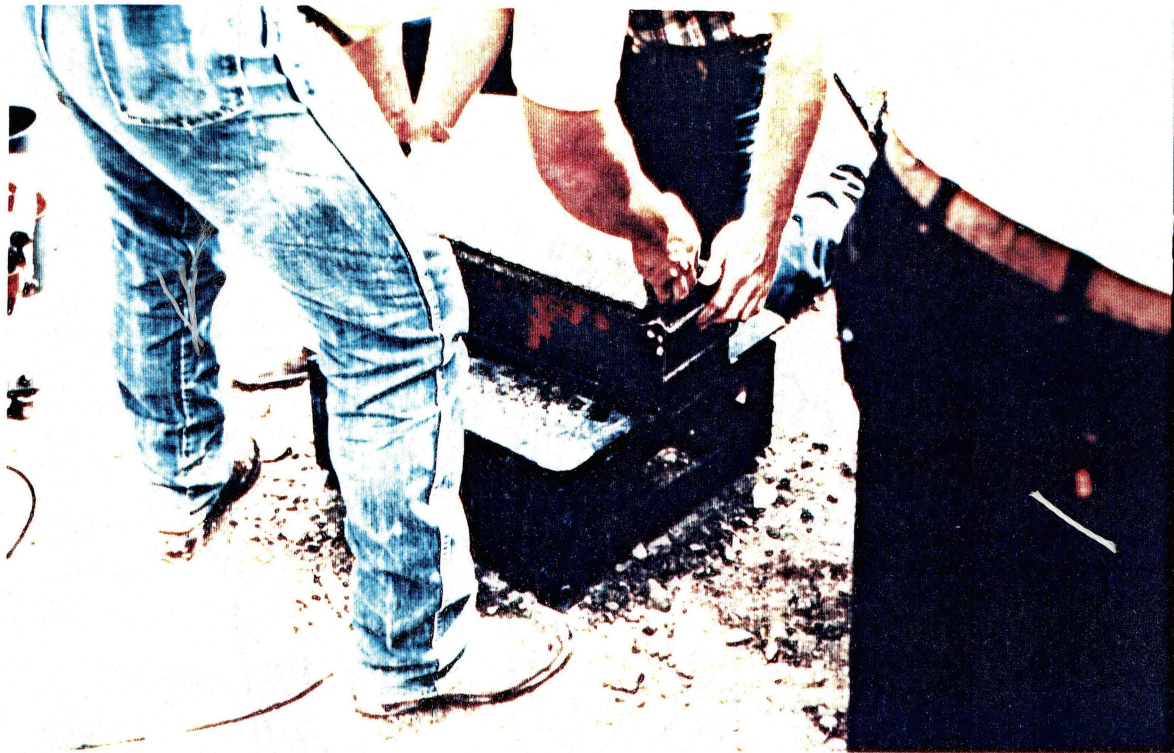
Figure 5. Beam Molding and 6-Inch Core Hole

(a) Field Molding of Beam on Portable Vibrating Table

(b) Surface Where 6-Inch Core Was Extracted

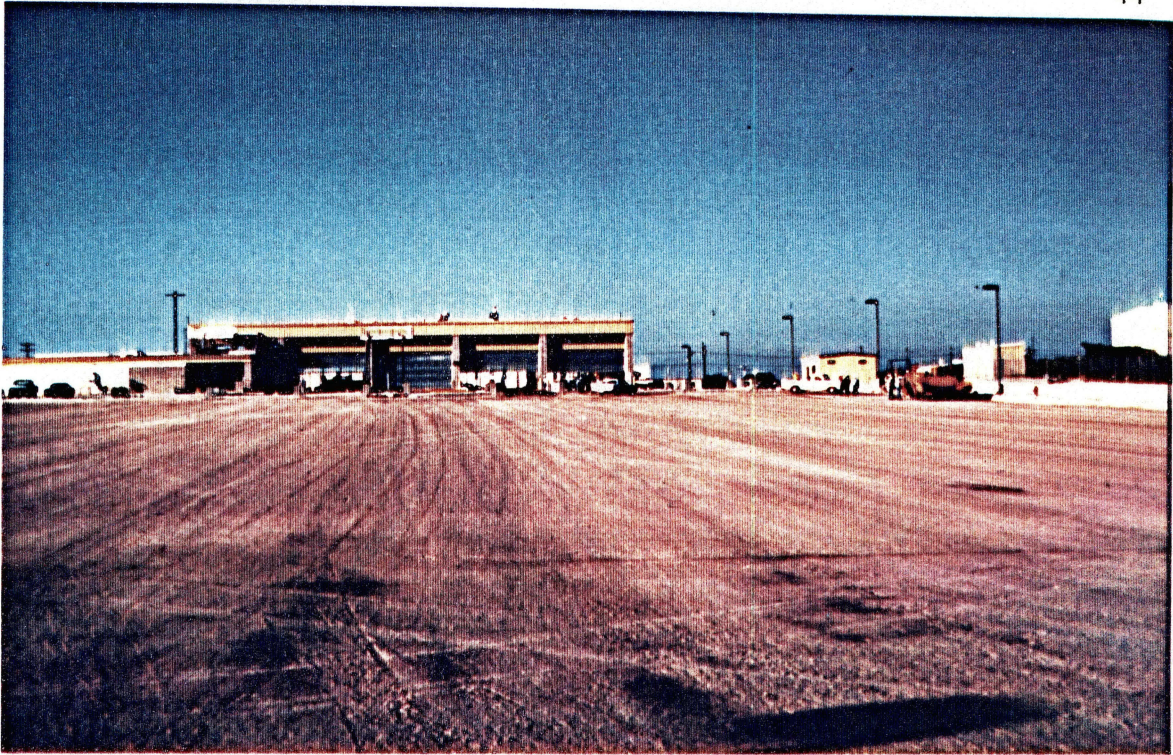
Figure 8. Prepared Foundation and Initial Setting of Laydown Machine

(a) Prepared Foundation Before Placement Began

(b) Adjusting of Height for Uncompacted Mix

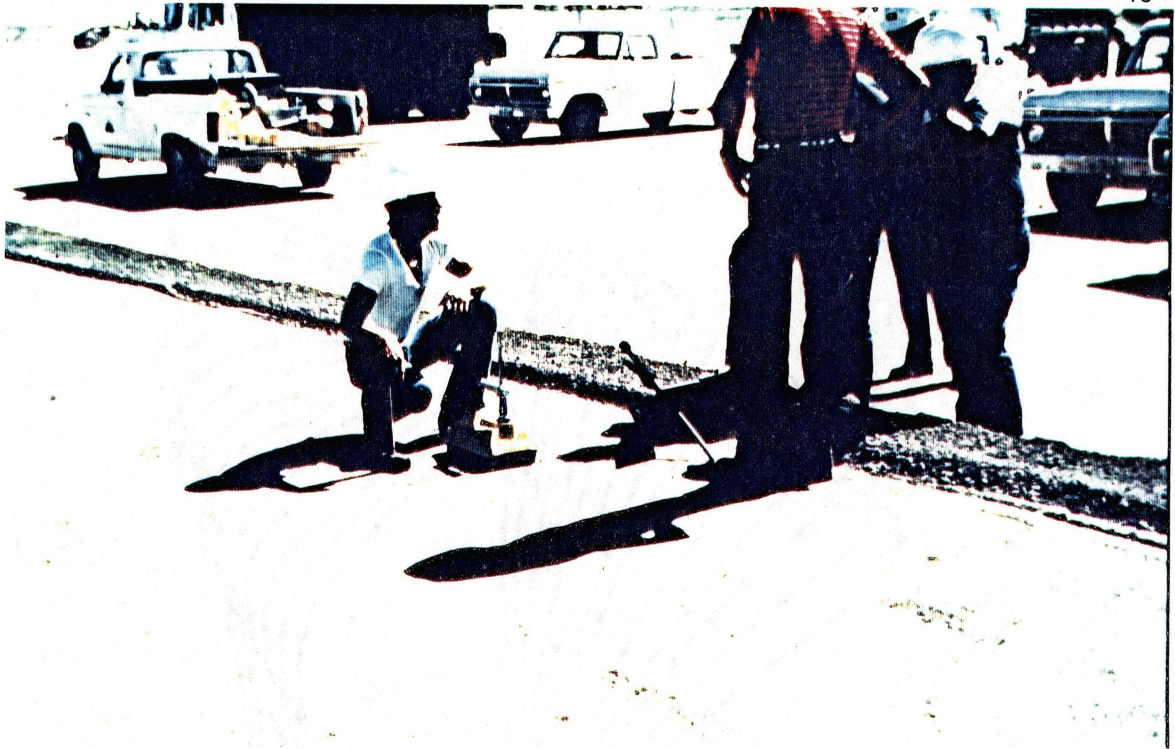
Figure 10. Measuring Moisture-Density and Lift Thickness

(a) Using Troxler Road Reader

(b) Verifying Specified Thickness of RCC Lift

Construction of the hardstand began on July 9, 1984; 12-, 14-, and 16-foot wide lanes were paved during the succeeding days of the operation. A layout of the paving sequence is shown in Figure 7. The lime-stabilized subgrade was prewetted and placement began. The foundation before placement operations and the mating of the laydown machine against the conventionally placed concrete section is shown in Figure 8. The laydown machine traveled only a short distance before problems developed with the augers. After a considerable delay to repair the augers, paving was resumed. Three complete lanes measuring 405 feet by 42 feet, 12 inches loose lift thickness compacted to 10 inches, were placed the first day. Initial placement and compaction of the first lane is shown in Figure 9. Some problems arose with compaction along the unconfined outer edge of the first lane, where the surface tended to undulate or wave. Other problems occurred with breakdowns of the plant, conveyor belt breakage and slippage, and breakdown of the laydown machine. The entire area was completed in 12 working days, including breakdowns and about a half day for a planned recalibration of the plant at the halfway point of the placement. Photographs of taking moisture-density measurements and verifying thickness are shown in Figure 10. Compaction was achieved by two

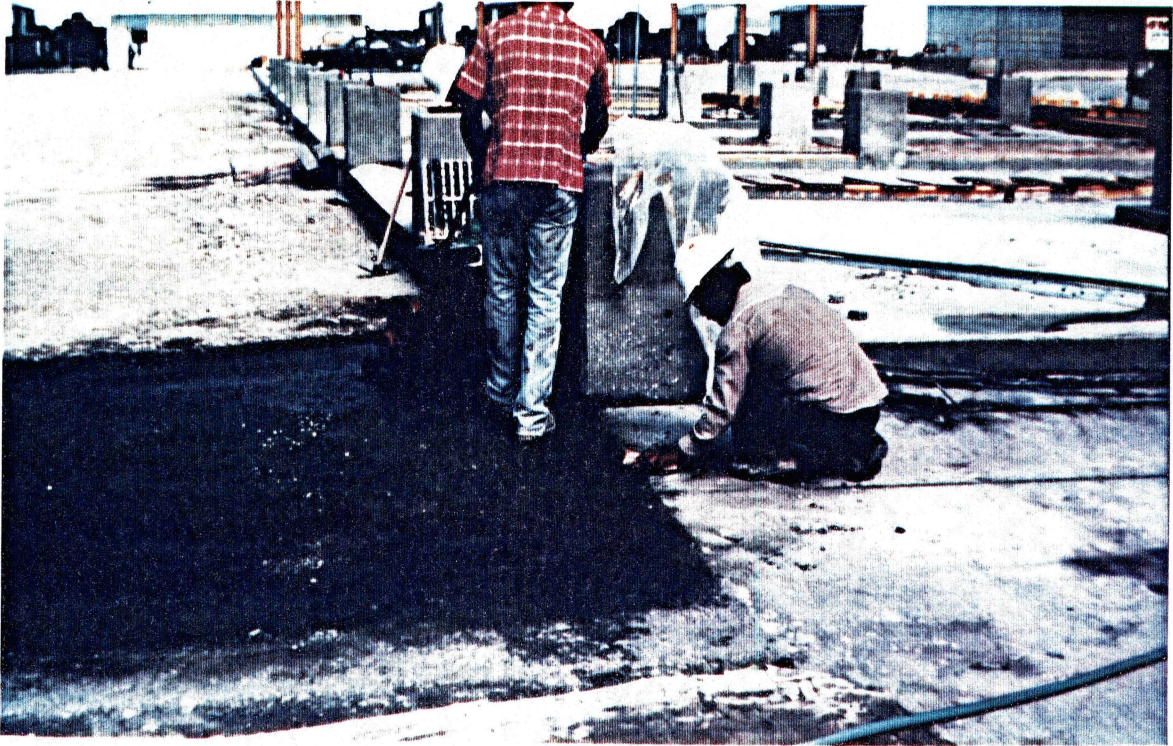
Figure 11. Hand Compaction and Second Day Operations

(a) Using Hand Compactor in Tight Areas

(b) Placement and Curing Operations, Second Day

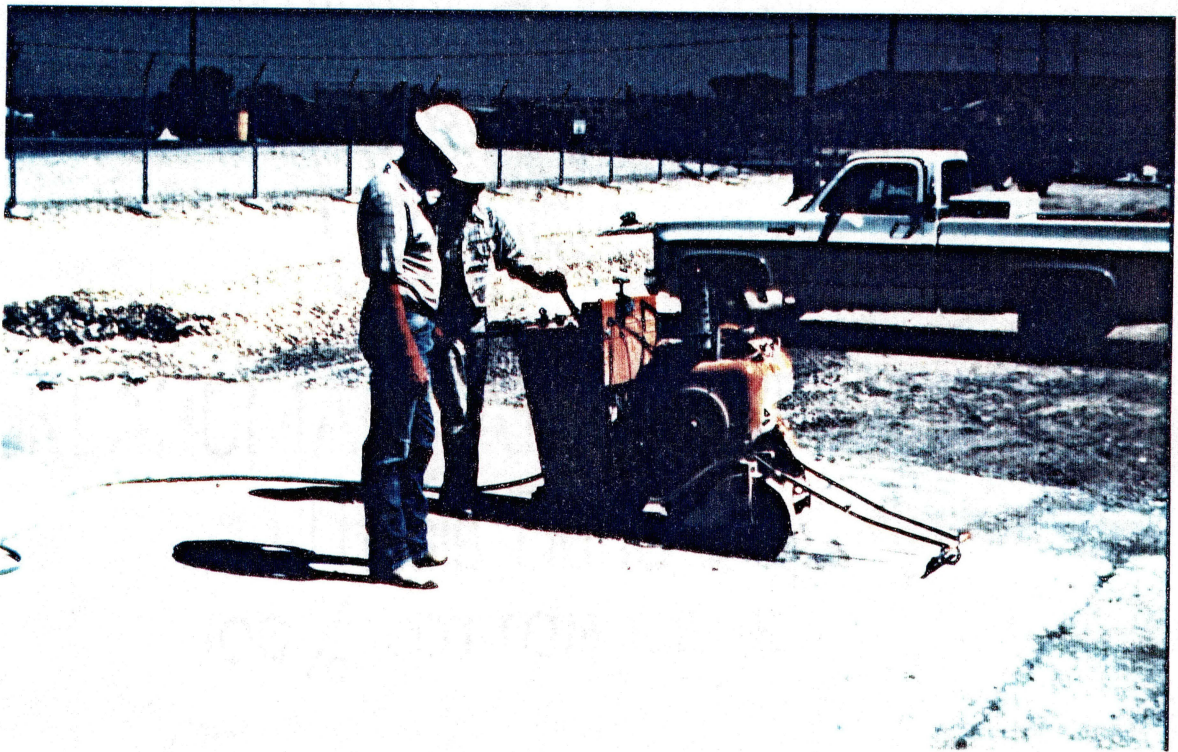
Figure 12. Curing and Sawing Operations

(a) Blankets Removed and Curing Compound Applied on Left

(b) Concrete Saw Used for Joints and Waste Removal

Attempts to saw joints failed; the surface of the RCC pavement raveled and tore, leaving the joint with a ragged appearance. Several factors contributed to the problem. Saw cutting was started before the proper time, the large aggregate size was partially to blame, and the

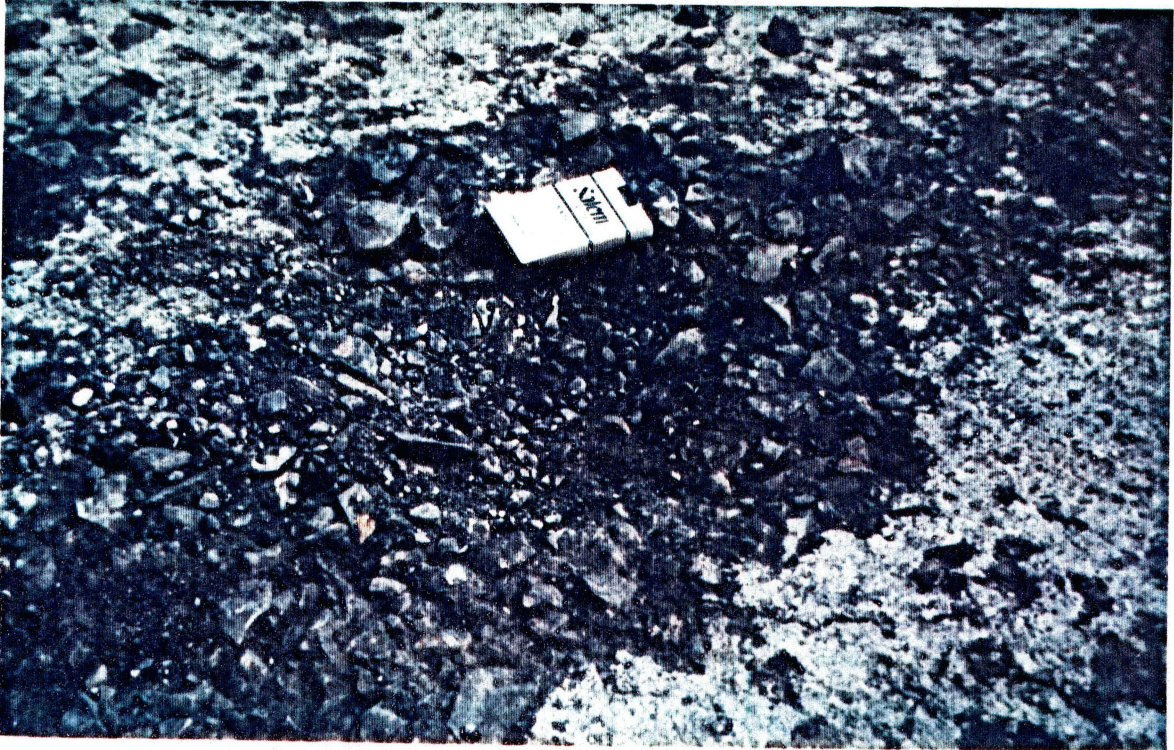
Figure 14. Spalled Surface Area and RCC-PCC Juncture

(a) Close-Up of Spalled Surface at a Cold Joint

(b) Joint Treatment of Existing PCC With New RCC

Joint treatment was a problem. The bonding of the joints at the end of a day's construction, both transverse and longitudinal joints between lanes, did prove to be sufficient. No apparent problems existed in these areas. However, maintaining tolerances between lanes was in some cases very poor. A ridge developed along some joints which tended to spall with time and in some locations the spalling developed without the ridge. Junctures with the previously placed PCC were in all cases satisfactory. A felt bond breaker was used at all of these junctures to separate the two concretes. Even the areas on which the hand compactor had to be used because of lack of work space for the larger vibratory roller appeared good. Figure 14 shows a spalled area at a longitudinal joint and a juncture of the PCC and RCC in the area of a drive entrance.

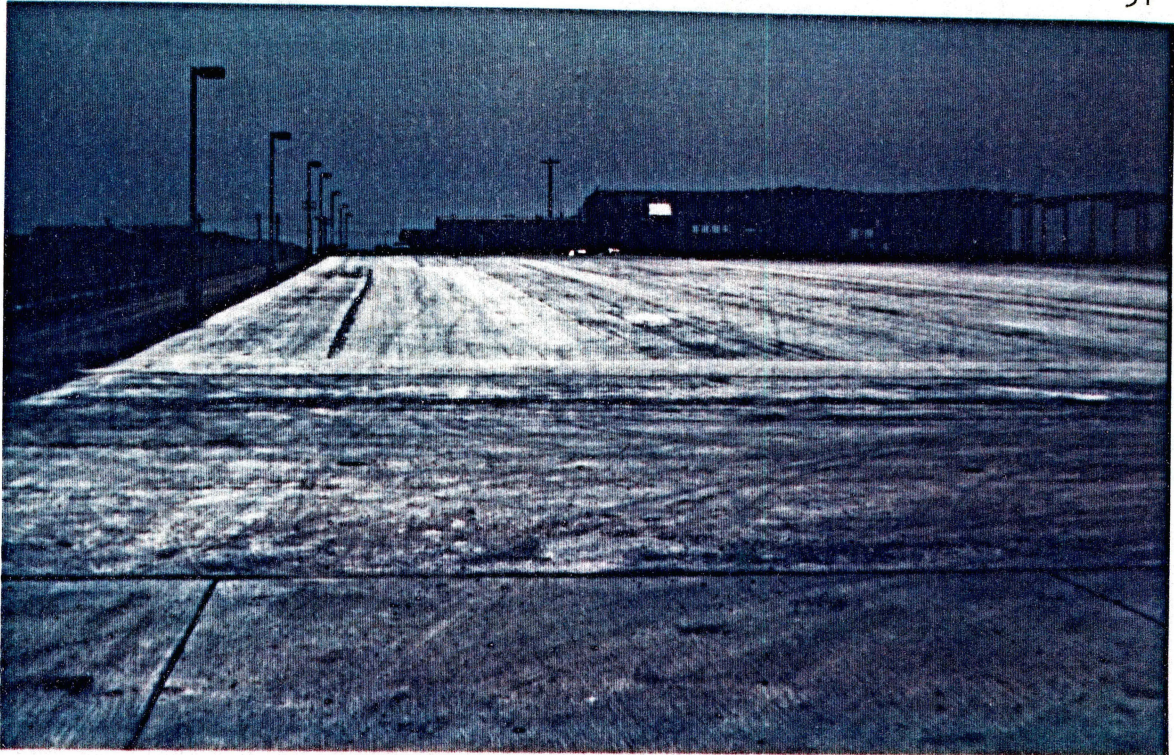
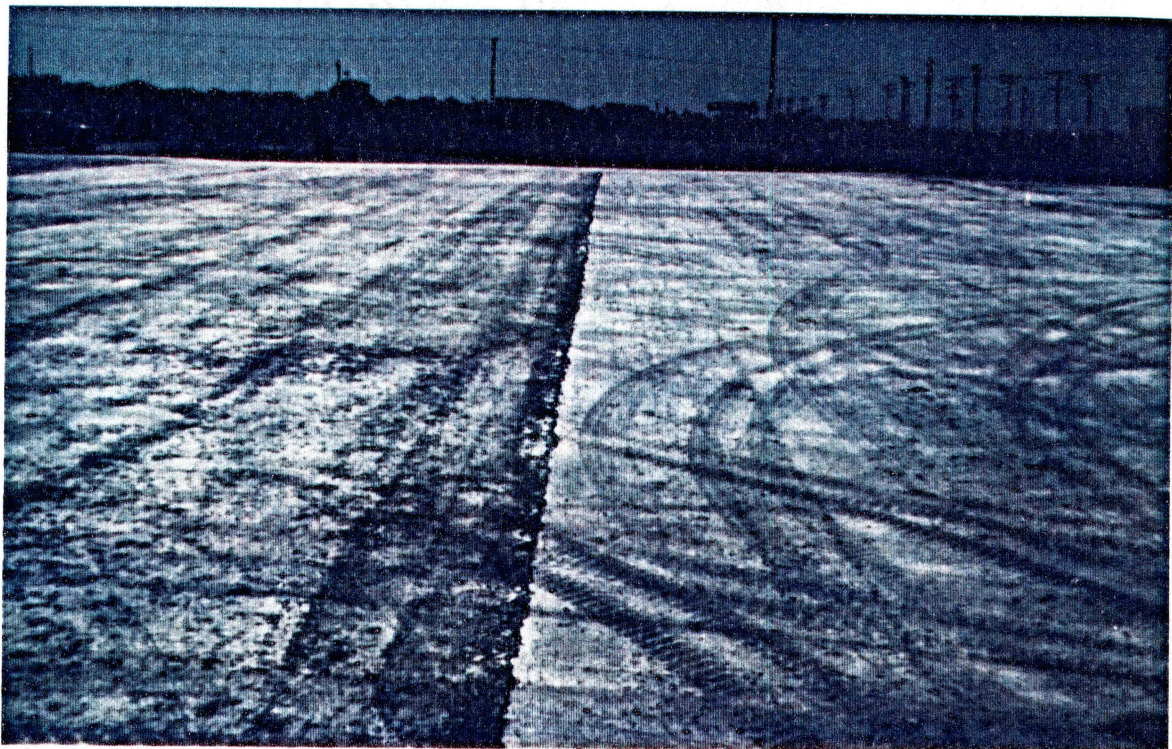
Figure 15. Photographs of Completed RCC Paving

(a) Immediate Foreground, PCC; Remainder Completed RCC

(b) $1\frac{1}{2}$ Mix on Left and $\frac{3}{4}$ Mix on Right

The areas where the 3/4-inch maximum aggregate size was used appeared to have a better surface. The surface had a tighter, smoother texture and a general overall better look. It should be noted that the curing compound was applied directly to the surface in this area. It is apparent that the less porous the surface is, the better it accepts the curing compound, which in turn aids in providing a better finish. Figure 15 contains photographs of the completed hardstand. Photograph (a) is a view to the south from the entrance drive that is PCC and shows the east-west constructed lanes in the middle of the photograph and the north-south constructed lanes at the top. Photograph (b) is an example of the 3/4-inch maximum size mix on the right and the 1½-inch maximum size mix on the left.
