A STUDY OF REVERSED BENDING FATIGUE  
IN THE NICKEL-COPPER ALLOY,  
MONEL K-500

Submitted to the Faculty of the Graduate College  
of the Oklahoma State University  
in partial fulfillment of the requirements  
for the Degree of  
MASTER OF SCIENCE  
December, 1979

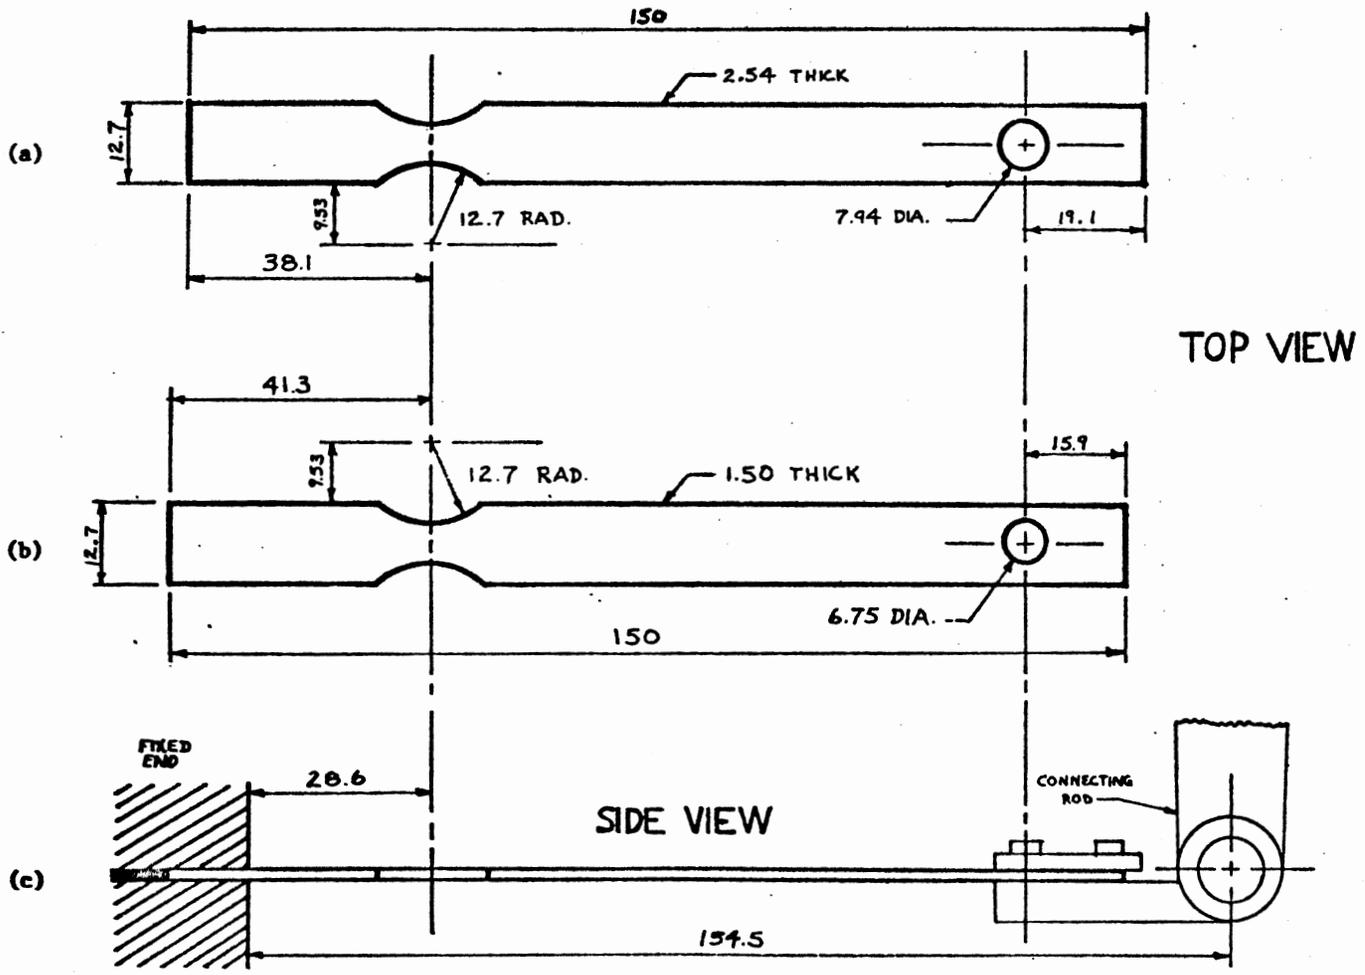
Figure 1. Specimen Geometry of the Original Design (a), Improved Design (b), and Fatigue Testing Configuration (c)

The basic specimen configuration chosen was chiefly a result of previous work done with nickel by Kreiner (13) and Fila (3) at Oklahoma State University. Early intentions with Monel were to retain the original geometry so as to encourage meaningful comparisons of data. In contrast to nickel specimens, Monel exhibited much higher strength and was approximately half as thick. This required a higher strain amplitude for an equivalent fatigue life. Preliminary fatigue tests with Monel exhibited fretting at the fixed end of the specimen and asymmetrical fracture "seams" along the fracture surface. Consequently, the specimen geometry was altered as shown in Figure 1. Material was removed from the connecting red clamp end and added to the fixed end of all specimens. It is important to note from this figure that the effective moment arm and gauge length dimensions were unchanged, thus the analysis of fatigue data could still be extended to the nickel.

The notched specimen configuration was selected since it renders increased reproducibility, with fatigue failures consistently occurring

in the same location. The gauge length incorporates a 12.7 mm radius which avoids an unnecessarily severe stress concentration. Furthermore, the smooth gradient of strain produces a correspondingly gradual change in surface hardness which is more successfully monitored with micro-hardness measurements. The overall dimensions were fixed because of size limitations imposed by the stage of the scanning electron microscope. Also the compactness of size allowed all specimens to be machined from the same sheet of material.

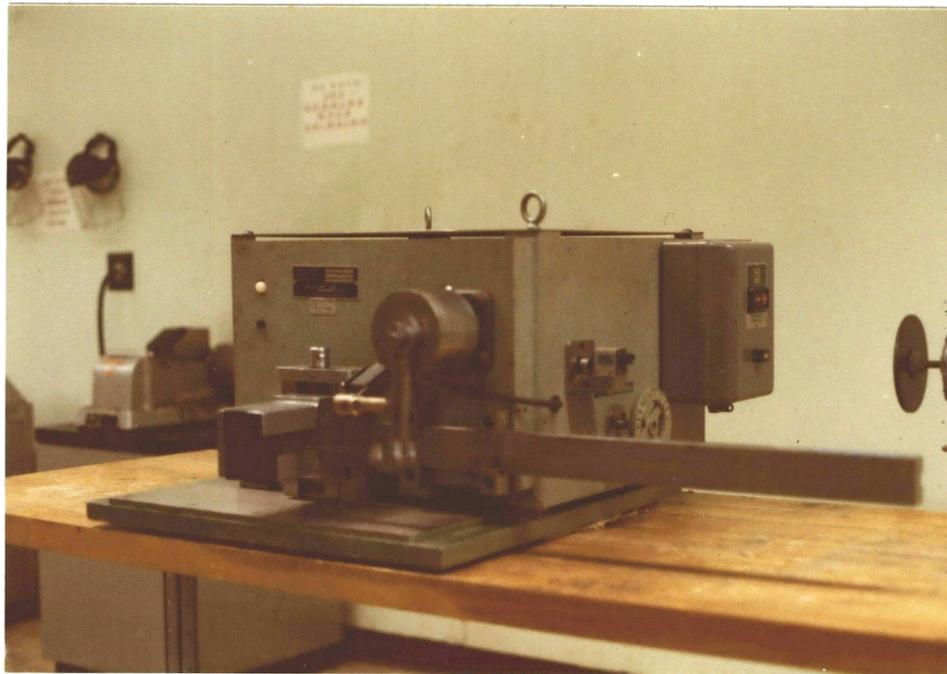
Figure 2. Budd Reversed Bending Fatigue Machine, Model VSP-150 with  
Strain Controlled Operation

All specimens were cycled to failure with a Budd VSP-150 reversed bending fatigue machine, Figure 2. This particular model is designed such that fatigue is strain controlled, with bending displacement confined to fixed limits. Bending is fully reversed and symmetric such that any particular location within the volume of the specimen is subjected to equal amounts of compression and tension. The frequency selected was 35 Hz while the ambient temperature remained at approximately 25°C.

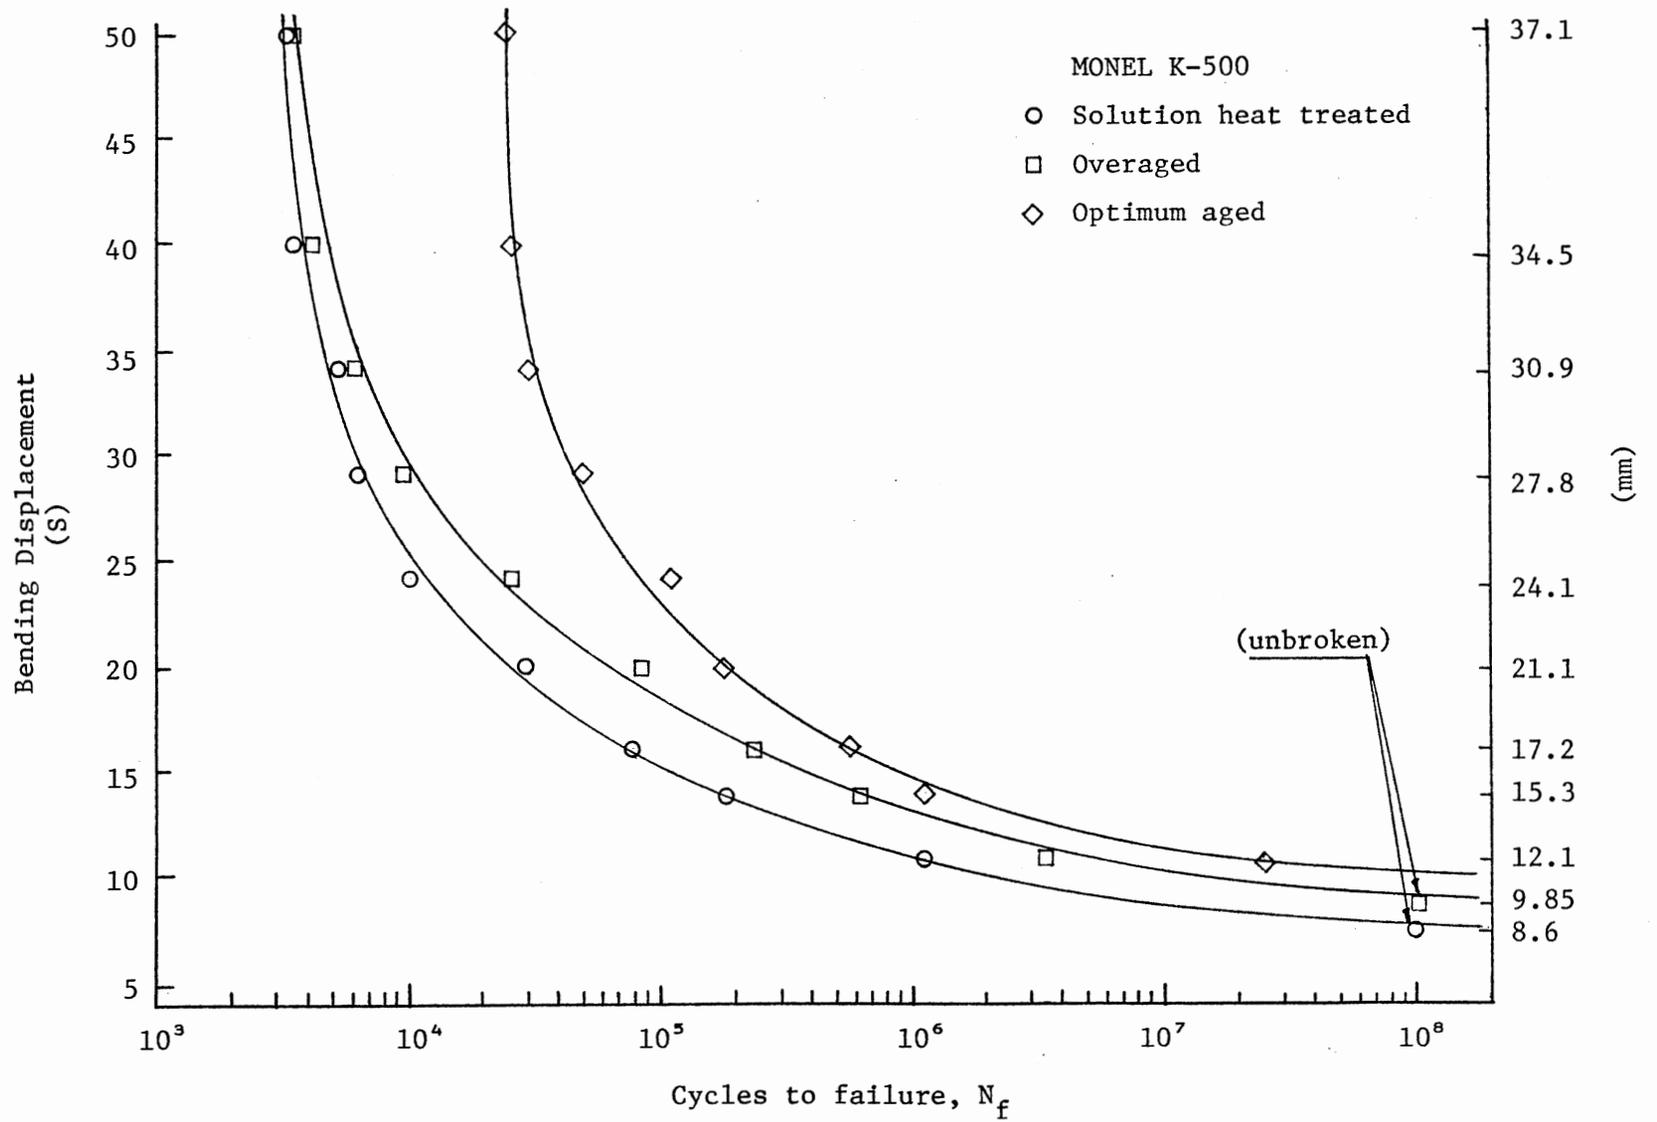
Figure 3. Fatigue Life As a Function of Bending Displacement for Three Heat Treatments

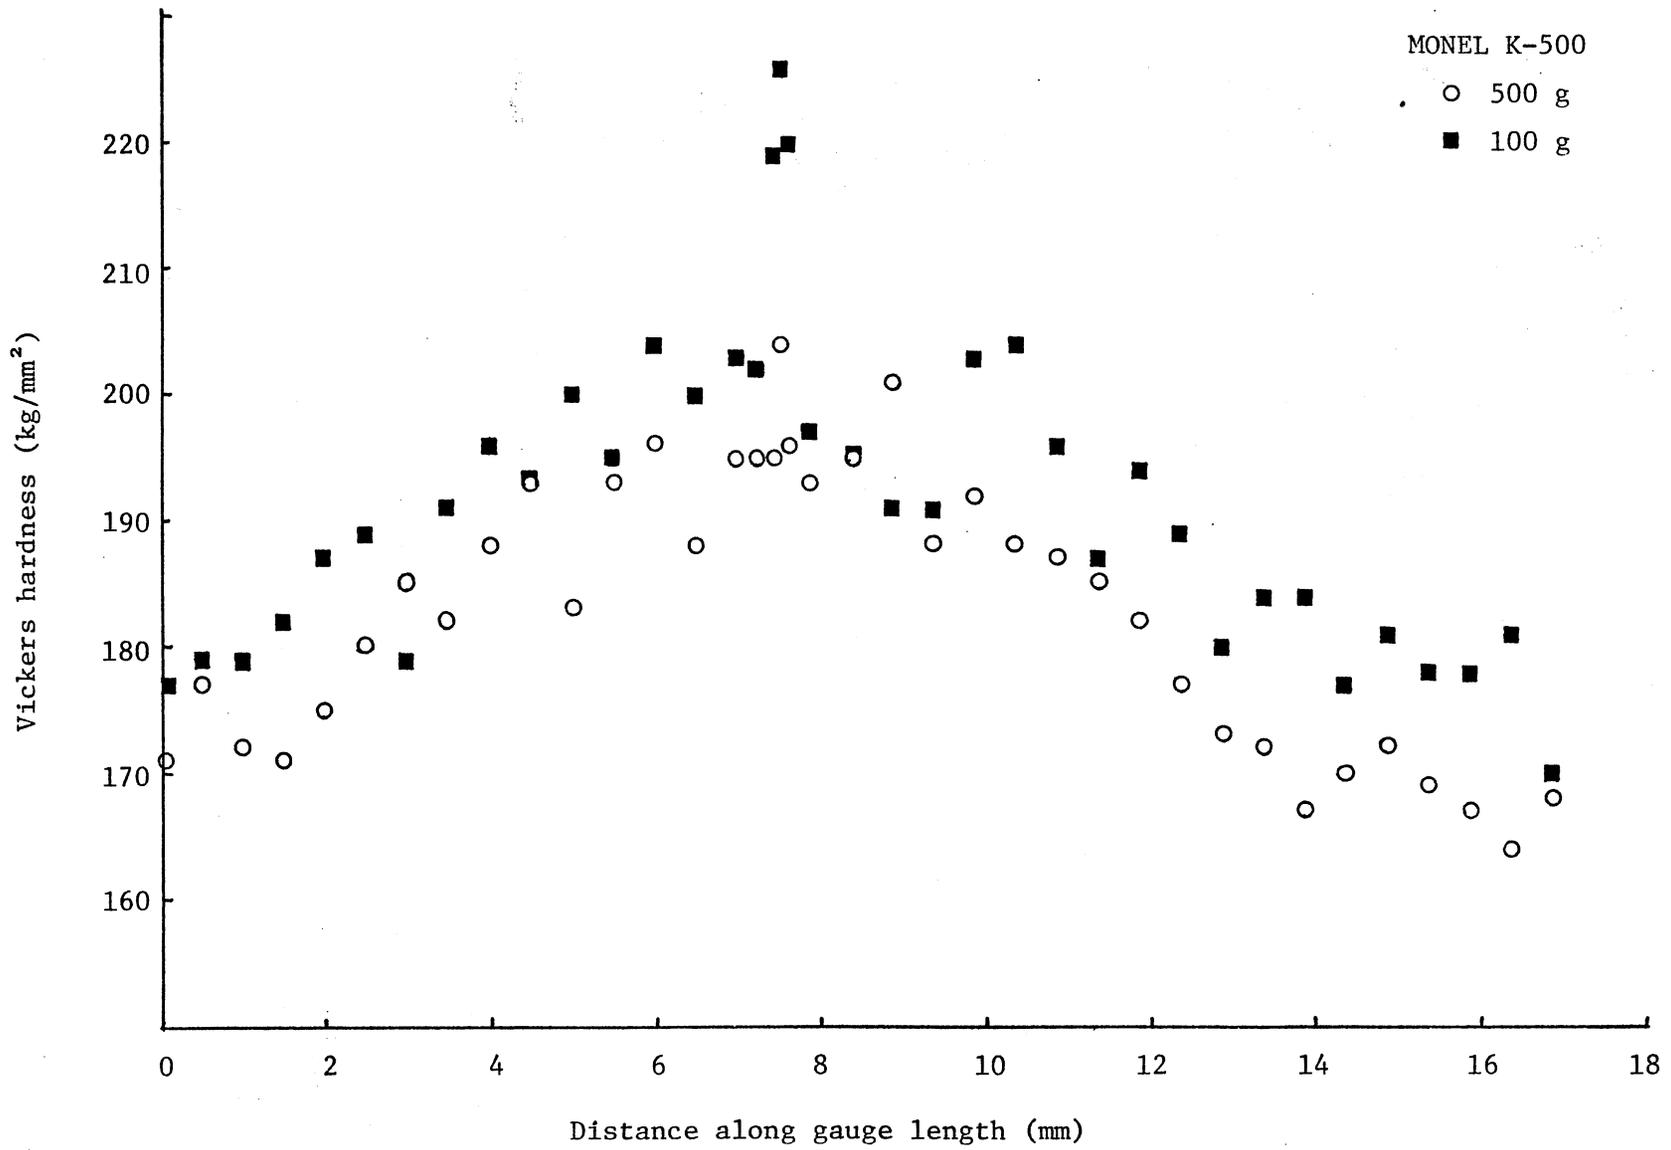
Figure 5. Surface Hardness Profile of Solution Heat Treated Specimen  
Number 31,  $N_f = 5400$

Surface hardness profiles for low cycle fatigue of selected specimens are presented in Figures 5 through 7. It was seen that the surface hardness varied measurably with the solution heat treated specimen for both indenter weights. The overaged specimen exhibited a more gradual hardening trend towards the fracture zone. The optimum aged specimen did not seem to show a hardness change at all.

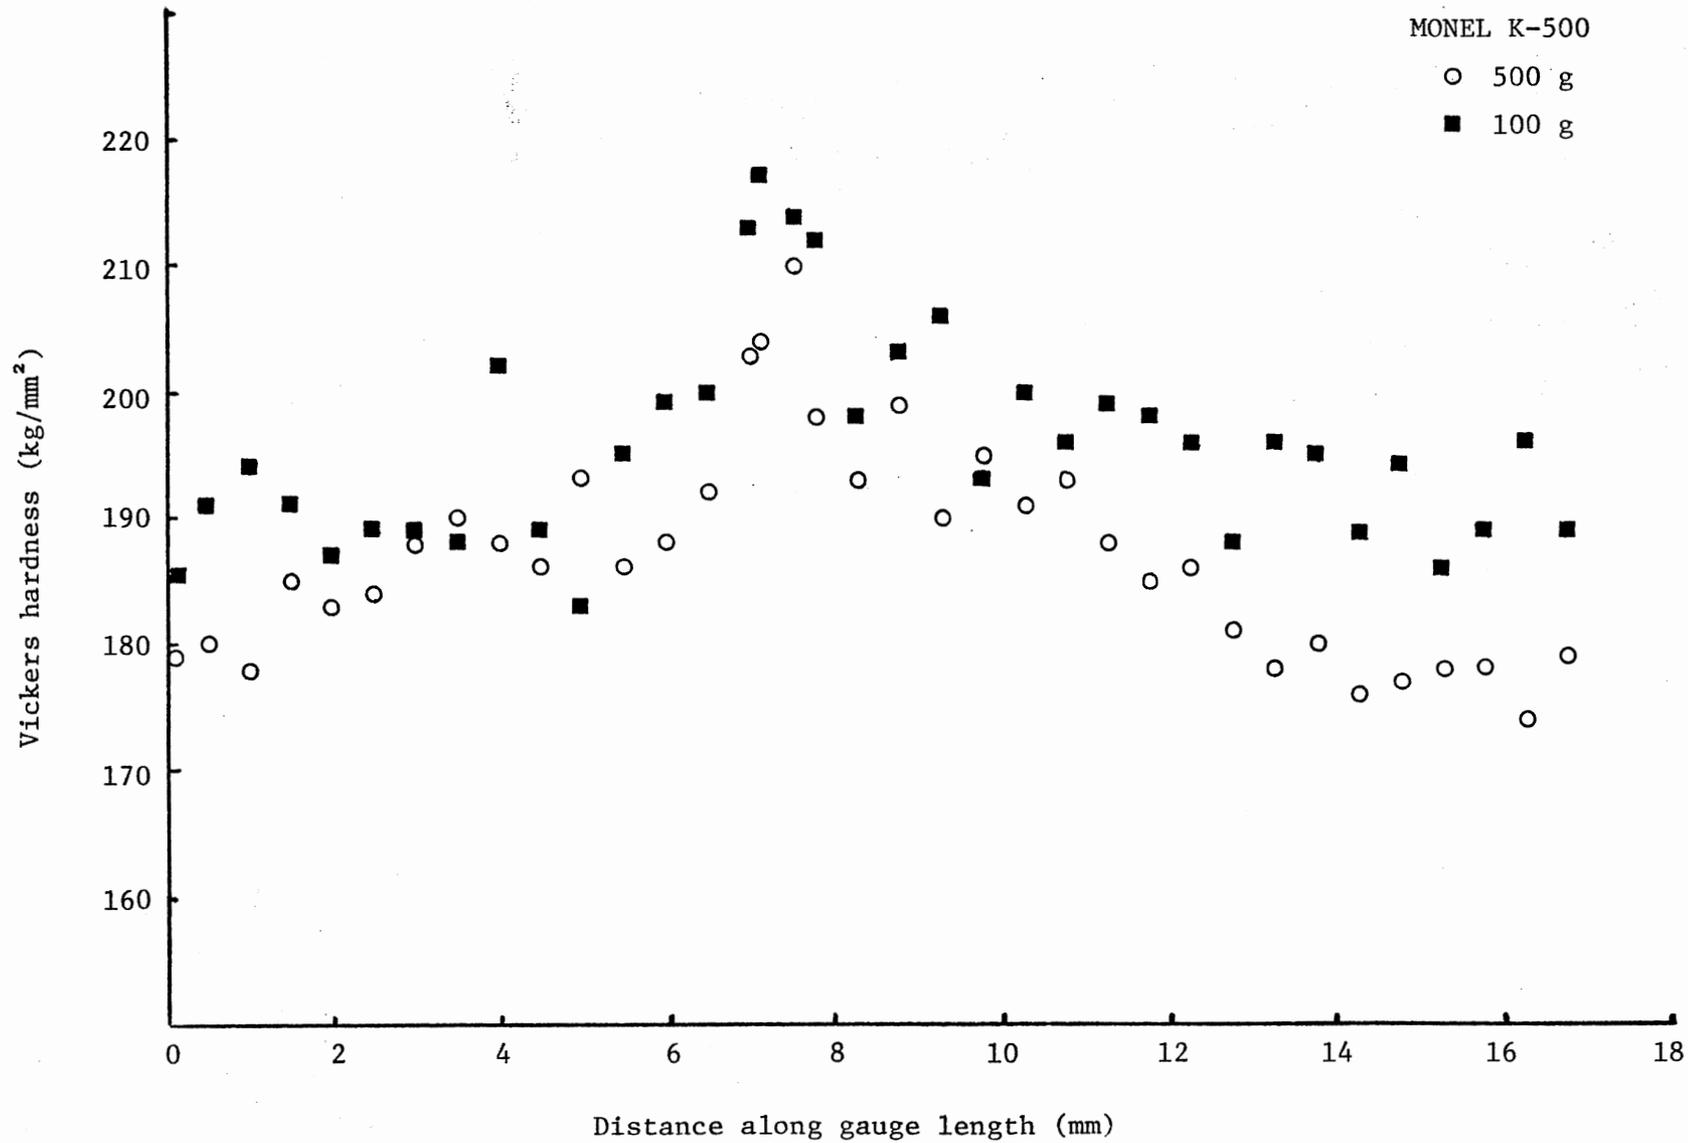
Figure 6. Surface Hardness Profile of Overaged Specimen Number 27,  
 $N_f = 5565$

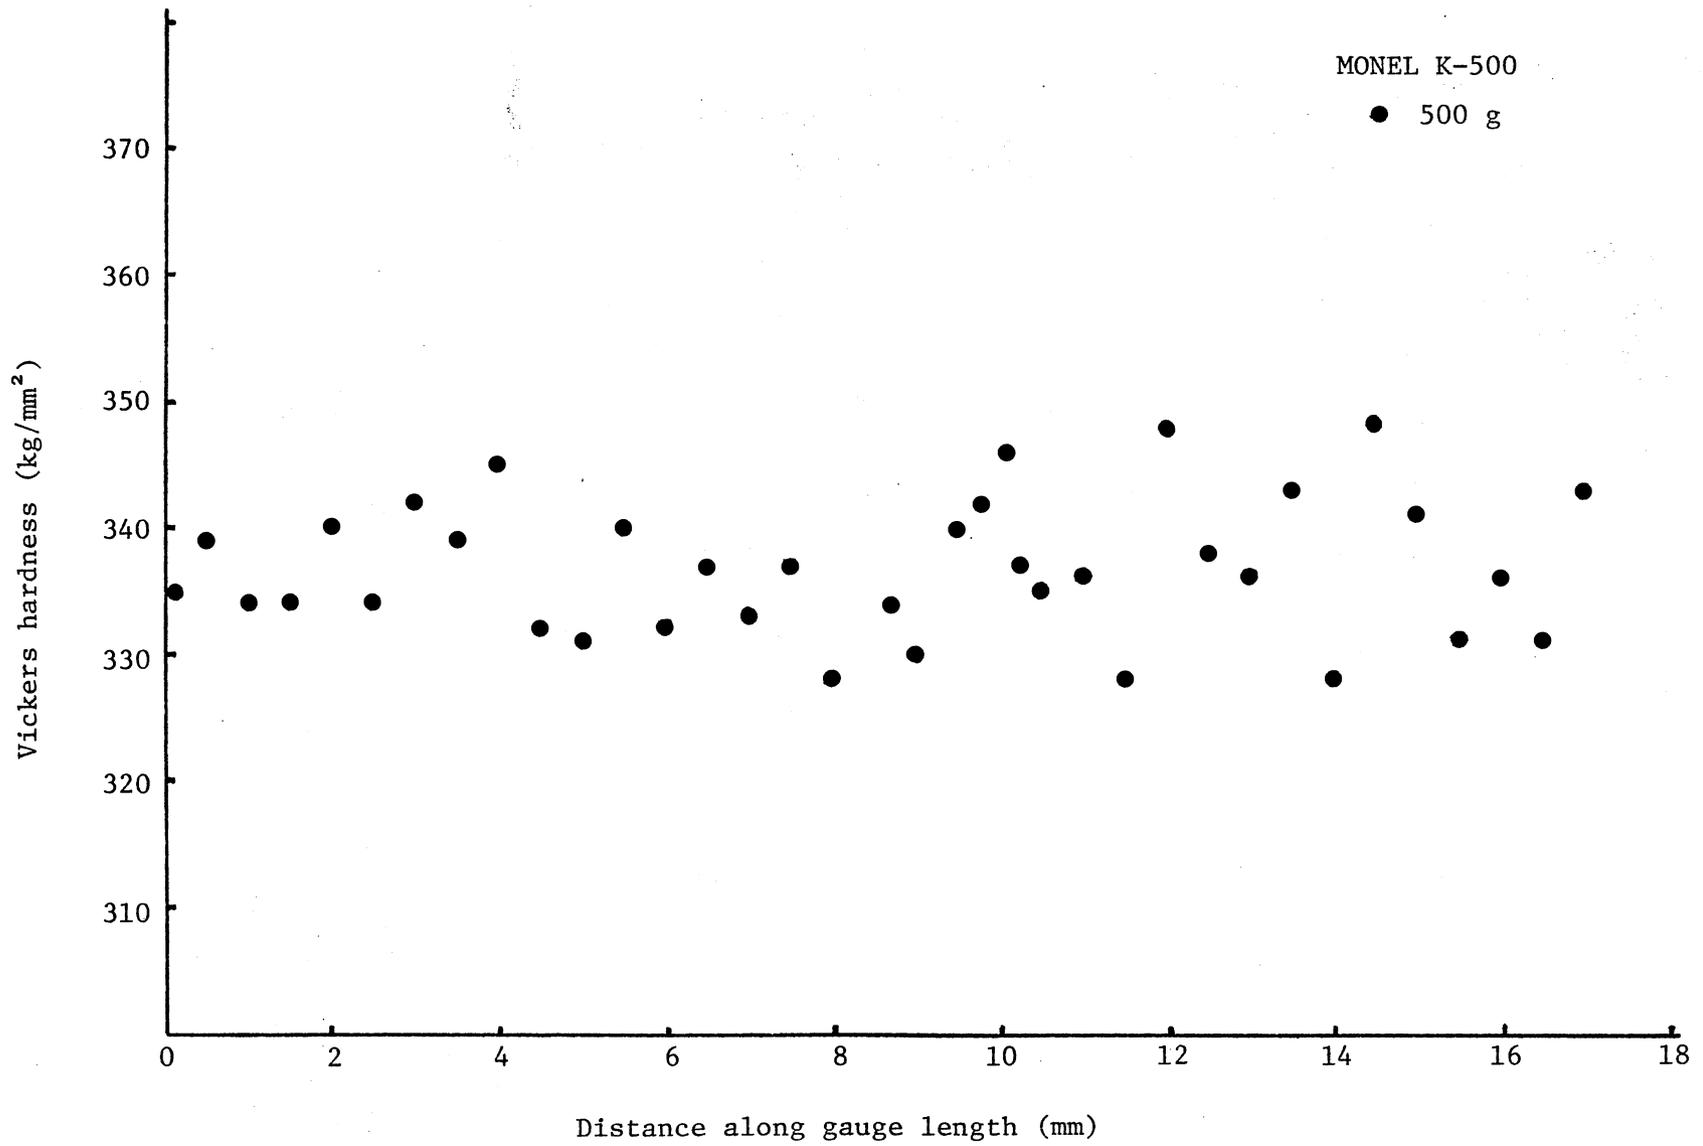
Figure 7. Surface Hardness Profile of Optimum Aged Specimen Number 18,  
 $N_f = 29,700$

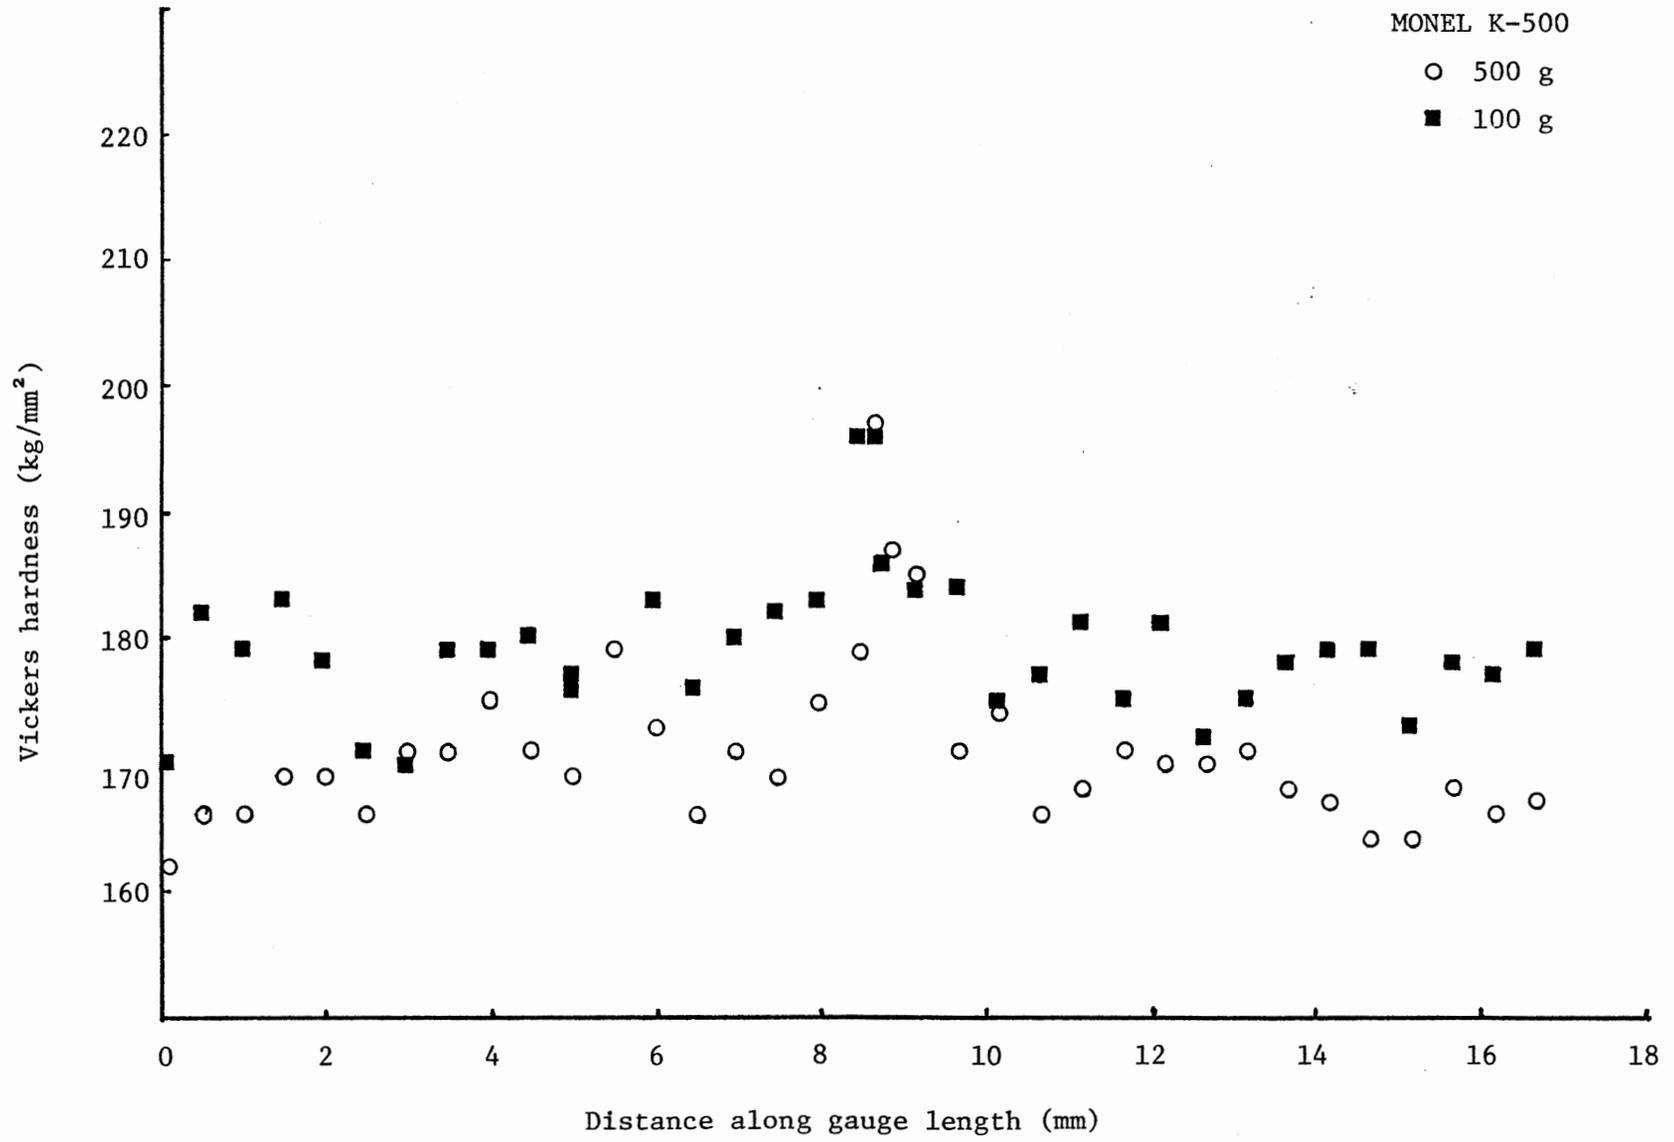
Figure 8. Surface Hardness Profile of Solution Heat Treated Specimen  
Number 8,  $N_f = 1,123,400$

dramatic, Figures 8 through 11. Further illustration of this is seen in Figures 12 and 13 where graphic superpositions of solution heat treated and overaged specimens are portrayed, respectively. Specimen 22, side "A", showed perhaps a slight softening in the vicinity of fracture. Note that specimen 22, side "B" did not harden in this same region. With the exception of the optimum aged heat treatment, specimens were characterized by conspicuously high surface hardness values immediately adjacent to the fracture zone. A summary of features regarding surface hardness profiles is included in Table IV.

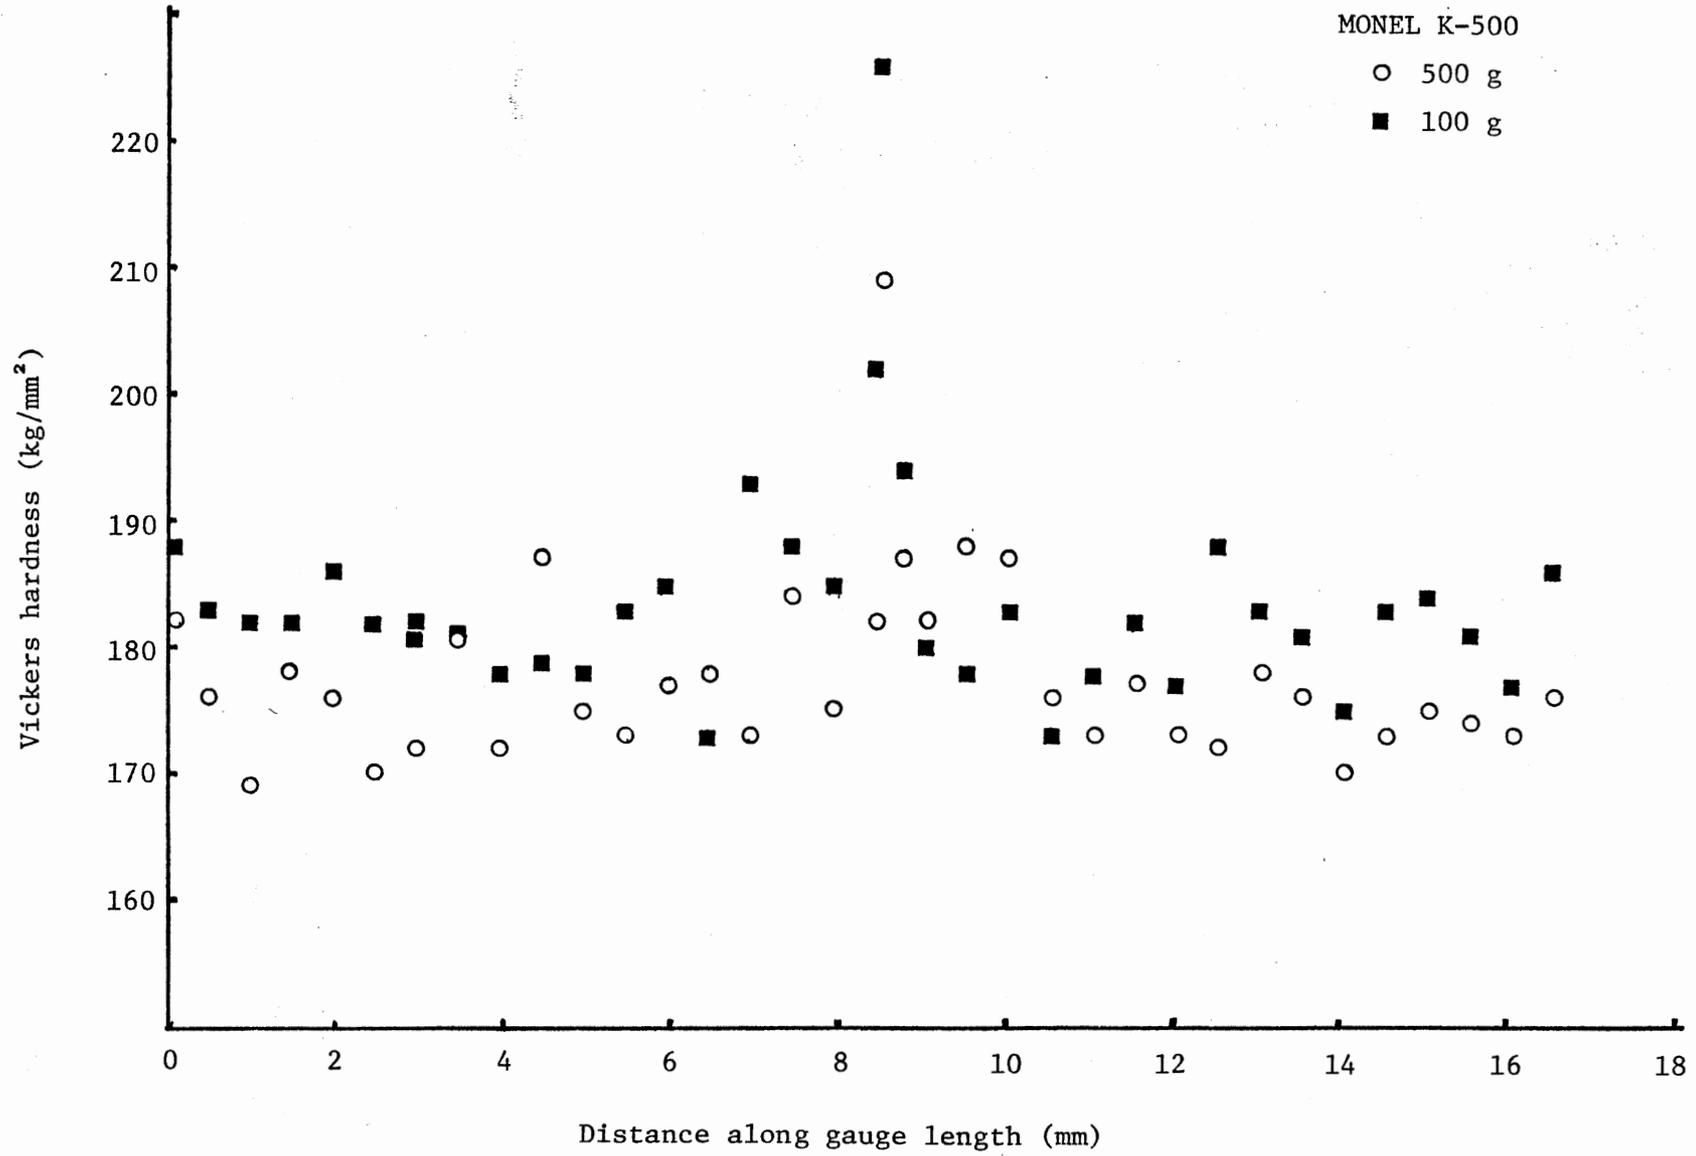
Figure 9. Surface Hardness Profile of Overaged Specimen Number 37,  
 $N_f = 3,261,900$

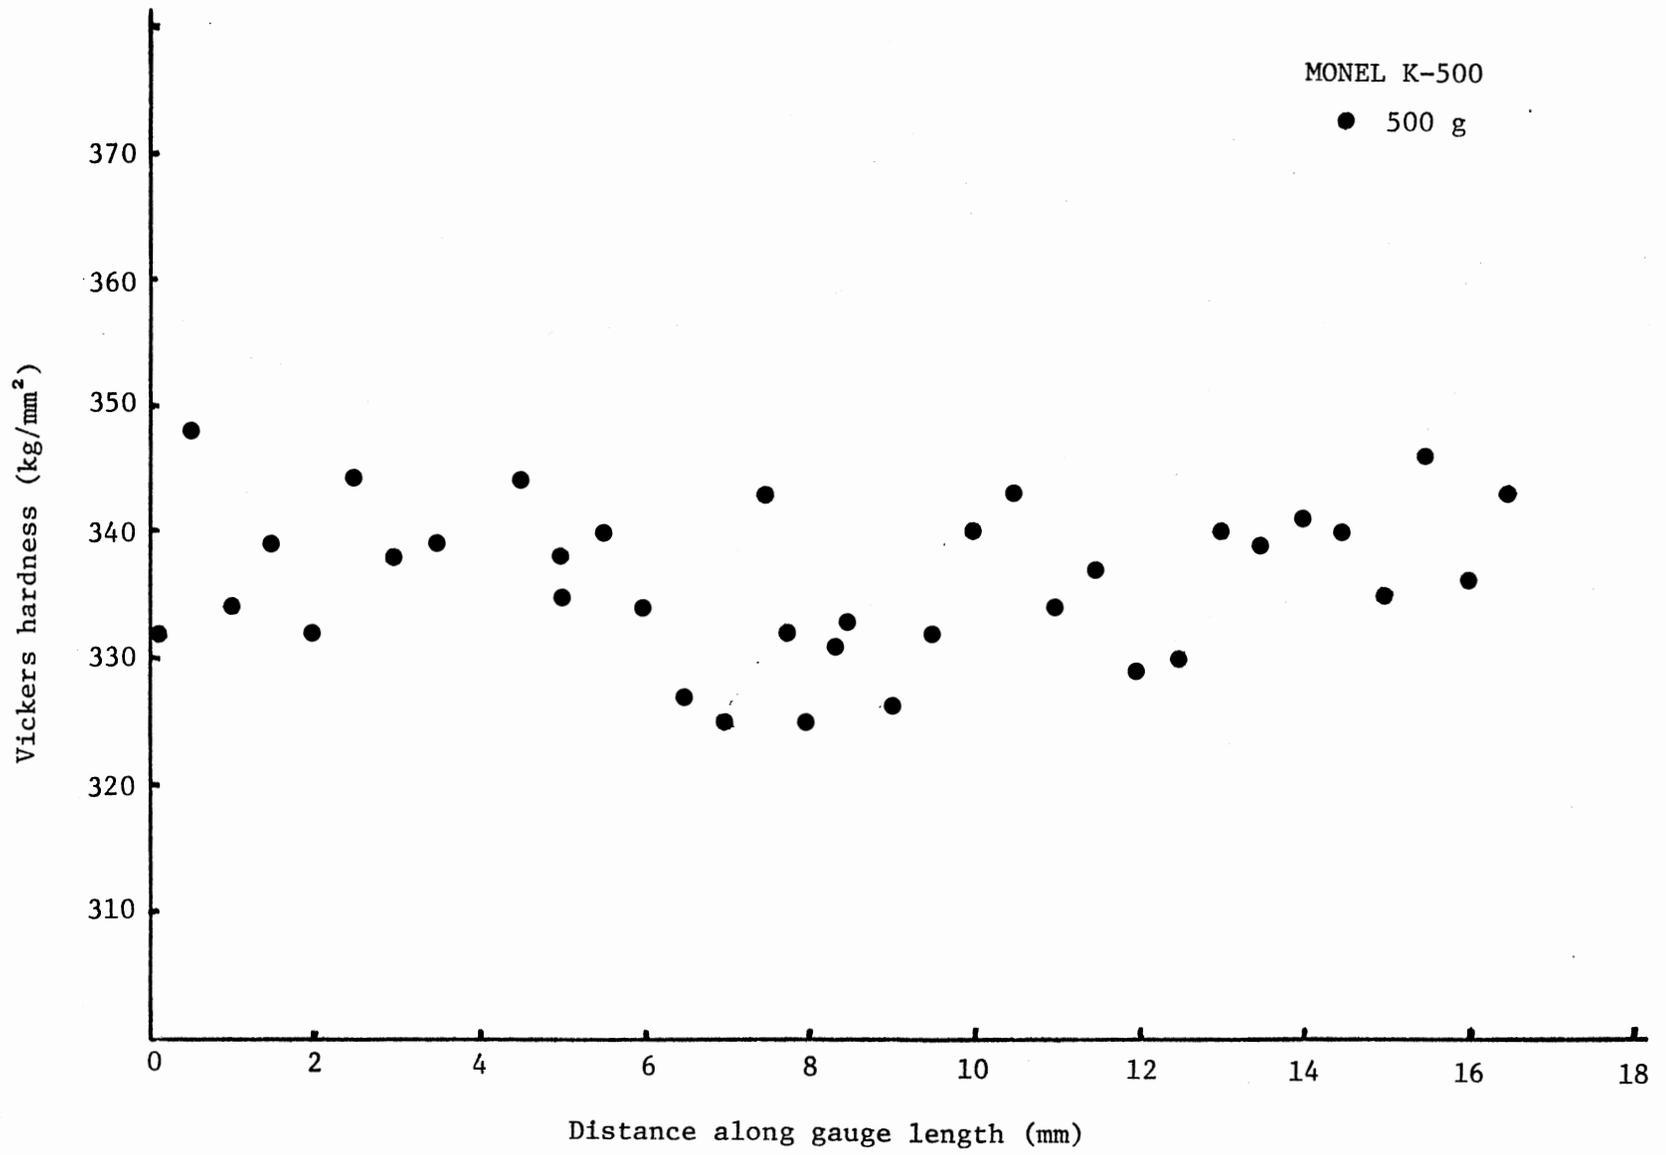
Figure 10. Surface Hardness Profile of Optimum Aged Specimen Number  
22, Side "A",  $N_f = 24,263,100$

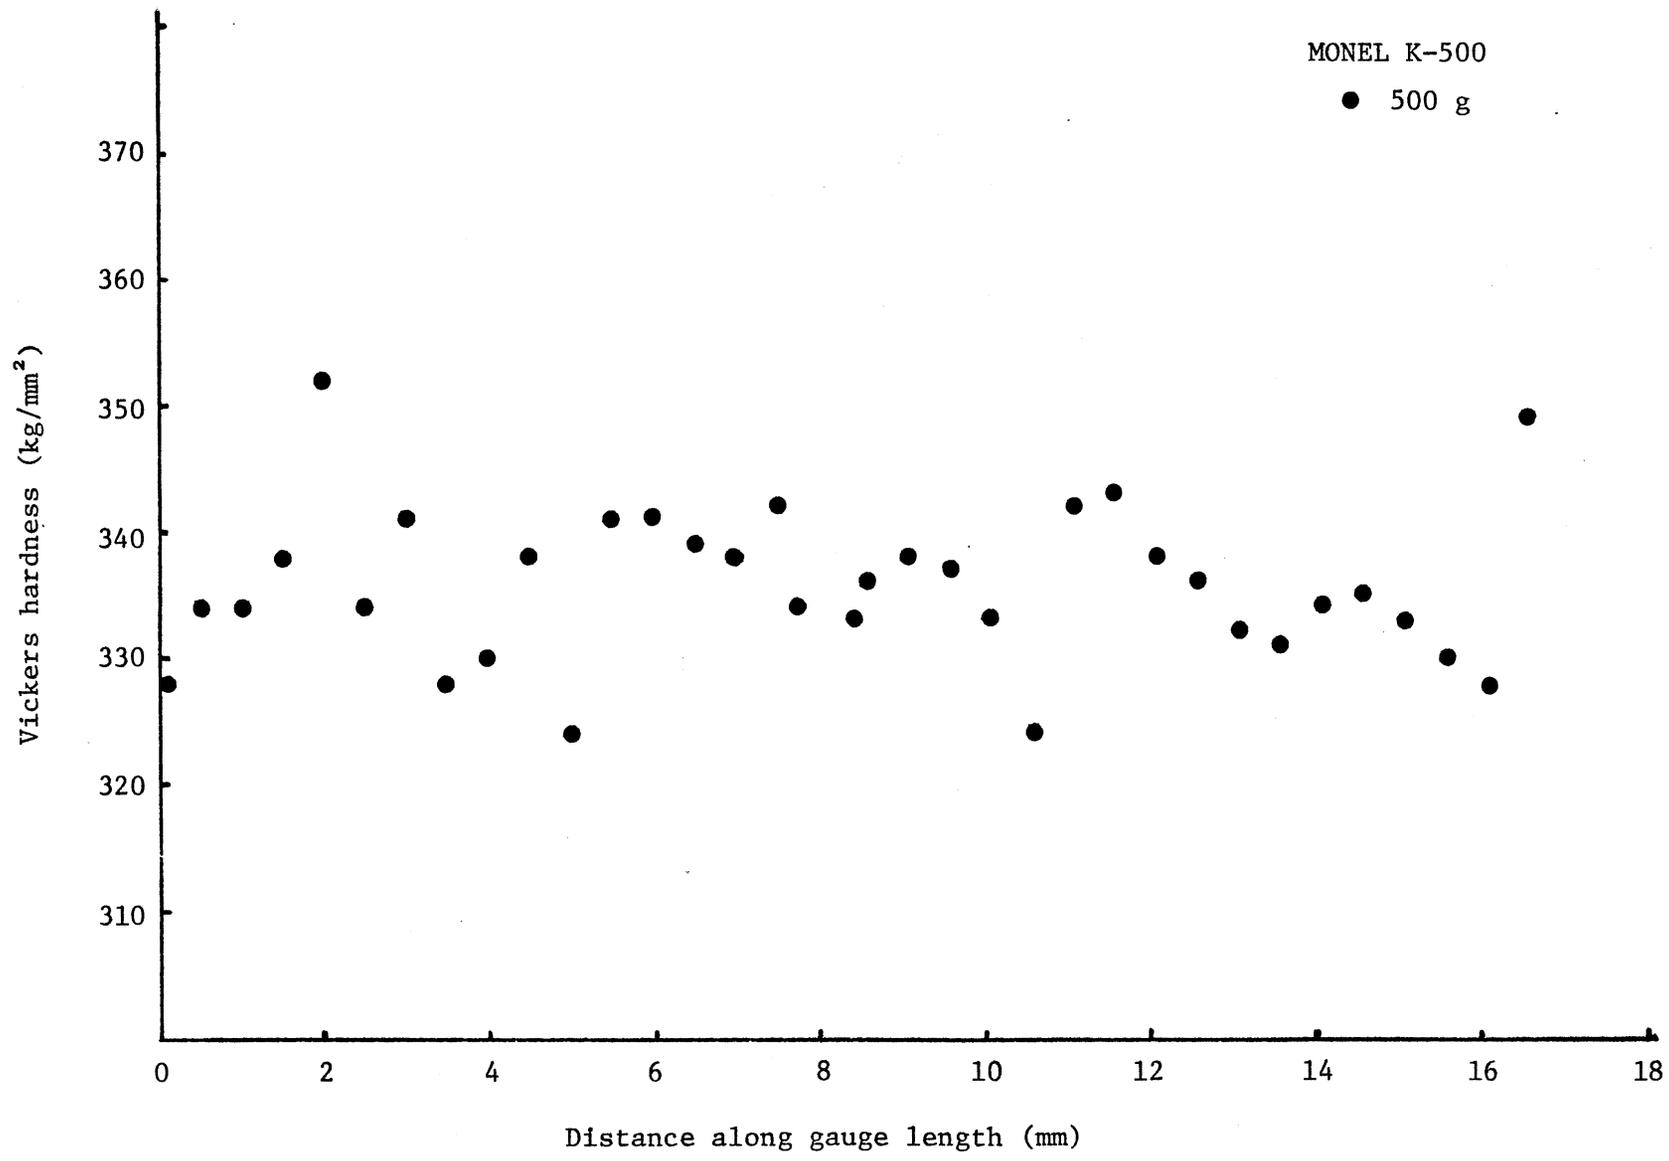
Figure 11. Surface Hardness Profile of Optimum Aged Specimen Number  
22, Side "B",  $N_f = 24,263,100$

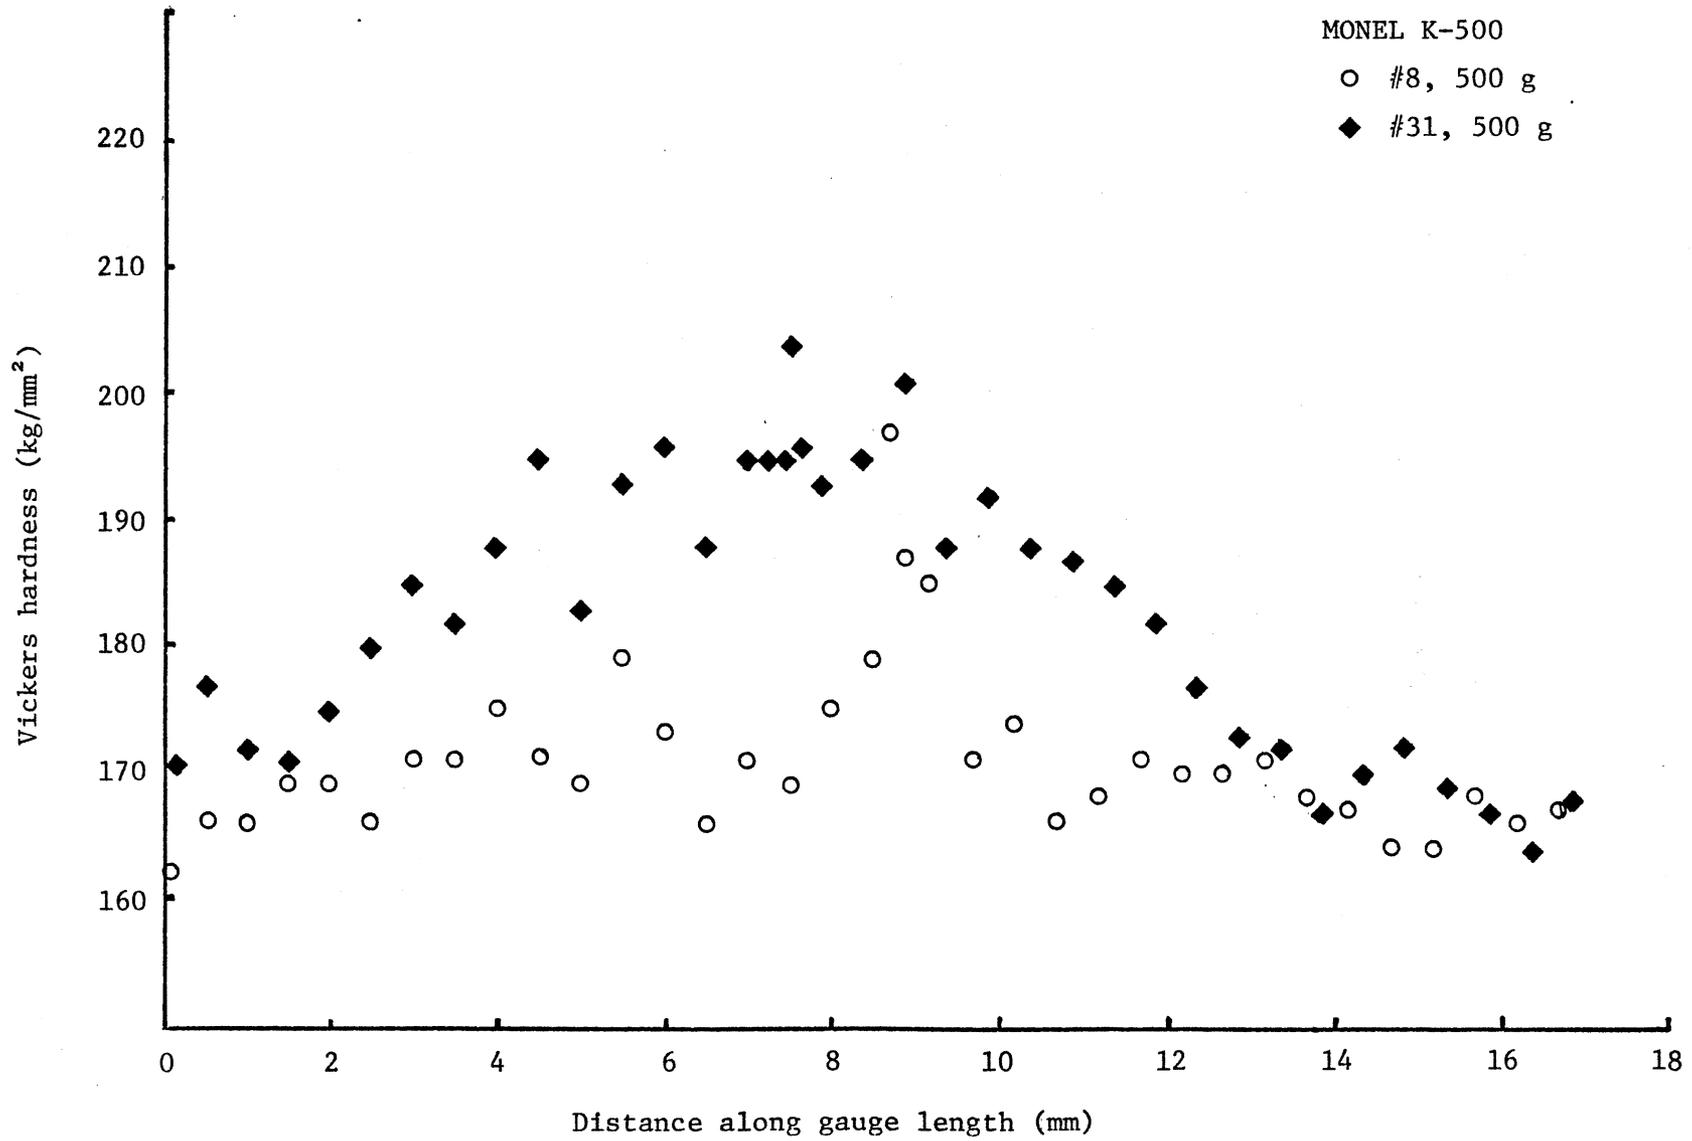
Figure 12. Superposition of Surface Hardness Profiles for Two Solution Heat Treated Specimens; Number 31,  $N_f = 5,400$ , and Number 8,  $N_f = 1,123,400$

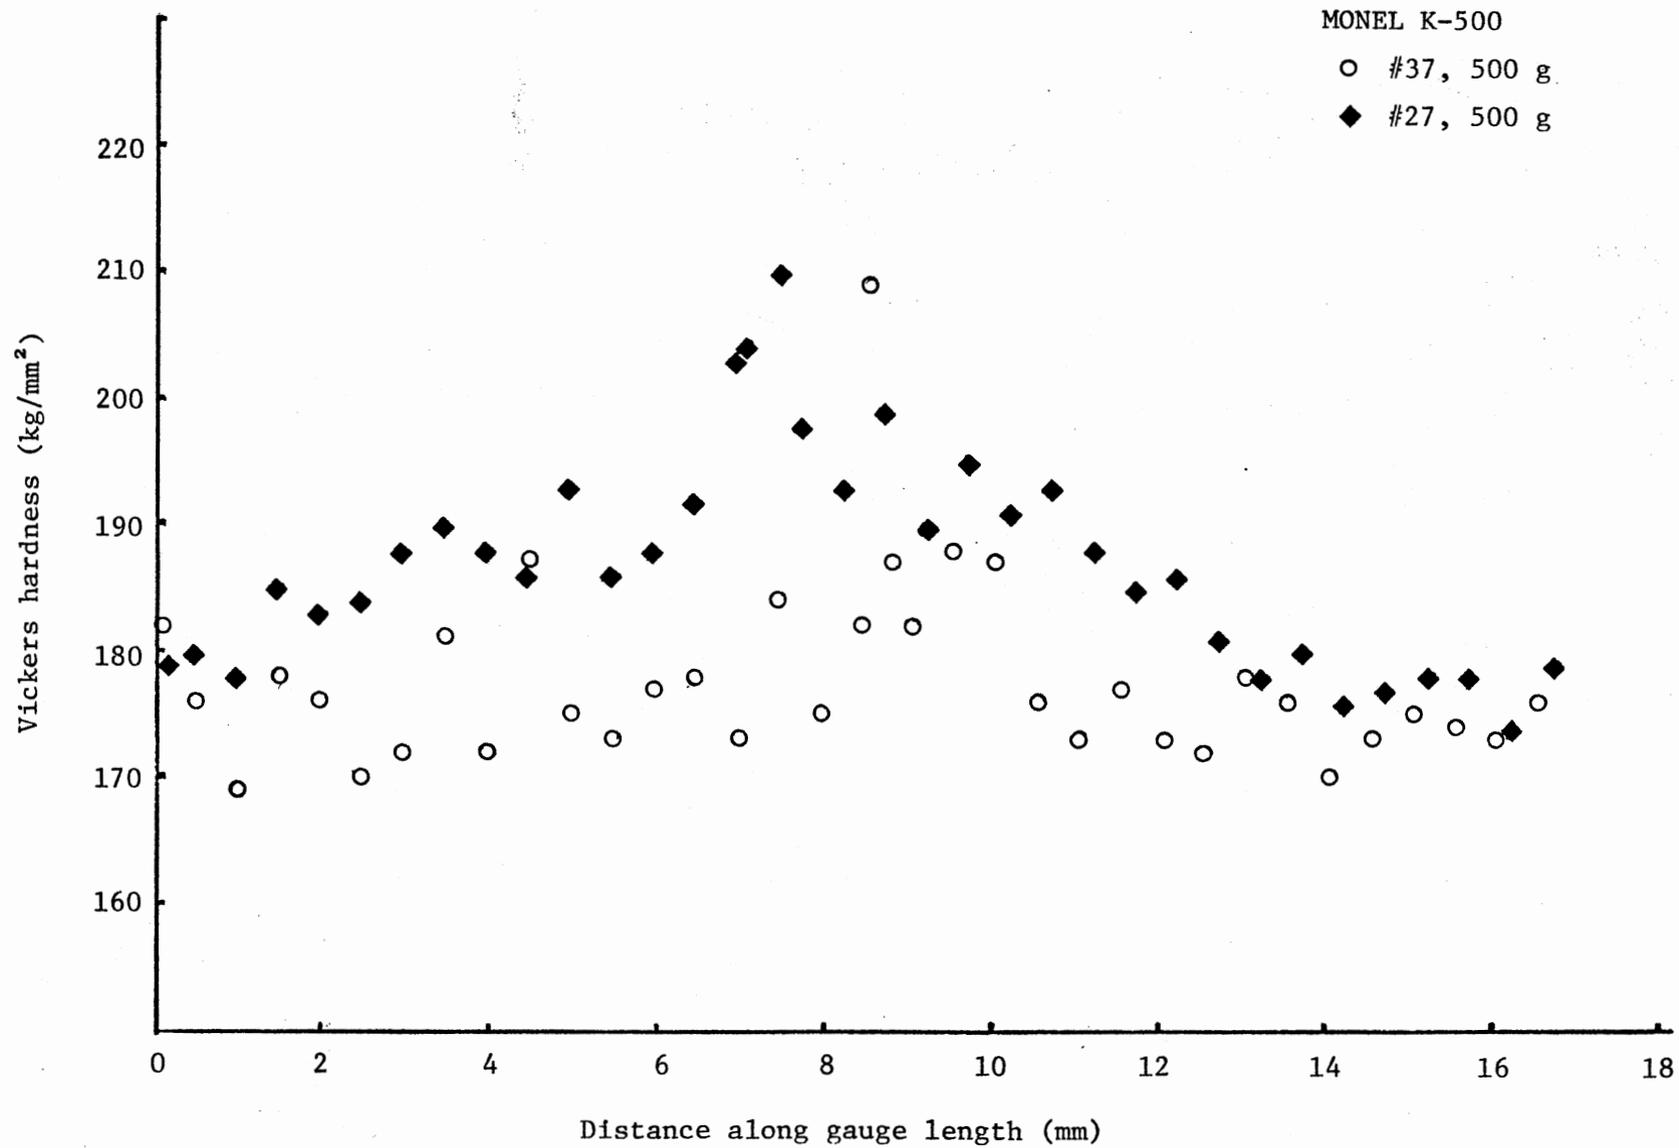
Figure 13. Superposition of Surface Hardness Profiles for Two Overaged Specimens; Number 27,  $N_f = 5,565$  and Number 37,  $N_f = 3,261,900$
