A STUDY OF REVERSED BENDING FATIGUE  
IN THE NICKEL-COPPER ALLOY,  
MONEL K-500

Submitted to the Faculty of the Graduate College  
of the Oklahoma State University  
in partial fulfillment of the requirements  
for the Degree of  
MASTER OF SCIENCE  
December, 1979

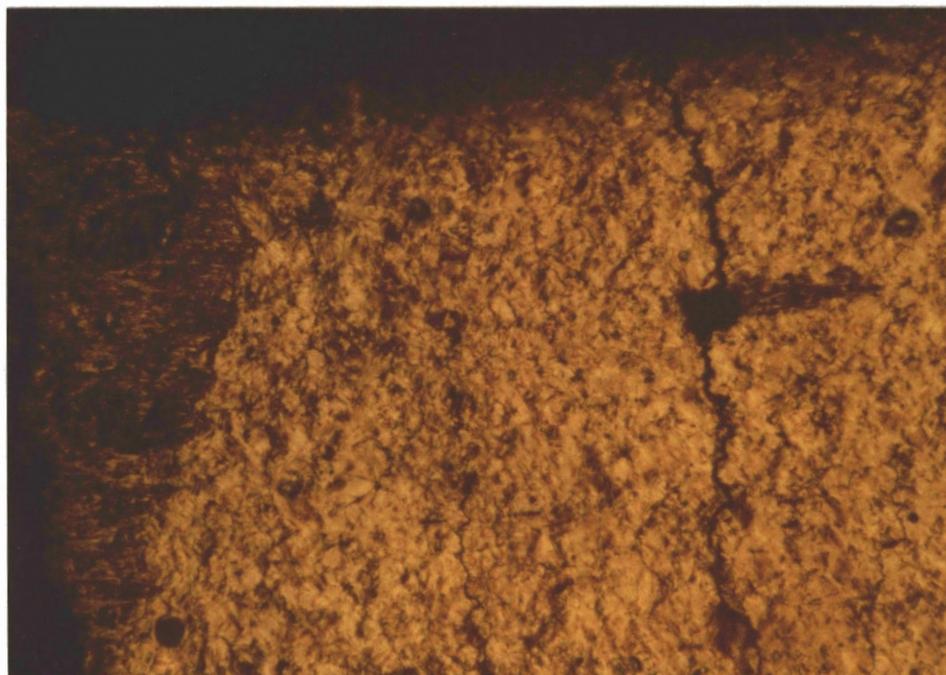
Figure 14. Optical Microscope Photograph of Massive Slip and Secondary Cracking at the Fracture Edge. Morphology is typical of high amplitude testing for soft material in LCF. Specimen number 32, SHT D = 37.1 mm,  $N_f = 3480$  (x 98).

Figures 14 and 16 indicate clearly that the extent of fatigue damage varied as a function of heat treatment and bending displacement. For each heat treatment, fatigue damage was seen to decrease with increasing life. Heat treatment appeared to have a greater effect than cycles to failure. The density of slip and cracking was observed to be roughly proportional to the magnitude of the strain hardening exponent. Solution heat treated specimens with the relatively high strain hardening exponent suffered the greatest amount of damage, Figures 14 and 15. Optimum aged specimens with the lowest strain hardening exponent suffered the least, Figure 16. While the quantity of fatigue damage seen at the surface varied with heat treatment and bending displacement, the important characteristics remained essentially the same.

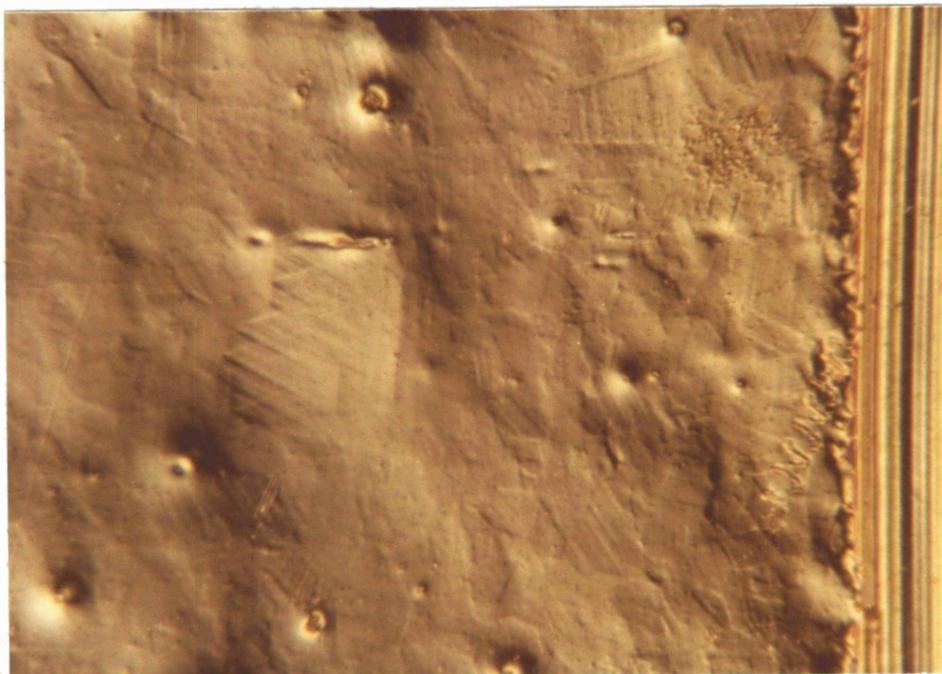
Figure 15. The Same Specimen as Shown in Figure 14 with Evidence of Slip Extending Back 28 mm to the Clamping Point. The vertical scratch at right serves to align the vise jaws. Specimen number 32, SHT, D = 37.1 mm,  $N_f = 3480$  (x 385).

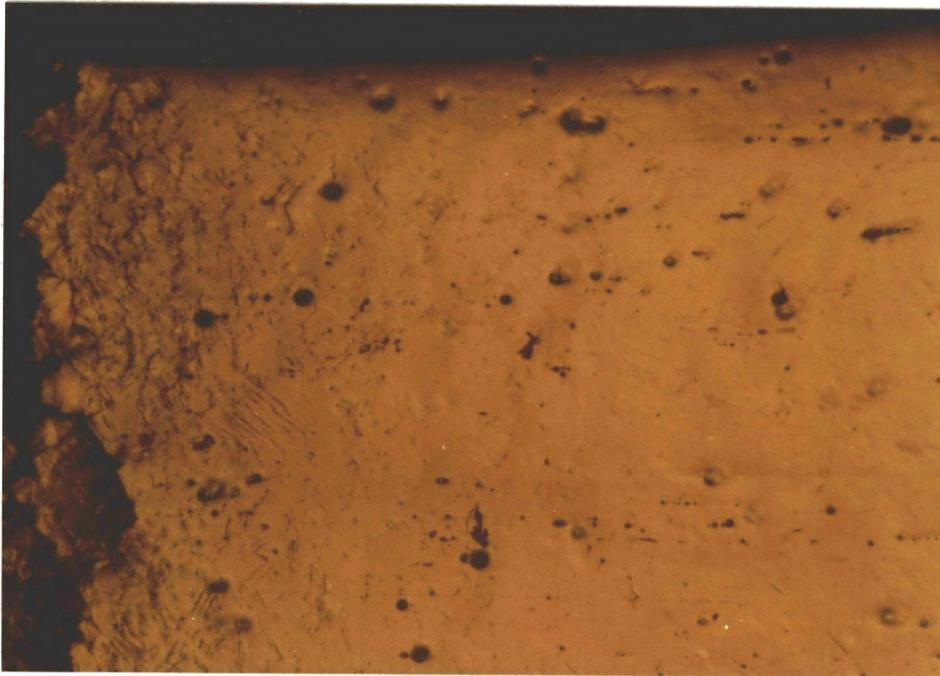
Figure 16. Localized Slip at Fracture Edge for HCF. Slip band density is low and extends back approximately 0.4 mm. Specimen number 22, OA, D = 12.2 mm,  $N_f = 24,263,000$  (x 98).

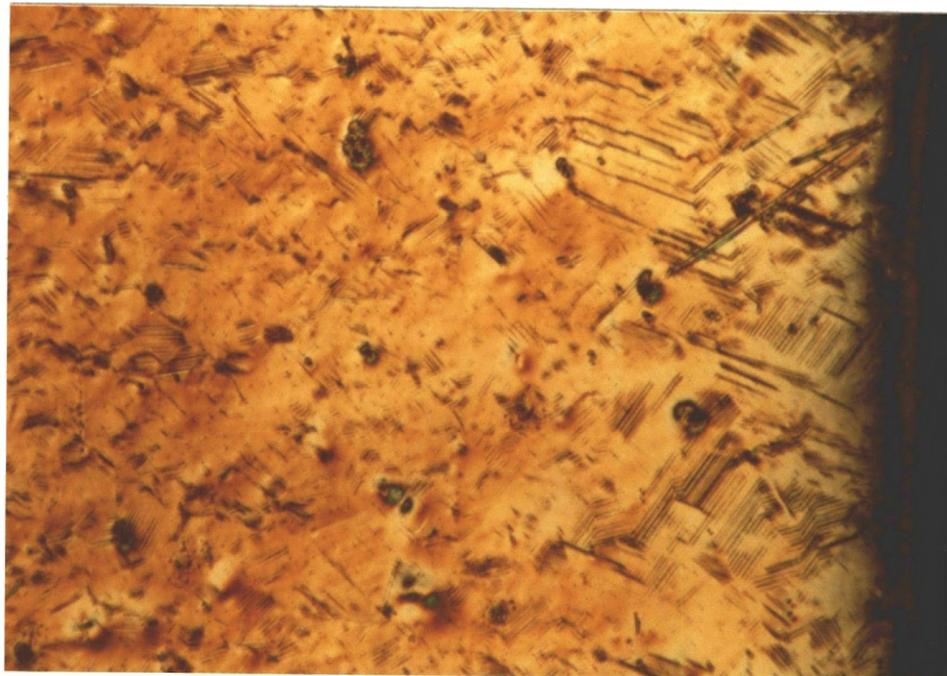
Figure 17. Transverse Slip Band Gradient with a Higher Concentration of Slip Markings Appearing at Gauge Length Edges. Specimen number 9, SHT, D = 15.3 mm,  $N_f = 253,400$  (x 195).

Other features included the transverse gradient of slip density, Figure 17. At the edges of the gauge length a relatively greater concentration of massive slip bands were produced. Multiple slip directions were most often seen at the higher bending displacements, Figures 18 and 19.

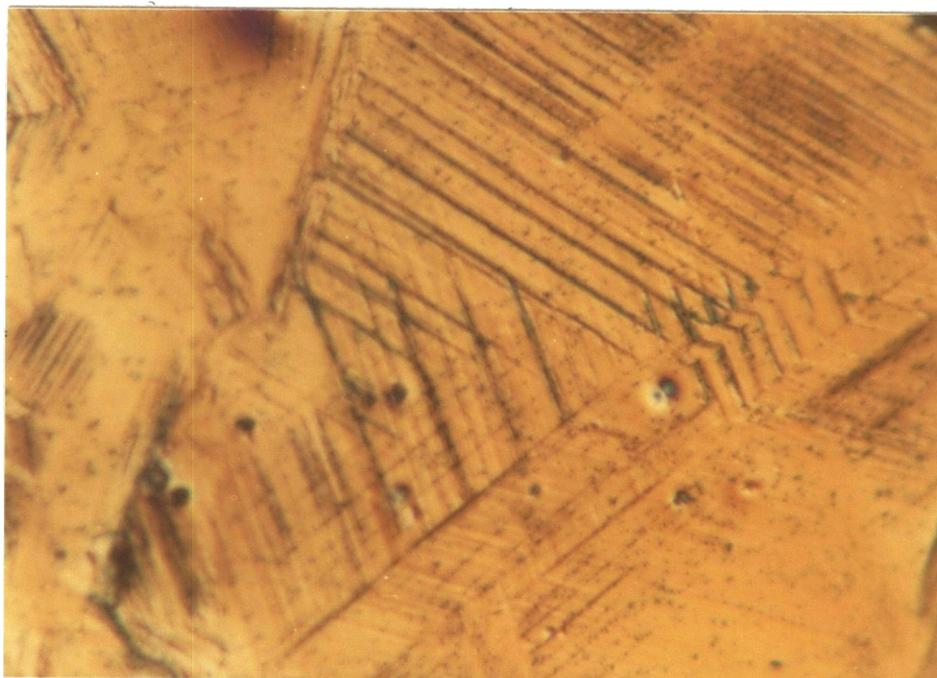
Figure 18. Triplex Slip Illustrating the Multiplicity of Slip Systems Activated in LCF. Specimen number 12, SHT, D = 24.2 mm,  $N_f = 10,300$  (x 780).

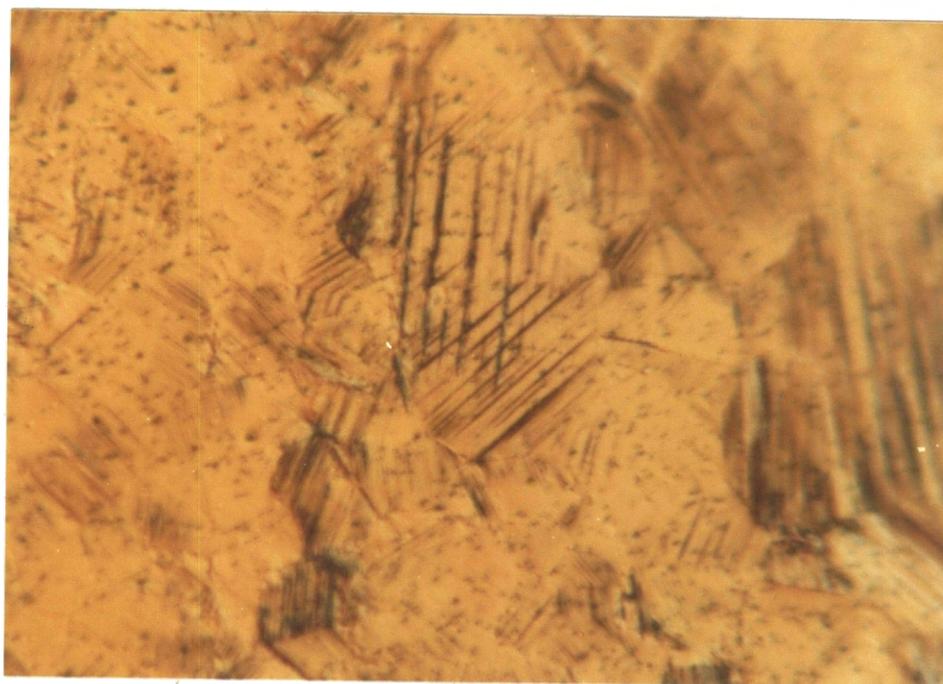
Figure 19. Duplex Slip with Pronounced Vertical Slip Bands Oriented Parallel to the Fracture Edge. Specimen number 26, OVA, D = 34.7 mm,  $N_f = 4,040$  (x 780).

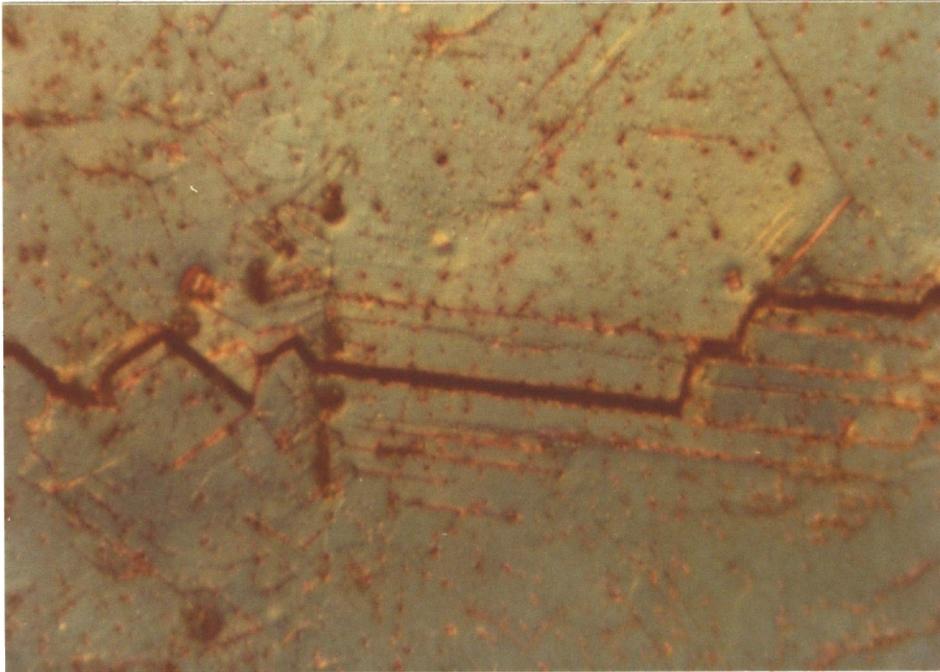
Figure 20. Longitudinal and Transverse Slip Band Cracking Occurring Adjacent to Intergranular Cracking. Crack oriented parallel to fracture edge. Specimen number 35, OA, D = 37.1 mm,  $N_f = 24,000$  (x 780).

The surfaces of 12 specimens were examined very closely with the optical microscope. Using the diameter of the field of vision as a measuring reference, cracking was discovered to be predominantly intergranular. With solution heat treated and overaged specimens, transgranular cracking accounted for less than 20 percent of the total. Optimum aged specimens were cracked intergranularly approximately 60 percent for low cycle fatigue and 80 percent for high cycle fatigue. The two modes of cracking are illustrated in Figures 20 and 21.

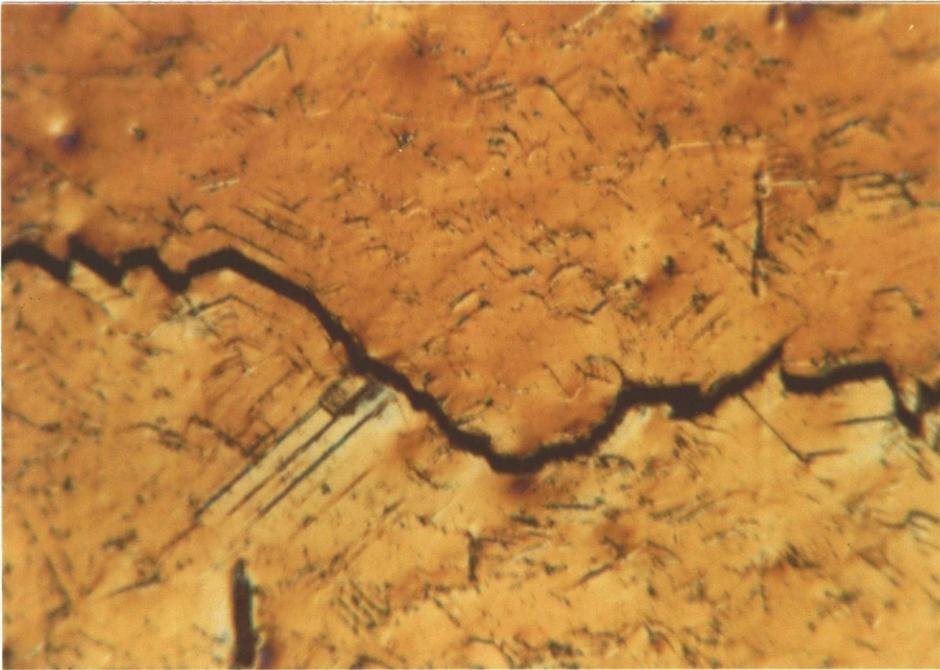
Figure 21. The Same Specimen as Shown in Figure 20 with Typical Mixed Mode Cracking. The intergranular mode comprises the majority observed. Crack oriented parallel to fracture edge. Specimen number 35, OA, D = 37.1 mm,  $N_f = 24,000$  (x 385).

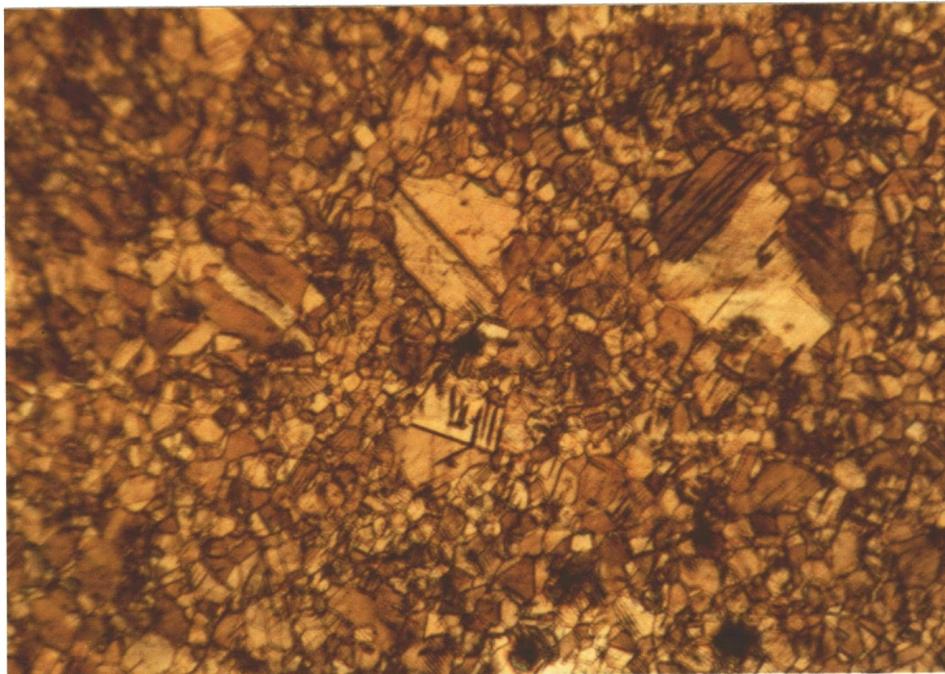
Figure 22. Fatigued and Then Etched Surface Marked by Existence of Inclusions, Slip Lines, and Cracks. Note that annealing twins are evidence of prior cold work. Grain size is 8.5. Specimen number 9, SHT, D = 15.3 mm,  $N_f = 253,400$  (x 195).

The majority of inclusions were located at grain boundaries, Figure 22. These have been shown to be composed of titanium compounds (5, 18). Inclusions and cracks often coincided, Figure 23. In a few cases, especially in high cycle fatigue, cracks unmistakably avoided inclusions, Figure 24.

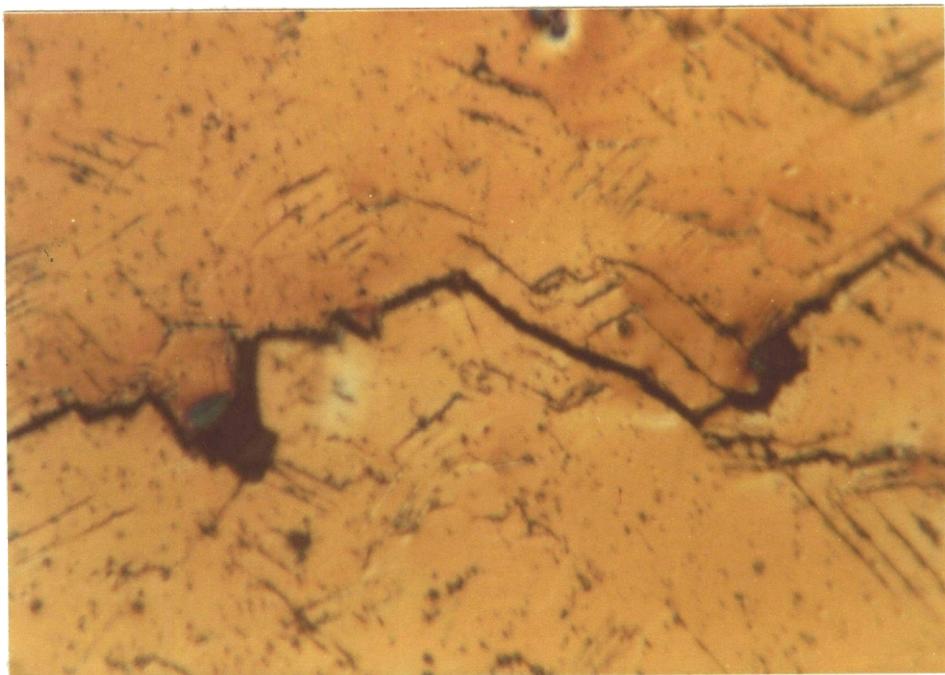
Figure 23. Intergranular Cracking Through Inclusions Located at Grain Boundaries. Specimen number 35, OA, D = 37.1 mm,  $N_f = 24,000$  (x 780).

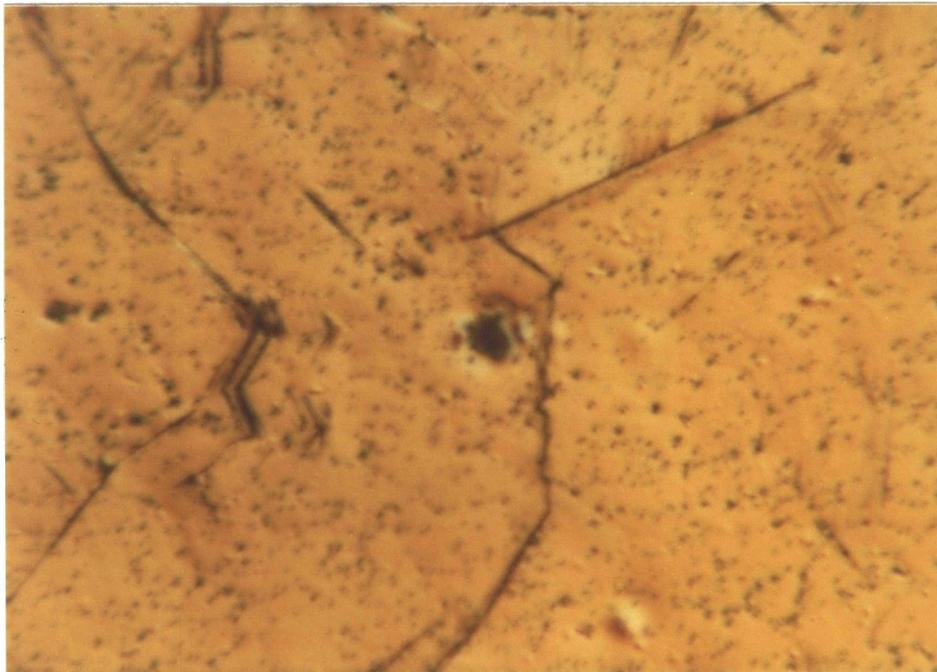
Figure 24. Intergranular Crack Adjacent to an Inclusion. Straight terminated end of crack is actually a twin boundary. Specimen number 37, OVA,  $D = 12.2$  mm,  $N_f = 3,262,000$  (x 780).

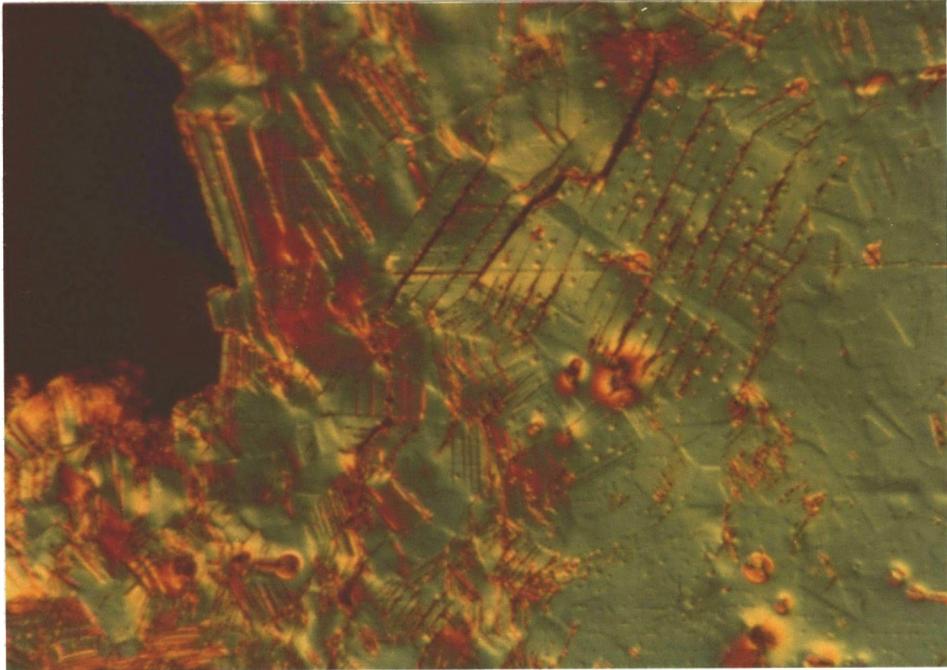
Figure 25. Group of Slip Bands Adjacent to Primary Fracture in HCF. Note primary fracture is both transgranular and intergranular. Specimen number 22, OA, D = 12.2 mm,  $N_f = 24,263,000$  (x 385).

The scanning electron microscope (SEM) offers a different perspective over that of the optical microscope. Figures 25 and 26 are a comparison of the same fracture edge of an optimum aged specimen. At higher magnifications with the SEM, extrusions became evident and prominent slip bands were cracked, Figure 27. In Figure 28, slip was mostly planar with perhaps local regions of wavy slip. Cracks often propagated through regions of dense slip band formation despite their intergranular nature, Figures 29 through 32. Ductile tearing was also observed. In Figure 33, a single transgranular crack formed as opposed to the multiple cracks of Figure 27. A second phase particle of Figure 34 is the site of an intergranular crack.

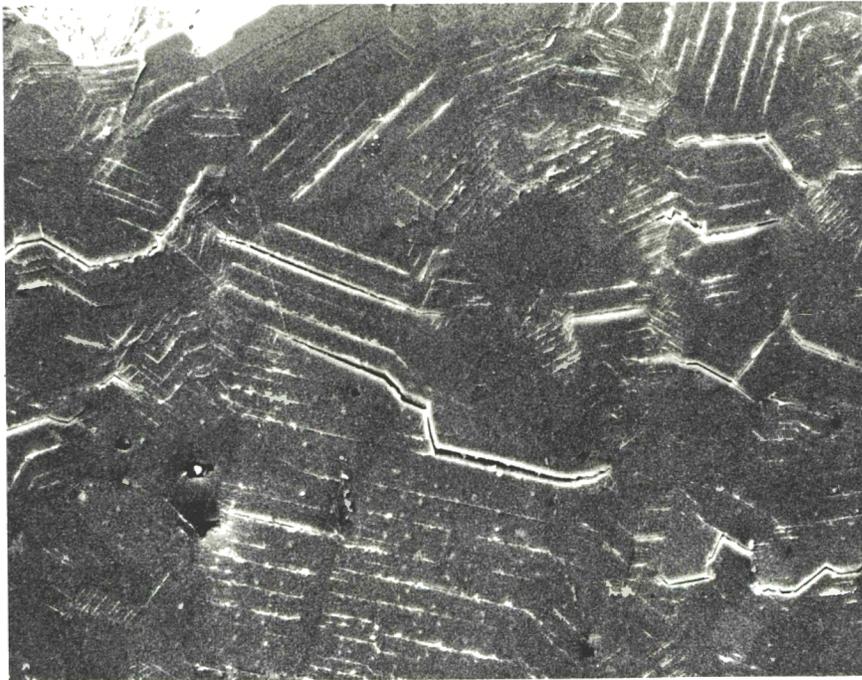
Figure 26. SEM Photograph of the Primary Fracture of Figure 25. Note the difference of orientation from Figure 25. Specimen number 22, OA, D = 12.2 mm,  $N_f = 24,263,000$  (x 390).

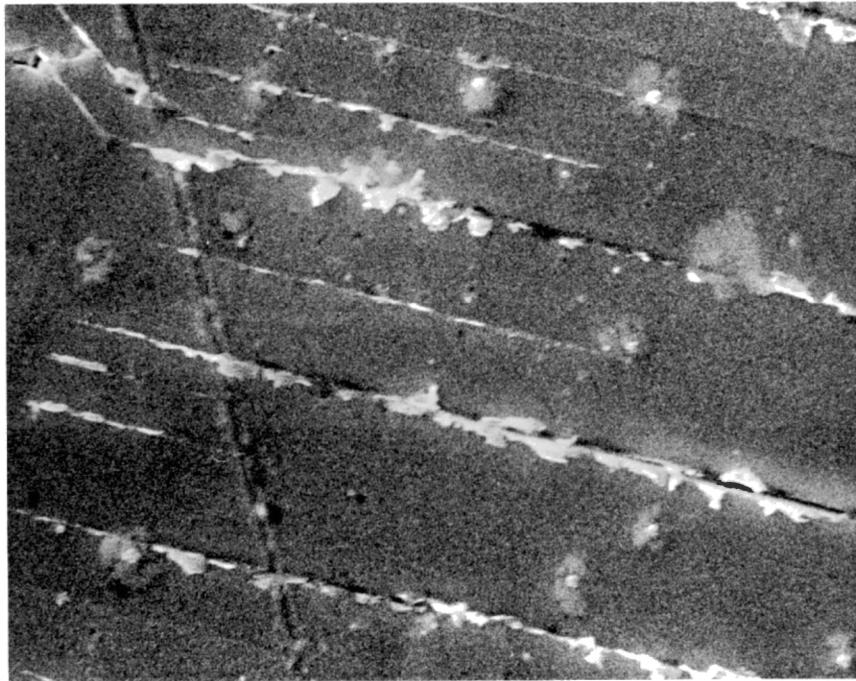
Figure 27. Extrusions and Cracks Emanating from the Prominent Slip Bands of Figures 25 and 26. Slip bands are irregularly spaced and are not uniform in length. Specimen number 22, OA, D = 12.2 mm,  $N_f = 24,263,000$  (x 3000).

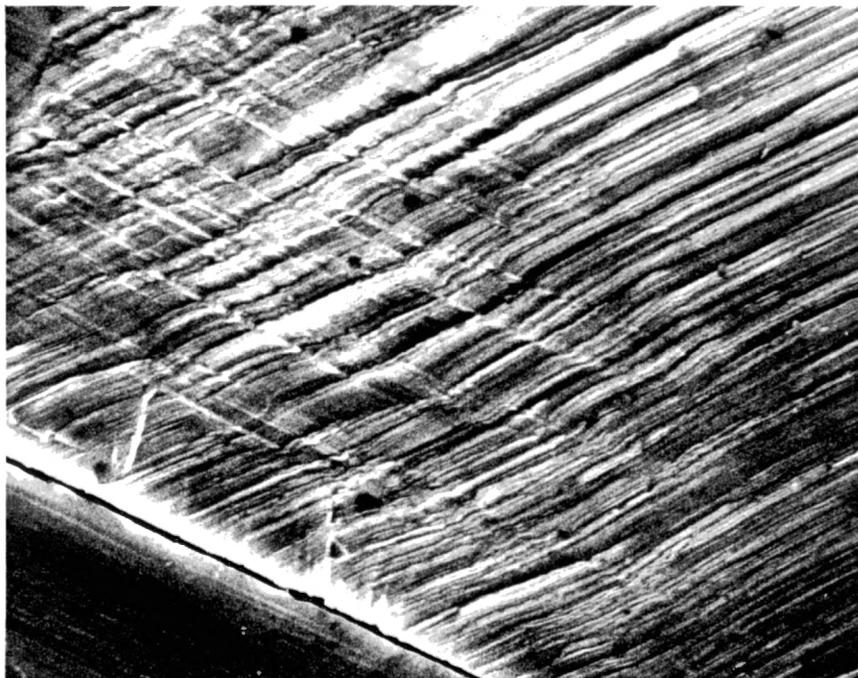
Figure 28. Slip in Two Directions with Some Extrusions. Note the predominance of planar slip along the more pronounced slip direction. Specimen number 32, SHT, D = 37.1 mm,  $N_f = 3480$  (x 3000).

The scanning electron microscope was instrumental in the evaluation of slip morphology. Slip bands were characterized by extrusions, similar to those seen by Fila and Price (4) with nickel. Figure 28 illustrates that slip was highly planar, although some wavy slip was discovered in regions of gross surface distortion near the fracture edge. Kriener (13) along with Fila and Price, detected mostly planar slip in their studies of nickel. According to Hertzberg (9), the proportion of planar versus wavy slip can be predicted by the magnitude of the stacking fault energy. It should be pointed out that the stacking fault energy of nickel and Monel K-500 are significantly different. In a recent study by Carter and Holmes (2), the stacking fault energy of nickel was calculated to be 120-130 erg/cm<sup>2</sup>. Karnthaler (11) reported that the stacking fault energy of nickel and copper was 120 and 41 erg/cm<sup>2</sup> respectively. Normalizing the data of Harris et al. (8), the author estimates the stacking fault energy of Monel K-500 to be 60-80 erg/cm<sup>2</sup>. The logical conclusion is that stacking fault energy by itself is not sufficient criteria for the prediction of planar or wavy slip.

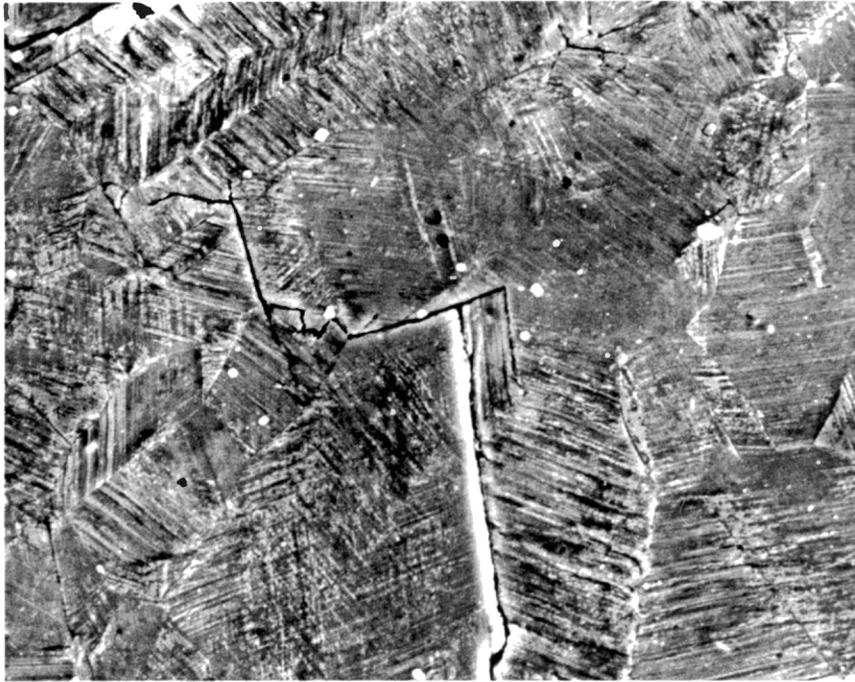
Figure 29. Mixed Mode Cracking in Areas of Concentrated Slip. Amidst much finer mixed mode cracking, intergranular cracks continue. Specimen number 13, SHT, D = 27.9 mm,  $N_f = 6,300$  (x 1300).

Other features relevant to Monel K-500 were often similar to those observed in nickel by Fila and Price (4). Slip bands were cracked, especially those in regions of massive plastic deformation. Cracks, regardless of mode, penetrated regions of massive localized slip for both materials. This is shown in Figures 29 and 30.

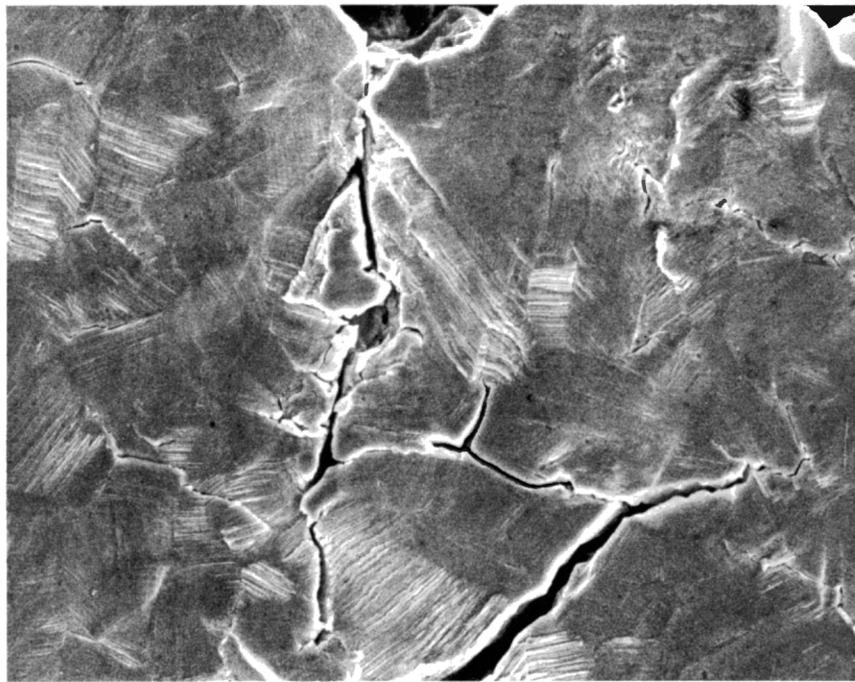
Figure 30. Intergranular Cracking Situated Near Regions of Dense Slip Band Formation. Gross rubbing of the surface adjacent to the fracture edge causes tearing. Specimen number 32, SHT, D = 37.1 mm,  $N_f = 3480$  (x 750).

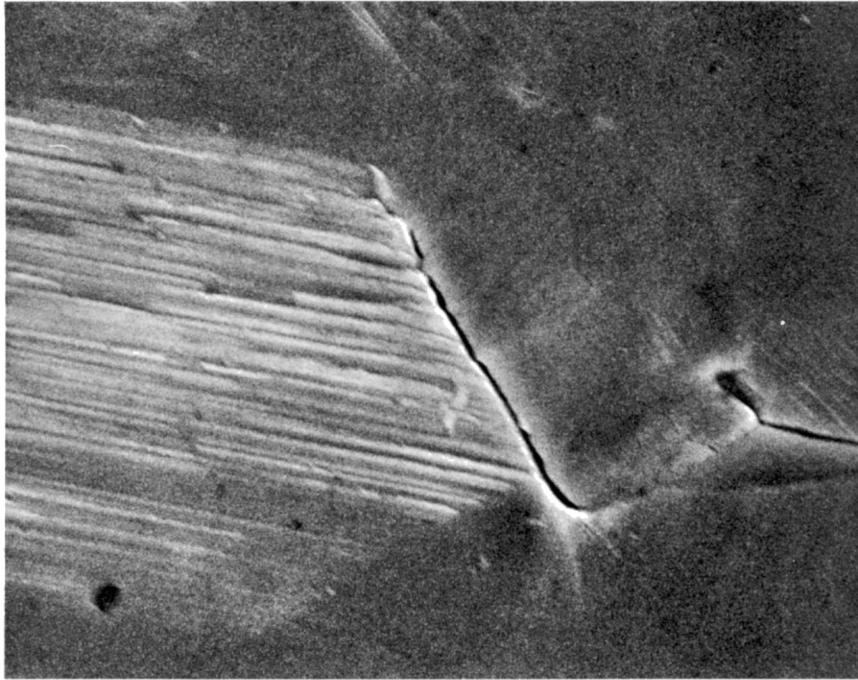
Figure 31. Local Accommodation of Stress is Achieved by Slip Band Formation and Intergranular Cracking. Specimen number 32, SHT, D = 37.1 mm,  $N_f = 3480$  (x 3000).

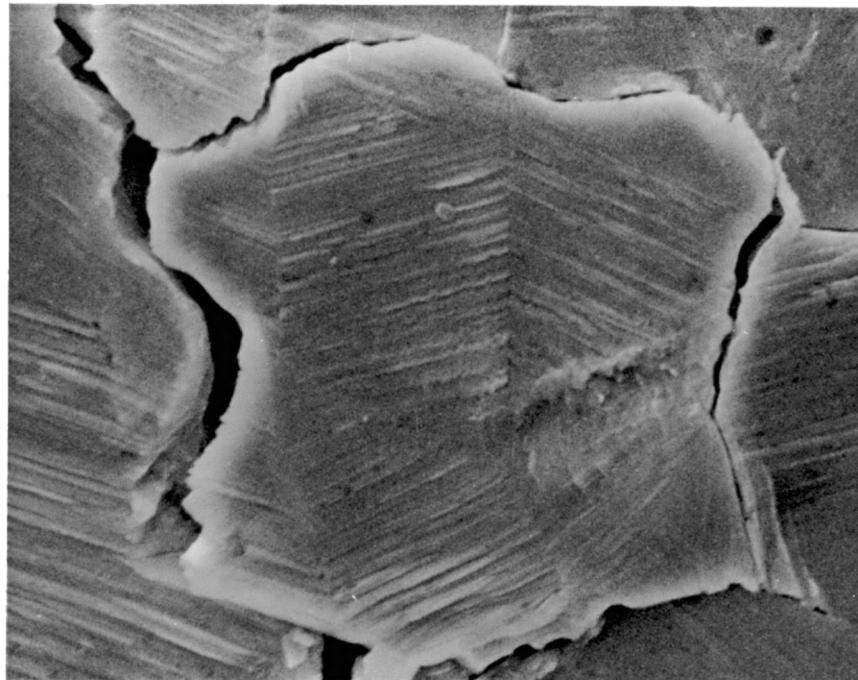
Figure 32. A Completely Isolated Grain Exhibiting Ductile Tearing Through Continuous Slip Lines and Twin Boundaries. High degree of deformation located near the fracture edge. Specimen number 32, SHT, D = 37.1 mm,  $N_f = 3480$  (x 3,000).

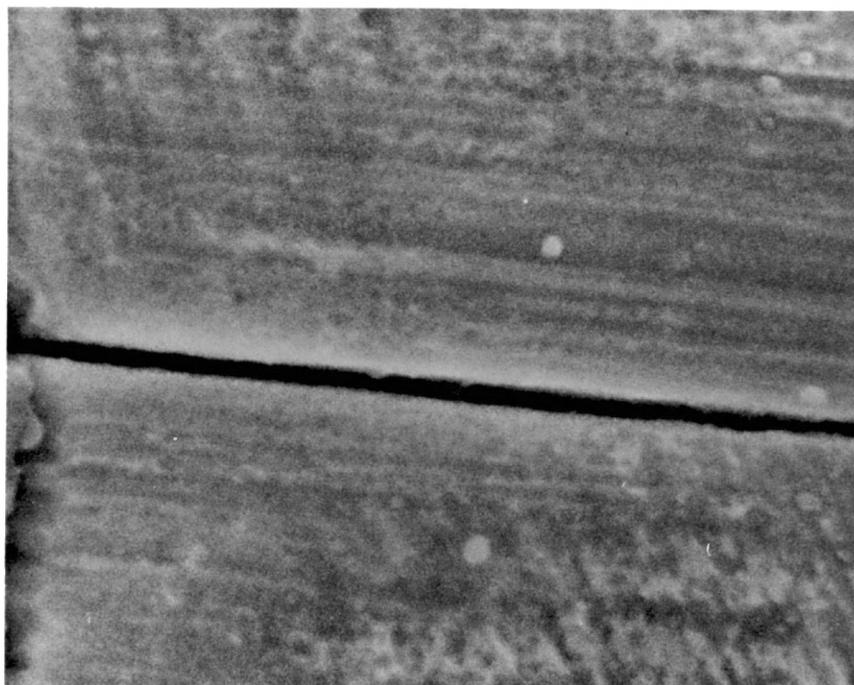
Figure 33. Duplex Slip on Both Sides of a Single Slip Band Crack That Terminates at a Cracked Grain Boundary. Specimen number 13, SHT, D = 27.9 mm,  $N_f = 6,300$  (x 9000).

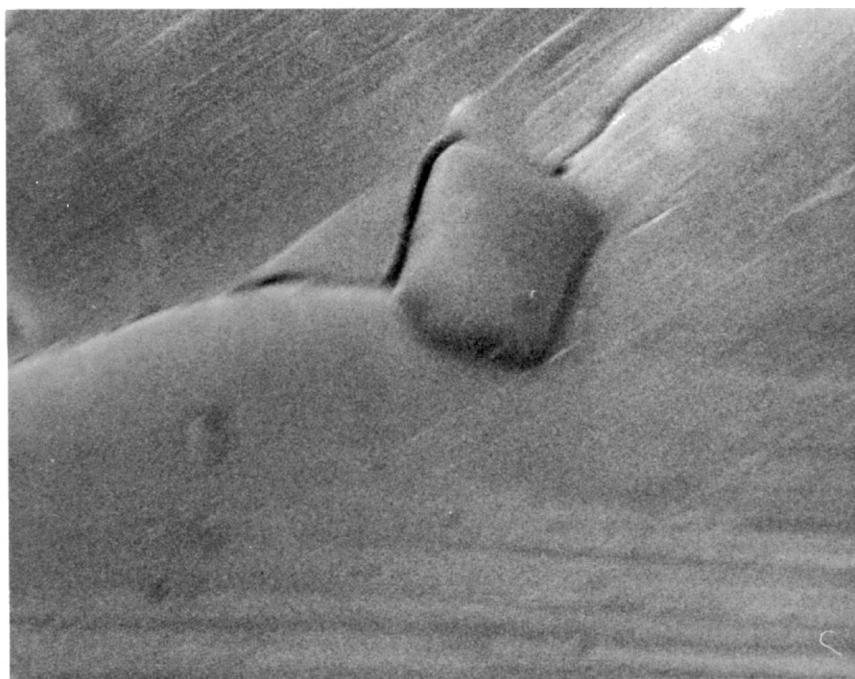
Figure 34. Crack at a Second Phase Particle. Adjacent slip is minimal. Specimen number 32, SHT, D = 37.1 mm,  $N_f = 3480$  (x 10,000).

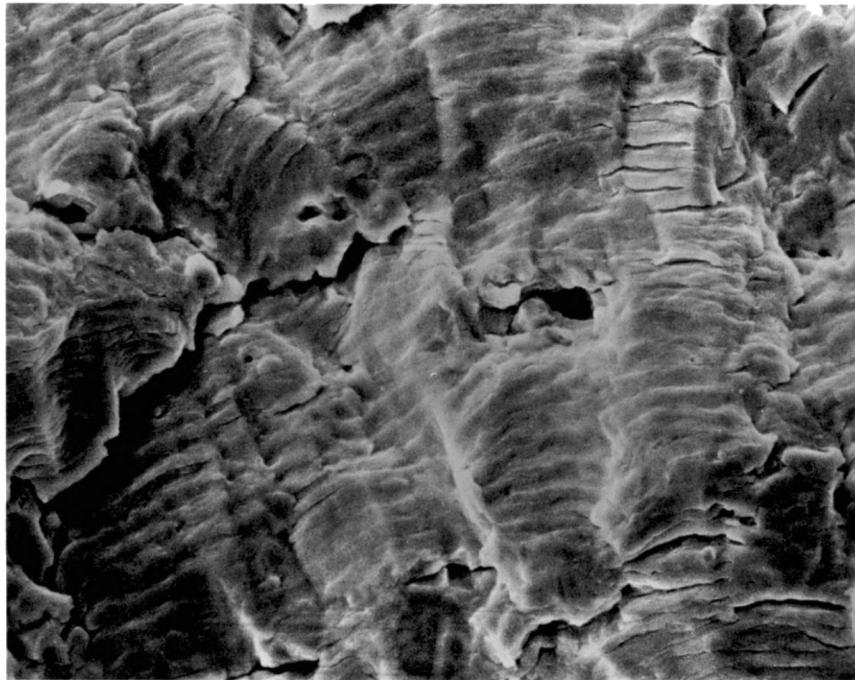
Figure 35. Considerable Amount of Secondary Cracking Amidst Coarse LCF Striations. Specimen number 31, SHT, D = 30.9 mm,  $N_f = 5,400$  (x 1500).

The orders of magnitude greater depth of focus of the SEM allowed fracture surfaces to be monitored. In Figure 35, a considerable amount of secondary cracking has developed. Striations were coarse, charac-

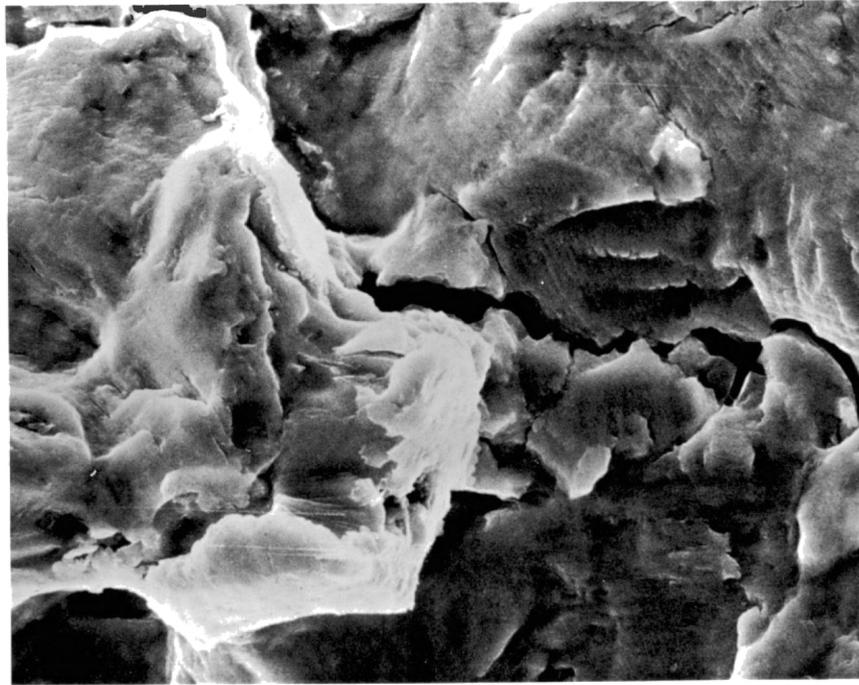
Figure 36. Secondary Cracking Associated with Fine HCF Striations in the Central Region of the Fracture Surface. Specimen number 22, OA, D = 12.2 mm,  $N_f = 24,263,000$  (x 3000).

teristic of low cycle fatigue. Correspondingly, in Figure 36, secondary cracks were seen in conjunction with very fine striations formed during high cycle fatigue.

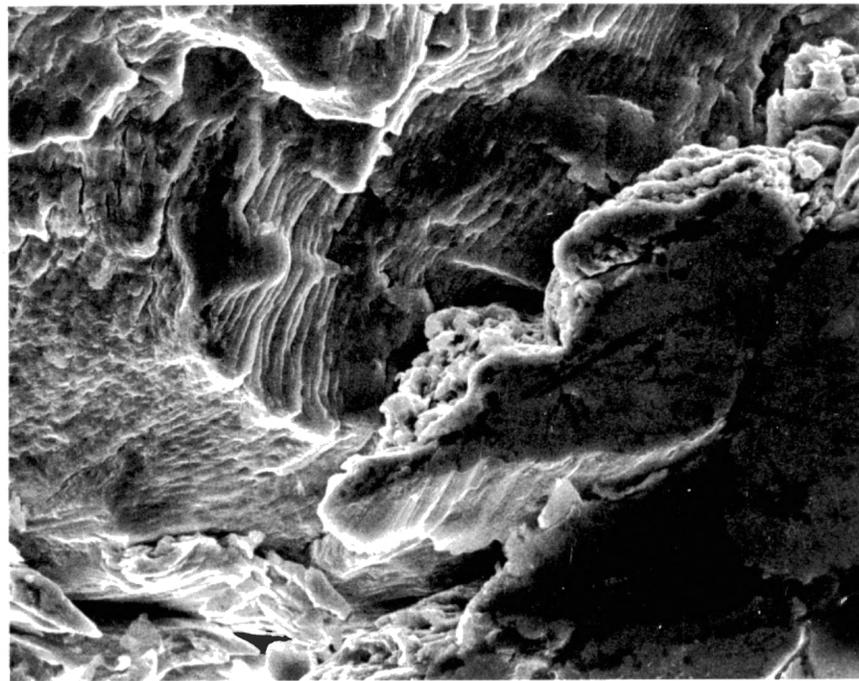
Figure 37. Stage I to Stage II Crack Propagation Transition. Depth of transition is approximately 10  $\mu\text{m}$  measured from edge of fracture seen at the top of the photograph. Specimen number 18, OA, D = 30.9 mm,  $N_f = 29,700$  (x 3000).

The stage I to stage II crack propagation transition in Monel K-500 was observed at different depths from the specimen surface. Typically the transition did not evolve at a unique depth, but varied from a consistent minimum depth of 10  $\mu\text{m}$  to over 100  $\mu\text{m}$ . In Figure 37, the transition was measured to be 10  $\mu\text{m}$ .

The stage I to stage II crack propagation transition shown in Figure 37 was not typical of all fracture surfaces. The transition most commonly occurred at a depth of approximately 100-150  $\mu\text{m}$ . The 10  $\mu\text{m}$  minimum transition depth was assumed to be the result of localized differences in the crack propagation rate. It was hypothesized that the areas exhibiting the 10  $\mu\text{m}$  dimension were "forced" to experience the transition at shallower depths by the already well developed fatigue crack at 100-150  $\mu\text{m}$ .

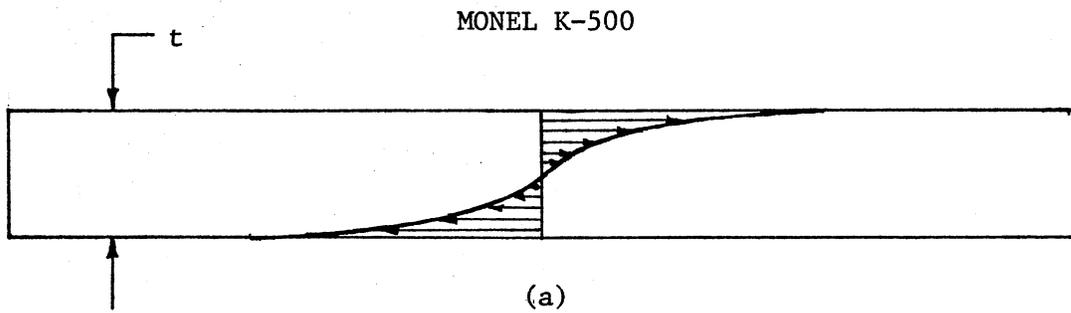
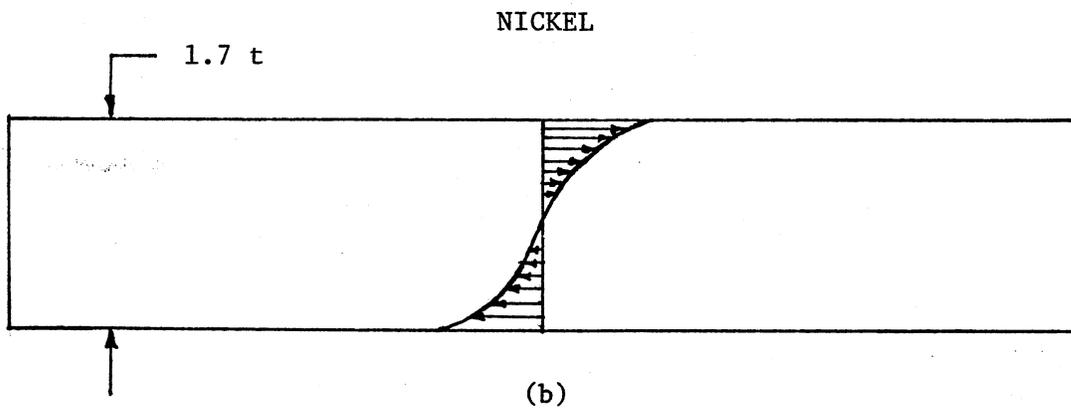
Figure 38. Representative Strain Gradients for Monel K-500 and Nickel 200 as a Function of Depth.  $t$  = thickness (Not to scale.)

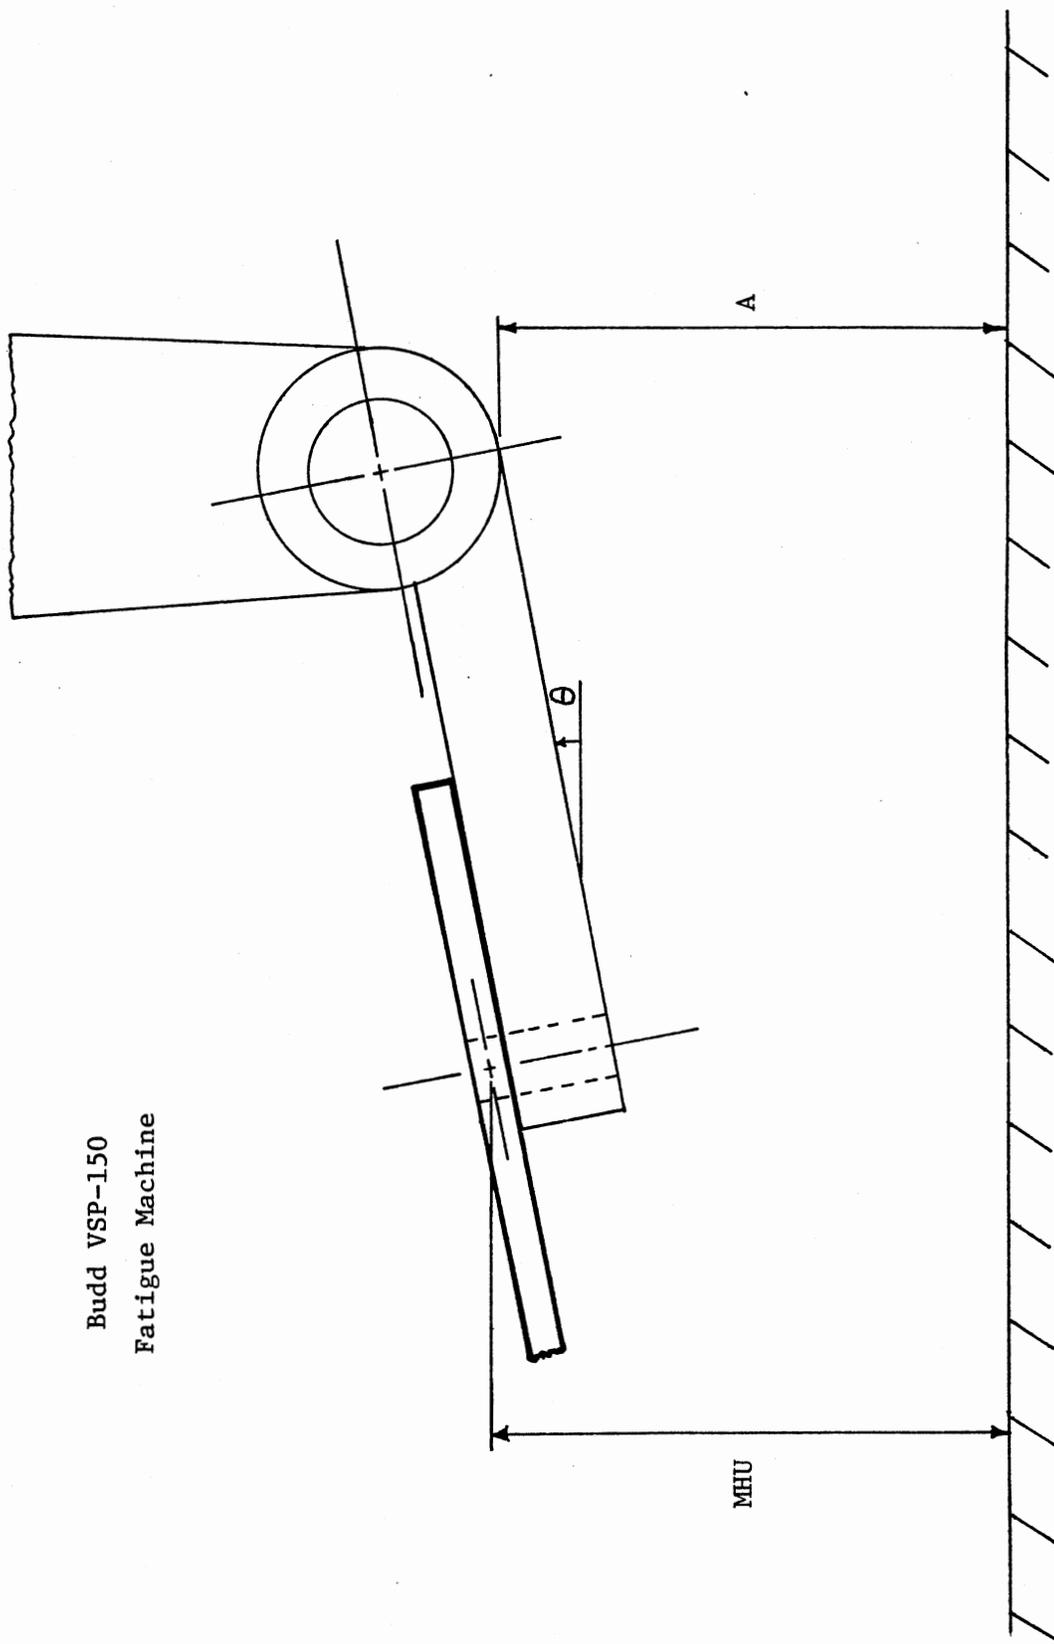
Figure 39. Geometry of Specimen Shown in "Maximum Height Upward"  
Position

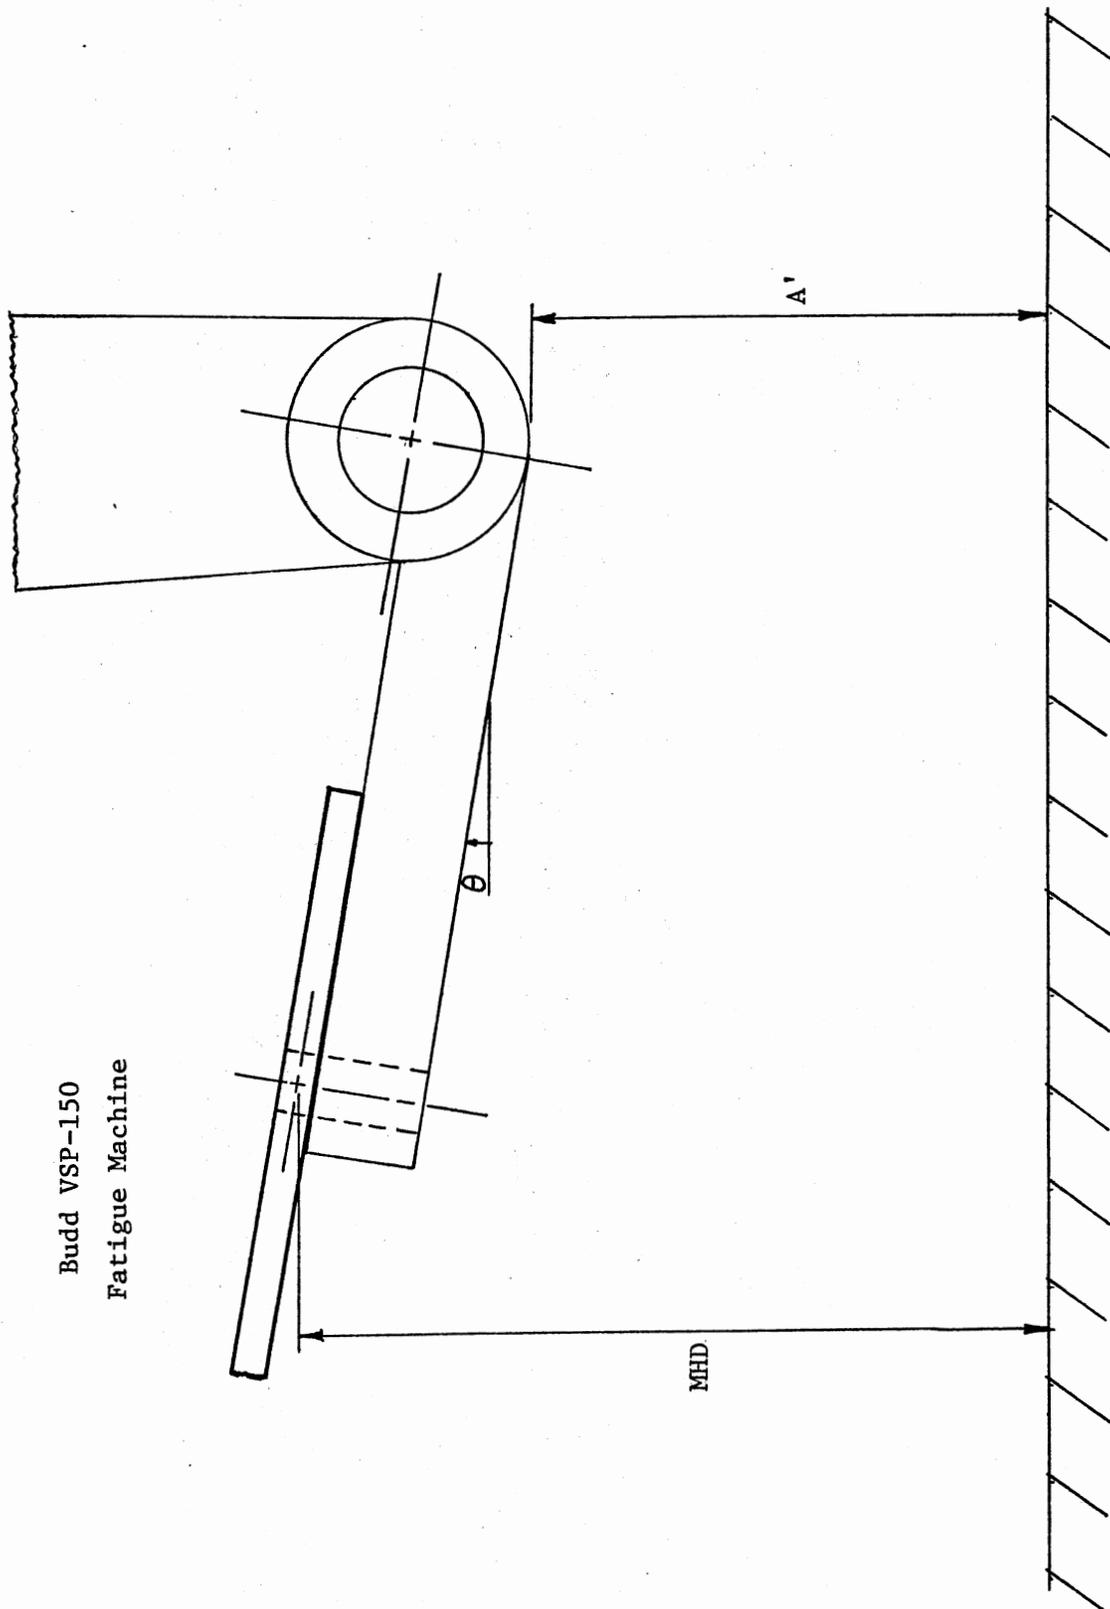
Figure 40. Geometry of Specimen Shown in "Minimum Height Downward"  
Position
