A STUDY OF REVERSED BENDING FATIGUE  
IN THE NICKEL-COPPER ALLOY,  
MONEL K-500

Submitted to the Faculty of the Graduate College  
of the Oklahoma State University  
in partial fulfillment of the requirements  
for the Degree of  
MASTER OF SCIENCE  
December, 1979

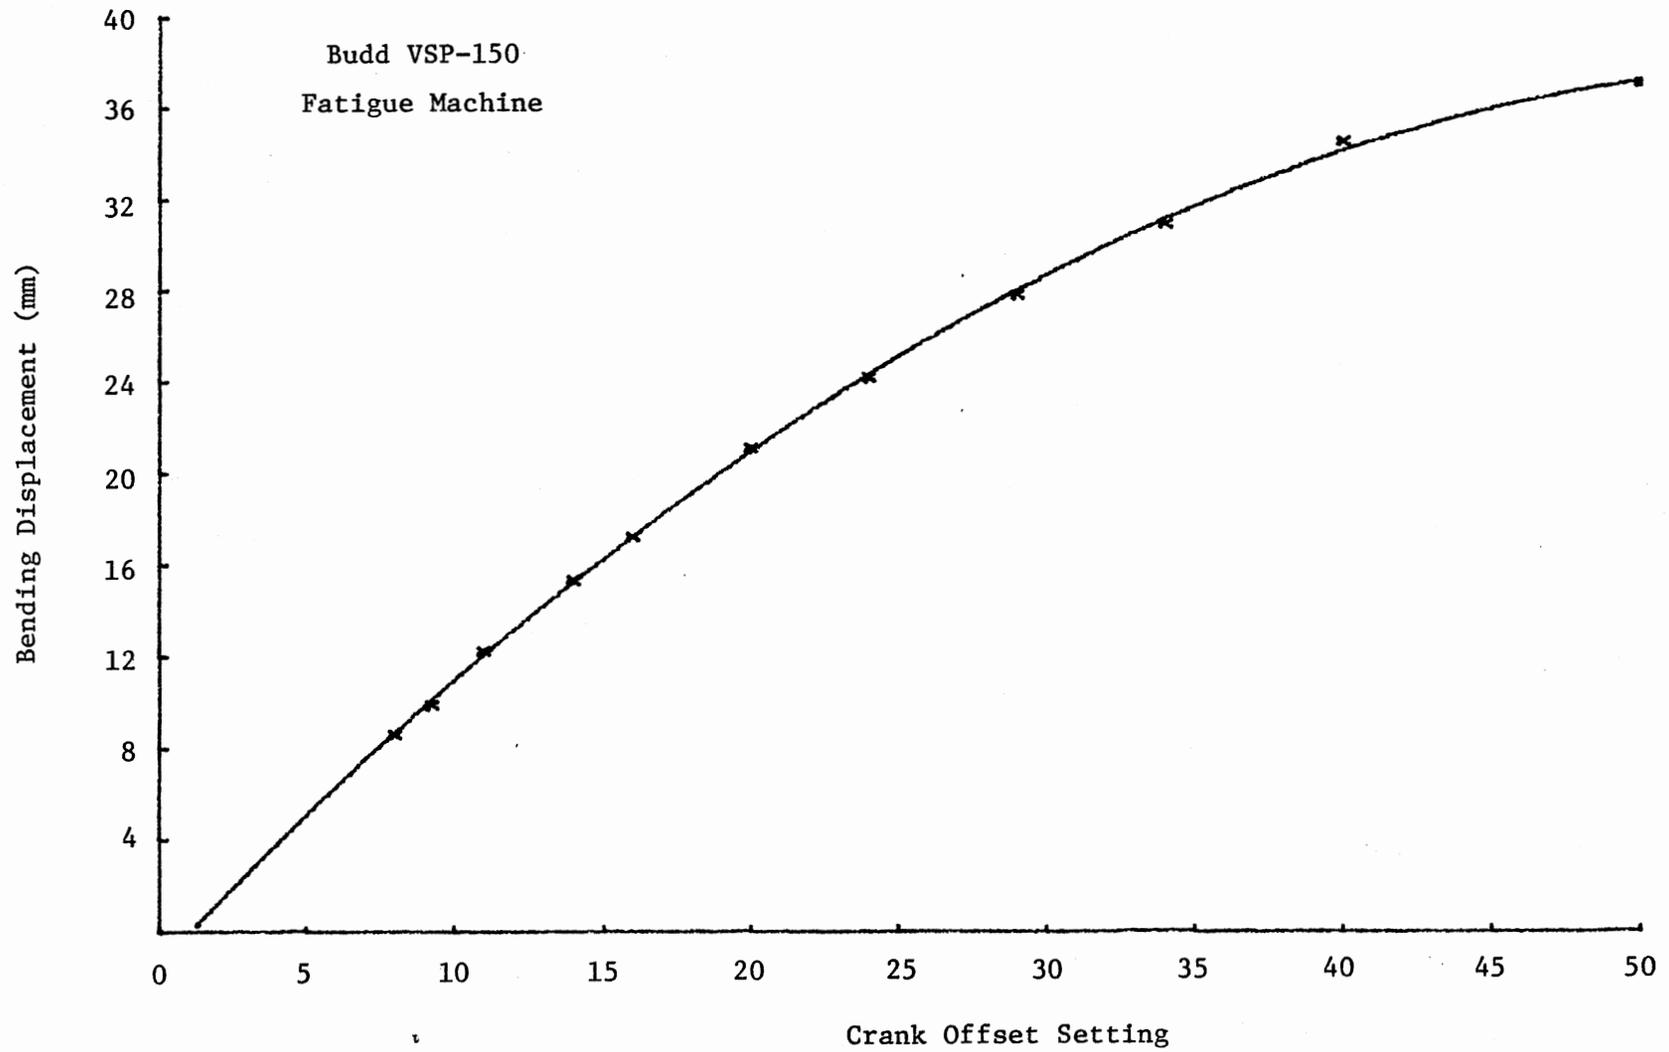
Figure 41. Bending Displacement as a Function of Crank Offset Setting

vs. crank setting curve, Figure 41. Once the crank setting is established, the bending displacement is accurate from this curve to a maximum tolerance of  $\pm 0.15$  mm. The author is pleased that the geometry of fracture seams had improved, with all specimens approximately symmetrical.
