A STUDY OF THE EFFECTS OF STRAIN AMPLITUDE AND
ENVIRONMENT ON THE MECHANISM OF FATIGUE
CRACK INITIATION IN NICKEL

Submitted to the Faculty of the Graduate College
of the Oklahoma State University
in partial fulfillment of the requirements
for the Degree of
MASTER OF SCIENCE
May, 1978

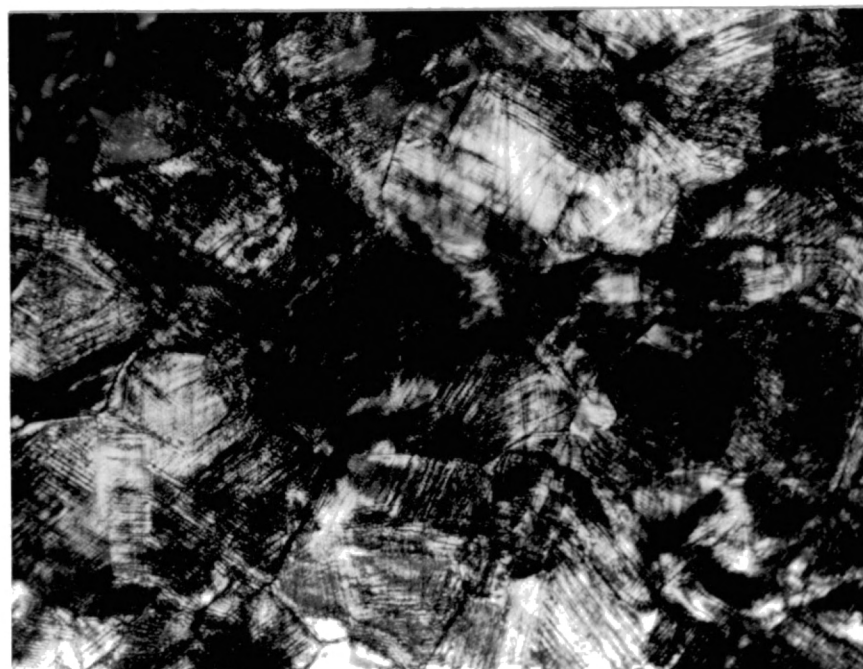
Figure 28. High Strain Amplitude Fracture Surface in a Corrosive Environment. In low cycle fatigue the corrosive damage is not apparent. The slip lines tend to be wider and more coarse when compared to the slip in the dry air environment. Sample 9B (X380)

Surface deterioration in the two environments varied with the strain amplitude. In Figures 25 and 26, at a low strain amplitude, the acid environment specimen displayed gross damage due to corrosion. In Figures 27 and 28, at a high strain amplitude, surface damage is primarily due to plastic deformation and no difference was noticed between the two environments. It is suggested that amount of corrosion is highly dependent on time of test and that in the case of short fatigue lives, such as Figure 28, the environment had very little time to attack the surface.

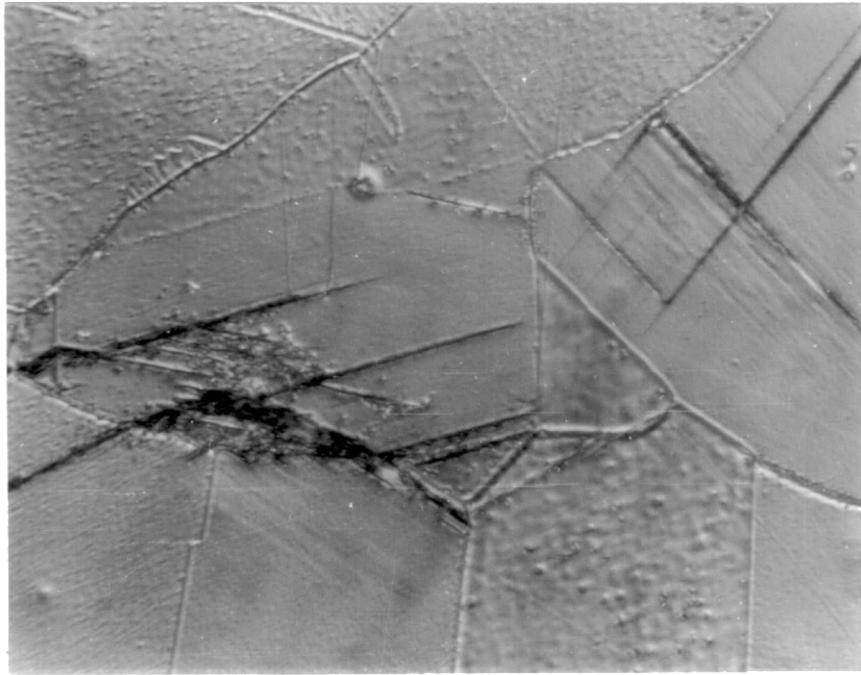
Figure 29. Progression of Slip in a Dry Air Environment. On the same sample as Figure 23, an area closer to the fracture edge is viewed to observe the progression of visible slip lines to a crack system. At a surface hardness of $H_v \approx 150$ some grains have multi-directional slip with slip lines and cracks connecting across grain boundaries. Sample 1A (X760)

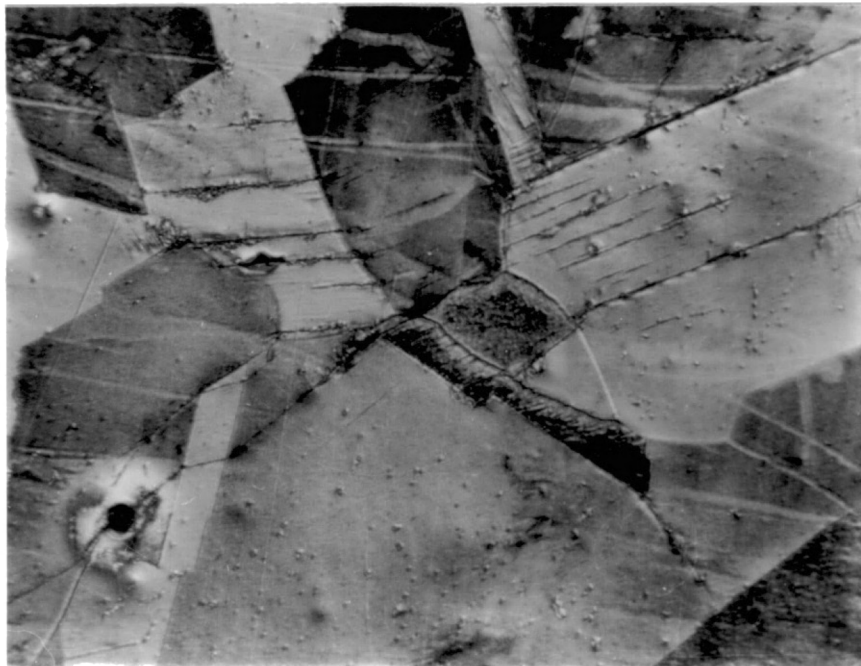
Figure 30. Progression of Slip in a Corrosive Environment. On the same sample as Figure 24 the progression of slip to cracks is seen in an area of $H_v \approx 150$. The slip is mostly one-directional with the lines/cracks being more dispersed and somewhat more coarse than that in Figure 29. The crack is seen to travel from the lower left through a grain and along grain boundaries to the upper right. Sample 6A (X380)

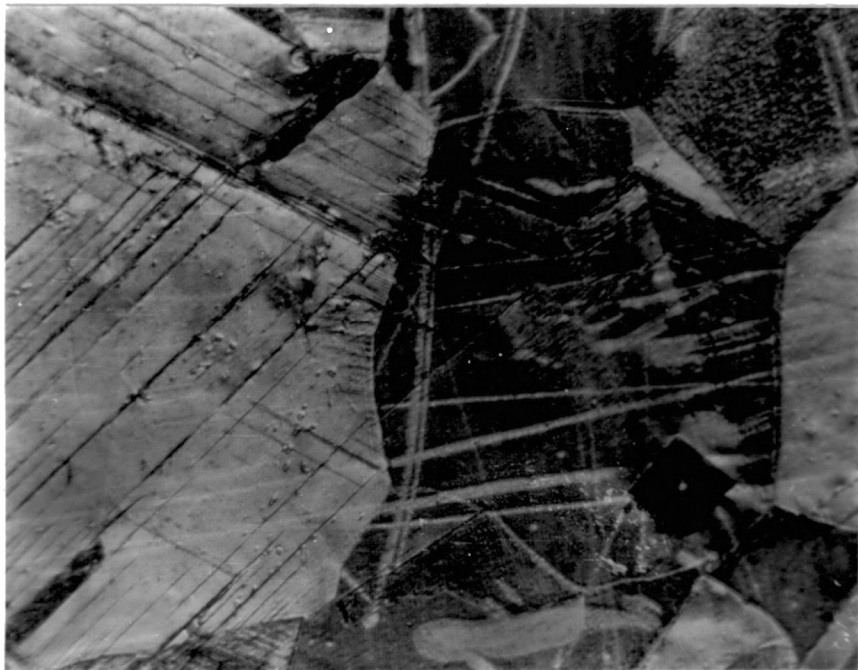
Figure 32. Surface Damage in the Vicinity of the Limiting Surface Hardness in a Corrosive Environment. Persistent slip bands and extrusions/intrusions are present but not as extensive as in Figure 31. Surface hardness is $H_V \approx 160$ and the location is adjacent to the fracture edge. Sample 6A (X380)
