The University of Oklahoma, Ph.D., 1966  
Engineering, metallurgy

CRACK MORPHOLOGY IN CORROSION-FATIGUE  
OF 2024-T4 ALUMINUM ALLOY

A DISSERTATION  
SUBMITTED TO THE GRADUATE FACULTY  
in partial fulfillment of the requirements for the  
degree of  
DOCTOR OF PHILOSOPHY

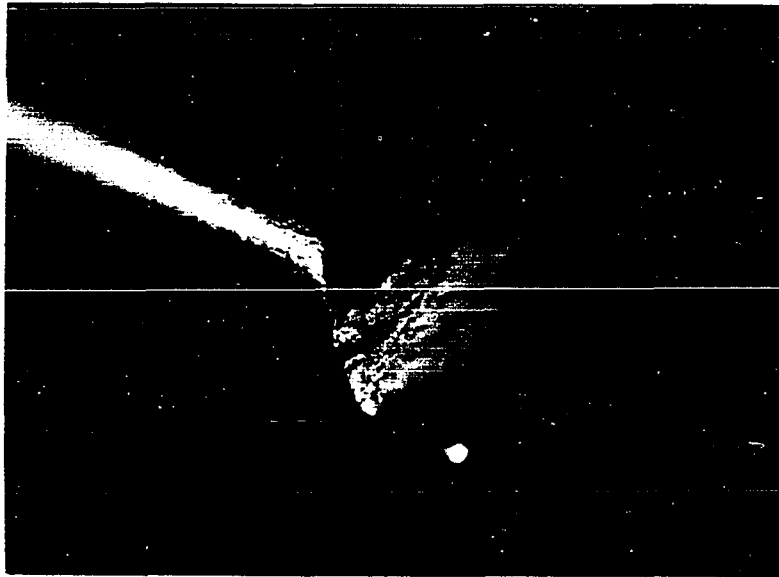
**Figure 15. Specimen No. 518. Small Fan-Shaped Two-Layered Fatigue Area**

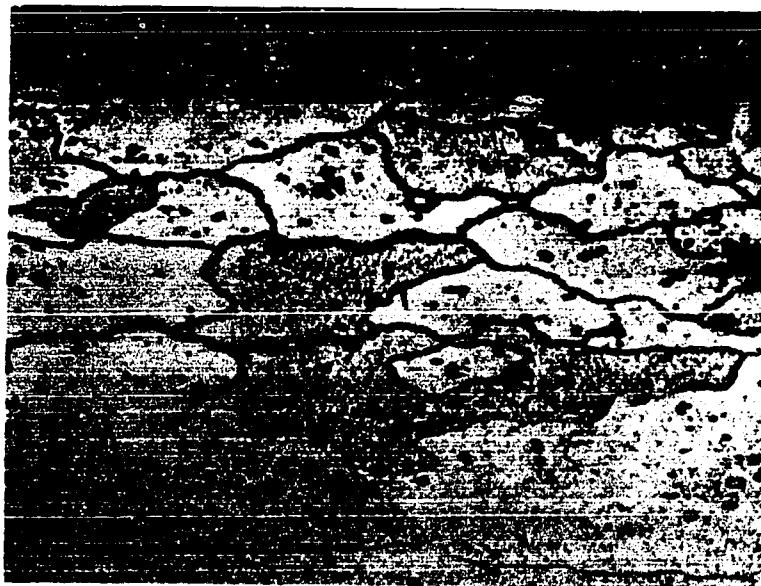
Figure 48. Specimen No. 24E. Magnification 300X.  
Typical Example of Group 3 Damage
