LABORATORY AND FIELD INVESTIGATIONS FOR
CAUSES OF UNWANTED DEFORMATIONS IN
EXISTING STEEL GIRDER BRIDGES
REHABILITATED WITH CONCRETE DECKS

Submitted to the Faculty of the
Graduate College of the
Oklahoma State University
in partial fulfillment of
the requirements for
the Degree of
MASTER OF SCIENCE
July, 2017

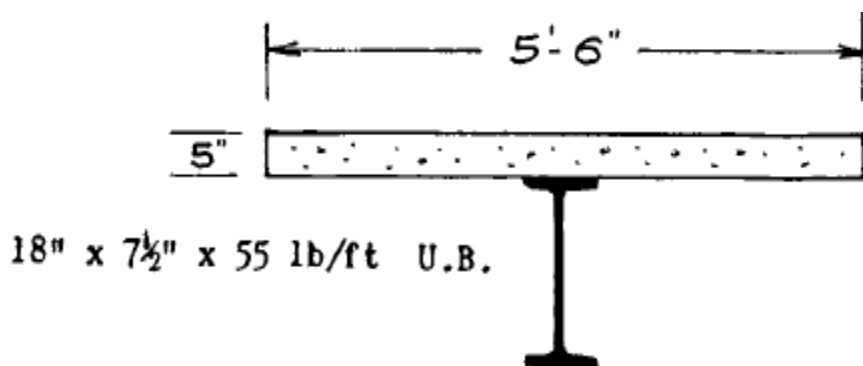
Figure 1: Cross Section Used in Analysis and Design

This paper analyzes the advantages and disadvantages of using composite construction and offers insight toward possible future development. The cross section shown below in Figure 1 has a 5” x 5’6” concrete slab atop of an 18” x 7.5” x 55 lb/ft. steel girder. Table 2 below shows the comparison between composite and non-composite sections for the cross section mentioned above and shown below.

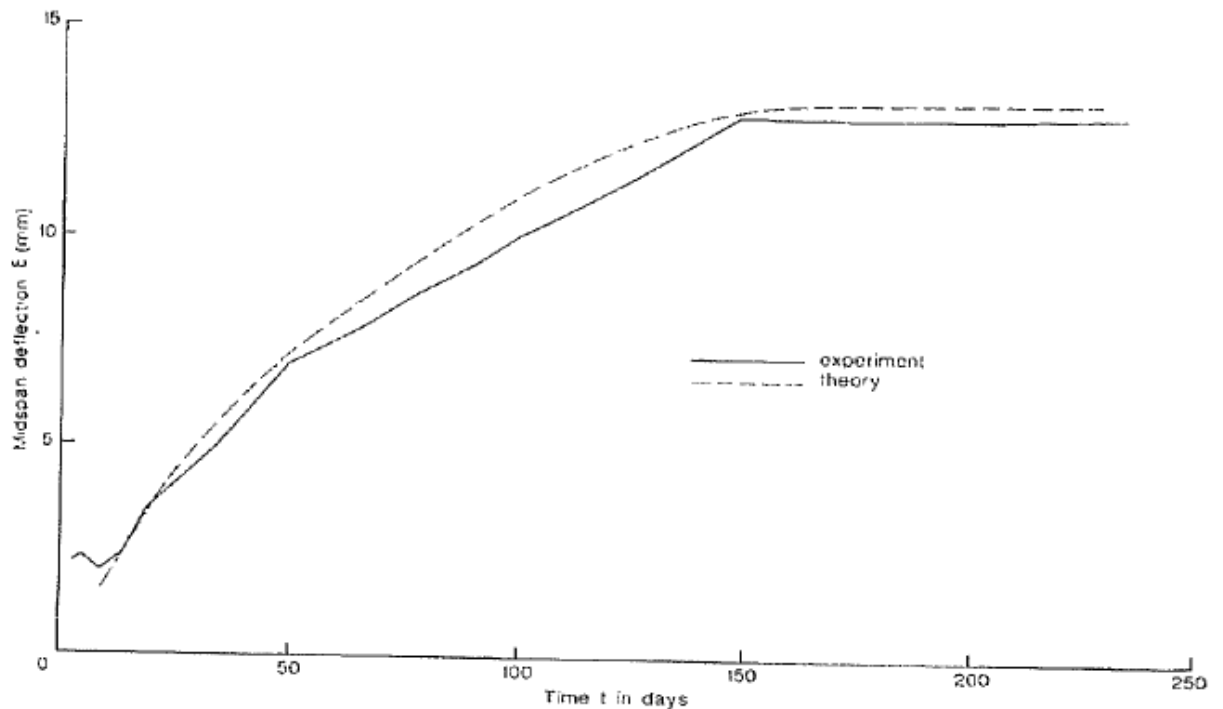
Figure 2: Midspan Deflection After 250 days

The author observed that the shrinkage induced curvatures may be high, up to 60% of the curvature to causes first yield of the steel joist, this effect is somewhat relived by providing reinforcement (Bradford 1997). Large reinforcement ratios for deflection control can cause cracking. In the absence of shear connectors and reinforcement, a concrete slab will contract due to shrinkage. The shear connectors and reinforcement serve as resistors to this contraction, and the forces in the connectors oppose those due to the gravity load so shrinkage is beneficial to the connectors (Bradford 1997). However, the contraction of concrete can offset this benefit because of the flexural stresses and deflections that arise. Furthermore, reinforcement in the concrete slab will increase the ductility of the composite beam, but the reinforcement can increase the tensile stresses in concrete due to shrinkage to the point of cracking. In conclusion, the author recommends that the structural designers are aware of the effects of concrete shrinkage in composite tee-beams when designing to meet serviceability limit states.

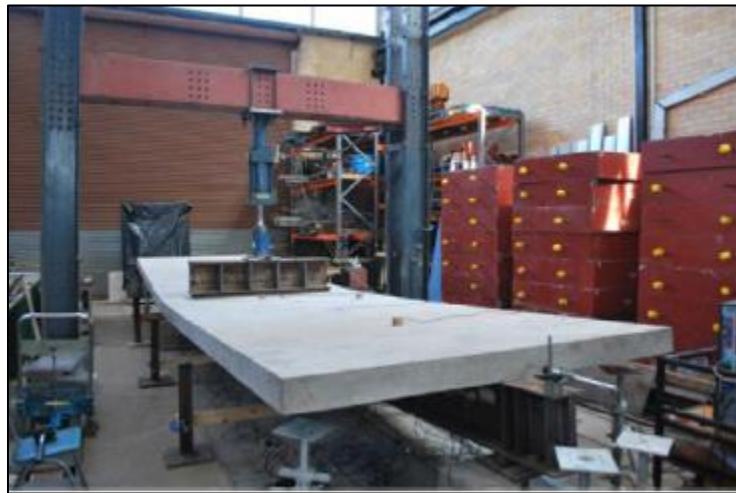
Figure 3: Testing Frame and Setup

The test configuration consisted of a point load applied on a spreader beam at midspan of the simply supported beam shown in Figure 3 below. The load was applied with a servo-controlled hydraulic jack. The two un-propped beams were tested through a series of load cycles until 25 mm of deflection was achieved and the propped beam was tested until deflection reached 32 mm. The process was repeated three times before the beams were loaded to failure. All the beams failed at the shear connectors due to the partial shear connection design and the test were terminated once the first set of shear connectors failed. The ultimate load for the two unpropped beams was 210 kN and 207 kN and for the propped beam was 216 kN.

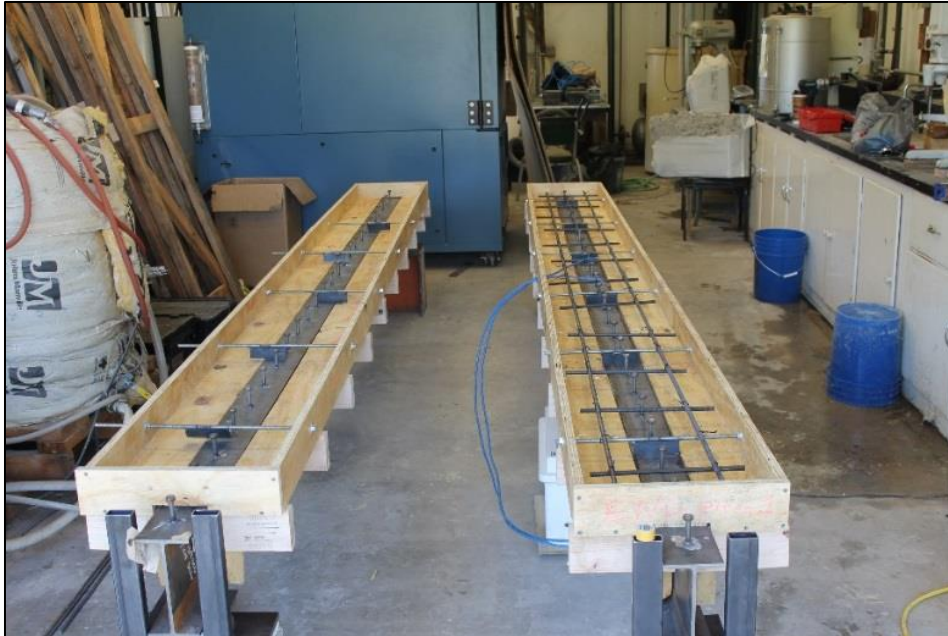
Figure 4: Formwork for concrete decks that were cast-in-place atop W8x15 steel girders.

Figure 4 shows the shear studs, transverse and longitudinal steel, and the placement of the thermocouples before casting. Figure 5 shows Prototype Beam 1 after the deck had cured and the formwork was removed and Prototype Beam 2 shortly after casting the slab. Prototype beam 1 was cast on August 28th, 2014 at 12:00 PM and prototype beam was cast on September 4th, 2014 at 12:00 PM.

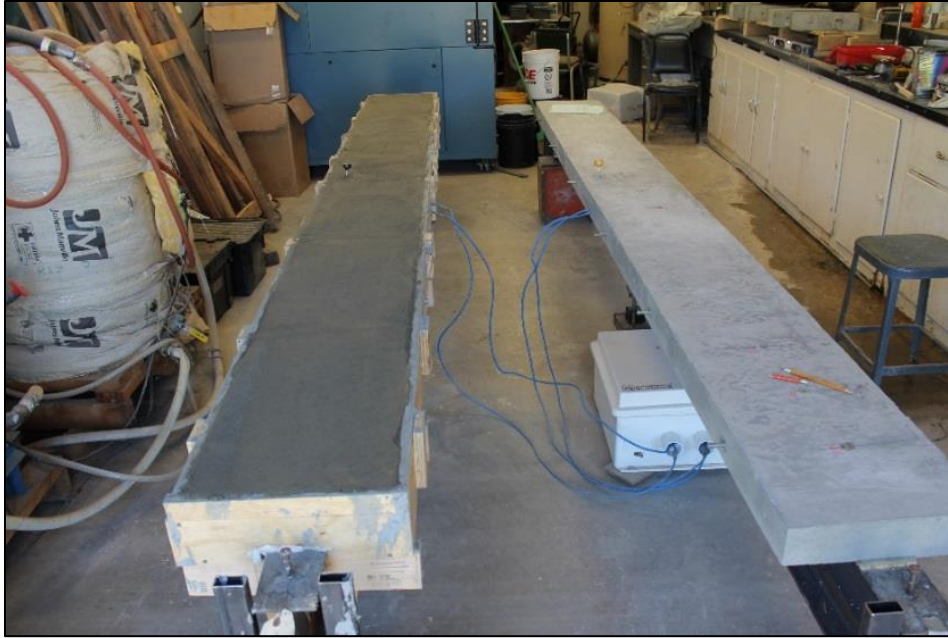
Figure 5: Prototype Beam 1 (to the right) and Prototype Beam 2 (to the left)

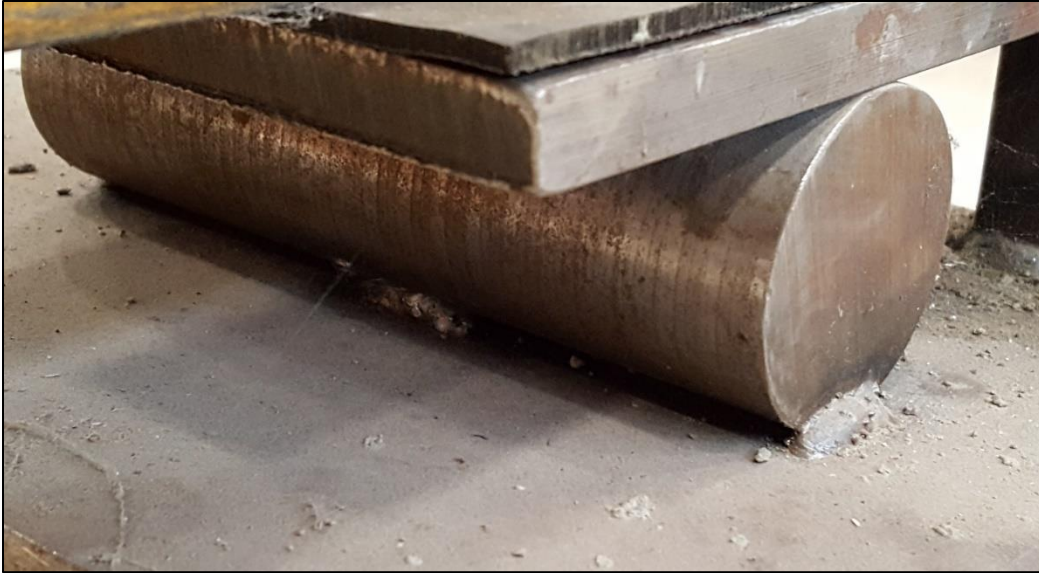
Figure 6: Welded pin support on the prototype beams

The prototype beams were cast-in-place to simulate a re-decking project typically done to aging steel girder bridges by ODOT. A welded pin and a roller supported each prototype beam as shown in Figures 6 and 7 respectively. Once the formwork had been installed, #3 reinforcing steel was added in the longitudinal and transverse direction. The transverse steel twelve bars was spaced at 12 in. The longitudinal steel was two bars spaced at 10 in.

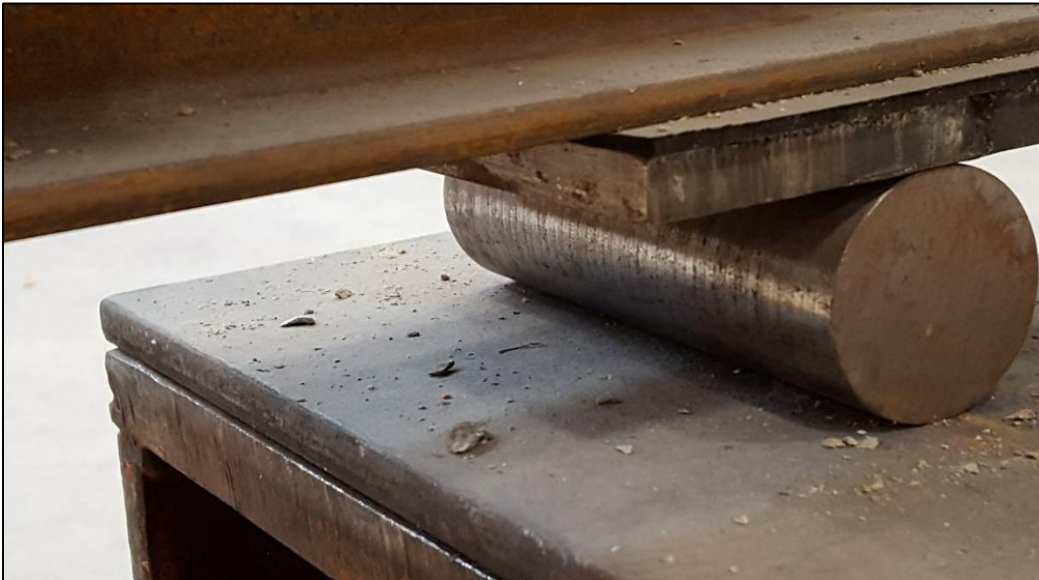
Figure 7: Roller support on the prototype beams

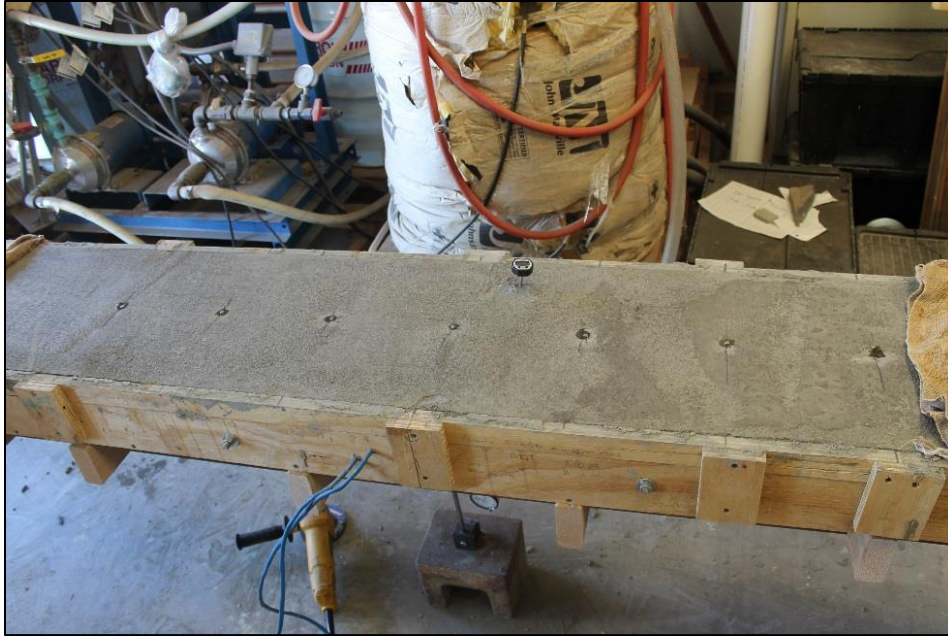
Figure 8: DEMEC points to measure strains and thermocouples and thermometer to measure temperature variance.

At midspan, thermocouples were embedded on the side of the slab before pouring the concrete and thermometers were embedded on top of the slab after the concrete was poured. The thermocouples and thermometers were utilized to monitor the temperature variations of the concrete. After the initial set, DEMEC points were glued to the surface of the concrete deck. These points are used to measure strains resulting from temperature variance, shrinkage, and other volumetric changes. The DEMEC points were placed on several locations throughout the surface of the concrete slabs and the web of the steel beams to provide an adequate representation of the cross section. The DEMEC points, thermometer, and thermocouples are shown below in Figure 8.

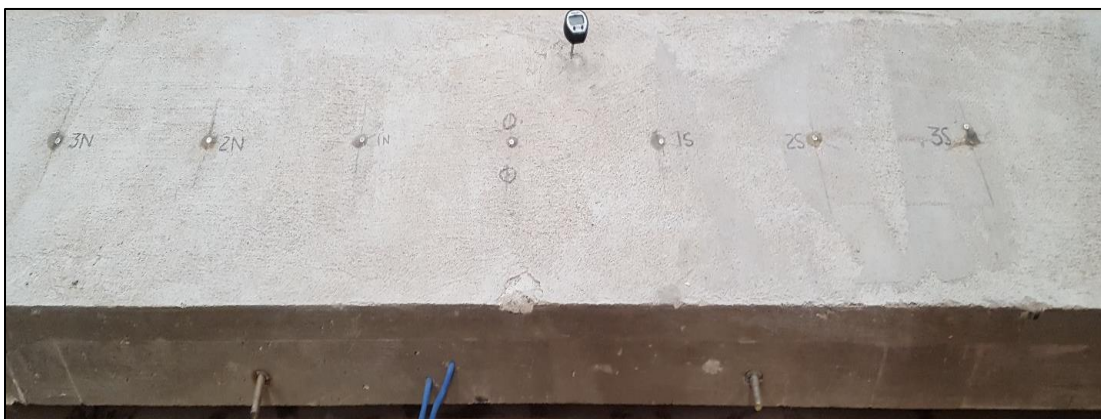
Figure 9: DEMEC points location on concrete slab for Prototype Beam 2

Figure 9 shows the location and pattern of the DEMEC points on the concrete slab for Prototype Beam 2. The DEMEC points on the slab of Prototype Beam 1 were similar in location to Prototype Beam 2. Figures 10 and 11 show the location and pattern of the DEMEC points on web of the steel girder for Prototype Beam 1 and 2 respectively. Also, Figure 11 shows the thermocouple.

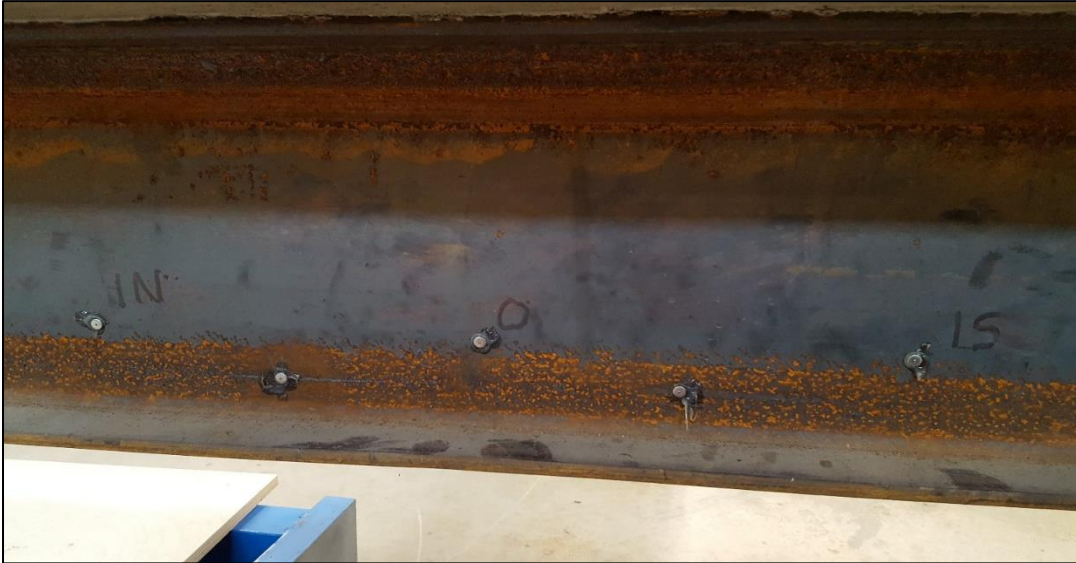
Figure 10: DEMEC points location on the web of the steel girder for Porotype Beam 1

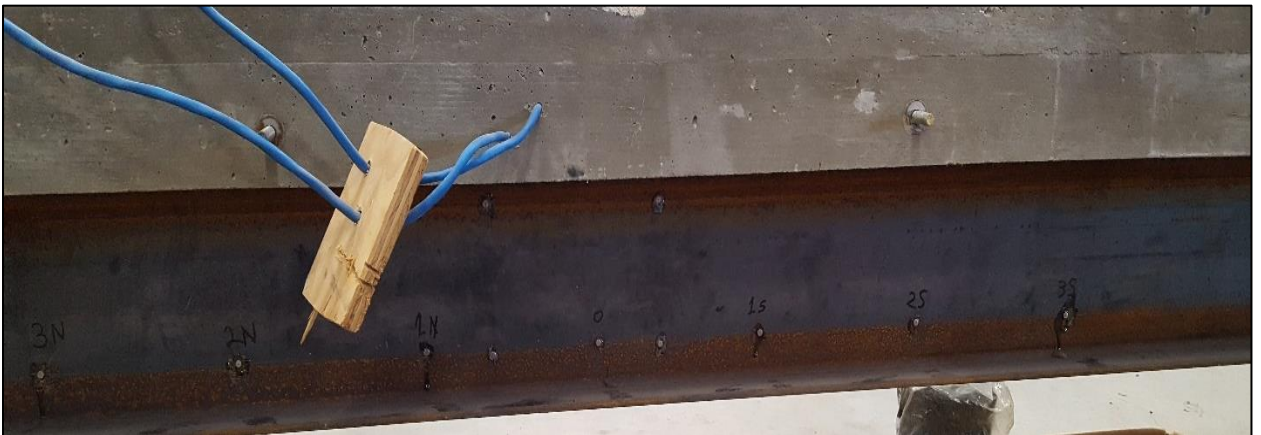
Figure 11: DEMEC points location on the web of the steel girder for Porotype Beam 2

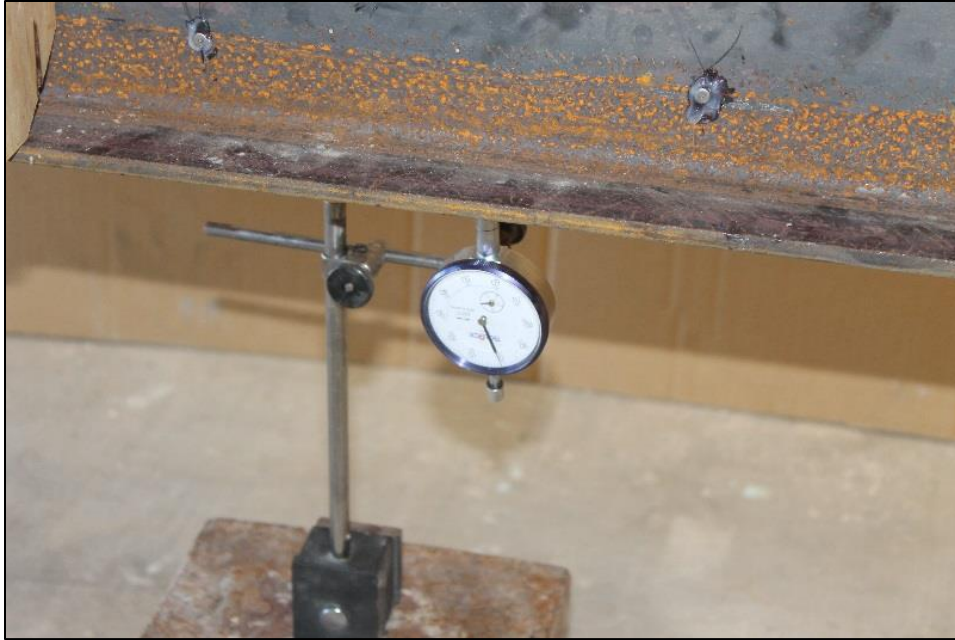
Figure 12: Dial gauge used to measure midspans displacements of prototype beams

Using dials gauges placed at midspan of each prototype beam, deflections were reported immediately before and immediately after slab pouring. The dial gauges are accurate to 0.001 in. The dial gauge at midspan is shown below in Figure 12. Also, Figure 12 shows the DEMEC points.

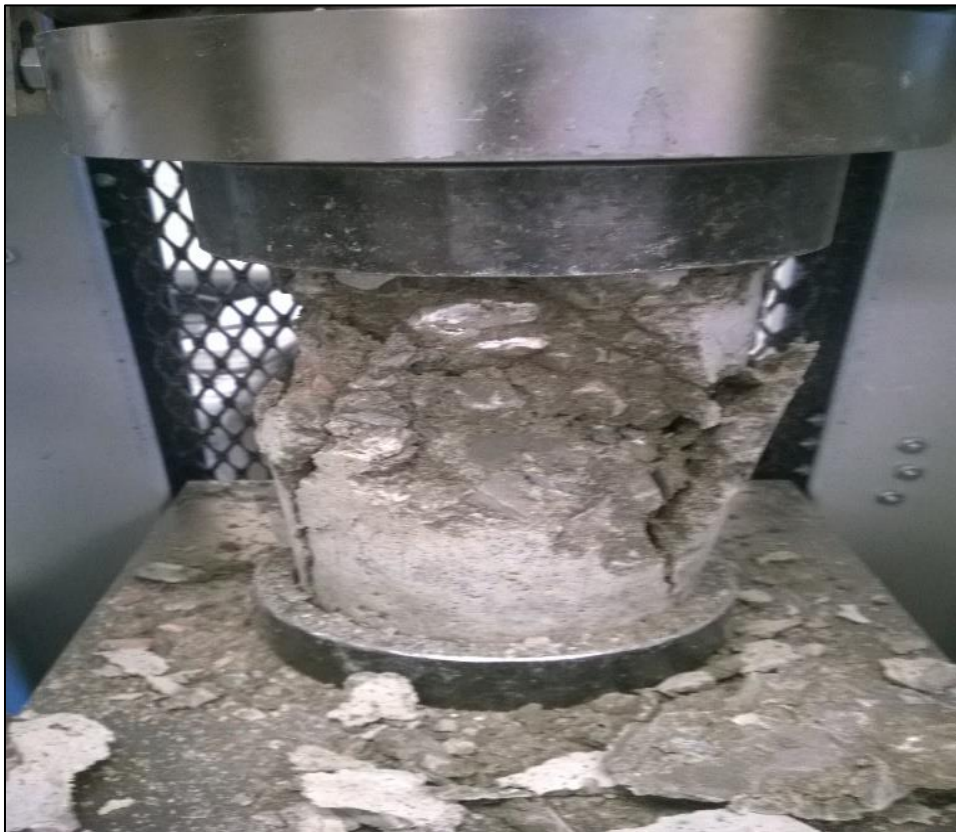
Figure 13: Concrete cylinder exhibiting a crushing failure (ASTM C39)

ASTM C39 test is used to determine the ultimate compressive failure load of a concrete specimen at a particular time interval. ASTM C496 test is used to determine the ultimate tensile failure load of a concrete specimen at a particular time interval. ASTM C469 test determines the modulus of elasticity of a concrete specimen at a particular time interval. ASTM C469 test must be performed after the compressive strength test as the failure load is required to get the loading rate. The data obtained can be used to calculate when the concrete will crack. Photographs of ASTM C39, ASTM C496, and ASTM C469 are shown below in Figures 13 through 15 respectively. The hardened concrete properties for Prototype Beams 1 and 2 are reported below in Tables 5 and 6.

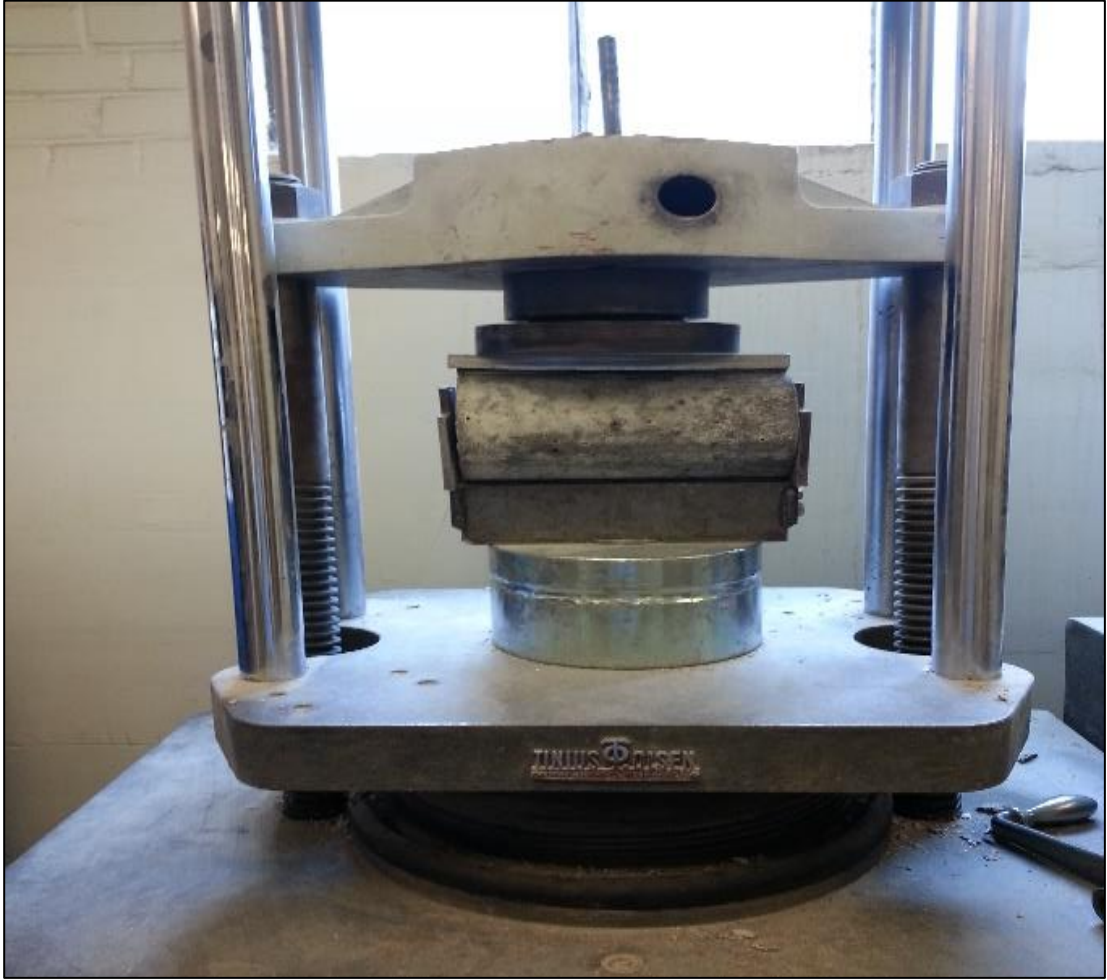
Figure 14: Splitting cylinder tensile strength test setup (ASTM C496)

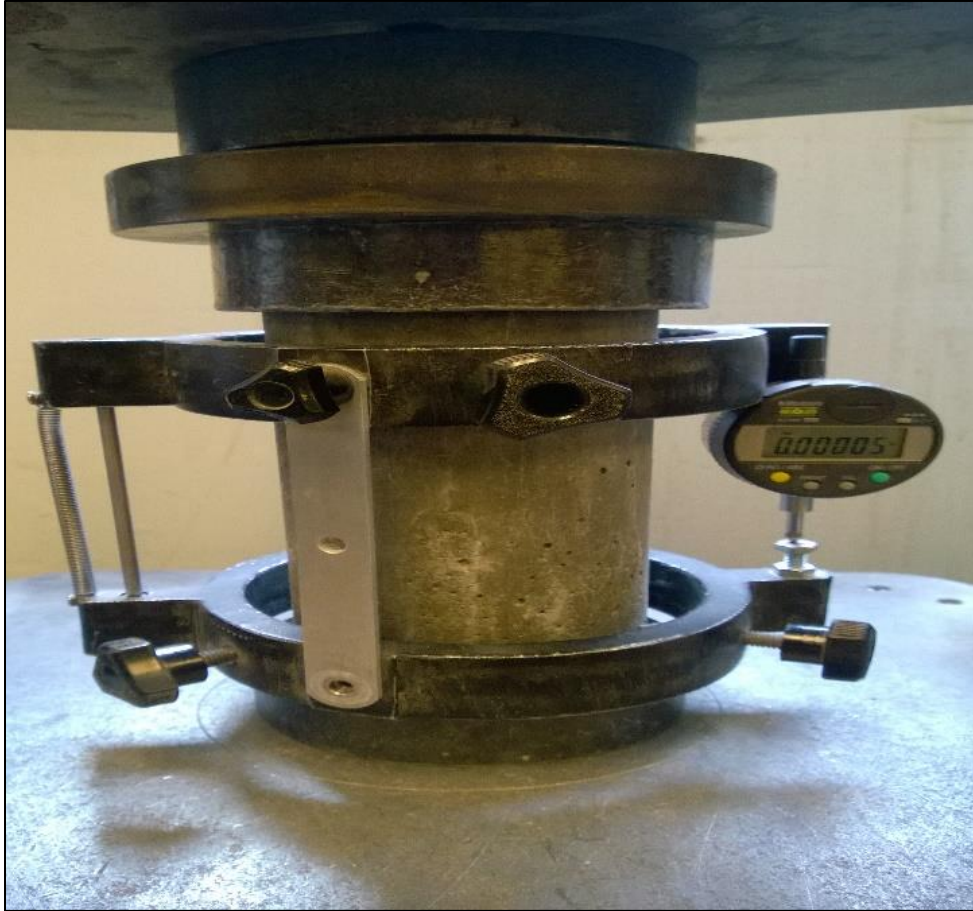
Figure 15: Measurement of the modulus of elasticity (ASTM C469)

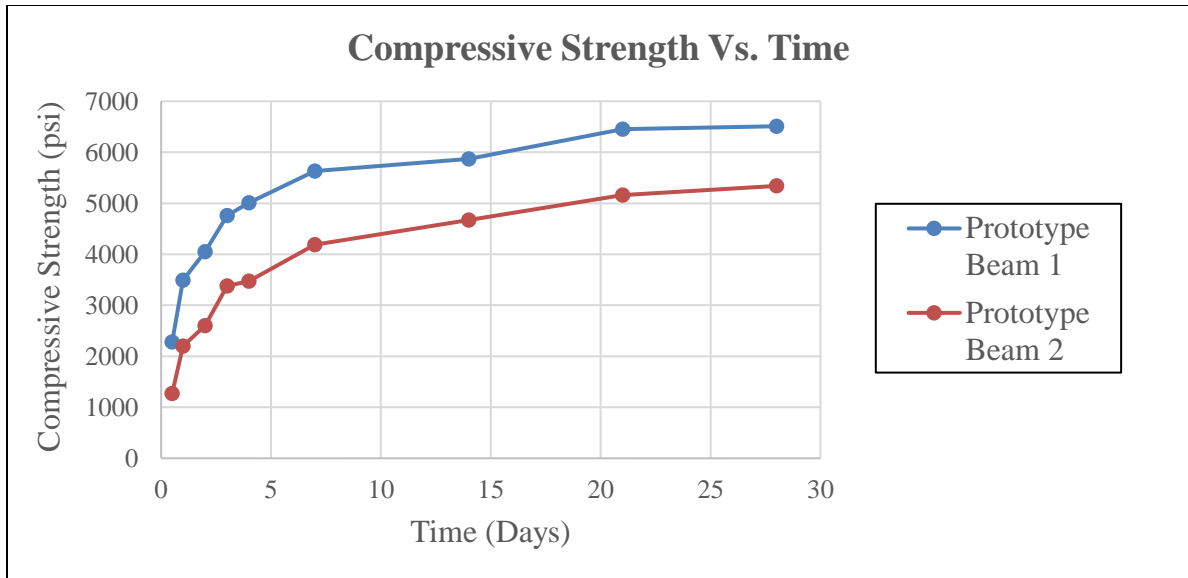
Figure 16: Compressive Strength (C39) for Prototype Beams 1 and 2

Figures 16, 17, and 20 depicts the graphs of the compressive strength test (C39), splitting cylinder tensile strength test (C496), and modulus of elasticity test (C469) for both Prototype Beams respectively. The data reported on C39 is an average of two specimens. For Prototype Beam 1, the 24 hour compressive strength was 2,280 psi and 28 day compressive strength was 6,510 psi. For Prototype Beam 2, The 24 hr. compressive strength was 1,270 psi and 28 day compressive strength was 5,340 psi. Prototype beam 2 had one additional test done at 36 hours. It is worth noting how there was no compressive strength gain from 36 hours to 48 hours for prototype beam 2. This is most likely due to only the six hr. window for the concrete to further develop strength. The visual representation is shown below in Figure 16.

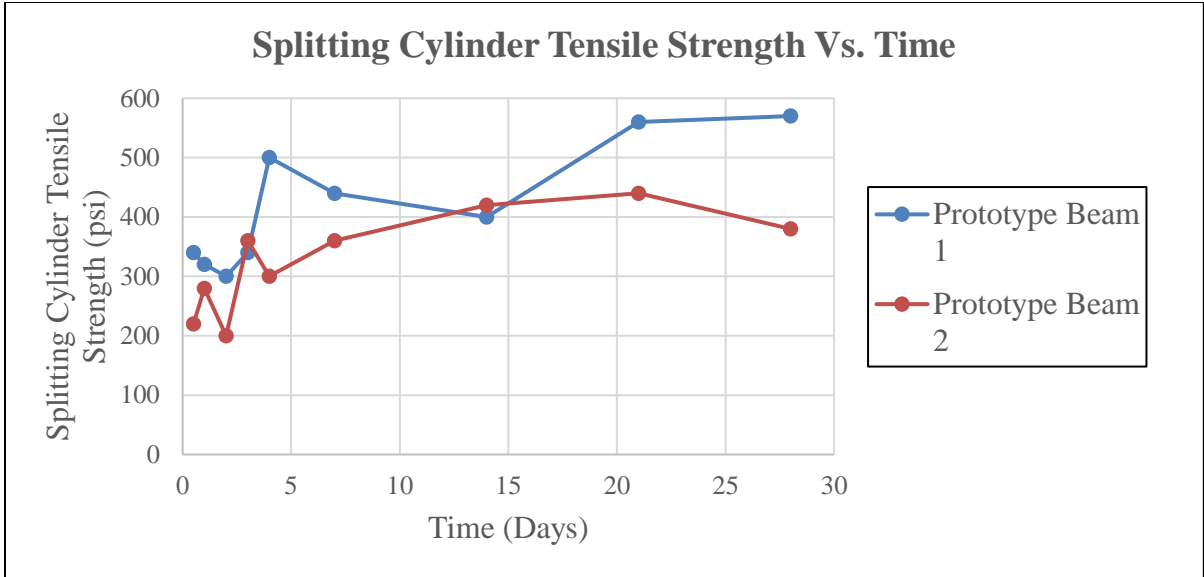
Figure 17: Splitting cylinder tensile strength (C496) for Prototype Beams 1 and 2

Figure 17 shows the graph of the splitting cylinder tensile strength test (C496) for both Prototype Beams. With the splitting cylinder tensile strength test, failure for early aged concrete occurs primarily in concrete paste. For more aged concrete the failures typically occur in the aggregates. Figure 18 provides an example of a splitting cylinder tensile strength test with failure in the concrete aggregates instead of the paste. Figure 19 provides an example of a splitting cylinder tensile strength test with failure in the concrete paste instead of the aggregates. For Prototype Beam 1, the 28 day splitting cylinder tensile strength of 570 psi was 8.8 % of the 28 day compressive strength of 6,510 psi. For Prototype Beam 2, the 28 d. tensile strength of 380 psi was 7.1 % of the 28 day compressive strength 5,301 psi. This relatively matches the general rule of thumb that the tensile strength of concrete is rough 10% of the compressive strength. In a sense, this validates the ASTM C39 and C496 tests.

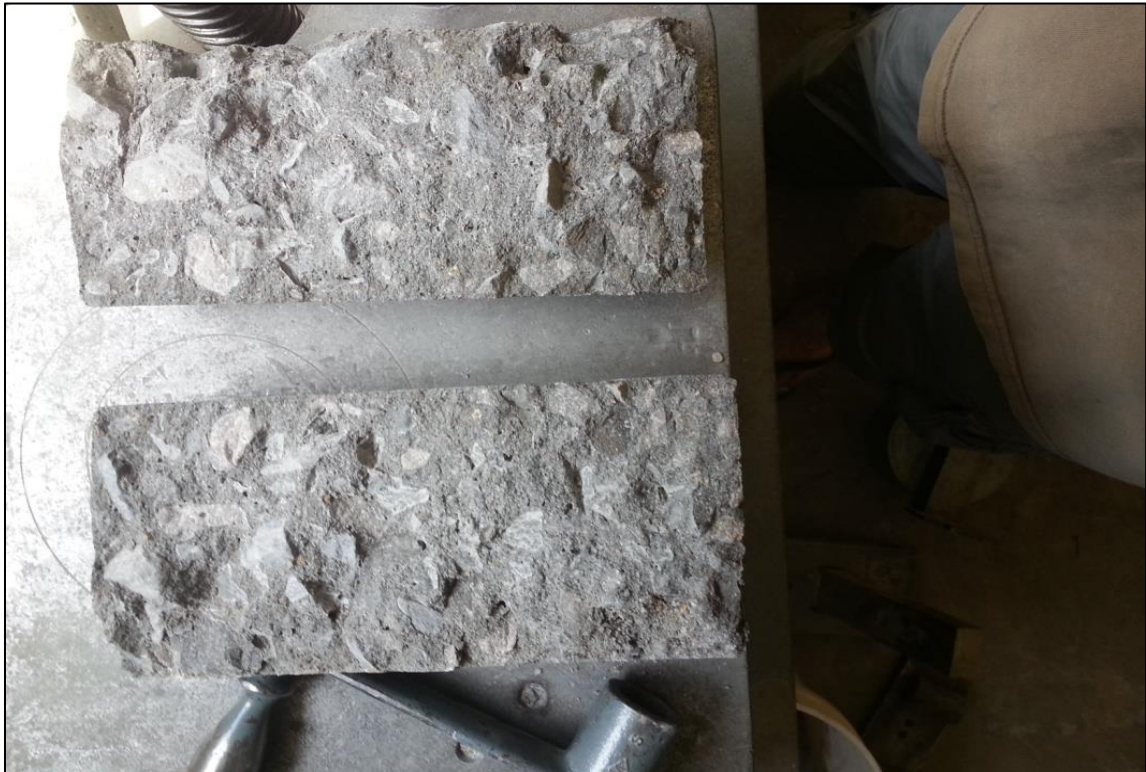
Figure 18: Example of failure in the concrete paste instead of the aggregates

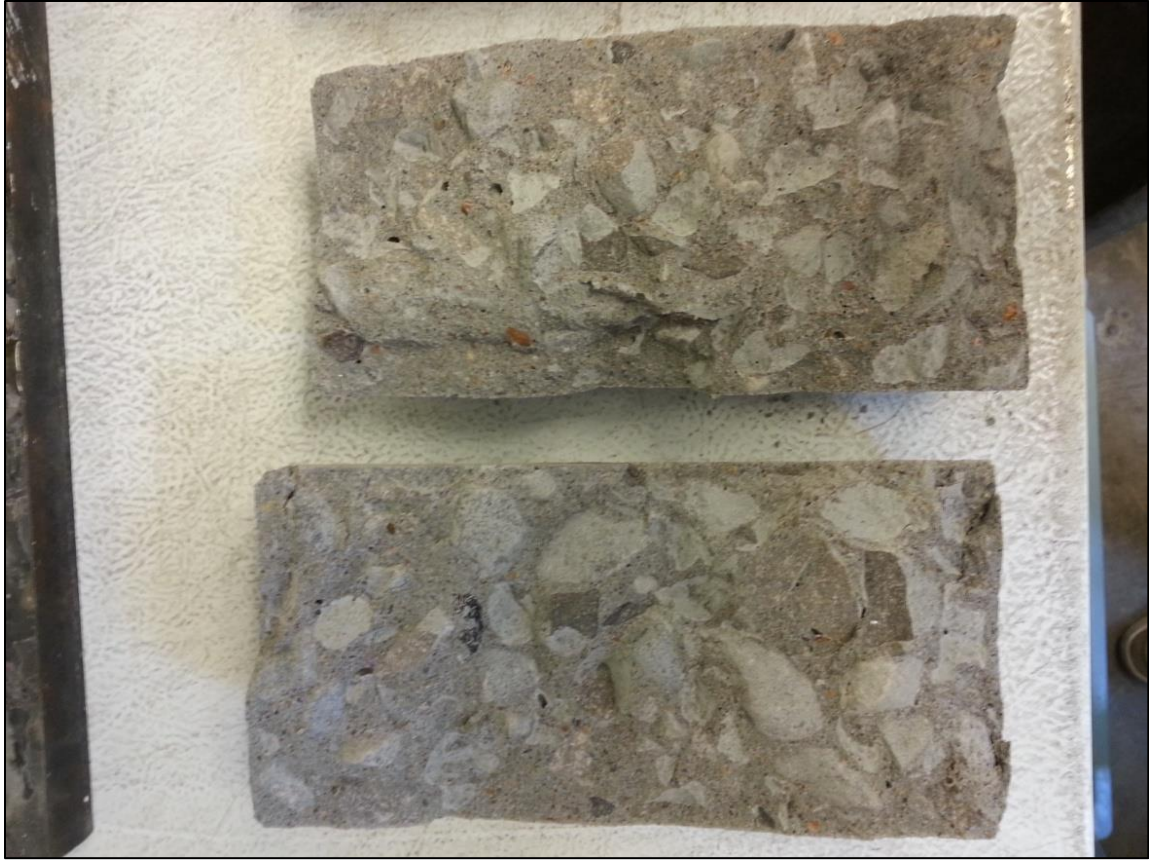
Figure 19: Example of failure in the concrete aggregates instead of the paste

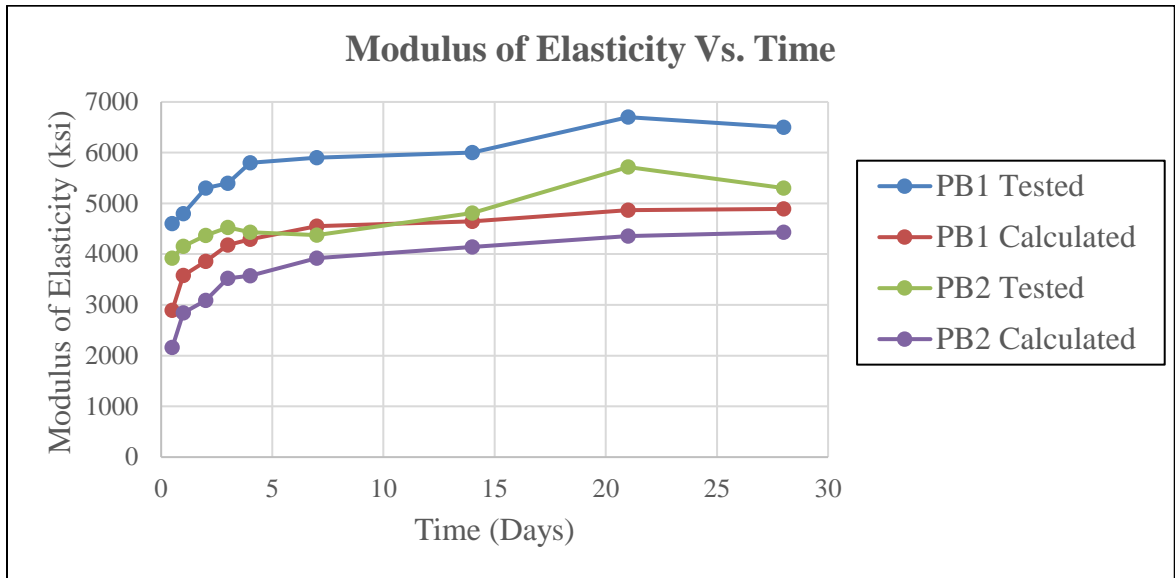
Figure 20: Tested (C469) and calculated (ACI 318) for Prototype Beams 1 and 2

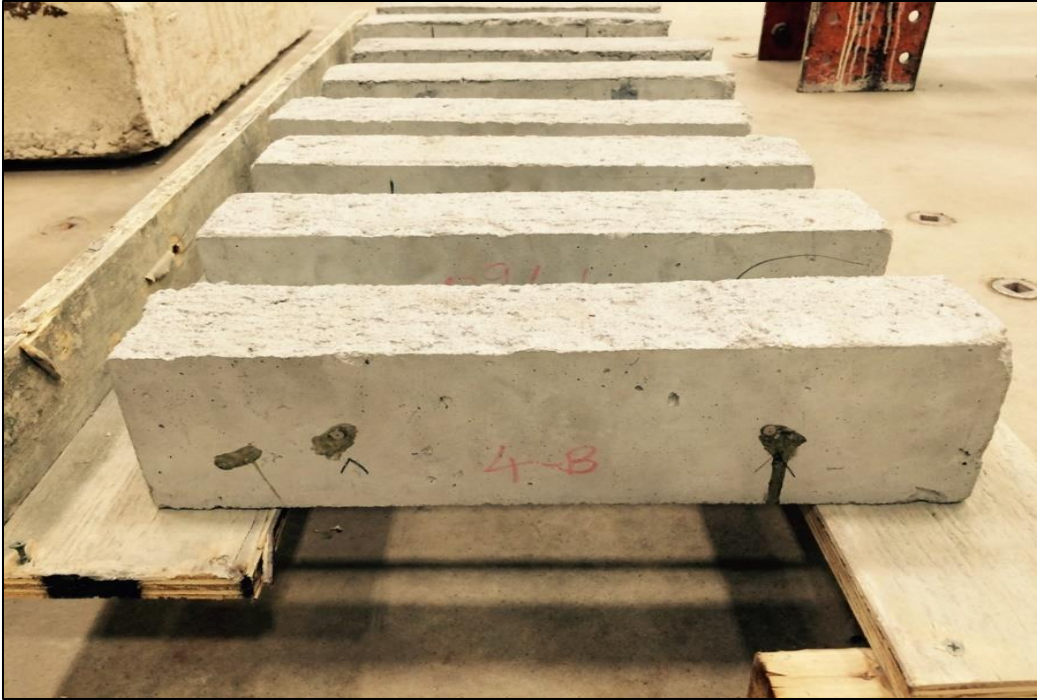
Figure 21: Transverse view of unrestrained shrinkage prisms for Prototype Beam 1 and 2

The shrinkage prisms will provide unrestrained shrinkage strains that can be compared to the restrained shrinkage strains of the composite prototype beams. On the shrinkage prisms, strains were measured daily with DEMEC strain gauges. The shrinkage prisms are shown in Figures 21 and 22. Figure 21 shows the location of the DEMEC points on the prisms.

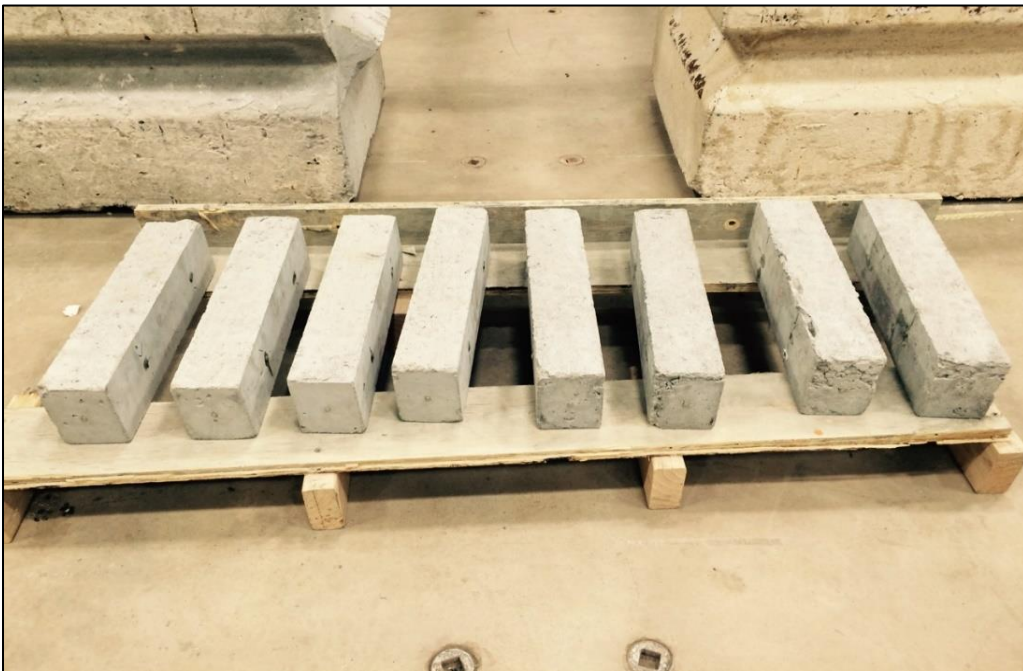
Figure 22: Longitudinal view of unrestrained shrinkage prisms for Prototype Beam 1 and 2

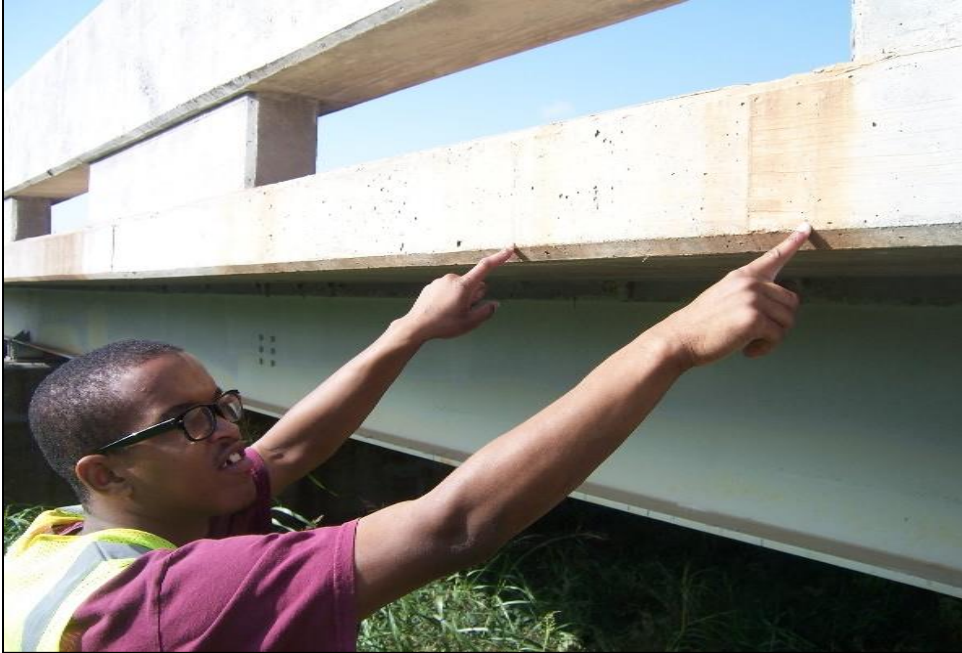
Figure 29: Identifying crack locations on SH 14 Eagle Chief Creek “A” in Woods County

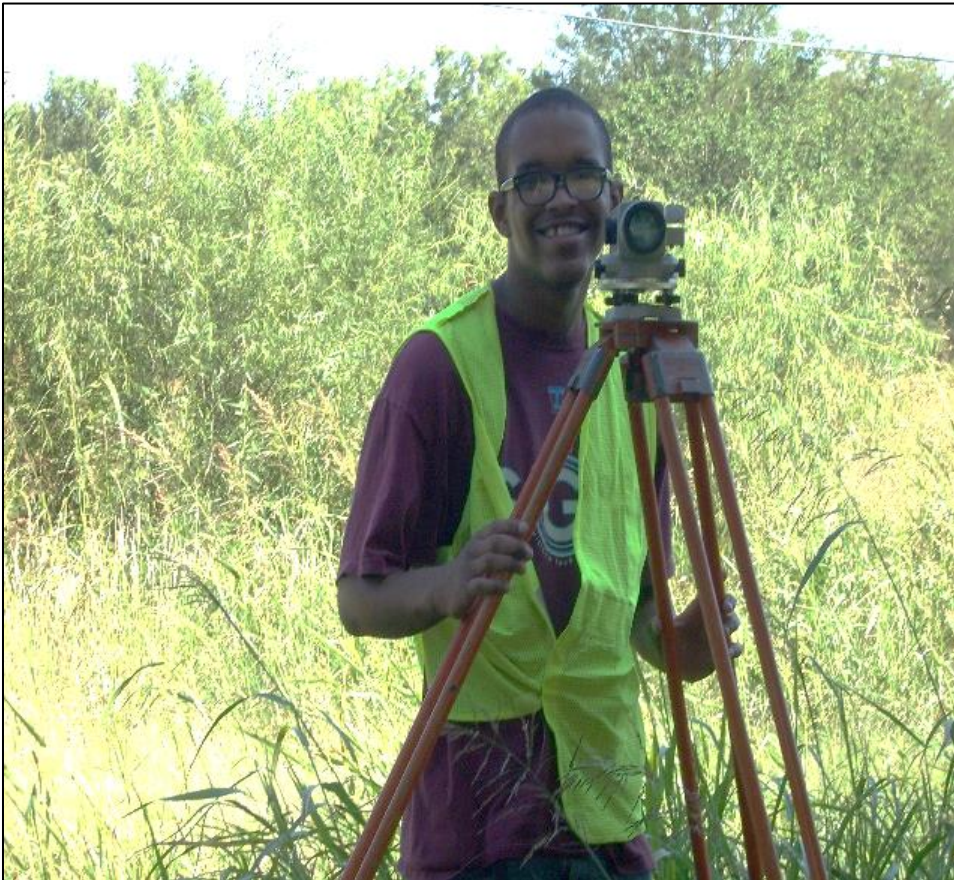
Figure 30: Elevation surveying with optical surveying instruments of the SH 14 bridge

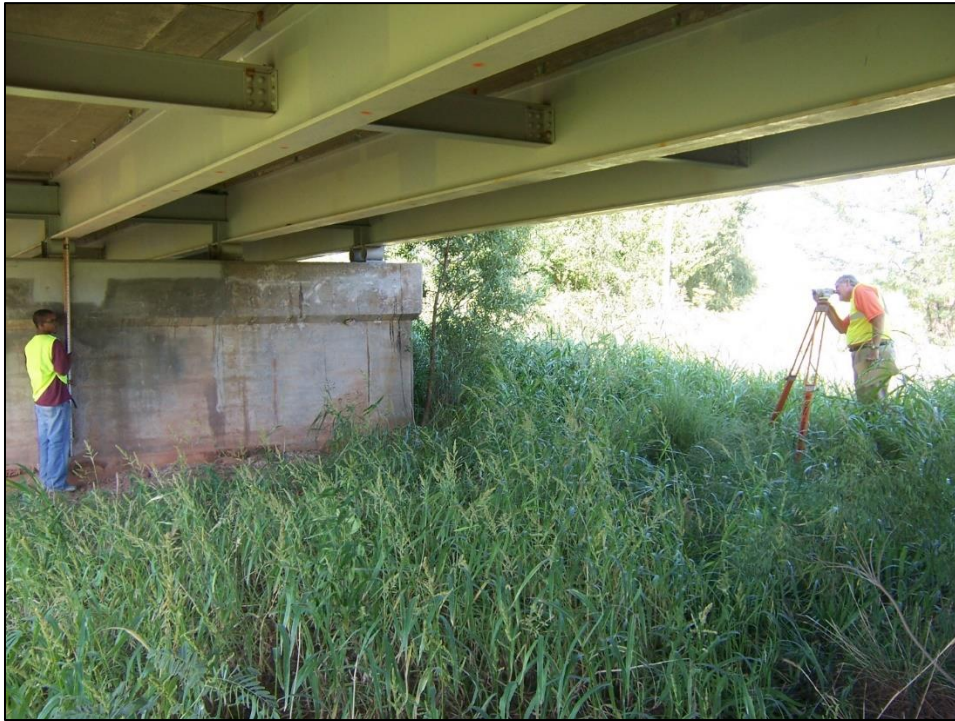
Figure 31: Elevation readings on the bottom of the steel girder at a pier for SH 14

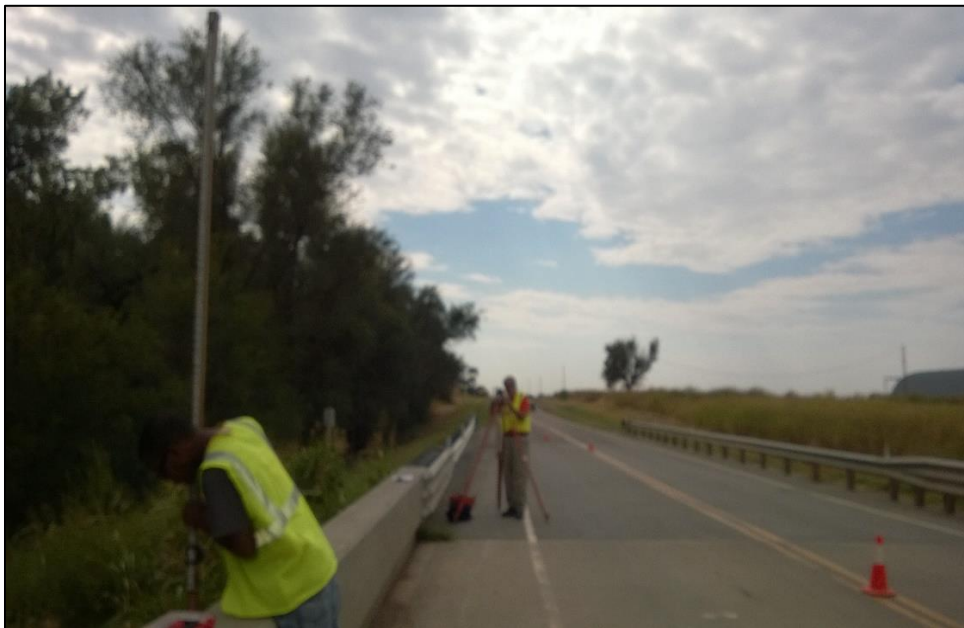
Figure 32: Slab elevations on the north approach of US 281

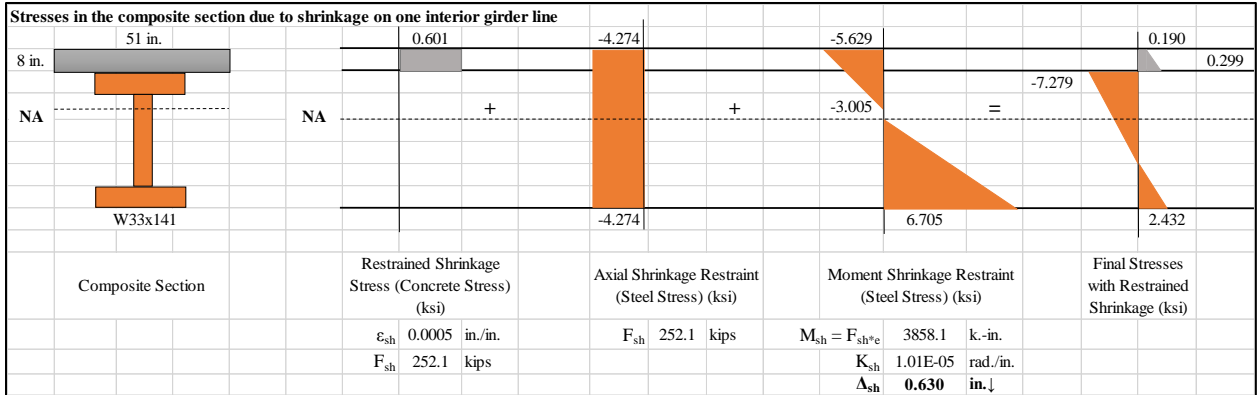
Figure 33: Stresses in the composite section due to shrinkage on one single interior girder line for SH 86

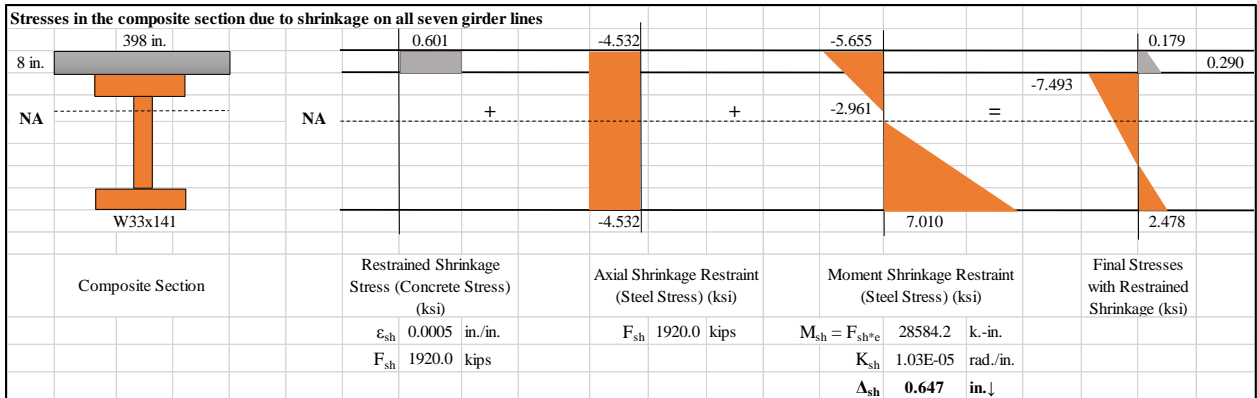
Figure 34: Stresses in the composite section due to shrinkage on all seven girder lines for SH 86

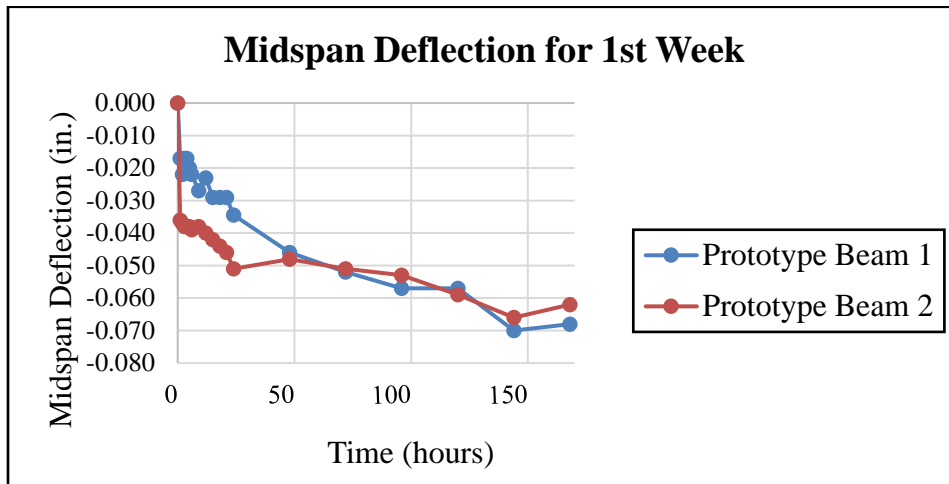
Figure 37: Midspan deflection for 1st Week

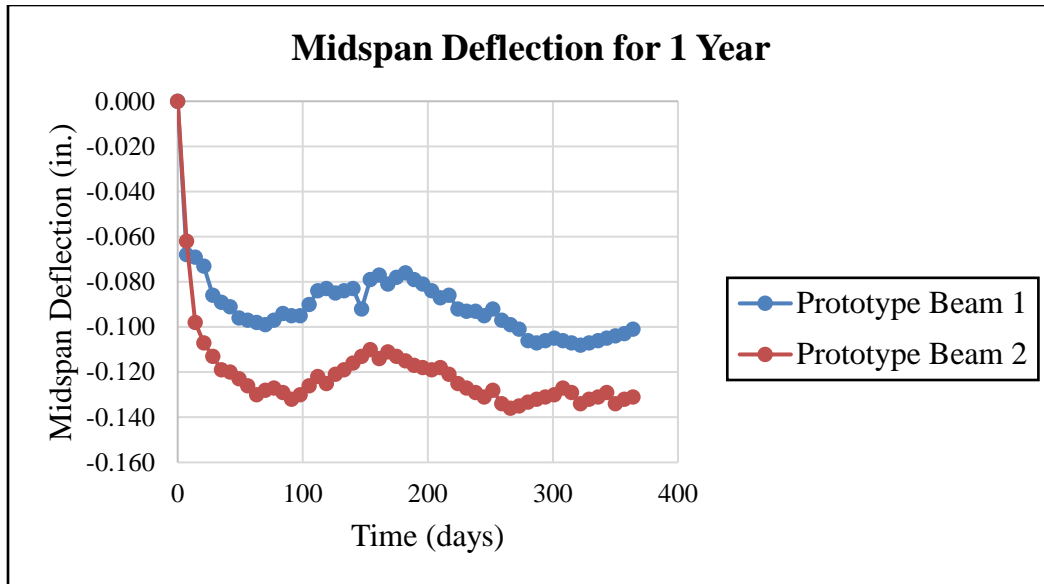
Figure 38: Midspan deflection for Year
