LABORATORY AND FIELD INVESTIGATIONS FOR
CAUSES OF UNWANTED DEFORMATIONS IN
EXISTING STEEL GIRDER BRIDGES
REHABILITATED WITH CONCRETE DECKS

Submitted to the Faculty of the
Graduate College of the
Oklahoma State University
in partial fulfillment of
the requirements for
the Degree of
MASTER OF SCIENCE
July, 2017

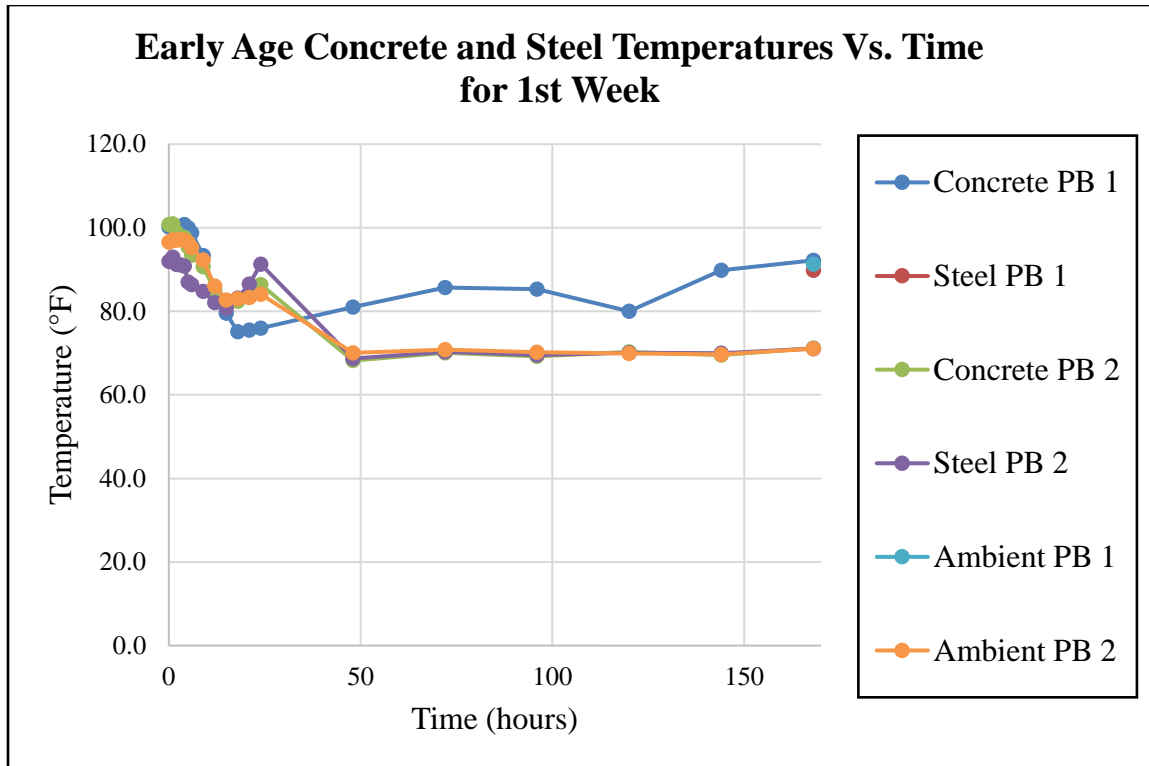
Figure 39: Early age concrete and temperatures for 1st Week

Initially after casting concrete, the heat of hydration cause the concrete temperature to increase as it cures in the first 48 hour period. After this period, concrete cools to match the ambient temperature. From this point forward, both steel and concrete will exhibit nearly identical temperatures due to the similar coefficient of thermal expansions. Table 20 and Figure 39 show the changes in temperature over a week for concrete and steel for Prototype Beams 1 and 2. Table 20 depicts the changes in temperature for the first twenty-four hours after casting for prototype beam 2 in tabular form. For prototype beam 1, it was not initially planned to take steel temperature readings, which explain the lack of readings until 170 hours and absence of readings during a similar time duration. Table 21 and Figure 40 show the changes in temperature over a week for concrete and steel for Prototype Beams 1 and 2.

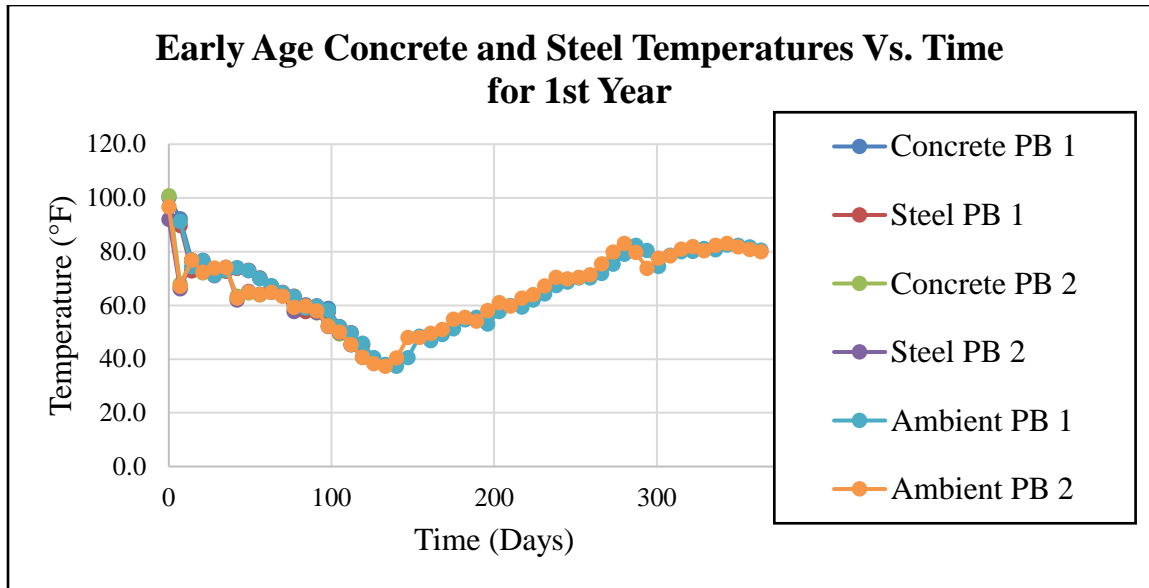
Figure 40: Concrete and Steel Temperatures for Year

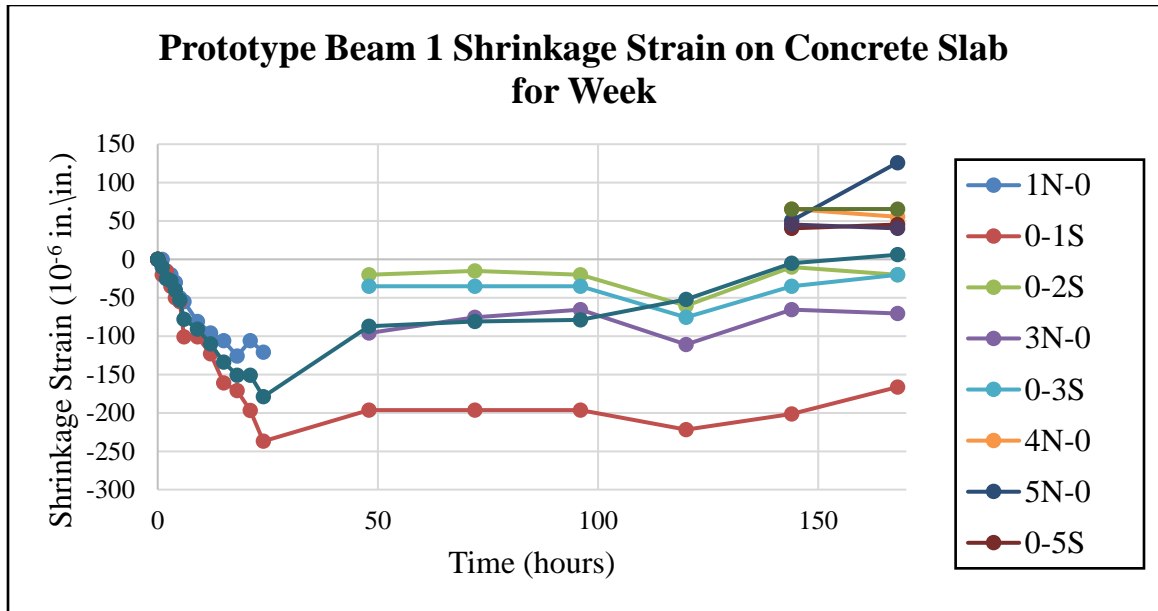
Figure 41: Prototype Beam 1 Shrinkage Strain on Concrete Slab for 1st Week

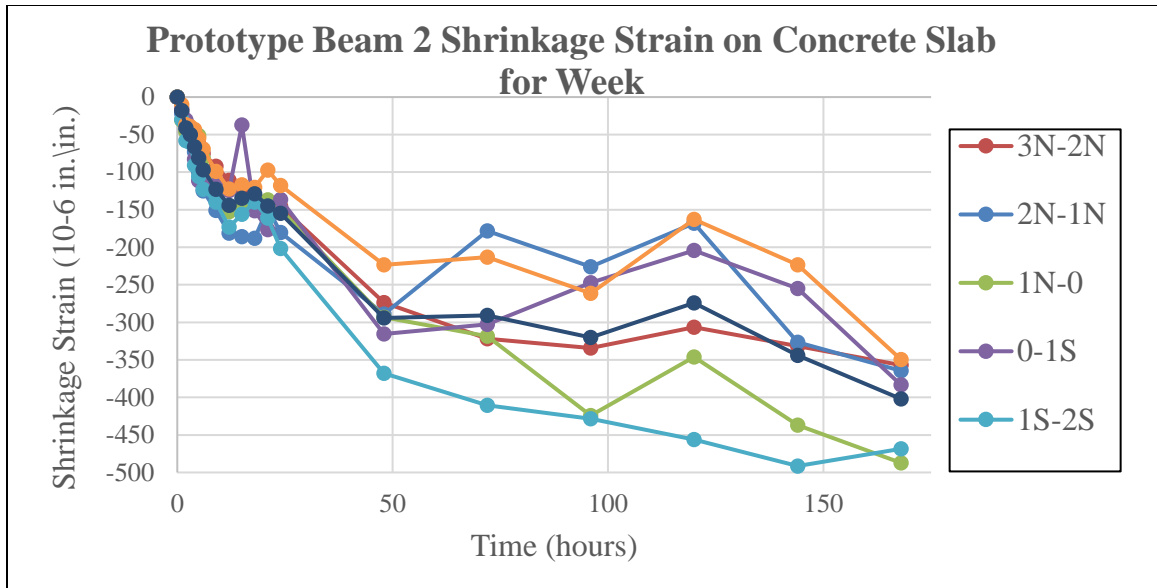
Figure 42: Prototype Beam 2 Shrinkage Strain on Concrete Slab for 1st Week

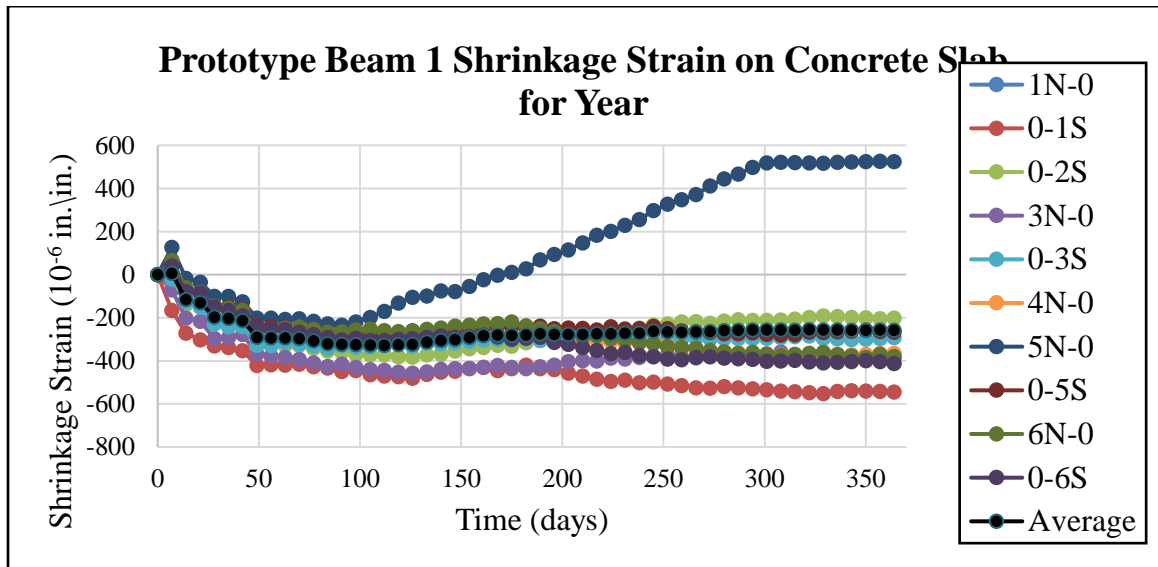
Figure 43: Prototype Beam 1 Shrinkage Strain on Concrete Slab for Year

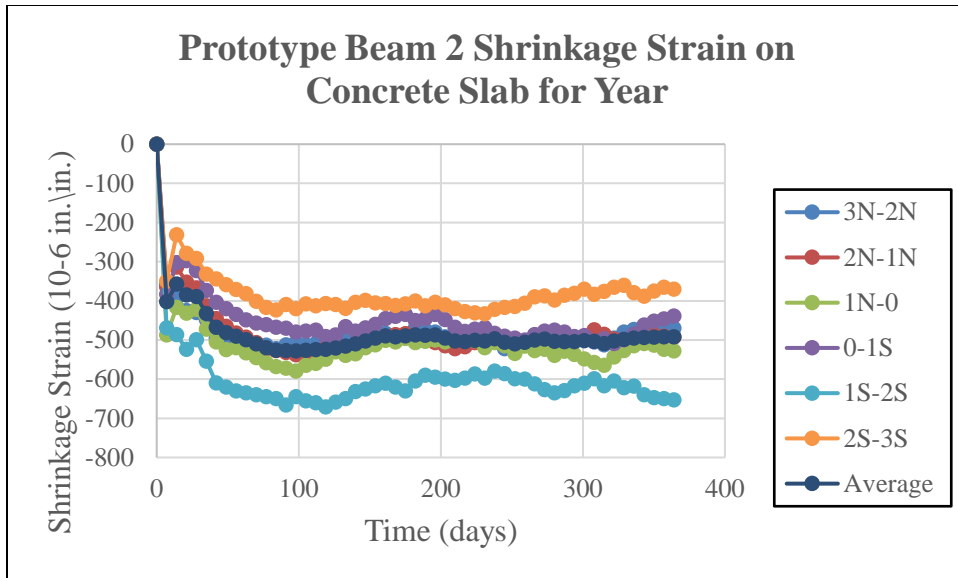
Figure 44: Prototype Beam 2 Shrinkage Strain on Concrete Slab for Year

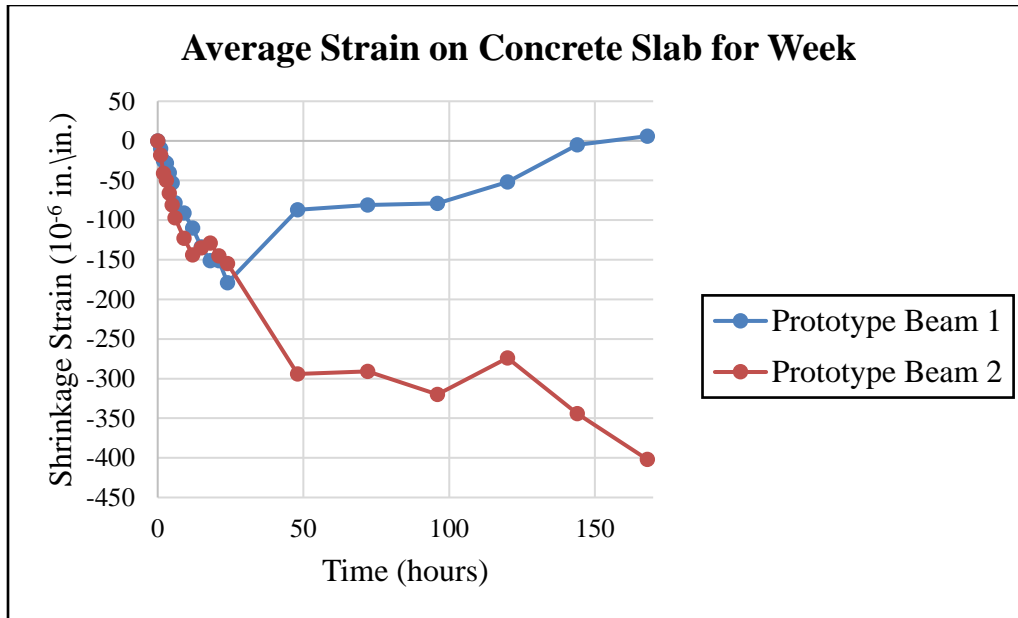
Figure 45: Average Shrinkage Strain on Concrete Slab 1st Week

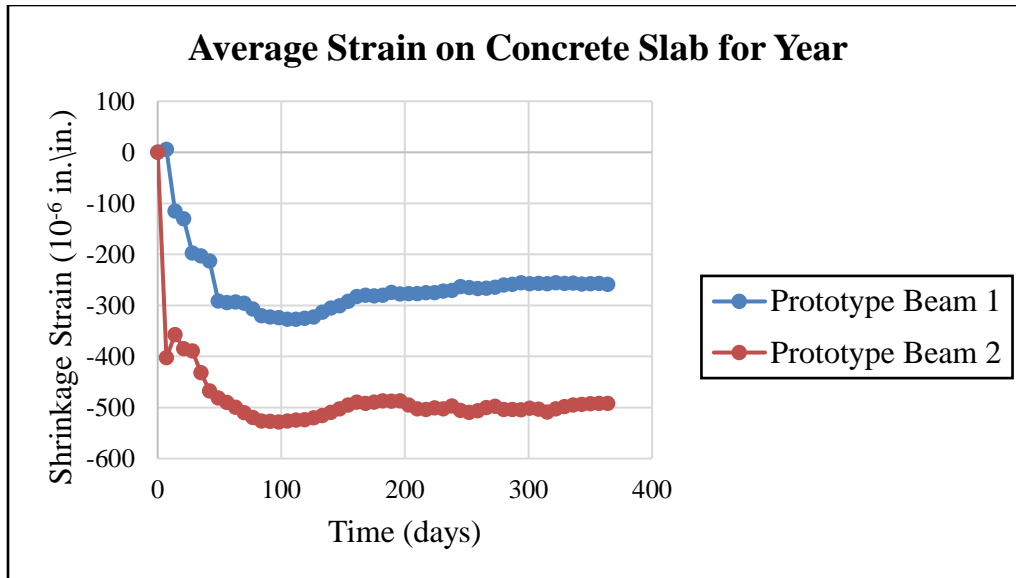
Figure 46: Average Shrinkage Strain on Concrete Slab for Year

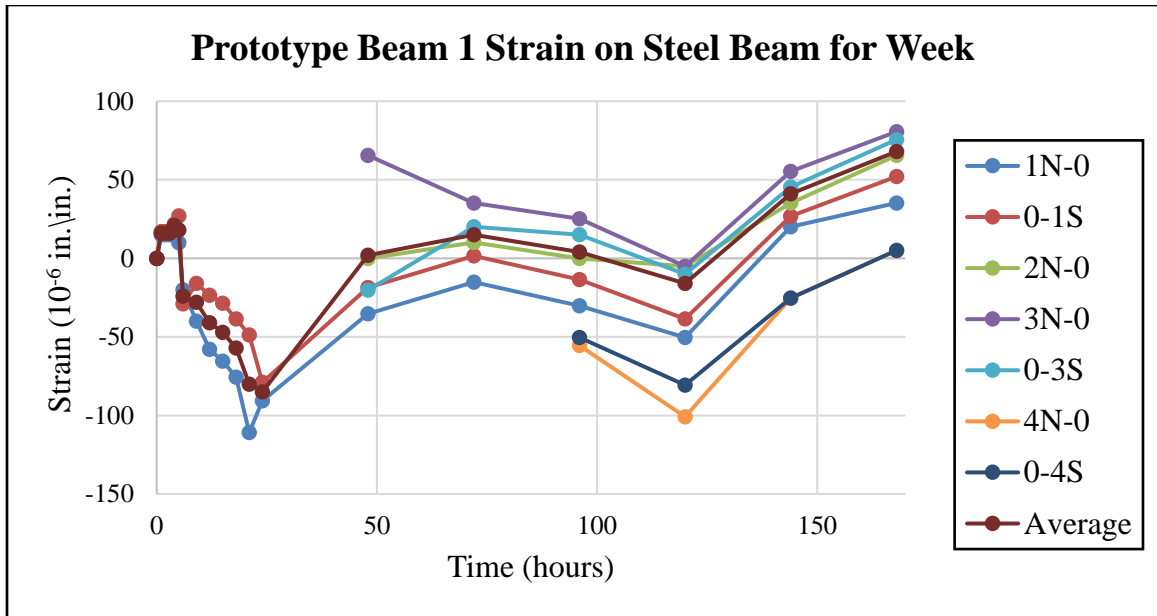
Figure 47: Prototype Beam 1 Strain on Steel Beam for 1st Week

For Prototype Beam 1, the strain readings from the 1st week for the web of the steel beam are depicted in Table 28 and Figure 47. The strains readings for Prototype Beam 2 for the 1st week for the web of the steel beams are depicted in Table 29 and Figure 48.

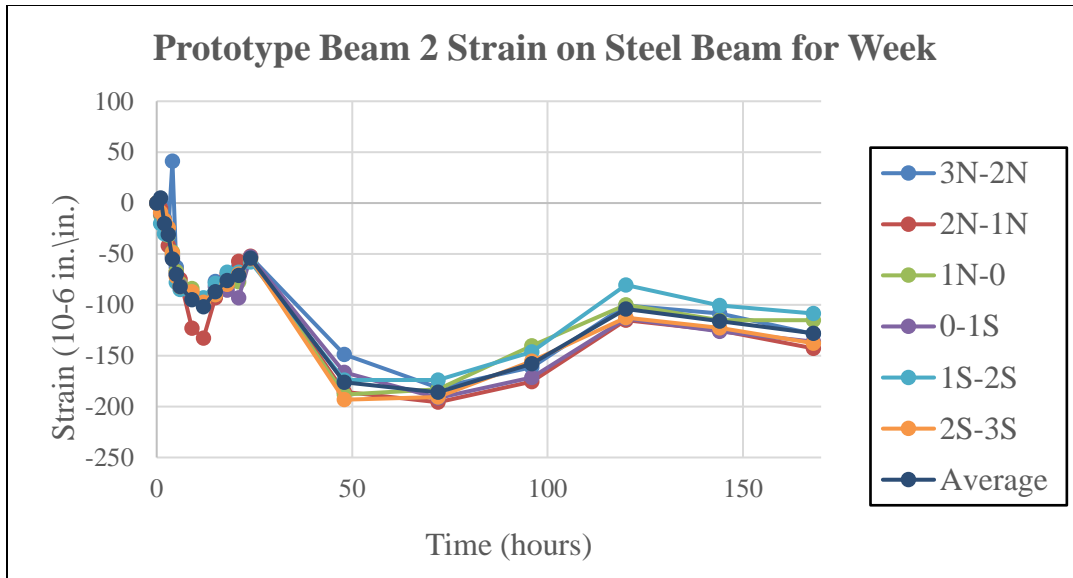
Figure 48: Prototype Beam 2 Strain on Steel Beam for 1st Week

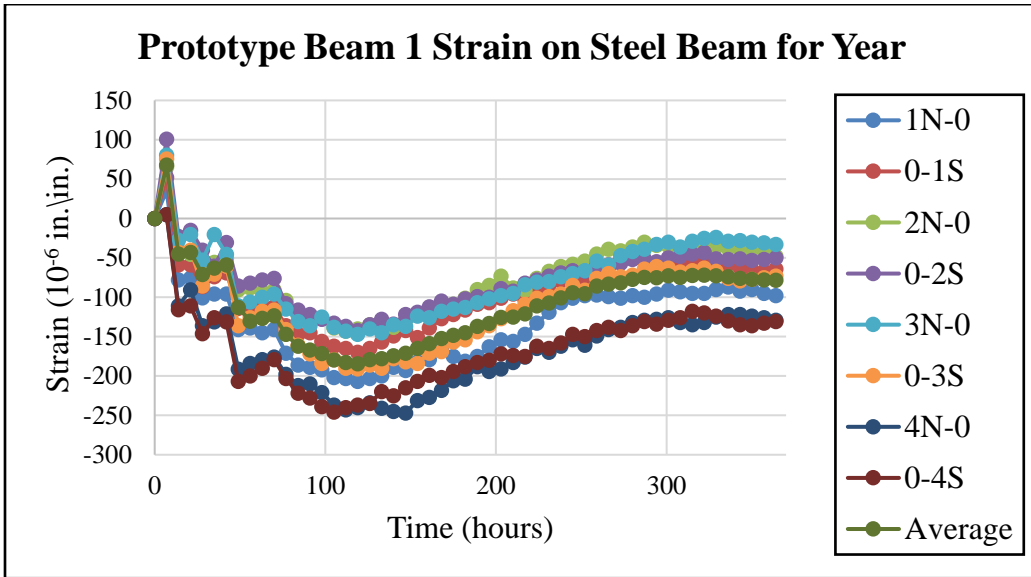
Figure 49: Prototype Beam 1 Strain on Steel Beam for Year

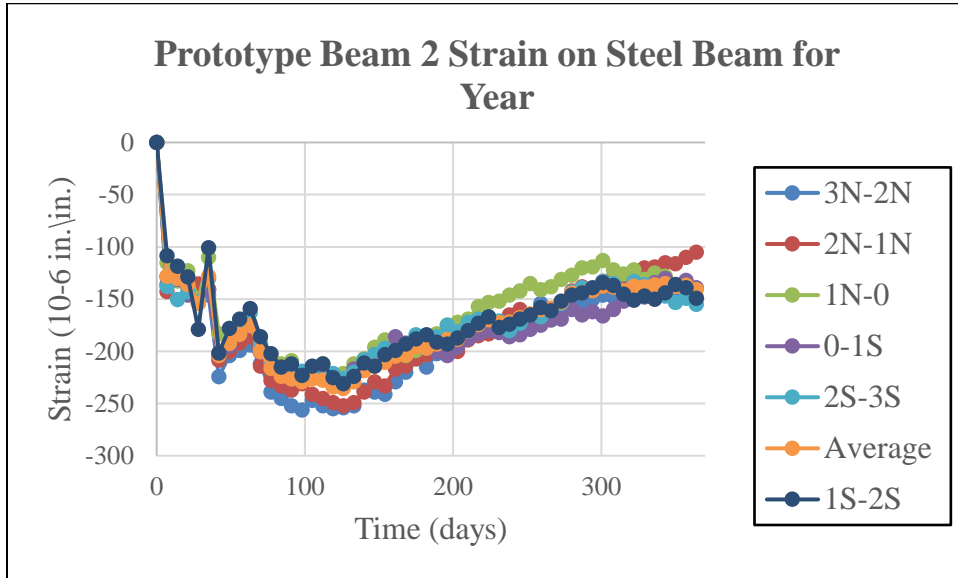
Figure 50: Prototype Beam 2 Strain on Steel Beam for Year

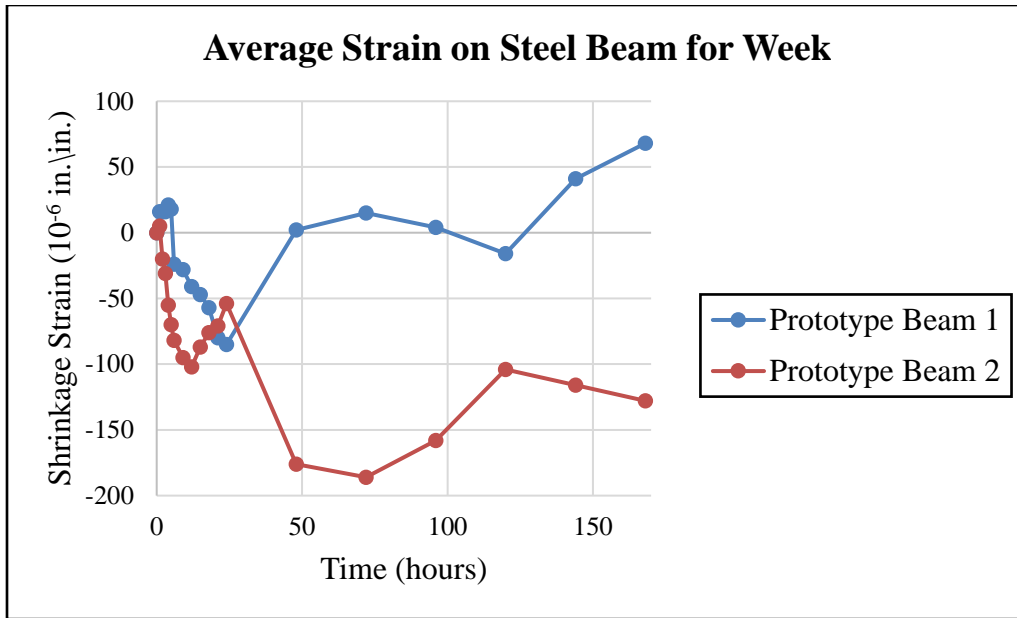
Figure 51: Average Strain in Steel Beam for 1st Week

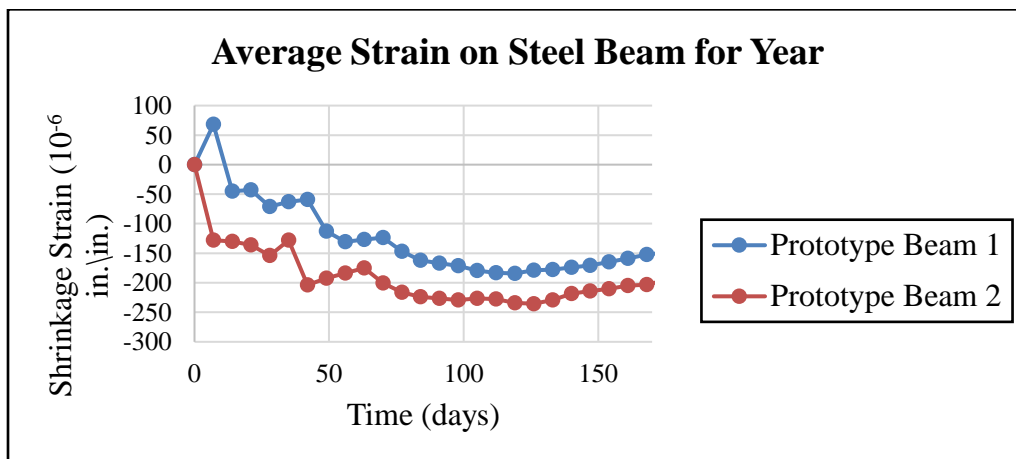
Figure 52: Average Strain in Steel Beam for Year

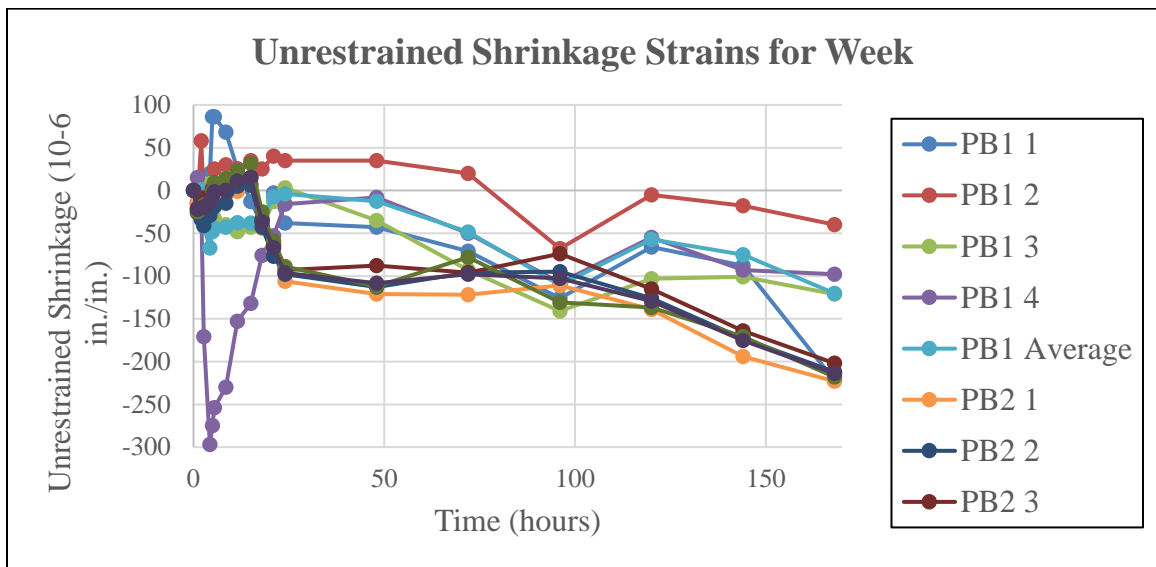
Figure 53: Unrestrained Shrinkage Strains for 1st Week

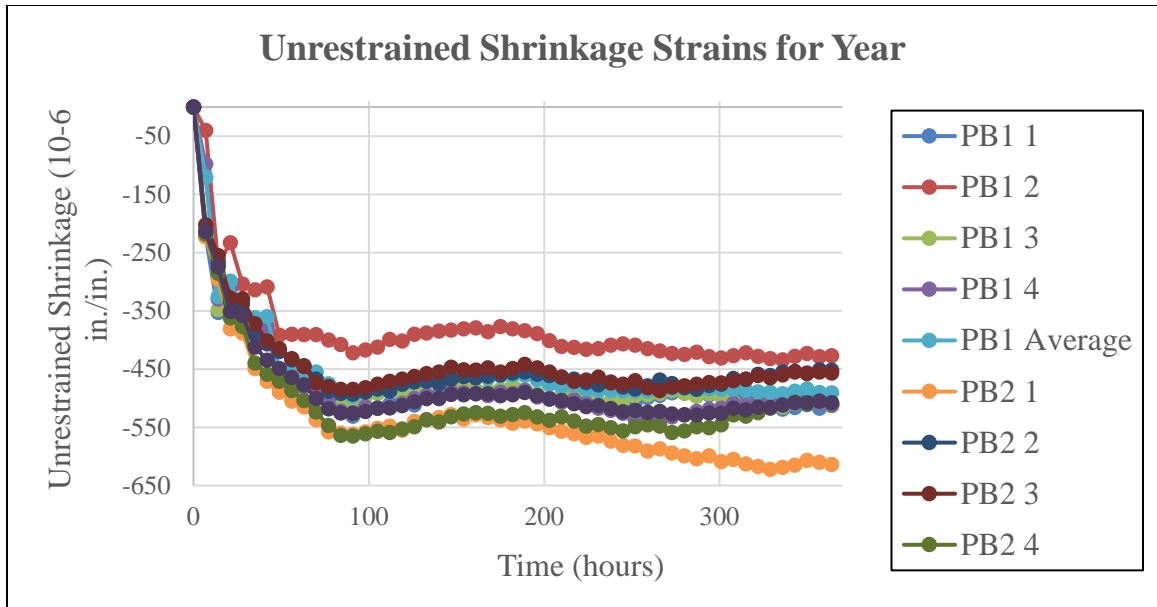
Figure 54: Unrestrained Shrinkage Strains for 1st Year

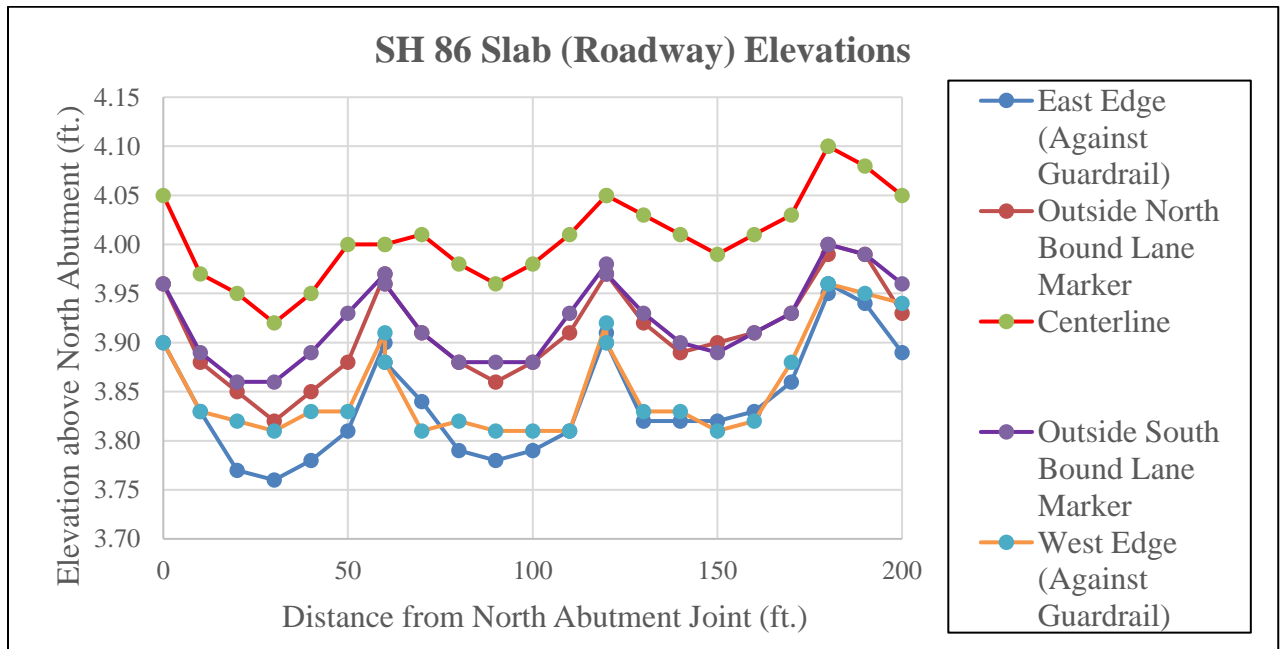
Figure 56: Roadway elevation profile for the SH 86 bridge

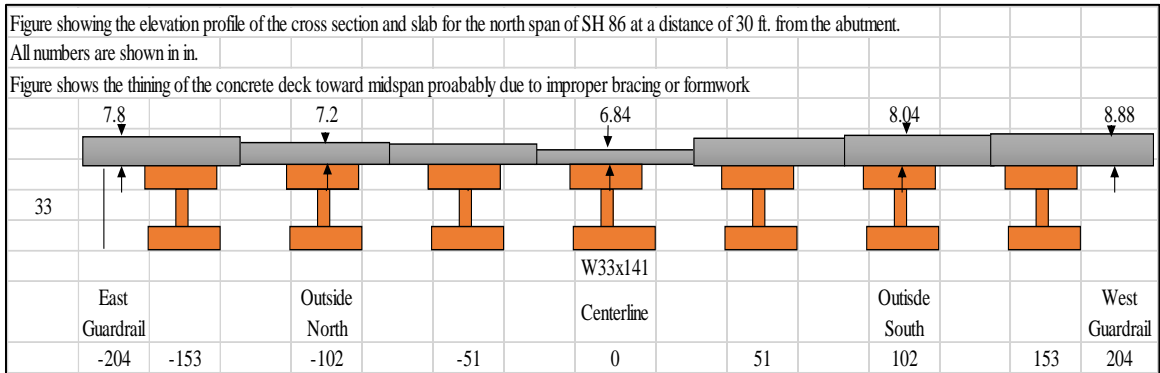
The figure above shows the elevation profile of the cross section and slab for the north span of SH 86 at a distance of 30 ft. from the abutment. All numbers shown are reported in in. The figure was computed using Table 40. The datum or origin is the CL of the middle interior girder. The figure accurately shows how as you approach the centerline, you can noticeably see the thinning of the concrete deck. The thinning toward the centerline is likely due to poor bracing or formwork. Furthermore, it is worth noting that on the slab area not supported by girders that some of the slab was deflecting downward more than expected. The Figure below provides a visual representation of the elevation change in the top and bottom of the concrete slab at a distance of 30 ft. from the north abutment or midspan of span 1. The values in the figure were obtained with Table 36 and 37. From observation, it is apparent that one side of the concrete slab slopes downward more than the other. This is likely due to localized deflection occurring during construction on the cantilever ends. In addition, in parts of the span the elevation variance every 4 ft. exceeds the 0.08 ft. specified by the 2% super elevation in the specs. Both Figure 58 and 59 show that the riding surface on SH 86 can cause poor ride quality due to variance in elevations.

Excessive slopes were measured and observed at the bottom of the concrete slab from the outsider girder line to the outside edge of the bridge deck. The ODOT drawings specify a super elevation of 2% and this amounts to 0.96 in. or 0.08 ft. elevation change in a 4 ft. area. This 4 ft. area is roughly equivalent to the 4'-8' cantilever from the centerline of the girder to the edge of slab. These values compare fairly well to the values in Table 38. From Table 38, one can see variance in elevations of the bottom of the concrete slab. This indicated that the formwork was perhaps not properly braced before pouring the concrete slab. This would create these unnecessary localized deflection on the driving surface. Elevation control is an important consistent with designing and constructing a bridge as any slight changes could have a significant impact. A difference of 0.96 in. would be expected, but in some cases the variations approached 2 in.

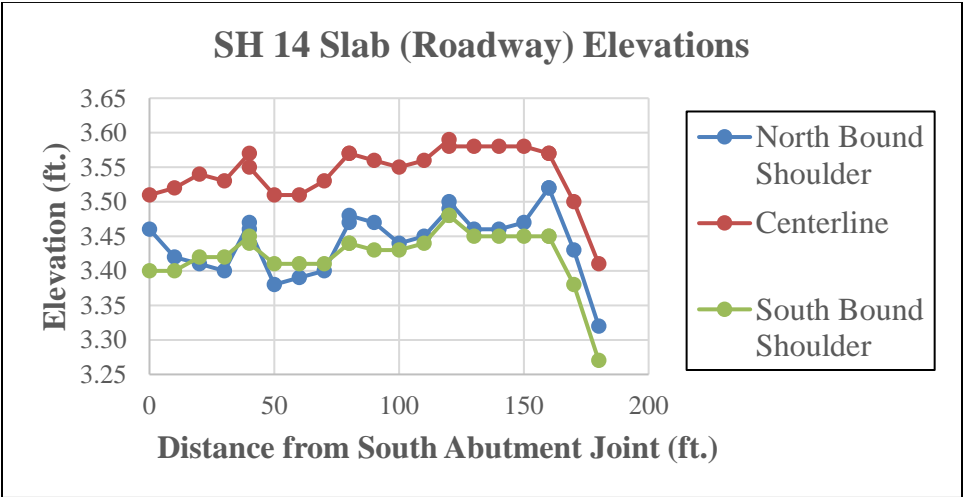
Figure 61: SH 14 Roadway Elevations

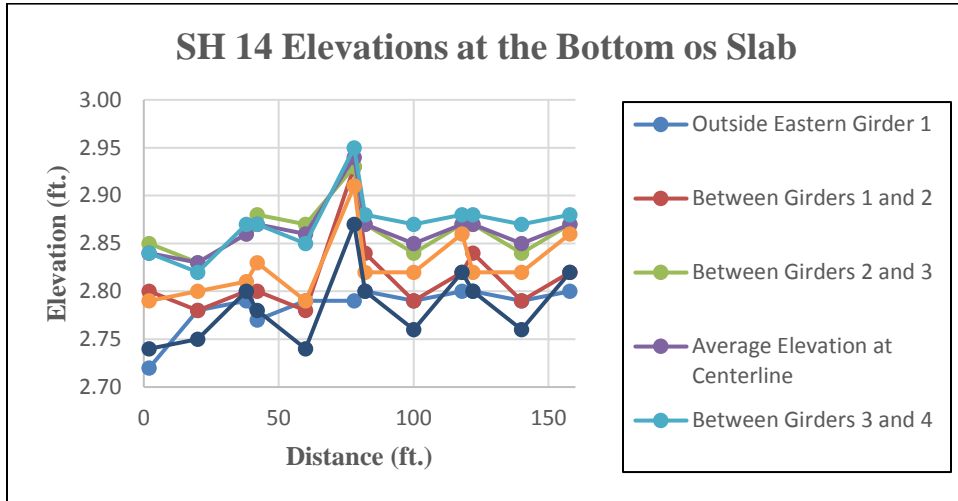
Figure 62: Elevations at the bottom of the concrete deck of SH 14

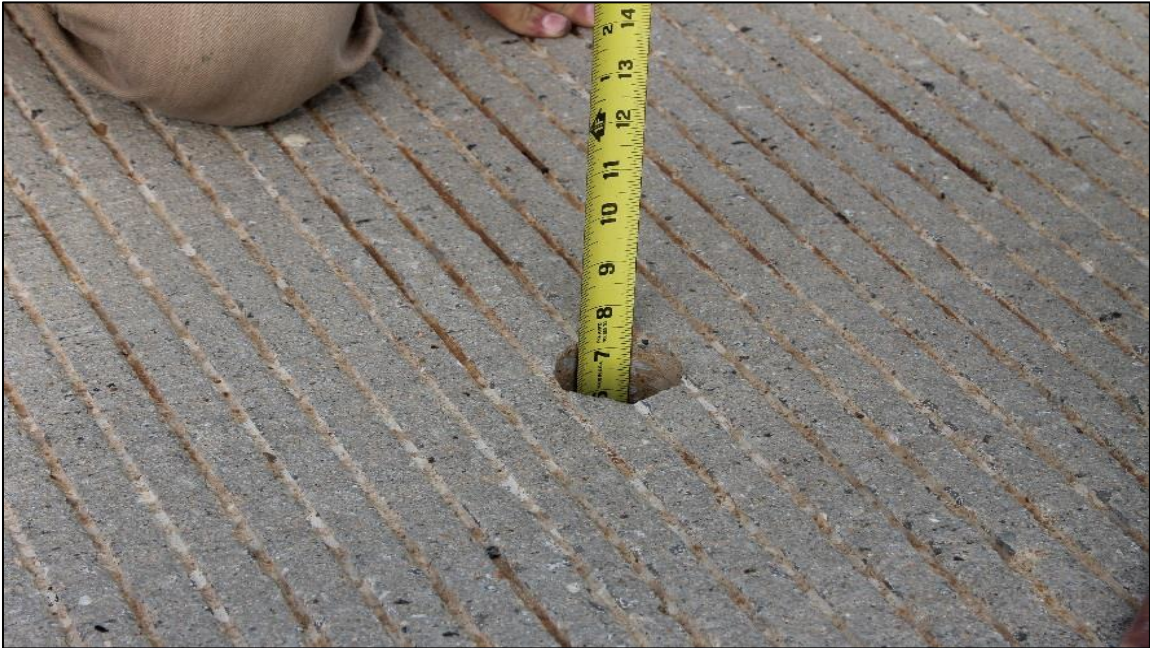
Figure 63: A pre-existing core hole discovered in span 2 of SH 14

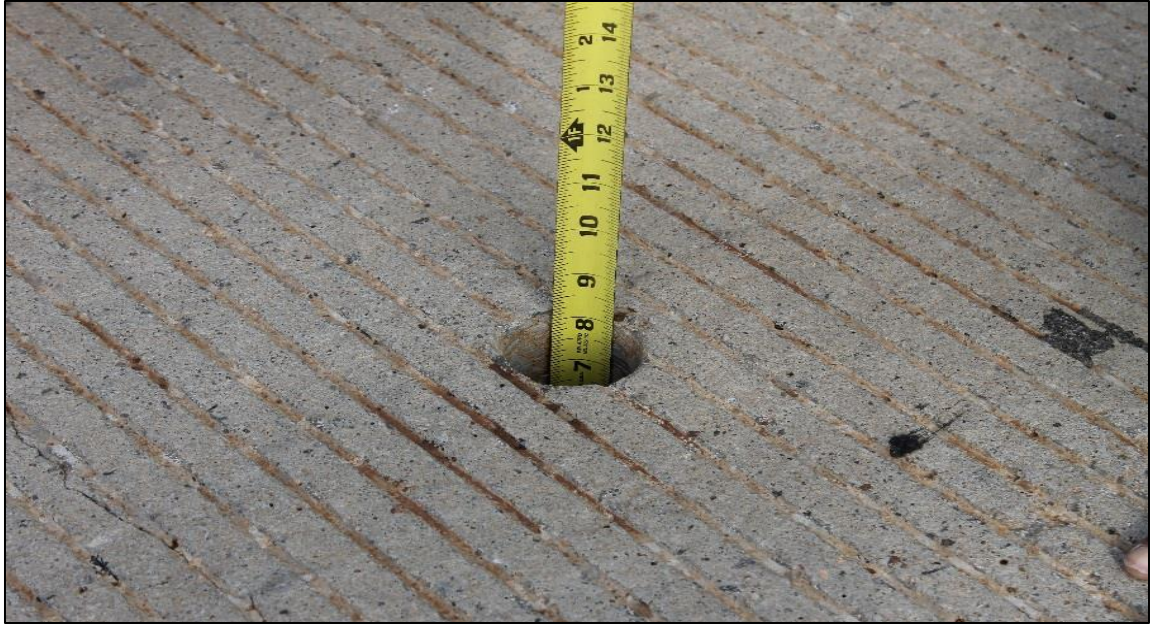
Figure 64: This pre-existing core hole discovered in span 4 of SH 14
