**DESIGN AND CONSTRUCTION**  
**of**  
**DARDANELLE BRIDGE**

by  
Clark A. Dunn  
Bachelor of Science  
University of Wisconsin  
Madison, Wisconsin  
1923

Submitted to the Department of Civil Engineering  
Oklahoma Agricultural and Mechanical College  
in partial fulfillment of the requirements  
for the Professional Degree of  
Civil Engineer

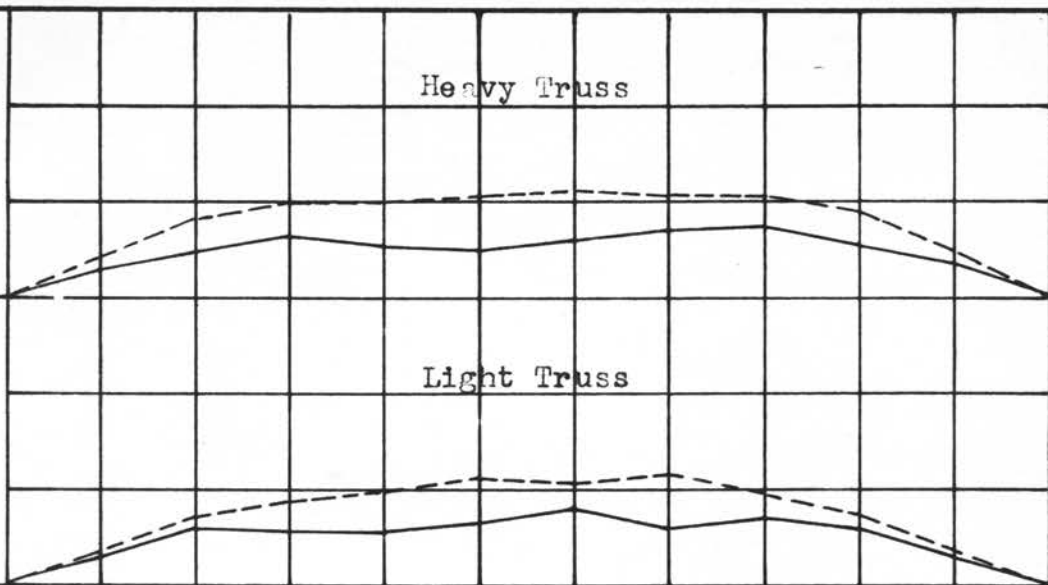
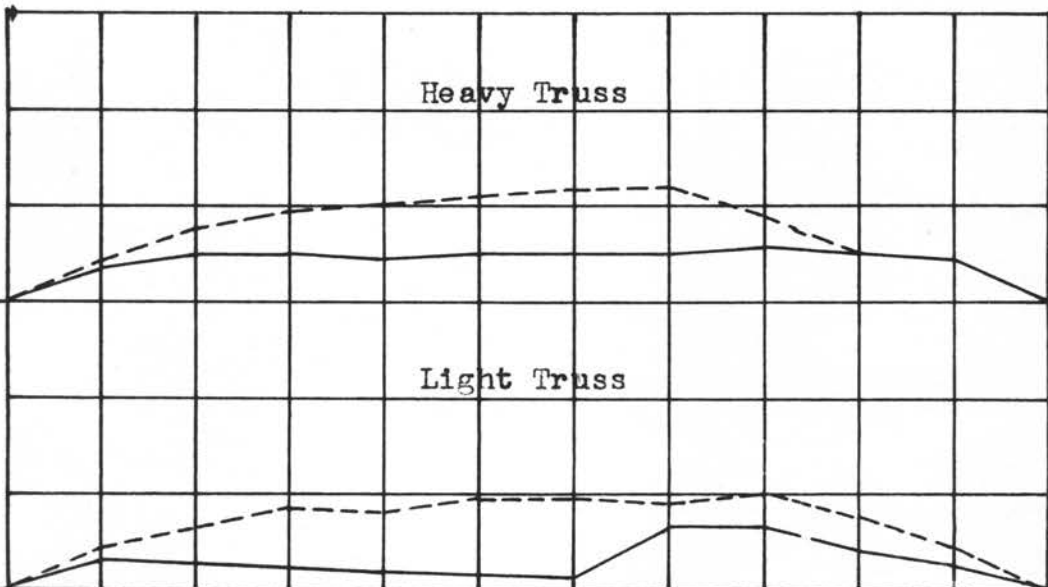
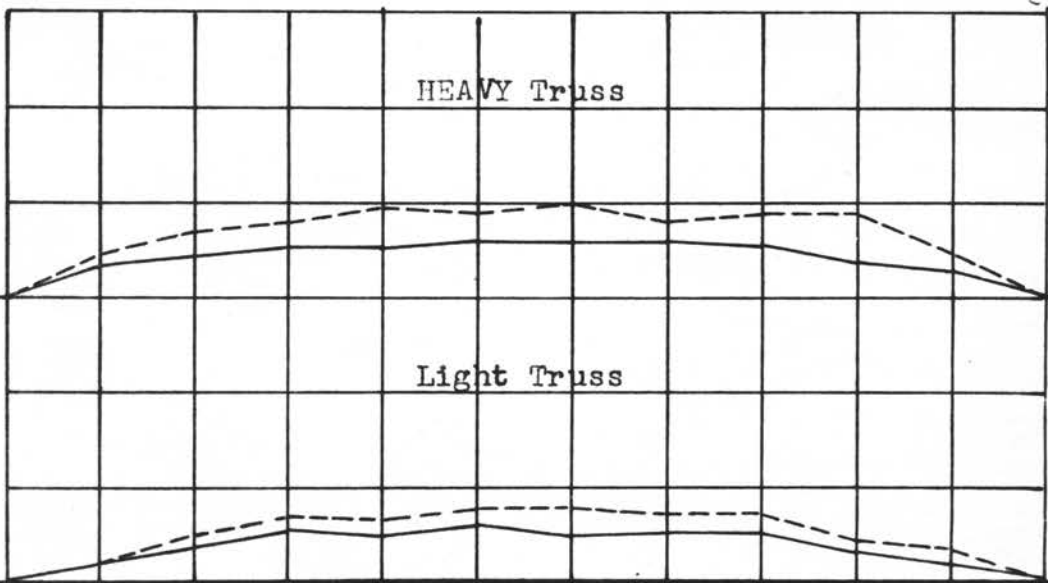
HEAVY Truss

Light Truss

The camber of steel spans has always been of interest to the author. It has always been a question as to what the final position of the lower chord points will be after the truss is placed in use. Due to the uniformity of erection conditions, that is, six spans were erected on one set of false work, it was felt that a rather thorough check could be obtained on the amount of camber lost when the span was swung and the amount lost when the floor was constructed. On page 52 is a graph of the initial camber, the camber after swinging the span and the camber after the floor had been poured. The diagram represents the average for all spans. On pages 53 and 54 will be found individual data for each truss of each span. A diagram has been made for each of the trusses since one was a heavy truss and the other a light truss.

It will be noted that only on one case for individual spans did the final position of any panel point fall below a straight line between the ends of the truss.
