FATIGUE ASSESSMENT OF BRIDGE MEMBERS
BASED ON IN-SERVICE STRESSES

INTERIM REPORT
NO. 1:
FIELD TESTS, ANALYSES,
AND LABORATORY TESTS

Report No. FHWA\OK-95(07)

August, 1996

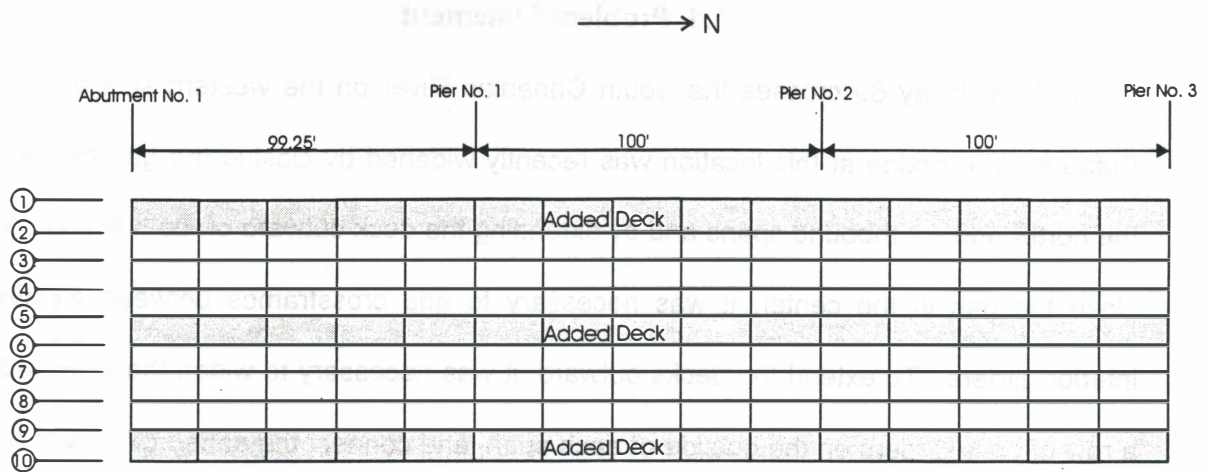
(a) Plan View of First Three Spans

The problem with weld quality is compounded by the fact that welding took place at unintended locations. According to the bridge modification design, new crossframes were to be welded to stiffeners on existing plate girders. In practice, crossframes were welded directly to the inside of the bottom flange of the existing and new plate girders, as

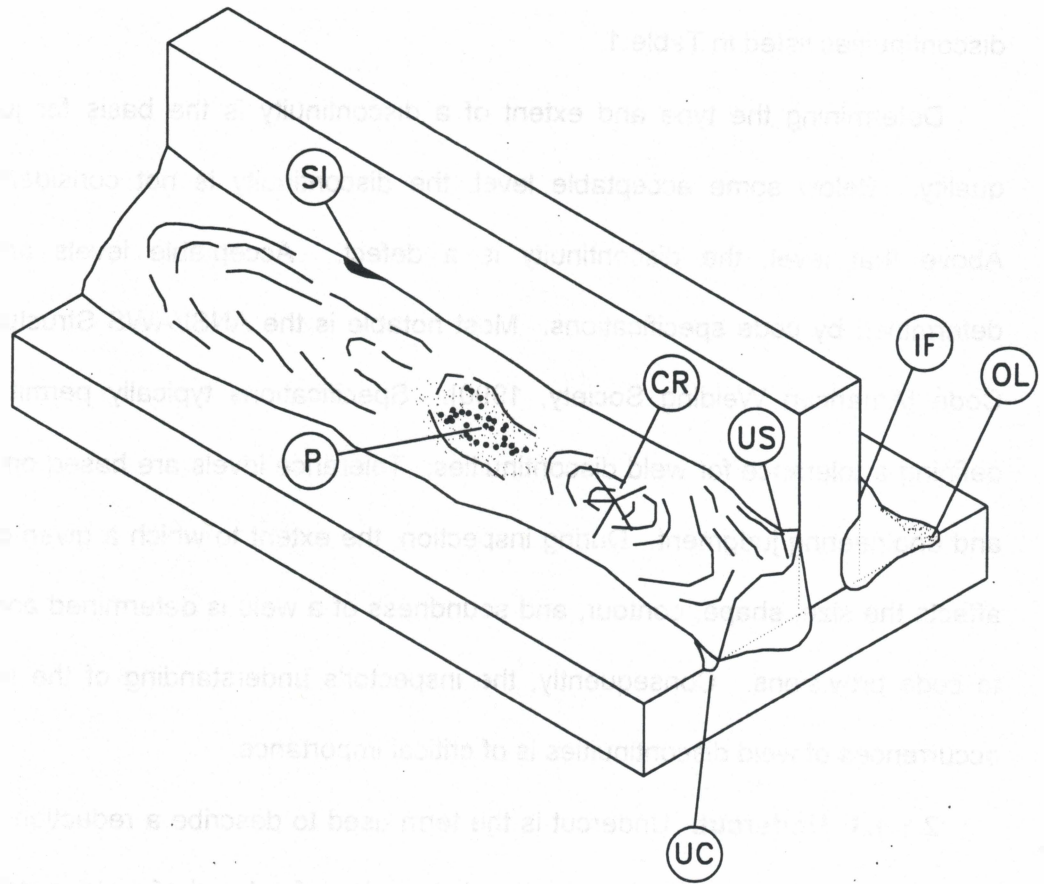
Figure 2. Fillet Weld Discontinuities in a T-Joint

In addition, metallurgical discontinuities may affect chemical properties such as corrosion resistance. Weld discontinuities may be found in the weld metal, base metal, or weld heat-affected zone. The T-joint shown in Figure 2 depicts the weld discontinuities listed in Table 1.

2.1.1.1 Undercut. Undercut is the term used to describe a reduction in thickness of base metal. The reduction occurs at the edge of a bead of weld metal joining the surface of the base metal. Undercut is generally caused by improper welding technique; however, a high amperage and a long arc increase the tendency. Typically, the welder incorrectly manipulates the electrode while depositing weld material, and undercut results [American Welding Society, 1991]. In addition to a reduction in cross-sectional area, the joint may experience local yielding at the tip of the undercut due to high stress concentrations. If excessive, undercut can significantly reduce the strength of the joint. Strength reduction is most prevalent in joints subject to severe fatigue conditions [Tsai et al., 1984].

2.1.1.2 Incomplete Fusion. The failure to fuse together adjacent layers of weld metal or weld metal and base metal is termed incomplete fusion. The welding arc must sufficiently penetrate the joint surfaces and raise the temperature of the base metal or previously deposited weld metal to the melting temperature or incomplete fusion will occur [Rodgers, 1983]. Penetration problems causing incomplete fusion can result from improper electrode manipulation or incorrect arc current. The electrode travel speed must not be too high, and the arc current must not be too low. Additionally, poor surface preparation can cause incomplete fusion. Preweld cleaning must be sufficient to remove slag, oxides, or other foreign material [Gurney, 1979].

2.1.1.3 Overlap. The term overlap is used to describe a surface discontinuity that forms a severe mechanical notch parallel to the weld axis. Overlap is commonly caused by incorrect welding technique, wrong selection of welding materials, or improper preparation of the base metal. If slag, oxides, or other foreign matter on the base metal interfere with fusion, overlap may result along the toe, face, or root of the weld [American Welding Society, 1987].

2.1.1.4 Undersize. Undersize refers to a lack of welding material along the welded joint. It occurs when welding technique is poor. The welder simply fails to deposit enough weld material along the joint [American Welding Society, 1987].

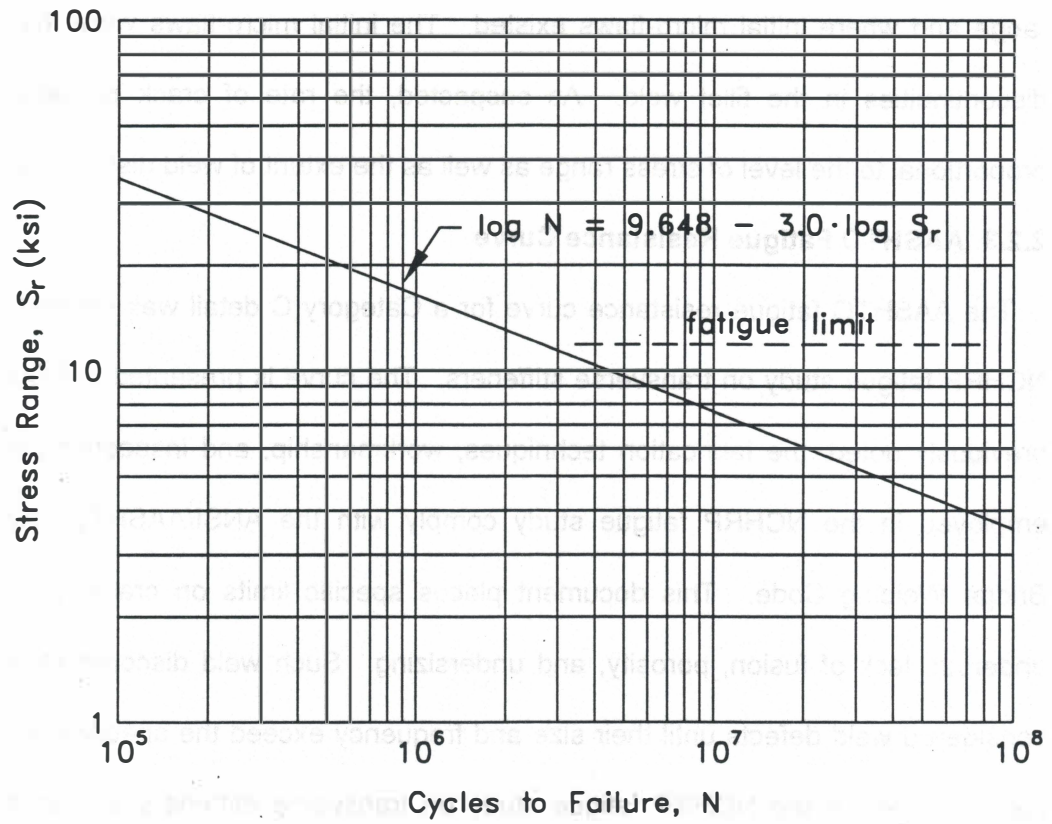
Figure 4. AASHTO Fatigue Resistance Curve for a Category C Detail

The AASHTO fatigue resistance curve for a Category C detail was derived from the NCHRP fatigue study on transverse stiffeners. The curve is presented in Figure 4. As previously noted, the fabrication techniques, workmanship, and inspection procedures employed in the NCHRP fatigue study comply with the ANSI/AASHTO/ AWS D1.5 Bridge Welding Code. This document places specific limits on cracking, convexity, undercut, lack of fusion, porosity, and undersizing. Such weld discontinuities are not considered weld defects until their size and frequency exceed the specified limits. The data obtained in the NCHRP fatigue study on transverse stiffeners applies to quality welds free of defects. Consequently, the AASHTO fatigue resistance curve for a Category C detail makes no allowance for substandard welding.

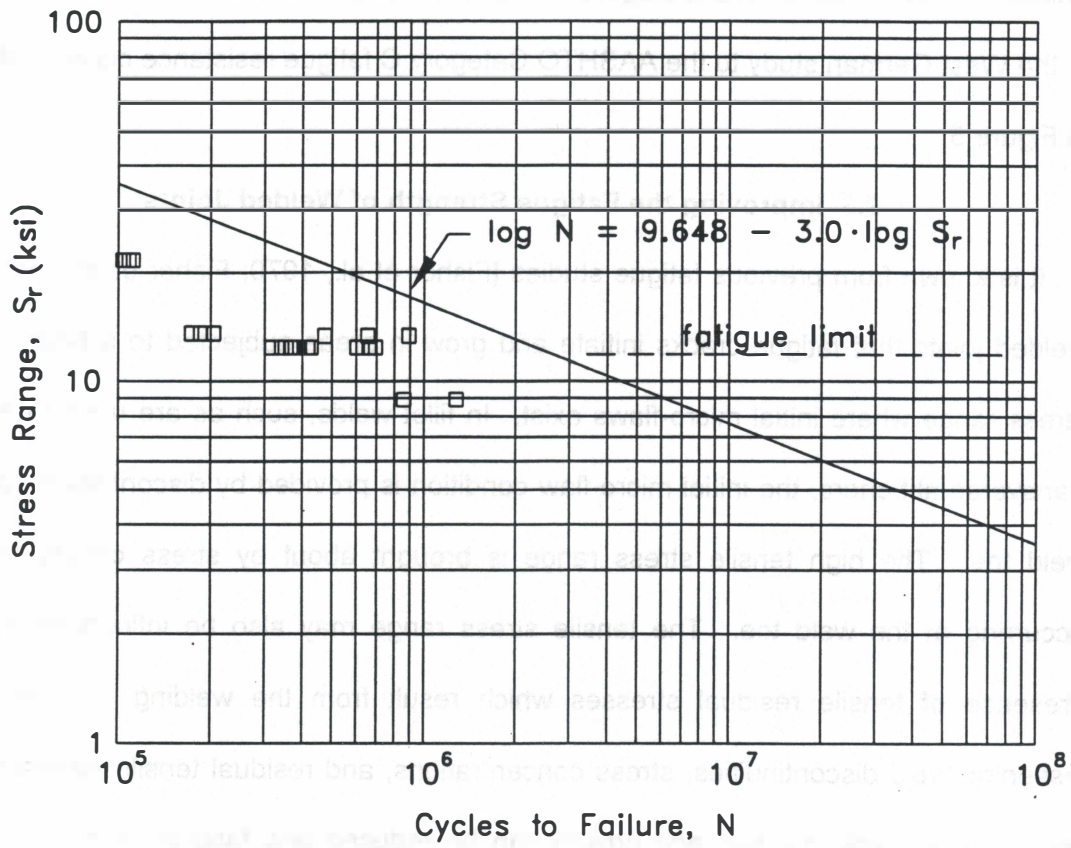
Figure 5. West German Test Data

that were significantly below the predicted strength. The reduced fatigue strength was reportedly due to unintended weld defects, namely hydrogen-induced cold cracking and weld undercutting. All the test data obtained in the West German study fell below the fatigue resistance curve for a Category C detail. A comparison of the test data obtained in the West German study to the AASHTO Category C fatigue resistance curve is shown in Figure 5.

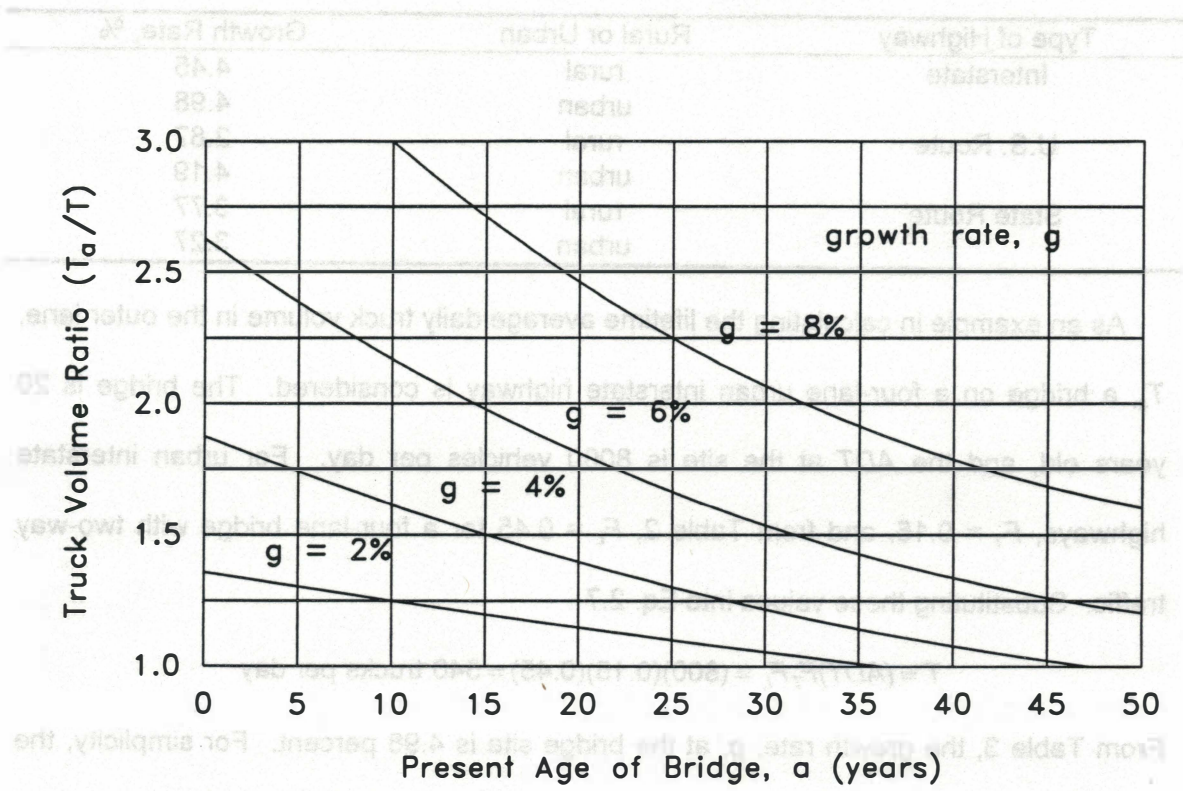
Figure 6. Truck Volume Ratio (T_a/T) [Moses et al, 1987]

were estimated from Annual Average Daily Traffic (AADT) data taken at counting stations throughout the United States between the years 1938 and 1985.

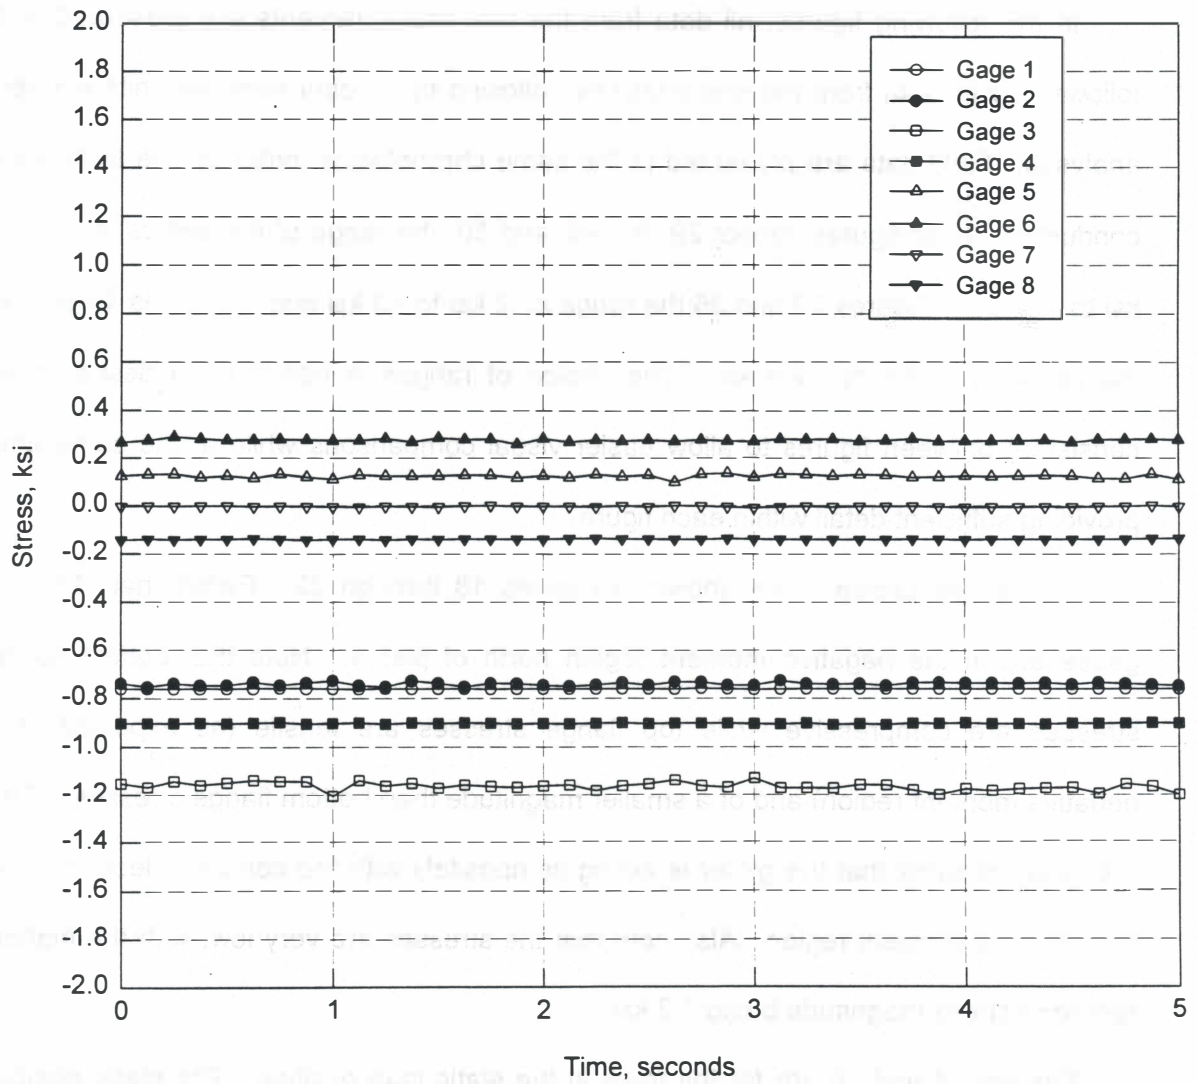
Figure 18. Stationary Truck in Shoulder, from Measurements at Group 1 Location

Figures 18 and 19 are for the truck in the static load position. The static position has the truck parked with its middle axle directly above the Group 2/3 crossframe, not

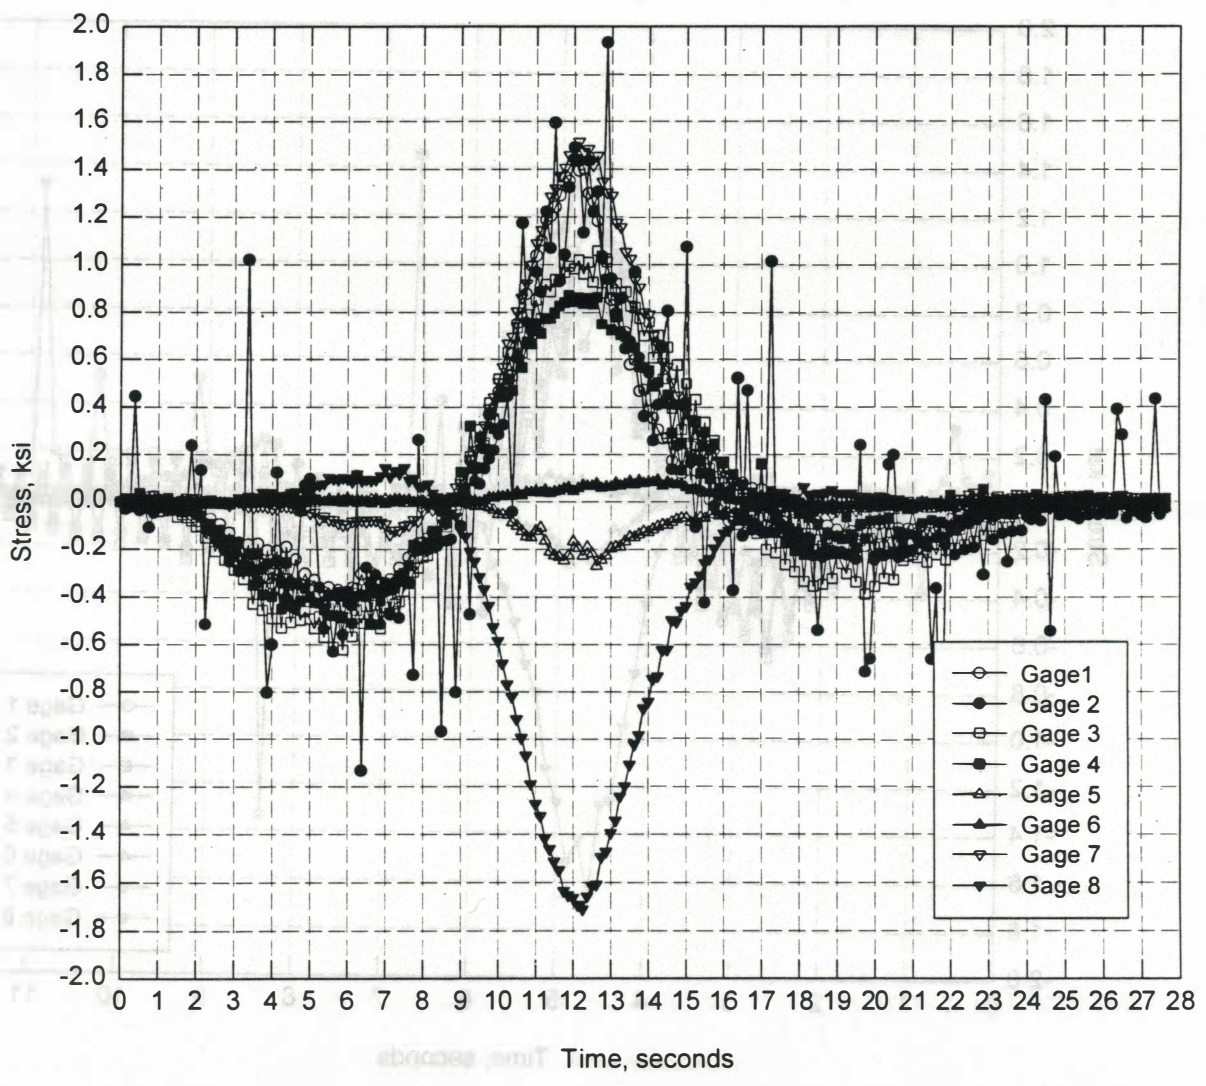
Figure 31. Truck Moving at 5 mph in Right Lane, from Measurements at Group 3 Location

Many of the same observations made on the basis of the Groups 1 and 2 data can be made from the Group 3 data. Under the static load, the bottom flange stresses are positive and much larger than the top flange stresses. The highest stress of 2.6 ksi occurs in the outside girder when the truck is parked in the shoulder over the crossframe. The highest stress range measured in any girder with substandard welds is approximately 1.9 ksi, as seen in Figures 31 and 32. There is no evidence of dynamic

Figure 37 compares to Figures 20 and 22, 38 to 21, 39 to 25 and 26, 40 to 27 and 28, 41 to 31 and 32, and 42 to 33 and 35. Both the shape of the curves and the peak magnitudes are remarkably similar. The maximum stress computed with the grid model is 1.7 ksi, and the maximum stress range is 2.1 ksi; both can be seen in Figure 41. The

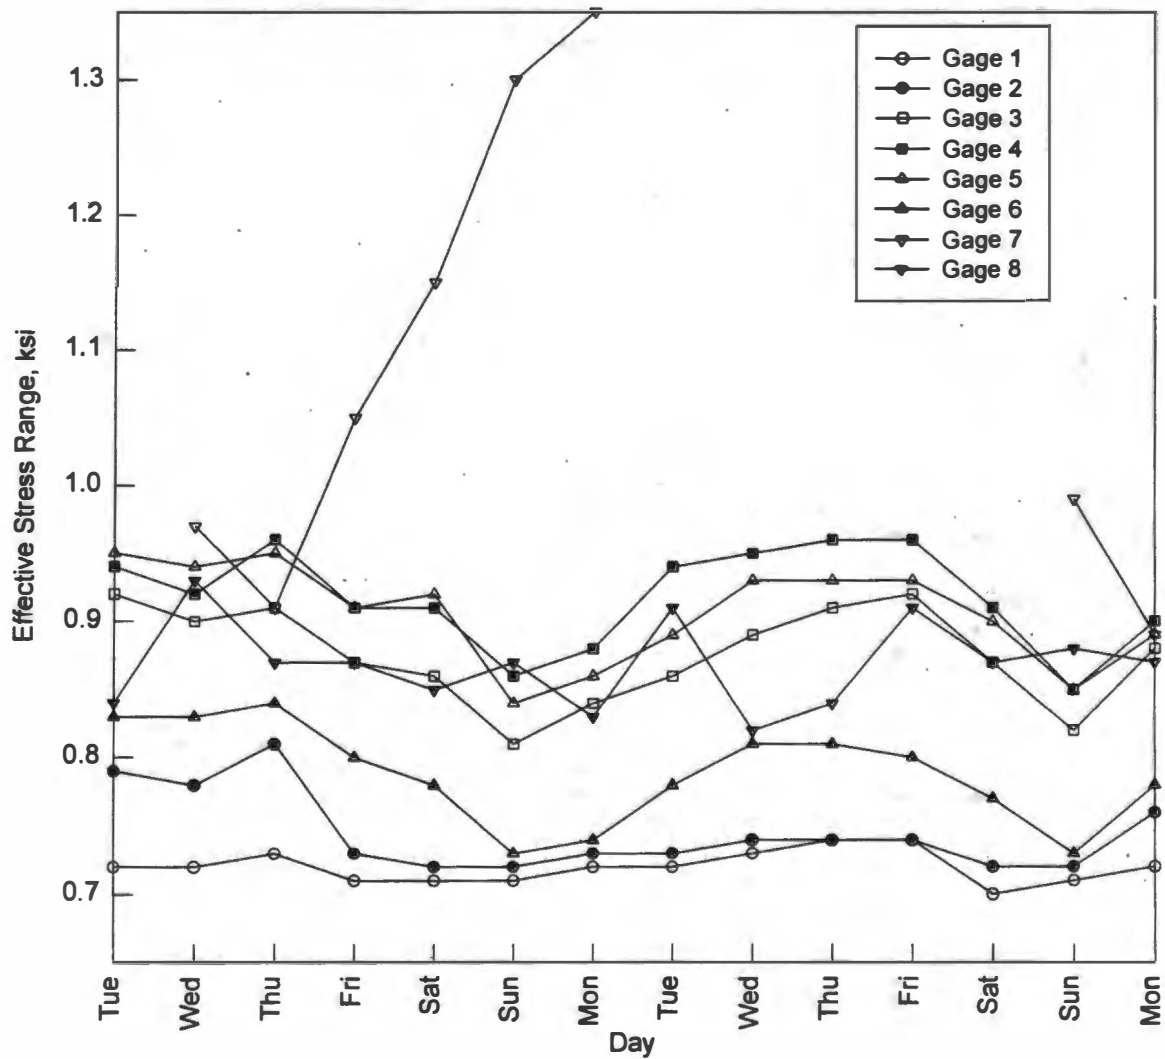
Figure 54. Effective Stress Ranges Over a Two Week Period

Figure 54 shows the variation of effective stress range for each gage over the two-week period of data acquisition. Gage 7 is obviously out of line with the other gages and goes completely off scale for a large portion of the record. The effective stress range data is replotted in Figure 55 with gage 7 omitted. Close study of the individual gage lines shows that gage 8 is also behaving erratically. The erratic behavior of gage 8 is more obvious in Figures 56 and 57. In Figure 56, gage 3 also behaves erratically for a short time, but falls back in line over most of the record. Gages 7 and 8 are on the exterior girder and may have been damaged by the rain which occurred during the test period. It is very unlikely that the exterior girder would have experienced stresses so

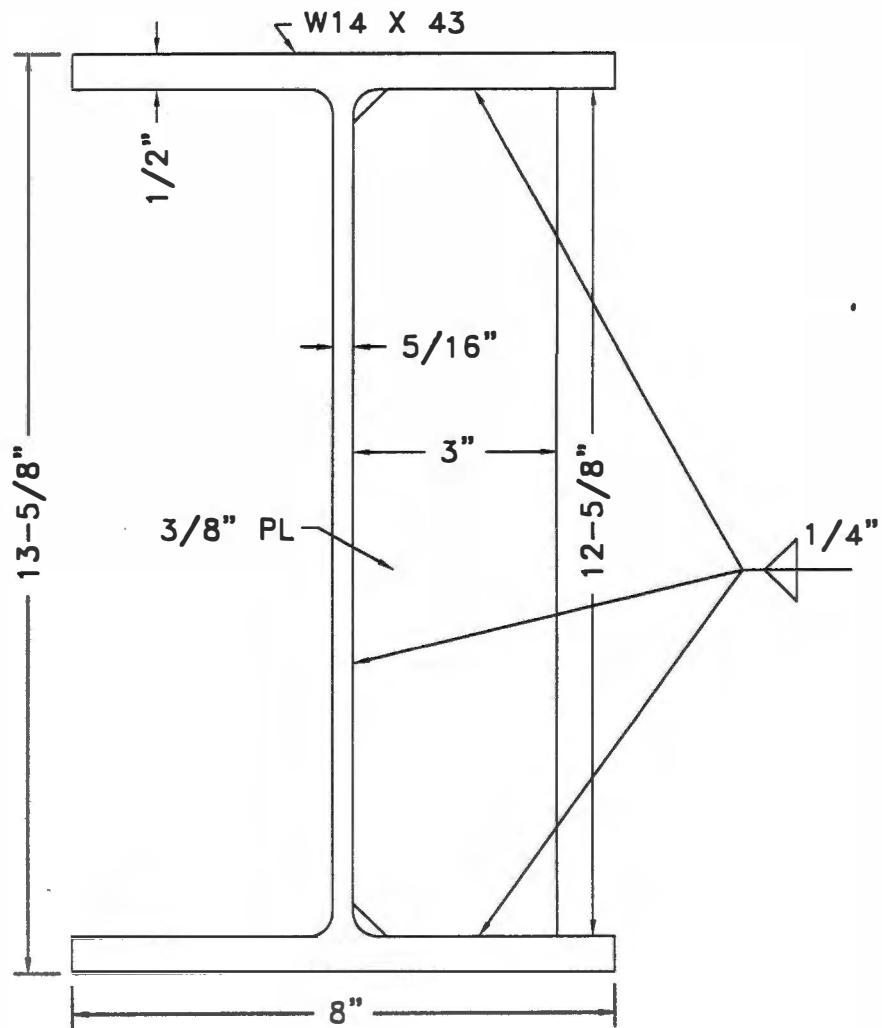
Figure 62. Cross Section of a Typical Test Specimen

Three specimens were prepared for fatigue testing. All three test specimens were W14x43 rolled beams with one-sided transverse stiffeners attached to the web and both flanges. The beam and stiffener material used for fabricating the test specimens was ASTM A36 structural steel. For all specimens, six one-sided transverse stiffeners were attached symmetrically about the midpoint of each beam length, where the length of each beam was 20 ft. Attaching the stiffeners in this fashion allowed the fatigue testing of one beam to result in two data points at three different stress ranges for a total of six possible data points per beam. A diagram showing longitudinal dimensions and stiffener locations for a typical test specimen is given in Figure 61. The stiffeners used on the test specimens were steel plates with a width of 3 in. and a thickness of 3/8 in. The

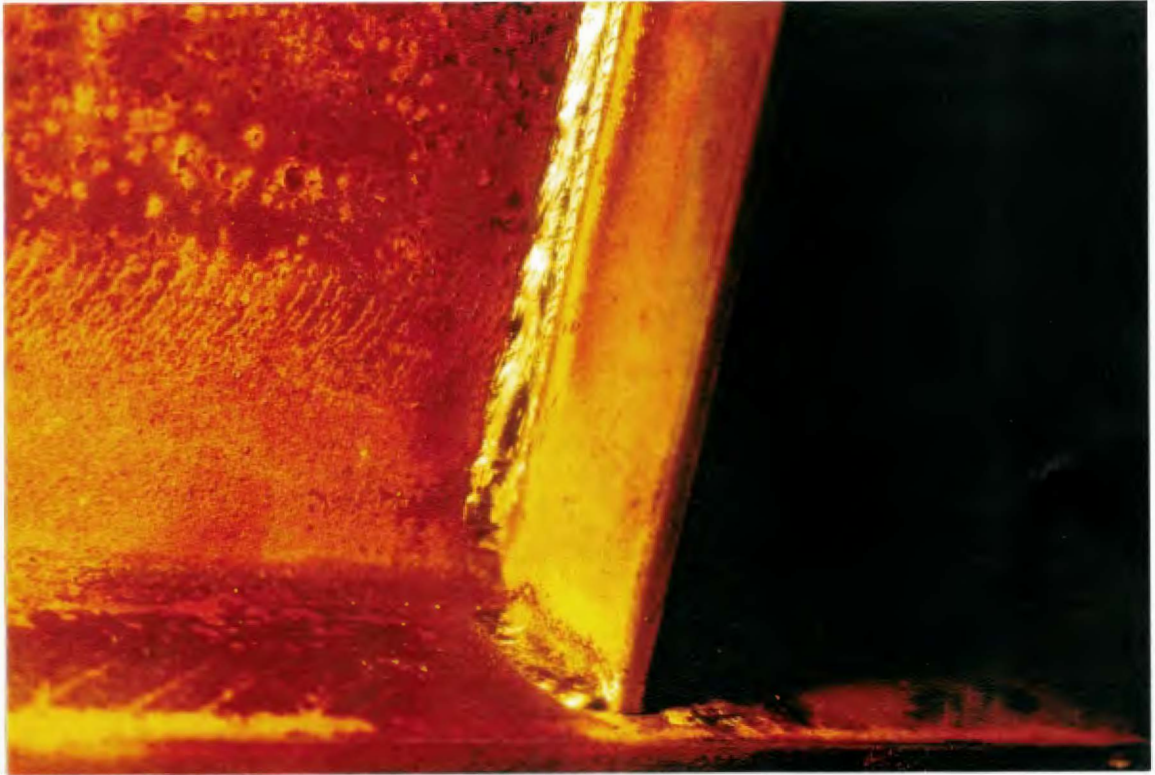
Figure 63. A Typical Welded Joint on the Control Specimen

The two remaining test specimens were fabricated in the testing laboratory. The completed control specimen along with two 20-ft long W14x43 plain rolled steel beams without stiffeners were transported on a trailer from the steel fabrication shop to the testing laboratory. The steel beams obtained from the fabricator were used to make the two remaining test specimens. Additionally, several feet of 3-in. by 3/8-in. flat plate stock needed for fabricating the test specimens were obtained from a local steel supplier, and the welding materials needed for fabricating the test specimens were obtained from a local materials distributor.

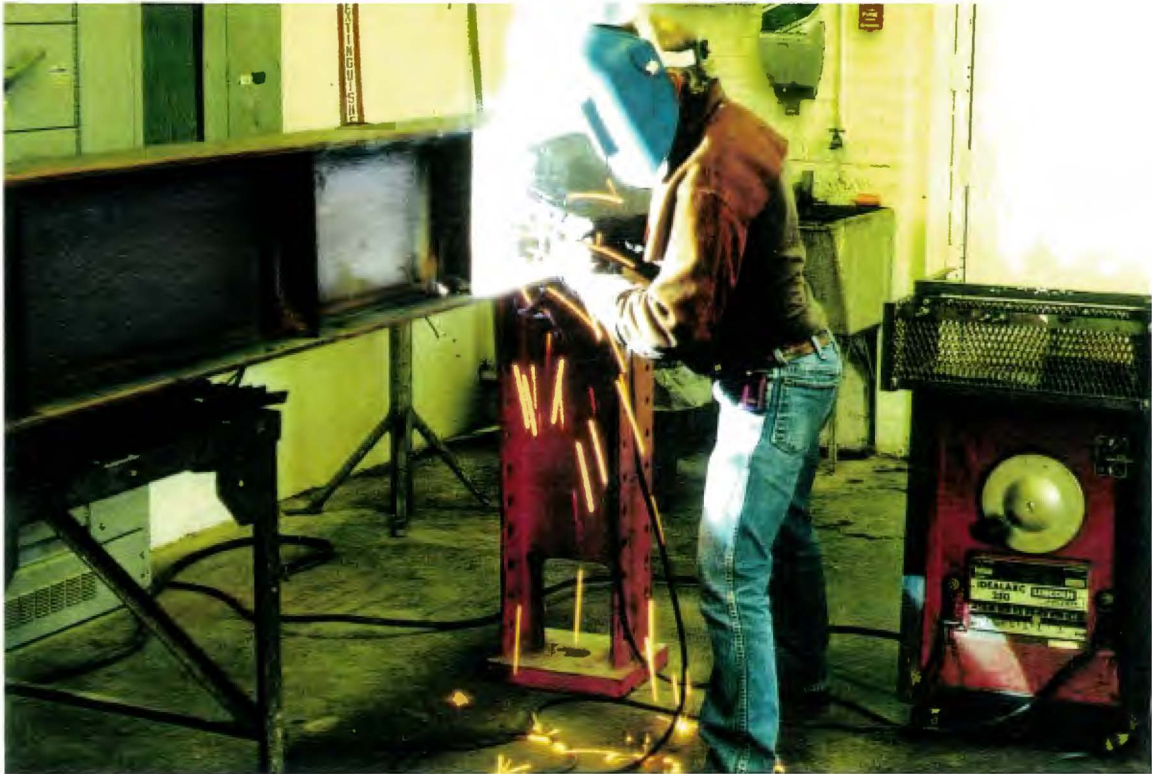
Figure 64. Welding a Test Specimen

To properly represent the field welds being evaluated, the welding performed on the two specimens fabricated in the laboratory was to be sufficiently poor as to produce

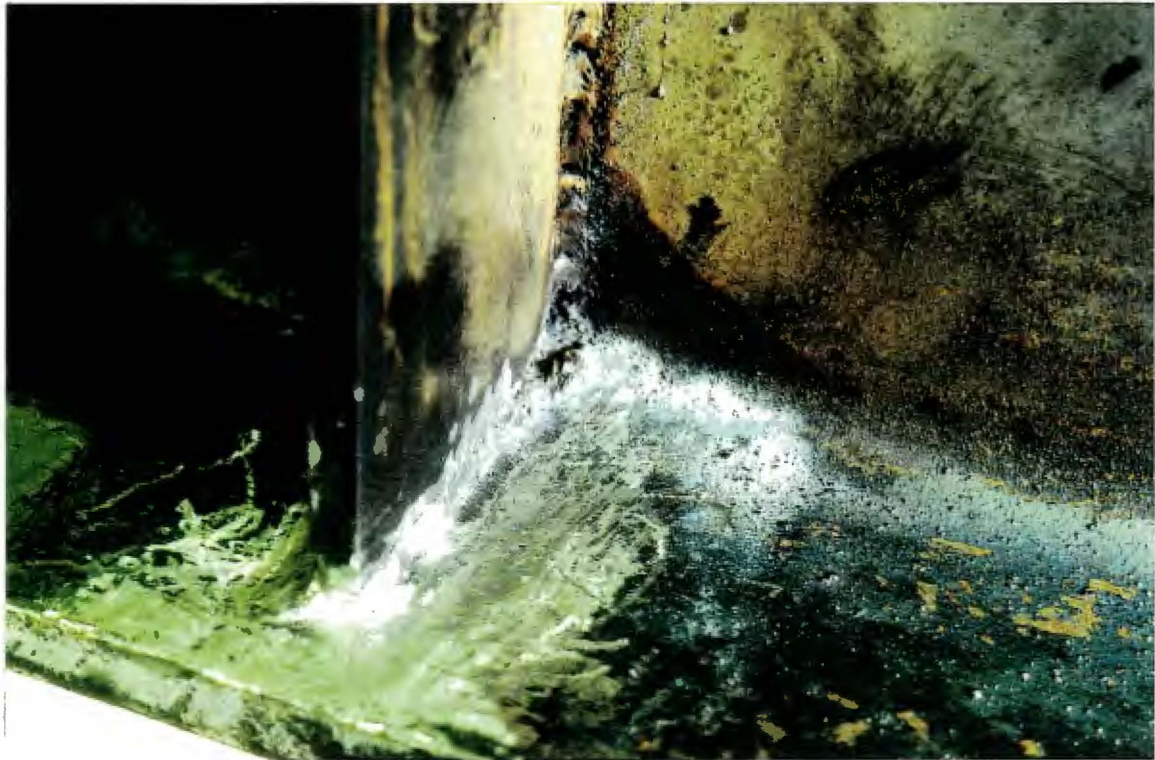
Figure 66. Repaired Joint

On one of the test specimens fabricated with poor quality welds, an attempt was made to repair a welded joint at one of the stiffener details. The stiffener detail selected was located closest to the midpoint of the beam where stress range would be the highest. Furthermore, the welded joint selected was located at the intersection of the stiffener plate and the tension flange of the beam, where obvious undercut was present in the flange. Repair was accomplished by grinding along the fillet welds joining both sides of the stiffener plate to the tension flange. Both weld material and flange material were reduced by grinding until undercut was removed and a smooth transition was obtained. This helped to minimize stress concentrations and reduce weld discontinuities. By grinding, the flange thickness was reduced by a maximum of 0.044 in. The ground joint is shown in Figure 66. Grinding was performed using both a rotary burr grinder and a small disc grinder. The pneumatically powered rotary burr grinder was used to quickly remove the majority of unwanted material. The electrically powered

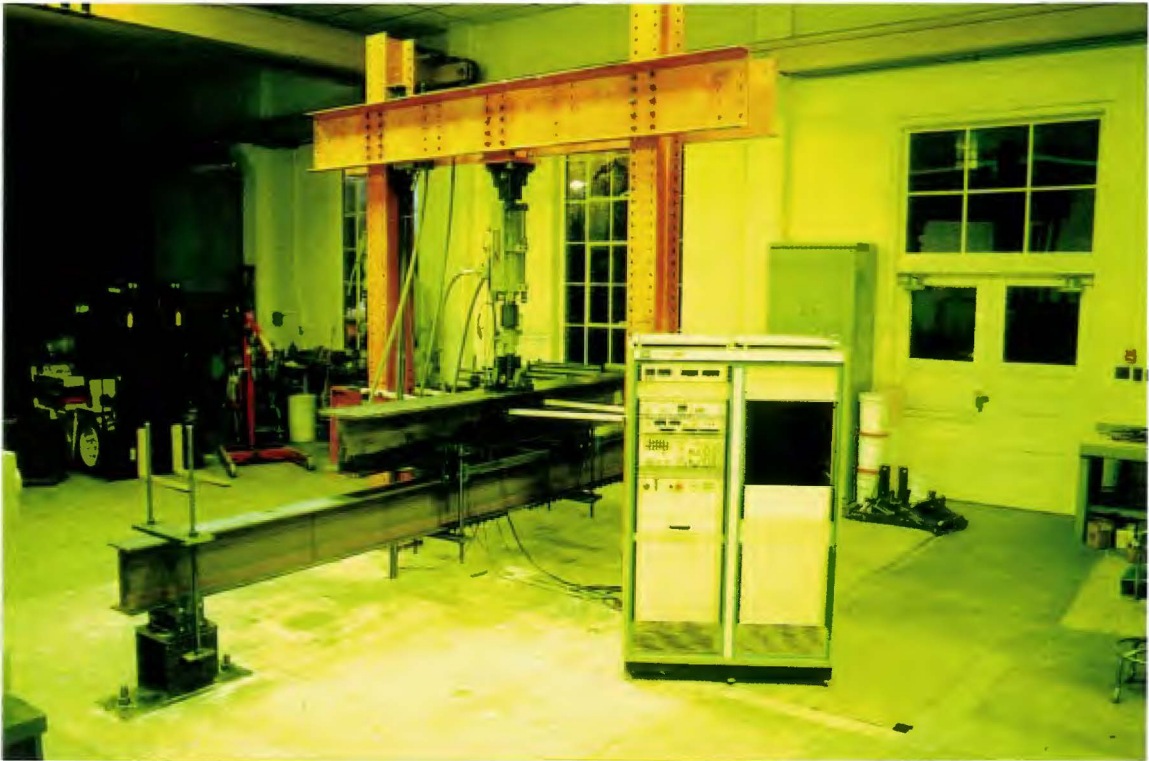
Figure 70. Test Setup

Before beginning the fatigue test on each specimen, a static load test was performed. These tests were performed while monitoring the strain gages along the tension flange of each specimen. For each static load test, the load was increased by increments of 5 to 10 kips up to a peak value. Once the peak value was reached, the load was decreased by increments of 5 to 10 kips. Strains were recorded for each increment of load and the corresponding stresses were calculated. To determine if the test specimen was properly aligned, the actual stresses occurring in the test specimen were compared to theoretical stresses, and the strains occurring on each side of the tension flange were compared to each other. If improper alignment was suspected, the test specimen was simply adjusted until favorable strains were measured.

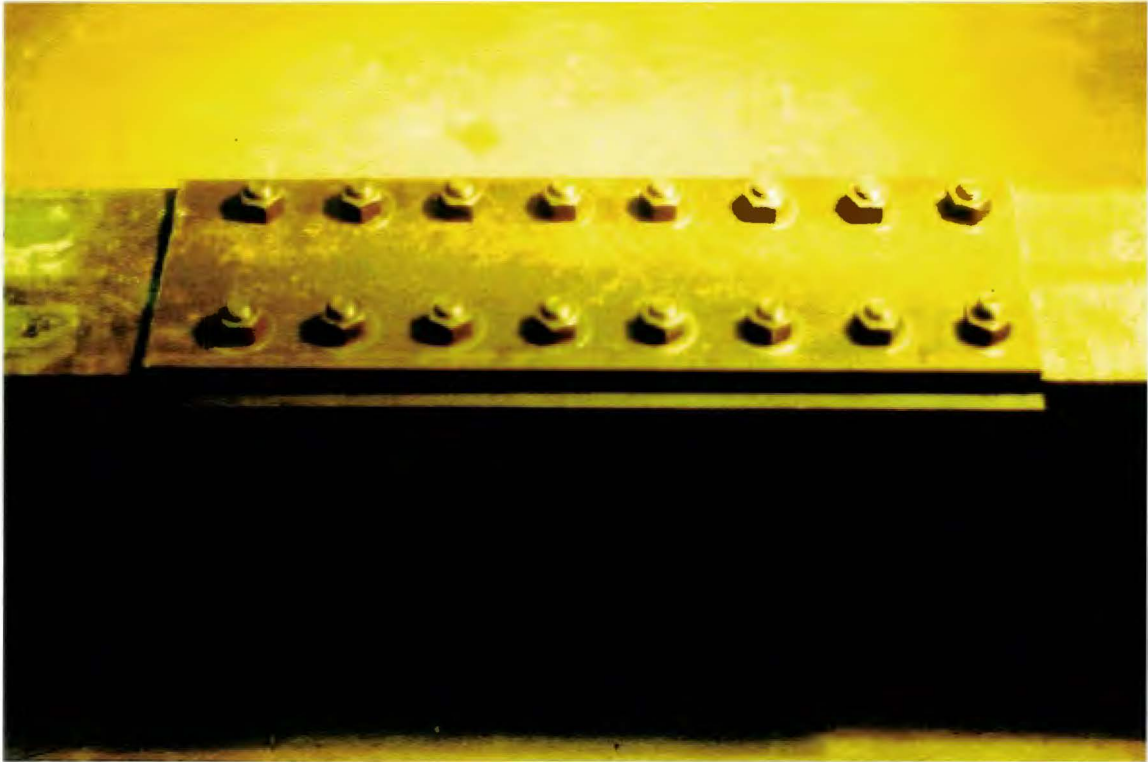
Figure 71. Splice Plate Detail

After failure, the cracked flange was repaired so that fatigue testing could be continued to obtain cracks at other stiffener locations. The repairs were accomplished by splicing across the cracked region. Splice plates with a thickness of 3/8-in. were bolted above and below the tension flange with 3/4-in. diameter A325 bolts. The bolts were accommodated by drilling holes through the tension flange and splice plates. Because of the nature of the fatigue loading, the splice plate details were designed as slip-critical connections requiring several bolts on each side of a crack. A typical splice plate detail is shown in Figure 71.

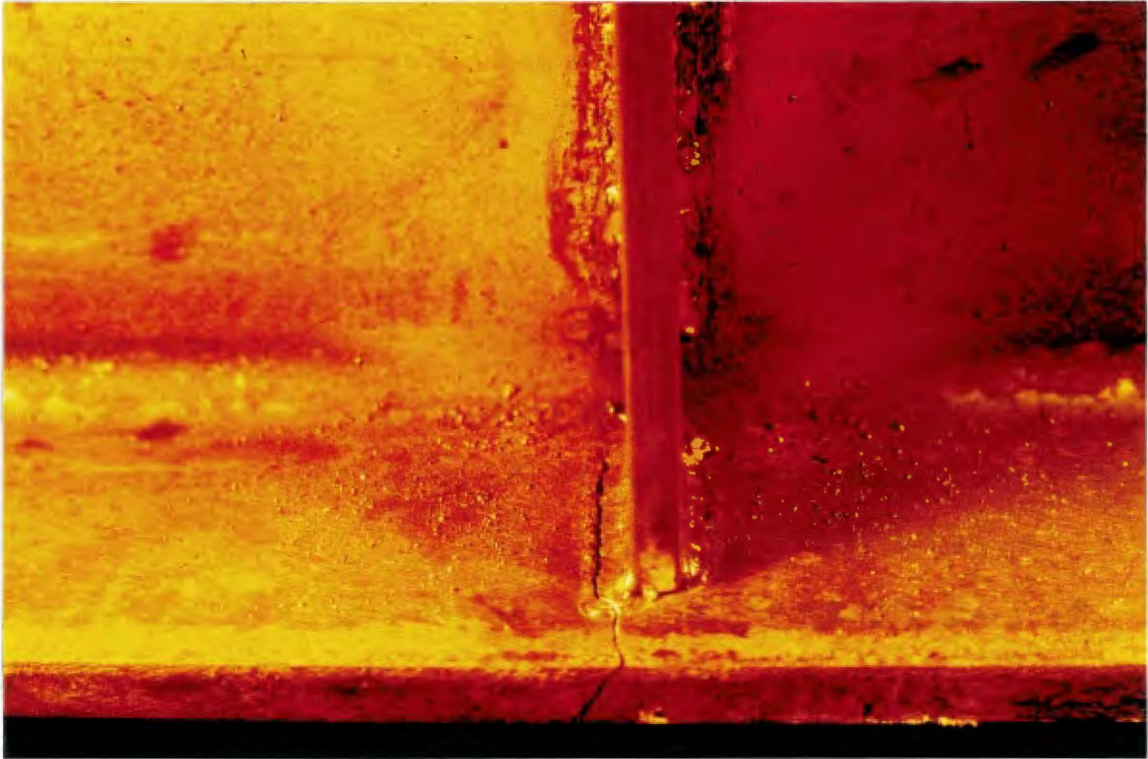
Figure 72. A Typical Crack at a Stiffener Detail

All failures occurring in the fatigue tests were the result of a crack initiating and growing adjacent to the fillet weld joining the stiffener to the tension flange. A typical failure is shown in Figure 72. Beams reached the end of their fatigue life when the crack had destroyed most of the tension flange and deflections had become large. Some of

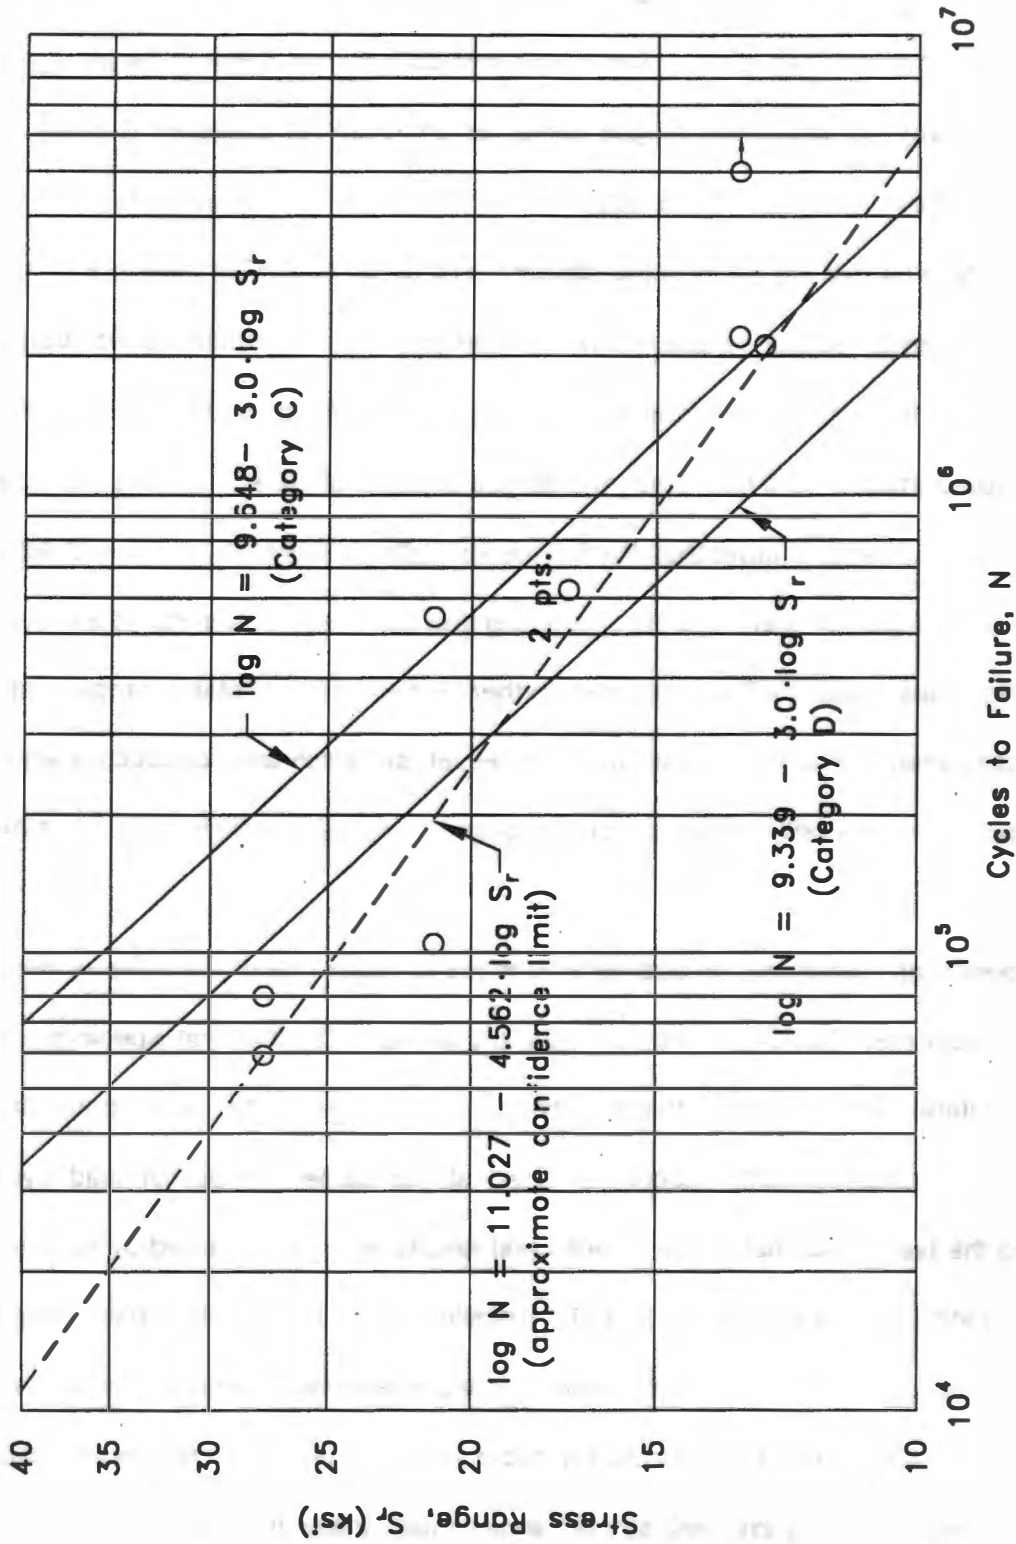
Figure 76. Comparison of Test Data to AASHTO Fatigue Curves

In Figure 76, the data for the stiffener details having poor weld quality are plotted along with the AASHTO fatigue curves for Category C and D details. Also shown in

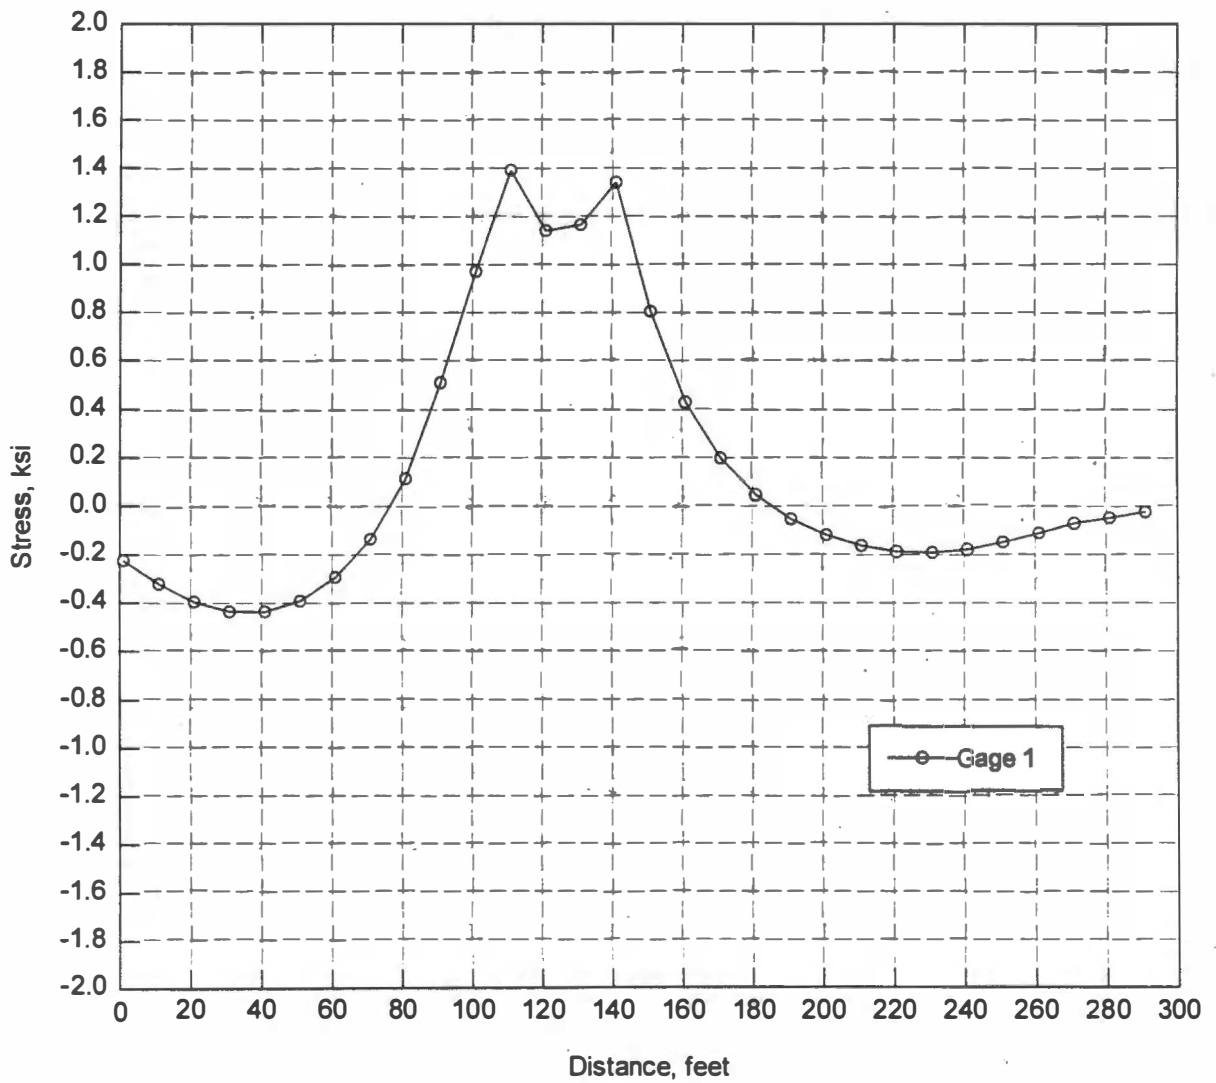
Figure 77. Fatigue Truck Moving in Right Lane, Grid Analysis at Group 3 Location

The grid model used for comparisons to field measurements can again be used to compute stresses, with the fatigue truck replacing the dump truck. The results of the analyses are shown in Figure 77. From previous calculations, it is known that the critical location is girder 9 at the crossframe 40 ft north of pier 1. The stress at this point varies
