QUICKCHANGE MOVEABLE CONCRETE BARRIER SYSTEM

FINAL REPORT

1. REPORT NO. FHWA/OK 92(06)	2. GOVERNMENT ACCESSION NO.	3. RECIPIENT'S CATALOG NO.	
4. TITLE AND SUBTITLE "QUICKCHANGE Moveable Concrete Barrier System"		5. REPORT DATE July, 1992

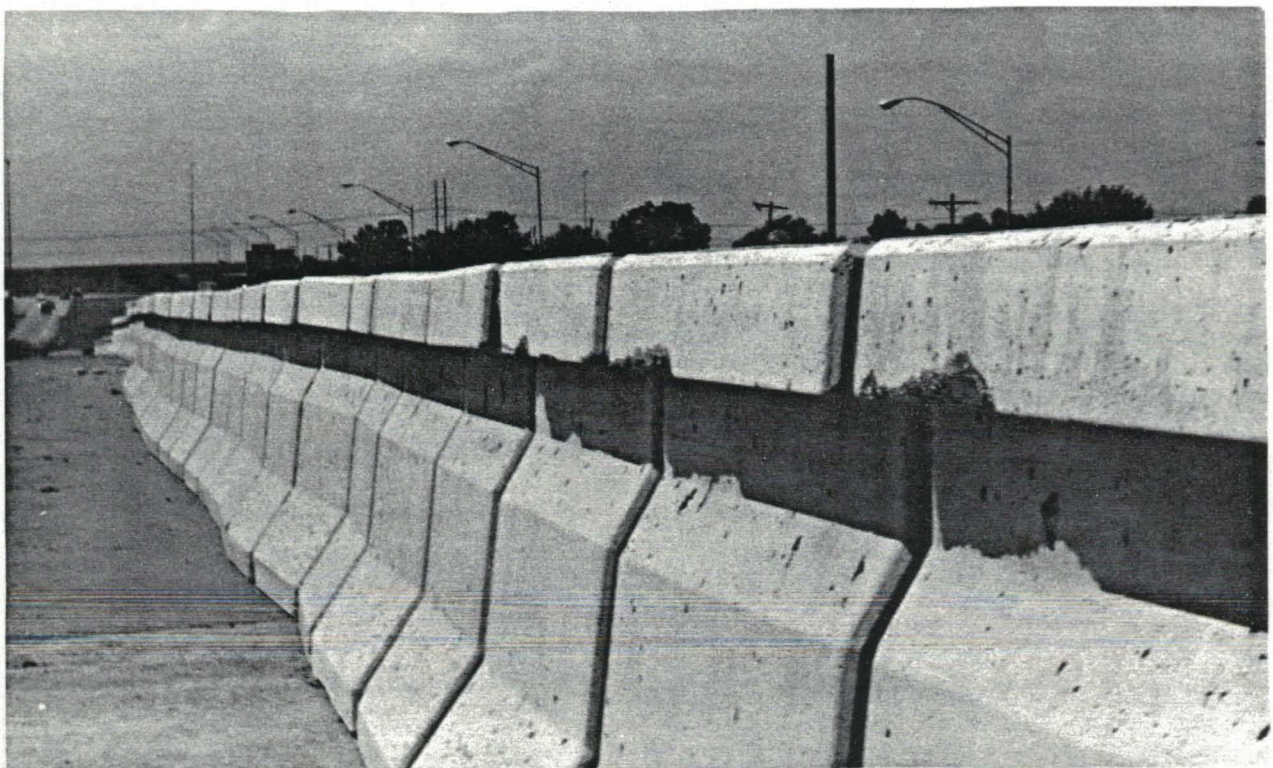
Figure 13. Chipping Under Flanges on Barrier Segments.

Barrier segments have shown some signs of wear over the duration of this project. A fairly large proportion of the segments, roughly 15 per cent, have corners chipped off at the base or chipping under the flanges. During work on IR-240-1(324)000, approximately 15 segments (0.34 percent) were damaged severely enough so that they were no longer usable. According to Nielson's employees, all were damaged during loading, unloading, and stacking operations associated with initial placement and removal. Chipping under the flanges, and chipped corners occurred during barrier shifts.

Damage to barrier segments in the form of chipped corners and flanges, spalls, etc. appears to be directly related to the number of times the barrier wall is shifted. Further study may show what the expected life of barrier segments is. Expected life will probably be in terms of number of barrier shifts.

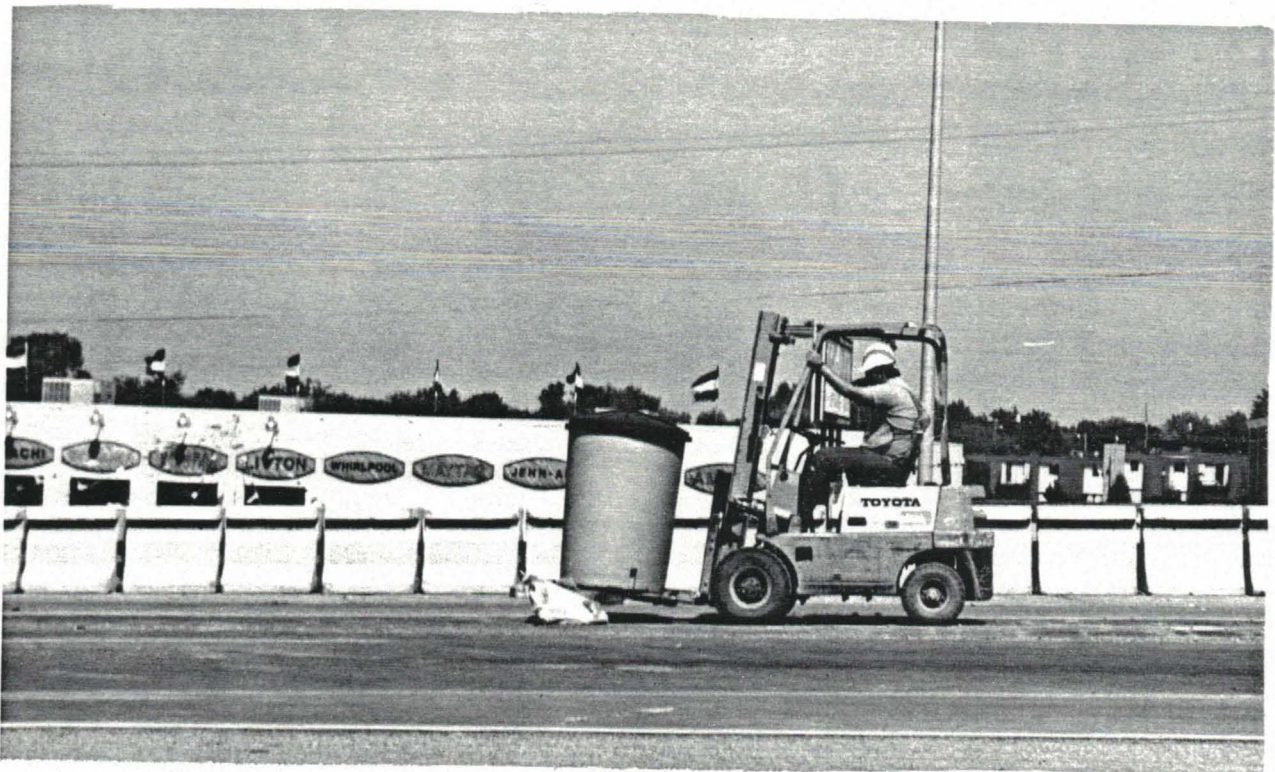
Figure 17. Moving End Protection Prior to Barrier Wall Shift.

Moving the end protection created a "bottleneck" situation when barrier walls were shifted. Sand barrels had to be moved one at a time by forklift. Relocating the sand barrel array took roughly 30 minutes. This had to be done in advance of barrier wall shifts which required approximately five (5) minutes per 1/2 mile of barrier wall shifted.
