JOINT HIGHWAY RESEARCH PROGRAM  
PROJECT 77-02-3  
SEALING CRACKS IN FLEXIBLE PAVEMENTS  
FINAL REPORT

FIELD AND LABORATORY EVALUATION  
OF CRACK SEALANTS

Publication No. R(S)-21

RESEARCH PROJECT 77-02-3  
Joint Highway Research Program

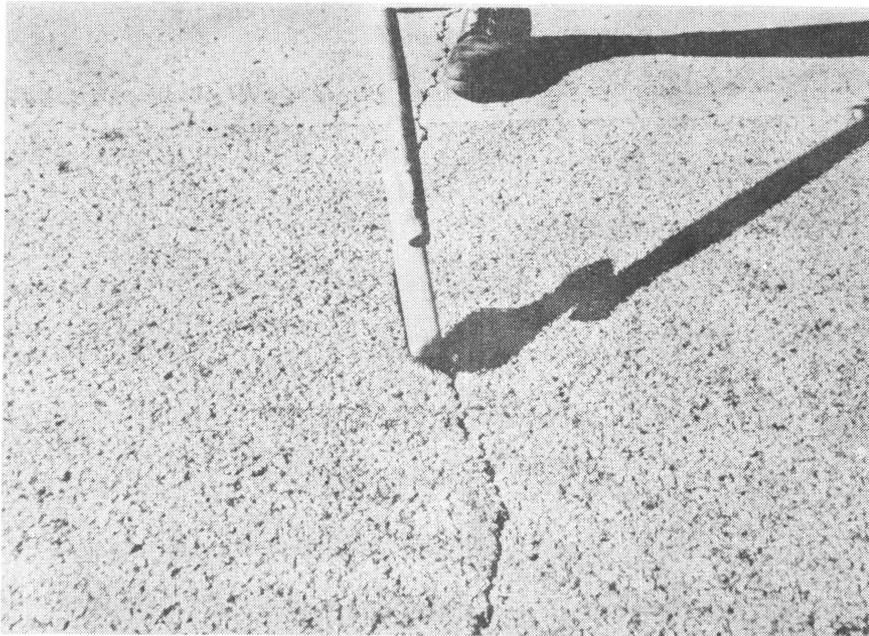
Figure 4. Wire Brushing a Traverse Crack

Air-blowing of the cracks at the test site was accomplished using a standard 200 cfm ( $944 \text{ m}^3/\text{s}$ ) gasoline powered air compressor. The compressor was operated at a pressure of about 240 psi (1655 kPa) which was sufficient to remove all loose material or debris from a crack. Brushing of the cracks was done with a stiff bristle wire brush attached to a short handle, as shown in Figure 4. This operation, along with subsequent

air-blowing, removed dust and any loose paving material from the edges of the crack and the crack walls near the pavement surface.

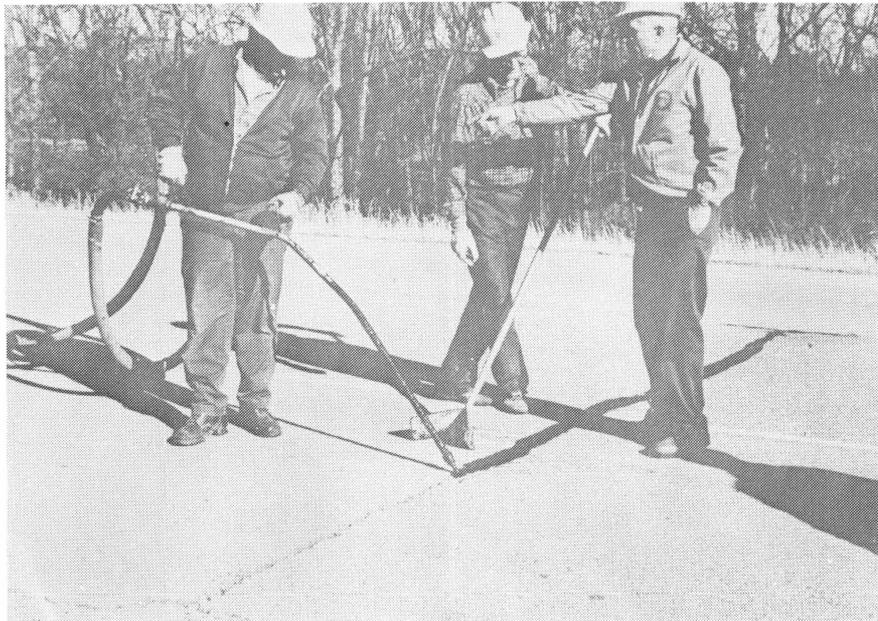
Figure 6. Installing High Viscosity Sealants

The pavement cracks were slightly overfilled with the high viscosity sealants and a V-shaped squeegee was used to strike off the excess material so that the crack was filled flush with the pavement surface. This is also shown in Figure 6.

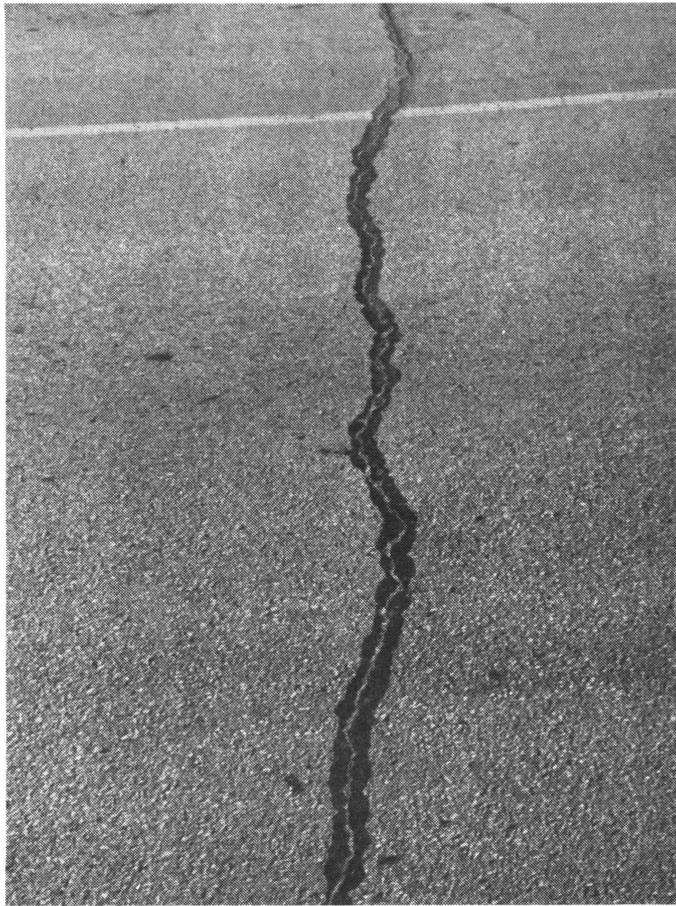
Figure 17. Cohesive Failure in CRS-2 Sealed Crack

the remaining emulsion freezes and becomes brittle with little or no tensile strength to resist the applied stresses from adjacent pavement sections. Evidence to substantiate this concept was observed both at the field test site and in preliminary laboratory tests of partially set bond-ductility specimens of the emulsion type sealants. Apparently, a long period of time (several months) may be required for complete setting or breaking of this type of sealant in a pavement crack.

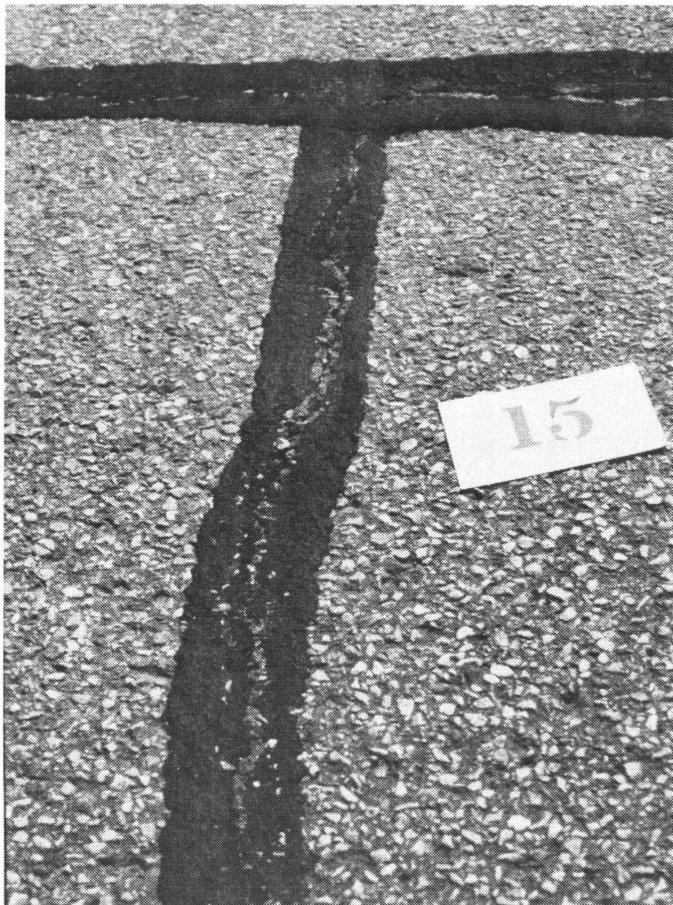
Figure 22. Adhesive and Cohesive Failures  
in MSLV Sealed Crack

From field observations, it was evident that this material had difficulty in developing good bond at the sealant/crack wall interface and, due to its highly viscous nature, it did not penetrate deeply in the more narrow cracks associated with the small ECS range. These observations were supported by the results of the statistical analysis. The significance levels for the MSLV, as shown in Figures 23 and 24, indicate rejection of the null hypothesis. That is, the performance of this sealant is influenced by the spacing of the cracks and the type of pretreatment. The amount of failure can be reduced by wire brushing and air-blowing of a crack before installing the sealant and also by sealing only those cracks falling within the medium ECS range. The interaction diagram in Figure 25 also shows that there is sufficient statistical evidence that failure can be reduced by using this combination of the two crack variables.

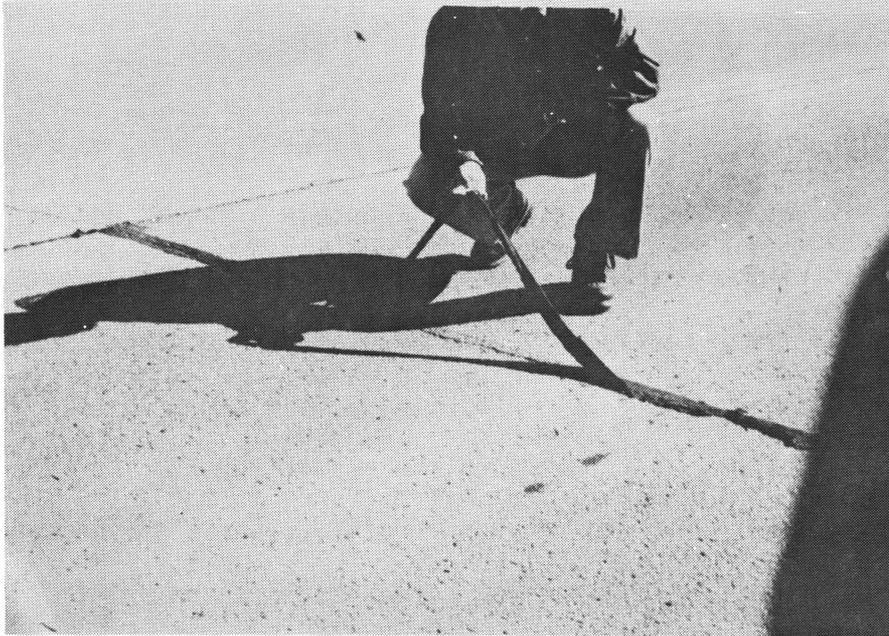
Figure 28. Rubber-Band Type Failure of SOFS Sealant

The preliminary failure percentage was due to a number of failures where, under the action of traffic, the applied sealant was pulled completely out of the cracks in rubber-band like strips. This is illustrated in Figure 28. The cause of this rather unusual type of failure was attributed to overheating of the sealant during the melting process and a concomitant decrease in adhesiveness of the material. Subsequent investigation indicated that there was not enough of the material in the double-wall melter to cover the inner chamber thermometer stem and provide an accurate temperature reading. The manufacturer of this product warns that heating above a temperature of 410 F (210 C) will cause the material to gel. Problems encountered in cleaning this material out of the melter and pump attested to the fact that gelling had occurred.
