BRIDGE DECK REHABILITATION

BRIDGE DECK REHABILITATION: METHODS AND MATERIALS

PART I

AUGUST, 1977

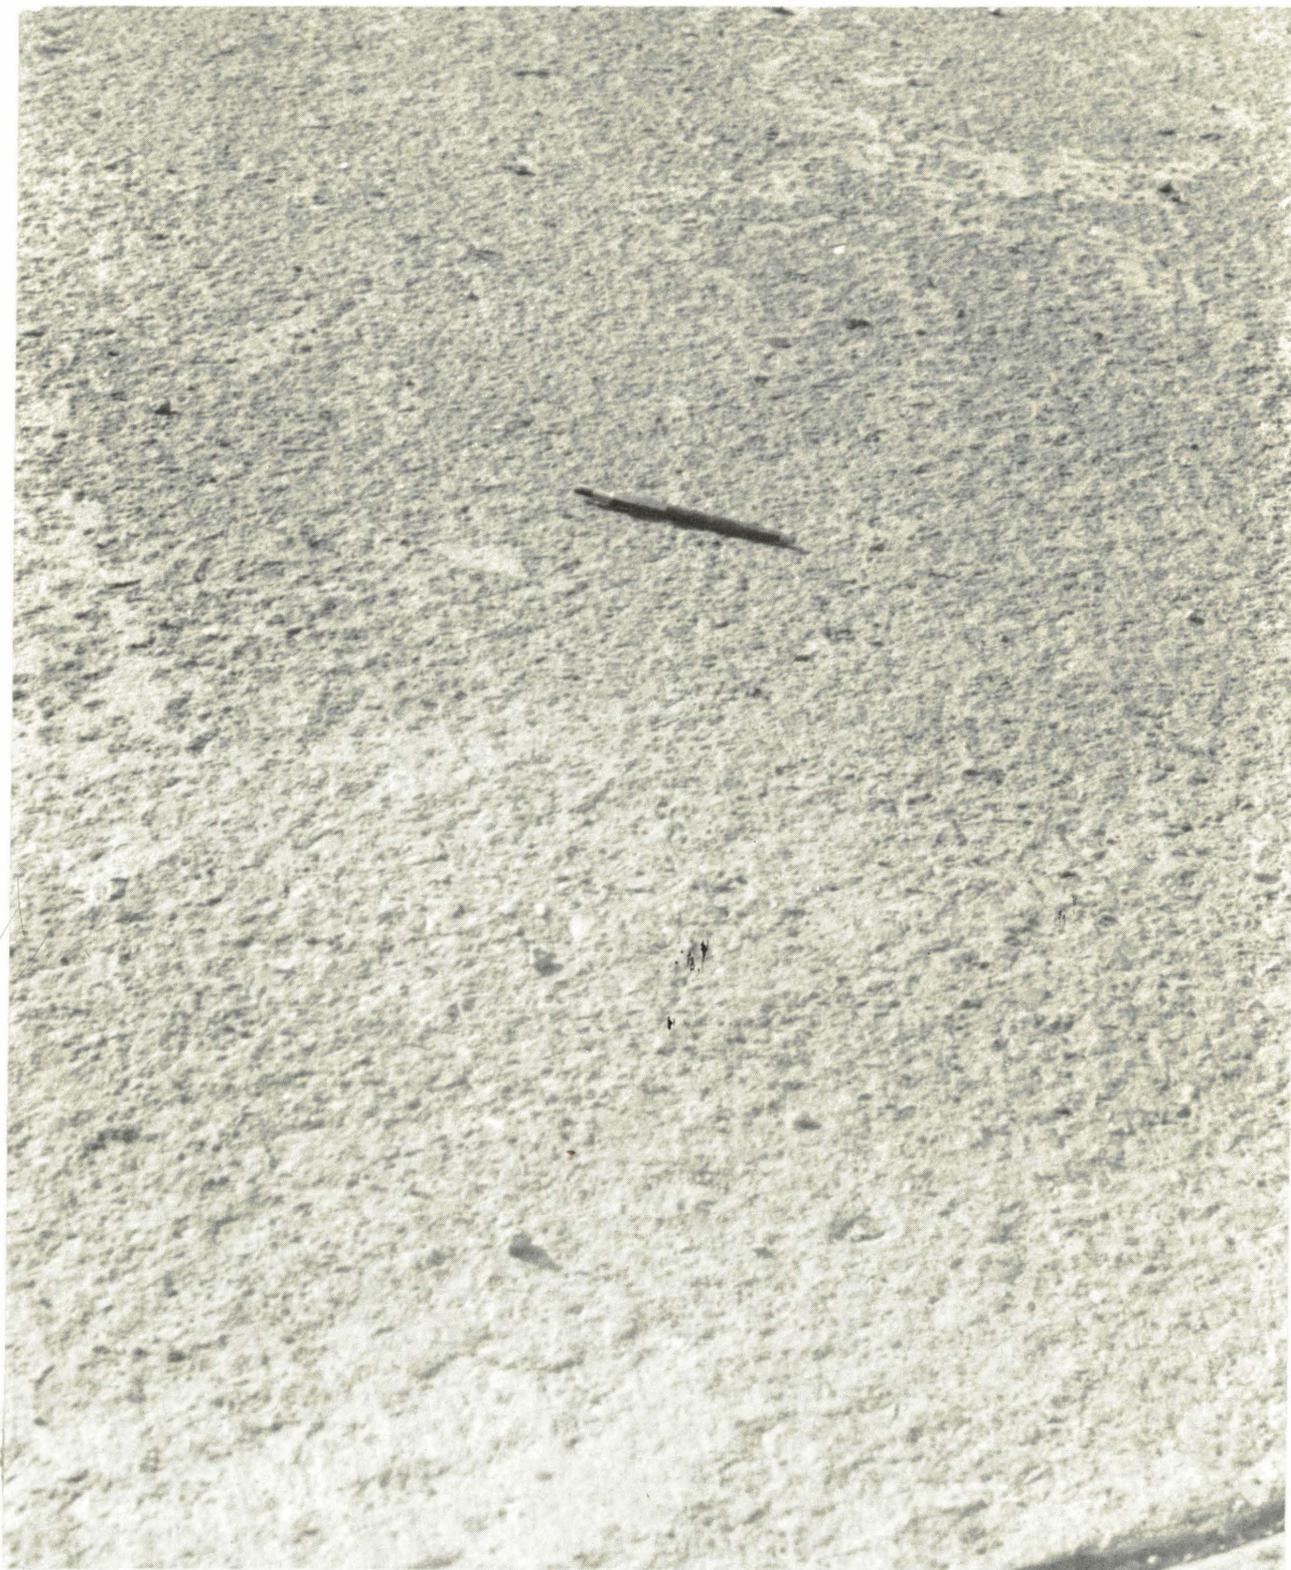
FIGURE 1

Section of Bridge Deck with Light Freeze-Thaw Scale

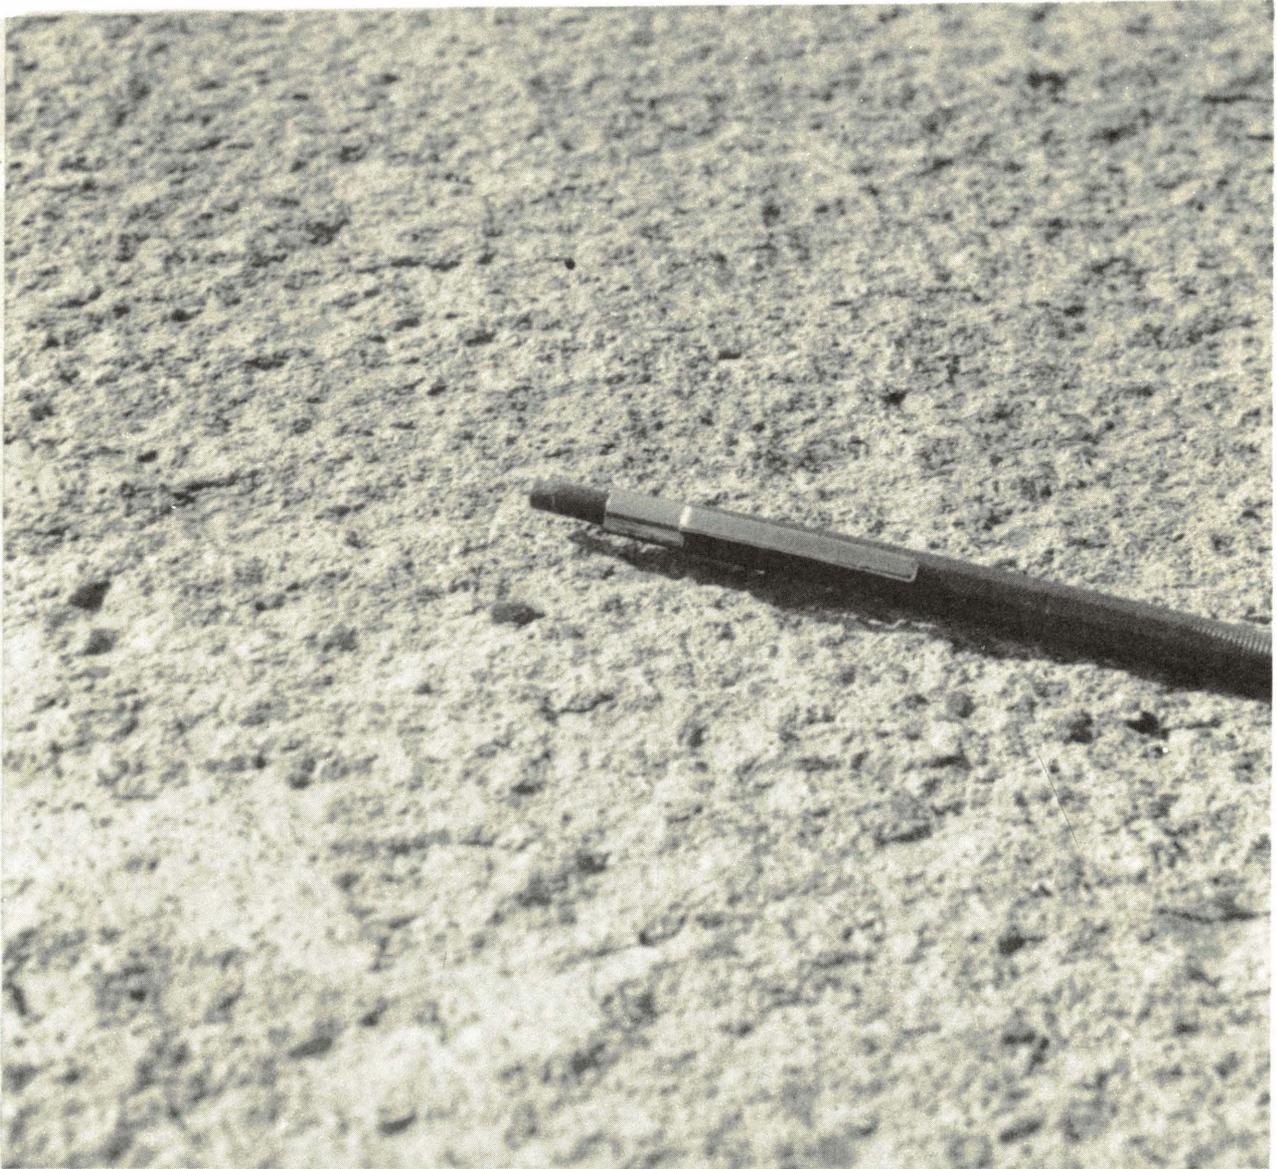
FIGURE 2

Close up of Figure 1

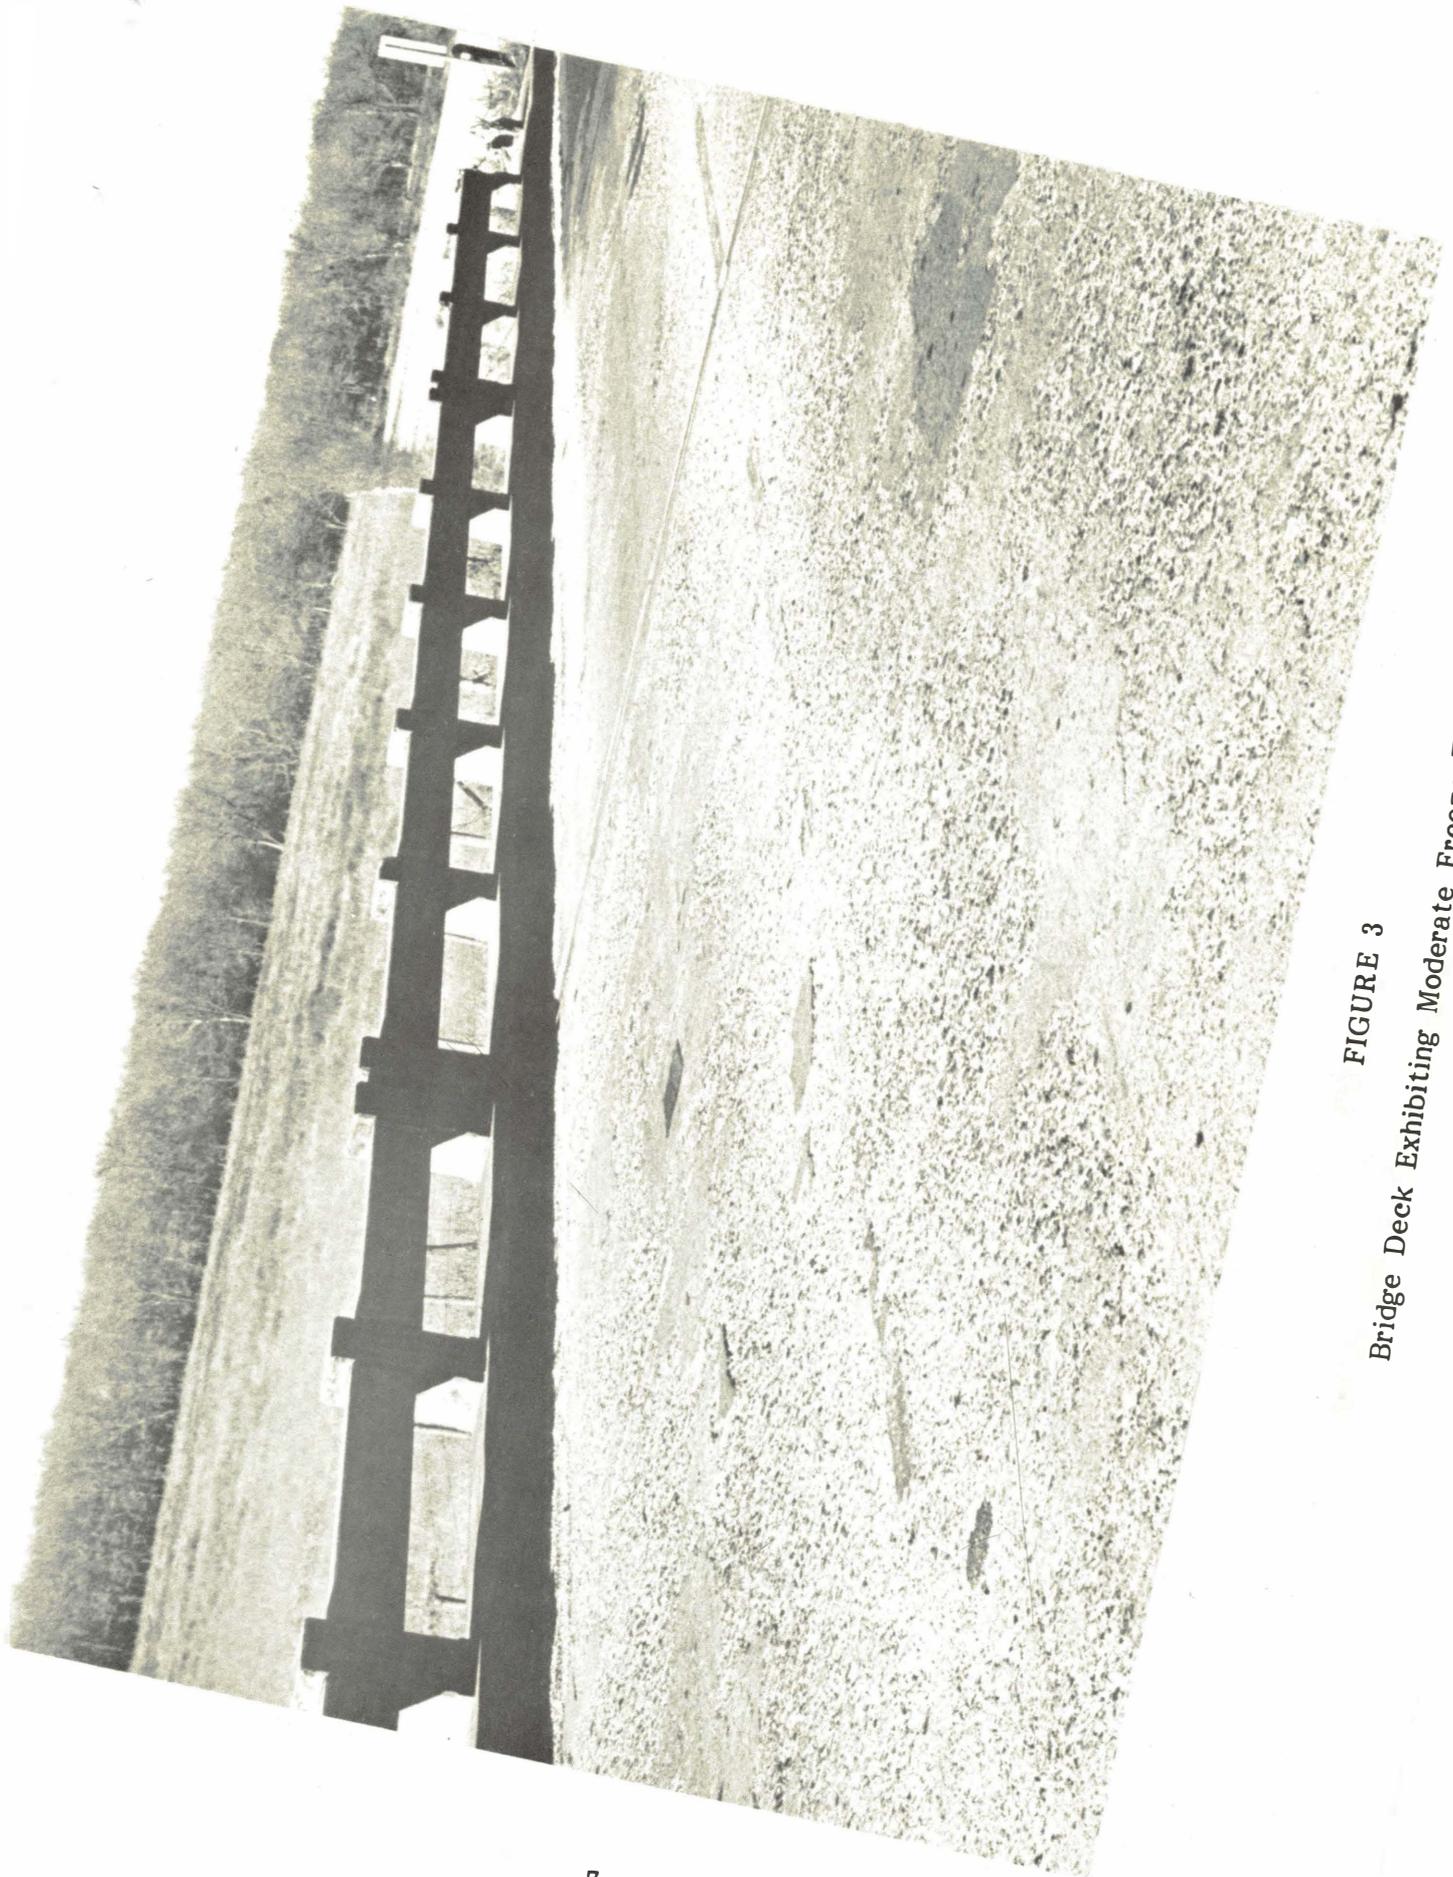
FIGURE 3
Bridge Deck Exhibiting Moderate Freeze-Thaw Scale

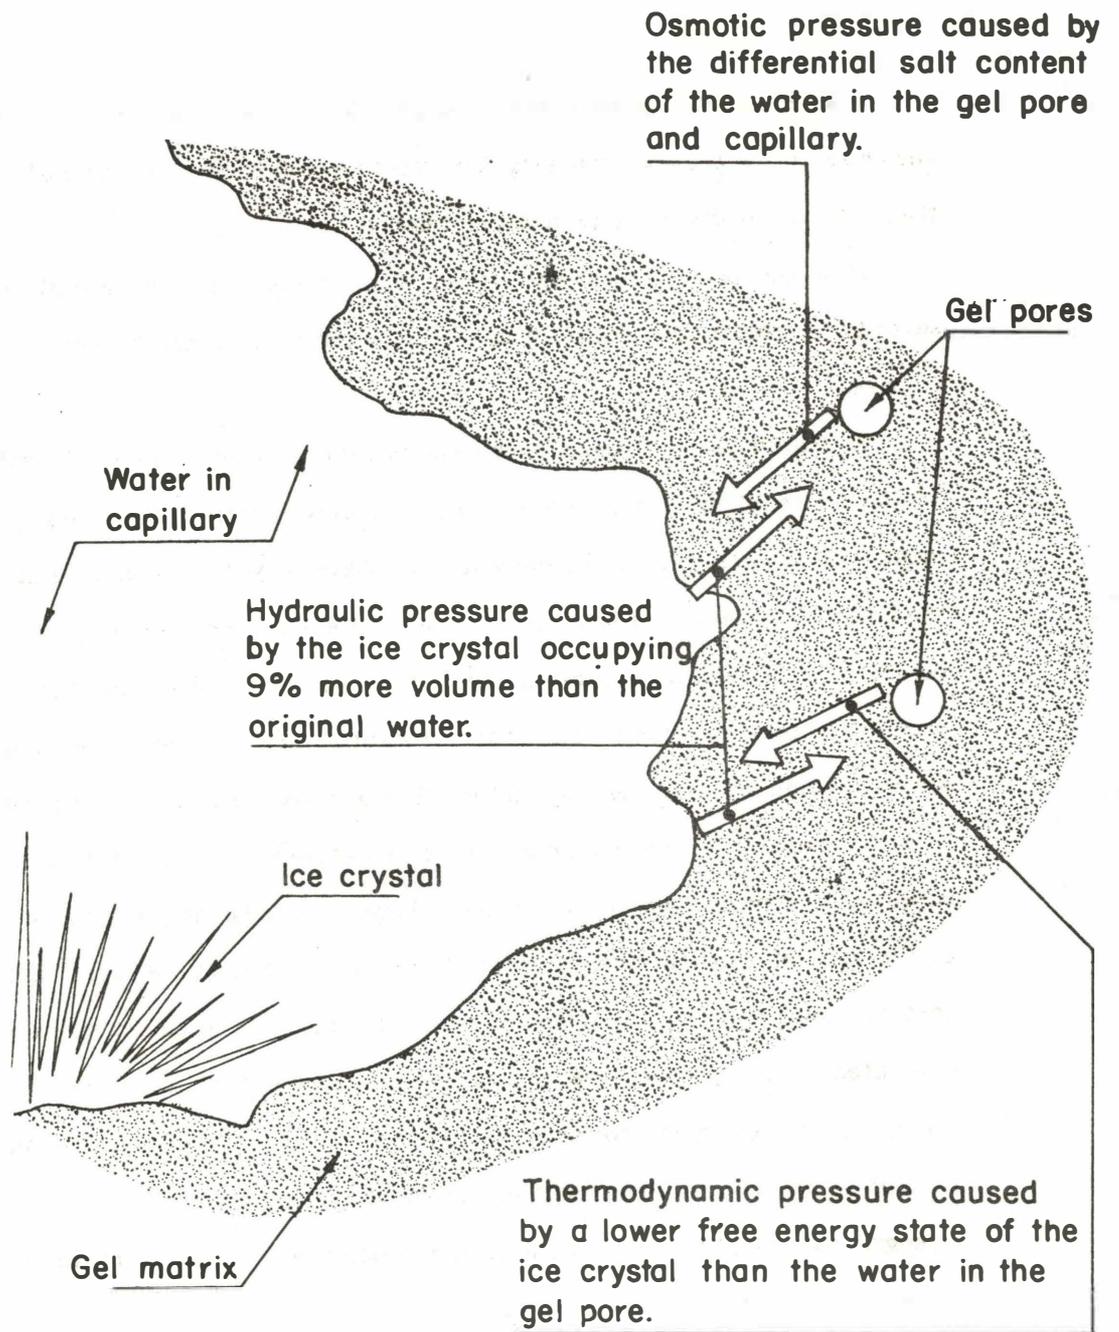
FIGURE 4

Theory Proposed to Account for Freeze-Thaw Scale

Let us assume that prior to freezing, water in capillary and gel pores contain an equal percentage of dissolved salts. These salts can be $\text{Ca}(\text{OH})_2$, NaOH , KOH , or NaCl and CaCl_2 or combinations of any or all of the preceding. When freezing begins in the capillaries the portion of the water not frozen attains a higher concentration of the above salts. This higher concentration then imbalances the concentration equilibrium that existed between capillary water and that in the surrounding gel pores. This imbalance leads to the creation of osmotic forces attempting to drive the pore water (lower concentration) to the capillary water (higher concentration). This pressure by itself would be considerable but it must be remembered that it, like the thermodynamic pressures, are in the opposite direction to the capillary hydraulic pressures and is therefore additive. See Figure 4.

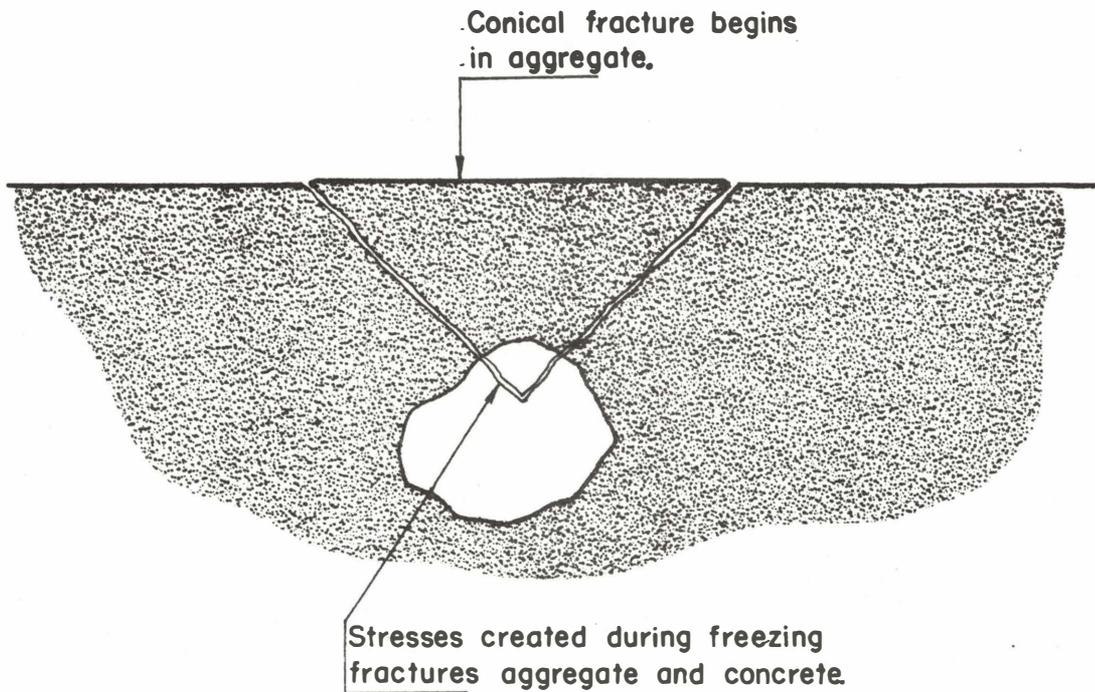
FIGURE 5
Formation of a Popout

Popouts can be identified by their characteristic conical shape. They result from the fracture of aggregate particles near the surface of a structure resulting from the action of the freezing of water trapped within the aggregate pores. A fragment of concrete is fractured from the surface as a result of the internal fracture of the aggregate. The resulting fractured particle is conical in shape and contains a piece of the fractured aggregate at the apex. The remainder of the offending aggregate remains in the concrete. In Oklahoma the offending aggregate particles are generally one of the two types, a chert of relatively low specific gravity or a shale particle.

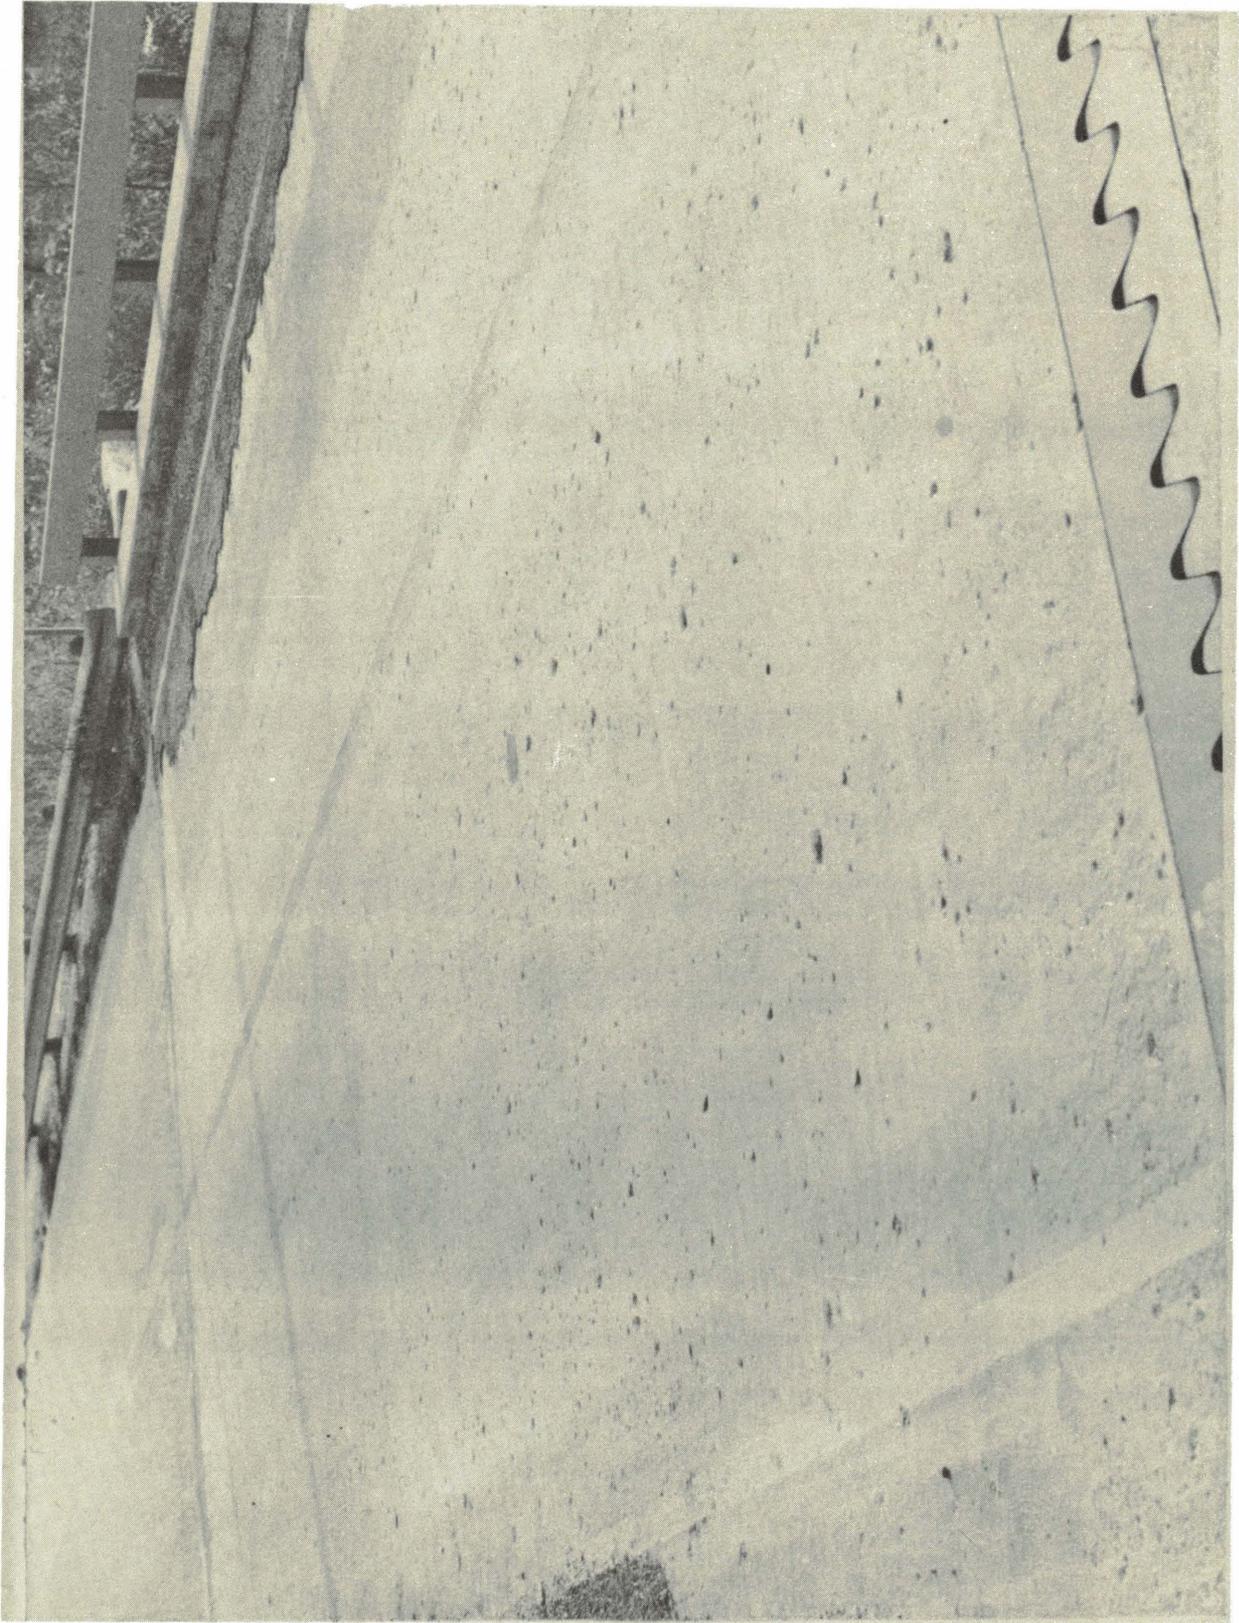
FIGURE 6
Light Concentration of Popouts

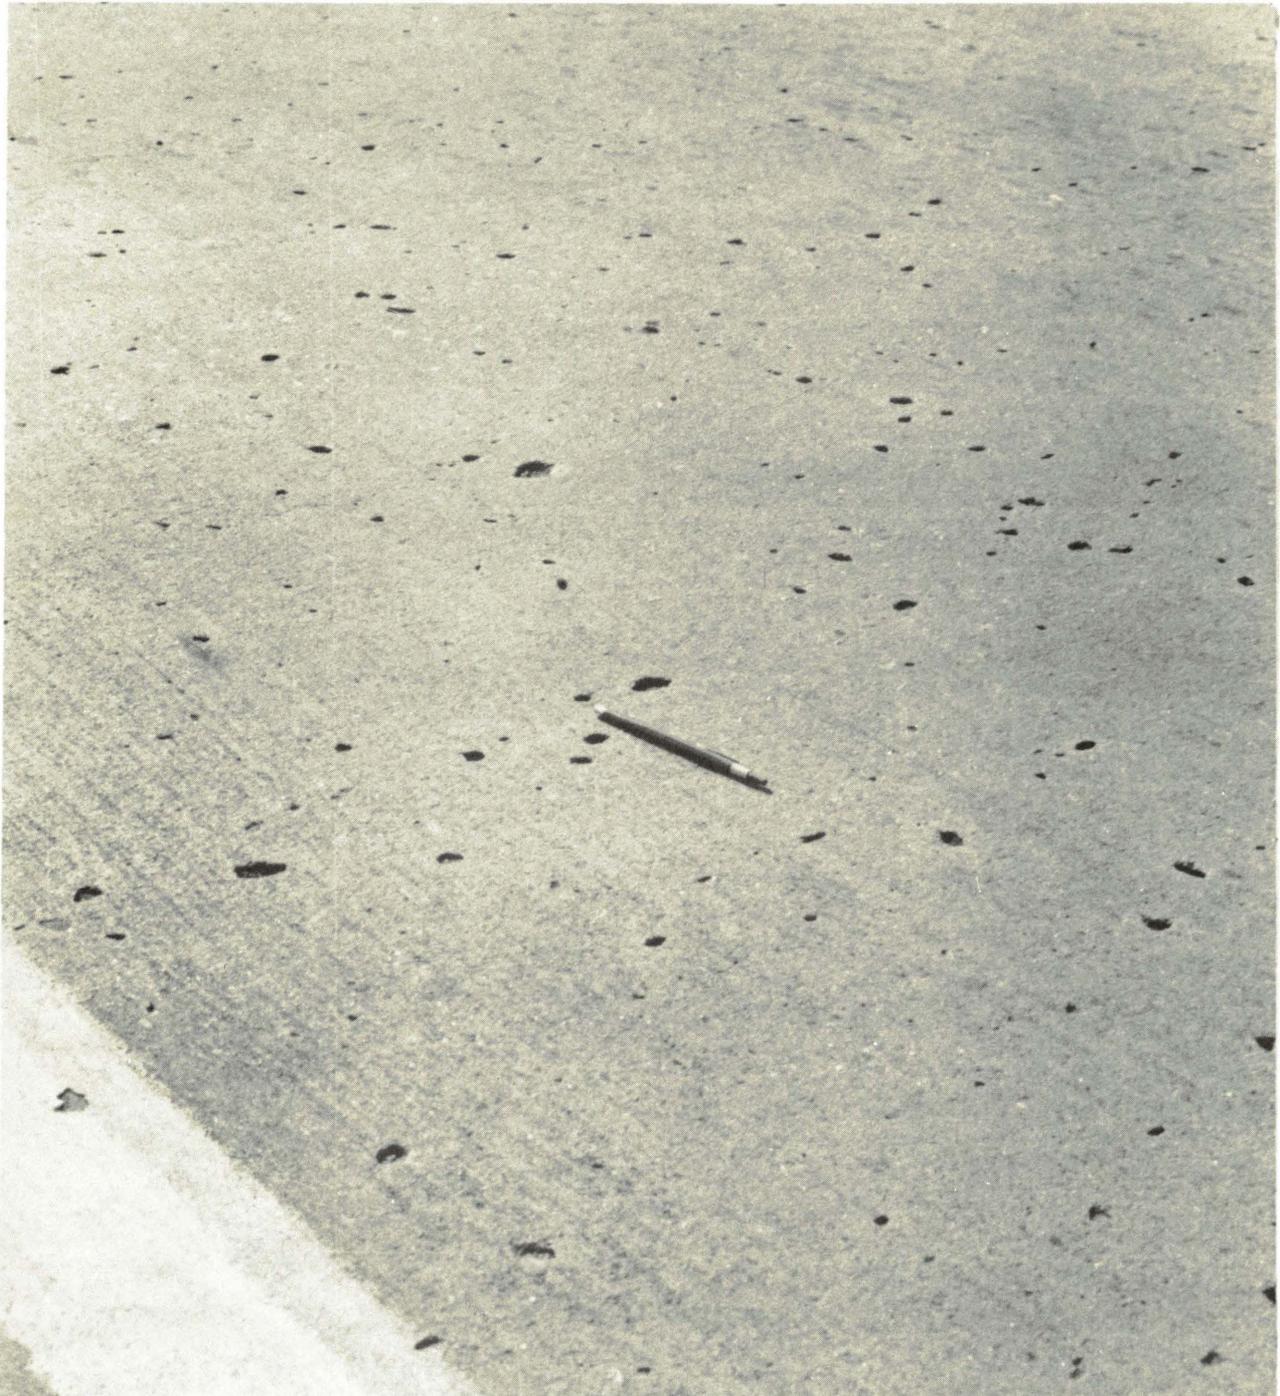
FIGURE 7

Deck Poured with Concrete Containing Shale Coarse Aggregate

Certain shale particles, particularly the softer less dense shales, may not have enough strength to create a popout but instead may simply crush within themselves during freezing and when near the surface create an irregular void similar to that created by a mud ball. This phenomena is referred to as pitting. Figures 7 and 8 depict light pitting of a bridge deck.

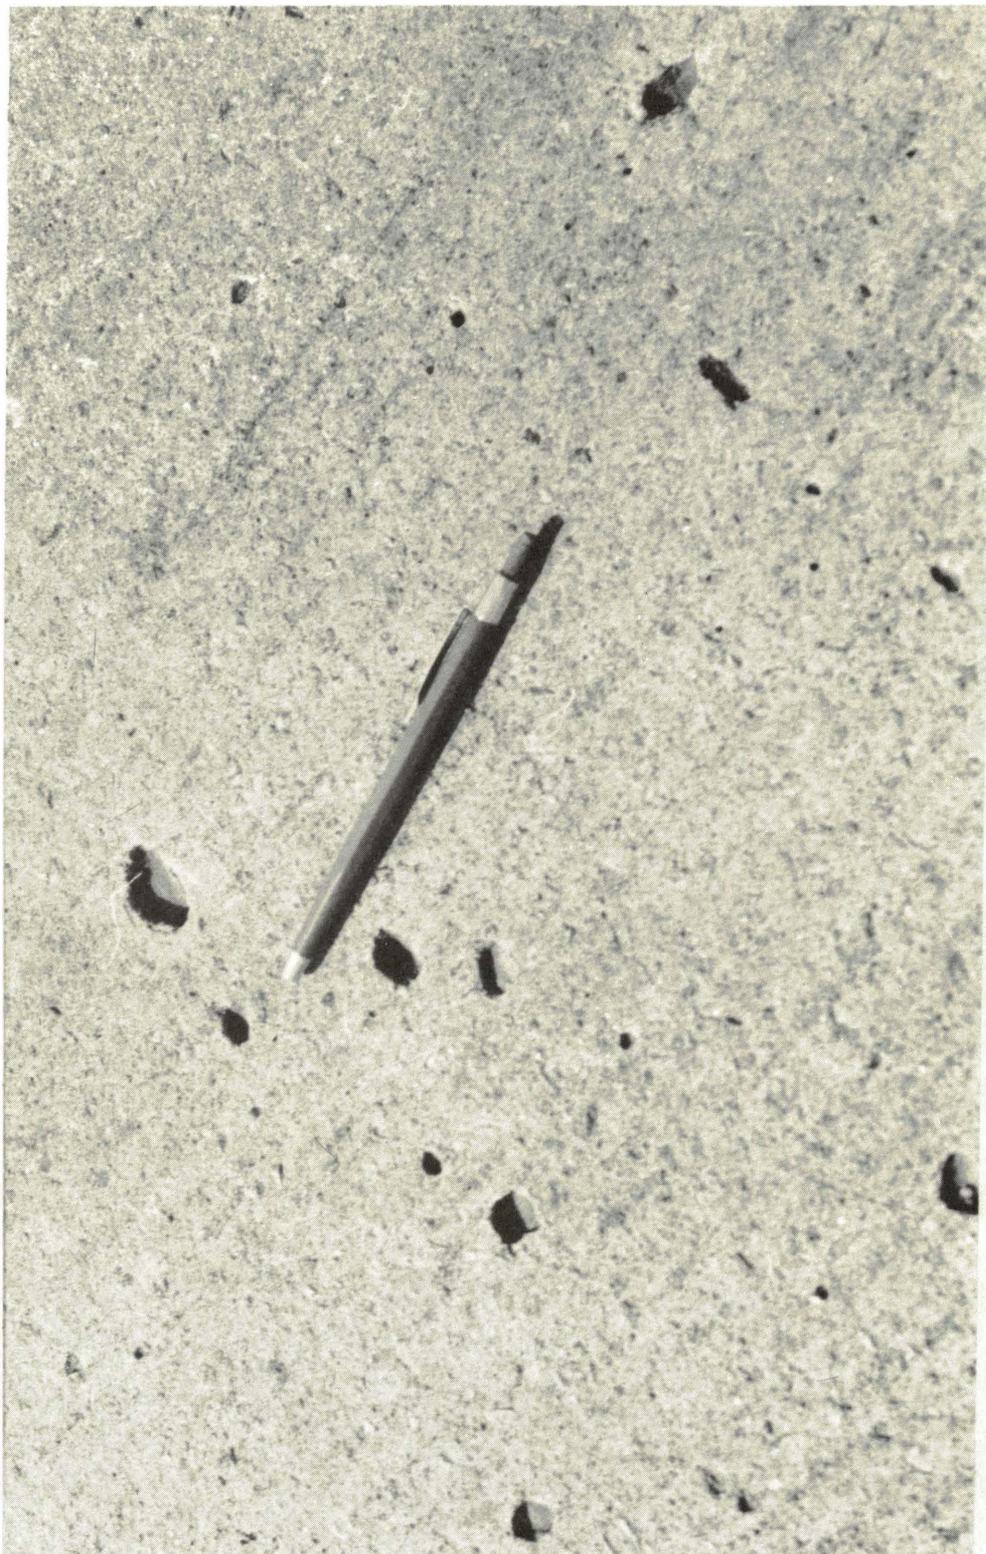
FIGURE 8

Close up of Figure 7

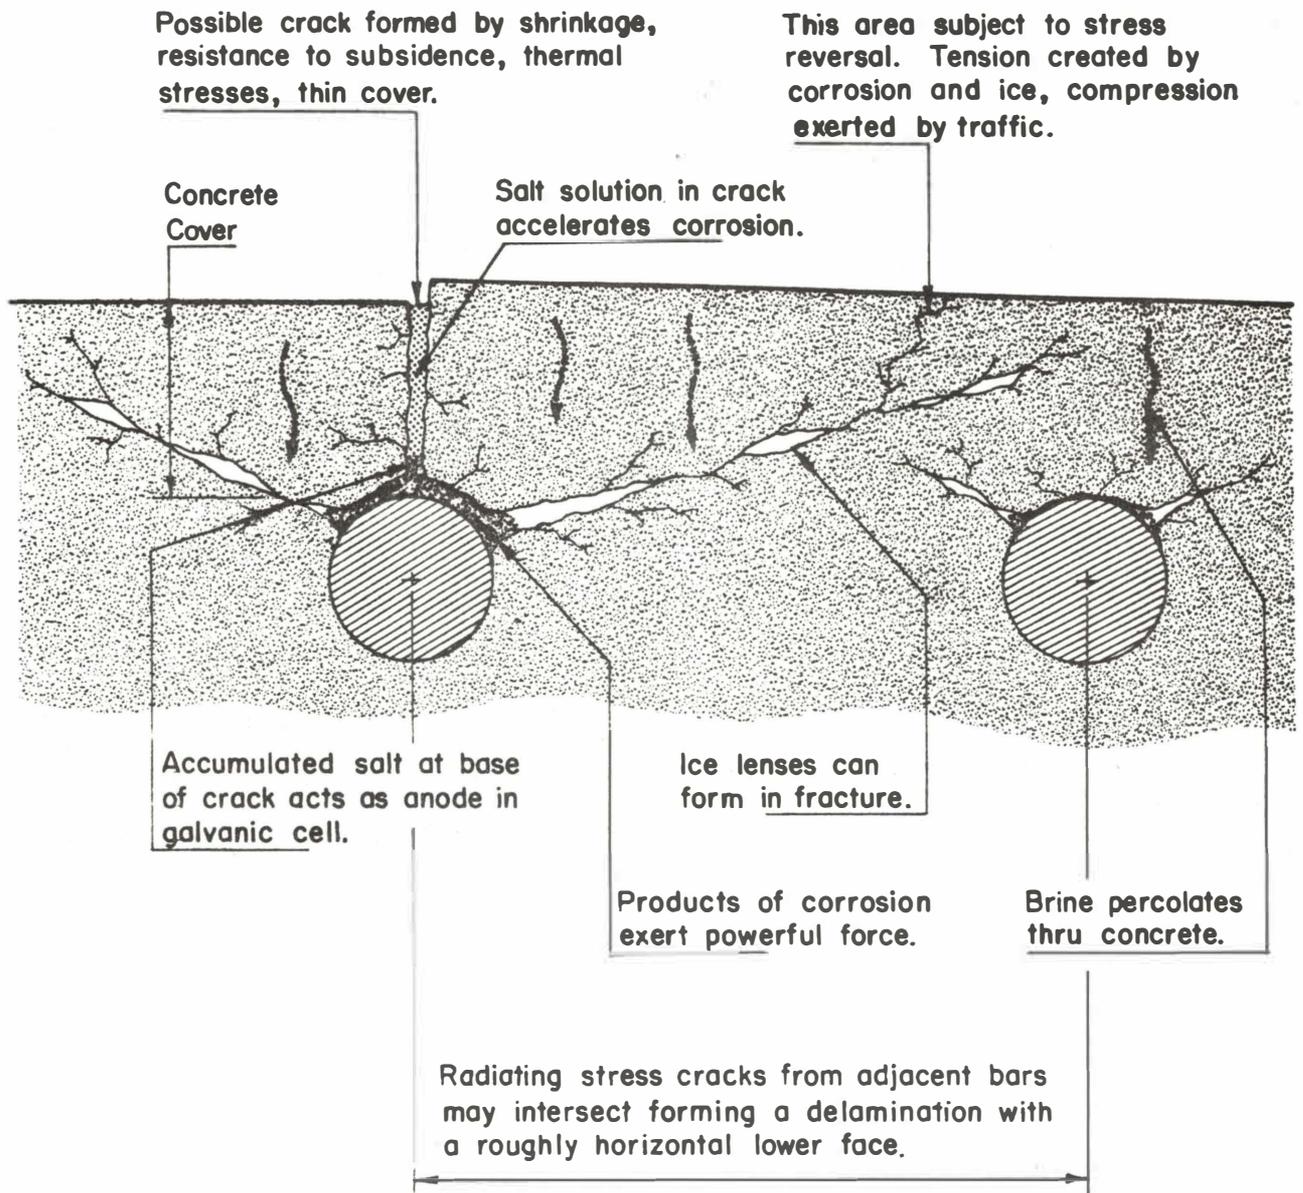
FIGURE 9

Factors Influencing and Accompanying Spall Formation

point of the "V" lying along the top of a reinforcing bar and the two lines forming the "V" are cracks that radiate from the bar to the deck surface. See Figures 9 and 10. When several adjacent bars are corroding, these radiating cracks may sometimes interconnect and form a delaminated face that is roughly horizontal and at the level of the upper rebar mat. The freezing of water in these cracks and the pounding of traffic soon break up these separated areas and leave spalls in the deck that can be several feet in diameter and up to two inches deep. See Figures 11 and 12.

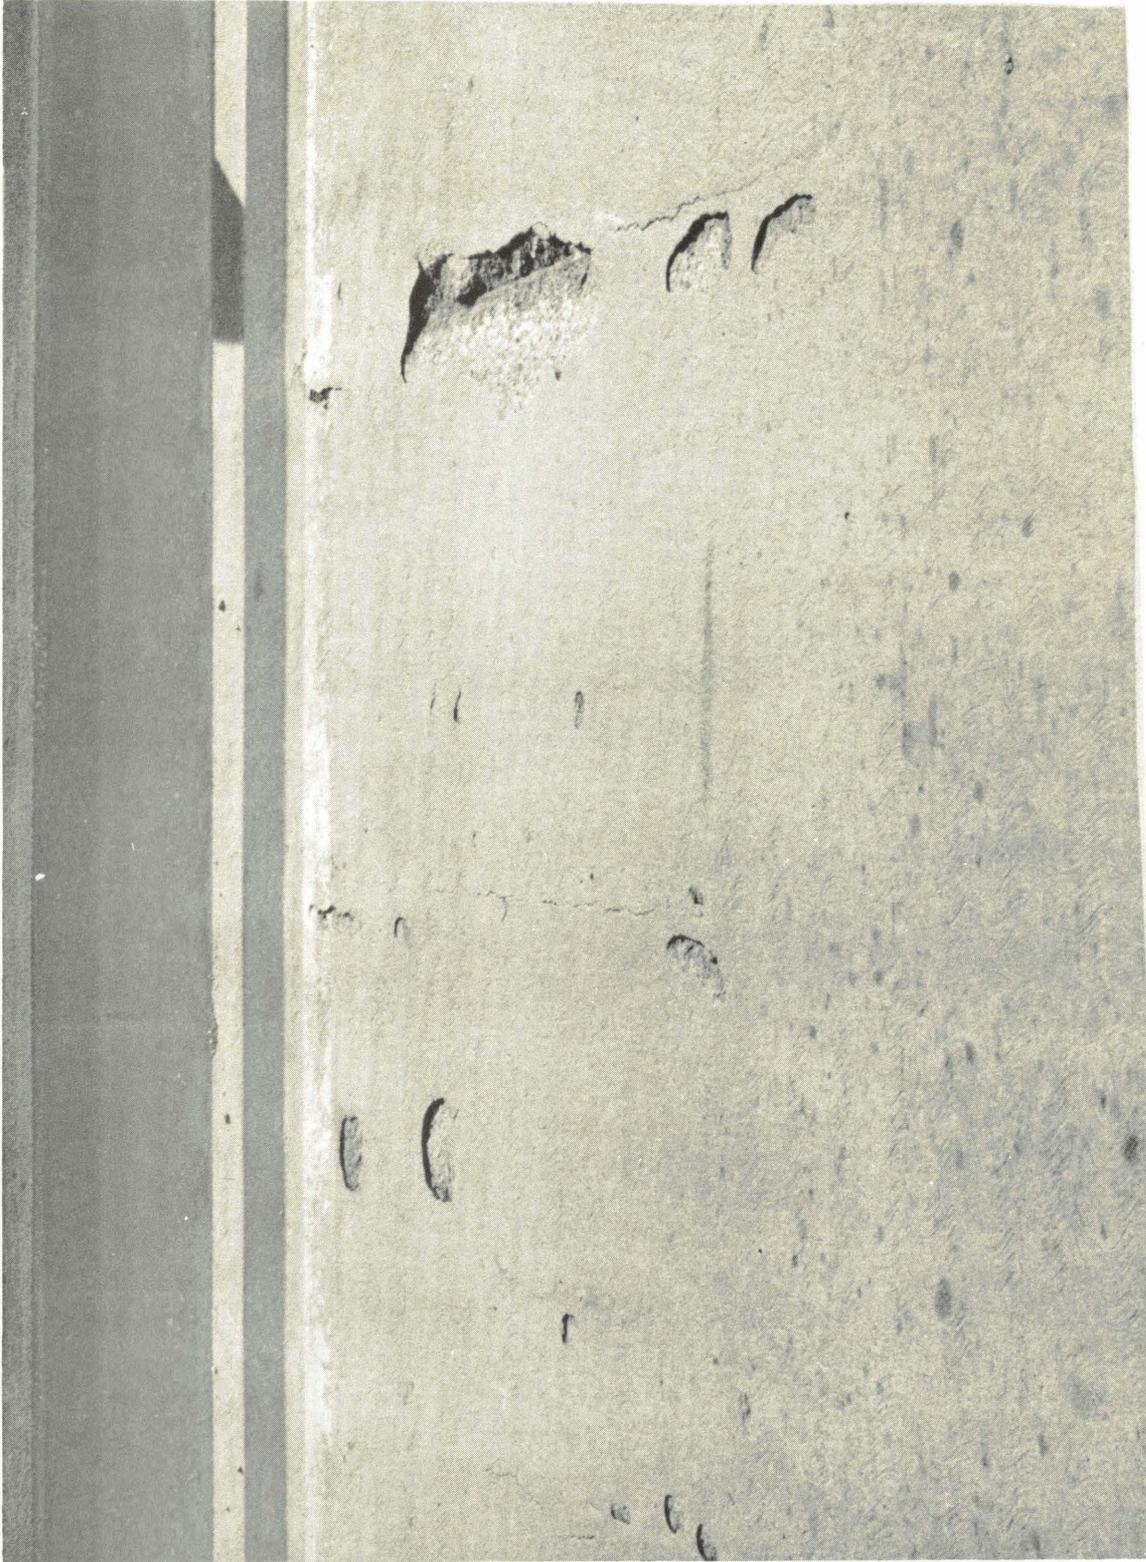
FIGURE 10
Single Bar Spall

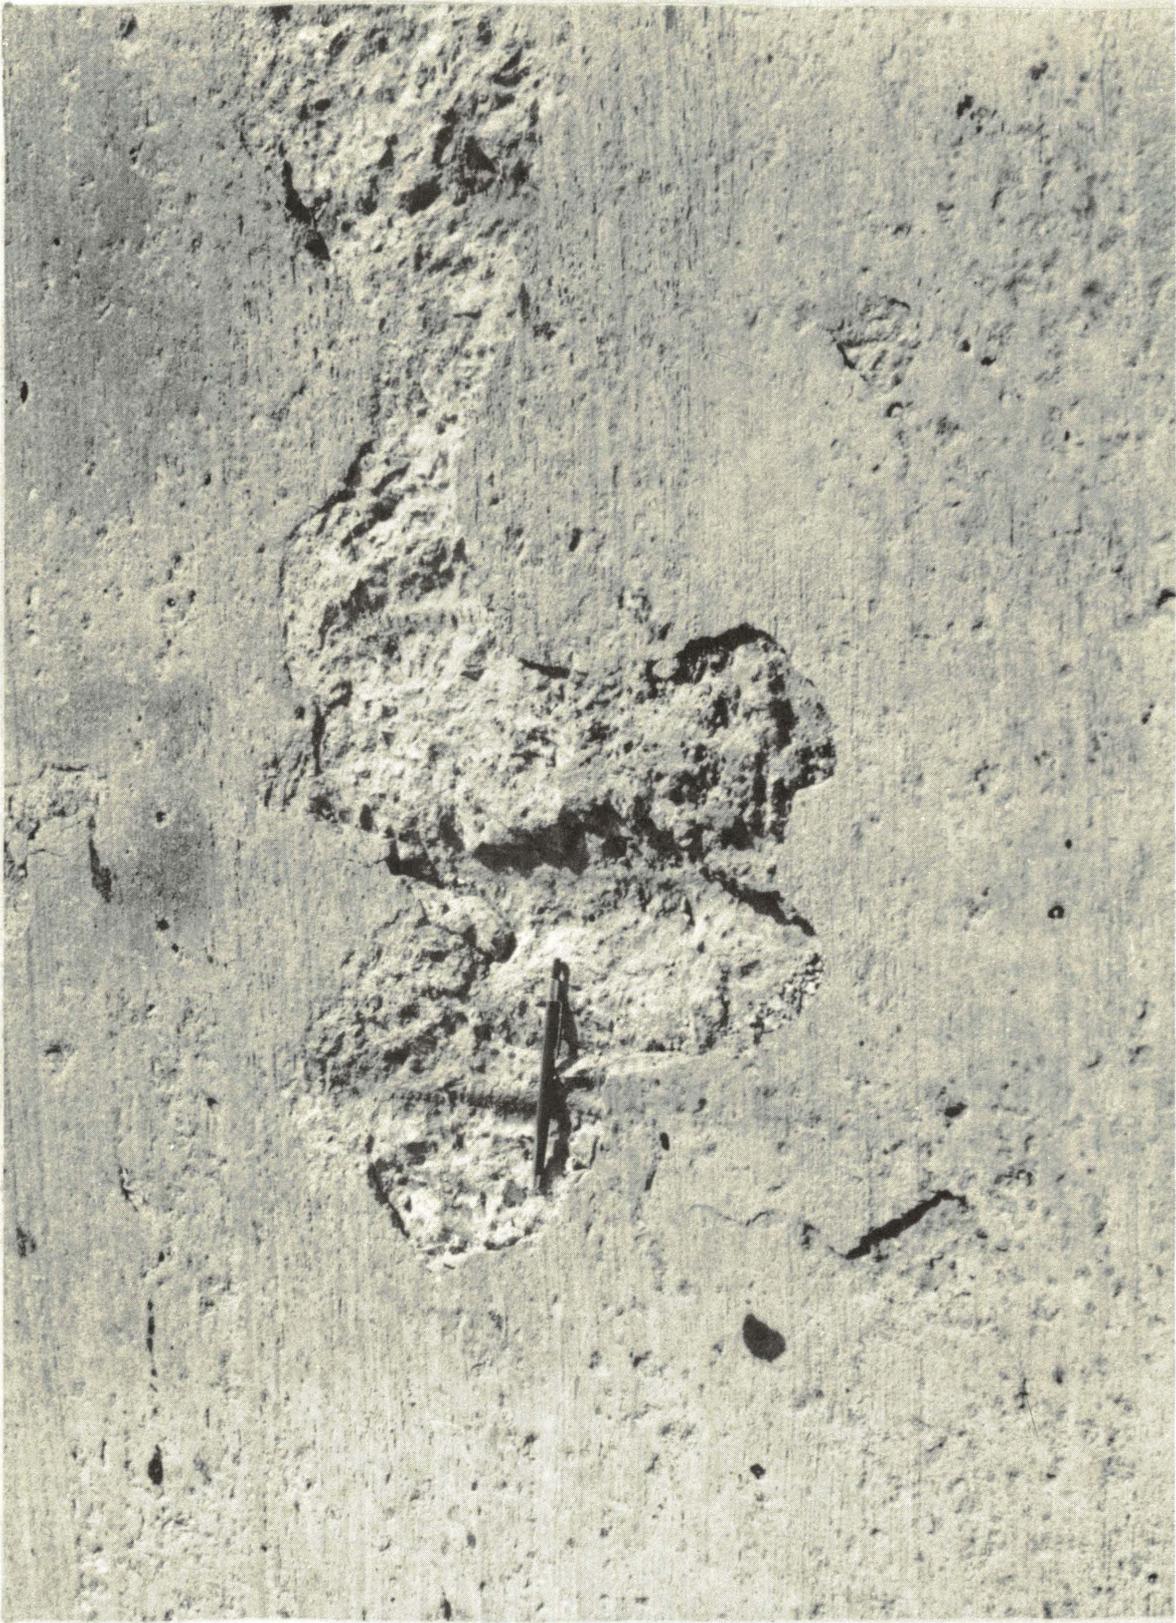
FIGURE 11
Multibar Spall
