BRIDGE DECK REHABILITATION

BRIDGE DECK REHABILITATION: METHODS AND MATERIALS

PART I

AUGUST, 1977

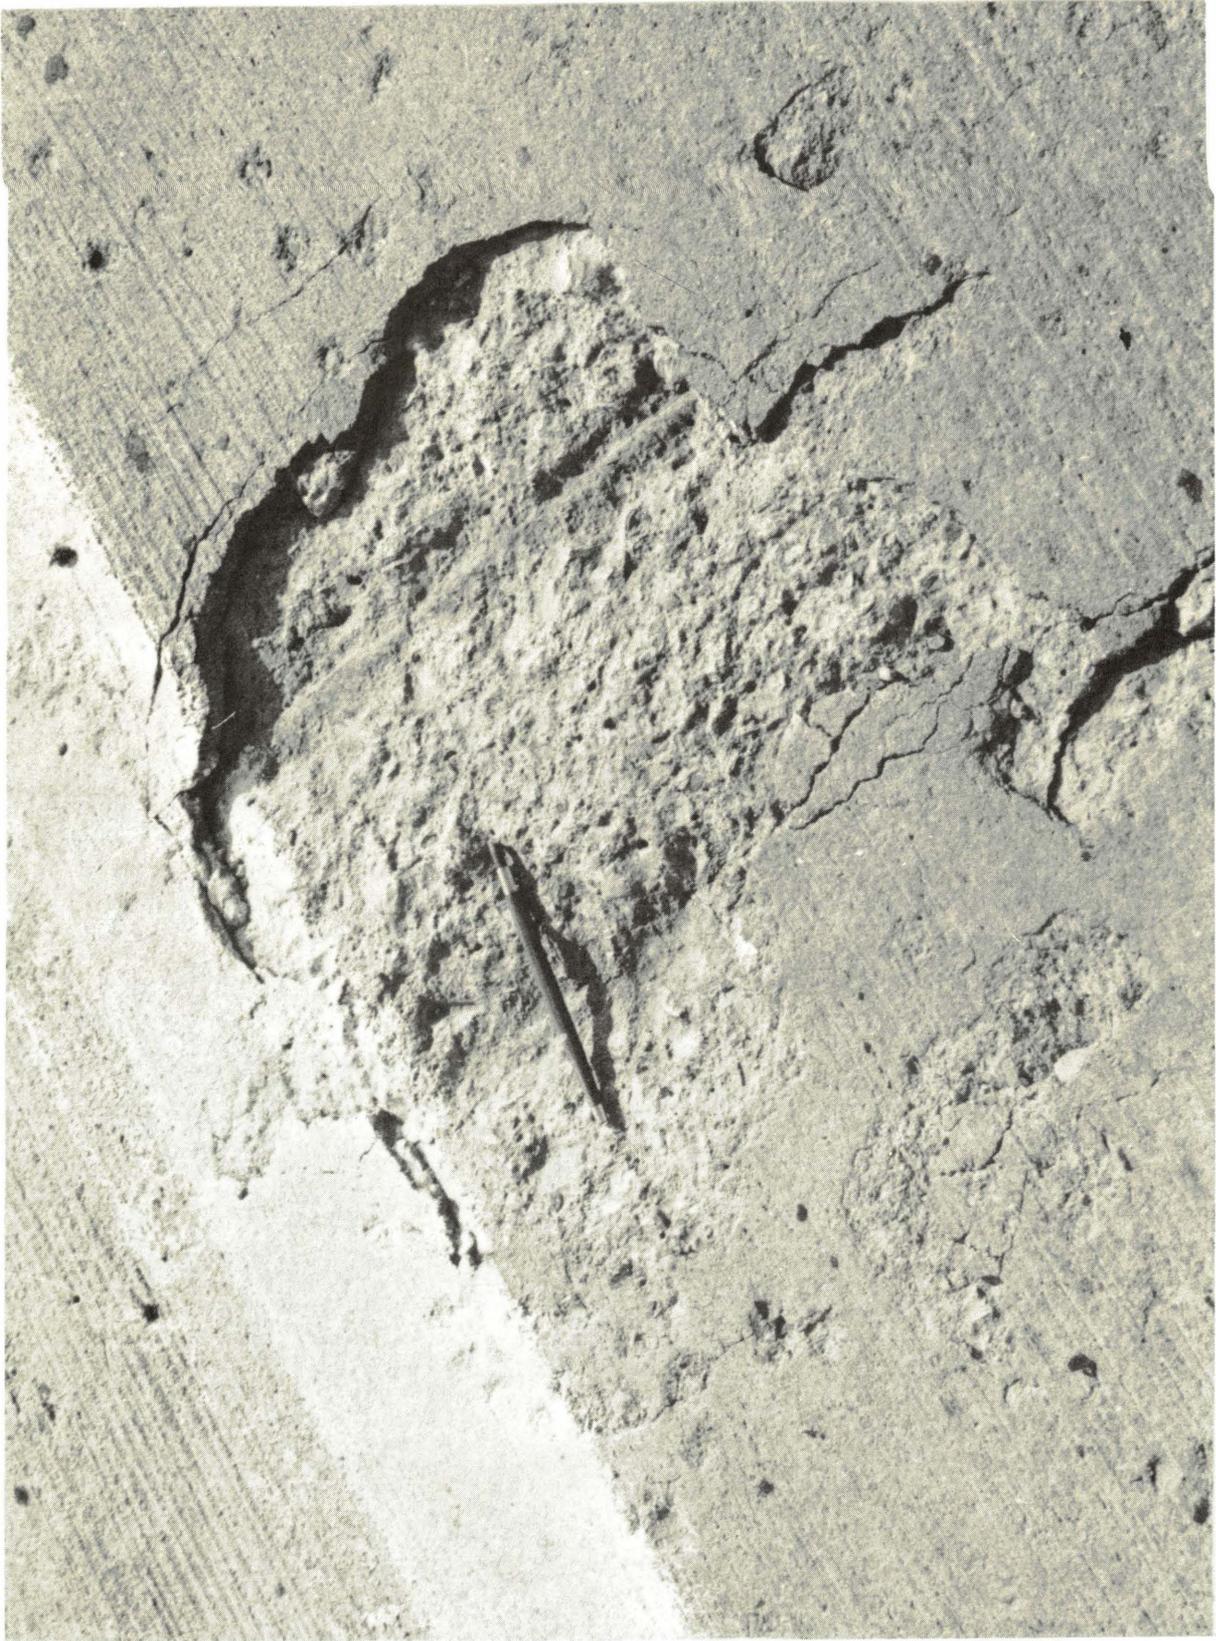
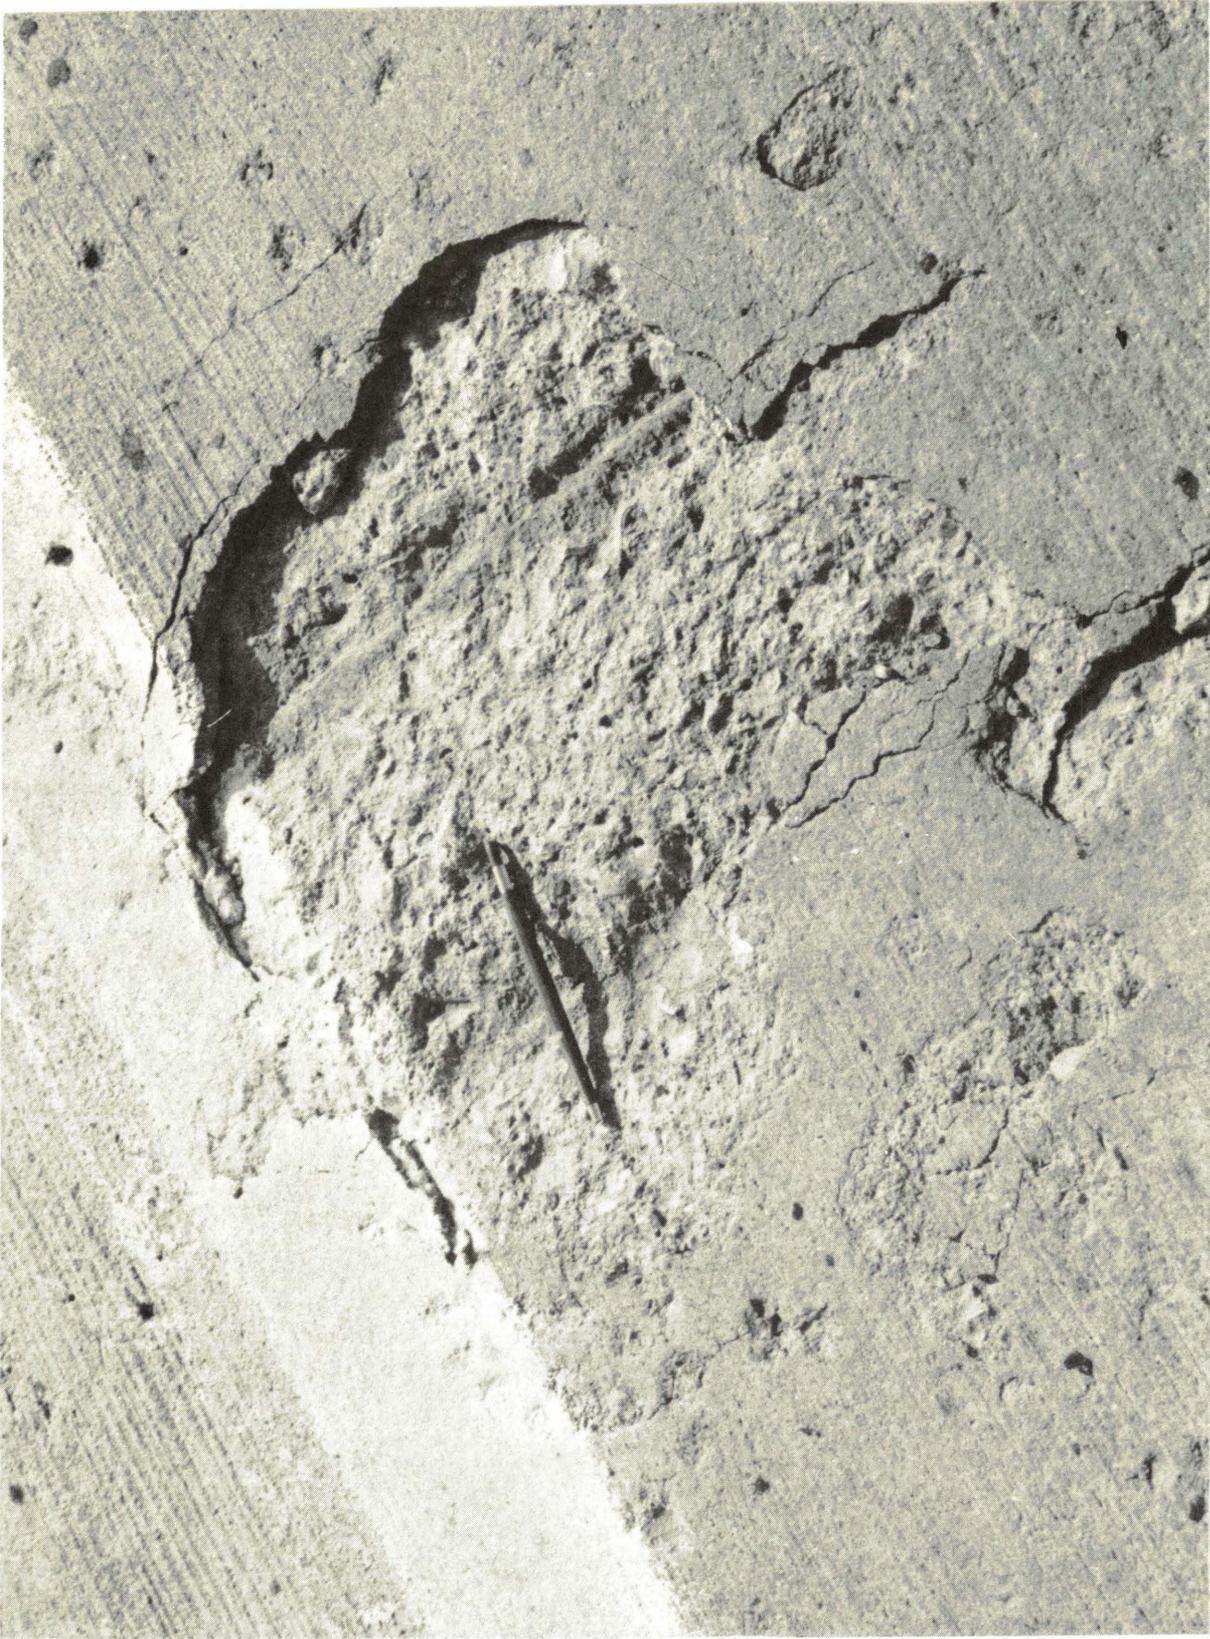
FIGURE 12

Multibar Spall

point of the "V" lying along the top of a reinforcing bar and the two lines forming the "V" are cracks that radiate from the bar to the deck surface. See Figures 9 and 10. When several adjacent bars are corroding, these radiating cracks may sometimes interconnect and form a delaminated face that is roughly horizontal and at the level of the upper rebar mat. The freezing of water in these cracks and the pounding of traffic soon break up these separated areas and leave spalls in the deck that can be several feet in diameter and up to two inches deep. See Figures 11 and 12.

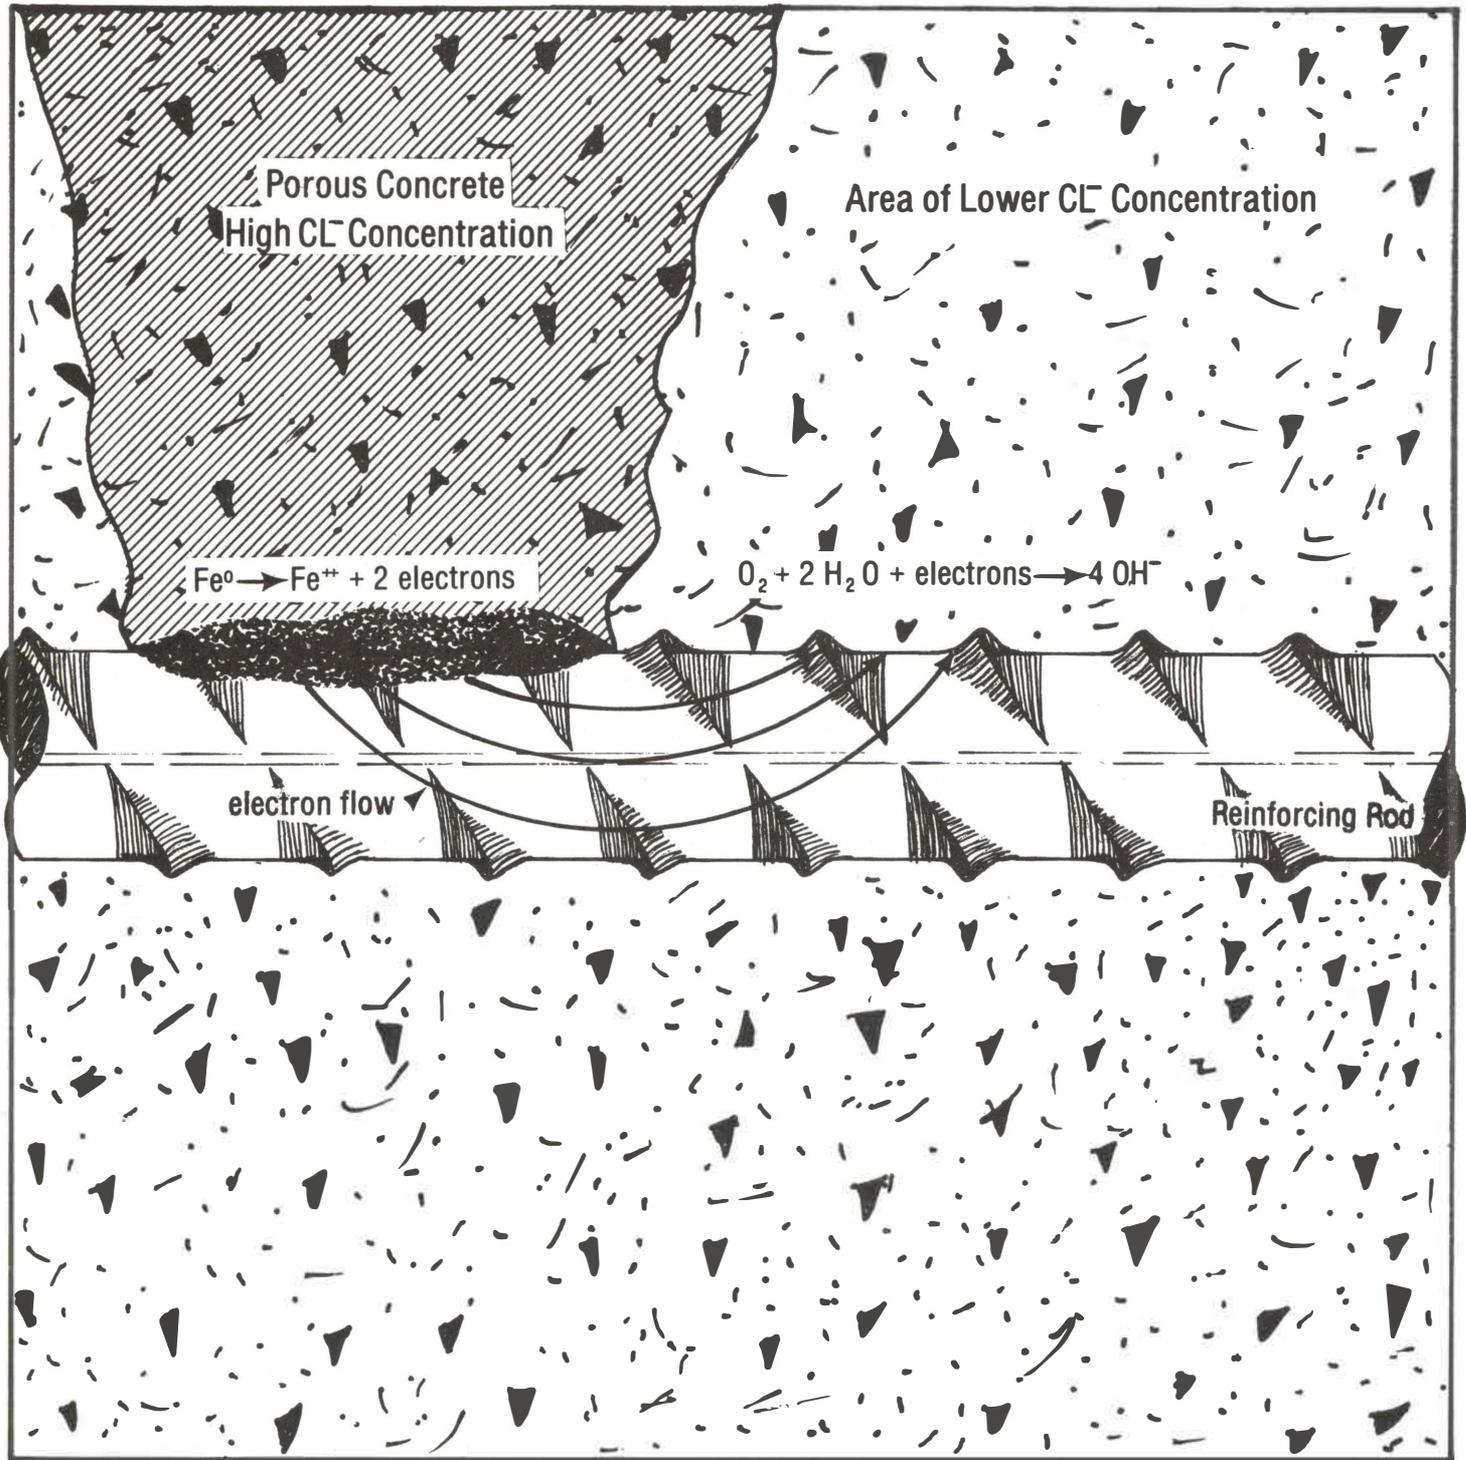
Figure 13

Reinforcing Steel in Concrete Containing unequal concentrations of Chloride ion

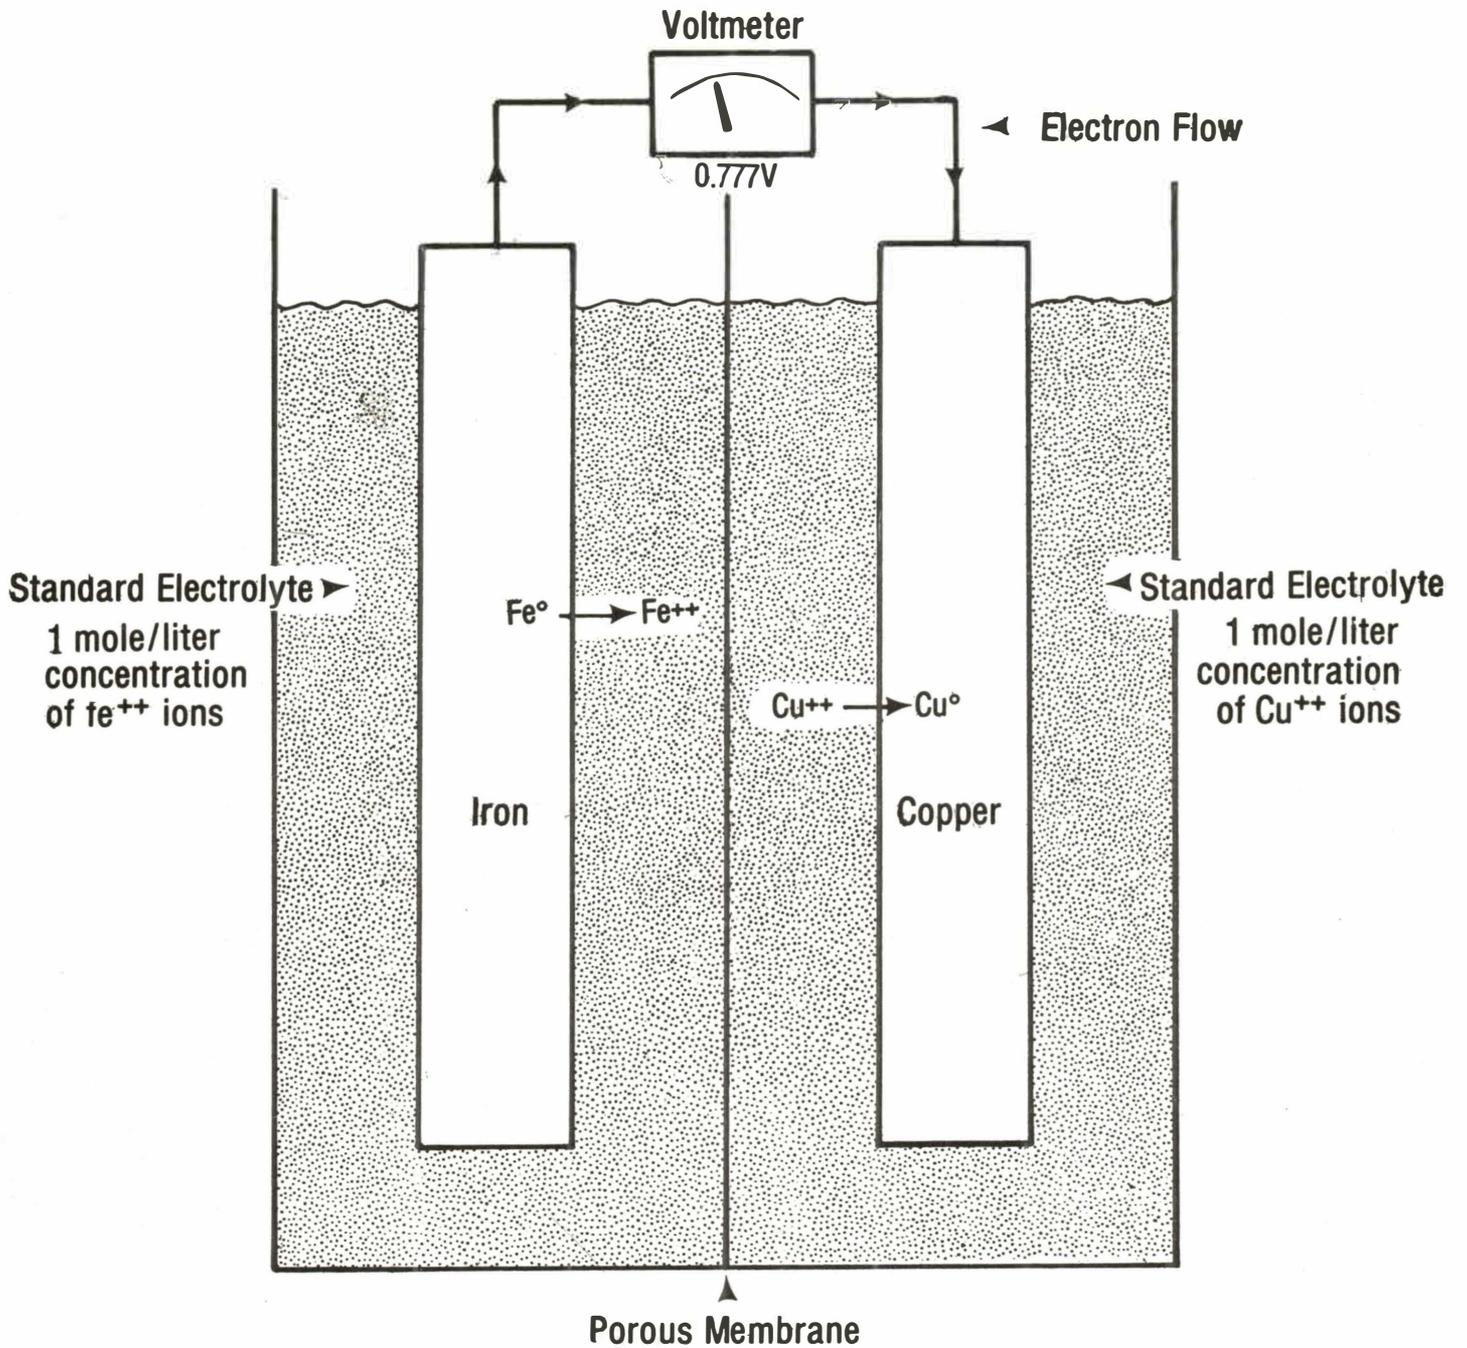
Standard Half-Cells of $Cu^{\circ} \rightarrow Cu^{++}$ and $Fe^{\circ} \rightarrow Fe^{++}$ Forming a Galvanic Cell

metal lower in the listing would corrode (anode) while a reduction reaction would occur on the surface of the metal higher in the listing (cathode). Should a high impedance voltmeter be connected in series between the half-cells, the voltage read would be the algebraic difference between the two standard half-cell potentials. Figure 15 depicts such a cell coupling the standard half-cells of iron and copper through a porous membrane and an external conductor. In this instance Fe, being lower (more negative half-cell potential) in the EMF series, would corrode while the copper would be reduced. The potential difference between these two half-cells would be $-0.440\text{V} - (+0.337\text{V}) = 0.777\text{V}$. It is this potential difference that creates the driving force for electrons to flow from the anode to the cathode. Without this potential difference and electron flow, corrosion would quickly halt. This concept of potential difference forms the foundation for understanding corrosion.

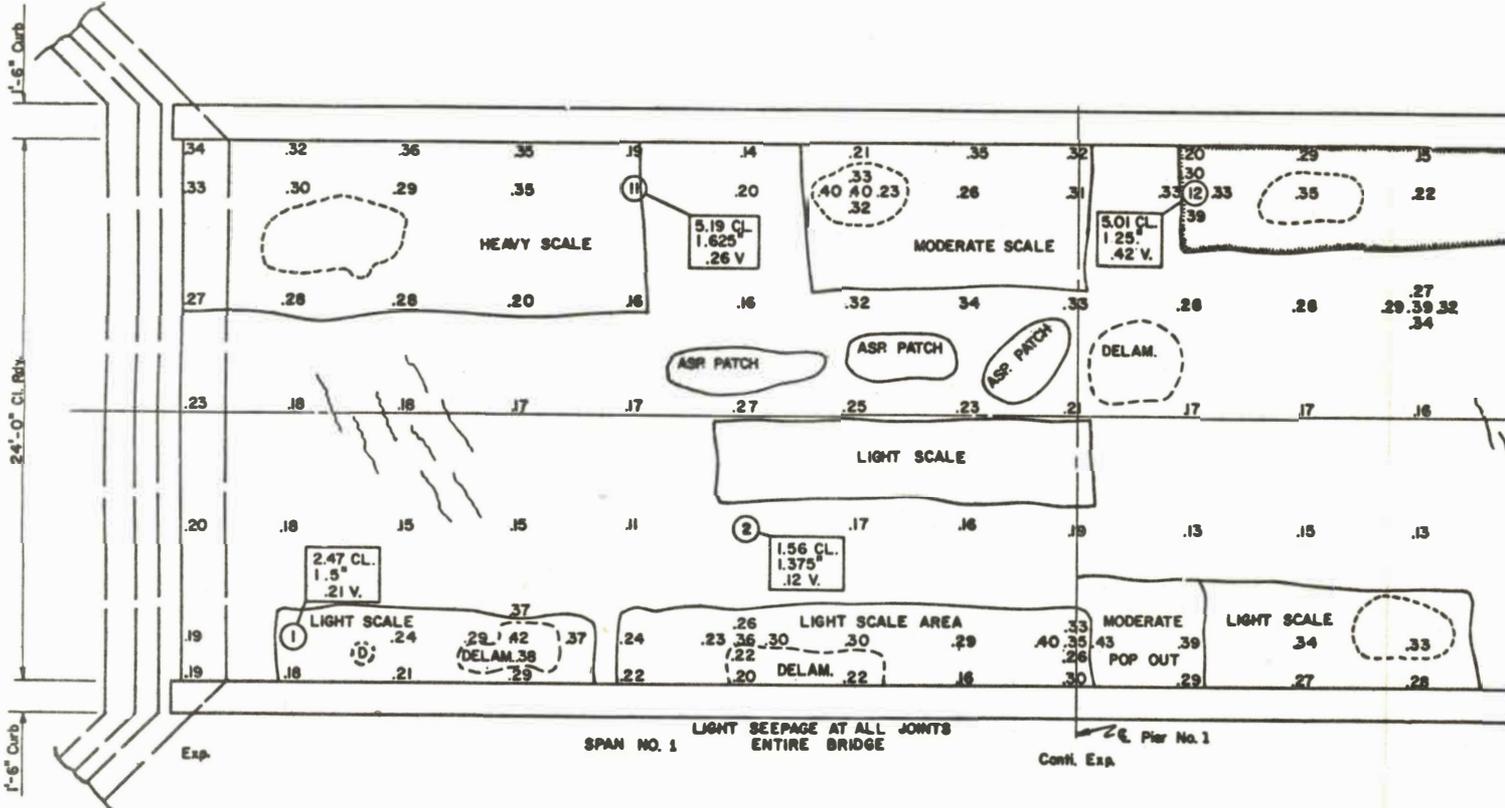
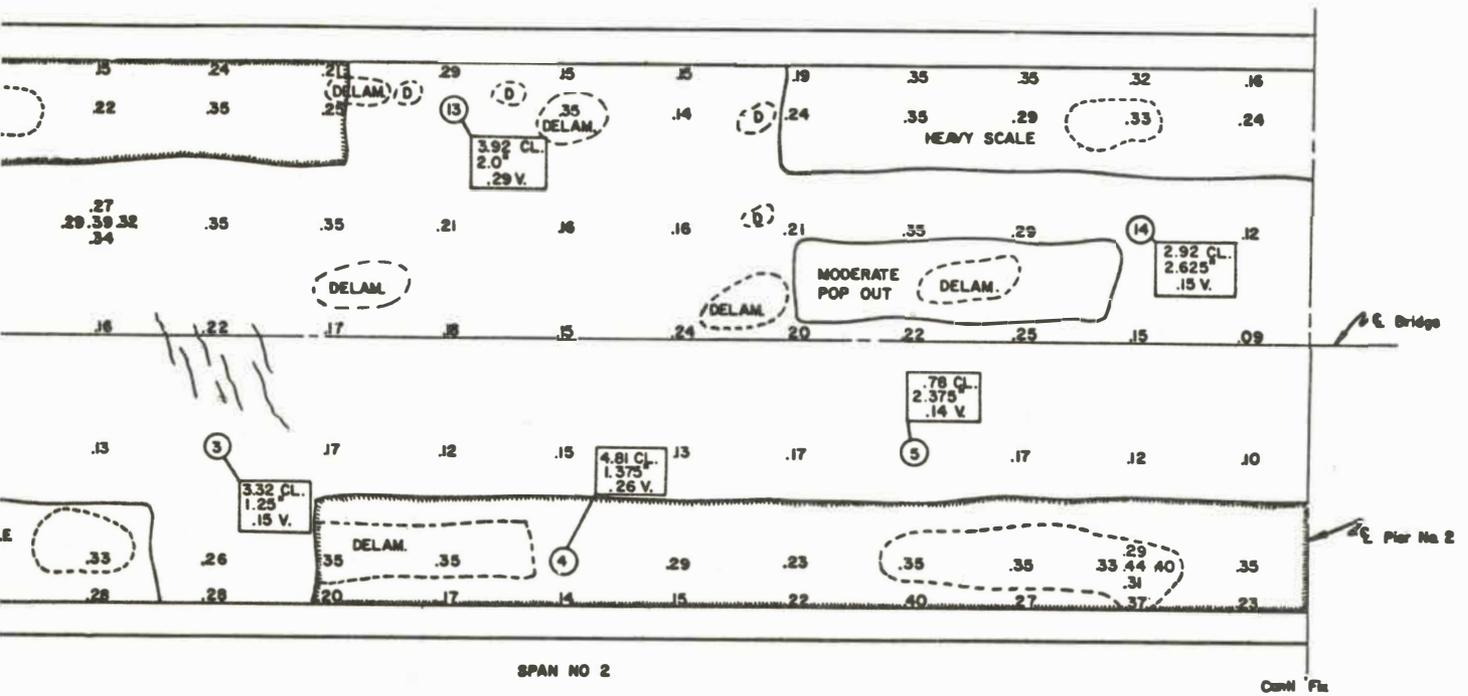
Figure 16

- Indicates areas of "Freeze and Thaw Scale"
- Indicates "Delaminated or Spalled" area
- Indicates "Seepage" area
- Indicates "Crack through Deck"
- Indicates "Halfcell Test Reading (V vs Cu/Cu SO₄)"
- Indicates "Locations of Chloride Sampling Hole"
(See Note #1)

Information listed with test holes includes
measured chloride content in Lbs. Per
cu ft, the depth of reinforcing steel and
halfcell reading.

presence and degree of popouts and pitting. This data was plotted on the work sheet along with the freeze-thaw scale data. Testing for extent of corroding steel reinforcing was accomplished by plotting of visible delaminations and by copper/copper sulfate half-cell survey. Later, chain drag sounding was incorporated into the testing for rebar corrosion. Even later, sampling for chloride analysis became a part of the bridge testing. The results of these tests were added to the bridge work sheets. Finally a visual inspection of the bridge soffit was performed and all cracks, areas of seepage, or other problem areas were added to the work sheet. The final product was a work sheet that appeared as an aerial view of the bridge deck with the above information plotted on it. See Figure 16.

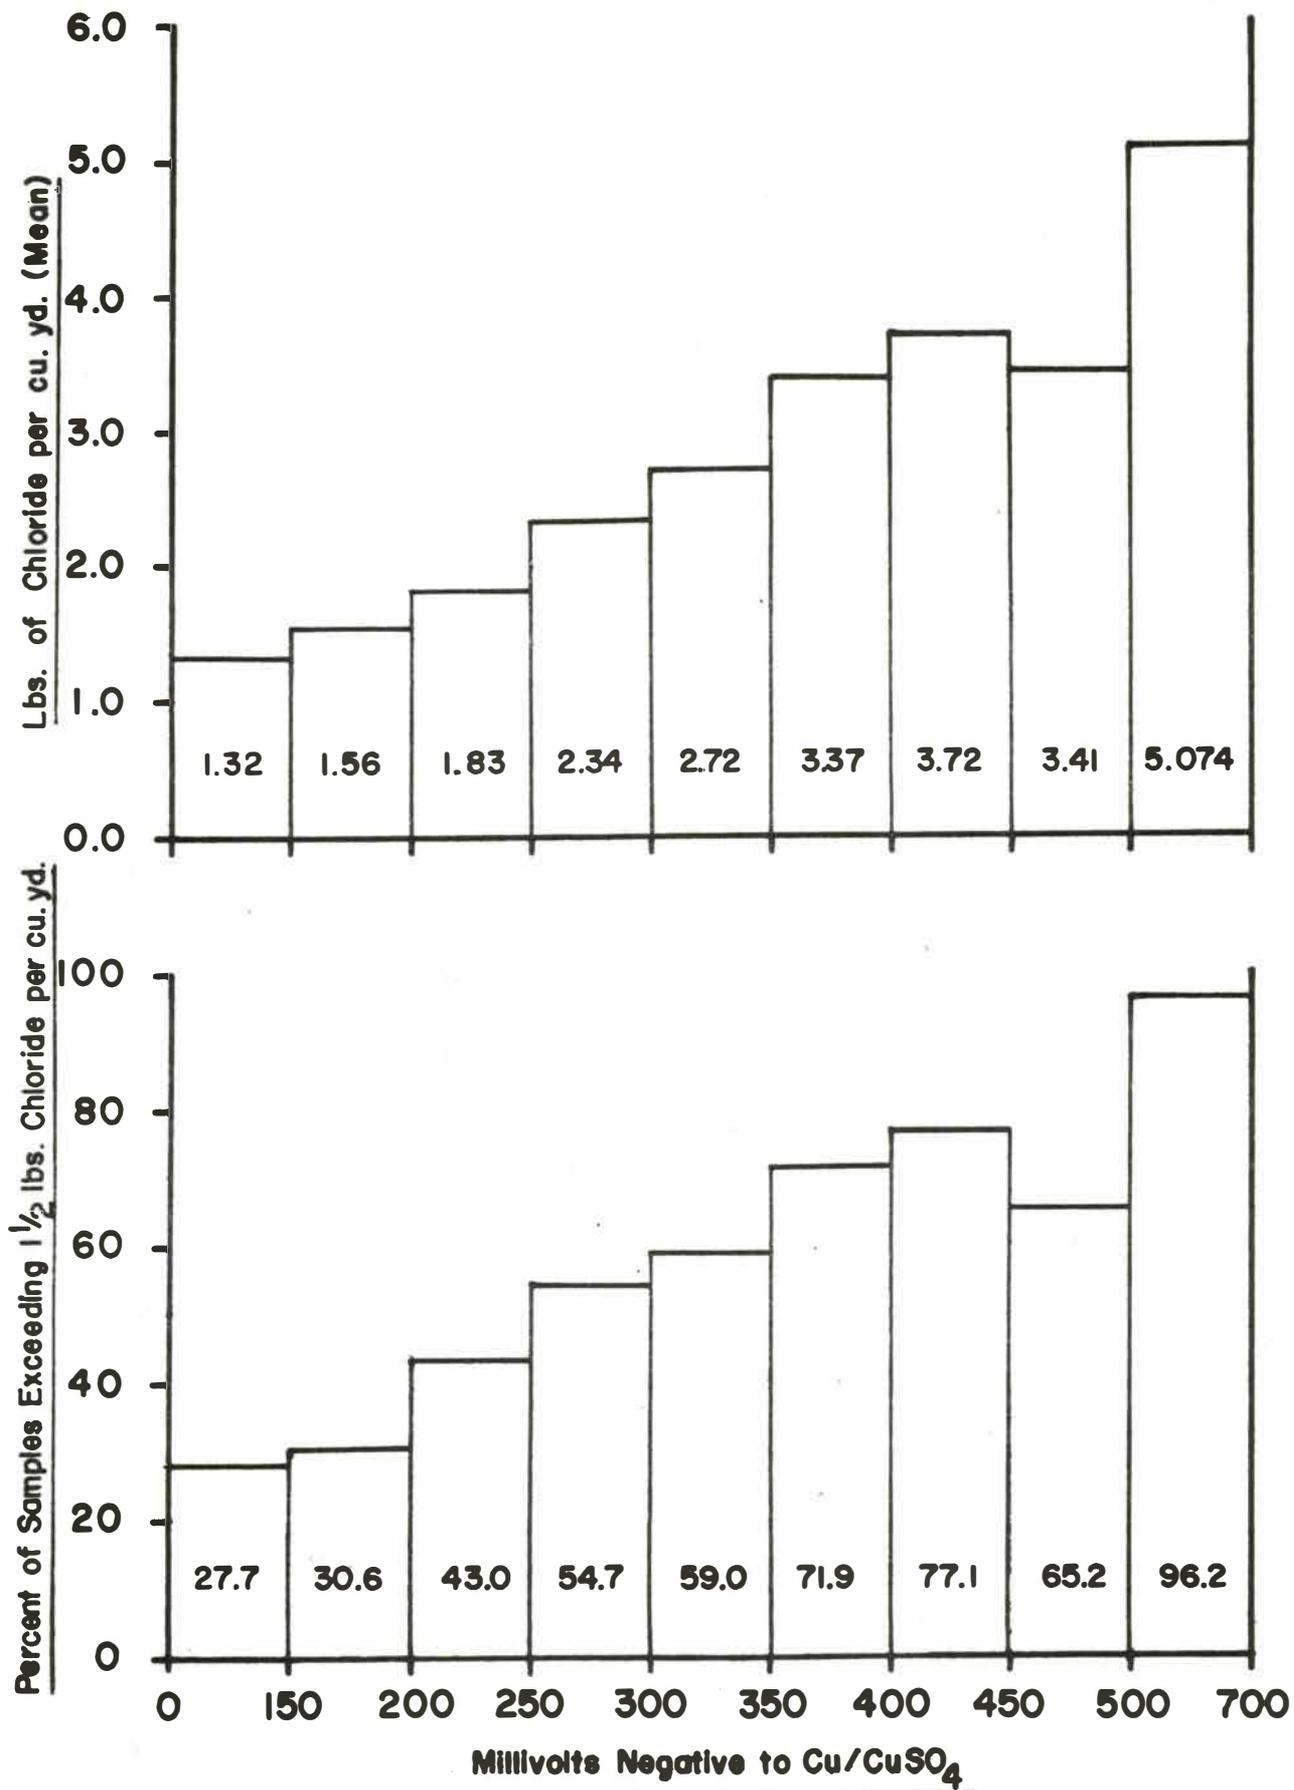
Figure 23
Millivolts Negative Cu/CuSO₄

1. Individual Bridges-The standard deviation for the raw chloride data was 1.908 lb. CL^-/yd^3 , the standard error as corrected by the regression lines relating half-cell data to chloride content at the level of the reinforcing for bridges taken as individuals was 1.432 lb. CL^-/yd^3 . This represents only a 25 percent improvement in estimation of chloride content by using this regression line vs. estimating chloride content by simply using the mean of the raw data. This standard error represents approximately 64 percent of the mean chloride content. When using these half-cell data, chloride contents at the rebar level could not be predicted with accuracy.
2. All Bridges - Regression analysis was performed on all the data taken as a population and resulted in a regression line with the following equation
