SUBGRADE MOISTURE VARIATIONS

INTERIM REPORT II

ACCESS TUBE INSTALLATION

OKLAHOMA STATE UNIVERSITY

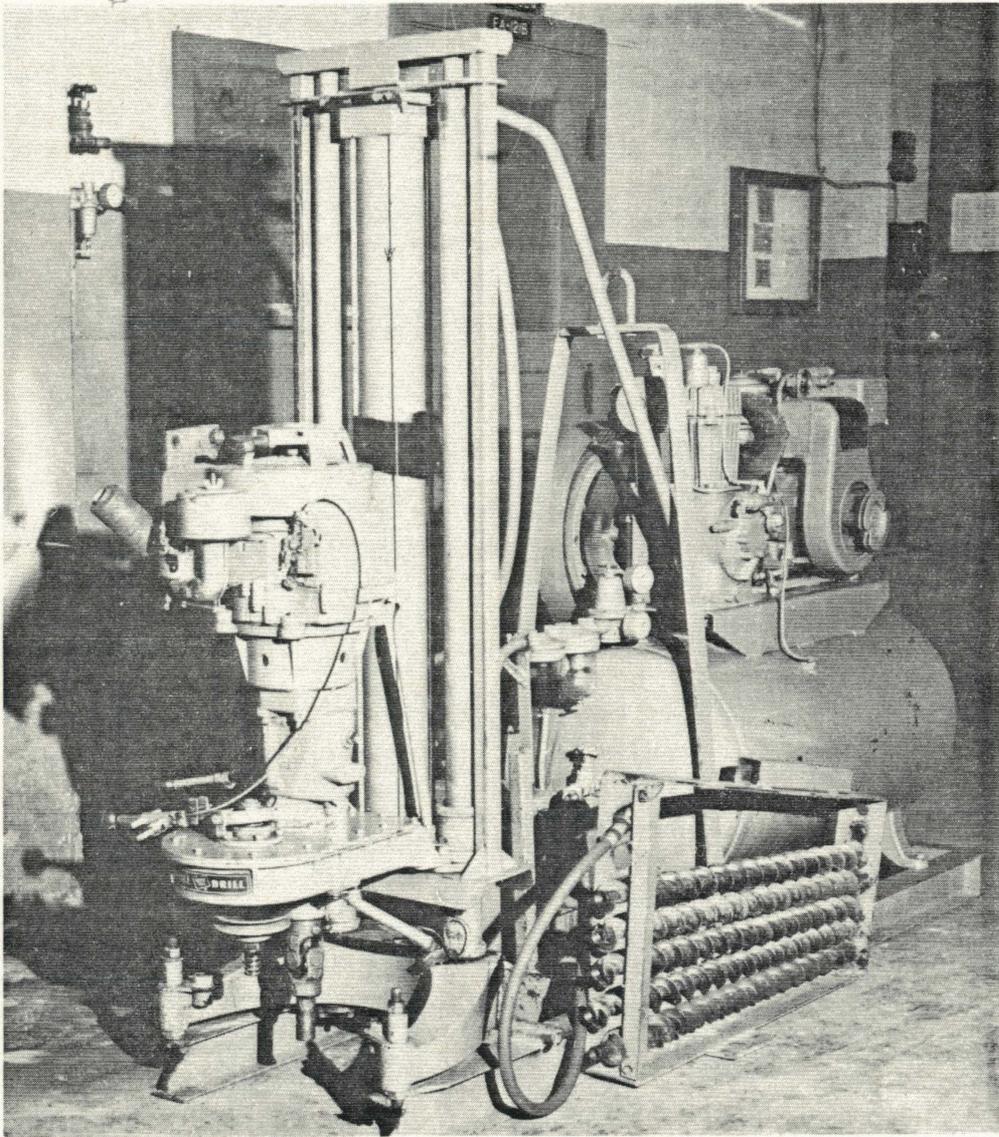
Fig 2.1. Drilling Unit

The drilling unit was assembled by R. A. Young and Son, Inc., Oklahoma City, Oklahoma. This unit was a combination of three component parts:

- 1) ~~Minuteman~~ Multi-purpose Rotary Drill manufactured by ~~Mobile Drilling, Inc.~~,
- 2) Quincy Air Compressor, Model 310, and
- 3) Hydraulic cylinder, four inch diameter and 42 inch length.

These parts were assembled into an integral drilling unit and mounted on a skid type framework suitable for use from a trailer or truck as shown in Fig 2.1.

The ~~Mobile-Minuteman~~ drill was originally equipped with a recirculating ball bearing screw feed mechanism. Satisfactory performance can be obtained with this unit, however, this mechanism requires a great deal of time to raise, lower, or position the drill. On advice from Mr. Sheets, this feed mechanism was replaced with a double acting hydraulic cylinder to provide direct control of cylinder movement.

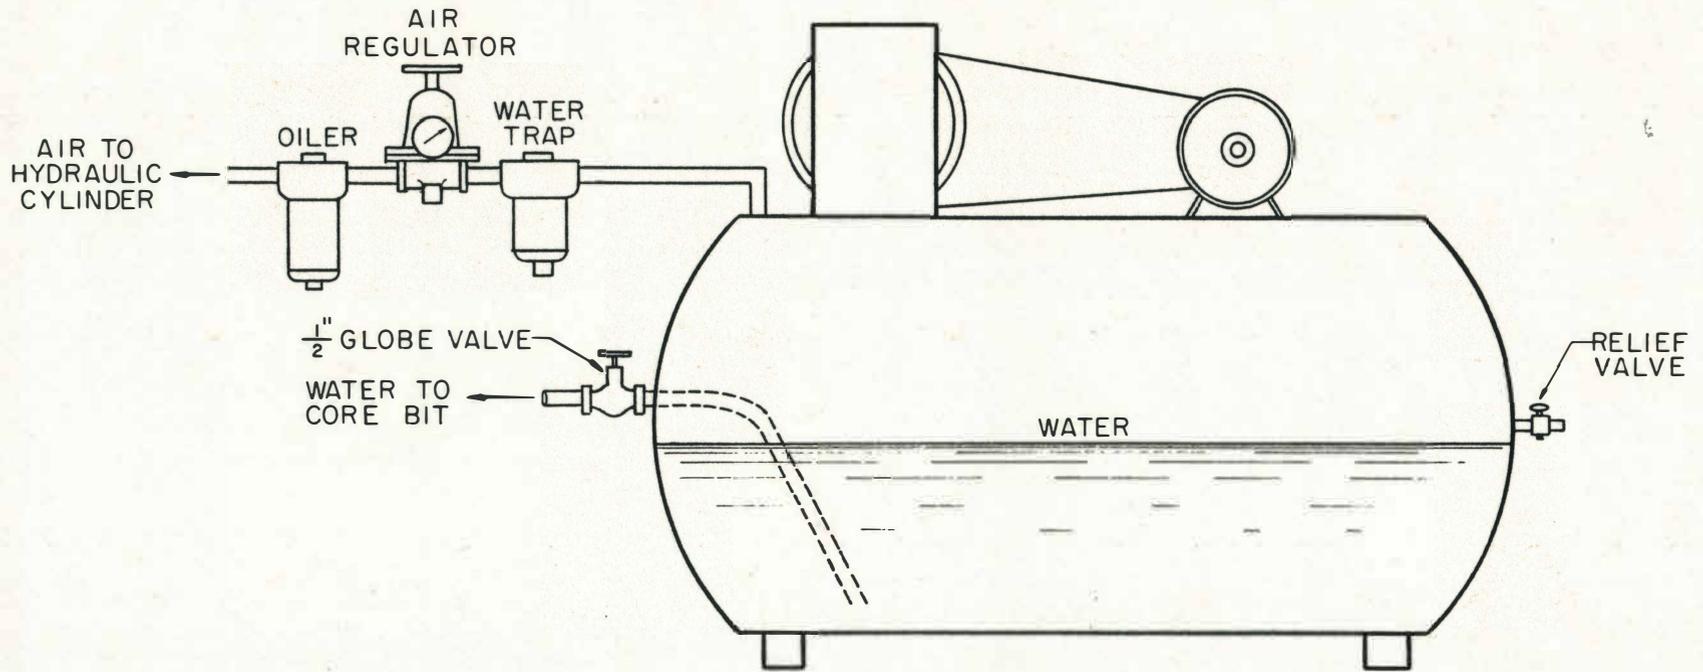
Fig 2.2. Pressurized Water System

The air tank served as water storage and provided a pressurized water system-for use in core drilling, see Fig 2.2. A "wet-valve", consisting of a tube extending to

the bottom of the air tank and a standard $\frac{1}{2}$ inch globe valve, was installed on the end of the air receiver. A relief valve was installed to release air when filling the tank with water. As a safety precaution the tank was not filled with water to more than half its capacity, approximately 30 gallons. This level was indicated by water flowing from the relief valve. Due to the presence of excess moisture in the system, the air line to the hydraulic cylinder was equipped with a water trap and oiler to prolong the working life of the hydraulic unit.

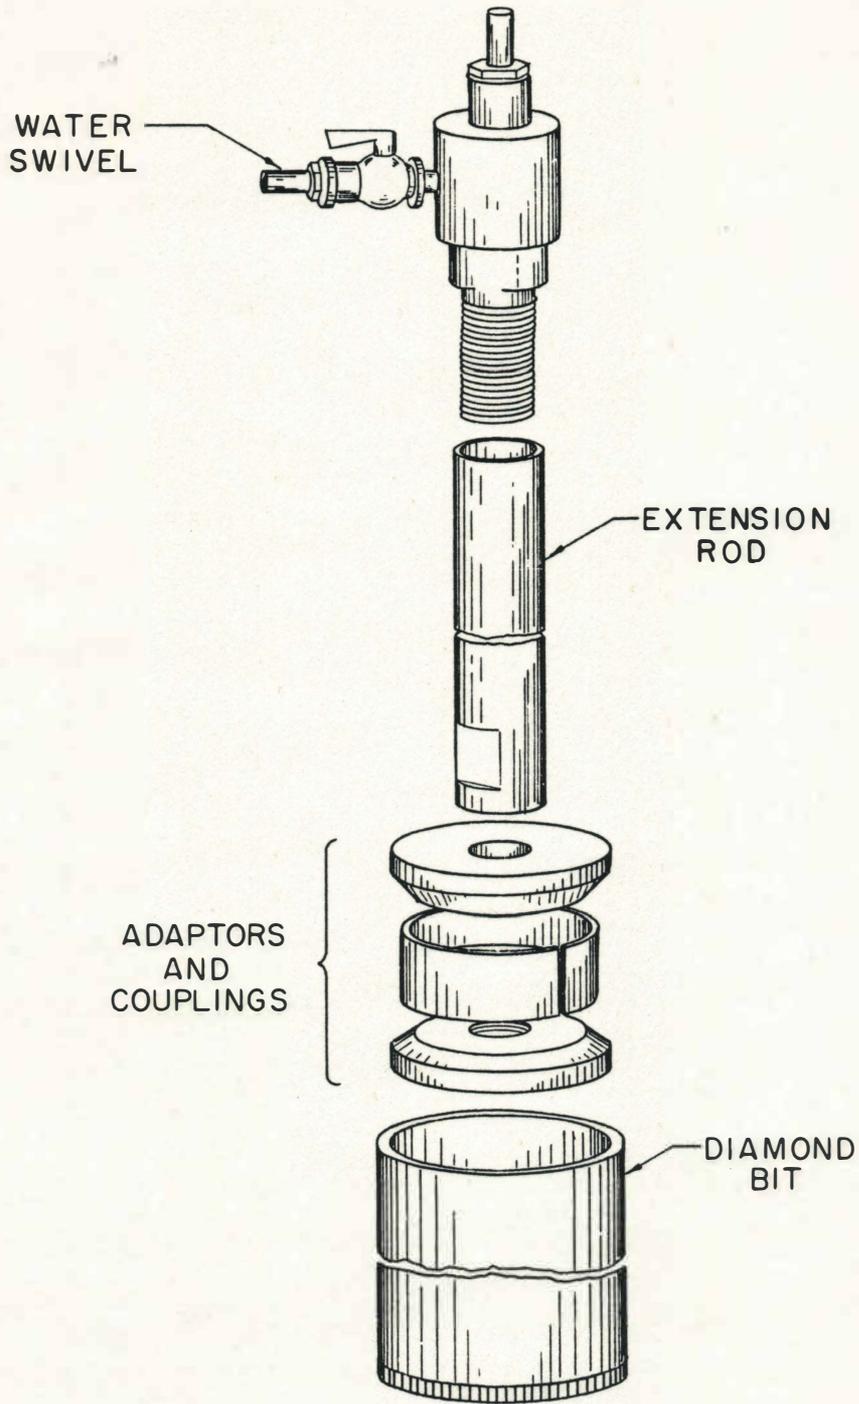
Fig 2.3. Core Drilling Apparatus

The drilling rig was supplied with a six inch diameter "oriented" diamond core bit, water swivel, extension rods, adaptors, and couplings, as shown in Fig 2.3. Oriented bits differ from "random set" bits in that the diamonds are carefully positioned so that cutting stresses and abrasion are borne by the hard edge or rib of each stone. Because wear and cleaving of the diamonds is substantially reduced, better performance and longer life is obtained.

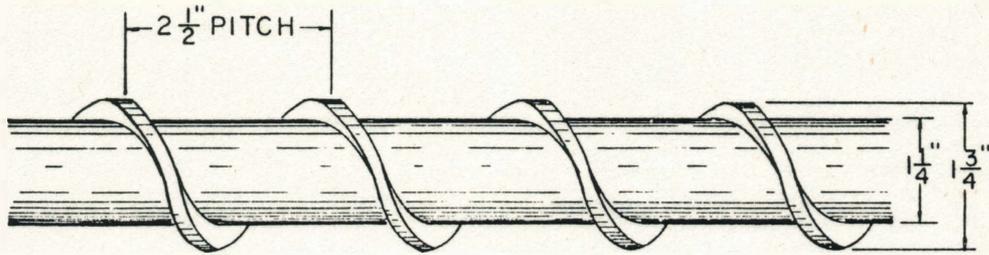
Fig 2.4. Mobile Drill Auger

Considerable difficulty was encountered in obtaining an auger suitable for drilling a two inch diameter hole. The auger furnished by Mobile Drill, Inc., see Fig 2.4, was totally unsatisfactory for drilling clay soils. The auger stem diameter was too large to allow sufficient auger flight surface for removal of the material. When drilling a hole with this auger, the soil was displaced rather than removed, and this increased the soil density around the periphery of the hole. Upon notification that the auger would not

perform properly, ~~Mobile Drill~~, Inc. sent another set of augers. The only/difference from the original auger was a hard surfacing applied to the auger flight. As would be expected, this auger was also unsuitable.

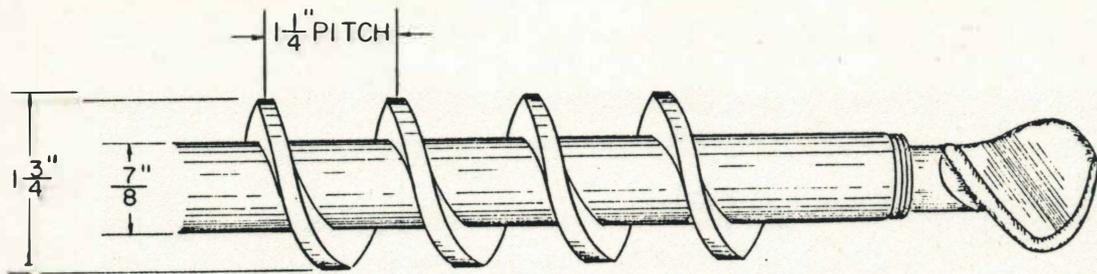
Fig 2.5. Acker Drill Auger

An attempt was made to adapt the auger purchased with the ~~Acker~~ auger kit to the ~~Mobile~~ drill. This auger was not suitable because the auger flight was not continuous at the joints and at the connection of the fishtail bit to the auger stem, as shown in Fig 2.5. Since the flight was discontinuous, cohesive soils had to be forced past these points and onto the next section of auger. This forcing effect increased the density of the soil by displacement rather than removal of the material.

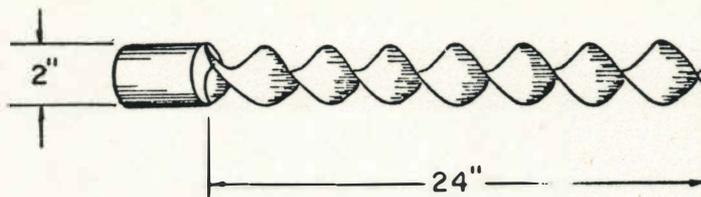
Fig 2.6. Ship Auger

Consideration was given to the use of a section of ship auger, see Fig 2.6. To use this type auger, it would be necessary to remove the entire length of drill stem from the hole after advancing 18-24 inches. This process would undoubtedly enlarge the upper portions of the hole and consume a great deal of time.

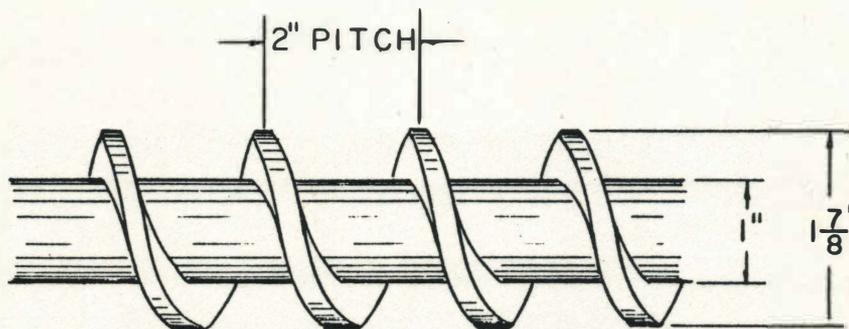
Fig 2.7. Auger from Haynes Manufacturing Company

An extended effort was made by the ~~Oklahoma~~ City Branch of ~~R. A. Young and Son~~, Inc. to locate and obtain a continuous flight two inch diameter auger with small diameter stem. An auger fitting this description, shown in Fig 2.7, was purchased from ~~Haynes Manufacturing Co.~~, Livingston, Texas. After adapting this auger to the ~~Mobile~~ drill, it was possible to drill and remove clay soils with a minimum of disturbance to the material adjacent to the hole.

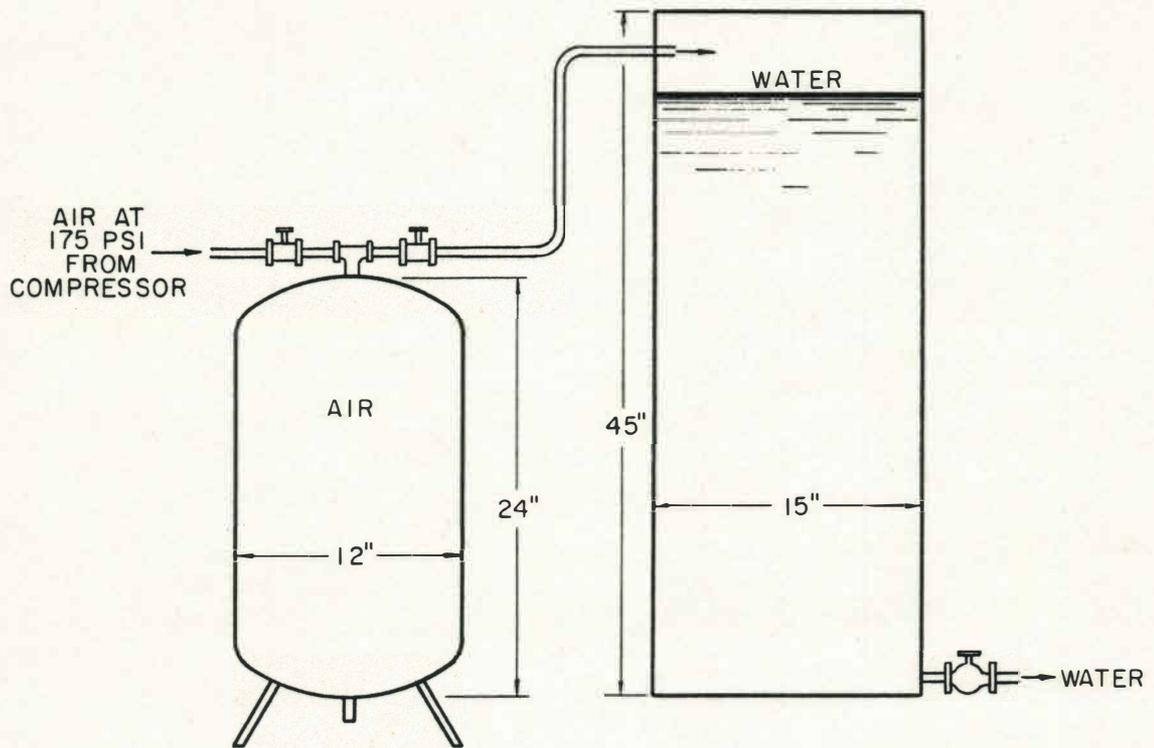
Fig 2.8. Secondary Water System

A secondary water storage system was used to supplement the water required by the core drilling process. This system included a portable air tank and a 30 gallon sealed container, see Fig 2.8. The portable air tank was connected to the air compressor and charged to 175 psi. By connecting an air line from the portable air tank to the auxilliary water tank, another pressurized water system was formed. This system could be used to force water into the air receiver, after relieving the pressure, or directly to the water swivel. As the secondary system did not provide a constant high pressure and regulated flow rate, it is not recommended for continuous core drilling.

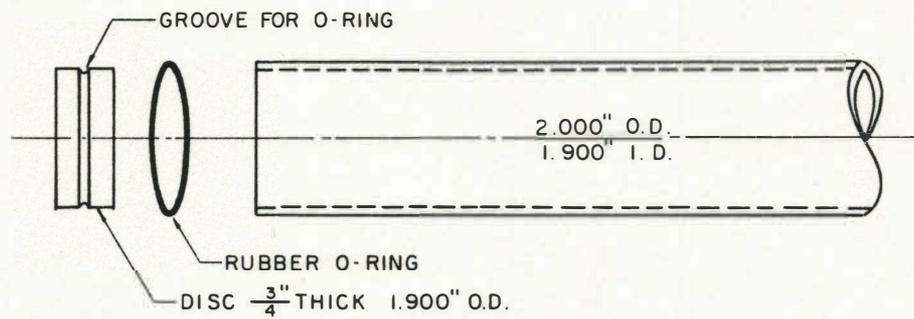
Fig 2.9. Sealed End of Access Tube

One end of the tube was sealed with a metal plug and a rubber O-ring, see Fig 2.9. By casting a lead alloy in a section of aluminum tubing and subsequently removing the tube, a lead shaft with an OD of 1.900 inch was obtained. This stock was cut into discs 3/4 inch thick, and a groove was machined in each disk to receive the O-ring. The plug was driven into the end of the access tube and tested for leakage. As an additional precaution against leaks, the end of the aluminum tube and the metal plug were externally sealed with epoxy paint.

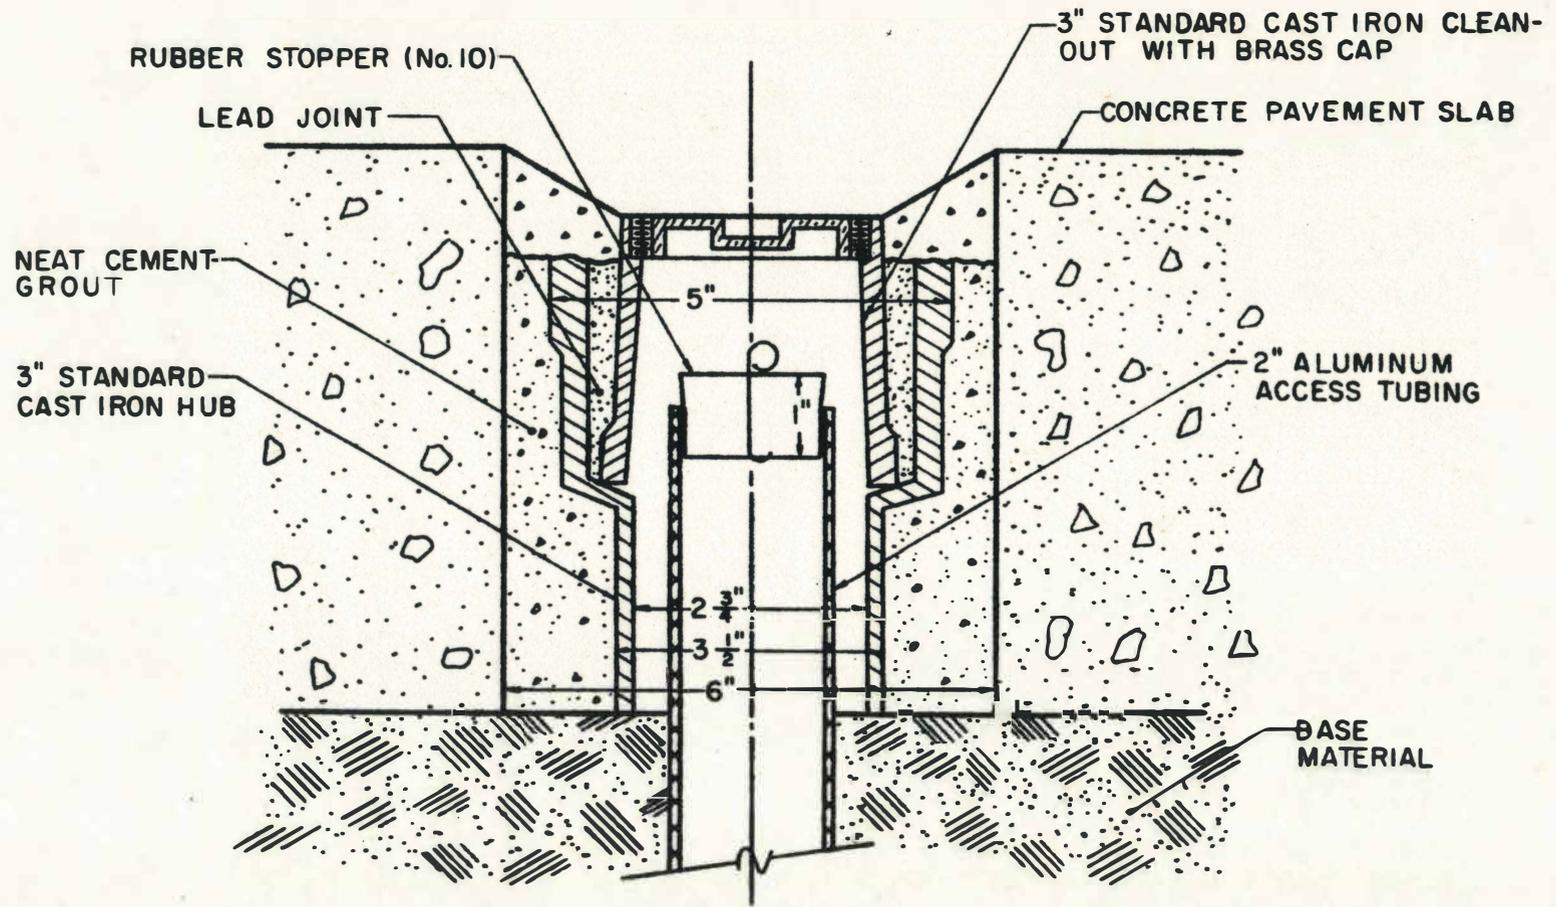
Fig 2.10. Protective Covering

Figure 2.10 shows a combination of plumbing supplies used to provide a water-tight, non-obstructive covering for the access tube. A standard cast-iron sewer clean-out was leaded into a three inch cast-iron hub section to form an

integral unit. This assembly was held in position around the access tube by a cement grout mixture.

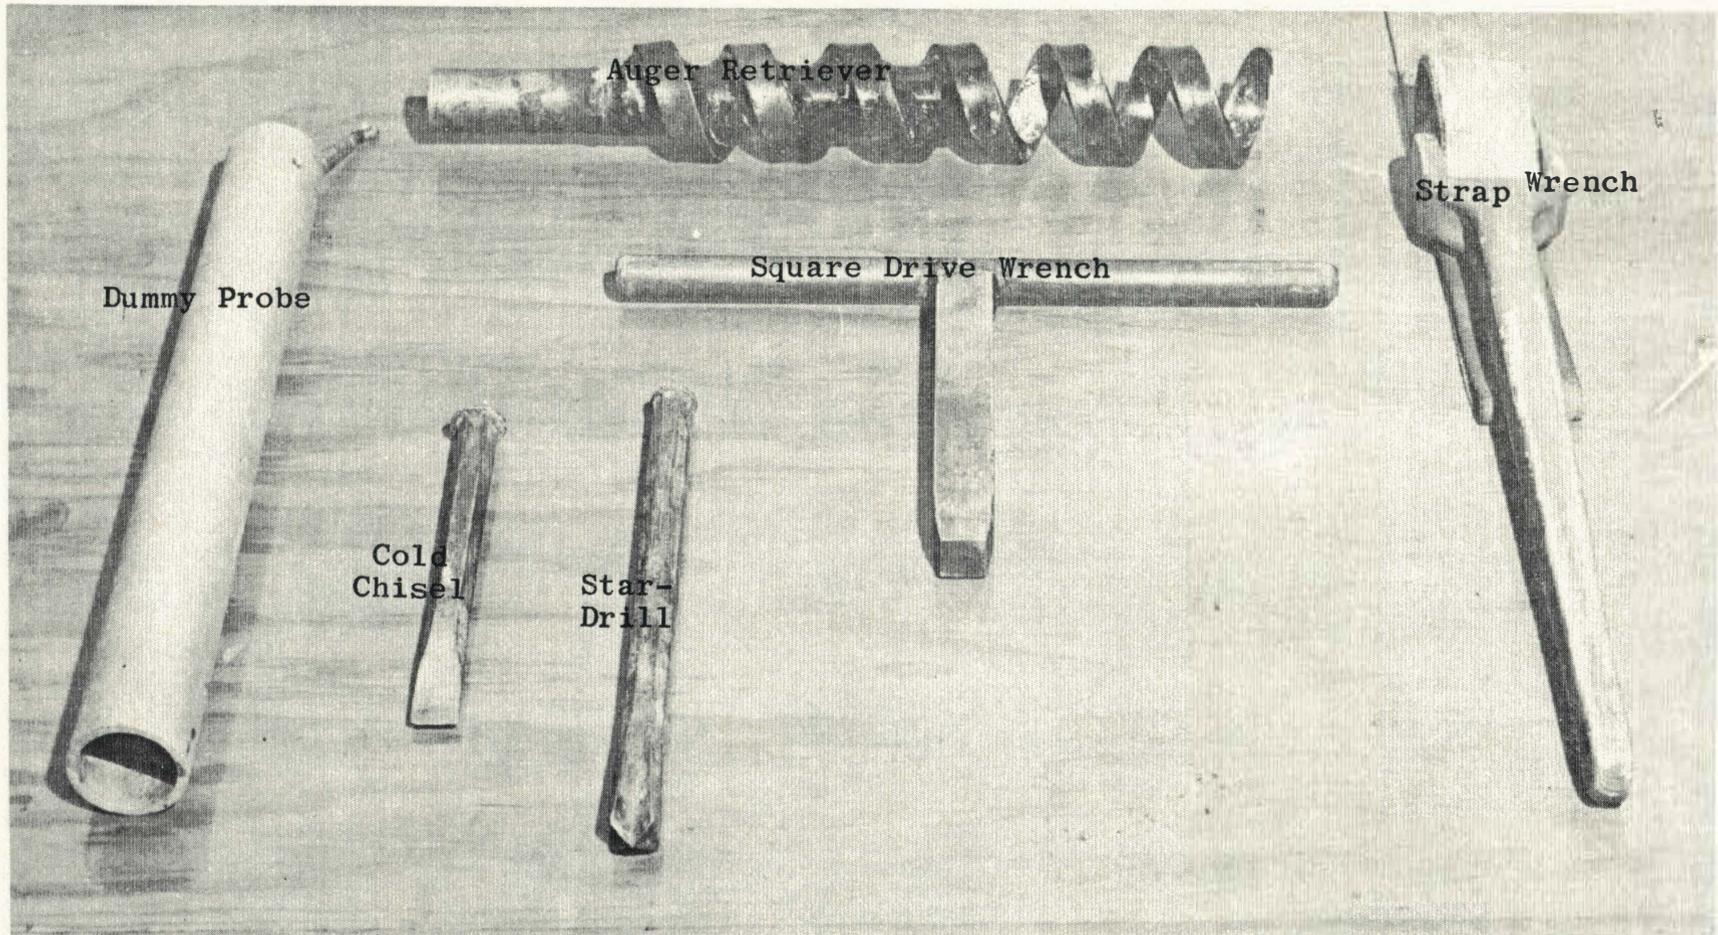
Fig 2.11. Special Tools

An assortment of small hand tools was required for the purpose of maintenance and minor adjustments to the equipment. Several "special" tools, seen in Fig 2.11, were required:

- 1) an auger retriever to remove dropped or broken auger sections from the hole,
- 2) a strap wrench to aid in break-down of the core barrel and accompanying adaptors,
- 3) a "square-drive" wrench to use when removing brass caps, and
- 4) star-drill and cold chisel to break away the top of cores greater than 12 inches thick (depth of core barrel) to allow further penetration of core bit assembly.

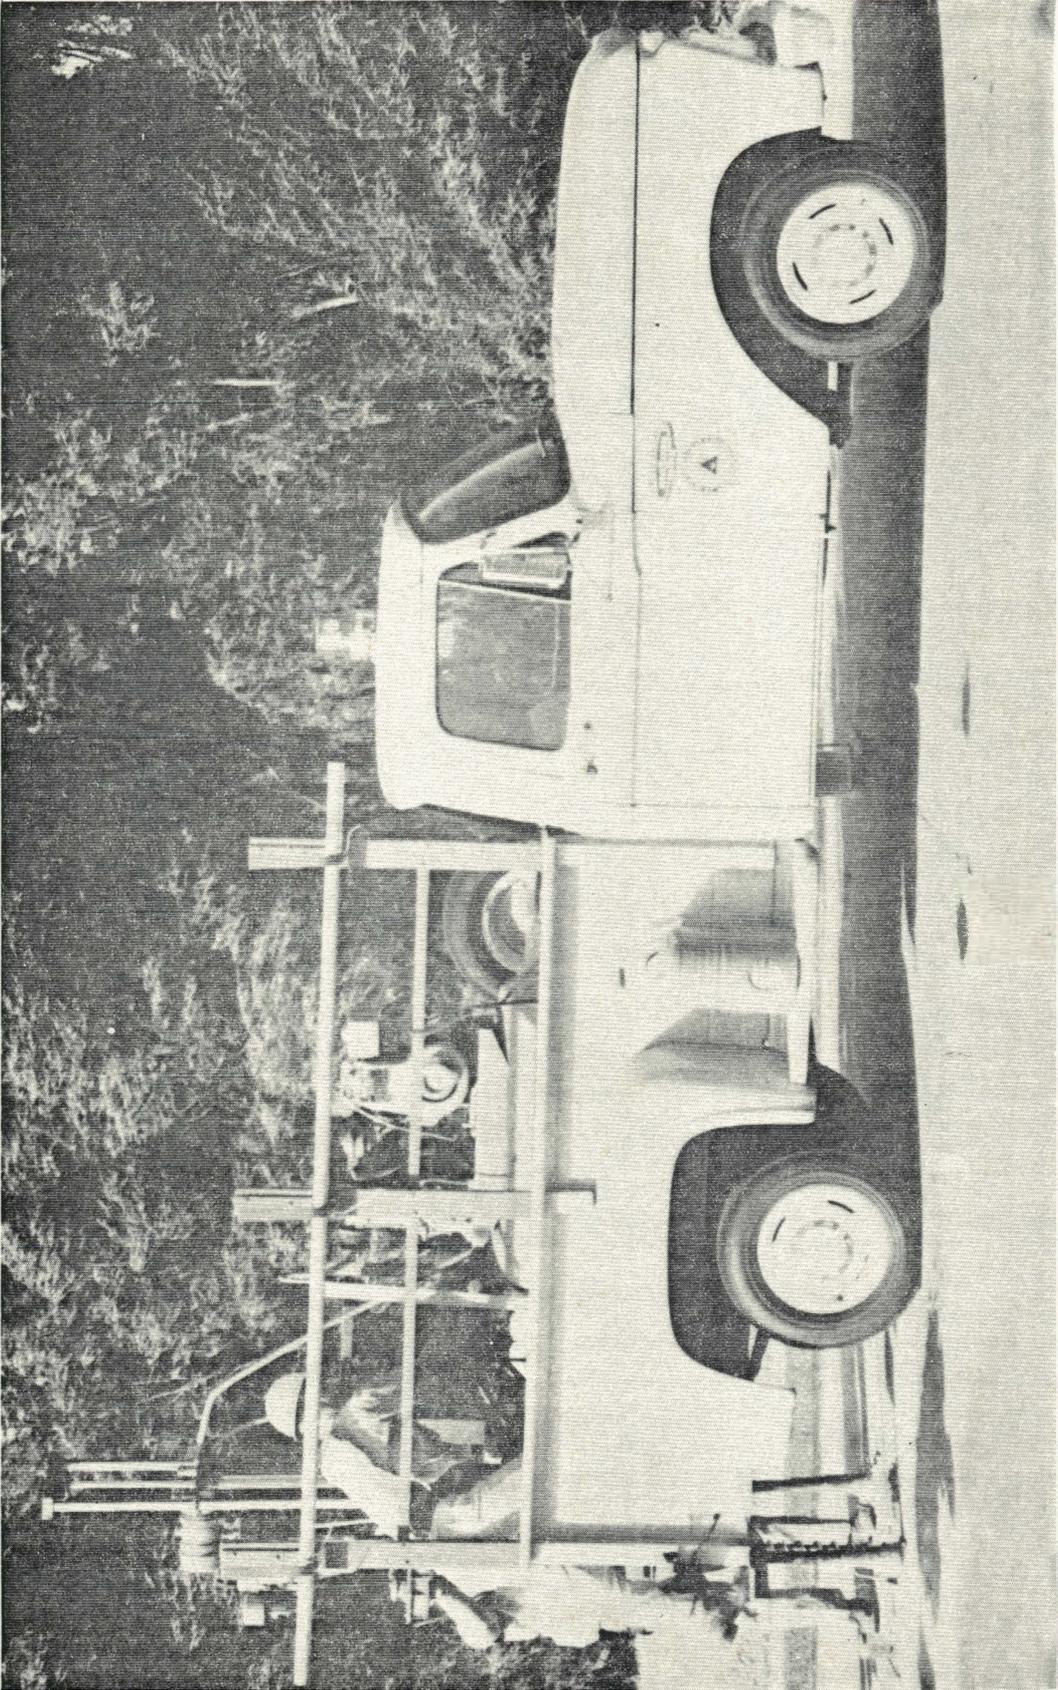
Fig 2.12. Drill Rig mounted on Vehicle

A ~~Ford F-100~~ step-side pickup was used to transport the equipment described in this chapter, see Fig 2.12. It was necessary to remove the tailgate and rear bumper to allow the proper positioning of the drilling unit. Several storage boxes and racks were installed to carry the tools and equipment required for field test site installation.

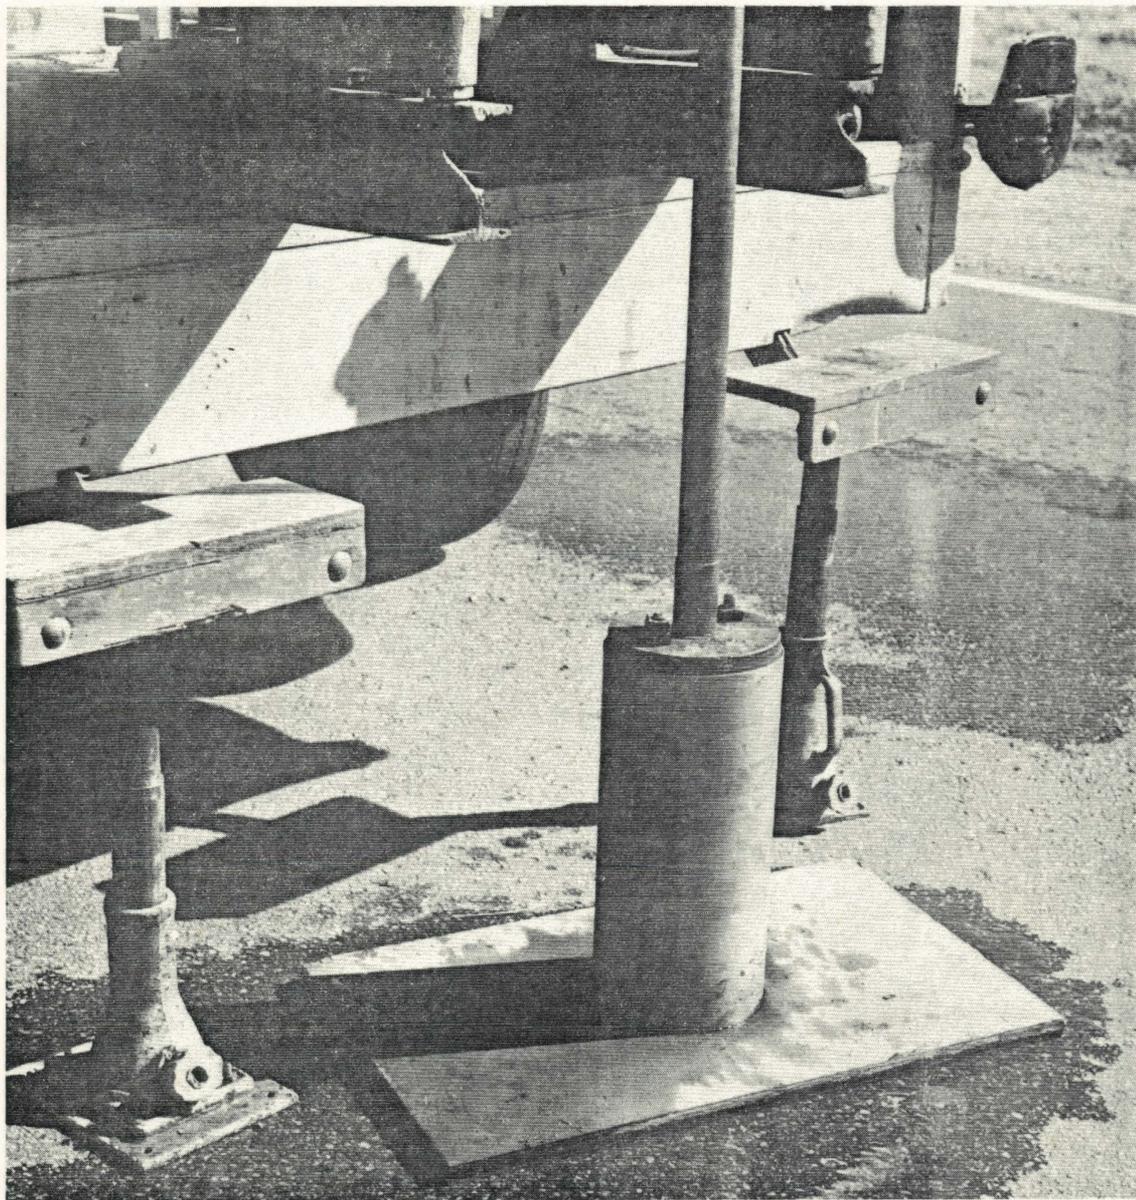
Fig 5.1. Core Bit and Template

- 1) level the vehicle with out-riggers, and
- 2) adjust the air pressure on the cylinder to 50 psi. At this pressure, sufficient downward force can be applied to the core bit without damage.
- 3) Connect the core bit assembly to the high-speed spindle of the drill.
- 4) Adjust the water flow rate to 1/2 gallon per minute. A higher flow rate, 1 gallon per minute, is necessary for asphaltic concrete due to the increased friction and drag of the asphalt binder.
- 5) Lower the core bit into a template to align and hold the core barrel when starting the hole, shown in Fig 5.1. When the bit is "seated" remove the template and increase

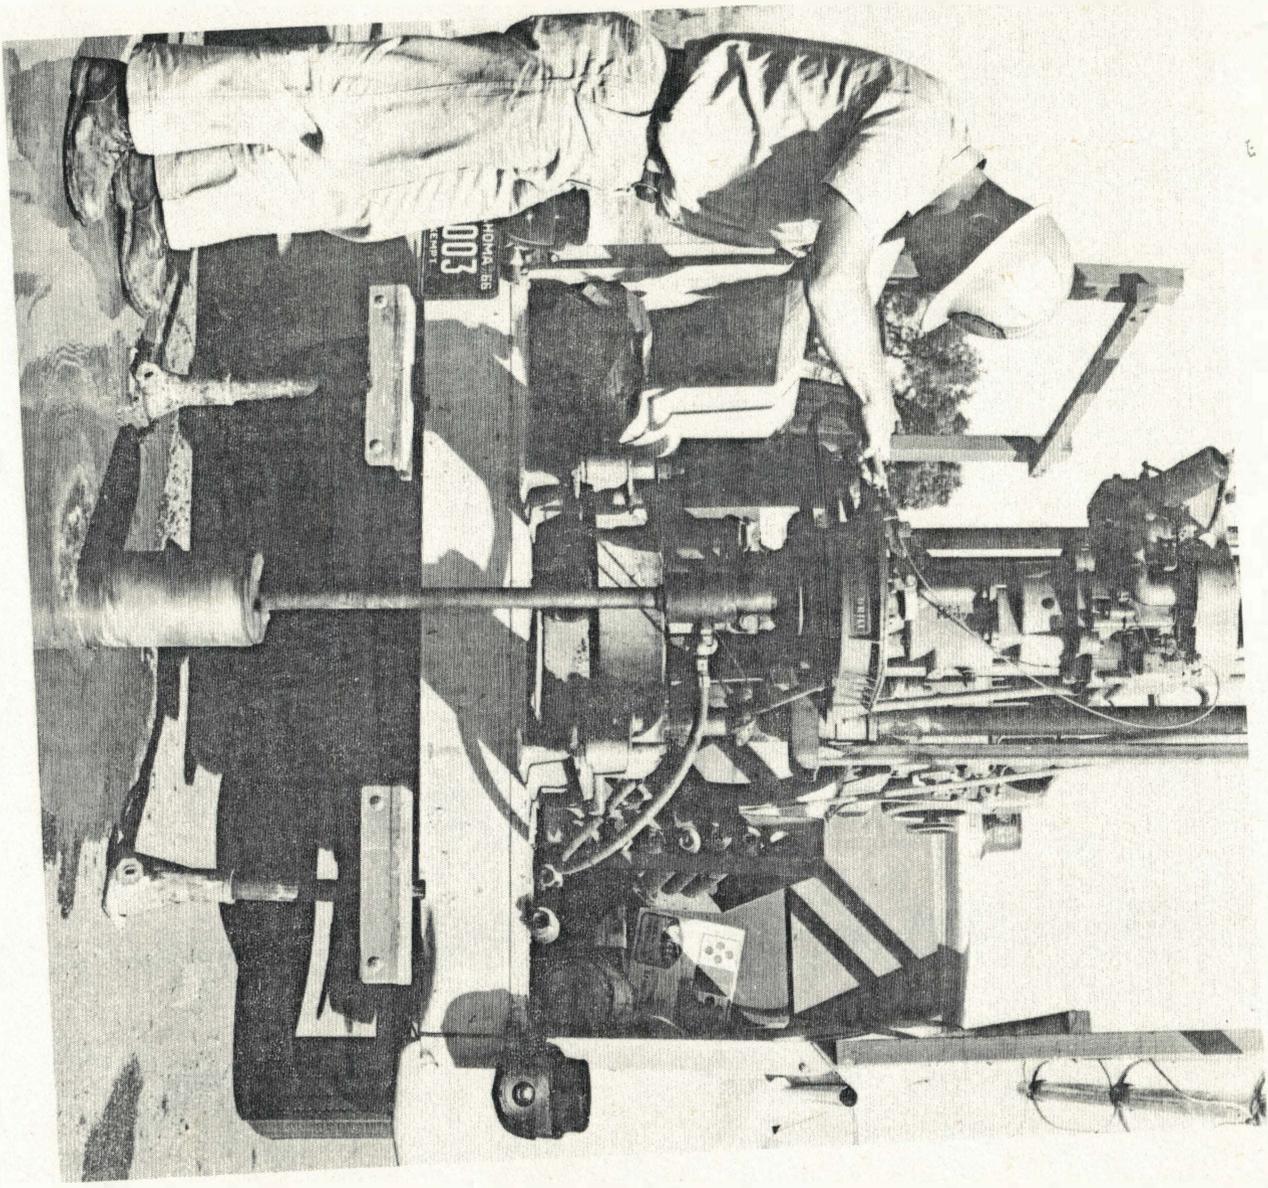
Fig 5.2. "Seated" Core Bit

the engine speed, as seen in Fig 5.2. With the transmission in first gear and maximum engine speed, the core bit rotates at 350 rpm.

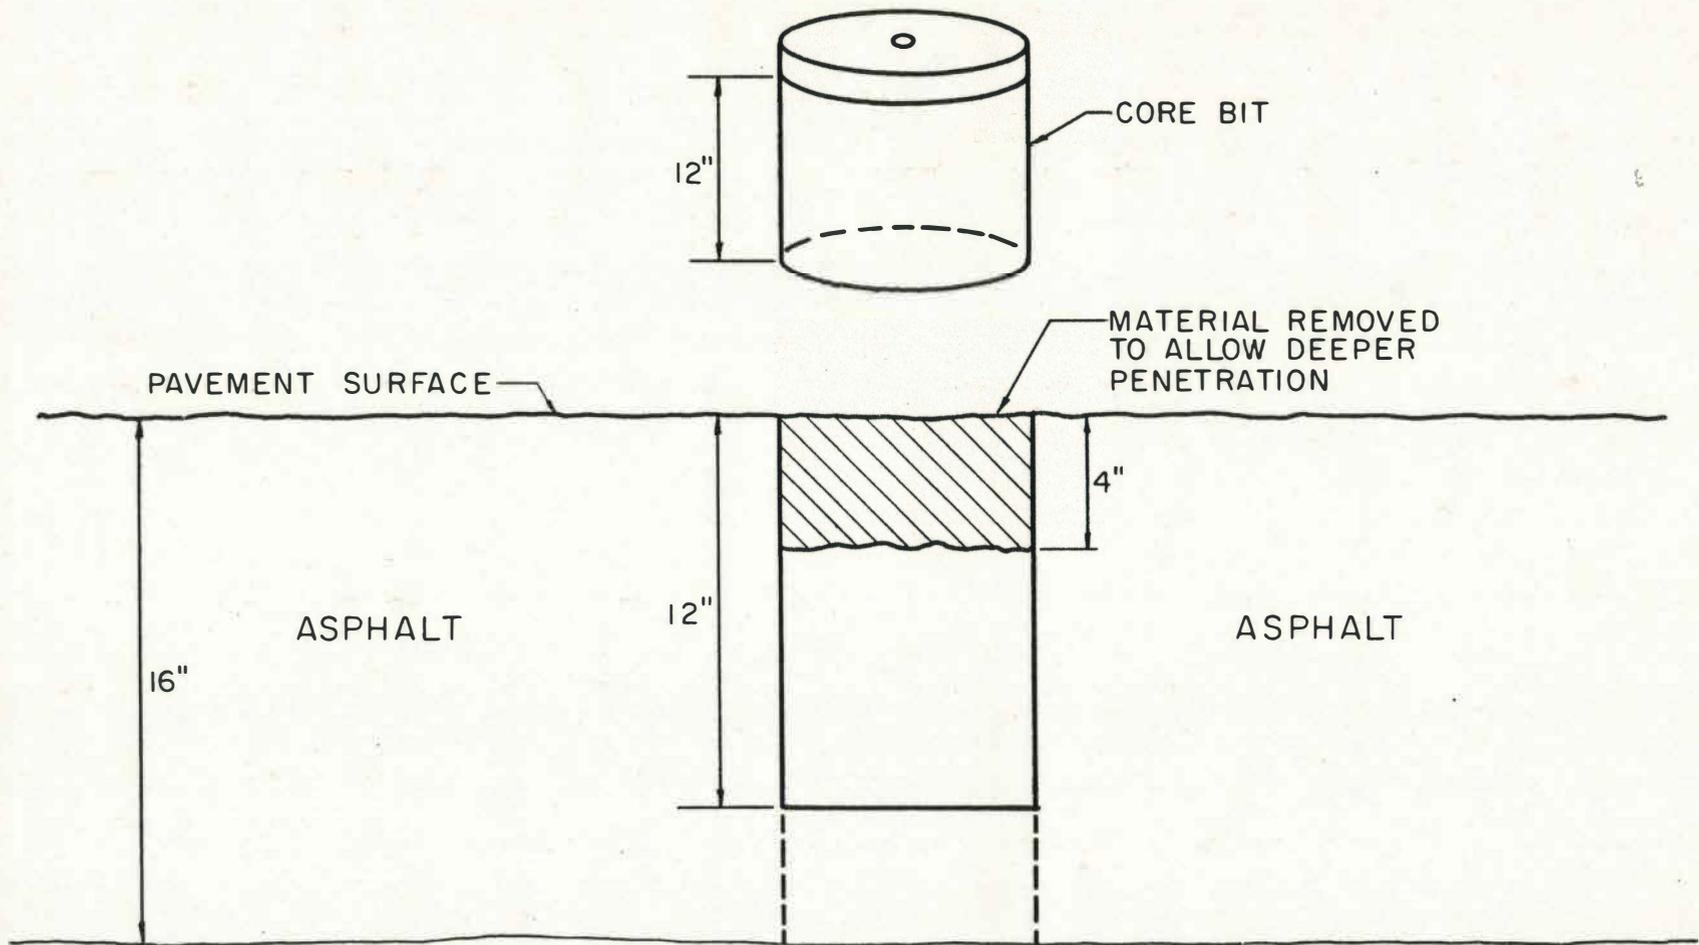
Fig 5.3. Coring Thick Pavements

Occasionally, asphaltic concrete pavements greater than 12 inches in thickness were encountered. By using a cold chisel, star-drill, and hammer, the top of the core

could be removed and depths greater than 12 inches could be bored, as shown in Fig 5.3.

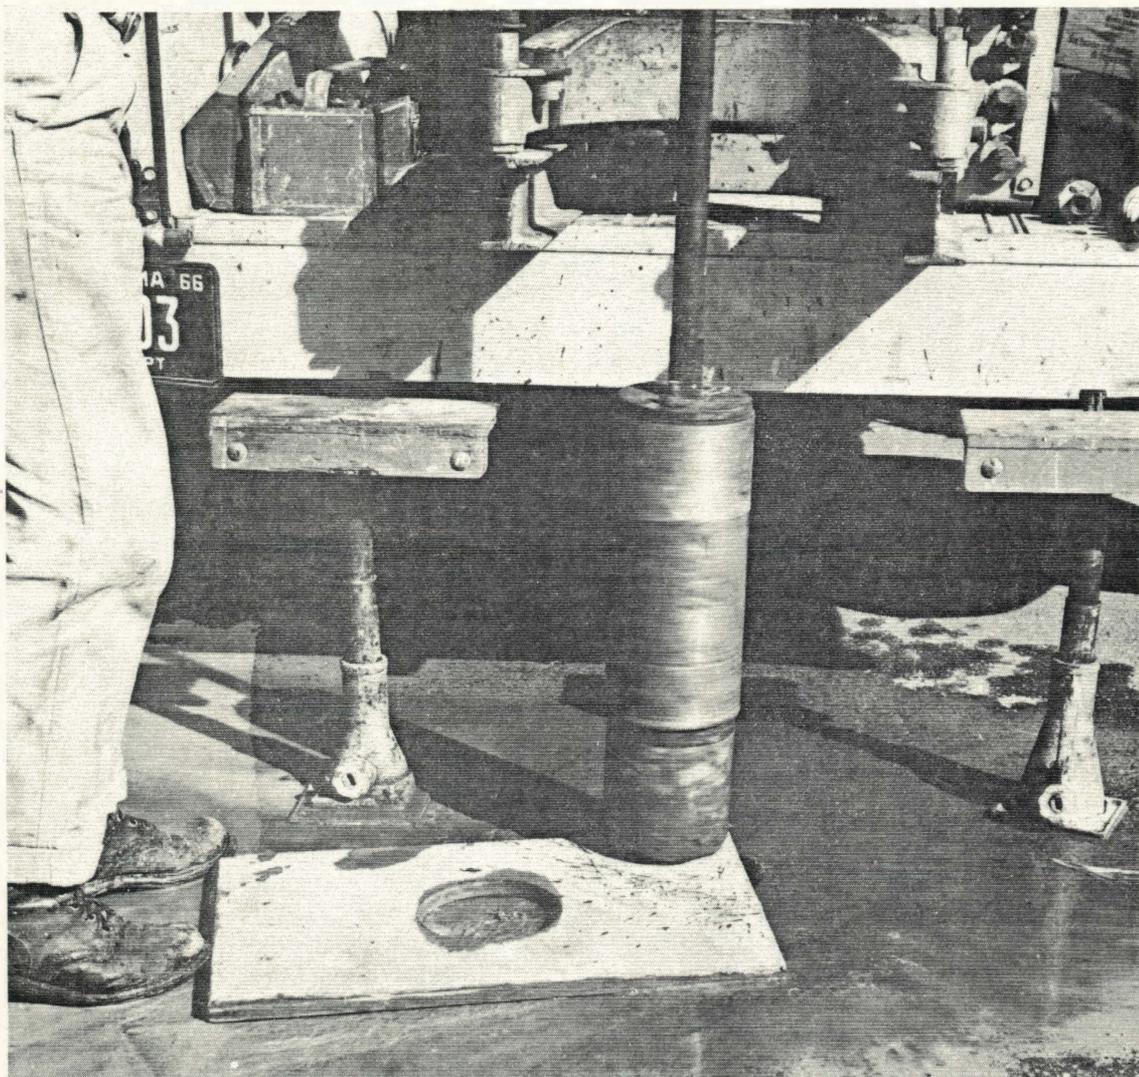
Fig 5.4. Vacuum Removal of Core

Extraction of the pavement core from the core barrel was often difficult. By applying the maximum water pressure, 175 psi, most cores were forced out of the core barrel. Thin asphalt cores of 2 to 4 inch thickness were broken and removed in separate pieces. The removal of the most difficult cores required disassembly of the core bit and couplings. When this was necessary, a strap wrench was used to prevent crushing and damage to the core barrel.

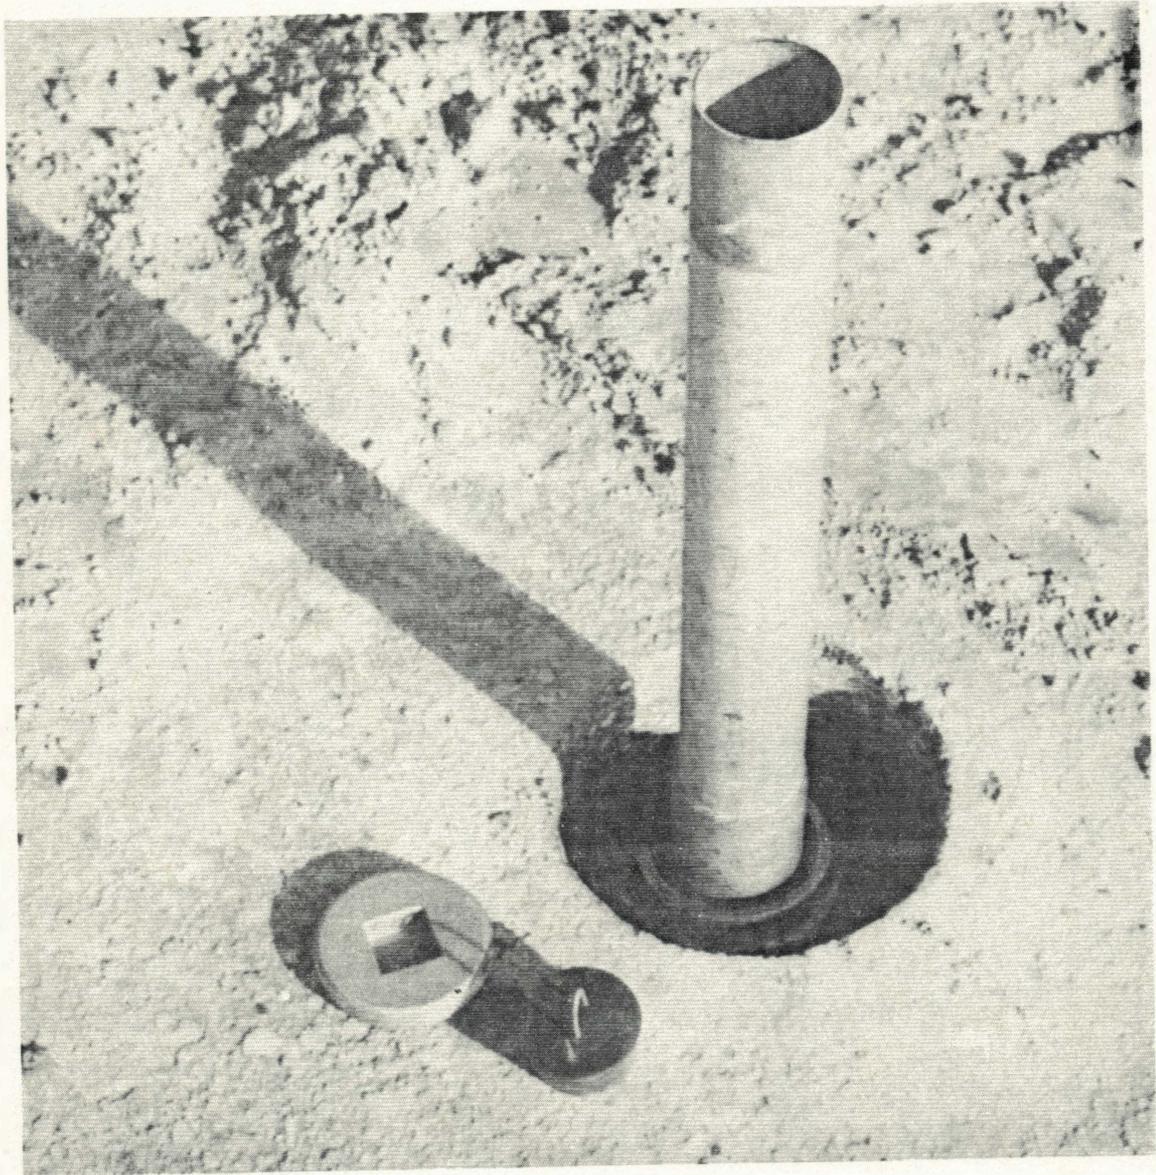
Fig 5.6. Hub in Place and Ready for Grouting

The access tube was inserted by hand. The top of the tube was positioned 4 inches below the pavement surface. An extension tube, see Fig 5.6, was connected to the access tube to aid in centering the hub and to prevent debris from falling into the access tube. Soil was placed around the tube to a level that would support the hub. The top of the hub was set below the surface of the pavement to avoid obstruction to traffic, snowplows, and other maintenance equipment.

A rapid-set cement was used to make a grout mixture for holding the hub in position around the tube. A rich mixture of 3 parts cement, one part sand, and water was combined to form a stiff paste. Adherence of the grout to the cast iron was excellent, but the smooth concrete surface produced by the core bit presented slight bonding problems when subject to heavy impact loads.

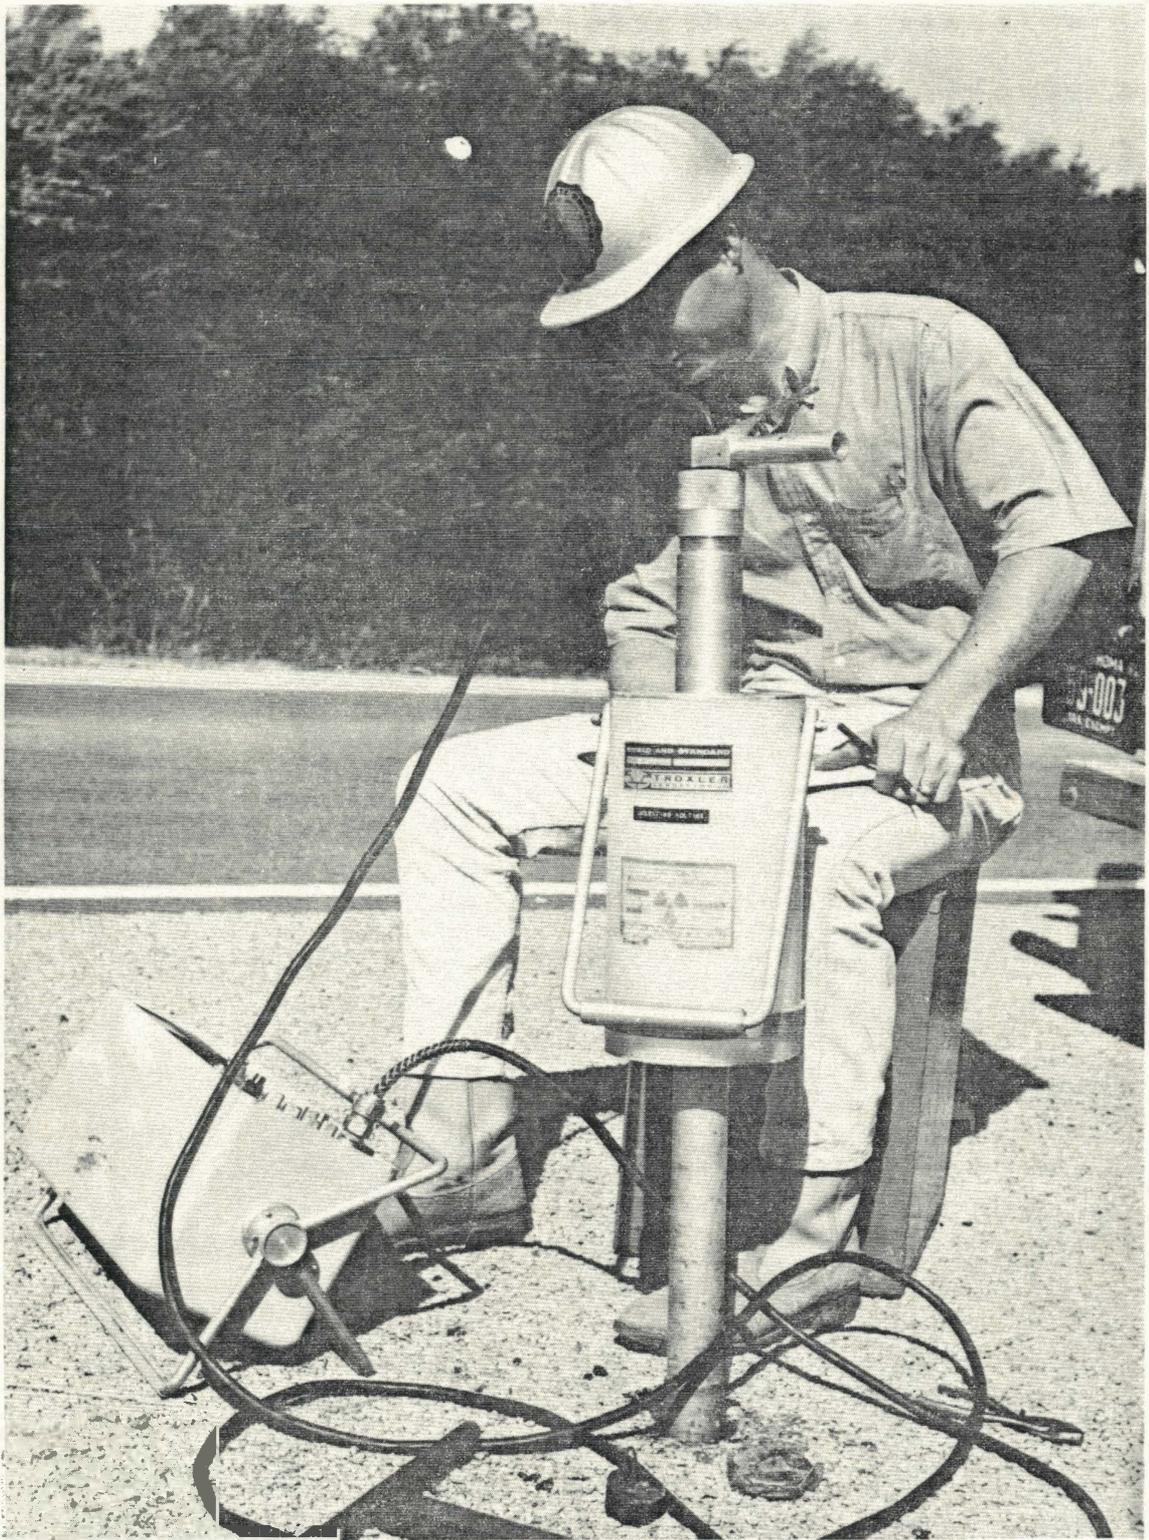
Fig 5.7. Initial Data Collection

The nuclear probes were used to collect data from the test hole immediately after completion. Ten readings were taken with the instrument in the shield. This provided the standard to use when calculating the count ratio. By connecting an extension tube to the access tube, the shield could be placed on the extension tube and the probe lowered into the access tube, as seen in Fig 5.7. Two readings were taken for each one foot interval. The one foot increment was established by calculating the probable sphere of influence for the probes (Ref 6). The basis of two readings per interval was used to obtain the desired accuracy in the 95% confidence level (Ref 7).
