SUBGRADE MOISTURE VARIATIONS

INTERIM REPORT II

ACCESS TUBE INSTALLATION

OKLAHOMA STATE UNIVERSITY

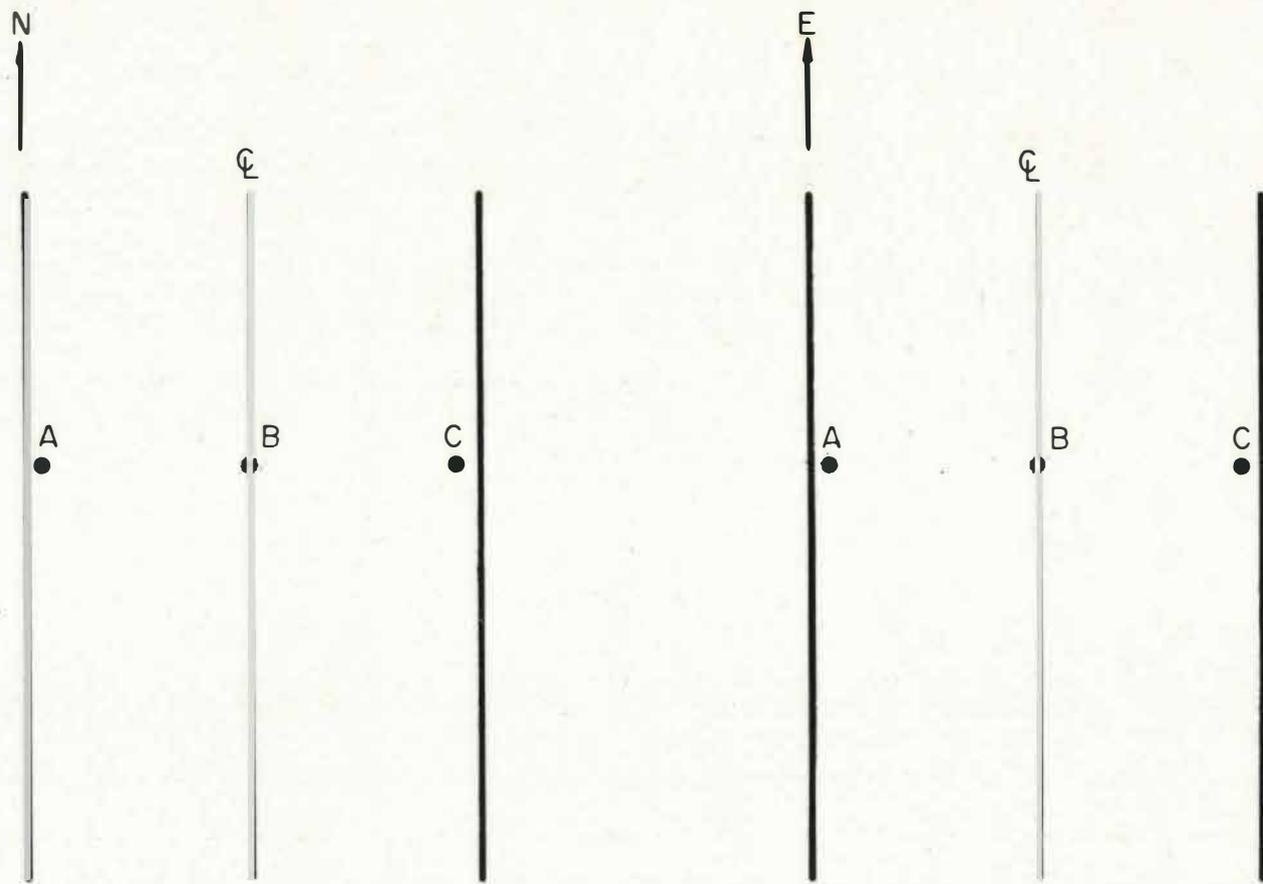
Fig 5.8. Layout of Operations

To provide a minimum obstruction to traffic, the layout of operations, shown in Fig 5.8, was 1) drill A, 2) read A, drill B, 3) read B, drill C, and 4) read C. It was possible for one man to drill a hole and install an access tube in the time required to take a set of readings from another hole.

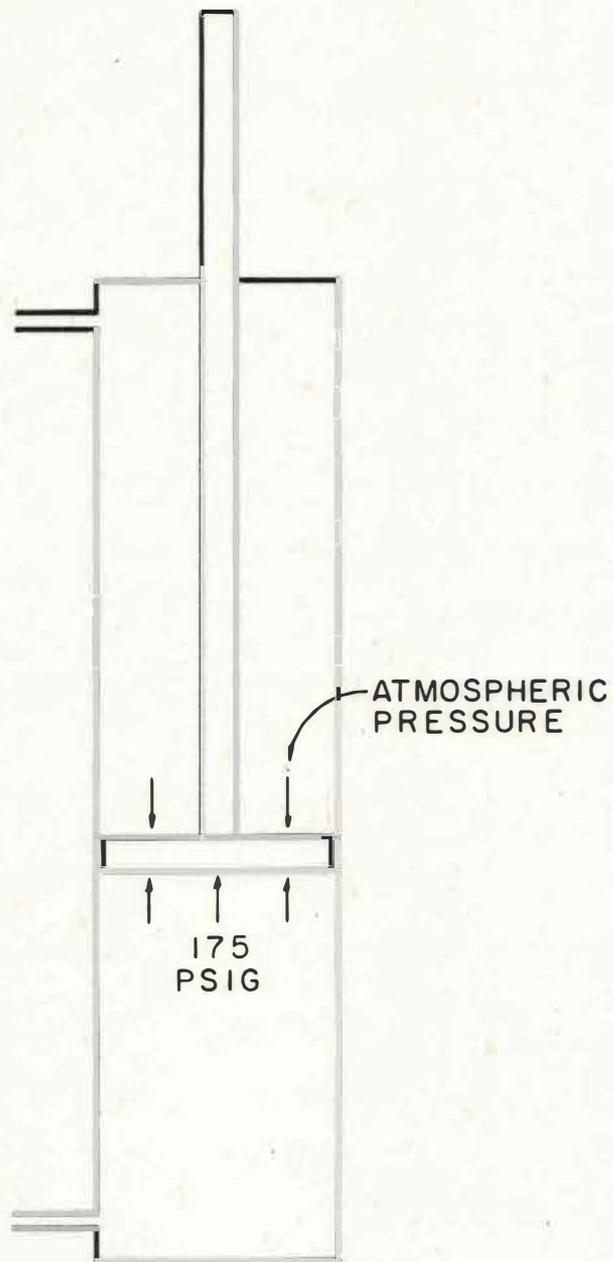
Fig 6.1. Unbalanced Air Cylinder

It has been mentioned previously that the auger has a tendency to screw itself into clay soils rather than cut and remove the material. When this occurs, the air on the bottom side of the piston has the pressure in the control system, 175 psi, and trying to counteract the unwanted downward movement by using the control valve reduces the pressure on the top side of the piston to atmospheric pressure, as shown in Fig 6.1. This unbalanced condition

can be dangerous. Any failure of the auger or connections will allow a rapid movement of the drill in an upward direction, stopping abruptly at the end of piston travel. This could damage the Mobile drill and cause injury to the drilling crew. By using a positive displacement system, the problem of unwanted downward movement would be minimized and the possibility of sudden upward movement eliminated.

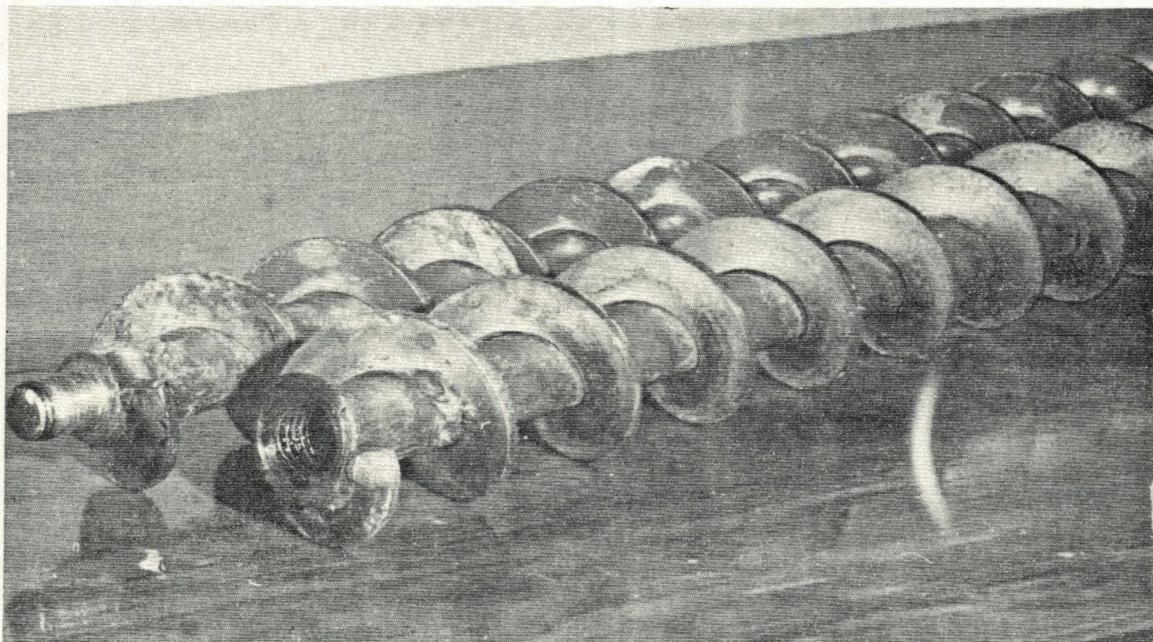
Fig 6.2. Flared Shoulders of Threaded Connections

Although the auger performance was satisfactory when new, several undesirable effects appear after nominal usage. It becomes obvious that the auger is not made to be used with a large drill. The applied torque causes the shoulders of the threaded connections to flare out, as shown in Fig 6.2. This condition creates two serious problems:

- 1) the auger flight ceases to be continuous, and
- 2) the alignment of the auger sections is not straight and enlargement of the hole occurs.

In relation to these problems a moderate degree of success was accomplished by placing washers between the shoulders of the auger sections. With the threaded connection, it is not possible to use the reverse gear to

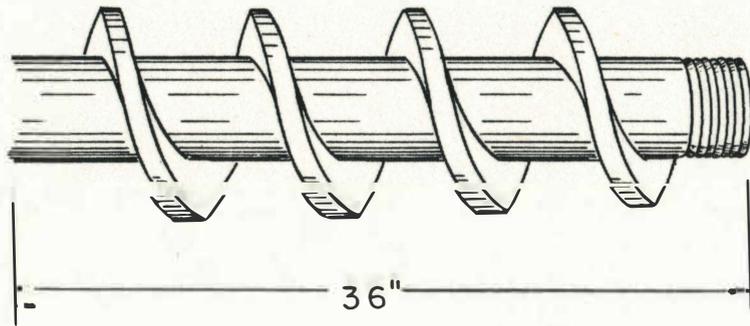
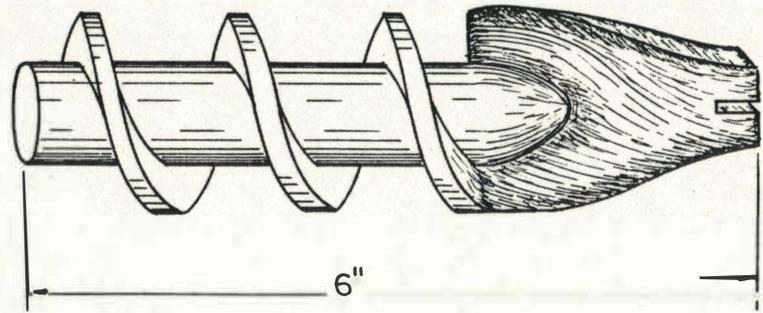
Fig 6.3. Spare Bit

The auger pieces are furnished in 3 foot and 3 1/2 foot lengths. The 3 1/2 foot sections contain the fish-tail bit. Rock is extremely detrimental to the bit, and it is necessary to replace the entire 42 inch section when the bit is ruined by rock. It is suggested that the manufacturer produce bits on auger lengths of 6 inches, as shown in Fig 6.3, thereby reducing the expense and allowing spare bits to be carried. The lead section of auger is subject to the most intense abrasion, therefore, it is desirable to rotate auger sections to obtain uniform wearing.
