USE OF ASPHALT MILLINGS IN SUBBASE APPLICATIONS

OKLAHOMA DEPARTMENT OF TRANSPORTATION

FINAL REPORT
(Item 2112: ORA 125-5545)

School of Civil Engineering
and Environmental Science
The University of Oklahoma
Norman, Oklahoma 73019

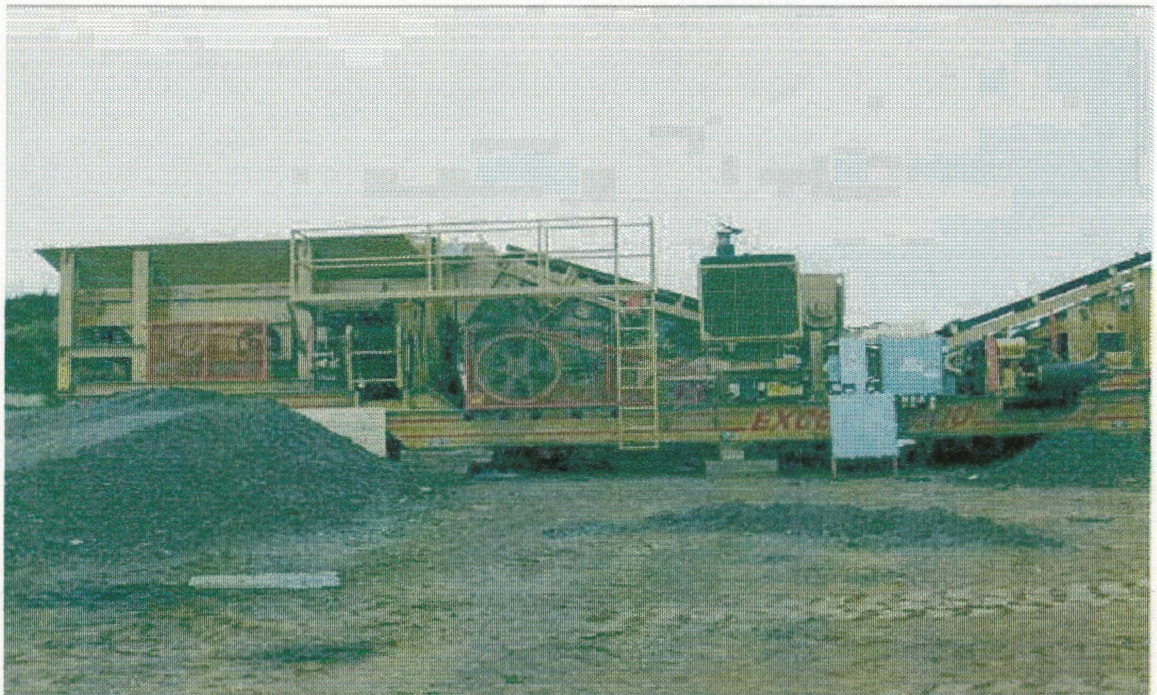
Figure 2.1 Portable Stationary Plant

- **Cold Process Recycling of Millings:** Figure 2.1 shows a portable stationary plant for processing of raw millings. The plant consists of a crusher to reduce the oversize millings. The millings coming out of the crusher are sieved and then conveyed into a pugmill. An emulsion properly formulated for a specific intended use is added to the pugmill from a tanker truck (Figure 2.2). Computerized methods are then used to control the exact amount of emulsion required (Figure 2.3).

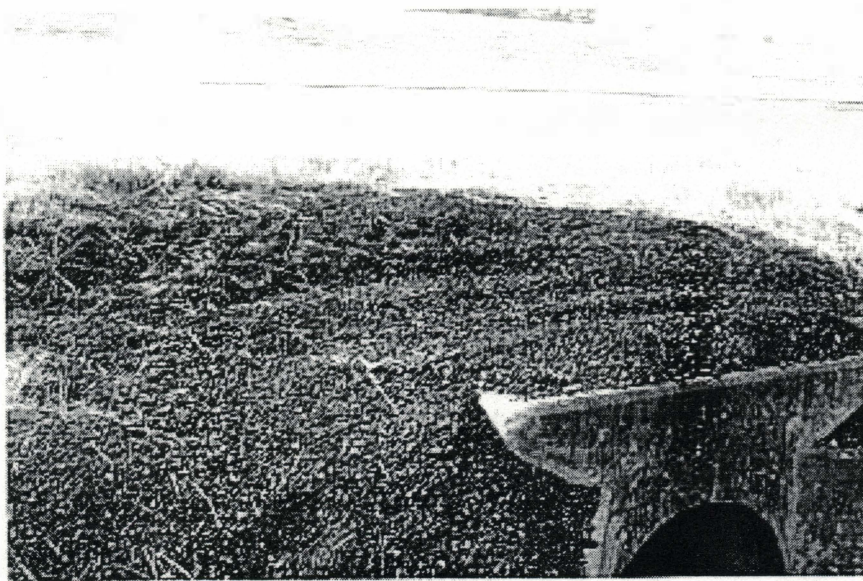
In this Division, the millings have been mainly used in level-up/shoulder-up operations and in the treatment of under guardrails. It was estimated that about 85 - 90 percent millings in this Division are used in shoulder-up operations. This Division has used less than five percent millings for erosion control measures; some of these applications have been successful, while others have had problems. The problems were created due to lack of cohesion, allowing the millings to float away. Figure 3.1 shows the

Figure 3.1 Untreated Millings in Erosion Control near I-40 in Sequoyah County

use of untreated millings in erosion control near I-40 on Sequoyah County. Recent observations have shown that a specific type of grass called 'Bermuda' grass grows well in asphalt millings. Figure 3.2 shows the use of untreated millings in shoulder applications on I-40 in Sequoyah County. In the right corner of Figure 3.2, growth of grass is seen on the shoulders which has enhanced the stability of shoulder. It was noted that prior to using millings as base or a subbase, stability and strength tests need to be carried out. The maximum size of millings recommended by this Division for base/subbase operations is two inches and for shoulder operations it is one and half inches.

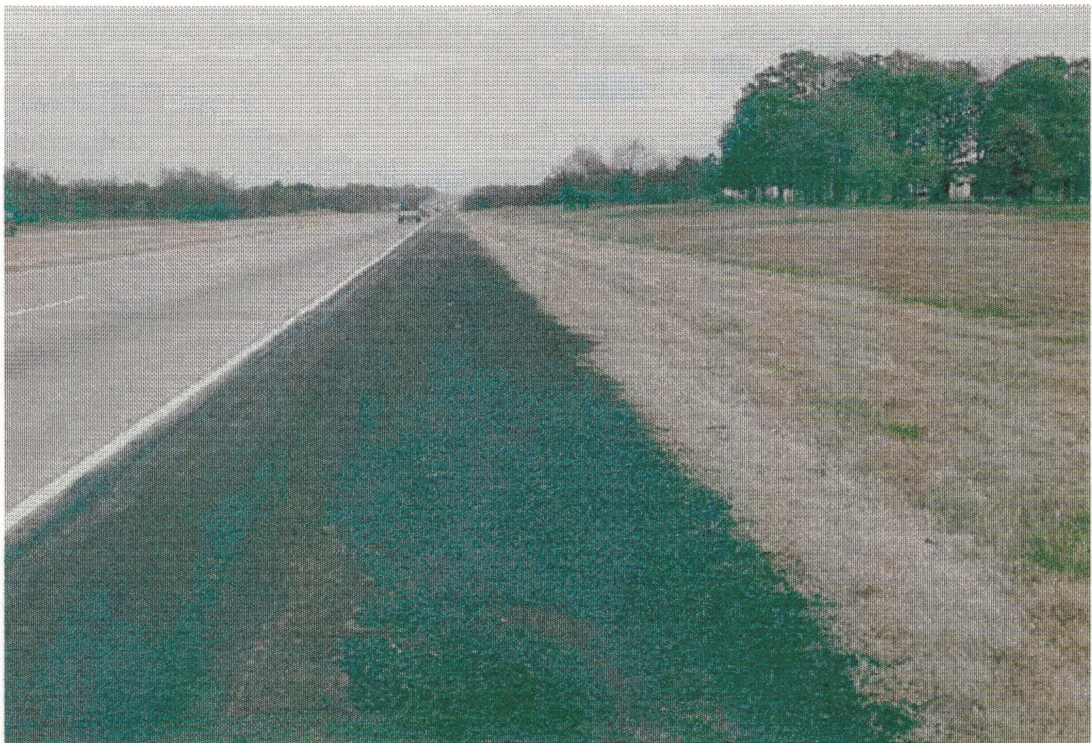
Figure 3.2 Untreated Millings for Shoulders on I-40 in Sequoyah County

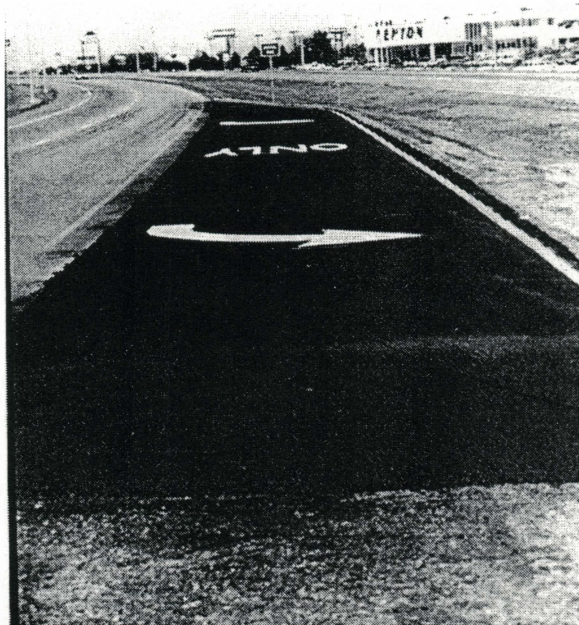
Figure 3.3 Millings Used as Base Material on McAlester, US 69 By Pass

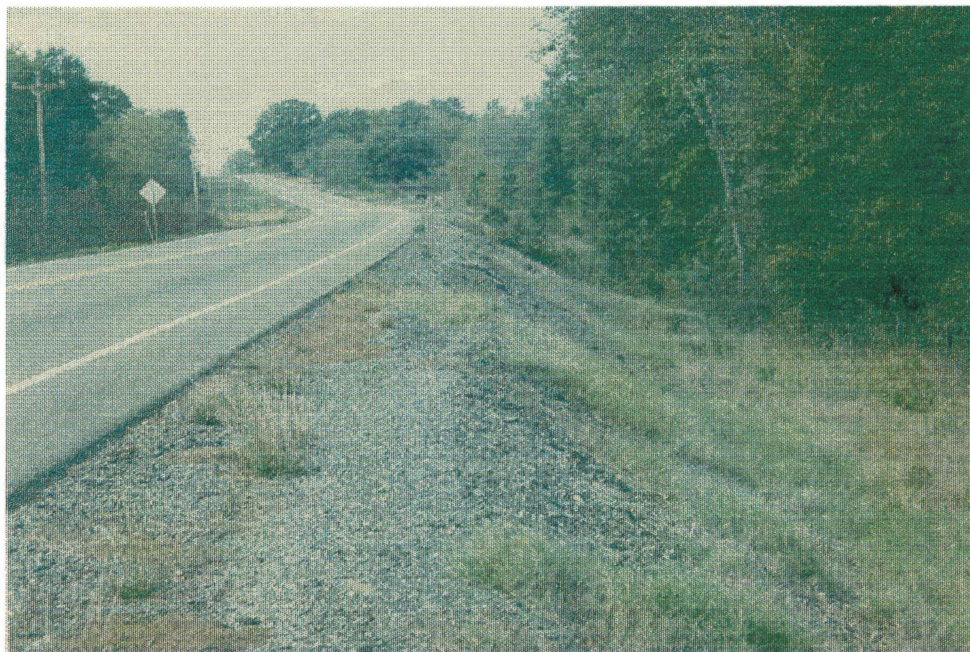
Figure 3.4 Millings Used for Shoulders on SH 3 near Farris

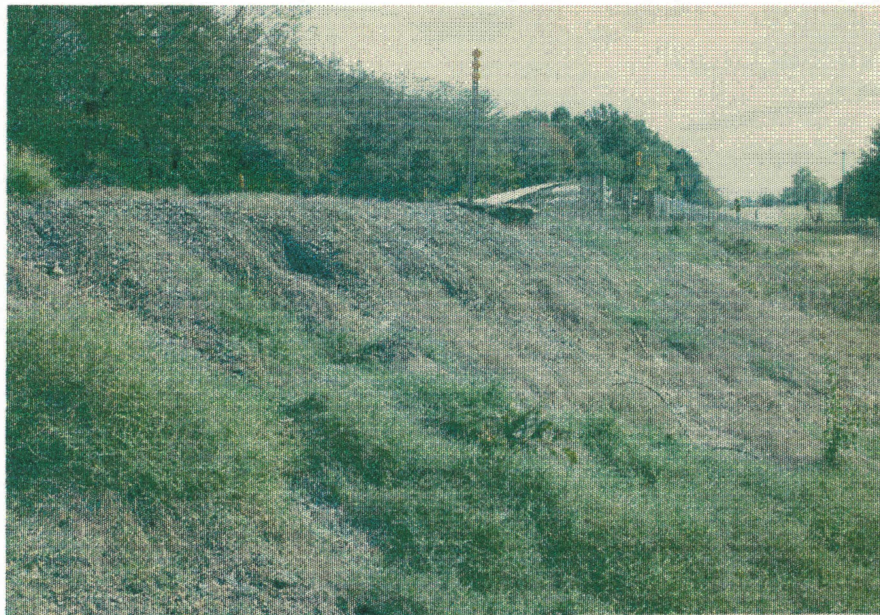
Figure 3.6 Millings Used for Erosion Control on SH 3 near Farris

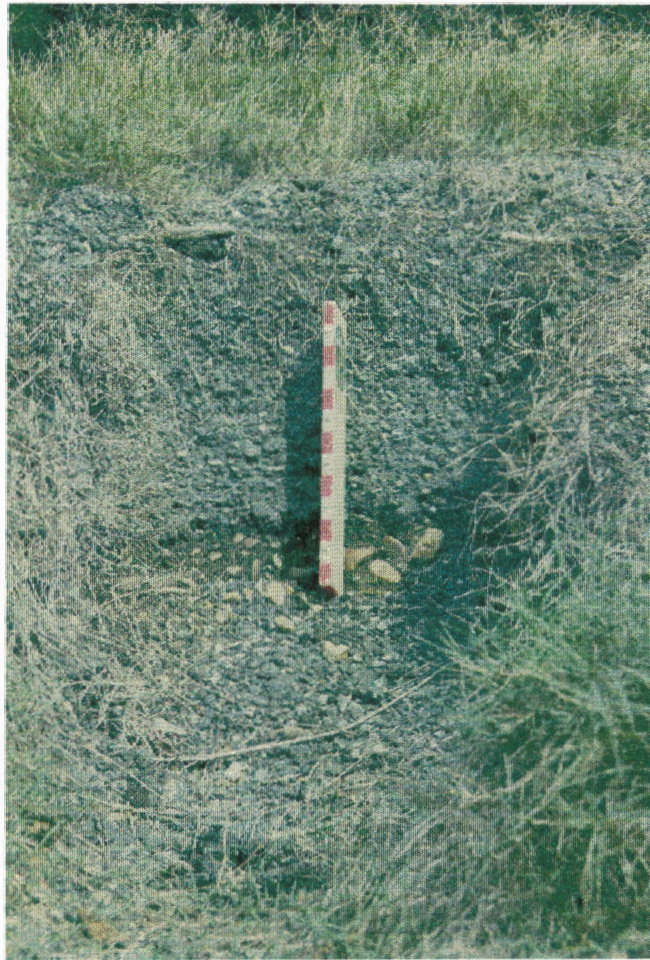
Figure 3.7 Millings Used for Erosion Control on SH 3 near Farris

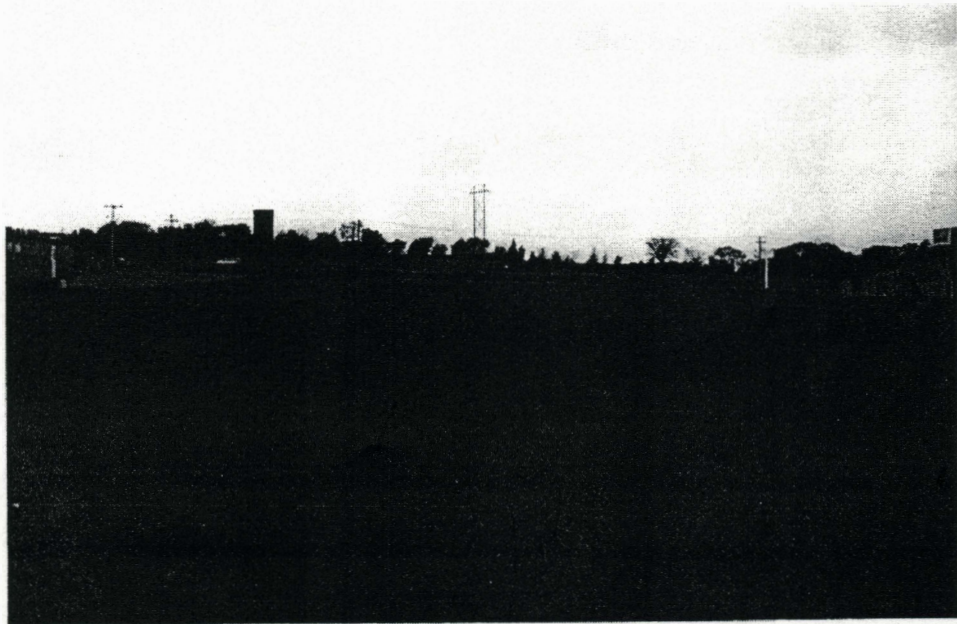
Figure 3.8 Millings Used in the Parking Lot of the EXPO Center in Purcell

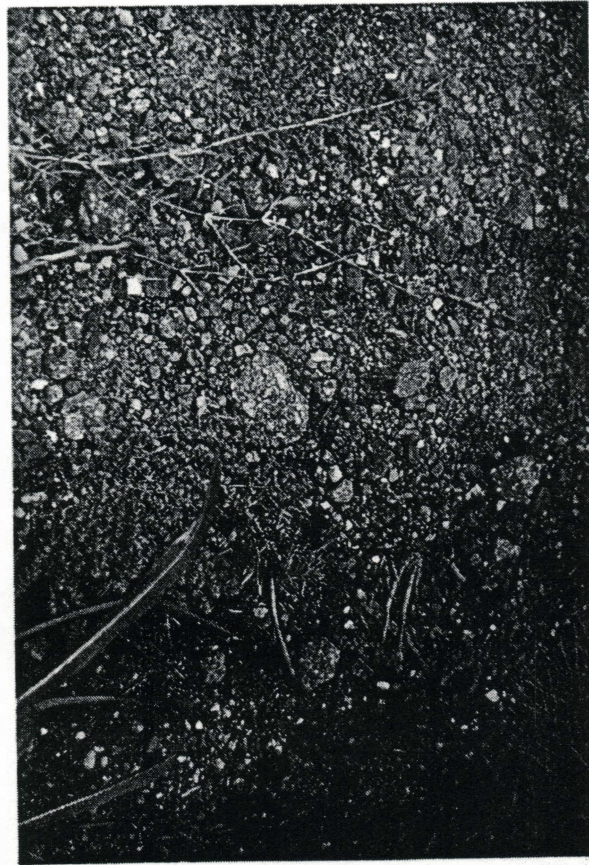
example of use of millings as ditchliner on SH 18 in Payne County can be seen in Figure 3.9 while Figure 3.10 shows the use of millings as shoulders on the same highway. However, in both the applications the millings did not stay in place, thereby leading to failures. There was wide diversity in the preference for the use of millings in different applications. Some Counties prefer to use millings in shoulders, while some others prefer to use them for erosion control and other applications.

Figure 3.9 Attempted Use of Millings as Ditchliner on SH 18 in Payne County

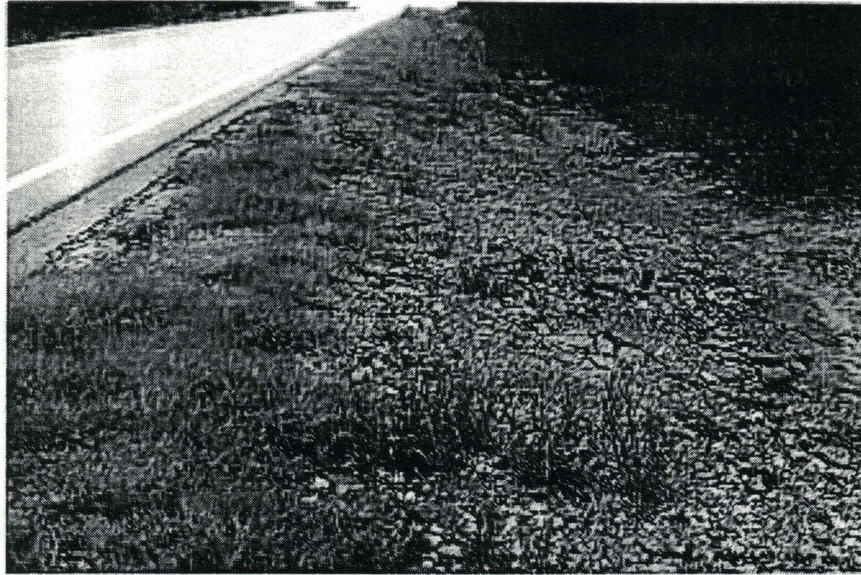
Figure 3.10 Millings Used as Shoulders on SH 18 in Payne County

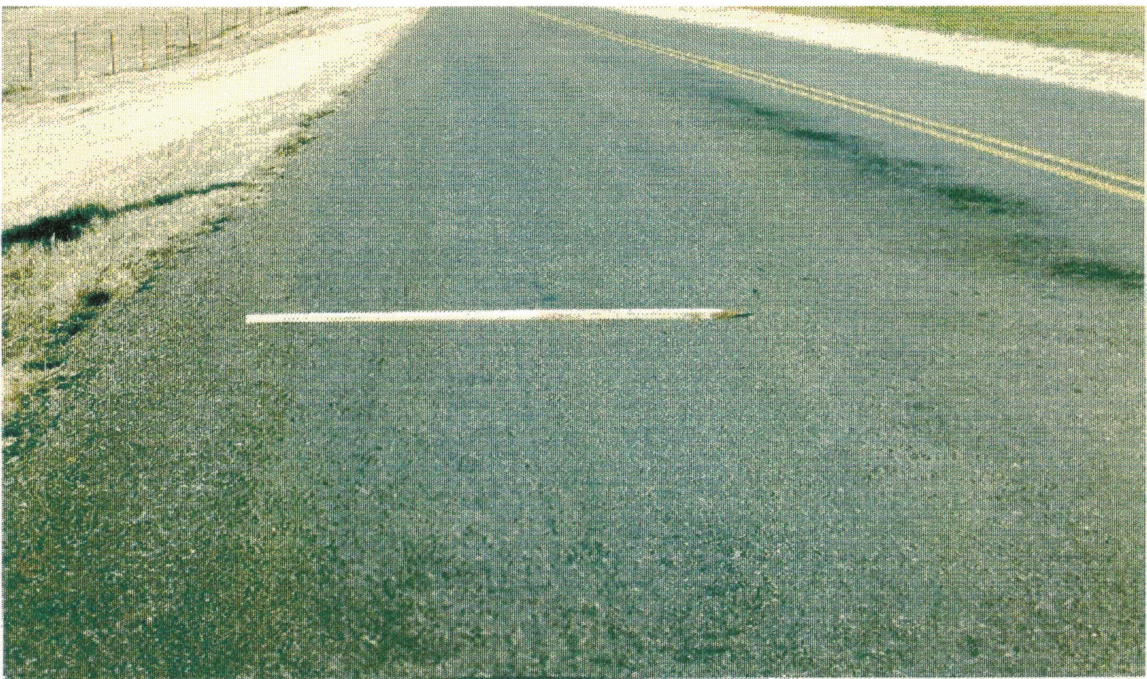
Figure 3.12 75mm Thick Surface Course on SH 183 A near Bessie

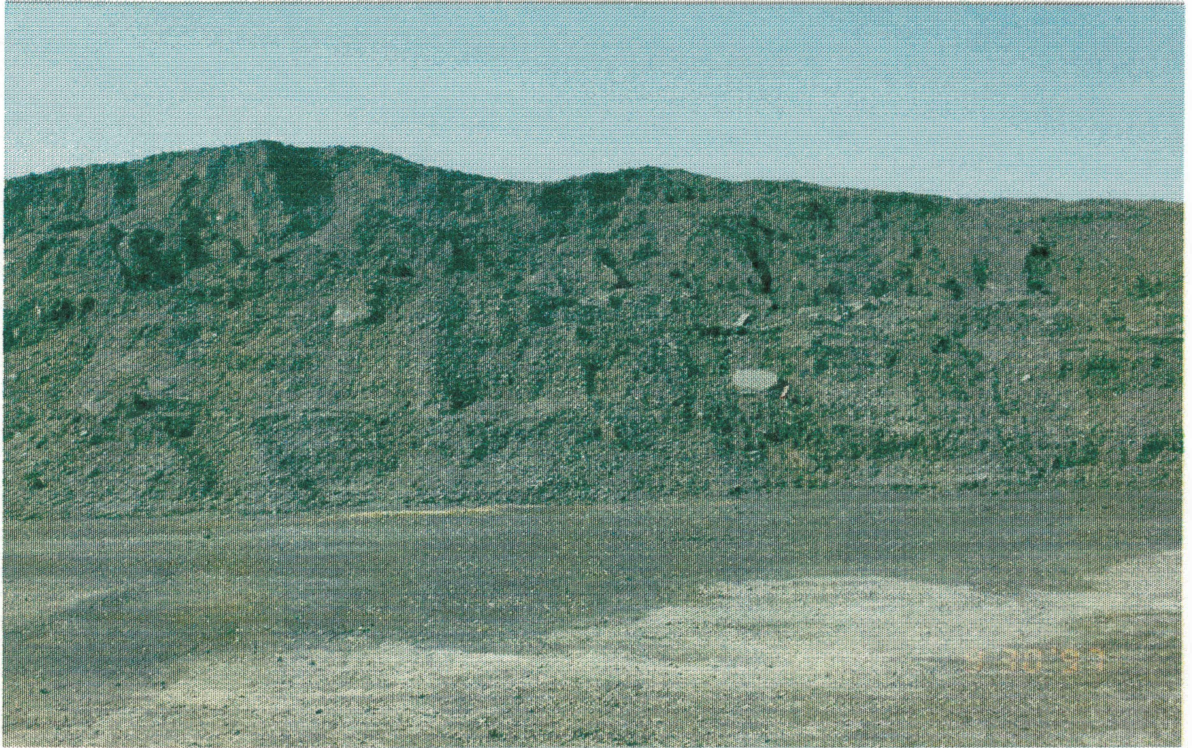
millings were produced, all of which were generated during the milling operations on I-40. Figure 3.13 shows the stockpile of millings which were generated from the I-40 project. Presently the millings are stored for potential future use. It should be noted that the low volumes are primarily due to the absence of Interstate roads in this Division

Figure 3.13 Stockpile of Millings From the I-40 Project

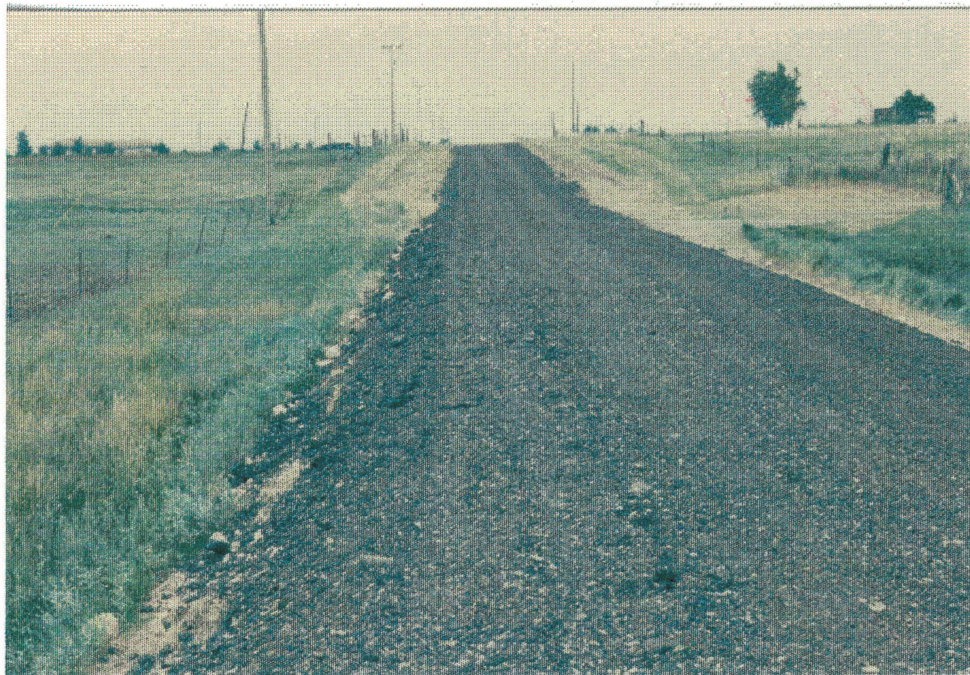
Figure 3.14 Millings Used as Base

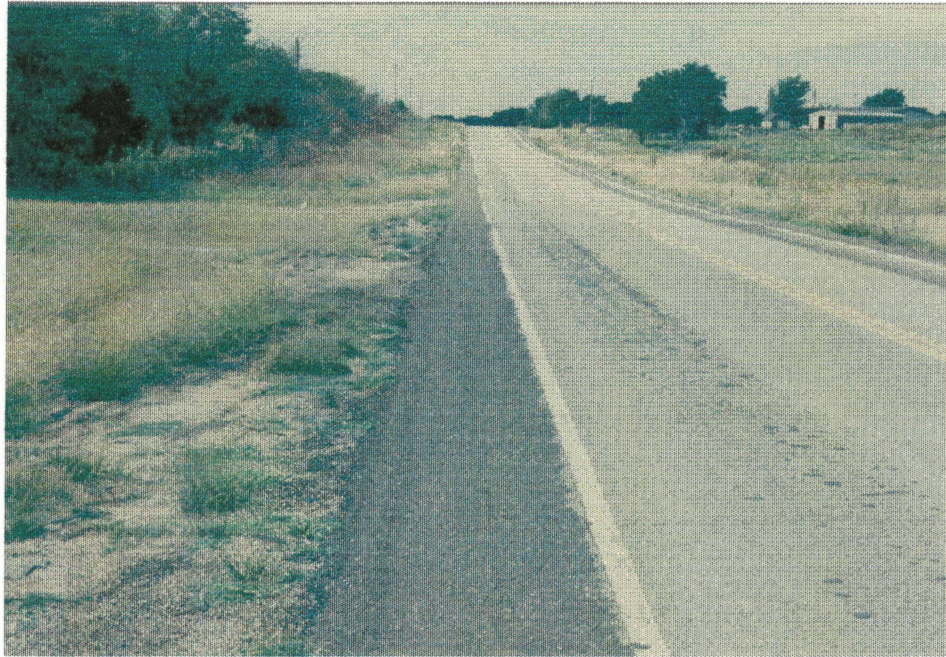
Figure 3.15 Millings Used as Shoulders from Chester to Fairview on US 60

a slight amount of drop off compared with the rest of the pavement. This may be due to rolling and lack of confinement during rolling compaction. Figure 3.16 shows the pneumatic compaction of processed millings on US 60 near Chester/Fairview. On the basis of its past experiences, Division VI prefers to use millings for widening, pavement layer and base/subbase construction because of good performance achieved so far.

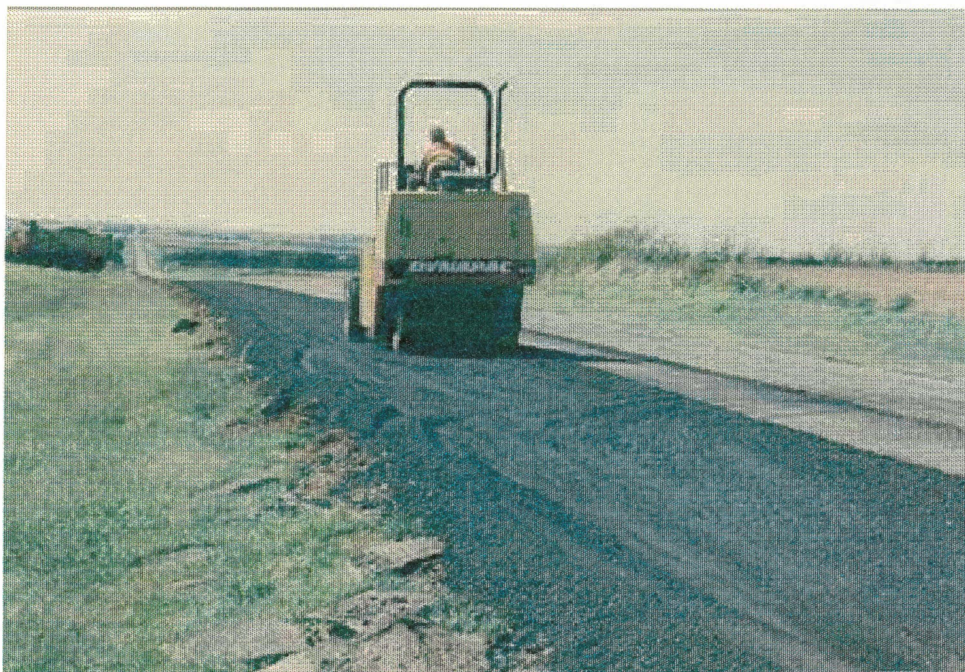
Figure 3.16 Pneumatic Compaction of Processed Millings on US 60

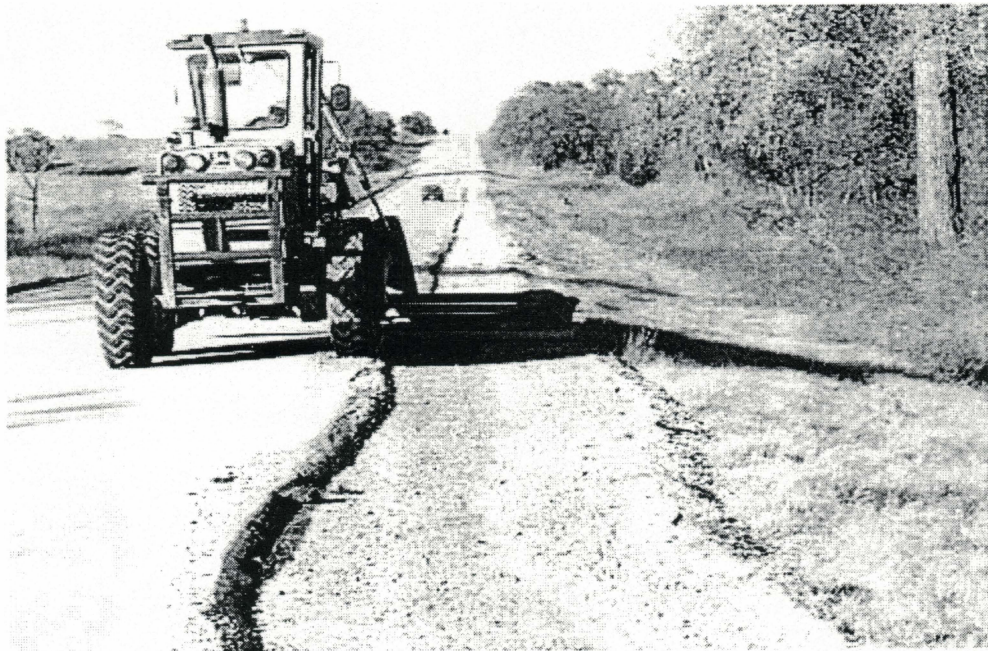
Figure 3.19 Trenching Operations for Shoulders on SH 18 in Pawnee County

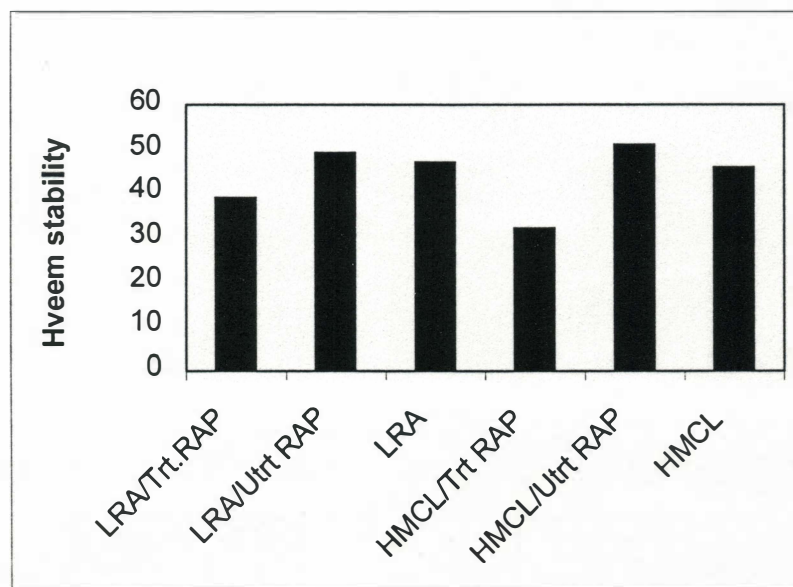
Hveem stability tests were conducted for the above six mixes. The values of Hveem stability for the McKinney test section shown in Figure I.1 suggest that untreated RAP blended with LRA and HMCL gave the highest value (51), while the lowest value (32) was observed for the treated RAP blended with HMCL. The reduction in the Hveem stability of treated RAP is attributed to the higher binder content in the mix.

Figure I.1 Hveem Stability Data for McKinney Test Section Materials

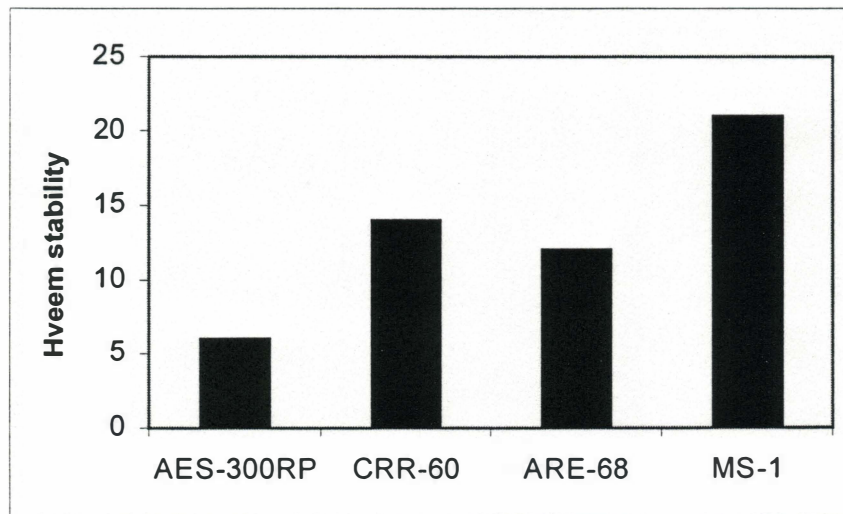
Figure I.3 Hveem Stability Data for Childress Test Section Materials.

Materials Used	Cost of finished mixture	Hveem stability value	Performance evaluation
RAP with 2 1/2 % AES-300RP	\$ 20.28/m ³ (\$15.21/cy)	6	NA
Rap with 3-3 1/2 % CRR-60	\$ 32.36/m ³ (\$24.27/cy)	14	NA
Rap with 3-3 1/2 % ARE-68	\$ 33.09/m ³ (\$24.82/cy)	12	Marginal success (rutting)
RAP with 3-3 1/2 % MS-1	\$22.80/m ³ (\$17.10/cy)	21	NA
