EVALUATION OF DURABILITY AND CORROSION BEHAVIOR OF ULTRA-HIGH
PERFORMANCE CONCRETE FOR USE IN BRIDGE CONNECTIONS AND REPAIR

A THESIS

CIVIL ENGINEERING

2019

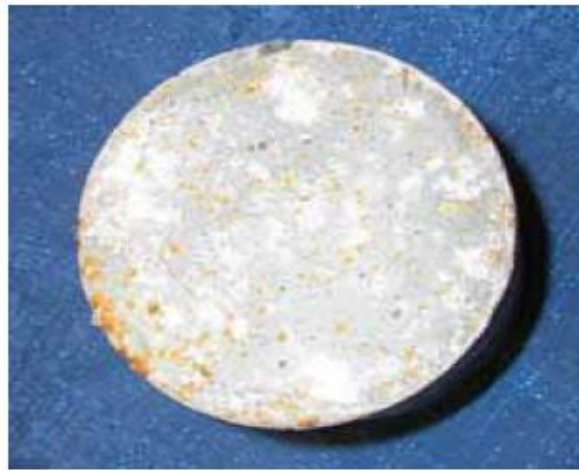
Figure 1: Graybeal (2006) Chloride Ion Specimen Post-Testing

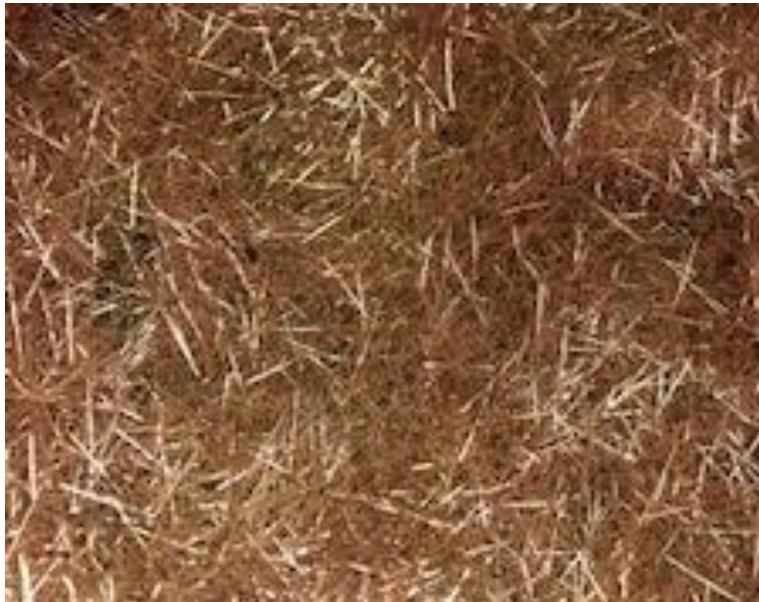
Figure 2 shows the 0.5 in. steel fibers used in both the J3 and Ductal[®] mix designs.

Figure 2: 0.5 in. Steel Fibers

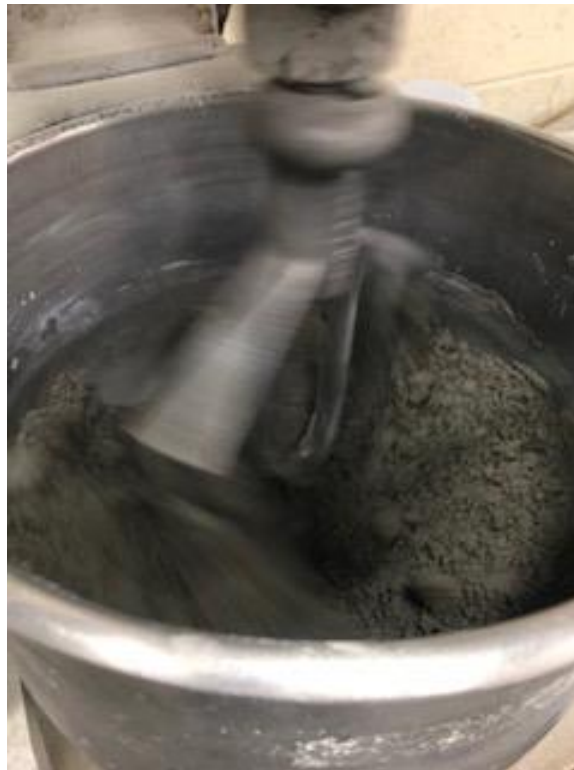
Figure 3: J3 before “Break Over”

would normally be completed, the mix was not fully saturated or “broken over” and therefore some of this water that was taken out, along with some additional HRWR, was added back in and mixed for an additional 5 minutes. An example of the J3 UHPC alternative before “break over” and at the end of mixing can be seen in Figures 3 and 4. In addition to J3, the Ductal[®] mix used for comparison was also prepared using the high shear mixing procedure detailed above. The main differences for the Ductal[®] mix being that the dry constituents come already pre-mixed, and that it took over 60 minutes to reach Ductal’s[®] “break over” point, but no additional water was added, only an additional small portion of HRWR.

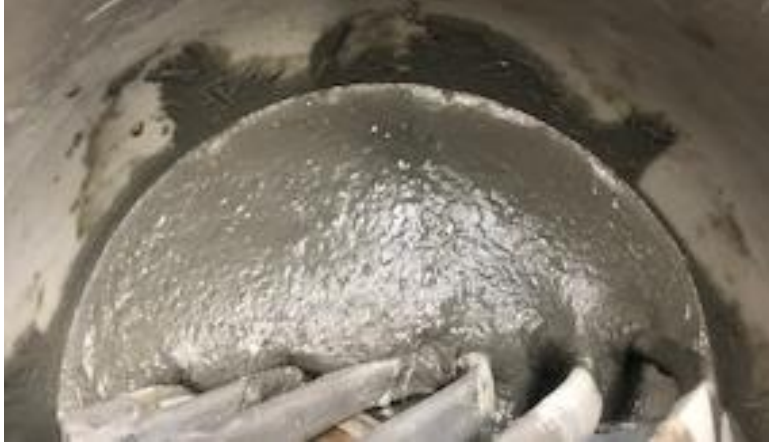
Figure 4: J3 after “Break Over”

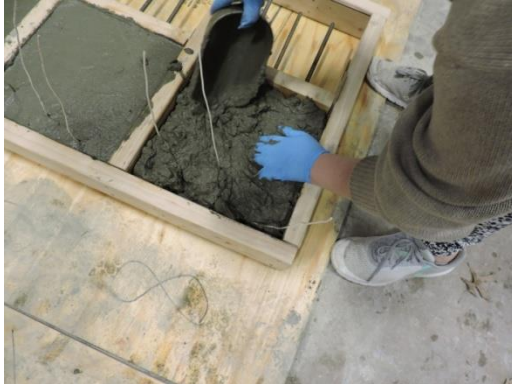
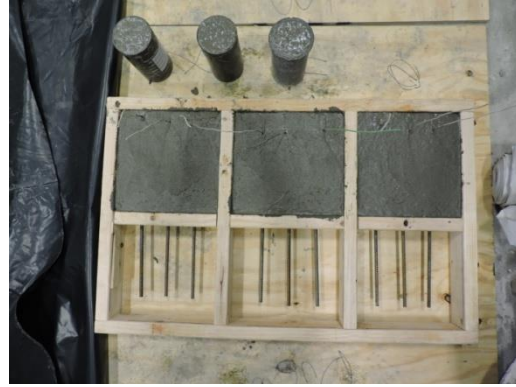
Figure 5: First Half of Small-Scale Corrosion Specimens

After all mixing procedures, except for Phoscrete which had no need to be finished, all specimens were cast into their appropriate molds for each test, finished with a (wetted) trowel, and cured according to the curing procedures outlined in the following sections. All curing procedures are variations on ambient air curing methods, because as described in Sections 2.2.1 and 2.2.2, though ambient air curing is the most vulnerable to durability issues, it is also the most reflective of what to expect in the field, and specimens should still produce more than adequate results no matter the curing method. Additionally, if the results are indeed sufficient for this curing method, they would only improve using other curing methods. Photographs of all of the cast specimens are shown in Figures 5-8.

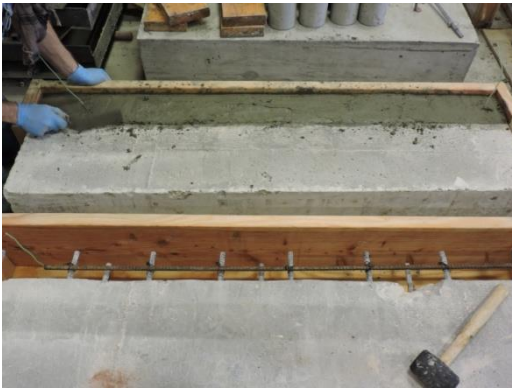
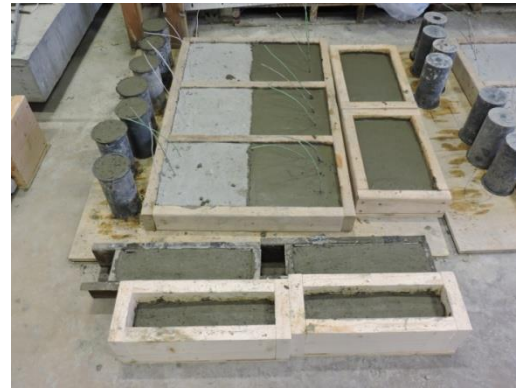
Figure 6: AA Large-Scale Corrosion Specimen (left) and Durability Specimens (right)

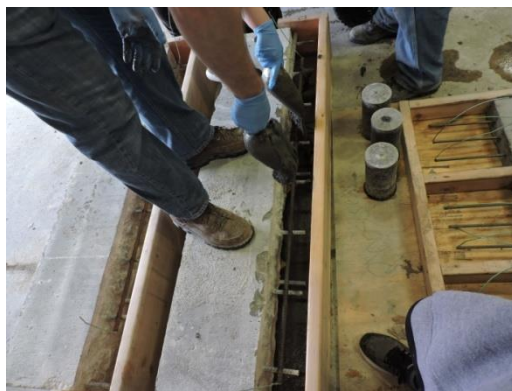
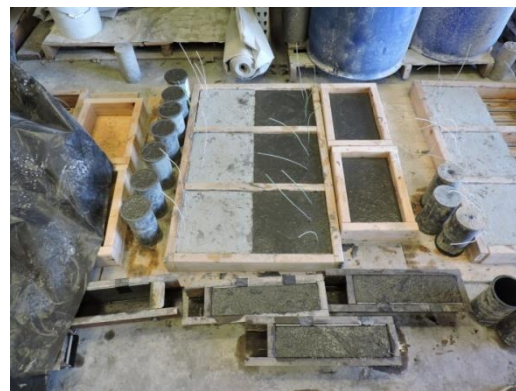
Figure 7: Ductal[®] Large-Scale Corrosion Specimen (left) and Durability Specimens (right)

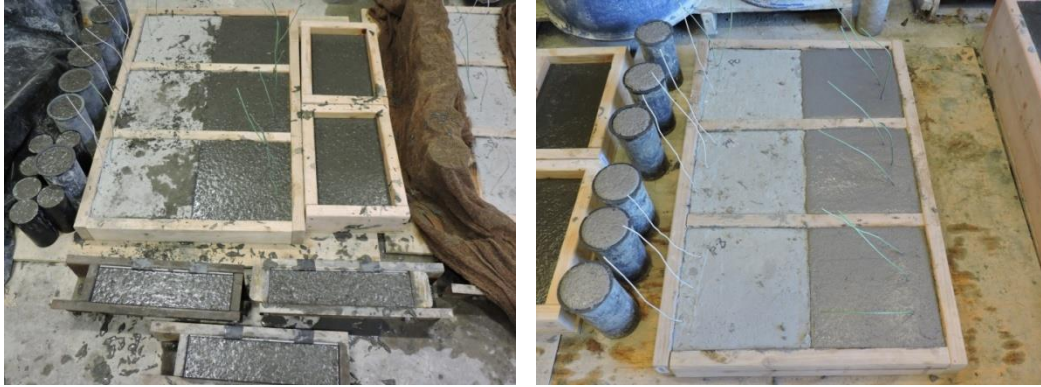
Figure 8: J3 Durability Specimens (left) and Phoscrete Durability Specimens (right)

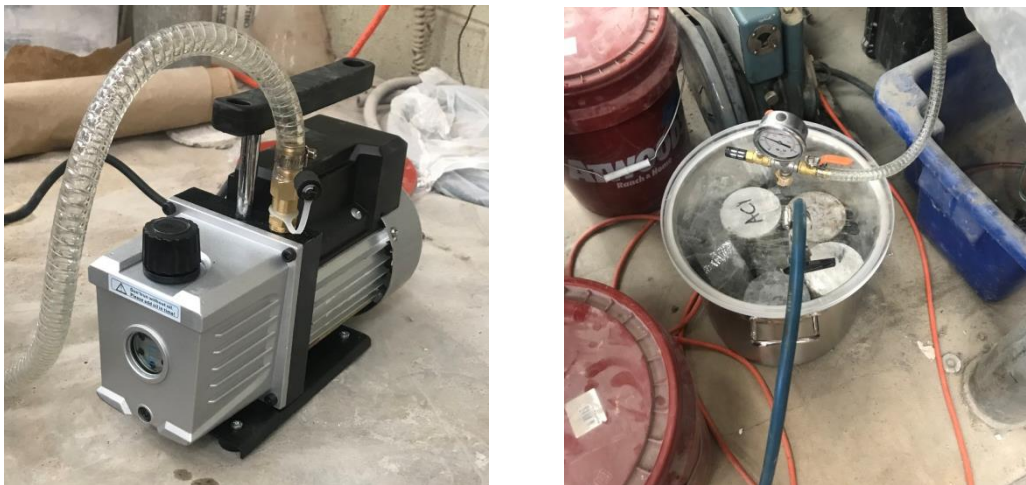
Figure 9: Vacuum Pump (right) and Desiccator (left)

One day before testing, specimens were placed in a vacuum desiccator with a pump system capable of maintaining vacuum pressure of less than 50-mm Hg. The vacuum pump was run on the dry specimens for 3 hours before pumping deionized water in and running the vacuum desiccators for another hour with the specimens completely submerged. After this, the pump was turned off and left sealed for 18 hours, at which time testing could begin. The pump system used is shown in Figure 9.

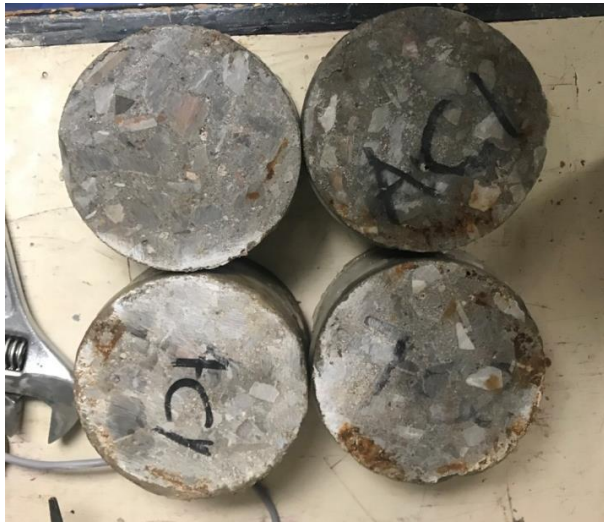
The visual state of the test specimens after 28 day testing are shown in Figure 11 to show how much surface corrosion occurred for each mix design due to testing, with minimal surface corrosion occurring on the ODOT AA specimens and little to no surface corrosion occurring on the Ductal[®] and J3 specimens.

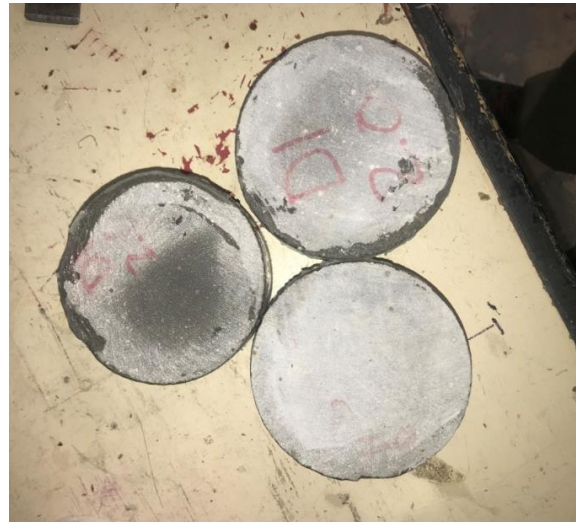
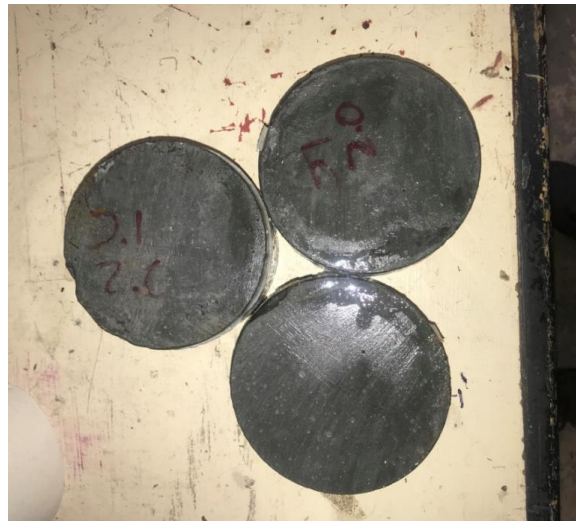
Figure 11: State of Chloride Ion Penetration Testing Specimens After 28 Day Testing for

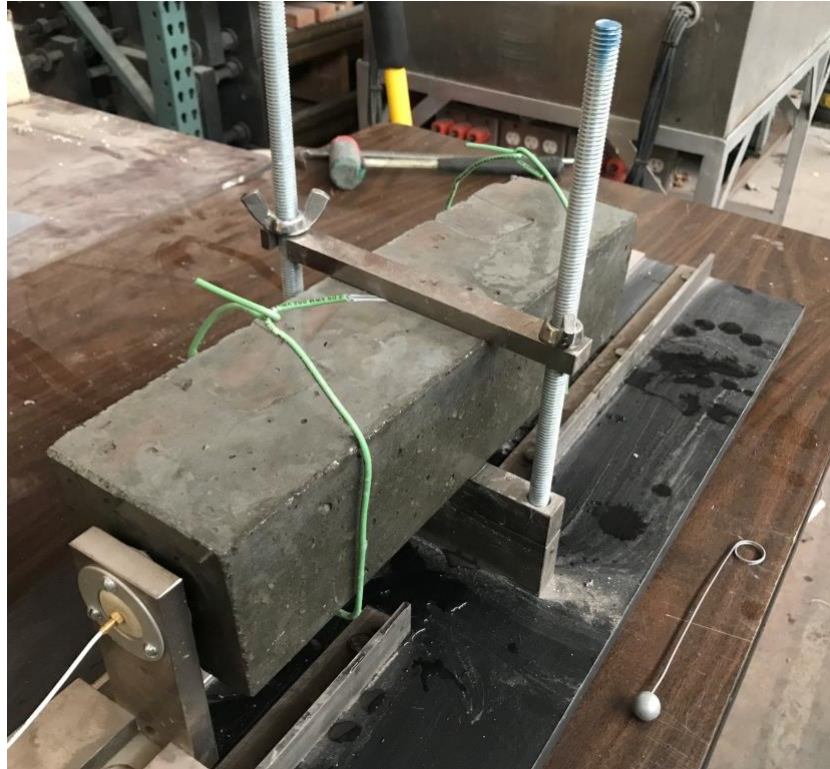
Figure 12: Freeze-Thaw Specimen in Testing Machine

These frequencies were measured with a frequency meter called an Emodumeter, which works by creating a mechanical impact with a small metal ball on one side of a specimen and measuring how long it takes for the vibrations to be felt by a sensor located on the other end of the specimen. This type of measurement is effective because it indicates the internal structure of the specimen (i.e., if a large amount of microcracks are present, it will take longer for the impact to be felt). The decision to only measure RDM was made because while RDM can be unreliable (due to ambient air curing methods resulting in high levels of un-hydrated cement in UHPC, as discussed in Section 2.2), mass loss and length change can be even more unpredictable, changing dramatically with any moisture level change. Figure 12 shows a specimen being tested in the Emodumeter while Figures 13 and 14 show a typical transverse frequency initial measurement and resulting final output, respectively.

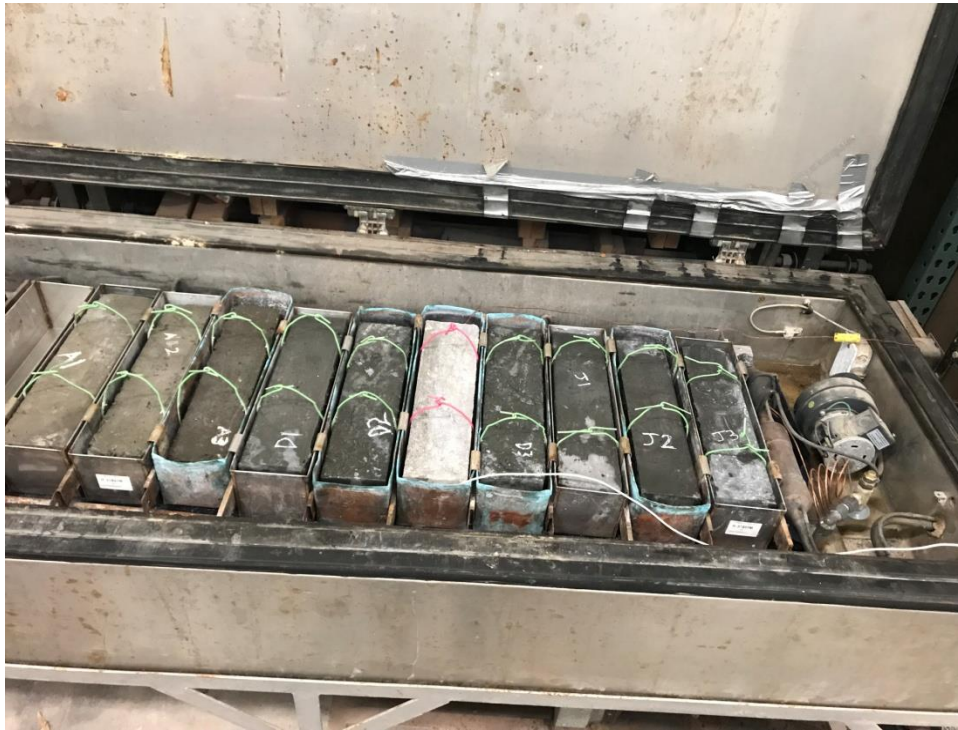
Figure 15: Freeze-Thaw Specimens in the Testing Chamber- Cycle 0

The freeze-thaw specimens prior to testing are shown in Figures 15 and 16. All specimens had limited surface deterioration at this point in testing, and their starting frequencies were recorded to be used as the original value for finding each specimen's RDM values throughout testing.

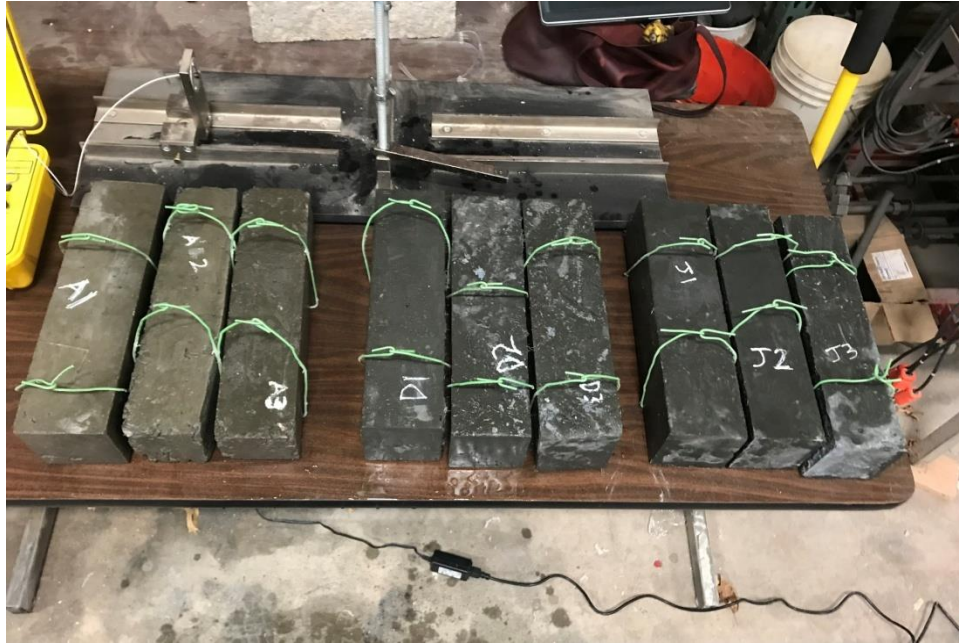
Figure 16: Condition of All Freeze-Thaw Specimens- Cycle 0

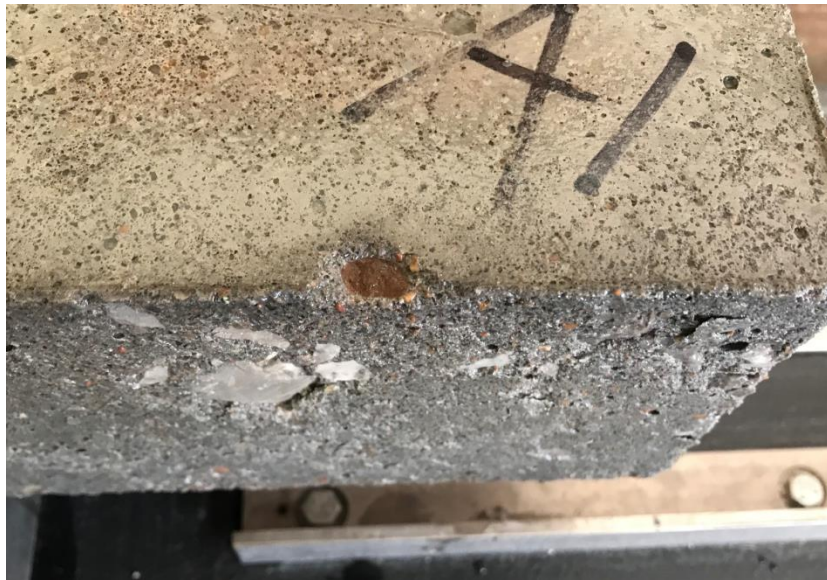
As evident in Figure 17, after 350 cycles significant deterioration of the ODOT AA specimens could be seen, including chipping of edges and wearing away of the surface to the point of coarse aggregate showing through.

Figure 17: Deteriorated State of an AA Freeze-Thaw Specimen- Cycle 350

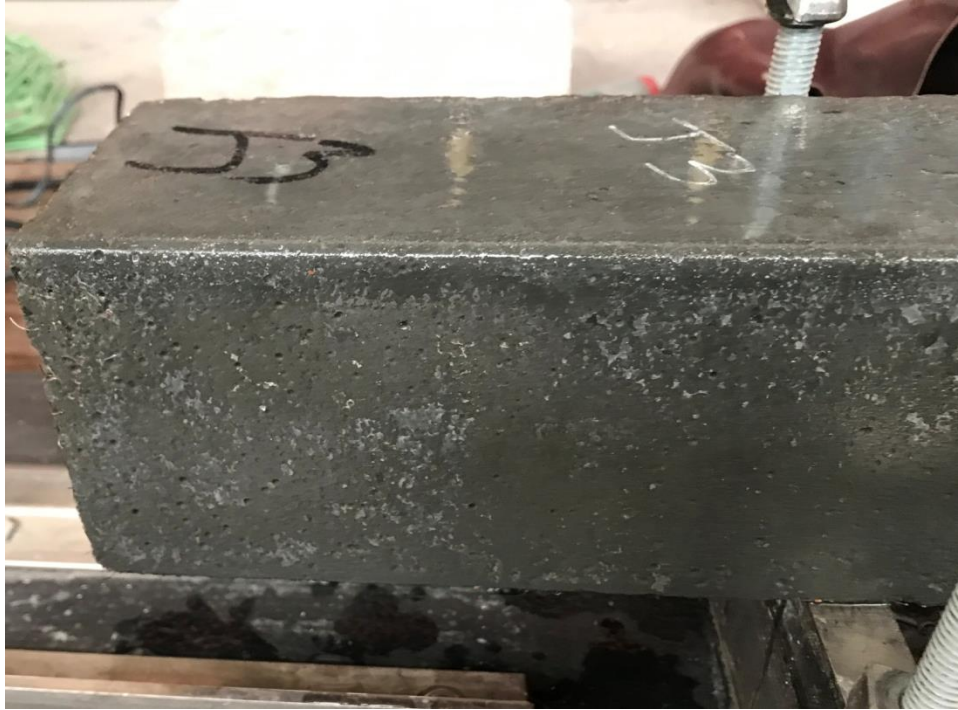
Figures 18 and 19 show that the Ductal[®] and J3 specimens show significantly less deterioration, with only small holes forming along their surfaces for the majority. The exception being a singular hole that formed between cycle 285 and cycle 315 in Specimen D1 (as seen in Figure 20) which triggered a spike in RDM for the specimen due to water now being able to penetrate farther into the specimen and hydrate more of the unhydrated cementitious materials within the specimen.

Figure 19: Deteriorated State of a J3 Freeze-Thaw Specimen- Cycle 350

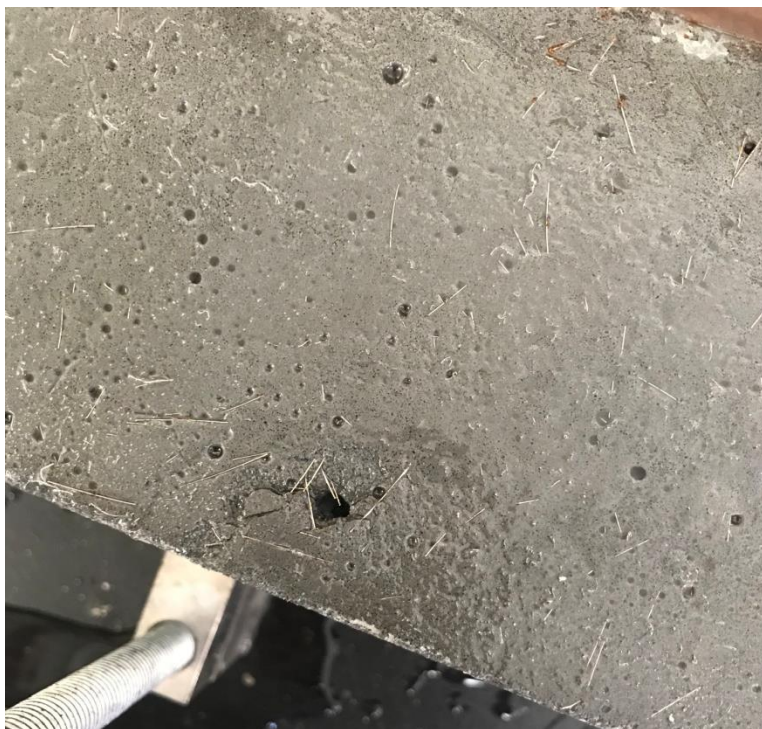
Figure 20: Hole Formed on the Side of Ductal® Freeze-Thaw Specimen- Cycle 315

However, though the Ductal[®] specimens only experienced the expected minimum amount of surface spalling, each of the three Ductal[®] specimens did experience a significant amount of surface corrosion of the steel reinforcing fibers on all four sides of each specimen, as shown Figure 21. At the conclusion of testing, all three J3 specimens had also begun to show this kind of surface corrosion of fibers, but to a significantly lesser extent. This is significant because very similar corrosion patterns were seen by Ductal[®] and J3 in scaling testing, as discussed in Sections 4.3.3 and 4.3.4, and could be indicative of J3 having better fiber suspension during concrete setting. It should be noted, however, that surface corrosion of fibers is expected for UHPC structures in highly abrasive environments like those simulated by freeze-thaw cycling and scaling resistance testing, and in no way affects the overall strength or durability of the UHPC. This is unlike the corrosion of internal reinforcing bars through contact with concrete, UHPC or otherwise, which is extremely detrimental to the strength and durability of the structure and is therefore the focus of Chapter 5. Instead, how well a specimen withstood freeze-thaw cycling is determined by the state of its internal structure, as represented by final RDM values.

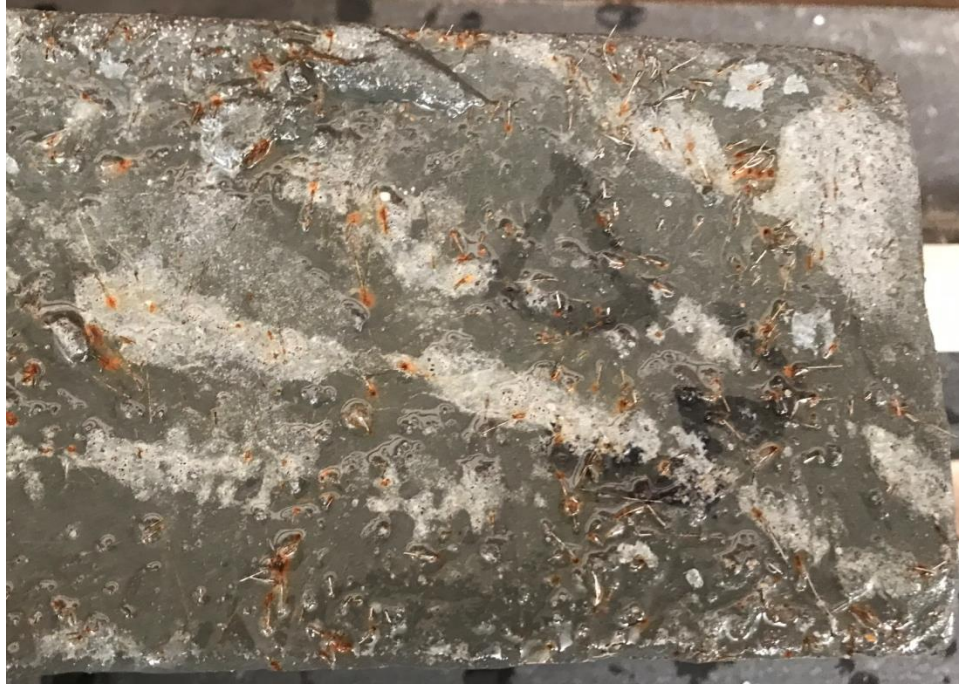
Figure 21: Surface Corrosion of Ductal[®] Freeze-Thaw Specimen- Cycle 350

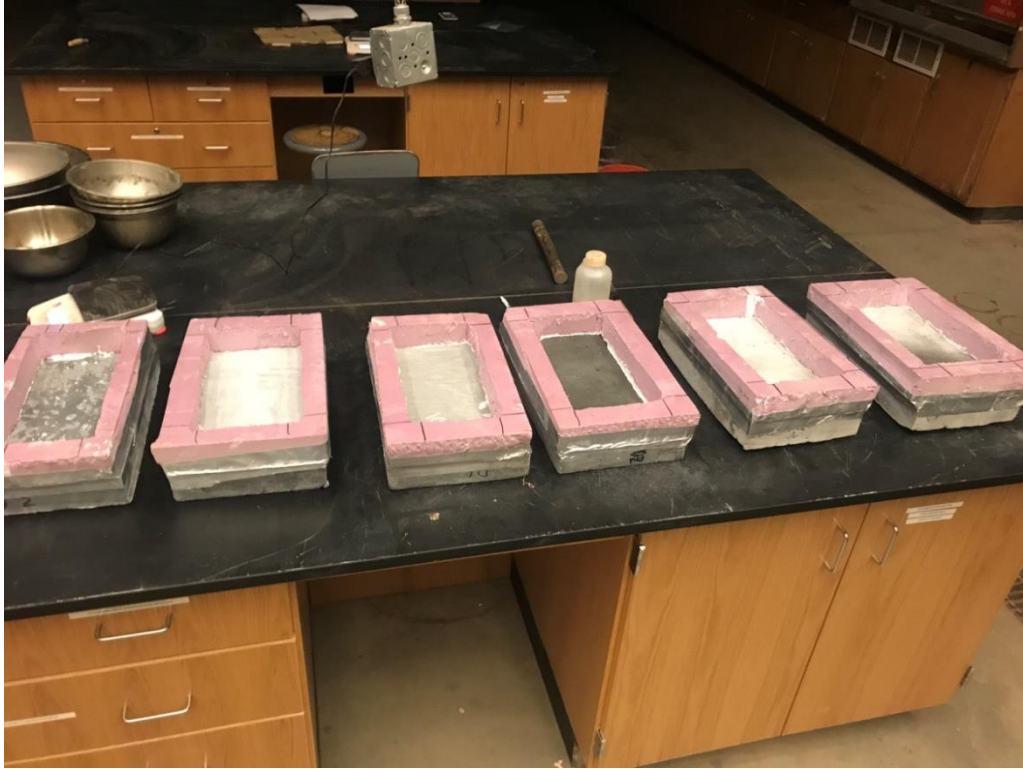
Figure 23: Condition of Scaling Specimens- Cycle 0

Scaling resistance was tested in accordance to ASTM C672-12 using two specimens for each of the UHPC mix designs, J3 and Ductal[®], and two for the conventional ODOT Class AA concrete mix, for a total of 6 specimens. All scaling specimens were 9 in. x 15 in. x 2 in. Scaling resistance testing was done after 28 total days of curing: 14 days of moist curing, done in the same fashion as that of the freeze-thaw specimens, and 14 days of ambient air curing, in accordance to ASTM 672-12. This testing was conducted by first covering each specimen with a ¼ in. layer of a calcium chloride and water solution containing 4 g of calcium chloride to each 100 mL of solution. Each specimen had a 1 in. x 1 in. foam boarder epoxied all the way around its outside edge prior to testing to act as a container for the testing solution, as shown in Figure 23.

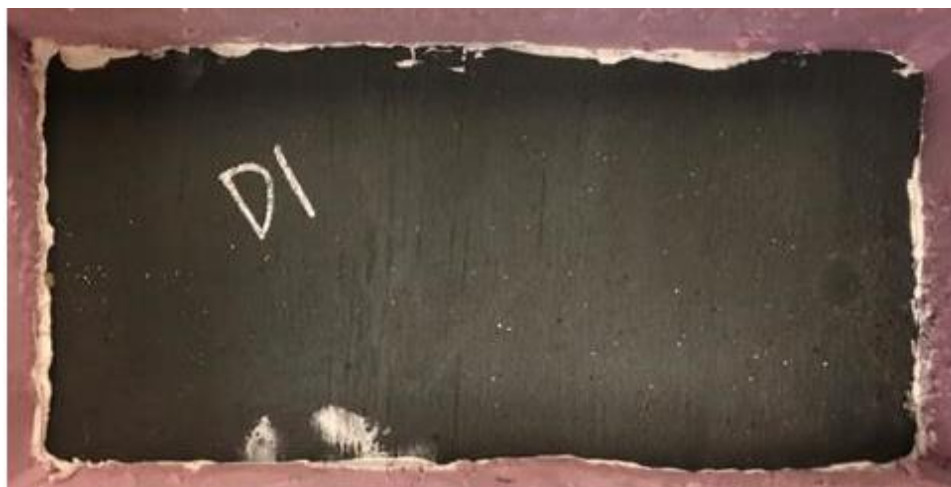
Figure 25: Visual Corrosion of Steel Fibers on Ductal[®] Specimen- 25 Cycles

steel fibers along its exposed surface, with slight dusting and pocketing visible. Little to no dusting or pocketing, as well as limited surface corrosion, was observed on the other Ductal[®] specimen or either of the J3 specimens.

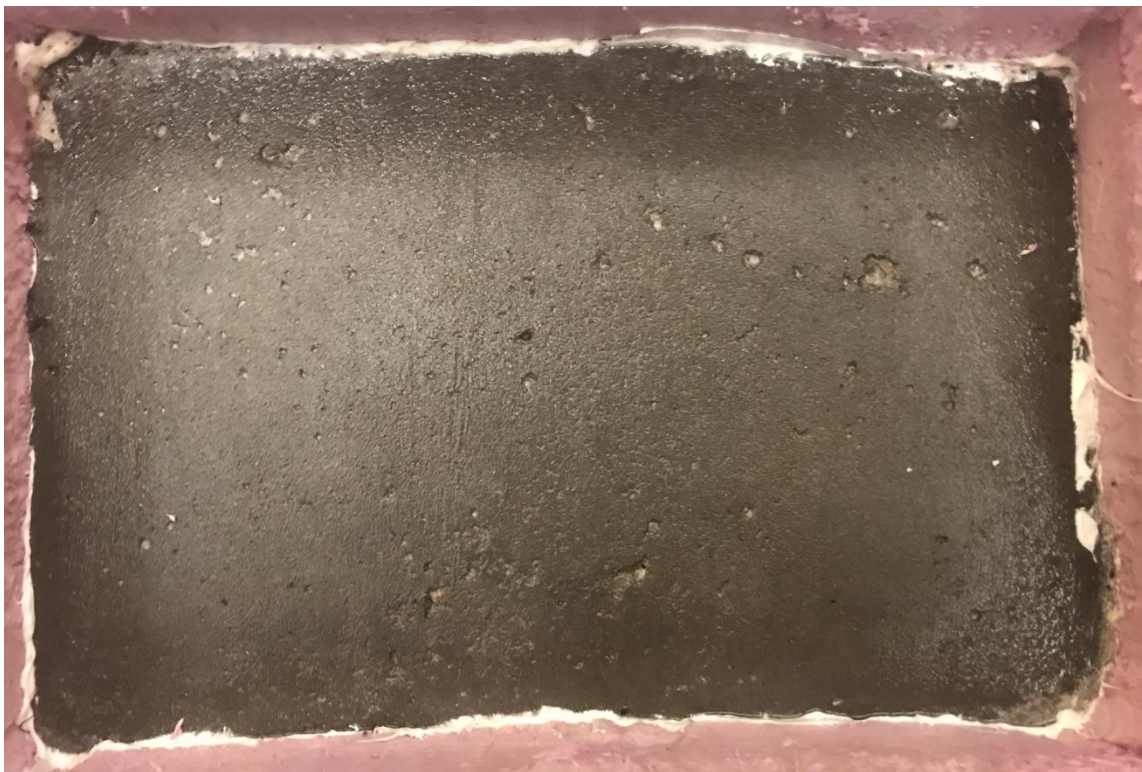
At 50 cycles, the specimens were in the states shown in Figure 26. Since 25 cycles, the pocketing of both of the ODOT AA specimens had increased a considerable amount, and pocketing had begun to occur on specimen D1, as shown in Figures 27 and 28, respectively. Dusting of the entire surface was also noted for each of these three specimens during this period of cycling, with the other Ductal[®] specimen, D2, experiencing dusting of almost its entire surface as well. No substantial dusting or pitting occurred on either of the J3 specimens, with the final state being almost completely unchanged, as shown in Figure 26(c).

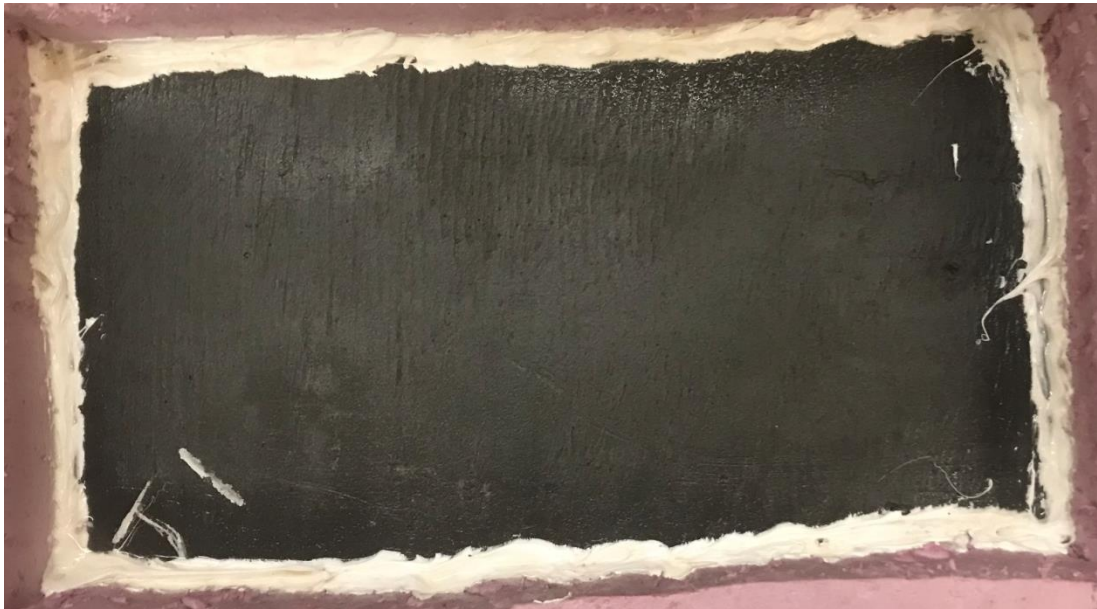
Figure 26: Visual Examination of Scaling Specimen at 50 Days for (a) ODOT AA

(b) Ductal® (c) J3

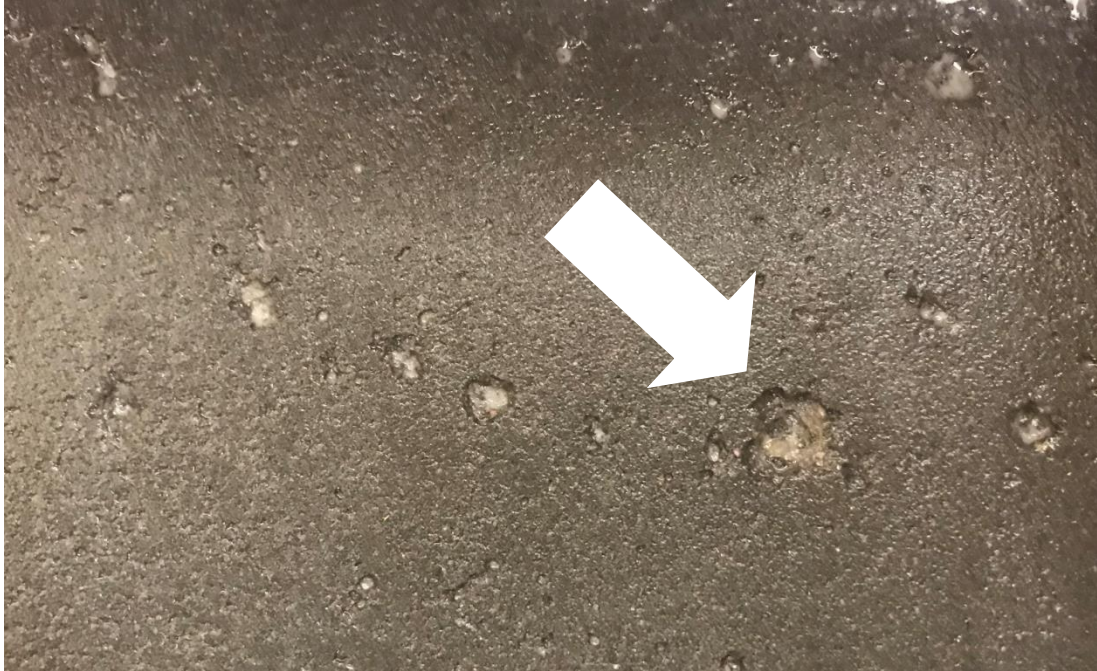
Figure 27: Progression of Visual Pocketing on AA Specimen- 50 Cycles

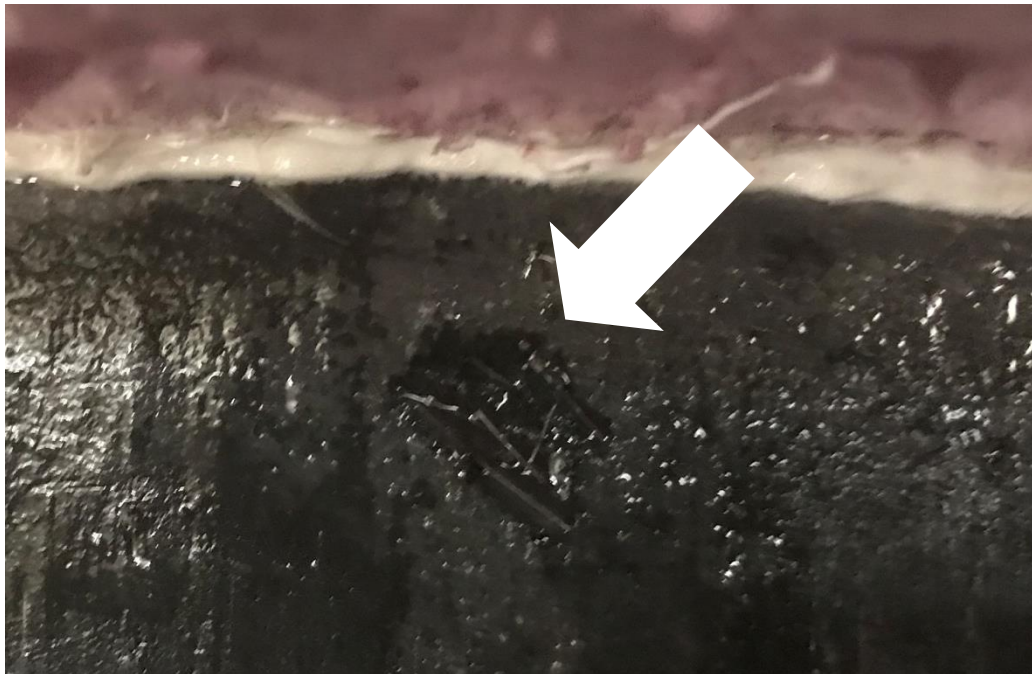
Figure 28: Visual Pocketing on Ductal® Specimen- 50 Cycles

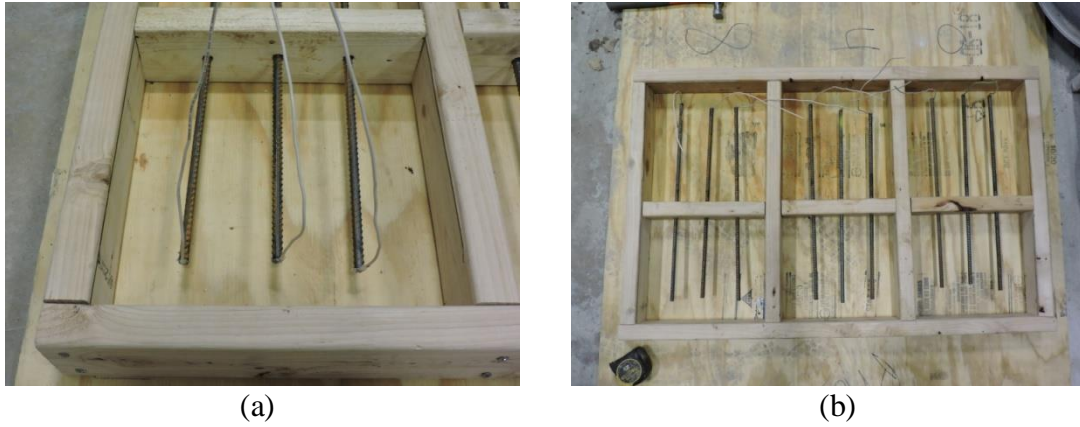
Figure 29: Small-Scale Corrosion Specimen Molds

Although the base concrete already contained varying levels of NaCl, specimens were also placed in a 5% NaCl solution, with the water level 0.5 in. below the top of the specimens, to prevent any damage to the electrical wiring coming out of the specimens. This was done to allow for easier passage of ions through the different concrete halves while also accelerating the corrosion within the specimens. The small-scale corrosion molds and testing set-up are shown in Figures 29 and 30, respectively.

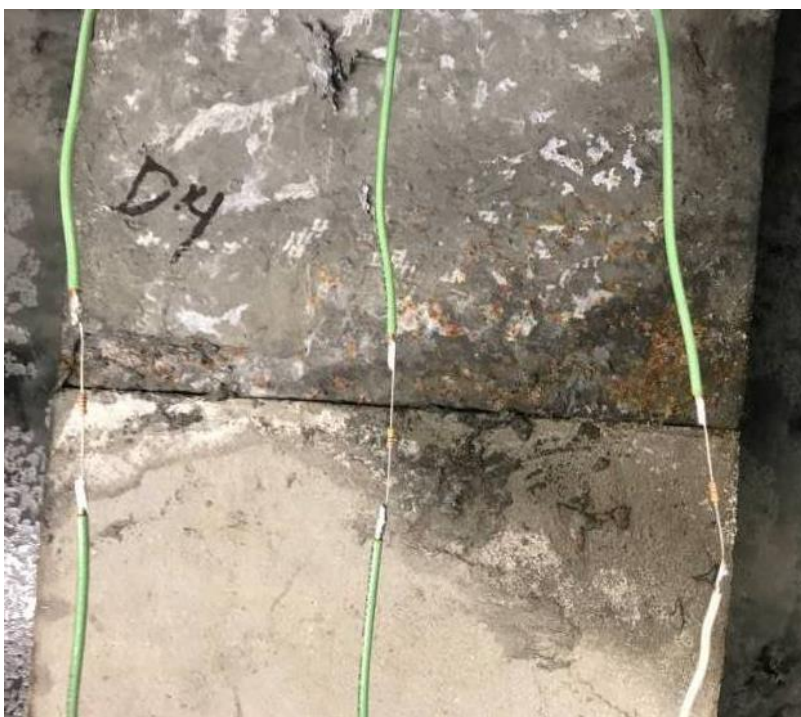
After a week of testing, the Ductal[®] small-scale corrosion specimen containing 0% NaCl, D0, began to show signs of corrosion at the joint, unlike anything seen in any of the other 11 specimens, as shown in Figure 31. By week two, all of the Ductal[®] specimens began to show signs of corrosion. The second and third specimens, however, showed signs of corrosion not through the obvious patching seen on D0, but through corrosion spotting, as shown in Figure 32. None of the other small-scale specimens experienced any signs of surface corrosion directly at the joint between the two materials, in either of these forms, only experiencing light coloration around their edges where they were in contact with the 5% NaCl solution. Additionally, during large-scale corrosion testing, a similar type of corrosion as that of D0 occurred along the Ductal[®] specimen joint. This will be further discussed in Section 5.3.3.

Figure 32: Joint Corrosion in Ductal® Small-Scale Corrosion Testing Specimen- Corrosion Spotting

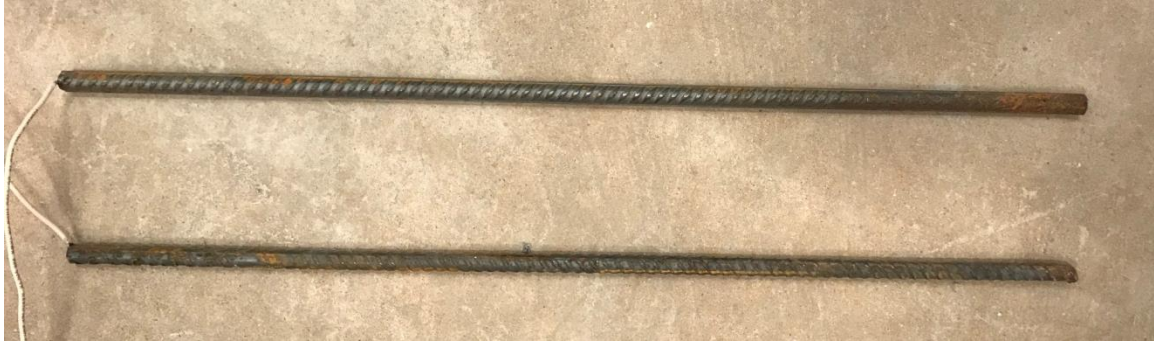
Additionally, a photograph of the type of steel rebar put into these specimens before testing is presented as Figure 33 so that the difference between the typical amount and type of corrosion present on a piece of steel rebar before and after testing can be made clear. This difference is made most clear by the darker color and distinct starting location of the active corrosion (after testing). It is assumed in this testing that all previous surface corrosion was purely superficial and would have come off completely during either casting or chipping, and all actual surficial or pitting corrosion due to testing conditions would have occurred with or without the initial presence of this light surface corrosion.

Figure 33: Steel Rebar Before Testing- Typical

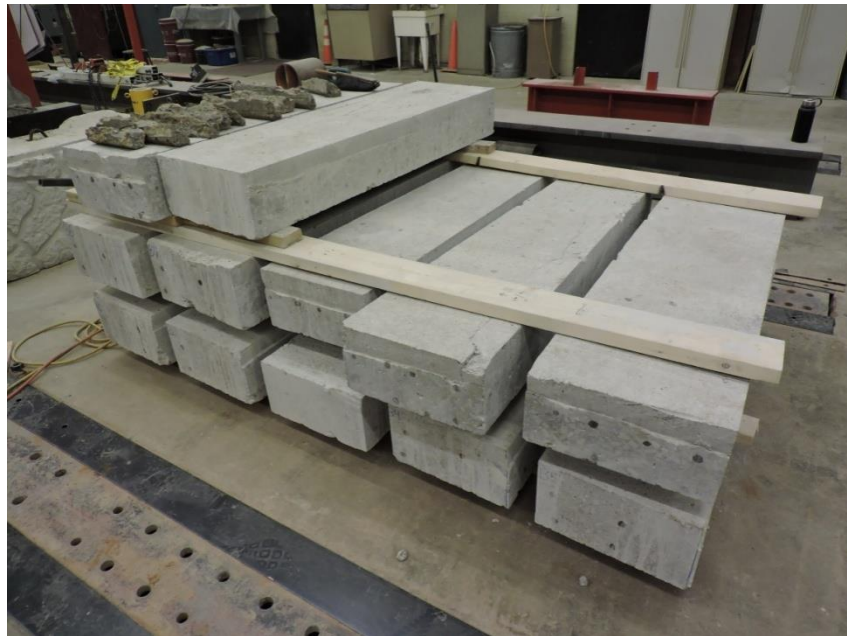
Figure 38: Joint Specimens before Chipping

in. repair replacement joint, producing a minimum 1 in. cover to the rebar exposed from the chipping process. The exposed No. 5 rebar layer revealed in each slab was connected together using a No. 5 longitudinal bar tied to the far ends of the exposed rebar sections. The longitudinal bar was placed on the top most layer of reinforcing when laid down flat, putting it closest to what ultimately became the finished surface, to allow for the needed wires to extend out of the top of the specimens. These electrical wires were soldered onto both ends of each connective longitudinal bar to allow for the DC power supplies to be connected after curing of the specimens, as discussed in the following paragraph. The slabs before and after chipping are shown in Figures 38 and 39, with Figure 40 showing the final rebar construction.

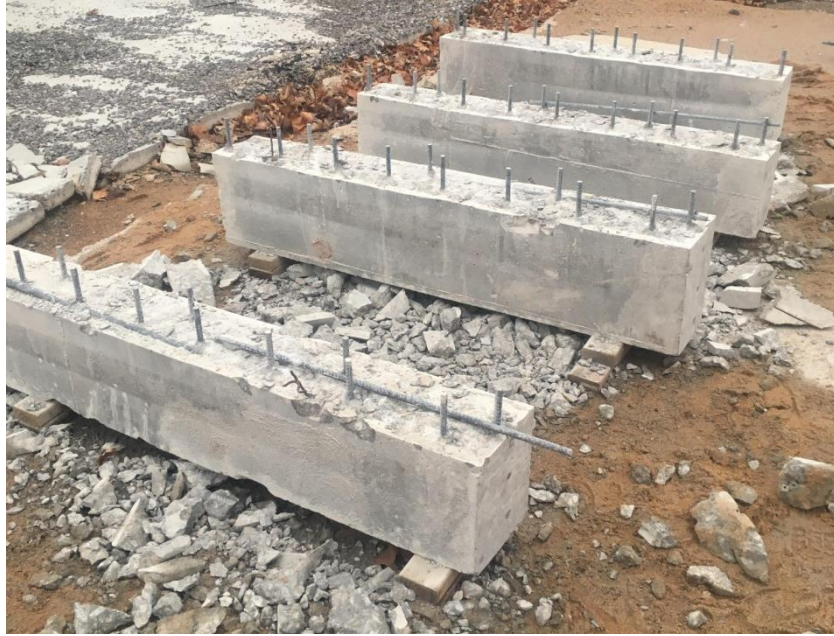
Figure 39: Joint Specimens after Chipping

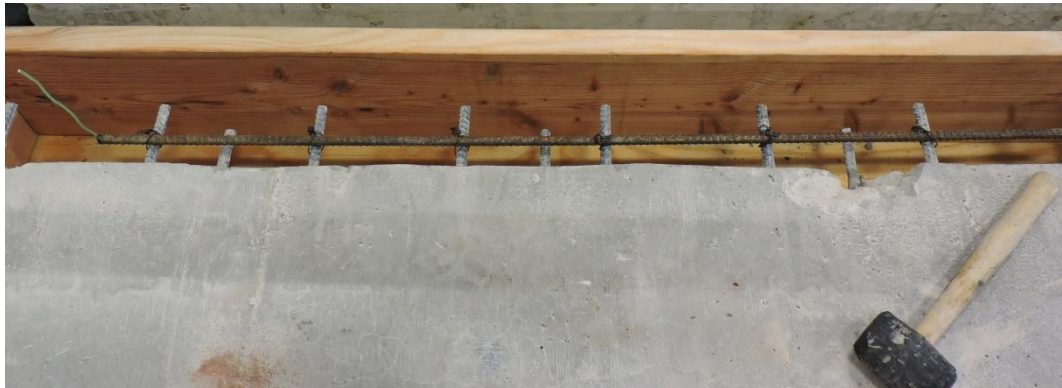
Figure 40: Joint Specimen Rebar Fully Tied Together

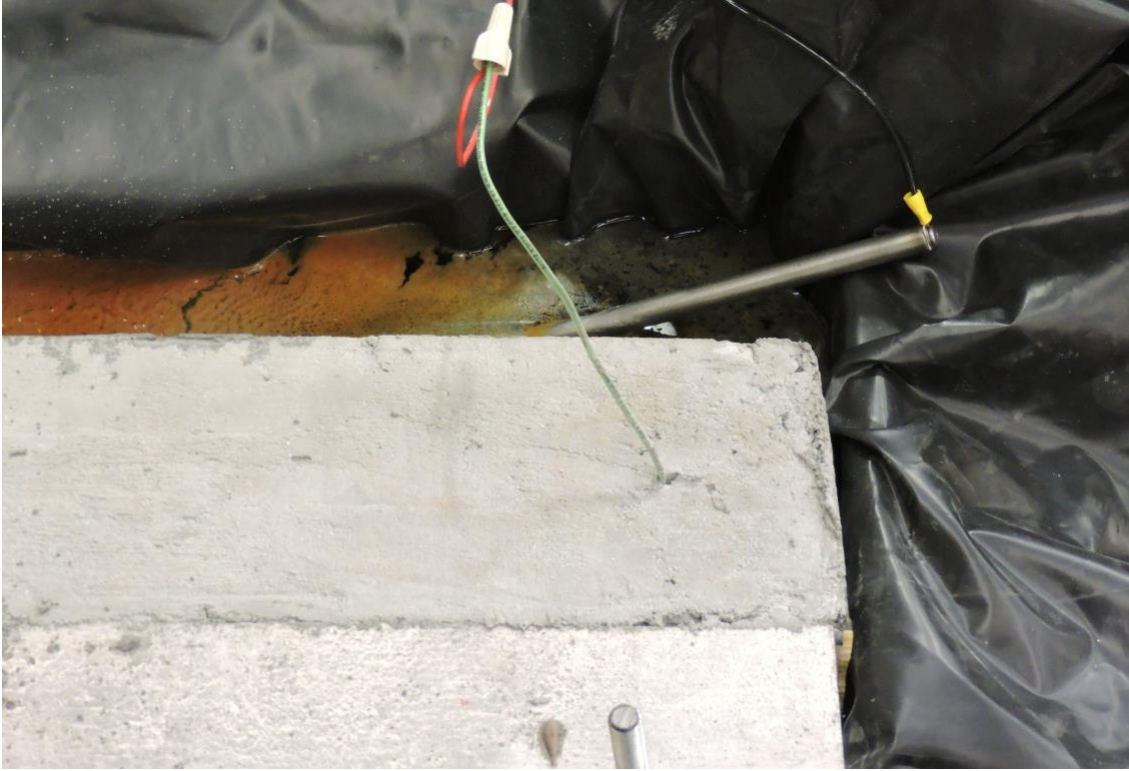
Figure 41: Stainless Steel Rod and Electrical Wiring for Large-Scale Corrosion Testing

From there, the testing set up followed the electrochemical method, which works by creating a complete circuit that runs through steel reinforcing (or similar conductive metals), which causes the steel reinforcing to release electrons, in turn oxidizing the steel reinforcing and corroding it. For this testing, the required complete circuit was achieved by using a stainless steel rod sitting in the NaCl solution as a cathode (as shown in Figure 41) and the longitudinal steel reinforcing rod in the repair material side of each specimen as the anode. From there, each specimen was connected using electrical wiring so that a 0.2 A current could flow continuously from the positive terminal of the power supply to the steel reinforcing, through the concrete and surrounding NaCl solution to steel rod, and ultimately back to the negative side of the power supply. This test set-up is shown in Figure 42.

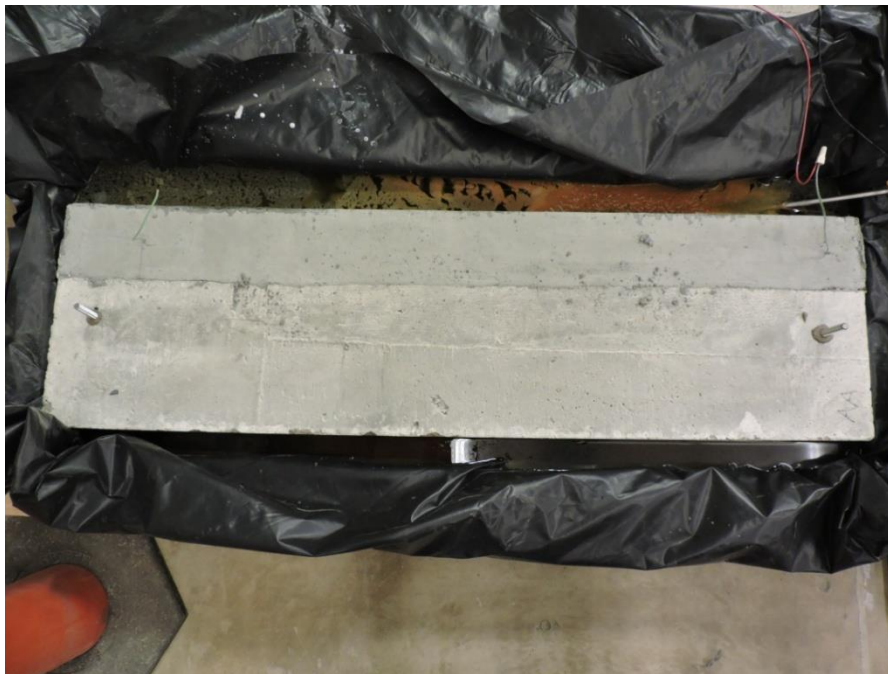
During the first week of testing, the water pools of each specimen began to fill with a coating of corrosion that had already begun to leech off, except for Phoscrete, which secreted a white film that has been previously unseen by work done in this laboratory. This film is present in Figure 43. After a week, the white film was covered with a corrosion film like the rest of the large-scale corrosion specimens. After two weeks of testing, the corrosion that was now in the water of all four specimens became great enough that it filled all of the testing water, but mostly occupied the bottom of the testing containers. This level of corrosion was maintained through to the end of testing and is shown in Figure 44.

Figure 44: Corrosion in Water of Large-Scale Corrosion Specimens- Typical

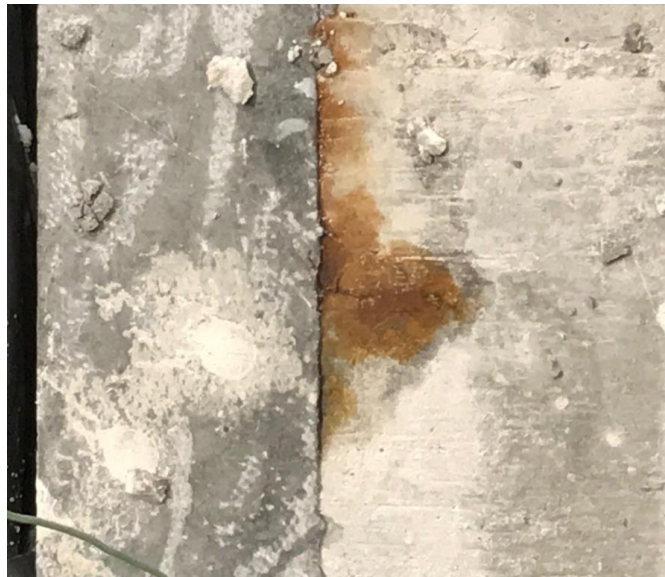
Also during the first week of testing, a corrosion spot along the joint of the Ductal[®] specimen began to form. By week two, this corrosion spot was in the state shown in Figure 45. This could have been due to a number of reasons relating to a poor joint-face connection between the Ductal[®] and the old AA concrete it was cast onto, but most likely it is due to the Halo Effect occurring rapidly along this joint. The justification for not assuming a simple poor joint-face connection being that previous Phase I testing showed that Ductal[®] possesses exceptional bond strength to substrate (base) concrete, and therefore a poor bond was unlikely in this scenario. From week three up until testing was concluded after 10 weeks, the surface corrosion along the Ductal[®] joint progressed at a steady and alarming rate, as shown in Figure 46. None of the other specimens showed any significant signs of surface corrosion during any point during testing, except along the anticipated reinforcing bar paths. This observation will be discussed more in Section 5.3.3.

*Figure 45: Joint Corrosion in Ductal[®] Large-Scale Corrosion Testing Specimen- Week Two
(Ductal[®] on left side of image)*
