EVALUATION OF DURABILITY AND CORROSION BEHAVIOR OF ULTRA-HIGH
PERFORMANCE CONCRETE FOR USE IN BRIDGE CONNECTIONS AND REPAIR

A THESIS

CIVIL ENGINEERING

2019

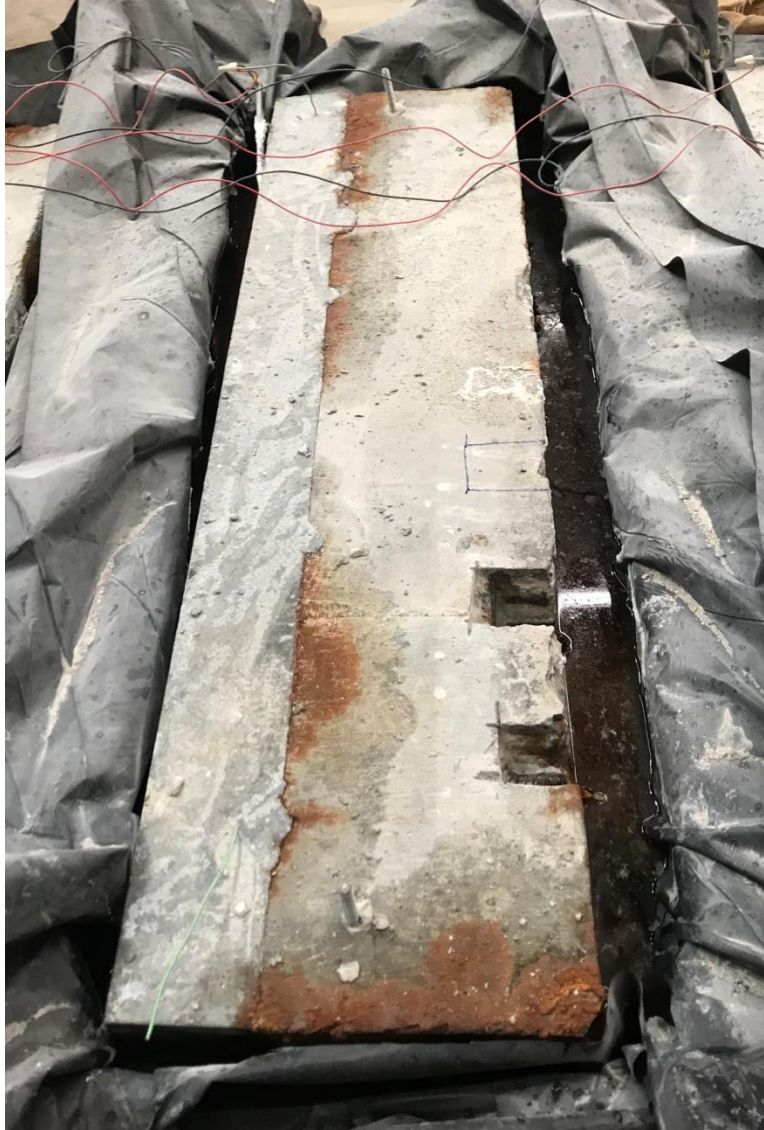
Figure 46: Joint Corrosion in Ductal® Large-Scale Corrosion Specimen- Week Five

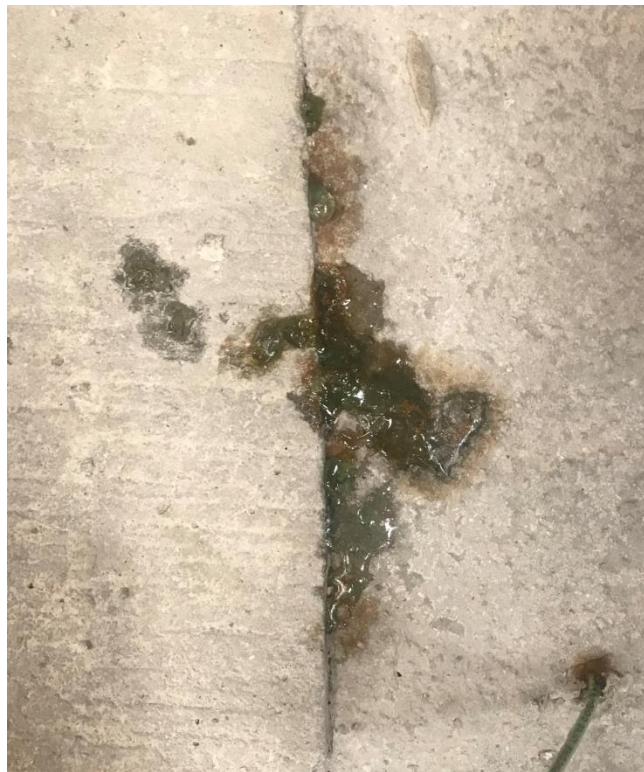
addresses if this is normal for a specimen in a highly corrosive environment. However, it is hypothesized that something in the chemical make-up of Phoscrete (which contains magnesium, aluminum, phosphate, and multiple other chemicals to try to help prevent corrosion and freeze-thaw damage) reacted with the NaCl in the surrounding solution, and at this point in the testing the solution had made its way far enough into the joint to begin to interact and produce the green substance shown in Figure 47.

Figure 47: Green Liquid in Joint of Phoscrete Large-Scale Corrosion Specimen- Week 7

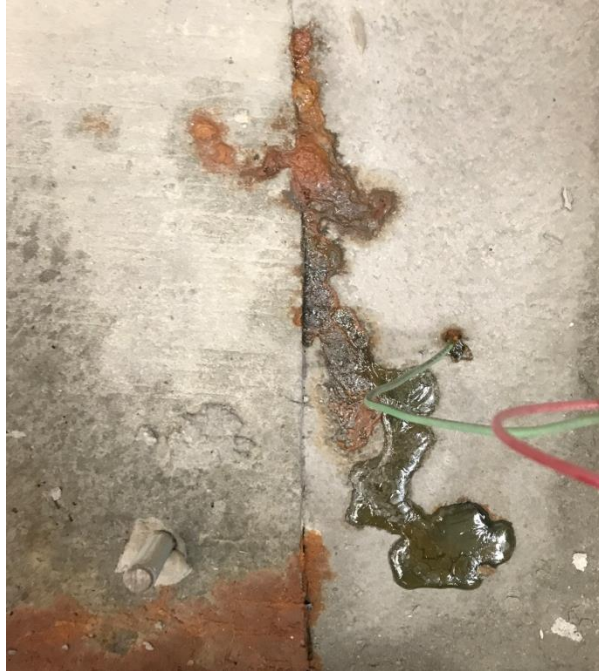
Final states of these two unexpected chemical reactions happening at the surface are shown in Figures 49 and 50.

Figure 49: Green Liquid in Joint of Phoscrete Large-Scale Corrosion Specimen- Week 10

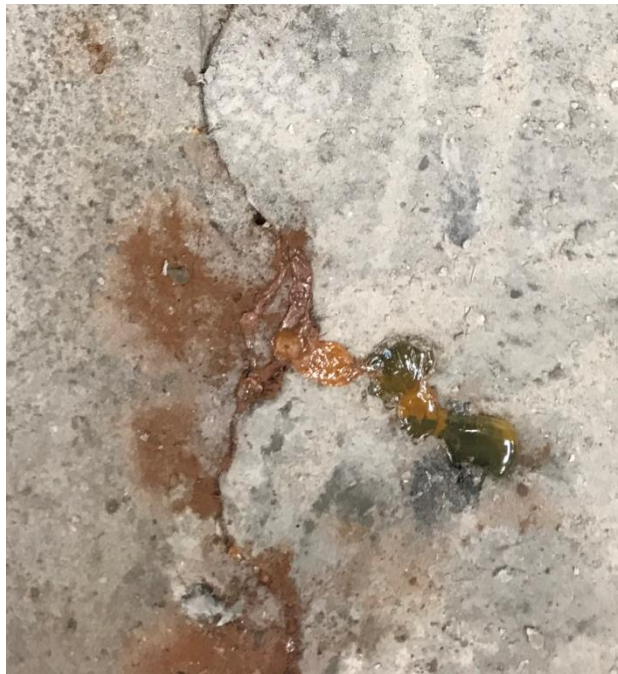
Figure 50: Green Liquid in Joint of Ductal® Large-Scale Corrosion Specimen- Week 10

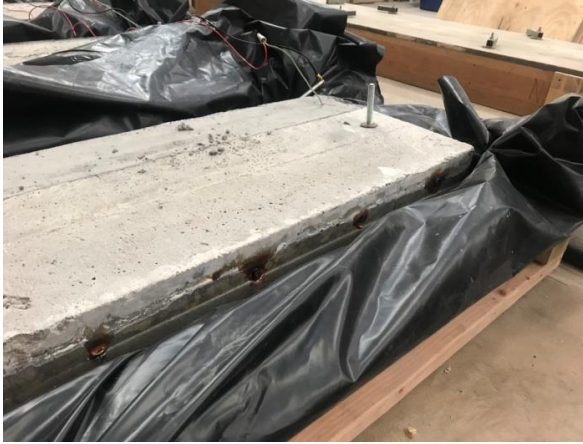
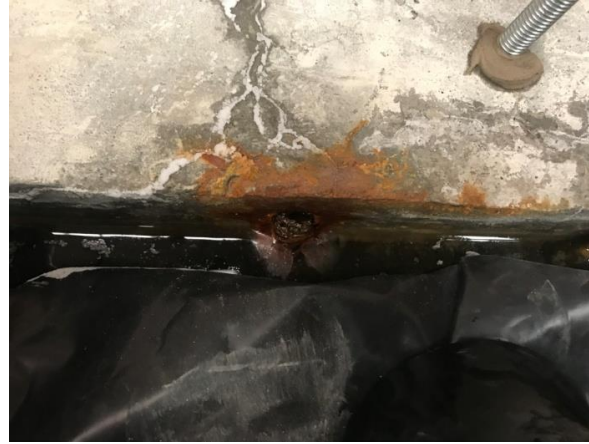
After only one week of testing, the first sign of rebar corrosion was also visible on all specimens. As shown in Figure 51, a thick black liquid began to be produced out of the exposed ends of each specimen. Though no more than a few inches of liquid was ever formed on any one bar, and the amount of each rebar end that was completely corroded off due to the formation of this liquid was never significantly high, only reaching a maximum of 0.75 inches, this level of corrosion could still be cause for concern in the field. This is because the chemistry of steel rebar reacts so violently with NaCl and other corrosive solutions found in the field that 5 to 10 times the volume of fully corroded steel rebar is produced in actual corrosion during this expansion reaction. This becomes a problem in the field because if internal reinforcing were to experience this kind of corrosion, like that seen on the exposed rebar ends, it could generate large expansive forces that can crack and spall the concrete the reinforcing steel resides in. Fortunately, this level of corrosion of rebar ends is expected for this testing set-up, and the joint made with J3 did not exhibit any more of this corrosion than any of the other joints, often actually being less or right at the level of rebar end corrosion of the other joints. By the end of testing, the corrosion of the exposed rebar ends had reached the extent shown in Figure 52. Both Figure 51 and 52 are of the ODOT AA specimen, which was considered the control specimen.

Figure 51: Visible Confirmation of Corrosion of Vertical Reinforcing Bars- Week 1

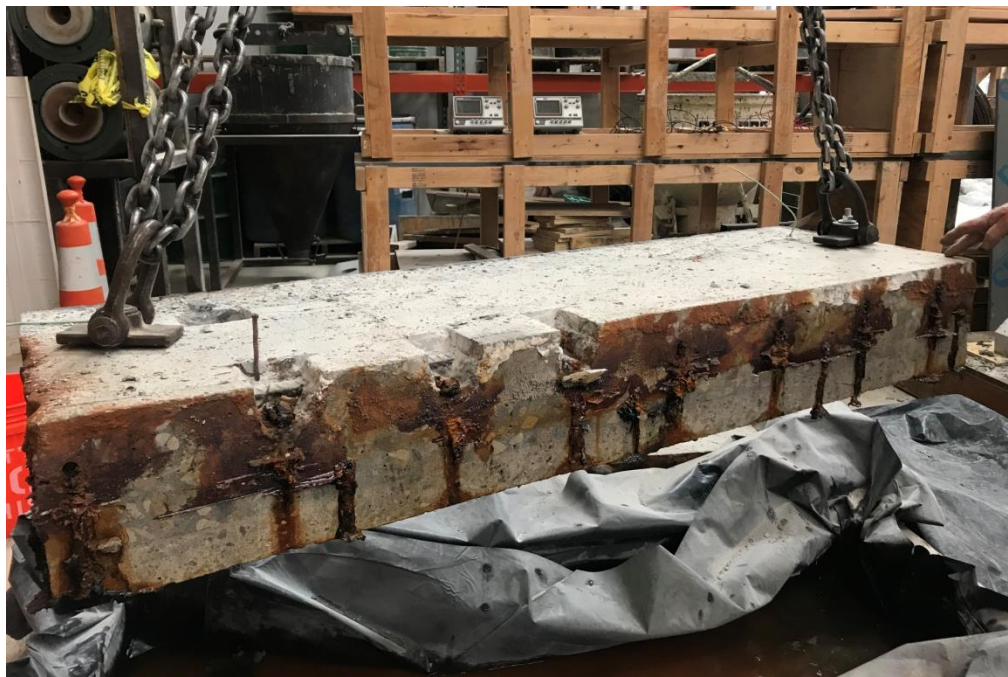
Figure 52: Typical Level of Corrosion at the Conclusion of Testing- Week 10

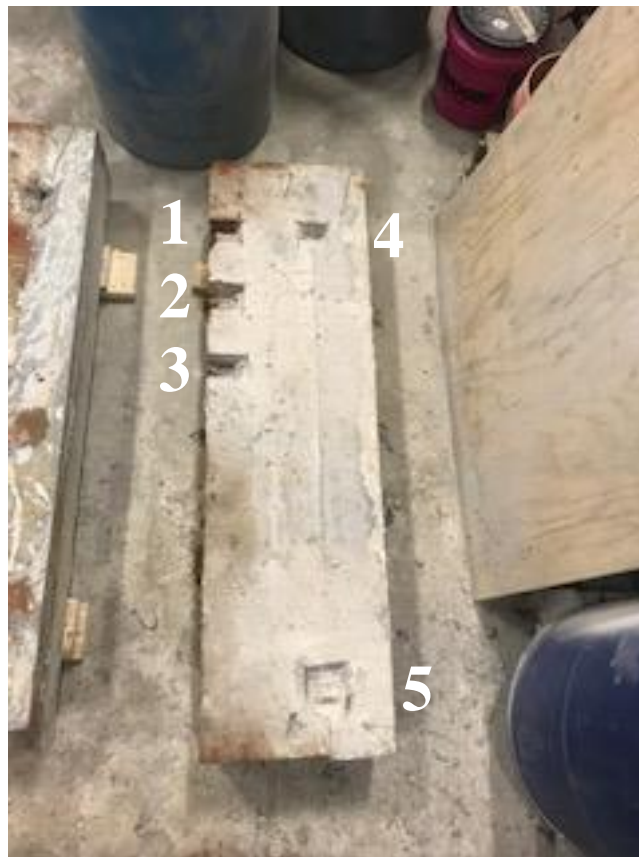
Figures 54-57 provide updates of the specimens over the 10 week testing period, while Figures 58-61 show each layer of reinforcing steel immediately after chipping. The last layer of steel reinforcing that was excavated and examined, after being completely removed from testing, chipped, and allowed to sit out in open air for 24 hours, is also presented as Figure 62. This is significant because with no forced current or surrounding NaCl solution, all reactions of this exposed reinforcing steel came only as a result from what had already occurred within the specimens, and all pitting corrosion that revealed itself was previously present in the steel reinforcing. Figure 53 is also used as a guide to show the order in which the layers were chipped away, as is referenced throughout the rest of this section and Section 5.3.3.

Figure 53: Chipping Sequence of Large-Scale Corrosion Specimens

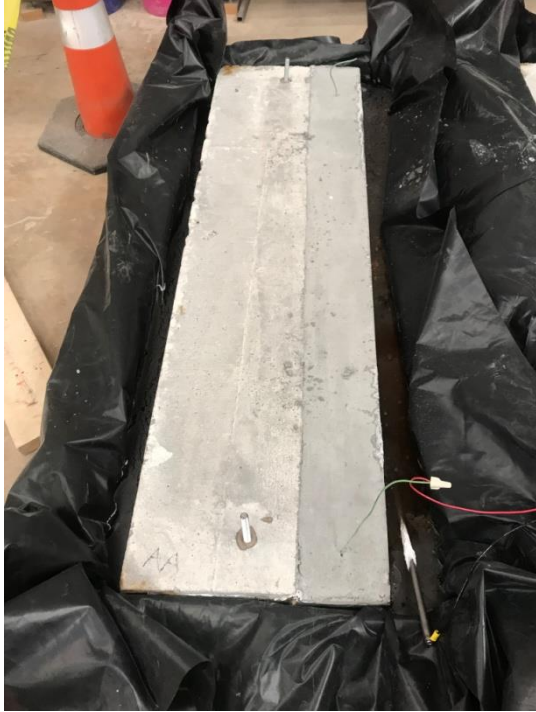
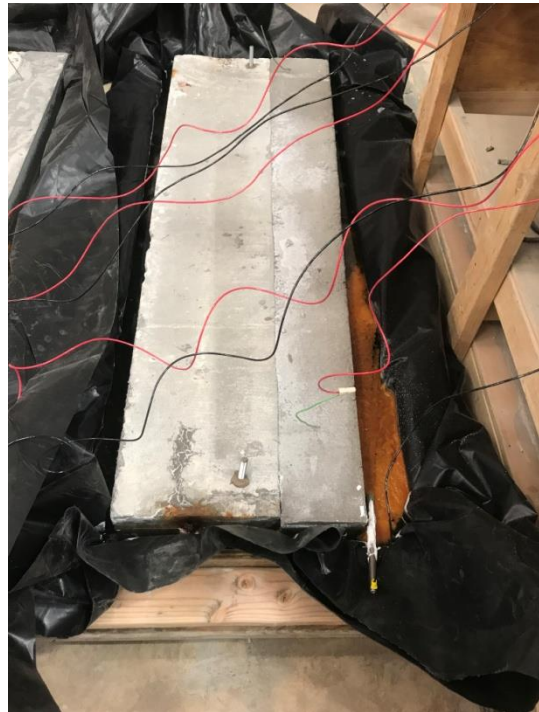
*Figure 54: Week 1 Update of Large-Scale Corrosion Specimens Using (a) ODOT AA (b) J3
(c) Ductal® (d) Phoscrete*

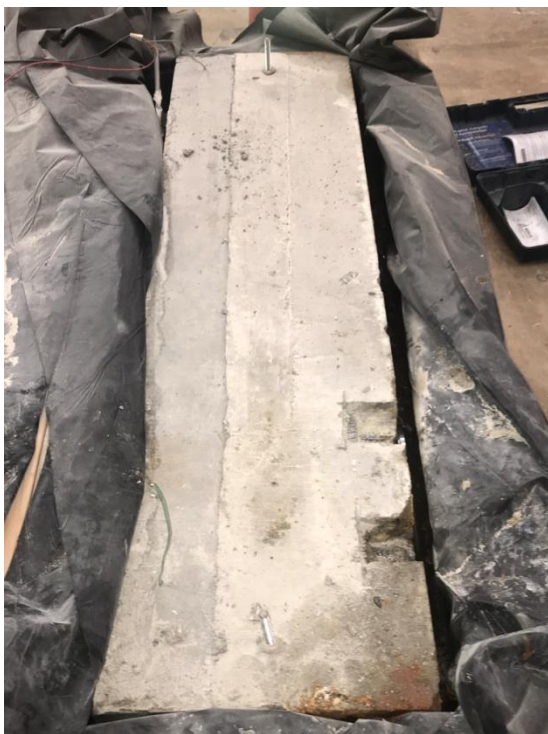
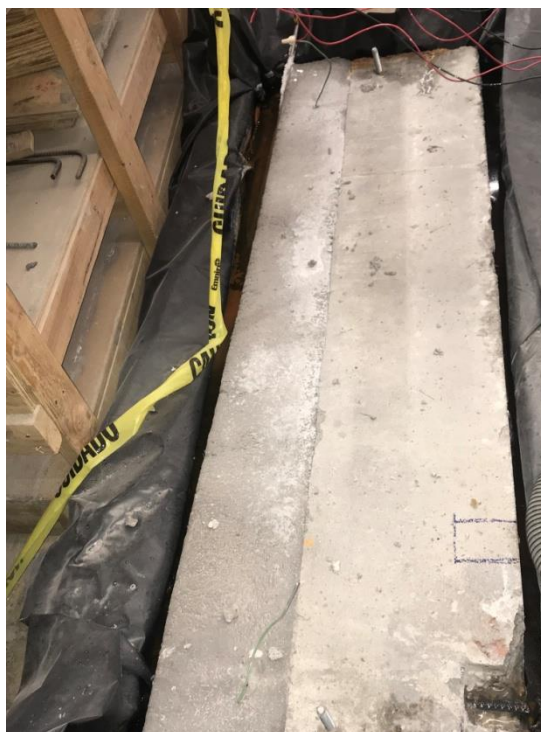
*Figure 55: Week 3 Update of Large-Scale Corrosion Specimens Using (a) ODOT AA (b) J3
(c) Ductal® (d) Phoscrete*

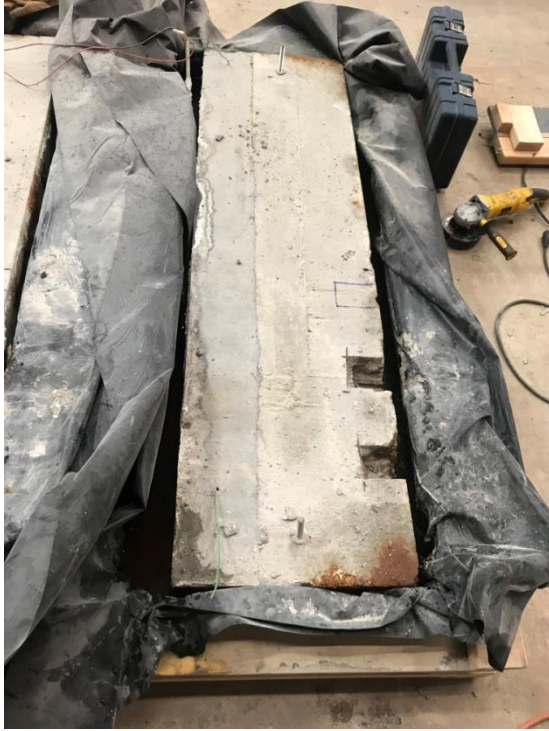
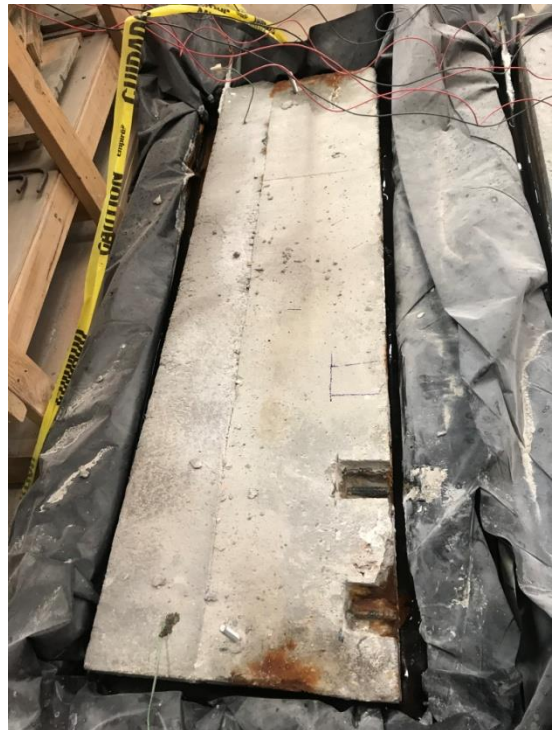
*Figure 56: Week 6 Update of Large-Scale Corrosion Specimens Using (a) ODOT AA (b) J3
(c) Ductal® (d) Phoscrete*

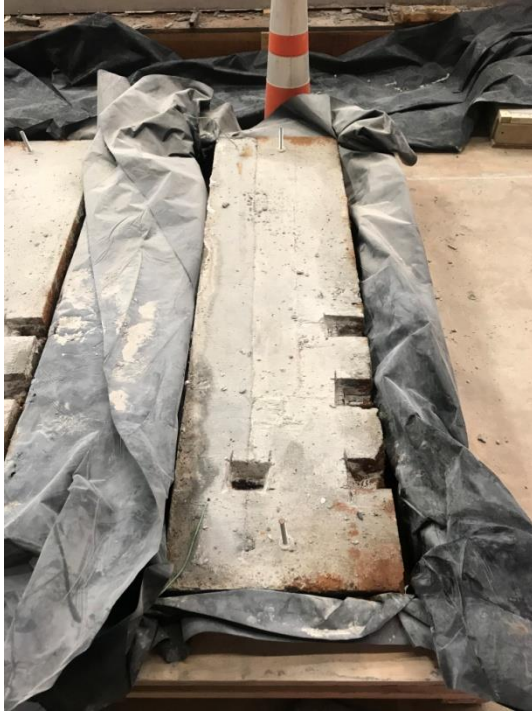
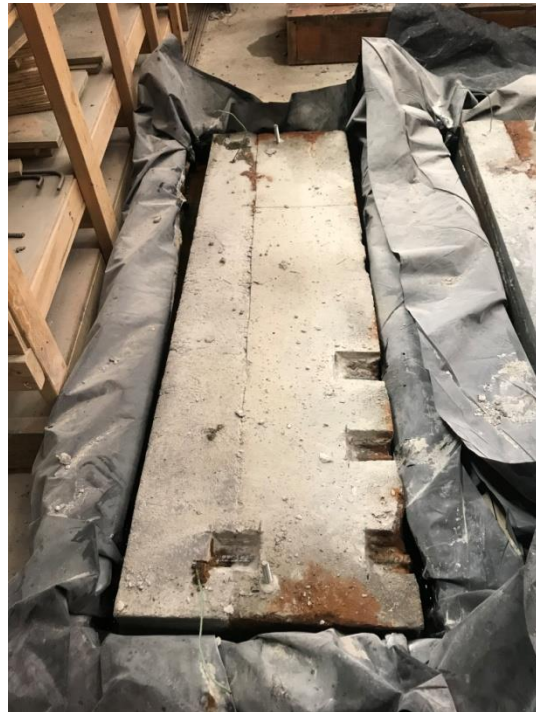
*Figure 57: Week 10 Update of Large-Scale Corrosion Specimens Using (a) ODOT AA (b) J3
(c) Ductal® (d) Phoscrete*

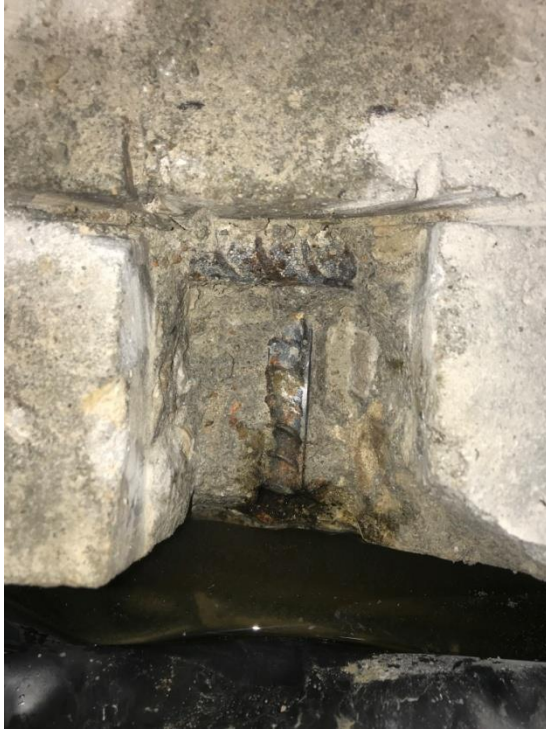
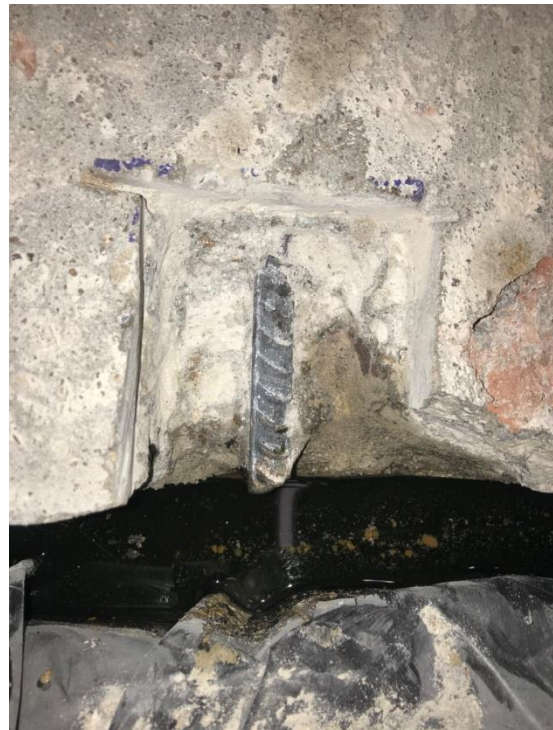
*Figure 58: First Chip of Large-Scale Corrosion Specimens Using (a) ODOT AA (b) J3
(c) Ductal® (d) Phoscrete*

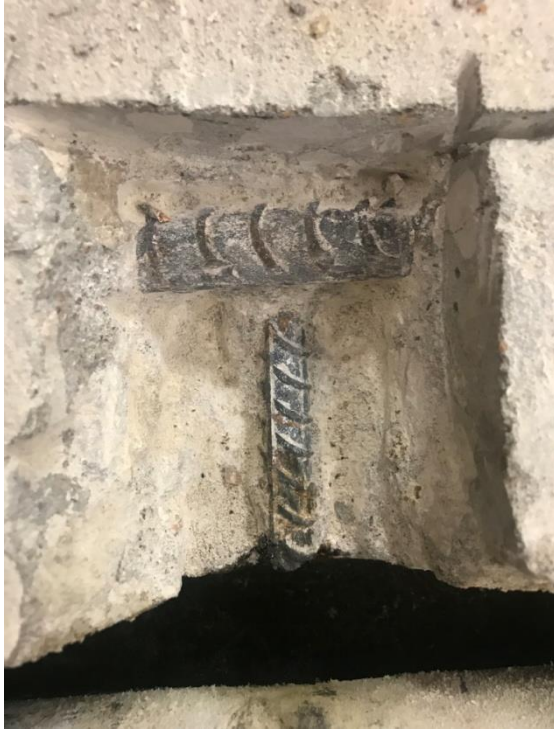
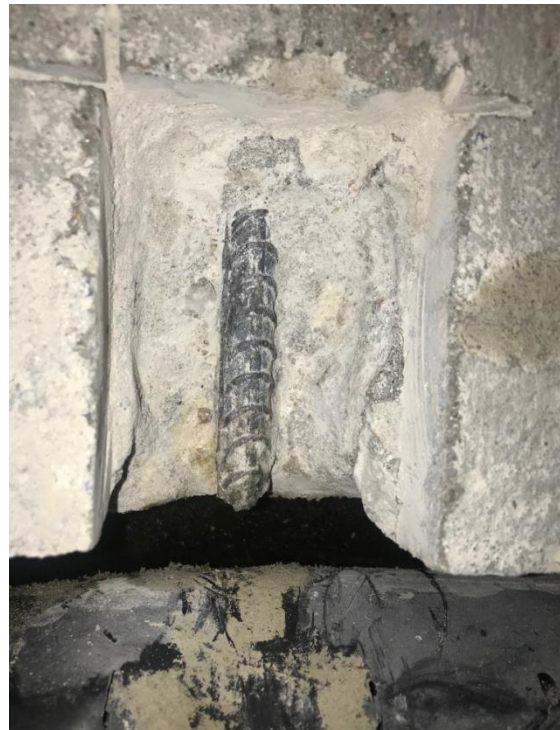
*Figure 59: Second Chip of Large-Scale Corrosion Specimens Using (a) ODOT AA (b) J3
(c) Ductal® (d) Phoscrete*

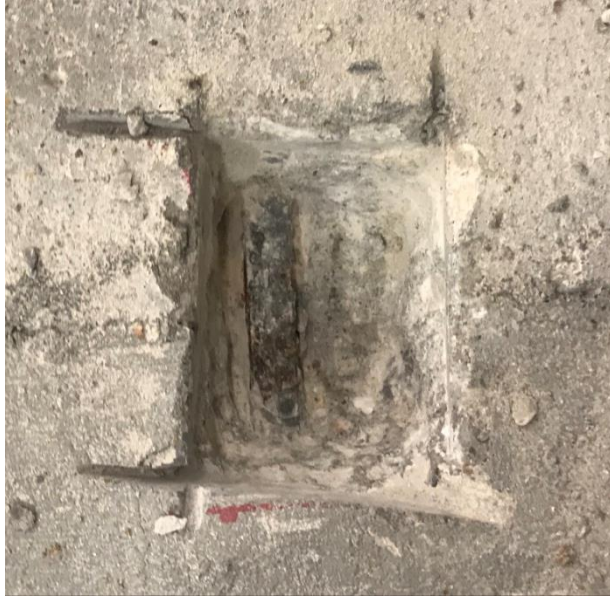
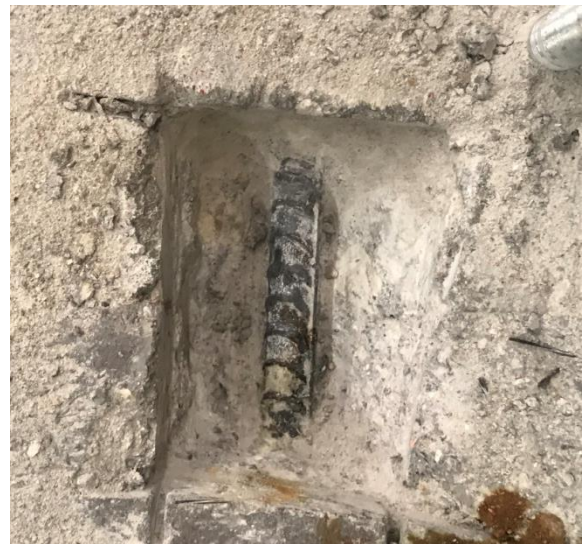
*Figure 60: Fourth Chip of Large-Scale Corrosion Specimens Using (a) ODOT AA (b) J3
(c) Ductal® (d) Phoscrete*

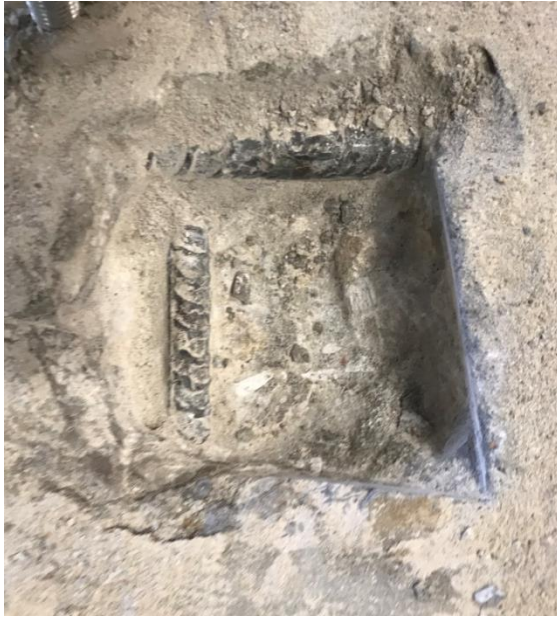
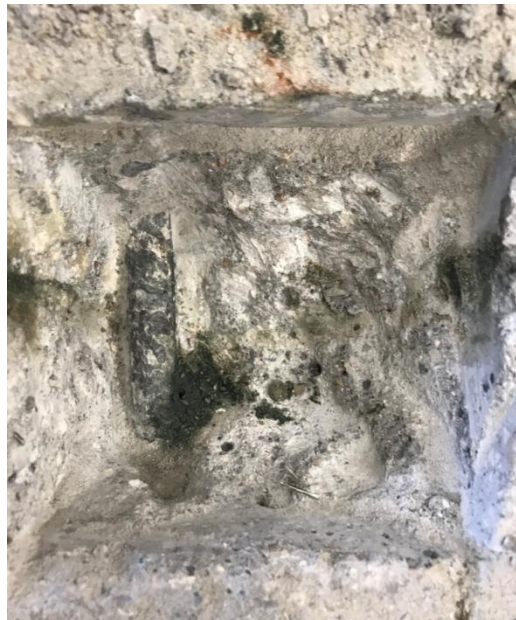
*Figure 61: Fifth Chip of Large-Scale Corrosion Specimens Using (a) ODOT AA (b) J3
(c) Ductal® (d) Phoscrete*

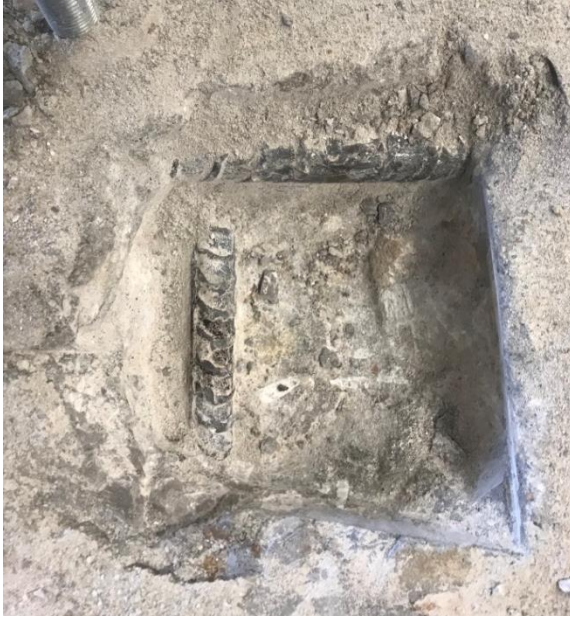
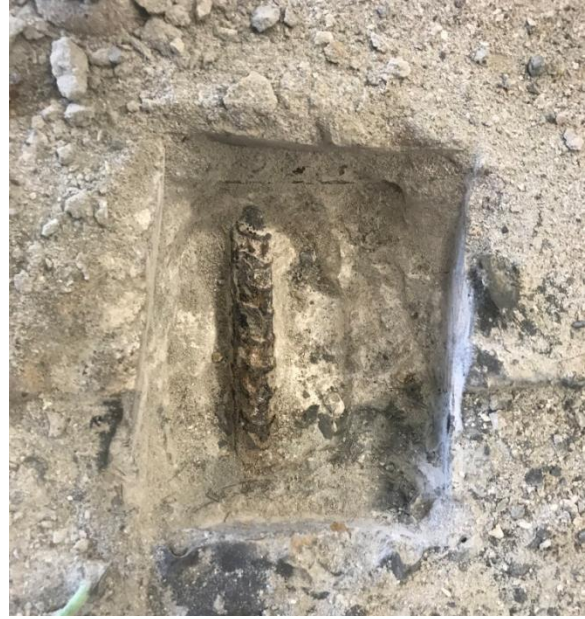
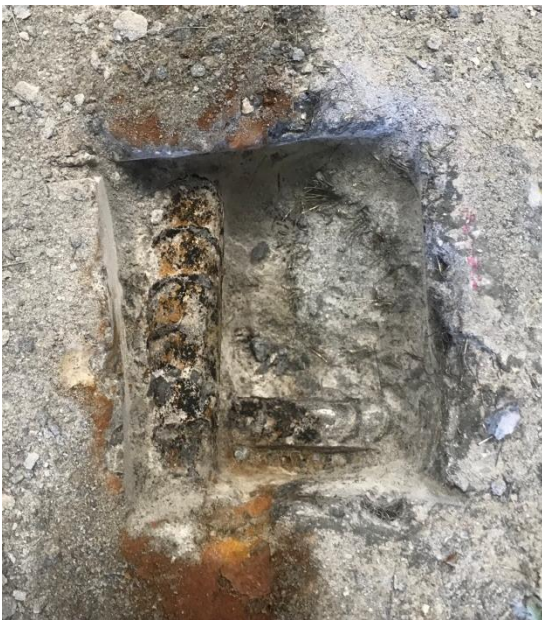
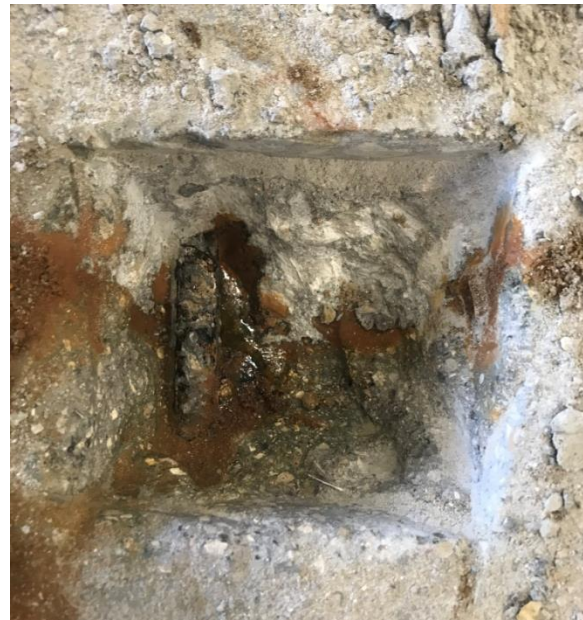
Figure 62: Fifth Chip of Large-Scale Corrosion Specimens 24 Hours After Chipping Using (a) ODOT AA (b) J3 (c) Ductal® (d) Phoscrete

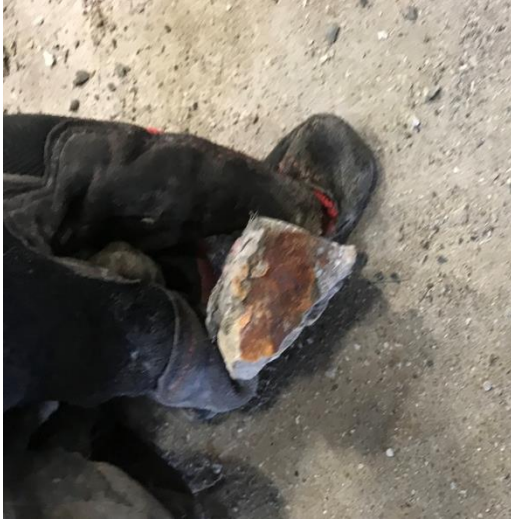
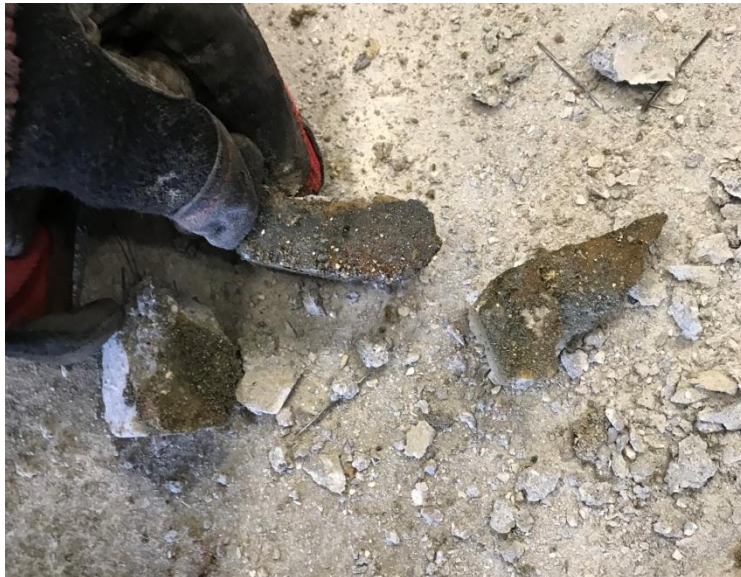
Figure 63(c) shows pieces of the base concrete that were chipped away during excavation five of the Phoscrete specimen and not only shows the presence of surficial corrosion along the joint of the Phoscrete specimen (like that shown in Figures 63(a) and 63(b) for J3 and Ductal[®], respectively) but also the presence of the kind of staining caused by the green liquid that has leaked through the joint, proving that the liquid was present even before excavation.

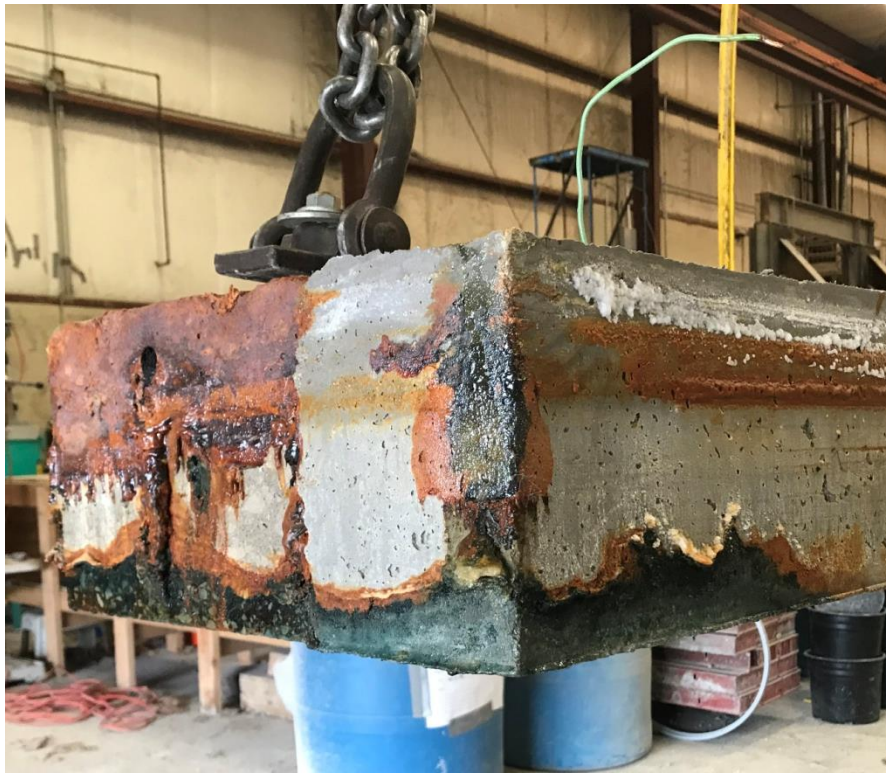
Figure 65: Final State of Phoscrete Large-Scale Corrosion Specimen- Week 10
