BEHAVIOR OF COMPOSITE BRIDGES AT  
EARLY AGES AND UNDER THERMAL LOADING

Submitted to the Faculty of the  
Graduate College of the  
Oklahoma State University  
in partial fulfillment of  
the requirements for  
the Degree of  
Master of Science  
December, 2018

Abstract: This paper focuses on deflections and deformations that occur at early ages and under thermal loading in newly rehabilitated bridges comprised of steel girders made composite with concrete deck slabs. A full-scale prototype bridge was constructed at the Bert Cooper Engineering laboratory. The prototype matches the Eagle Chief Creek (Bridge "A") on SH14 in Woods Co. A large array of sensors and instruments were installed to measure strains, deflections, and temperature in both concrete and steel.

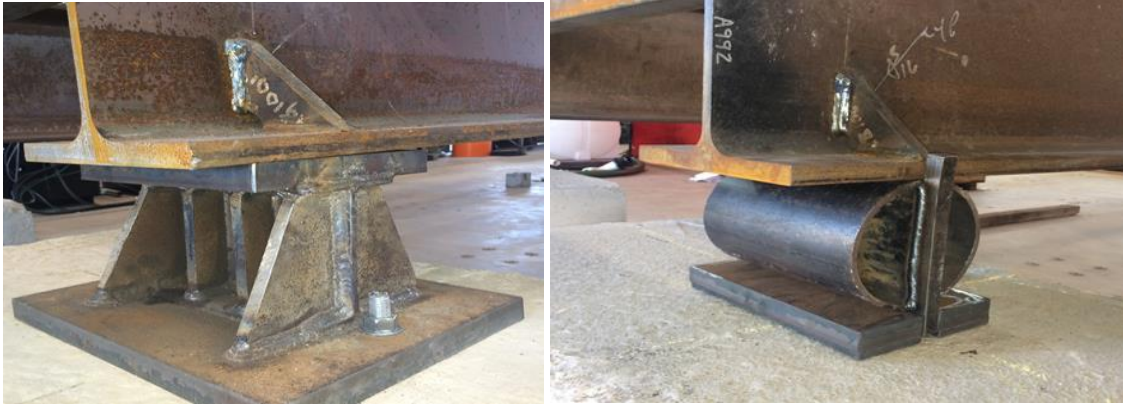
provided in Figure 3.1. Diaphragms are provided at mid-span as well as at the ends of the beams. The cross section details are shown in Figure 3.2.

**Figure 3.1: Bridge Support Conditions**

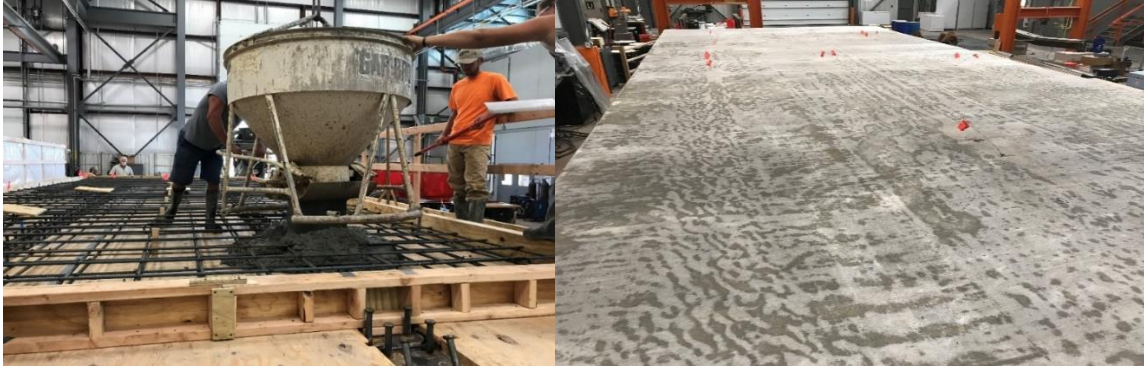
**Figure 3.3 - Photograph of bridge slab (a) during cast (b) at 14 days after finishing and wet curing with burlap for 14 days**

The deck slab was covered with wet burlap at 3:55 pm. Plastic was placed over the burlap to prevent the escape of moisture and water was applied to the burlap periodically after initial covering to ensure moist curing for a duration of 14 days after casting.

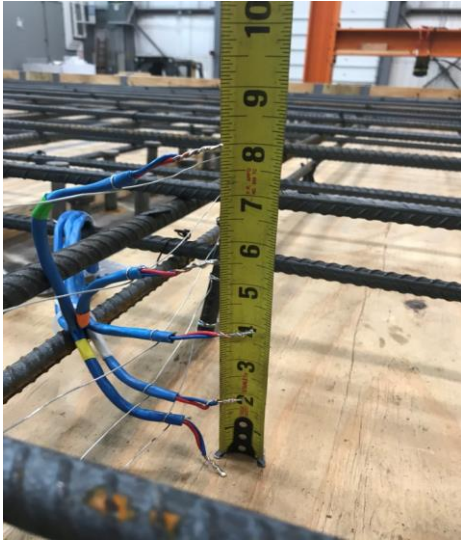
**Figure 3.4 - Photograph of thermocouples used for data collection: Thermocouples were placed at the top and bottom surface of the deck and at 2in., 4in., and 6in. depths.**

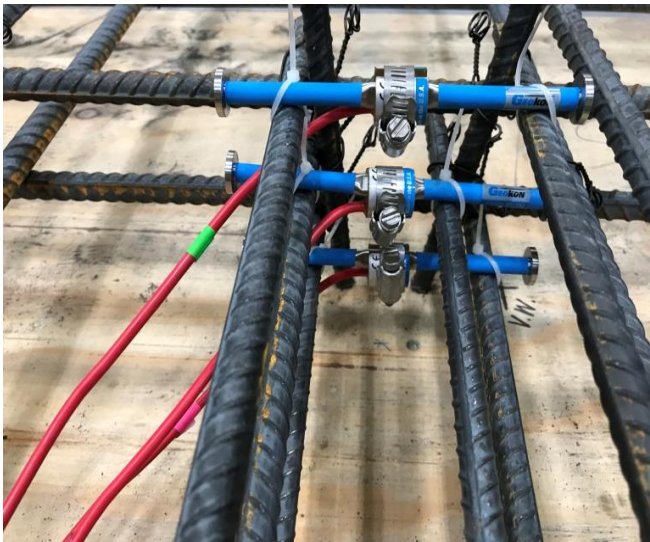
**Figure 3.5 - Photographs of VWSG used for data collection: VWSG were placed at 2 in., 4 in. and 6in. depths.**

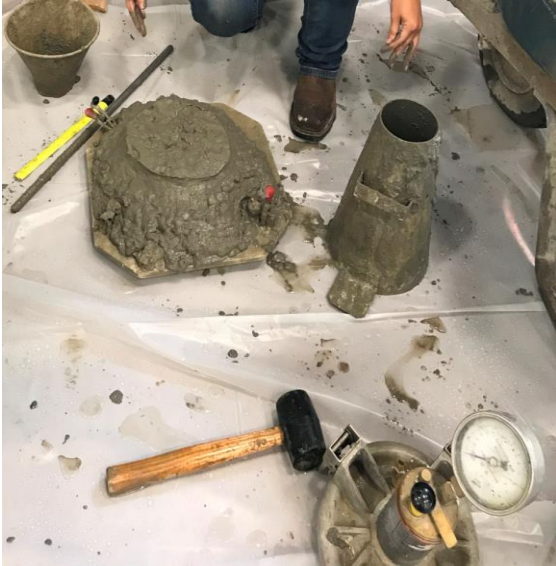
Fresh property measurements were taken for both trucks. Tests performed included slump, unit weight and air content in accordance with ASTM C143-15a and ASTM C138-17a respectively. The temperature of the fresh concrete was also obtained. 5 gallons of water were added to the second truck at the laboratory before casting so that the slump would be consistent with the first truck. The w/cm was gaged with the amount of slump we measured.

**Figure 3.7 - Performing slump test on bridge deck concrete**

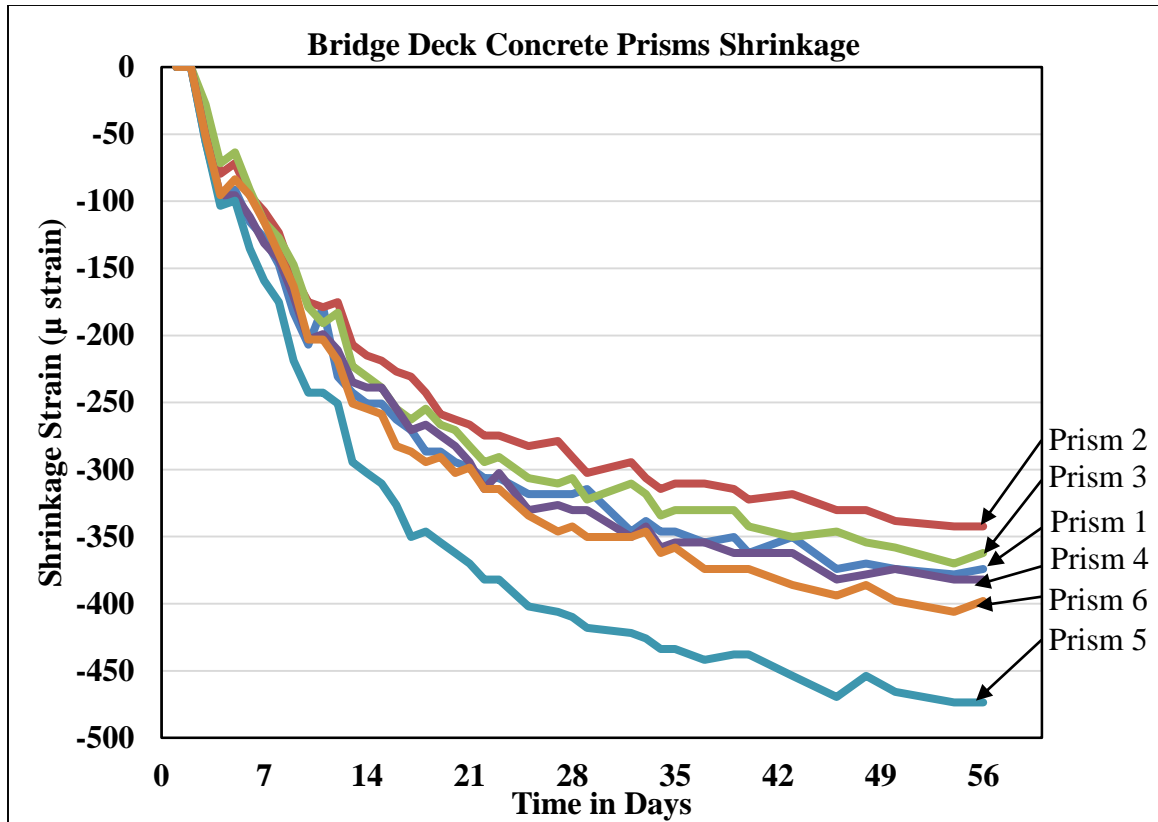
The unrestrained concrete shrinkage strains recorded from the concrete prisms made during casting are represented in Figure 3.8. These measurements were taken using DEMEC points on the top surface of the concrete prisms. It is noticed that there is a difference between the shrinkage of the unrestrained concrete prisms and the shrinkage in the deck slab. This indicates that the steel is restraining expansion and contraction in the deck slab.

**Figure 3.8 - Bridge Deck Concrete Prism Strains:** Concrete prism unrestrained shrinkage strains were measured using DMEC points on 6 prisms made at casting. The average strain after 56 days was approximately 380  $\mu$  strain.

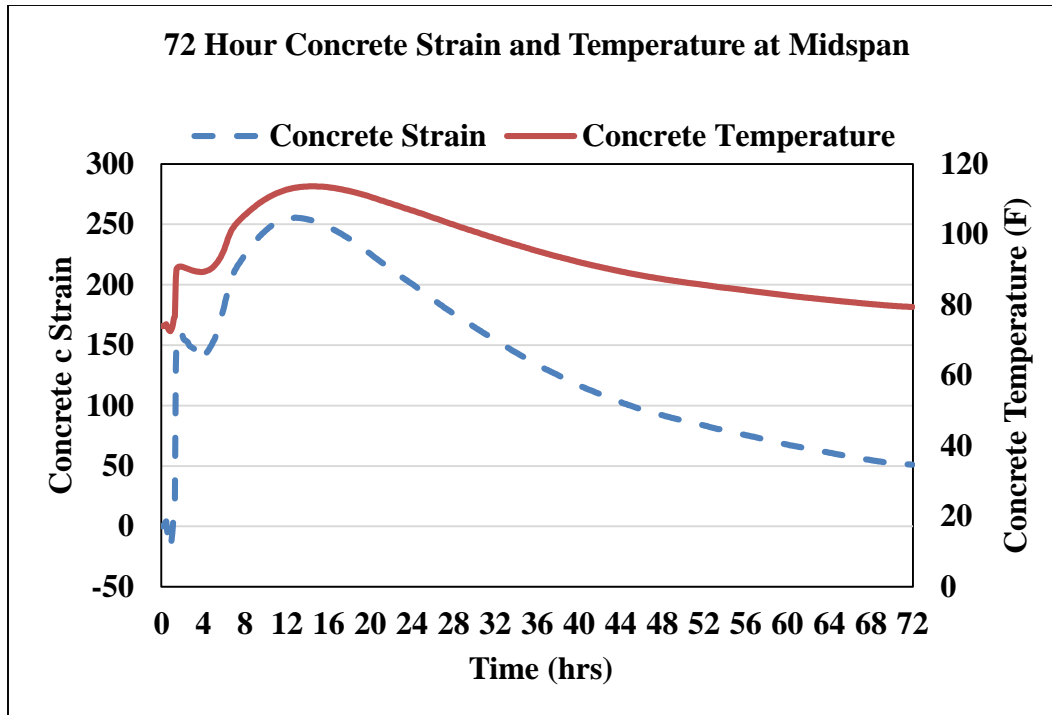
The strains and temperatures of the concrete deck are presented in Figure 3.12. As the concrete temperature changed during the hydration process, the change in strains in the concrete followed a pattern similar to that of the change in temperature.

**Figure 3.12 - Concrete Mid-Span Strain and Temperature 72 Hrs After Deck Cast: Strain and temperature were measured using a VWSG 2 in. from the bottom of the slab. A maximum hydration temperature of 114 °F was reached approximately 14 hrs. after casting with a corresponding strain of approximately 240 µ strain.**

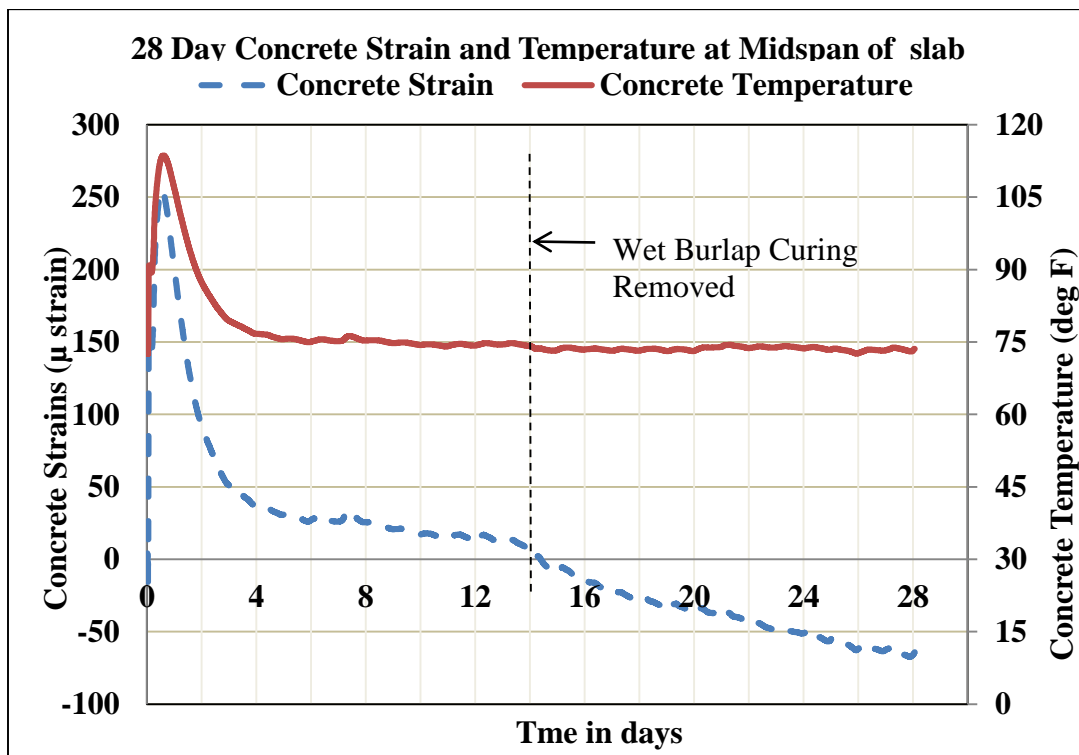
Figure 3.13 shows the concrete temperatures and strains measured over time for the first 28 days after deck casting. The chart shows elevated concrete temperatures in the first 24 hrs., followed by falling temperatures as the concrete deck gradually returns to ambient temperature conditions. As the concrete reaches this ambient temperature condition, concrete compressive strains continued to increase with the likely cause being concrete shrinkage.

**Figure 3.13 - Concrete Mid-Span Strain and Temperature 28 Days After Deck Cast: Wet burlap curing was removed 14 days after slab cast. Concrete temperatures leveled out to approximately 73 °F. Restrained shrinkage strains continue to increase over time.**

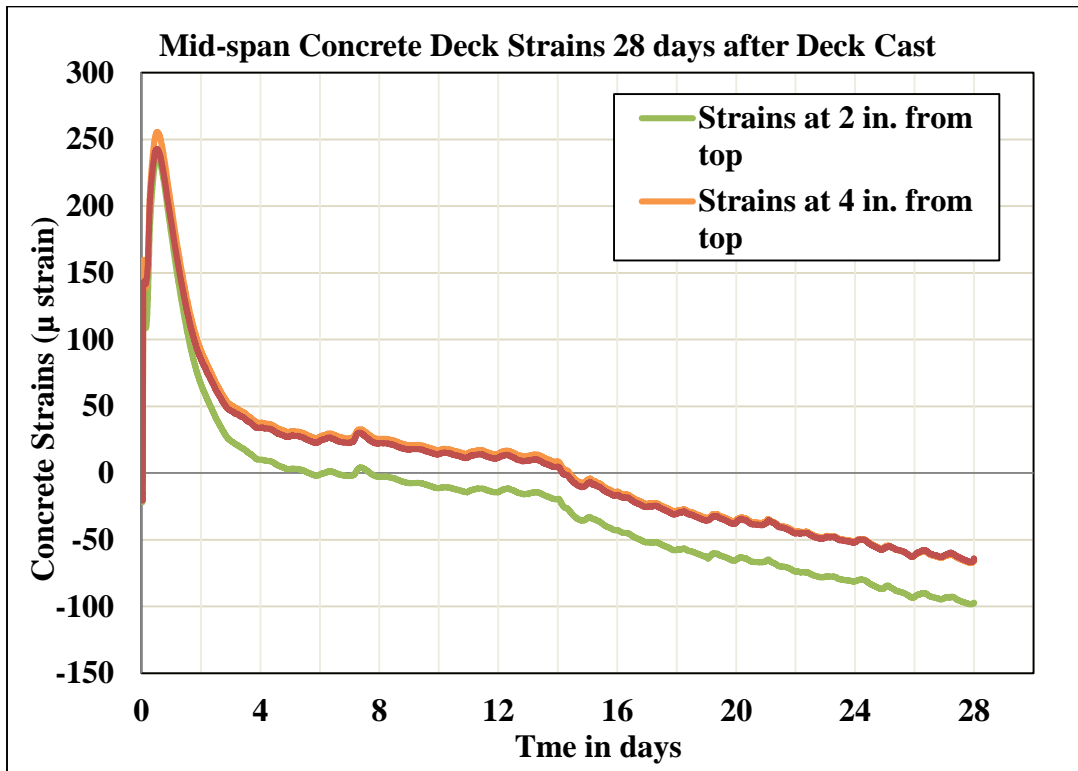
slab. The concrete compressive strains continued to increase with the most likely cause being concrete shrinkage. This restrained concrete shrinkage strain continued to increase over time and was found to be larger near the top surface of the deck.

**Figure 3.14 - Concrete Mid-Span Strains 28 Days After Deck Cast: Strains were measured using VWSG at depths of 2, 4, and 6 in. from the top of the deck slab. Restrained concrete shrinkage strains reached a maximum of 250  $\mu$  strain after 14 hrs. and then continually decreased. Strains were found to be larger near the top surface of the deck.**

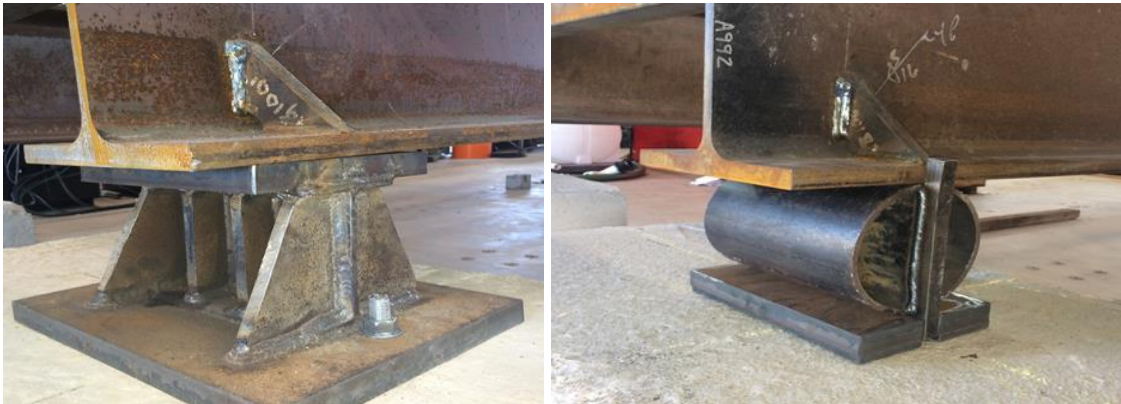
A full-sized prototype bridge was constructed in the Bert Cooper Engineering Laboratory with two W24x94 girders made with A50 steel. Each girder is 39'-10" long, and spaced at 6 ft. center-to-center (c/c). The bridge replicates both the span and cross section dimensions from the Eagle Chief Creek Bridge "A" on SH 14 in Woods Co., OK. The actual bridge has a bridge deck measuring 36'-0" o/o supported by five W24x94 girders. Our full-sized prototype has two girders with an overall deck width of 14'-0". The spans in both the SH14 Bridge in Woods Co. and the full-sized prototype match at 40'-0" nominal span with c/c of bearings spanning 38'-10". The steel beams are supported by a pin at one end and a roller at the other. A photograph of the support conditions is provided in Figure 4.1. Diaphragms are provided at mid-span as well as at the ends of the beams. The cross section details are shown in Figure 4.2.

**Figure 4.1: Bridge Support Conditions**

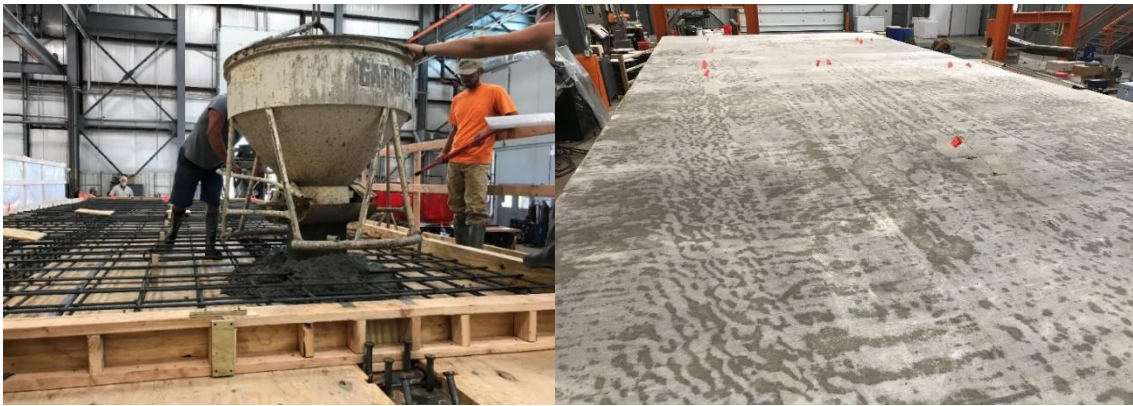
**Figure 4.3: Photograph of bridge slab (a) during cast (b) at 14 days after finishing and wet curing with burlap for 14 days**

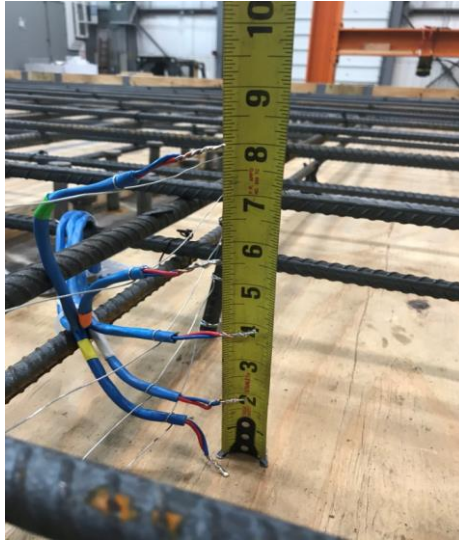
**Figure 4.4 - Photograph of thermocouples used for data collection: Thermocouples were placed at the top and bottom surfaces of the deck and at depths of 2 in., 4 in., and 6 in.**

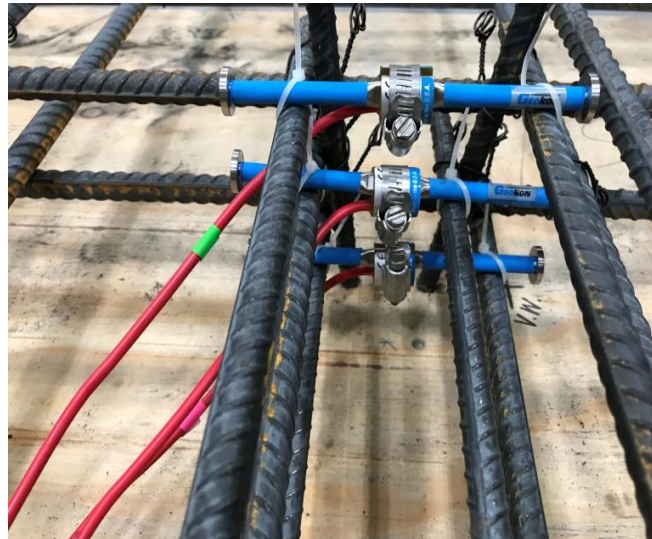
**Figure 4.5 - Photographs of VWSG used for data collection: VWSG were placed at depths of 2 in., 4 in. and 6in. prior to slab casting.**

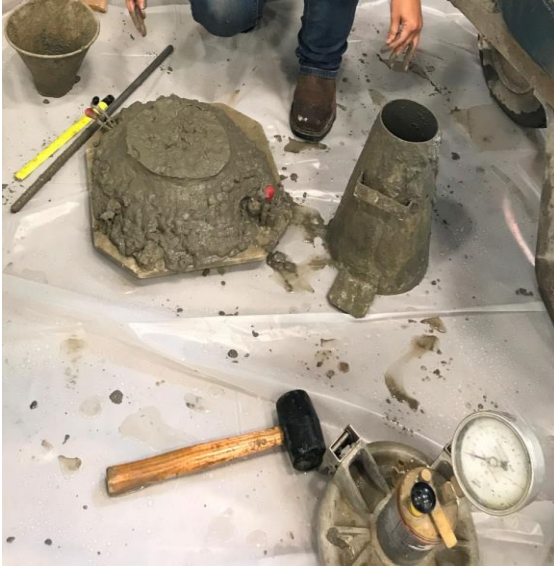
Fresh concrete properties were measured for both trucks, and included measurements for slump, unit weight and air content in accordance with ASTM C143-15a and ASTM C138-17a respectively. The temperature of the fresh concrete was also obtained. Fresh concrete properties are presented in Table 4.2. 5 gallons of water were added to the second truck at the laboratory before casting so that the slump would be consistent with the first truck. The w/cm was gaged with the amount of slump we measured.

**Figure 4.7 - Performing slump test on bridge deck concrete**

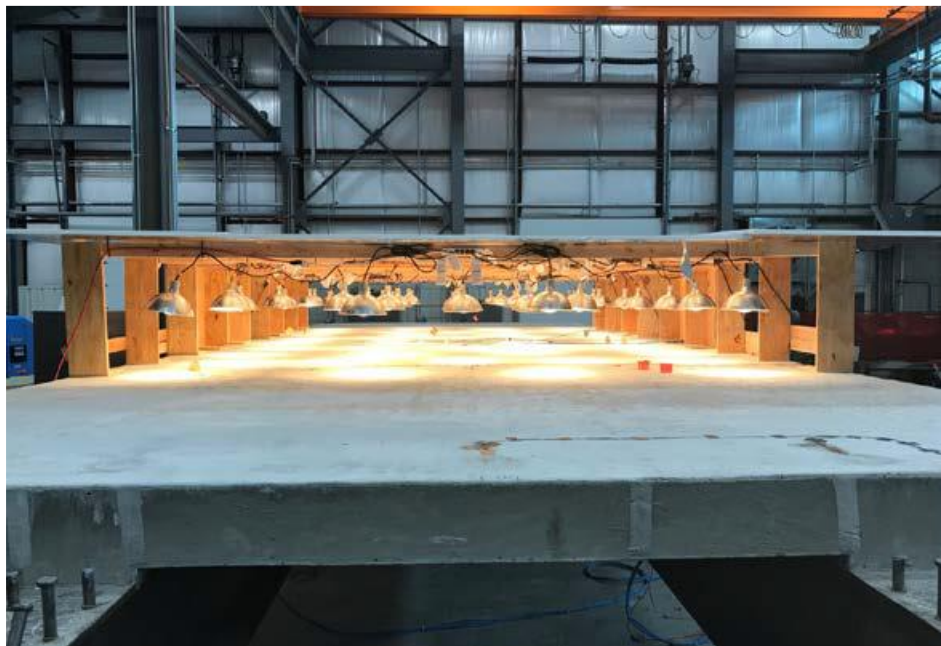
Heating was performed by an array of 250 W infrared heat lamps mounted atop the bridge deck. The orientation and location of the lamps is shown in Figures 4.8 and 4.9. As shown, a total of 54 heating lamps were used. Concrete temperature gradients throughout the depth of the slab, concrete steel strains, and deflections were monitored continuously for the 24-hr. cycle.

**Figure 4.8 - Photograph of Thermal Loading Testing Frame Setup**

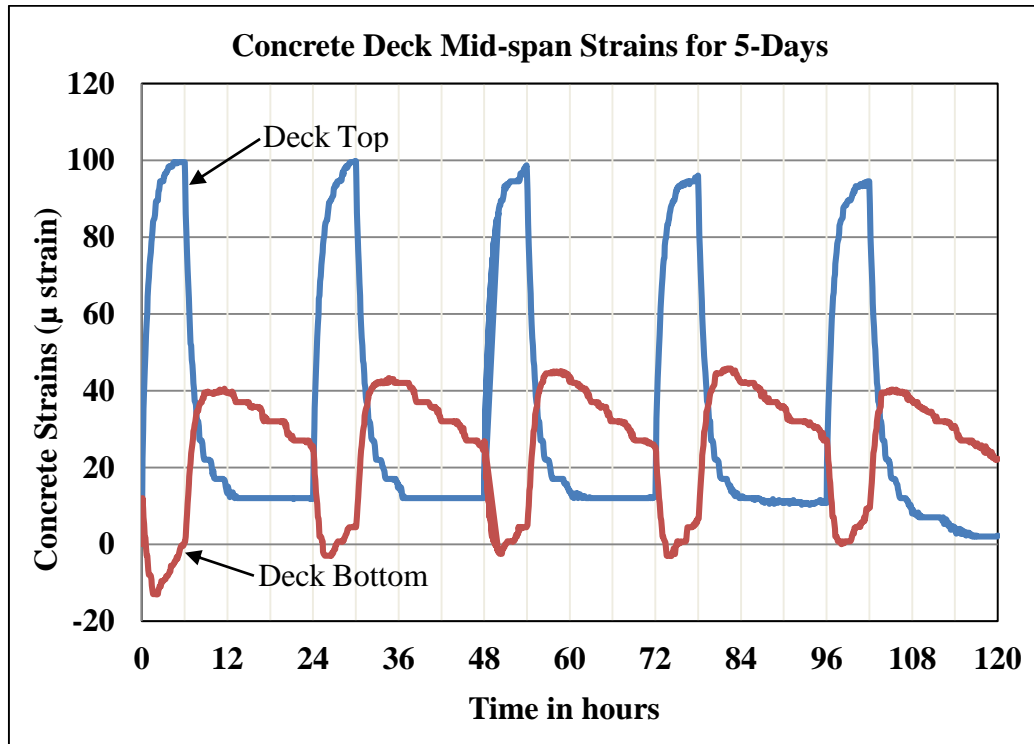
The effects of residual strains are further studied by analyzing the typical concrete strains for a 5-day loading cycle as presented in Figure 4.11.

**Figure 4.11 - Typical Concrete Deck Mid-Span Strains for a 5-Day Loading Cycle:** The cumulative effects of residual strains throughout the week are seen by presenting the strains for a 5-day loading cycle. The strains in the top of the deck decreased over the cycle while the strains in the deck bottom increased. Bonded foil strain gages were placed on the top and bottom surfaces of the slab for measurements. The loaded cycle represented is for testing on October 2 thru October 7, 2017.

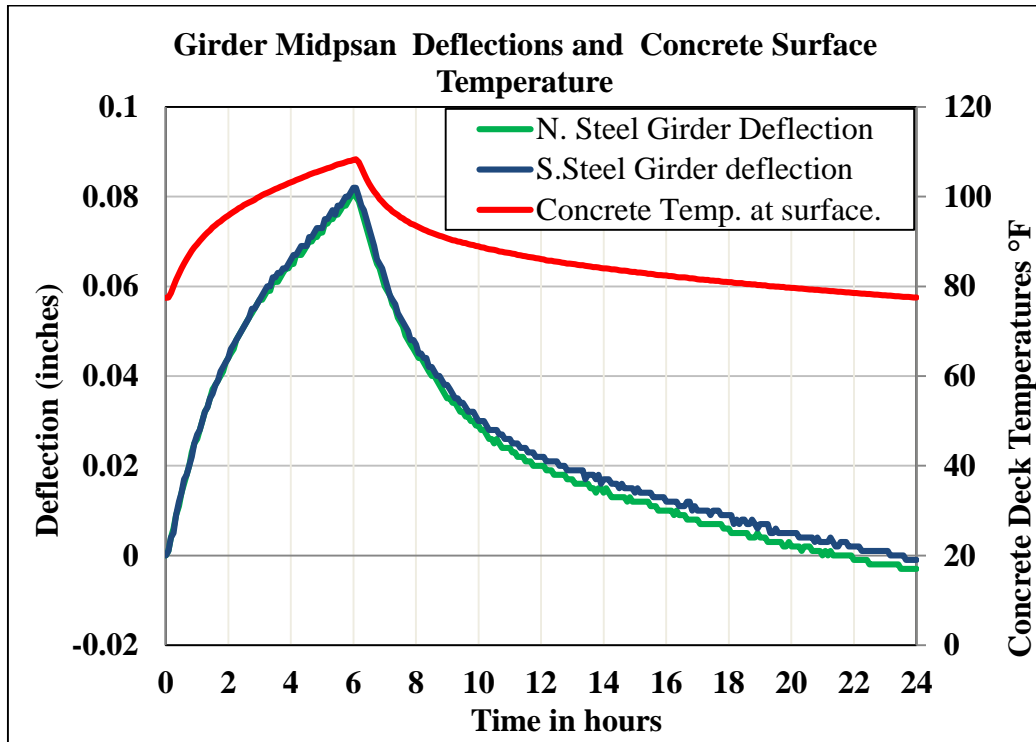
Figure 4.14 - girder mid-span deflections and concrete surface temperature on September 28, 2017: Girder deflections are consistent with the uniform heating of the concrete bridge deck. There are minimal residual deflections at the end of the 24 hr cycle.

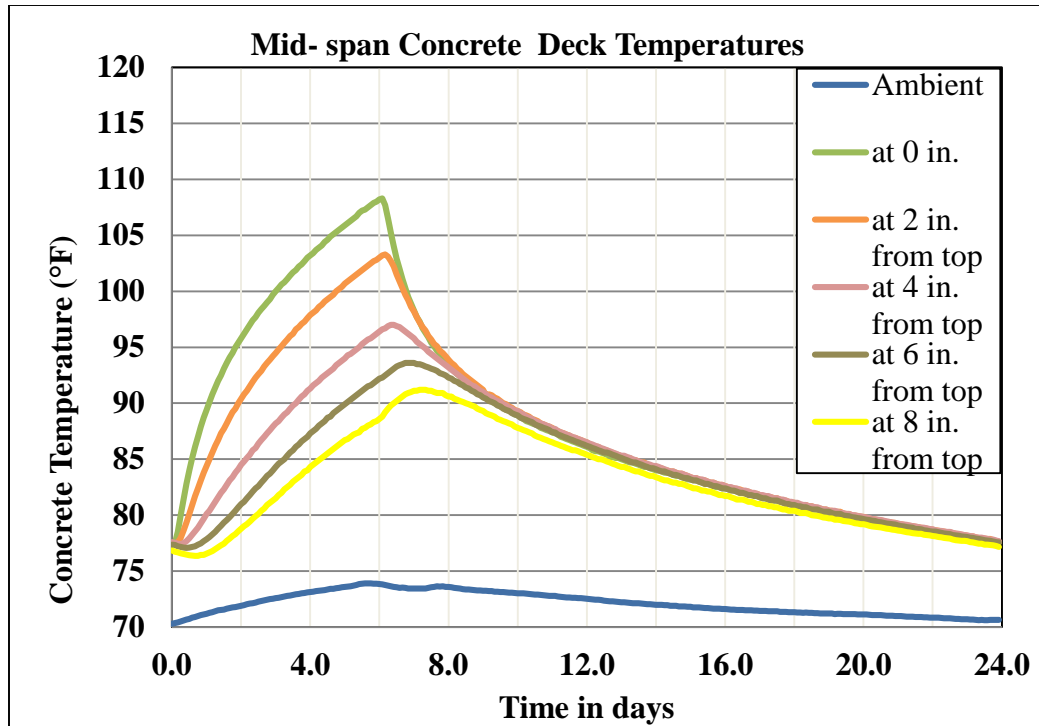
**Figure 4.15 - mid-span concrete deck temperatures on September 28, 2017: Concrete temperatures are presented at depths of 0, 2, 4, 6, and 8 in. from the top of the concrete deck surface along with the ambient temperature in the lab during temperature loading. The maximum temperature at the surface it reached at the end of the 6 hr heating cycle with maximum temperatures throughout the deck being reached after the heating cycle has ended.**

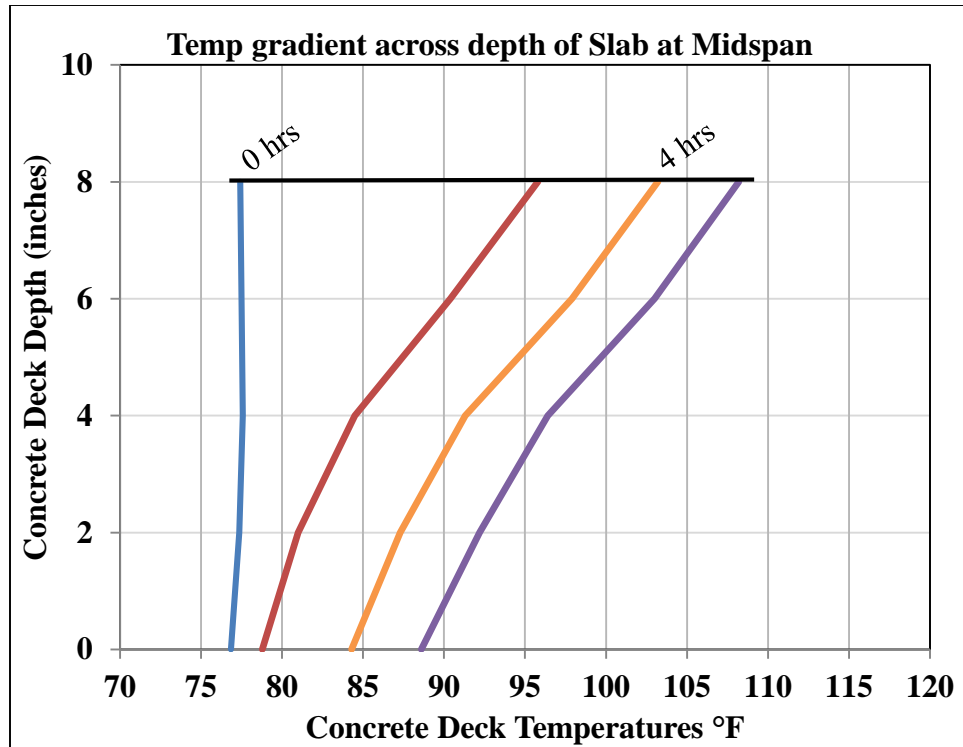
Figure 4.17 - Temperature gradient across depth of slab at mid-span for September 28, 2017: The T1 and T2 temperature values were recorded as 108 °F and 96 °F respectively after 6 hrs of heating.

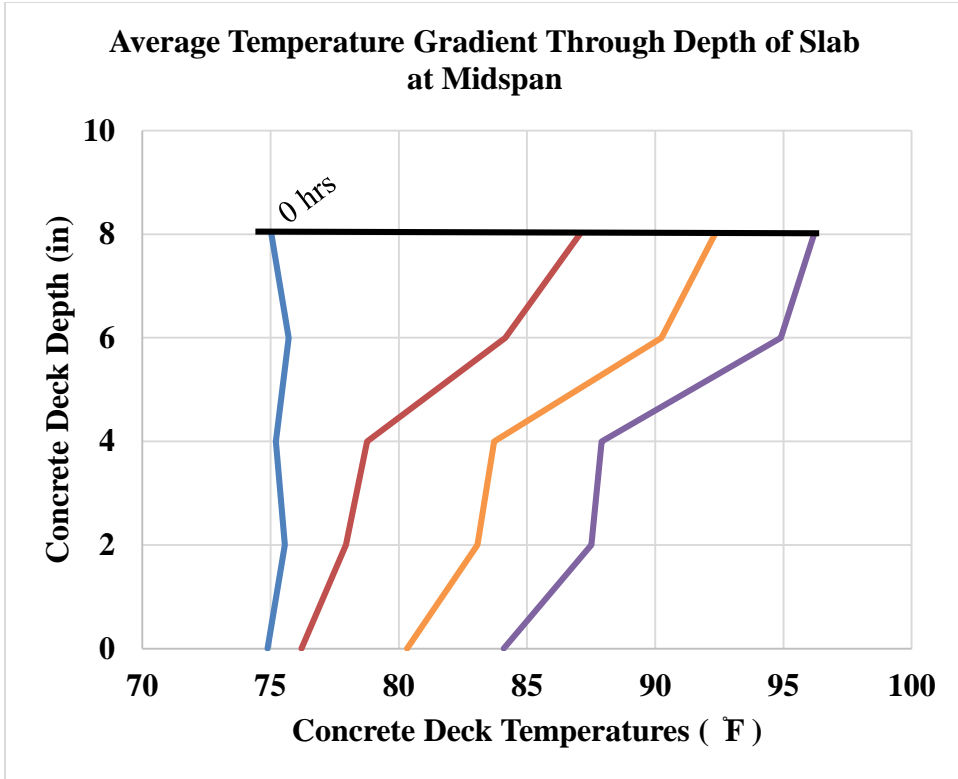
**Figure 4.18 - Average Temperature Gradient for All Days of Thermal Load Testing: The average T1 and T2 values after 6 hrs of temperature loading were recorded as 96 °F and 88 °F respectively.**

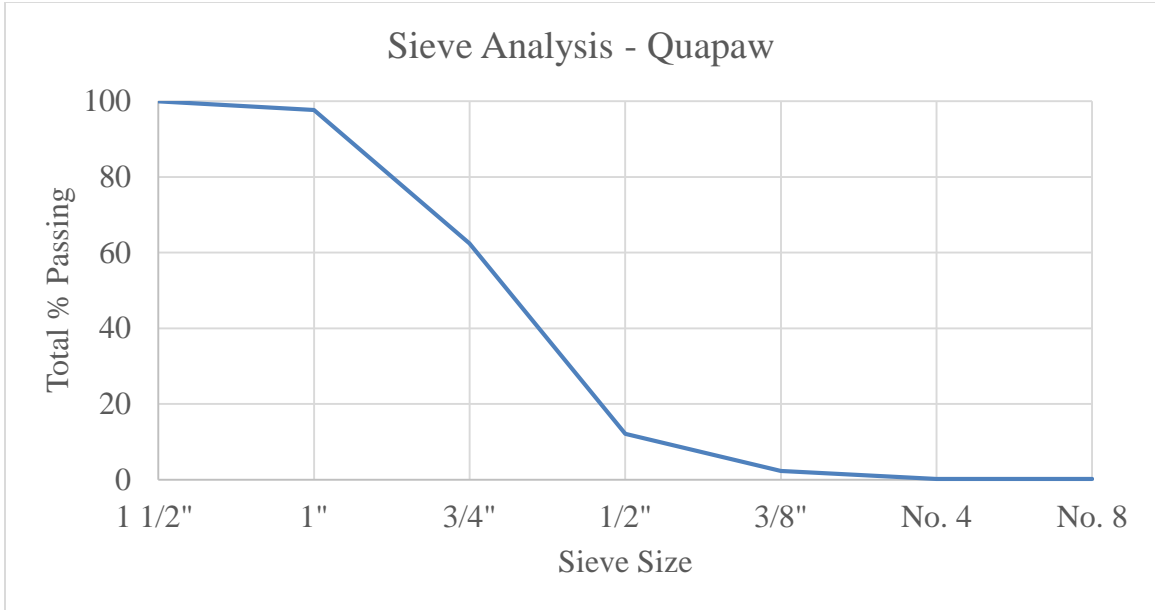
**Figure A.1.1.1 – Sieve Analysis Results of Quapaw Rock**

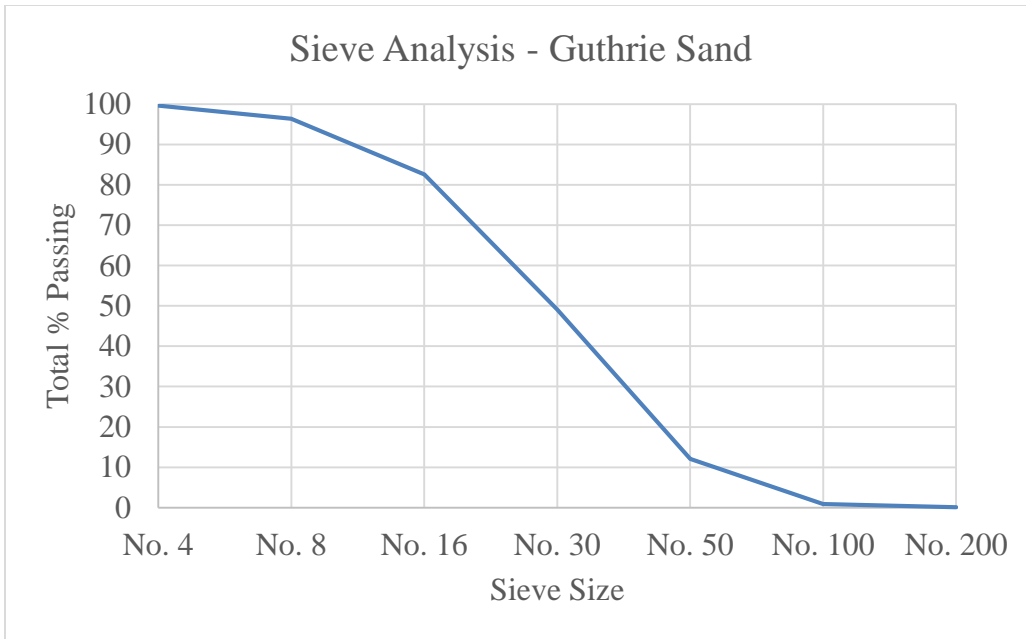
**Figure A.1.2.1 – Sieve Analysis Results of Guthrie Sand**
