ULTRA-HIGH PERFORMANCE CONCRETE FOR CONNECTIONS OF PRECAST,  
PRESTRESSED GIRDERS MADE CONTINUOUS FOR LIVE LOAD

A THESIS  
SUBMITTED TO THE GRADUATE FACULTY  
In partial fulfillment of the requirements for the  
Degree of  
MASTER OF SCIENCE

By  
CONNOR WILLIAM CASEY

2019

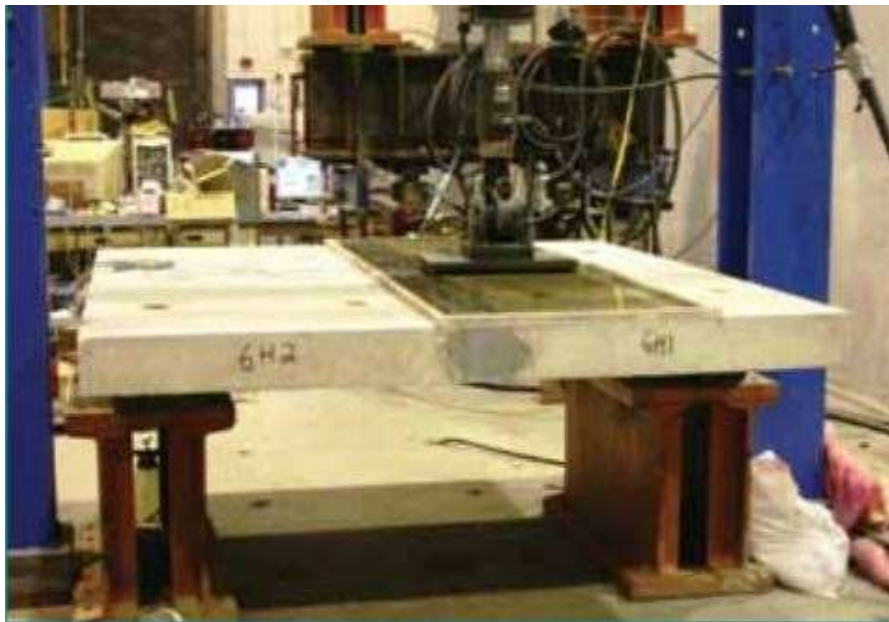
Figure 10. FHWA UHPC slab connection test (Graybeal 2010).

To understand the behavior of using UHPC in joints for modular bridges, FHWA conducted tests on slabs with UHPC joints having several different types of reinforcement detailing (Graybeal 2010). Cyclic and static loading conditions were applied to the joint specimens. Cyclic loading was used to model actual roadway conditions for a vehicle driving over the connections and to achieve fatigue failure, and a single point load was used to test the ultimate capacity. The results from the dynamic loading tests on the joints indicated far better performance than expected, and the overall ultimate failure capacity of the joints also exceeded expectations. As a result, using UHPC as a type of connection proved to be favorable, since in most cases the load path going through a connection is the weak link in the overall structure. Having a robust connection allows concrete around the connection to fail, which is much more desirable from a design standpoint. Figure 10 depicts the test layout of the slabs used in the 2010 FHWA study (Graybeal 2010).

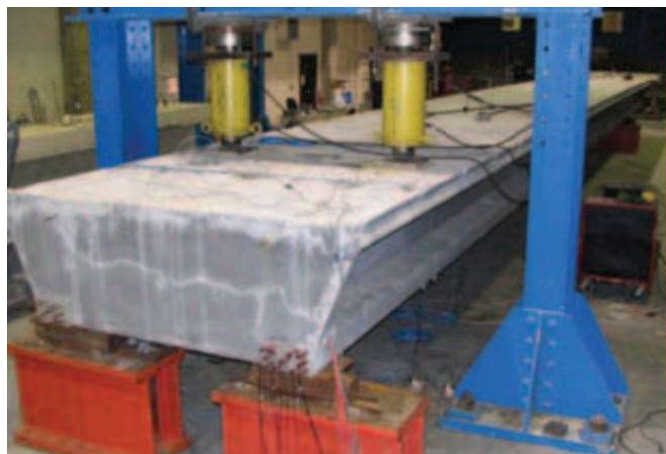
The next phase was to do physical full scale testing on the prototype pi-girder with a span of 70 feet. The pi-girder was fabricated at a precast plant and then transported to the testing facility. The tests conducted examined flexural, shear, transverse flexural, and load distribution behaviors. Shown in Figure 14 is the prototype pi-girder set up in the load frame for shear testing (Graybeal 2009).

Figure 14. Prototype pi-girder in load frame for shear testing (Graybeal 2009).

The results of the physical tests showed that this type of decked UHPC girder is possible, as the prototype met all design requirements in the primary flexural and shear tests. However, the load distribution was limited, and the transverse flexural capacity was not able to elastically resist service-level wheel loads. In response to the prototype not meeting all of the design requirements, the prototype was modified to not only increase the structural capacity, but to allow for ease of fabrication and simplify modular construction. Shown in Figure 15 is the cross-sectional view of the 2<sup>nd</sup> generation pi-girder (Graybeal 2009).

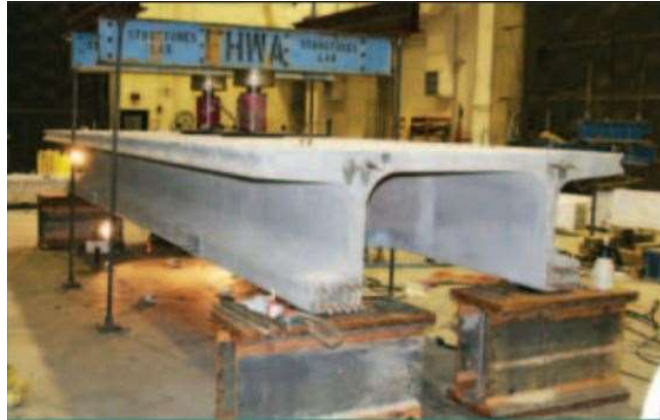
The new pi-girder was not retested for primary flexural and shear capacities, as the researches expected similar portion to the prototype in these areas and wanted to focus on the transverse flexural response when subjected to increasing simulated wheel loads. This allowed a reduction of specimen's span length to 25 ft for testing. Shown in Figure 16 is the 2<sup>nd</sup> generation pi-girder in a load frame for the transverse flexural test (Graybeal 2009).

Figure 16. 2nd generation pi-girder setup in the load frame for a transverse flexural test (Graybeal 2009).

The results of the transverse flexural tests showed an overall improvement of the transverse flexural capacity from the prototype pi-girder and met the AASHTO LRFD bridge standards (AASHTO 2014). With the improvements done to the prototype pi-girder in the 2<sup>nd</sup> generation girder would allow the pi-girder to be used in service with a maximum span length of 87 ft. This generation of pi-girder was initially deployed in Buchanan County, IA and went into service in late 2008 with three adjacent pi-girders being used (Graybeal 2009).

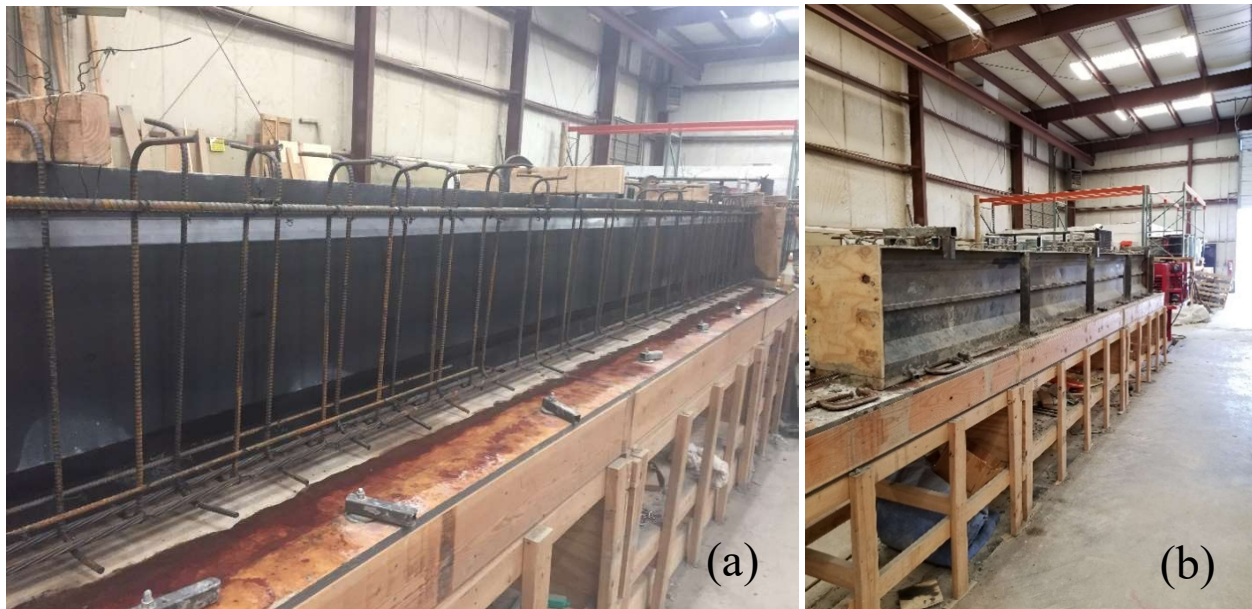
The construction process for the prestressed girders involved two main building activities. The first activity was the setup of the prestressed girders. The first step was preparing the prestressing bed for prestressing strands and the two sided steel formwork. Figure 19a shows the prestressing bed, which is made from five 8 ft. wooden tables, and two steel prestressing abutments. This configuration allows the construction of two prestressed girders at a time. The next step involved running the prestressing strands through both abutments and using strand chucks to hold the prestressing strands against the abutments. The strands were then tensioned to 2 kips each to pull the strands to the correct elevation. After the strands were tensioned half of the formwork was put into place to allow for the top longitudinal mild steel to be placed. Following this the shear

Figure 20. Prestressing bed with formwork showing reinforcement (a) and exterior formwork in place (b).

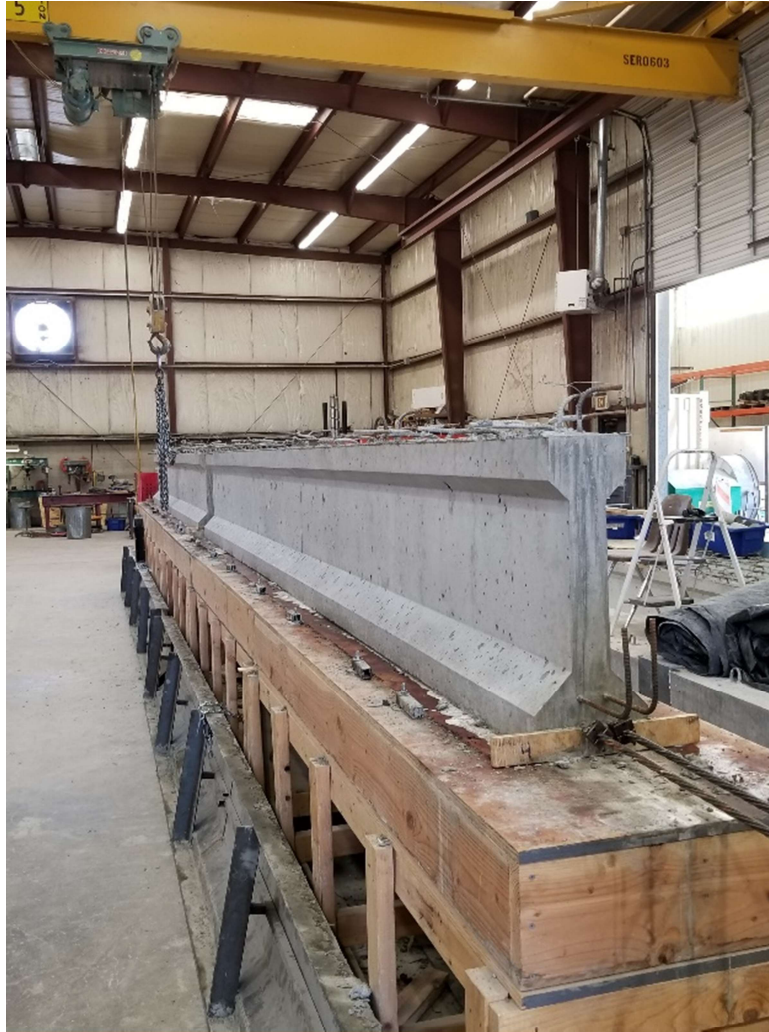
stirrups were placed and tied in place. The remaining formwork was then put into place, and the prestressing strands were tensioned slightly past 75% of the ultimate capacity, to account for seating losses from the nuts holding the strands in place after tensioning. When the hydraulic rams were released the target load was 75% of the ultimate capacity, or 202.5 ksi (33.4 kips) per strand. The load was monitored on one prestressing strand using a through hole load cell that the strand chuck would react against. The formwork during construction and after completion is shown in Figure 20. The second building activity consisted of mixing and placing the concrete. All concrete was mixed at Fears Lab in order to properly maintain quality control of the concrete mix design. The largest capacity mixer available at the lab was a Praschak spiral blade mixer with a 21 ft<sup>3</sup> capacity. Each girder required 16 ft<sup>3</sup> of concrete, and two back to back batches were done for each set of two specimens, one for each girder. As a result of having a separate batch for each girder, the time difference between girder placements was up to 30-60 minutes affected the actual age of each girder when prestress was released. After the concrete was placed in both sets of formwork, the concrete was left to cure for 24 hours. Upon reaching the 24 hour mark after casting the second girder cylinders were tested from each batch to verify the 4000 psi compressive strength required for prestressing strand release had been reached. Once the strength was verified, the prestressing strands were de-tensioned gradually using the hydraulics included in the prestressing abutment shown in Figure 19b, allowing the prestressing force from the strands to transfer into the concrete creating two prestressed girders. A completed set of girder specimens is shown in Figure 21.

Figure 21. Finished prestressed girder before Detensioning.

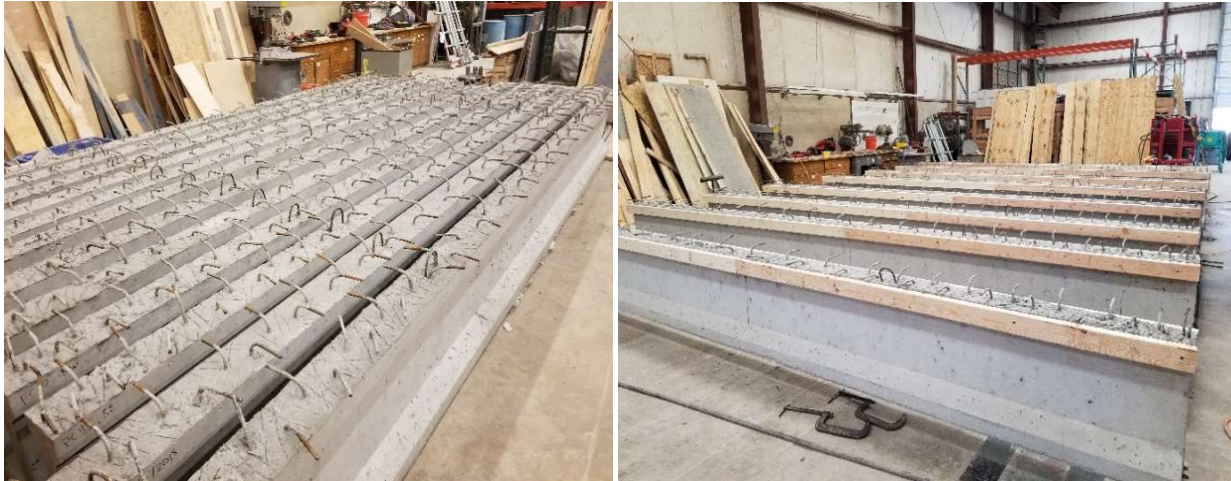
The construction of the composite deck involved two activities; construction of formwork and casting the concrete. The slab construction consisted of making unshored wood formwork for each individual prestressed concrete beam. Unshored formwork was chosen to model actual composite deck construction that occurs on full scale bridges. To achieve this type of formwork, 2 x 4 dimensional lumber was first attached to each side of the flange of each beam using concrete screws, to obtain the designed tributary width. The top of each 2 x 4 was made flush with the top of the beam flange. Plywood was then attached to the 2 x 4's to obtain the required depth of the slab. The required negative moment reinforcing steel for the continuity joint was then tied at the desired elevation near the end of the beam to be connected. At the same end of the deck where the negative moment reinforcing steel goes into the joint, a portion of the deck was blocked off from normal concrete to allow UHPC to go into a portion of the deck slab as shown in Figure 11b. After the formwork was finished the next step was to place concrete into forms. To further model full scale bridge construction, ODOT Class AA concrete was delivered in a concrete ready mix truck. This type of concrete mix has a design 28 day compressive strength of 4000 psi and is used by ODOT in their full scale bridge deck construction. After the concrete was cast into the forms, covered, and cured for 24 hours, the slabs were surface water cured for 7 days using wet burlap before removing the formwork. The various stages of construction of the slabs are shown in Figures 23-25.

Figure 23. Initial composite deck formwork.

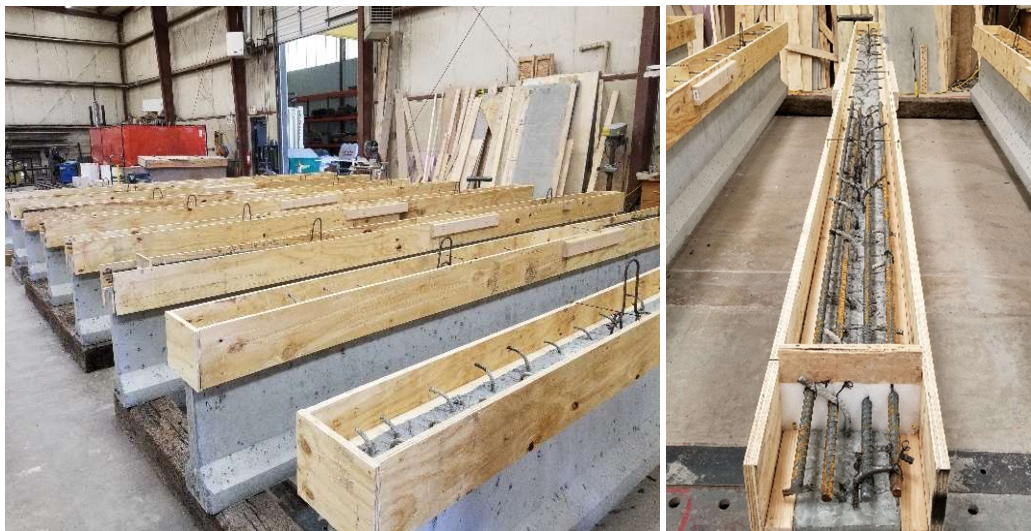
Figure 24. Composite deck formwork prior to casting.

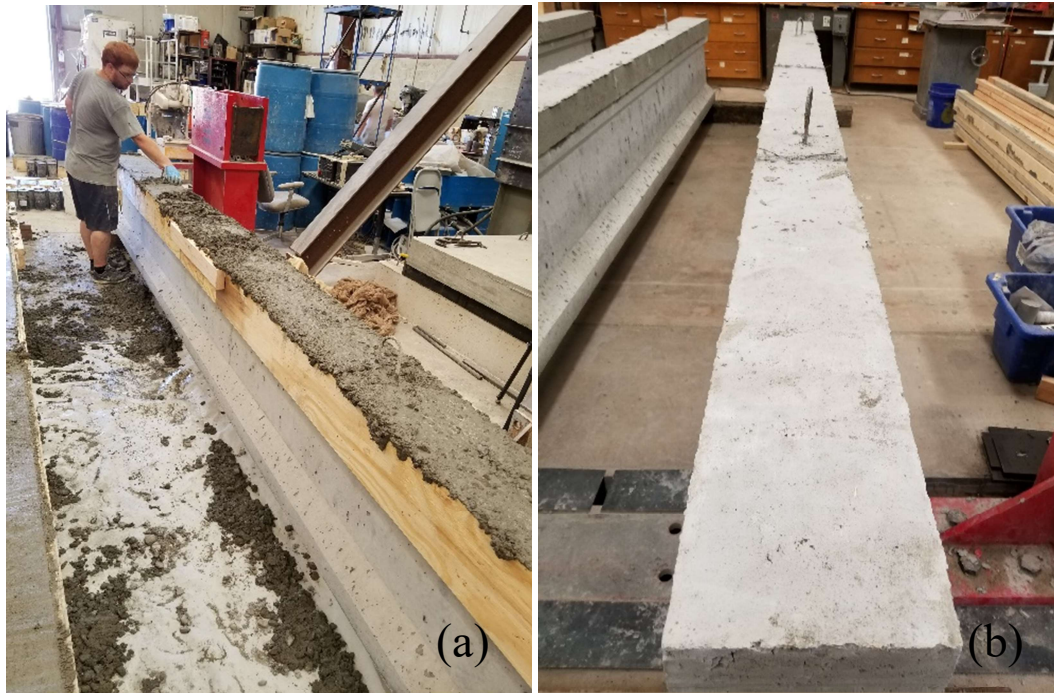
Figure 25. Concrete being placed (a) and finished composite deck (b).

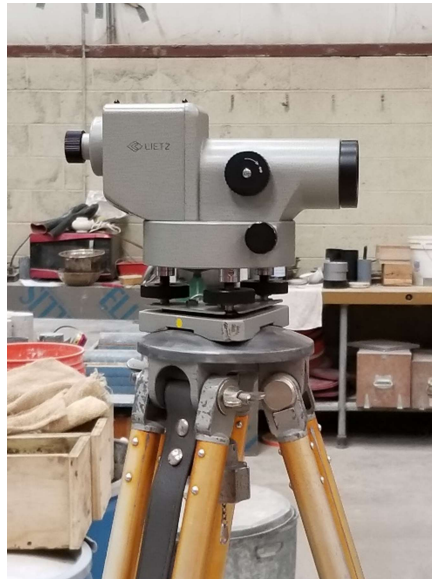
Continuity joint construction for both types of joints was very similar. The only difference was that the retrofit connections extended 6 in. beyond the end of the girder, and the joint was 3 in. wider, which resulted in different formwork requirements. The first step in the construction was aligning the pairs of prestressed concrete girders constructed together such that the ends with the negative moment and positive moment steel were placed together in the required joint configuration. A survey transit and level rod were used ensure the girders were in a straight line. Figures 40 and 41 show the transit and survey rod.

Figure 40. Transit.

A reference point was taken at the far end of the first girder, then the opposite end was adjusted until it was in line with the reference point. The second girder was then set to an estimated position with the ends placed with correct gap space for the joint. Then, the joint end of the second girder was adjusted to line up with the reference point, and finally, the opposite end of the second girder was adjusted to line up with the reference point. This was done for all 6 pairs of girders.

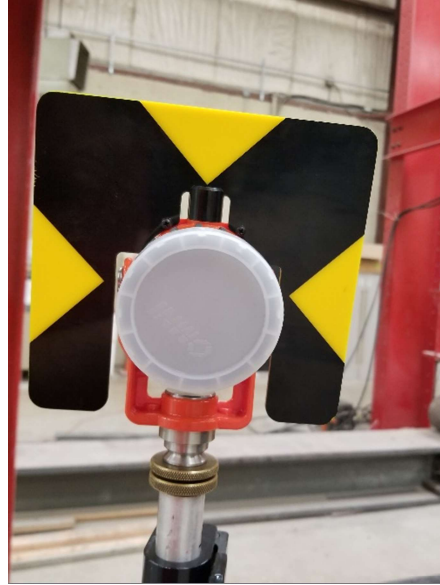
Figure 41. Survey rod.

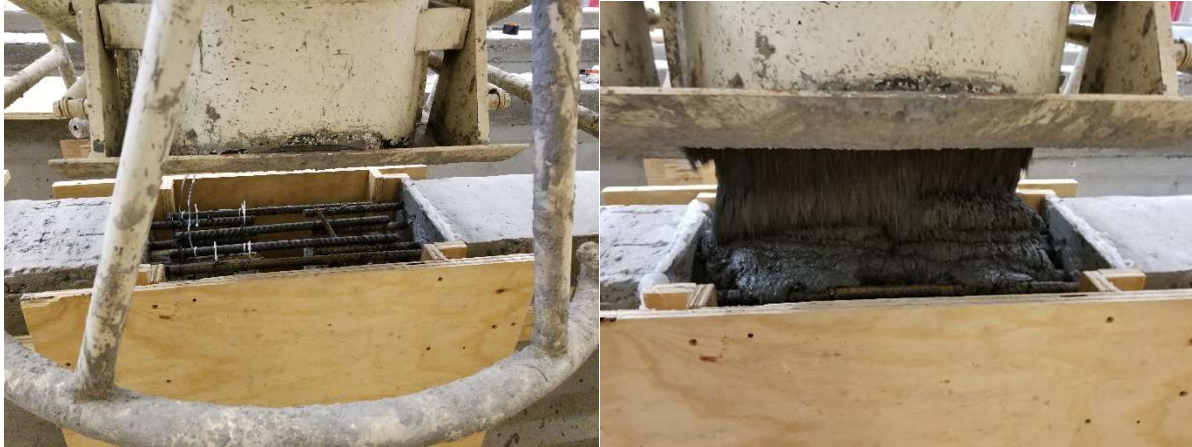
over the course of 1 minute. The UHPC was mixed until flowable with a consistency similar to cake batter. Upon reaching the correct consistency, the steel fibers were added into the mixer. After the steel fibers mixed thoroughly in the UHPC, a flow test was conducted using the methods of ASTM C1437 and C1856 to check for proper flowability before placing the UHPC into the joints. UHPC was transported from the mix and placed in the joint formwork using a transfer bucket. After UHPC placement pieces of plywood and plastic sheeting were placed on top of the joints to prevent moisture loss. Twelve 3 in. x 6 in. cylinders were made to test the UHPC compressive strength at 3 days, 7 days, 28 days and day of specimen testing. The UHPC was cured for 7 days before removing the formwork around the joint. Figures 43 and 44 show the UHPC being placed, and the formwork being removed after the 7 day curing time.

Figure 43. UHPC being poured into the joint formwork for one of the retrofit specimens.

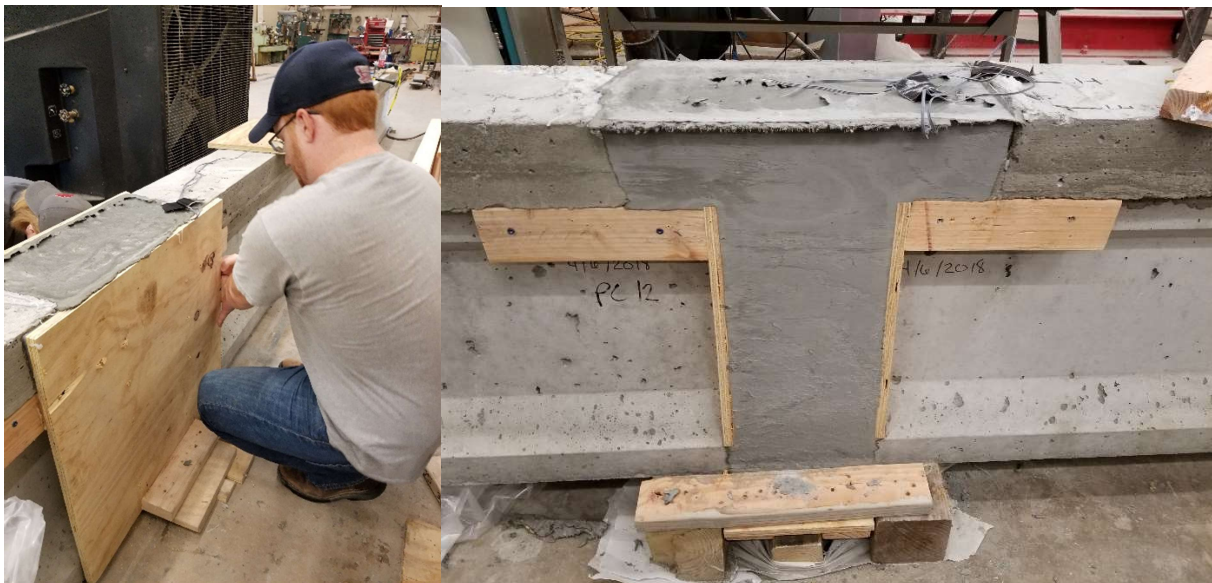
Figure 44. Removing formwork from a newly constructed joint specimen.

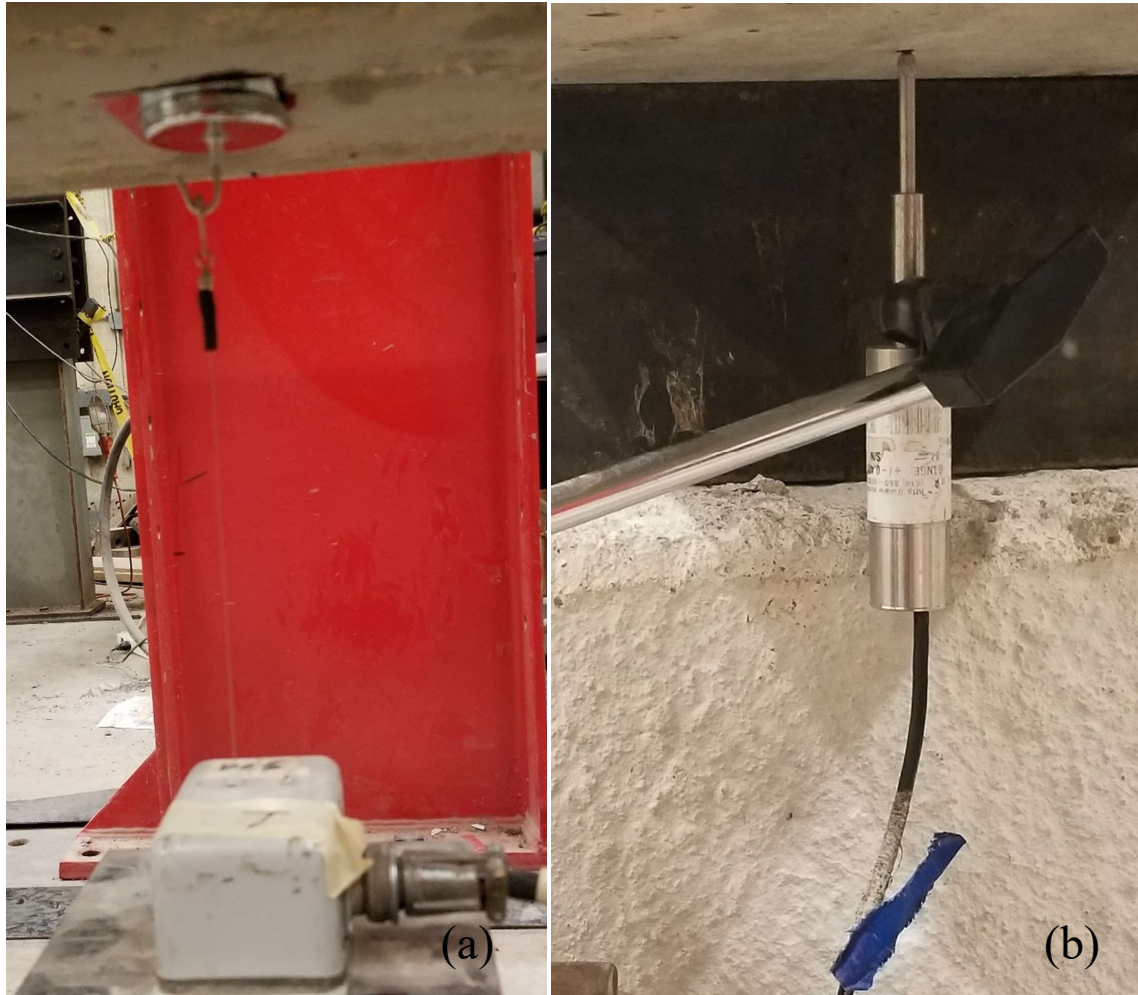
One wire potentiometer (pot) was placed directly under the beam at each load point to measure the deflection of each beam at mid-span. Linear voltage differential transformers (LVDTs) were placed under the girder center line at each of the supports. These LVDTs were used to measure the deflection of the neoprene pads supporting the girders during loading to subtract from the wire pot readings to get a true deflection of the girder at mid-span. Figure 47 shows a wire pot set up at midspan of the girder, and the LVDT set up at one of the supports.

Figure 47. Wire potentiometer (pot) attached to bottom of girder at midspan (a) and linear voltage differential transformer (LVDTs) placed under girder near the support (b).

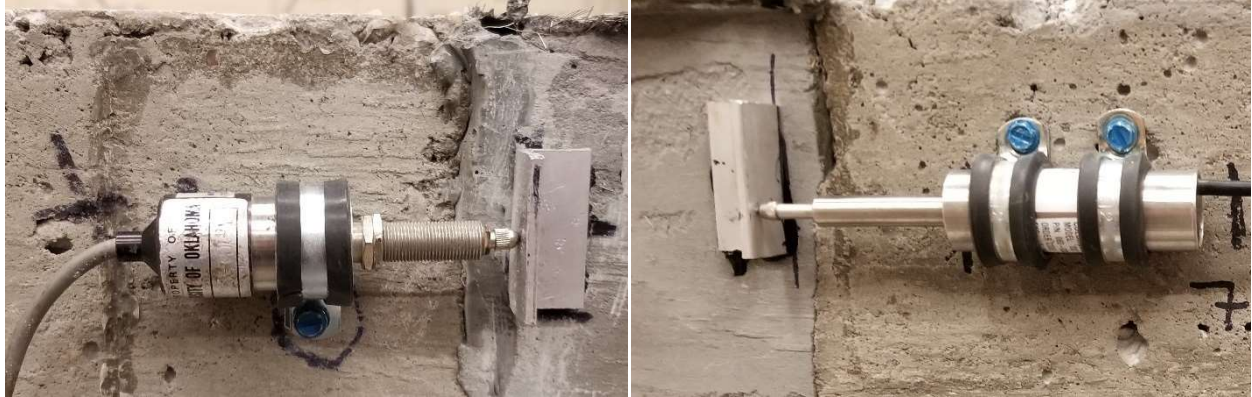
Four more LVDTs were attached around the negative moment region of the joint to measure joint separation at the interface of the connection if it occurred. One LVDT was attached directly to the concrete deck 2 in. below the top of the deck on each side of the joint on each side of the specimen using two conduit clamps and concrete screws. The LVDTs pushed against an aluminum angle attached to the UHPC joint. This allowed the LVDT to measure joint separation at the top portion of each interface on the side of the joint. Figure 48 shows two LVDT's attached to one face of the continuity joint.

Figure 48. LVDTs used to measure joint separation attached to the girder.

Figure 61 shows the load-joint separation curve between the NC1-N girder's concrete deck and the UHPC joint from the reload test. The readings from the LVDTs on the east and west faces of the concrete deck were averaged to get a better representation of the joint separation. Figure 48 shows the location of the LVDTs on the joint interface and are located 2 inches below the top of the deck. The reload curve showed a linear trend from zero back to where the final load of the initial test had stopped. Beyond the 60 kip load joint separation increased significantly with each load increment. At this point the NC1-N girder began to exhibit an increase in deflection, resulting in a less stiff member and creating a hinge at the weak point, that is the joint interface. Figure 62 shows the reload joint separation curve between the NC1-S girder's concrete deck and the UHPC joint. This figure only represents LVDT11 on the west face of the deck. LVDT 7 was not included for any of the six tests, as the data was unreliable. This load joint separation curve

Figure 72 shows the load-joint separation curve between the NC2-N girder's concrete deck and the UHPC joint. The average of the readings from the LVDTs on the east and west faces of the concrete deck was taken to get a better representation of the joint separation. Figure 48 shows the location of the LVDT's on the joint interface and are located two inches below the top of the deck. The deck joint had minor separation until reaching the initial flexural cracking of 40 kips. After that load, indicated by a diamond shape in Figure 72, the joint separation began to increase significantly with each load increment. It is reasonable that major joint separation could only occur after the girder cracked due to flexure, resulting in a less stiff member and creating a hinge at the weak point; the joint interface. Figure 73 shows the load-joint separation curve between the NC2-S girder's concrete deck and the UHPC joint. This figure only includes results from LVDT11 on the west face of the deck. This load-joint separation curve shows the opposite of what was expected. As the girder cracked in flexure, the reduction of girder stiffness appeared to

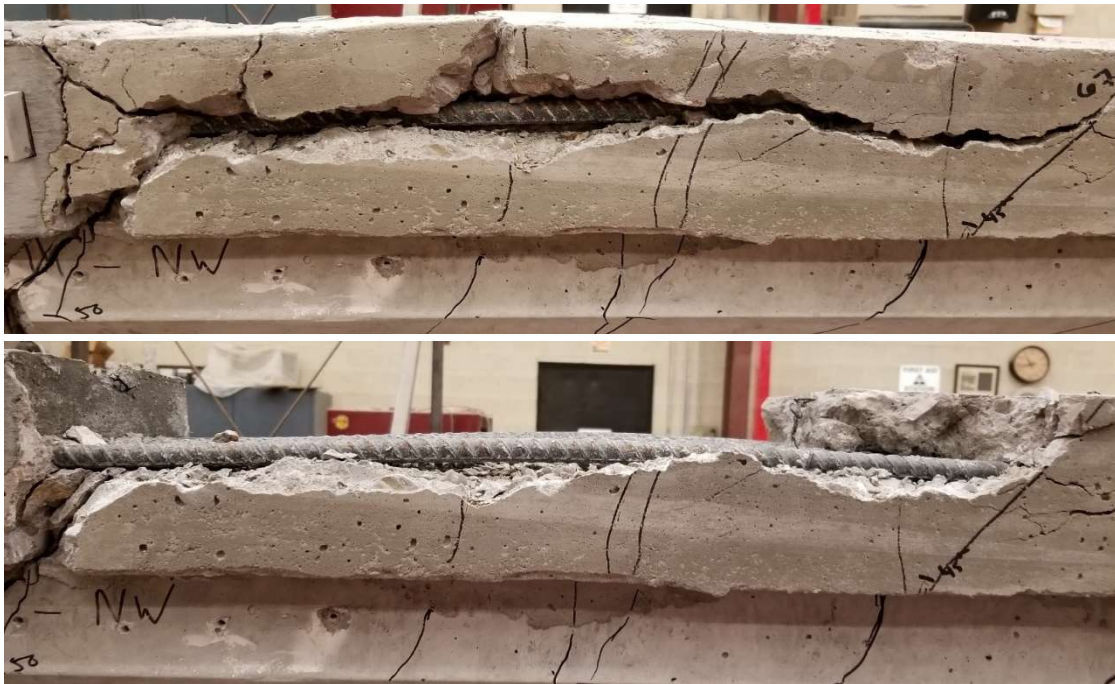
Figure 69. NC2-S girder before excavation of the concrete in the deck (top) and the deck after excavation exposing the reinforcement (bottom)
