FIELD AND LABORATORY EVALUATION OF SELECTED  
FLEXIBLE PAVEMENT CRACK SEALANTS

Submitted to the Faculty of the Graduate College  
of the Oklahoma State University  
in partial fulfillment of the requirements  
for the Degree of  
MASTER OF SCIENCE  
December, 1980

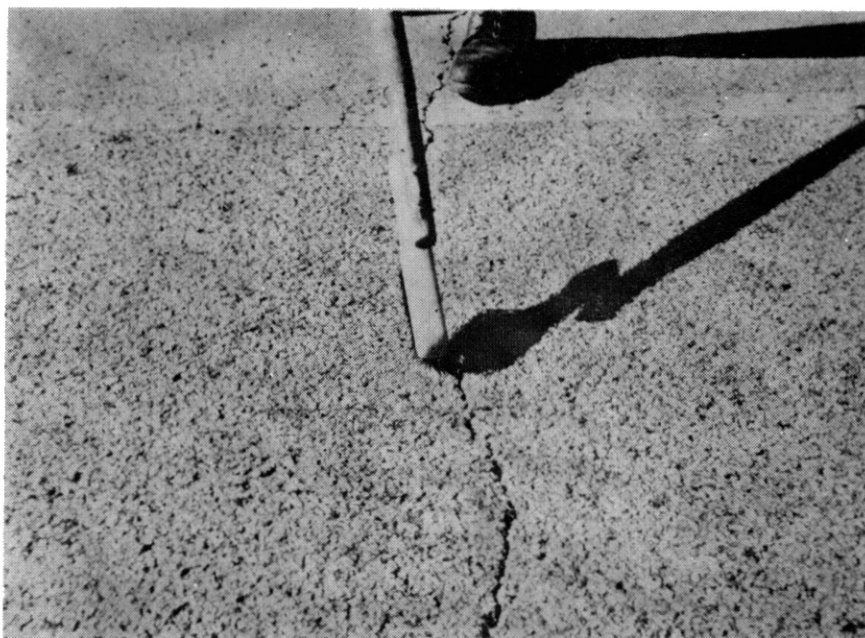
Figure 10. Brushing Transverse Crack Prior to Air-Blowing.

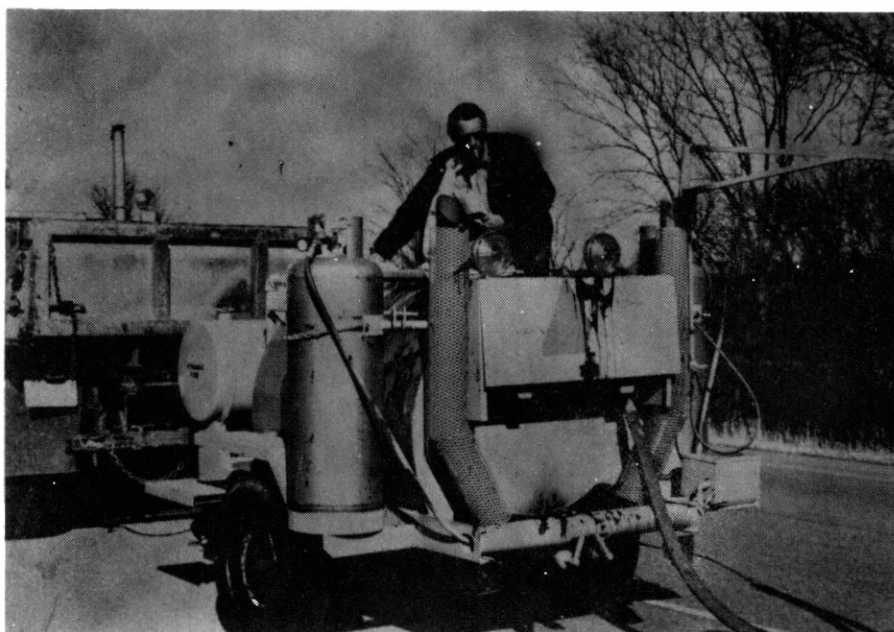
Figure 11. Oklahoma Department of Transportation Double-Wall Melter.

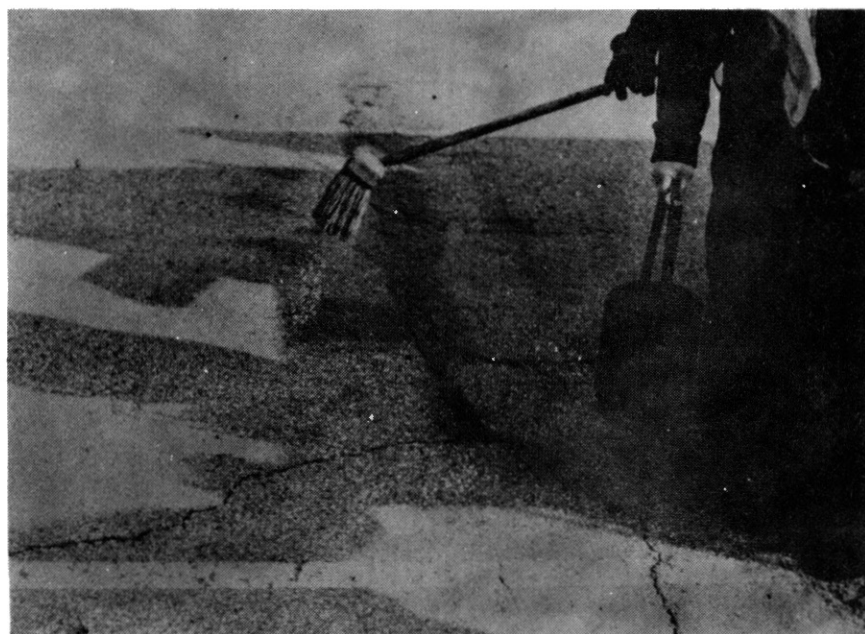
Figure 13. Application and Sanding of Emulsions.

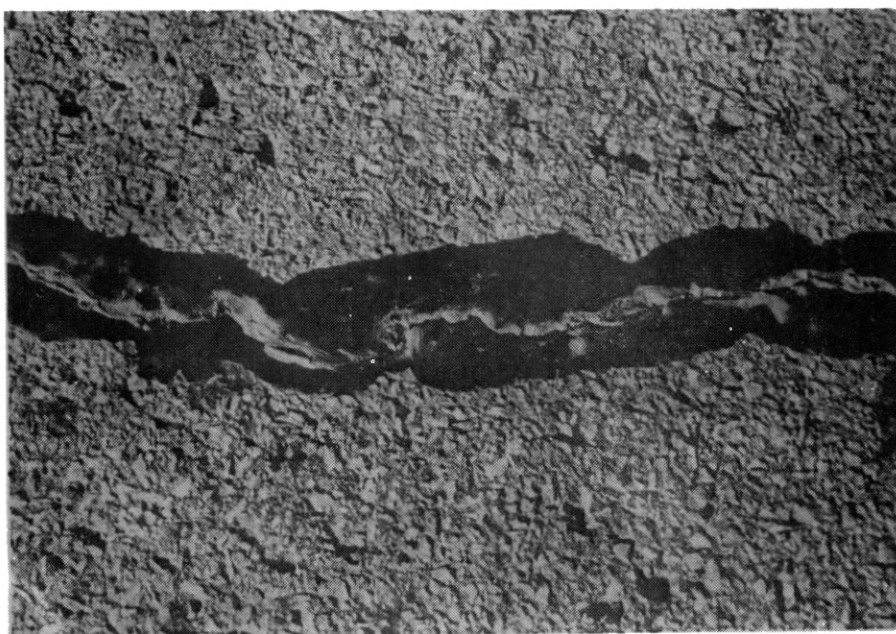
Figure 17. Cohesive Failure of CRS-2 Emulsion.

The failures in the emulsion sealants were primarily cohesive in nature (Figure 17). The celerity of these failures is attributed to the incomplete setting of the emulsion prior to exposure to below freezing temperatures. After being poured into a pavement crack, the surfaces of the cationic emulsions in contact with the crack bottom and sides and the free surface break rapidly to form an asphalt skin or film that retards evaporation and/or drainage of the emulsifying water from the bulk of the

installed sealant. This has been observed both in the laboratory and field portions of this study. A lengthy period of time (several weeks) may be required for complete setting or breaking of this type of sealant. If the pavement temperature drops below 32<sup>o</sup>F prior to complete setting, the remaining emulsion freezes and becomes quite brittle. With little or no tensile strength, the emulsion sealant in a crack cannot resist the applied stresses from adjacent pavement sections.

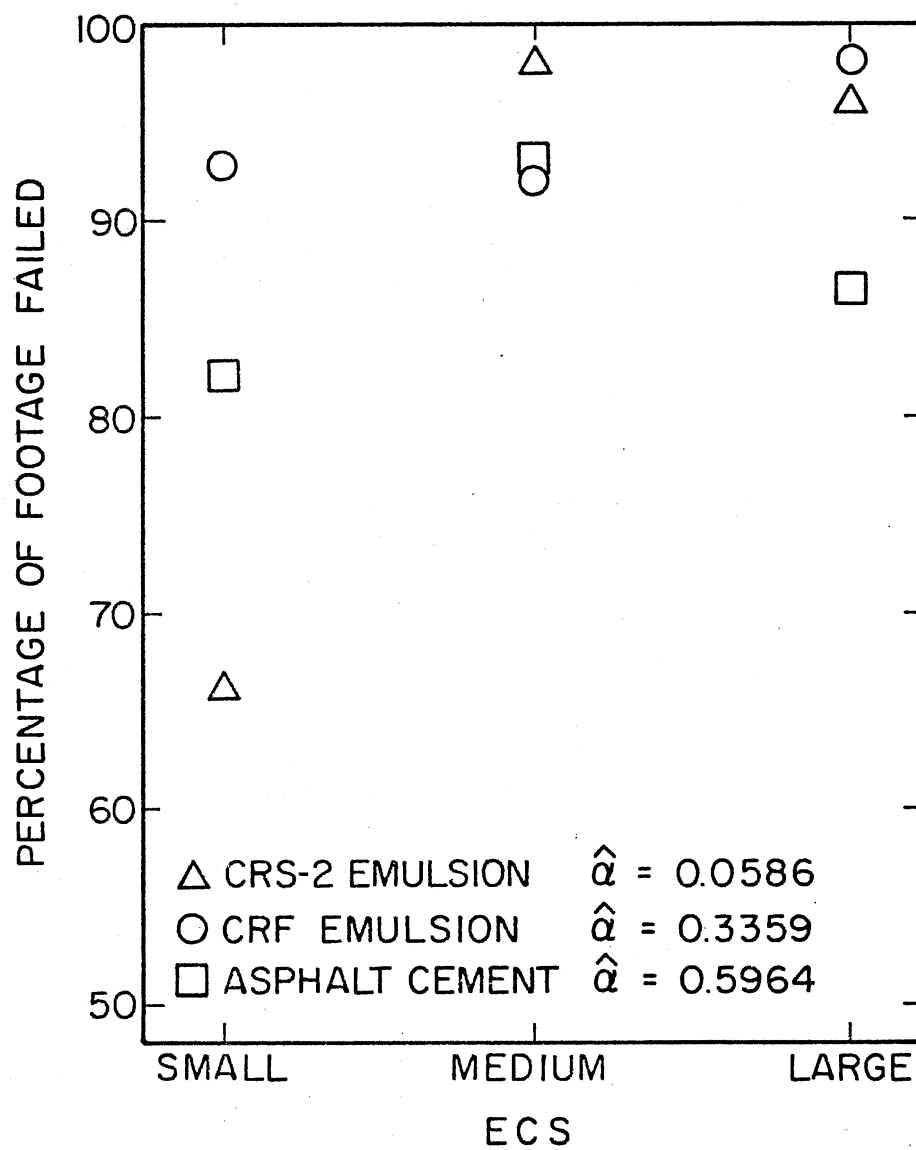
Figure 18. Percentage of Footage Failed vs. ECS for the CRS-2 and CRF Emulsions and 85-100 Pen AC and the Respective Observed Significance Levels.

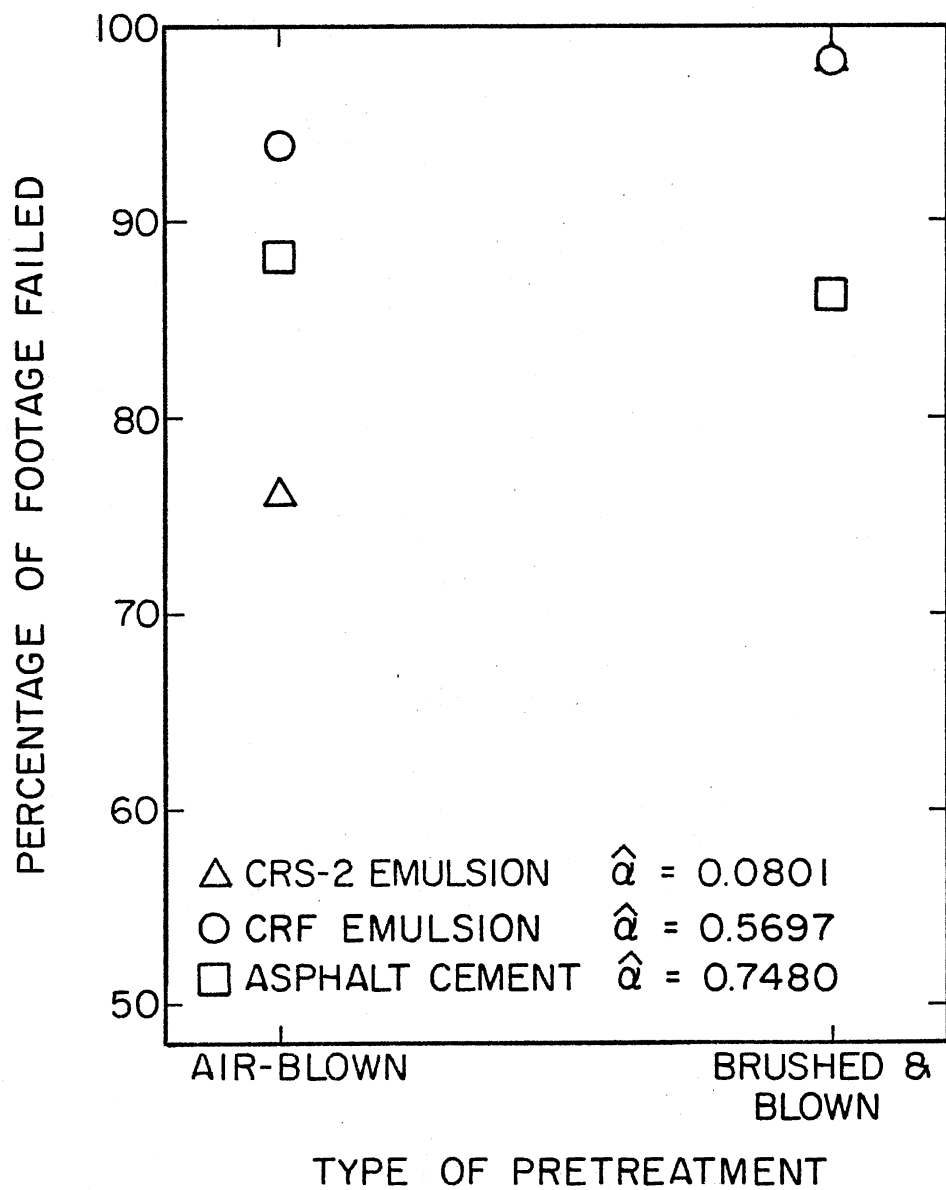
Figure 19. Percentage of Footage Failed vs. Crack Pretreatment for the CRS-2 and CRF Emulsions and 85-100 Pen AC and the Respective Observed Significance Levels.

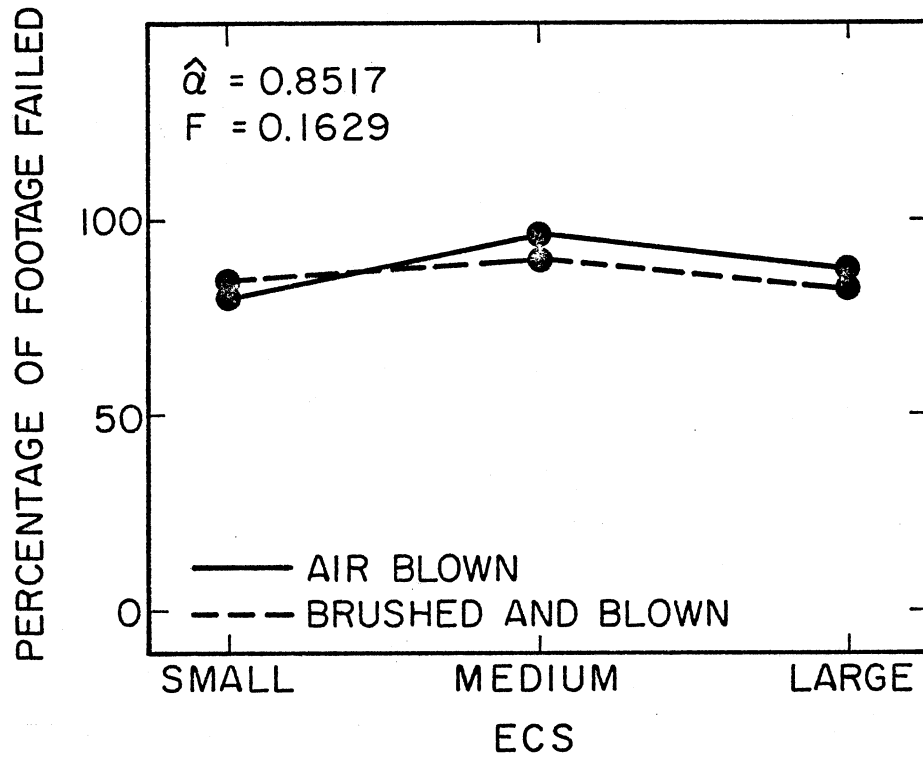
Figure 23. Interaction of Crack Pretreatment and ECS for the 85-100 Pen AC Sealant and Observed Significance Levels.

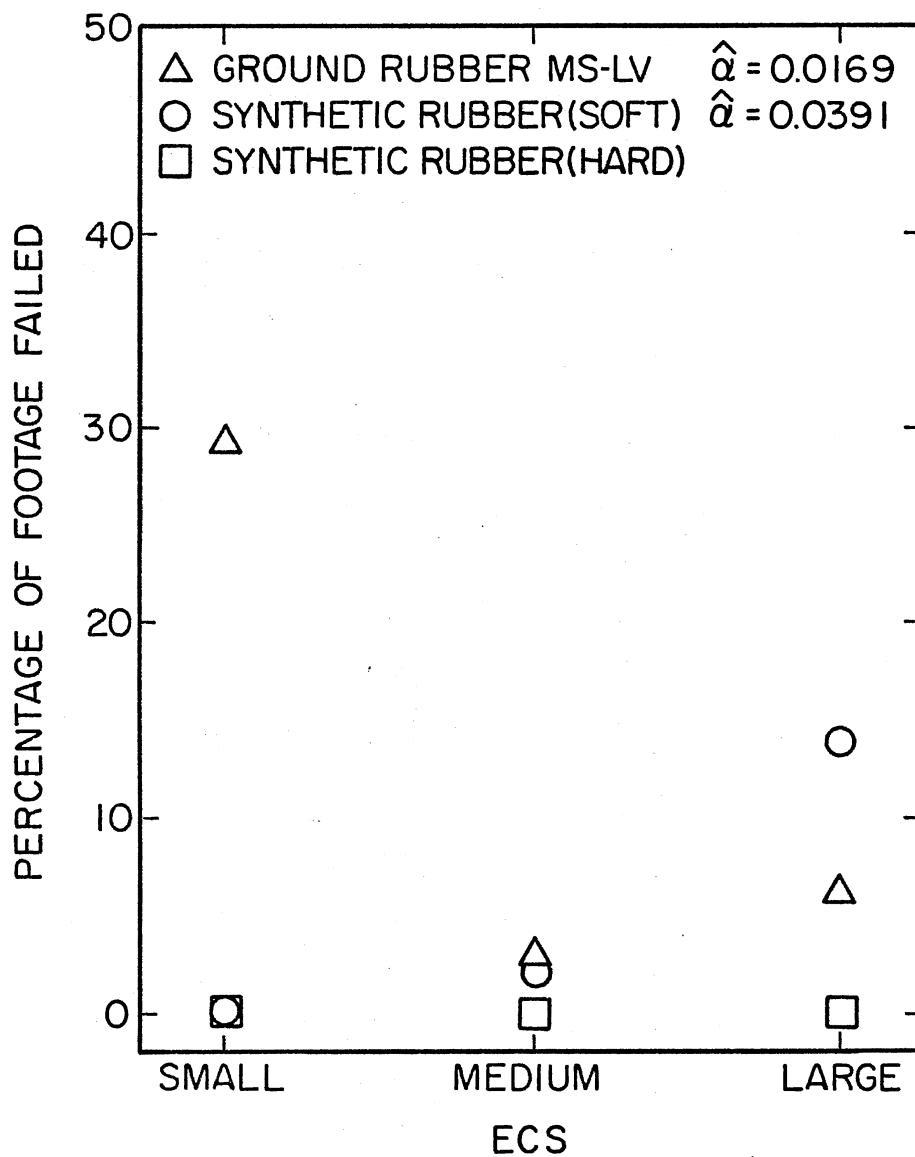
Figure 24. Percentage of Footage Failed vs. ECS for the Ground Rubber (MS-LV). Synthetic rubber (soft), and the synthetic rubber (hard) sealants and the respective observed significance levels.

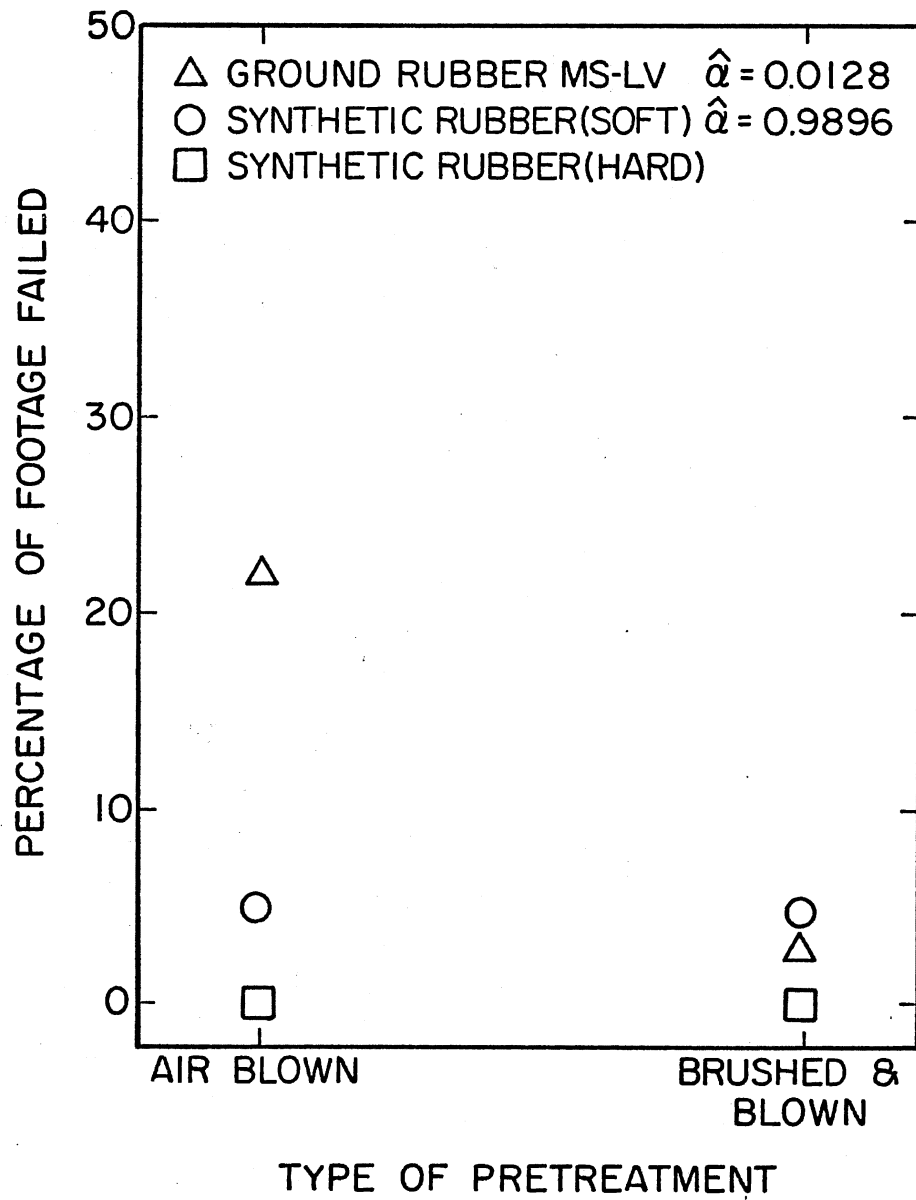
Figure 25. Percentage of Footage Failed vs. Crack Pretreatment for the Ground Rubber (MS-LV), Synthetic rubber (soft), and the Synthetic rubber (hard) sealants and the respective observed significance levels.

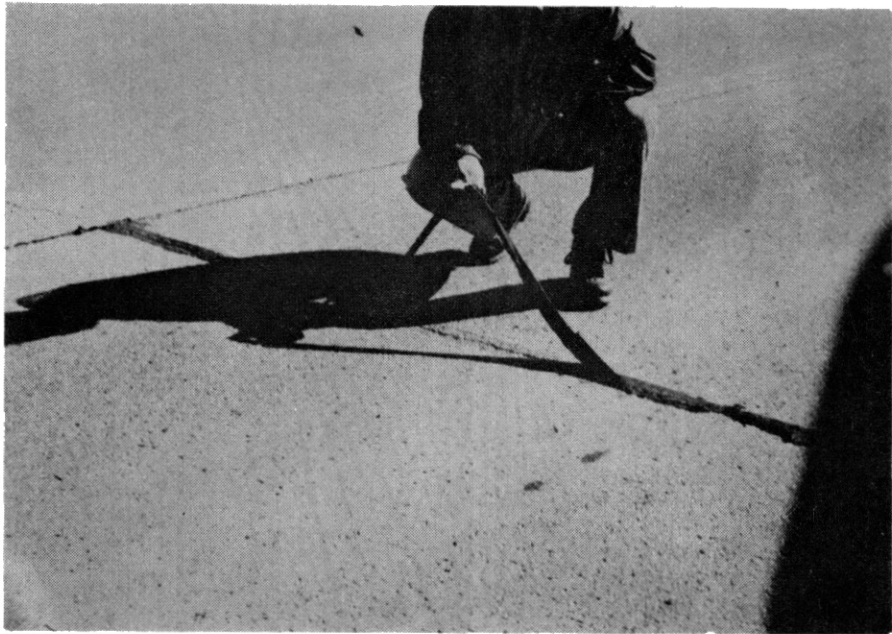
Figure 27. Rubber-Band Type Failure of Synthetic Rubber (Soft) Sealant.

During this investigative period the synthetic rubber (soft) sealant exhibited less than 15 percent failure. Unlike the other sealants, this material failed adhesively. Where failure occurred it was due to the applied sealant pulling away from the pavement surface in rubber-band like strips, this is illustrated in Figure 27. Exactly what caused this type of failure is not known but a possibility may be that it is a result of

poor field application. By referring to Table III it can be seen that this sealant was not applied at its recommended pouring temperature. The temperature recorded in this table may not be accurate. It is suspected that at the time of heating there was not enough material in the double-wall melter to cover the inner chamber thermometer stem. This may have caused over-heating and subsequent damage of the material.

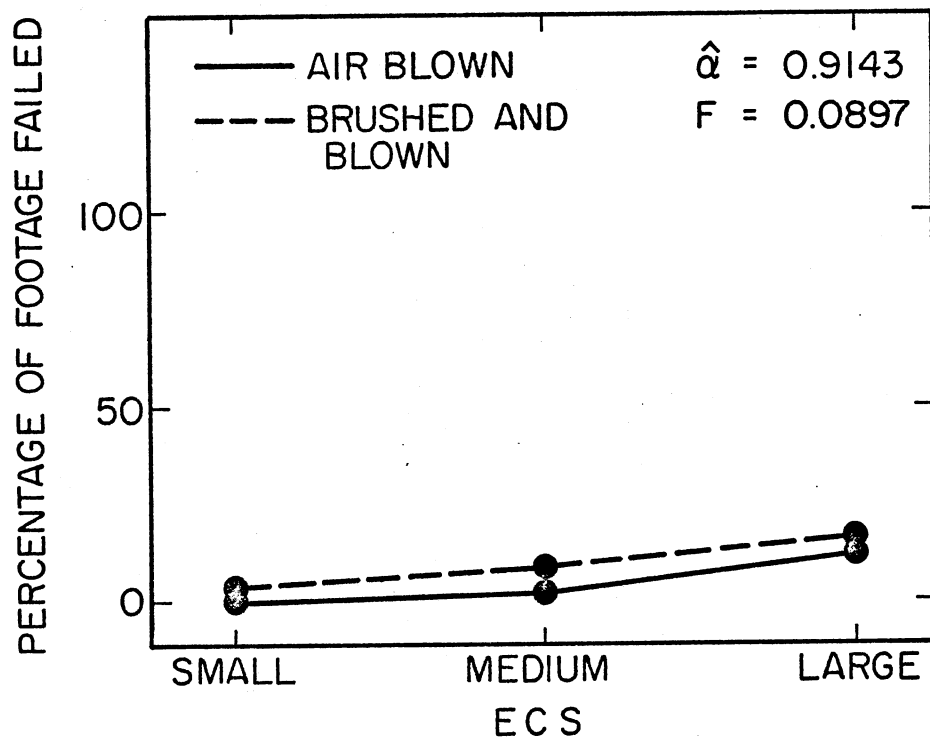
Figure 28. Interaction of Crack Pretreatment and ECS for the Synthetic Rubber (Soft) Sealant and Observed Significance Levels.
