EVALUATION OF LINER HANGER SEAL ASSEMBLY AND CEMENT SHEATH  
AS A DUAL BARRIER SYSTEM: IMPLICATIONS FOR INDUSTRY AND  
REGULATORS

A DISSERTATION

SHAWGI MOHMED ELZAKI AHMED

2020

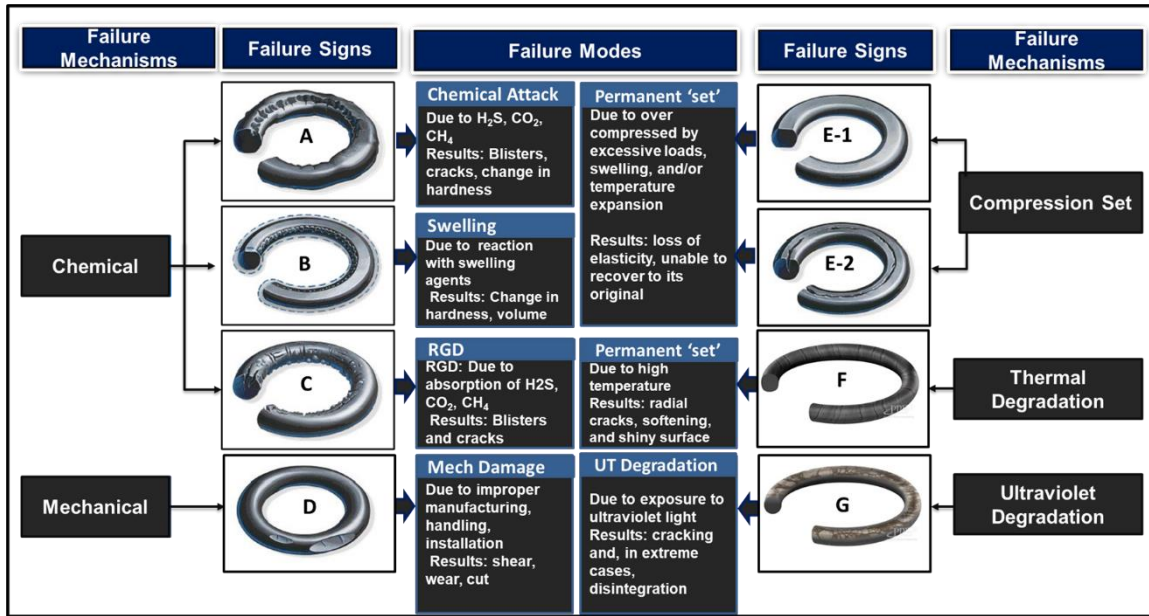
Figure 3.5: Elastomer common failure mechanisms (images source: Marco Rubber Inc. 2019; PPE 2019)

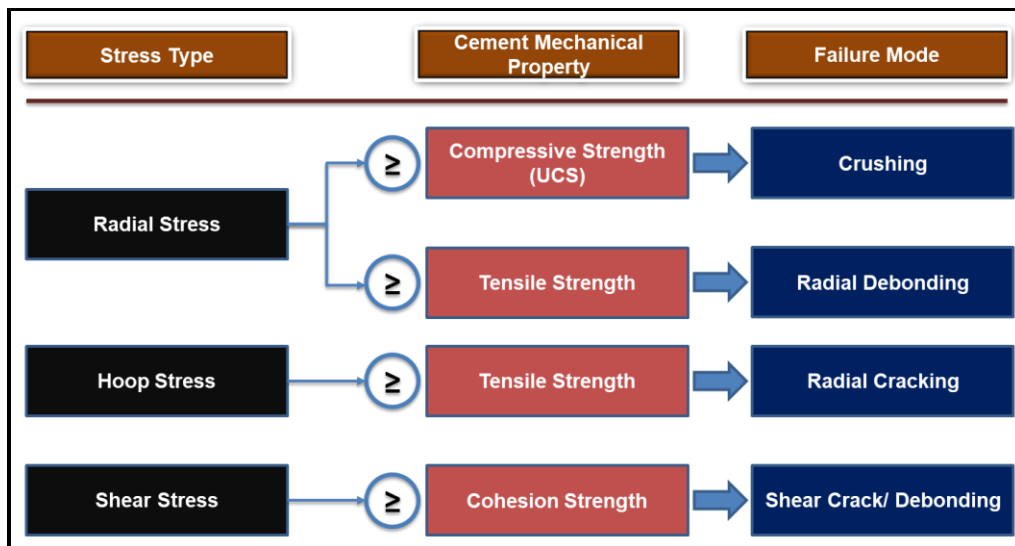
Figure 3.8: Stresses influencing set cement failure modes

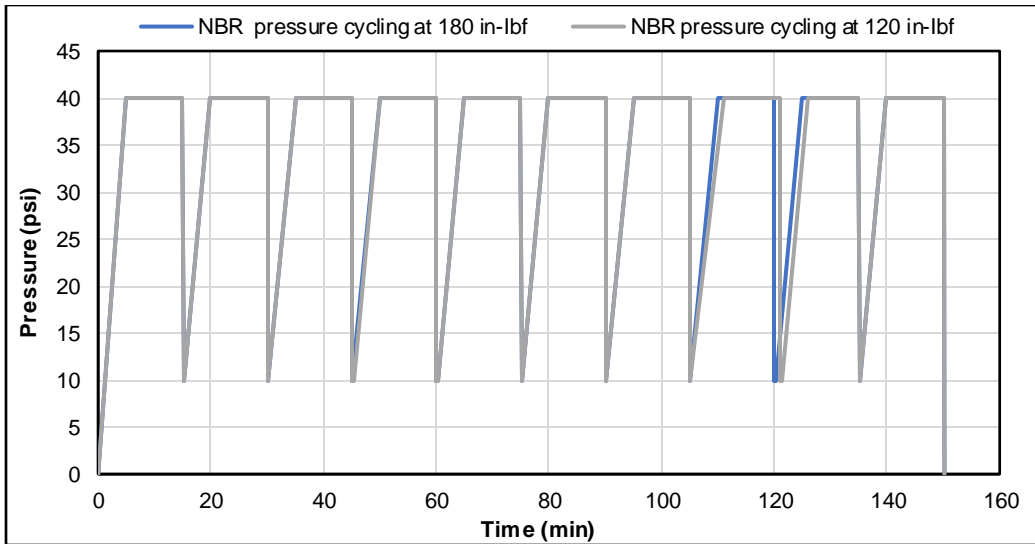
**Figure 5.5: NBR pressure cycling test at 180 in-lbf and 120 in-lbf (successful tests)**

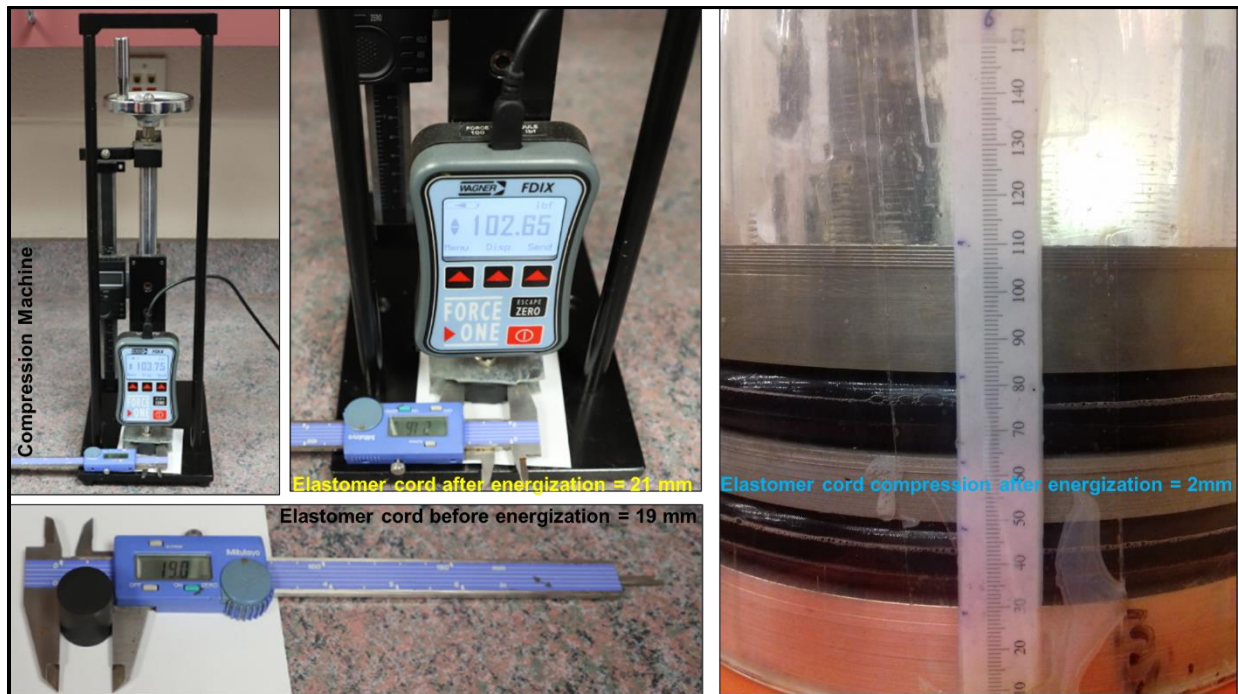
Figure 6.2: Elastomer displacement measurement using compression machine and paper scale
