INFLUENCE OF TIME DEPENDENT PROPERTIES  
AND TEMPERATURE EFFECTS ON THE  
PERFORMANCE OF COMPOSITE BRIDGE GIRDERS

Submitted to the Faculty of the  
Graduate College of the  
Oklahoma State University  
in partial fulfillment of  
the requirements for  
the Degree of  
DOCTOR OF PHILOSOPHY  
December, 2019

Title of Study: INFLUENCE OF TIME DEPENDENT PROPERTIES AND TEMPERATURE EFFECTS ON THE PERFORMANCE OF COMPOSITE BRIDGE GIRDERS

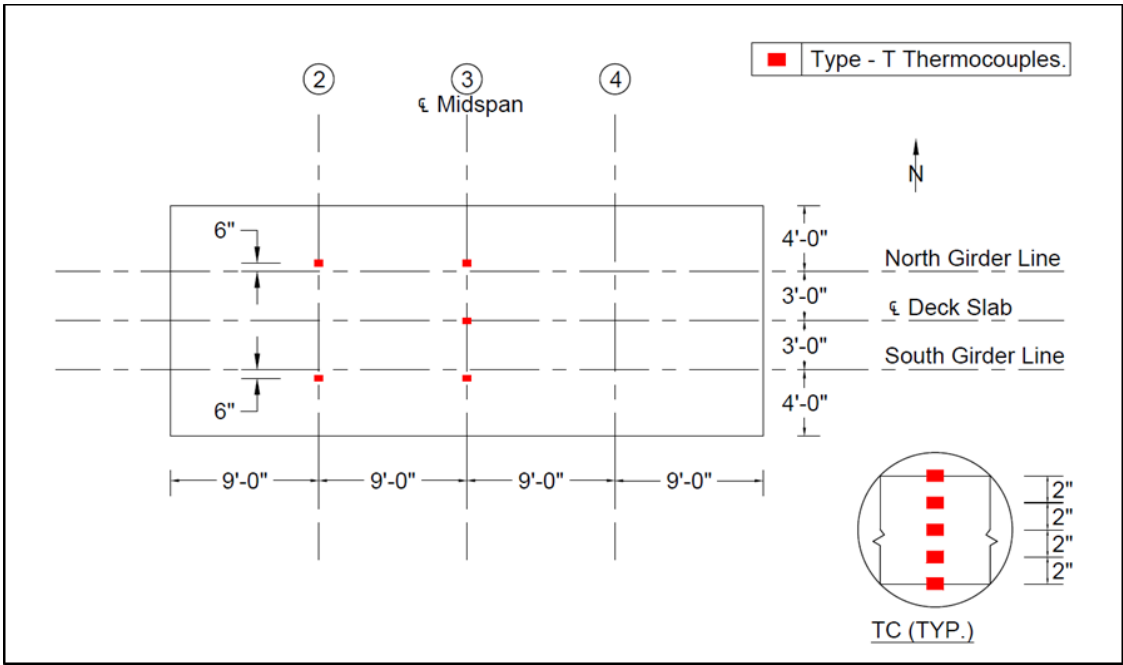
Figure 9. Layout of thermocouple sensors on the prototype bridge deck.

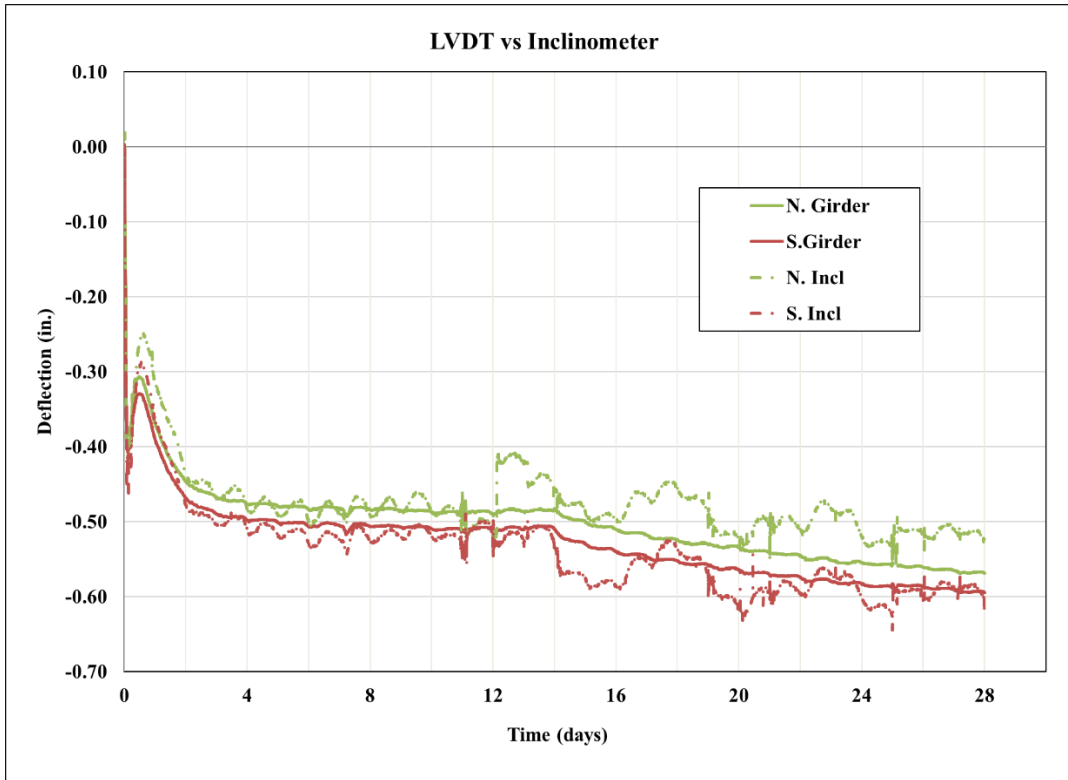
Figure 15. LVDT vs Inclinometer deflection comparisons

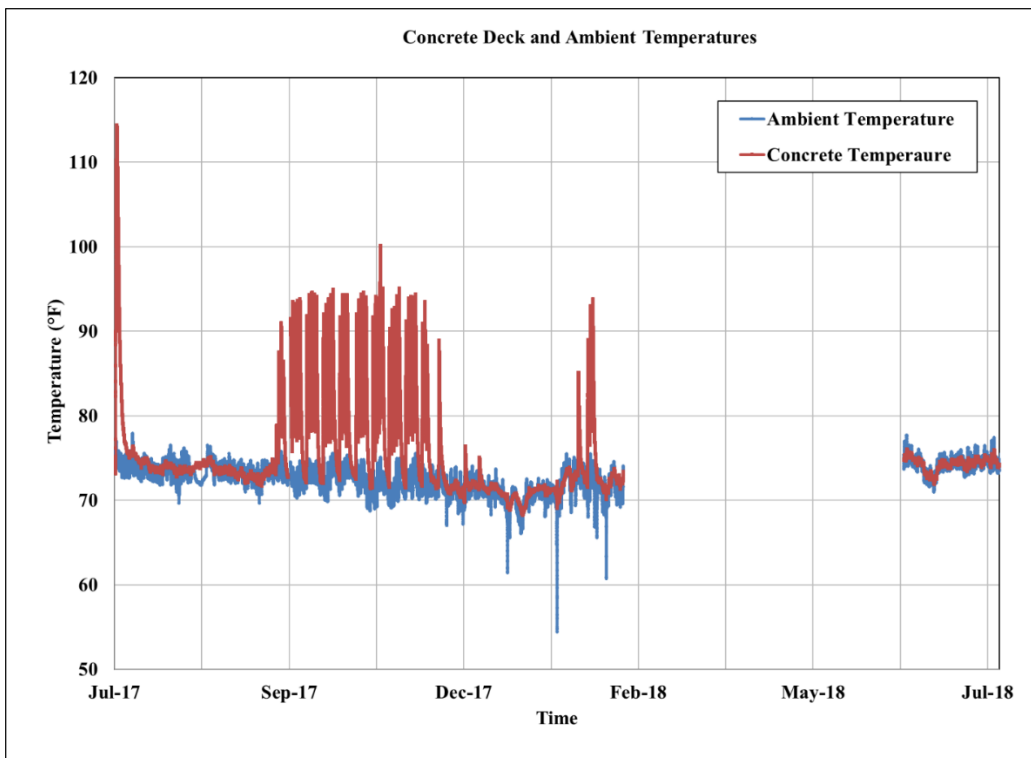
Figure 17. Long-term monitoring of concrete deck and ambient temperatures on the prototype bridge

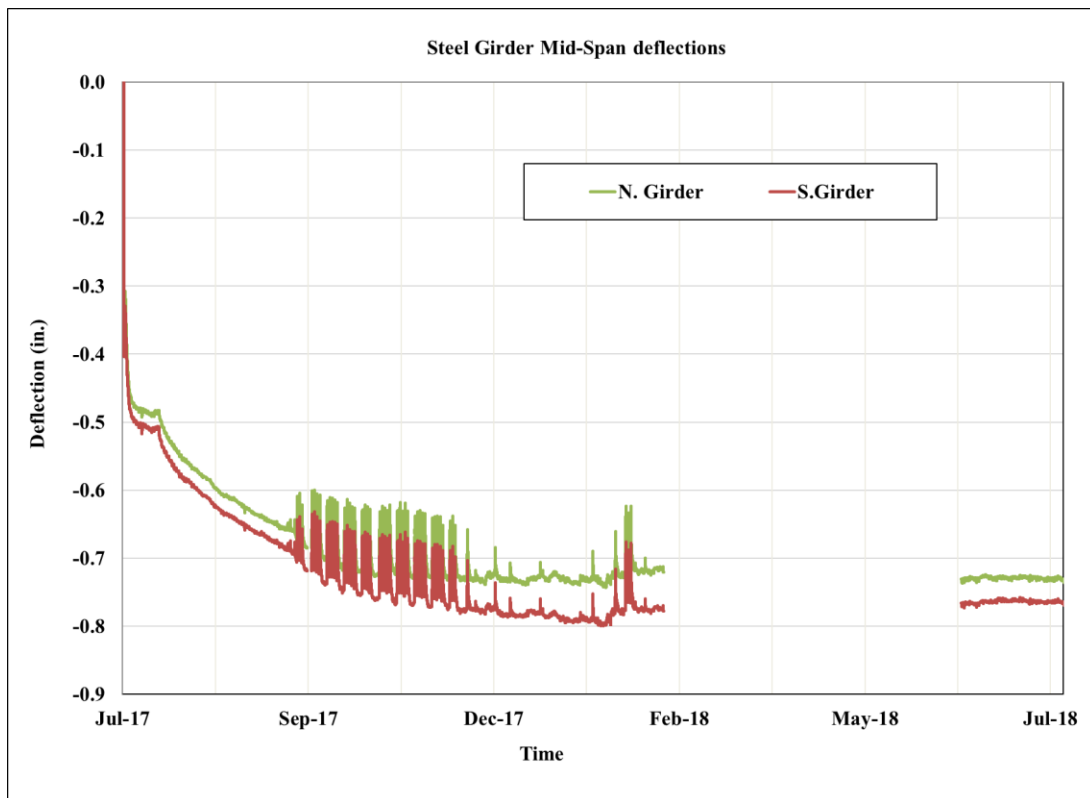
in Figs 17 and 18. These changes were a result of differential heating and cooling of the bridge deck causing differential thermal expansion and contraction during the heat load testing. The higher temperatures produced upward defections and the lower temperatures resulted in downward defections in the bridge girders.

Figure 19. Long-term defections in the steel girders of the laboratory prototype bridge

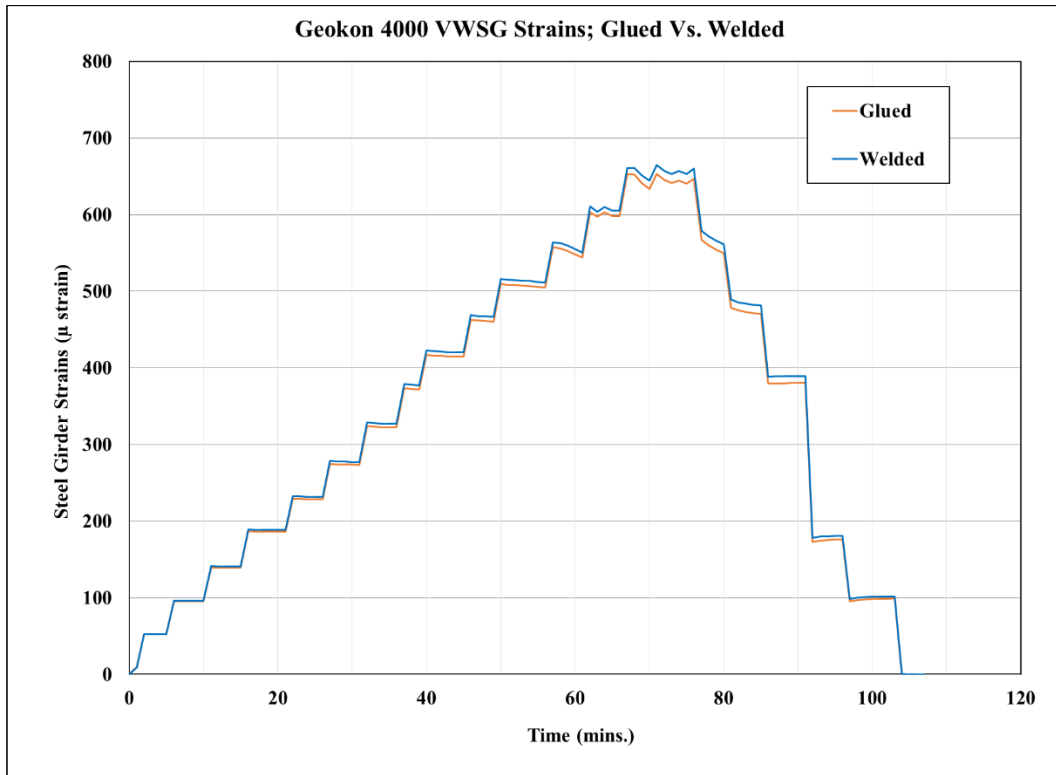
Figure 25. Performance of Glued vs. Welded Geokon 4000 VWSGs

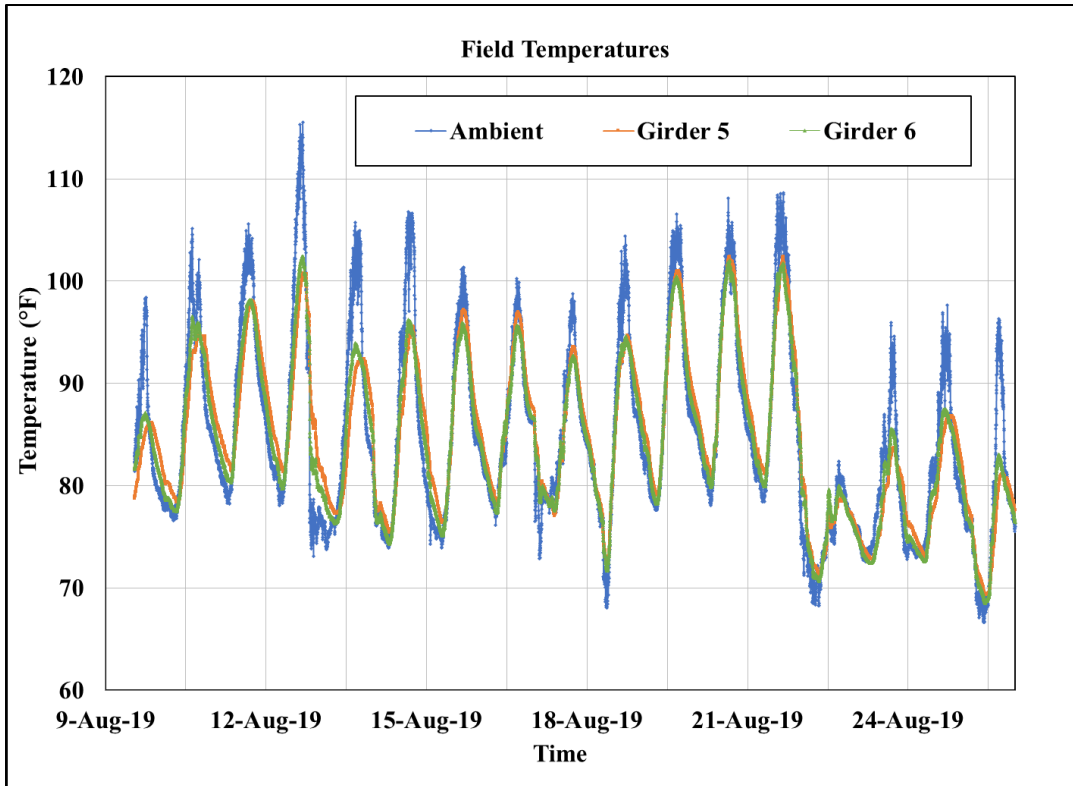
Figure 26. Trend Plot of girder temperatures measured on SH-11 Bridge “A”

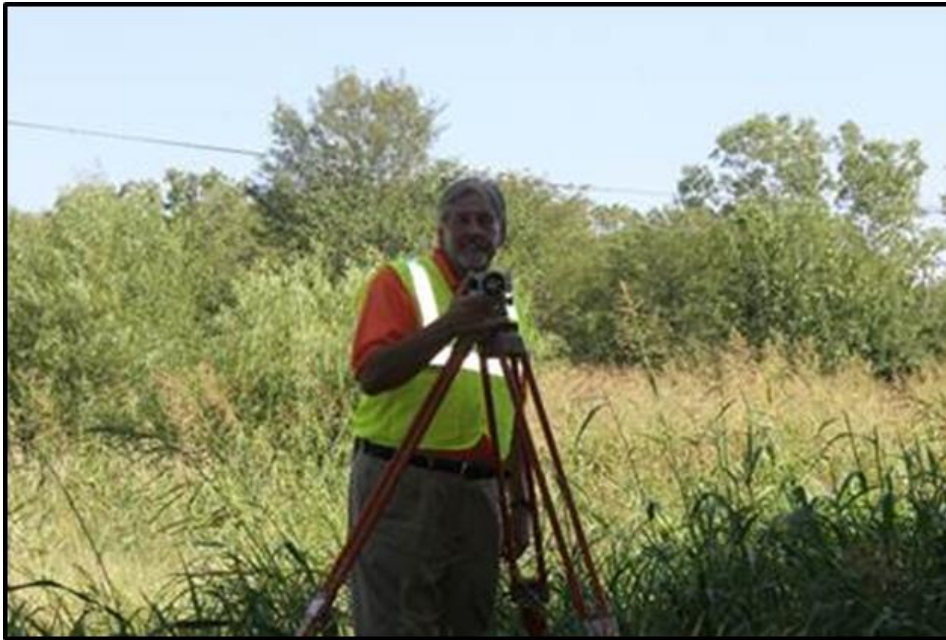
Figure 28. Elevations measurements made with traditional surveying equipment including an engineering level and a leveling rod.

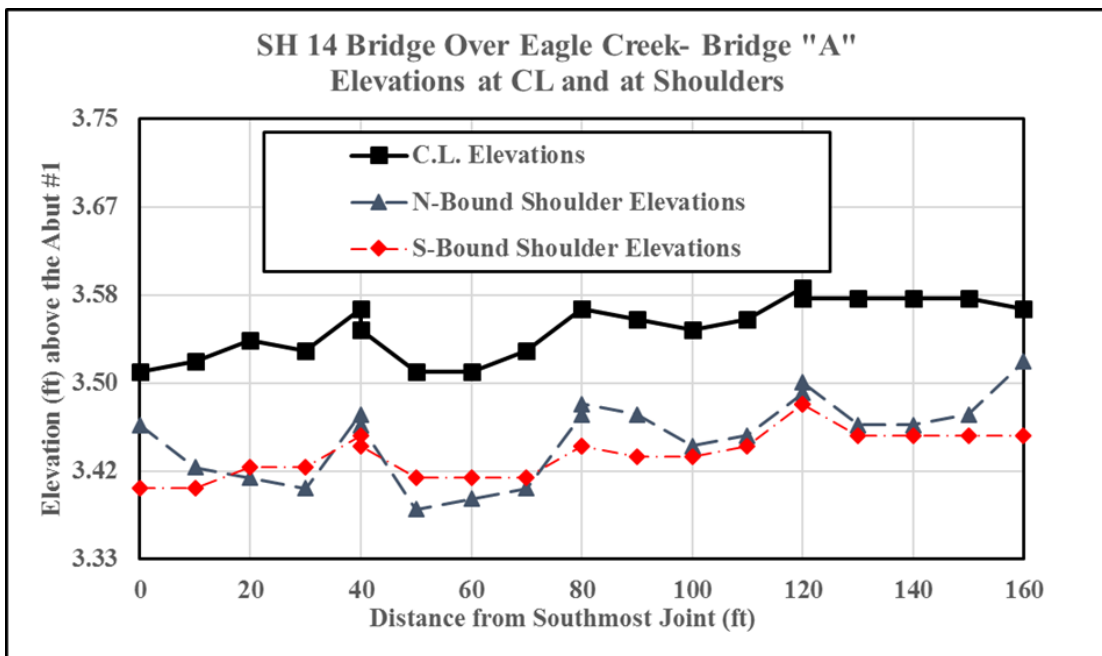
Figure 29. Elevations charted from the South end of the bridge to the North end.

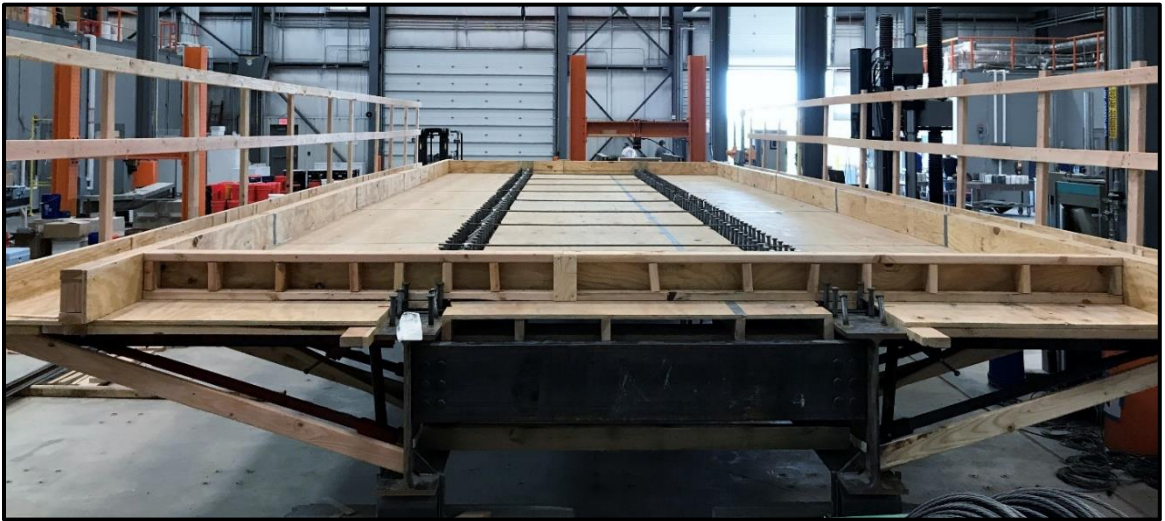
Figure 36. Laboratory Prototype Bridge built with formwork and bracing. View Looking East

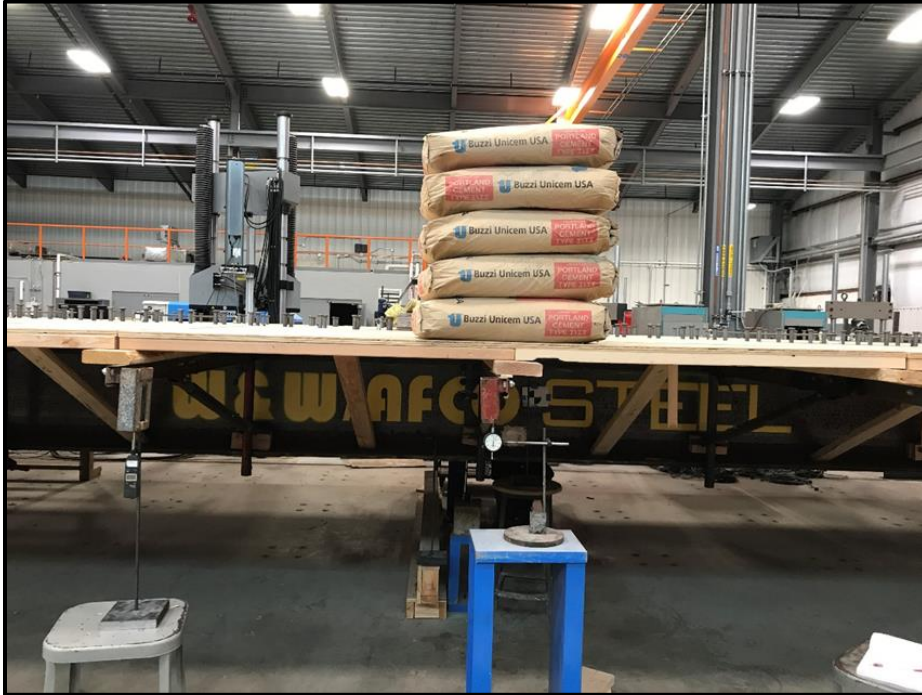
Figure 38. Cement Bag load testing performed on South Girder Walkway Platform

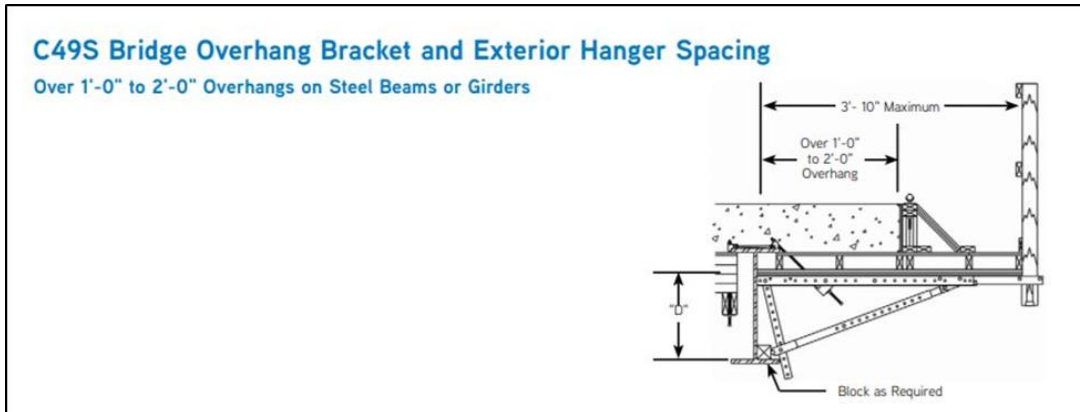
Figure 39. Typical C49S Bridge Overhang Bracket and Exterior Hanger Spacing (Dayton Superior Bridge deck Handbook)

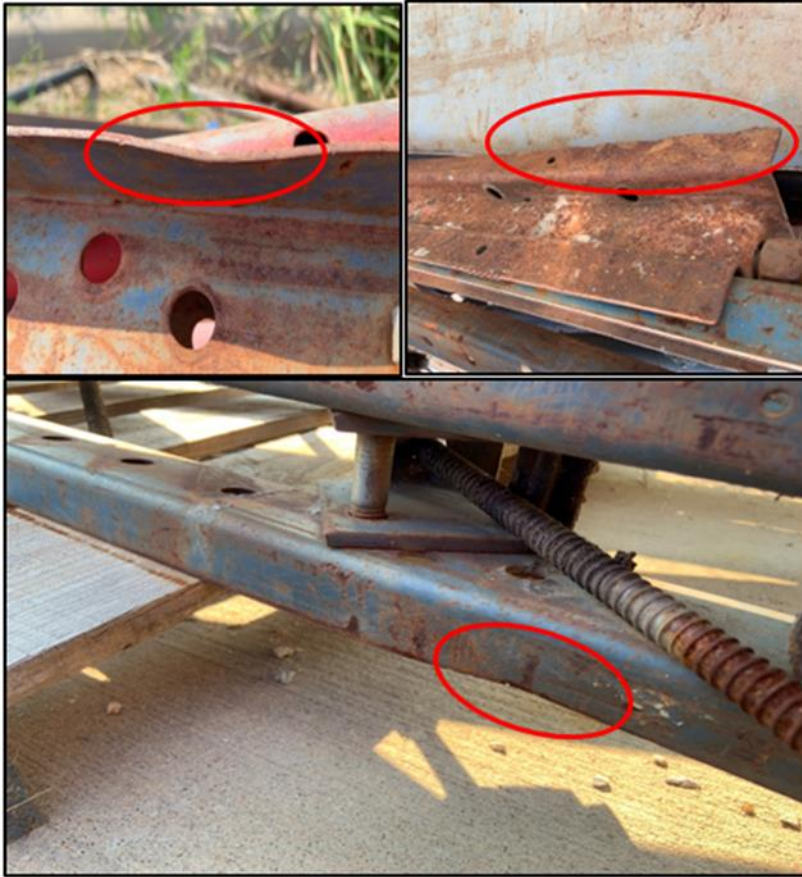
Figure 40. C-49 Overhang brackets with warped and permanently deformed sections

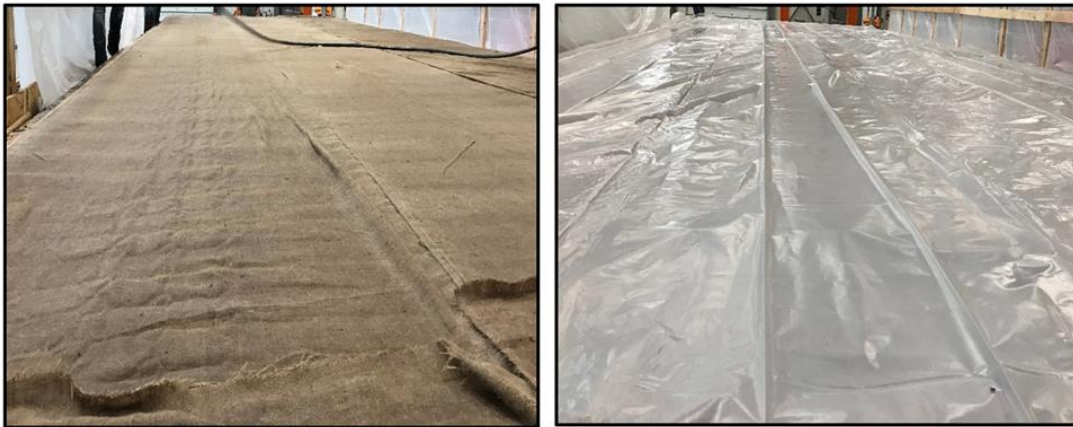
Figure 53. Wet burlap and 2 mil plastic was applied for 14 days

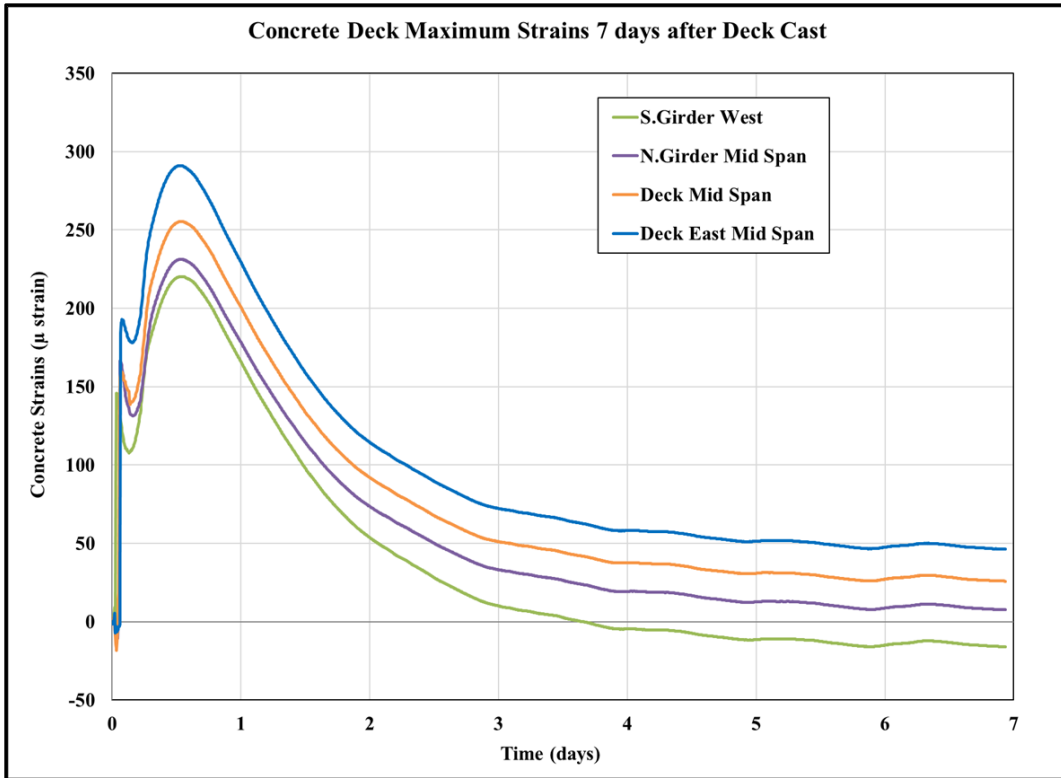
Figure 66. Variation in concrete thermal strains during hydration

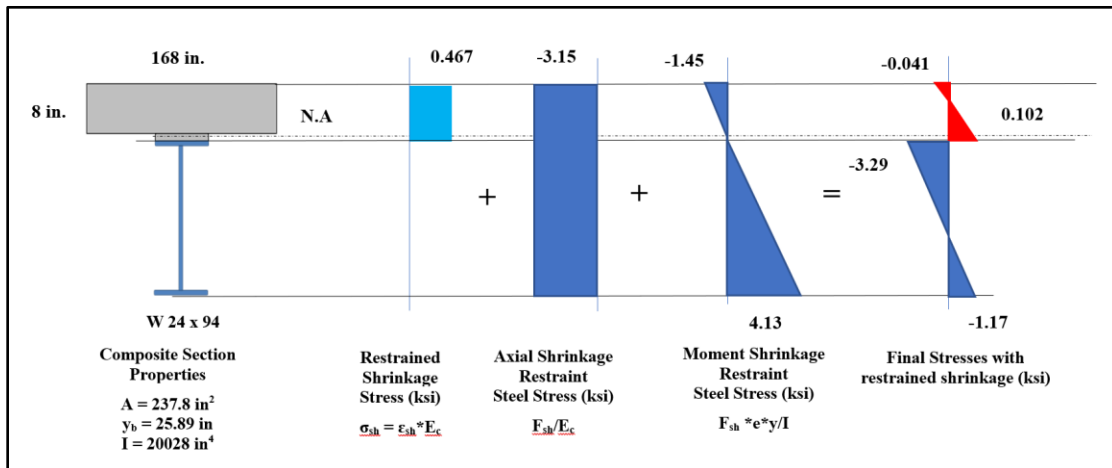
Figure 68. Computational Analysis of Early age Shrinkage strains in laboratory prototype bridge deck

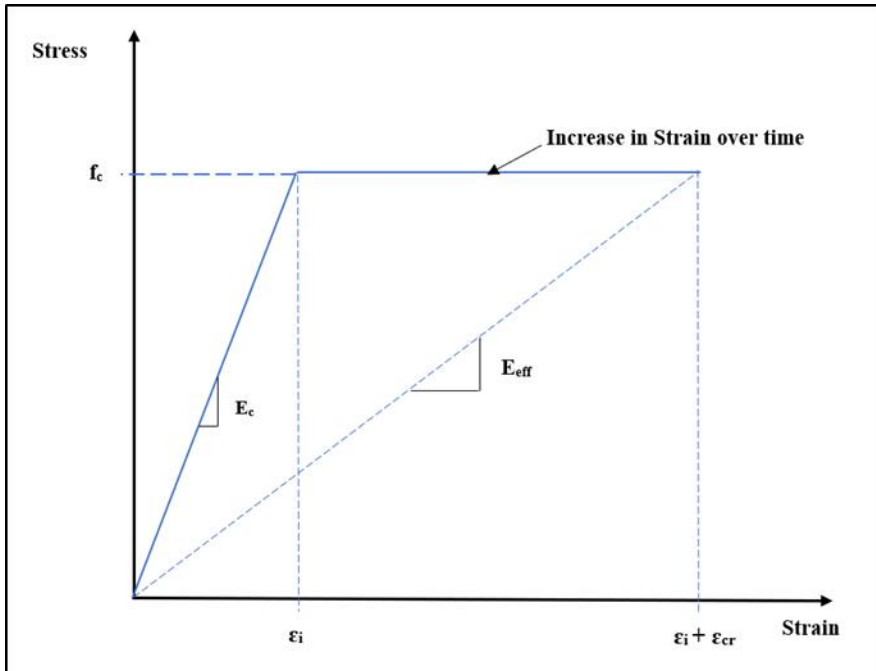
Figure 69. Mechanism of Creep Phenomenon in Concrete

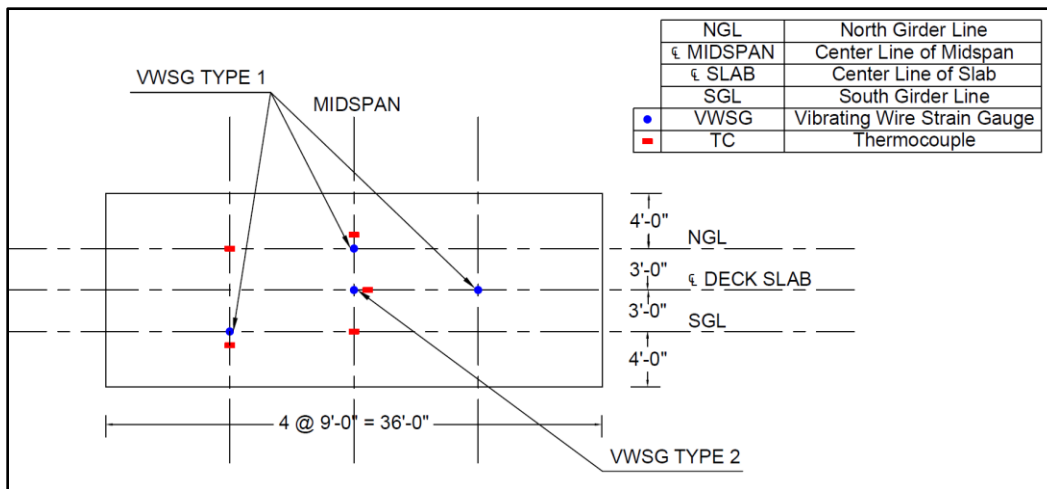
Figure 72. Plan View of Prototype bridge deck showing the location of Sensors

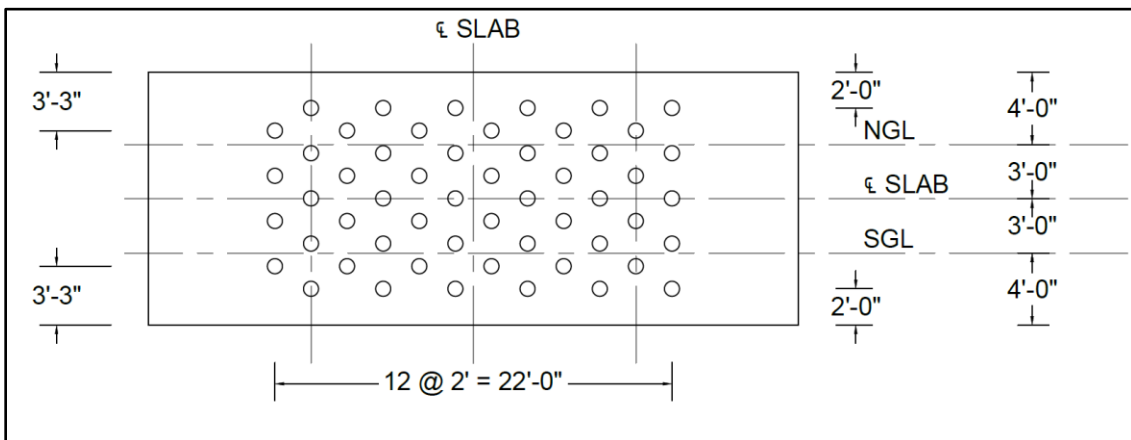
Figure 76. Plan view showing the layout of heating lamps on the prototype bridge deck

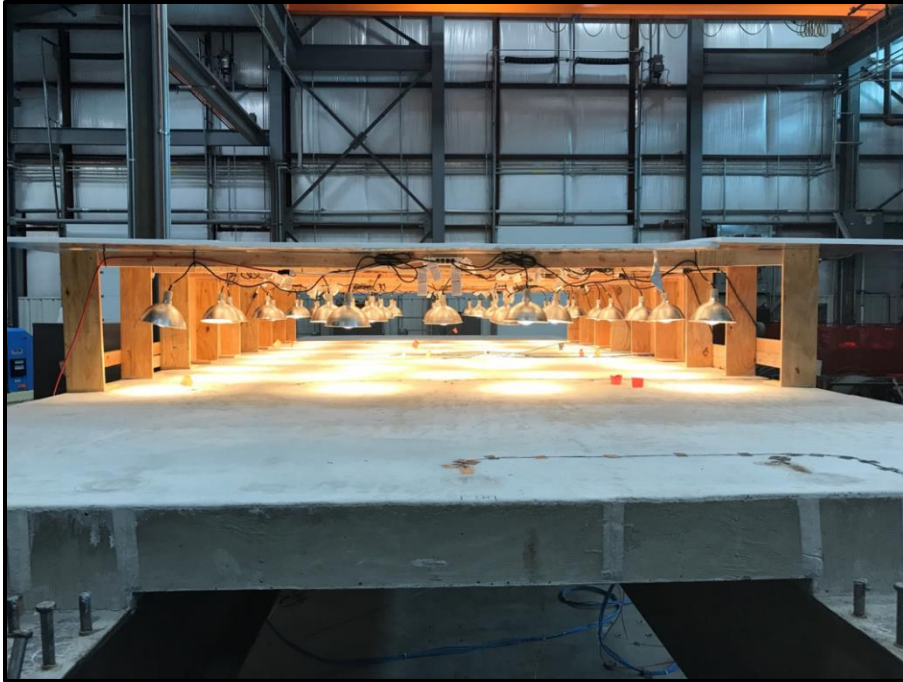
Figure 77. Photograph showing the setup of Heat lamps atop the prototype bridge deck

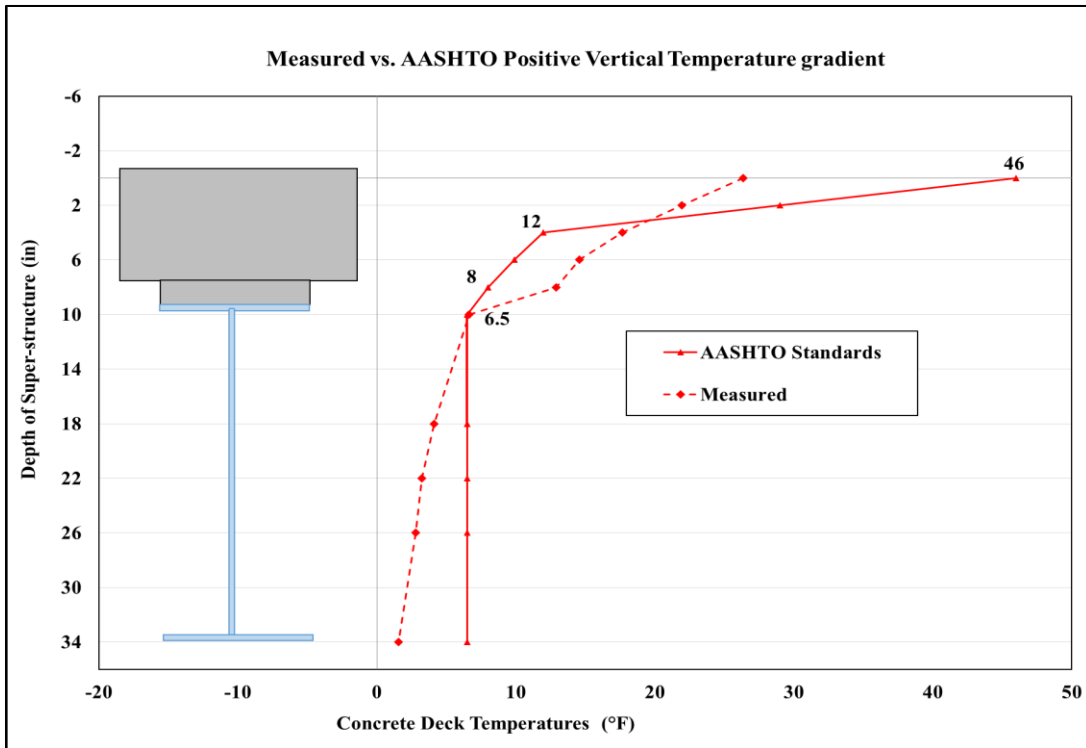
Figure 81. Comparison between the measured and AASHTO standard temperature gradient

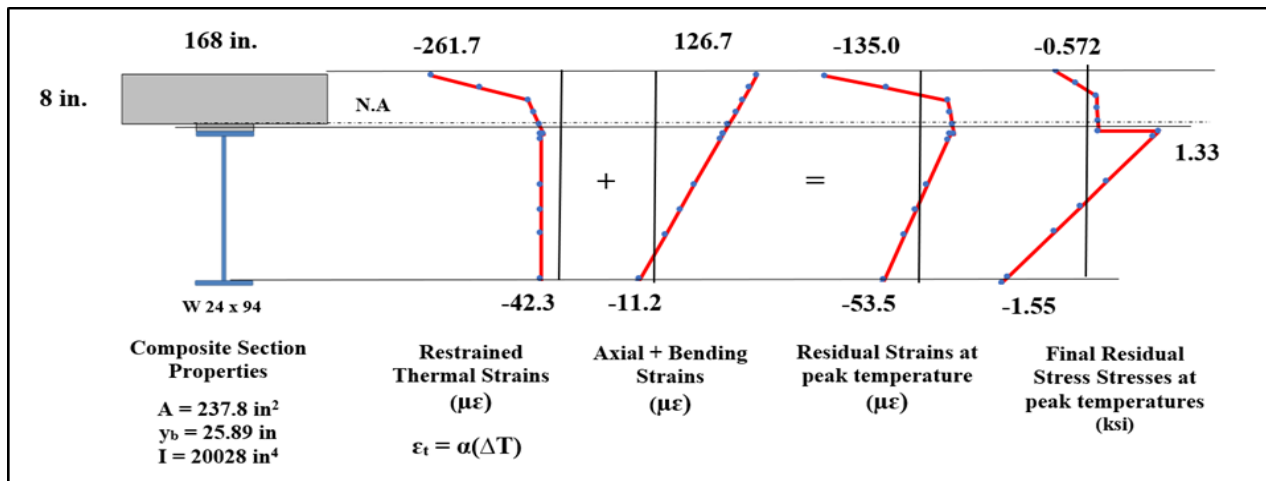
Figure 83. Average Thermal Strain and Stress gradients from AASHTO temperature gradient

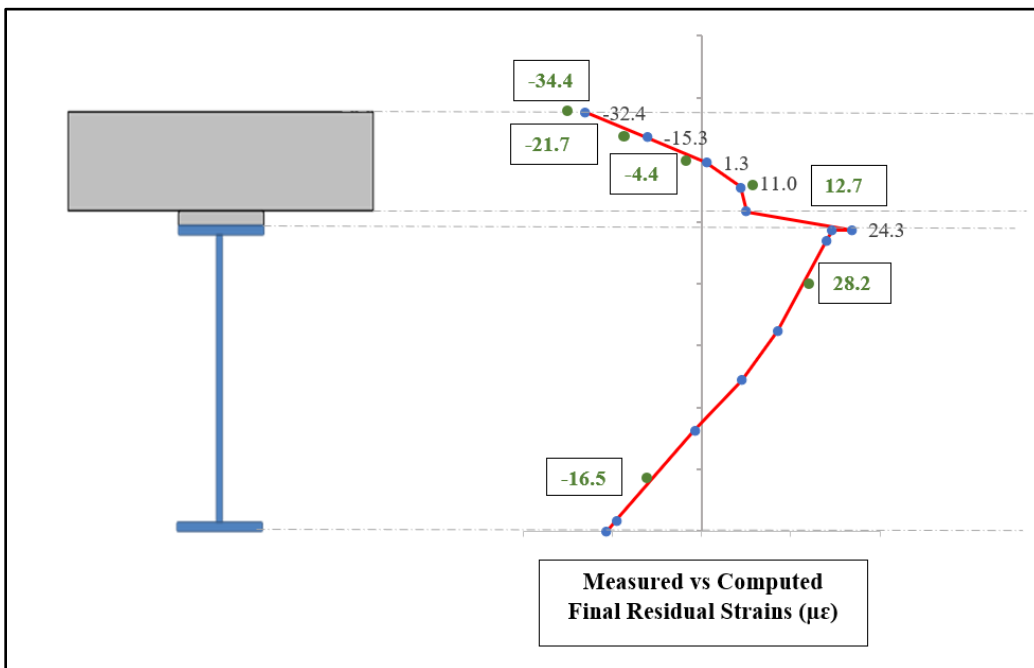
Figure 84. Correlation of Measured vs. Computed final strains
