FOUNDATION CONSOLIDATION UNDER EARTH DAMS DURING AND IMMEDIATELY FOLLOWING CONSTRUCTION OPERATIONS

Submitted to the Faculty of the Graduate School of the Oklahoma Agricultural and Mechanical College in Partial Fulfillment of the Requirements for the Degree of MASTER OF SCIENCE May, 1956

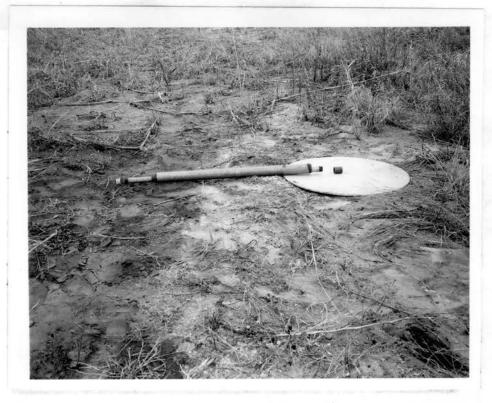
Figure 5. Basic elements of consolidation gages showing 24" plate, 1" union, 1" gage pipe and 2" protecting pipe

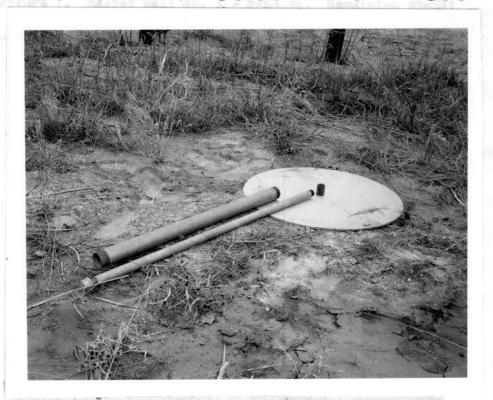
Figure 6. Basic elements of consolidation gages showing relative location of pipes.

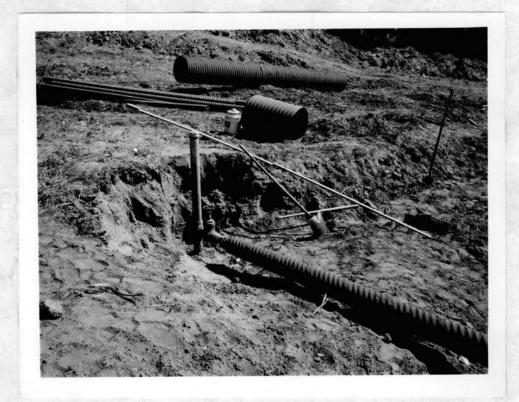
Figure 7. Relief Well No. 1 - Site 34. Remaining steps: Installing well cover and covering collector line with earth.

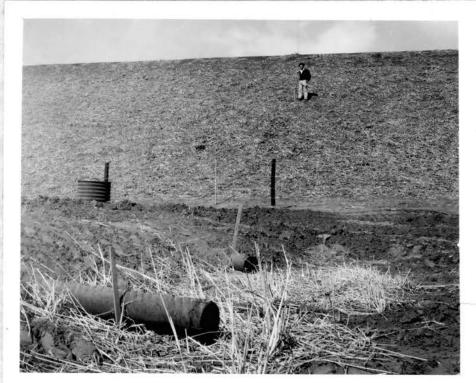
Figure 8. Relative location of Relief Well outfall lines, Relief Well No. 2 and gages in 2:1 slope of Site 16.

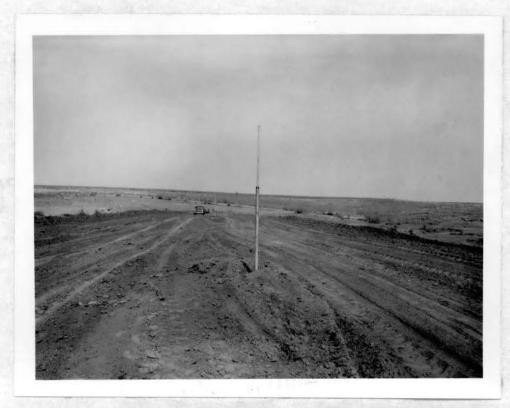
Figure 11. Gage pipes on Site 34 showing relative location of Gages Nos. 3 and 6. (No. 6 is by the open door of the car.)

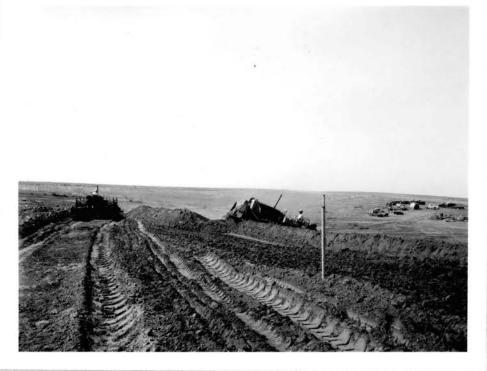
Figure 12. Gage pipws 3 and 6 on Site 34 shown two days before the embankment was completed.

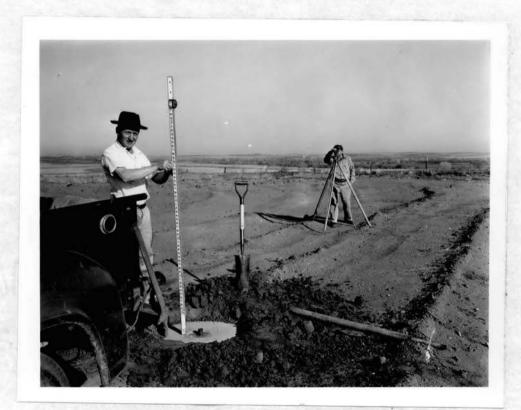
Figure 14. Determining the elevation of the installed plate.

- the foundation. The hole was very carefully levelled and compacted, and the plate with the one-inch union welded to it was lowered into the hole.
- 2. The plate was levelled using an Abney Hand Level. Differential Levels were run to determine the plate elevation (Figures 13 and 14).

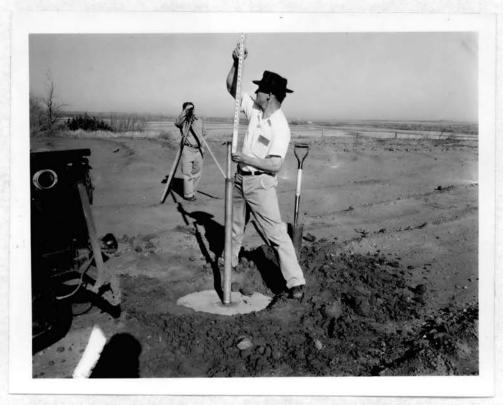
Figure 15. Determining the elevation of the notch in the 1" gage pipe.

- 4. A notch was cut into the one-inch pipe using a regular hack saw. The Mean Sea Level Elevation of the notch and the plate were checked and noted (Figure 15).

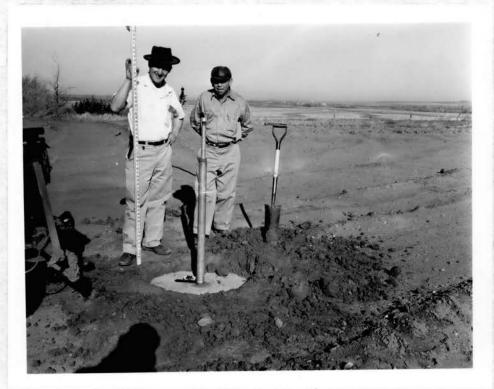
Figure 16. The complete gage with first joints of gage (1") pipe and protecting (2") pipe installed.

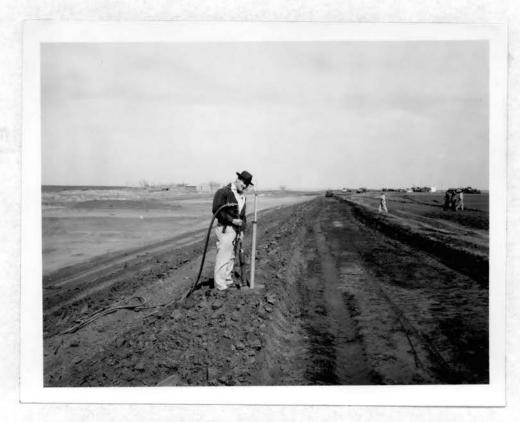
Figure 17. Supplementary compaction of soil around protecting pipe.

compacting the embankment fill were operated as closely to the protector pipes as possible. Very careful checks were made in the immediate area around the gages as fill was placed, and all uncompacted earth was compacted to approximately the same density as that of the adjacent soil. The compacting was accomplished using hand tampers and air-driven tampers (Figures 17 and 18).

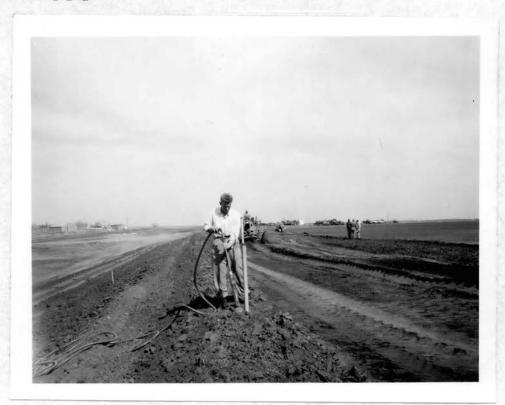
Figure 18. Compacting the soil around the gages using an air-driven tamper.

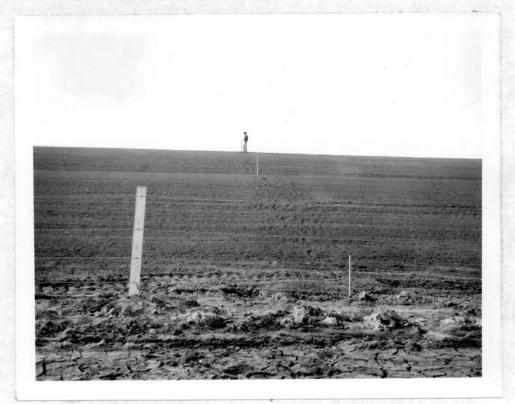
Figure 20. Gages Nos. 1, 2 and 3 on Site 34 shown after the completion of the embankment.

Figures 19, 20, 21 and 22 show the gages during construction and after completion of the sites.

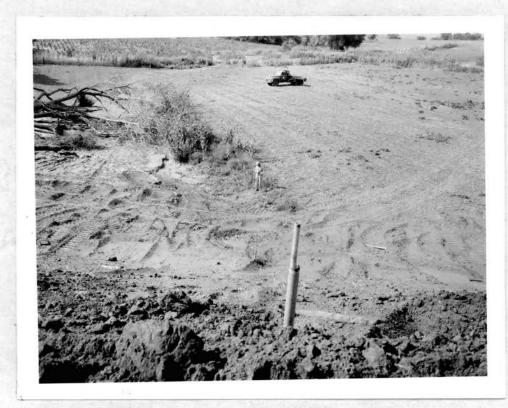
Figure 21. Site 34. View showing Gages Nos. 4 and 5 during construction of dam. The man is standing by Relief Well No. 1.

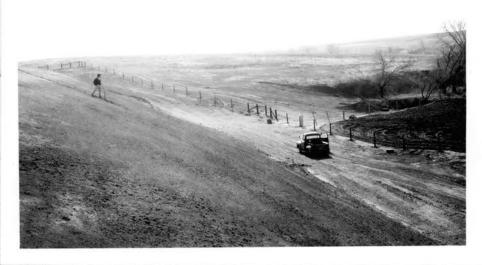
Figure 22. Back (2:1) slope of Site 34 after completion of the embankment showing the relative location of Gages Nos. 4 and 5 and Relief Wells Nos. 1 and 2.
