EVALUATION OF CAUSES OF TRANSVERSE AND FATIGUE CRACKING IN  
FLEXIBLE PAVEMENTS USING LABORATORY AND FIELD TESTING  
AND PMED SIMULATION

A THESIS

MASTER OF SCIENCE

Norman, Oklahoma

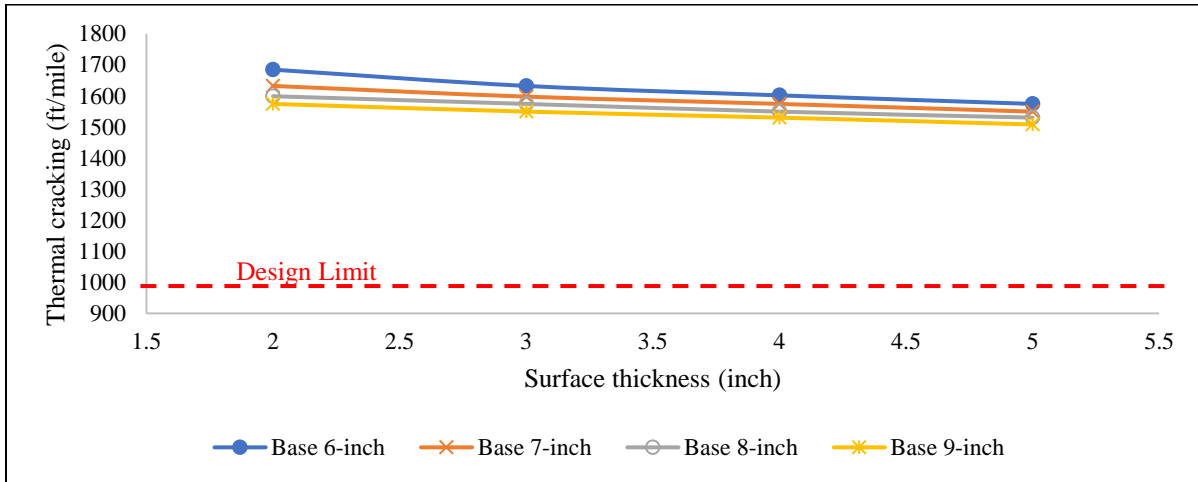
Figure 2.2 Variation of thermal cracking with surface thickness

The sensitivities of different design inputs with respect to pavement responses, namely thermal cracking, top-down fatigue cracking, and bottom-up fatigue cracking were analyzed in this study. Figure 2.2 presents the variation of thermal cracking performance with surface thickness. From Figure 2.2, it was observed that thermal cracking decreased with an increase in surface thickness. For example, the thermal cracking was found to reduce from 1,602-ft/mile to 1,575-ft/mile with a change in surface thickness from 4-in. to 5-in. Also, it was observed that thermal cracking decreased with an increase in base thickness for a fixed surface thickness (Figure 2.2). Similarly, top-down fatigue and bottom-up fatigue cracking were found to decrease with an increase in surface and base thickness. The variation of top-down fatigue cracking with surface and base thickness is illustrated in Figure 2.3. According to AASHTOWare PMED, the design threshold for thermal cracking is 1,000-ft/mile (AASHTO, 2008). All the above combinations did not satisfy the threshold limit of 1,000-ft/mile for thermal cracking. The results indicate that an increase in pavement thickness would not be enough for resisting the thermal cracking in US 270. However, an increase in pavement thickness was found to decrease fatigue

cracking and hence, satisfied the threshold limit of 2,000-ft/mile. Therefore, increasing the pavement thickness are expected to be helpful for resisting fatigue cracking in US 270.

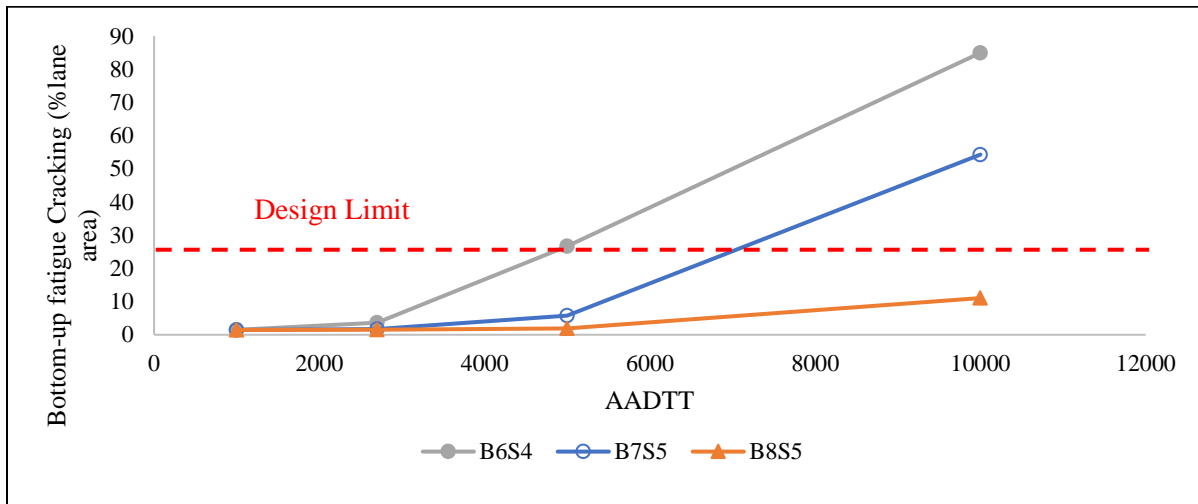
Figure 2.4 Variation of bottom-up fatigue cracking with AADTT

Variation of bottom-up fatigue cracking with AADTT is presented in Figure 2.4. Both top-down and bottom-up fatigue cracking were found to increase with an increase in traffic level (AADTT). The trend was expected as fatigue crack is a load-related distress. Also, from Figure

2.4, it was found that US 270 did not exhibit fatigue cracking at an AADTT of 2,700. These results support the field investigation result of structurally sound base for this pavement to withstand the current level of traffic. However, AADTT was found not to have any significant impact on thermal cracking performance.

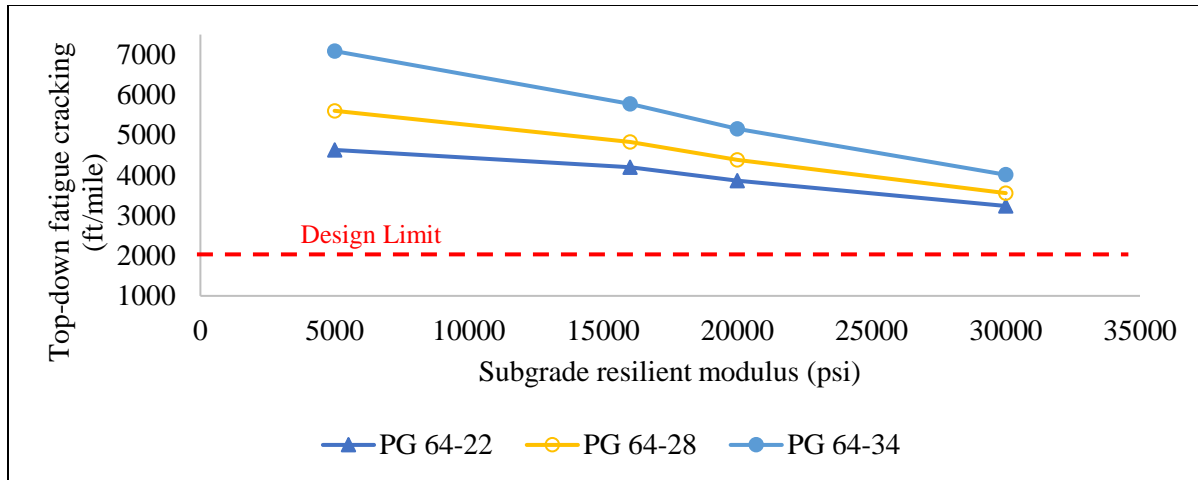
Figure 2.5 Variation of top-down fatigue cracking with subgrade resilient modulus

Variation of top-down fatigue cracking with subgrade resilient modulus is illustrated in Figure 2.5. Both top-down and bottom-up fatigue cracking decreased with an increase in subgrade resilient modulus. As expected, an increase in subgrade resilient modulus increases the load-bearing capacity of the pavement, which resulted in less top-down fatigue cracking. For example, the top-down fatigue cracking was found to reduce from 4,200-ft/mile to 3,869-ft/mile with a change in resilient modulus from 16,000-psi to 20,000-psi. However, the variation of subgrade resilient modulus did not have any significant impact on the thermal cracking performance.

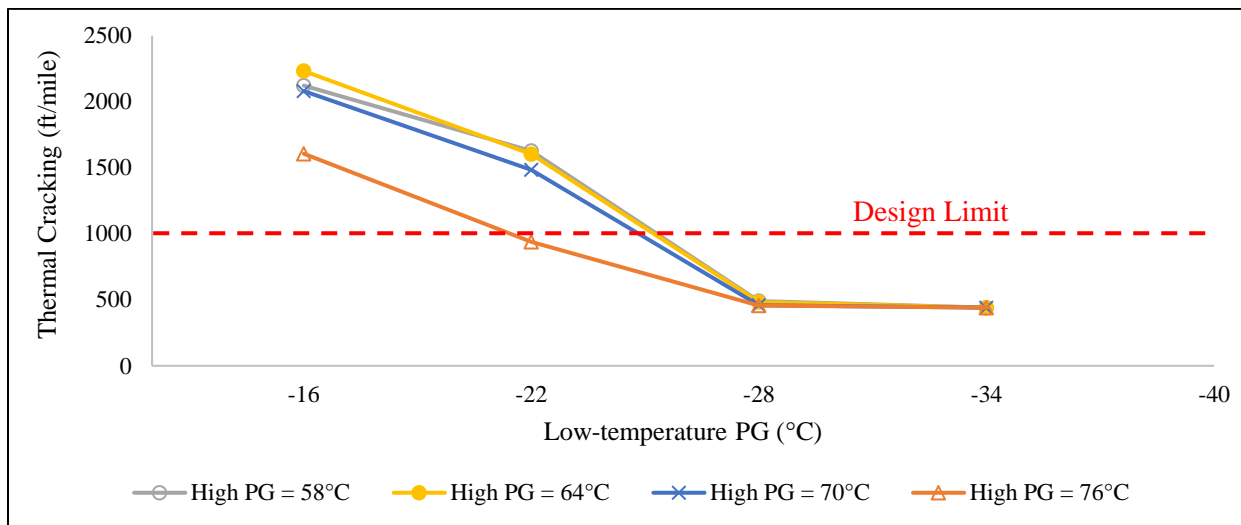
Thermal cracking decreased with an increase in high-temperature PG and a decrease in low-temperature PG of asphalt binder (Figures 2.6 and 2.7). For example, the thermal cracking for US 270 was found to reduce from 1,484-ft/mile to 939-ft/mile with a change in high-temperature PG from 70°C to 76°C. As expected, the change in thermal cracking was found as much flatter for stiff binders (such as PG 70-34 to PG 76-34). Similarly, fatigue cracking also decreased with an increase of high-temperature PG. However, a reverse trend was observed for fatigue cracking (both top-down and bottom-up) in case of low-temperature PG (Figure 2.8). As binder becomes stiffer with a decrease in low-temperature PG, so, this trend was expected for fatigue cracking. It is observed that thermal cracking could be reduced by selecting proper binder grade in reconstructing US 270.

Figure 2.6 Variation of thermal cracking with high-temperature PG

Figure 2.7 Variation of thermal cracking with low-temperature PG

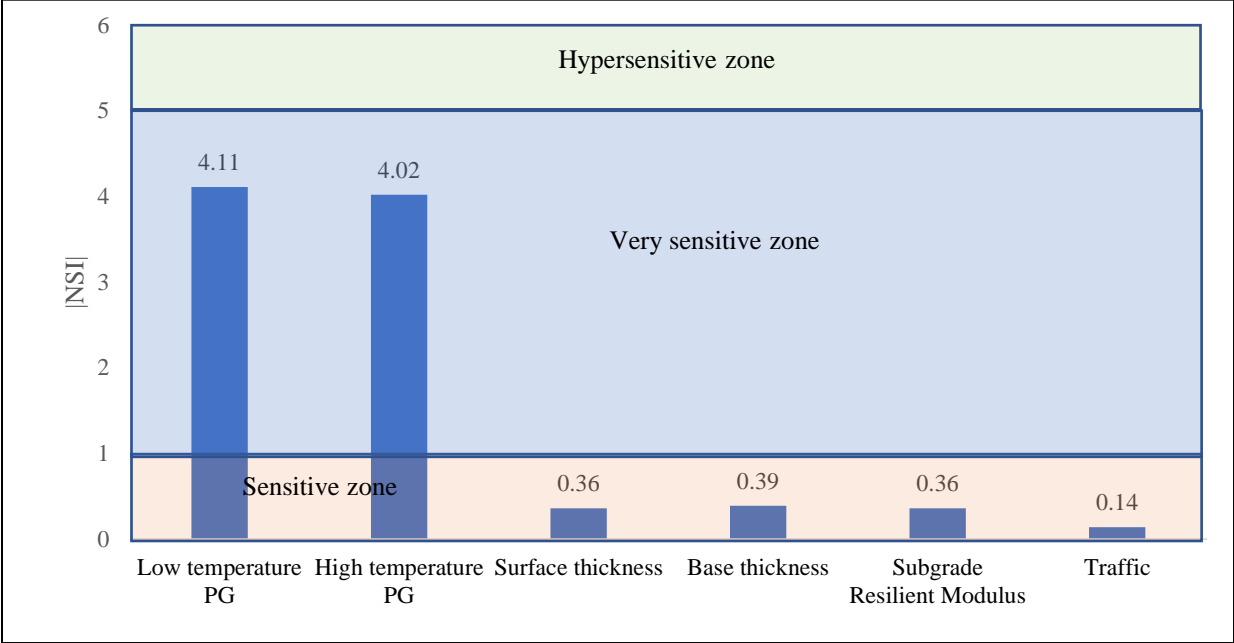
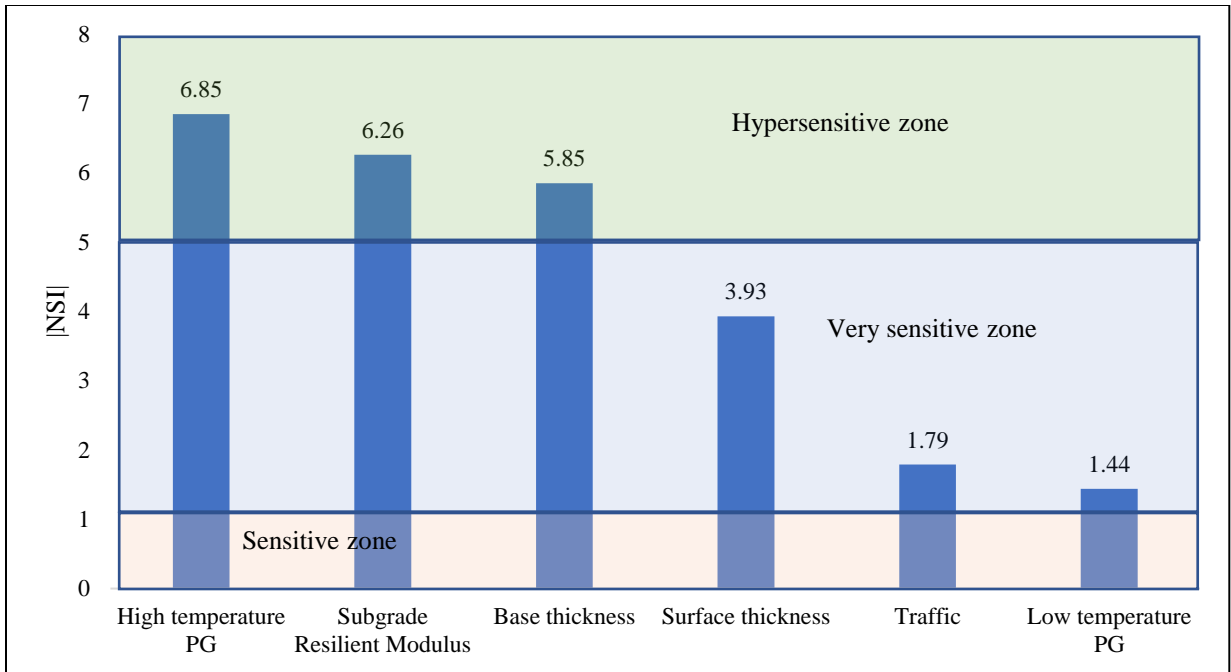
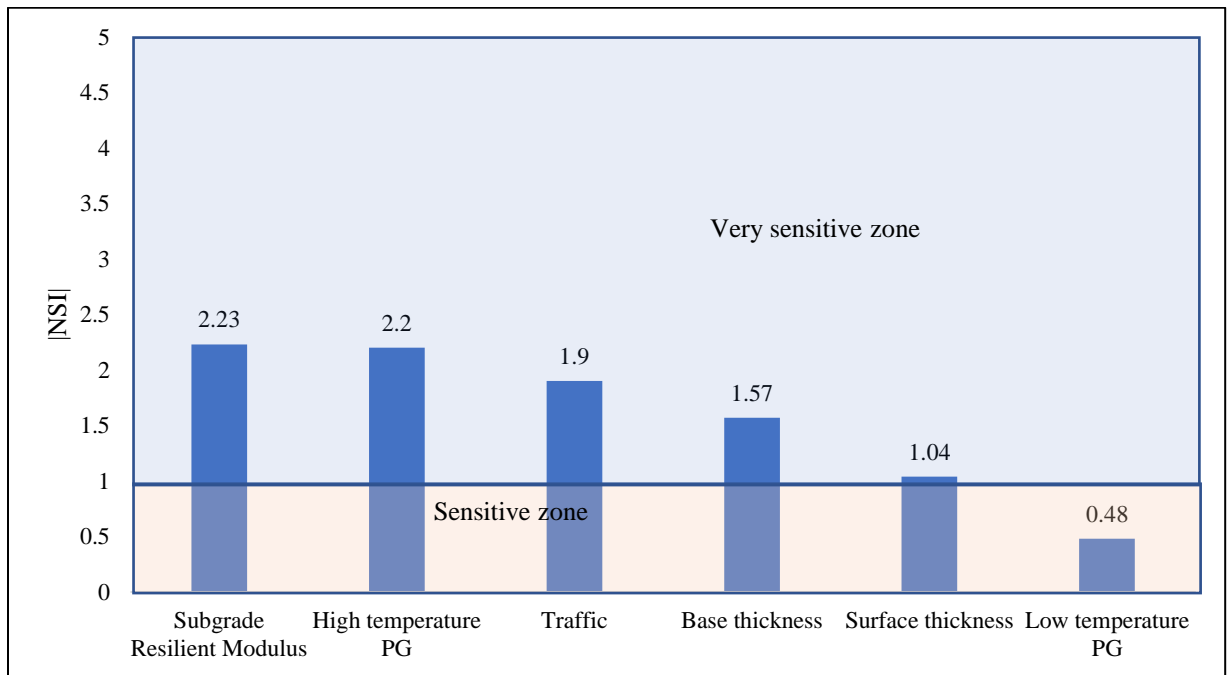
Variations of transverse cracking and fatigue cracking with design inputs were discussed in the previous sections. However, the changes in performances due to the changes in input variables were not same for all distresses. In this context, the |NSI| was calculated for each input variable against transverse cracking, top-down fatigue cracking, and bottom-up fatigue cracking. The |NSI| was calculated by changing each design inputs from its baseline values. The summarized sensitivity analysis results are presented in Figures 2.9, 2.10, and 2.11. Transverse cracking was found to be very sensitive to high- and low-temperature PG of asphalt binder. However, asphalt surface thickness, base thickness, subgrade resilient modulus and traffic level were found to be sensitive for transverse cracking. Also, top-down fatigue cracking-was found hypersensitive to high-temperature PG, asphalt base thickness and subgrade resilient modulus. Moreover, asphalt surface thickness, low-temperature PG and traffic level was found very sensitive for top-down fatigue cracking performance. Similarly, the bottom-up fatigue cracking was found as very sensitive to subgrade resilient modulus, high-temperature PG, asphalt surface

and base thickness, and traffic level. On the other hand, the low-temperature PG of asphalt binder was found sensitive for bottom-up fatigue cracking. Based on these results, the amount of thermal cracking could be reduced by properly selecting asphalt binder PG during the pavement design stage.

Figure 2.9 Sensitivity analysis summary of transverse cracking

Figure 2.10 Sensitivity analysis summary of top-down fatigue cracking

Figure 2.11 Sensitivity analysis summary of bottom-up fatigue cracking

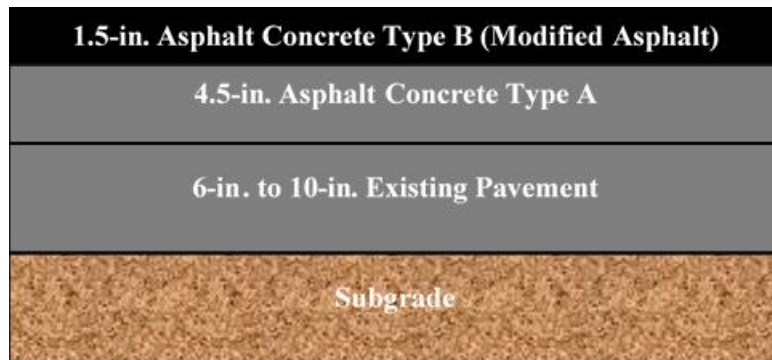
Figure 3.1 Typical pavement structures of US 287

A significant amount of transverse cracking was observed in US 287 in Cimarron County starting from 7.0-miles north of the Texas State line and continuing for 6-miles in the same direction. A 1,200-ft long test site was selected within this segment. As a part of the preliminary investigation, Google satellite images, construction records, historical weather data, and documents collected from the Oklahoma Department of Transportation (ODOT) were examined carefully. The pavement in this test section was constructed in the 1980s. Figure 3.1 shows the typical structure of the pavement in the test section. A 4.5-in. asphalt concrete with “Type A” mix with AC-20 binder was constructed over the existing pavement. In this study, the binder AC-20 was considered equivalent to Superpave PG 64-22. A 1.5-in. asphalt concrete “Type B”

mix with modified binder was used as the surface course. The equivalent Superpave PG of modified binder for “Type B” mix was assumed as PG 70-28. Also, it was determined that the existing pavement had “Type A” mix with AC-20 (i.e., PG 64-22) binder. Thickness of the existing pavement layer was calculated from the GPR images and inspection of asphalt cores. The GPR and core inspection results are discussed subsequently. The effect of variation in pavement thickness, high- and low-temperature PG on transverse cracking characteristics was evaluated using the PMED simulations. Based on the pavement maintenance data, the transverse cracks were developed at this section before 2008. Figure 3.2 (a) shows the aerial view of the test section, collected from Google Earth. The spacings of these cracks were found to vary between 30-ft and 90-ft along the pavement length. Also, the width and depth of these cracks varied throughout the section, the maximum width being about 3-in. Figures 3.2 (b) and 3.2 (c) show the photographic view of a typical crack that was 2-in. wide and 4.5-in. deep. In addition to lanes carrying traffic, many cracks extended in the shoulders.

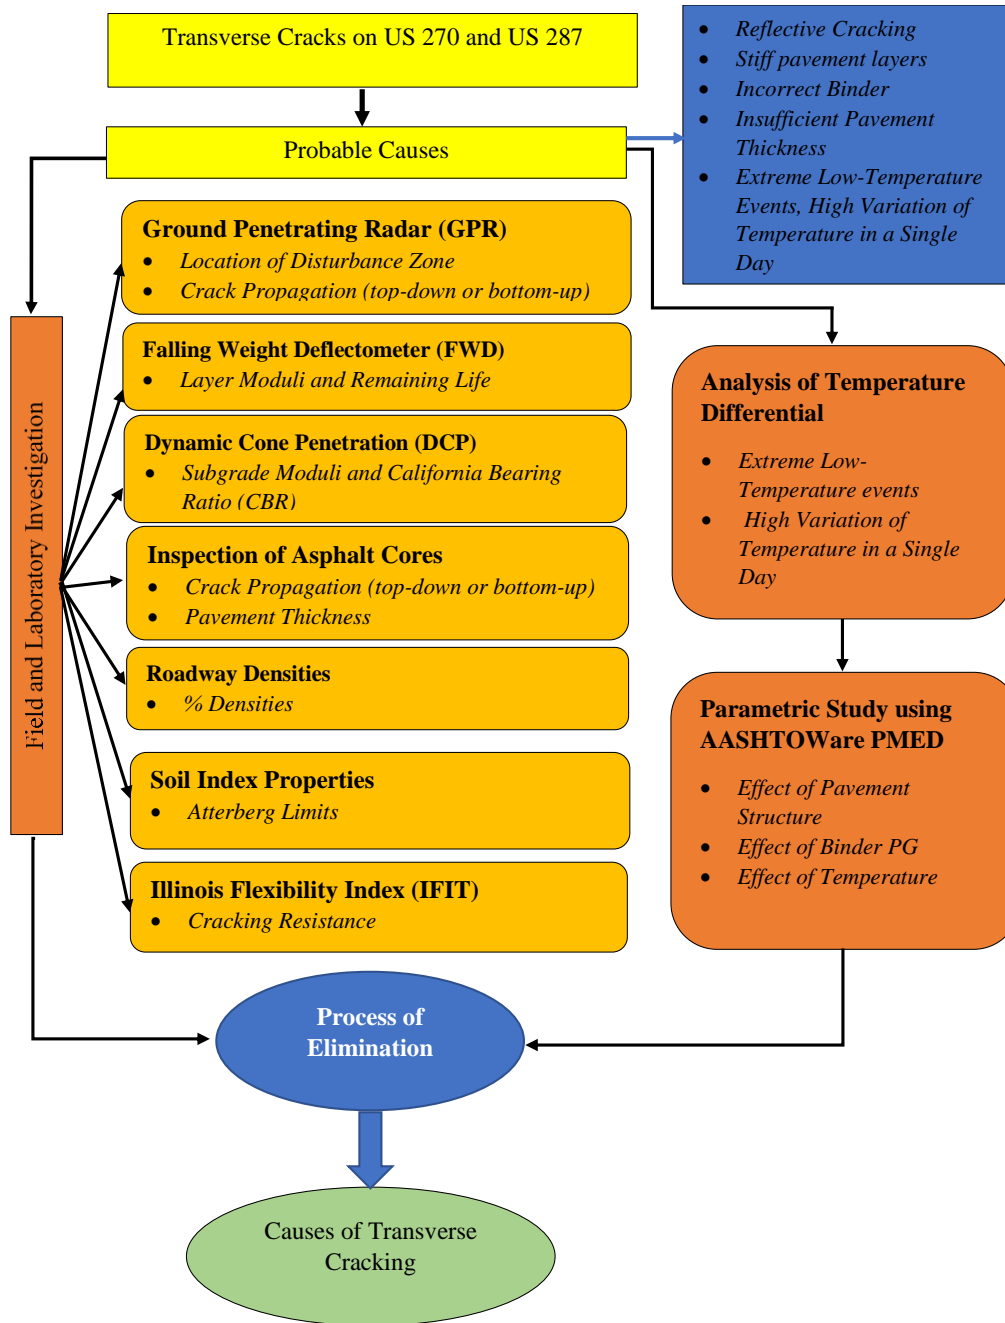
Figure 3.5 Workflow diagram for investigating transverse cracking in US 270 and US 287

In this study, a series of field and laboratory tests was selected, following the NCHRP 747 guidelines (Rada, 2013), to identify probable causes of transverse cracks at the selected test sites. In addition to field and laboratory testing, historical temperature data were used to examine the influence of thermal cycles with significant temperature differential. PMED simulations were used to identify the degree of influence of selected factors pertaining to pavement geometry,

materials and traffic. As shown in Figure 3.5, field and laboratory investigations were used to determine the pavement thickness, crack propagation path, modulus of pavement layers, remaining life of the pavements, cracking resistance of asphalt, and subgrade support in terms of California Bearing Ratio (CBR) and composite modulus. Probable causes of transverse cracks in US 270 and US 287 were identified based on these findings. Temperature data from nearby weather stations were analyzed to determine extreme temperature events and variation of temperature in a single day. Also, a parametric study using PMED was performed to understand the influence of pavement thickness, binder PG, traffic and temperature on the development of transverse crack. Different test methods and their findings are presented in in the following sections. The results of the parametric study are discussed subsequently.

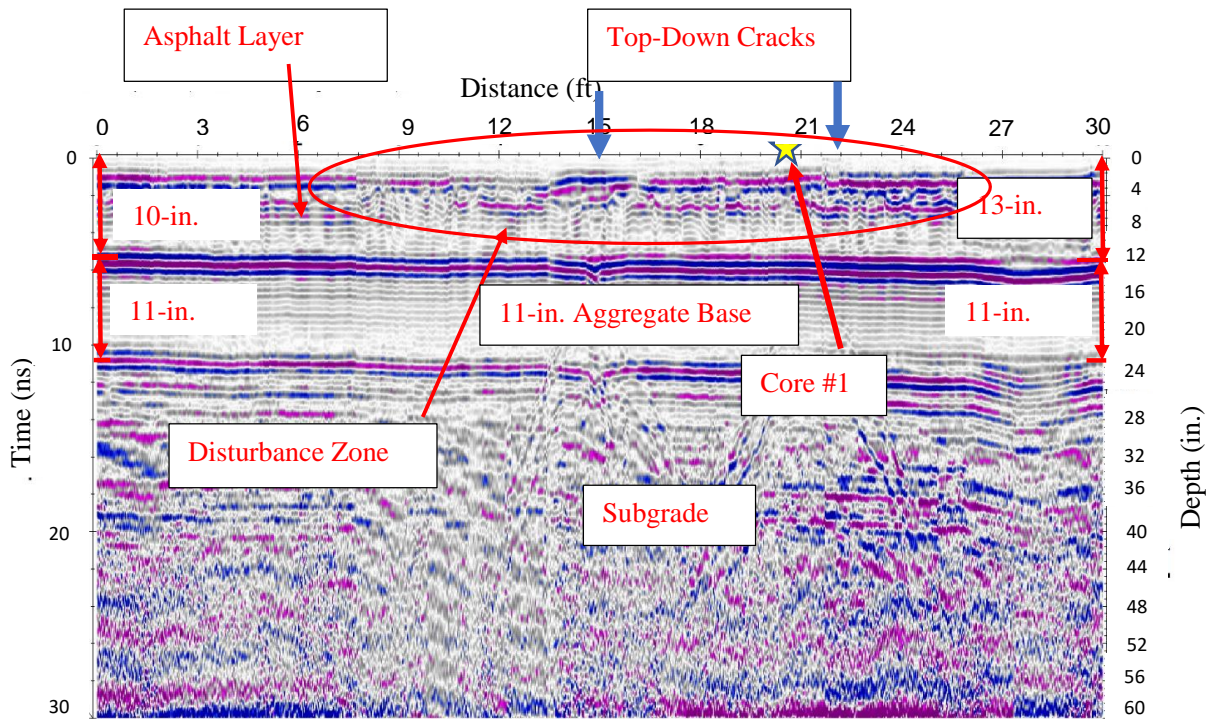
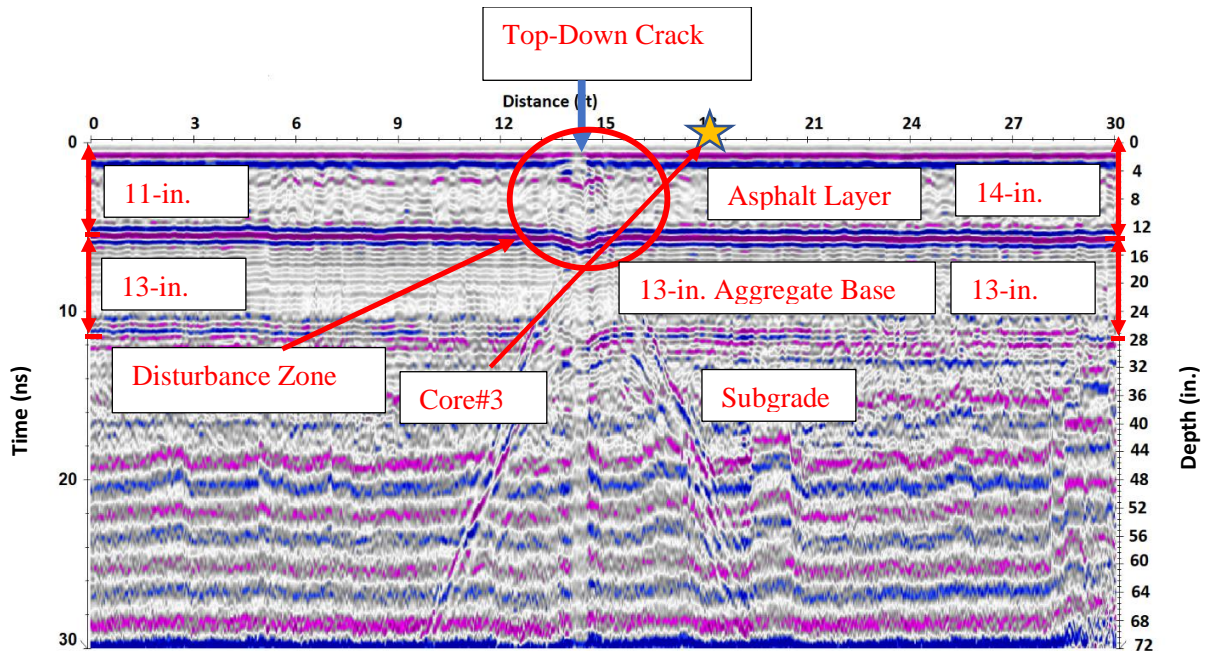
contained within the asphalt layer. Also, the GPR data did not find indication of settlements in the base and underlying layers. In addition, no reflective cracks were found from the GPR test results. Finally, asphalt layer thicknesses of both pavements were obtained from the GPR results. The asphalt layer thicknesses at both sites were found to vary along both transverse and longitudinal directions, as evident from Figures 3.6 (a) and 3.6 (b). The average asphalt thickness for US 270 and US 287 were found as 12-in. and 14-in., respectively. These results were also verified by the thicknesses of the cores taken from both sites. Mechanistically, pavement thickness is a major contributor to stiffness. Effect of variation in pavement thickness on transverse cracking characteristics was investigated using the PMED simulation. The results of the parametric study are discussed subsequently.

Figure 3.6 Processed longitudinal GPR profiles along US 270 (a) and US 287 (b). Depth conversion velocities are 0.1 m/ns (a) and 0.12 m/ns (b)

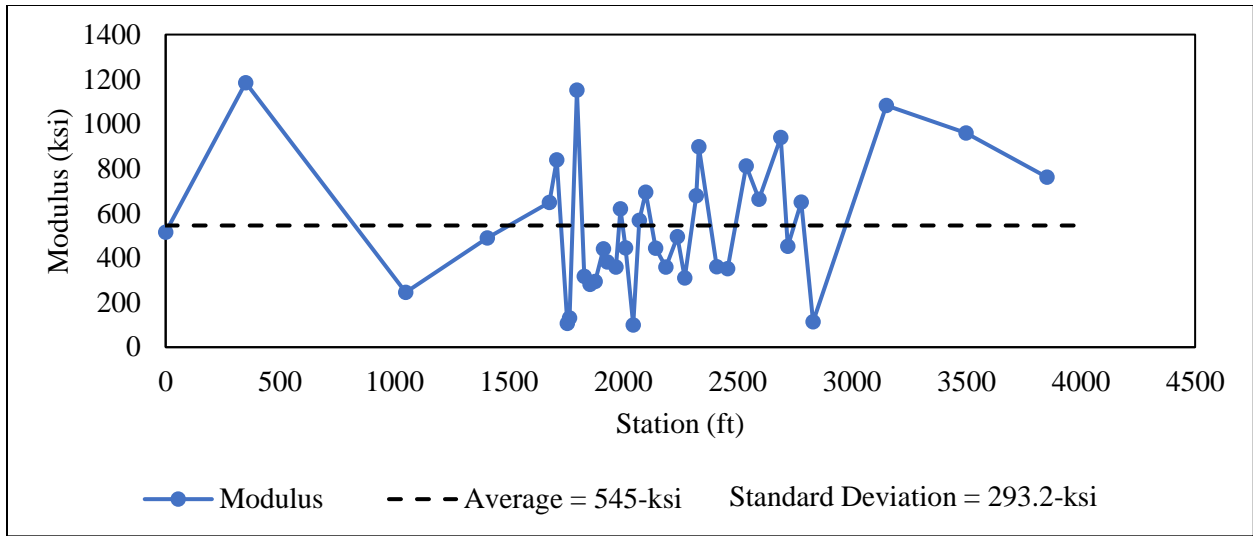
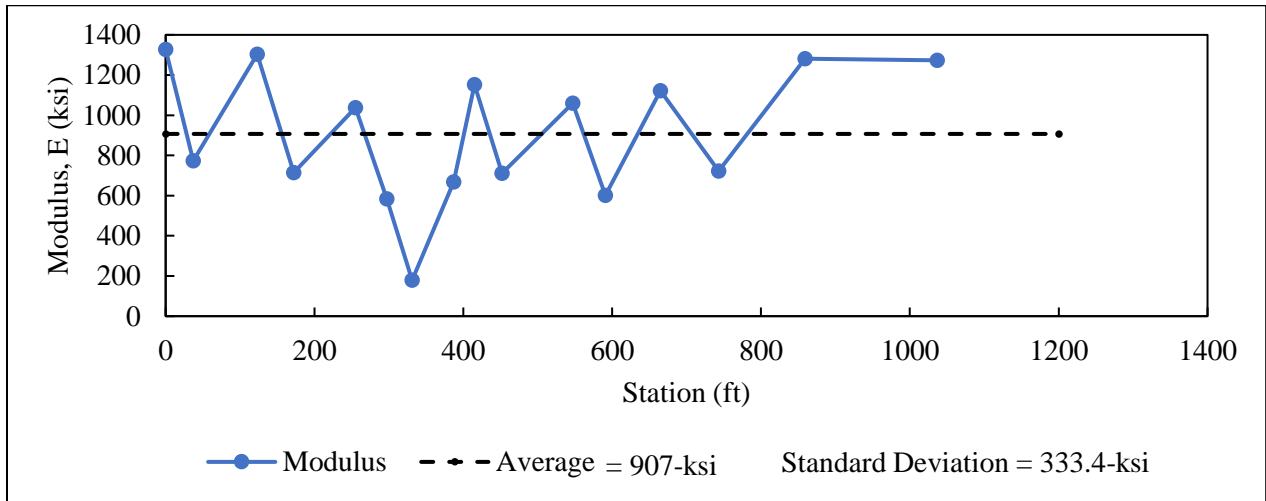
Variations in the modulus of asphalt layers for US 270 and US 287 are illustrated in Figures 3.7 (a) and 3.7 (b), respectively. The layer modulus of US 270 was found to vary between 100-ksi to 1,185-ksi with an average modulus of 545-ksi and a standard deviation of 293.2-ksi. The average layer modulus of US 287 was found as 907-ksi, with the maximum and minimum values being 1,328-ksi and 179-ksi, respectively, and a standard deviation of 333.4-ksi. The layer modulus of HMA generally varies between 100-ksi and 1,000-ksi (Rada, 2013; Smith et al., 2017). The probable reason behind these large variations in modulus are aging, variations in densities, and variations in asphalt thicknesses. Because the layer thicknesses varied throughout the test sites, the layer moduli obtained from the FWD data should be viewed accordingly. Overall, both pavements were found to have more than 10 years of remaining life, if maintained appropriately. The actual remaining life would also depend on traffic growth and other distresses. From the FWD tests, it can be concluded that both pavements sections currently have enough structural support except at few locations. The high modulus of asphalt layer is a potential contributing factor for transverse cracks observed in both pavements.

Figure 3.7 Variation of pavement layer modulus obtained from FWD testing: (a) US 270; and (b) US 287

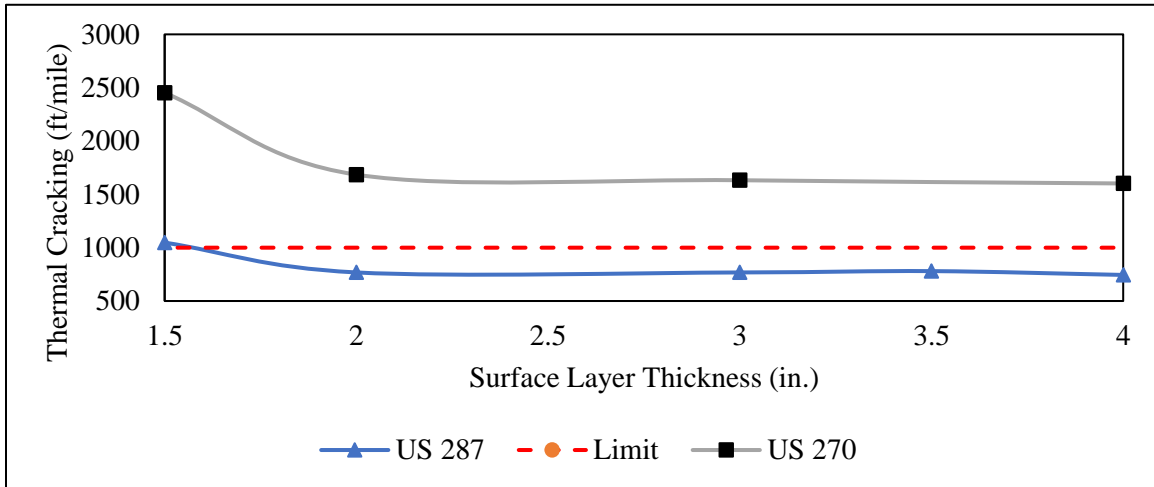
Figure 3.9 Variation of thermal cracking with surface thickness

lowered the thermal cracking of the pavement in US 270 test site below this threshold. However, an increase in surface and base thicknesses lowered the thermal cracking below the threshold limit for the pavement at the US 287 test site.

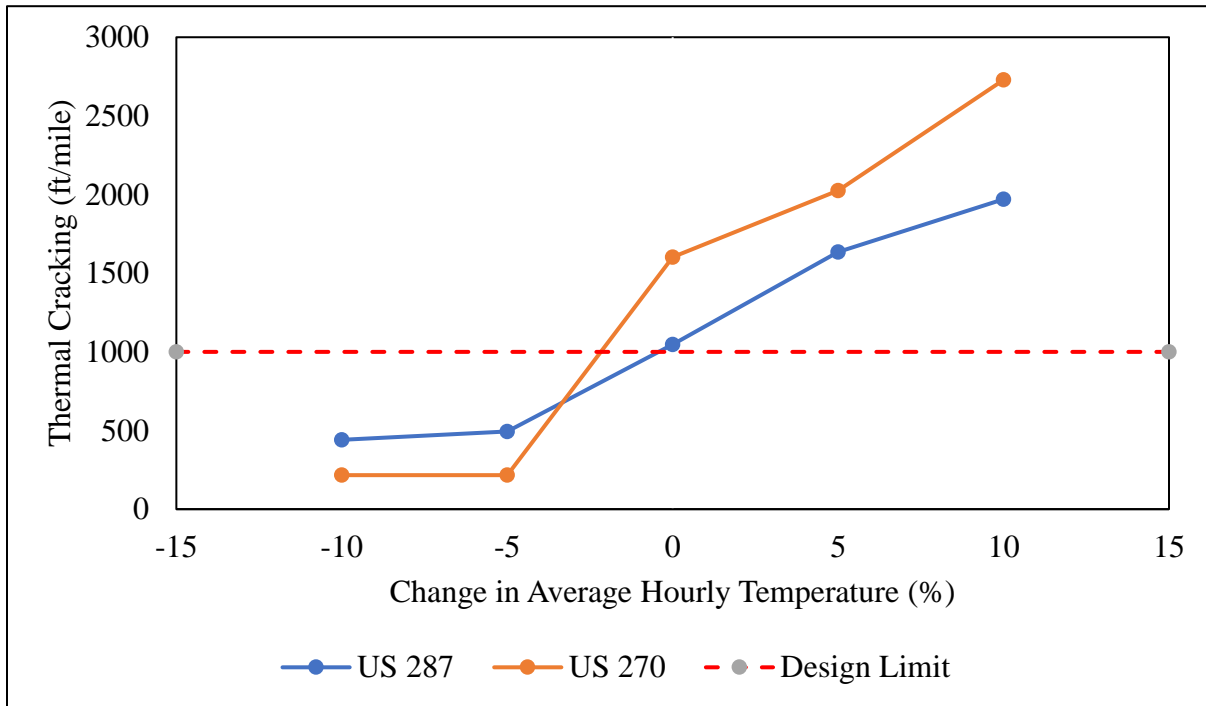
Figure 3.12 Variation of thermal cracking with change in average hourly temperature

pavement, respectively. The hourly damage may be small for an hour or a single day. However, over time, this variation could cause significant cracking in the pavement.

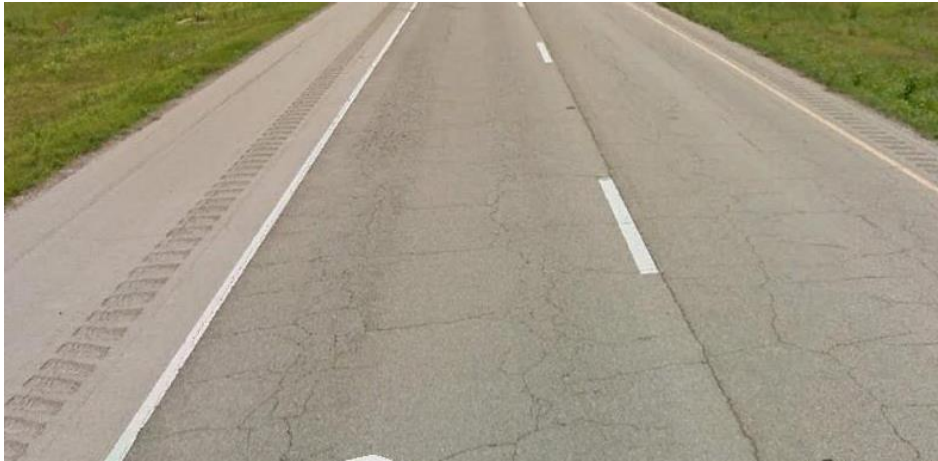
Figure 4.1 Typical fatigue cracks observed in US 412 in Noble County: (a) project location; and (b) Google satellite view

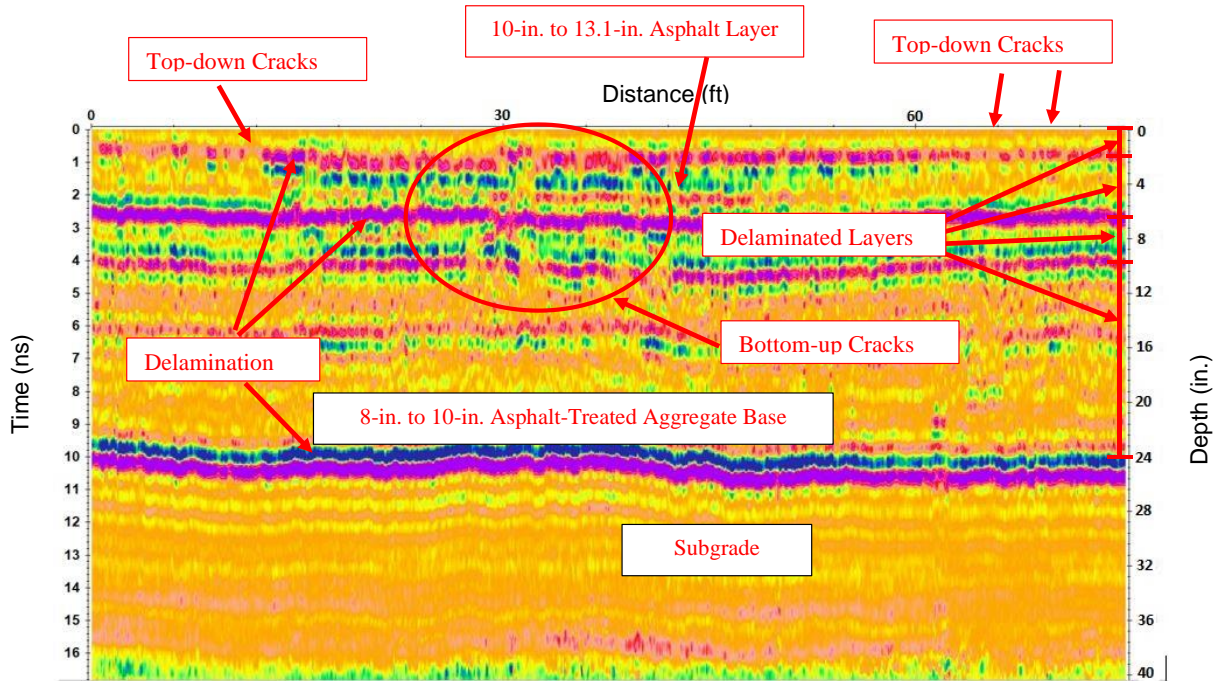
Figure 4.5 Longitudinal profile of US 412

well as from the existing pavement layer (bottom-up) (Figure 4.5). Distinct delamination was observed at two different depths, dividing the overall asphalt into three layers. Also, significant stripping was observed in several extracted asphalt cores. Thickness of the top layer was found to vary from 2-in. to 2.5-in. Thickness of the middle layer was found to vary from 4-in. to 7-in. and thickness of the bottom asphalt layer was found to vary from 3-in. to 4-in. In addition, thickness of asphalt treated aggregate base (also known as “hot sand”) in US 412 was obtained from the GPR images. The base thickness at this site was observed to vary from 7-in. to 8.5-in. These results were also verified by physically inspecting the cores extracted from the test site. Relative influence of the variation in asphalt thickness on fatigue cracking characteristics was further investigated using the PMED simulations. The results of the PMED simulations are discussed subsequently.

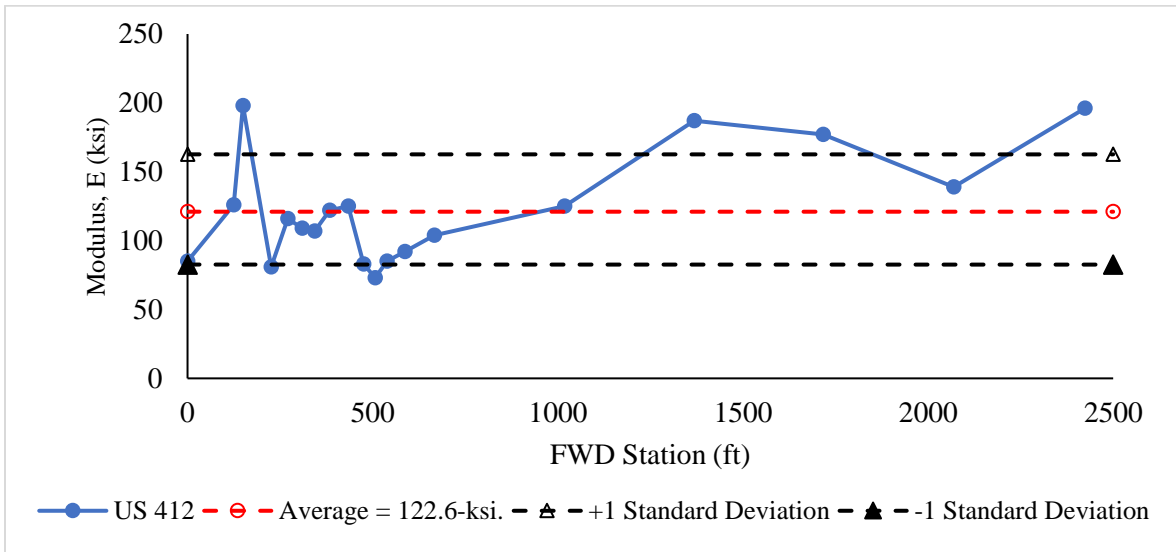
Figure 4.7 Variation of asphalt layer modulus with FWD station for US 412

Figure 4.7 shows the variation of layer modulus of the asphalt layer with FWD stations. The layer modulus was found to vary from 75.0-ksi to 200.0-ksi with an average of 120.8-ksi and a standard deviation of 40.0-ksi. The layer modulus of HMA generally varies between 100-ksi to 1,000-ksi (Rada, 2013; Smith et al., 2017). Several locations exhibited a layer modulus less than 100-ksi, which is very low. Overall, the layer moduli were low and found to vary throughout the pavement section (Figure 4.7). The probable reasons behind these low layer moduli could be aging, low roadway densities and variations in asphalt layer thicknesses (Qiu et al., 2014). Effects of these factors on fatigue cracking are discussed in respective sections. Also, the layer moduli of base and subgrade were determined from the FWD test results. The layer modulus of subgrade was found to vary from 4.0-ksi to 26.6-ksi with an average of 11.0-ksi and a standard deviation of 6-ksi. Effect of variations in layer moduli on fatigue cracking was further investigated using PMED simulations. Results of the PMED simulation are discussed subsequently. Overall, the pavement section was found to have 2 to 5 years of remaining life, based on the FWD analysis.

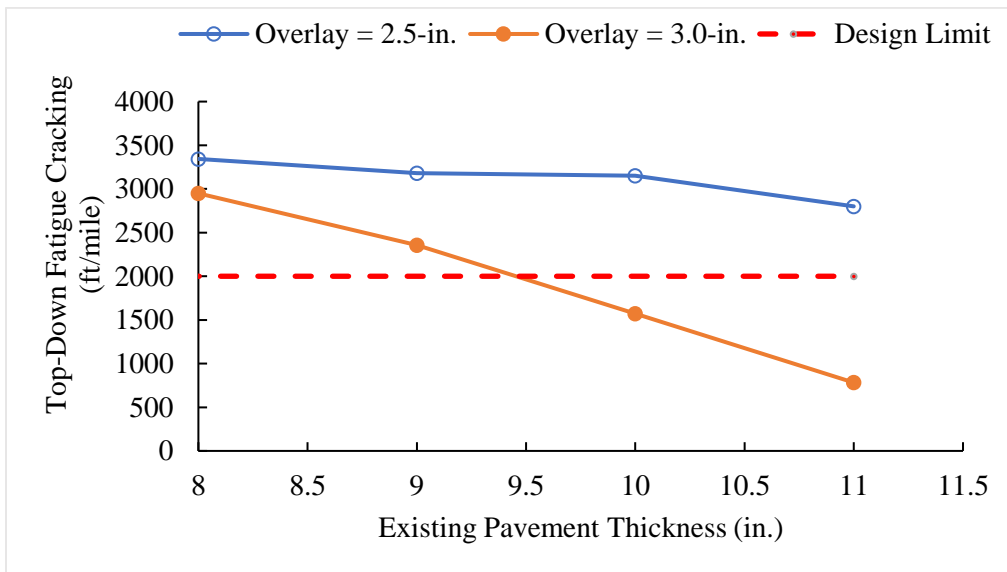
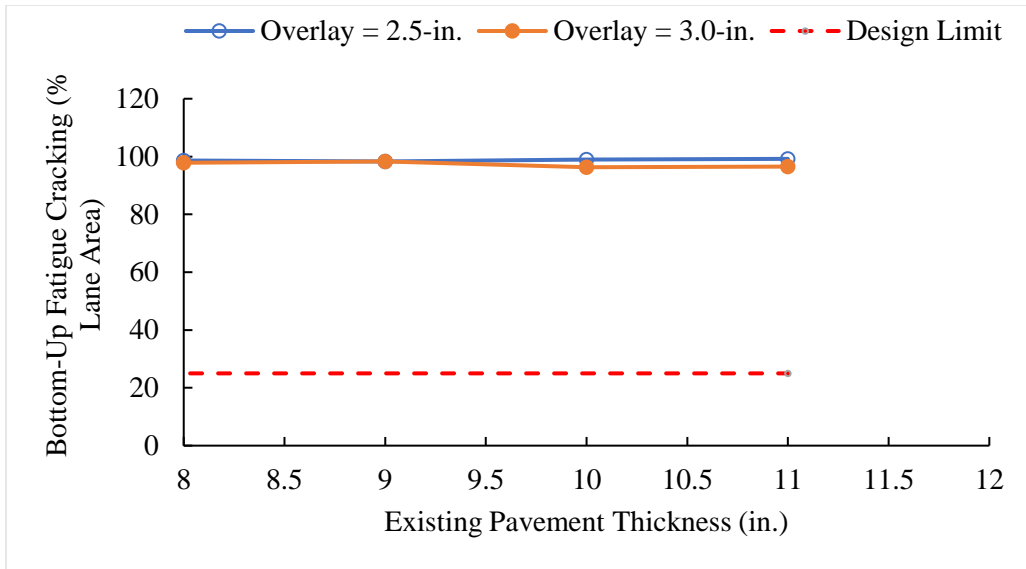
thickness for thicker pavements (Alae et al., 2020). Also, as noted previously, no delamination was considered in PMED simulations. Therefore, the pavement structure behaved like thicker pavements and the effect of pavement thickness on bottom-up fatigue cracking could not be captured through the PMED simulations. Also, it was observed that top-down fatigue cracking decreased with an increase in the overlay thickness. For example, the top-down fatigue cracking was found to reduce from 3,240-ft/mile to 2,356-ft/mile with an increase in overlay thickness from 2.5-in. to 3.0-in. while the existing pavement thickness remained constant at 9.0-in. This result indicated that 2.5-in. milling and 3-in overlay would be helpful in reducing top-down fatigue cracking in future rehabilitation. Thus, lower overlay thickness and variations in existing pavement thickness throughout the test site have likely contributed to the variations in top-down fatigue cracking throughout the pavement section.

Figure 4.12 Variation of fatigue cracking with pavement thickness: (a) top-down; and (b) bottom-up

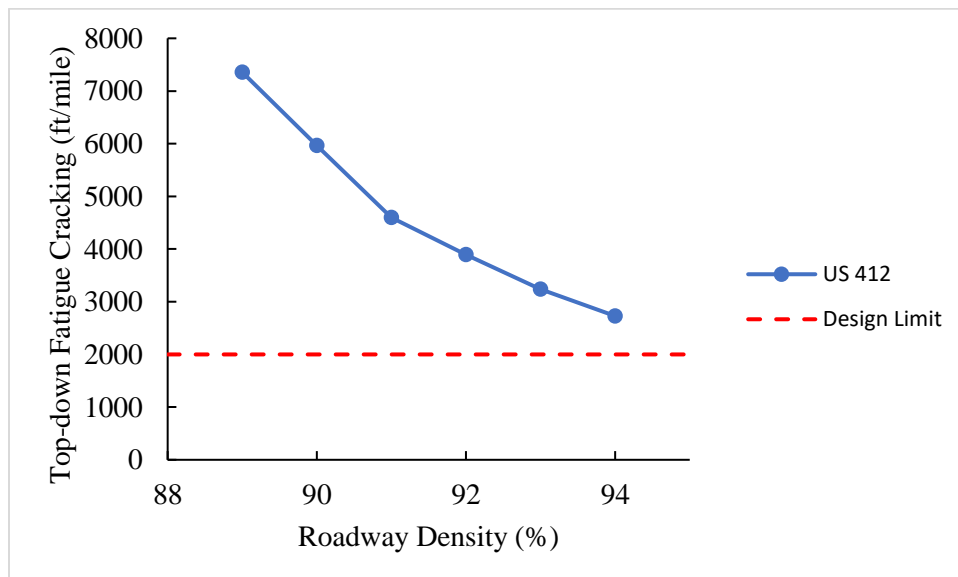
Figure 4.16 (a) and 4.16 (b) show variations in top-down and bottom-up fatigue cracking with roadway densities. It was observed that both top-down and bottom-up fatigue cracking increased with a decrease in the roadway density. For example, top-down fatigue cracking was found to increase from 2,729-ft/mile to 3,895-ft/mile with a change in roadway density from 94% to 92%. Also, bottom-up fatigue cracking was found to increase from 86.8% to 99.7% of lane area with a change in roadway density 94% to 92%. The current roadway density of US 412 at the test site was found to vary from 91.4% to 94.3% with an average of 92.7%, as evident from the roadway density test results. A similar trend was also observed in the field. Overall, higher fatigue cracking was observed in the vicinity of Core#3M (density 91.8%) as compared to that of Core#9M (density 94.3%), as shown in Figures 4.17 (a) and 4.17 (b). Therefore, it can be concluded that the low density was a potential contributor for fatigue cracking at the test site. Also, obtaining a higher density (e.g. 94% or above) during reconstruction or rehabilitation would be helpful for limiting fatigue cracking in future.

Figure 4.16 Variation of fatigue cracking with roadway density: (a) top-down; (b) bottom-up
