DURABILITY EVALUATION OF CONCRETE SEALED
WITH POLYUREA POLYASPARTIC COATINGS

EVAN KARUNARATNE

Submitted to the Faculty of the
Graduate College of the
Oklahoma State University
in partial fulfillment of
the requirements for
the Degree of
MASTER OF SCIENCE

May, 2020

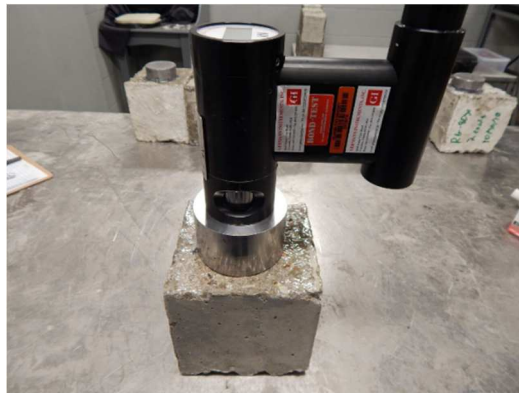
To assess the bond performance of the products to the surface of concrete, pull-off testing as per ASTM D7234 was performed. 6"x6"x6" block samples were used for that purpose. (Figure 1)

Figure 1: Example of Pull-off Testing

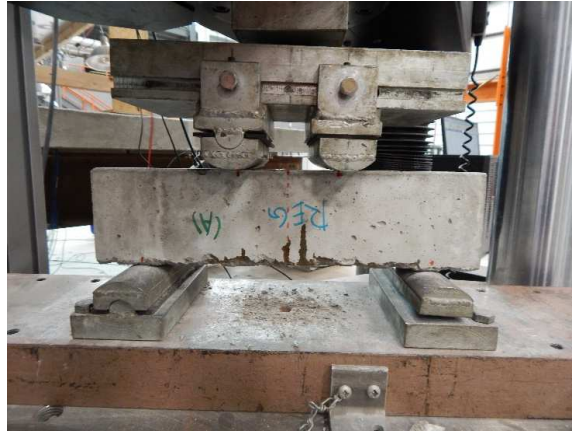
Flexural testing as per ASTM C78 was carried-out to determine the performance in resisting crack initiation and propagation under tensile loading (Figure 2). For each coating system evaluated, the sample size consisted of three beam replicates and three notched-beam replicates (3" x 4" x 12") in accordance with the standard. The beams were cast, conditioned and prepared following the methodology described previously. Only one coating thickness was evaluated, the three-layer system.

Figure 2: Flexural test setup

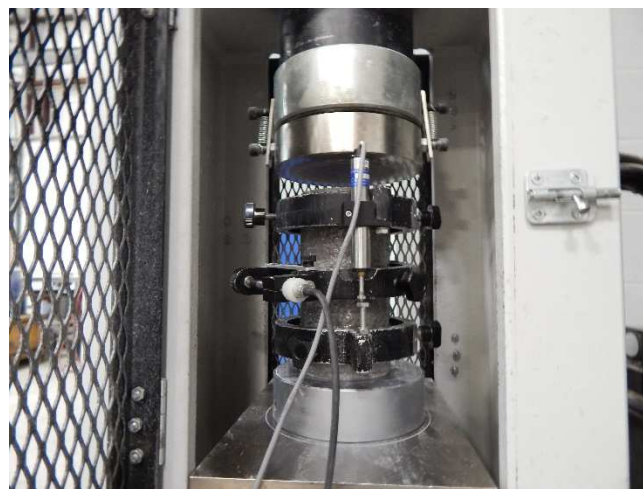
To determine the ability of the coating system to confine surface deterioration. A series of 4 in x 8 in cylinder samples were cast and conditioned as previously described. Nine sample replicates for each coating type were scaled as following that described previously. For each pair of nine cylindrical samples, one, two and three layers of the product were applied on three of the nine replicates. After extended curing time, the samples were subjected to a displacement controlled compression load in accordance with the ASTM C469 standard (Figure 3). The stress-strain behavior of the composite systems was evaluated to determine the efficacy of the coating system to contain fissured concrete and fragments.

Figure 3: Example of a cylindrical sample and Modulus of Elasticity Testing

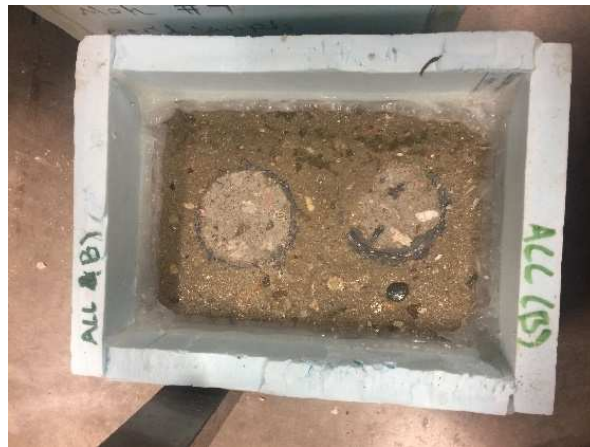
Figure 6: Pull-off testing of salt ponding samples

As per described previously, the pull-off test method (ASTM D7234) was performed. This was done to demonstrate the impact of deicing salts on concrete covered with a polyaspartic/polyurea coating system. Two test replicates per sample surface were performed ([Figure 5](#)).

chloride ions into concrete through ponding. However, the difference between this standard and the method used in the laboratory is that samples were not chemically analyzed over time. Here, salt solution ponding was performed to assess the coatings' resistance to chemical degradation along with bond performance after three months of continuous ponding. The setup is shown in [Figure 6](#).

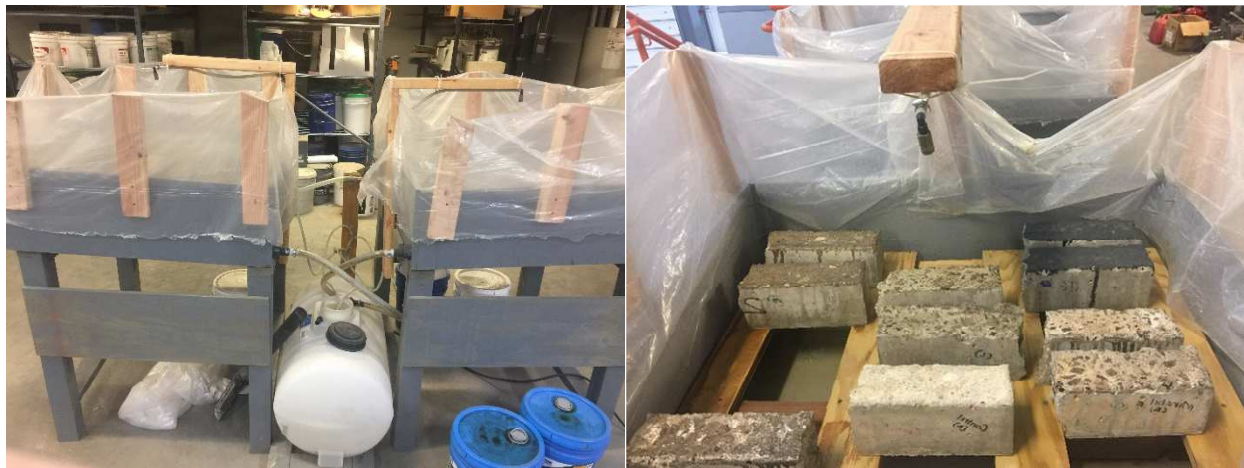
Figure 7: Cyclic wet-dry exposure setup (rain precipitation simulation)

After undergoing the flexure test, the scaled standard beams (no notch) were further investigated under wet-dry conditions ([Figure 7](#)). The procedure followed that of Hartell and Zeng where significant damage to concrete after the weathering exposure occurred (Hartell & Zeng, 2020). The beams were exposed to simulated rain exposure for an hour every day for 100 days or 100 wet-dry cycles. The precipitation event was determined by finding the average rainfall data for a northern region in the Midwest, which was

found to be approximately an inch in a 30 minute event. Subsequently, the samples were allowed to dry in laboratory conditions for a period of 24 hours. To avoid water ponding, the samples were elevated above the bottom of the tank.

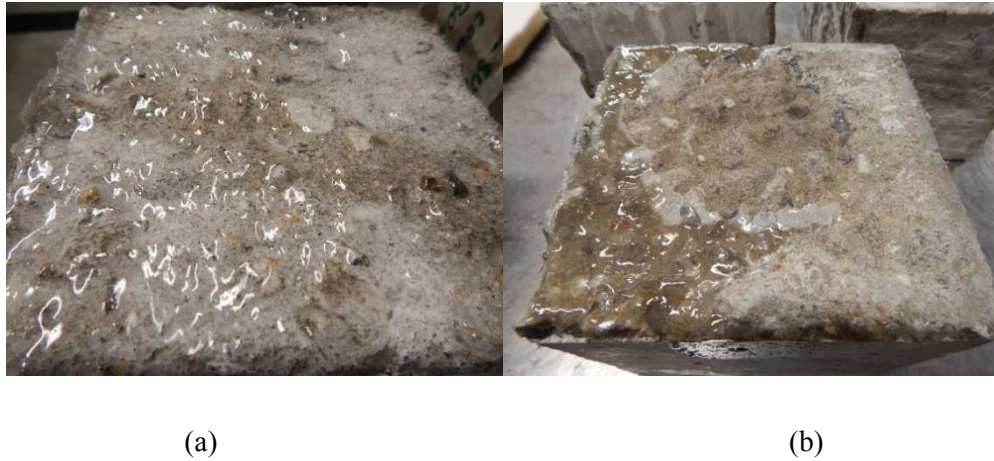
Moreover, a few of the samples prepared with the Clear Seal coating system demonstrated disbondment from the concrete surface which resulted in low bond-strength and high variability in the measurements. There were signs of coating flaking for all samples post-testing after an extended period of time (Figure 9). Pull-off test results are presented in Table 8.

Figure 9: (a) Rustoleum RG-80X disbondment prior to testing flaking and (b) VersaFlex Clear Seal flaking from the surface

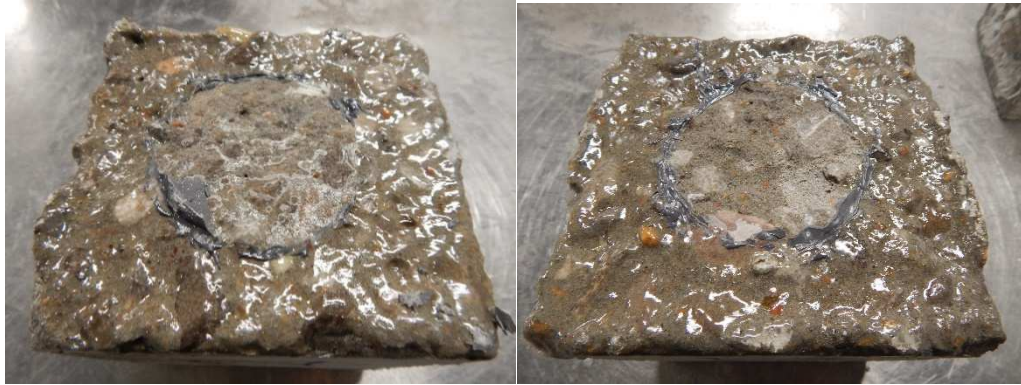
Figure 12: VersaFlex Aliphatic Clear Coat failure type for dry samples with one layer of product: (a) replicate A and (b) replicate B.

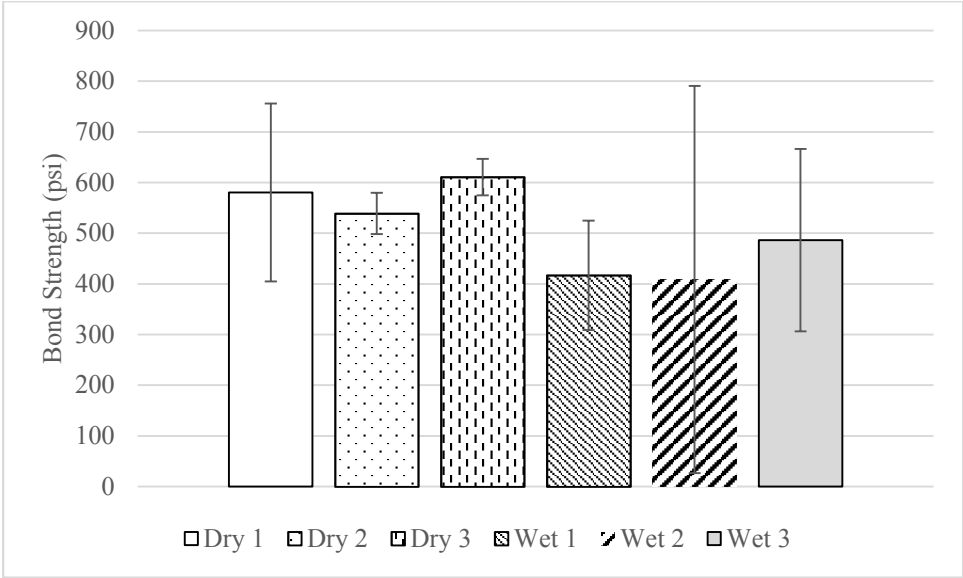
Figure 28: DYNA-PUR7416 NT6: Pull-off test result comparison between dry and wet samples and coating thicknesses

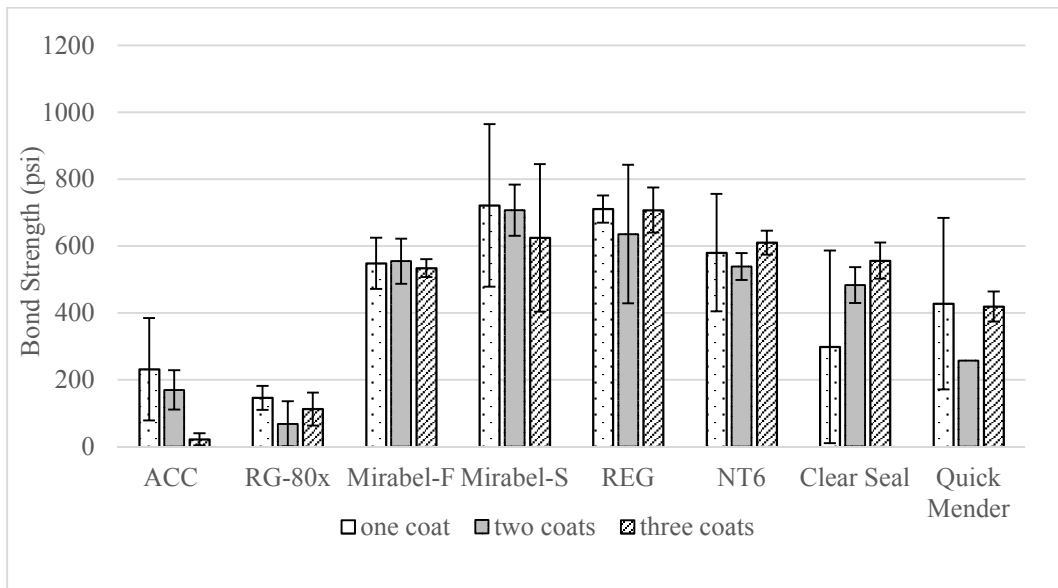
Figure 31: Pull-off test results comparison for all products, dry samples

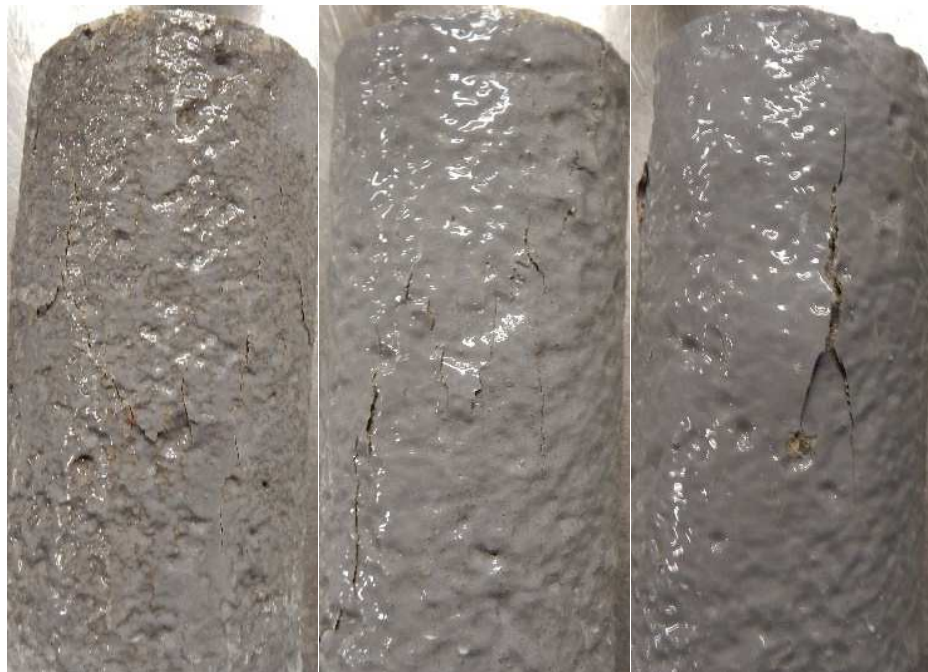
Figure 40: DYNA-PUR7416 (REG) failure type with a) one coat, b) two coats, and c) three coats

Concrete Moisture Conditioning	Number of Coats	Coating Thickness (mils, ± 0.4)	Average Strength (psi)	Coefficient of Variation (%)	ANOVA F-Value/ p-value
Creative Material Technologies						
DYNA-PUR7416	Dry	One	7.4	3983	3.8	3.978/0.201
	Dry	Two	9.8	3878	5.6	
	Dry	Three	11.9	3936	3.1	
DYNA-PUR7416-NT6	Dry	One	12.2	4113	6.7	0.483/0.658
	Dry	Two	12.9	1741	6.5	
	Dry	Three	14.2	3979	6.1

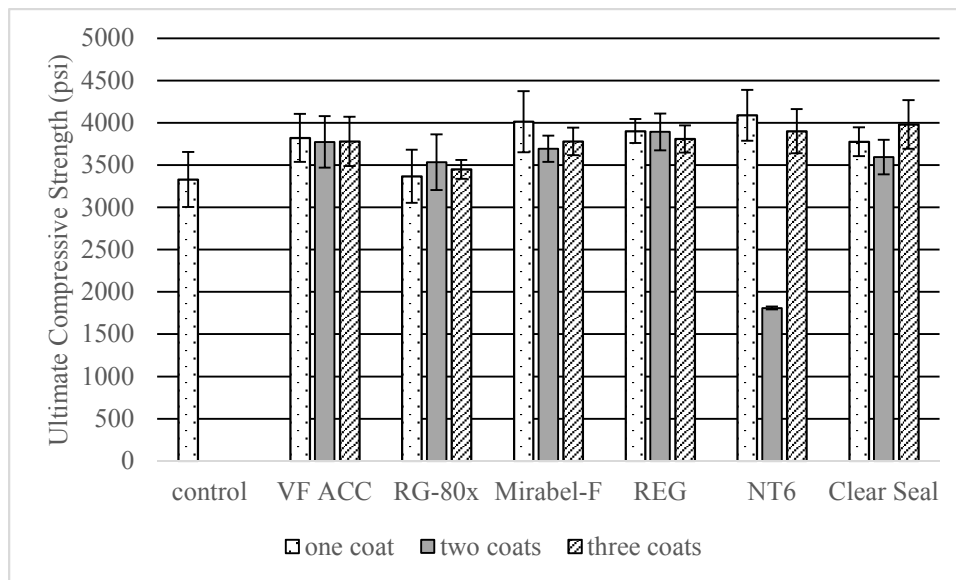
Figure 42: Compression test results, all samples

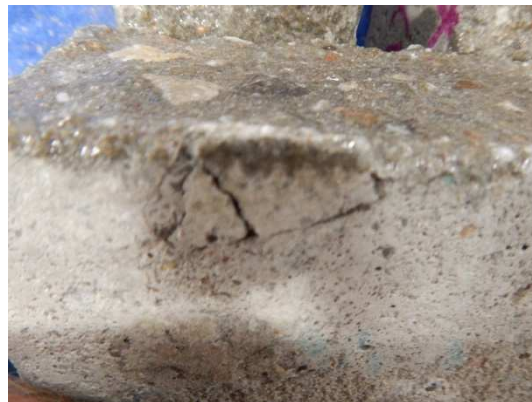
Figure 45: Mirabel Fast Freeze-Thaw Test Surface Results

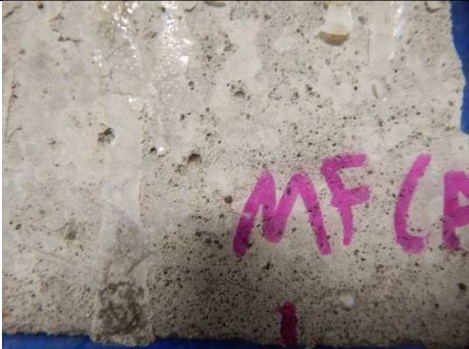
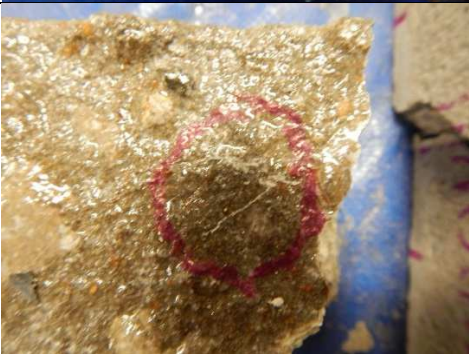
<p style="text-align: center;">Distress Features</p> <ul style="list-style-type: none"> • Mortar Flaking • Deterioration of Edges • Abrasion on the coating surface exposing the aggregate • Thinner coating than first applied

<p style="text-align: center;">Results</p> <ul style="list-style-type: none"> • Could not peel back coating • Coating disintegrated

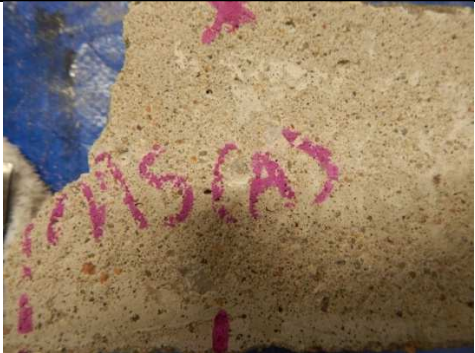
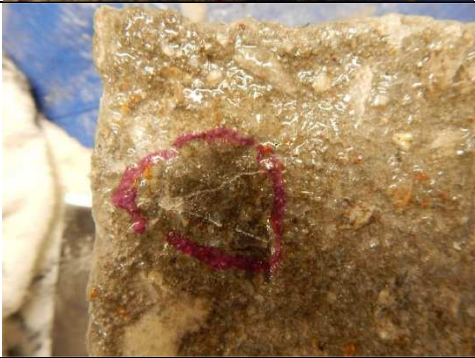
<p style="text-align: center;">Distress Features</p> <ul style="list-style-type: none"> • Mortar Flaking • Deterioration of Edges • Abrasion on the coating surface exposing the aggregate • Thinner coating than first applied

<p style="text-align: center;">Results</p> <ul style="list-style-type: none"> • Could not peel back coating • Coating disintegrated

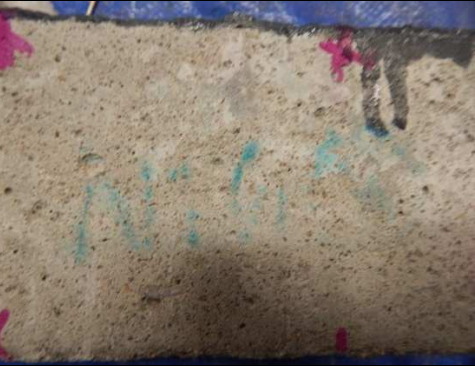
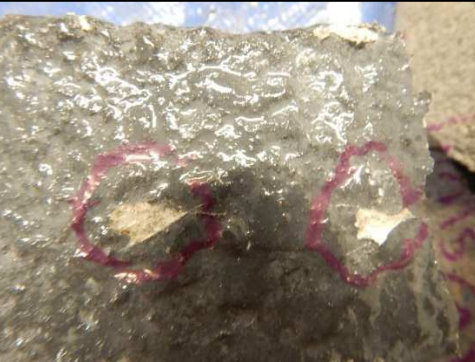
<p style="text-align: center;">Distress Features</p> <ul style="list-style-type: none"> • Mortar Flaking • Deterioration of Edges • Abrasion on the coating surface exposing the aggregate • Thinner coating than first applied

<p style="text-align: center;">Results</p> <ul style="list-style-type: none"> • Coating peeled very easily in strips

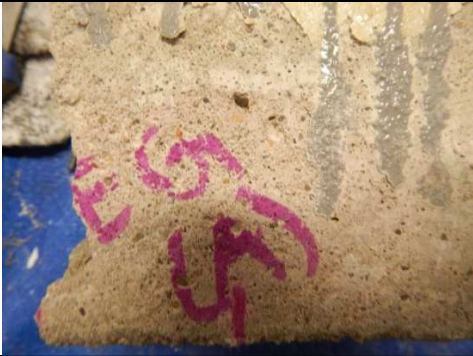
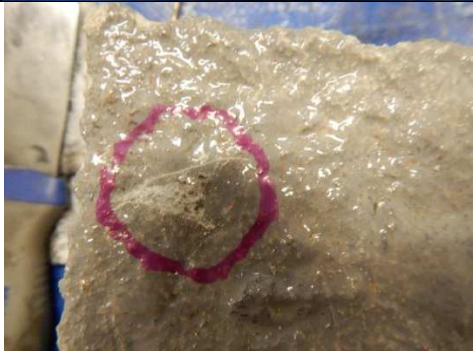
<p style="text-align: center;">Distress Features</p> <ul style="list-style-type: none"> • Mortar Flaking • Deterioration of Edges • Abrasion on the coating surface exposing the aggregate • Thinner coating than first applied

<p style="text-align: center;">Results</p> <ul style="list-style-type: none"> • Coating peeled very easily in strips

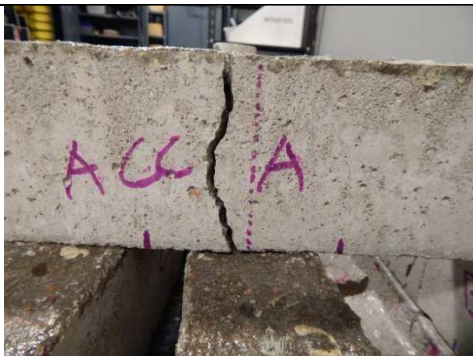
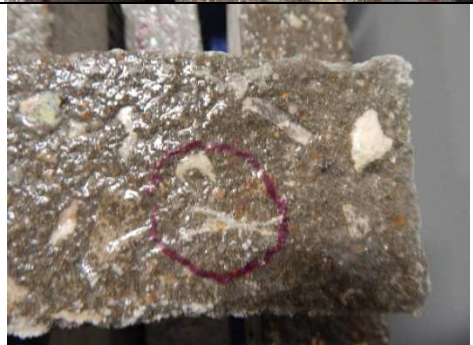
<p style="text-align: center;">Distress Features</p> <ul style="list-style-type: none"> • Mortar Flaking • Deterioration of Edges • Abrasion on the coating surface exposing the aggregate • Thinner coating than first applied

<p style="text-align: center;">Results</p> <ul style="list-style-type: none"> • Could not peel back coating • Coating disintegrated

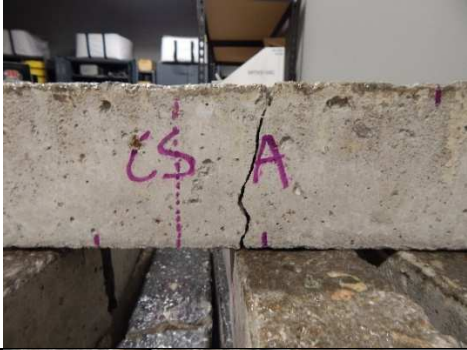
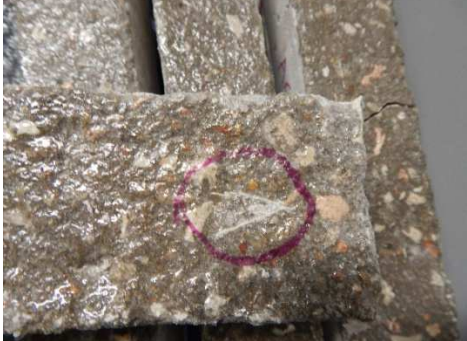
<p style="text-align: center;">Distress Features</p> <ul style="list-style-type: none"> • Mortar Flaking • Deterioration of Edges • Abrasion on the coating surface exposing the aggregate • Thinner coating than first applied

<p style="text-align: center;">Results</p> <ul style="list-style-type: none"> • Could not peel back coating • Coating disintegrated

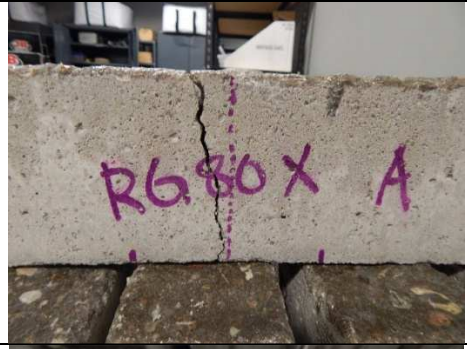
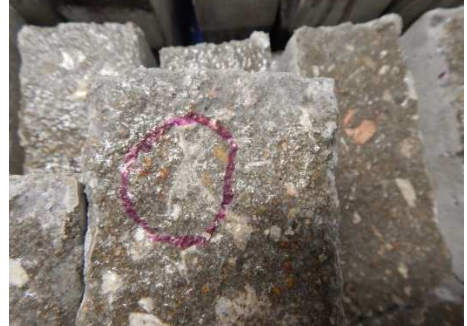
<p style="text-align: center;">Distress Features</p> <ul style="list-style-type: none"> • Mortar Flaking • Deterioration of Edges • Abrasion on the coating surface exposing the aggregate • Thinner coating than first applied

<p style="text-align: center;">Results</p> <ul style="list-style-type: none"> • Could not peel back coating • Coating disintegrated

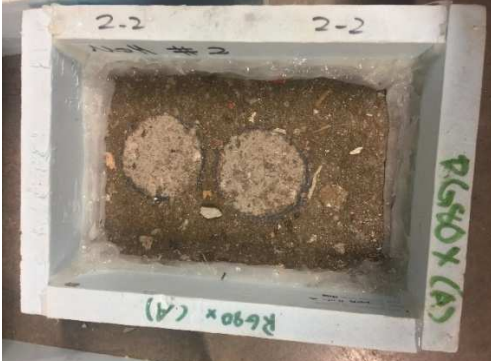
<p style="text-align: center;">Distress Features</p> <ul style="list-style-type: none"> • Thinner coating than first applied • Few partial failures of combined coating and adhesive • Most failures in the concrete substrate
---	---

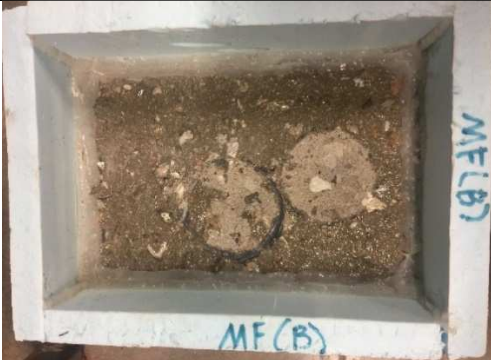
<p style="text-align: center;">Distress Features</p> <ul style="list-style-type: none"> • Thinner coating than first applied • Few partial failures of combined coating and adhesive • Few failures of the coating bond
--	--

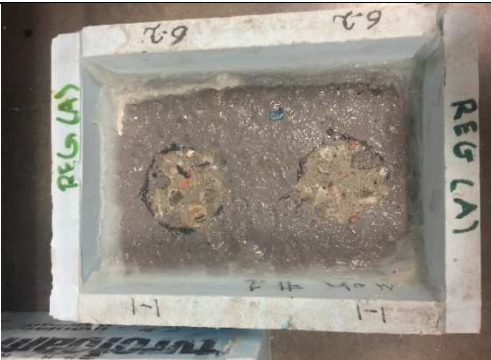
<p style="text-align: center;">Distress Features</p> <ul style="list-style-type: none"> • Thinner coating than first applied • Few partial failures of combined coating and adhesive • Few failures of adhesive itself • Few failures of the coating bond
---	---

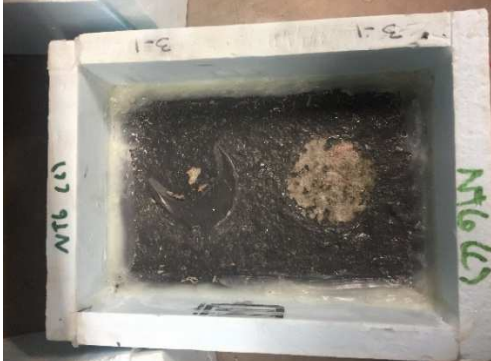
<p style="text-align: center;">Distress Features</p> <ul style="list-style-type: none"> • Thinner coating than first applied • Few partial failures of combined coating and adhesive • Few failures of adhesive itself
---	---

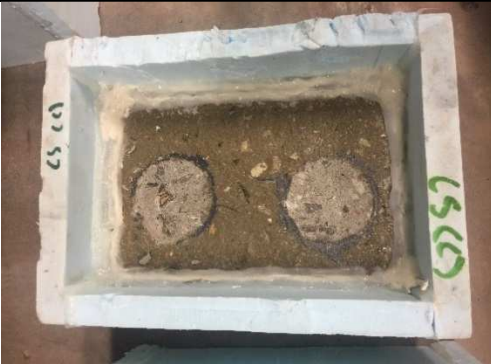
<p style="text-align: center;">Distress Features</p> <ul style="list-style-type: none"> • Thinner coating than first applied • Few partial failures of combined coating and adhesive • Most failures in the concrete substrate
--	---

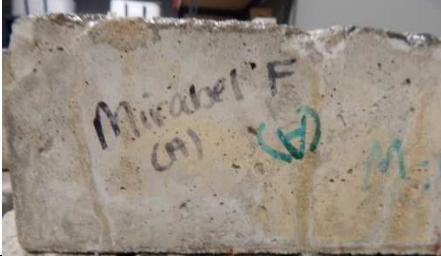
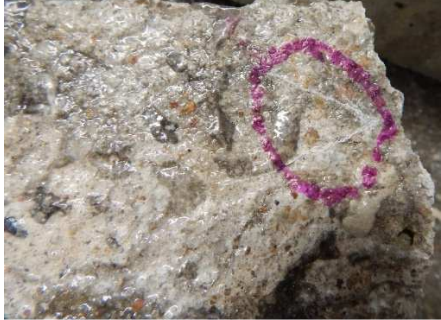
<p style="text-align: center;">Distress Features</p> <ul style="list-style-type: none"> • Mortar Flaking • Deterioration of Edges • Abrasion on the coating surface exposing the aggregate • Thinner coating than first applied

<p style="text-align: center;">Results</p> <ul style="list-style-type: none"> • Could not peel back coating • Coating disintegrated

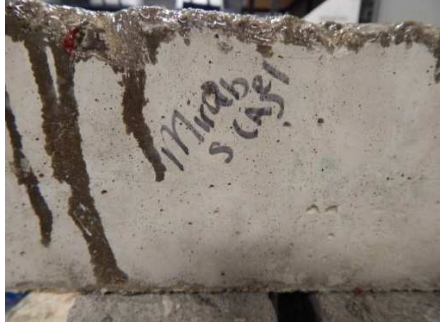
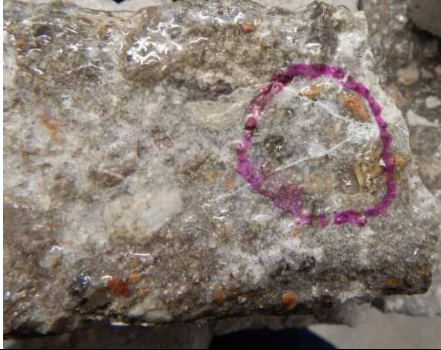
<p style="text-align: center;">Distress Features</p> <ul style="list-style-type: none"> • Mortar Flaking • Deterioration of Edges • Abrasion on the coating surface exposing the aggregate • Thinner coating than first applied

<p style="text-align: center;">Results</p> <ul style="list-style-type: none"> • Could not peel back coating • Coating disintegrated

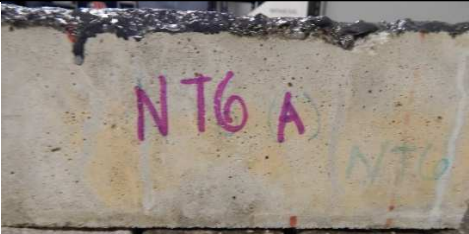
Table 38: DYNA-PUR7416-NT6 Visual Characterization and V-Notch Test Results after Wet-Dry Exposure

<p style="text-align: center;">Distress Features</p> <ul style="list-style-type: none"> • Mortar Flaking • Deterioration of Edges • Thinner coating than first applied

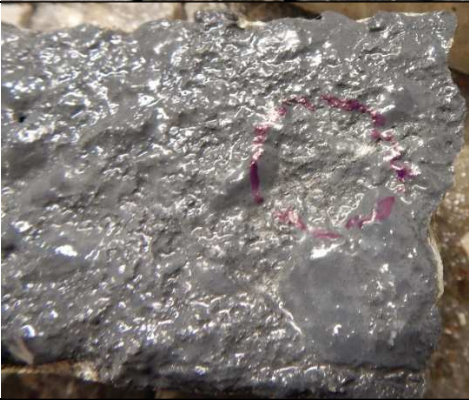
<p style="text-align: center;">Results</p> <ul style="list-style-type: none"> • Coating peeled very easily in strips

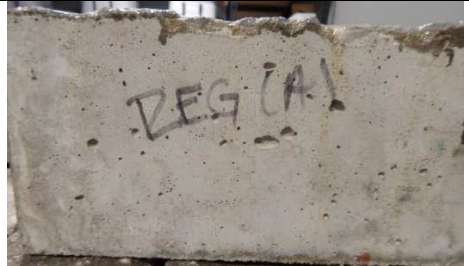
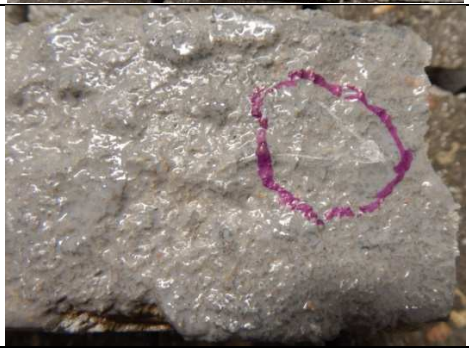
<p style="text-align: center;">Distress Features</p> <ul style="list-style-type: none"> • Mortar Flaking • Deterioration of Edges • Thinner coating than first applied

<p style="text-align: center;">Results</p> <ul style="list-style-type: none"> • Coating peeled very easily in strips

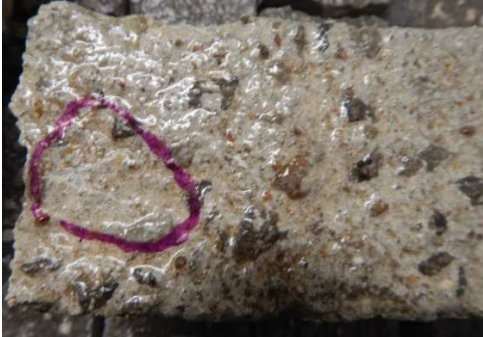
Table 41: Clear Seal Visual Characterization and V-Notch Test Results

<p style="text-align: center;">Distress Features</p> <ul style="list-style-type: none"> • Mortar Flaking • Thinner coating than first applied

<p style="text-align: center;">Results</p> <ul style="list-style-type: none"> • Could not peel back coating • Coating disintegrated

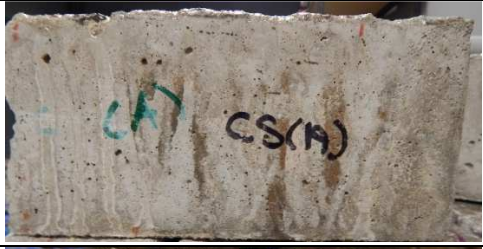
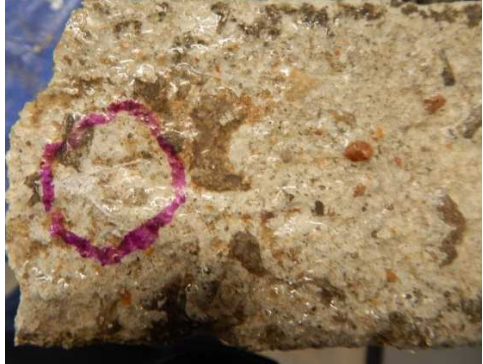
<p style="text-align: center;">Distress Features</p> <ul style="list-style-type: none"> • Mortar Flaking • Deterioration of Edges • Abrasion on the coating surface exposing the aggregate • Thinner coating than first applied

<p style="text-align: center;">Results</p> <ul style="list-style-type: none"> • Could not peel back coating • Coating disintegrated

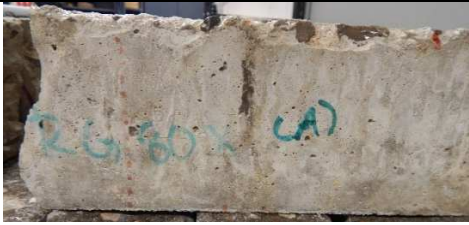
Table 42: Polyurea Polyaspartic RG-80X V-Notch Test Results after Wet-Dry Exposure

<p style="text-align: center;">Distress Features</p> <ul style="list-style-type: none"> • Mortar Flaking • Deterioration of Edges • Abrasion on the coating surface exposing the aggregate • Thinner coating than first applied

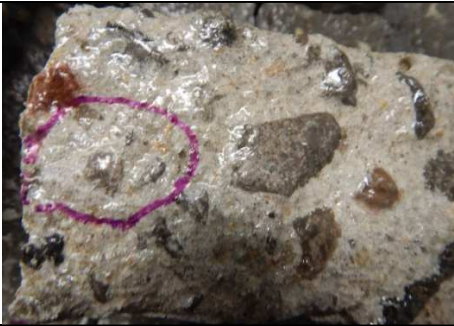
<p style="text-align: center;">Results</p> <ul style="list-style-type: none"> • Could not peel back coating • Coating disintegrated
