COMPARATIVE STUDY OF PROPRIETARY AND NON-PROPRIETARY ULTRA-HIGH
PERFORMANCE CONCRETE AS PARTIAL-DEPTH JOINT REPLACEMENT

A THESIS
SUBMITTED TO THE GRADUATE FACULTY
in partial fulfillment of the requirements for the
Degree of
MASTER OF SCIENCE

By
KIM SEREY VUTH CHEA
Norman, Oklahoma
2020

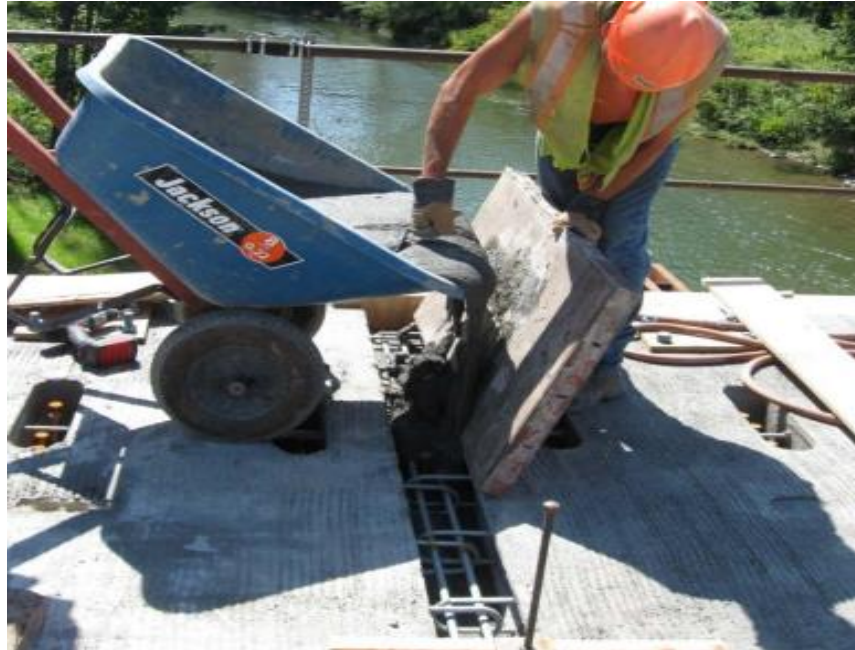
Figure 1: Field-casting and placement of UHPC (Graybeal 2010)

focus. Figure 1 shows UHPC transported to a site for field casting and placement. Figure 2 depicts the longitudinal connections using UHPC after field-casting.

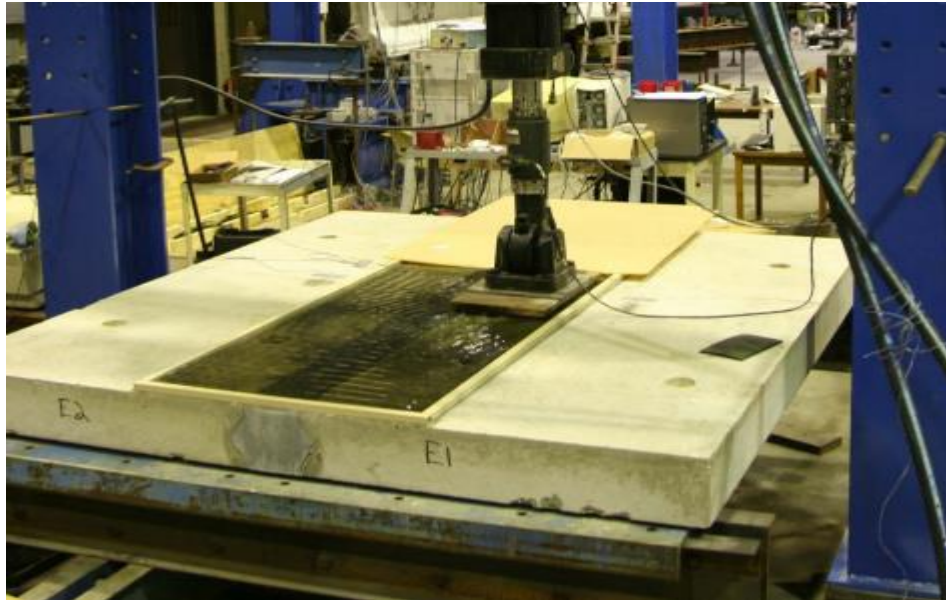
Figure 5: Cyclic test setup for longitudinal UHPC connection (Graybeal 2010)

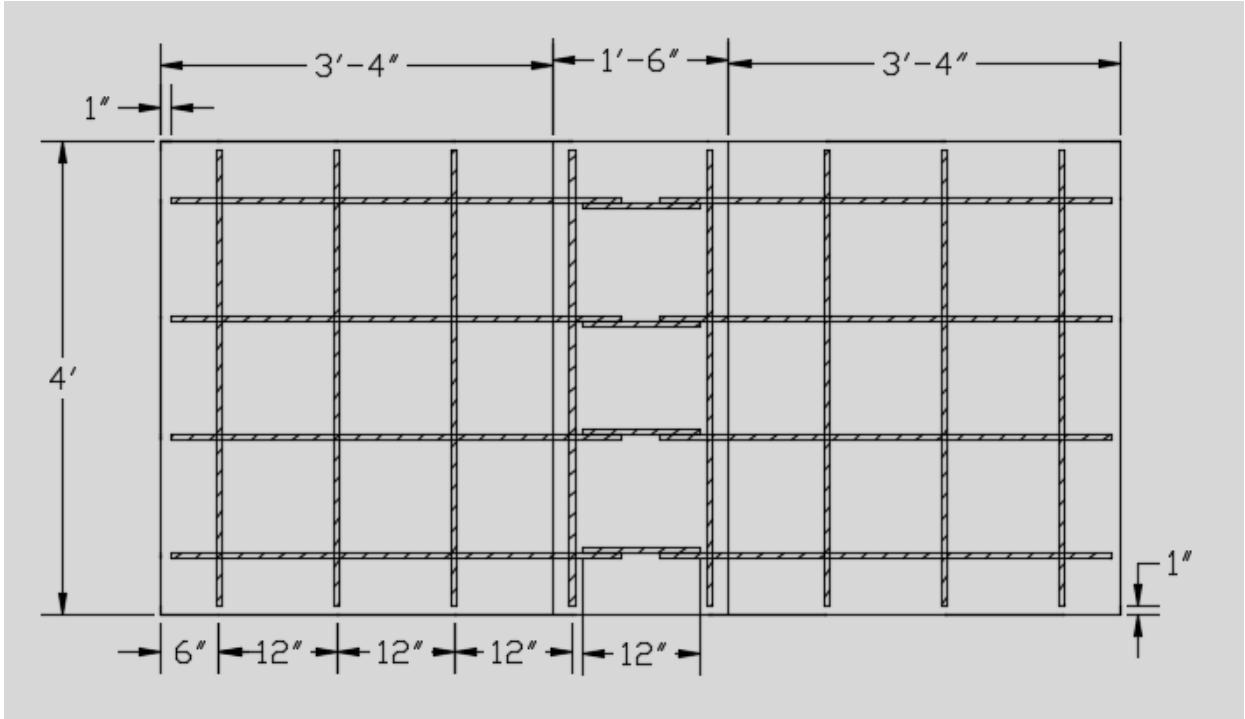
Figure 9: Plan view of reinforcement of slab specimens

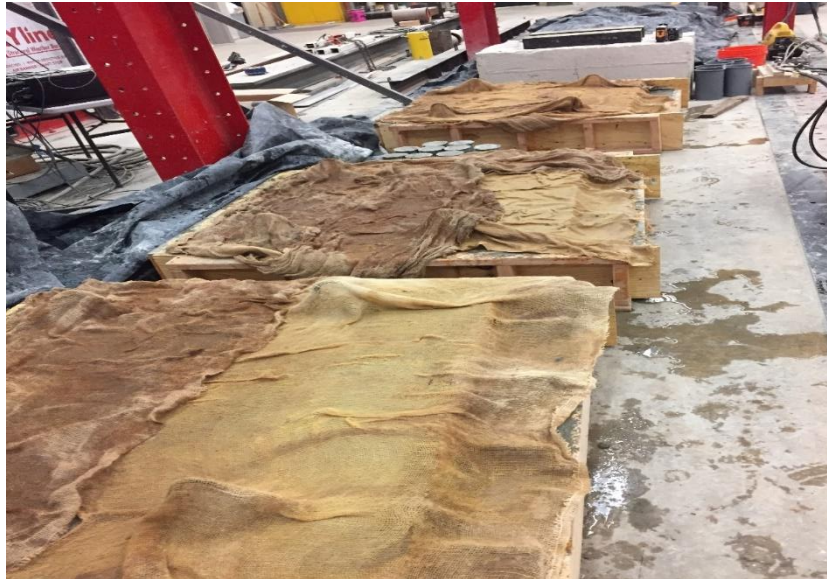
Figure 14: Concrete panels curing covered by wet burlap

connections. These cylinders were 4 in. in diameter by 8 in. in height. Figures 14 and 15 show the slabs covered in burlap and a plastic tarp.

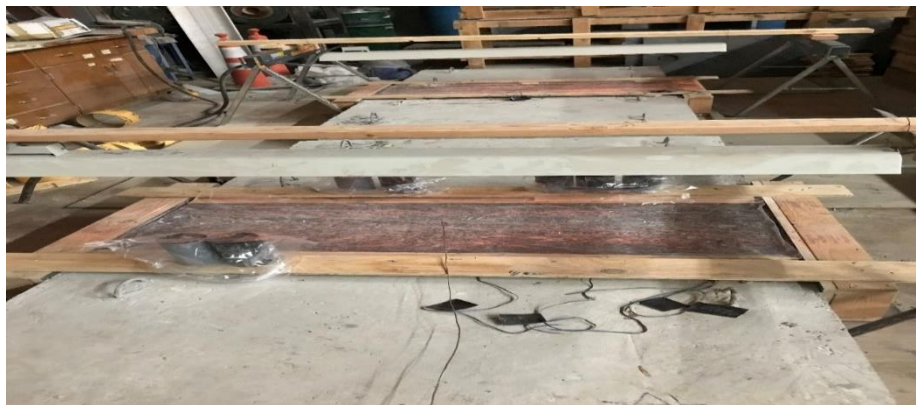
Figure 22: Heat lamp setup to cure UHPC

The non-proprietary UHPC joints were heat-cured for 36 hours with heat lamps installed at 16 in. above the top surface of the joints to ensure constant heat was provided throughout the joints as determined by Coleman (2018) and the internal temperature was approximately 200°F. The proprietary UHPC joints were cured using the same setup but for a duration of 12 hours and the internal temperature was approximately 180°F. Heat resistant plastic sheeting was placed over the UHPC joints to retain moisture during. Companion cylinder specimens were placed alongside the joints to be subjected to heat curing as well. At the end of the 36 or 12 hour curing period, the heat lamps were removed, and the joints were allowed to cure under ambient laboratory conditions for at least 28 days before testing. Figure 22 shows the setup of the heat lamps and the UHPC joints being cured.

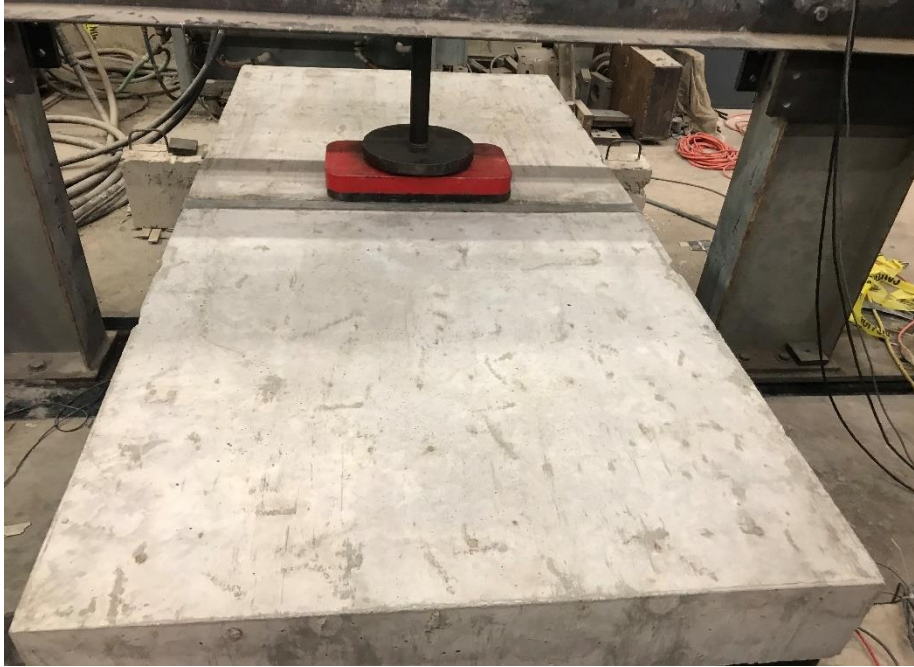
Figure 25: Test setup for slabs using the MTS hydraulic ram

Slabs 1 and 2 with non-proprietary UHPC joints were tested using an MTS hydraulic ram with a maximum capacity of 22 kips. A load cell was used to measure the load, and the load was applied through a 10 in. by 20 in. metal plate on top of a rubber pad. Both slabs were loaded in 1-kip increments up to the maximum capacity of the MTS. Once the MTS capacity was reached, the slab was unloaded and the MTS was replaced with a manually controlled hydraulic cylinder and pump with a capacity of 50 kips. The slabs were then reloaded again to failure. In addition, the three LVDTs around the joint were replaced with wire pots to provide more deflection measurement capacity and prevent damage to the LVDTs. The slabs were then loaded until flexural failure using 1-kip load increments. The results of the tests of slab 1 and 2 were used to plan the loading used for slab 3.

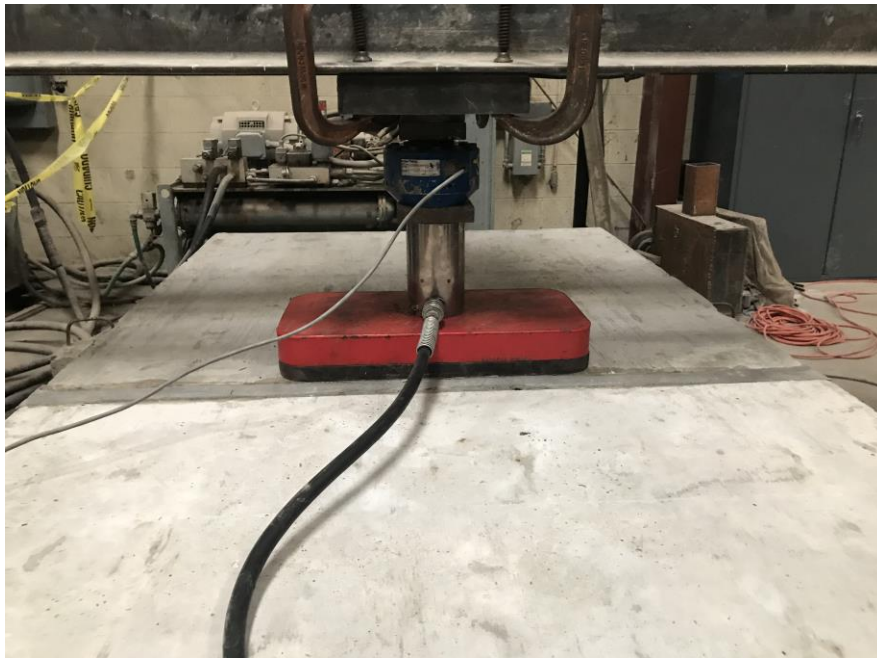
Figure 26: Test setup for slabs using the manually controlled hydraulic cylinder and pump

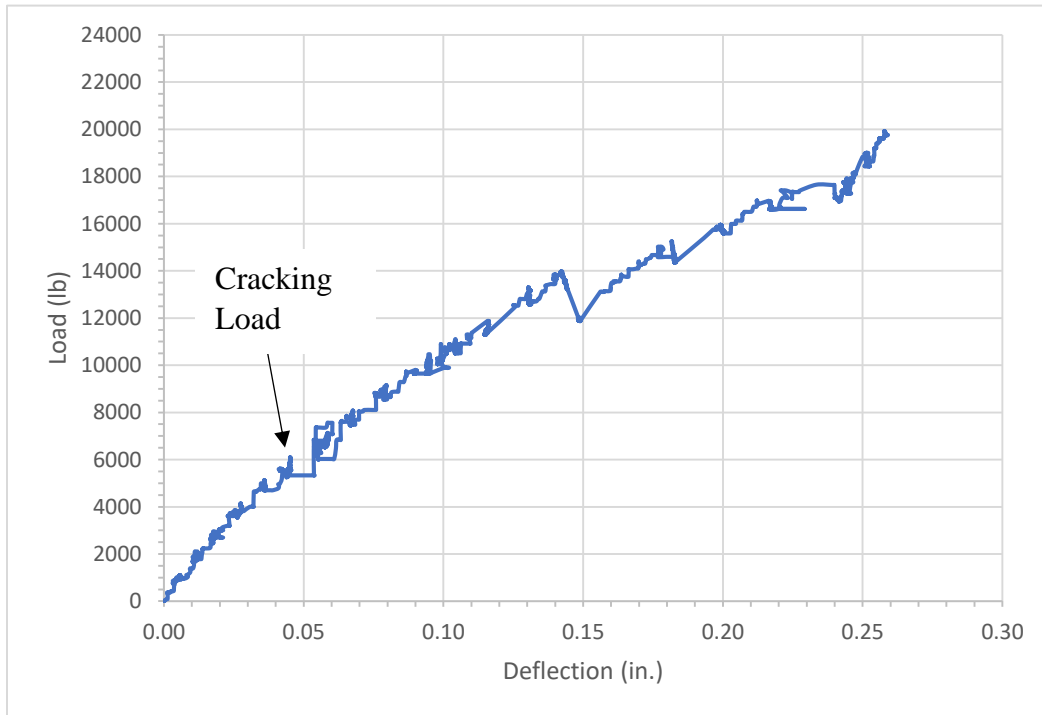
Figure 27: Load vs. deflection curve for J3 slab 1, part 1

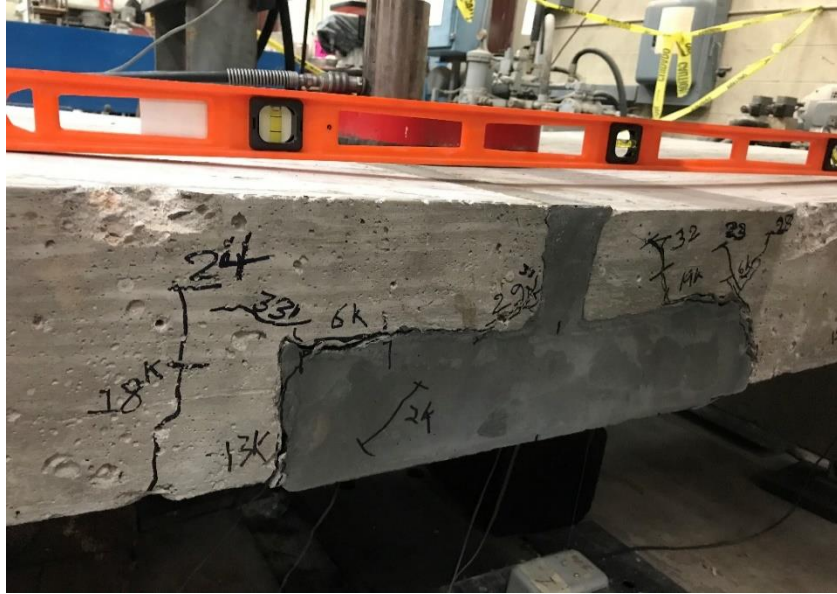
Figure 30: Cracks formed at interface between UHPC and conventional concrete and underneath the load point on the south side

At failure, the cracks were mainly at the interface between the conventional concrete and UHPC, with some cracks in the conventional concrete. Figure 30 and 31 show cracks on the slab after failure. The majority of the cracks at failure appeared to be evenly distributed on both sides of the joint. Significant cracks appeared at the interface between the UHPC and conventional concrete. Additional cracks can be found approximately 3, 4, and 5 in. away from the interface. There was also substantial separation at the conventional concrete to UHPC interface at the as-tested bottom of the slab, which was visible while loading, but could not be seen once the load was removed from the slab. Figures 32 and 33 show images of cracks and deformation of the slab after failure.

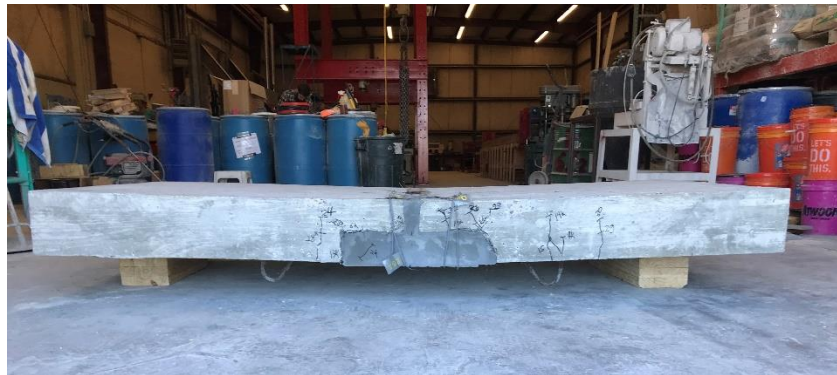
Figure 33: Slab curvature after failure

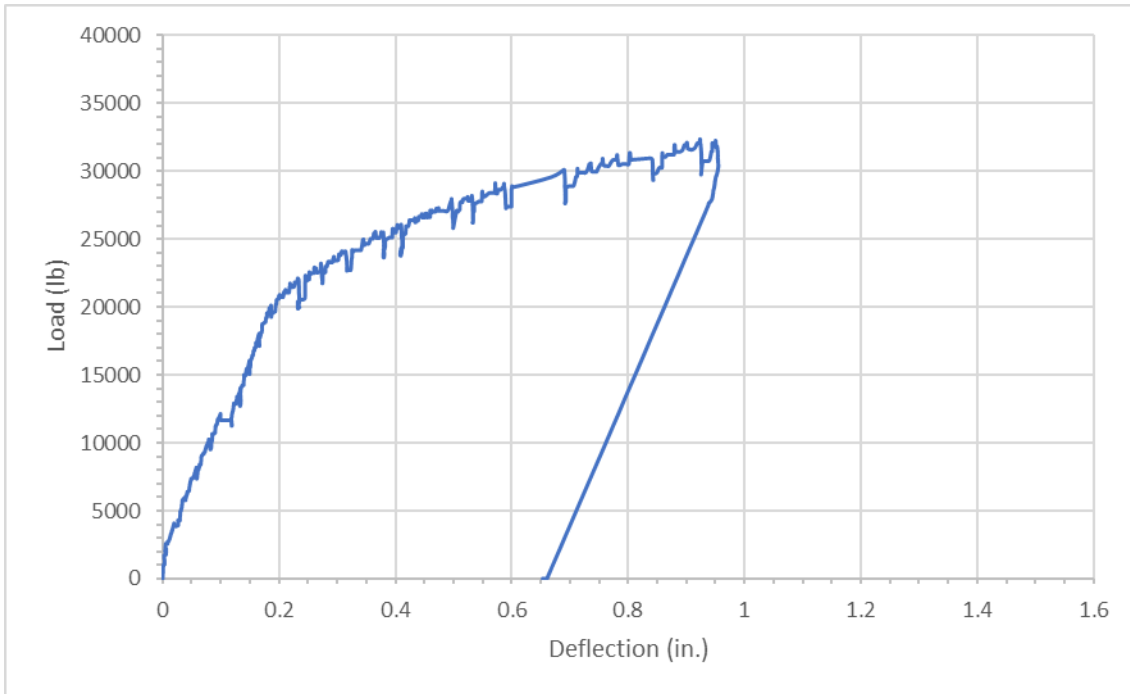
Figure 37: Load vs. deflection curve for J3 slab 2, part 2

Figure 37 shows the load vs. deflection for J3 slab 2 part 2. Like J3 slab 1 part 2, the load was applied using a manual hydraulic pump instead of the MTS system. The load dropped slightly with every 1 kip of load increase. The calculated failure load for a monolithic normal-strength concrete slab is 27.3 kips, the same as for J3 slab 1. The ultimate load achieved for J3 slab 2 was approximately 32.5 kips. The actual failure load of J3 slab 2 exceeded the calculated failure load by 19%. The plateau visible on the load vs. deflection curve indicates that the steel reinforcement yielded. The maximum deflection at failure is approximately 1.0 in. After failure, the specimen was unloaded and had a residual deflection of 0.68 in. Concrete crushing at the top of the slab indicated that the slab had failed.

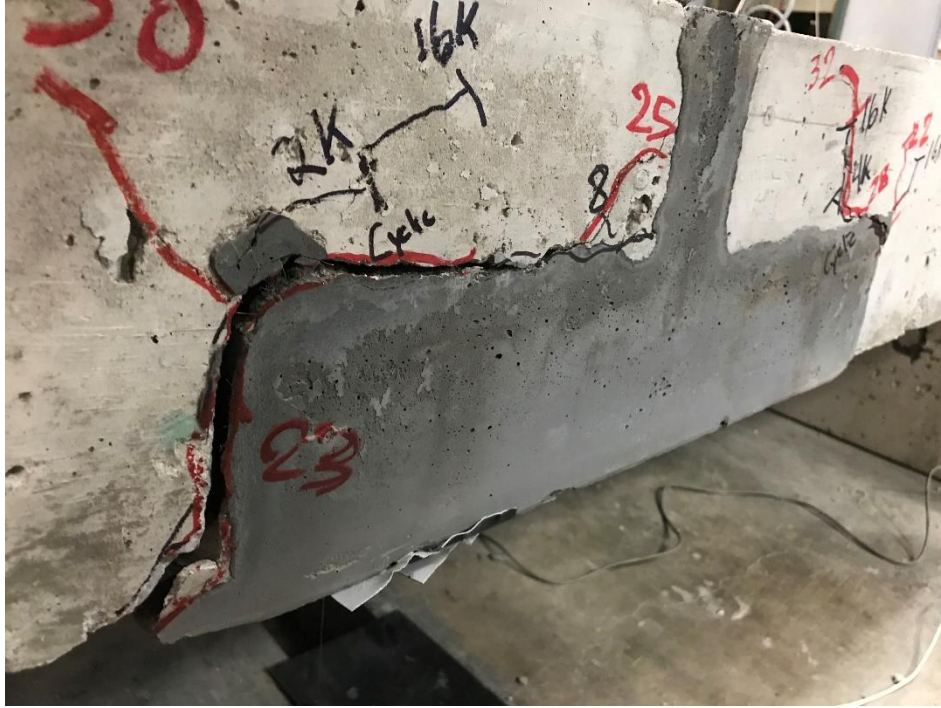
Figure 39: Cracks formed at the conventional concrete to UHPC interface on the north side of J3 slab 2

Similar to slab 1, multiple cracks appeared at the interface between the conventional concrete and UHPC. Some cracks also appeared in the conventional concrete. Figures 39 and 40 show cracks in the slab after failure for the north and south sides of the slabs. The majority of the cracks at failure appeared below the load point and there was a large separation between the conventional concrete and UHPC. A gap of approximately 0.25 in. was visible. Figure 42 shows concrete crushing at the top of the slab indicating failure.

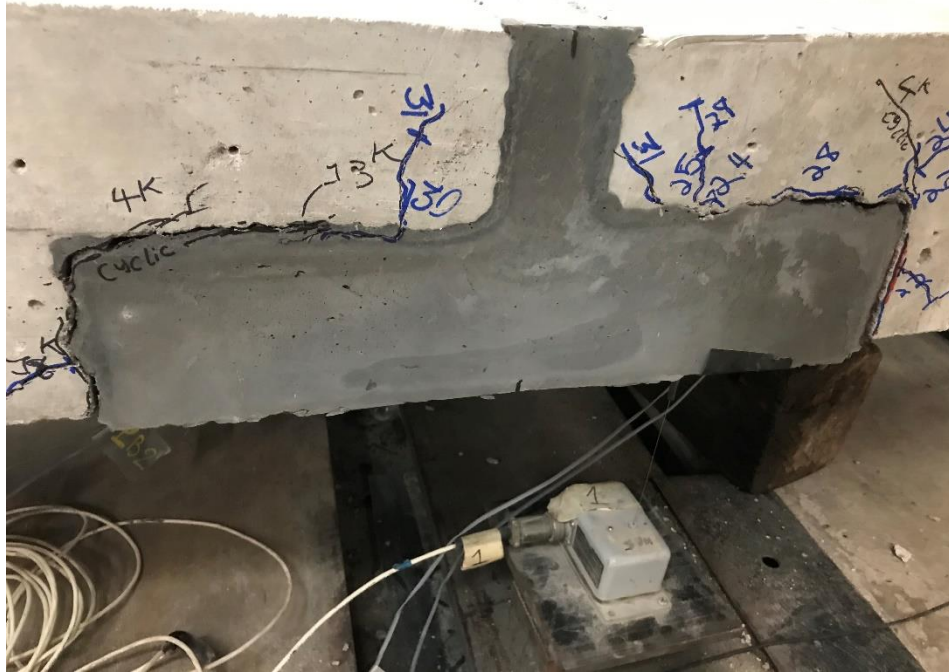
Figure 41: Cracks formed at the conventional concrete to UHPC interface and propagating upward on the south side

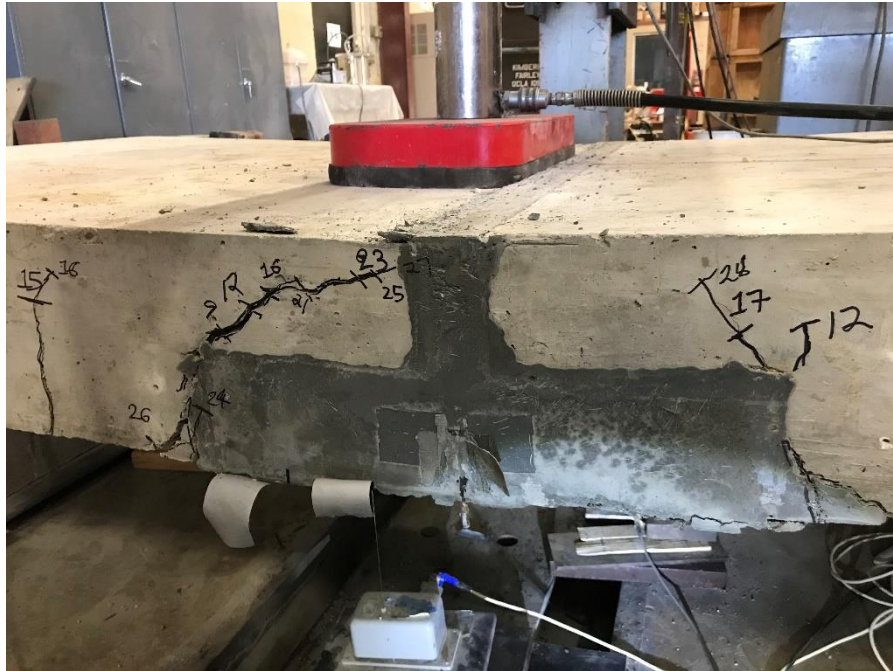
Figure 45: Large cracks at the conventional concrete to UHPC interface after part 1 of testing

Figure 45 shows cracks after part 1 of testing where the maximum load was 33.3 kips. The primary cracks occurred at the interface between the conventional concrete and UHPC. The gap grew larger as higher loads were applied. Cracks started at the bottom of the slab and propagated toward the top of the slab. In addition, cracks appeared at 2.25 in. away from the interface.

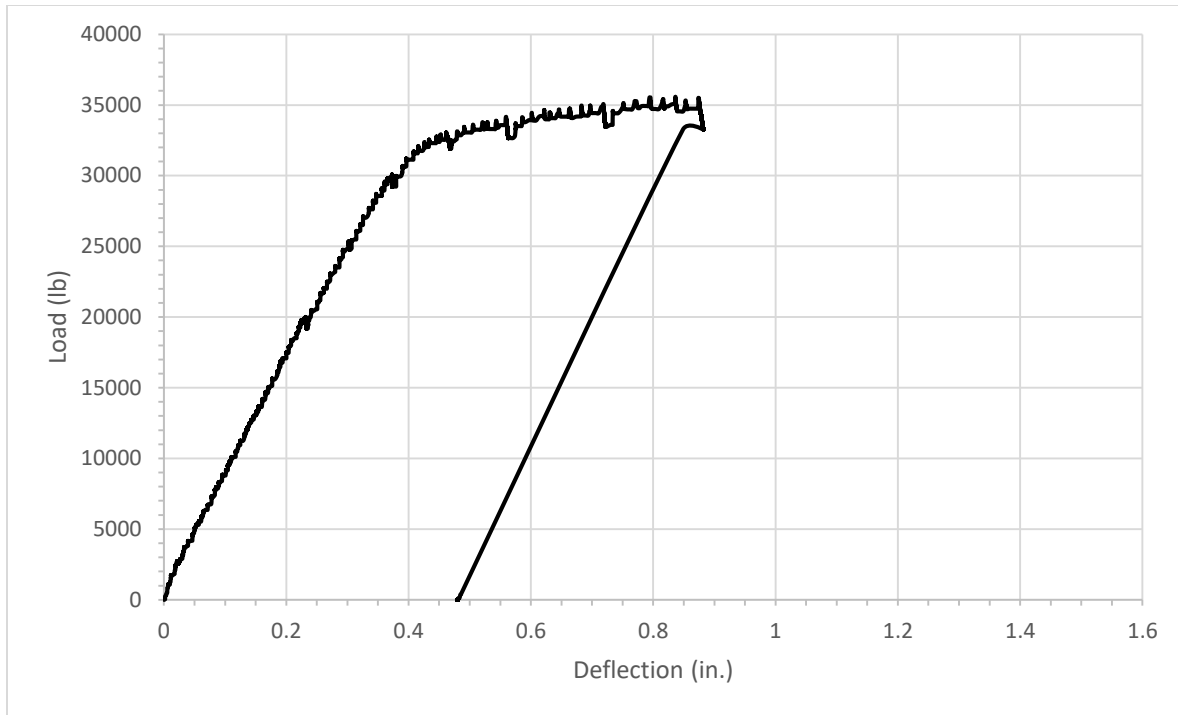
Figure 46: Load vs. deflection curve for Ductal® slab 1, part 2

Figure 46 shows the load vs. deflection curve for part 2 of the Ductal® slab 1 testing. Similar to part 1, this testing was performed using a manual hydraulic pump. However, 3-kip load increments were applied instead of 1-kip load increments until the maximum load from part 1 was applied, and the slab was inspected for cracks between load increments using a flashlight and marker to label when and where the cracks appeared. The ultimate load for Ductal® slab 1, part 2 was approximately 35.8 kips. The maximum load from part 2 was 8% greater than the maximum load of part 1. For comparison, the calculated failure load for a monolithic normal-strength concrete slab was 27.3 kips. The actual failure load of the specimen exceeded the calculated failure load by 31%. The curve plateaued, which suggests yielding of the steel reinforcement within the joint. Failure was evident due to the concrete crushing at the top surface.

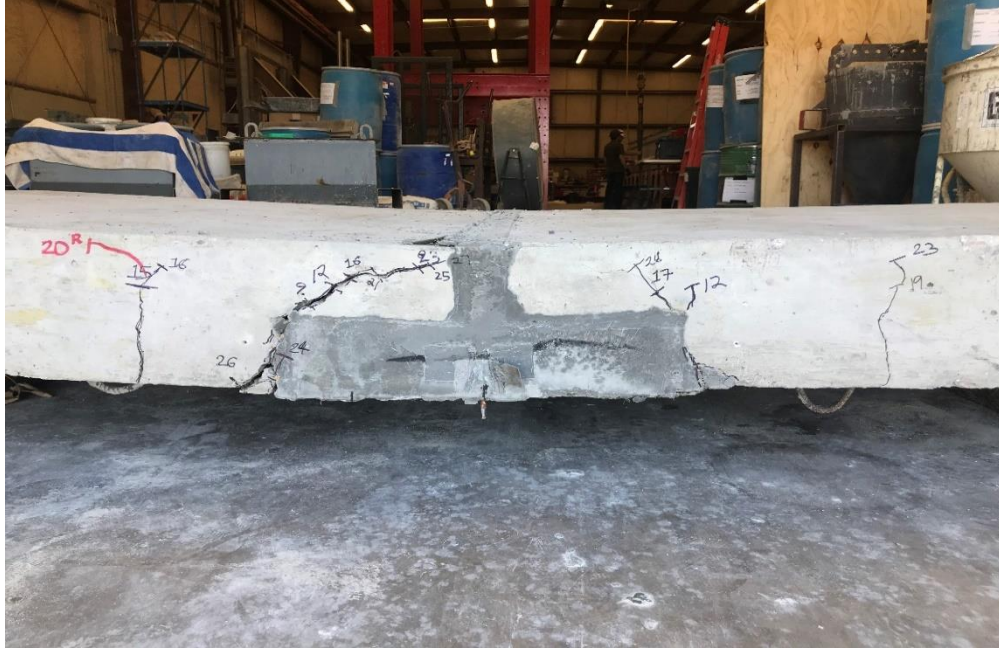
Figure 48: Ductal® slab 1 after part 2 of testing

After the completion of part 2 of testing, more cracks were observed at the interface between the conventional concrete and UHPC. Additional cracks also appeared in the conventional concrete. Figures 48-50 show cracks on the north side of the slab after failure, on the as-tested underside of the slab, and concrete crushing on the as-tested top of the slab. The majority of the cracks at failure appeared below the load point. From the bottom surface of the slab, it was evident that cracks extended across the entire width of the slab at the interface and approximately 3 in. away from the interface as shown in Figure 49. Large separation between the conventional concrete and the UHPC joint was visible. Figure 50 shows concrete crushing at the top of the slab indicating failure.

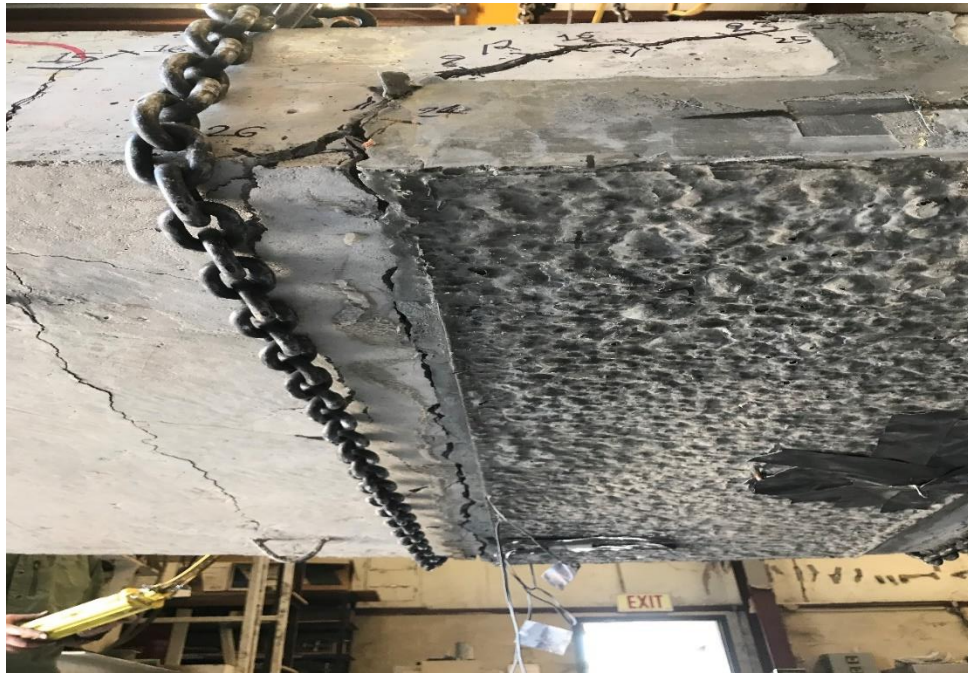
Figure 49: Cracks extending across the entire width of the slab at the joint and in the conventional concrete

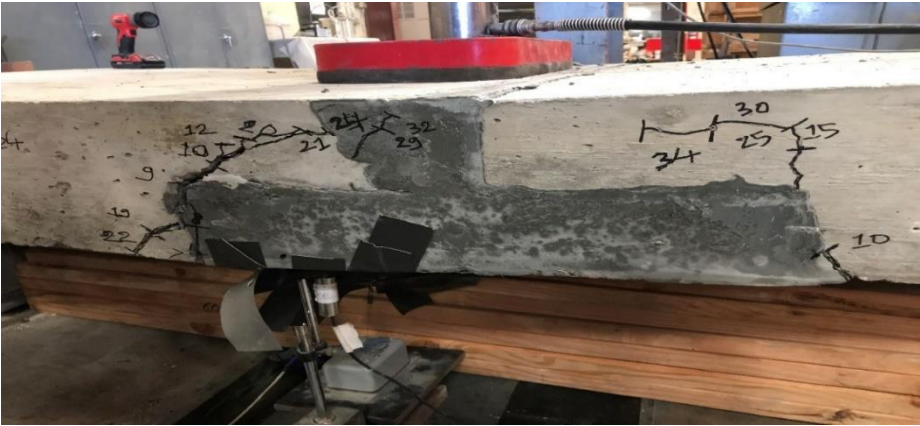
Figure 53: Cracks on the north side of Ductal® slab 2 after part 1 testing

Figures 53 and 54 show cracks after part 1 of testing on the north and south sides of the slab. Cracks occurred at the interface between the conventional concrete and UHPC and within the conventional concrete away from the joint. The gap between the UHPC and conventional concrete grew larger as higher loads were applied. All cracks started at the bottom of the slab and propagated toward the top of the slab while curving toward the load point.

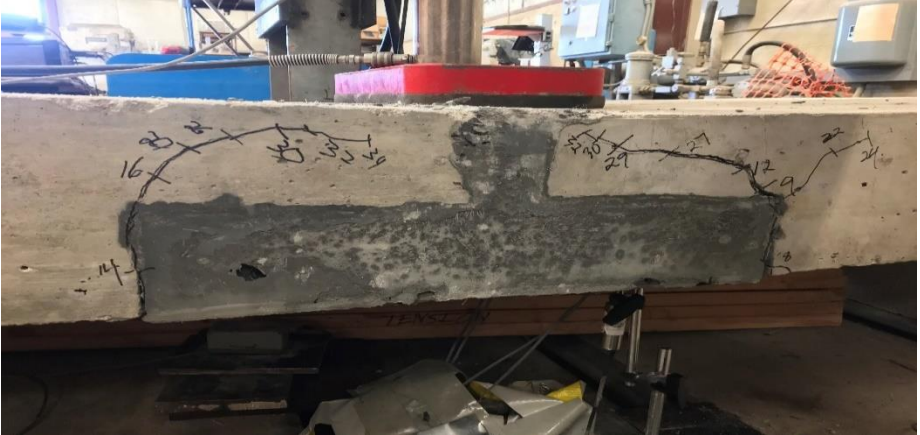
Figure 54: Cracks on the south side of Ductal® slab 2 after part 1 testing

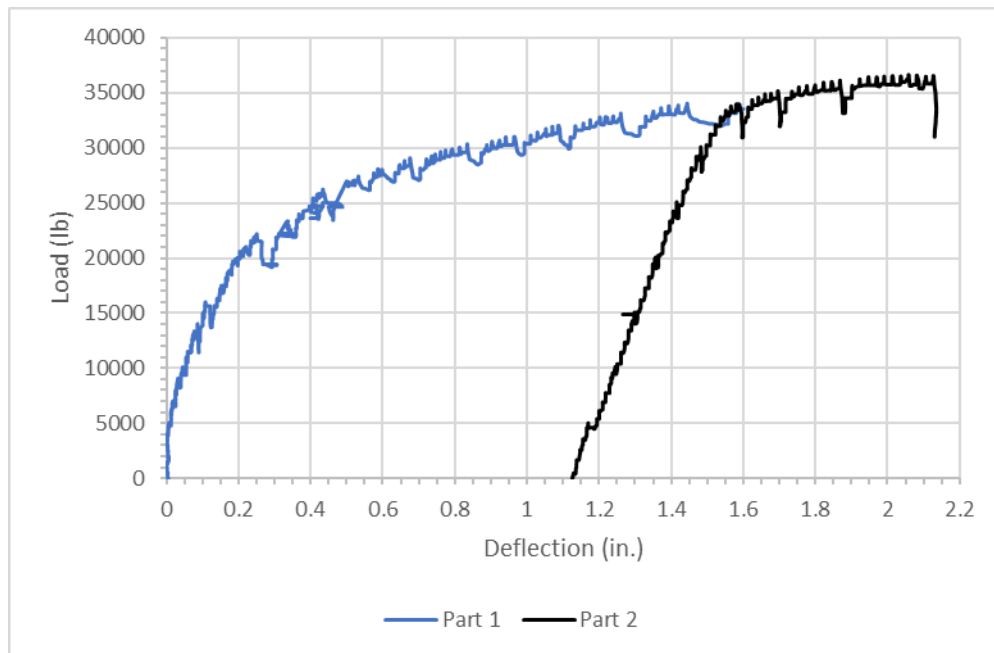
Figure 56: Load vs. deflection curve for Ductal® slab 2, part 1 and part 2

Figure 56 shows a comparison for slab 2 by plotting the part 1 and part 2 load vs. deflection curves on the same graph. The part 2 curve started at the residual deflection of the part 1 curve. Because there was not enough data from the part 1 test to determine residual deflection, the starting point of the part 2 curve is based on the slope and pattern of both curves. Based on this figure, the total deflection at failure was 2.14 in. There was not enough data to determine the total residual deflection. The part 2 curve has a lower slope than part 1. This was expected as the slab already cracked in part 1.

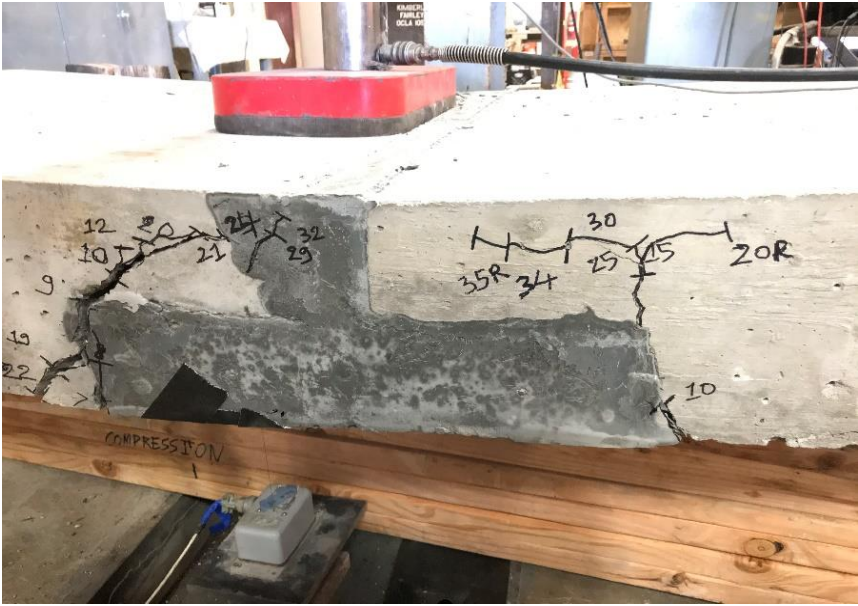
Figure 57: Cracks on the north side of Ductal® slab 2 after part 2 testing

between the conventional concrete and UHPC at the interface, which Figure 57 illustrates. Similar to previous static tests, concrete crushing at the top of the slab indicated that the slab failed.

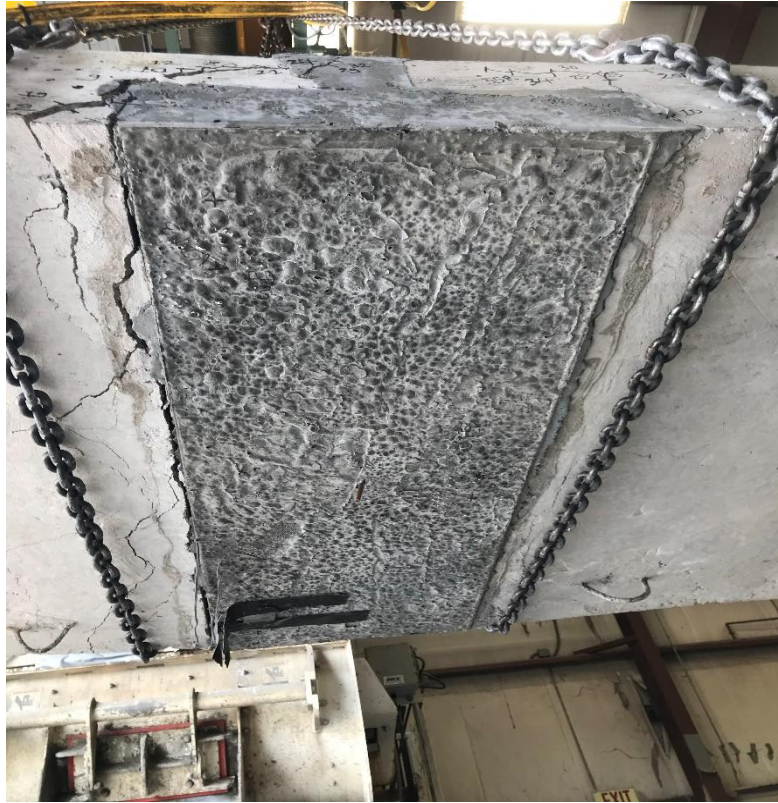
Figure 58: Cracks on the as-tested underside of Ductal® slab 2 after testing
