END REGIONS REPAIR OF PRESTRESSED GIRDERS FOR RESTORING THE SHEAR

CAPACITY USING UHPC, FR-SCC, AND MALP

A THESIS

Mujtaba Ahmadi
Norman, Oklahoma
2021

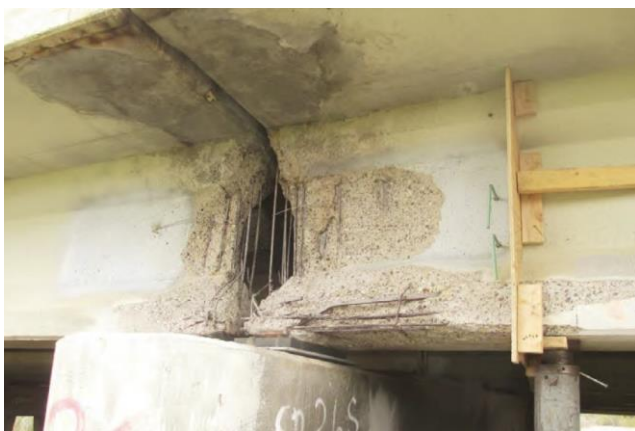
Figure 2.1: End region damage of prestressed girders

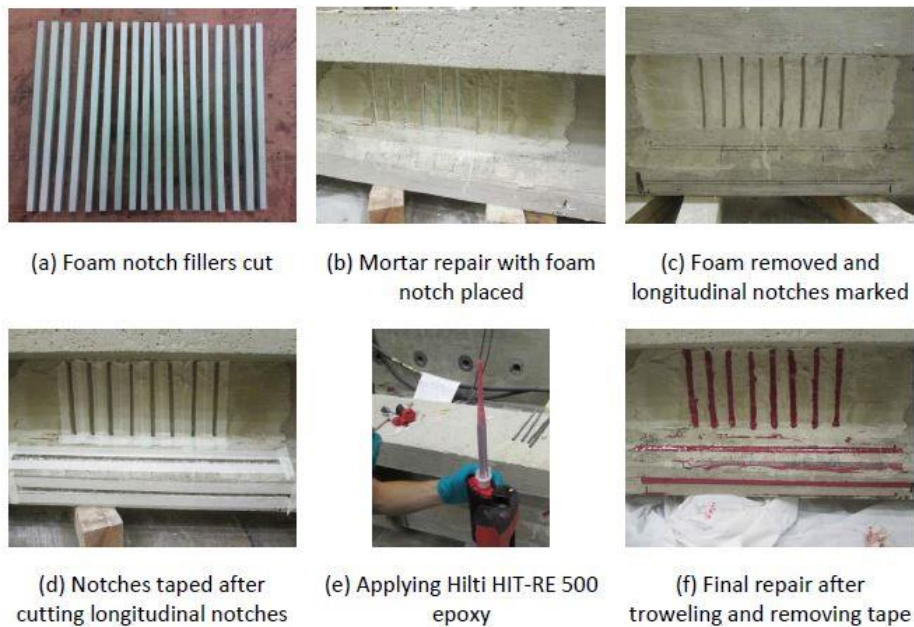
Figure 2.5: Application of NSM bars (Andrawes, 2018)

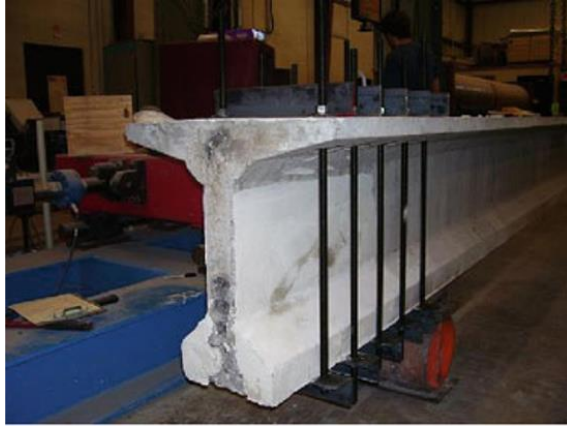
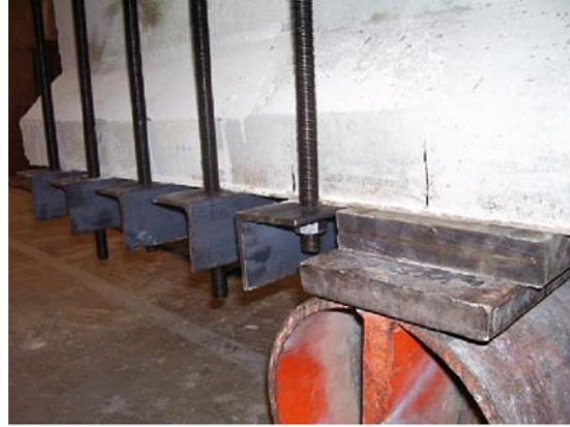
(a) Beam after steel repair

(b) Steel repair and support

Figure 2.7: Shear damage repair using surface-mounted rods (Ramseyer, 2012)

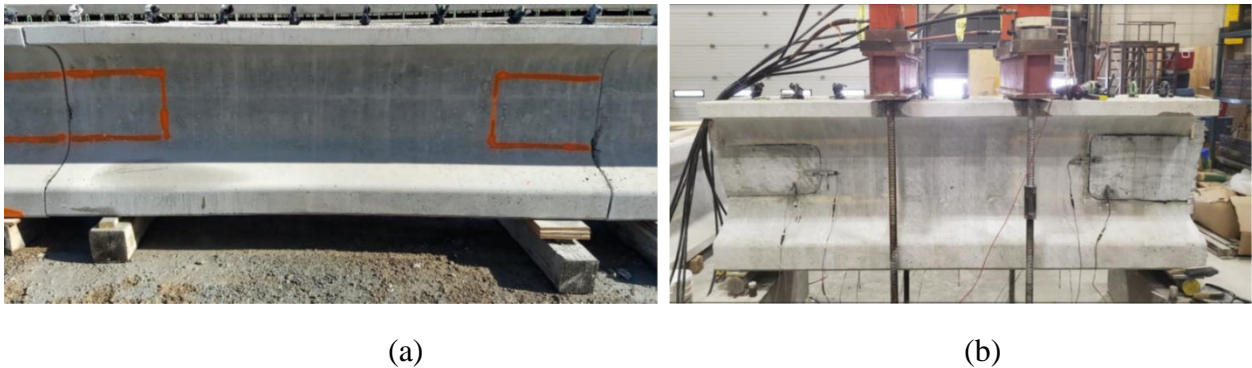
Figure 2.10: (a) Cut beam segment marked for controlled damage and (b) loading setup for testing repaired beam segment (Shafei, 2020)

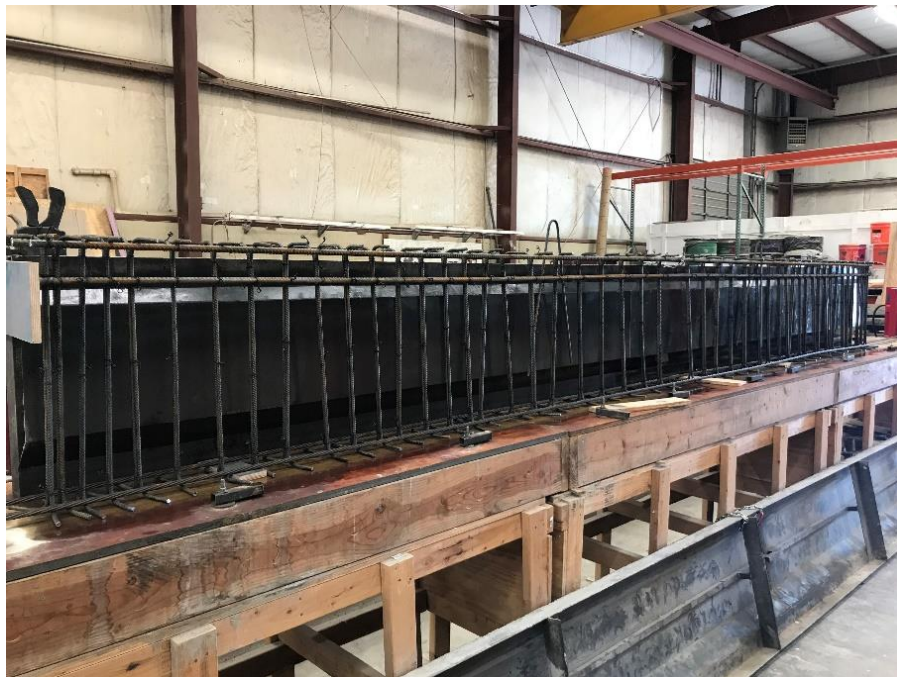
Figure 3.6: Reinforcement cage for a typical girder immediately after prestressing

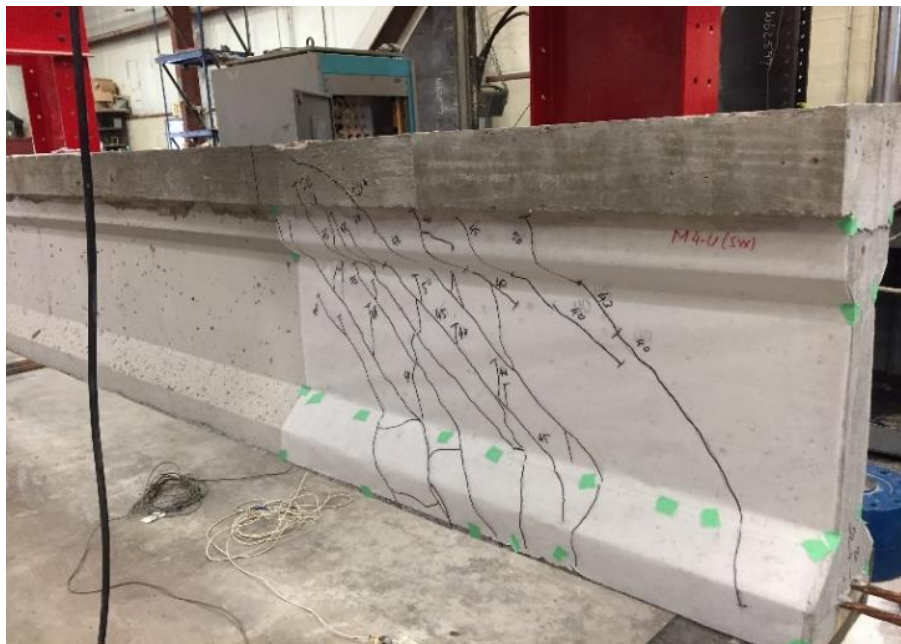
After removing the point load, tracing paper was used to document the cracks on both sides of each beam's damaged end (Figure 3.11), which were superimposed to the repaired beams once tested to failure. This comparison was intended to develop a relationship between the cracks of both the original member and repair material.

Figure 3.11: Tracing paper on one side of the cracked girder to copy the cracks' location

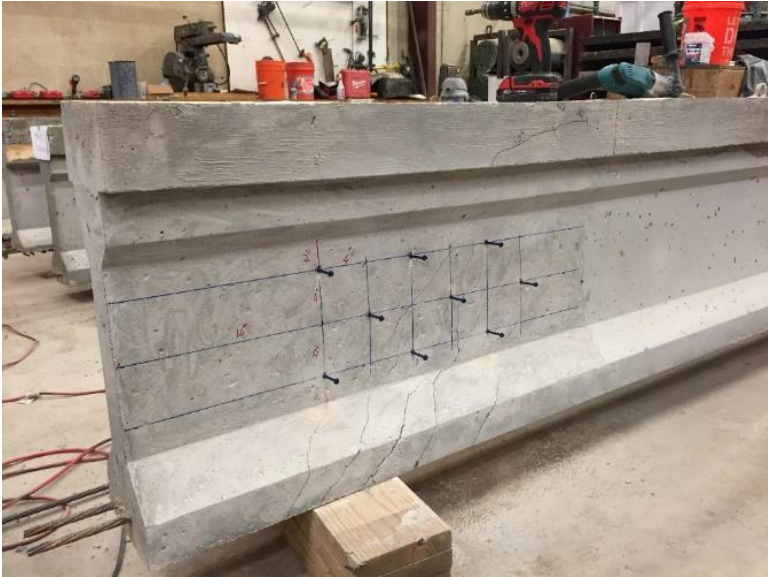
Figure 3.13: Screws used for shear studs in the web

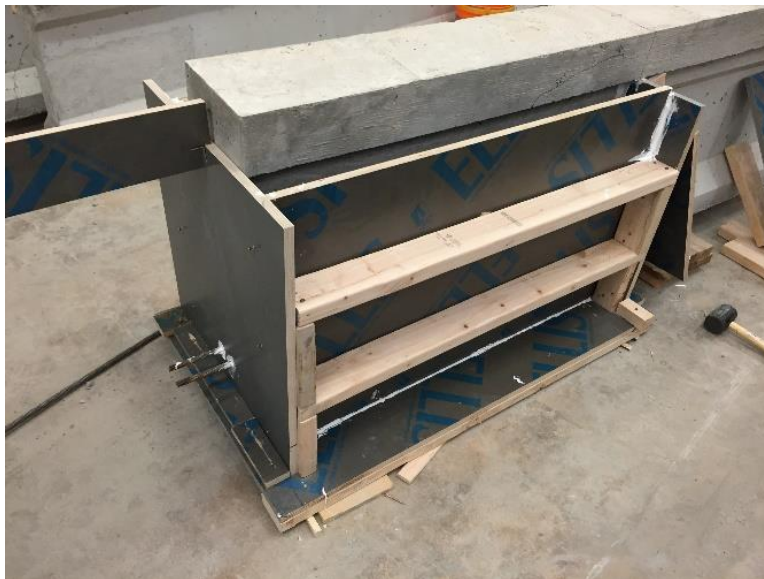
Figure 3.15: Repair formwork

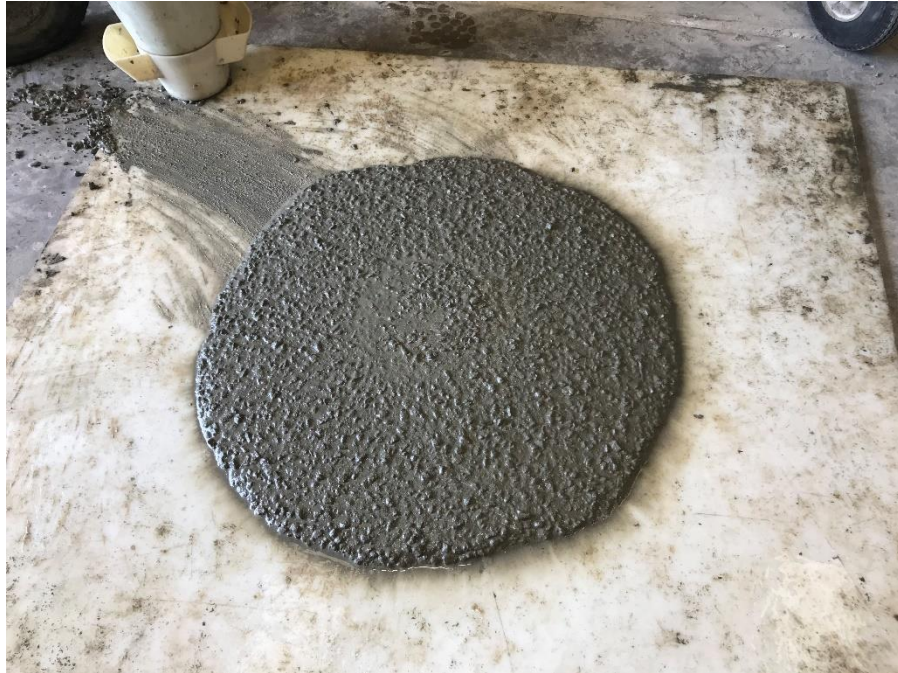
Figure 3.17: FR-SCC flow for the slump measurement

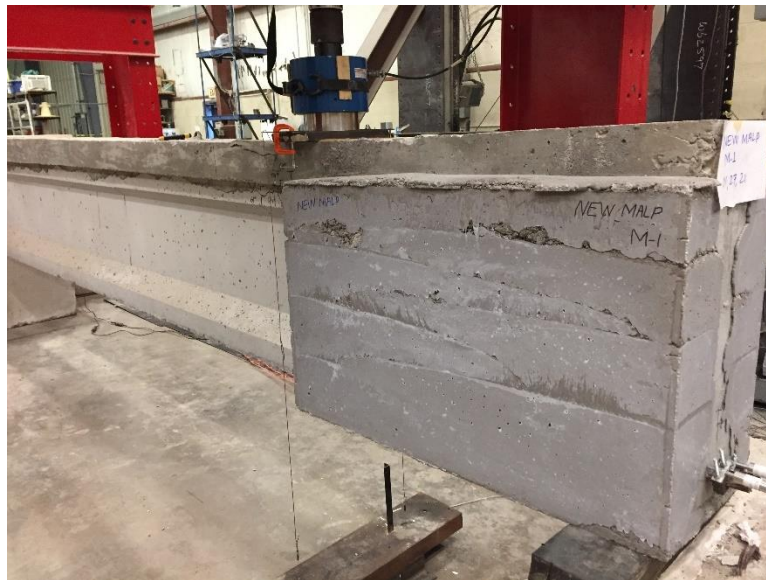
no delamination or differential movement was observed. Failure started with vertical cracks in the bottom flange at the junction of the beam with the repair material and dispersed diagonally to the corner of the repair material. The cracks also propagated upward and turned diagonally as they moved above the half-depth point in the web. They further divided into small branches around the girder's top flange. As the load was approaching the ultimate capacity, the deck started crushing and formed a hinge at the load application point. Once the deck began to crush, the loading was stopped. Figure 4.2 shows the longitudinal profile of the M1-R during the load test.

Figure 4.2: Beam M1-R during the load test

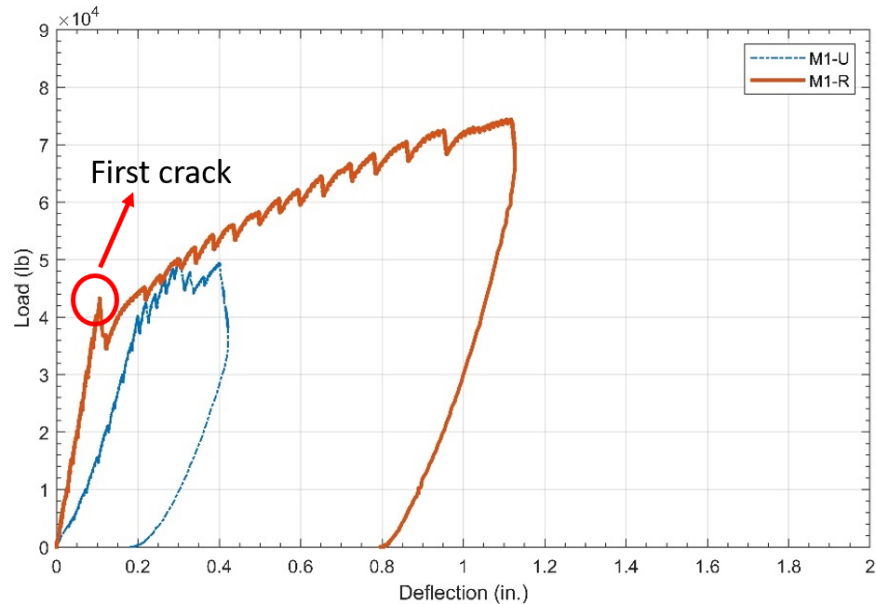
The load and deflection readings were recorded using the load cell and wire-pots, respectively, described in Figure 3.22. For the deflection, the average reading of both wire-pots was used. Figure 4.3 shows the load vs. deflection curves for the M1-U and M1-R beam tests.

Figure 4.3: Load vs. deflection curves for beam M-1

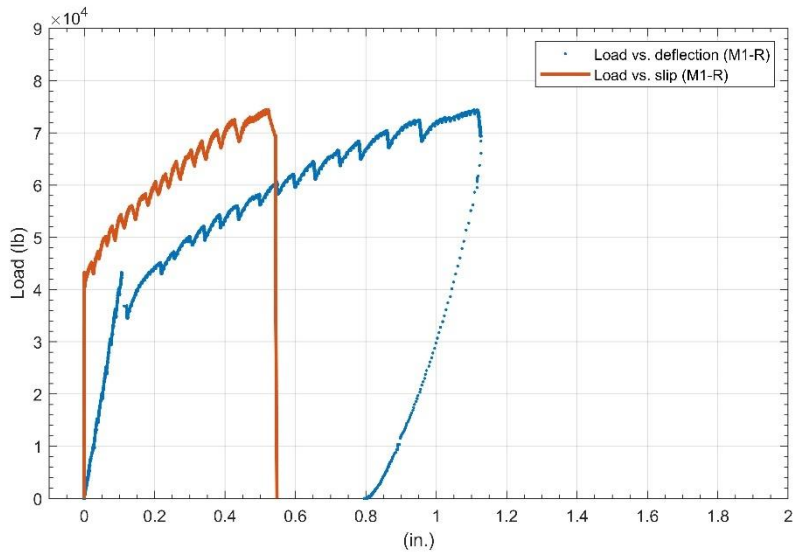
Figure 4.5: Load vs. deflection and load vs. strand slip curves for M1-R

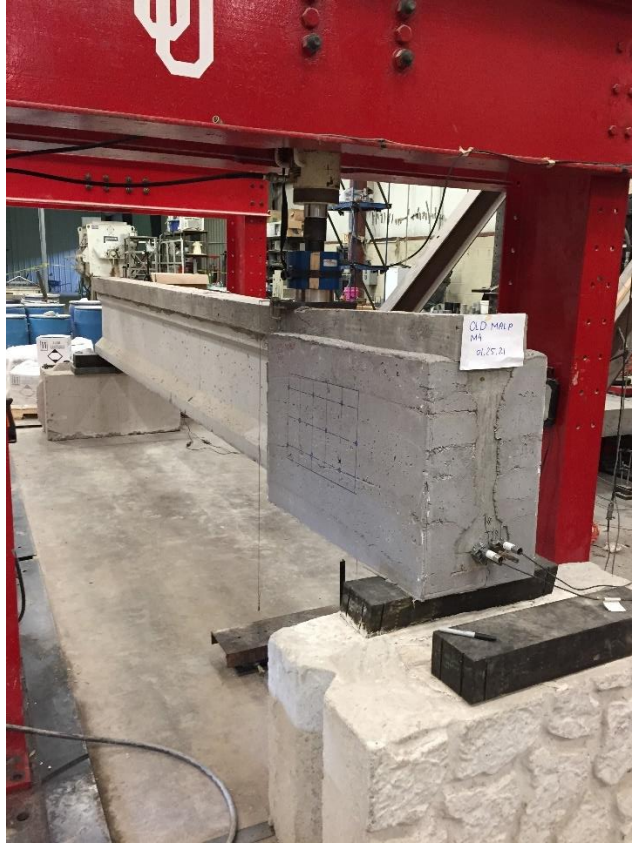
Figure 4.7: Beam M4-R during the load test

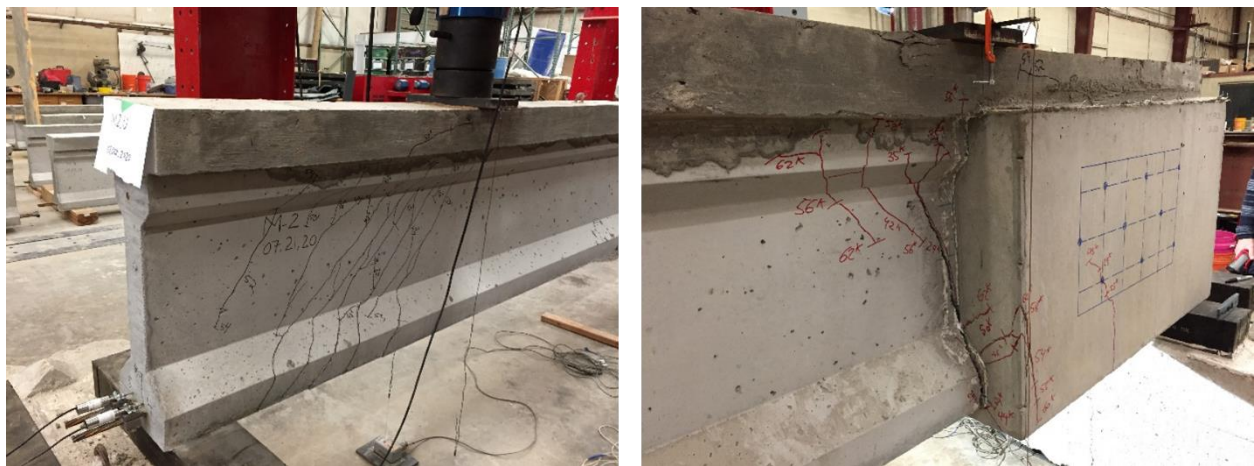
Figure 4.11: (a) Beam M2-U after the initial test and (b) beam M2-R after the final test

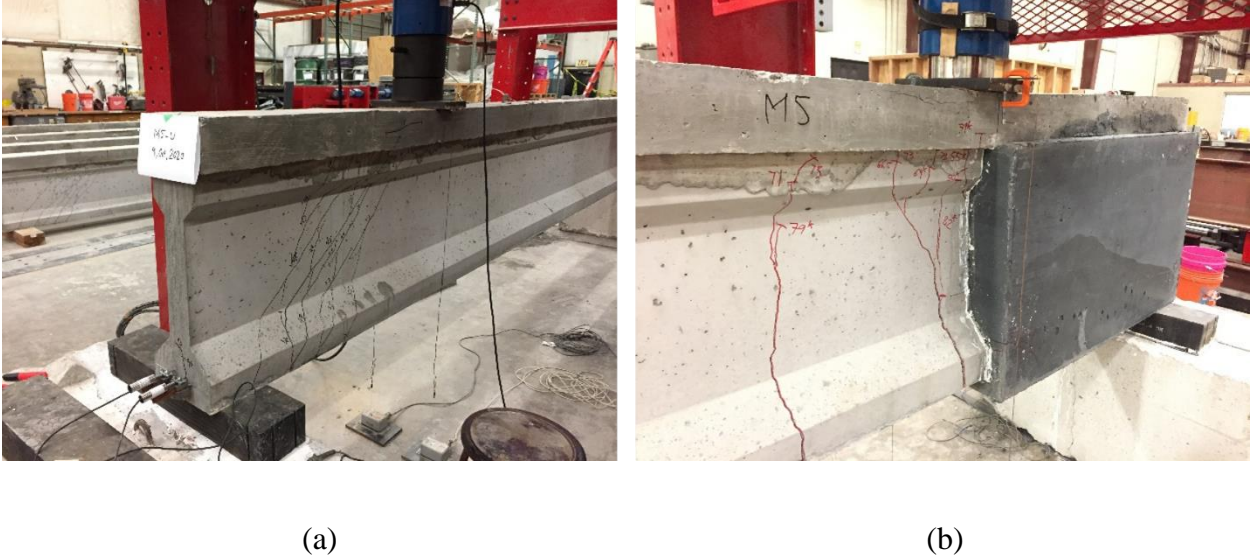
Figure 4.21: (a) Beam M5-U after the initial test and (b) beam M5-R after the final load test

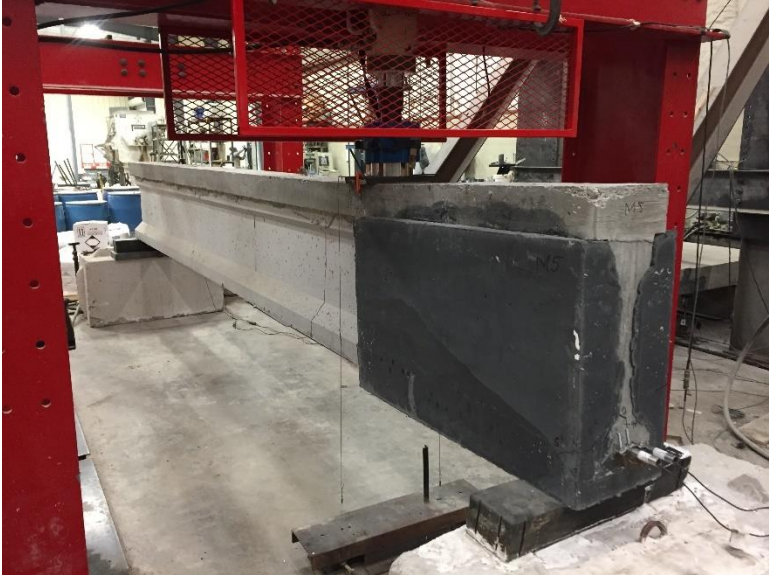
Figure 4.22: Beam M5-R during the load test

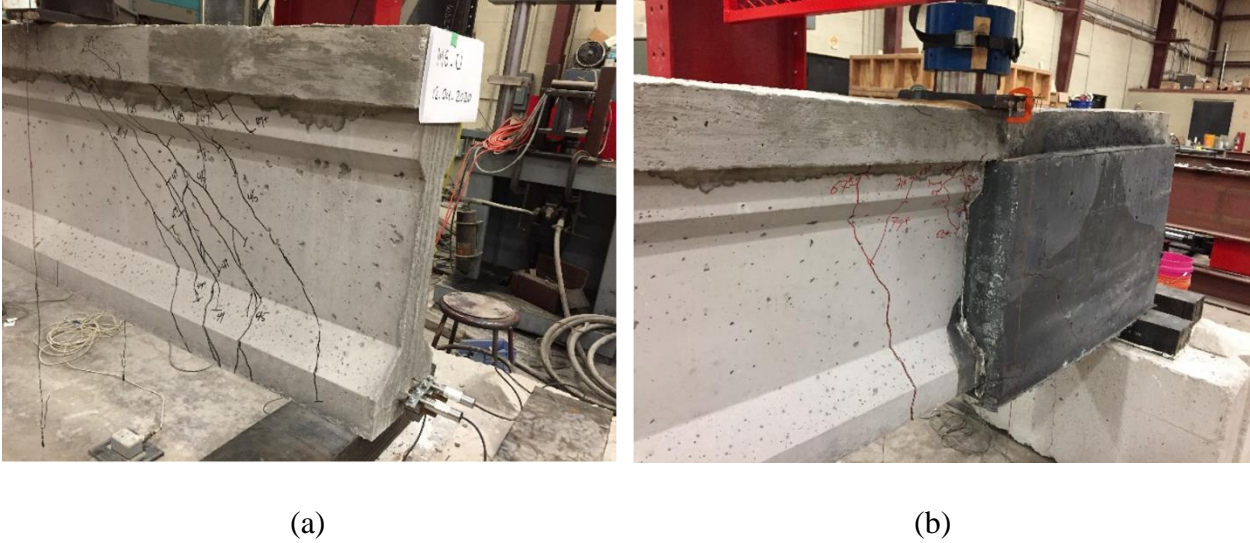
Figure 4.26: (a) Beam M6-U after the initial test and (b) beam M6-R after the final load test

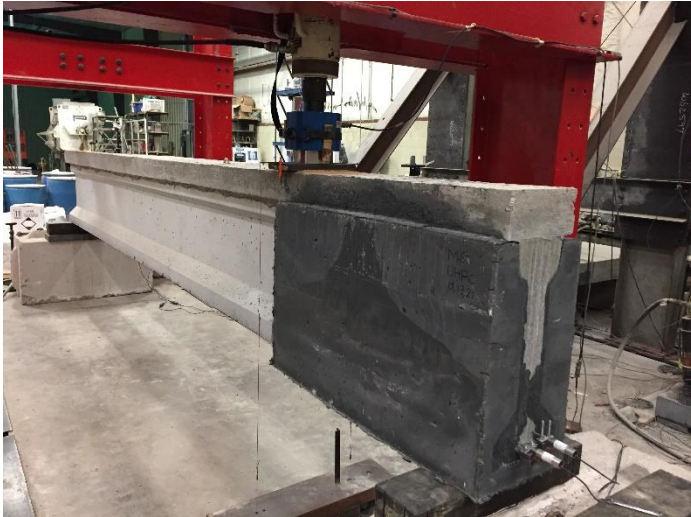
Figure 4.27: Beam M6-R during the load test
