NONDESTRUCTIVE TESTING FOR CORROSION
ASSESSMENT OF EPOXY COATED REBAR

Submitted to the Faculty of the
Graduate College of the
Oklahoma State University
in partial fulfillment of
the requirements for
the Degree of
MASTER OF SCIENCE
December, 2020

The proposed methodology will be performed on 9-inch-thick reinforced bridge-deck slabs from I-35 in Oklahoma. The bridge was constructed with both standard and epoxy coated rebar; a corrosion assessment of the standard rebar will be used for comparison and validation of the ECR assessment. The experimental results will reveal the accuracy of the test methodology compared to standard rebar assessment and determine if it is adequate to evaluate the probability of corrosion in bridge decks with ECR.

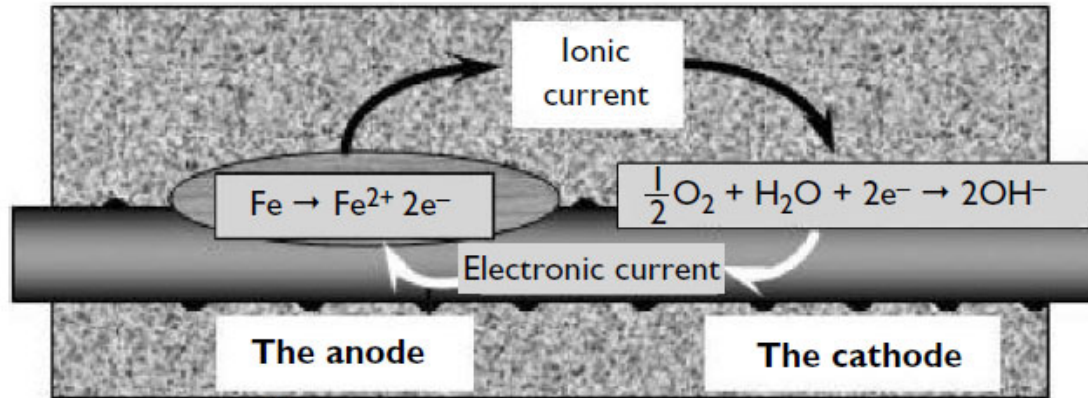
Figure 2.1: Anodic and Cathodic Reactions of Steel Corrosion

Corrosion is the widely known term used to describe the product of a reaction between metal oxides/hydroxides with water and oxygen. The corrosion process is caused by two electrochemical reactions: the oxidation of a metal (anodic reaction) and the reduction of an oxidizing agent (cathodic reaction).

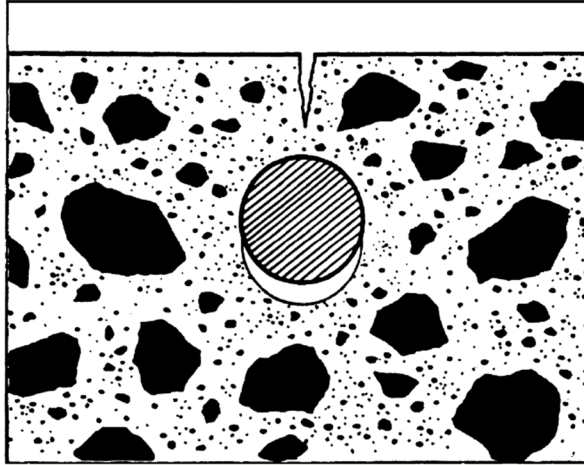
Figure 2.2: Crack formed due to obstructed settlement (ACI 224.1)

As mentioned before, the presence of longitudinal cracks along the rebar can be detrimental. These cracks are formed by factors other than corrosion initiation and can be present immediately after construction due to settlement and shrinkage (ACI 224). After initial placement and finishing, concrete will continue to consolidate which will cause a local restraining of the plastic concrete surrounding a rebar. As the concrete continues to settle, the tensile forces above the rebar can be enough to cause a surface crack. This is more prevalent when inadequate vibrating techniques or curing regimens are implemented. Additionally, when these problems occur it is common construction practice to simply refinish the concrete which if done early enough will be acceptable but if done after prolonged cracking, will result in an internal crack leading directly to the rebar without any indication on the concrete surface.

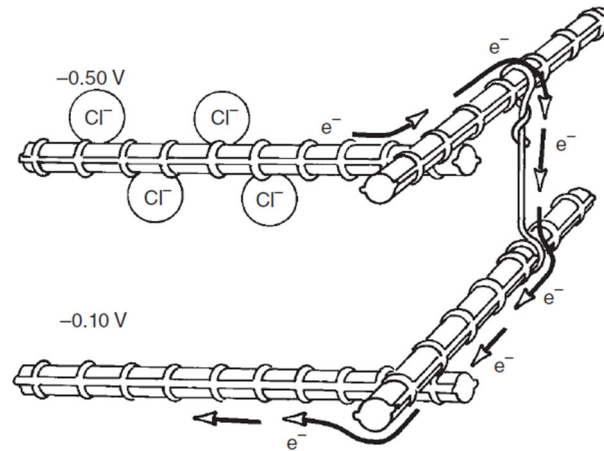
Figure 2.3: Differences in Chloride Ion Concentration Establish Formation of Macro-Cell

Black reinforcement in bridge decks is extremely susceptible to large macro-cells through wire tied connections between the top and bottom rebar mats. Exposure to chlorides from the surface will create anodic sites in the top mat while exposure to carbon dioxide will create large cathodic sites in the bottom mat (Breysse 2010).

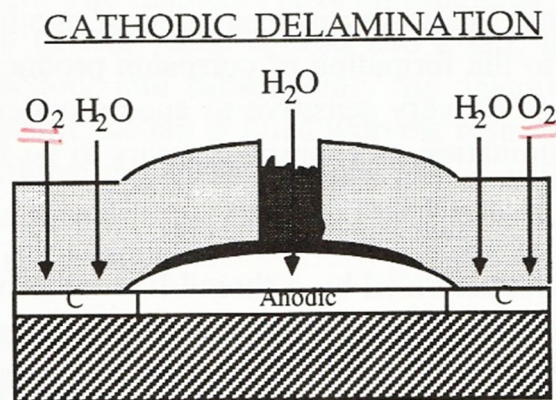
Figure 2.4: Blister Initiation and Propagation Due to Cathodic Delamination

There is also the case of a localized cathodic delamination due to defects within the coating; this is usually referred to as pitting corrosion. The presence of a defect in the coating means that a small area of the rebar is more exposed to the corrosive environment and will have an earlier onset of corrosion than the surrounding areas. Once corrosion products have formed at the defected area, permeation of oxygen is no longer possible which will result in a large anodic area underneath the defect while cathodic sites are pushed away to locations where oxygen can still permeate the coating; this in essence is the formation of a “blister.” The limited ionic transport between anodic and cathodic sites due to the epoxy coating results in the propagation of corrosion products laterally at the edges of the blister. This lateral progression along with the high pH environment of concrete will cause local debonding and an area of accelerated corrosion (Oudar and Marcus 1995).

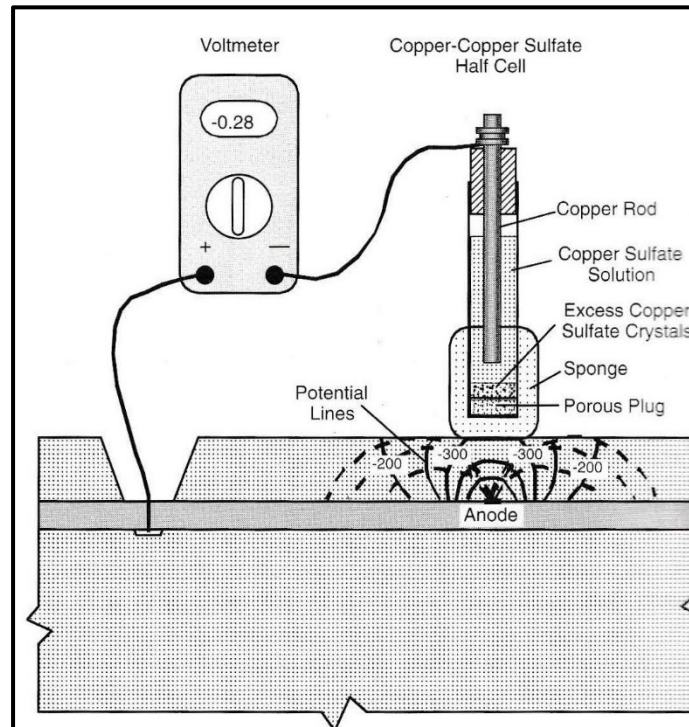
Figure 2.5: Half-Cell Potential Test Schematic

The term 'half-cell' is used to refer to the independent reactions that occur at the anode and cathode within an electrolytic cell. These reactions which govern the rate at which the anode and cathode release electrons and enter solution as positive ions, is called 'half-cell potential.' Replacing the external circuit required of an electrolytic cell with a voltmeter will create an 'open-circuit condition' and calculate the difference between the anodic and cathodic half-cell potentials. The result of this is a measurement in volts which indicates the direction of electron flow as well as the magnitude. The magnitude in volts gives an indication of possibility for corrosion because it displays how readily the material will give up electrons, which is the first step of the corrosion reaction.

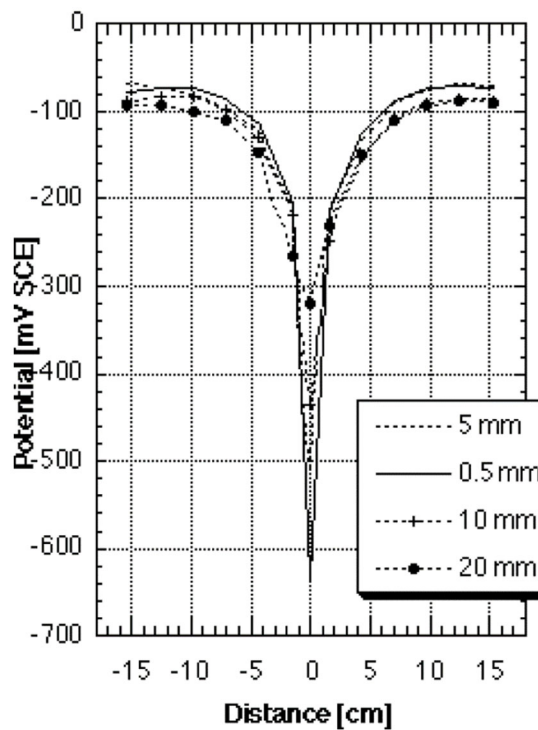
Figure 2.7: Influence of Cover Depth on Half Cell Potentials (Elsener and Bohni 1997)

In reinforced concrete, the half-cell potential cannot be measured directly at the steel surface due to the presence of concrete cover. Because of this, the composition and depth of concrete cover will greatly influence observed half-cell potential measurements as it can induce a significant ohmic potential drop (IR). “The potential difference between the position above the anode and a distant cathode become smaller with increasing cover depth – thus the location of a small corroding spot becomes more difficult with high cover depth – thus the location of a small corroding spot becomes more difficult with high cover depth” (Elsener and Bohni 1997). Additionally, a dense concrete cover can limit the oxygen diffusion process resulting in a low oxygen content at the rebar-concrete interface, shifting the potential to a more negative value.

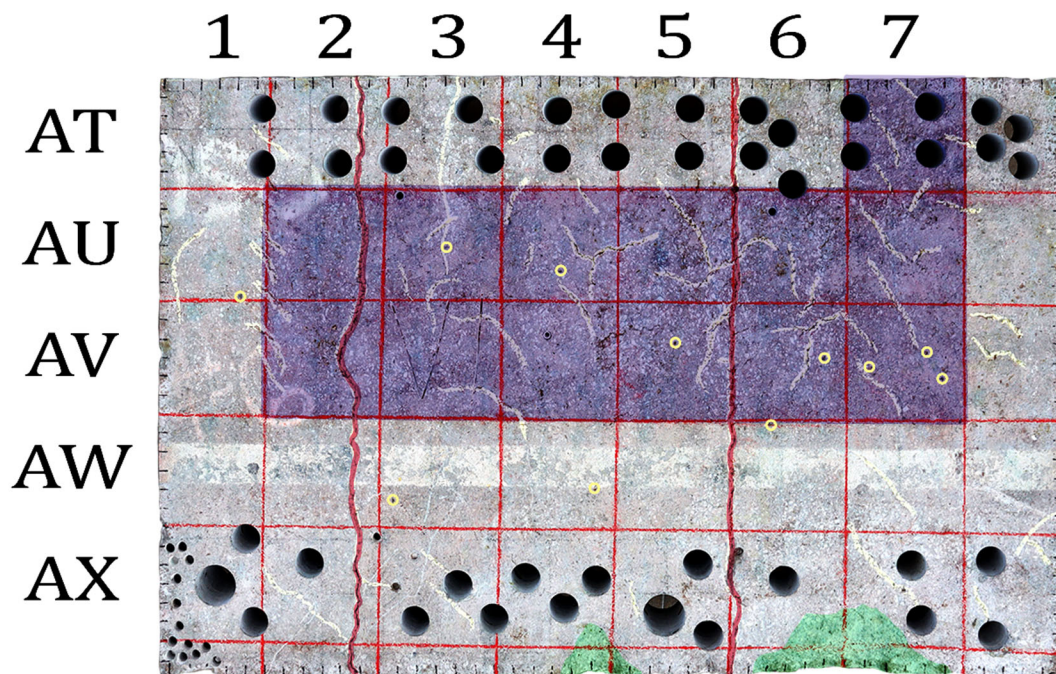
Figure 4.1: Grid Naming Convention for Slab 10

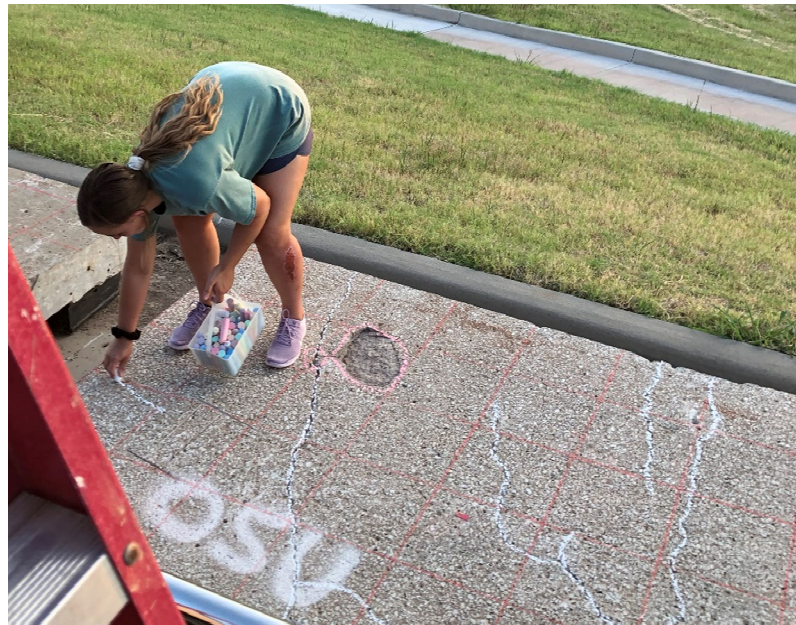
Figure 4.2: Crack Mapping for Visual Condition Survey

Another method of crack quantification is the ‘crack density’ or ‘crack intensity’ which has been implemented in many studies. This method is dissimilar to the commonly used ‘crack frequency’ by taking crack length into account. Crack density is a ratio of the total length of cracks and the surface area in question. This method can provide some indication of crack severity between different areas of the structure and allows for a consistent means of crack monitoring without any excessive field equipment. As suggested, only cracks that were visible to the unaided eye from a standing position were considered for calculation of the crack density.

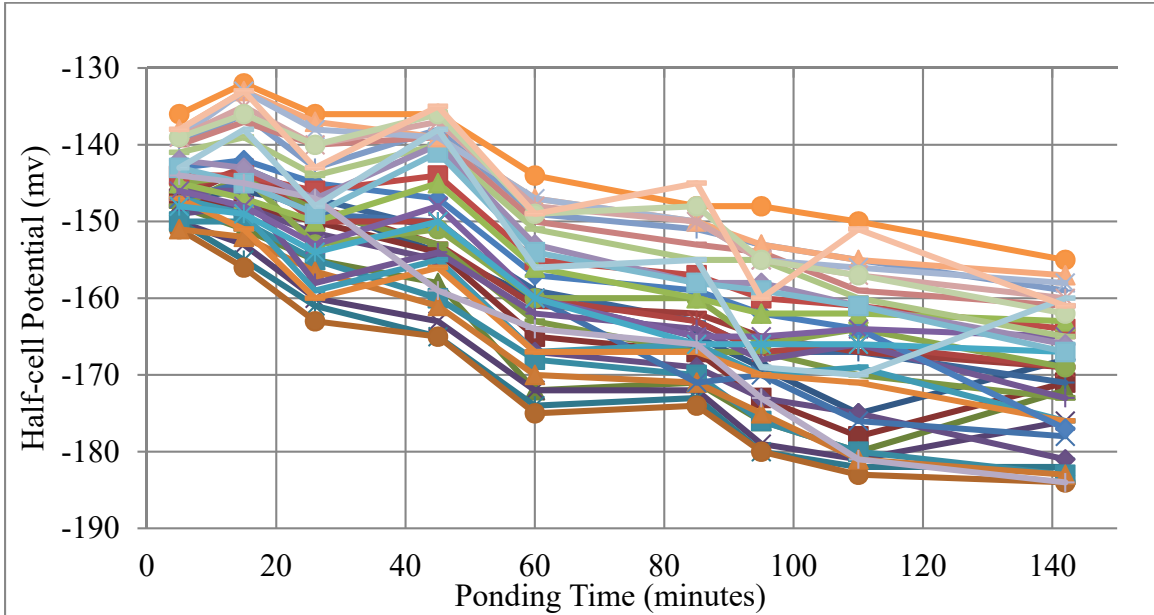
Figure 4.3: Effect of Ponding Time on Half-Cell Potential for AU6

<i>Time(min)</i>	15	25	45	60	85	95	110	140
<i>p-value</i>	0.433	0.417	0.298	0.102	0.079	0.037	0.013	0.011
<i>Reject H_o</i>	No	No	No	No	No	Yes	Yes	Yes

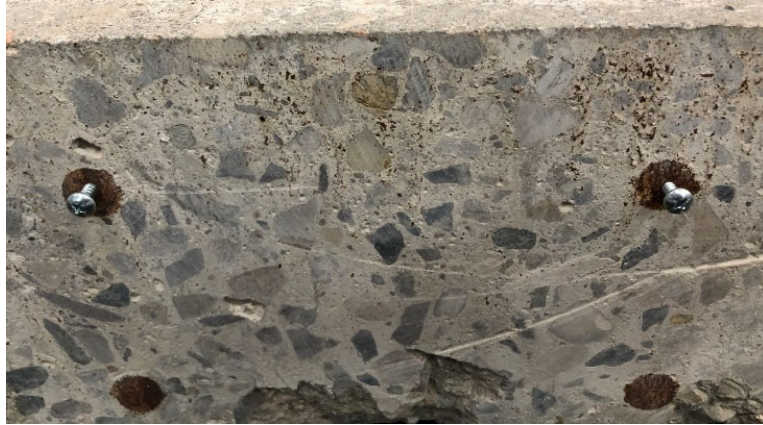
Figure 4.4: Example of Rebar Connection Using Screws

In order to achieve the most representative corrosion potential map, half-cells were collected when connected to the closest rebar. In order to maintain a constant proximity, the path of data collection moved parallel to the rebar. This method was carried out for both orientations of rebar: longitudinal and transverse. Electrical connection was made by means of welding a bolt to the externally exposed rebar end and in some cases, drilling a screw into the rebar. For the purpose of this research, only top layer reinforcement was considered since the top layer is the most at risk of corrosion in a bridge deck.

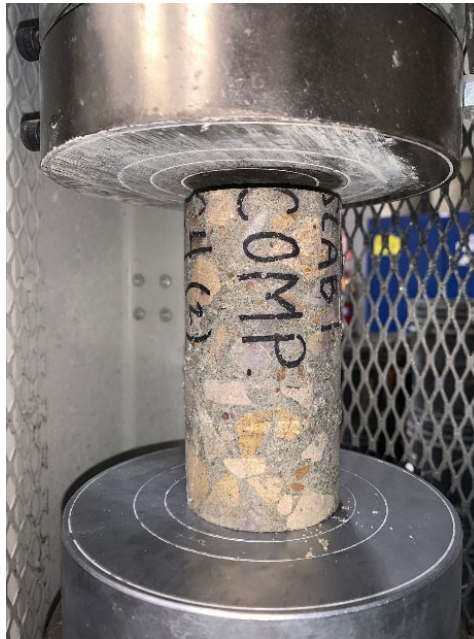
Figure 4.5: Compression Test Setup

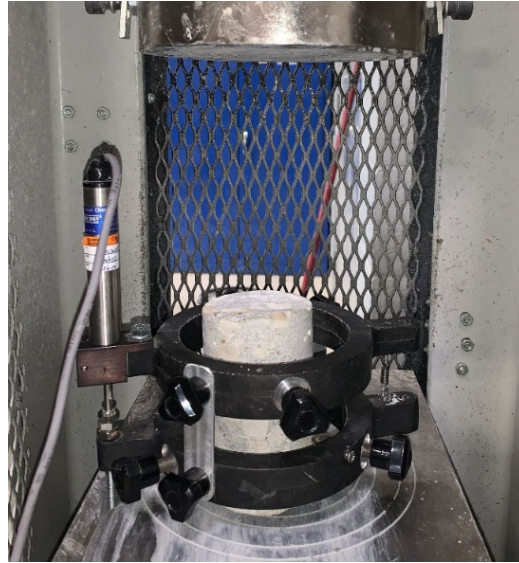
Figure 4.6: Modulus of Elasticity Test Setup

In accordance with ASTM C469, one core from each sample set was tested for modulus of elasticity. The third core from each sample set was to be tested for modulus by loading to 40% of the ultimate load while recording the longitudinal strain. The ultimate load was determined to be the lowest resulting value from the compression tests done from the preceding cores of the same sample set. This loading and unloading procedure was

completed a total of five times for each core tested. The first data set was disregarded in order to account for seating, while the stress-strain behavior was evaluated for the other four tests in order to calculate the modulus of the elasticity based on the load vs. strain data received.

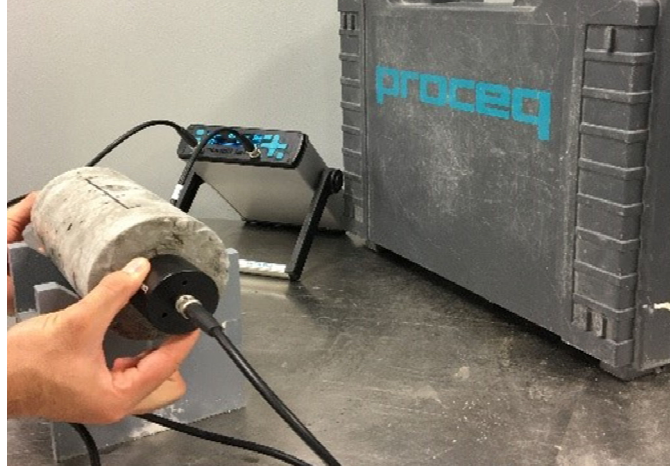
Figure 4.8: UPV Test Setup

L = length between transducers (ft)

t = pulse transit time (s)

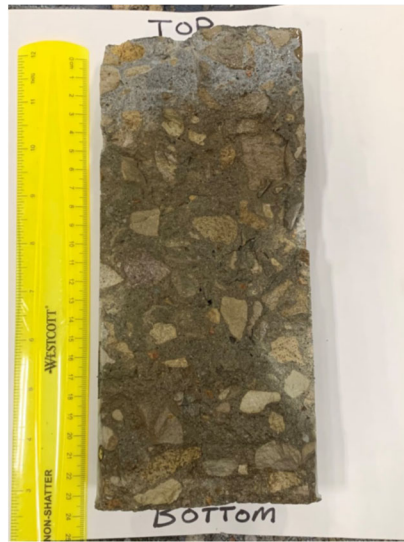
Figure 4.9: Silver Nitrate Test Setup

The primary limitation to this test is witnessed in the presence of carbonates because the lower pH will also result in a reaction of silver chloride to produce a discoloration. It has been observed that when the pH is below 10, determination of the chloride penetration depth becomes unreasonable (Real et al. 2015). To address this uncertainty, it is recommended for structures exposed to both chlorides and CO_2 that the carbonation depth be assessed in conjunction with chloride profiling.

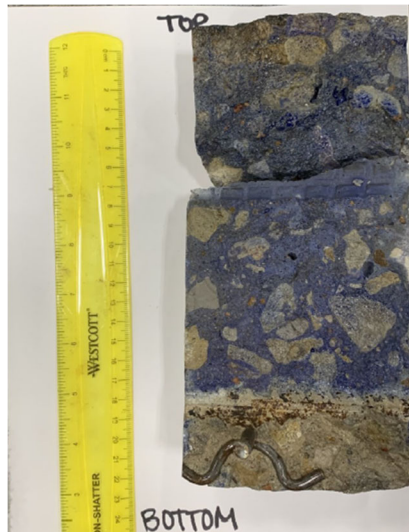
Figure 4.10: Carbonation Depth Test Setup

Coloration threshold for the phenolphthalein indicator is at a pH of 8.2 to 14 with a darker coloration at a pH of 10 and above. However, steel corrosion mechanisms, due to depassivation of the steel rebar, may initiate at an approximate pH of 10-11. Here, Thymolphthalein may be more appropriate colorimetric indicator of the change in pH as its threshold is 9.3 to 14 with a darker marker at a pH of 10.5. Therefore, the depth at which a detrimental change in pH occurs can be better identified with Thymolphthalein as opposed to underestimated with phenolphthalein.

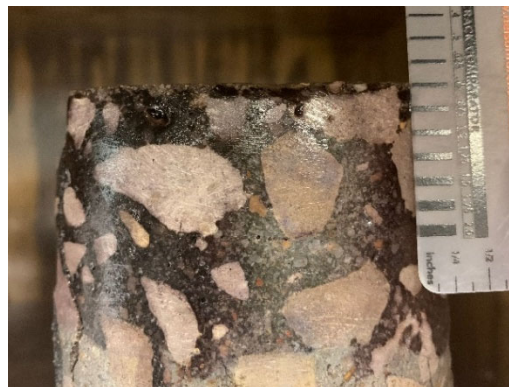
Figure 4.11: Silane Treatment Test Setup

Determination of the presence of a hydrophobic agent such as silane was tested by measurement of the depth of absorption for a water based dye into the concrete surface. Proceeding testing for carbonation depth and chloride penetration depth, the cores were placed in bins containing a dark dye for 30 minutes, then removed and measured for penetration depth.

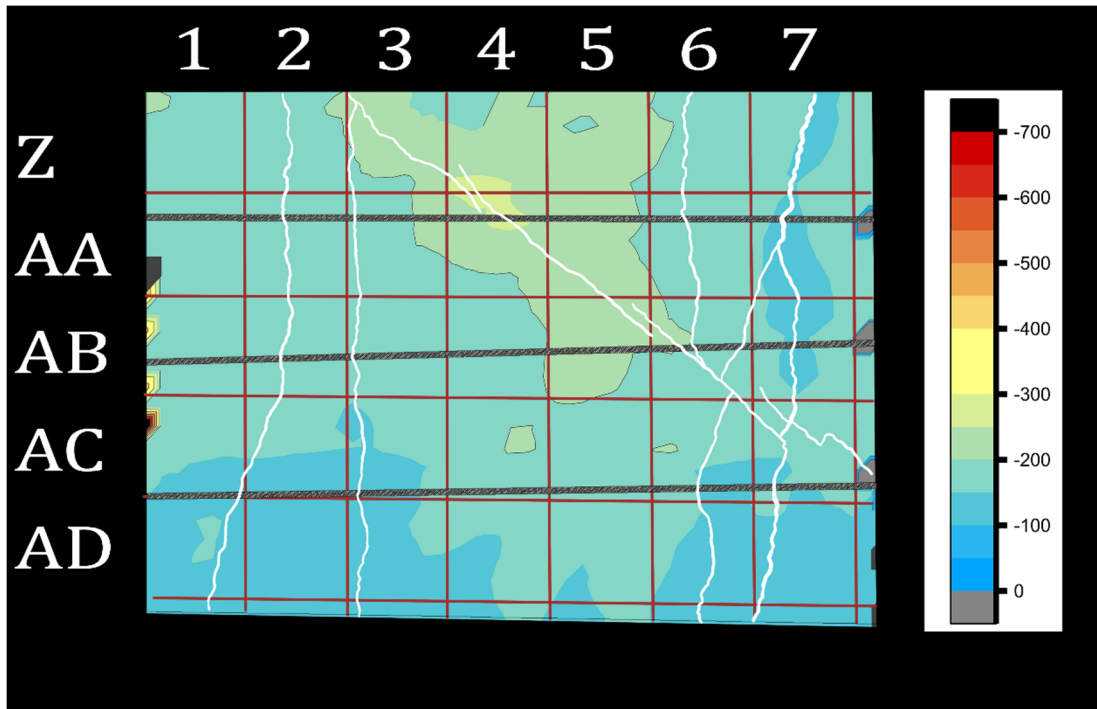
Figure 5.10: Half-Cell Potential Map for Longitudinal Rebar – Slab 6

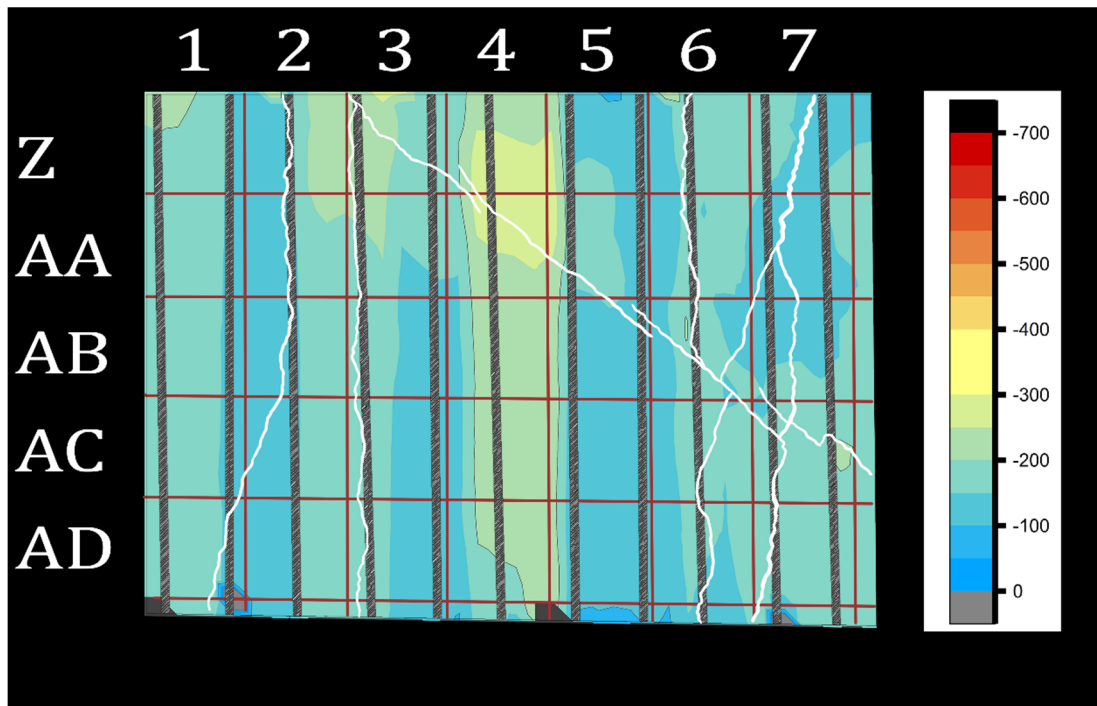
Figure 5.11: Half-Cell Potential Map for Transverse Rebar – Slab 6

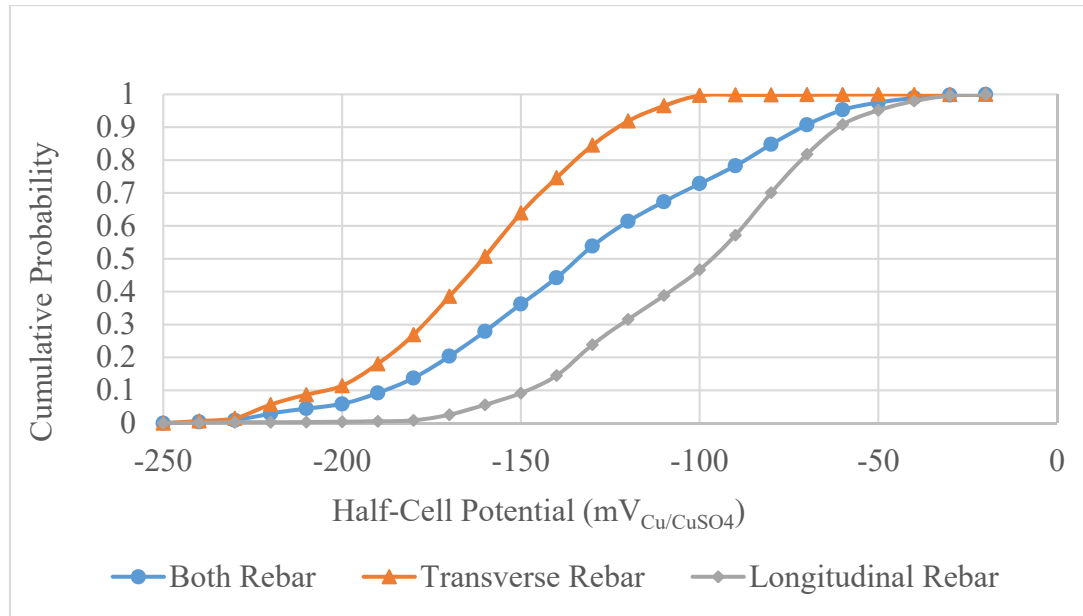
Figure 5.12: Half-Cell Probability Distribution – Slab 6

The cumulative probability distribution in figure 5.12, reveals that the longitudinal rebar exhibits the expected bimodal distribution needed to determine potential thresholds. For this reason, the threshold limits were determined based on the longitudinal rebar distribution. The determined potential thresholds are shown in table 5.13.

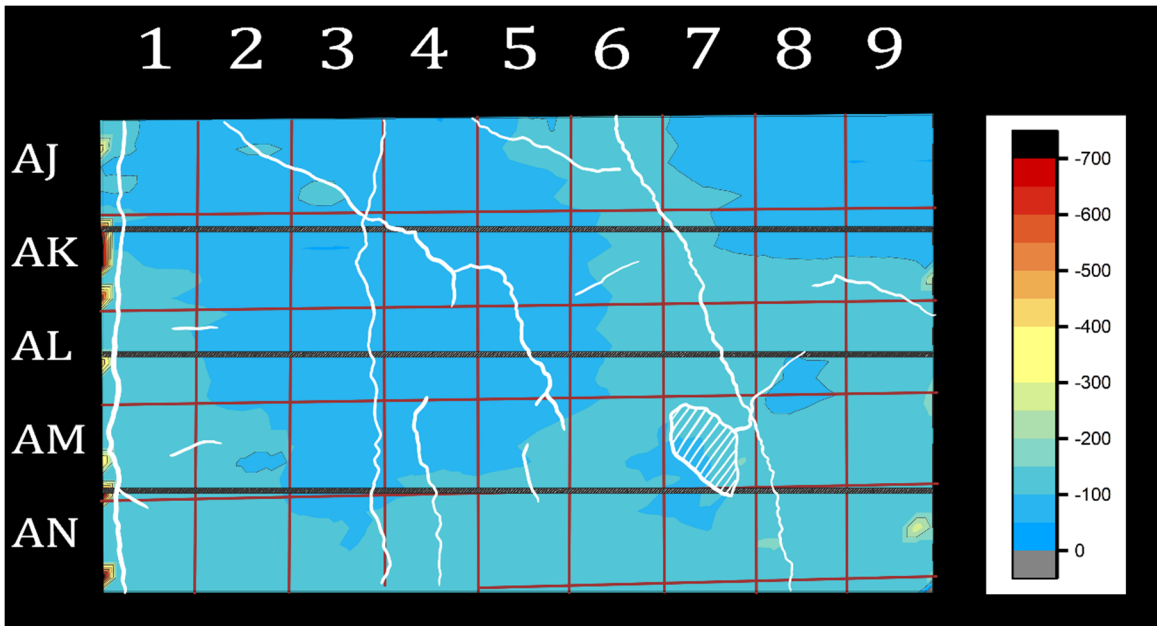
Figure 5.17: Half-Cell Potential Map for Longitudinal Rebar – Slab 7

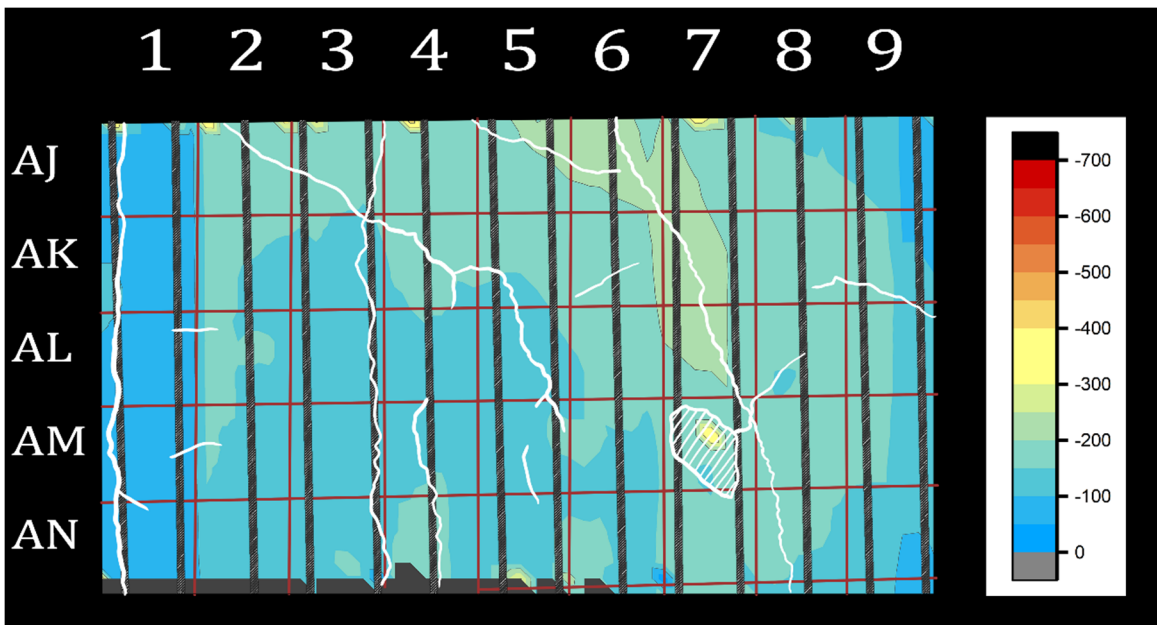
Figure 5.18: Half-Cell Potential Map for Transverse Rebar – Slab 7

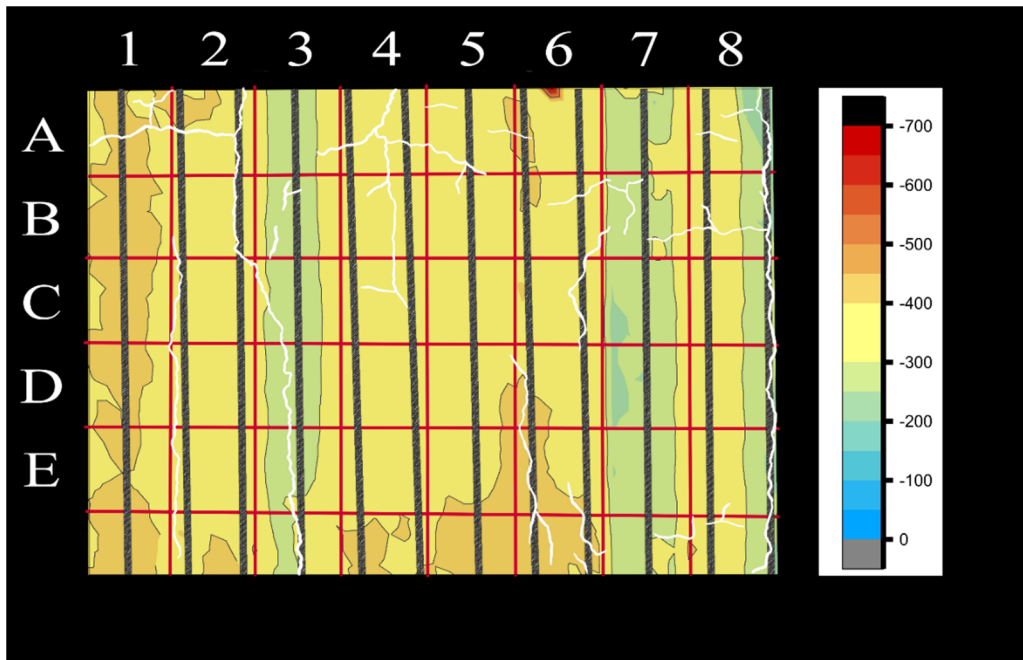
Figure 5.25: Half-Cell Potential Map for Transverse Rebar – Slab 1

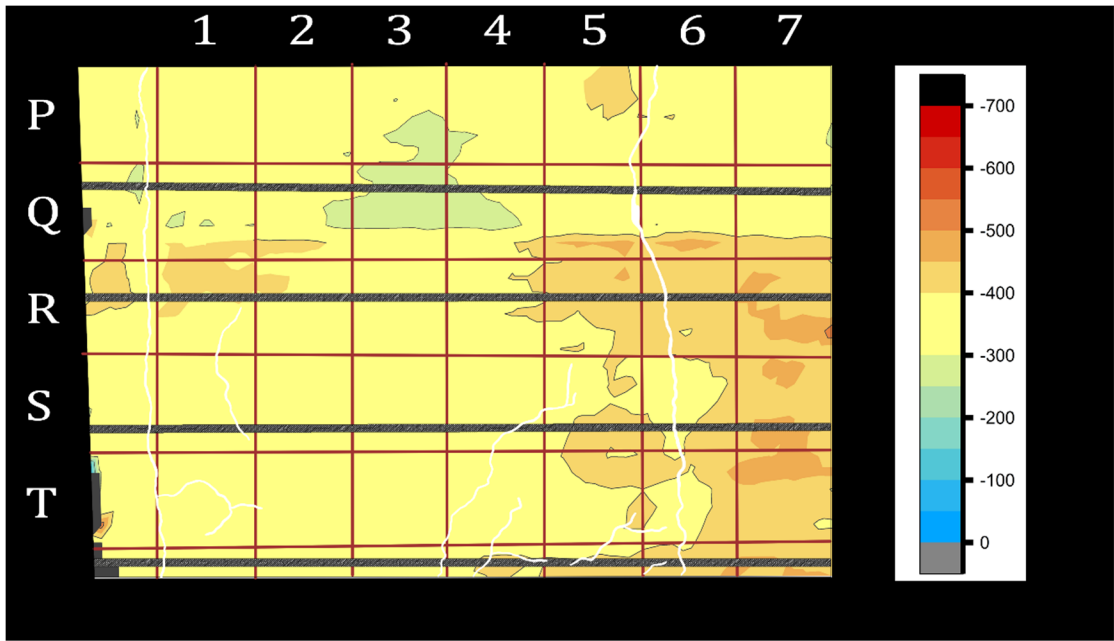
Figure 5.31: Half-Cell Potential Map for Longitudinal Rebar – Slab 4

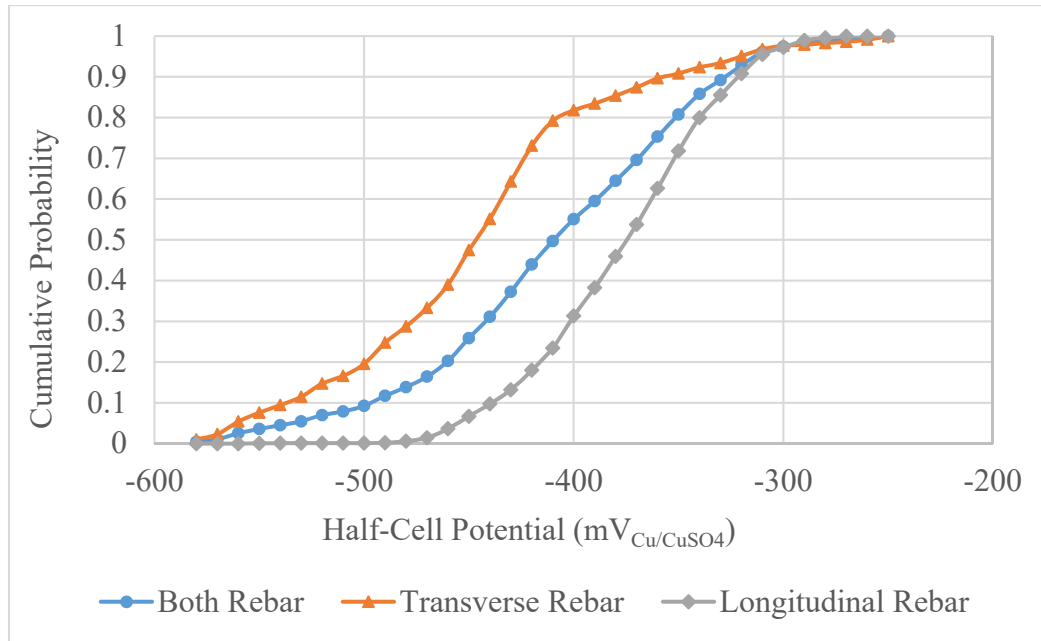
Figure 5.33: Half-Cell Probability Distribution – Slab 4

The probability distributions shown in figure 5.33, is difficult to interpret for potential threshold levels due to the normally distributed results. Threshold levels seen in table 5.14 were determined by the slight point of inflection seen in the combined distribution for both transverse and longitudinal rebar.

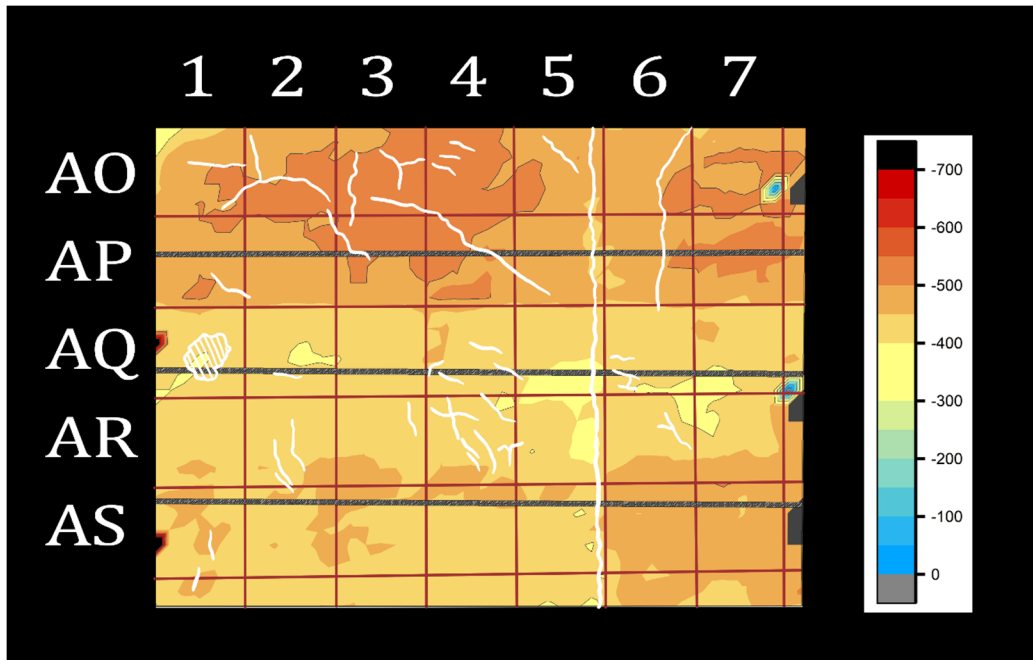
Figure 5.38: Half-Cell Potential Map for Longitudinal Rebar – Slab 9

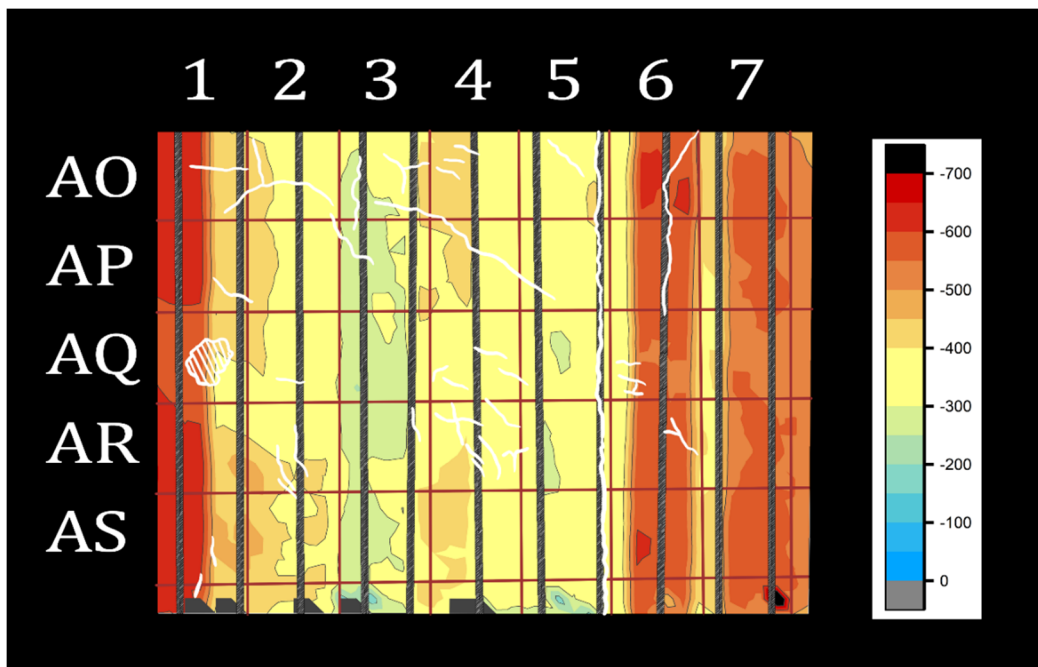
Figure 5.39: Half-Cell Potential Map for Transverse Rebar – Slab 9

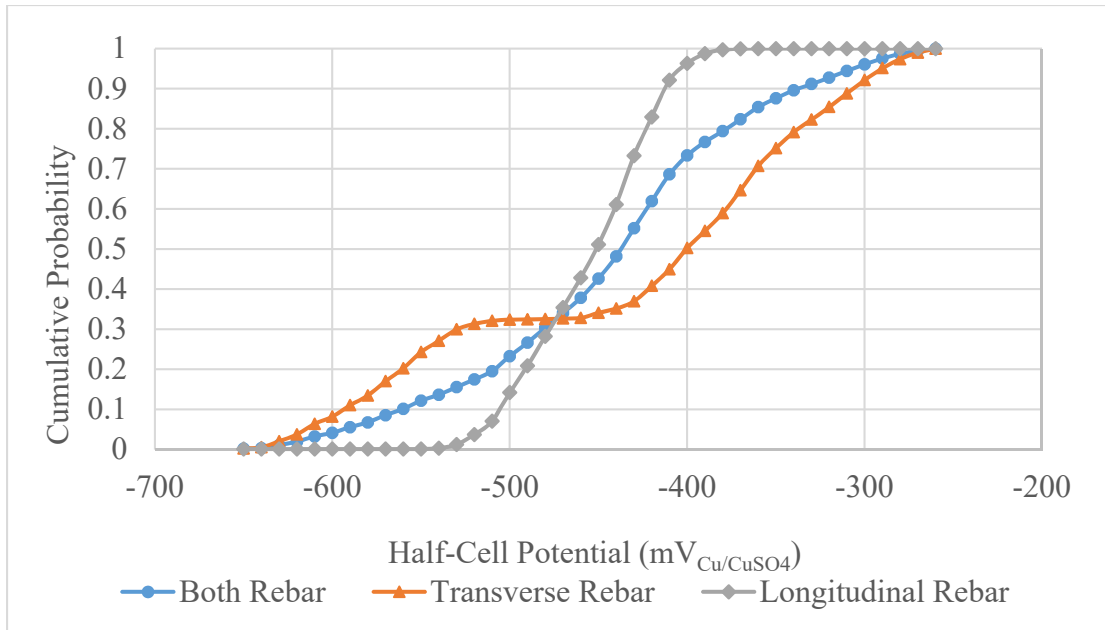
Figure 5.40: Half-Cell Probability Distribution – Slab 9

The probability distributions for transverse rebar shown in figure 5.40 is the most ideal representation of a bimodal distribution, making the determination of the potential threshold levels found in table 5.14 simple. The transverse rebar also displays a majority of data points falling into the less negative region, while the longitudinal rebar data falls heavily in the intermediate range.

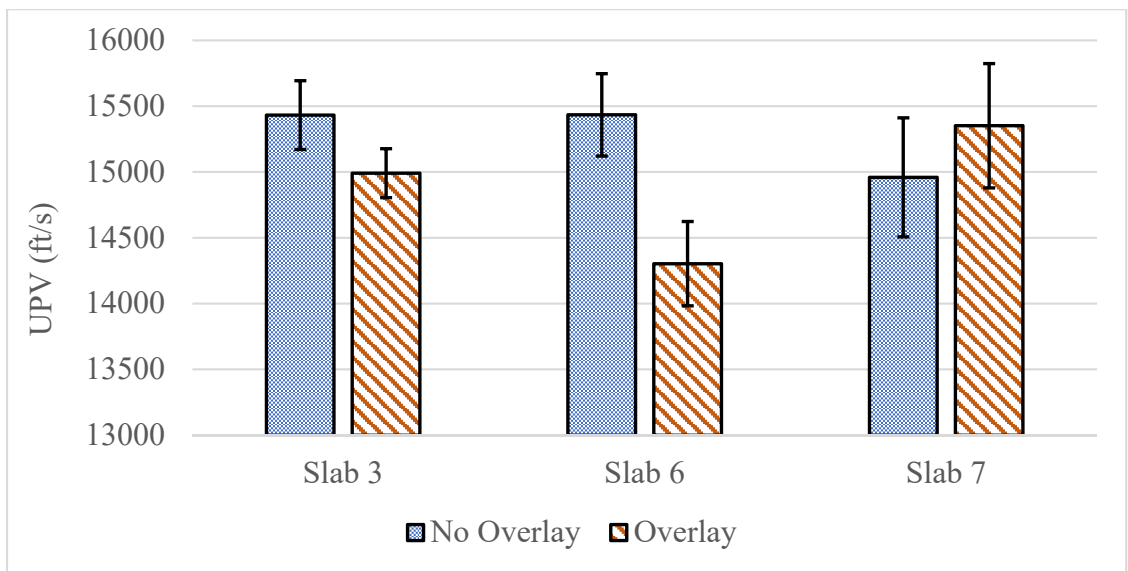
As shown in figure 5.41, there is no significant effect on UPV created by the overlay, except for in slab 6. As mentioned in section 1.1.1, the low COV for all samples means that the significant difference seen in slab 6 may be indicative of a lesser quality bulk material as compared to the rest of the slabs.

Figure 5.41: Effect of Overlay on UPV

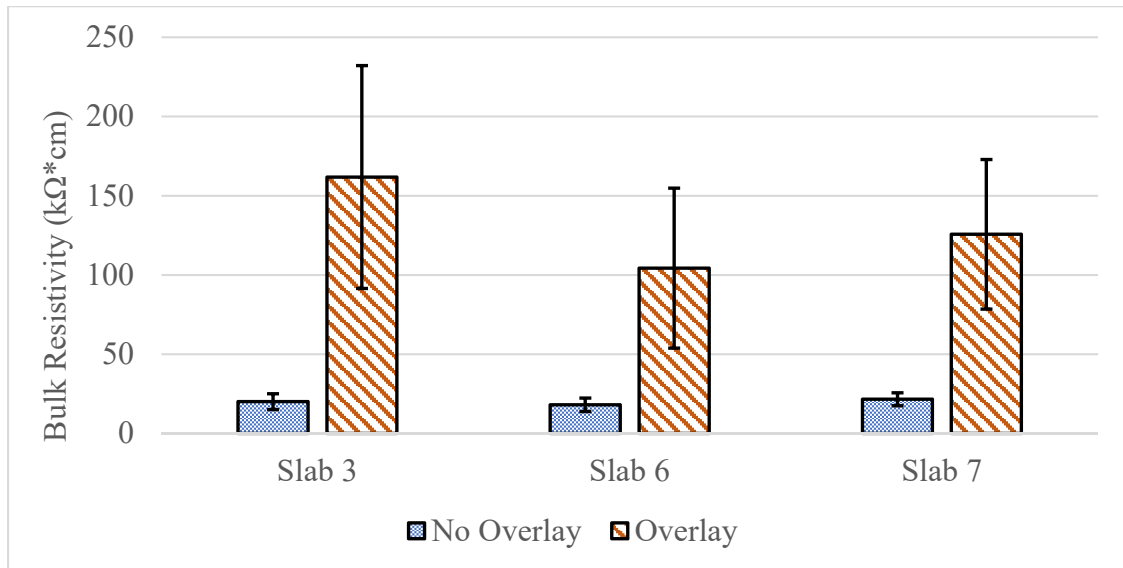
The most apparent of dissimilarities caused by the overlay is seen in the bulk resistivity, figure 5.42. In increase in resistance with the overlay was expected, as the concrete is newer and will exhibit less material deterioration with lessened negative exposure conditions to that of the bulk material underneath. The resistivity increase is drastic and certainly would influence the half-cell potential results observed in the black rebar panels. As mentioned in section 1.1.1, the COV for overlay samples is high and probably influenced by the variability in overlay depth and quality between cores. Despite this, it is apparent that the influence of the overlay material on resistivity is significant.

Figure 5.42: Effect of Overlay on Bulk Resistivity

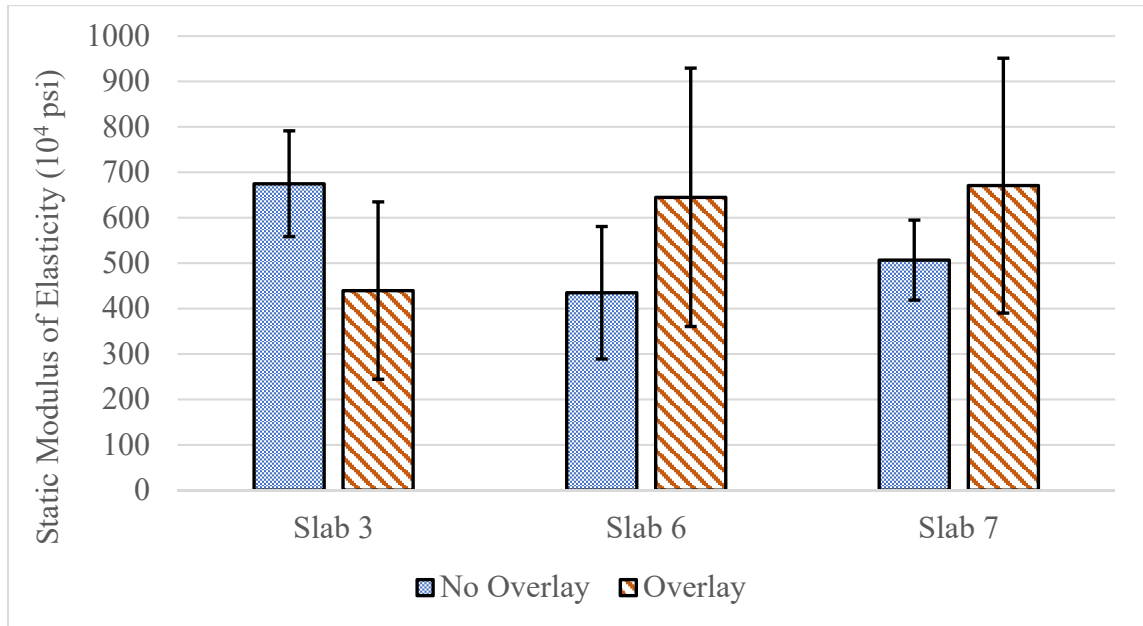
It can be observed in figure 5.43, that there exists no significant relationship between static modulus of elasticity and the presence of an overlay material. The variances observed for the overlay cores are much higher than those of the non-overlay cores, which is presumably the result of having two very different concrete materials in each core. Specifically, the coarse aggregate content and size in the overlay material is much smaller than in the bulk concrete. In this case, the change in coarse aggregate size will have a large effect on small cores (3”) since the size effect of the cores is prevalent in compression testing.

Figure 5.43: Effect of Overlay on Static Modulus of Elasticity

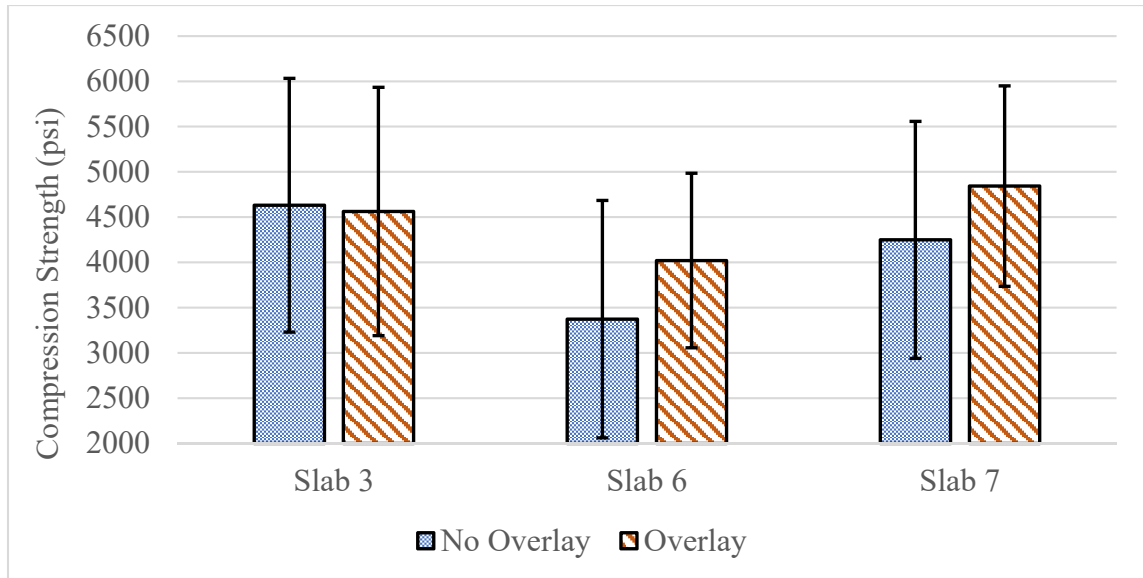
As observed in figure 5.44, the presence of the overlay induced an increase in core compression strength. The effects are considerably lower than that of bulk resistivity, but it can be inferred that the increase in strength can be attributed, in part, to the less deteriorated overlay material within the core. If this is the case, then the reduced effect can be explained by the combined strength of both materials, since the compression failure mechanism occurs in the middle of the core where the transition between the overlay and bulk material takes place. This strength increase along with the increase in bulk resistivity suggests that the overlay material is composed of a concrete mixture with a low w/cm ratio, designed to reduce permeability into the concrete surface. The large variances observed for all compression testing is probably the result of the small core size as compared to the coarse aggregate size in the bulk material. The location of coarse aggregate in relation to the core failure type, will therefore determine the core compression strength. In some cases, the inclusion of coarse aggregate for a core is low and produced a double cone failure type and significantly increasing the core compression strength, thus being the cause of large variations within each sample set.

Figure 5.44: Effect of Overlay on Compression Strength

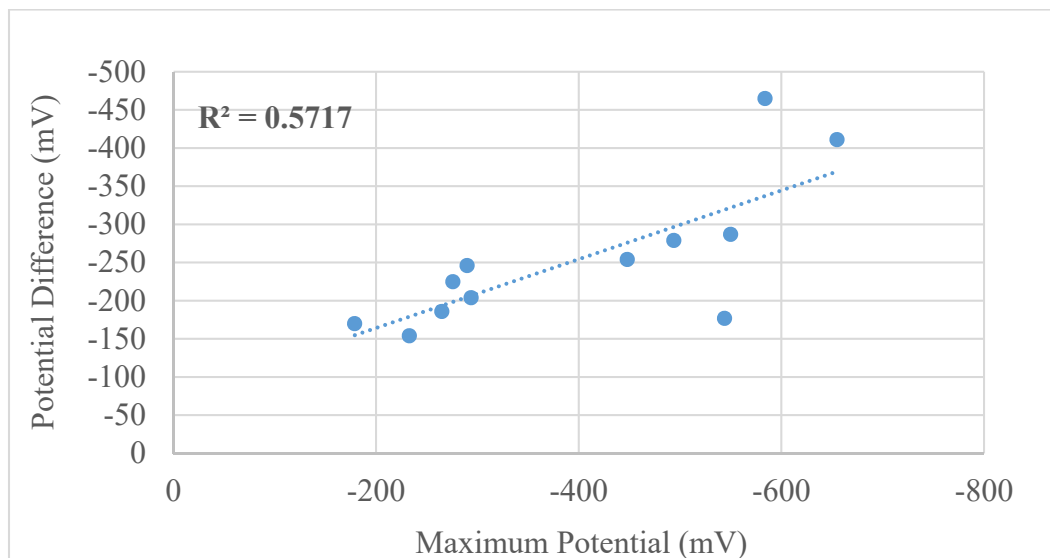
The maximum potential for each rebar orientation within each slab was calculated and plotted against the potential difference. The results in figure 5.45, indicate a linear relationship with the most outlying data points belonging to the ECR samples. This relationship may indicate that there is a strong correlation between the numeric method and potential difference method, under certain conditions. If this is the case, the potential difference method would be superior to the numeric method as it will eliminate misinterpretations of half-cell data on the premise of magnitude alone. Further explanation of the complications of using the numeric method are discussed in following sections.

Figure 5.45: Numeric Method vs. Potential Difference for each Slab

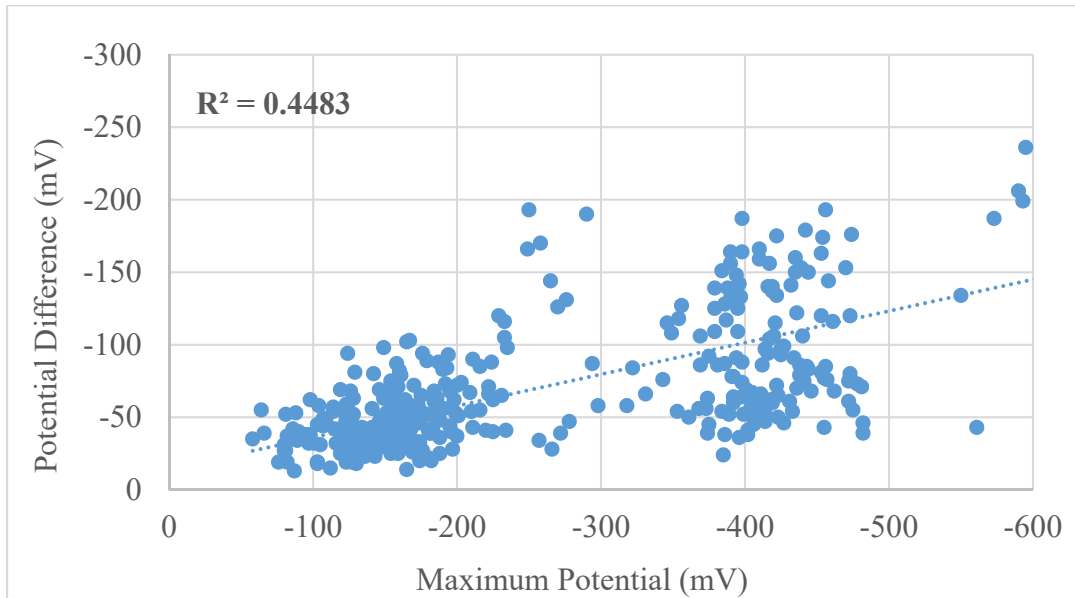
To see if this relationship holds true on a smaller scale, the potential difference within each 1'x1' grid box was calculated and plotted against the associated maximum potential for each rebar orientation. The results are shown in figure 5.46 and indicate the same trend with an increasing variance at higher levels of half-cell potential.

Figure 5.46: Numeric Method vs. Potential Difference for each Grid Box

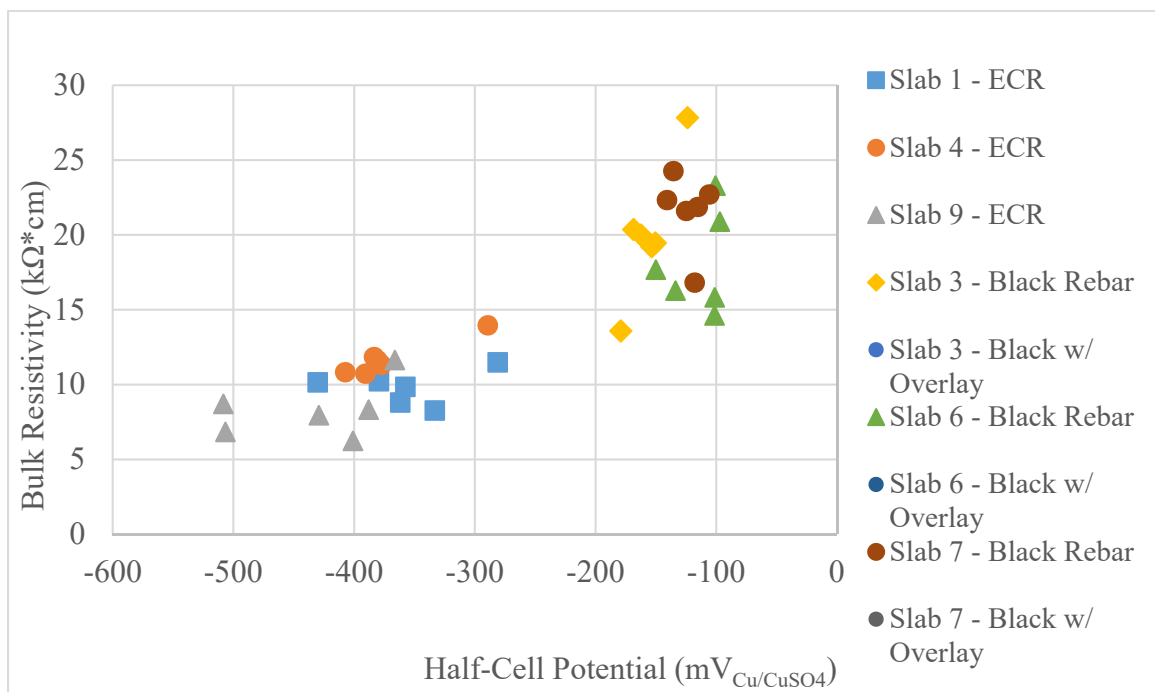
Figure 5.49: Influence of Resistivity on Half-Cell Potential
