NONDESTRUCTIVE TESTING FOR CORROSION
ASSESSMENT OF EPOXY COATED REBAR

Submitted to the Faculty of the
Graduate College of the
Oklahoma State University
in partial fulfillment of
the requirements for
the Degree of
MASTER OF SCIENCE
December, 2020

The proposed methodology will be performed on 9-inch-thick reinforced bridge-deck slabs from I-35 in Oklahoma. The bridge was constructed with both standard and epoxy coated rebar; a corrosion assessment of the standard rebar will be used for comparison and validation of the ECR assessment. The experimental results will reveal the accuracy of the test methodology compared to standard rebar assessment and determine if it is adequate to evaluate the probability of corrosion in bridge decks with ECR.

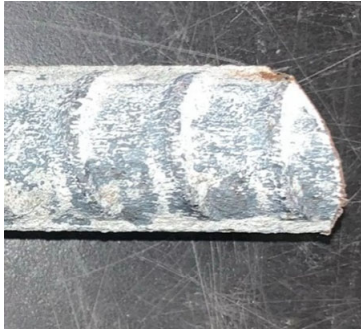
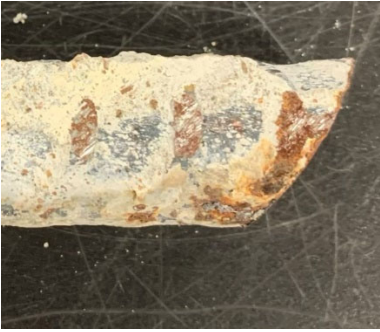
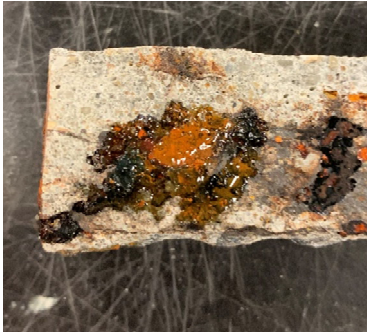
Table 5.24: Corrosion Severity Index for Black Rebar

<i>Class 1</i>	<i>Class 2</i>	<i>Class3</i>
<ul style="list-style-type: none"> <i>No visible corrosion</i> 	<ul style="list-style-type: none"> <i>Visible corrosion on surface</i> 	<ul style="list-style-type: none"> <i>Visible corrosion</i> <i>corrosion product on surrounding concrete</i> <i>loss of material</i>

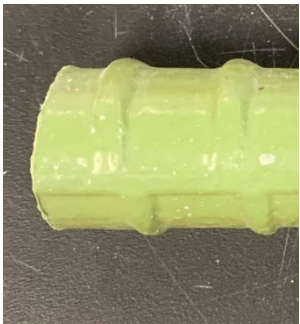
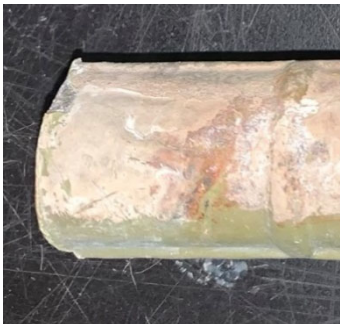
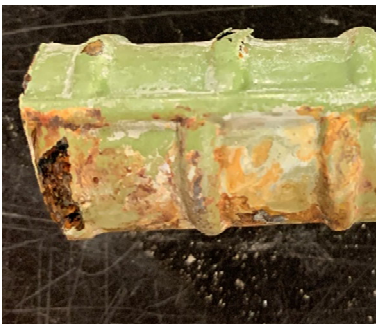
Table 5.25: Corrosion Severity Index for ECR

<i>Class 1</i>	<i>Class 2</i>	<i>Class 3</i>
<ul style="list-style-type: none"> • <i>No visible corrosion</i> • <i>No coating defects</i> 	<ul style="list-style-type: none"> • <i>Visible corrosion in defects</i> • <i>Coating defects</i> 	<ul style="list-style-type: none"> • <i>Corrosion product on surrounding concrete</i> • <i>Debonded coating</i>

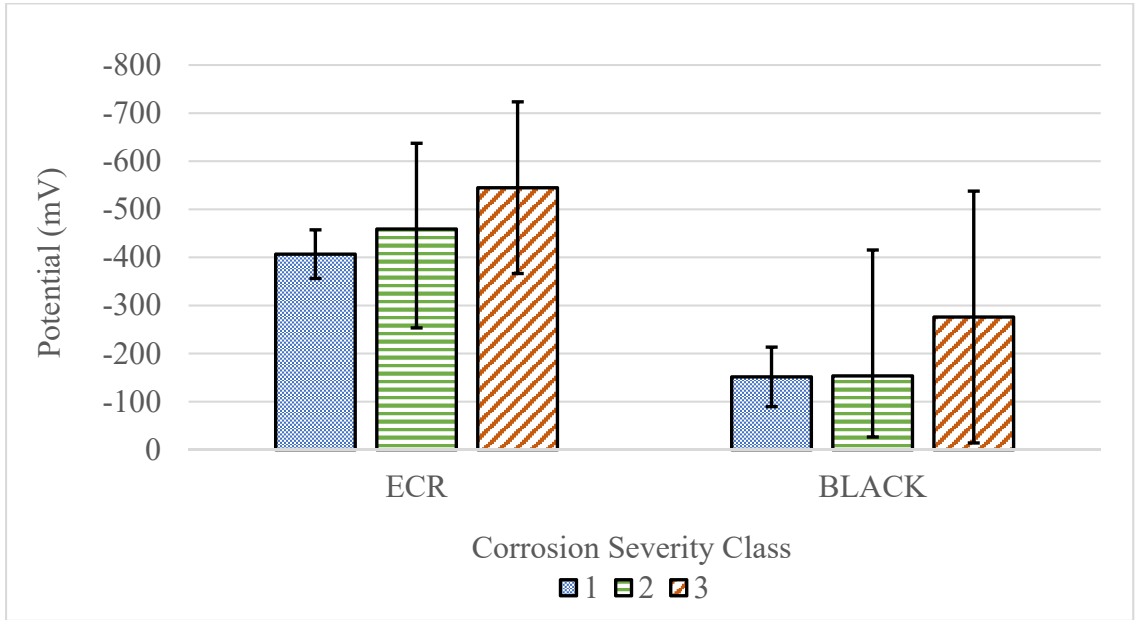
Figure 5.58: Average Potential Based on Corrosion Severity Class

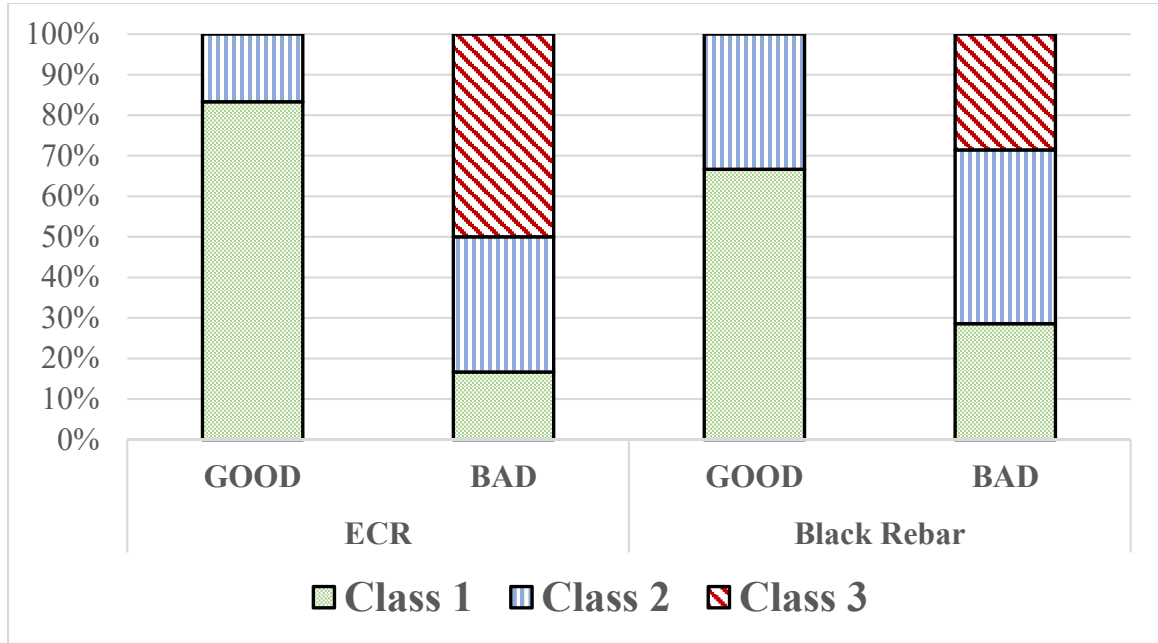
Figure 5.61: Corrosion Class Frequency for Good and Bad Cores
