BARNES OF THE SOUTH CENTRAL RED-BED PLAINS: 1889-1940

A THESIS

LYNDA L. RAMSEY

2008

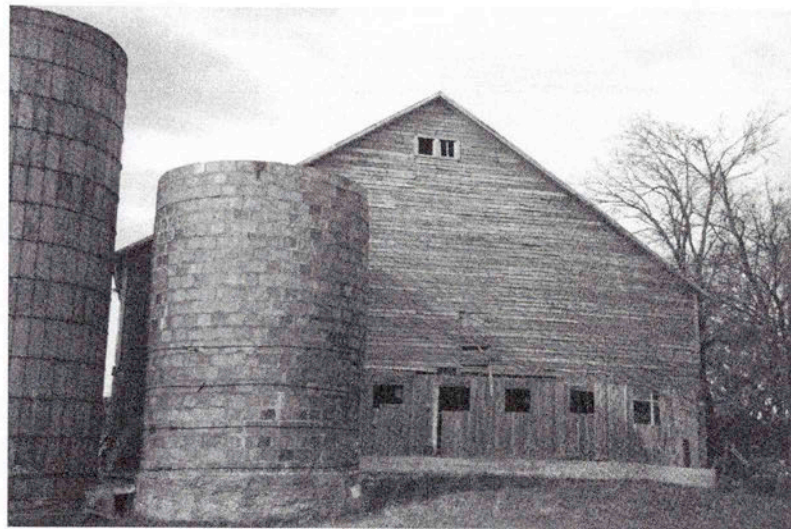
Fig. 5.6 The east gable end of Jack Cooksey's barn with the two small windows located high in the gable. The lower windows were used for ventilation and light in the dairy. The clay tile silo was the first silo built on the farm. (Photo by Lynda Ramsey)

patiently waited in wooden stanchions below. As the cut silage was blown into the silo, Jack Cooksey used goats to stomp and pack the silage (Fig. 5.6).

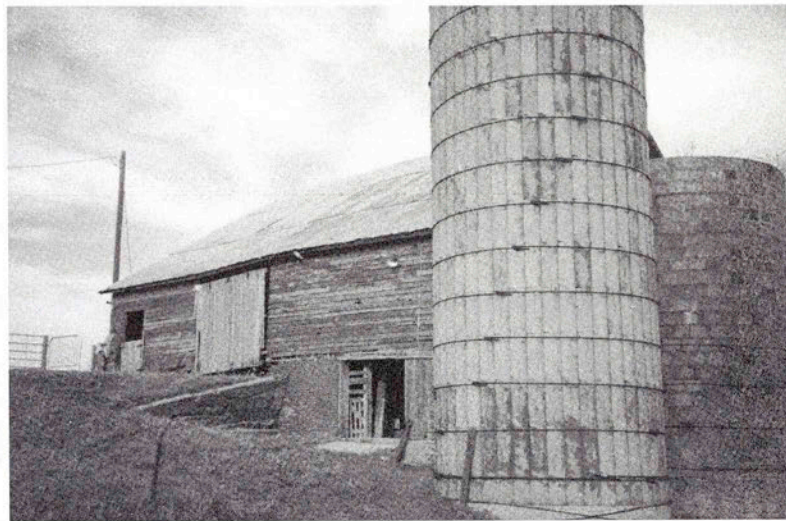
Fig. 5.7 The south side of Jack Cooksey's barn showing the Dutch door entry, an earthen ramp allowing wagons to enter the drive through, and the lower basement entry.

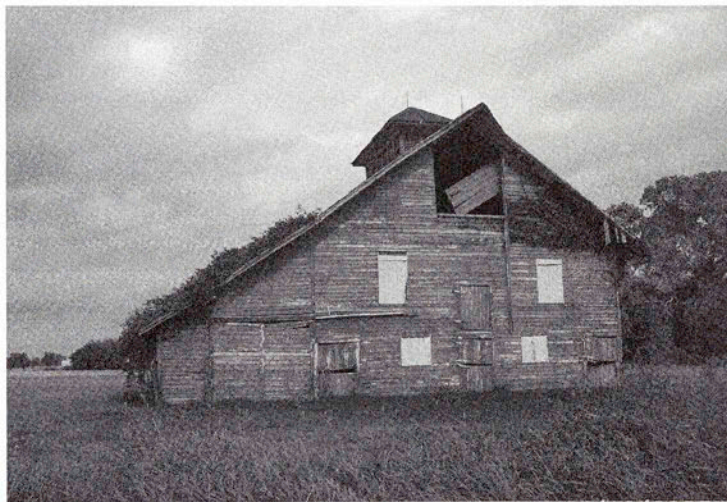
Fig. 5.11 Josephine Dolezal's barn constructed ca. 1900 with a saltbox roof. (Photo by Lynda Ramsey)

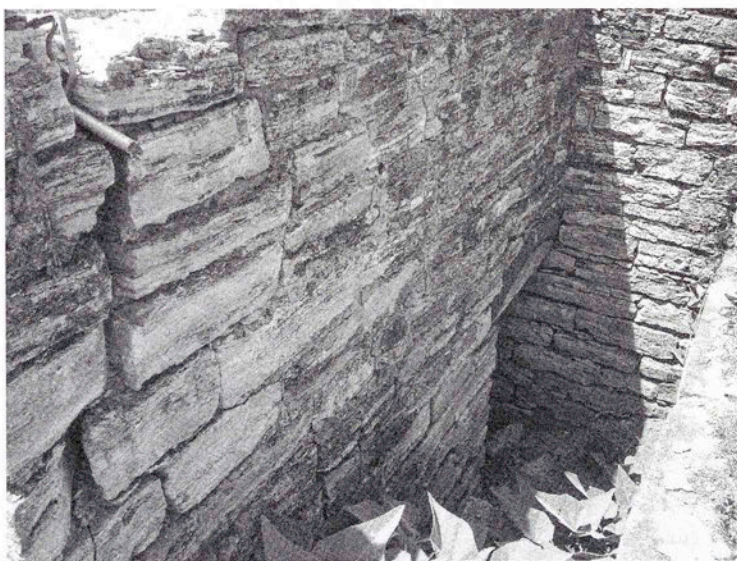
Fig.5.18 Quarried Dolomite stone used to build the foundation of the barn and outer walls of the root cellar. (Photo by Lynda Ramsey)

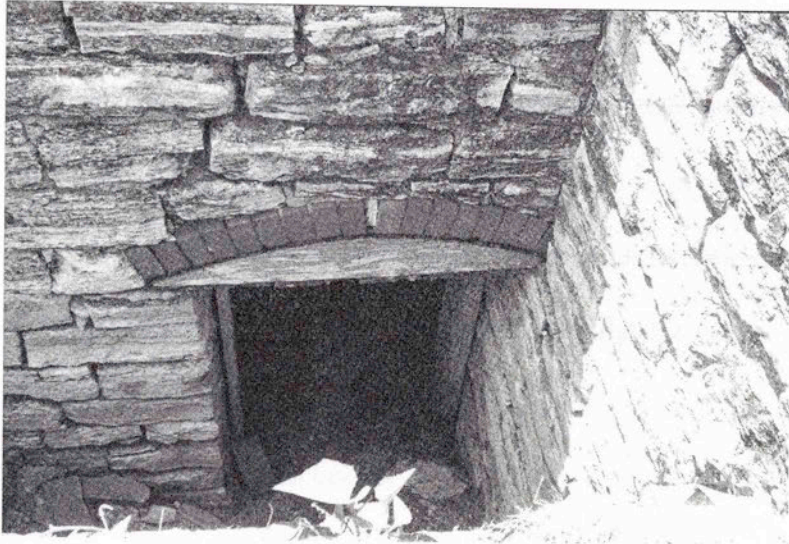
Fig. 5.19 A red brick *jack arch* over the root cellar door. (Photo by Lynda Ramsey)

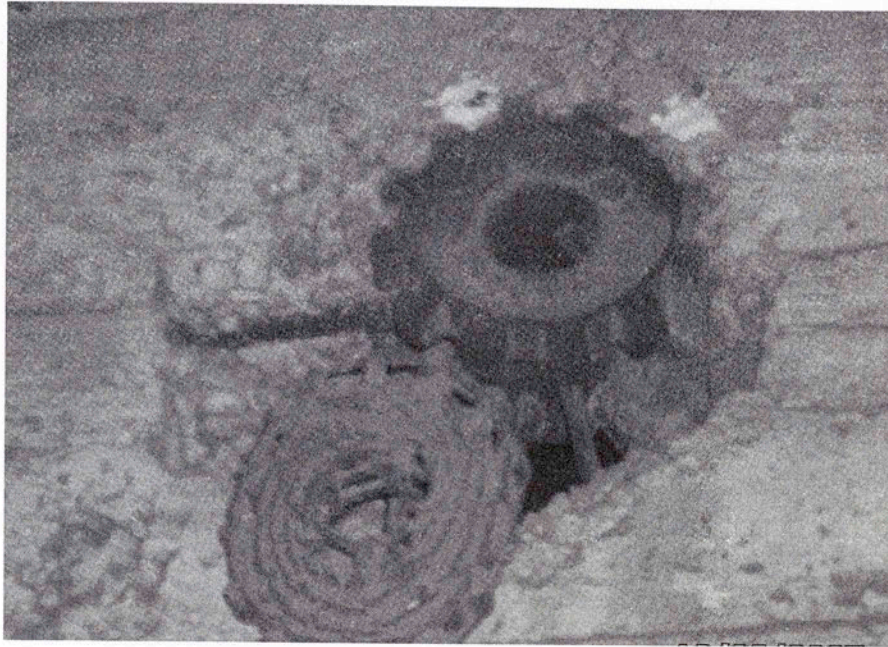
Figure 5.21 Wagon wheel hub in concrete of John W. Carter's barn. (Photo by Lynda Ramsey)

During the 1910s, Carter and other farmers began mixing their own concrete where sand and gravel were plentiful. Many Oklahoma barn foundations are made of concrete combined with local field stone, scrap metal or other materials as a result. By 1920s, however, the primary use of concrete was for the walls and basements of side hill barns. John Carter's grandson, Harold Duke, told how his grandfather used old wagon wheels and even steel wire in the walls of the side hill barn (Fig. 5.21-23). Carter's recipe for concrete was one scoop of cement, two scoops sand, and four scoops of any kind of fill from rocks to wagon wheels.

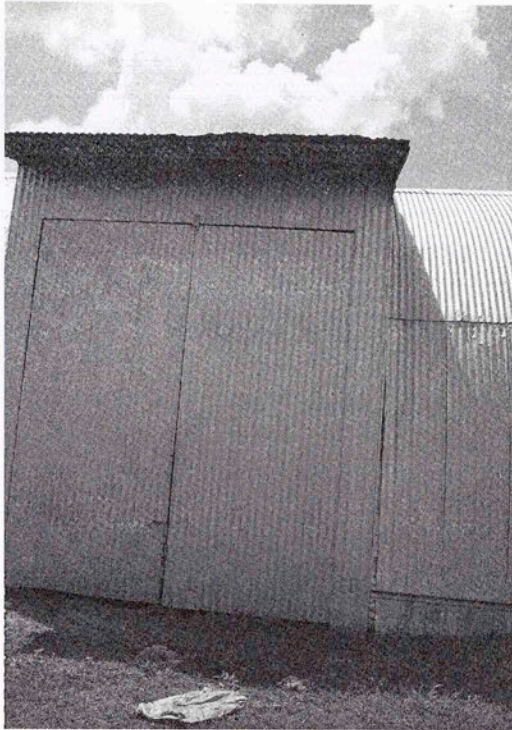
Figure 5.24 This “extended bay” is built as a continuation of the roof to protect the exterior doors from weather conditions. “When the extended bay becomes a complete addition to the barn with a continued roof, it is called a “forebay.”⁴⁹ (Photo by Lynda Ramsey)

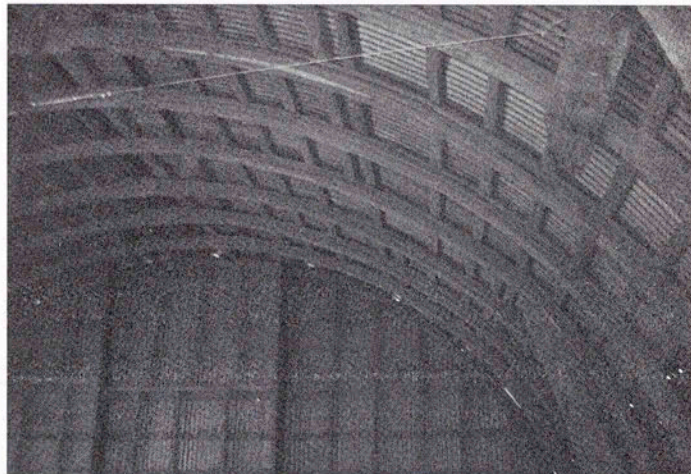
Figure 5.25 Ribs were constructed with multiple layers of 1”x 4” lumber placed inside two stakes in the ground to create the curved form. They were then treated with linseed oil to protect them from rot. (Photo by Lynda Ramsey)

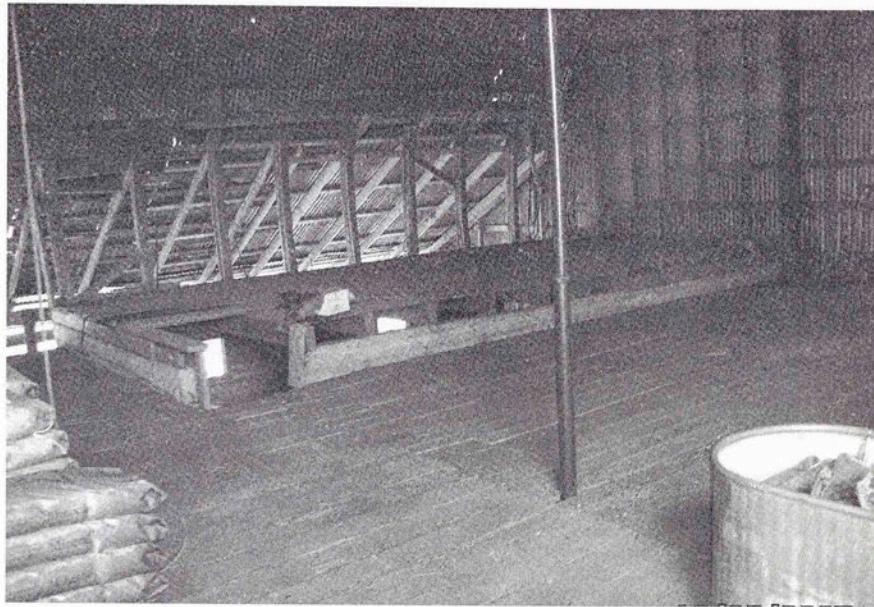
Figure 5.26 Loft floor with concrete granary built into the floor. (Photo by Lynda Ramsey)

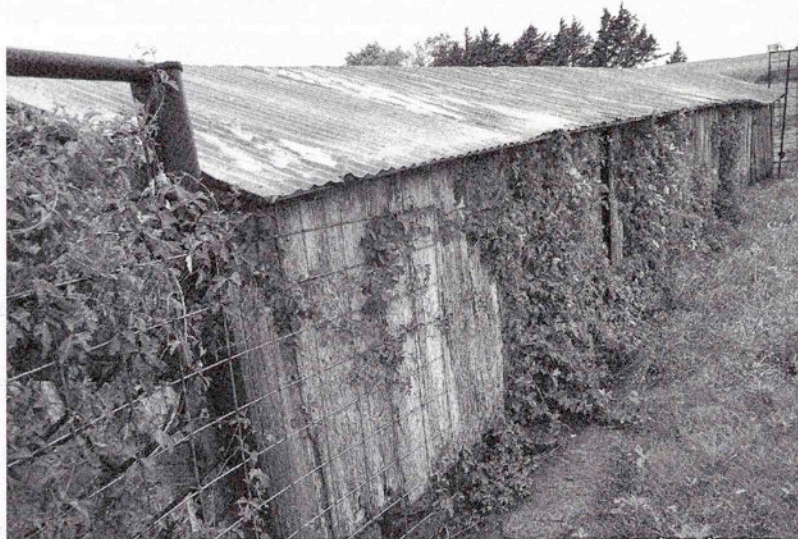
Figure 5.32 The upper level of Martin Stadler and Tom Beck's barn facing the north. There are three doors that open into the loft. The red shale stone is used as the foundation for the wooden upper loft. (Photo by Lynda Ramsey)

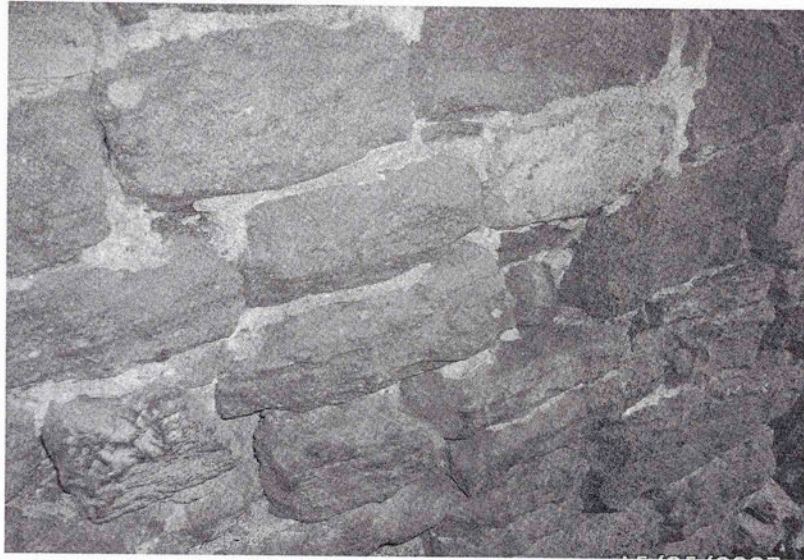
Fig. 5.33 Red sandstone brick wall in Martin Stadler and Tom Beck's barn. (Photo by Lynda Ramsey)

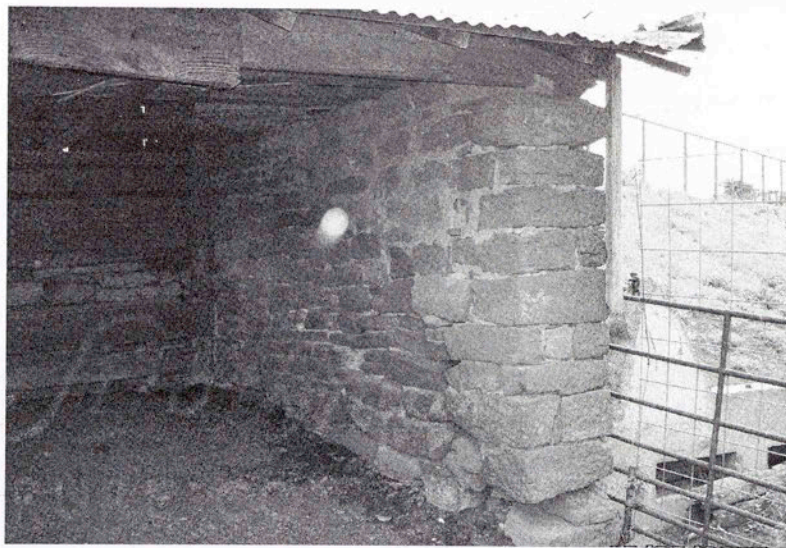
Figure 5.34 The south opening into the barn reveals the thickness of the sidewall and a portion of the back wall of the barn. (Photo by Lynda Ramsey)

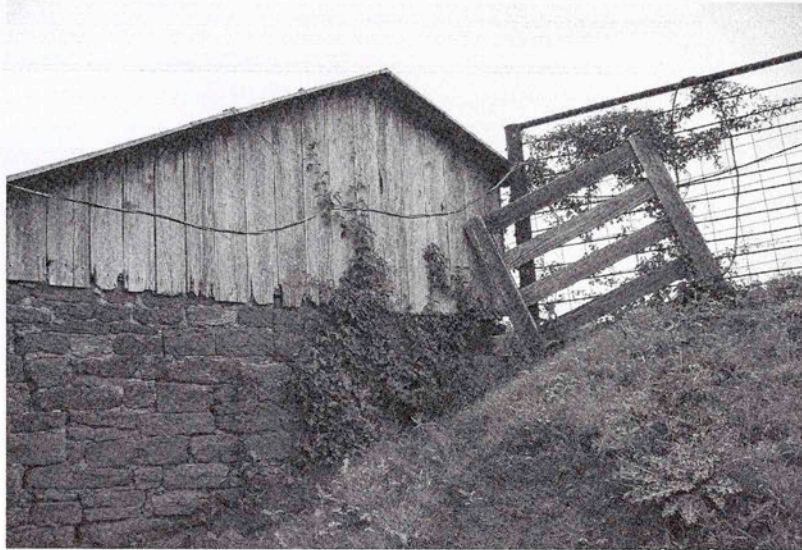
Fig. 5.35 The east side of the barn with red sandstone as the foundation and walls is built into the steep slope of the hill. (Photo by Lynda Ramsey)

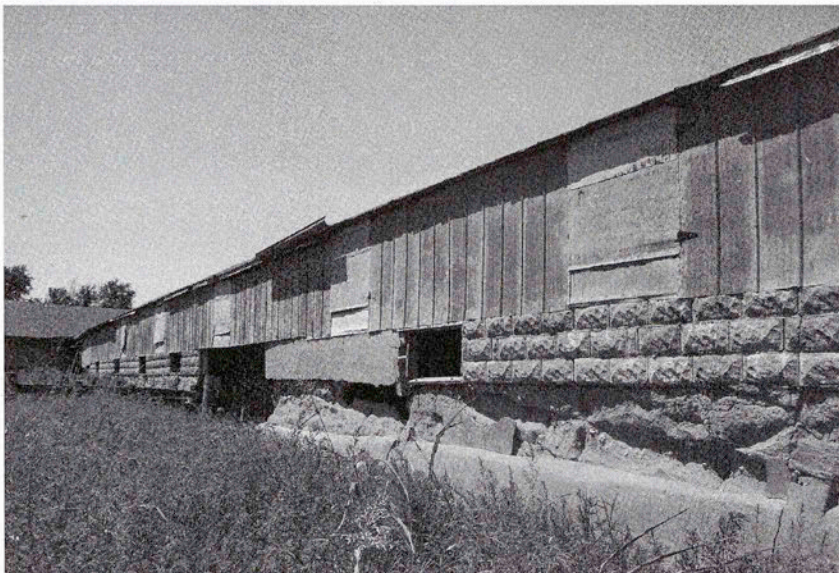
Fig. 5.42 The south side of the Bredel horse and cattle barn where Otto Bredel used three types of masonry construction to build the foundation and lower wall of the barn. Above the masonry wall are loft openings. Windows built into the concrete blocks open into the livestock stalls.

North of the original Bredel home stands a large, L-shaped horse and cattle barn. Bredel combined many unusual construction features in the linear, L-shaped barn. The barn's foundation is like a skirt with three layers of fabric. The lowest portion of the foundation is a beveled wall of poured-in-place concrete with a smooth finish and a water table to carry rainwater away from the foundation. Above the smooth skirting is another wall of stone and brick rubble placed randomly in concrete and veneered with Portland cement plaster. Above the second wall is another band of concrete blocks. Bredel also used concrete block in the construction of his smokehouse and blacksmith shop (Fig. 5.43,44).

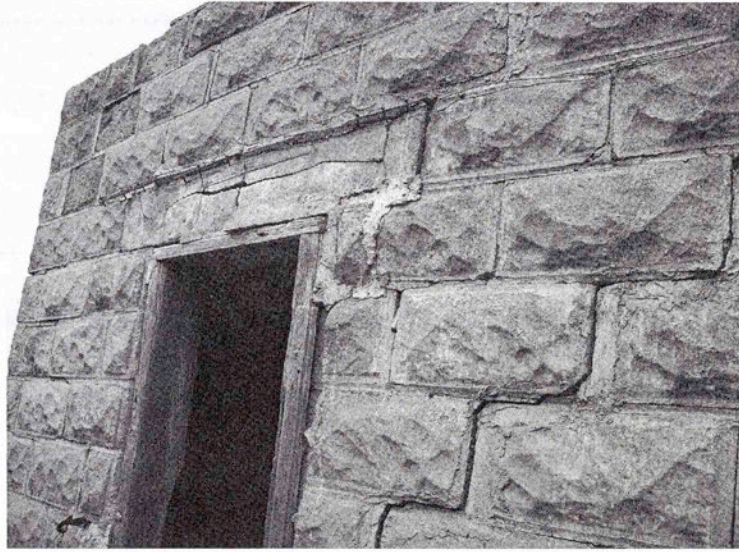
Fig. 5.43 The Otto Bredel's blacksmith shop with *O Bredel* imprinted in stone above the door. (Photo by Lynda Ramsey)

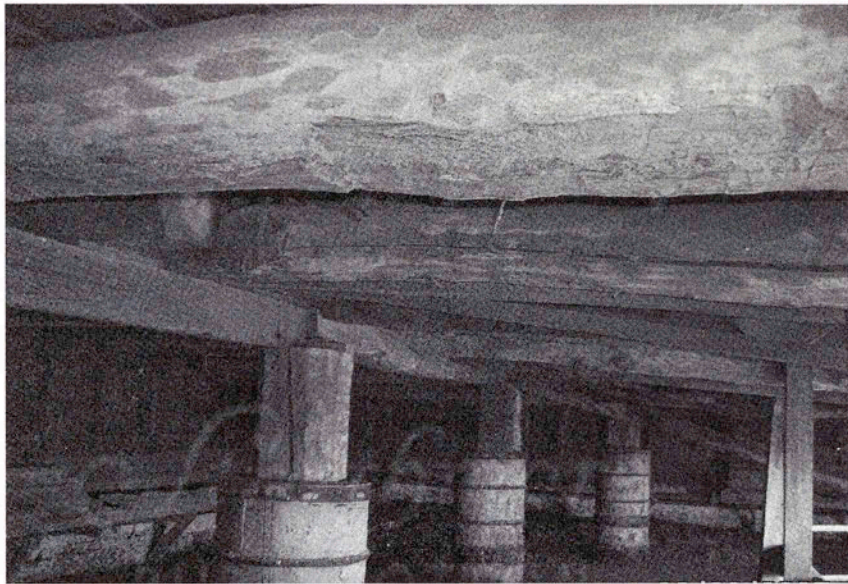
Fig. 5.45 Each post is set into a concrete barrel form sheathed in tin. The tin is fastened around the concrete with iron bands. The heavy axe hewn logs are used as loft floor joists. (Photo by Lynda Ramsey)

The concrete foundation has eroded and exposes red fieldstone. A steep handmade ladder on the left, leads to the loft. A forest of hewn posts protrude from the uneven earthen floor. Both posts and floor joists are solid cottonwood round logs that reveal marks from the broad axe. The large round girder posts have been set into concrete cylinders that are made to look like barrels. These concrete cylinders are covered with the tin from ice box containers and fastened with iron straps (Fig.5.45-48).⁵³ The floor joists for the upper loft floor are thick, and weighty, and look as if they could collapse with any sudden movement or sound. Wooden feeding troughs, built against the walls surround the huge timbers. The tin feed chute that once transported the grain from the upper loft to the troughs is now blistered by rust.

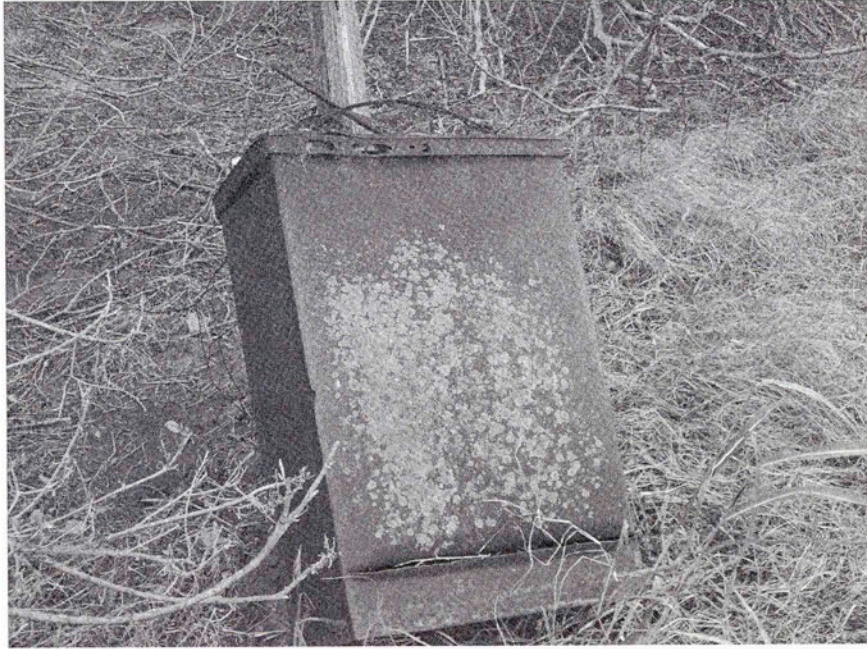
Fig. 5.46 Ice boxes Otto Bredel found discarded in Oklahoma City. He used the metal from these containers as protective sheeting on many of his farm structures. (Photo by Lynda Ramsey)

⁵³ Otto Bredel brought discarded ice block freezing containers and used bricks from Oklahoma City after selling his cattle. The ice cans were made from heavy tin and Otto forged a special tool designed to cut the container. He flattened the heavy tin and used it as a covering on most of his barns.

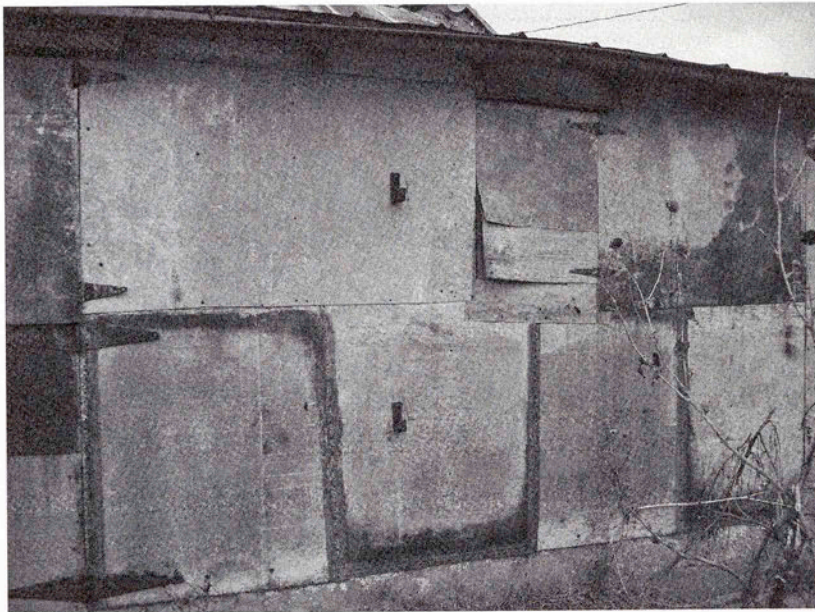
Fig. 5.47 Metal from ice box freezing containers used on the siding of one of Bredel's barns. (Photo by Lynda Ramsey)

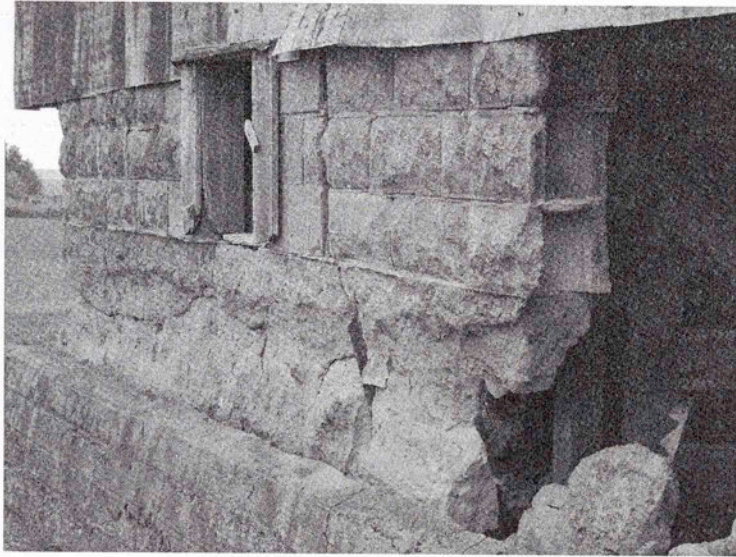
Fig. 5.51 The northeast corner of Otto Bredel's barn has collapsed, showing a tripartite expression of three different masonry materials in a banded composition: poured-in-place concrete foundation, a foundation wall of brick and stone infill, and rock-faced concrete block. (Photo by Lynda Ramsey)

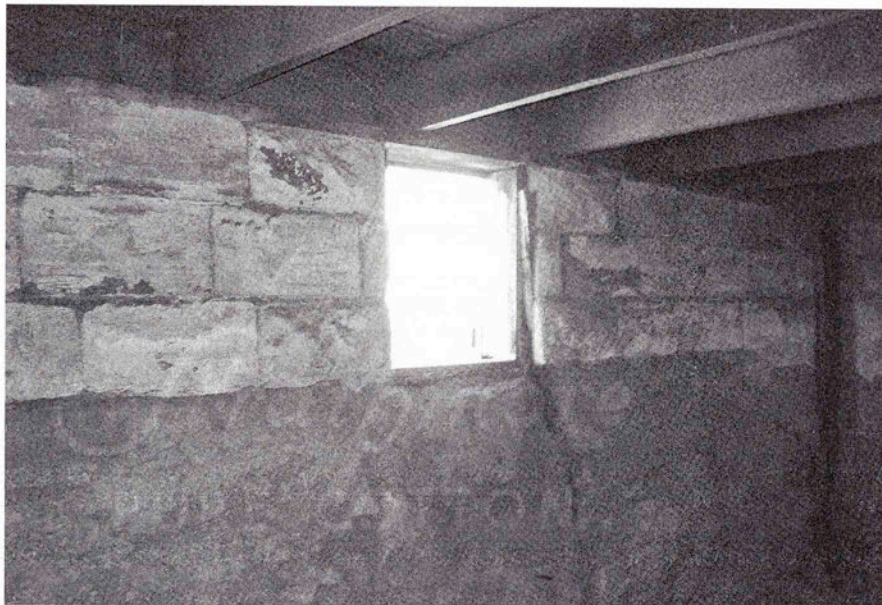
Fig. 5.52 The lower wall is red brick covered with a veneer of concrete plaster. The upper wall level is hollow concrete blocks with a decorative, carved face placed towards the outside. Whitewash has been used to coat the inside wall of blocks. Above, the block masonry wall the floor beams are seated on the wood plate. (Photo by Lynda Ramsey)

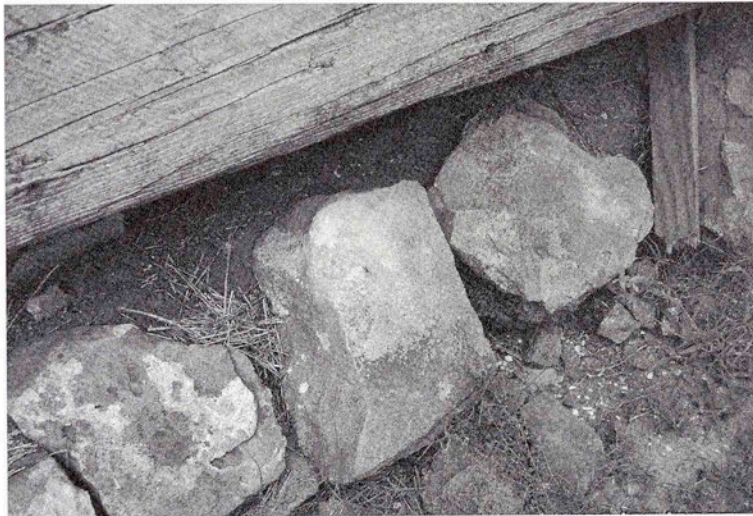
Figure 5.72 Fieldstone foundation in Don Elemnhorst and Frank Blaha's barn. (Photo by Lynda Ramsey)

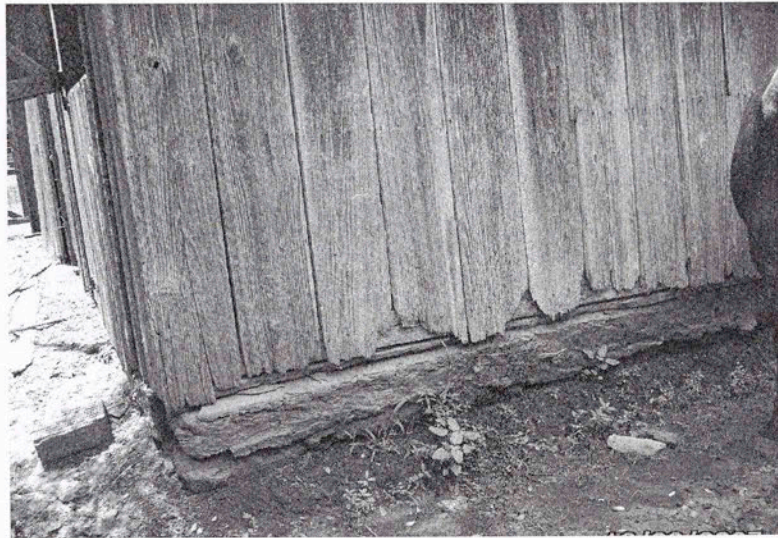
Figure 5.73 Concrete foundation on Elemnhorst and Blaha's barn.

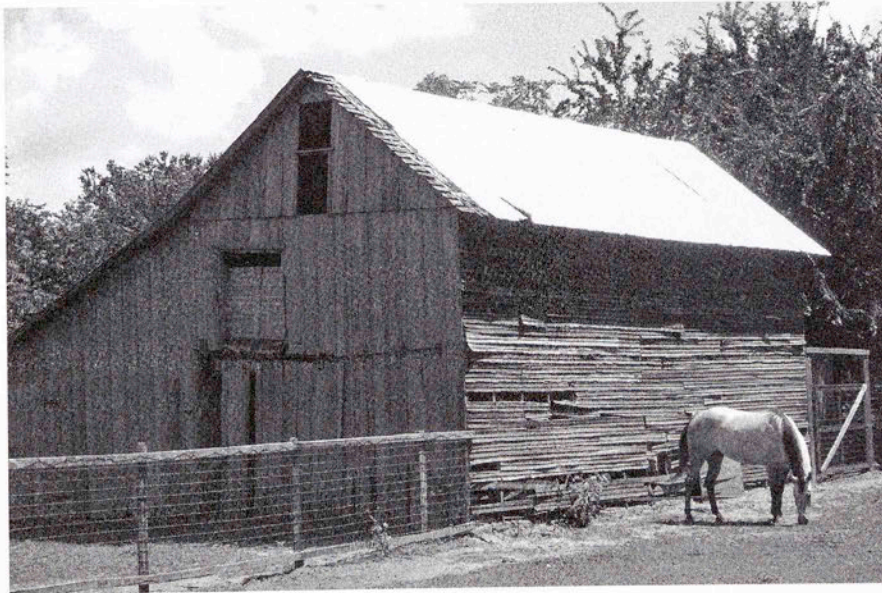
Figure 5.74 Frank Blaha barn with vertical siding on the north and horizontal siding on the west. (Photo by Lynda Ramsey)

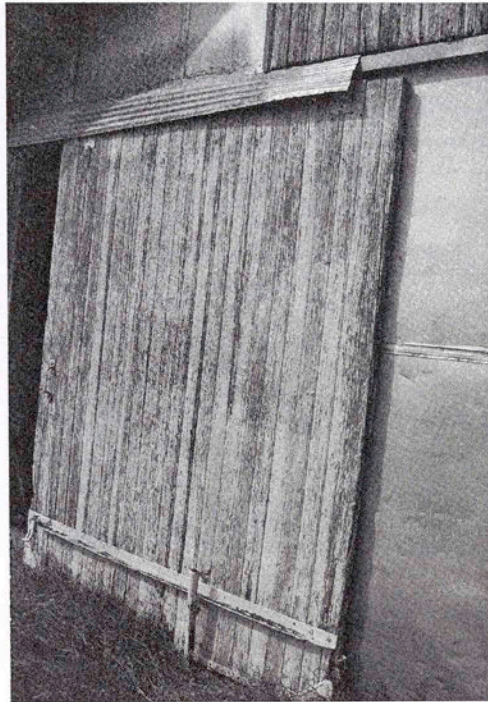
Fig. 5.78 Railroad Box car door used as a wagon door to the drive through in Hrdy's barn.

The wide gambrel roof covers an immense loft space in the Hrdy's barn for hay storage. Below the loft, a dairy operation once occupied each side of the central drive through. Railroad ties still brandishing their stamped numbers and initials R. I. stand as support post and cross beams (Fig. 5.79,80). They remain a source of pride and a symbol of the builder's frugality, ingenuity, and creative use of materials.

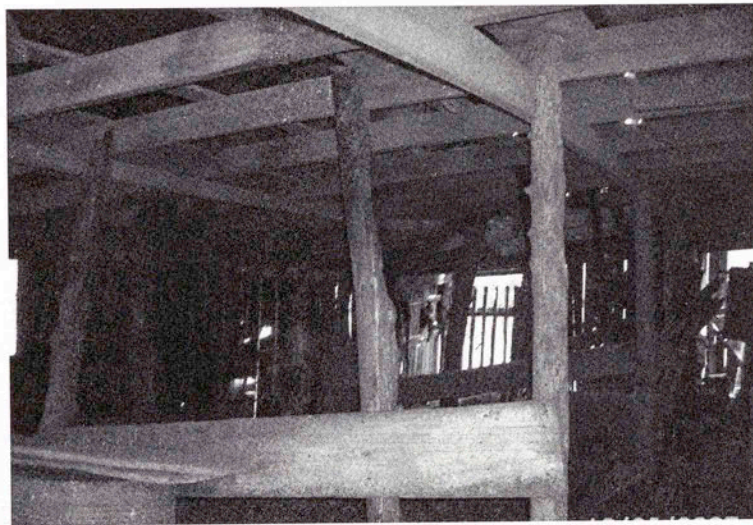
Hewn posts used to support floor ceiling joists. Charred post indicate the barn burned at one time.

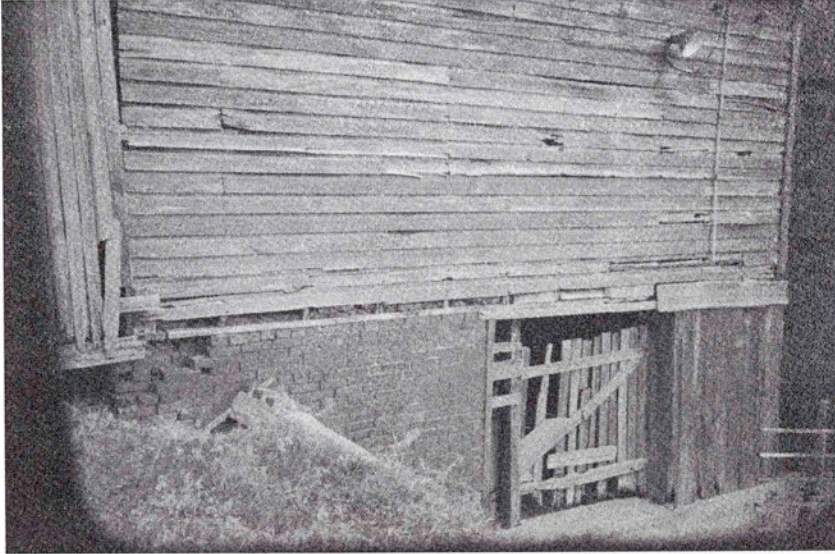
South lower level with a red brick foundation wall and gate entrance into the dairy.

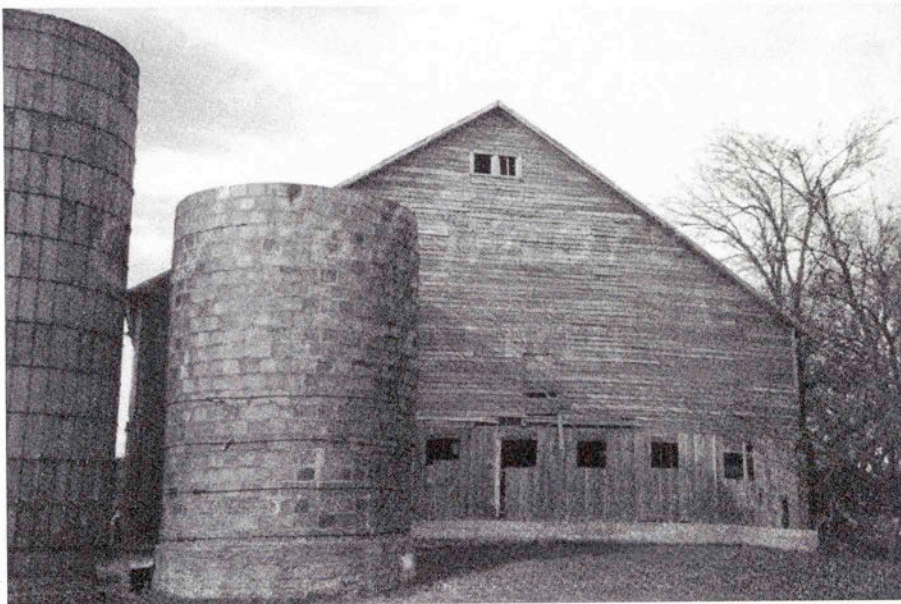
East end of the Cooksey's barn with early granary constructed from clay brick.

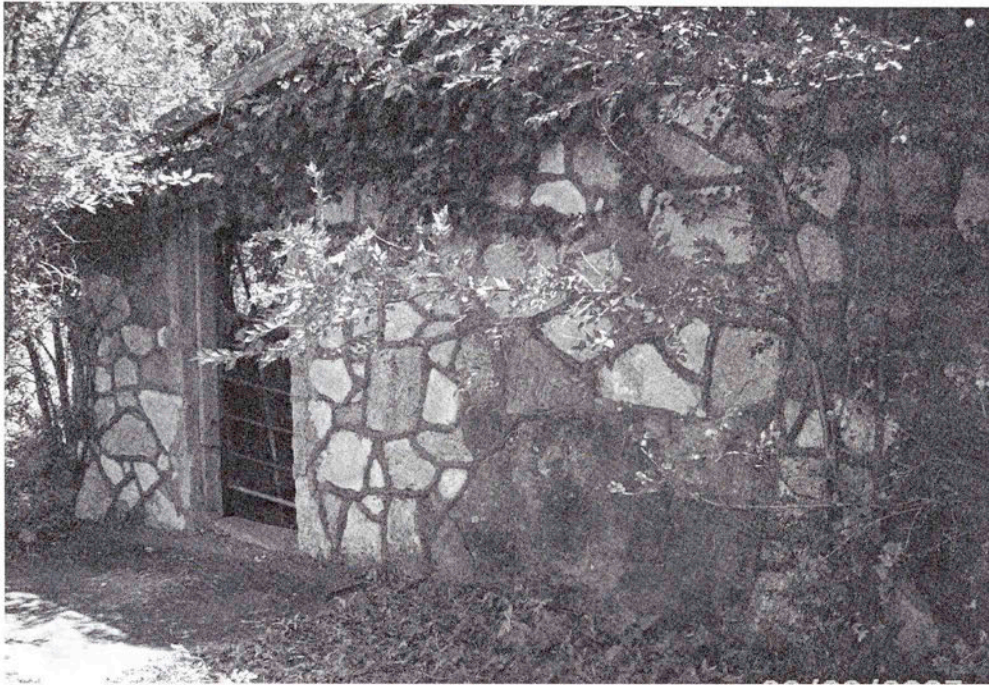
North stone exterior of Huckleberry's horse barn.

36. CONDITION OF RESOURCE: 03 FAIR
37. DESCRIPTION OF RESOURCE: (Present and Historic) Metal sheets have been added to cover the wooden shingle roof. Doors are missing and some of the stonework has collapsed on the east side of the barn.

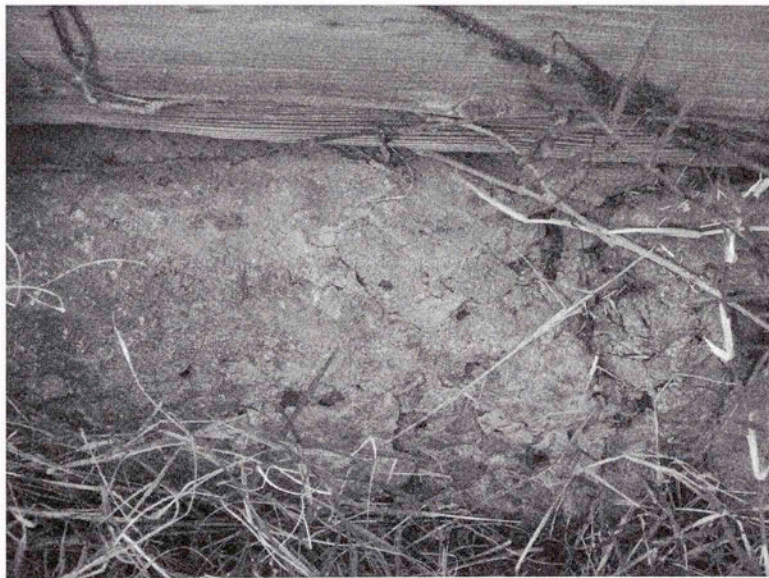
Concrete foundation mixed with red fieldstone.

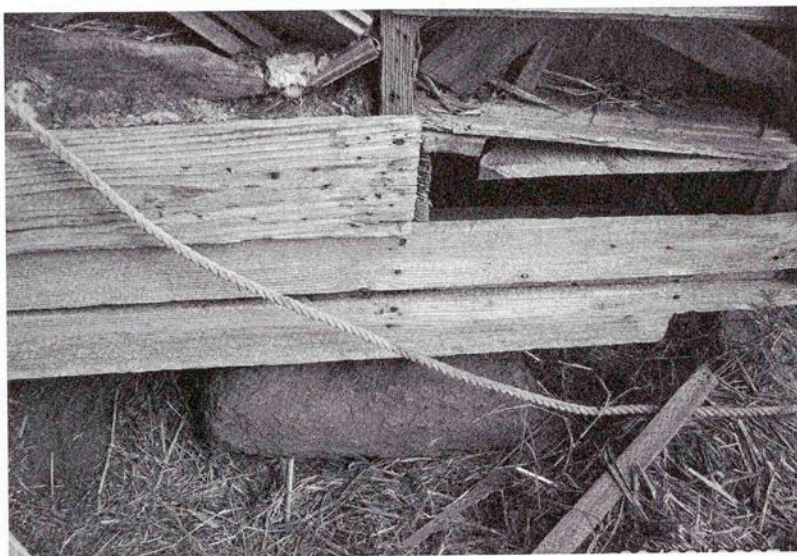
Field stone used as foundation.

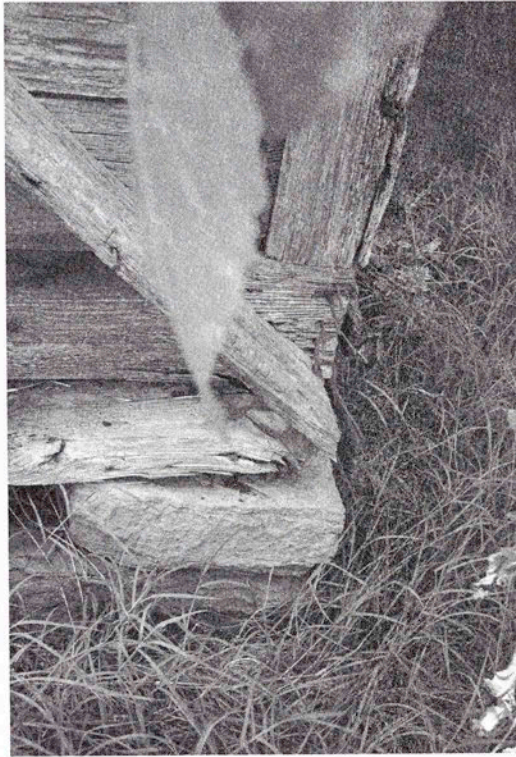
Field stones used as corner support.
