FINAL REPORT ~ FHWA-OK-21-03

EVALUATION OF ULTRA-HIGH-PERFORMANCE CONCRETE FOR USE IN BRIDGE CONNECTIONS AND REPAIR

School of Civil Engineering and Environmental Science
The University of Oklahoma
Norman, Oklahoma

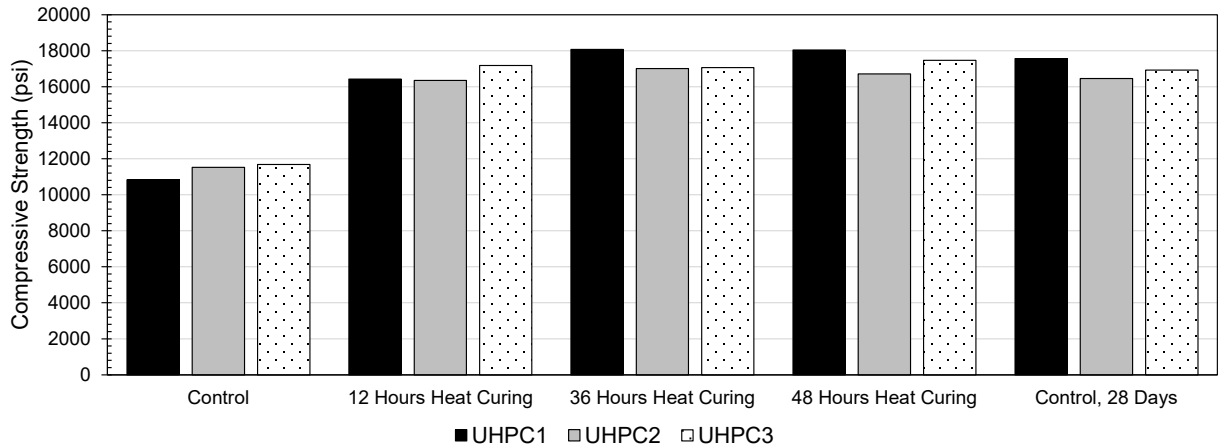
Figure 41. Compressive strengths of heat-cured (3-day) vs. non-heat-cured (28-day) for mixes J8 (1), J3 (2), and J13 (3) without fibers

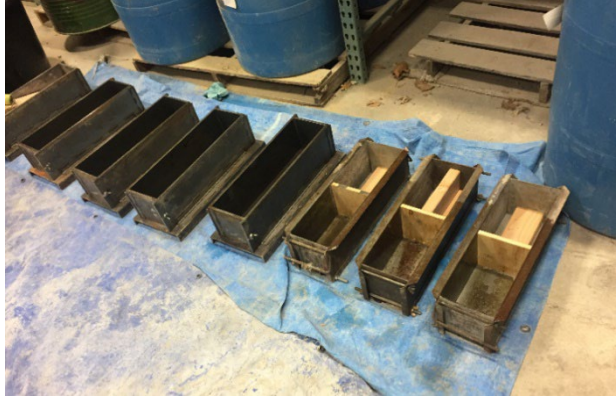
Figure 51. Formwork prepared for small-scale MOR specimens to be cast. Three half specimens for exposed aggregate finish are visible in the right of the photo

Small-scale interface bond modulus of rupture (MOR) specimens were designed for evaluating the effect of different concrete surface preparations and orientation of saw cut on UHPC joints. The dimensions of these specimens (6 in. x 6 in. x 20 in.) were based on ASTM C78, the methods of which were used for testing the composite joints. Twenty-four small-scale modulus of rupture (MOR) style specimens with dimensions based on ASTM C 78 (6 in. x 6 in. x 20 in.) were cast for evaluating the effect of different concrete surface preparations and orientation of saw cut on bond between both Ductal® and the J3 UHPC and the base concrete. Twelve full-length specimens were cast, which were cut in half at angles of 90°, 60°, and 30° from the horizontal after 28 days of curing. The cut surfaces of the half specimens were then prepared using two different surface preparations, wire brushing and sandblasting. The remaining twelve

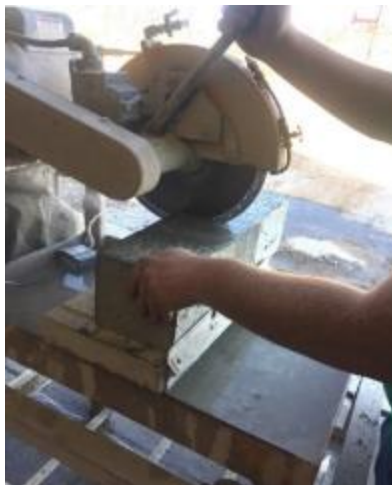
Figure 52. Cutting small-scale specimen at 90° angle to the horizontal

All specimens that required cutting were cut with a diamond blade concrete saw, as seen in Figure 52. Specimens were then either sand-blasted until a uniform surface roughness was visually observed, or wire-brushing was performed on the smooth cut surface to clean away any debris depending on the specified variable combination. All exposed aggregate specimens were pre-prepared. Wooden inserts were placed in the standard MOR beam forms to create the proper surface orientation, as shown in Figure 51. The faces of the wooden inserts were sprayed with adhesive and then coated with sugar. This prevented the concrete in contact with the sugar from curing, allowing extra chunks of cement paste to be power washed off the face of the concrete when the forms were removed, thereby exposing the aggregate. The exposed aggregate surface after power washing is shown in Figure 53.

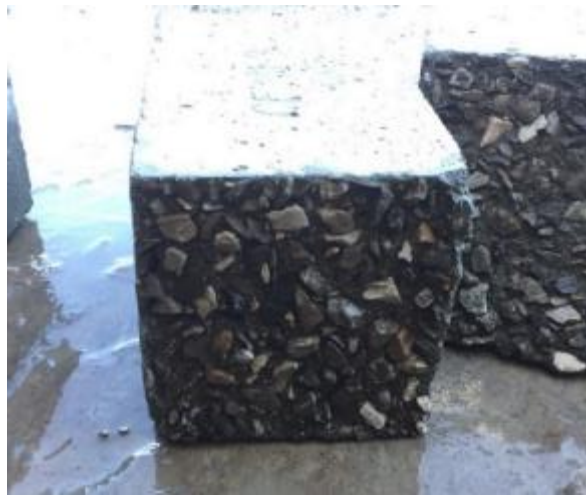
Figure 53. Exposed aggregate surface after power washing

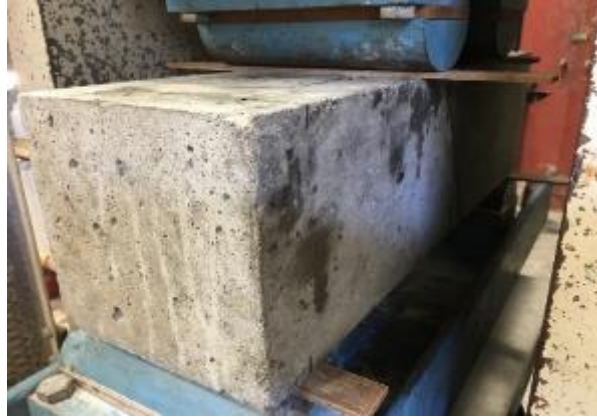
Figure 55. Composite MOR specimen testing apparatus

All composite specimens were tested in flexure using third point loading with the procedures of ASTM C78 when the UHPC portion of the specimen reached an age of 28 days. The test setup is shown in Figure 55. The thirty-six specimens were tested broken into ten groups. Four specimens were tested for each combination of wire brushed or sand blasted surface and angle of cut with the horizontal (90°, 60°, and 45°). Three exposed aggregate finish specimens were tested for each angle and three

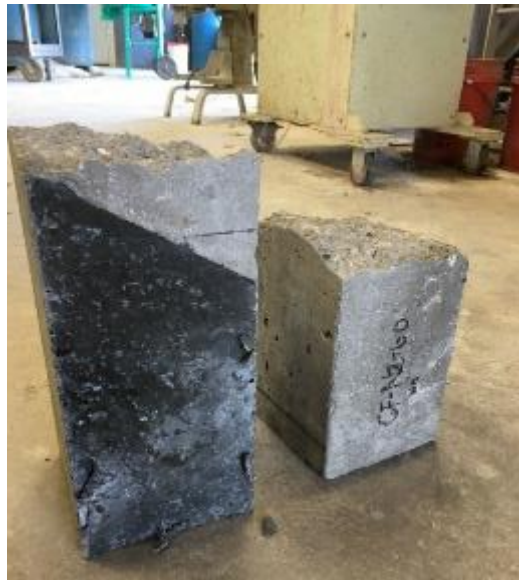
Figure 57. Example of failure pattern for one of the 60° joint specimens

A summary of the results for composite specimens cast with Ductal[®] is shown in Figure 56. Only the specimens cut at 90° with a wire brushed surface failed at the base concrete/UHPC interface. All other specimens failed in the base concrete, but within the middle third of the span. An example of the failure pattern for one of the 60° specimens is shown in Figure 57. The compressive strength of the UHPC for each specimen group was in excess of 21,500 psi at 28 days with no heat curing. Results indicate that all surface preparations create a joint stronger than the value calculated for the base concrete for the 90° and 45° specimens. The exposed aggregate finish provided the best results for these two orientations with the sandblasted and wire brushed preparations producing very similar results. The 60° specimens did not exceed the calculated flexural strength based on the base concrete compressive strength even though all specimens failed in the base concrete.

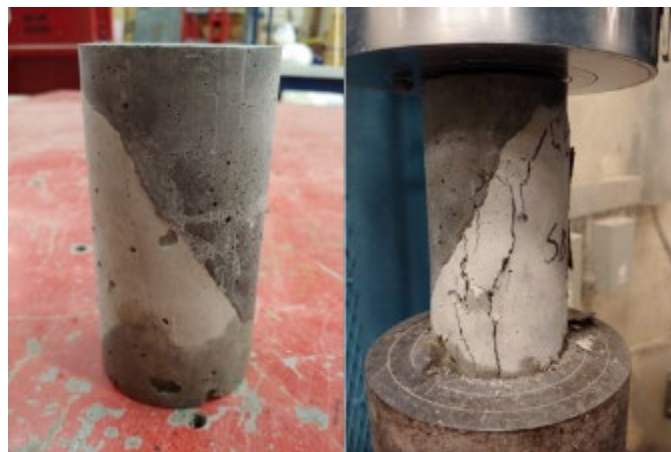
Figure 59. Composite slant shear specimen prior to testing (left) and after testing (right)

Slant shear specimens were cast in the form of 6 in. x 12 in. cylinders based on an adaptation of ASTM C882. A completed slant shear specimen before and after testing is shown in Figure 59.

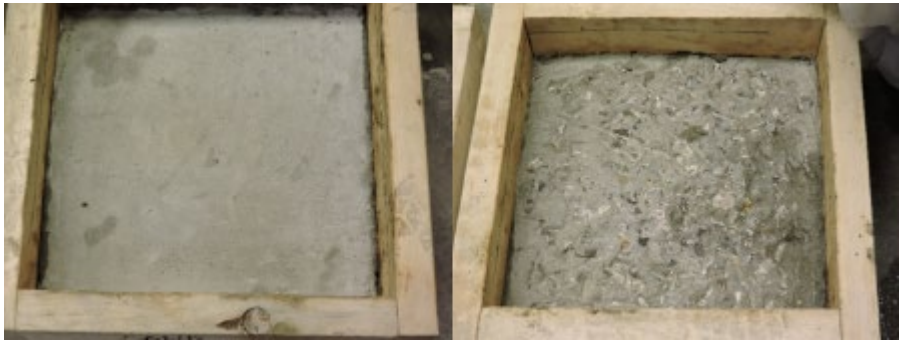
Figure 60. Sandblasted (left) and chipped (right) surface preparations

The research team constructed Class AA substrate specimens for direct pull-off testing and the surfaces of these specimens were prepared for overlay casting with different surface preparations: wire brushed, sand blasted, and chipped, shown in Figure 60. These specimens were allowed to cure for 28 days before Ductal® and J3 overlay placement, which was then allowed to cure 28 days before testing. Completed specimens are shown in Figure 61.

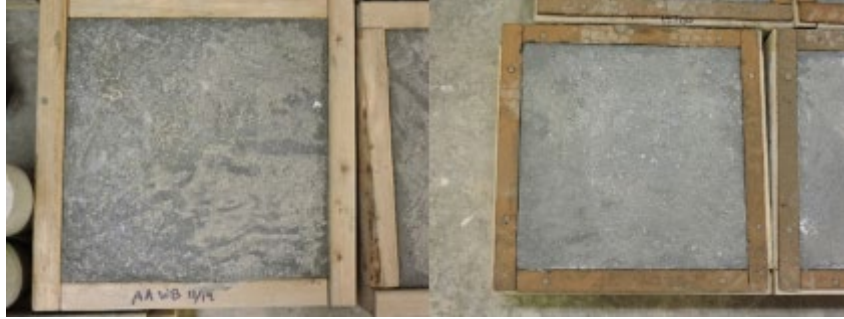
Figure 61. Pull-off test specimens for Ductal® (left) and J3 (right)

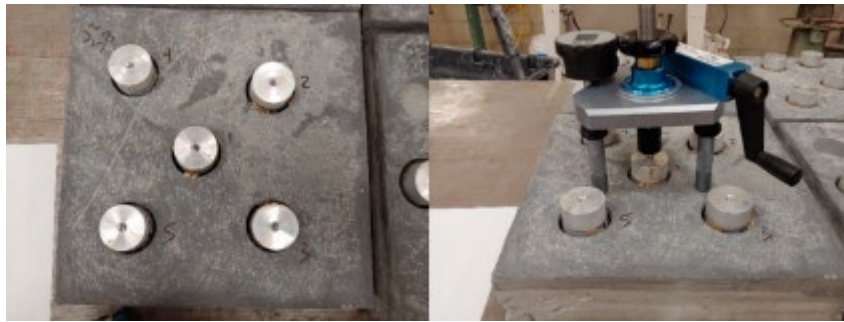
Figure 62. Pull-off tests for J3 with overall layout (left) and test setup (right)

Pull-off tests were conducted for both Ductal® and J3 specimens using the methods of ASTM C1583 as shown in Figure 62. The results of the pull-off tests are shown in Table 27. The Ductal® UHPC performed better than the J3 in the direct pull-off tests.

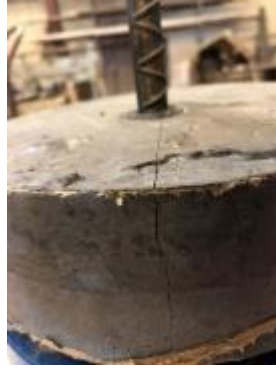
Figure 64. Splitting failure of $2d_b$ embedment bond test specimen

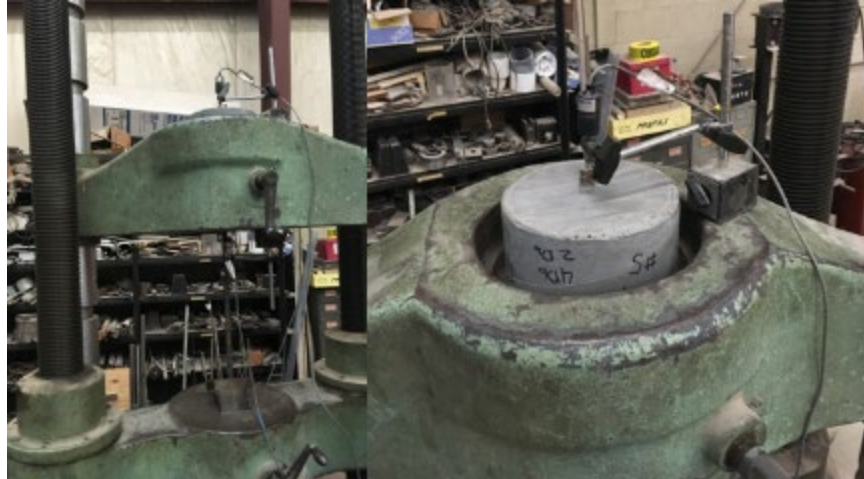
Figure 66. Pullout test of No. 5 bar specimen with 1% fiber mix showing the overall setup (left) and a closeup view of the as tested top of the specimen (right)

Pullout specimens for the J3 mix with No. 3, No. 5, and No. 8 bar and 0%, 1%, 2%, 4%, and 6% fiber mixes were cast and tested at 28 days of age. Ductal® specimens with 2% steel fibers were also cast and tested. The specimens were tested in a Baldwin universal testing machine with a neoprene pad placed under the specimen to ensure uniform bearing. Load was applied constantly until failure and bar slip was measured with an LVDT on each side of the specimen. The pullout test setup is shown in Figure 66.

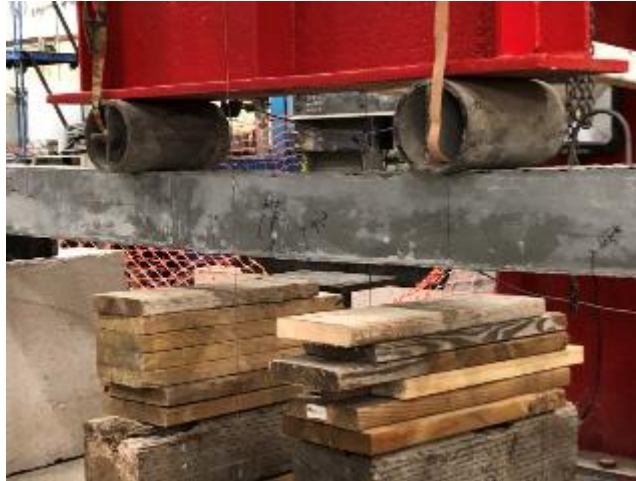
Figure 75. Crack pattern for test SB-D5-1

The SB-D5 tests both exhibited minimal visible cracking throughout the tests; in each test, a few small vertical cracks appeared near or just outside the load points (which bracketed the constant moment region) at loads between 6 and 7 kips. Subsequently, a few more vertical cracks began to propagate between the load points, near midspan of the beam at the splice location. These cracks appeared at around 7 to 7.5 kips, and a few more such cracks appeared and propagated from bottom to top of the section as load was increased towards ultimate, which was around 11 kips for both SB-D5 beams. In both cases, at loads of around 9 to 9.5 kips, the crack nearest the splice location began to widen and lengthen considerably as the beam neared ultimate load; then, after the peak load was reached, the load began to fall rapidly as the midspan crack opened very wide. After that point, continuing to pump the hydraulics still resulted in falling load levels, until eventually the last fibers holding the beam together near the top were pulled out, and the beam collapsed onto wooden fall supports, in two more or less separate halves. Figures 75 and 76 show the relatively minimal and discrete cracking patterns that were observed in beams SB-D5-1 and 2 respectively. In both Figures 75 and 76, it is clear that the cracks were confined to a few at or just outside the load points, and a few clustered near the beam midspan, although test SB-D5-2 had more cracks between midspan and the load points.

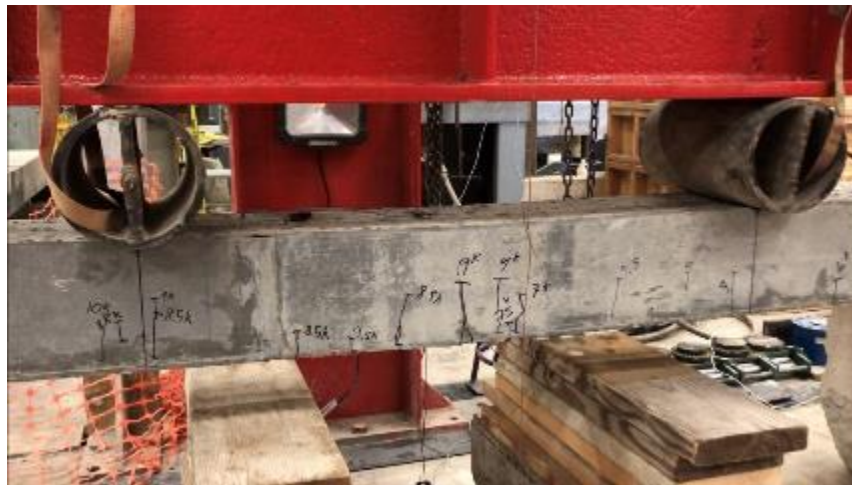
Figure 76. Crack pattern for test SB-D5-2

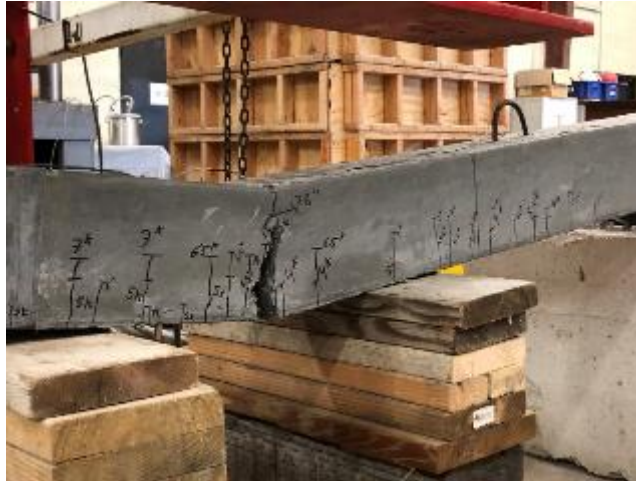
Figure 77. Crack pattern typical of SB-J5 with 2% fibers

The SB-J5 tests, however, exhibited significantly more visible cracking throughout the tests, and this cracking was substantially more distributed along the span. In addition, the cracking began to appear at substantially lower loads, as low as around 4 kips for the 2% beams and as low as 2 kips for the 1% beams. Once the beams approached their ultimate failure loads, however, the cracking behavior closely mirrored the SB-D5 beams, in that the vertical cracks near midspan began to propagate more quickly, while the smaller distributed cracks away from midspan mostly stopped growing. Figures 77 and 78 show the typical cracking pattern for 2% and 1% SB-J5 beams respectively.

Figures 77 and 78 clearly show that the crack patterns for the SB-J5 beams were significantly more numerous and widely distributed along the spans than those of the SB-D5 beams. In addition, they appeared at loads of 2 to 4 kips as opposed to around 7 kips for the SB-D5 beams. Both the slope of the ascending branches of the load deflection curves and the observed cracking patterns both indicate a stiffer response by the proprietary material compared to the non-proprietary, as well as a stiffer response by the 2% fiber mixes compared to the 1% fiber mix.

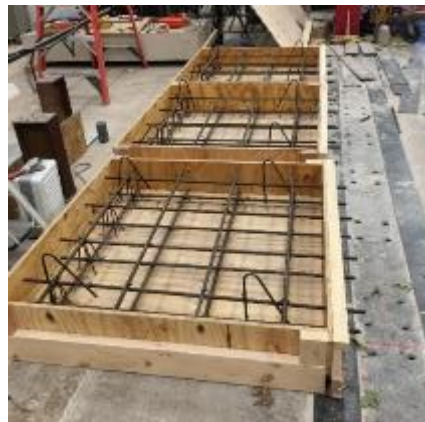
Figure 80. Formwork and reinforcement for slab specimens immediately before casting

The formwork and reinforcement for three of the slab specimens immediately before casting are shown in Figure 80. Approximately 5 in. of each bar was left exposed to provide dowels into the 12 in. UHPC joint. This bar extension is based on the short anticipated development length of $8d_b$ (5 in. for this case) embedment recommended by FHWA for mild steel reinforcing bars cast in UHPC (Graybeal 2014). This arrangement was intended to represent the steel that will be exposed in the field after an existing joint is sawn out to be replaced.

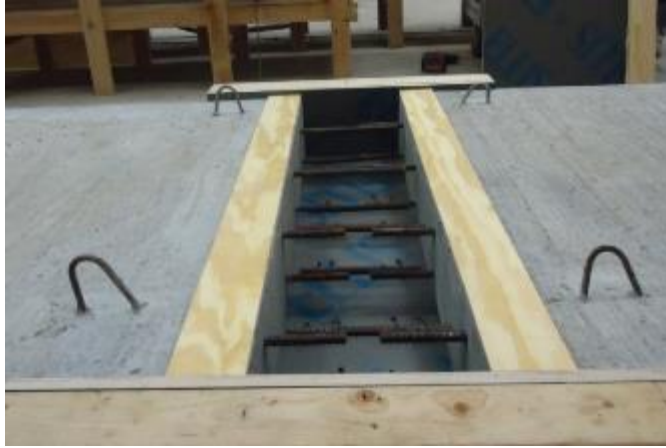
Figure 82. UHPC slab joint formwork and reinforcement before placing the formwork top

The joint was formed $\frac{1}{4}$ in. high along the entire width of the slab and formwork was placed for the joint ends and top. Copper tubes for embedding thermocouples were placed at approximately the levels of the two rebar mats near the joint end and near the center of the joint thickness at the joint center. A 4 in. diameter hole was cut near each end of the formwork top to allow placement of the UHPC and an air vent. A large funnel was placed in one of the holes to direct the UHPC into the formwork for the Ductal[®] specimens and first J3 specimen. The funnel is visible in Figure 83.

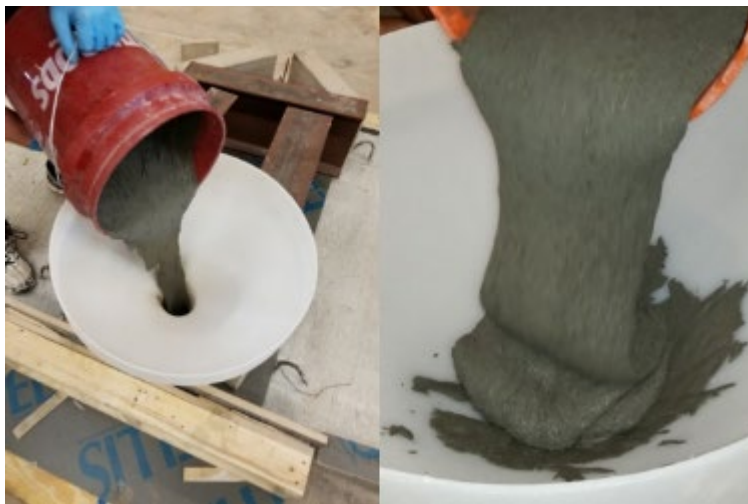
Figure 83. Placement of UHPC into the slab joint formwork

consecutively with a time between placements of 20 min to 30 min. The material was very flowable, as shown in Figure 83 and was all placed from the same location and allowed to flow across the joint. Material was placed until it began to run out of the vent hole on the opposite end of the formwork. The J3 joints were cast using a single batch of UHPC mixed in the larger rotary mixer. The funnel placement method was abandoned after the first J3 specimen and the UHPC was poured directly into the forms and then topped due to the extremely thixotropic behavior of that batch. Once casting of all specimens was complete, the top of the formwork was removed, the thermocouples were inserted, and the top of the joint was covered with heat resistant plastic. The heat lamp was moved into place and heat curing was conducted on both the joint and companion compressive strength specimens for 12 hours using the regimen identified during previous testing for the Ductal[®] specimens and 36 hours for the J3 specimens. When the heat curing duration was reached, the heat lamp was removed, and the joint was allowed to cure in ambient conditions for the remainder of 28 days. The heat curing setup is shown in Figure 84 and the temperature history for the first slab is shown in Figure 85. Compressive strength tests were conducted on heat cured cylinders at the end of curing. Companion cylinders cured in ambient conditions were tested at 24 hours and 3 days of age for comparison.

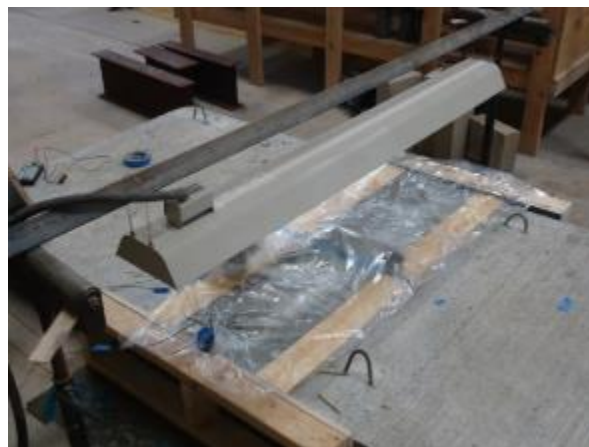
Figure 84. Heat curing for Ductal[®] slab joint 1

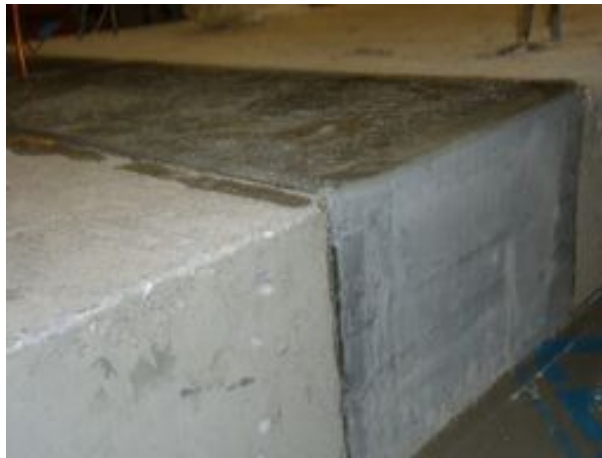
Figure 86. Completed Ductal® slab joint after formwork removal

Formwork was removed from the joint the day following the end of heat curing. A completed Ductal® joint after removal of the formwork is shown in Figure 86. Faint lines were visible between the placement layers but no indication of poor consolidation or poor bond between layers was observed.

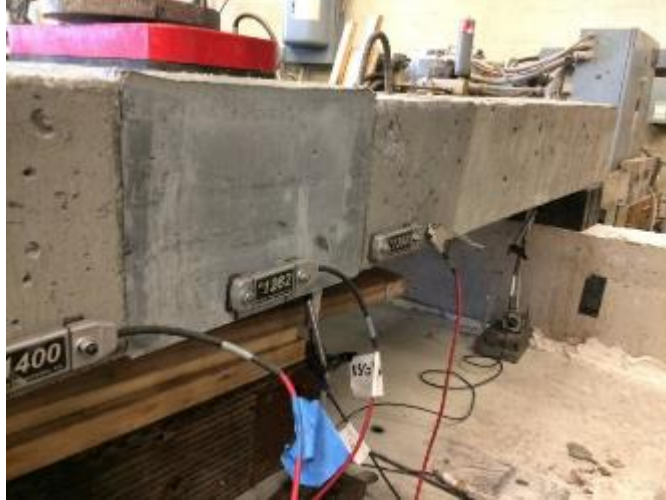
Figure 88. Placement of external strain gauges and LVDTs on the south side of the slab specimen

MTS servo hydraulic cylinder and corresponding load frame. The point load was distributed over a 10 in. by 20 in. area using a steel plate and neoprene pad designed to mimic the wheel patch area specified in AASHTO LRFD Chapter 3 (2017). A photo of the load test setup is shown in Figure 87. For all tests, deflection was monitored on both sides of the joint using linear voltage differential transformers (LVDTs) or wire potentiometers (pots). Deflection was also monitored near the supports using LVDTs in order to remove the effects of support deflection from the results. Applied load was measured using a load cell placed at the load point. External strain gages were placed on the base concrete on either side of the joint and in the center of the UHPC joint material on the south side of each specimen and one strain gage was placed at the center of the UHPC joint material on the north side of the specimen. A photo showing the strain gauges and LVDTs on the south side of the slab is provided in Figure 88. After testing the Ductal® joints it was determined that strain gages on the reinforcing bars would provide additional useful information. For the three J3 joints foil strain gages were placed on two of the bottom reinforcing bars extending from the slab nearest the load point and on the corresponding splice bars.

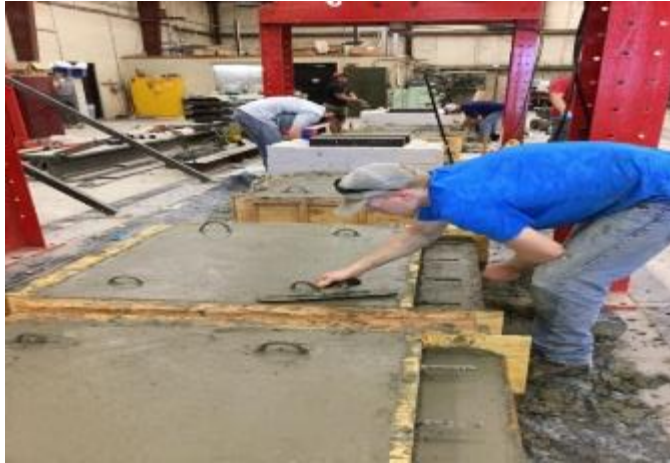
Figure 93. Finishing the top surface of the base concrete slabs

The twelve base slabs required for the joints were cast in two sets of six using the same Class AA concrete mix from Table 30 obtained from Dolese Bros. Finishing work was required at the top surface as shown in Figure 93 before a final broom finish was applied. Completed slabs are shown in Figure 94. A total of 24 4 in. x 8 in. cylinders were also cast from the same conventional concrete mixture. A group of 12 cylinders were used for testing compressive strength of conventional concrete for non-proprietary UHPC joint connections. The other 12 cylinders were used for testing compressive strength of conventional concrete for proprietary UHPC joint connections.

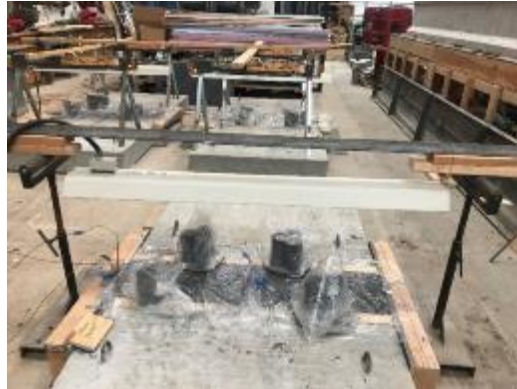
Figure 102. Heat curing of OU J3 half-depth slab joint specimens

Copper tubing was embedded in the UHPC joints and thermocouples were installed to monitor the temperature of the joints during heat curing. The non-proprietary UHPC joints were heat-cured for 36 hours with heat lamps installed at 16 in. above the top surface of the joints to ensure constant heat was provided throughout the joints as determined by Coleman (2018) and the internal temperature was approximately 200°F. The proprietary UHPC joints were cured using the same setup but for a duration of 12 hours and the internal temperature was approximately 180°F. Heat resistant plastic

sheeting was placed over the UHPC joints to retain moisture during. Companion cylinder specimens were placed alongside the joints to be subjected to heat curing as well. Figure 102 shows the setup of the heat lamps and the UHPC joints being cured. At the end of the 36- or 12-hour curing period, the heat lamps were removed, and the joints were allowed to cure under ambient laboratory conditions for at least 28 days before testing. Figure 103 shows a completed UHPC joint.

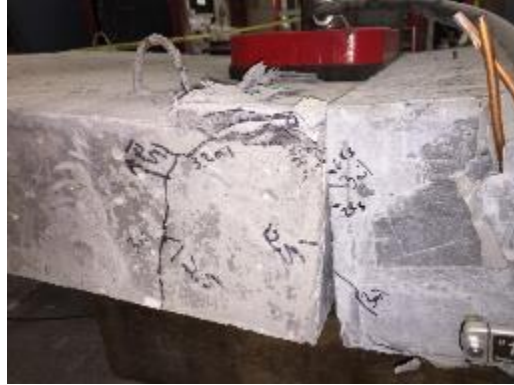
Figure 114. Ductal® slab joint 3 after completion of testing showing concrete crushing and separation at joint indicative of rebar failure

Very little change in behavior was observed over time for the first 3,000,000 load cycles. The load was then increased to a load greater than the cracking load and loading continued until specimen failure after approximately 244,000 additional load cycles. There was significant visible cracking and a residual deflection of 0.38 inches. The major failure crack on the bottom of the slab began on the south side 5.9 inches away from the joint interface closest to the load. Halfway across the slab (in the north-south direction) the crack migrated westward toward the joint and continued along the interface to the north edge. The slab was then statically loaded to complete failure at an ultimate load of approximately 17.7 kips, significantly less than the other two slabs and less than the expected capacity. It was determined that the steel stress for the increased loading beyond 3,000,000 cycles exceeded the fatigue stress limit for the reinforcing steel and that at least one of the reinforcing bars fractured during fatigue testing. The slab joint after completion of testing is shown in Figure 114.

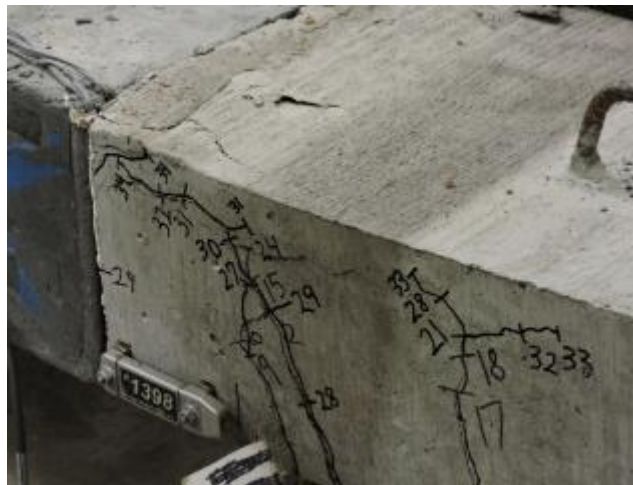
Figure 117. Slab joint at failure showing concrete crushing on the compression face, cracking in base concrete, and opening at joint interface

Failure of the first two non-proprietary J3 UHPC slab joints tested statically initiated due to yielding of the lapped reinforcing steel within the joint, as indicated by both a plateau in the load-deflection plot (Figure 115 and Figure 116) and through strain gage readings from sensors installed on the reinforcing steel. The lap lengths measured only 5 in. for the No. 5 reinforcing steel, indicating exceptional bond strength within the UHPC joint. Cracking occurred exclusively within the base concrete and not within the UHPC joint, although the interface did begin to open as the stresses exceeded the bond strength between the UHPC and base concrete and the reinforcing steel yielded, as shown in Figure 117.

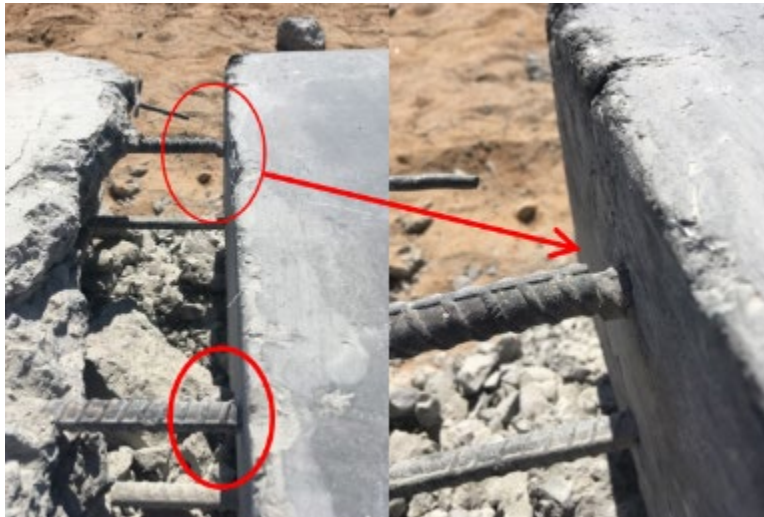
Figure 118. Fractured tension reinforcing bars after fatigue failure of slab joint (note that the slab has been flipped relative to the testing orientation)

to determine residual capacity. The J3 specimen exhibited similar performance to the previously tested Ductal® specimen. After testing the concrete on the load side of the joint was removed to expose the reinforcement, shown in Figure 118. Two fractured reinforcing bars resulting from fatigue failure were observed, but no evidence of bar pullout from the UHPC was visible.

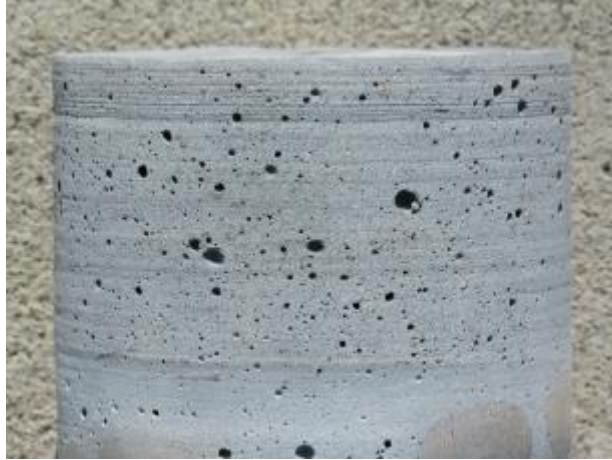
Figure 119. Non-proprietary UHPC slab joint core indicating uniform consistency

Concrete cores were removed from one of the statically tested J3 slab joint specimens to examine the upper surface of the non-proprietary UHPC. It was noted previously that the non-proprietary UHPC did not experience a very friable upper portion as what normally occurs with the Ductal® material. Ductal® tends to experience a very high degree of bubbles and thus weak, friable material near the top surface and typically requires grinding/removal of that poor material. As such, the manufacturers of Ductal® require the material to be cast at least $\frac{1}{4}$ in. higher than finished grade. However, the non-proprietary UHPC does not show a comparable weakened upper surface, as shown in Figure 119. As a result, it may be possible to cast the non-proprietary material at the finished grade and eliminate the need for grinding the top surface, saving considerable cost in a bridge joint replacement or other application.

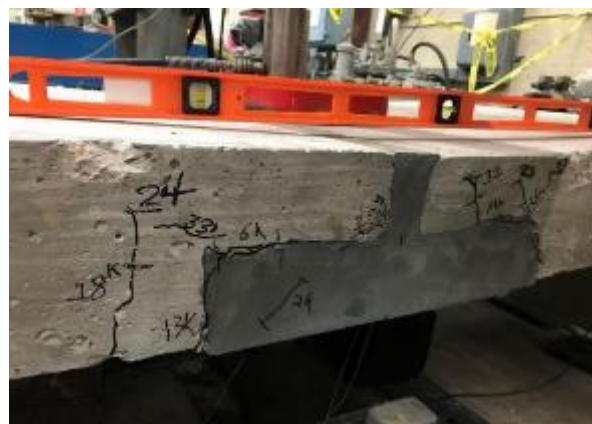
Figure 126. Cracks formed at interface between UHPC and conventional concrete and underneath the load point on the south side of J3 slab joint 1

At failure, the cracks were mainly at the interface between the conventional concrete and UHPC, with some cracks in the conventional concrete. Figures 126 and 127 show cracks on the slab after failure. The majority of the cracks at failure appeared to be evenly distributed on both sides of the joint. Significant cracks appeared at the interface between the UHPC and conventional concrete. Additional cracks were located approximately 3 in., 4 in., and 5 in. away from the interface. There was also substantial separation at the conventional concrete to UHPC interface at the as-tested bottom of the slab, which was visible while loading, but could not be seen once the load was removed from the slab. Figures 128 and 129 show images of cracks and deformation of the slab after failure.

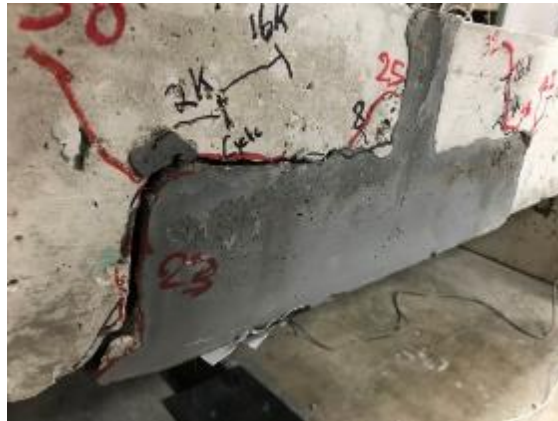
Figure 135. Cracks formed at the conventional concrete to UHPC interface on the north side of J3 slab joint 2

Similar to slab 1, multiple cracks appeared at the interface between the conventional concrete and UHPC. Some cracks also appeared in the conventional concrete. Figures 135 and 136 show cracks in the slab after failure for the north and south sides of the slabs. The majority of the cracks at failure appeared below the load point and there was a large separation between the conventional concrete and UHPC. A gap of approximately 0.25 in. was visible. Figure 137 shows concrete crushing at the top of the slab indicating failure.

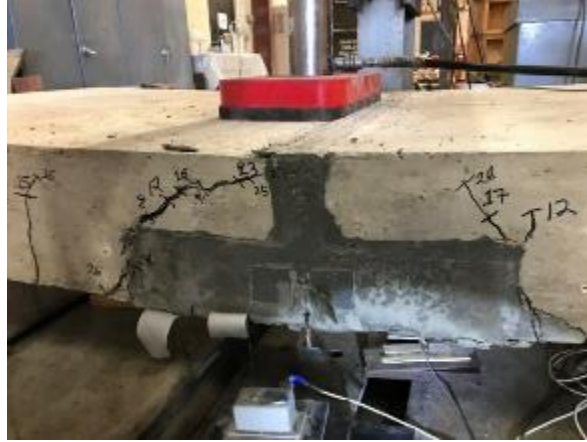
Figure 140. Large cracks at the conventional concrete to UHPC interface after part 1 of testing for Ductal® slab joint 1

Figure 140 shows cracks after part 1 of testing where the maximum load was 33.3 kips. The primary cracks occurred at the interface between the conventional concrete and UHPC. The gap grew larger as higher loads were applied. Cracks started at the bottom of the slab and propagated toward the top of the slab. In addition, cracks appeared at 2.25 in. away from the interface.

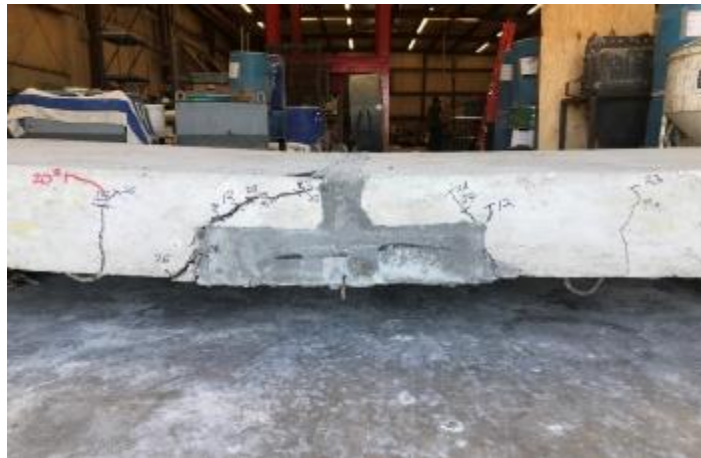
Figure 143. Ductal® slab 1 after part 2 of testing

appeared in the conventional concrete. Figure 143 shows cracks on the north side of the slab after failure, on the as-tested underside of the slab, and concrete crushing on the as-tested top of the slab. The majority of the cracks at failure appeared below the load point. From the bottom surface of the slab, it was evident that cracks extended across the entire width of the slab at the interface and approximately 3 in. away from the interface as shown in Figure 144. Large separation between the conventional concrete and the UHPC joint was visible. Figure 145 shows concrete crushing at the top of the slab indicating failure.

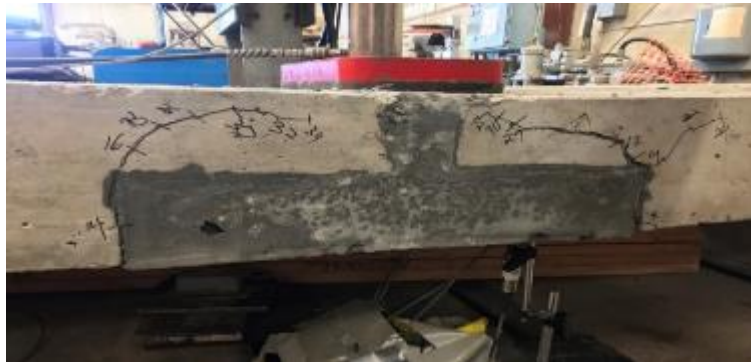
Figure 149. Cracks on the south side of Ductal® slab joint 2 after part 1 testing

Figures 148 and 149 show cracks after part 1 of testing on the north and south sides of the slab. Cracks occurred at the interface between the conventional concrete and UHPC and within the conventional concrete away from the joint. The gap between the UHPC and conventional concrete grew larger as higher loads were applied. All cracks started at the bottom of the slab and propagated toward the top of the slab while curving toward the load point.

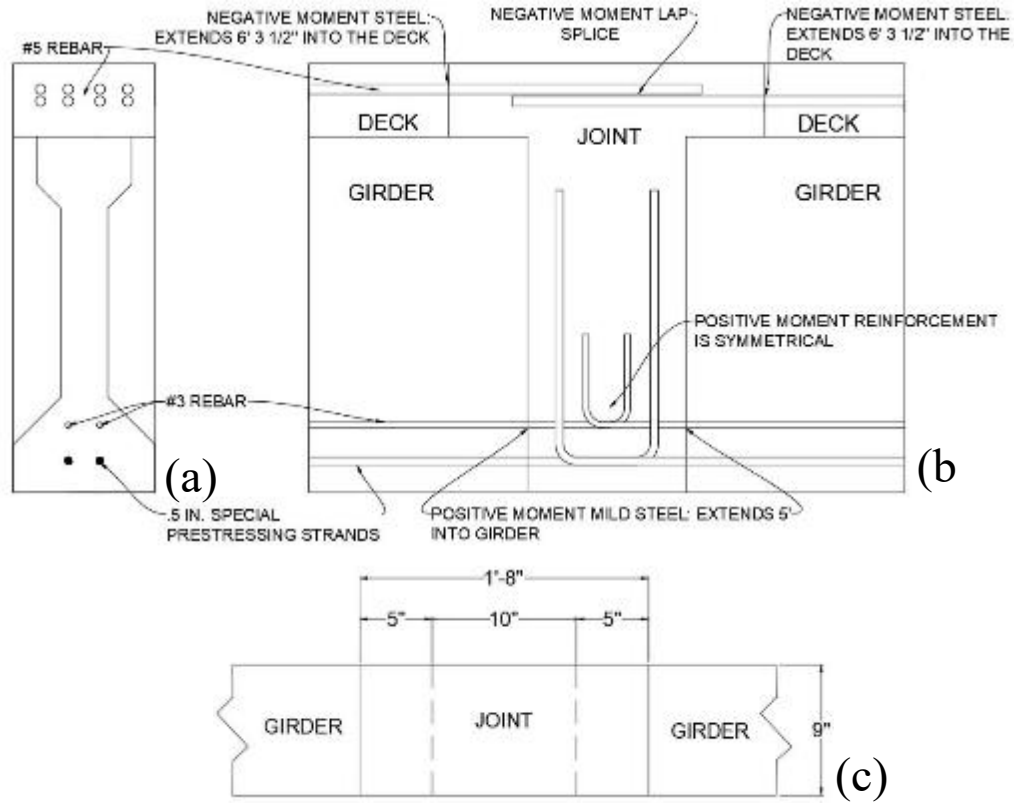
Figure 176. Newly constructed continuity joint cross-section (a), elevation view, (b), and plan view (c)

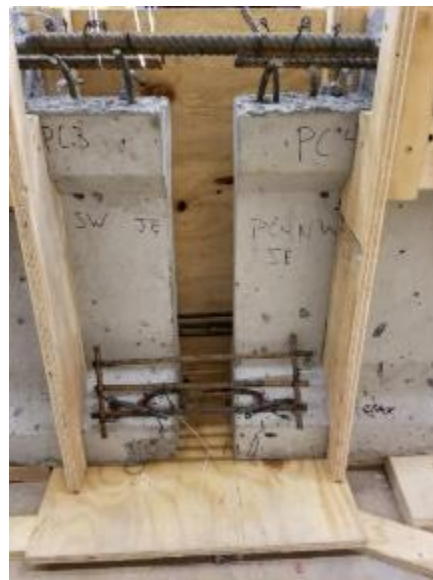
Figure 186. Reinforcement within continuity joint representing retrofit of an existing structure

The retrofit continuity joint was designed with the intention that it could be implemented on existing bridges in service with a simple span configuration. ODOT standard detailing sheets showed a 4 in. gap between girder ends in simple span configuration, which does not allow positive moment steel to be added in the end face of the girders. A solution had to be created for attaching reinforcing steel in another location on the girder at the required elevation. The solution decided on was to attach rebar shear studs on the outside surface of each side of the flange near the end of the girder. This would allow the steel required to resist the positive moment induced at the joint to be transferred into the girders as if the steel was fully developed into the girders as in the newly constructed joint design. The positive moment value used for determination of the required reinforcing steel was based on the same method as used for the newly constructed joint design since the age of the girders would far exceed 90 days for pre-existing girders to be retrofitted in the field. Reinforcement for the retrofit specimens (Figures 181-186) consisted of dowels embedded in the beam bottom flange using Hilti concrete epoxy with standard hooks extending into the UHPC joint material, three No. 3 splice bars extending across the joint at the beam bottom flange, and No. 5 splice bars between the reinforcement in the two beam slabs.

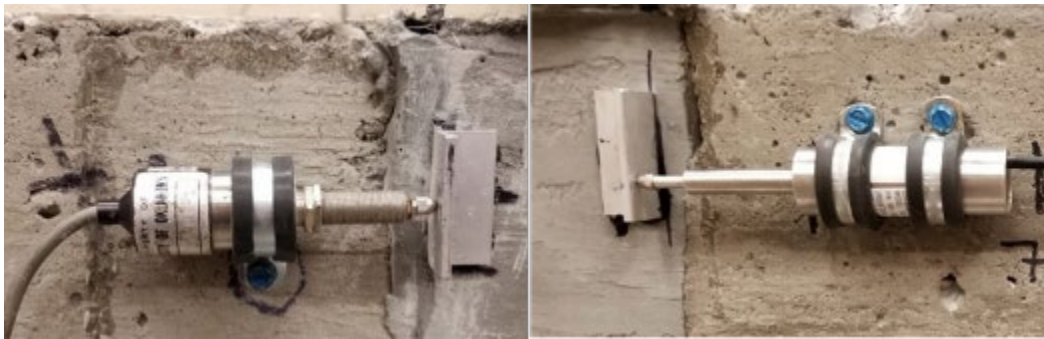
Figure 192. LVDTs used to measure joint separation attached to the girder

Four more LVDTs were attached around the negative moment region of the joint to measure joint separation at the interface of the connection if it occurred. One LVDT was attached directly to the concrete deck 2 in. below the top of the deck on each side of the joint on each side of the specimen using two conduit clamps and concrete screws. The LVDTs pushed against an aluminum angle attached to the UHPC joint. This allowed the LVDT to measure joint separation at the top portion of each interface on the side of the joint. Figure 192 shows two LVDTs attached to one face of the continuity joint.

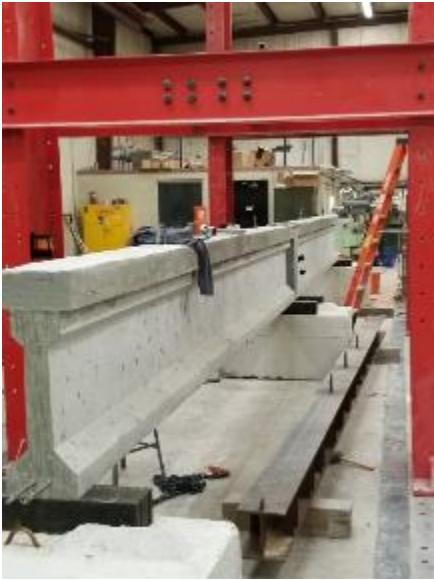
Figure 195. Continuity joint specimen in place for testing

The procedure to begin testing a new specimen started with moving the specimen into the load frames and aligning the specimen on the supports to ensure each girder was in line with the hydraulic ram. After the specimen was correctly aligned, the load cells, wire pots, and LVDTs were attached/placed into the correct position based on the sensor diagram. A specimen in place and ready for testing is shown in Figure 195. Once the sensors were in place, each sensor was tested to verify a signal change was being read on the data acquisition system, and all sensors were zeroed. Load was applied to each specimen in 5 kip increments until initial cracking. The specimen was inspected for initial cracking between each load increment. Upon finding initial cracking, the cracks were traced with a black marker, and the corresponding load increment was written at the end of the crack. Loading increments were changed from 5 kips to 2 kips after initial cracking occurred to allow a more precise crack tracking on the

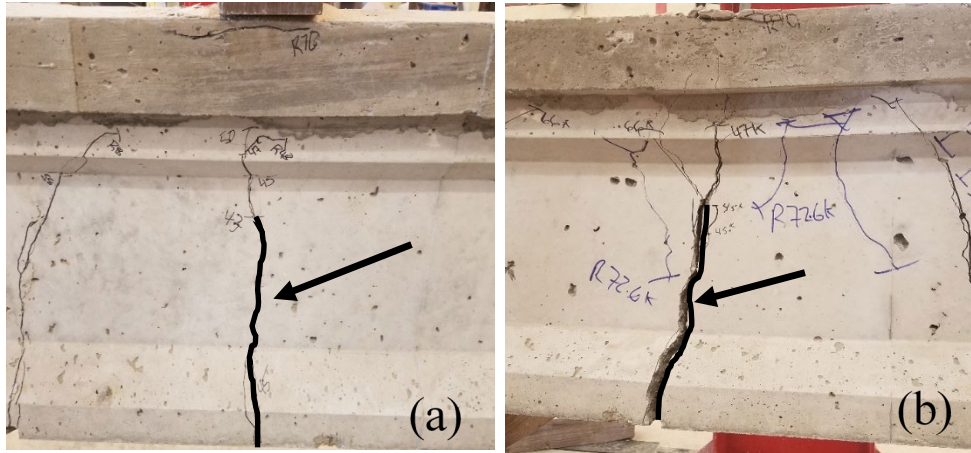
Figure 196. Initial flexural cracking under the load point on the NC1-N girder at 43 kips of load (a) and initial flexural cracking under the load point on the NC1-S girder at 45 kips of load (b). Arrows point to the dark lines that indicate the initial flexural cracks.

Initial flexural cracking was observed during the first loading near the joint interface on the NC1-S girder at a load of 35 kips, shown in Figure 197(b). The next flexural crack was observed directly under the load point on the NC1-N girder at a load of 43 kips, shown in Figure 196(a). In addition, two more cracks had developed at a load of 43 kips, a flexural crack near the joint interface on the NC1-N girder, shown in Figure 197(a), and a flexure-shear crack near the joint interface on NC1-S, shown in Figure 197(b). On the next load increment a flexural crack was observed on the NC1-S girder directly under the load point at a load of 45 kips, shown in Figure 196(b). A flexure-shear crack had also developed near the joint interface on the NC1-N girder at the same load, shown in Figure 197(a). Asymmetrical hairline flexural cracks were observed in the continuity joint at a load of 52 kips during the first loading, as indicated with dark lines in Figure 198. During the reload test a flexural crack was observed on the east face of continuity joint at a load of 44 kips, as indicated in Figure 197(b) with a dark oval. Additional flexural cracks developed during the reload test in the continuity joint at a load of 46 kips, as indicated in Figure 199 with dark ovals. These flexural cracks in the continuity joint developed at a lower load increment during the reload test

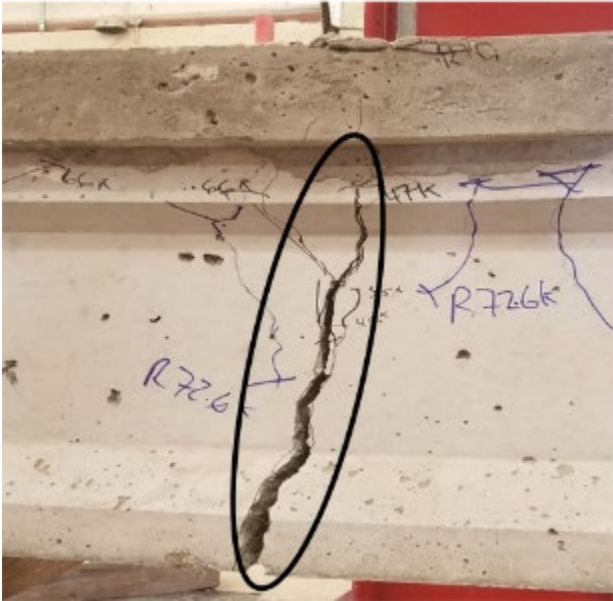
Figure 201. Flexural crack where the prestressing strands ruptured under the load point on the NC1-S girder, indicated by a dark oval

Loading of the specimen was stopped when the prestressing strands in the NC1-S girder ruptured directly under the load point at a load of 73.8 kips. The flexural crack directly under the load point where the prestressing strands ruptured is indicated in Figure 201 with a dark oval. The concrete deck began to crush at the load point in both girders under the loading conditions immediately before the prestressing strands ruptured, as shown by the dark circles in Figure 202. In addition, there was significant widening of the flexural cracks under both load points with additional load application, as shown by dark lines in Figure 202. These conditions were taken to indicate flexural failure of the beam specimens. Allowing the prestressing strands to rupture on the first test specimen helped indicate the capacity of the prestressed concrete girders

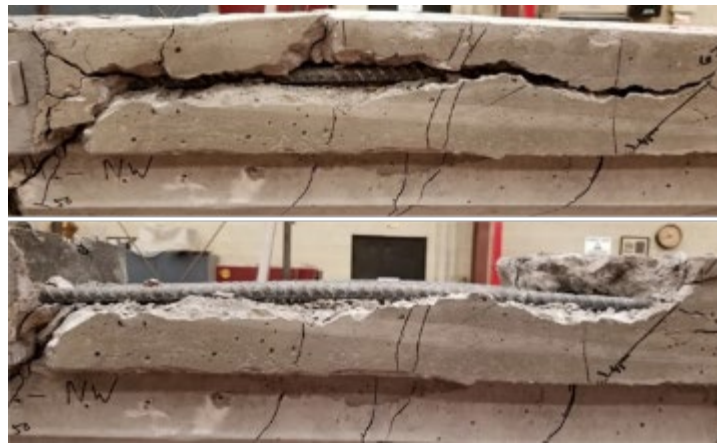
Figure 214. NC2-S girder before excavation of the concrete in the deck (top) and the deck after excavation exposing the reinforcement (bottom)

The NC2-S girder deck near the joint interface exhibited severe cracking along the side of the deck in the longitudinal direction at the level of the negative moment

reinforcement. After testing was complete, the top portion of the deck was removed to determine the cause of this behavior. After the concrete had been removed above the negative reinforcement, it was determined that the rebar had plastically deformed during loading. There was no sign of cracking around the reinforcement entering the UHPC joint, which indicated that the UHPC joint acted as a fixed end for the reinforcement. As the load increased during the test, the girder deflected more than the relatively rigid joint causing the rebar to follow the same curvature as the girder but remain fixed in the UHPC joint. This caused the rebar to bend sharply upward, and it separated the concrete along the longitudinal negative moment reinforcement in the deck. Figure 214 shows the NC2-S girder deck before and after the excavation of the concrete separation in the deck.

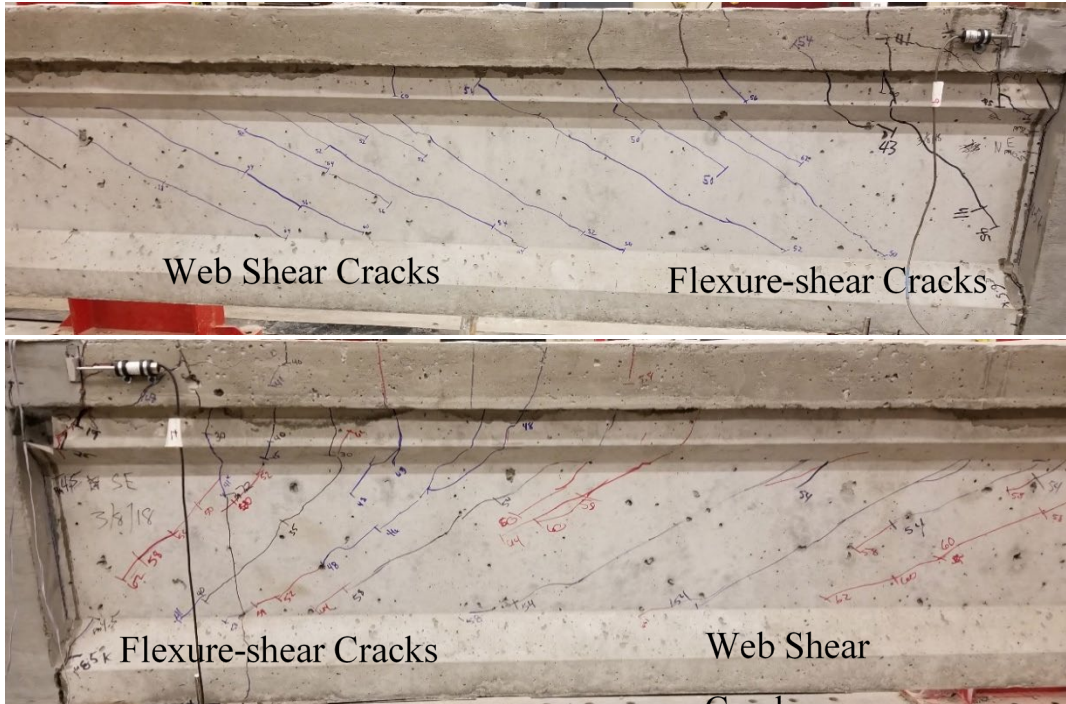
Figure 223. NC3-N girder with flexure-shear and shear cracks top and NC3-S girder with flexure-shear and shear cracks (bottom).

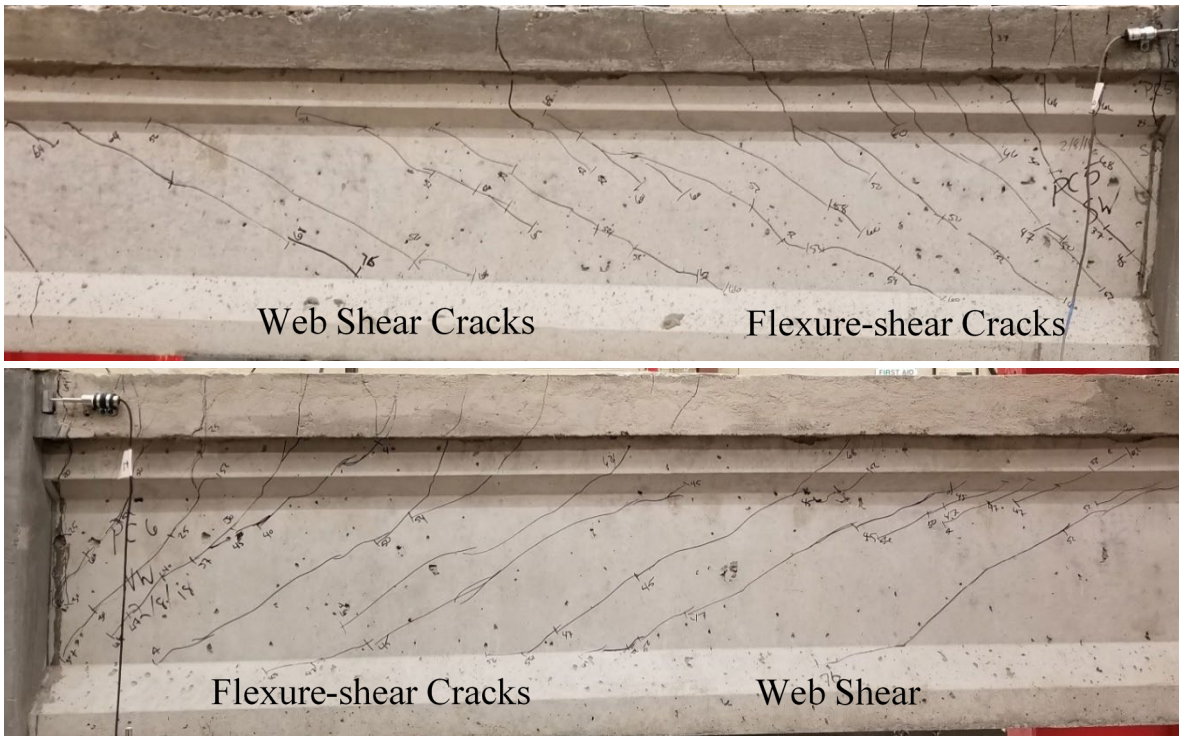
Figure 233. RC1-N girder with flexure-shear cracks and web shear cracks at failure (top) and RC1-S girder with flexure-shear cracks and web shear cracks at failure (bottom)
