FINAL REPORT ~ FHWA-OK-21-03

EVALUATION OF ULTRA-HIGH-PERFORMANCE CONCRETE FOR USE IN BRIDGE CONNECTIONS AND REPAIR

School of Civil Engineering and Environmental Science
The University of Oklahoma
Norman, Oklahoma

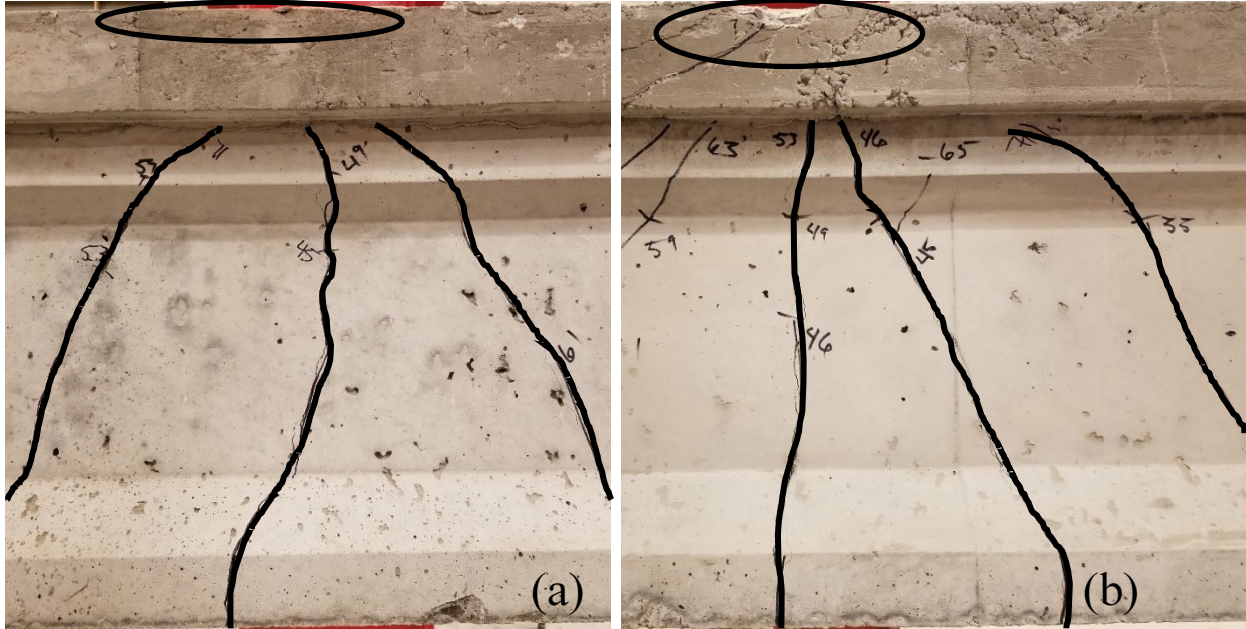
Figure 254. Final flexural cracking under the load point in the RC3-N (a) and RC3-S (b) girders are indicated by dark lines and concrete deck crushing is indicated by dark ovals.

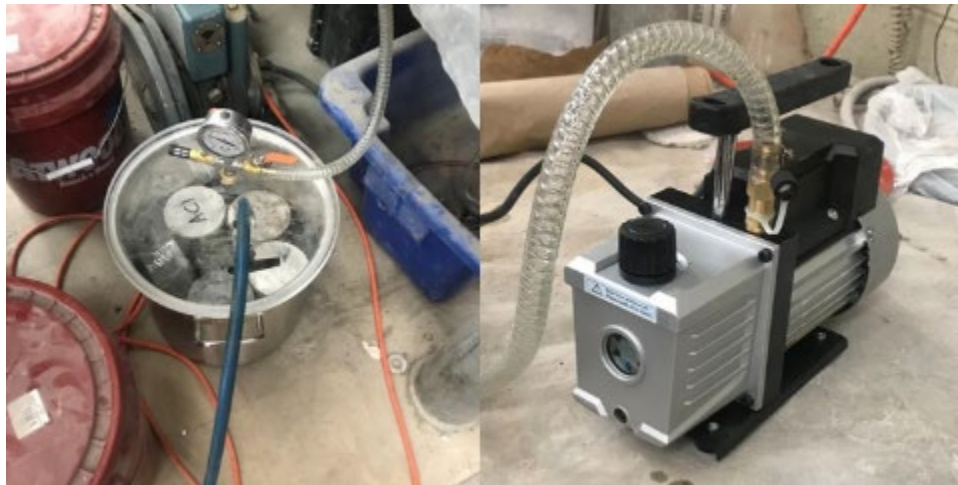
Figure 270. Vacuum desiccator (left) and pump (right) used for RCIP specimen preparation

One day before testing, specimens were placed in a vacuum desiccator with a pump system capable of maintaining vacuum pressure of less than 50-mm Hg. The vacuum pump was run on the dry specimens for 3 hours before pumping deionized water in and running the vacuum desiccators for another hour with the specimens completely submerged. After this, the pump was turned off and left sealed for 18 hours, at which time testing could begin. The pump system used is shown in Figure 270.

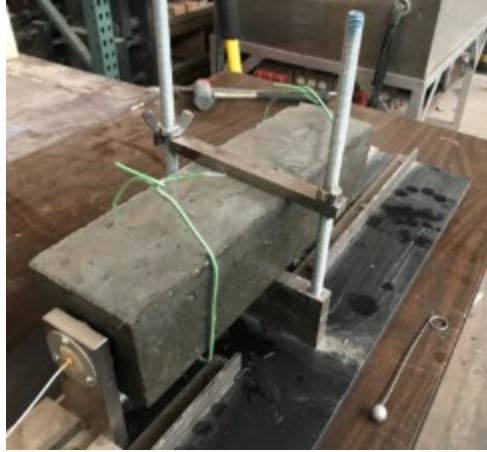
Figure 272. Freeze-thaw specimen arranged for dynamic modulus testing

Only RDM values of each specimen were taken throughout testing. These values were calculated by measuring the fundamental longitudinal (flexural) frequency and dividing it by the original fundamental longitudinal (flexural) frequency for each specimen. This results in RDM in the form of a percentage, where 100% is the starting point of the internal structure of the specimen, and deterioration results in ever decreasing values. These frequencies were measured with a frequency meter called an Emodumeter, which works by creating a mechanical impact with a small metal ball on one side of a specimen and measuring how long it takes for the impact to be felt by an accelerometer located on the other end of the specimen. This type of measurement is effective because it indicates the internal structure of the specimen (i.e., if a large amount of microcracks are present, it will take longer for the impact to be felt). The decision to only measure RDM was made because while RDM can be unreliable (due to ambient air curing methods resulting in high levels of un-hydrated cement in UHPC), mass loss and length change can be even more unpredictable, changing dramatically with any moisture level change. Figure 272 shows a specimen being tested in the Emodumeter while Figure 273 and 274 show a typical transverse frequency initial measurement and resulting final output, respectively.

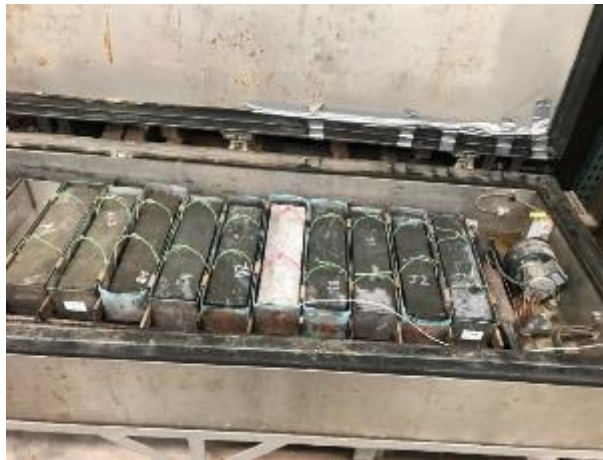
Figure 275. Freeze-thaw specimens in the testing chamber - Cycle 0

The freeze-thaw specimens prior to testing are shown in Figure 275 and Figure 276. All specimens had limited surface deterioration at this point in testing, and their starting frequencies were recorded to be used as the original value for finding each specimen's RDM values throughout testing.

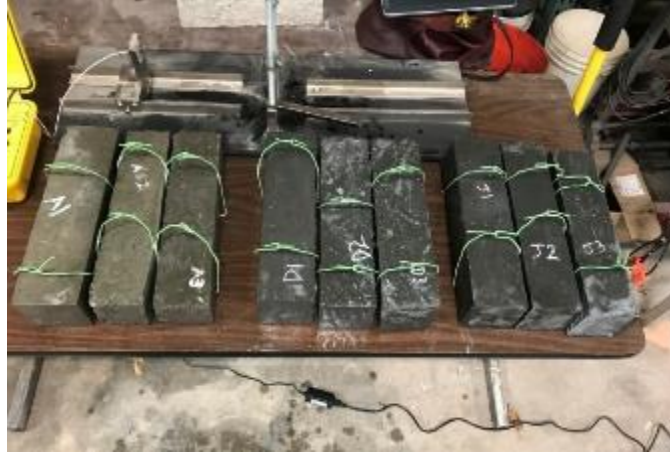
Figure 276. Condition of all freeze-thaw specimens - Cycle 0

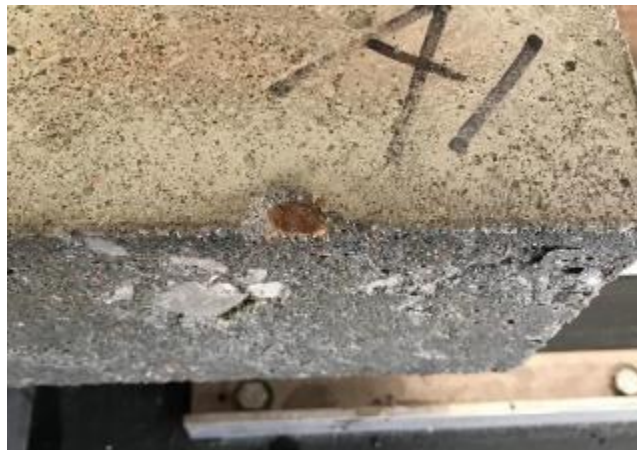
Figure 277. Deteriorated state of a class AA freeze-thaw specimen - Cycle 350

As evident in Figure 277, after 350 cycles significant deterioration of the ODOT AA specimens could be seen, including chipping of edges and wearing away of the surface to the point of coarse aggregation showing through. Figure 278 and Figure 279 show that the Ductal[®] and J3 specimens exhibited significantly less deterioration, with only small holes forming along their surfaces for the majority. The exception being a singular large hole that formed between cycle 285 and cycle 315 in specimen D1 (as seen in Figure 280) which triggered a spike in RDM for the specimen due to water now being able to penetrate farther into the specimen and hydrate more of the unhydrated cementitious materials within the specimen.

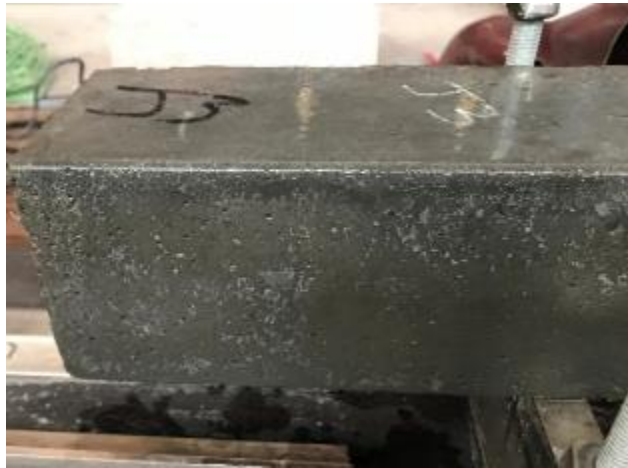
Figure 279. Deteriorated state of a J3 freeze-thaw specimen - Cycle 350

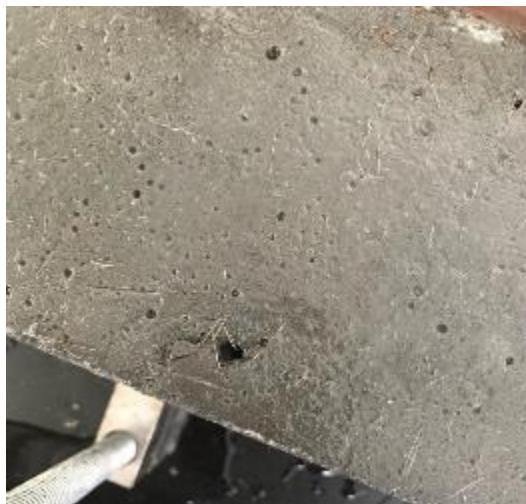
Figure 280. Hole formed on the side of Ductal® freeze-thaw specimen - Cycle 315

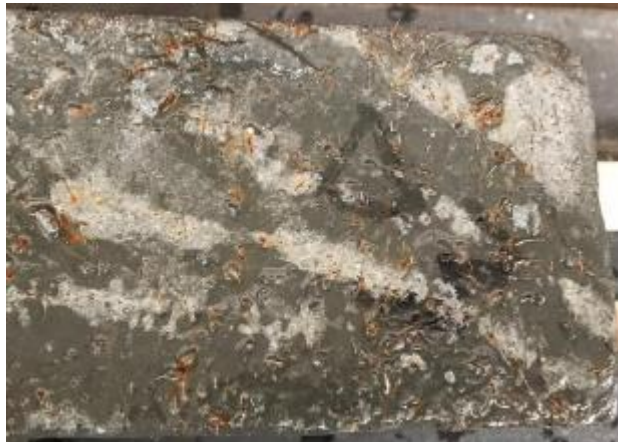
Figure 281. Surface corrosion of Ductal[®] freeze-thaw specimen - Cycle 350

However, though the Ductal[®] specimens only experienced a minimum amount of surface spalling, each of the three Ductal[®] specimens did experience a significant amount of surface corrosion of the steel reinforcing fibers on all four sides of each specimen, as shown in Figure 281. At the conclusion of testing, all three J3 specimens had also begun to show this kind of surface corrosion of fibers, but to a lesser extent. This is significant because very similar corrosion patterns were seen by Ductal[®] and J3 in scaling testing, as discussed in Section 7.4, and could be indicative of J3 having better fiber suspension during concrete setting. It should be noted, however, that surface corrosion of fibers is expected for UHPC structures in highly abrasive environments like those simulated by freeze-thaw cycling and scaling resistance testing, and is not expected to affect the overall strength or durability of the UHPC. This is unlike the corrosion of internal reinforcing bars, which is extremely detrimental to the strength and durability of the structure.

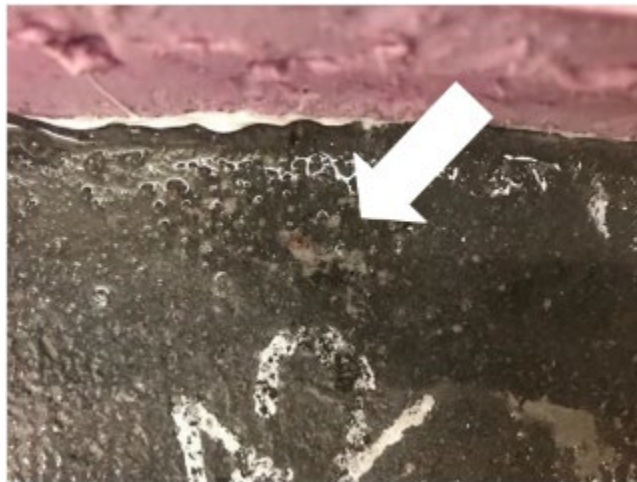
Figure 283. Visual pocketing on AA specimen - 25 cycles

After 7 cycles, slight pockets could be observed on the surface of both of the ODOT AA specimens; though none of the J3 or Ductal® specimens showed any signs of visible deterioration at this stage of testing. At 25 cycles, both ODOT AA specimens had significant pocketing, as shown in Figure 283, almost to the point of exposing coarse aggregate in select places, with a majority of the surface area showing signs of dusting. Also, at this point during testing, one of the Ductal® specimens (D1), shown in Figure 284, began to show significant visual signs of corrosion of the steel fibers along its exposed surface, with slight dusting and pocketing visible. Little to no dusting or pocketing, as well as limited surface corrosion, was observed on the other Ductal® specimen or either of the J3 specimens.

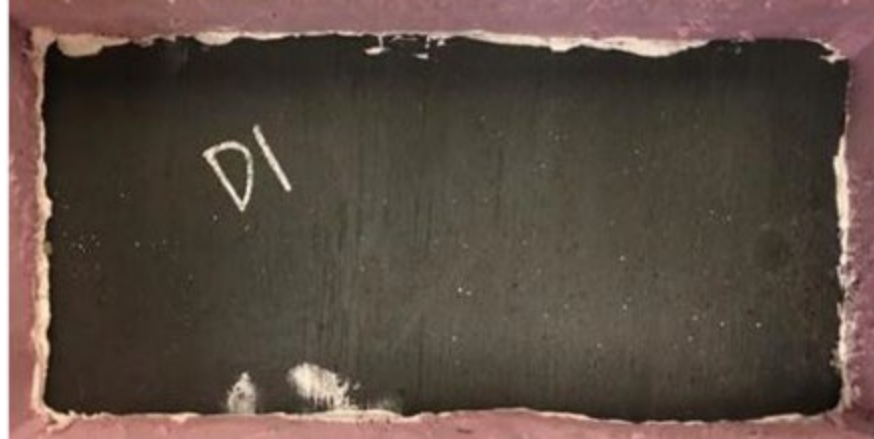
Figure 284. Visual corrosion of steel fibers on Ductal® specimen - 25 cycles

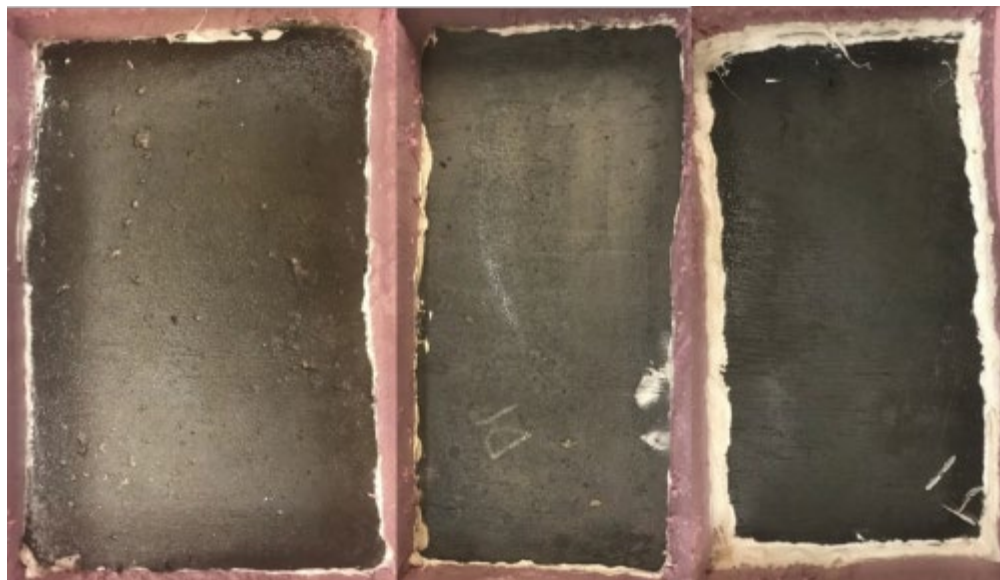
Figure 285. Visual examination of scaling specimens at 50 Days for ODOT AA (left), Ductal® (middle), and J3 (right)

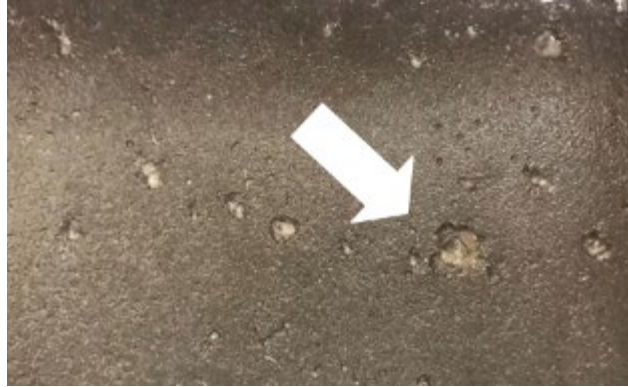
Figure 286. Progression of visual pocketing on AA specimen - 50 cycles

At 50 cycles, the specimens were in the states shown in Figure 285. Since 25 cycles, the pocketing of both of the ODOT AA specimens had increased a considerable amount, and pocketing had begun to occur on specimen D1, as shown in Figure 286 and Figure 287, respectively. Dusting of the entire surface was also noted for each of these three specimens during this period of cycling, with the other Ductal® specimen, D2, experiencing dusting of almost its entire surface as well. No substantial dusting or pitting occurred on either of the J3 specimens, with the final state being almost completely unchanged, as shown in Figure 286.

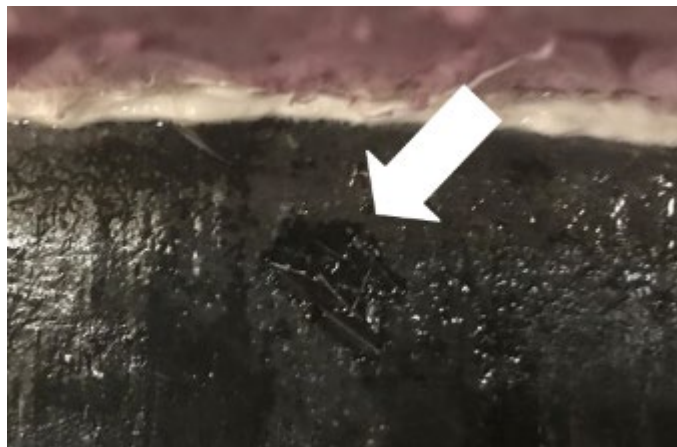
Figure 287. Visual pocketing on Ductal® specimen - 50 cycles

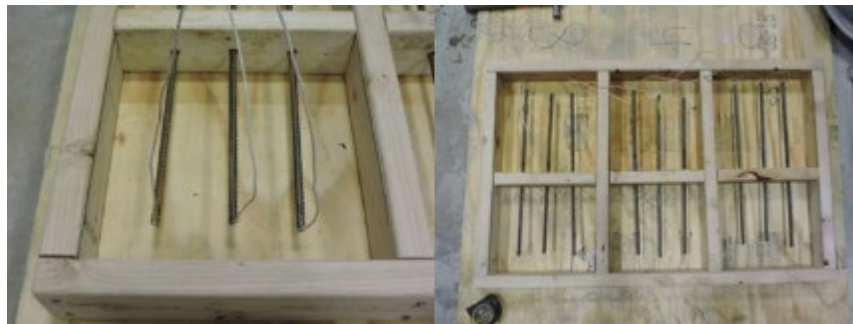
Figure 288. Small-scale corrosion specimen molds

Although the base concrete already contained varying levels of NaCl, specimens were also placed in a 5% NaCl solution, with the water level 0.5 in. below the top of the specimens, to prevent any damage to the electrical wiring coming out of the specimens. This was done to allow for easier passage of ions through the different concrete halves while also accelerating the corrosion within the specimens. The small-scale corrosion molds and testing set-up are shown in Figure 288 and Figure 289, respectively.

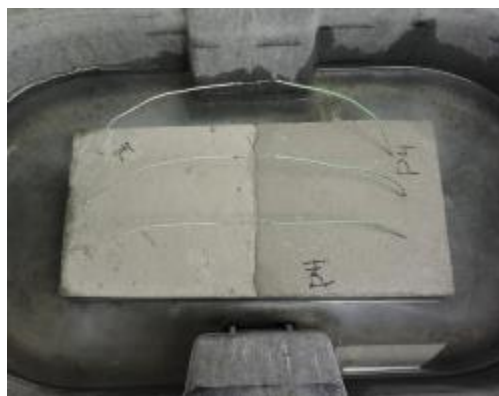
Figure 289. Typical small-scale corrosion testing specimen in the chloride solution

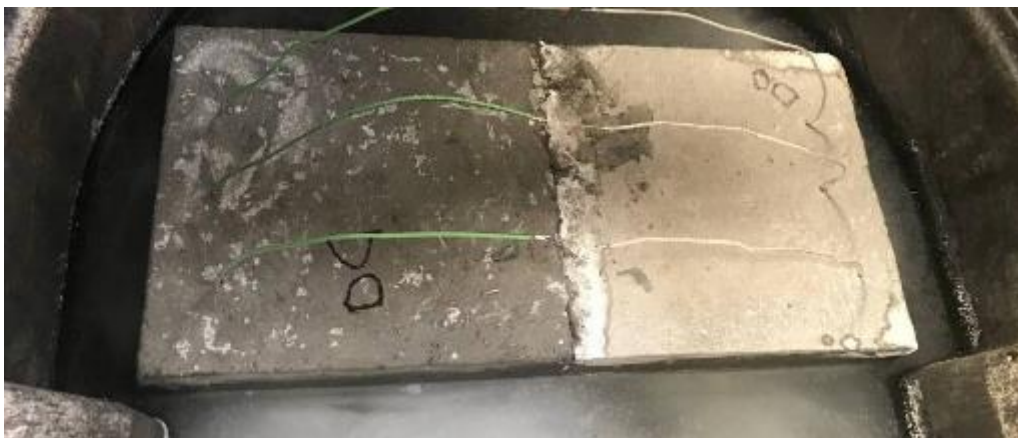
Figure 290. Initial joint corrosion in Ductal® small-scale corrosion testing specimen D0 - patching

After a week of testing, the Ductal® small-scale corrosion specimen containing 0% NaCl, D0, began to show signs of corrosion at the joint, unlike any of the other 11 specimens, as shown in Figure 290. By week two, all of the Ductal® specimens began to show signs of corrosion. The second and third specimens, however, showed signs of corrosion not through the obvious patching seen on D0, but through corrosion spotting, as shown in Figure 291. None of the other small-scale specimens exhibited signs of surface corrosion directly at the joint between the two materials, only experiencing light coloration around their edges where they were in contact with the 5% NaCl solution.

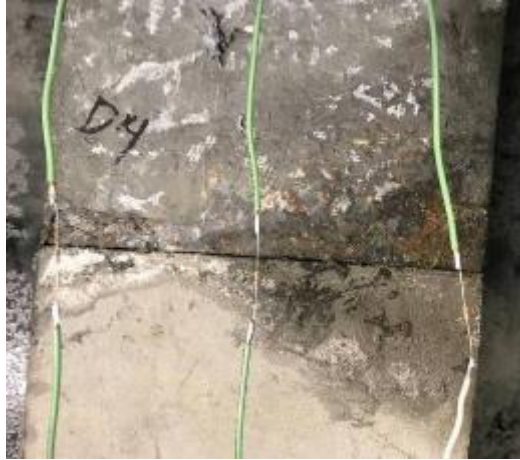
Figure 291. Initial joint corrosion in Ductal® small-scale corrosion testing specimen - corrosion spotting

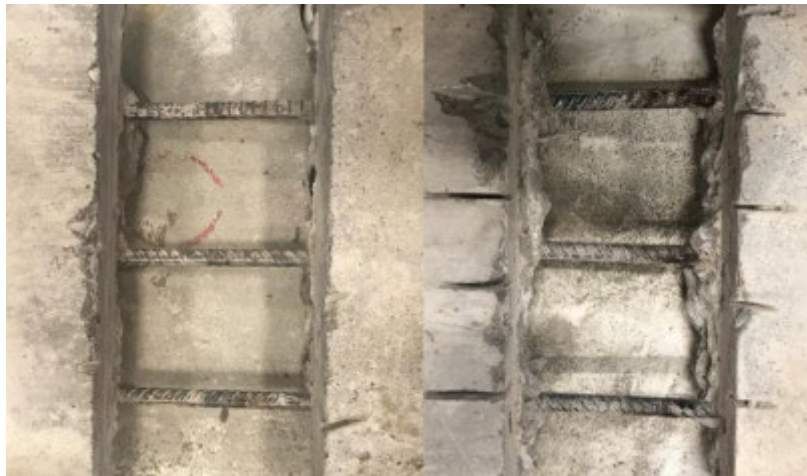
Figure 292. Corrosion state of rebar reinforcing at joint of ODOT Class AA small-scale corrosion specimens with 4% NaCl (left) and 8% NaCl (right)

Though no macrocell current values can be reported, the joints of the 4% and 8% NaCl specimens were chipped away to give some comparison of corrosion response of the four different repair materials, as discussed in the rest of this section and shown in Figures 292 – 295. Additionally, a photograph of the type of steel rebar put into these specimens before testing is presented as Figure 296 so that the difference between the typical amount and type of corrosion present on a piece of steel rebar before and after testing can be made clear. This difference is made most clear by the darker color and distinct starting location of the active corrosion (after testing). It is assumed in this testing that all previous surface corrosion was purely superficial and would have come off completely during either casting or chipping, and all actual surficial or pitting corrosion due to testing conditions would have occurred with or without the initial presence of this light surface corrosion.

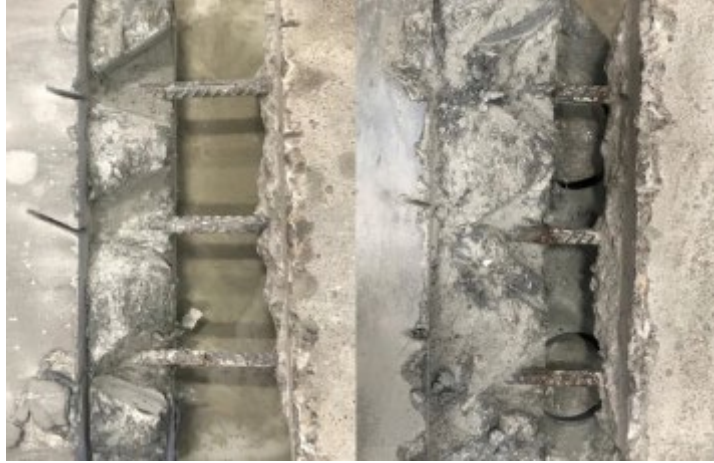
Figure 293. Corrosion state of rebar reinforcing at joint of J3 small-scale corrosion specimens with 4% NaCl (left) and 8% NaCl (right)

As illustrated in Figure 293 and Figure 294, the excavation of the Ductal® and J3 specimens with 4% and 8% NaCl in the base concrete revealed minor pitting corrosion on a majority of their reinforcing bars, all congregated at the joint, with some traces of this pitting also forming on the base concrete side. Similarly, but to a higher degree, excavation of the ODOT AA specimens (Figure 292) revealed significant pitting corrosion on all of its reinforcing bars, starting exactly along the line of the joint and moving along the original ODOT AA (base) concrete side, almost to the point of complete coverage. This kind of corrosion happening only in the base material is exactly what could be expected of these specimens from the “Halo Effect” given the time period of testing.

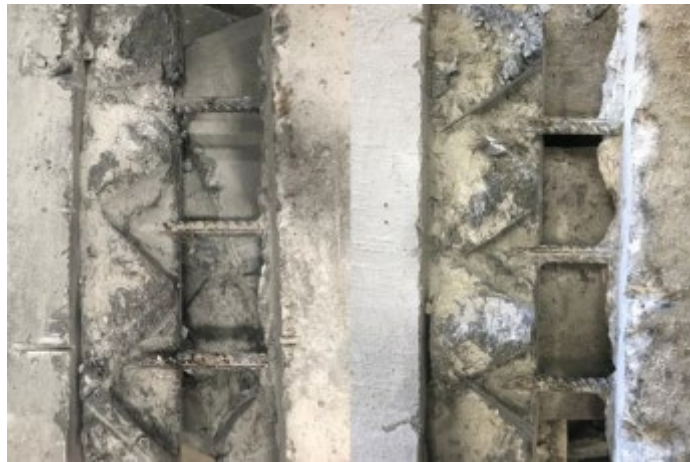
Figure 294. Corrosion state of rebar reinforcing at joint of Ductal® small-scale corrosion specimens with 4% NaCl (left) and 8% NaCl (right)

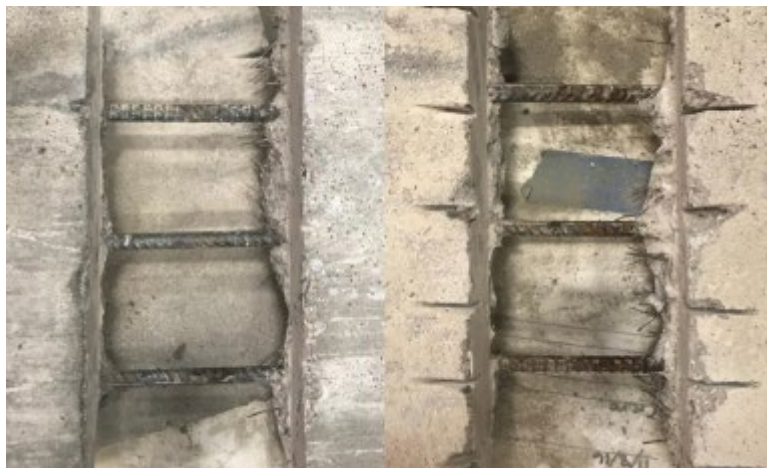
Figure 295. Corrosion state of rebar reinforcing at joint of Phoscrete small-scale corrosion specimens with 4% NaCl (left) and 8% NaCl (right)

Excavation of the Phoscrete specimens revealed significant amounts of pitting corrosion along the repair material side, with the 8% NaCl specimen also exhibiting a visible layer of surficial corrosion completely covering the reinforcing steel along the base concrete side.

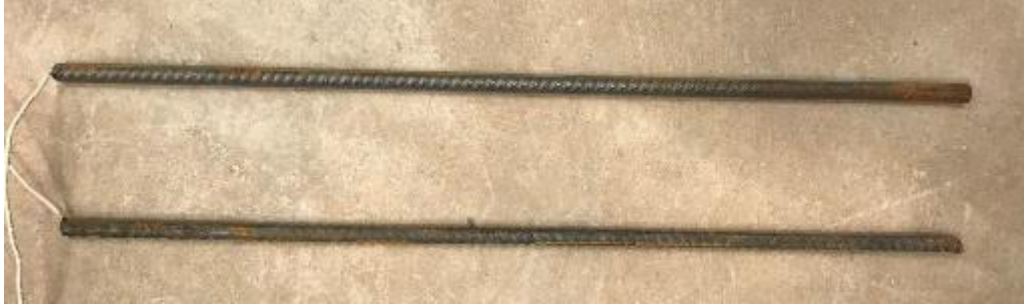
Figure 296. Steel rebar before testing - typical

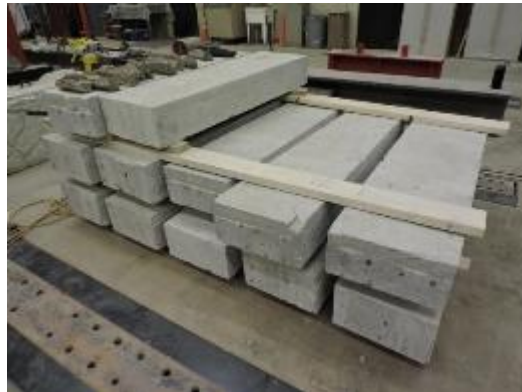
Figure 297. Large-scale corrosion joint specimens before chipping

The retrofitting process for the large-scale joint specimens included cutting the ODOT bridge slabs to an appropriate size (18 in. wide x 60 in. deep x 9 in. thick), chipping away 4 in. of the damaged concrete from the 18 in. width to expose the steel rebar, and casting a 5 in. x 60 in. x 9 in. repair replacement joint, producing a minimum 1 in. cover to the rebar exposed from the chipping process. The exposed No. 5 rebar layer revealed in each slab was connected together using a No. 5 longitudinal bar tied to the far ends of the exposed rebar sections. The longitudinal bar was placed on the topmost layer of reinforcing when laid down flat, putting it closest to what ultimately

became the finished surface, to allow for the needed wires to extend out of the top of the specimens. These electrical wires were soldered onto both ends of each connective longitudinal bar to allow for the DC power supplies to be connected after curing of the specimens. The slabs before and after chipping are shown in Figure 297 and Figure 298, with Figure 299 showing the final rebar construction.

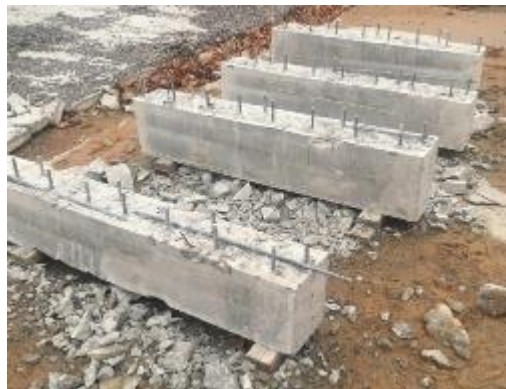
Figure 298. Large-scale corrosion joint specimens after chipping

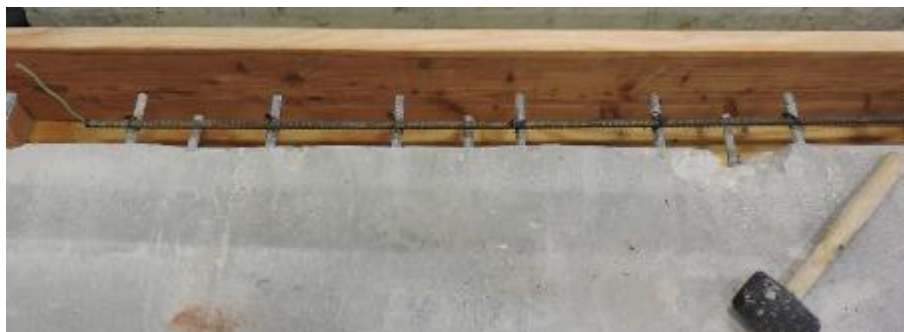
Figure 299. Large-scale corrosion joint specimen with longitudinal connection bar in place

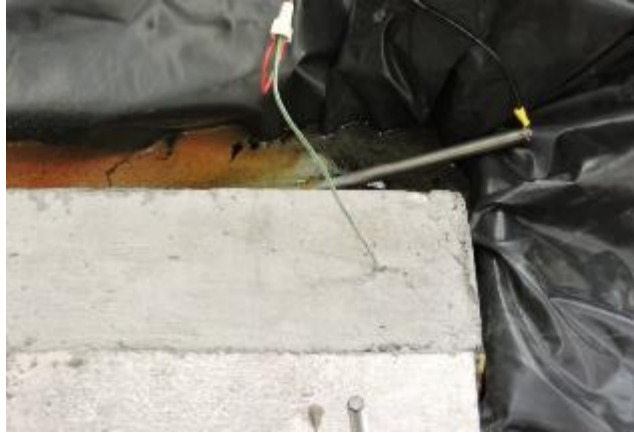
Figure 300. Stainless steel rod and electrical wiring for large-scale corrosion testing

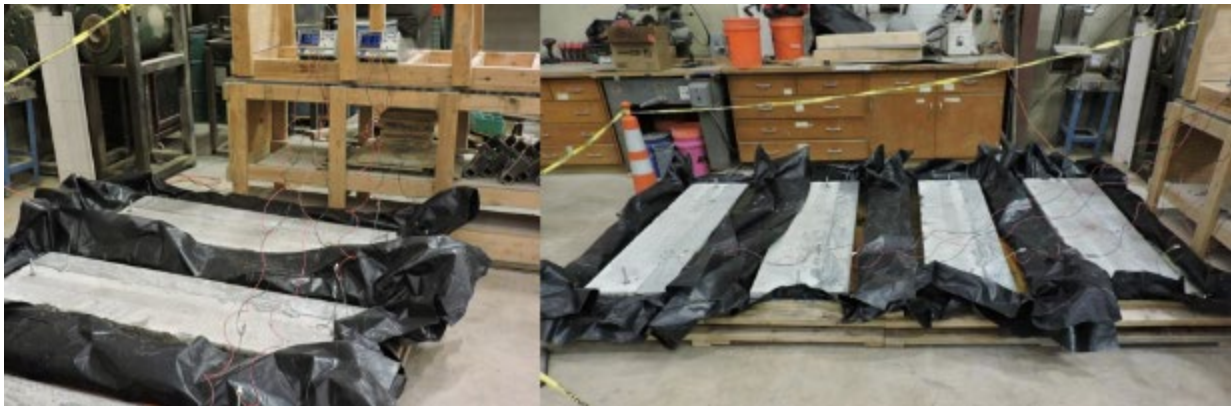
From there, a proven corrosion testing set-up called the “electrochemical method” was utilized. The electrochemical method works by creating a complete circuit that runs through steel reinforcing (or similar conductive metals), which causes the steel reinforcing to release electrons, in turn oxidizing the steel reinforcing and corroding it. For this testing the required complete circuit was achieved by using a stainless steel rod sitting in the NaCl solution as a cathode (as shown in Figure 300) and the longitudinal steel reinforcing bar in the repair material side of each specimen as the anode. From there, each specimen was connected using electrical wiring so that a 0.2 A current could flow continuously from the positive terminal of the power supply to the steel reinforcing, through the concrete and surrounding NaCl solution to steel rod, and ultimately back to the negative side of the power supply. This test setup is shown in Figure 301.

Figure 301. Large-scale corrosion testing setup showing power supplies (left) and all specimens in place (right)

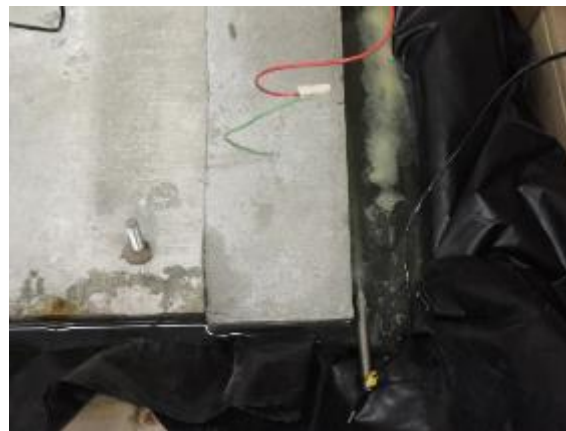
During the first week of testing, the water pools of each specimen began to fill with a coating of corrosion that had already begun to leech off, except for Phoscrete, which secreted a white film of unknown composition. This film is visible in Figure 302. After a week, the white film was covered with a corrosion film like the rest of the large-scale corrosion specimens. After two weeks of testing, the corrosion that was now in the water of all four specimens became sufficient to be present in all of the testing water, but mostly occupied the bottom of the testing containers. This level of corrosion was maintained through to the end of testing and is shown in Figure 303.

Figure 302. White film in water of Phoscrete large-scale corrosion specimen

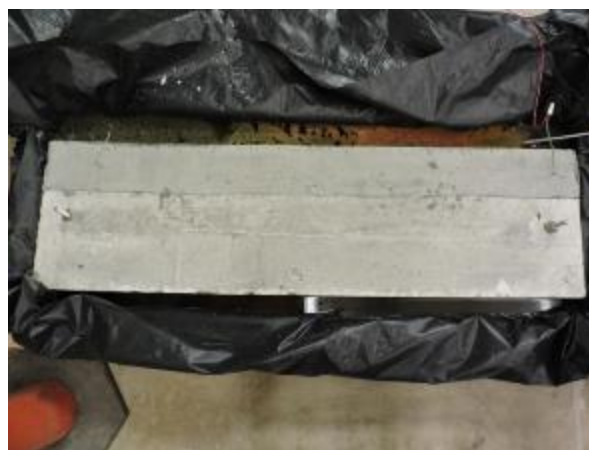
Figure 303. Corrosion in water of typical large-scale corrosion specimens

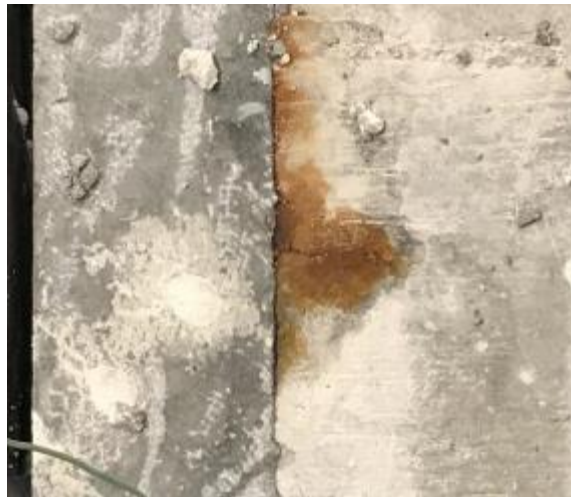
During the first week of testing, a corrosion spot along the joint of the Ductal[®] specimen began to form. By week two, this corrosion spot was in the state shown in Figure 304. This could have been due to several reasons relating to a poor joint-face connection between the Ductal[®] and the old conventional concrete it was cast onto, but could also have been due to the Halo Effect occurring rapidly along this joint. The justification for not assuming a simple poor joint-face connection being that previous testing showed that Ductal[®] possesses exceptional bond strength to substrate (base) concrete, and therefore a poor bond was unlikely in this scenario.

Figure 304. Joint corrosion in Ductal[®] large-scale corrosion testing specimen during week 2 of testing (Ductal[®] on left side of image)

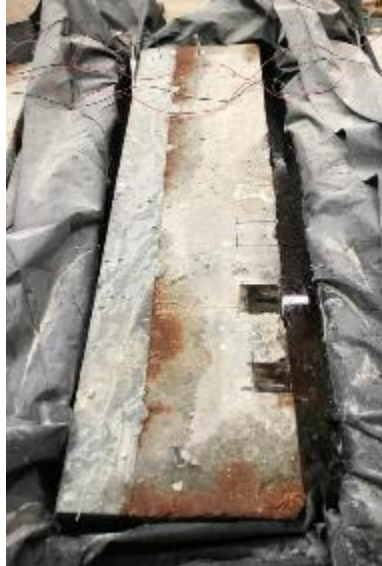
From week three up until testing was concluded after 10 weeks, the surface corrosion along the Ductal[®] joint progressed at a steady rate, as shown in Figure 305. None of the other specimens showed any significant signs of surface corrosion during testing, except along the anticipated reinforcing bar paths.

Figure 305. Joint corrosion in Ductal® large-scale corrosion specimen during week 5 of testing

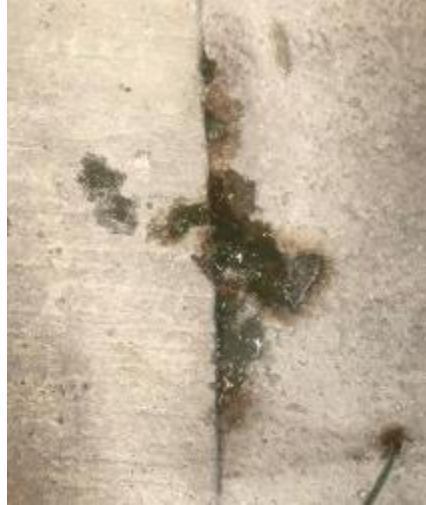
Though none of the other specimens experienced joint corrosion, a strange interaction did begin to occur at the joint of the Phoscrete specimen starting roughly 45 days (week 7) after corrosion testing began. A thick, dark green liquid began to appear around the joint, similar to what leaked out and caused the white film in the surrounding solution in the first week of testing. The makeup and reasoning for this liquid forming are unknown, and no information on this phenomenon was found in the literature. However, it is hypothesized that something in the chemical make-up of Phoscrete (which contains magnesium, aluminum, phosphate, and multiple other chemicals to try to help prevent corrosion and freeze-thaw damage) reacted with the NaCl in the surrounding solution, and at this point in the testing the solution had made its way far enough into the joint to begin to interact and produce the green substance shown in Figure 306.

Figure 306. Green liquid in joint of Phoscrete large-scale corrosion specimen during week 7 of testing

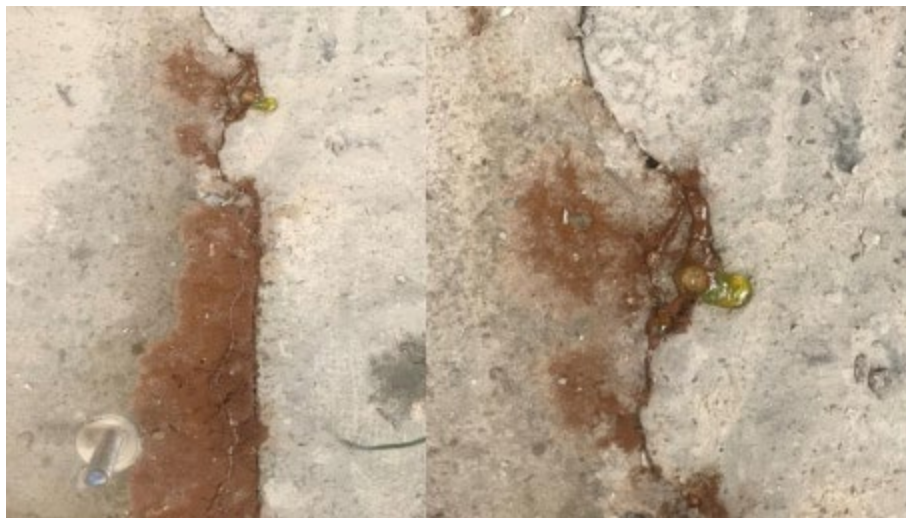
Roughly 8 weeks into testing, the Ductal[®] specimen also began to produce a small amount of green liquid from its joint, however this liquid was much lighter in color than that seen on the Phoscrete specimen and was accompanied by streams of white liquid that seemed to trail down the joint, as seen in Figure 307. It is hypothesized that this liquid was also a by-product of a chemical reaction occurring between the NaCl solution and the Ductal[®] mix. The final states of these two unexpected chemical reactions happening at the surface of the Phoscrete and Ductal[®] specimens are shown in Figure 308 and Figure 309, respectively.

Figure 307. Green liquid in joint of Ductal[®] large-scale corrosion specimen during week 8 of testing

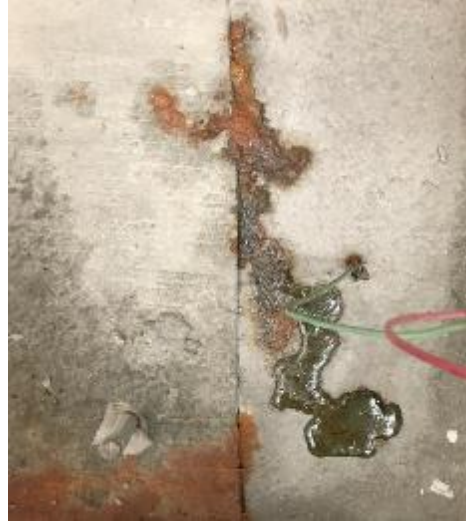
Figure 308. Green liquid in joint of Phoscrete large-scale corrosion specimen during week 10 of testing

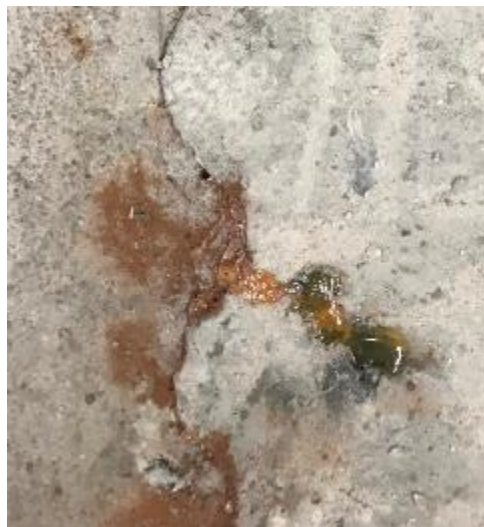
Figure 309. Green liquid in joint of Ductal® large-scale corrosion specimen during week 10 of testing

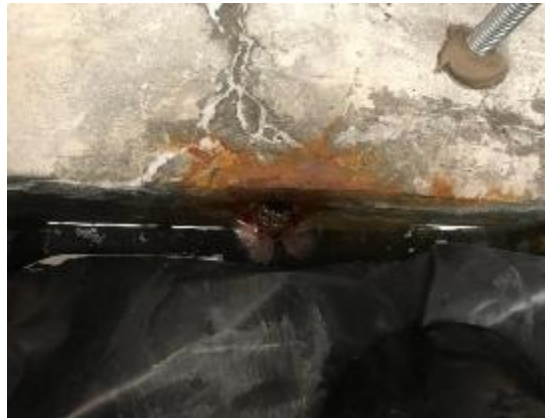
After only a week of testing, the first sign of rebar corrosion was also visible. As shown in Figure 310, a thick black liquid began to be produced out of the exposed ends of each specimen. Though no more than a few inches of liquid was ever formed on any one bar, and the amount of each rebar end that was completely corroded off due to the formation of this liquid was never significantly high, only reaching a max of 0.75 in., this level of corrosion could still be cause for concern in the field. This is because the chemistry of steel rebar reacts with NaCl and other corrosive solutions found in the field

Figure 310. Visible confirmation of reinforcing bar corrosion during week 1

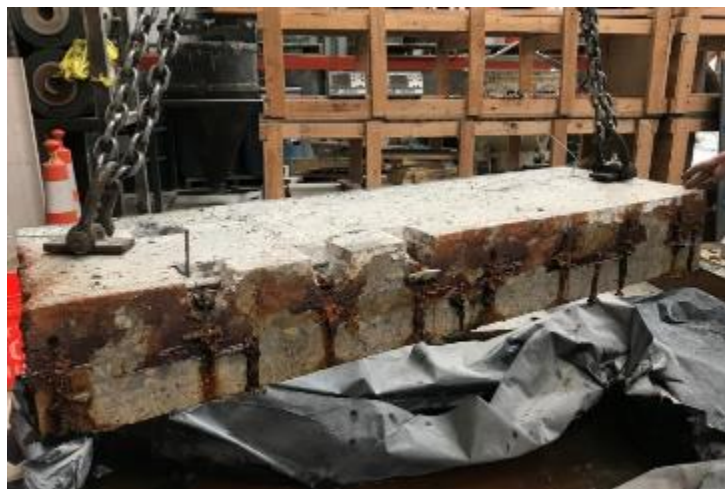
to produce a volume of reaction products 5 to 10 times that of the original material. This becomes a problem in the field because if internal reinforcing were to experience the kind of corrosion seen on the exposed rebar ends, it could generate large expansive forces that can crack and spall the concrete surrounding the reinforcing steel. The observed level of corrosion of the rebar ends was expected for this testing set-up. By the end of testing, the corrosion of the exposed rebar ends had reached the extent shown in Figure 311.

Figure 311. Typical level of reinforcing bar corrosion at the conclusion of testing - week 10

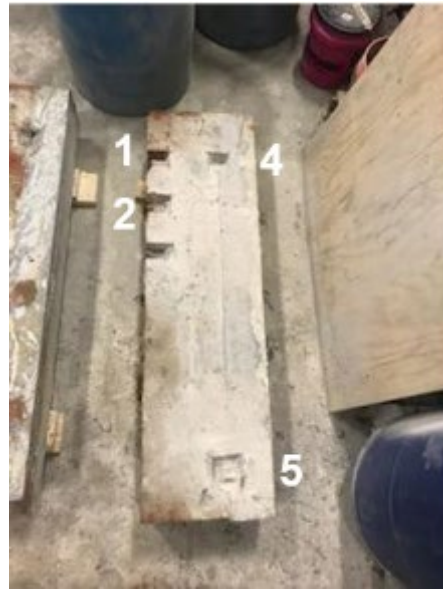
Figure 312 can be used as a guide to show the order in which sections of each specimen were chipped away to expose the reinforcing bars. Figures 313 – 316 provide updates of the specimens over the 10 week testing period, while Figures 317 – 320

Figure 312. Chipping sequence of large-scale corrosion specimens

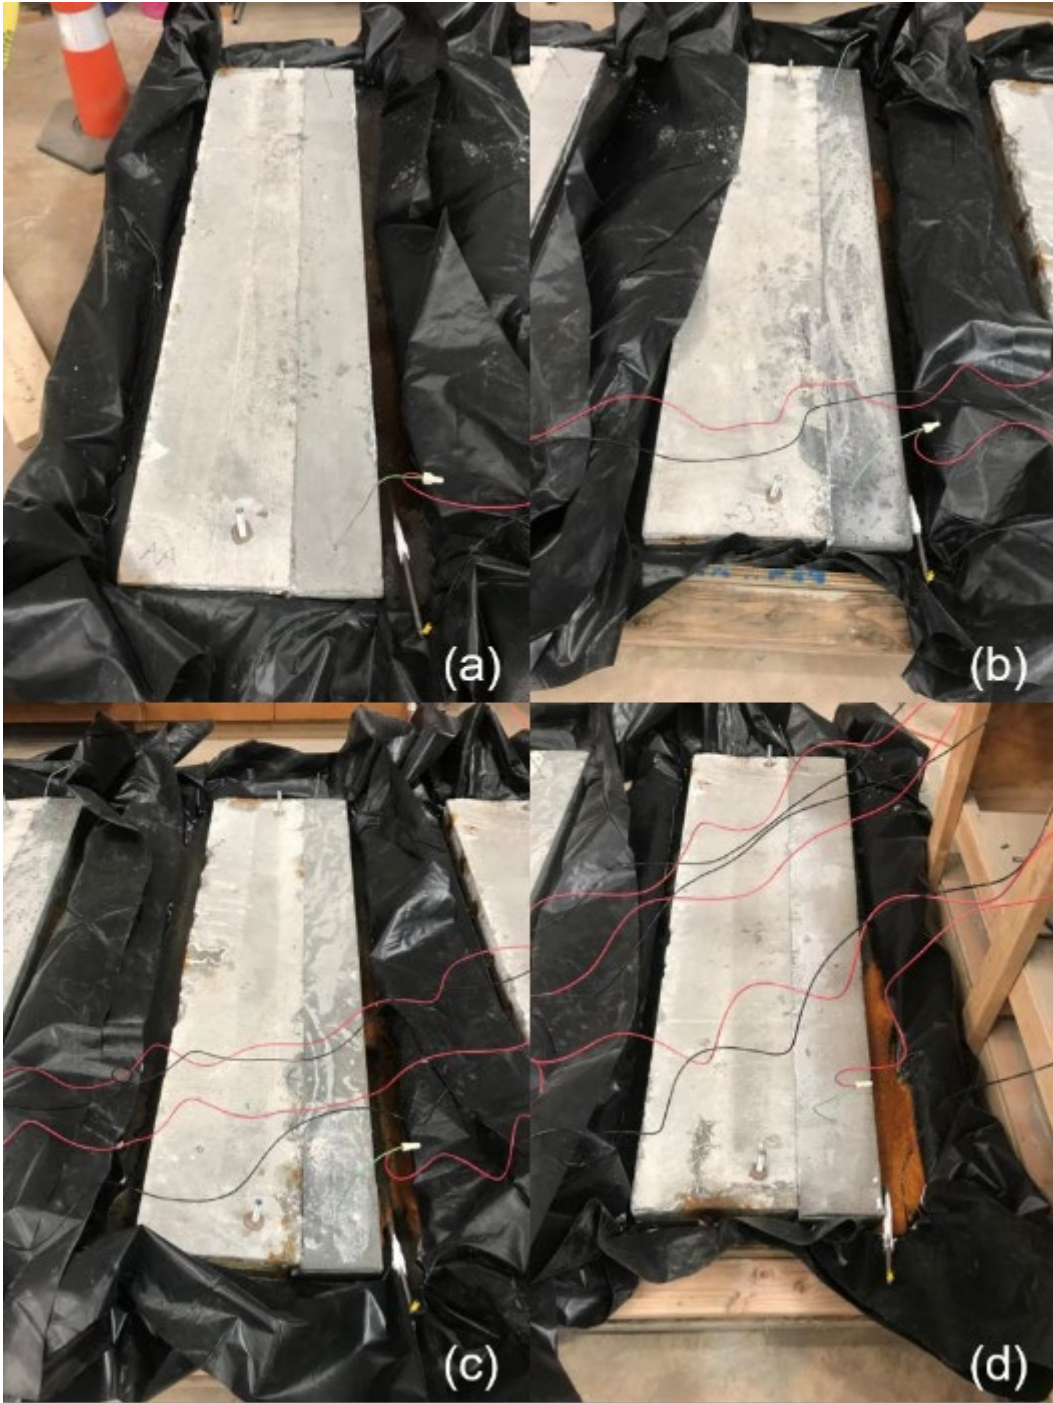
Figure 313. Week 1 update for large-scale corrosion specimens using (a) ODOT AA, (b) J3, (c) Ductal®, and (d) Phoscrete

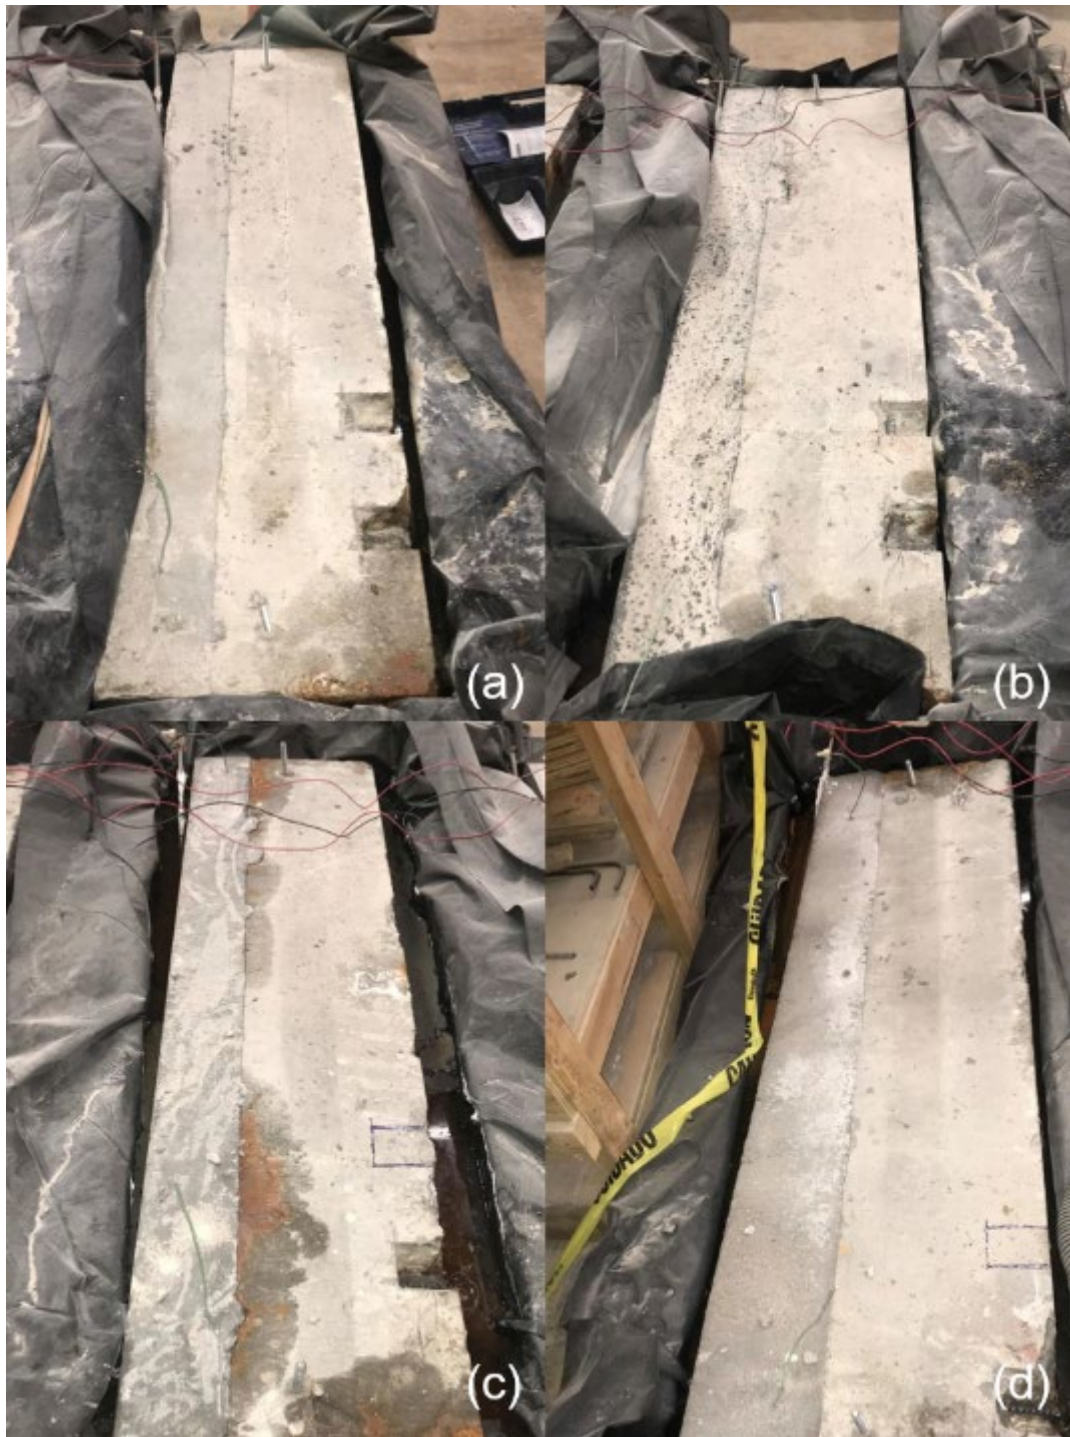
Figure 314. Week 3 update for large-scale corrosion specimens using (a) ODOT AA, (b) J3 (c) Ductal®, and (d) Phoscrete

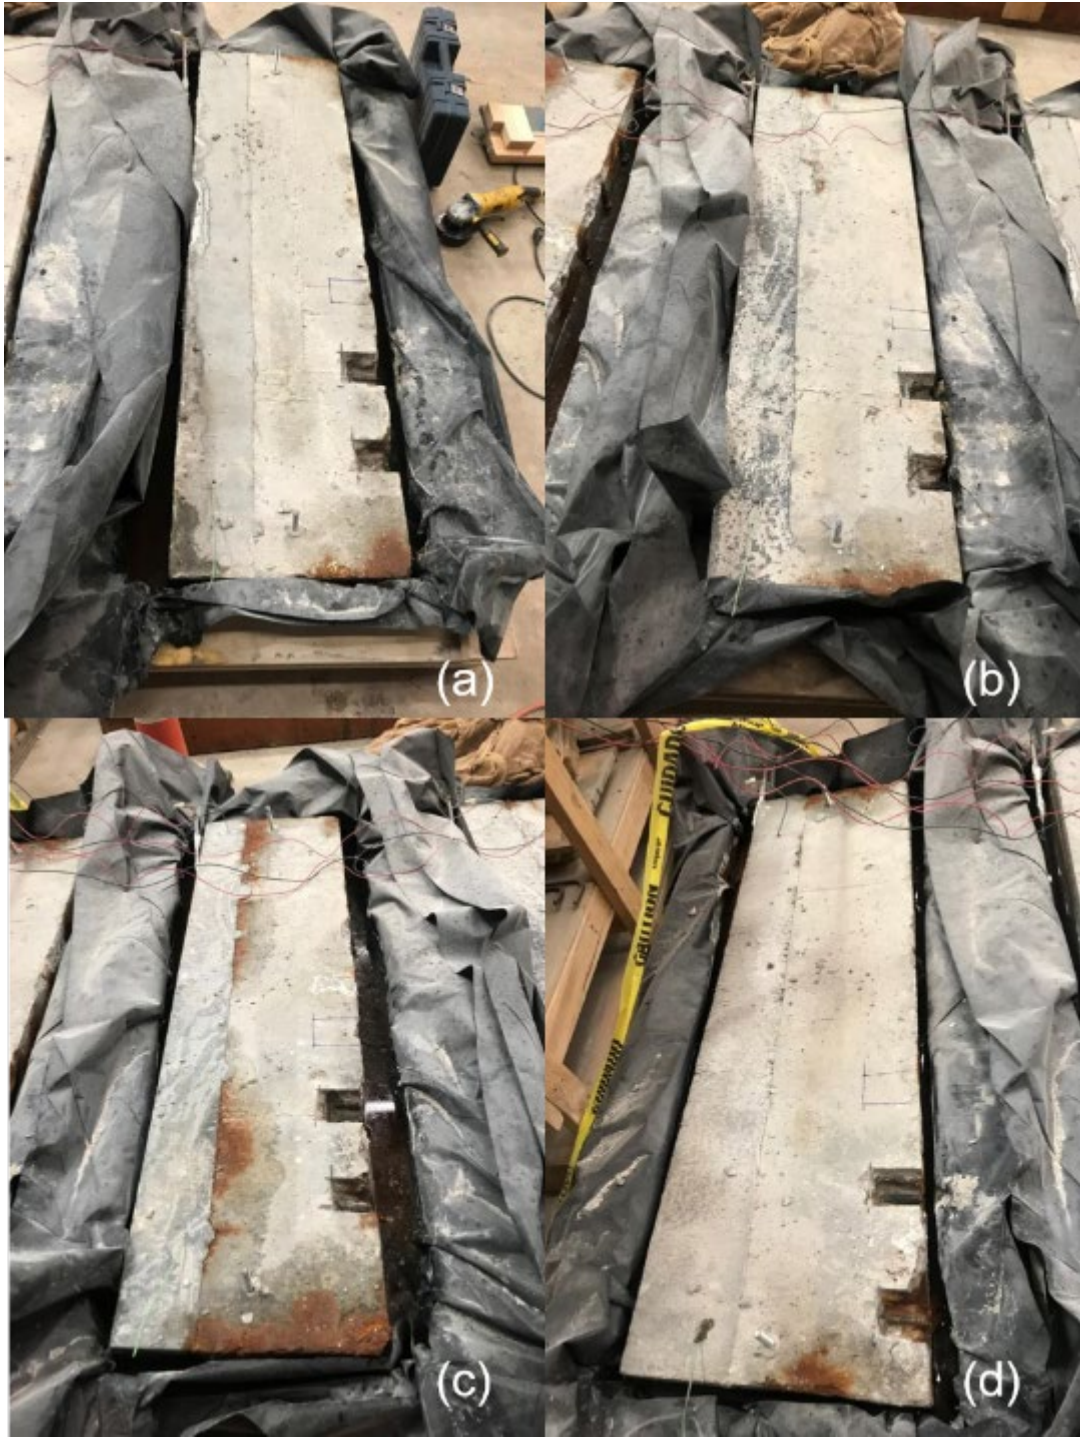
Figure 315. Week 6 update for large-scale corrosion specimens using (a) ODOT AA, (b) J3, (c) Ductal®, and (d) Phoscrete
