FINAL REPORT ~ FHWA-OK-21-03

EVALUATION OF ULTRA-HIGH-PERFORMANCE CONCRETE FOR USE IN BRIDGE CONNECTIONS AND REPAIR

School of Civil Engineering and Environmental Science
The University of Oklahoma
Norman, Oklahoma

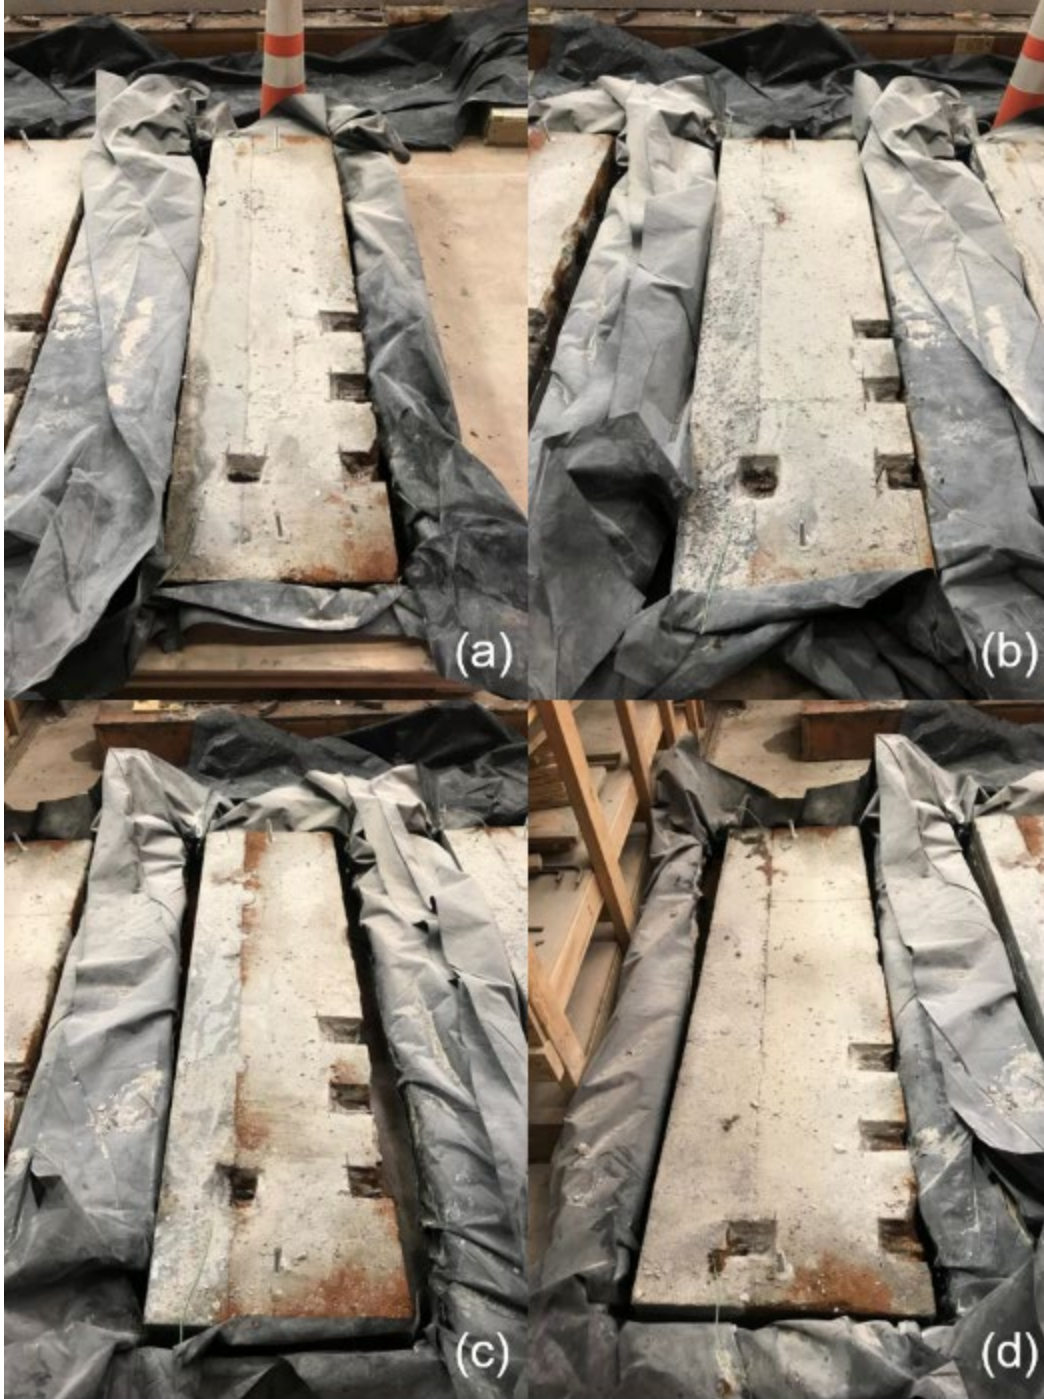
Figure 316. Week 10 update for large-scale corrosion specimens using (a) ODOT AA, (b) J3, (c) Ductal®, and (d) Phoscrete

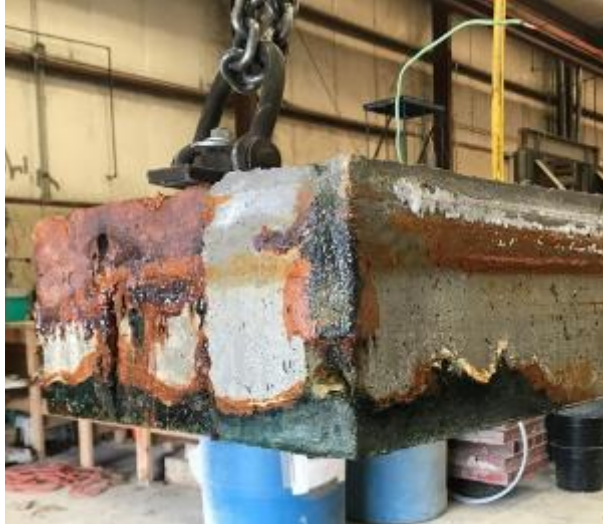
Based on the observed results additional testing is advised to assess Phoscrete’s durability and corrosion properties to fully understand its behavior in the field. The final state of the south side of the large-scale Phoscrete corrosion specimen, the side that experienced the secretion of the unknown green liquid, is shown in Figure 324, which reveals the entire end to be a dark green color.

Figure 324. Final state of Phoscrete large-scale corrosion specimen after week 10

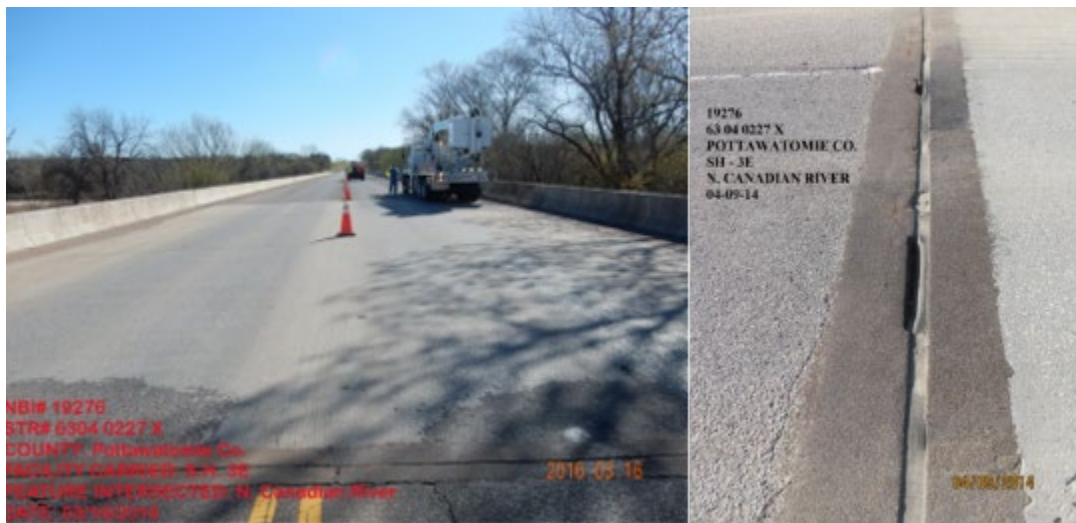
Figure 326. SH-3 bridge over N. Canadian River (left) and expansion joint to be replaced (right)

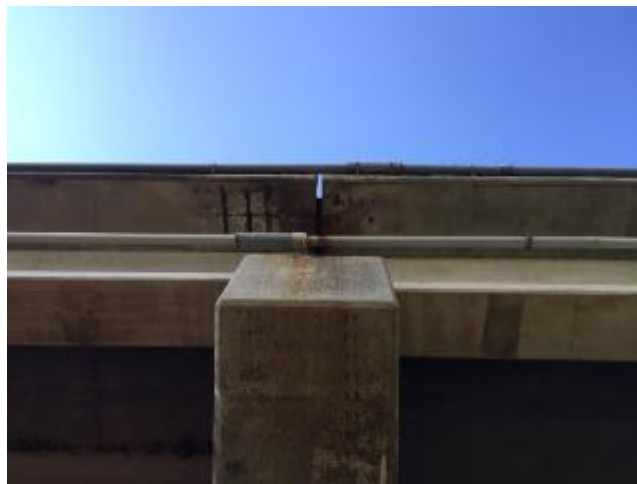
A site visit was made to the candidate bridge in May 2017 to identify potential sensor locations, pathways for sensor cables, and locations for the data acquisition equipment. A location on the parapet wall near the joint to be replaced was selected as a possible location for the data acquisition box and measurements were made across the shoulder to determine required cable lengths. Corrosion damage was visible at most piers in the end diaphragms, underside of the slab, beam ends, or pier caps, providing an indication of the need for joint replacement. Deterioration near the candidate joint is visible in the picture of the underside of the deck overhang shown in Figure 327.

Figure 327. Underside of the SH-3 bridge over N. Canadian River at the candidate joint showing concrete deterioration

Concerns with differential shrinkage would be addressed by ensuring properly roughened and dampened surfaces of the existing concrete and exposing the top rebar mat. The deterioration shown in Figure 327 would not be disturbed as part of the proposed half depth patch and additional repairs would be necessary to repair that area. This additional repair was considered outside the scope of the UHPC implementation.

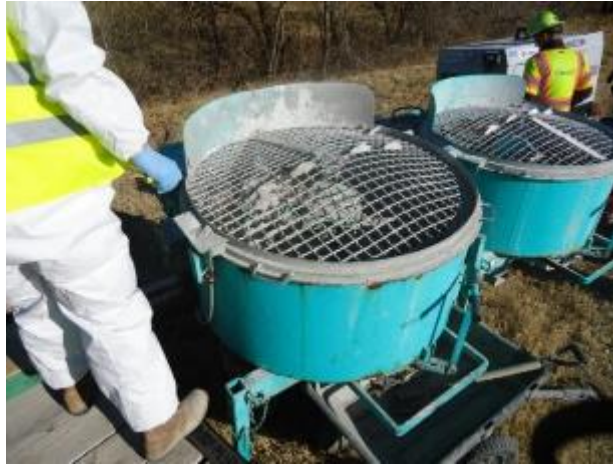
Figure 329. High shear mixers used for mixing UHPC

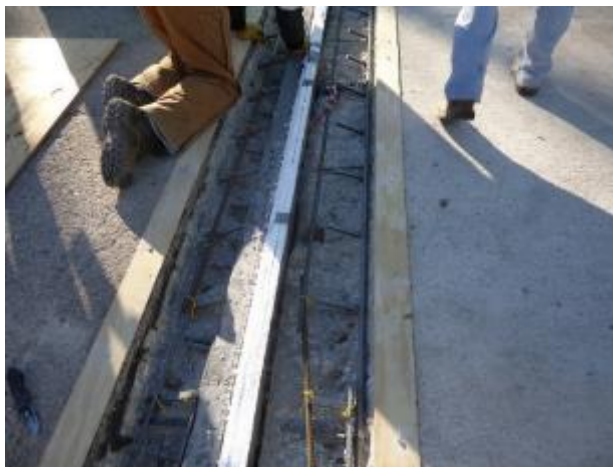
the older joint. Existing rebar was kept in place and cleaned by sand blasting and a single No. 5 rebar (not epoxy coated) was placed parallel to the joint on each side. The concrete surface was roughened during removal and was sand blasted clean. Figure 330 shows the joint after concrete removal and other preparations, except for placement of the top form. All exposed concrete surfaces were wetted to a damp, surface dry condition immediately before the top form was placed.

Figure 330. Joint after removal of existing concrete and before placement of the top form

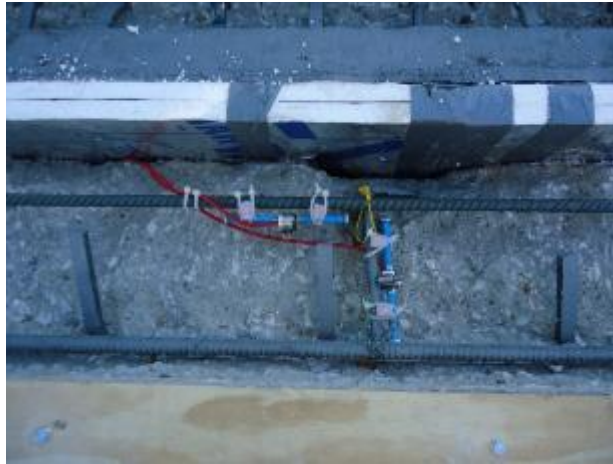
Two 6 in. Geokon vibrating wire strain gauges were placed in the joint header on the west side, one with its axis oriented perpendicular to the roadway (parallel to the joint) and one oriented parallel to the roadway (perpendicular to the joint). The gauge perpendicular to the roadway was located 83 in. from the face of the parapet and 4 in.

from the face of the joint. The gauge parallel to the roadway was located 88 in. from the face of the parapet and 7 in. from the joint face. The gauges are shown in Figure 331. Both gauges were connected to a Geokon datalogger placed in a steel box attached to the back side of the bridge parapet.

Figure 331. Strain gages within the joint header

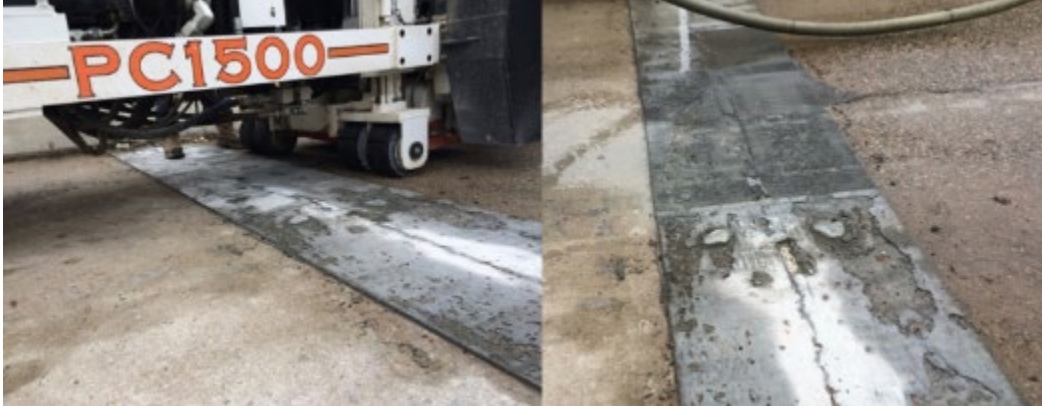
The UHPC used for the joint was cast $\frac{1}{4}$ in. above the intended finished grade to allow for grinding of the portion containing a high concentration of air bubbles that tends to collect at the top of the material. Manhattan Road & Bridge agreed to provide grinding services in conjunction with another project in the area. Grinding was conducted on December 20, 2017 by a subcontractor to Manhattan, with two representatives of Manhattan present at the time of grinding. The UHPC had a compressive strength of approximately 15,500 psi at the time of grinding, and the machinery operator indicated no problems grinding the material. Photos before and after grinding are shown in Figure 332. The difference in elevation between the two bridge sections did create a problem in grinding the UHPC on both sides of the joint to the same elevation. A decision was made by the research team and ODOT maintenance engineers to match the grade of the higher section to avoid any damage to the bridge deck. The dimensions of the grinding equipment also did not allow for grinding immediately adjacent to the parapet. The difference in ground surfaces can be seen in Figure 332 and the entire section after grinding is shown in Figure 333.

Figure 332. UHPC joint before (left) and after (right) grinding

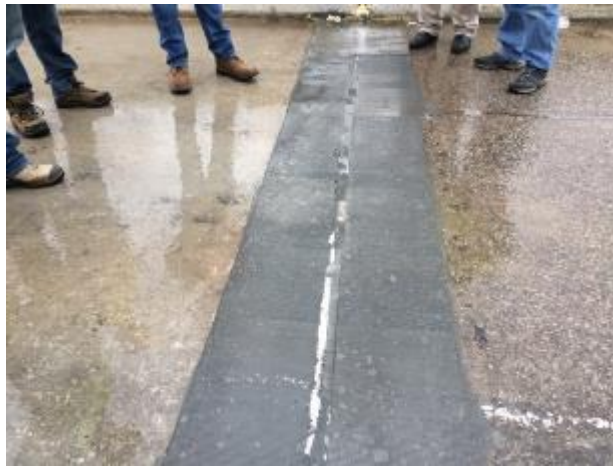
Figure 333. Entire joint after grinding

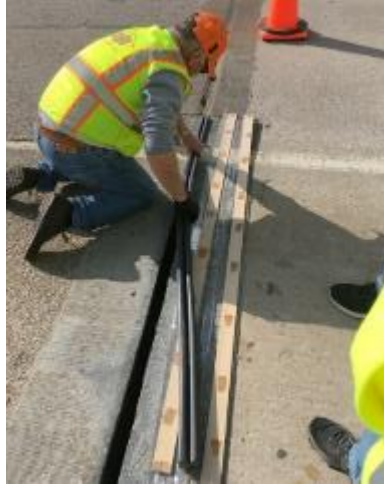
A representative of SSI Highway Products and the Division 3 bridge maintenance crew installed the joint sealant material in the replaced portion of the joint on the SH-3E bridge on March 30, 2018. Figure 334 shows placement of the sealant material after each header had been coated with epoxy. Figure 335 shows the end of a section of sealant where a bead of epoxy was applied to connect the next section. Since the original joint was wider than the planned 2 in. opening, the new joint headers were formed to produce an opening with a step down from a 2 in. width to a 3 in. width approximately 2 in. from the top of the joint. This prevented the joint material from being installed with the appropriate recess from the top of the joint. It was determined that this should not be a major issue since most of the replacement is on the shoulder area of the bridge but was noted for future installations. The completed joint fill material is shown in Figure 336.

Figure 334. Installation of joint sealant material by SSI Highway Products personnel

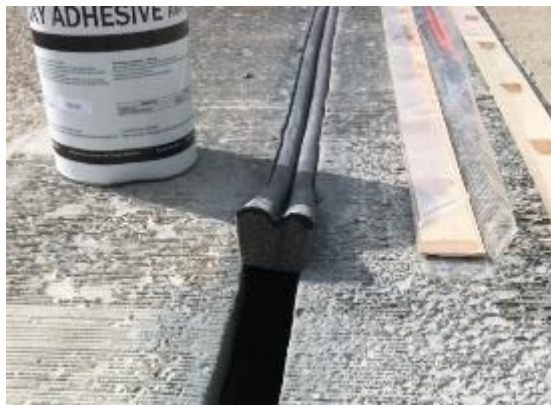
Figure 335. End of joint sealant prepared for splicing

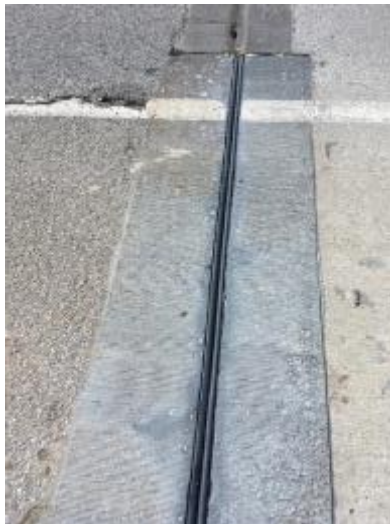
Figure 336. UHPC joint headers on SH-3E bridge immediately after joint sealant was placed

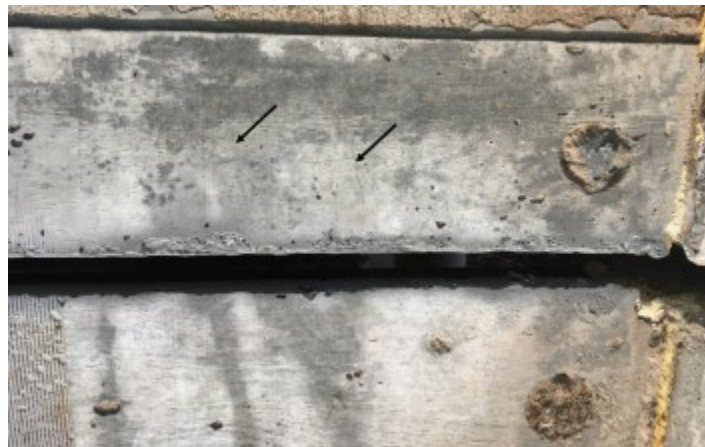
Detailed photographs were taken of the joint immediately after formwork removal and grinding to provide a baseline for a visual assessment of joint performance. Visits were made to the SH-3E bridge periodically until December 2020 to take photos of the joint and monitor progress of any cracks. No cracking was observed between the UHPC header and the pre-existing bridge deck. Minor cracking transverse to the joint headers was observed in one of the first visits to the joint spaced along the length of the joint at 6 in. to 12 in. The crack widths were very small, but crack width was not measured and they did not widen over time. These hairline cracks are identified by black arrows in Figure 337. Some surface rusting of the steel fibers was also observed and is shown in Figure 338. Any exposed fibers broke away from the matrix, but no deterioration of the UHPC material around these locations was observed. Figure 339 shows photos of the joint over time. It is apparent from these photos that other than being covered with grit and gravel the joint is in very similar condition to when it was placed after 3 years of exposure. No new cracks or additional deterioration were observed over time.

Figure 337. UHPC joint headers on SH-3E bridge before joint sealant was placed and showing hairline cracks

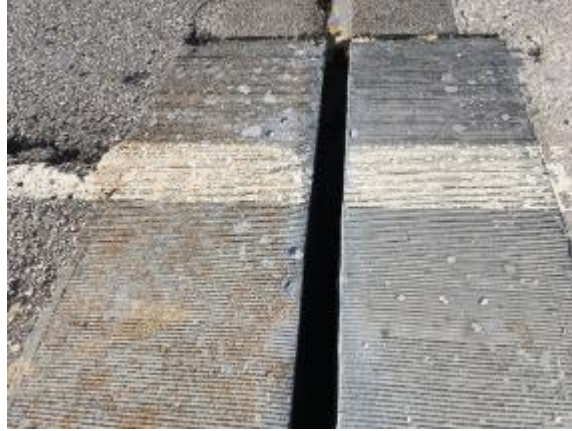
Figure 338. UHPC joint headers on SH-3E bridge before joint sealant was placed and showing surface rusting of the exposed steel fibers

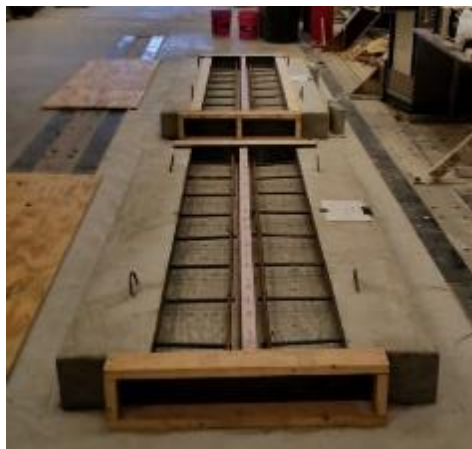
Figure 340. Demonstration joint specimens before UHPC placement

Two small joint specimens were cast at Fears Lab in conjunction with training provided as part of this project in June 2018. One joint was cast with the Lafarge product Ductal® and one was cast with the J3 UHPC mixture developed by the OU research team. These joints were constructed using details based on those from the SH-3E bridge, but with the slabs placed on the ground. Each slab measured 2 ft wide by 8 ft long and was 8 in. thick. A 12 in. wide, half-depth section was formed into the slab during casting and reinforcing bars were left exposed to simulate removal of the concrete in the immediate vicinity of an expansion joint during retrofit, as shown in Figure 340. The Ductal® joint was cast $\frac{1}{4}$ in. high, but the J3 joint was cast flush with the top of the slab as air pockets were not observed near the top of cores taken from the slab joints tested and described in Section 5.4.2, making a sacrificial top surface unnecessary. The UHPC was placed into the forms directly (Figure 341) and then covered with plywood with weights placed on the plywood to seal the top. Each of the two UHPC materials had adequate workability to fill the forms under its own weight; however, the J3 mixture exhibited better flowability. All procedures developed from previous testing were implemented successfully. The slabs were cast inside Fears Lab but were moved outside and were monitored visually over time. The finished slab sections after formwork removal, but before placement outside are shown in Figure 342. Figures 343 and 344 shows the demonstration joints over time. No separation between the joint and base concrete nor any significant deterioration was observed.

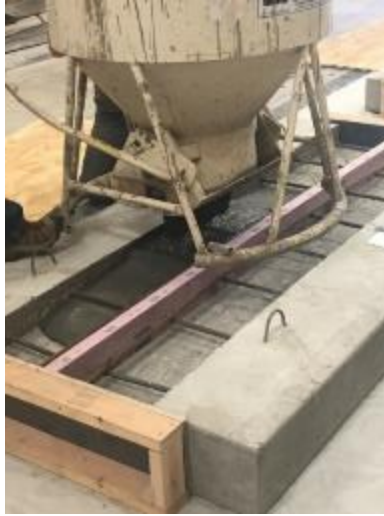
Figure 341. Placement of the J3 UHPC into the demonstration joint specimen

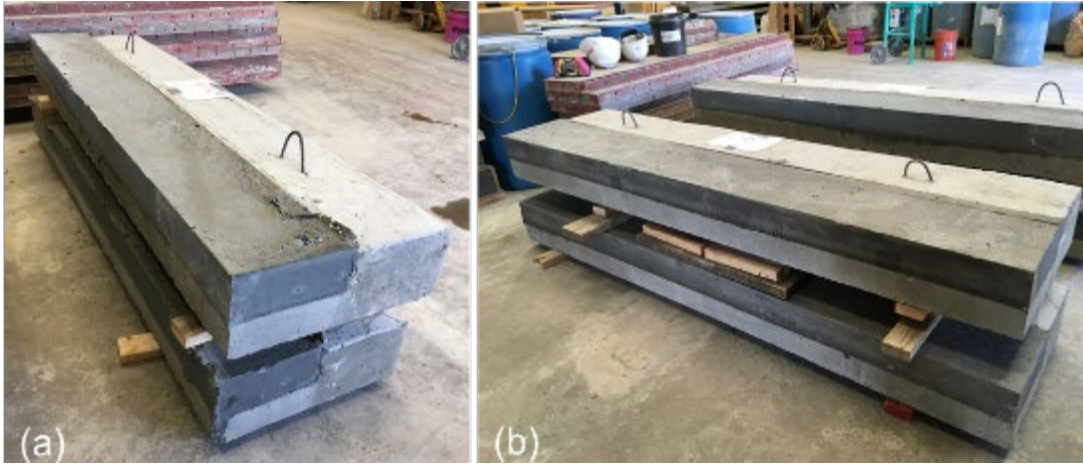
Figure 342. Completed (a) Ductal® and (b) J3 expansion joint specimens
