METHOD OF REHABILITATION FOR CORROSION DAMAGE
IN THE END REGION OF PRESTRESSED CONCRETE BRIDGE GIRDERS

A THESIS
SUBMITTED TO THE GRADUATE FACULTY
in partial fulfillment of the requirements for the degree of
MASTER OF SCIENCE

By
MINH PHUOC HUYNH
Norman, Oklahoma
2021

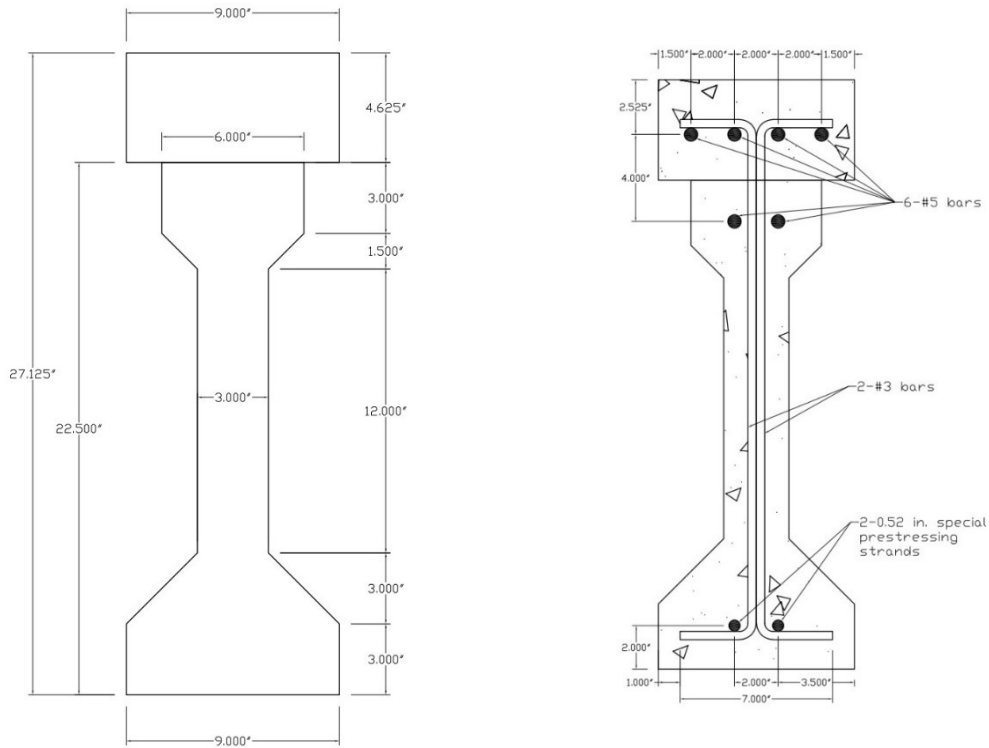
Figure 3.1: Girder Dimensions (Left) and Stirrup Dimensions (Right)

The prestressed girder specimen used for this research was designed based on selecting desired geometry, location and number of prestressing strands used, shear reinforcement and concrete mix design. All of the design and construction steps were conducted at Donald G. Fears Structural Engineering Laboratory. The geometry of the girder was selected as an approximately half-scale AASHTO Type II girder with a length of 18 ft used in previous research projects at the University of Oklahoma (Mayhorn, 2016 and Mesigh 2021). The prestressing strand type was selected to be 0.5 in. special Grade 270 low-relaxation strand based on material availability. The prestressing strands were spaced 2 in. center to center and placed 2 in. from the bottom of the girder to center of the strands. A value of 2 in. from the bottom of the flange would provide the minimum concrete cover while maximizing the compression stress and moment capacity. Also, it matched the design from the previous research done at the University of Oklahoma. During the design process, stresses at the midspan of the girder's top exceeded the tension limits given by ACI 318-14 Section 24.5.3 at prestress release. To counter the tension force and meet the code requirements, two additional No. 5 Grade 60 reinforcing bars were placed 2.465 in. from the top of the girder's deck. For shear reinforcement, double No. 3 C-shaped stirrups were used along the girder with four different stirrup spacing intervals based on shear capacity calculation in Chapter 7 Section 7.3 with extra projection at the top of the girder to create composite action with the concrete deck as shown in Figures 3.1 and 3.2.

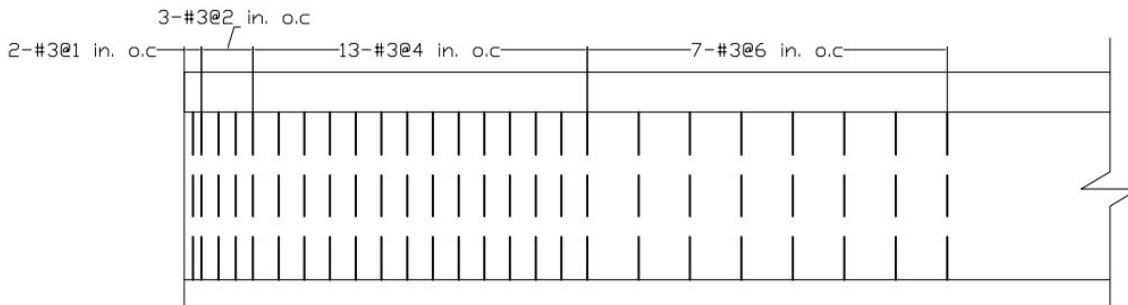
Figure 3.2: Stirrup Distribution in Girder

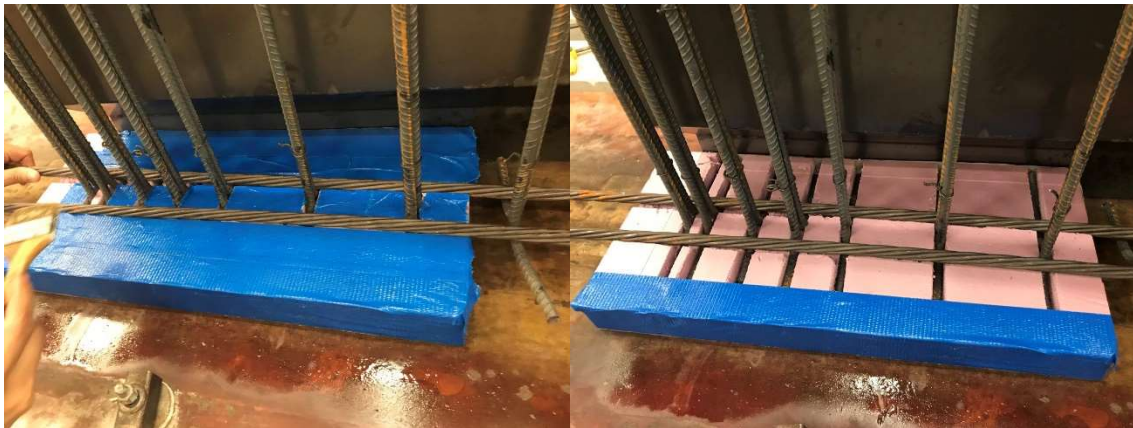
Figure 3.3: Foam Creating the Simulated Corroded Region

The construction process for each prestressed girder involved two main activities: set up and casting. The girder set up process started with cutting and bending the shear stirrups. The stirrups were next tied to the top steel reinforcing bars at the required spacings shown in Figure 3.2 to create a reinforcement cage. The next step was to set up, level and oil the prestressing bed in order to prevent concrete hardening on the bed during settlement. One of the steel formwork sides was put into place on the prestressing bed and the reinforcement cage was placed on the prestressing bed and attached to the steel beam form on one side. An 18 in. x 9 in. x 2 in. foam block, in which 0.5 in. deep trenches to cover half of the strands were created, was placed at one end of the girder to represent the corroded region, as shown in Figure 3.3.

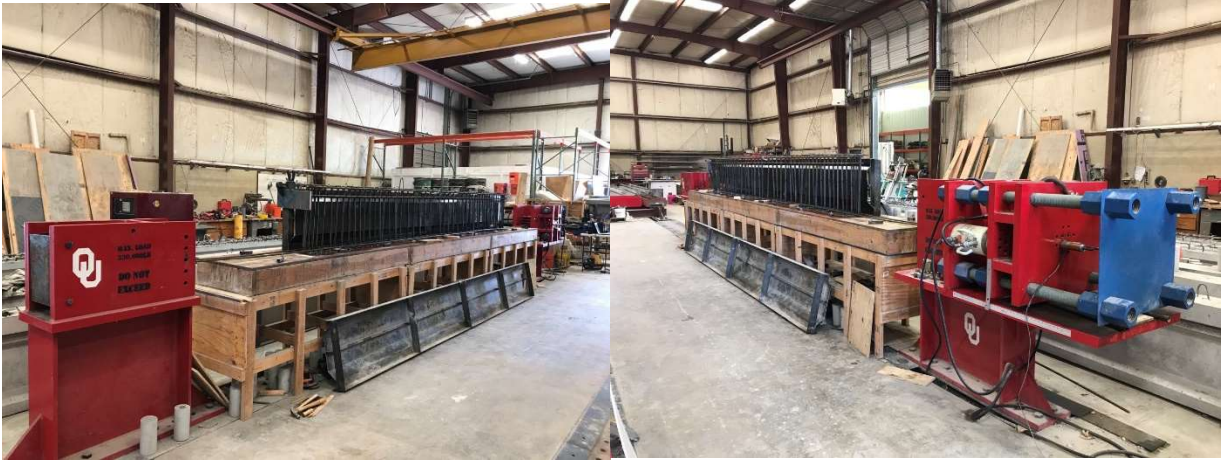
Figure 3.4: Dead-end Abutment (Left) and Live-end Abutment (Right) for Prestressing Bed

live-end and dead-end abutments with the placement of reinforcement cage and prestressing strands. The live-end abutment attaches with hydraulic rams and pump to pull the strands with the purpose of creating tension while the dead-end abutment anchors the strands.

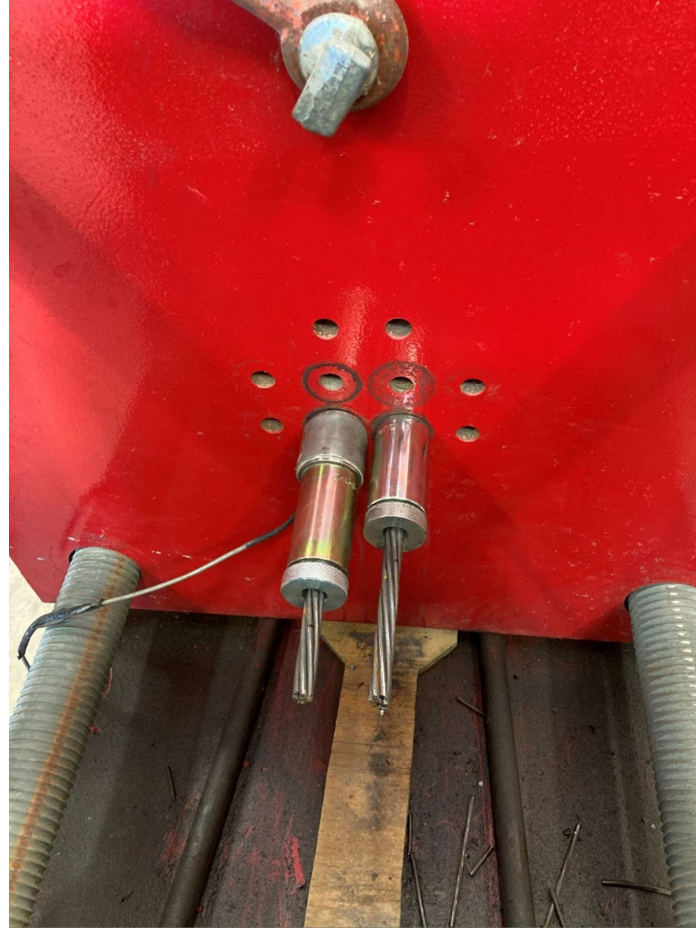
Figure 3.5: Position of Mark, Load Cell, and Chuck in Preparation for Pre-tensioning

The prestressing strands were cut approximately 34 ft long to provide extra length beyond the prestressing bed for installing the chucks following proper procedures for pre-tensioning. Chucks were attached to all strands at the outer face of the abutments for anchoring the prestressing strands during tensioning. A 50-kip capacity load cell was placed between the chuck and the live-end abutment on one strand to monitor the instantaneous increment of applied load from the hydraulic rams. A mark was noted on the strands on the back side of the chucks from the abutments to observe and measure strand slip from the end of the chucks before, during, and after tensioning. Figure 3.5 shows the position of the mark, load cell, and chucks in preparation for pre-tensioning application.

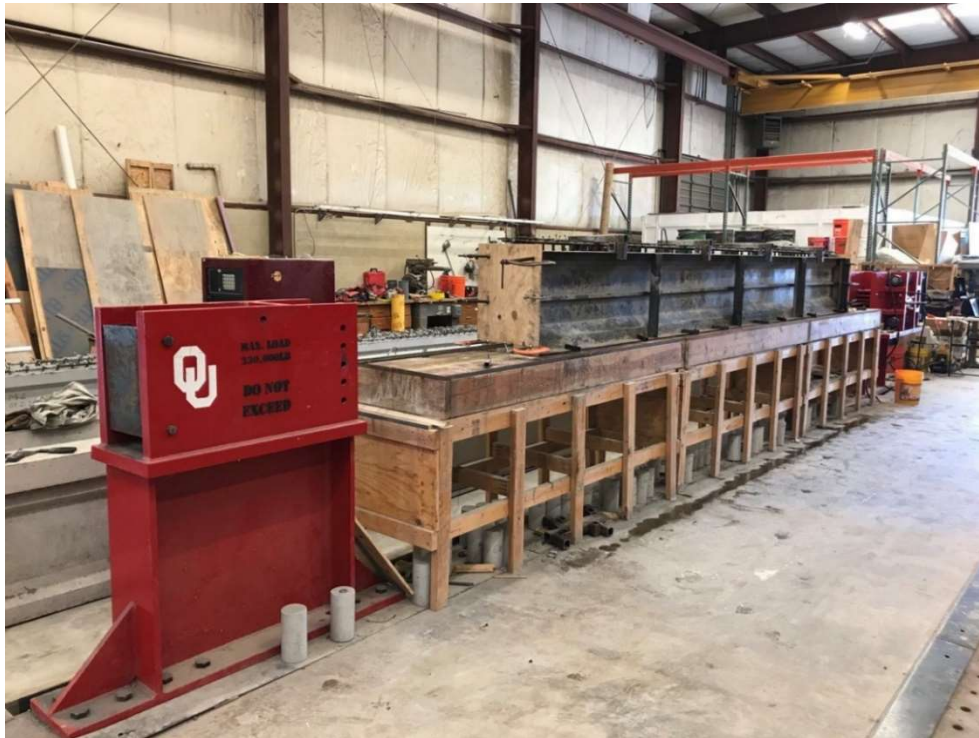
Figure 3.6: Prepared Formwork for Casting

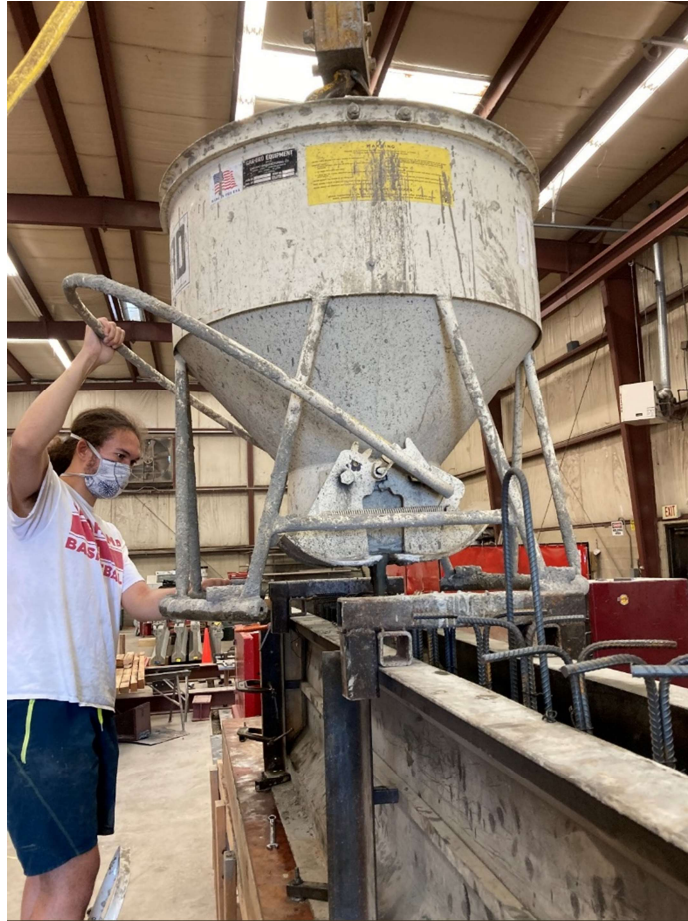
Figure 3.7: Casting Girder without Vibration

During casting each girder, the slump flow test was conducted to verify adequate workability of the SCC for compaction requirement. Also, the concrete was placed in the girder's formwork without vibration as shown in Figure 3.7. After casting, the girder was covered with plastic placed on top of the girder to ensure proper curing. Nine 4 in. x 8 in. concrete cylinder specimens were prepared when casting every girder in order to examine the compressive strength at 1 and 28 days after casting and on the girder test day. The first three cylinders were tested 24 hours after casting to determine if the concrete had reached the minimum required release strength, f'_{ci} , of 4000 psi. The next three specimens were tested at 28 days for compressive strength, f'_c .

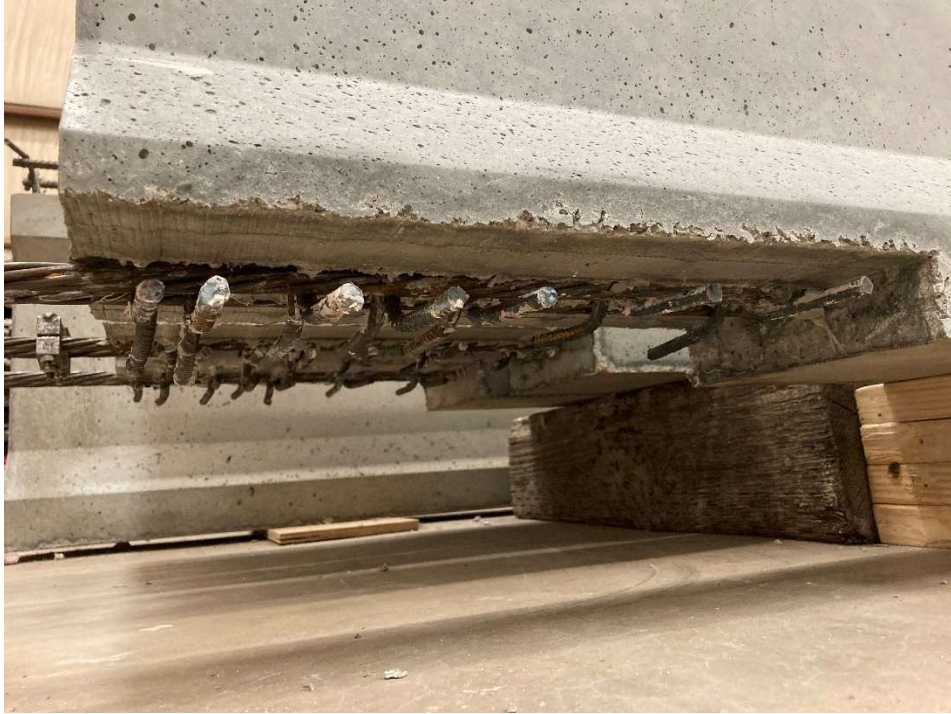
Figure 3.10: The Representative Corroded Region without the Foam

After the deck was cast and the foam at the bottom of the girder was removed, the surfaces around the corroded region were roughed using a grinding disk on an angle grinder for MALP and sandblasted for FR-SCC and UHPC to improve the area of contact between the conventional concrete and repair material, as shown in Figures 3.10 and 3.11. An air compressor was then operated to remove all dust on the damaged surfaces after grinding. Formwork having a dimension of 22 in. x 13 in. x 14 in for FR-SCC and MALP girders while 22 in. x 12 in. x 14 in. formwork was used for UHPC girders. These formworks would encapsulate the damaged region of the scaled AASHTO Type II girder dimensions (with some modifications) and cover the prepared surfaces. Silicone was used to seal all connections between the formwork and the girder to prevent leaking repair materials during casting, as shown in Figure 3.12.

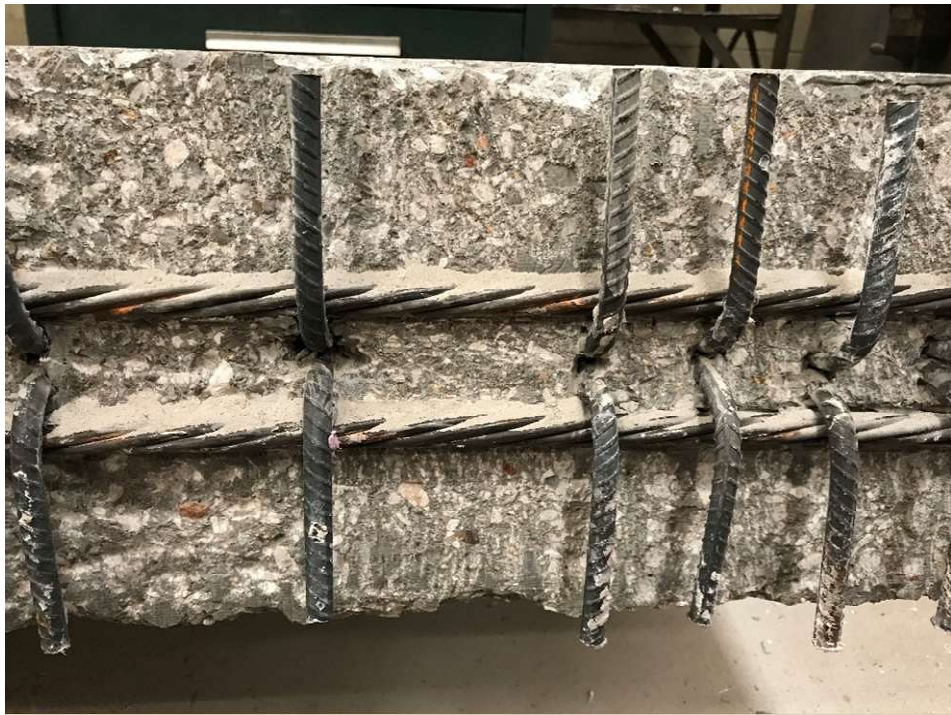
Figure 3.11: Surface Preparation at the Corroded Region

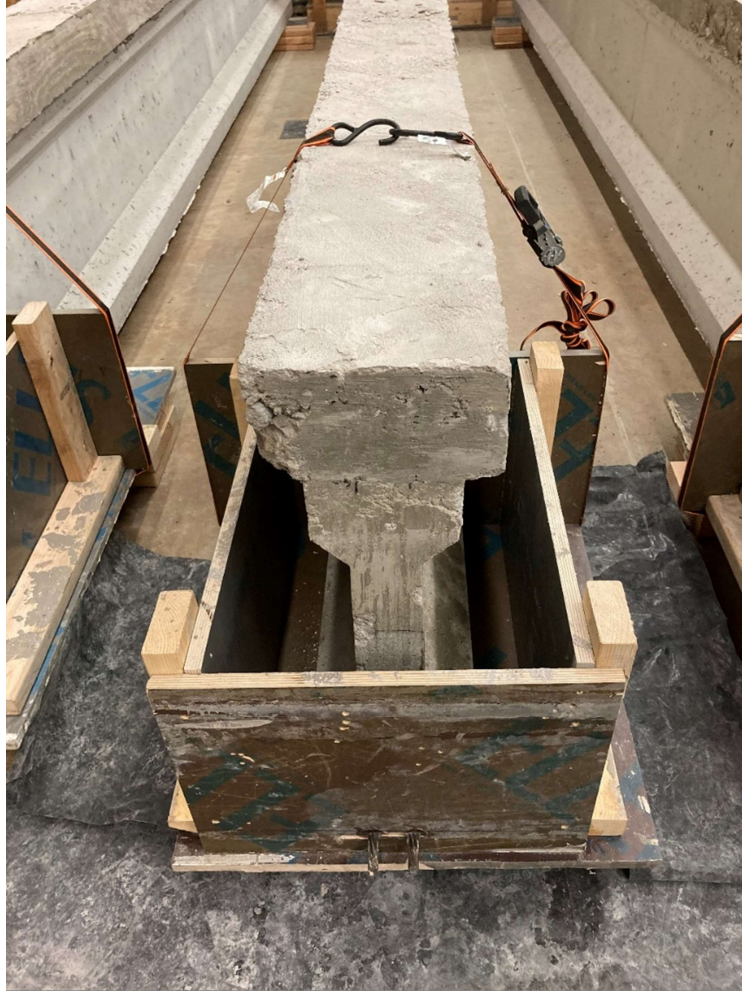
Figure 3.12: Formwork Encapsulating the Repaired Region

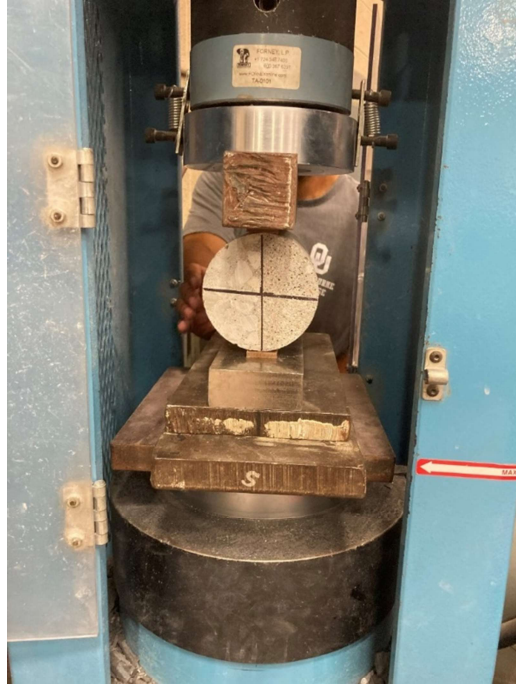
Figure 3.14: Splitting Tensile Strength Test Set Up

After 28 days, all specimens were ready to test. The tests were conducted using the Forney compression machine and set up as shown in Figure 3.14 and 3.15 based on ASTM C496. Based on Figure 3.15, the vertical load from compression machine would create the lateral tensile stress in cylinder and split it in tension along the cylinder's diameter or at the interface between the two concrete materials.

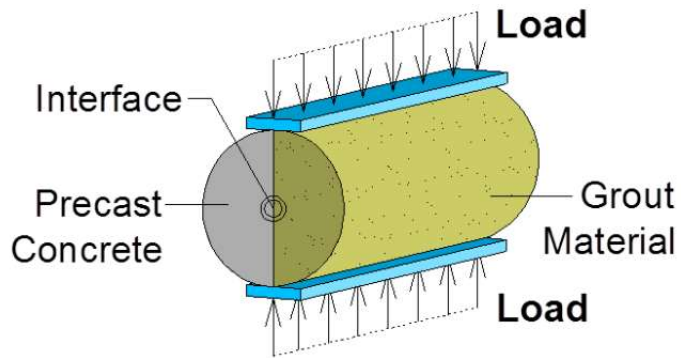
Figure 3.15: Load Application Splitting Tensile Strength Bond Test (Graybeal, 2016)

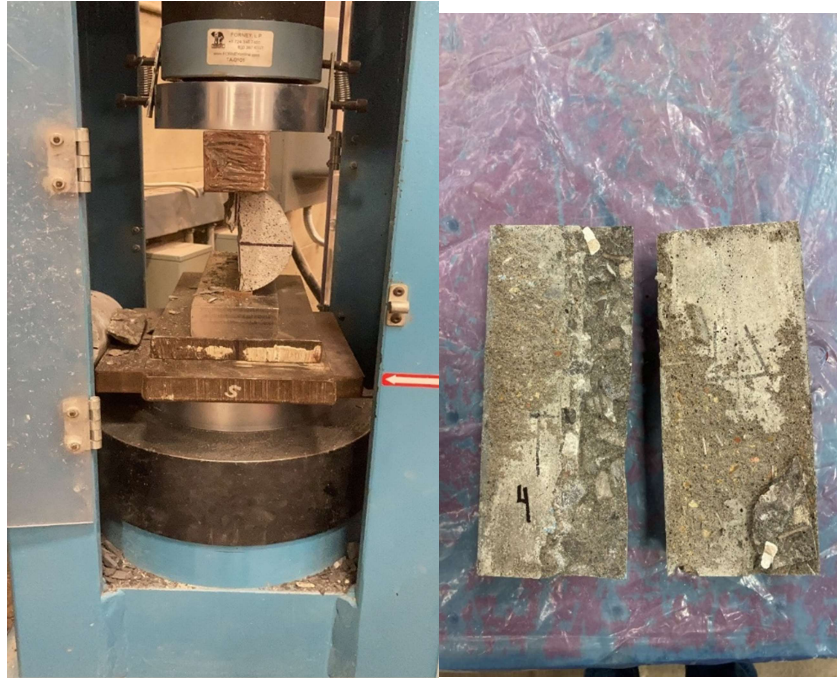
Figure 3.16: Specimen Break at Maximum Stress (Left) and Specimen Separated in Half After Test (Right)

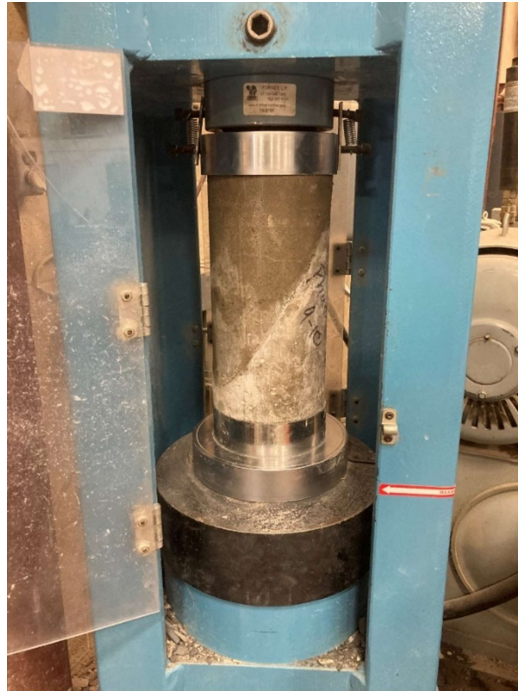
Figure 3.17: Slant Shear Test Set Up

After 28 days, the composite cylinders were end ground to make both top and bottom surfaces flat in order to avoid the uneven stress distribution during the testing process. Finally, all specimens were placed under the Forney compression machine and tested to failure based on the instructions from ASTM C882, as shown in Figures 3.16 and 3.17. As illustrated in Figure 3.18, the vertical load would produce a stress on the interface between two concrete materials by a shear force that applies across the interface between two concrete materials.

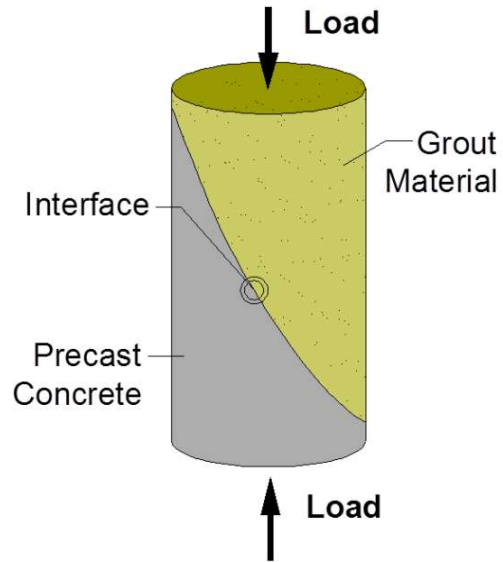
Figure 3.18: Illustration of load application in Slant Shear Bond Test (Graybeal, 2016)

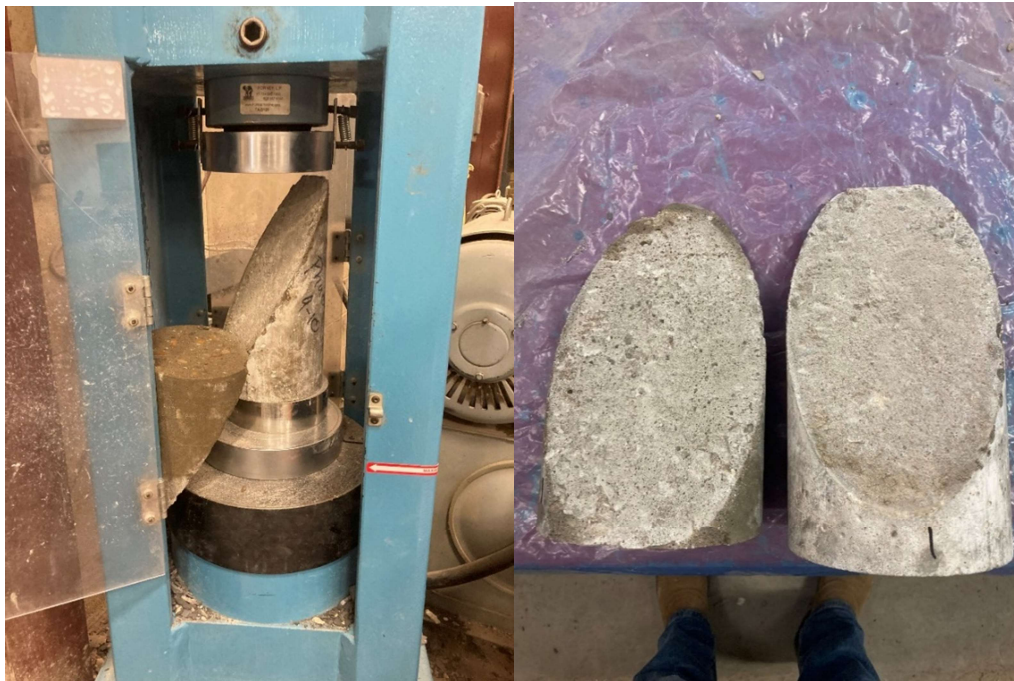
Figure 3.19: Specimen Break at Maximum Stress (Left) and Specimen Separated at the Inclined Surface (Right)

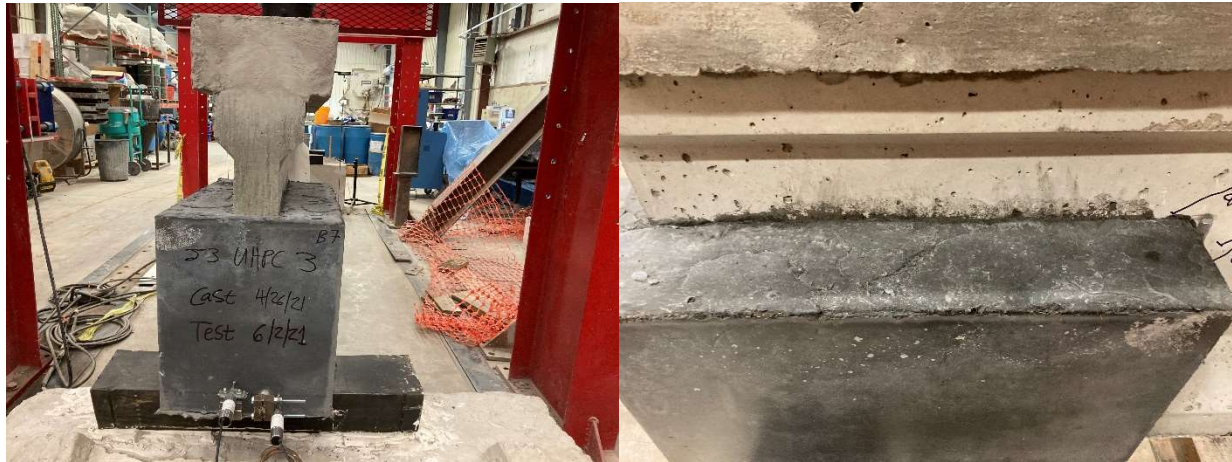
Figure 3.20: Finished UHPC Repaired Region at Front View (Left) and Side View (Right)

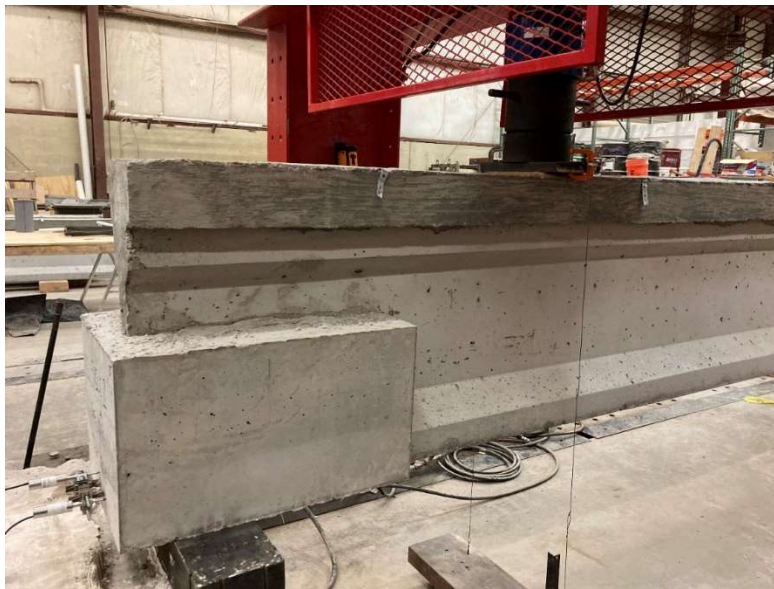
Figure 3.21: Finished FR-SCC Repaired Girder

As with FR-SCC, the repaired zone was wetted with water to avoid the absorption of water from the FR-SCC into the girder's surface. During the casting process, the slump flow test (ASTM C1611) was performed to verify the flowability of the FR-SCC batch. The mix was transported using the concrete transfer bucket and poured into the formwork from one side of the girder in order to avoid entrapping air below the bottom flange. The mix transfer process was the same as for UHPC. When the FR-SCC hardened, the formwork was removed, as shown in Figure 3.19. In contrast to UHPC, eight 6 in. x 12 in. cylinders were cast for determining the compressive strength. The size of the 2.1 in. long polypropylene fibers required the size of mold to be increased.

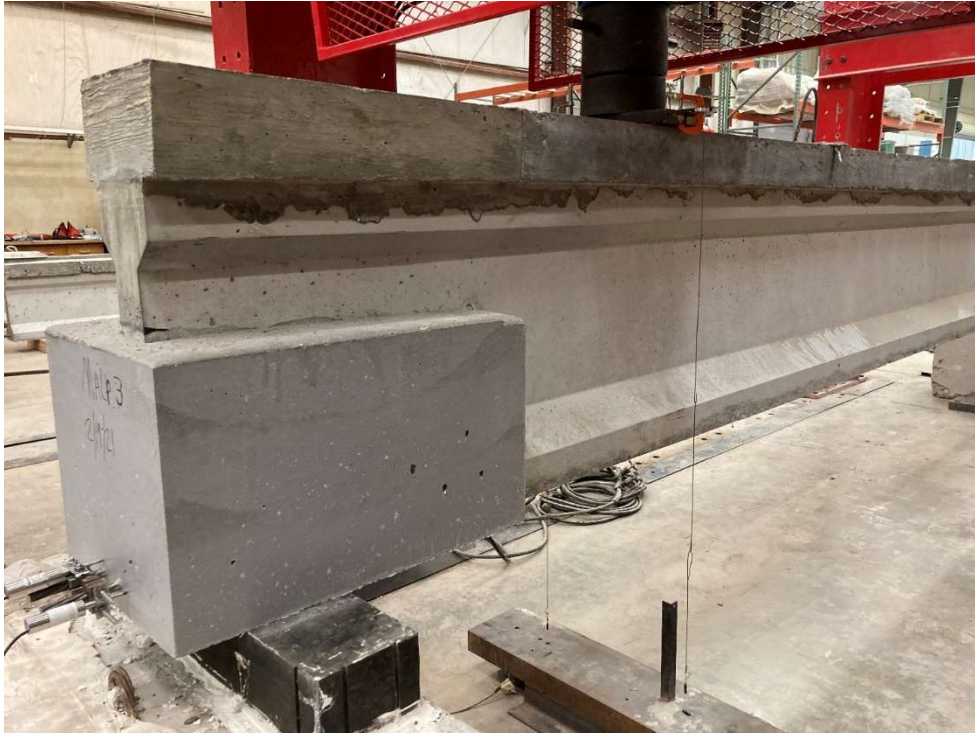
Figure 3.22: Finished MALP Repaired Girder

The MALP material used in this research was a two-part mixture marketed under the name Phoscrete. According to the manufacture's instruction, a bag of magnesium-alumino-aggregate dry powder is mixed with a jug of the liquid phosphate activator without water or other liquids. Both the dry powder and liquid activator bottle were kept in the cool environmentally controlled room (approximately 72 °F) to slow down the chemical reaction during mixing and the setting time of the concrete. First, the liquid activator was poured into a dry plastic bucket before adding the dry aggregate powder. A urethane auger paddle provided by Phoscrete was then used to mix these two components for one minute. The mixture was placed in the formwork immediately after mixing not only to avoid the concrete hardening quickly before it flowed into the formwork, but also to begin the next batch as soon as the first was completed. For the damaged region, MALP was cast from one side first to ensure the concrete flow along the formwork and prevent entrapping air. Until the concrete was filled up to the half-height of the formwork, the MALP was poured alternatively from both sides of the formwork to balance the height of the repair material. A steel rod was used to compact the MALP in order to avoid honeycombing and fill any remaining voids. A total of nine 4 in. x 8 in. cylindrical molds were used to cast MALP at the same time with casting a girder. These specimens were tested to determine the compressive strength at 1 day, 28 days, and test day. Figure 3.20 shows the completed repaired girder with MALP.

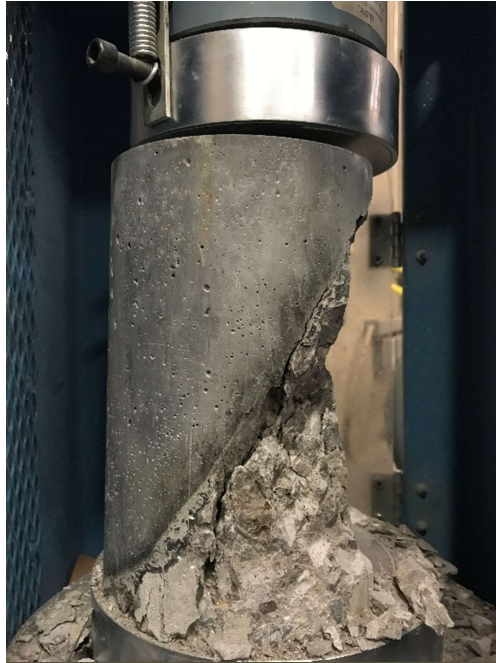
Figure 4.1: Specimen after Slant Shear Test

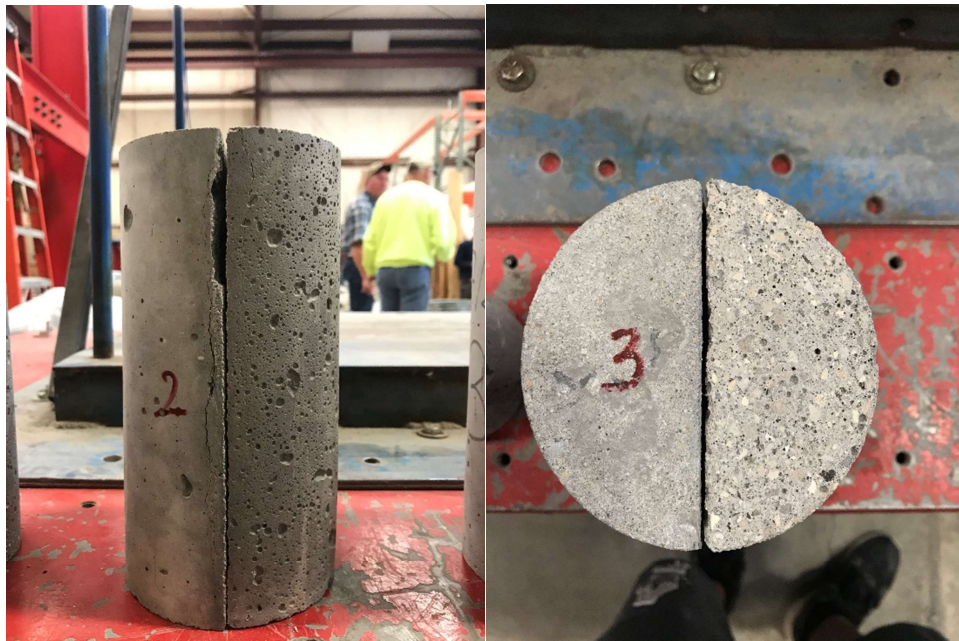
Figure 4.2: Specimen after Splitting Tensile Test at Side View (Left) and Top View (Right)

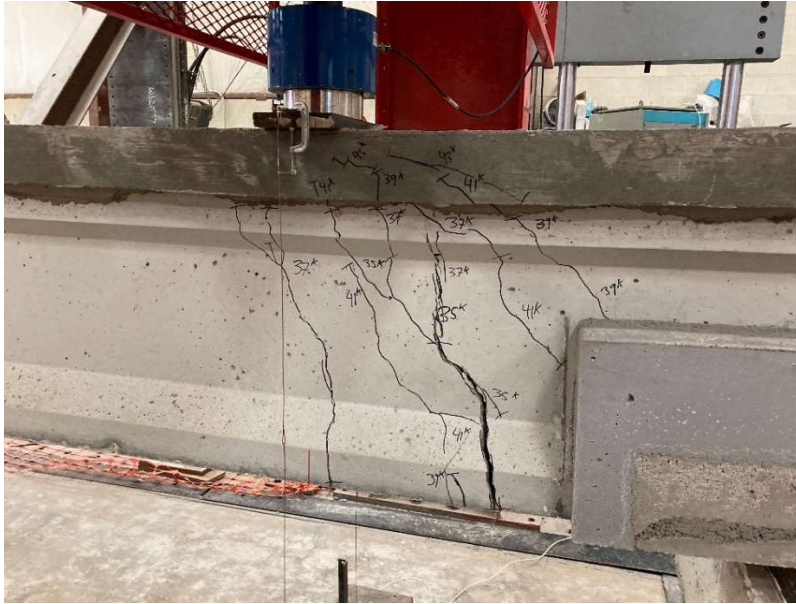
Figure 4.3: MALP-1 Girder after Test

The shear force was induced on the repaired beam end by applying a point load at 3.5 ft from the simulated corroded end of the girder, as described in Section 3.2.4 and Figure 3.13. The load was increased gradually, and the relative deflection and strand slip were monitored. For this girder a layer of repair material was cast first, but the repair was stopped due to high temperatures. Later on, additional repair layers were cast. The behavior of the girder may have been affected for this reason. Figure 4.3 shows the appearance of cracks on the girder after testing. There was no crack observed in the repair region, which means the repair was successfully designed to handle the load and the failure zone was moved away from the simulated corroded end region. During the experiment, there was no delamination or differential movement observed between the girder and the repair. The specimen failure started with a flexure/flexure-shear crack at web of the girder extending away from the junction of the repair material and the girder. This crack was observed to be the widest at the point of failure and potentially led to the failure of the girder. The cracks generated upward diagonally as they moved to the loading point and vertically downward to the bottom flange. At 39 kips, it was observed that there was a crack started at the junction between the girder and MALP concrete. When the applied load was approaching 43 kips, the deck started crushing at the load point and the loading was stopped at the same time. Therefore, the maximum capacity of the girder was just under 43 kips.

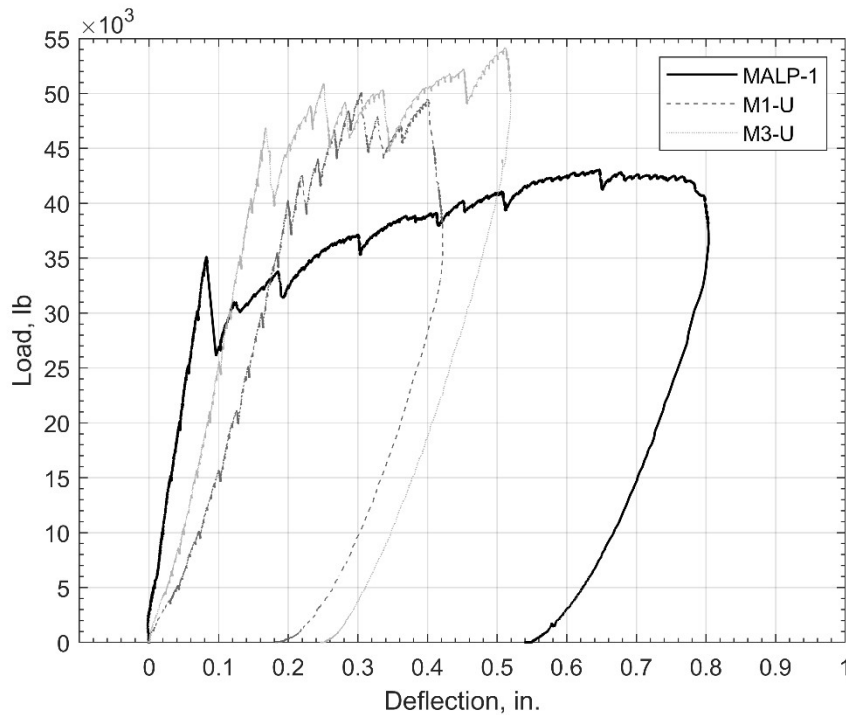
Figure 4.4: Load vs. Deflection Curves of MALP-1 Girder and Undamaged Reference Beams

girder M3-U had a peak load of 54 kips with 0.51 in. of deflection. In addition, the peak load measured for the MALP-1 girder was less than the estimated capacity calculated in Appendix 7.3 and 7.4.

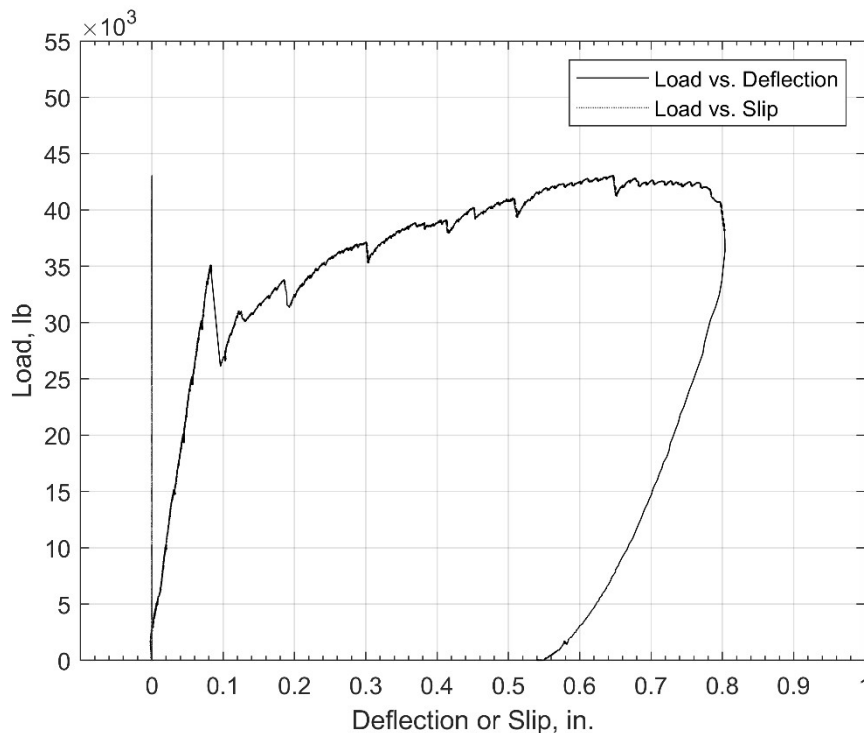
Figure 4.5: Load vs. Deflection and Load vs. Slip Curves of MALP-1 Girder

Strand slip was calculated by averaging the measured values from both LVDTs at the end of girder close to the loading point. However, there was an extremely small amount of strand slip measured for the MALP-1 girder; therefore, the curve of load vs. slip in Figure 4.5 looked like a vertical line. Figure 4.5 shows the strand slip and the deflection of the MALP-1 girder relative to load to show the relative timing between occurrence of slip and deflection. In addition, the crack pattern showed that most of the cracks were inclined and started in the web near the girder end. Based on these factors, the failure mechanism was determined to be a bond-shear failure using criteria from previous research (Naji, Ross, & Floyd, 2016).

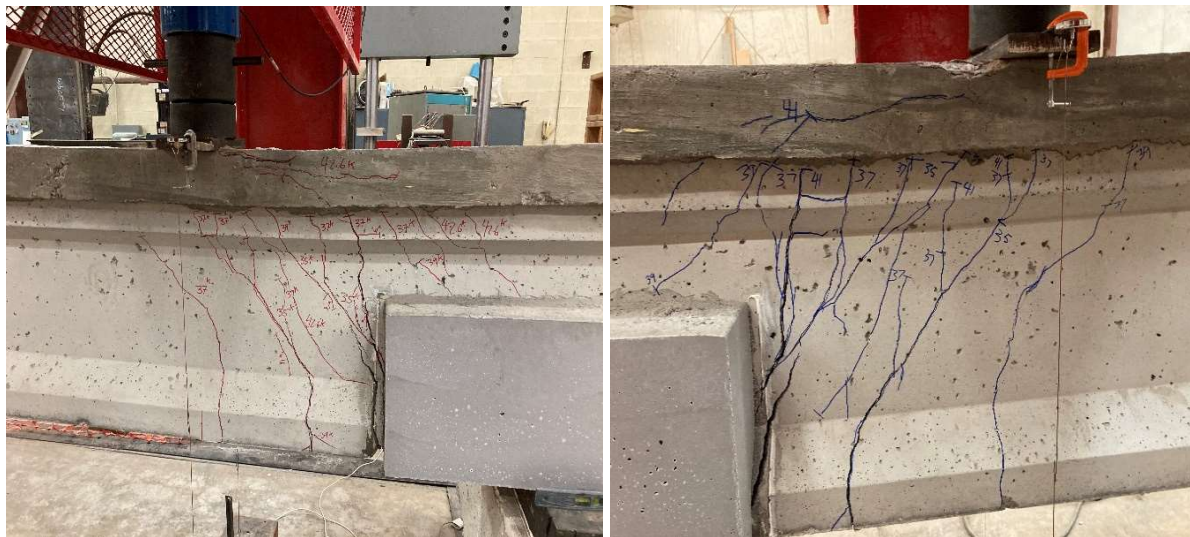
Figure 4.6: MALP-2 Girder after Test with SW Side (Left) and SE Side (Right)

Figure 4.6 shows repair girder MALP-2 after testing. The first flexure-shear crack appeared in the web of the girder, at the junction between the repair material and the girder, and approximately an inch away from the repair material. As the load increased, the crack developed slightly vertically before it propagated upward towards the loading point and downward to the bottom flange of the girder. Other flexure and flexure-shear cracks beginning at the bottom flange of the girder were observed at the load of 37 kips and 39 kips. The maximum load of 42.6 kips was noted at the point of crushing of the girder's deck.

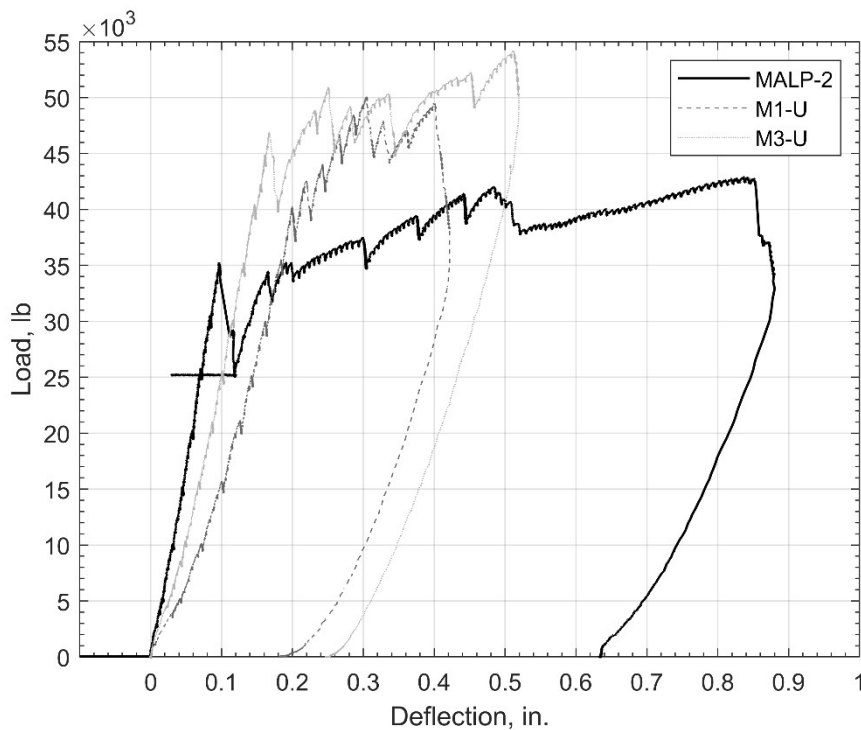
Figure 4.7: Load vs. Deflection Curves of MALP-2 Girder and Undamaged Reference Beams

original, undamaged reference beams. At the point the first crack occurred, there was a sharp drop in load, approximately 10 kips, and the stiffness of the girder was reduced. However, as compared to girders M1-U and M3-U which were artificially stopped before reaching the ultimate limit state, the MALP-2 girder had a deflection of 0.84 in. at the peak load (42.6 kips). An issue occurred with the data collection equipment at a load of 25 kips, which is visible as a horizontal line in Figure 4.7. Deflection data for girder MALP-2 was observed to move backward then returned. This issue could come from the unstable electric current of the data collecting system, noise of data collection or from someone bumping the instrument. In addition, the MALP-2 girder's measured capacity was less than the calculated capacity presented in Appendix 7.3 and 7.4.

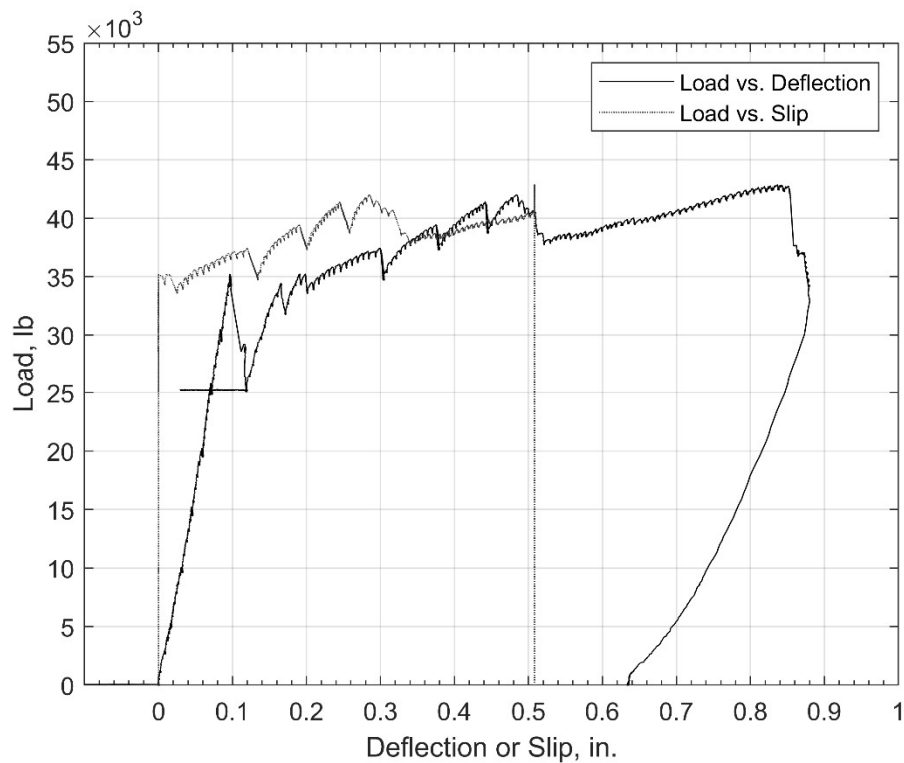
Figure 4.8: Load vs. Deflection and Load vs. Slip Curves of MALP-2 Girder

Figure 4.8 shows the load vs. deflection and load vs. slip curves for the MALP-2 girder to identify the relationship between the two. The comparison indicates the web shear and flexure-shear cracks that started at 35 kips correspond with the initial strand slip. In addition, there was a large amount of strand slip change after the first crack that indicated the significance of the contribution of bond to the overall failure for girder MALP-2. Unlike the MALP-1 girder, the MALP-2 girder's peak load was associated with the flange crushing in compression. In addition, a crack was observed adjacent to the support which opened widely due to strand slip as load increased, as shown in Figure 4.6. Also, the peak load of the MALP-2 girder was less than the nominal flexural capacity. These items together indicate that the failure of MALP-1 was bond-flexure failure based on the criteria of Naji et al. (2016).

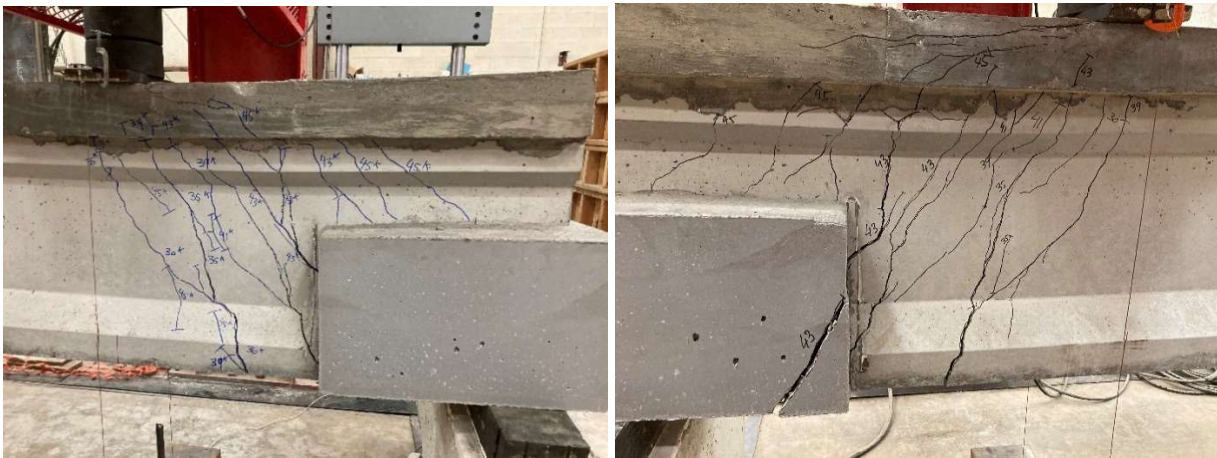
Figure 4.9: MALP-3 Girder after Test with SW Side (Left) and SE Side (Right)

The cracking pattern for the MALP-3 girder after failure is shown in Figure 4.9. The first crack for the MALP-3 girder appeared at the bottom flange approximately 8 in. away from the junction of the repair and the girder on the SW side. Similar to both other MALP girders, the crack started nearly vertical in the bottom flange and at the web began propagating toward to the loading point. In contrast to MALP-1 and MALP-2, the first crack occurred early for MALP-3, at a load of 30 kips and at the bottom flange. In addition, when the load reached 43 kips, there was a crack observed at the junction of the girder and the repair and passing through the MALP repair material.

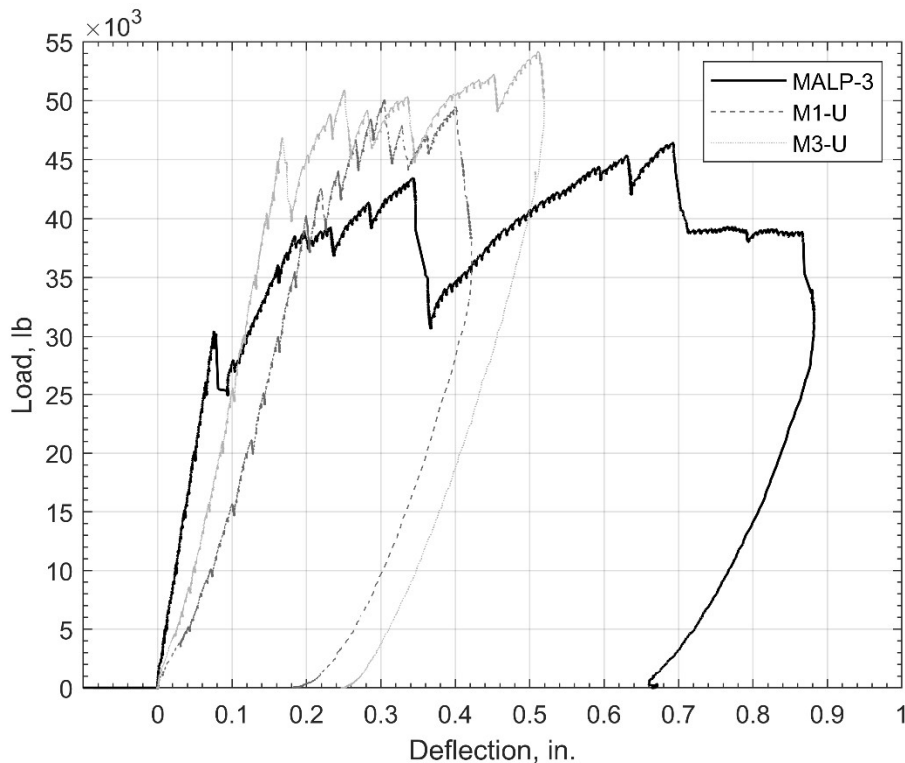
Figure 4.10: Load vs. Deflection Curves of MALP-3 Girder and Undamaged Reference Beams

Figure 4.10 shows the load vs. deflection curve of the MALP-3 girder with those of the two undamaged reference beams. Unlike MALP-1 and MALP-2, there was a significant increase in load after the first crack for MALP-3 with limited deflection, which indicated a higher stiffness of the girder after cracking compared to the MALP-1 and MALP-2 girders. The peak load of 46.4 kips was observed as the deck started crushing and with 0.69 in. deflection. In comparison to girders M1-U and M3-U, the MALP-3 girder had a lower capacity and larger deflection. Furthermore, the measured capacity of the MALP-3 girder was less than the estimated capacity computed in Appendix 7.3 and 7.4.

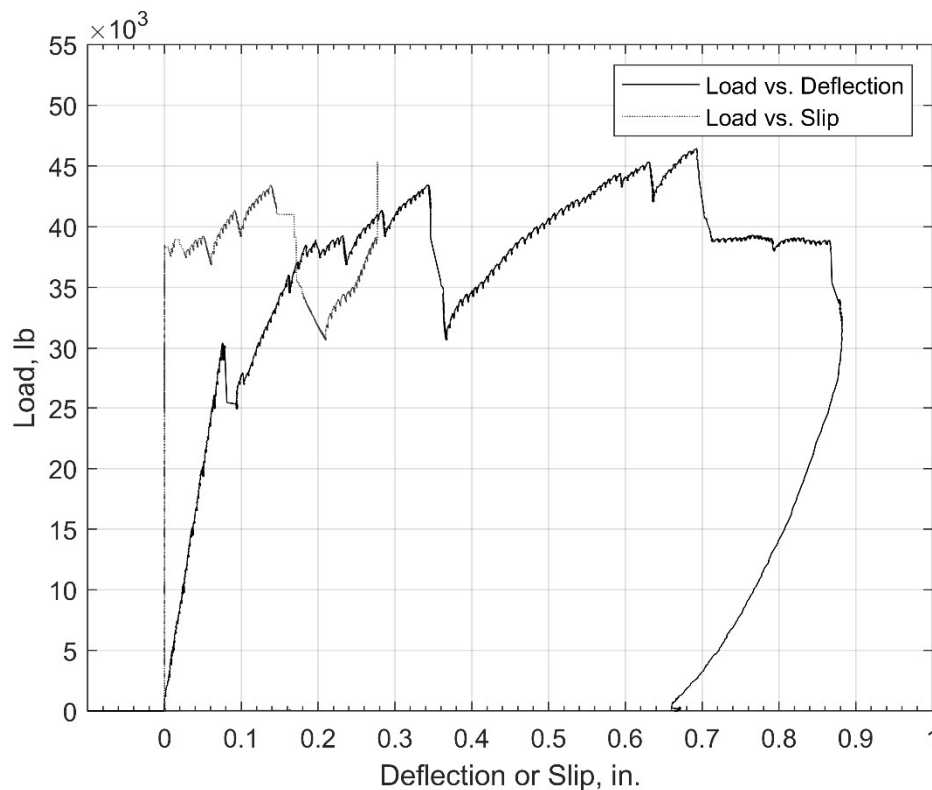
Figure 4.11: Load vs. Deflection and Load vs. Slip Curves of MALP-3 Girder

Based on Figure 4.11, the prestressing strands began slipping at 38.5 kips of load, which was higher than the first cracking load of 30 kips. In addition, the stiffness of the girder was reduced significantly after slip was observed, which could be a major difference between MALP-3 and MALP-1 and 2. It should be noted that the slip data in Figure 4.11 for the MALP-3 girder was incomplete due to the LVDT running out of measurement range. However, the significant amount of slip measured indicates a bond failure. Figure 4.9 shows that the compression zone (top flange) of the girder was crushed at 45 kips with the appearance of flexural cracks at 43 kips. The combination of the strand slip, cracking pattern, and flange crushing indicate the failure type of this girder was bond-shear/flexure.
