METHOD OF REHABILITATION FOR CORROSION DAMAGE
IN THE END REGION OF PRESTRESSED CONCRETE BRIDGE GIRDERS

A THESIS
SUBMITTED TO THE GRADUATE FACULTY
in partial fulfillment of the requirements for the degree of
MASTER OF SCIENCE

By
MINH PHUOC HUYNH
Norman, Oklahoma
2021

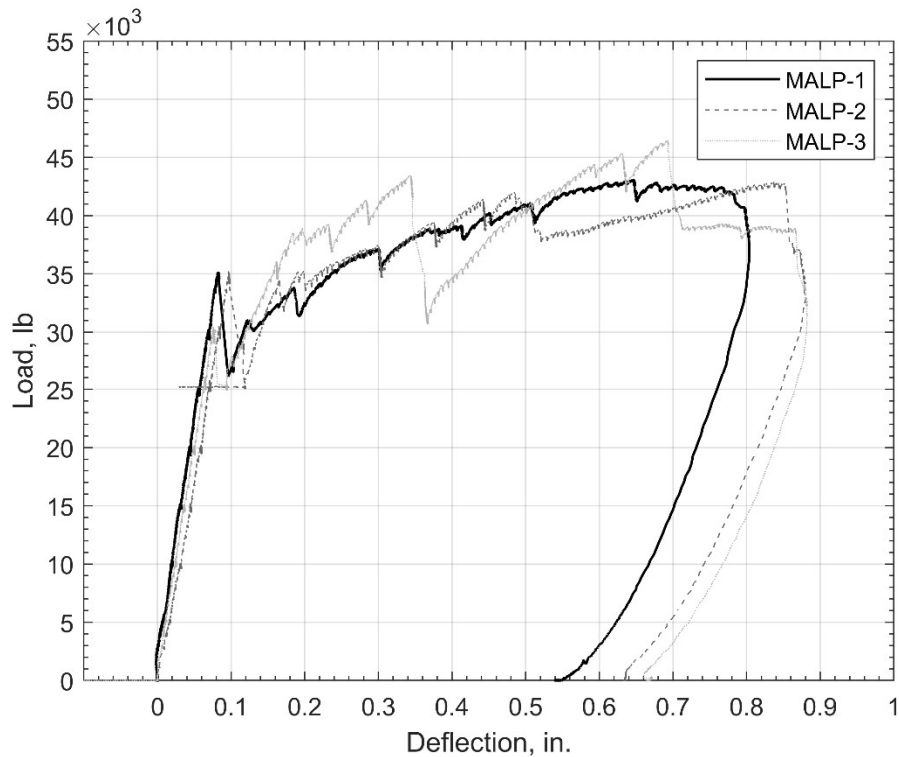
Figure 4.12: Load vs. Deflection Curves of MALP Girders

In summary, all MALP repair girders had a higher initial stiffness but lower capacity, higher deflection, and earlier first cracking as compared to the undamaged reference beams. However, for the simulated corroded girders the loading point was in the transfer length region (measured from the end of the damaged section) while the loading point of the undamaged reference beams was in the constant initial prestress region (with transfer length beginning at the end of the beam). It could be understood that this difference in location of the transfer length changed the bond behavior and maximum load resistance. Figure 4.12 shows that all three girders exhibited very similar behavior including some ductility.

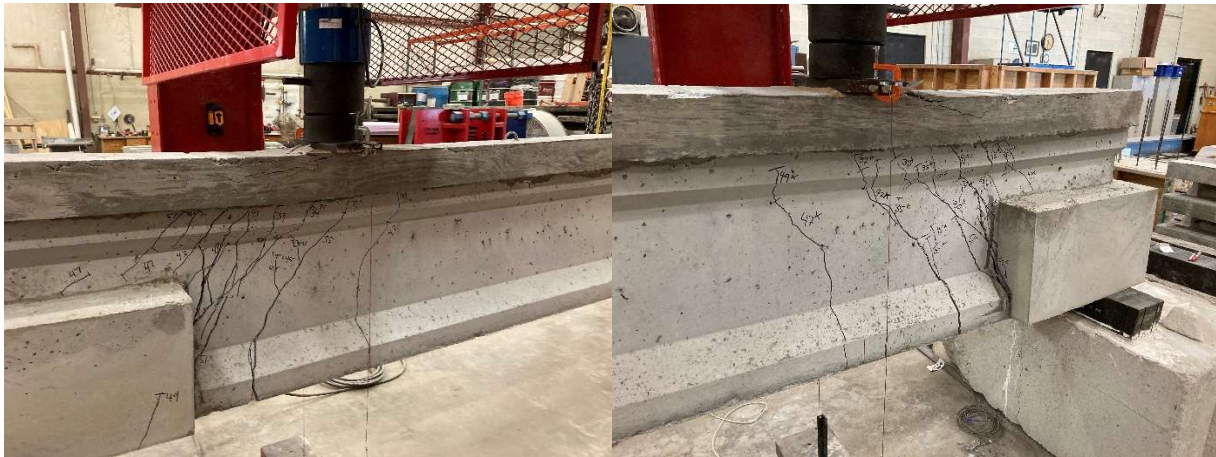
Figure 4.13: FR-SCC-1 Girder after Test with SE Side (Left) and SW Side (Right)

The cracking pattern at failure of the FR-SCC-1 girder is shown in Figure 4.12. The first crack was a web shear crack that appeared at the middle of the web on both sides, and at the bottom flange on SE side of the girder at a load of 30 kips, visible in Figure 4.12 and 4.13. As the load increased, the first crack developed diagonally and propagated both upward to the loading point, and downward to the bottom flange. Additional flexural and shear cracks appeared as the load increased. The concrete at the junction between the FR-SCC repair and the girder spalled before beam failure and created a crack between the two materials as shown in Figure 4.12 and 4.13. The peak load was recorded as 51 kips as the deck crushed.

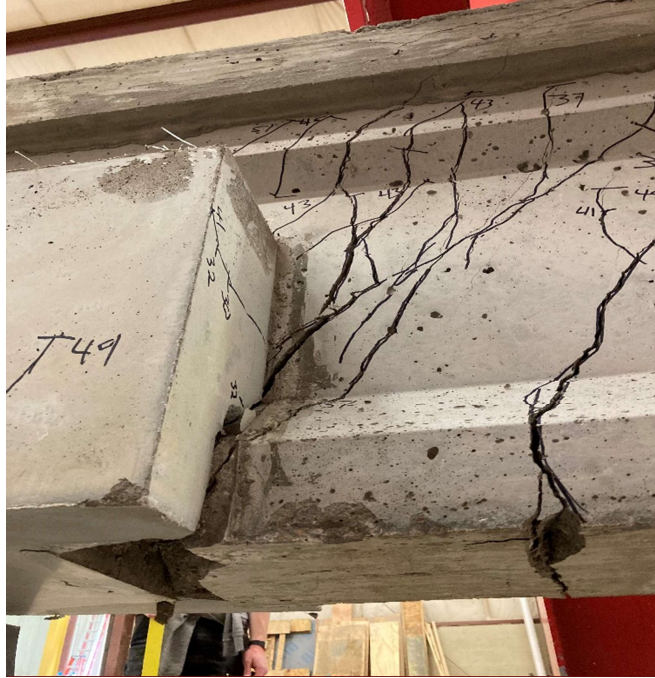
Figure 4.14: Cracks in Bottom Flange of FR-SCC-1 Girder after Test

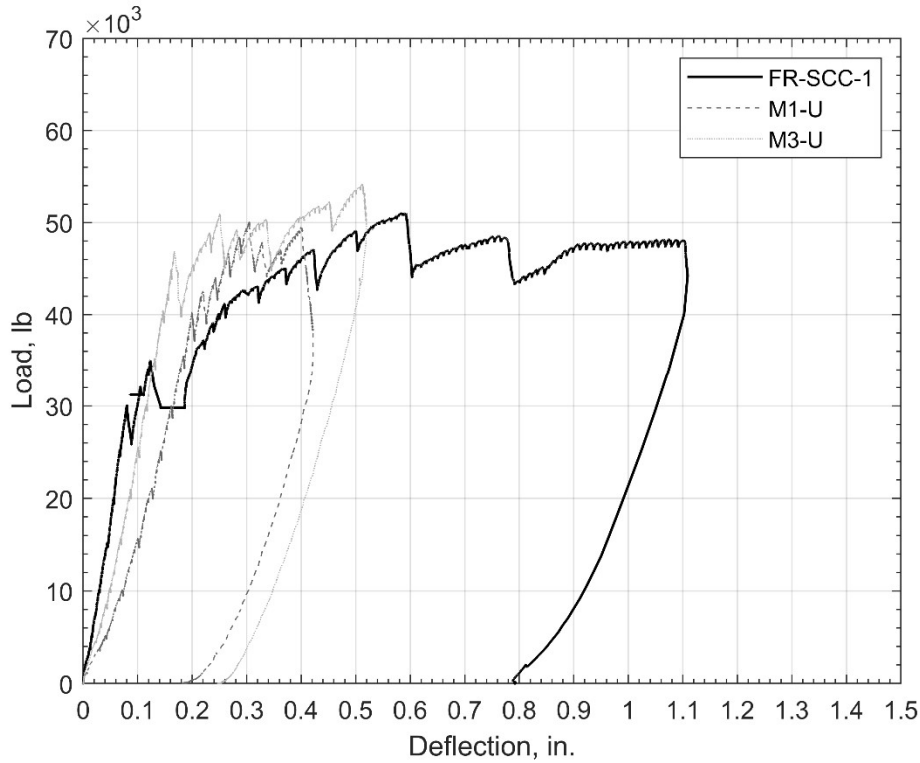
Figure 4.15: Load vs. Deflection Curves of FR-SCC-1 Girder and Undamaged Reference Beams

Based on Figure 4.14, the FR-SCC-1 girder started cracking at a load of 30 kips indicated by observation of the drop in load, which was less than the reference undamaged M1-U (40 kips) and M3-U (47 kips) girders. However, the peak load of FR-SCC-1 girder was 51 kips, which was slightly larger than the M1-U (lower bound, 50 kips), and smaller than the M3-U (upper bound, 54 kips) values. Although FR-SCC-1 did not have the largest peak load or higher cracking load compared to both M1-U and M3-U, it had larger deflection. The maximum monitored deflection was 1.1 in. compared to 0.4 in. (M1-U) and 0.5 in. (M3-U), which were artificially stopped before reaching their ultimate limit state. In addition, the measured capacity of the FR-SCC-1 girder was less than the estimated capacity presented in Appendix 7.3 and 7.4.

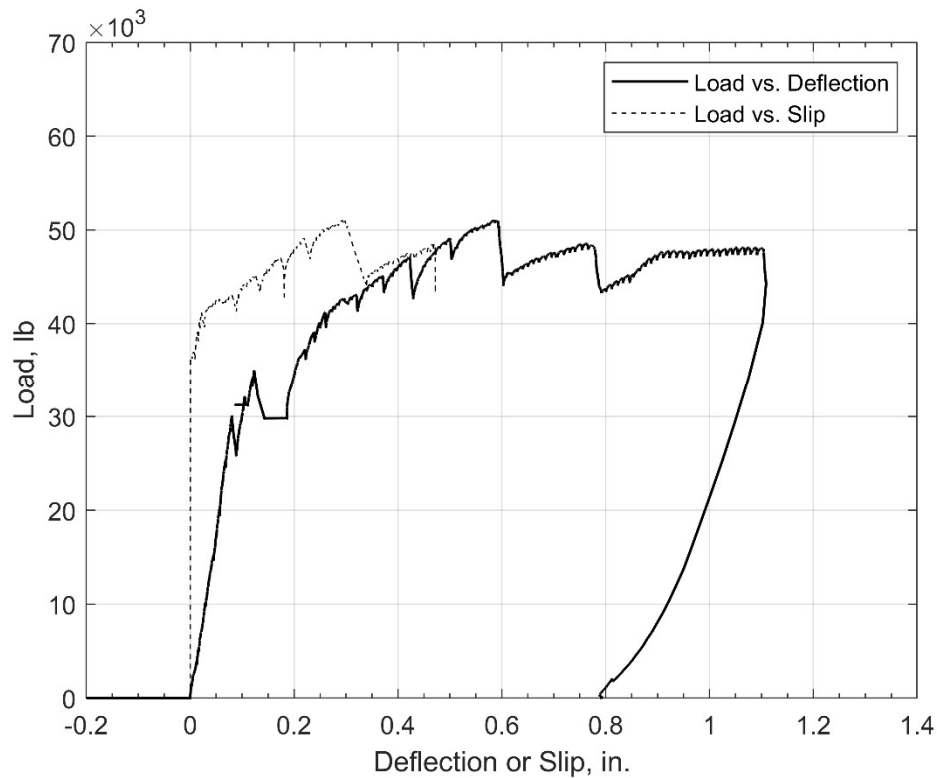
Figure 4.16: Load vs. Deflection and Load vs. Slip Curves of FR-SCC-1 Girder

As shown in Figure 4.15, the strand did not slip as the first crack occurred because the crack occurred in the web first and had not propagated into the strands to disturb the bond. At 32 kips, the crack seemed to start disturbing the anchorage of the prestressing strand, and the strand started slipping at approximately 36 kips. The stiffness of the girder was also reduced after the strands started slipping. Thereafter, as the load increased, the strand slipped further. The cracks were also opened wider, and the deflection increased with increasing load. The slip data of FR-SCC-1 girder was stopped before completion of the test because the LVDTs run out of measurement range. The widest inclined crack was observed at the junction between the new material and the girder. Combining all factors above, the failure mechanism could be classified as bond-shear/flexure (Naji et al., 2016).

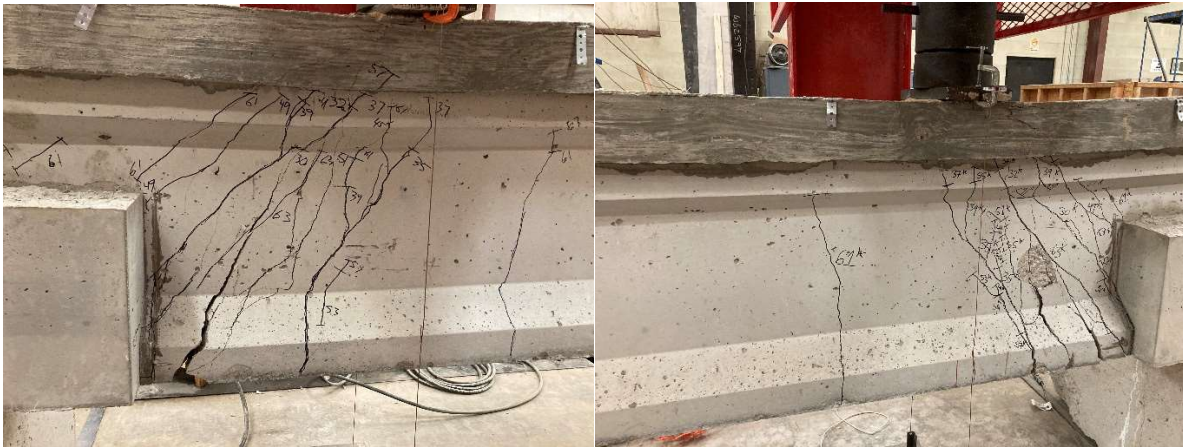
Figure 4.17: FR-SCC-2 Girder after Test with SE Side (Left) and SW Side (Right)

bottom flange into the web. Additional shear and flexural cracks occurred as the load was increased.

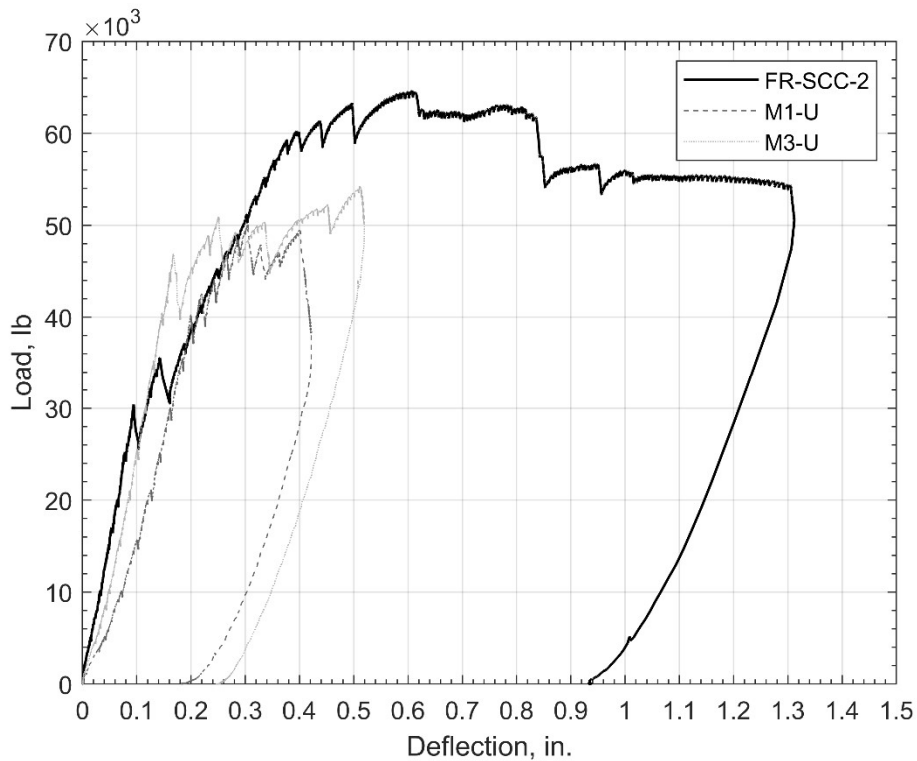
Figure 4.18: Load vs. Deflection Curves of FR-SCC-2 Girder and Undamaged Reference Beams

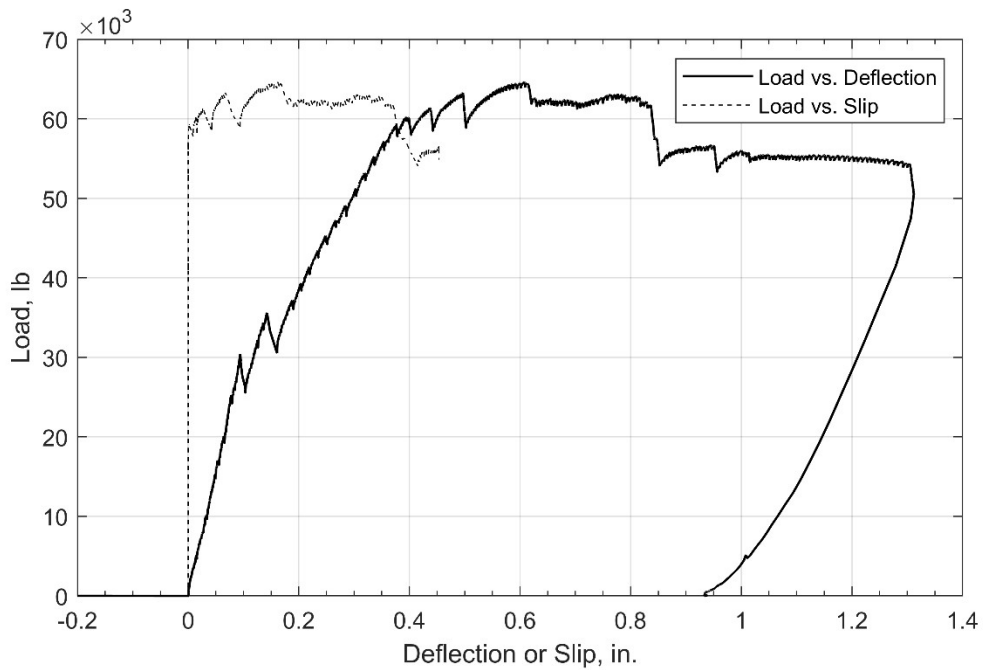
Figure 4.19: Load vs. Deflection and Load vs. Slip Curves of FR-SCC-2 Girder

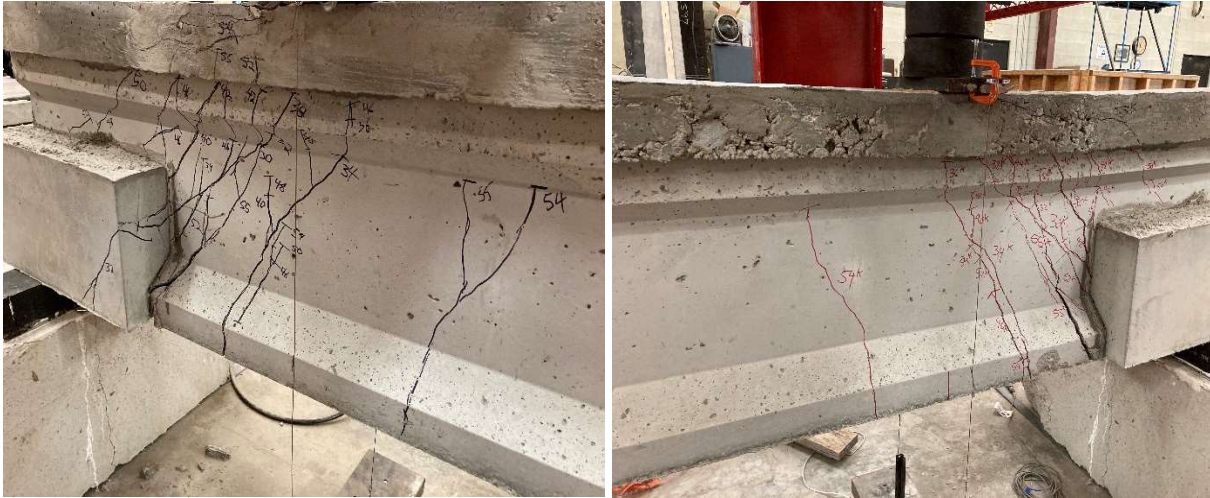
Figure 4.20: FR-SCC-3 Girder after Test with SE Side (Left) and SW Side (Right)

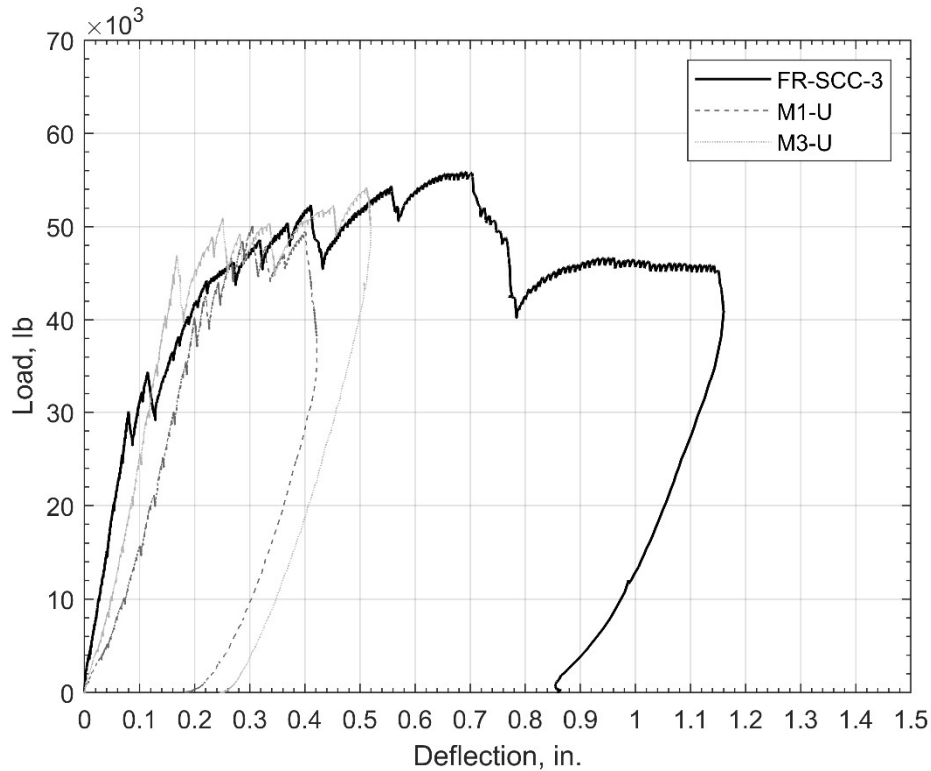
Figure 4.21: Load vs. Deflection Curves of FR-SCC-3 Girder and Undamaged Reference Beams

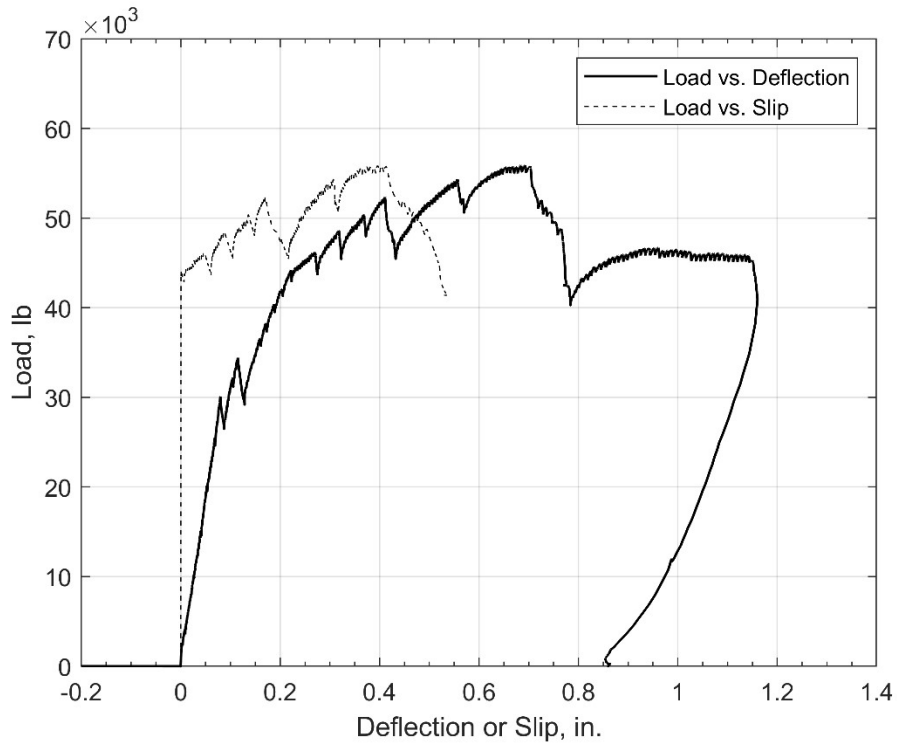
Figure 4.22: Load vs. Deflection and Load vs. Slip Curves of FR-SCC-3 Girder

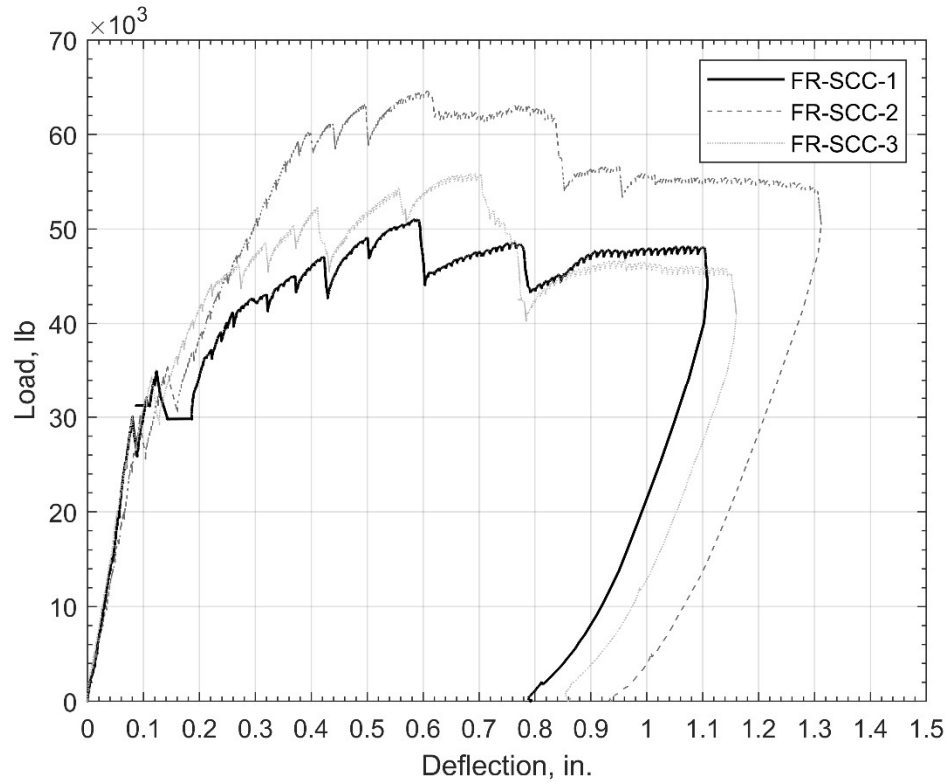
Figure 4.23: Load vs. Deflection Curves of FR-SCC Girders

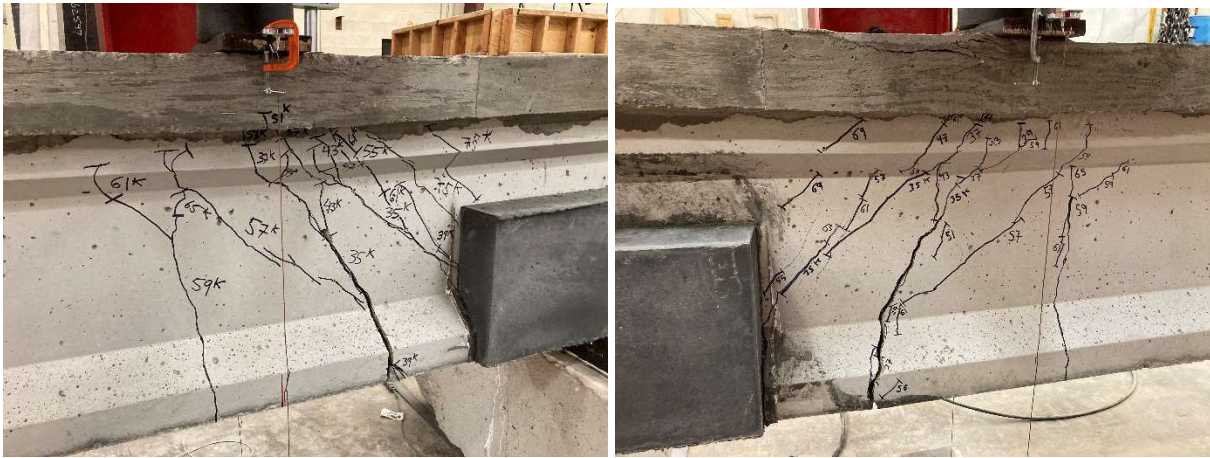
Figure 4.24: UHPC-1 Girder after Test with SW Side (Left) and SE Side (Right)

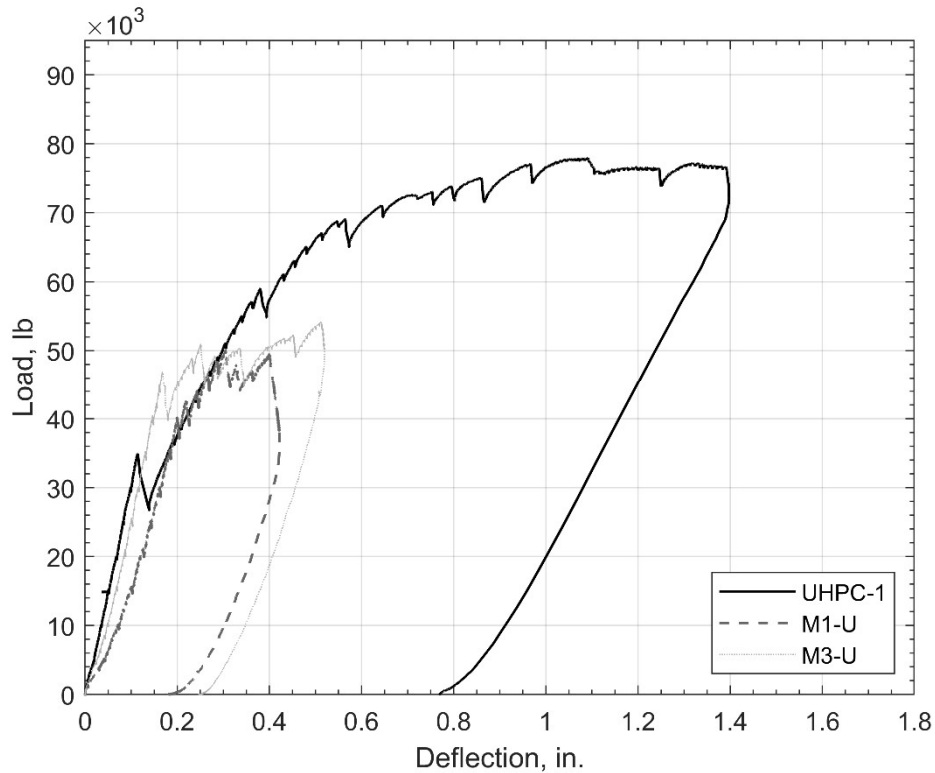
Figure 4.25: Load vs. Deflection Curves of UHPC-1 Girder and Undamaged Reference Beams

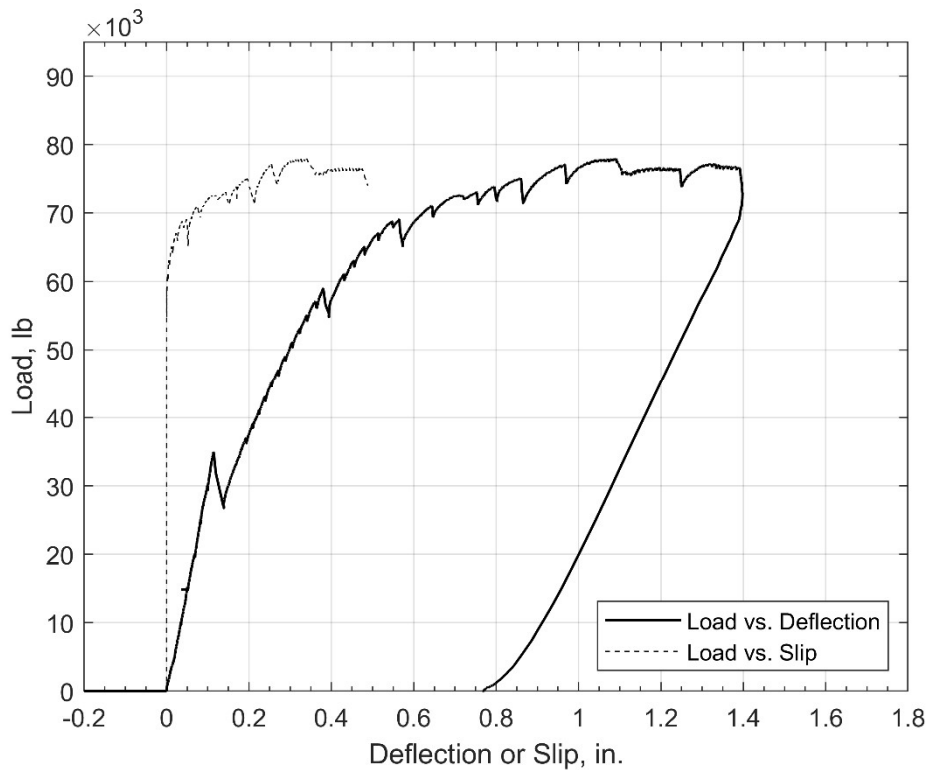
Figure 4.26: Load vs. Deflection and Load vs. Slip Curves of UHPC-1 Girder

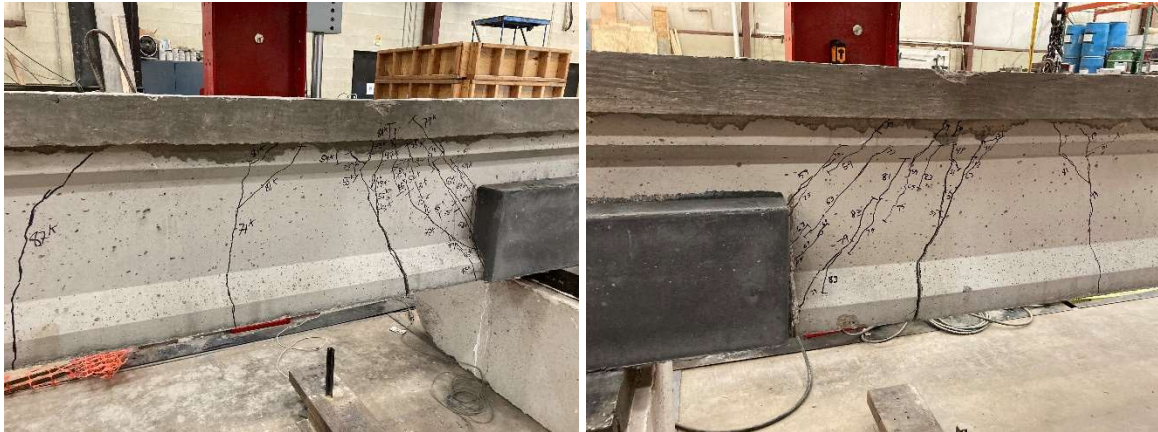
Figure 4.27: UHPC-2 Girder after Test with SW Side (Left) and SE Side (Right)

load increased, other flexure/flexure-shear cracks occurred and propagated at the middle of the girder on both sides.

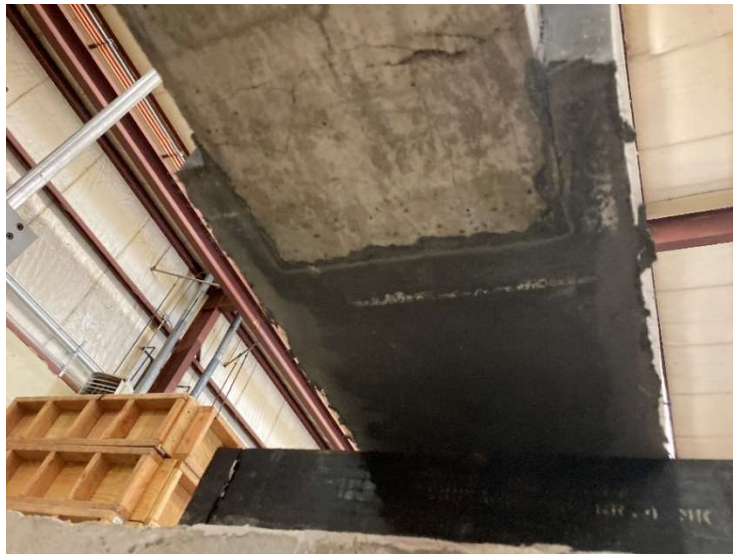
Figure 4.28: Cracks in Bottom Flange of UHPC-2 Girder after Test

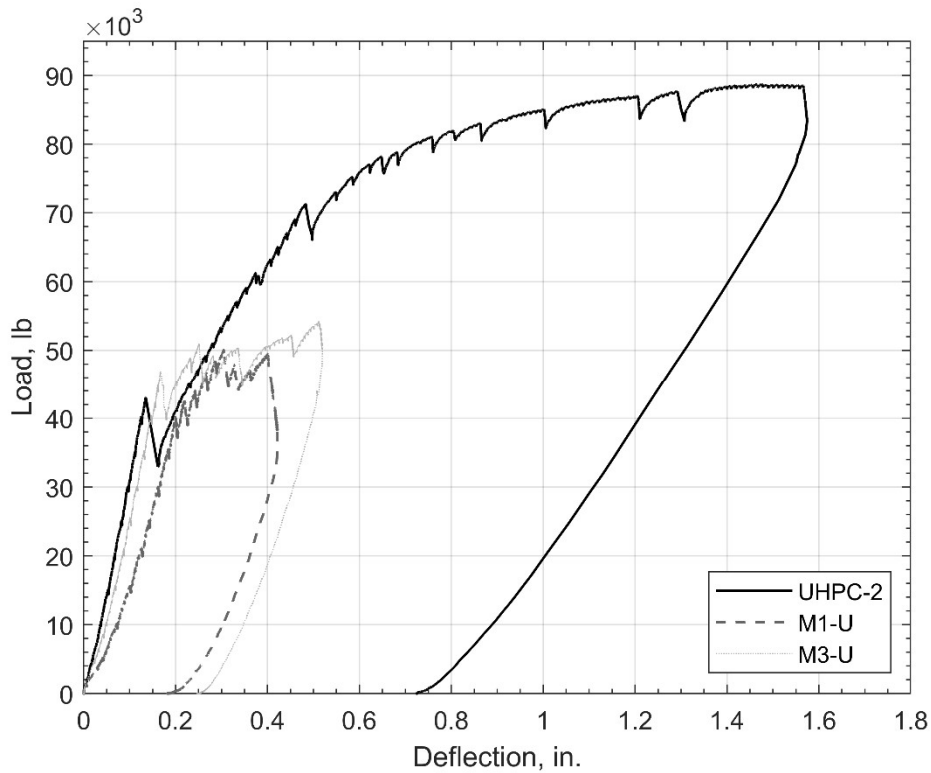
Figure 4.29: Load vs. Deflection Curves of UHPC-2 Girder and Undamaged Reference Beams

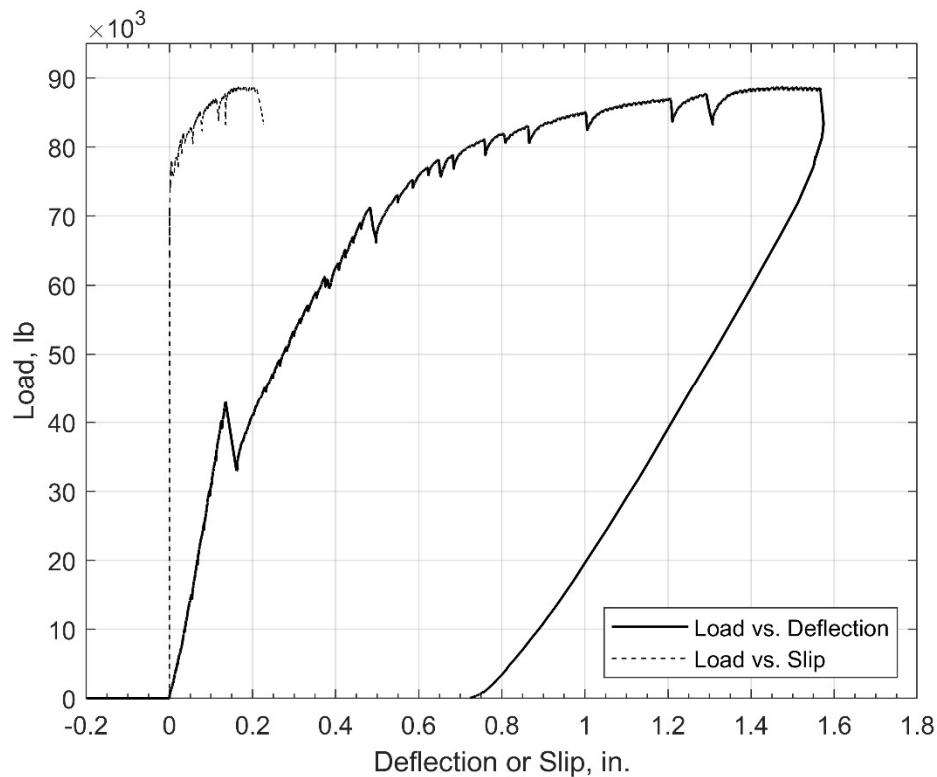
Figure 4.30: Load vs. Deflection and Load vs. Slip Curves of UHPC-2 Girder

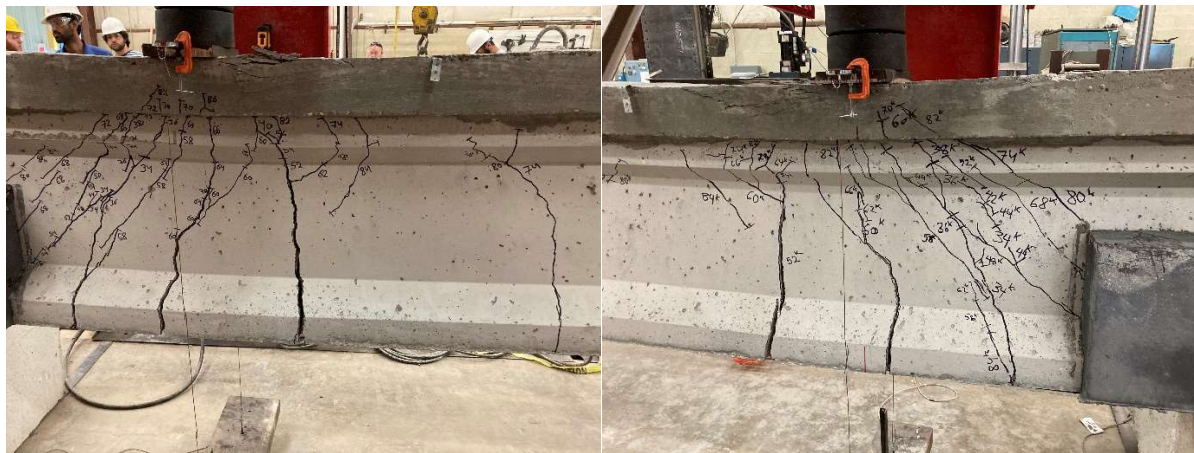
Figure 4.31: UHPC-3 Girder after Test with SE Side (Left) and SW Side (Right)

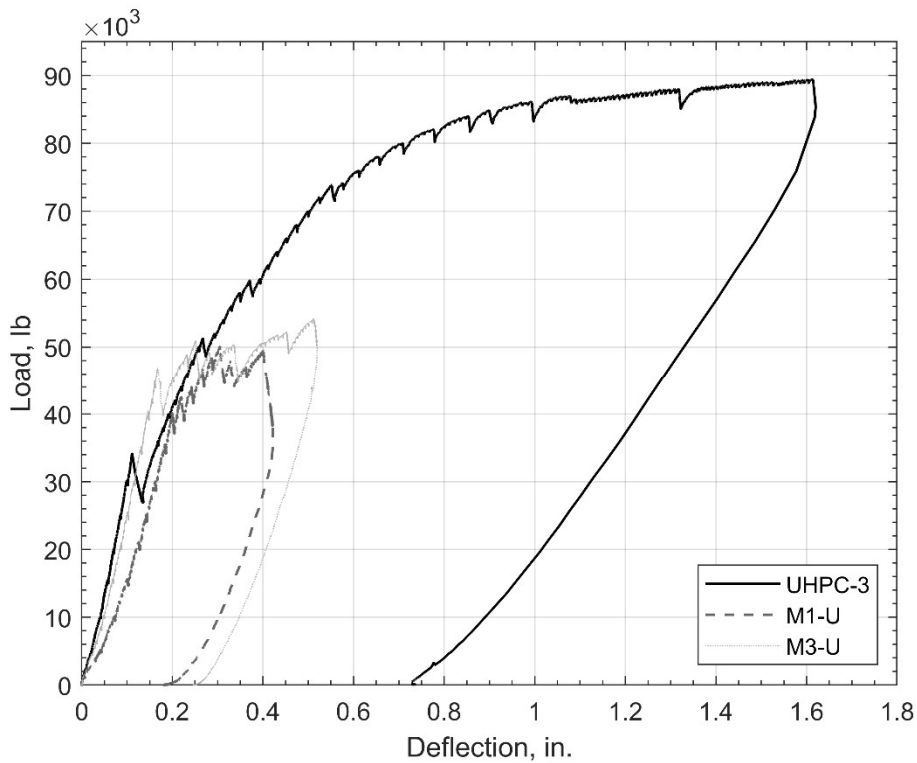
Figure 4.32: Load vs. Deflection Curves of UHPC-3 Girder and Undamaged Reference Beams

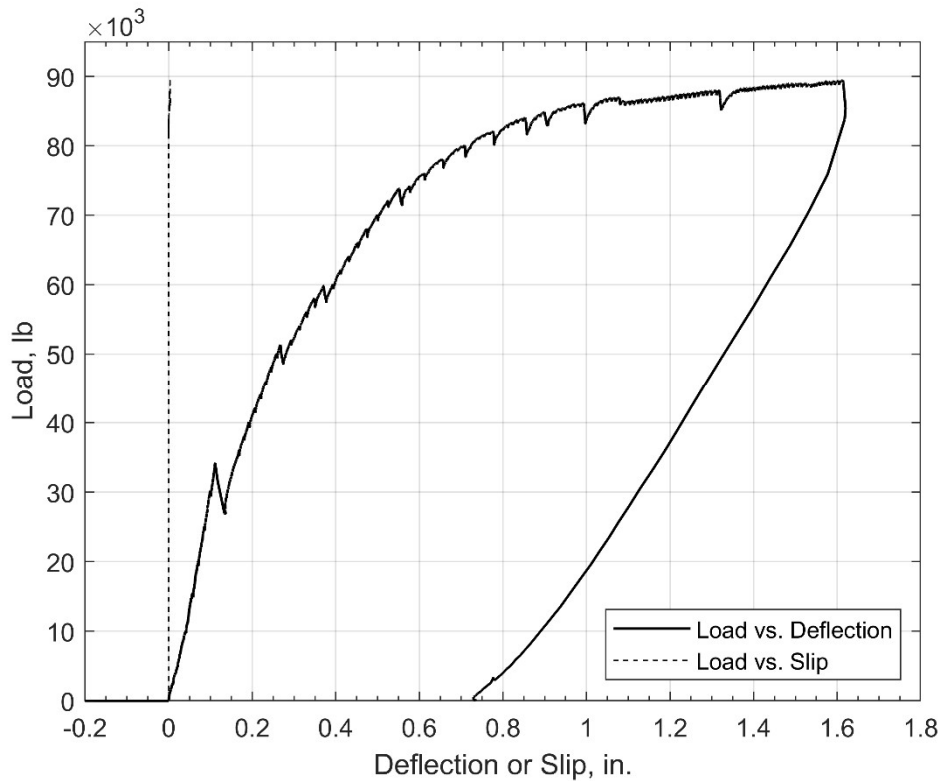
Figure 4.33: Load vs. Deflection and Load vs. Slip Curves of UHPC-3 Girder

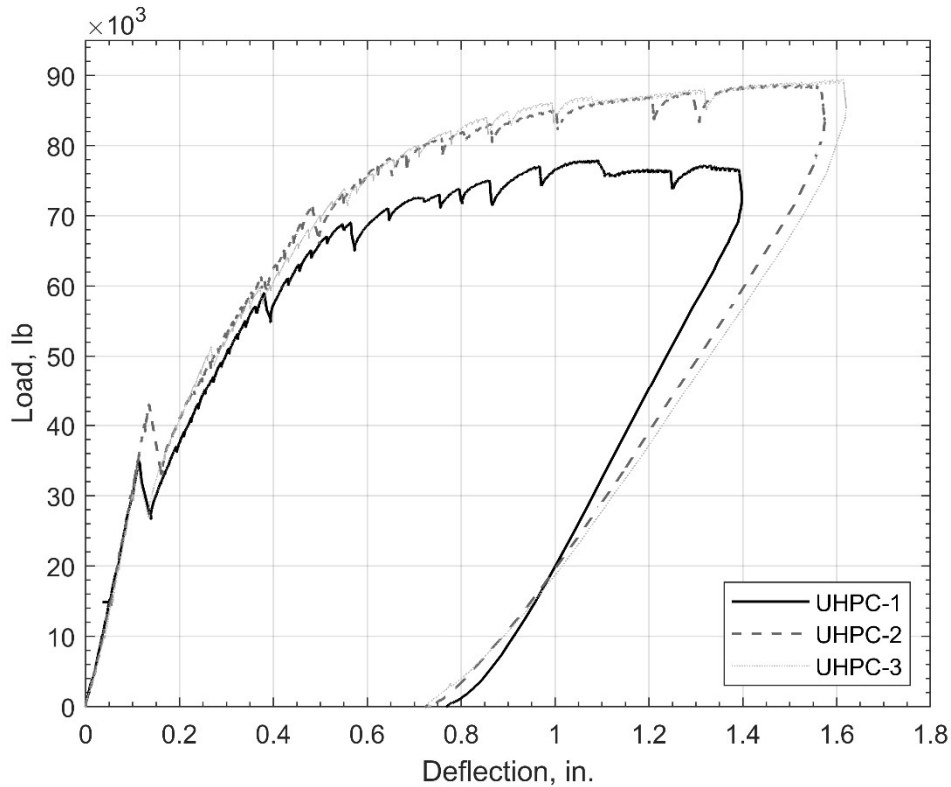
Figure 4.34: Load vs. Deflection Curves of UHPC Girders

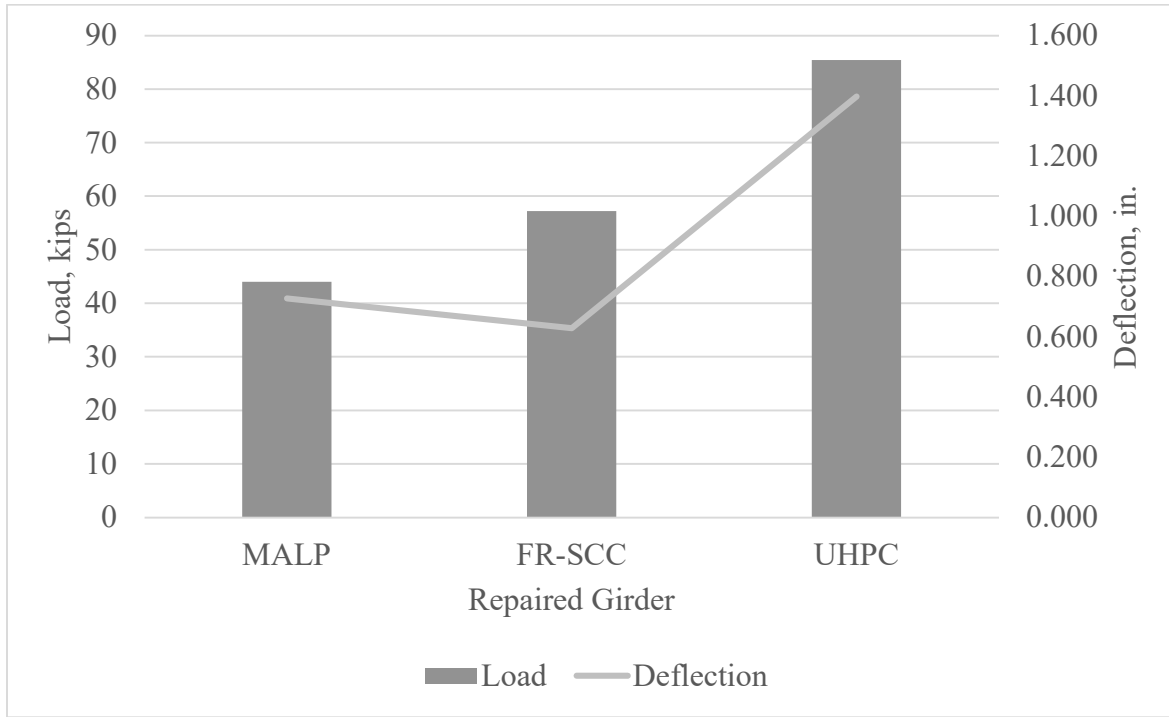
Figure 4.35: Average Peak Loads and Average Deflection at Peak Loads of Repaired Girders

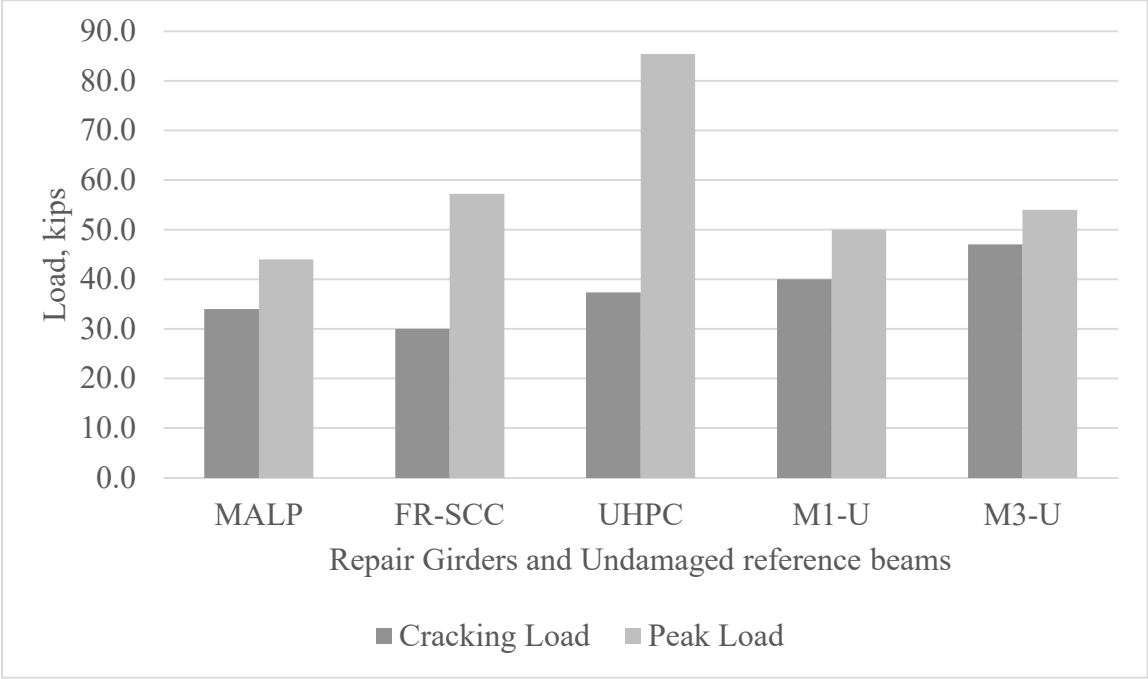
Figure 4.36: Average Cracking Loads and Average Peak Loads of Repaired Girders and Undamaged Reference Beams
