PRESERVATION SITE SURVEY REPORT for MAX CHAMBERS LIBRARY UNIVERSITY OF CENTRAL OKLAHOMA

Final Report May 18, 2010

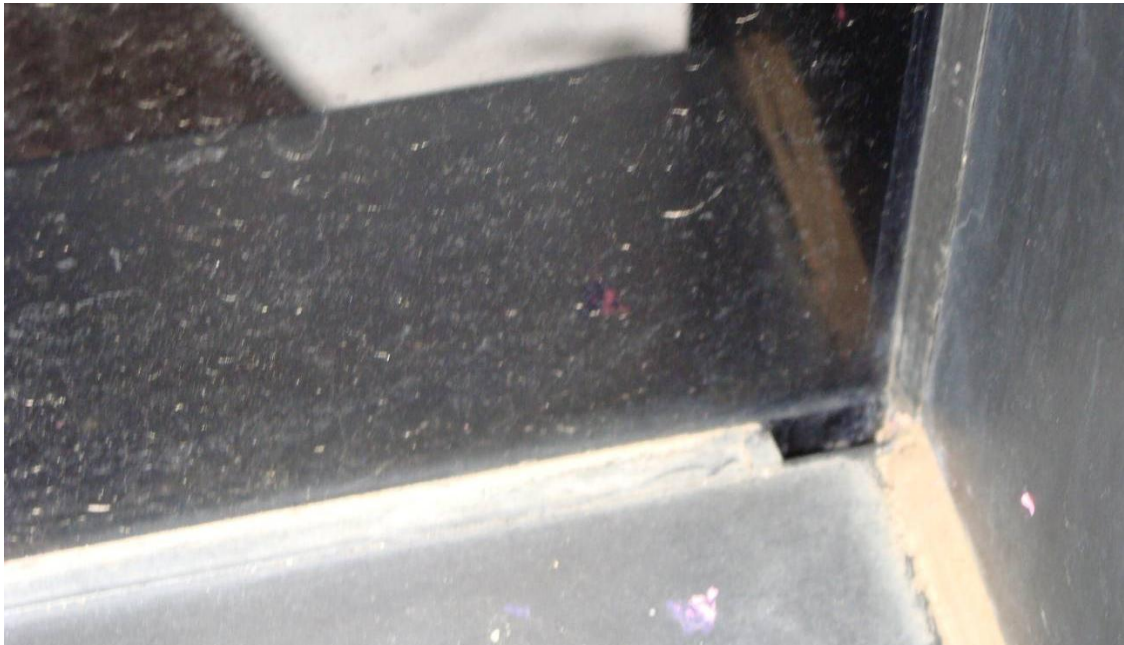
Figure 1: Gap in caulk

Having good seals around windows and using weather-stripping at the bottom of doors will make it more difficult for pests to enter the building, and for the conditioned air to escape from the building. There are isolated gaps in window caulking, as well as caulk pulling back from the windows on the north wall.

Daylight is visible between the doors on the north entrance. In addition, the library reports that the north entrance leaks, likely due to caulk issues. Physical Plant has inspected the area and plans to repair the damage.

To better seal the library, I recommend the following:

- Weather-strip doors as necessary
- Caulk windows with gaps or pulling.
- Repair north entrance

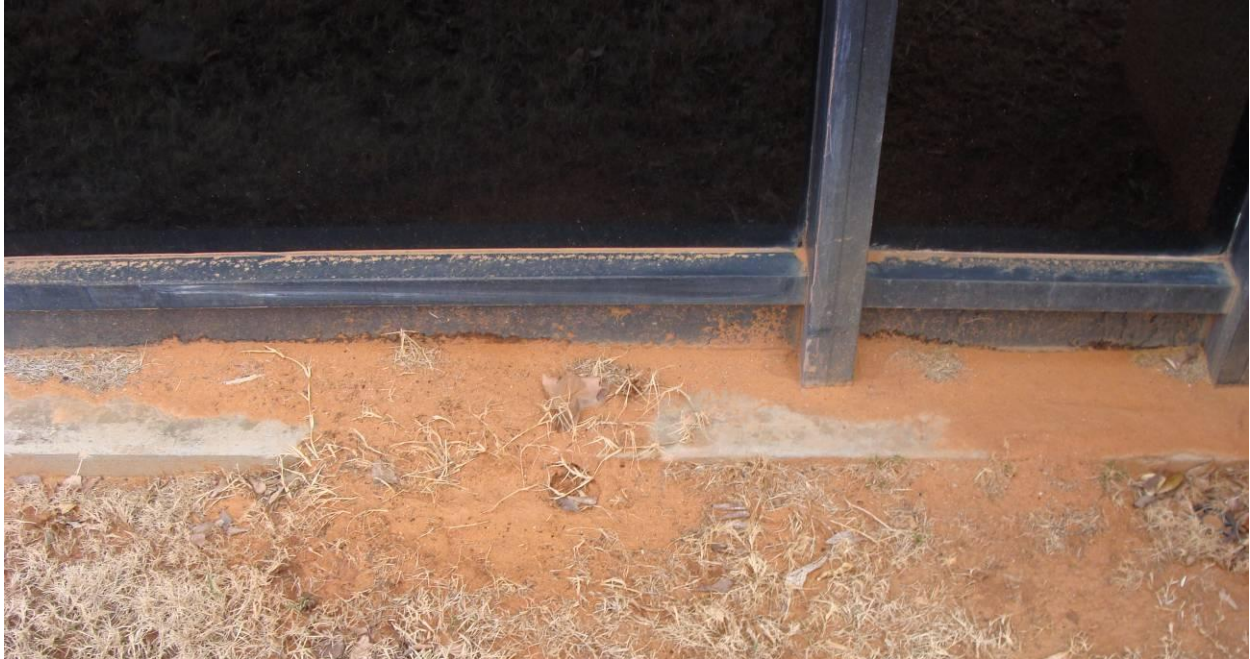
Figure 3: Dirt at the base of ground floor windows

Pest infestations can be contributed to by mulch and plant material build-up near and around the perimeter of the building. The best design would be to leave a three to six foot perimeter of gravel or cement around the building. In addition, pests are attracted to trash and large dumpsters near library entrances. The day of the survey the outside grounds were in generally good condition, although much dirt has built up around the bases of the windows. Also trees are touching the building on the northeast corner and the south side. This encourages pests to enter.

To continue to discourage insects and pests from entering the building and for safety reasons, I recommend to:

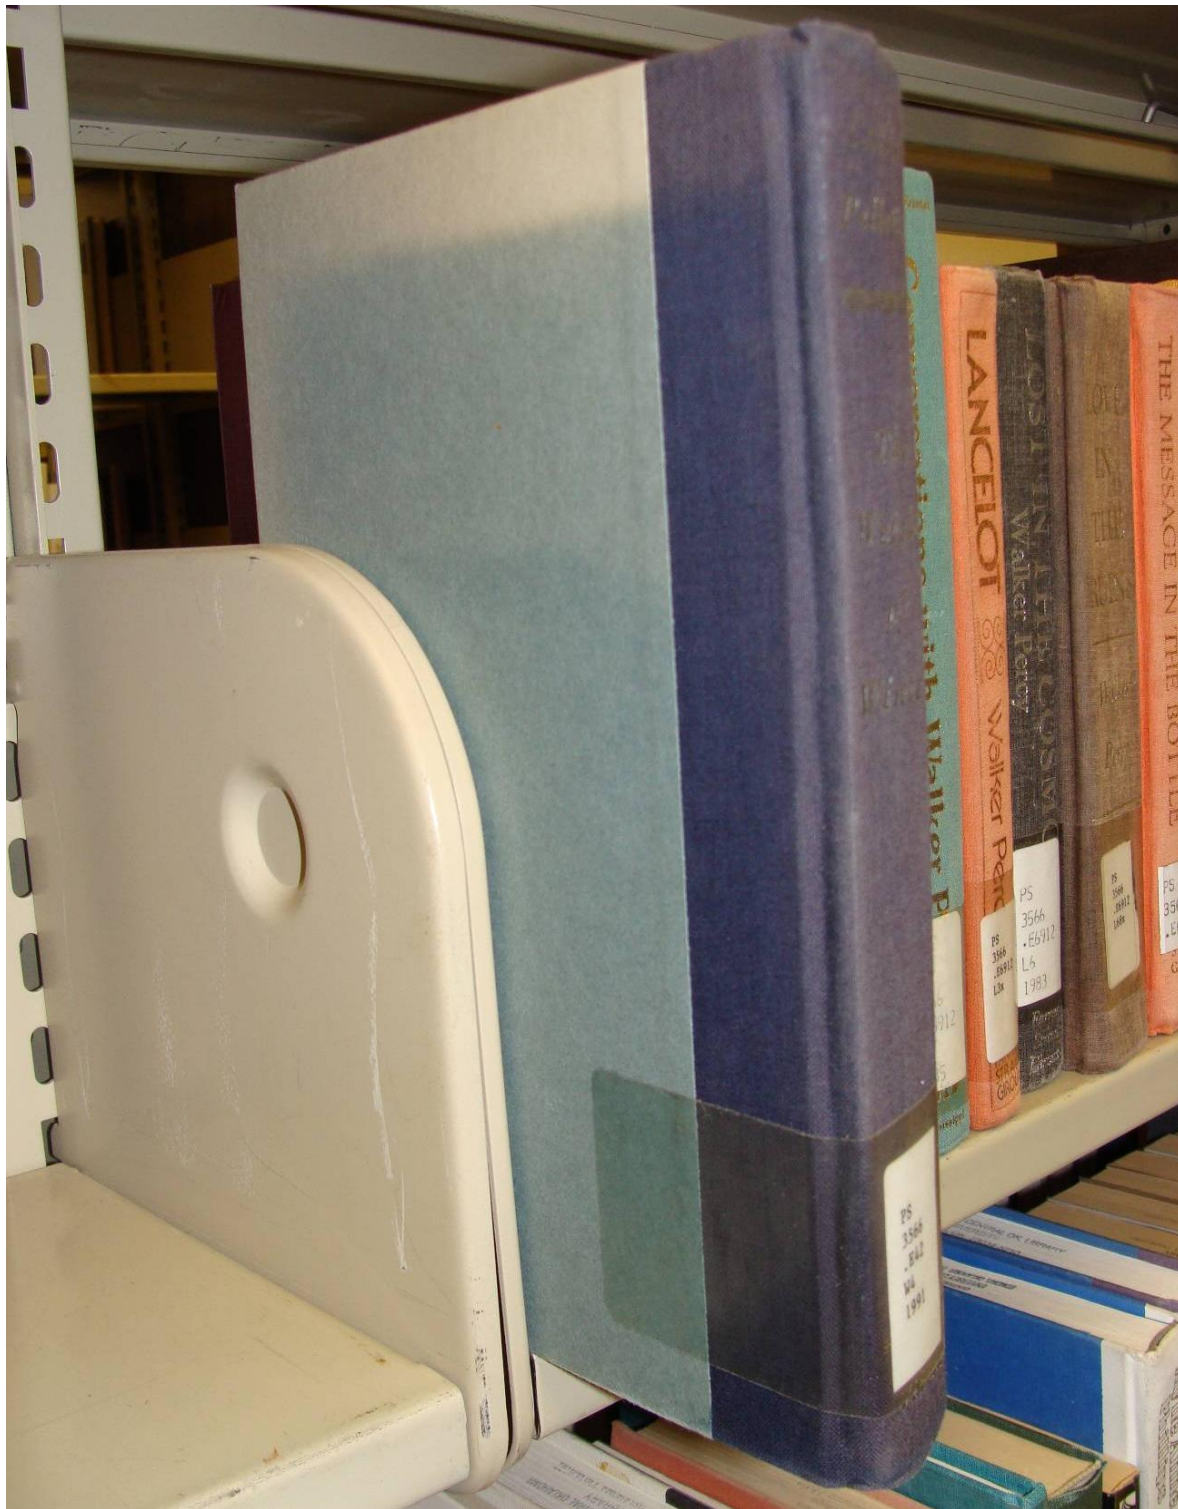
Figure 5: Book showing two distinct levels of light damage

There are two light sources in the library: window and lamps. Sunlight creates high infrared (IR) radiation and ultraviolet (UV) radiation, which is the portion of the light spectrum most damaging to library materials. With lamps, fluorescent bulbs produce high levels of UV radiation, while, incandescent lights emit a lower ultraviolet (UV) radiation. Incandescent lights, however, emit considerable amounts of infrared (IR) radiation, which can cause materials to heat up, and they generate a lot of heat which may affect the room temperature. There are large windows in most areas of the library. The placement of the shelves seems to be effective, as direct sunlight was not observed striking the collection in most areas. There is a considerable amount of light damage, particularly in the circulating collections.

This is likely due to the fluorescent lamps which are used throughout the building. Light levels from 81.6-695 footcandles (fc) were recorded during the visit. March 24 was cloudy, and March 25 was sunny. See Table 3 for more detail.

Most of the levels were within recommended limits, however the large amount of light damage seen in the library indicate that the ultraviolet light from the light fixtures is a great concern. Light damage—which is cumulative and irreversible—can be reduced by:

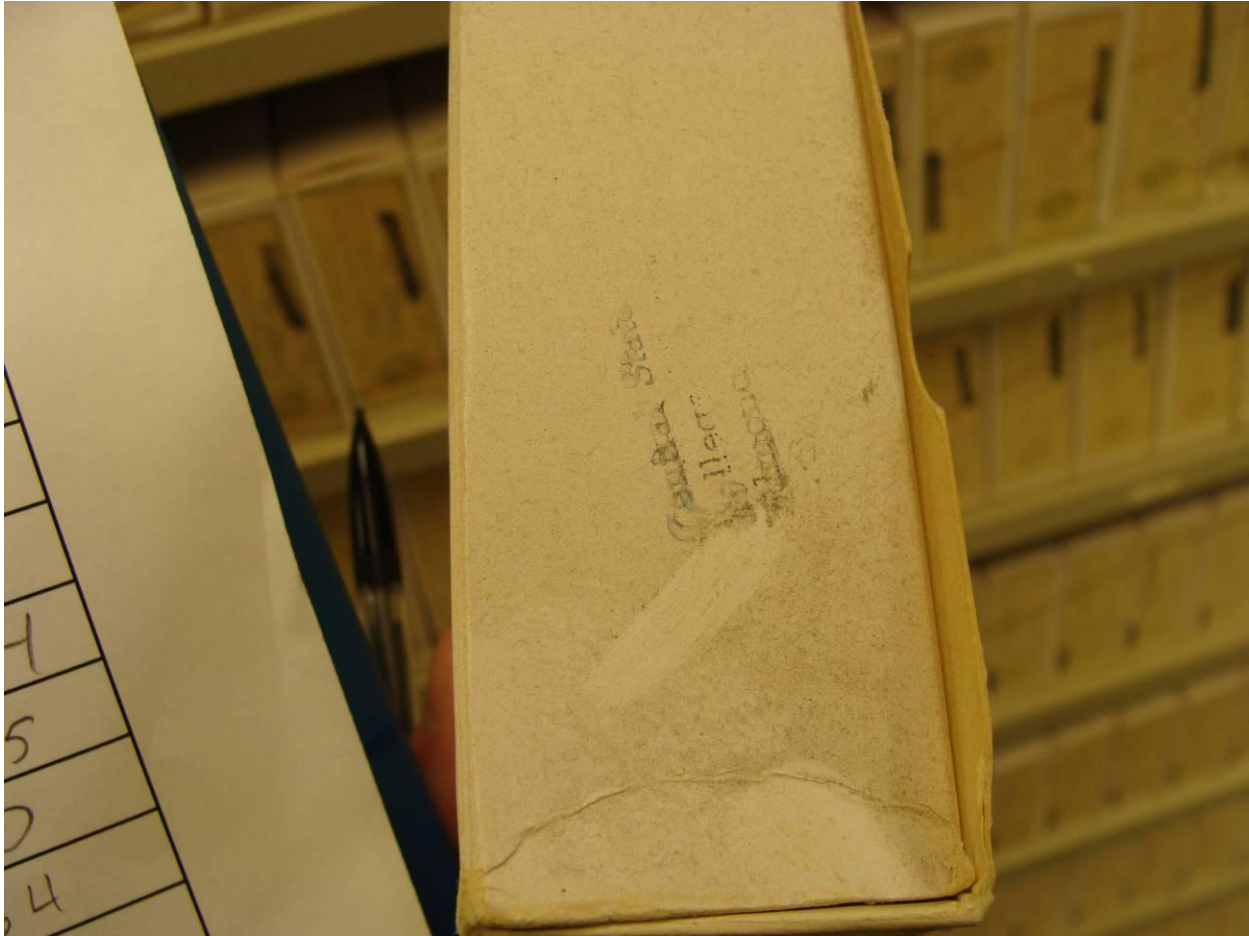
Figure 6: Dusty microfilm

On the day of the survey, the library was found to be quite clean, although dust was found in several areas, notably in periodicals and some areas of the third floor stacks and government documents. The library seems to do a good job with its regular schedule of housekeeping, and the staff of third floor stacks (where the entire circulating collection is stored) does vacuum the books every summer.

I would recommend the housekeeping staff:

- Clean around all windows and doors to allow for easy visual inspection for leaks, cracks, and active pest problems etc.
- Dust/vacuum collections and shelves in all areas on an annual basis.

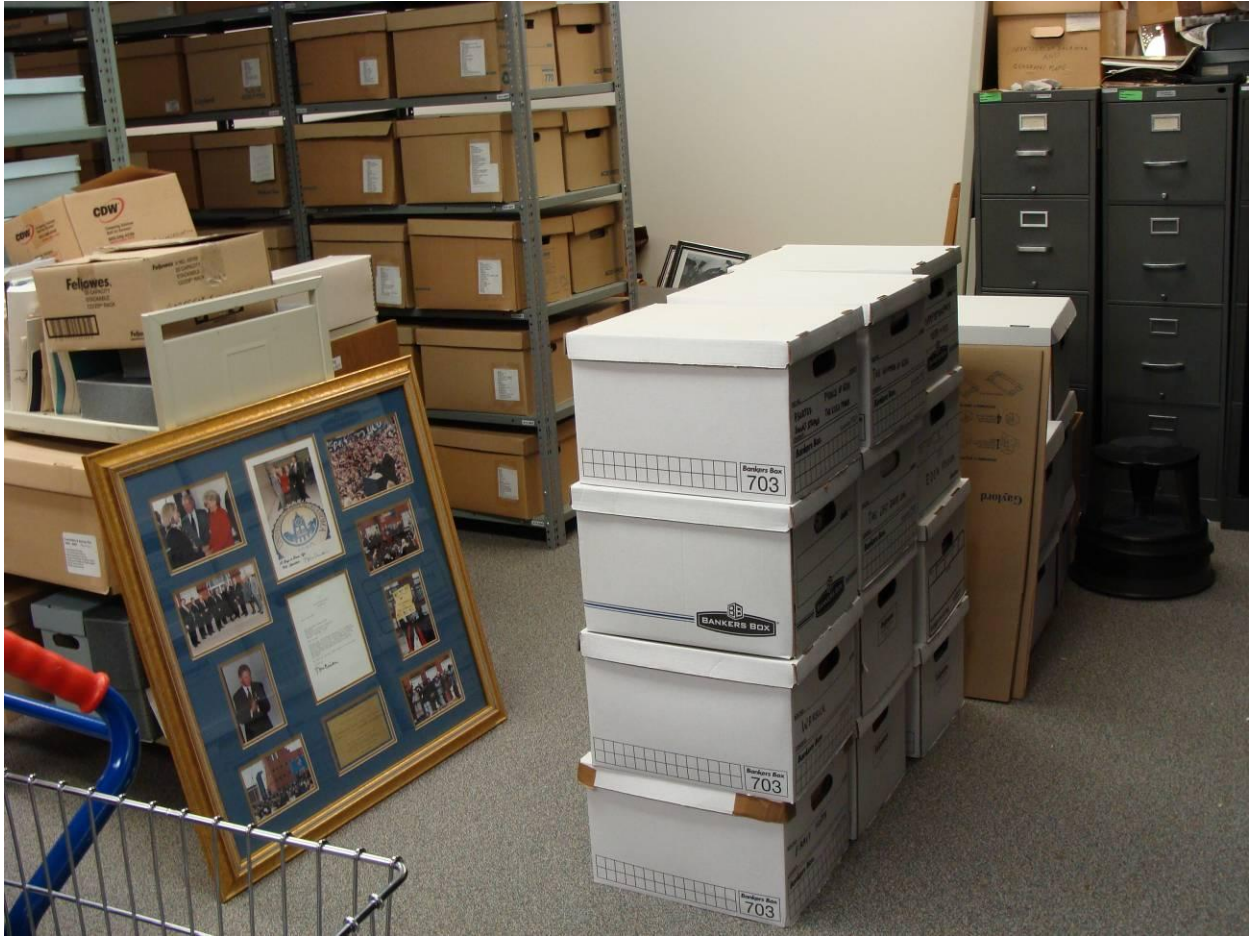
Figure 7: Special Collections cage, showing materials on floor because of a lack of storage space

Collections are stored on four floors of the library, as well as in the basement. The reference collection is housed on the first floor. Special Collections and government documents occupy the second floor, and special collections also has some storage in the basement. The circulating collection is housed on the third floor, and periodicals are housed on the fourth floor. There appears to be adequate room for staff offices and processing. At the moment, there is adequate space for all areas except Special Collections, which needs much more storage space.

I recommend to:

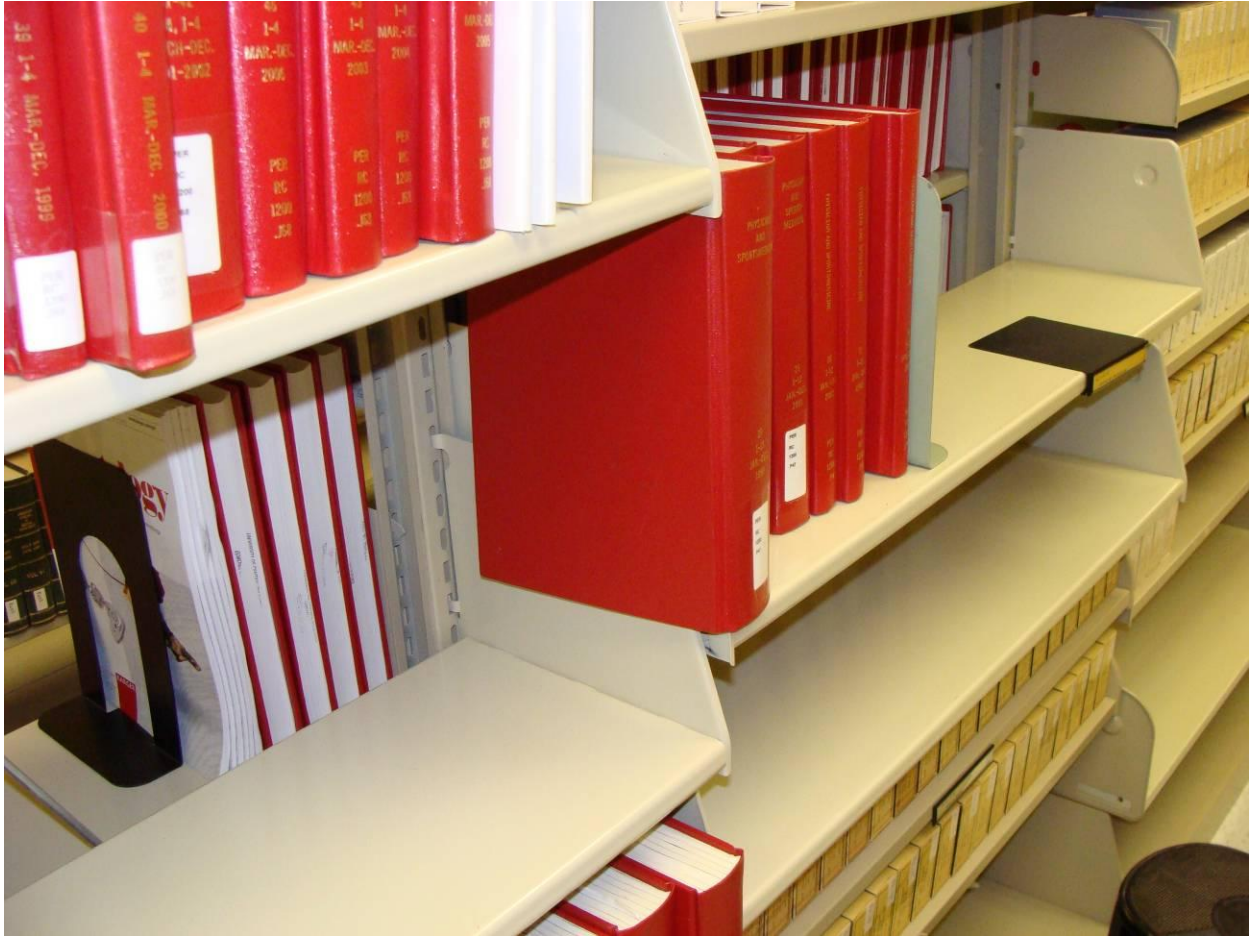
Figure 8: Microfilm and periodicals shelved together

At the moment, in periodicals and government documents, microfilm is interfiled with standard sized materials, making for a very inefficient use of space. Likewise, in circulating collections, oversized materials do not have their own section, which means that fewer shelves can fit in a range.

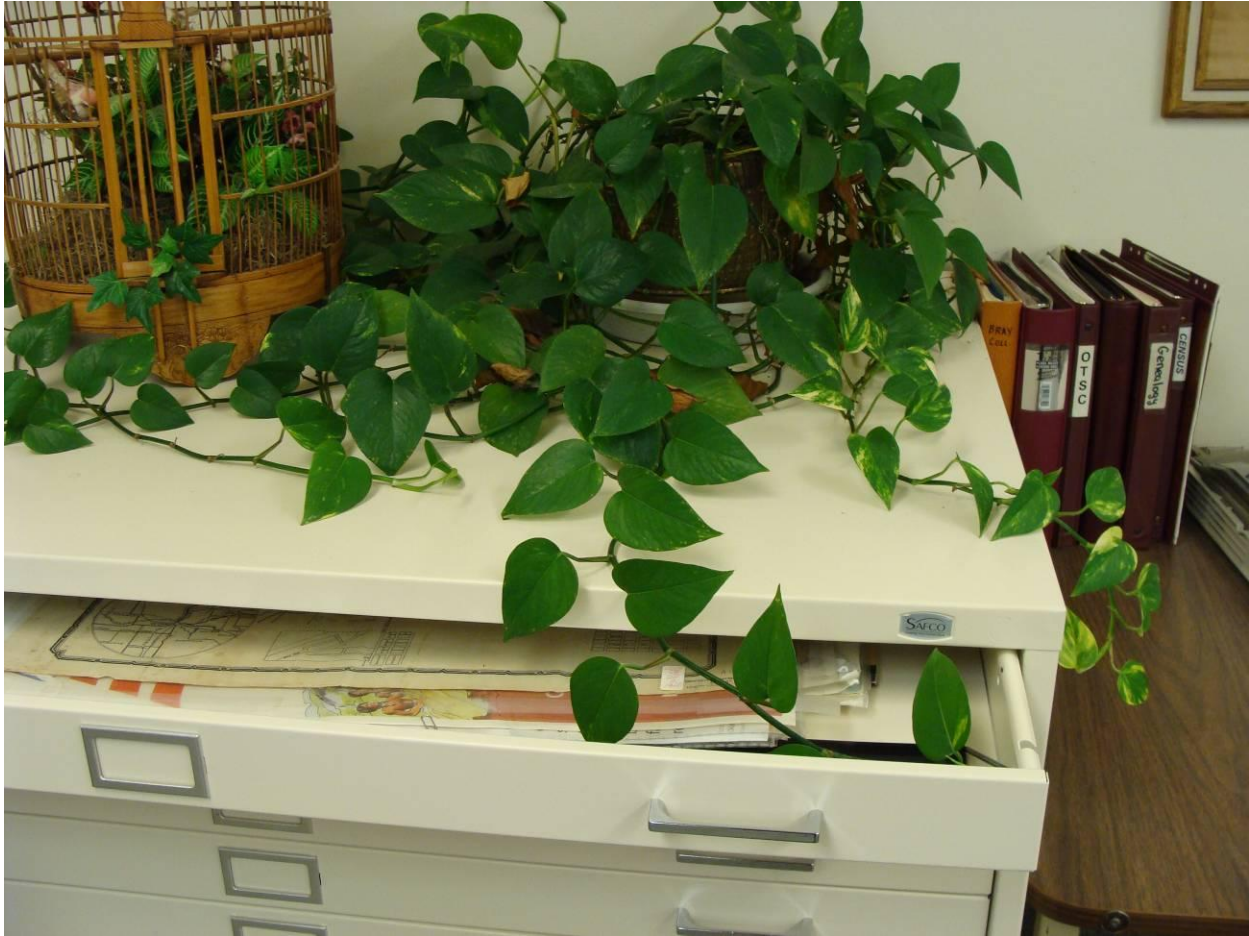
On the day of the visit, zero instances of insects and other pests were found during a visual inspection of the building, while only a few spiders and dirt daubers were seen outside the building. The library reports annual infestations of wasps, ants and ladybugs. Currently, the library does not monitor for pests. The only type of pest control used by the library is a monthly spray by a pest control contractor. Gifts are inspected before introducing them into the collection. Book sale materials are not stored in collection areas. There are large numbers of plants in many collections areas of the library. These invite pests into the collection, and should be removed. The best practice is to have no plants in the library. However, the library may consider allowing plants in non-collections areas like the atrium lobby.

Figure 9: Plant in Special Collections. This plant poses multiple dangers to the collection. First, it can draw pests. Second, it can damage materials stored in this flat file if it gets closed in the file's drawer.

To ensure there is no hidden pest problem, I would recommend the following:

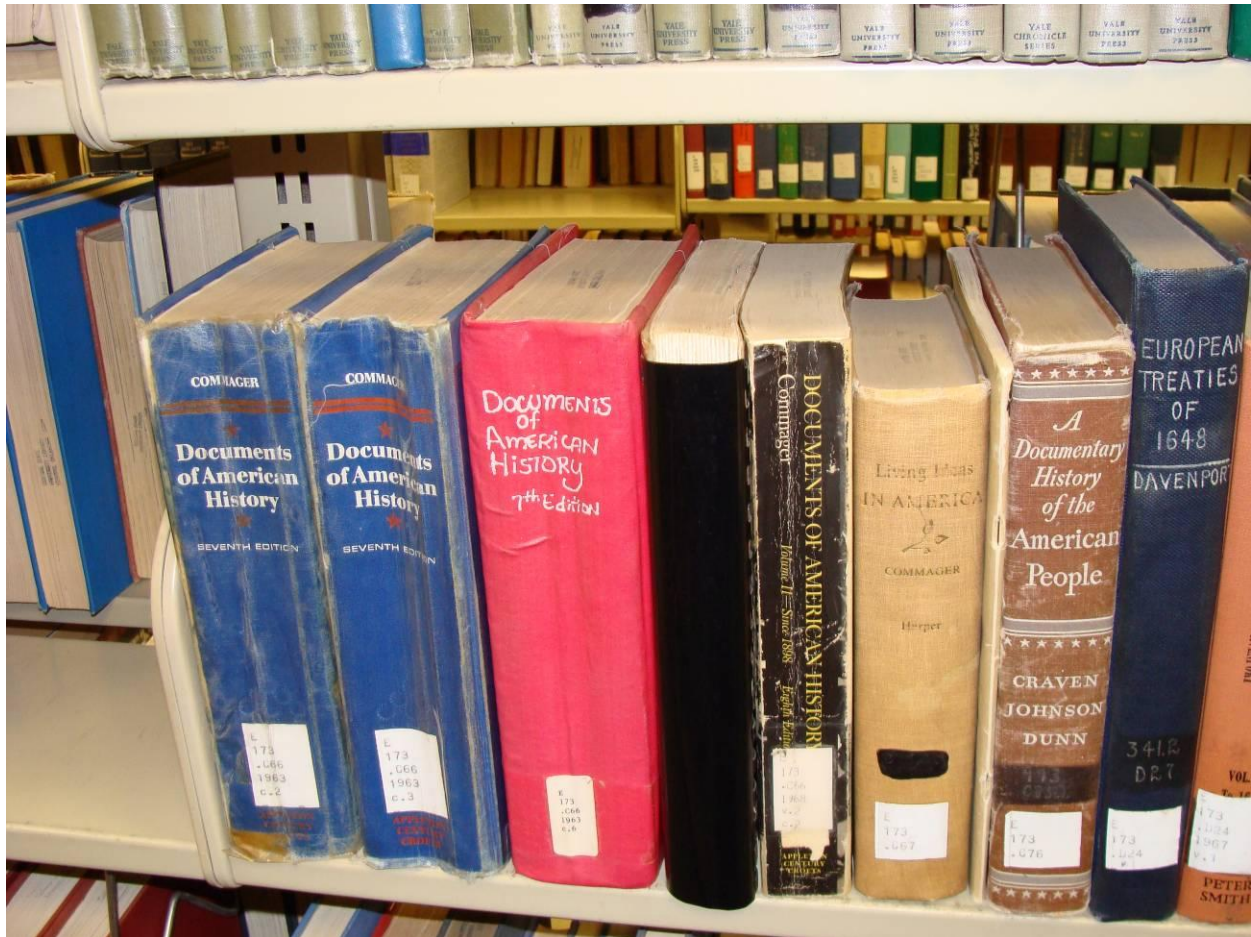
Figure 10: Books showing spine damage and poor quality repairs

The circulating and reference collections of monographs are two of the largest areas of concern at Max Chambers Library. In general, they show much evidence of light damage and a considerable amount of spine damage as well. The spine damage is caused by removing the books from the shelves by pulling at the endcaps, and is exacerbated by the extensive light damage, which causes embrittlement of bookcloth. The circulating collections also display the most poor quality previous repairs, with large amounts of cloth book tape.

I recommend to:

- Continue the library's aggressive library binding program for paperbacks and damaged books. Consider binding spiral bound books either before they are sent to the shelves or after a first circulation.
- As a summer project, inspect reference on a book-by-book basis, performing hinge tightening (see Appendix H) in the stacks, and pulling books for repair or rebinding. This is usually best done in the early summer, as summer is a lower time of use for collections. If the books are pulled and sent to the bindery in the summer, they should be back in time for the fall semester.

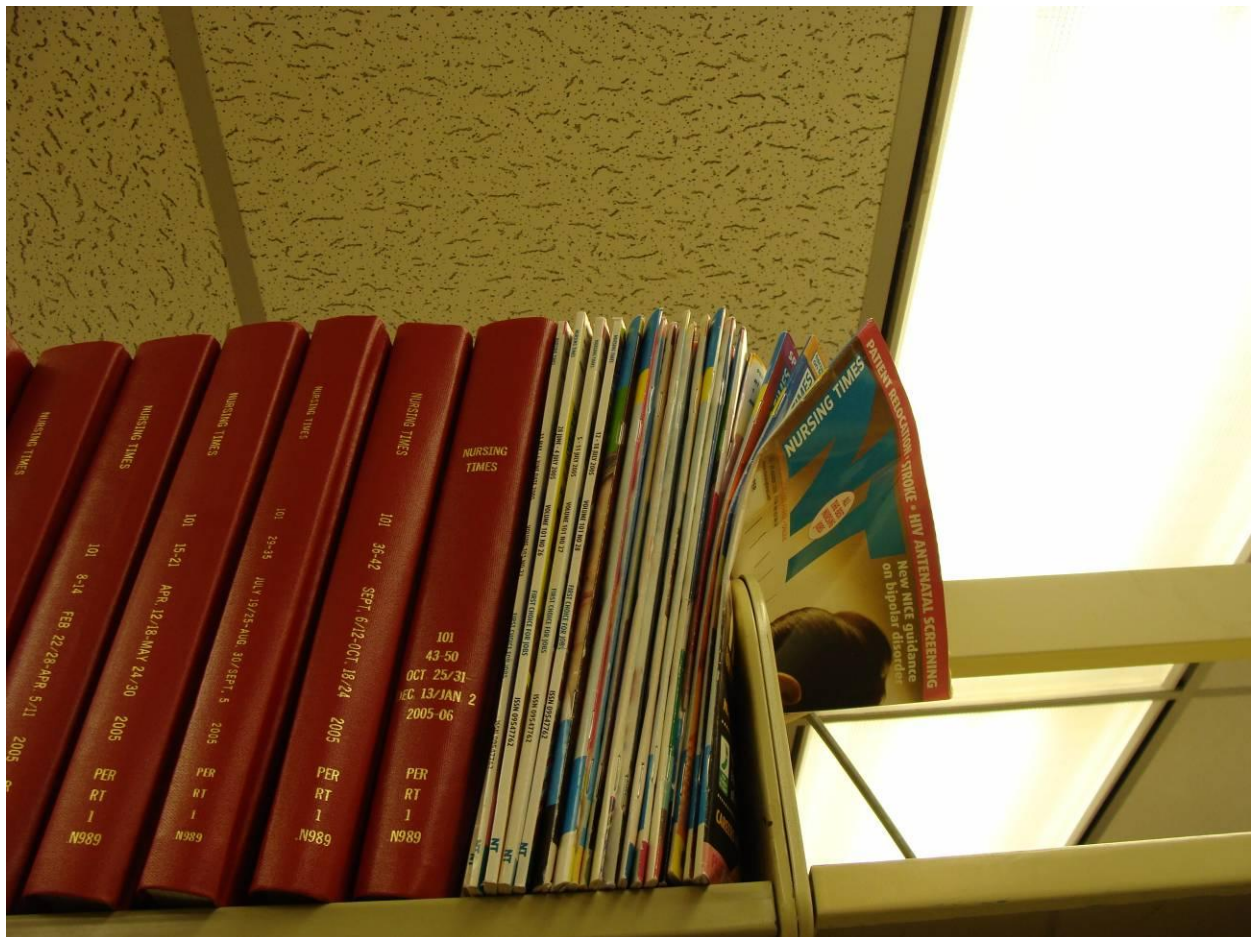
Figure 11: Inappropriately shelved serials

Serials are housed in two areas on the fourth floor. The first area is for current serials, and has a higher level of security to ensure that the periodicals stay in the library until they can be bound. These are generally housed in acidic magazine files. The second is for backfile periodicals. The periodicals are in generally good condition, however there are many unbound periodicals shelved on their tails in both areas. Because periodicals are often soft and floppy, these can develop permanent warping, if not supported completely.

To prolong the life of the serials collection, I recommend to:

- Shelf periodicals flat, if they cannot be completely supported to prevent permanent deformation.
- Replace acidic magazine boxes with acid-free boxes.
- Make more extensive use of magazine boxes in the backfile periodicals area.
- If self-bound periodicals are found waiting to be shelved, they should be sent to the library bindery for appropriate binding, since this indicates use.

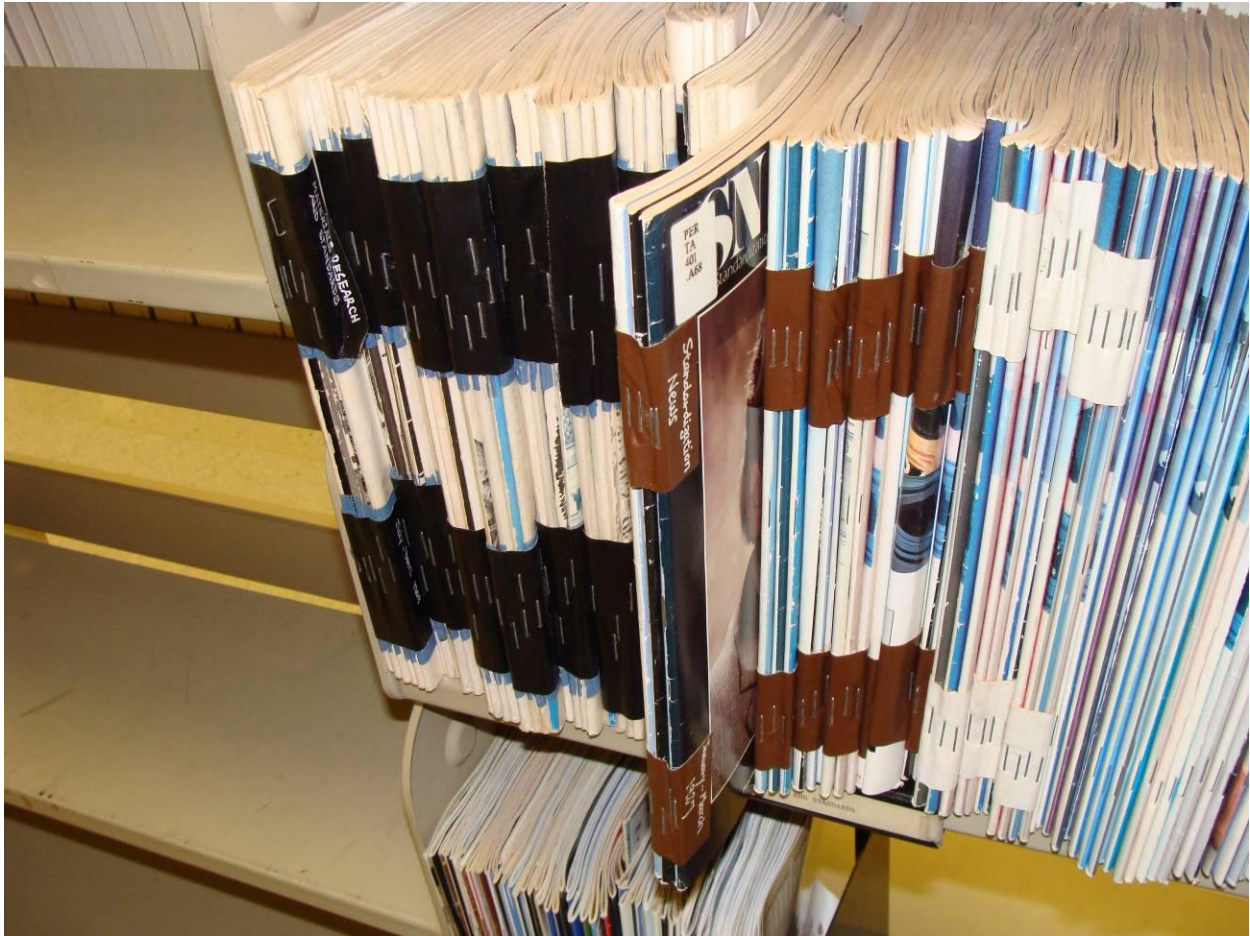
Figure 12: Self-bound periodicals

Also, self-binding of periodicals with tape was a common practice in the past, although it is no longer being practiced. This structure is potentially damaging to the periodicals inside it.

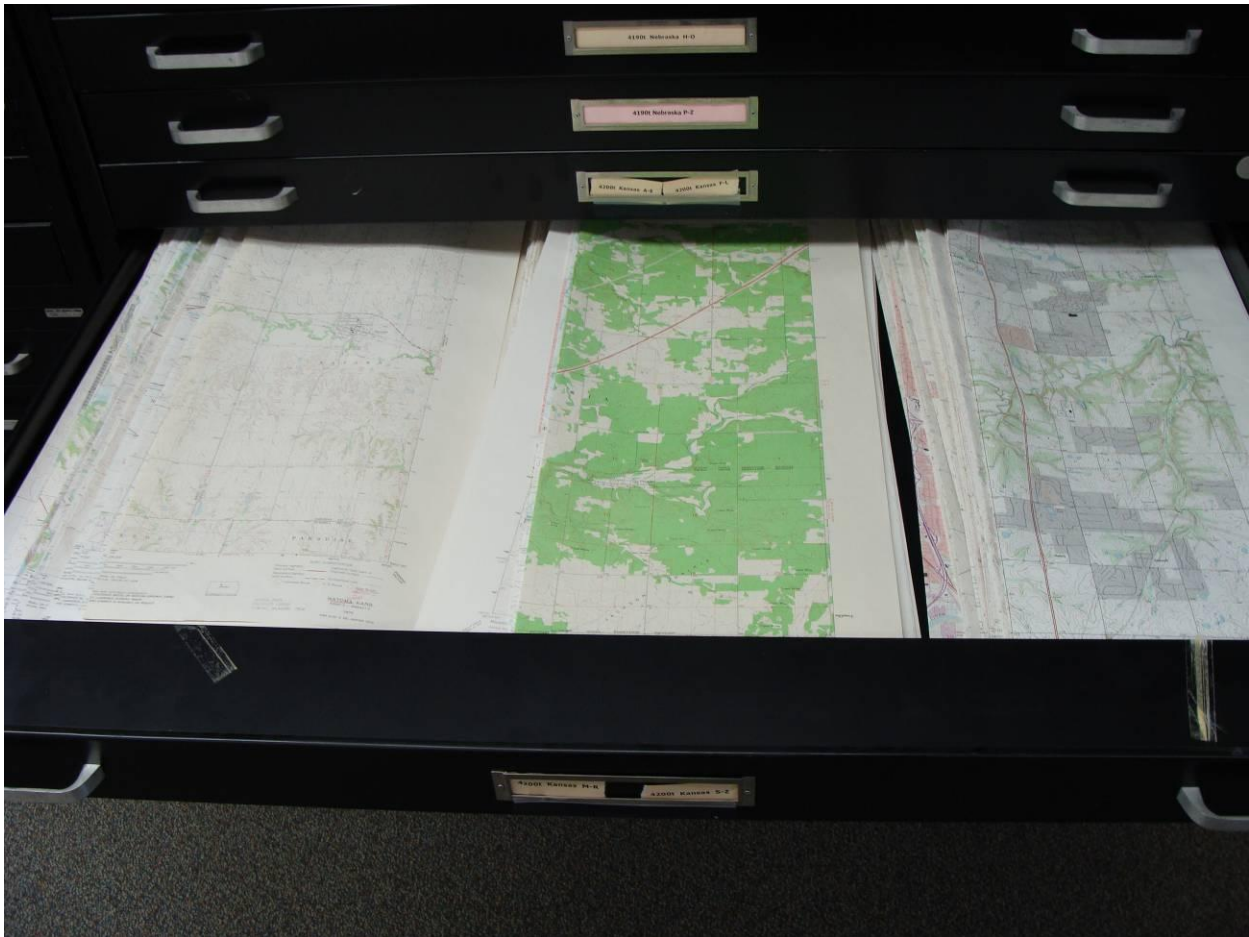
Figure 13: Folded maps that can get caught on the flat files.

There are some problems in the map collection. While the collection is housed in wonderful flat files, many of the maps are folded, and none of the maps are housed in map folders within the flat files. This means that it is quite easy for maps to get damaged as the files are opened and closed. Also some of the maps are encapsulated in plastic that is sealed with Magic™ Tape. This tape has a damaging adhesive, and should be removed from the collection.

I recommend to:

- Unfold all maps to protect from damage, both in use and from the file cabinets.
- House all maps in map folders to provide support and protection.
- Remove all improper encapsulation.

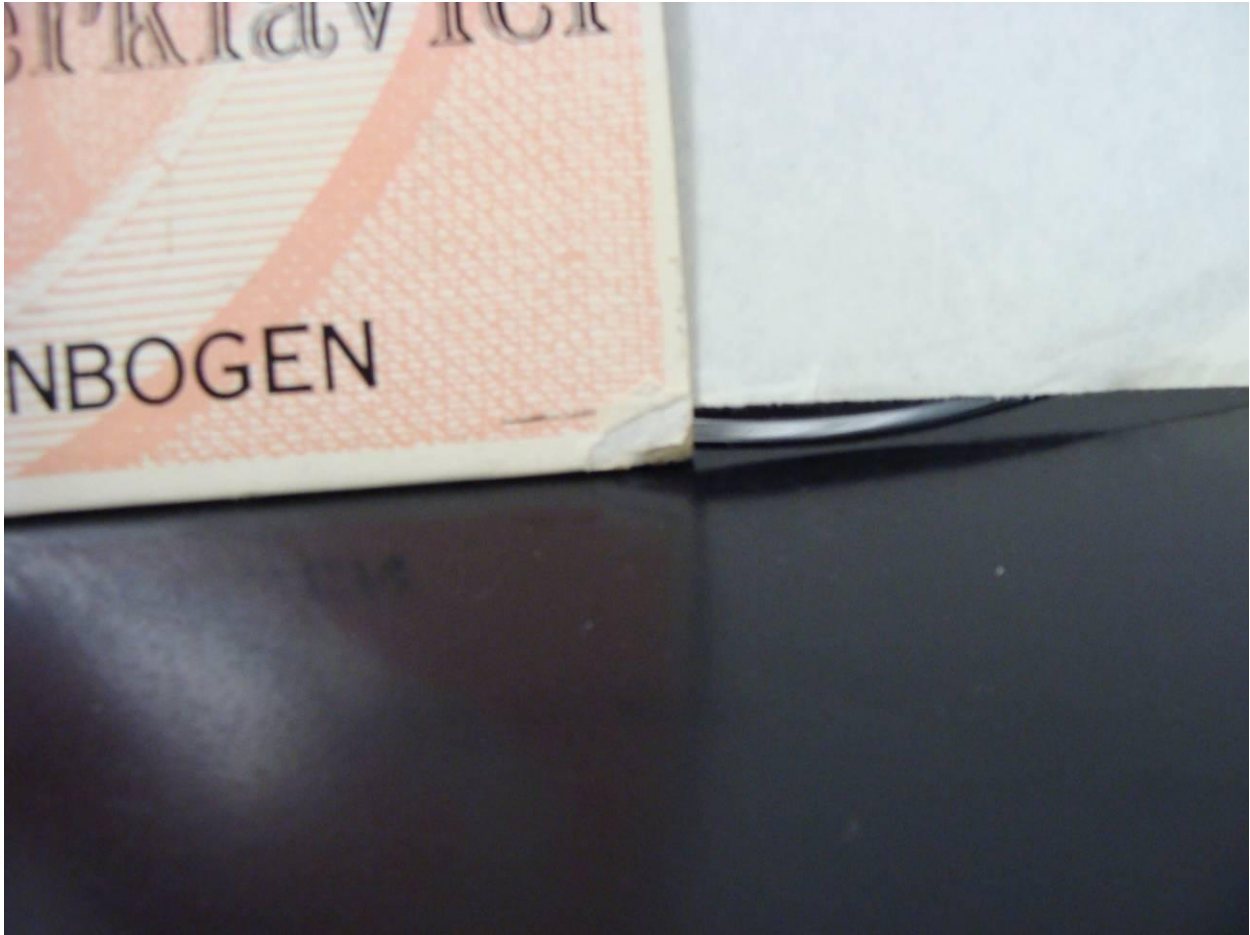
Figure 14: Acidic paper sleeve splitting at the bottom

- Replace acidic paper sleeves for LP records with stable plastic sleeves made out of polyethylene or polypropylene. Many of these paper sleeves are splitting, which means that they are no longer providing adequate protection for the records.

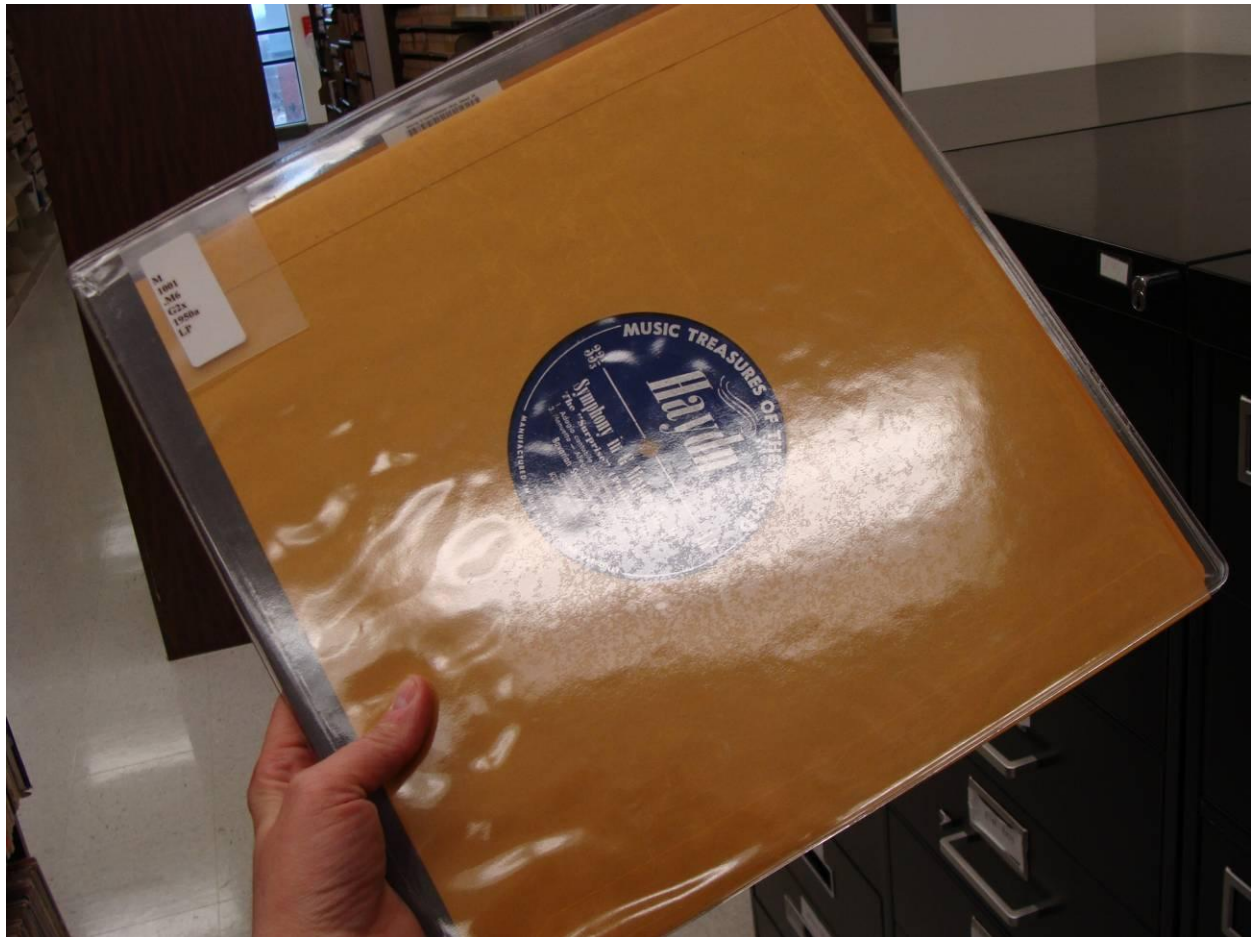
Figure 15: Jacket made of damaging plastic

- Remove all plastic jackets in the collection, as these are made of a plastic which encourages deterioration in the materials it is ostensibly protecting.

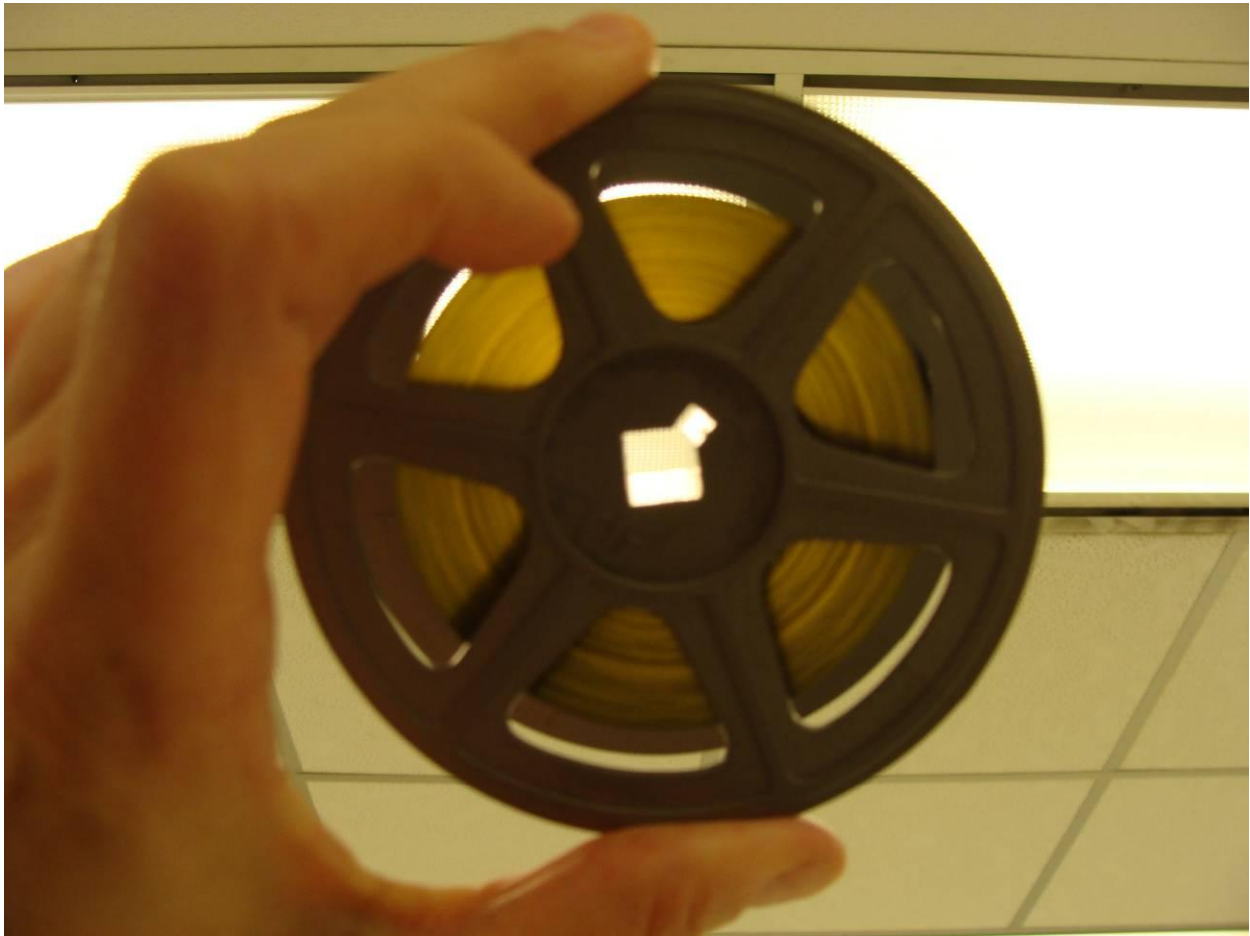
Figure 16: Polyester microfilm

monitored for replacement. Polyester microfilm (which is extremely stable) and acetate microfilm are easily distinguished by holding the reels up to the light. Polyester will glow, and acetate will appear dark.

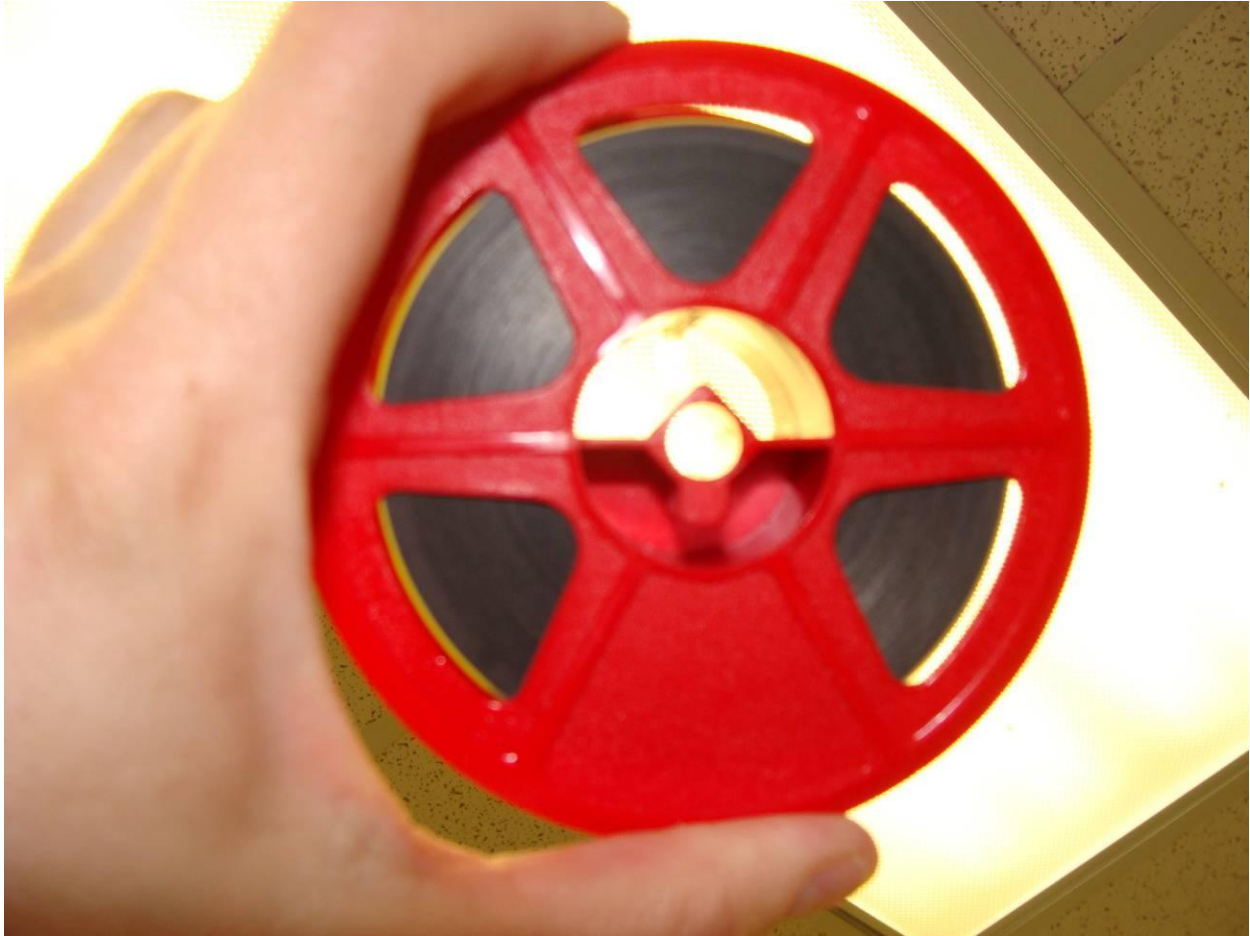
Figure 17: Acetate microfilm

Max Chambers Library has an extensive microfilm collection that is one of the library's self-reported greatest preservation concerns. Part of this stems from a flooding incident several years ago that affected the newspaper microfilm collection. The microfilm appears in generally quite good condition, however there is a large amount of microfilm on acetate film base. This is a less stable material, and needs to be

I recommend to:

- Monitor acetate microfilm for a vinegar odor. When this odor becomes apparent, replace the film.
- Replace all acidic boxes.
- Move the Special Collections Texas Townsite microfilm masters to secure offsite microfilm storage.

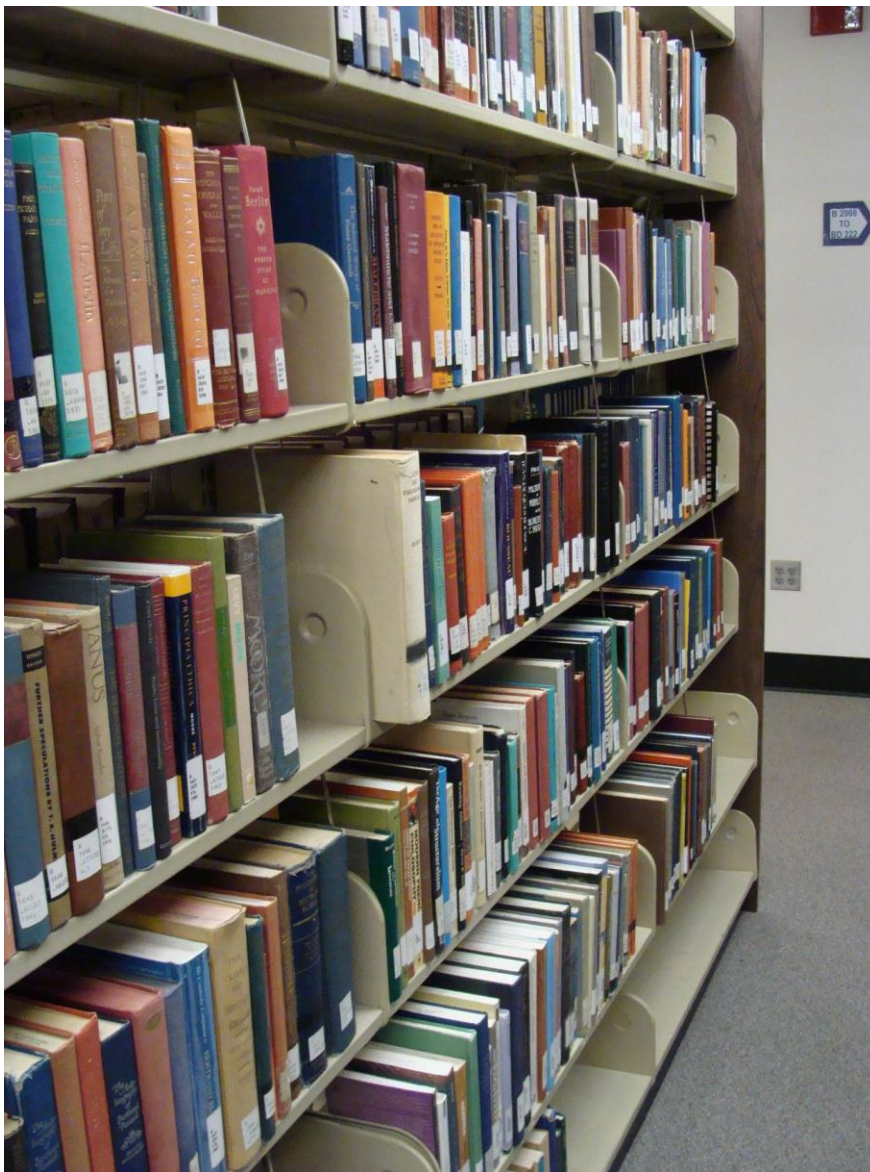
Figure 18: Stacks of well-shelved material on the third floor

In general, shelving in the Max Chambers Library is quite good. The circulating collection, in particular, is to be commended for their shelving efforts. As mentioned previously, the major problems with shelving include shelving material on the top shelves and not properly supporting soft material, leading to permanent deformation. The interfiling of oversized material is also a potential preservation issue, as the largest books will not be properly supported, and therefore can warp. Recommendations for dealing with all of these problems are contained earlier in this report.
