EVALUATION OF FUNCTIONALITY AND SERVICE LIFE OF  
ULTRA-HIGH PERFORMANCE CONCRETE LINK SLAB CONNECTIONS FOR BRIDGES

A THESIS

CIVIL ENGINEERING

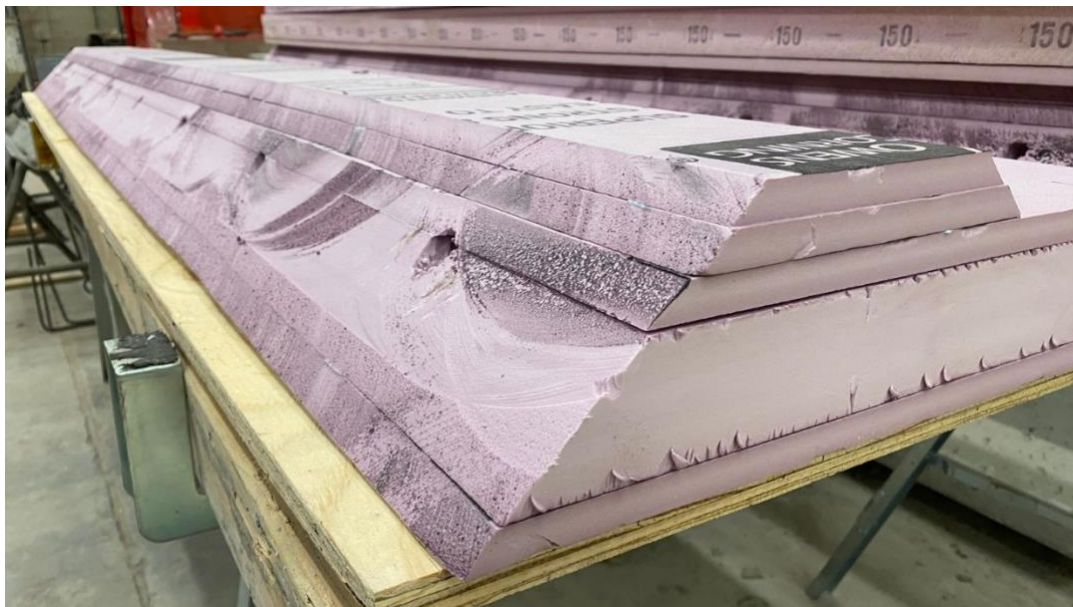
*Figure 3-8: Foam insert with drilled holes for rebar*

To create the connection design, a foam insert was constructed and placed in each section. Each foam section spanned the entire 8 ft. length. Figure 3-6 provides the dimensions for the insert's uniform cross-section, with all non-right angles at 45 degrees. Figures 3-7 and 3-8 show the finished cross-section of one of the inserts. These connection dimensions are based on the NYDOT link slab design reported in the literature review. One insert was placed in each form along one side of the 8 ft. length with the 17 in. side face down and the larger slope facing into the form. The placement was the same for all slab sections. Holes were drilled into the slanted face of the foam to insert rebar extending out of the concrete, which is shown in Figure 3-8.

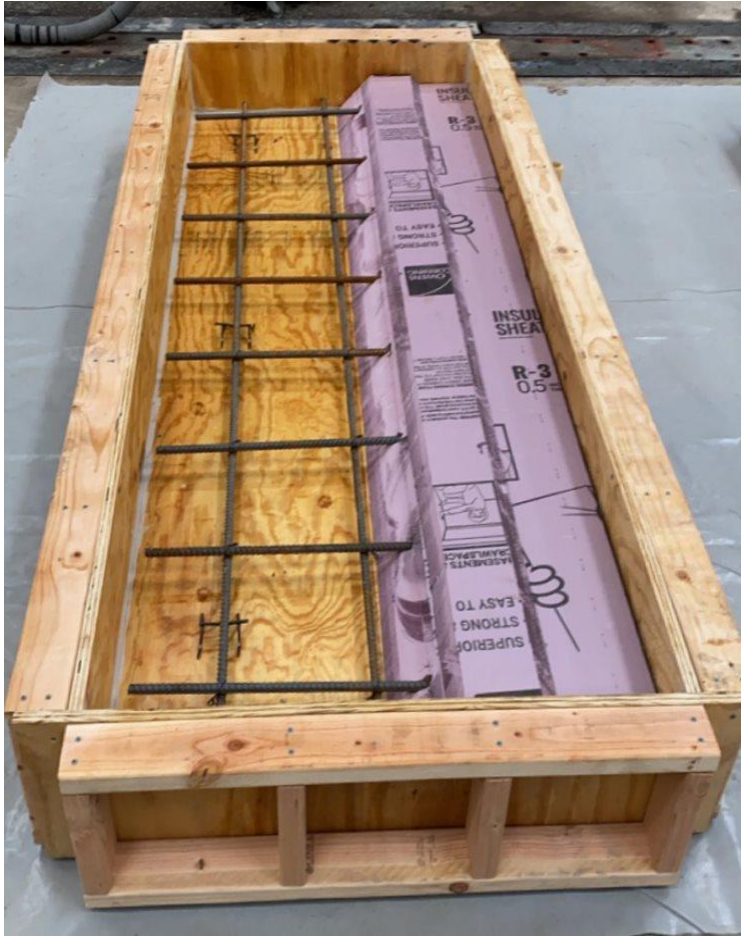
*Figure 3-13: Slab formwork with foam insert and "top" rebar cage layer*

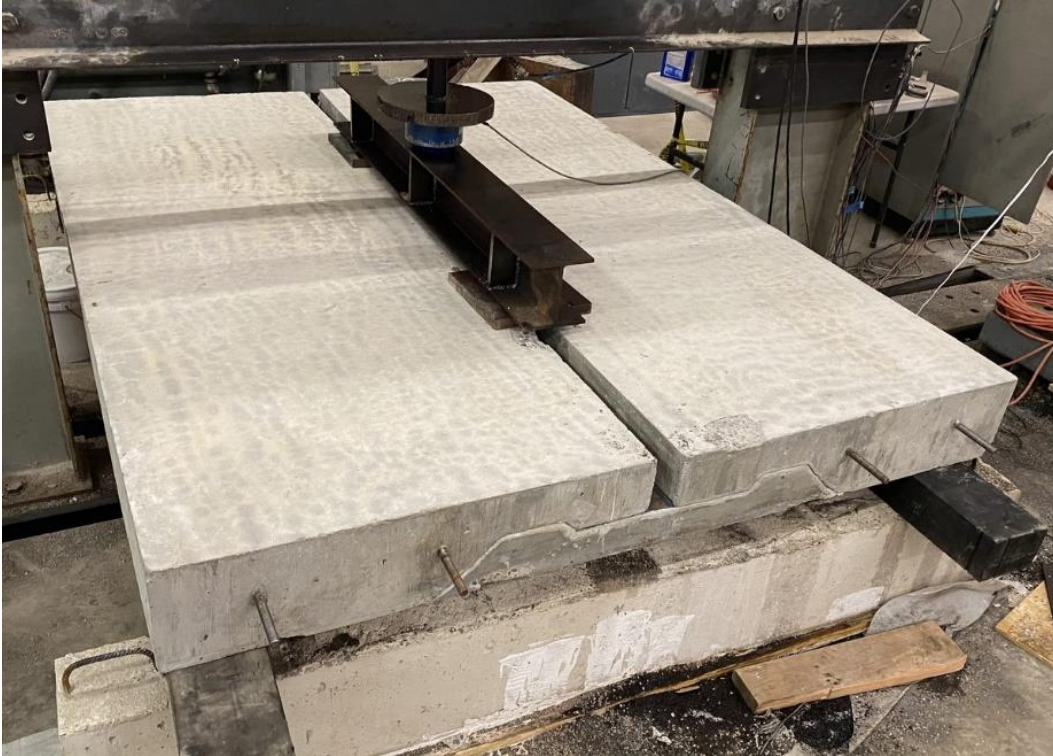
*Figure 3-25: Cyclic load testing setup for tension on link slab surface*

The specimen was placed upside down and loaded to produce tension stresses perpendicular to the joint. This loading was to simulate instances where loads were on the adjacent decks of the connection and no loading was on the link slab. The test loading consisted of 100,000 cycles of 5,000 pounds, which was based on the cracking stress of the link slab for the AA material. The end supports of the specimen during this testing were at the four corners of the specimen.

Loading was applied through a steel beam in the middle of the specimen to distribute loading along the joint. Figure 3-25 shows the testing setup for tension loading. After reaching the cycle count, each specimen was inspected for cracking.

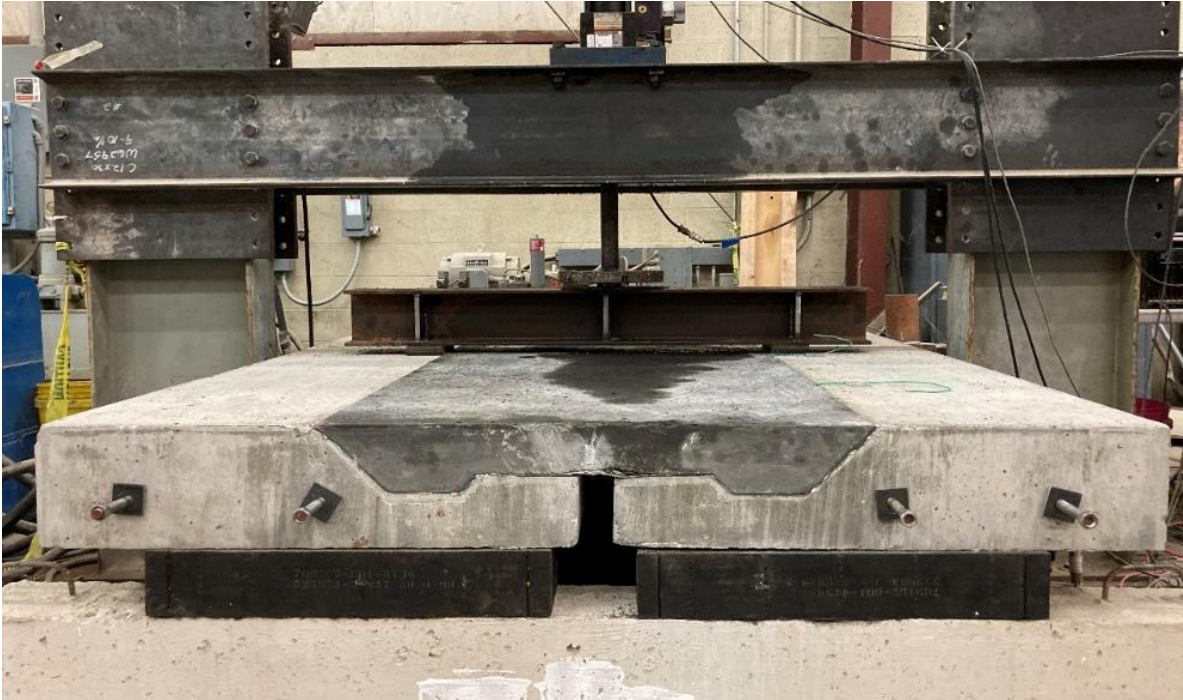
*Figure 3-26: Cyclic load testing setup for compression on link slab surface*

Compression loading applied 20 cycles of 18,000 pounds with the surface face up to simulate traffic loads on the connection. This loading is based on the cracking moment of the AA concrete for the full deck section of 8 in. The end supports of the specimen during testing were along the 6 ft. edge of the specimen. The steel beam was oriented perpendicular to the connection width to promote bending along the connection width. Figure 3-26 shows the testing setup for compression loading. After reaching the cycle count, each specimen was inspected for cracking.

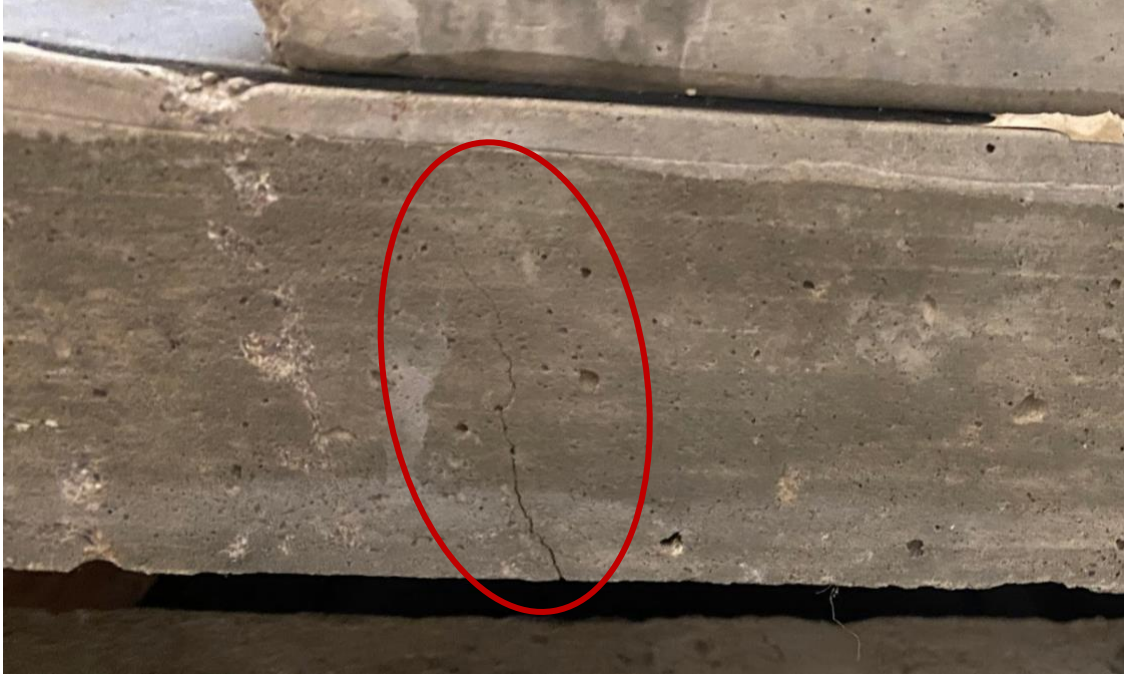
*Figure 3-27: Cracking in AA-L during cyclic loading (annotated)*

While cyclically loaded under tension, the Class AA specimen (AA-L) developed a significant crack near the center of the connection. Figure 3-27 shows the crack as it was observed during testing. No such cracking developed in specimen U-L.

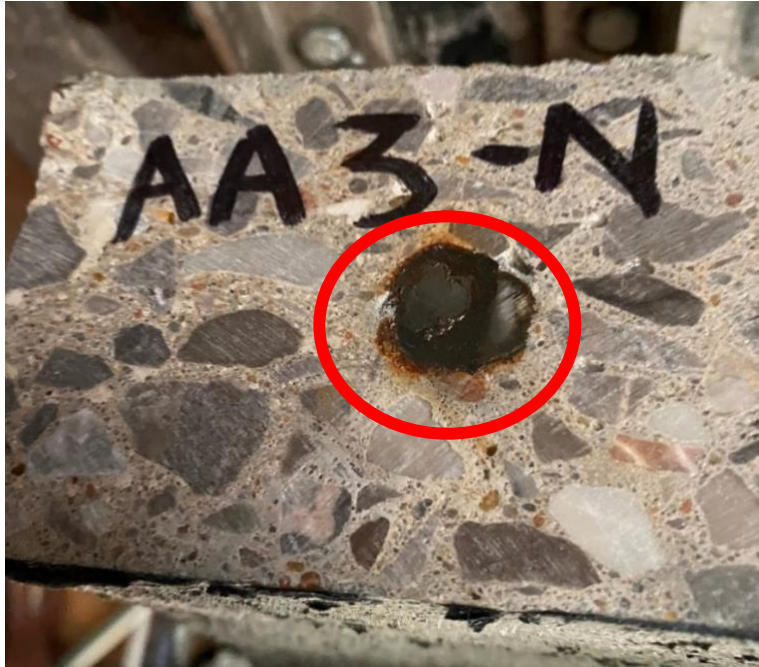
*Figure 4-4: End profile of AA3-N with rebar near center (annotated)*

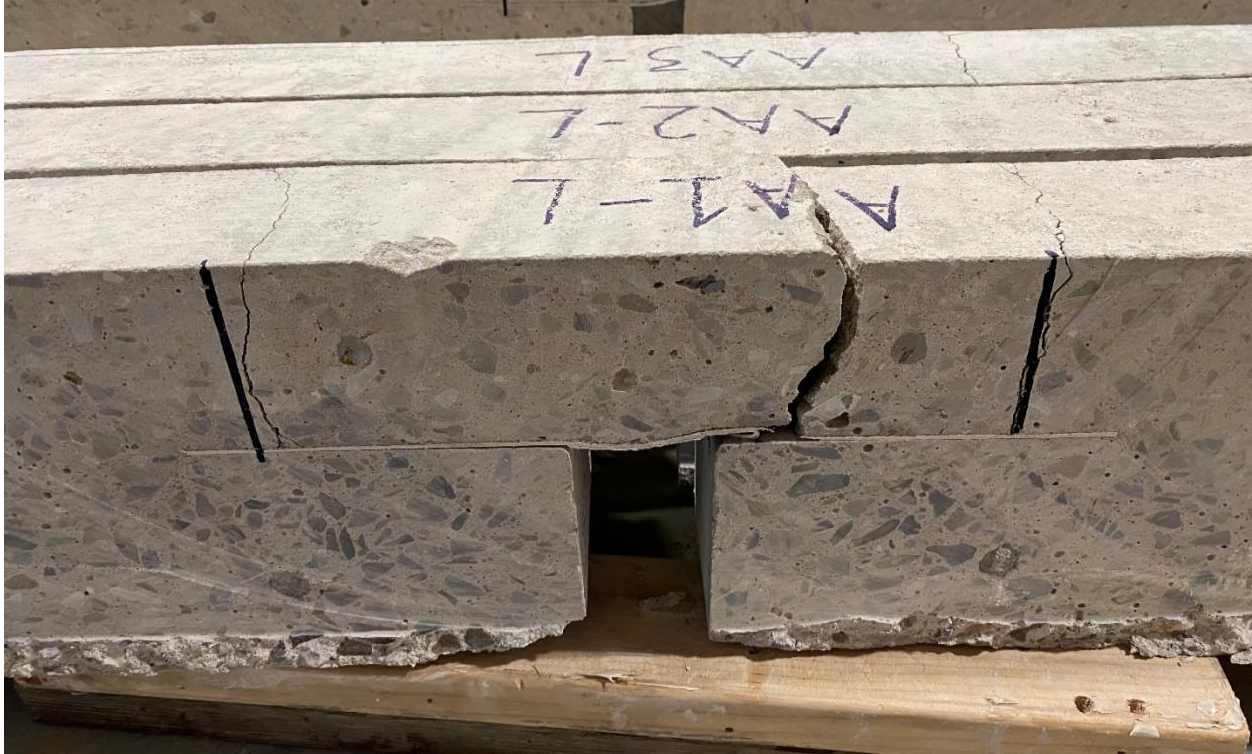
*Figure 4-5: Cracking in AA1-N within 12-inch length denoted with marker*

For connection specimen AA-L, only one freeze-thaw specimen (AA2-L) was able to be cut close to the desired 12-in. length. The parent specimen experienced cracking close to the 2-inch gap of the link slab joint during cyclic loading. This cracking caused the other two freeze-thaw specimens, which did not have rebar running along their lengths, to break into uneven sections shorter than 12 in. An example of the effects of cracking is shown in Figure 4-5. The resulting lengths of each AA-L specimen are as follows: AA1-L is 6 in., AA2-L is 11 in., and AA3-L is 8 in. The cracking would be expected to affect overall durability, both in this research and during service.

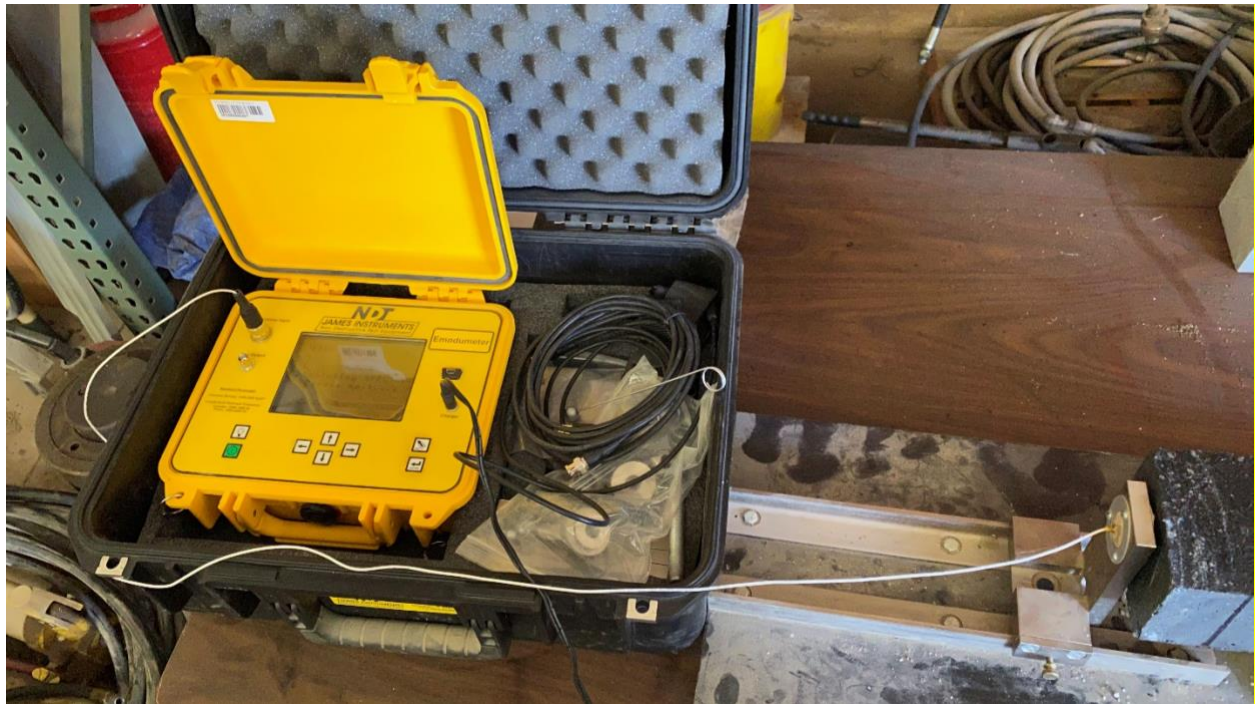
*Figure 4-11: Emodometer with accelerometer connected (white wire)*

0.55 in. Figure 4-10 shows the striking instrument. On the other end of the specimen, a miniature accelerometer was placed against the center of the face. This sensor was attached to an emodumeter and read the vibrations when the concrete was struck. The emodumeter then determined and provided the resonant frequency of the concrete specimen. This instrument setup is shown in Figure 4-11. Three readings were collected for each specimen per round of testing. The averaged frequency values were used to calculate the specimen's relative dynamic modulus (RDM) of elasticity. The short specimen being tested, AA3-L, had inconsistent readings throughout testing, so five readings were collected per round.

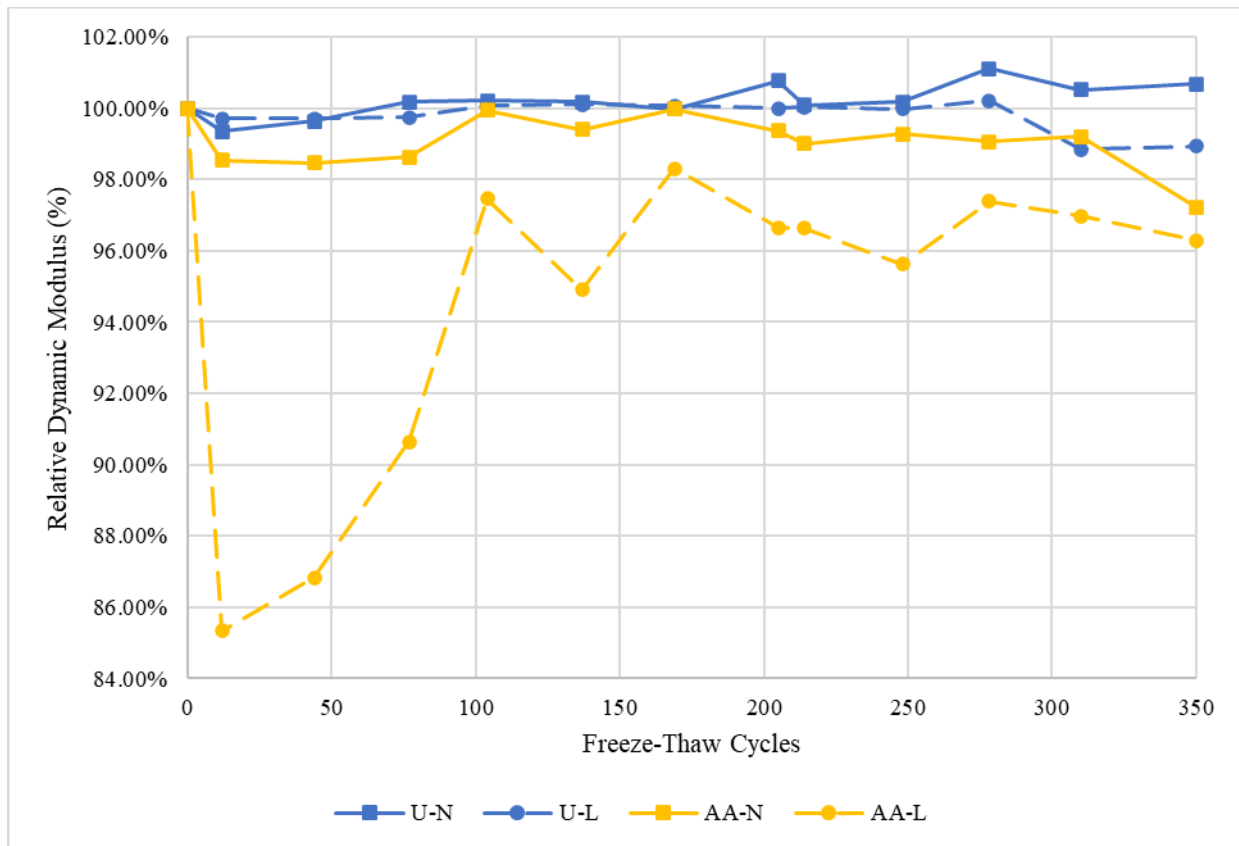
Figure 4-12: Plot of average RDM values for link slab specimens

The RDM of each freeze-thaw specimen was determined as a squared ratio of the specimen's measured frequency to its initial frequency collected before testing began. This calculation was based on ASTM C666. These values were calculated for each interval resonant frequencies were measured. Figure 4-12 shows a plot of the average RDM values for each specimen type throughout testing. The dramatic dip in value in the first 100 cycles of AA-L is unexpected and may be due to issues in collecting data during testing.

Overall, the UHPC specimens fared better than the AA specimens. When looking at specimens similarly loaded, this holds true; the J3 specimens retained higher RDM values than AA specimens. Prolonged saturation throughout testing promoted further curing in UHPC specimens with water seeping superficially into the surface of specimens and activating dry cementitious material. This reaction likely caused most of the UHPC specimens to develop slightly higher stiffness by the end of testing. This increase in stiffness is denoted by RDM values greater than 100%. Specimens U3-N and U3-L were the only UHPC specimens to lose strength.

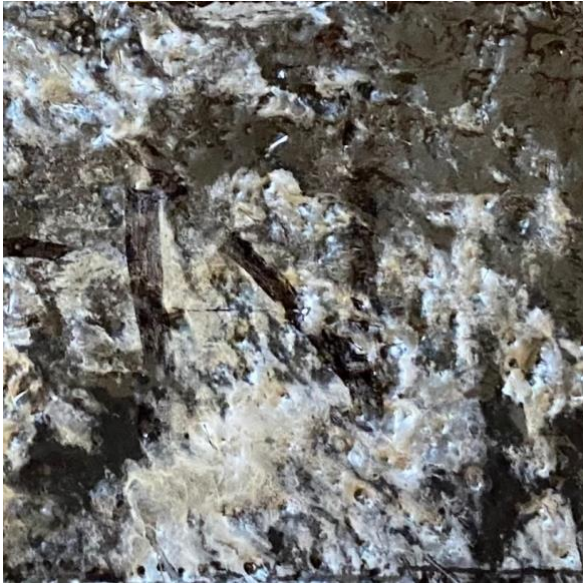
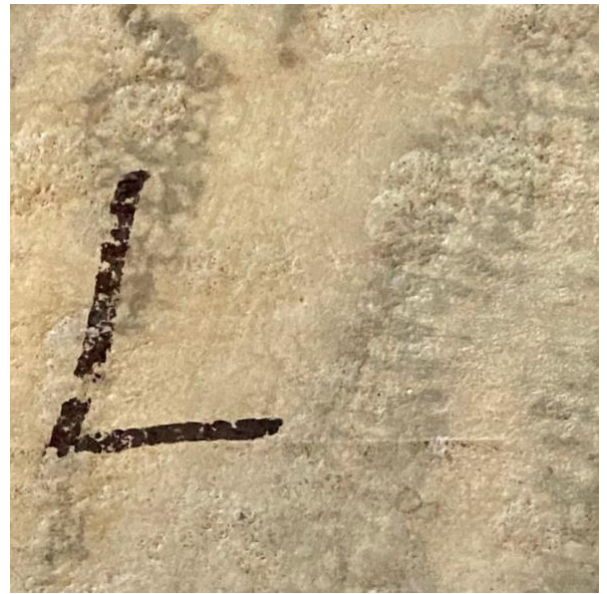
*Figure 4-13: Surface condition at beginning of testing (0 freeze-thaw cycles) for specimens (a) U2-N, (b) U2-L, (c) AA2-N, (d) AA2-L*

Physical changes were observed and recorded during testing. One specimen from each link slab is pictured in Figures 4-13 through 4-15 showing the progression of their surface states from before testing, after 170 cycles, and after 350 cycles when testing concluded. All respective specimens showed similar changes due to testing. Photos for these figures are of the same location of each specimen, as best as could have been achieved with the deterioration of distinguishing marks such as marker labels.

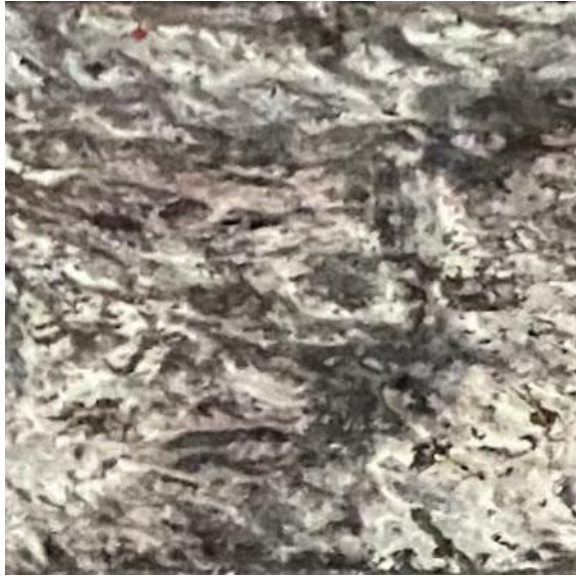
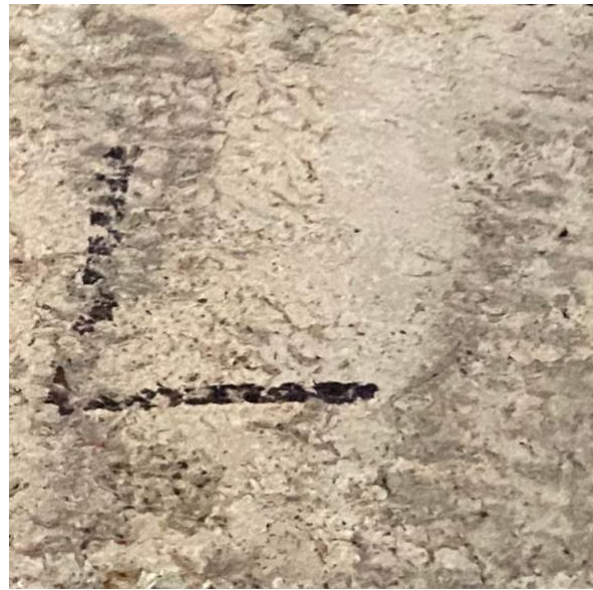
*Figure 4-14: Surface condition at 170 freeze-thaw cycles for specimens (a) U2-N, (b) U2-L, (c) AA2-N, (d) AA2-L*

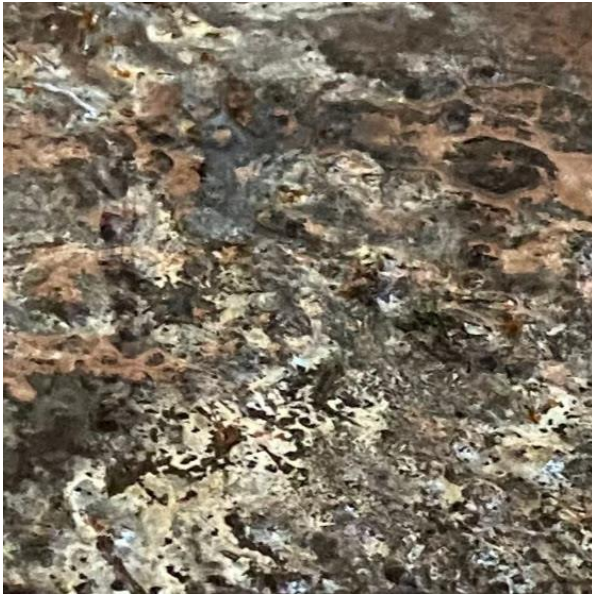
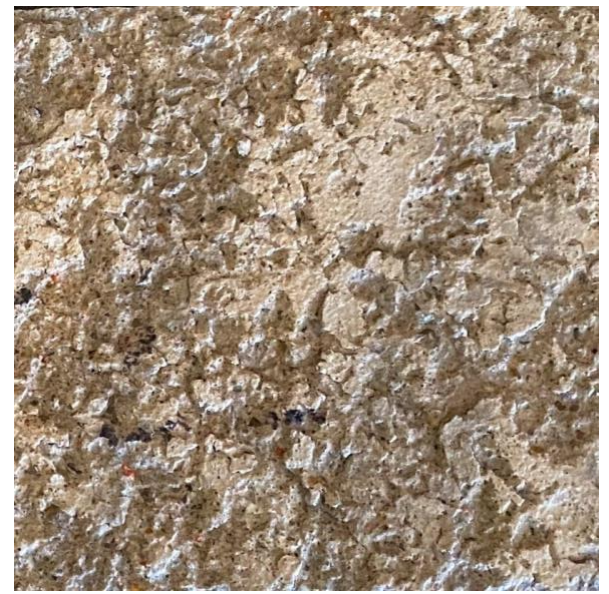
*Figure 4-15: Surface condition at 350 freeze-thaw cycles for specimens (a) U2-N, (b) U2-L, (c) AA2-N, (d) AA2-L*

For the U-L, AA-N, and AA-L specimens, varying degrees of scaling developed on the top surface, with the loaded specimens having the more severe scaling. While AA specimens developed this scaling during testing, U-L specimens had preexisting pockets on their surfaces, as shown in Figure 4-13b. Scaling pieces on the U-L specimens were considerably larger than the AA specimens due to the steel fibers present. Mass was not measured during for this test; any discussion of material loss is based on observations. The finer residue from AA specimens is shown in a testing tray during testing in Figure 4-16. Pronounced pockets on UHPC surfaces indicate material loss as well, but not to the degree observed by AA specimens. Furthermore, AA specimens experienced chipped edges. Figures 4-17 through 4-20 show these affected areas. U-N specimens have little to no observable scaling to its surface, demonstrated in Figure 4-15a, while none of the UHPC specimens showed signs of chipping.

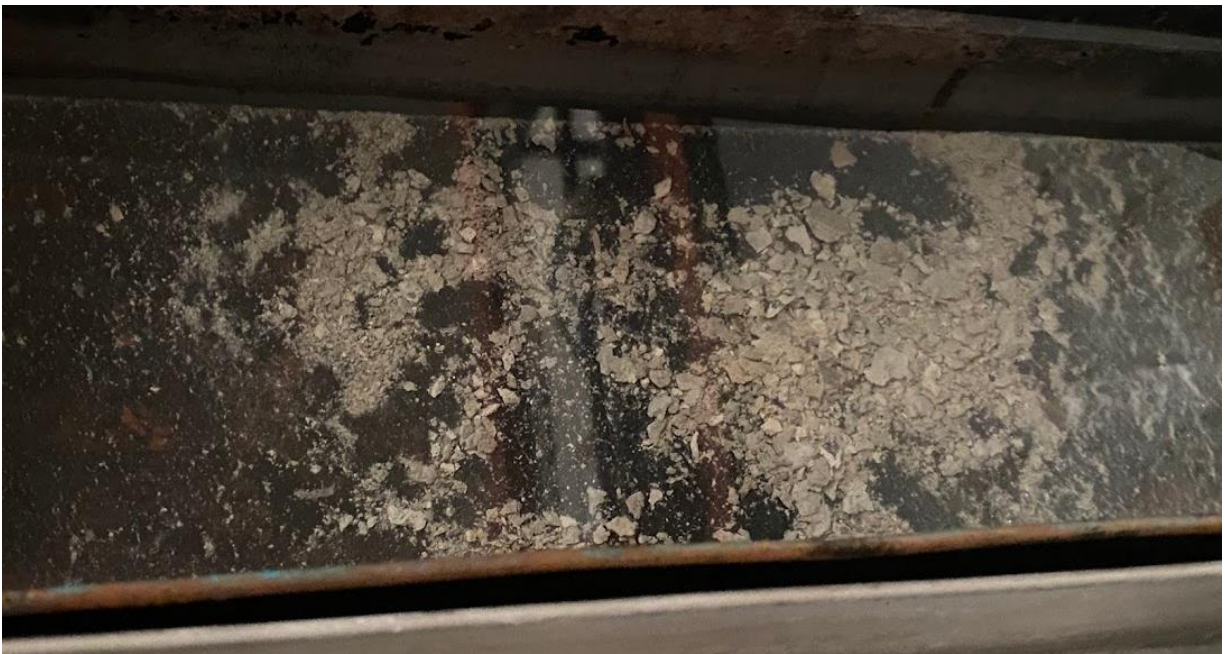
*Figure 4-16: Concrete residue in tray after removal of specimen AA2-L*

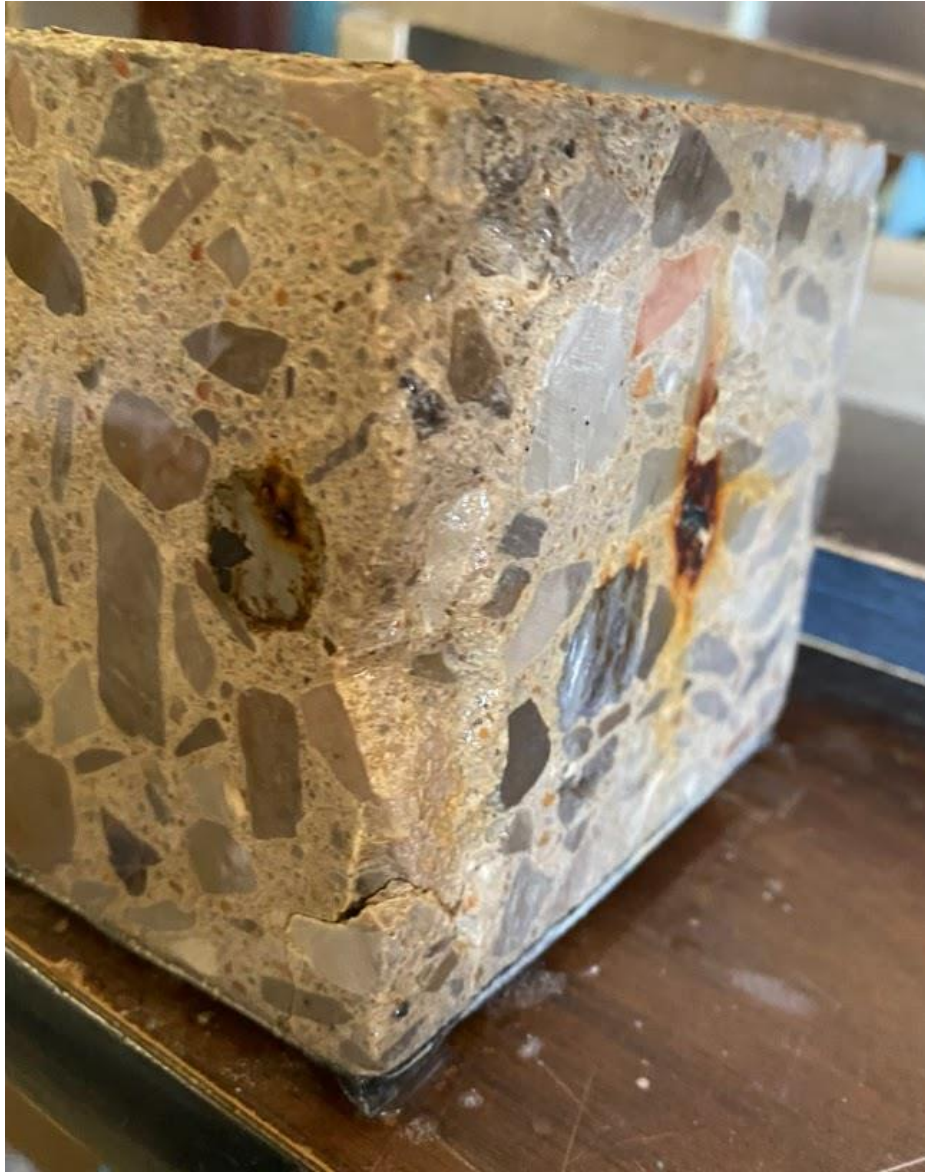
*Figure 4-19: Chipped edges of specimen AA2-L*

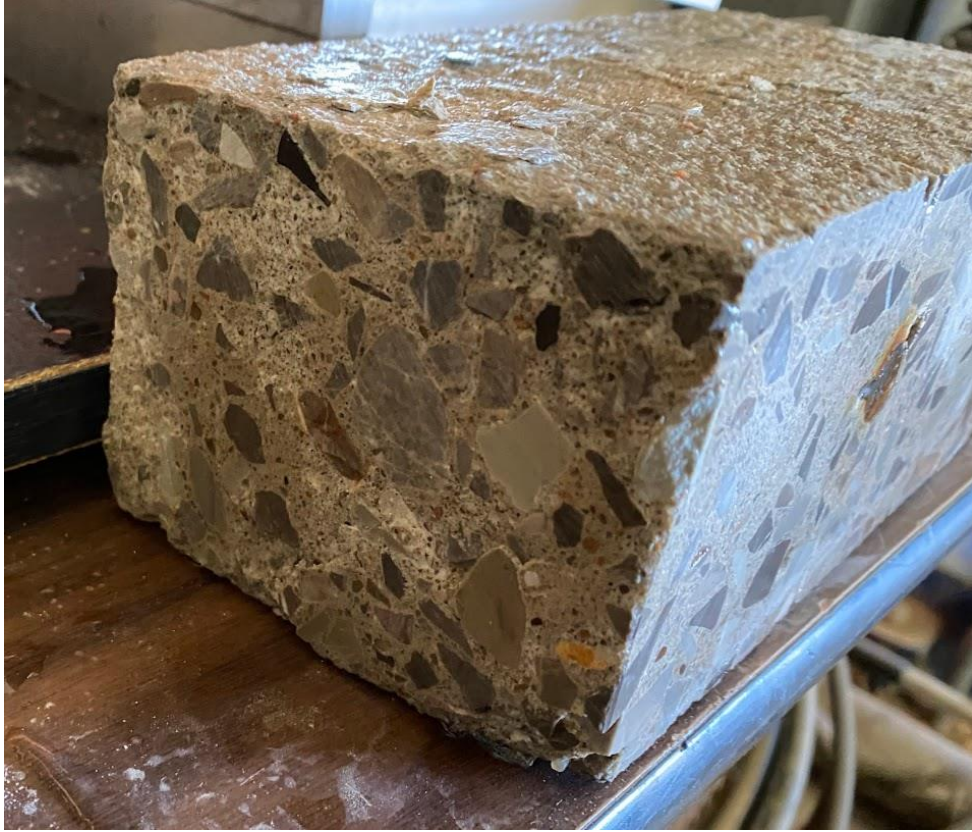
*Figure 4-20: Chipped edges, face of specimen AA3-L*

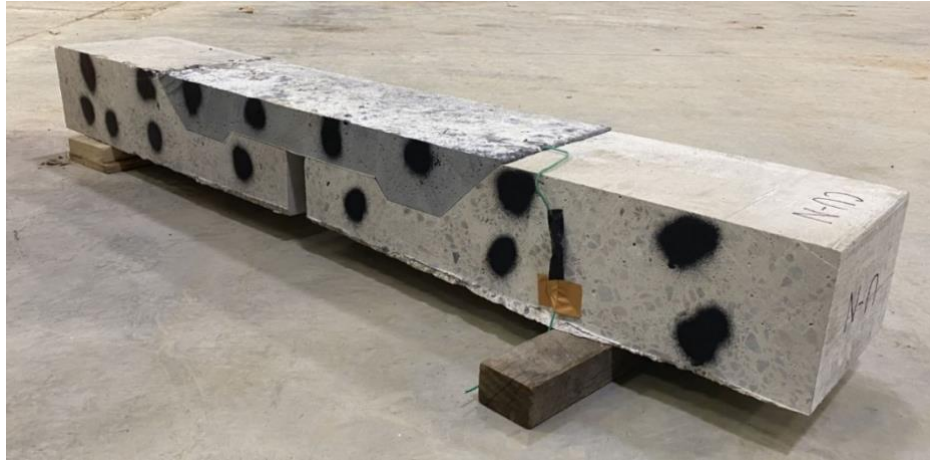
*Figure 5-1: Corrosion specimen CU-N with sealant applied to exposed rebar ends*

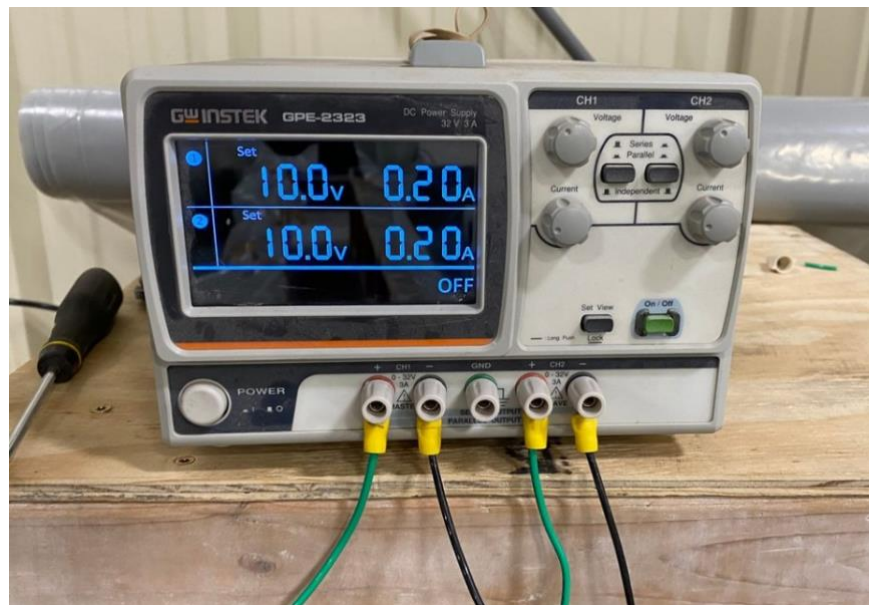
*Figure 5-3: DC power supply with test settings*

Two DC power supplies were utilized to provide the electric current for corrosion testing. One of the power sources is shown in Figure 5-3 along with the set values of 0.2 amps and 10.0 volts.

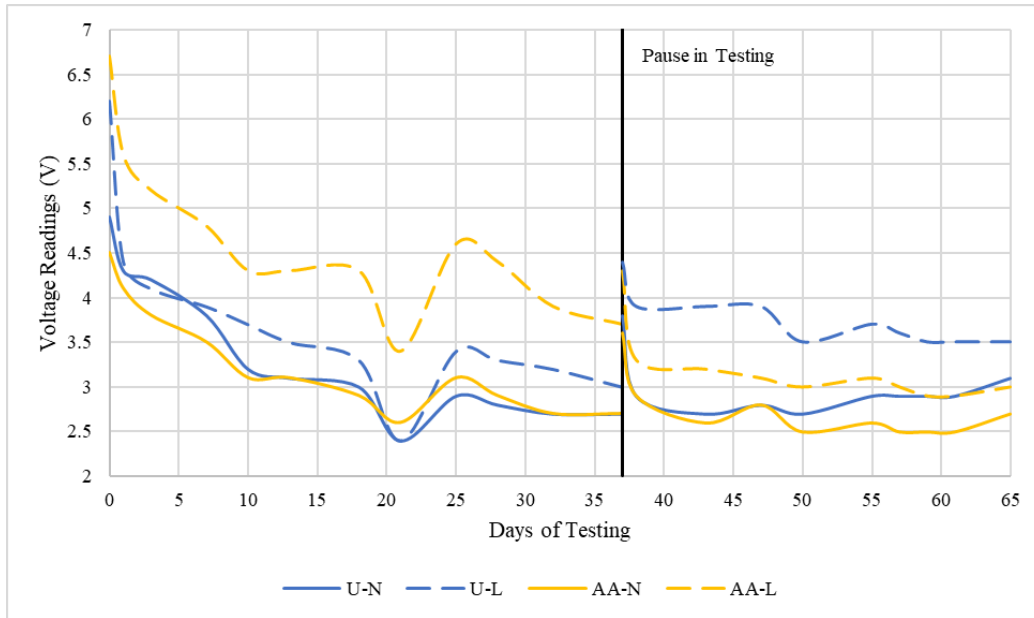
Figure 5-5: Plot comparing corrosion specimen voltage readings during testing

Note the break at day 37 when testing was paused and resumed with new saline solution.

In general, lower voltage readings would indicate increased corrosion potential. Unloaded specimens tended to have similar readings throughout testing, with the highest spread between them being 0.5V at the conclusion of testing. It is unclear why the loaded specimens developed different reading trends after the pause in testing than before. The following figure shows the setup for the accelerated corrosion testing of specimen CU-L through its first 5 weeks. Photos shown in Figure 5-6 were taken at the following time increments: 0 days (when testing began), 3 days, 18 days, and 37 days. All corrosion specimens experienced similar progressions during testing.

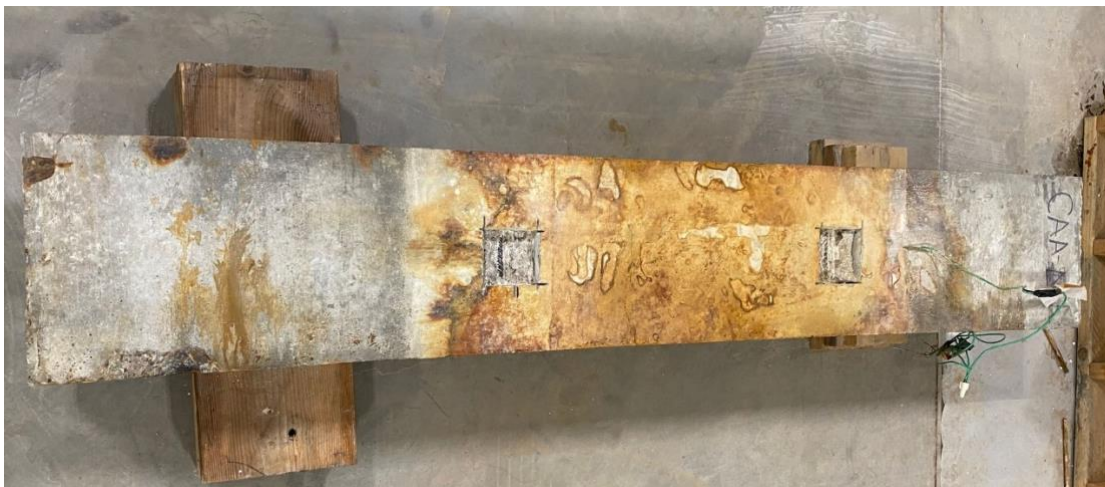
*Figure 5-7: Surface of CAA-L after 37 days of testing, windows cut*

After 5 weeks, specimens were removed from the solution baths, flipped, and windows were cut to observe the state of the reinforcing steel within the link slab connection. Figure 5-7 shows the surface of specimen CAA-L after being flipped over. The rebar and surrounding concrete observed in this specimen are shown in Figures 5-8 and 5-9. Cracking in the connection observed in this specimen are shown in Figures 5-8 and 5-9. Cracking in the connection developed in CAA-L during cyclic loading and is shown in Figure 5-10. Surface cracking raises the potential for the solution to seep into the connection and initiate premature cracking. Similar photographs of all other specimens are provided in Figures 5-11 through 5-20. Cracking was also observed on the surface of CAA-N. The crack coincided with rebar layouts and is corrosion-induced. No cracking was observed in the UHPC corrosion specimens.

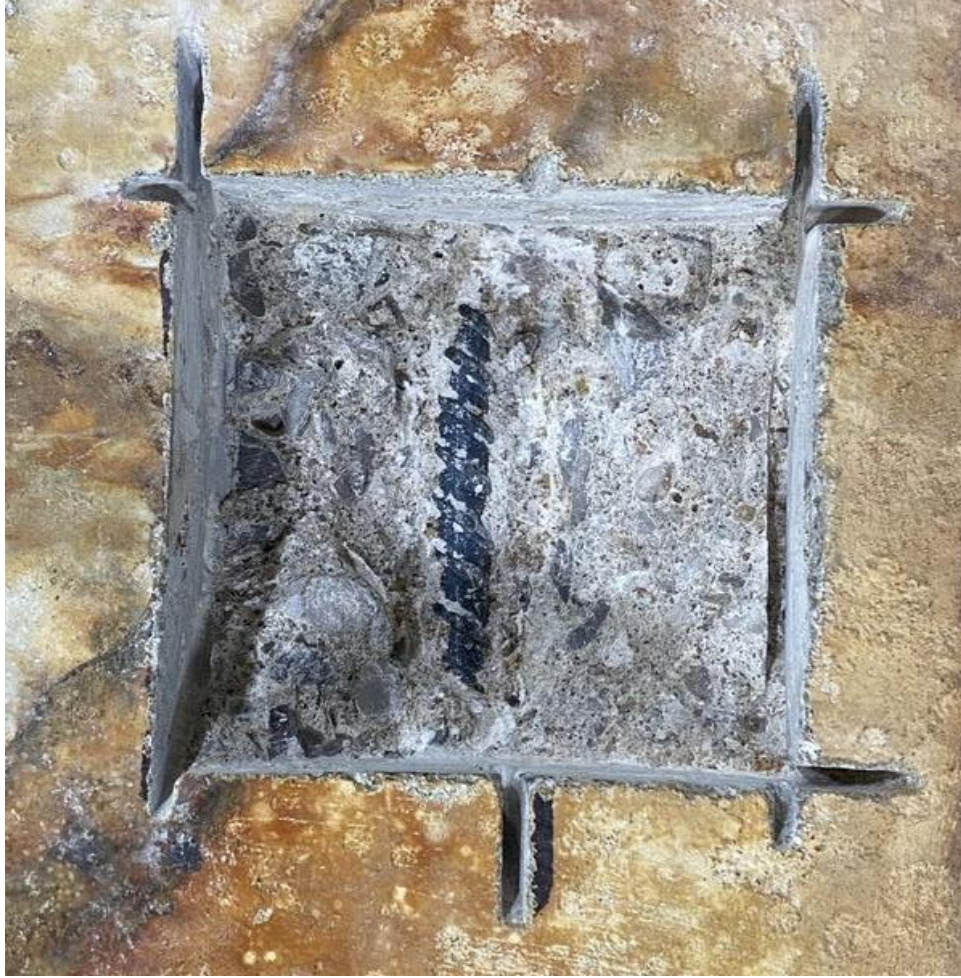
*Figure 5-8: CAA-L observed rebar A, 37 days tested*

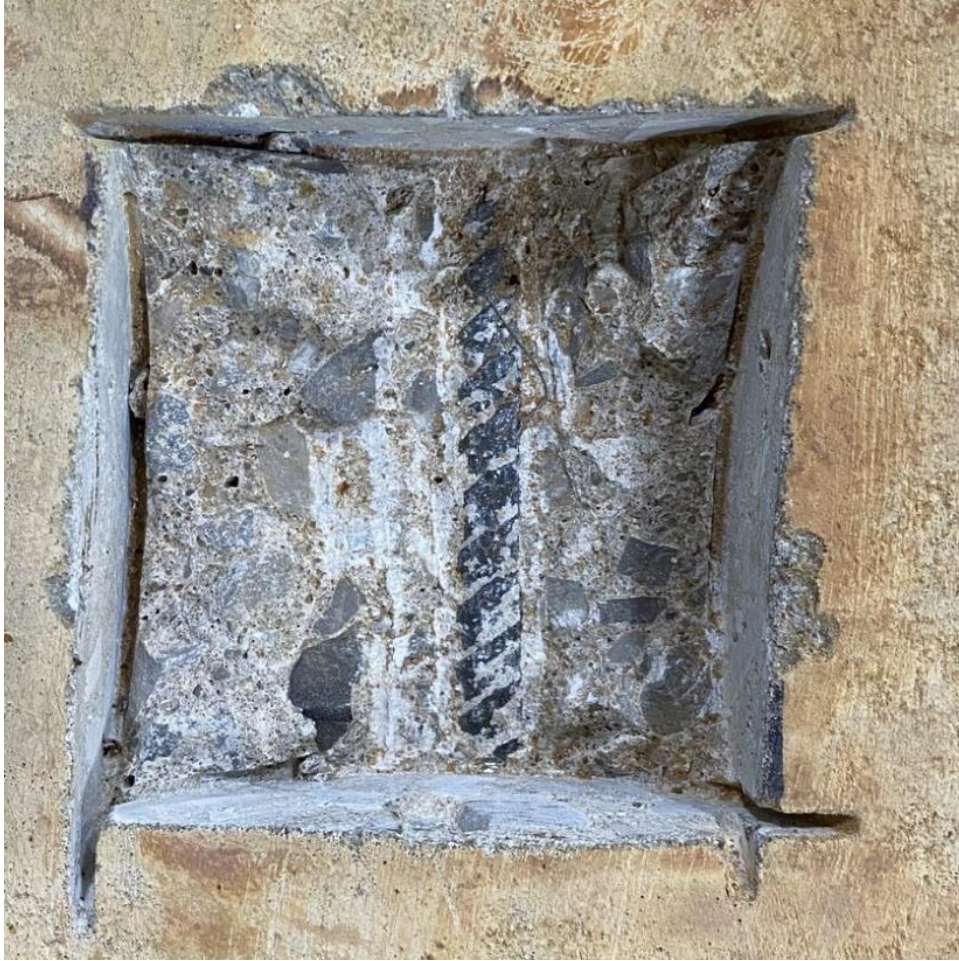
*Figure 5-9: CAA-L observed rebar B, 37 days tested*

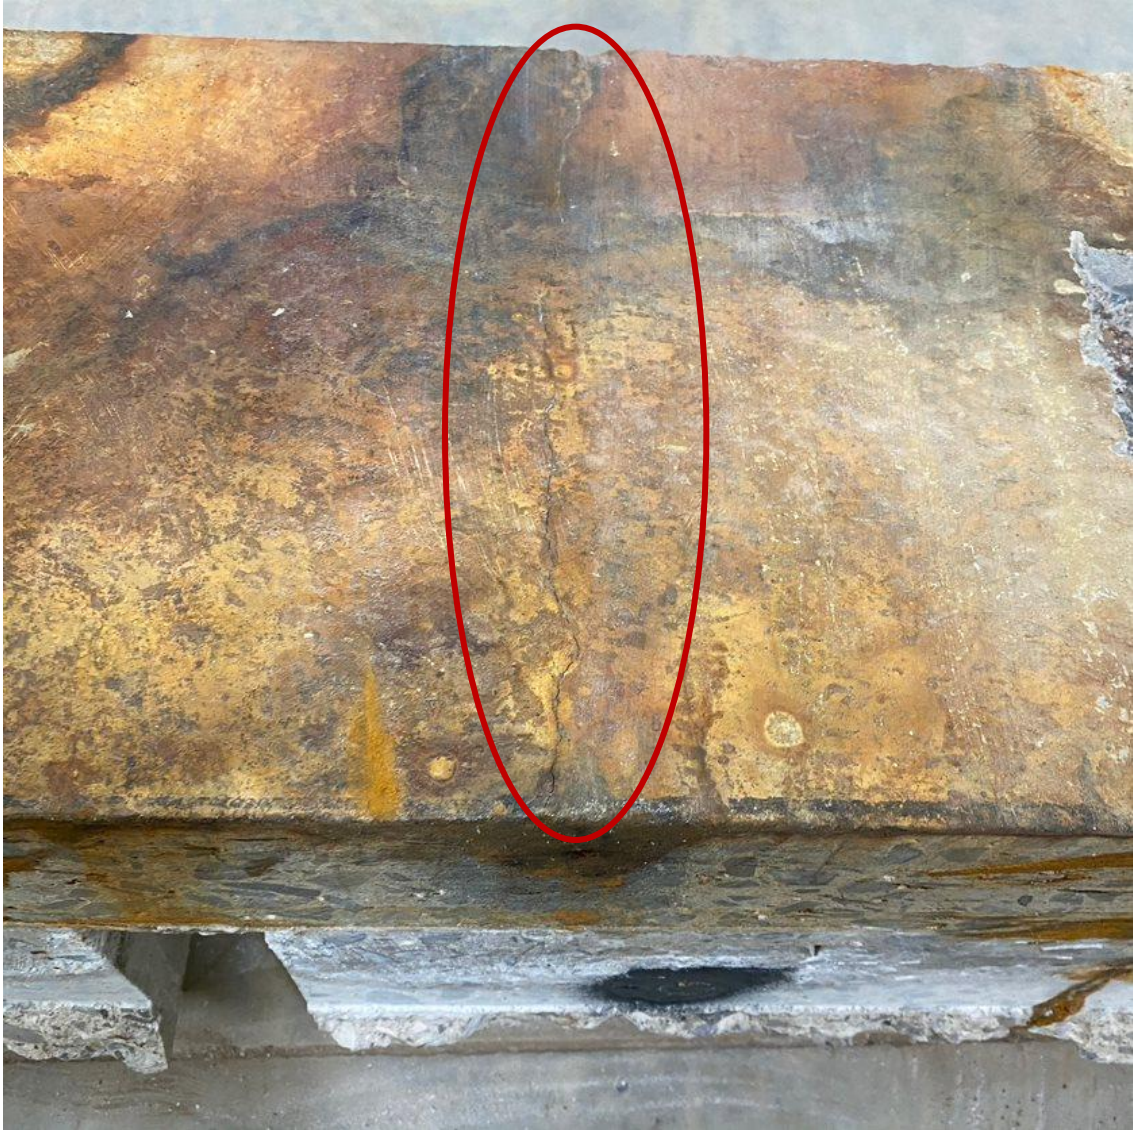
*Figure 5-10: Cracking in specimen CAA-L (present prior to testing, annotated)*

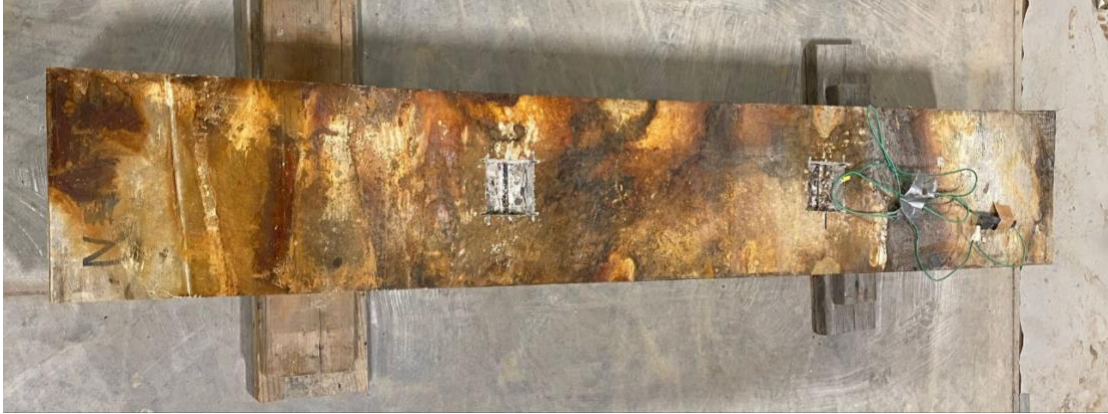
*Figure 5-11: Surface of CAA-N after 37 days of testing, windows cut*

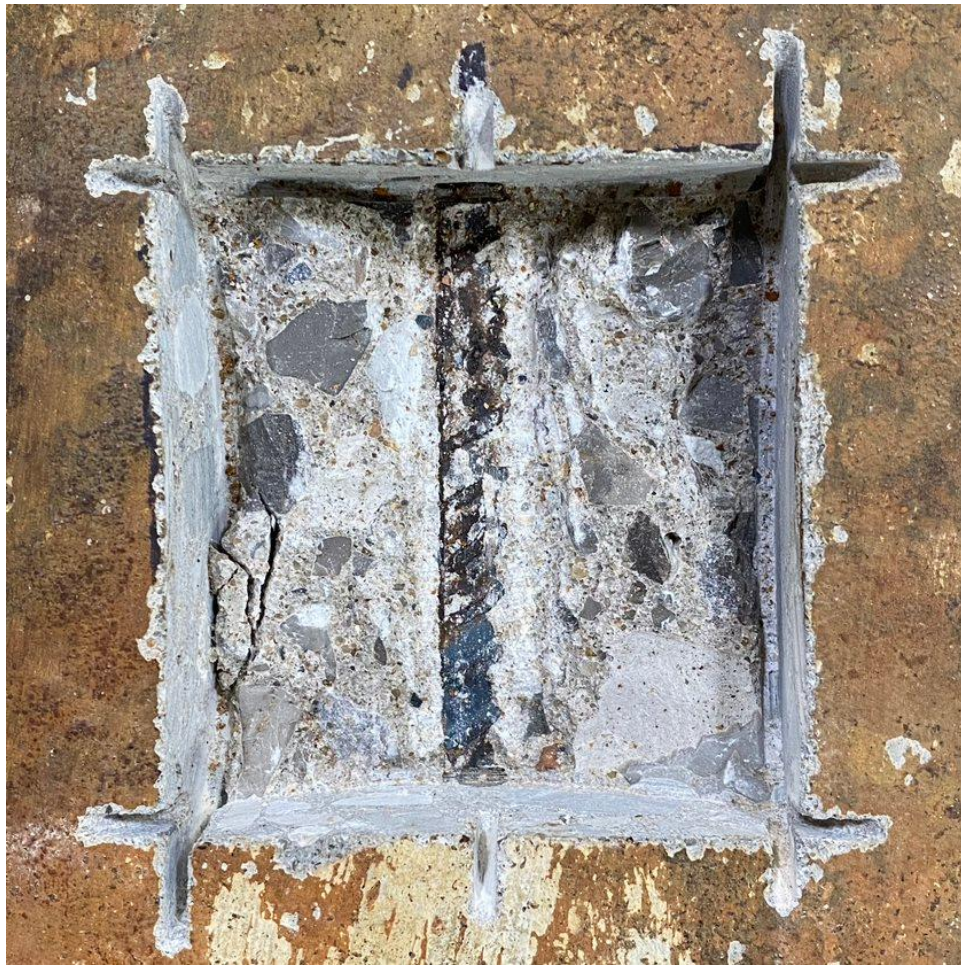
*Figure 5-12: CAA-N observed rebar A, 37 days tested*

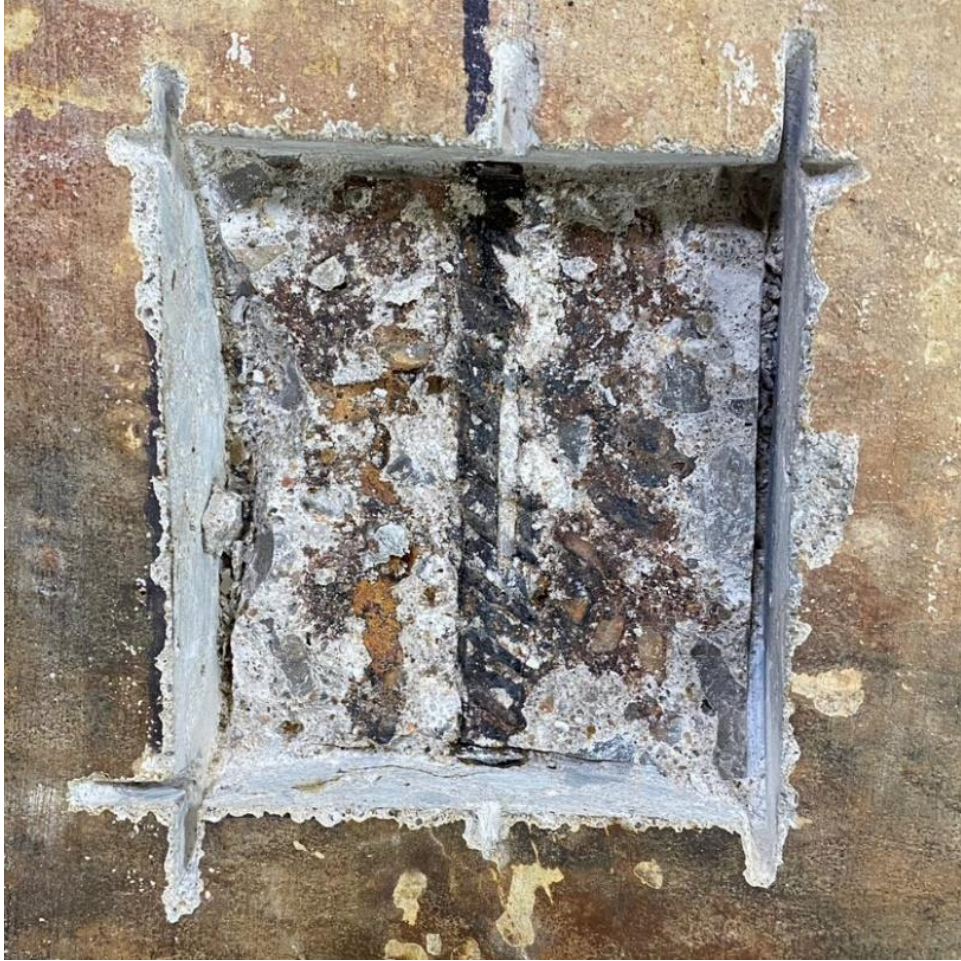
*Figure 5-13: CAA-N observed rebar B, 37 days tested*
