EVALUATION OF FUNCTIONALITY AND SERVICE LIFE OF  
ULTRA-HIGH PERFORMANCE CONCRETE LINK SLAB CONNECTIONS FOR BRIDGES

A THESIS

CIVIL ENGINEERING

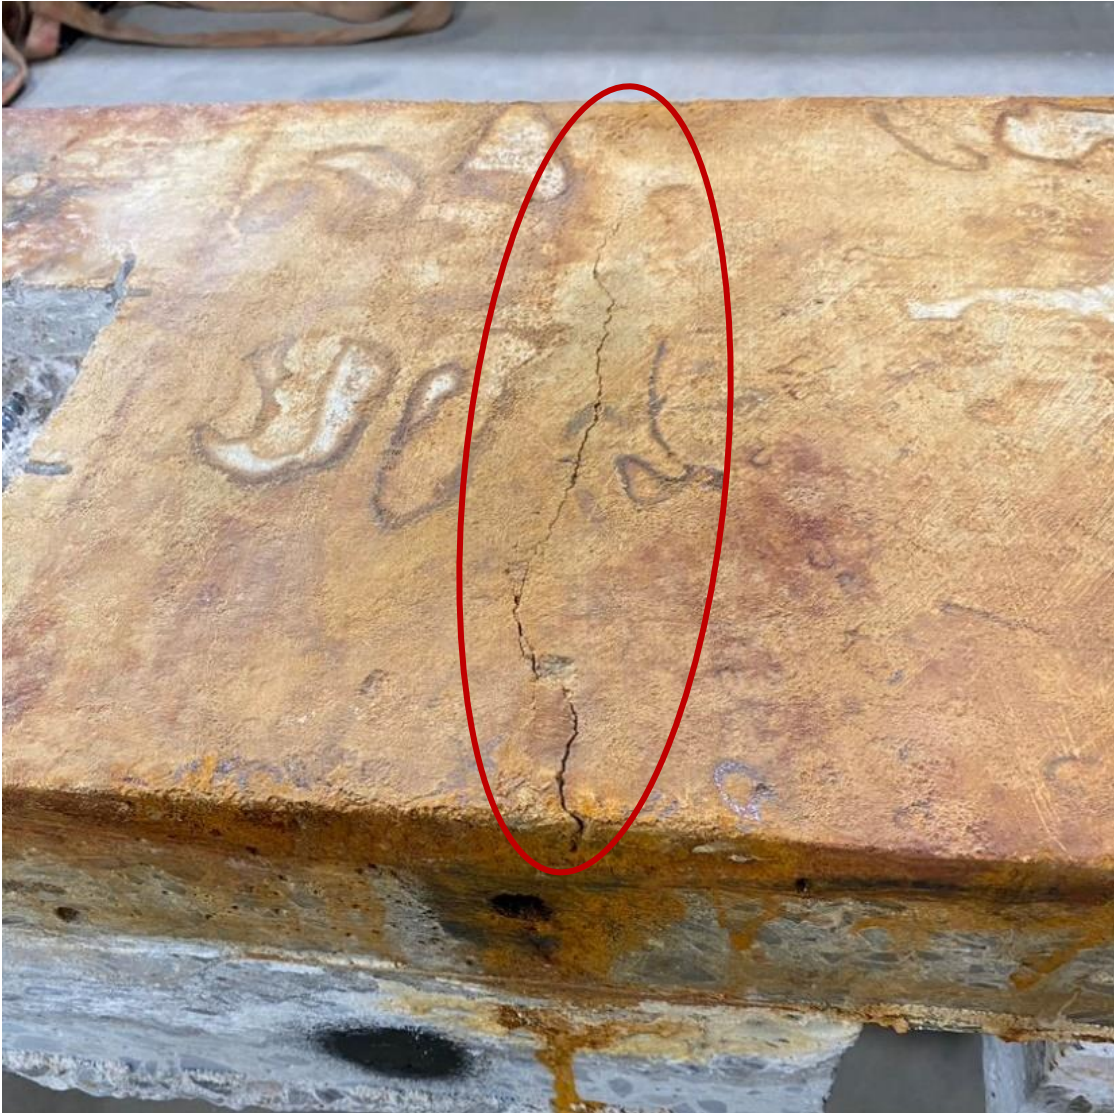
*Figure 5-14: Cracking in specimen CAA-N (annotated)*

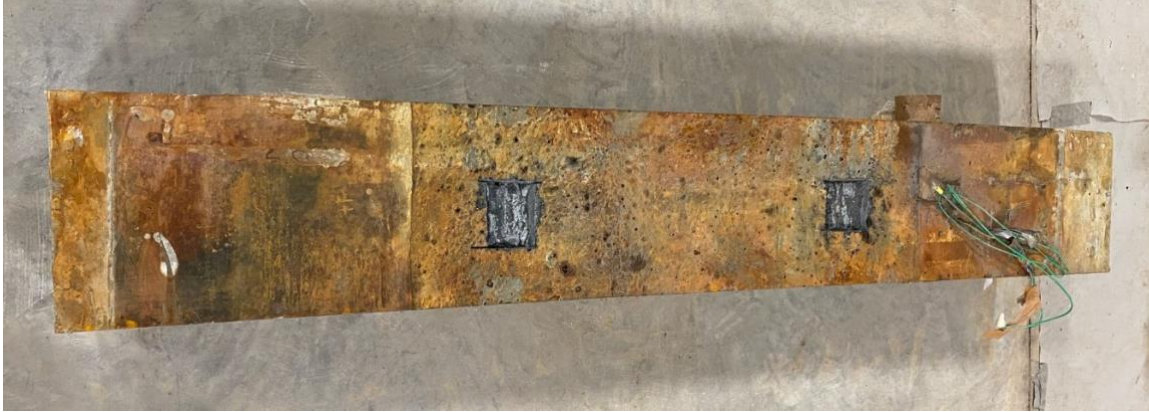
*Figure 5-15: Surface of CU-L after 37 days of testing, windows cut*

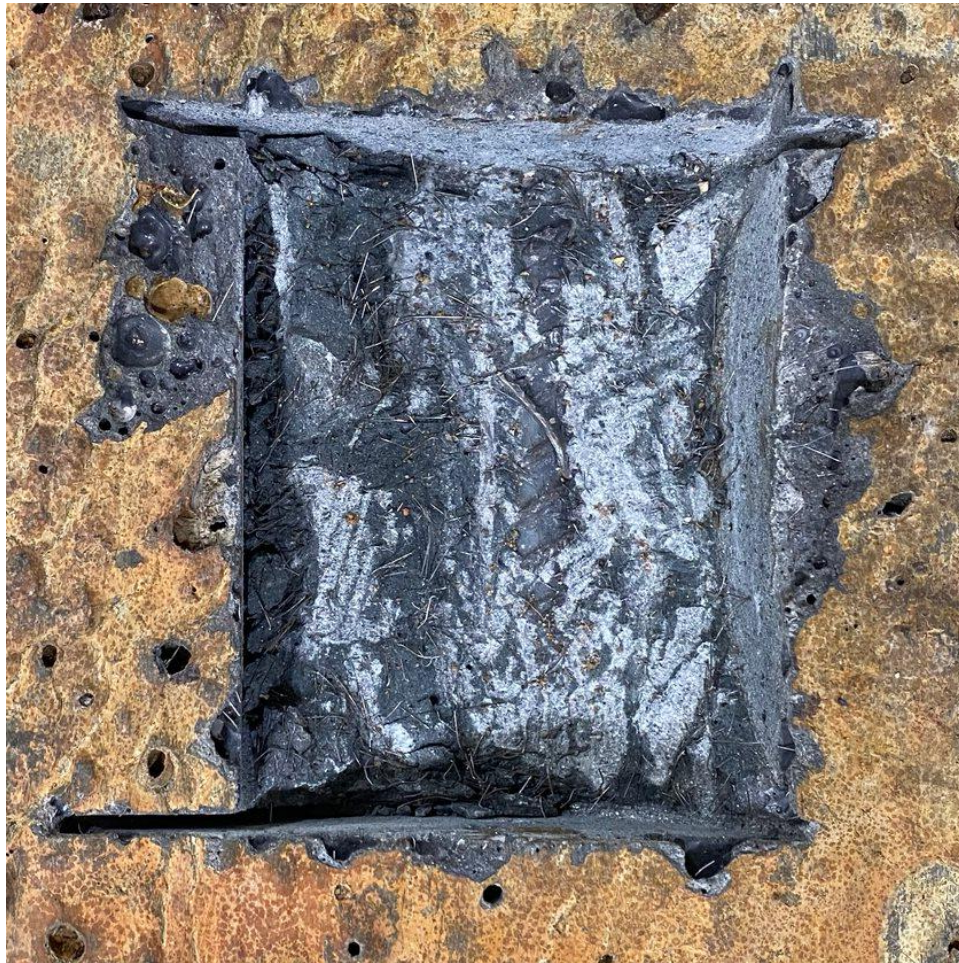
*Figure 5-16: CU-L observed rebar A, 37 days tested*

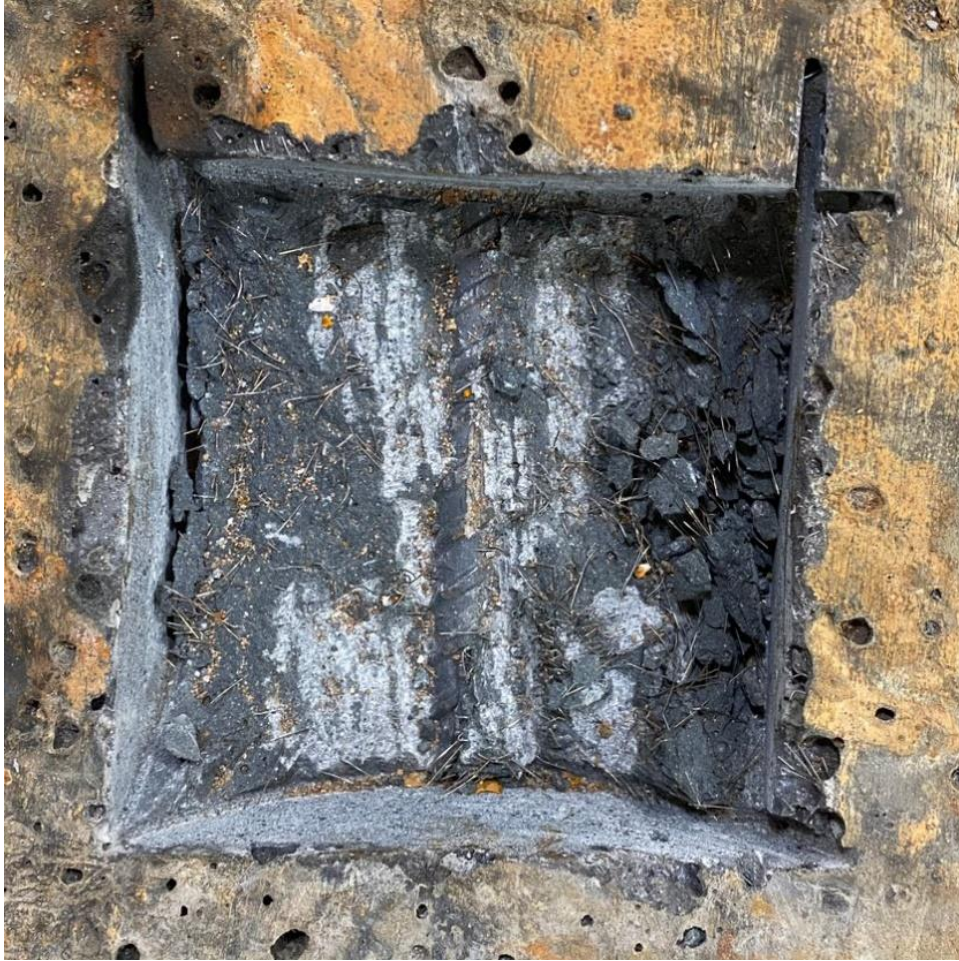
*Figure 5-17: CU-L observed rebar B, 37 days tested*

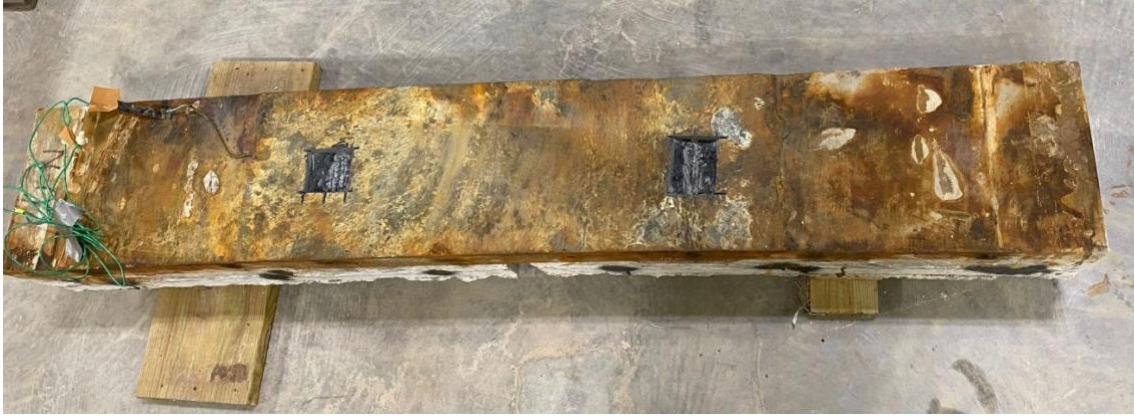
*Figure 5-18: Surface of CU-N after 37 days of testing, windows cut*

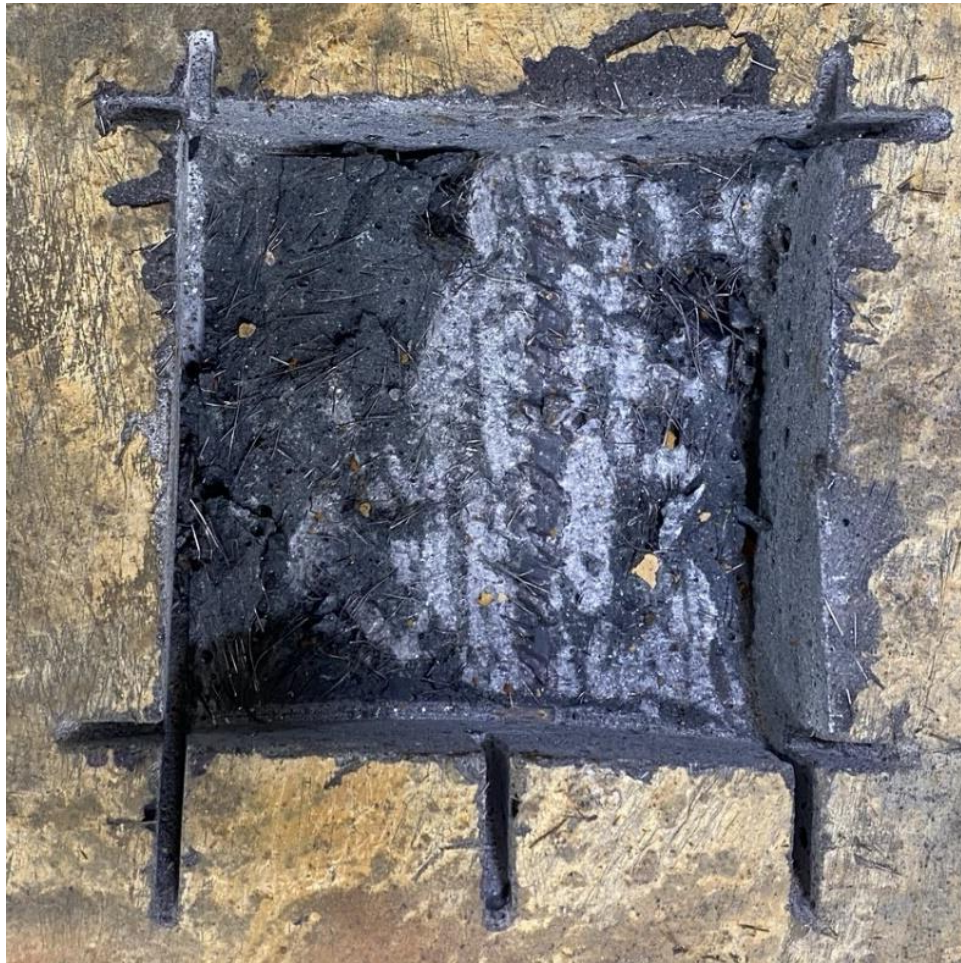
*Figure 5-19: CU-N observed rebar A, 37 days tested*

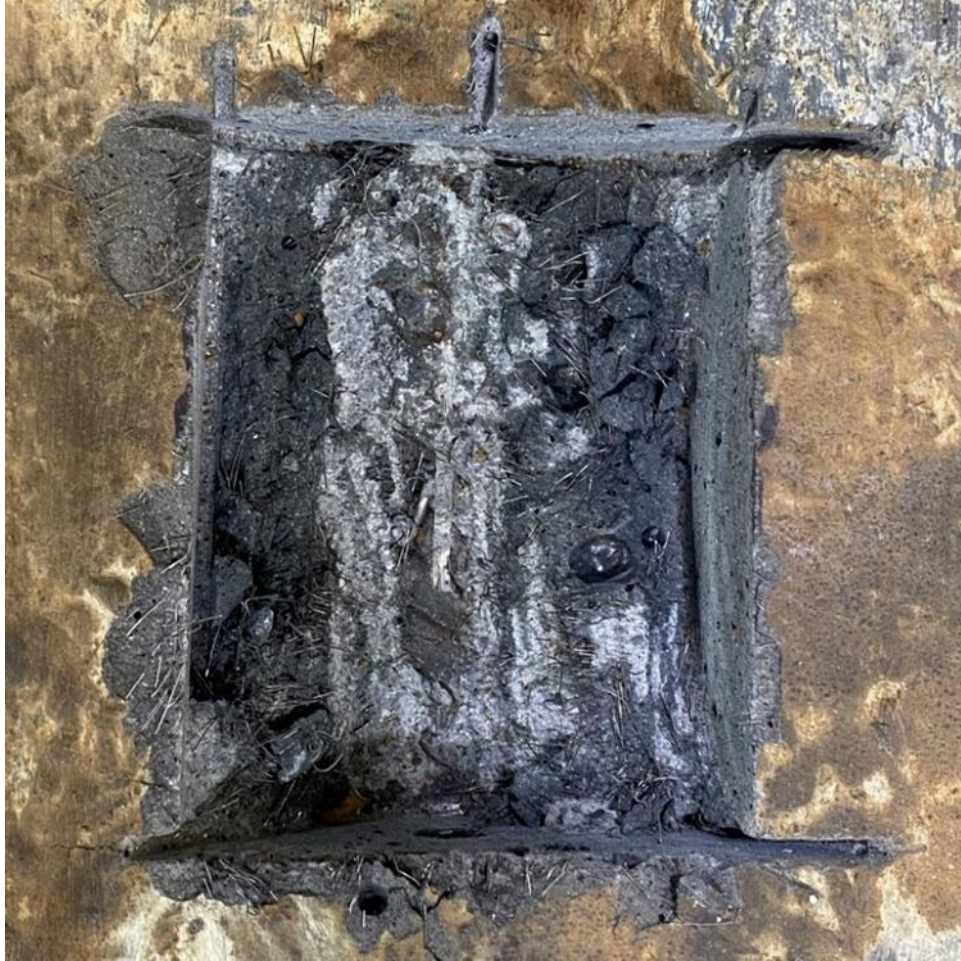
*Figure 5-20: CU-N observed rebar B, 37 days tested*

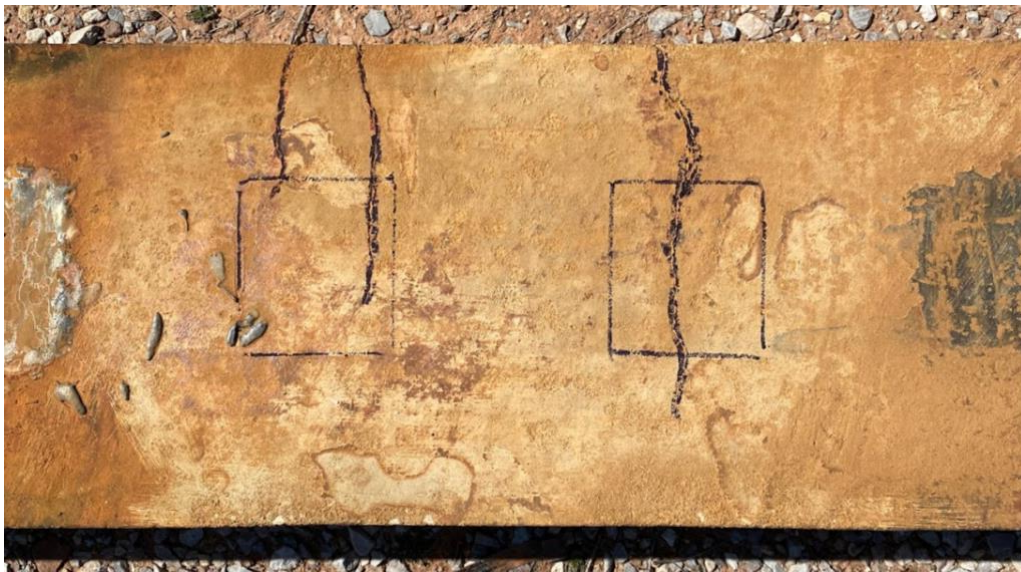
*Figure 5-22: Surface of specimen CAA-L after 65 days of corrosion testing*

After 65 days of total testing time, the state of the connection rebar was observed in the same process conducted at the 37-day checkpoint. Windows were cut for two more segments of rebar in the link slab. Figures 5-22 through 5-27 show the surface and rebar of the AA specimens. Figures 5-28 through 5-33 show the surface and rebar of the UHPC specimens. As with the status of the rebar and surrounding concrete observed at 37 days of corrosion, the status of the rebar in UHPC specimens fared better than Class AA specimens, regardless of whether they were cyclically loaded prior to testing. The Class AA specimens show no signs of corrosion in the rebar and minor signs in the surrounding concrete are seen in CAA-L (Figure 5-23). Cracking observed previously on AA specimens was more pronounced and is annotated in Figures 5-22 and 5-25, indicating further effects of corrosion. No damage was observed at the patched areas of the first set of windows for any specimen.

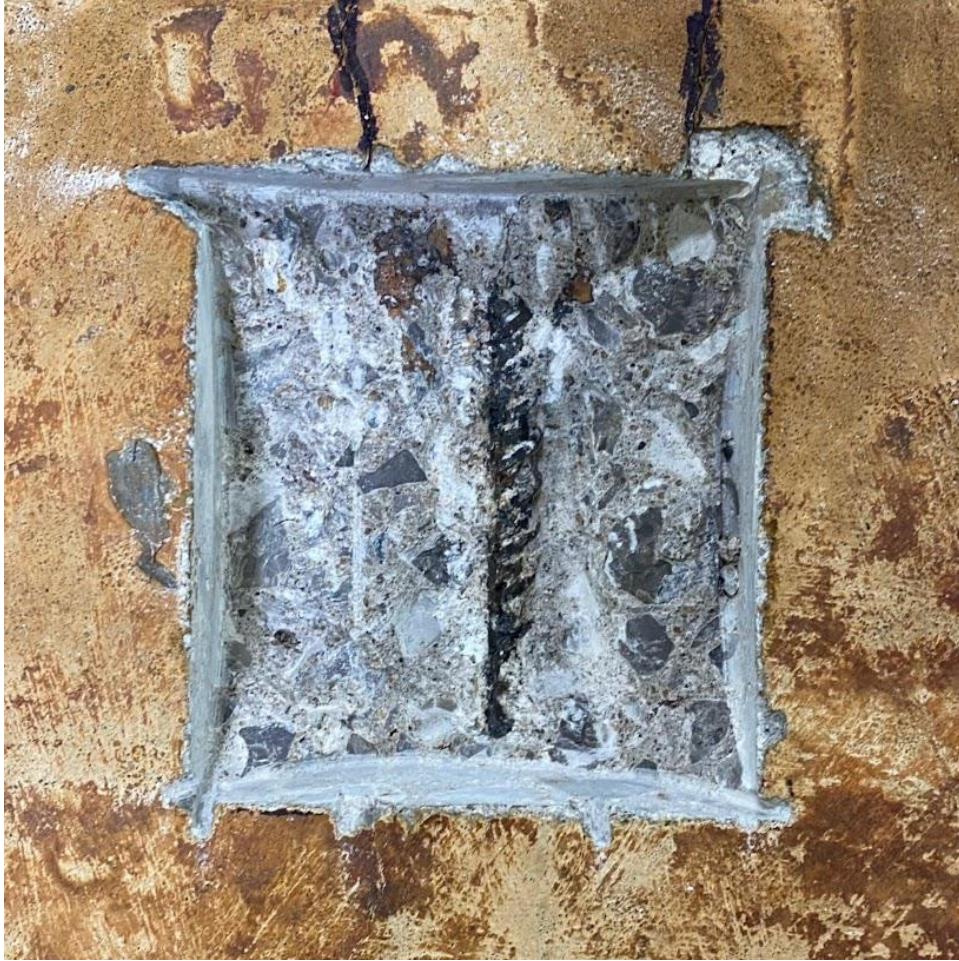
*Figure 5-23: CAA-L observed rebar C, 65 days tested*

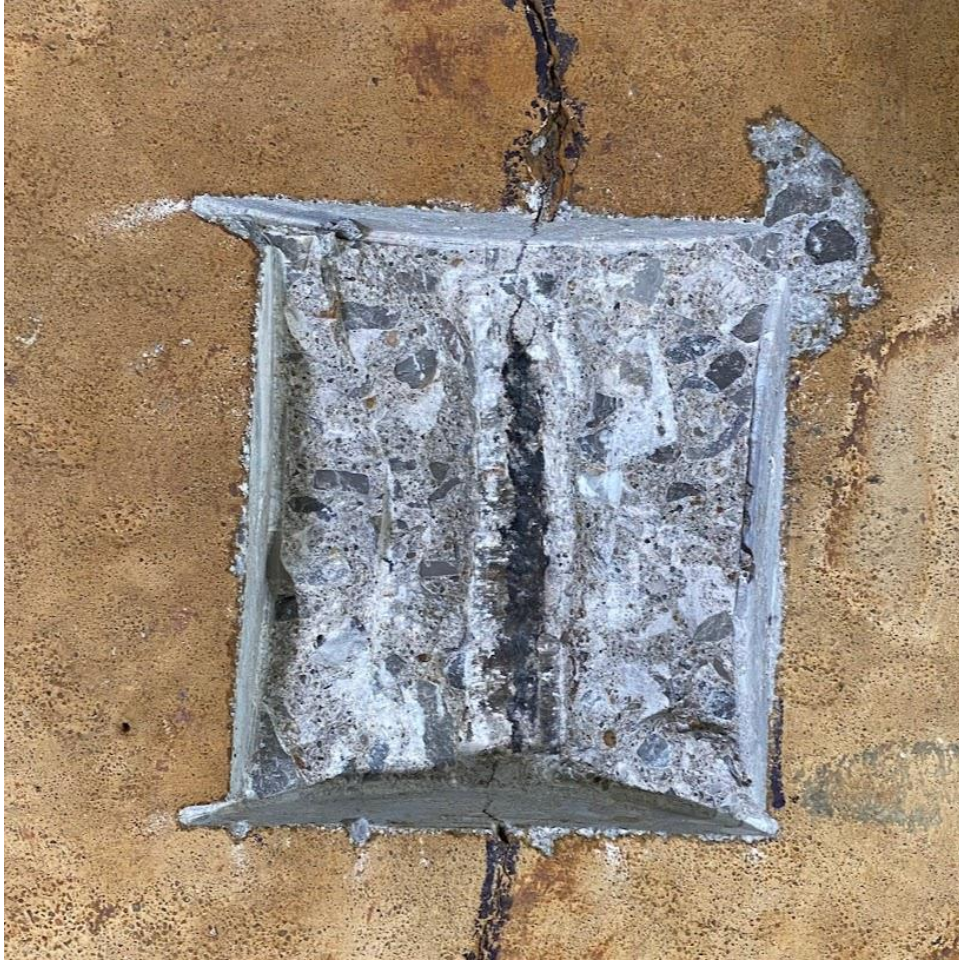
*Figure 5-24: CAA-L observed rebar D, 65 days tested*

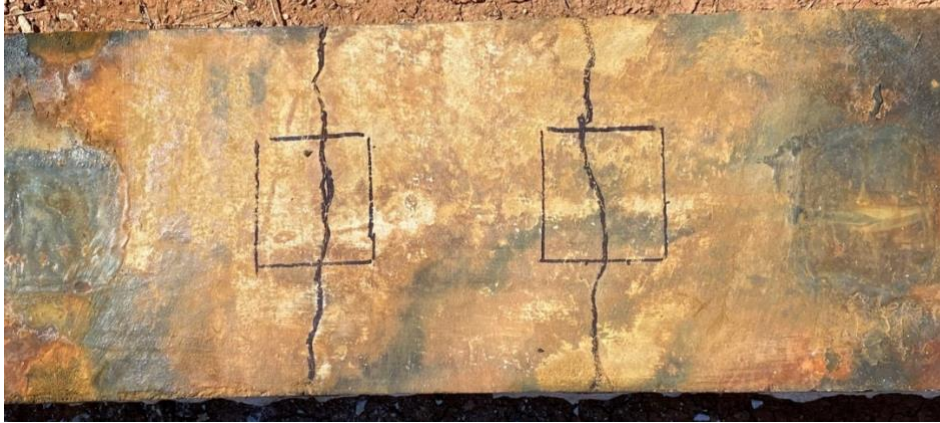
*Figure 5-25: Surface of specimen CAA-N after 65 days of corrosion testing*

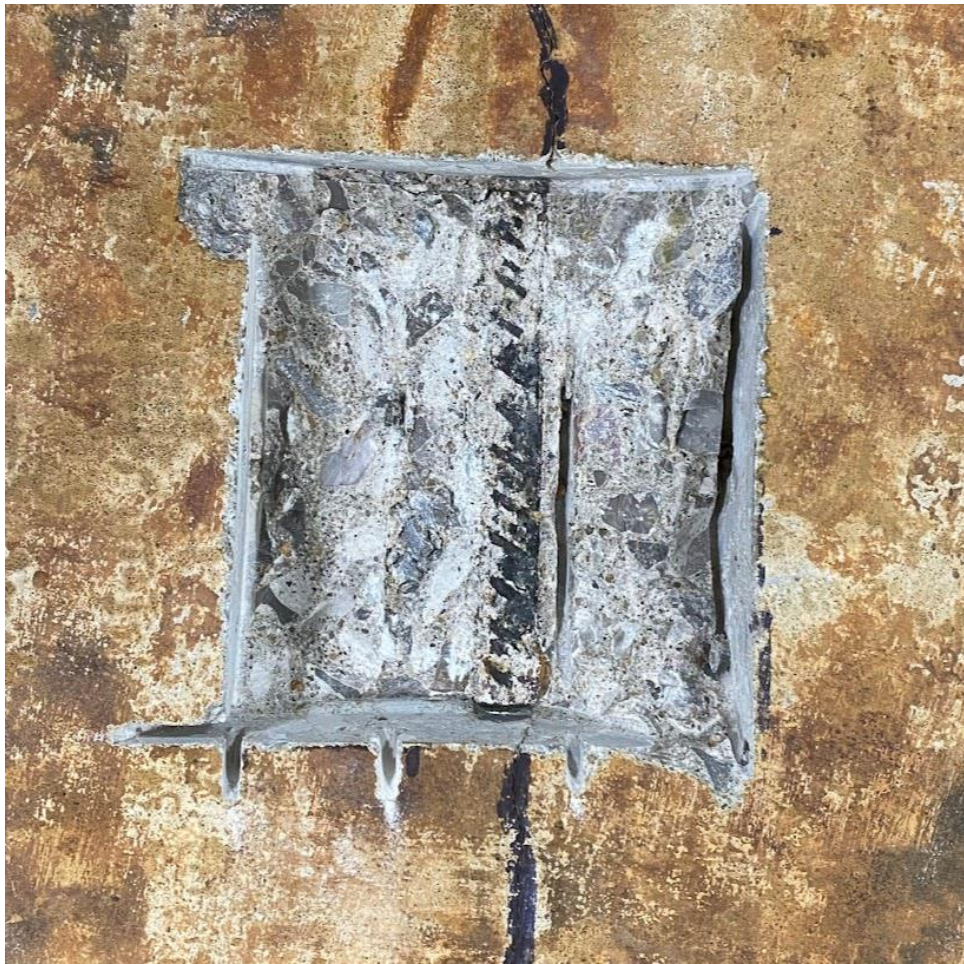
*Figure 5-26: CAA-N observed rebar C, 65 days tested*

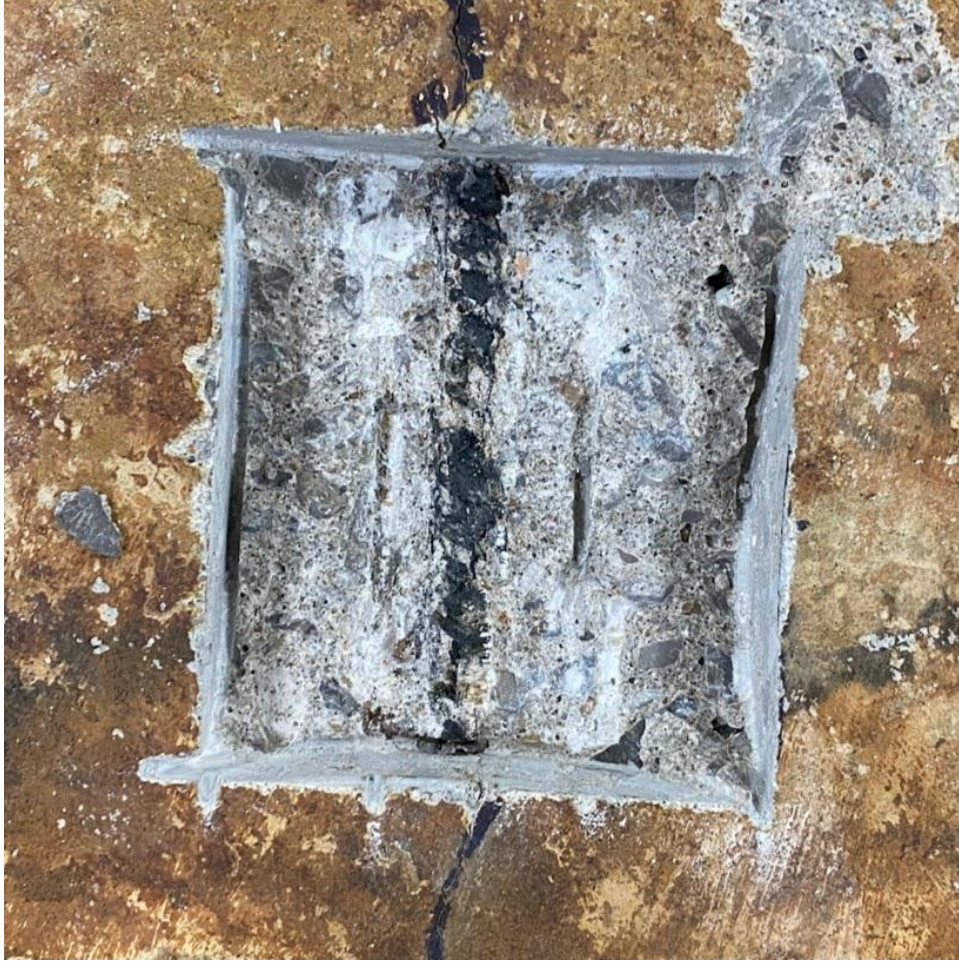
*Figure 5-27: CAA-N observed rebar D, 65 days tested*

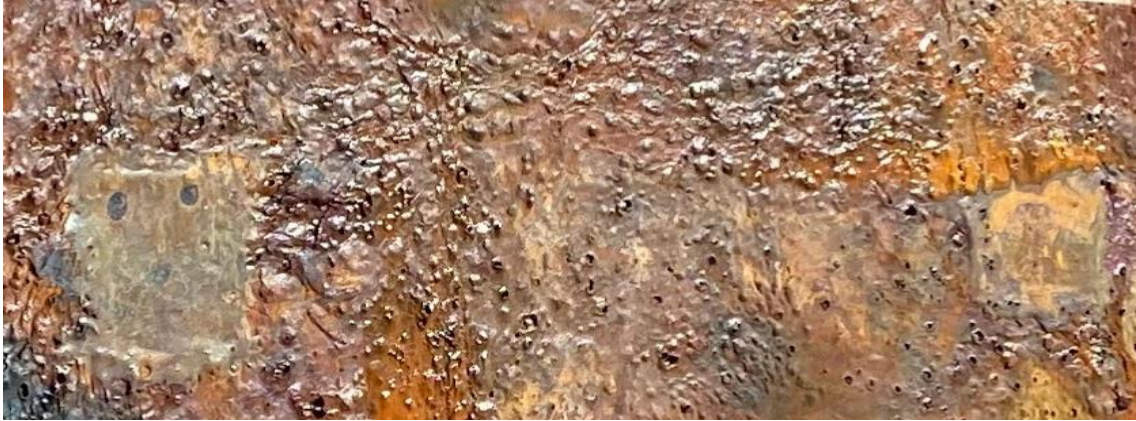
*Figure 5-28: Surface of specimen CU-L after 65 days of corrosion testing*

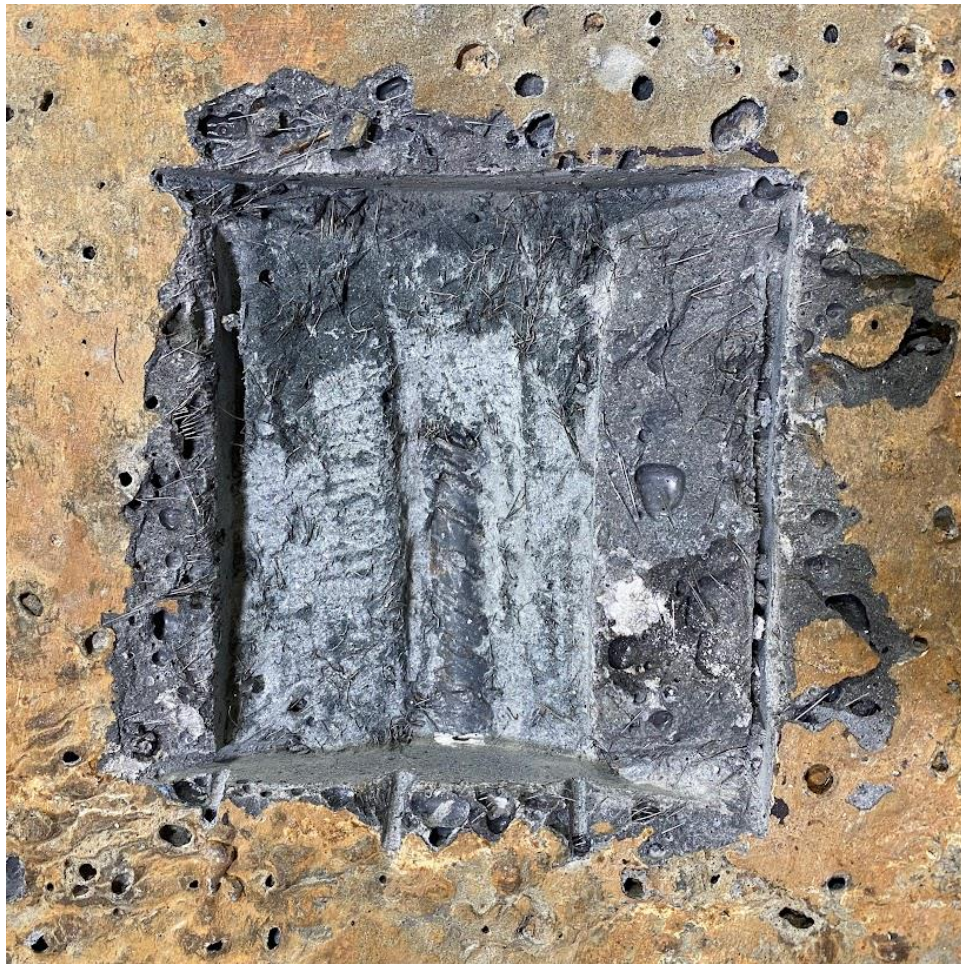
*Figure 5-29: CU-L observed rebar C, 65 days tested*

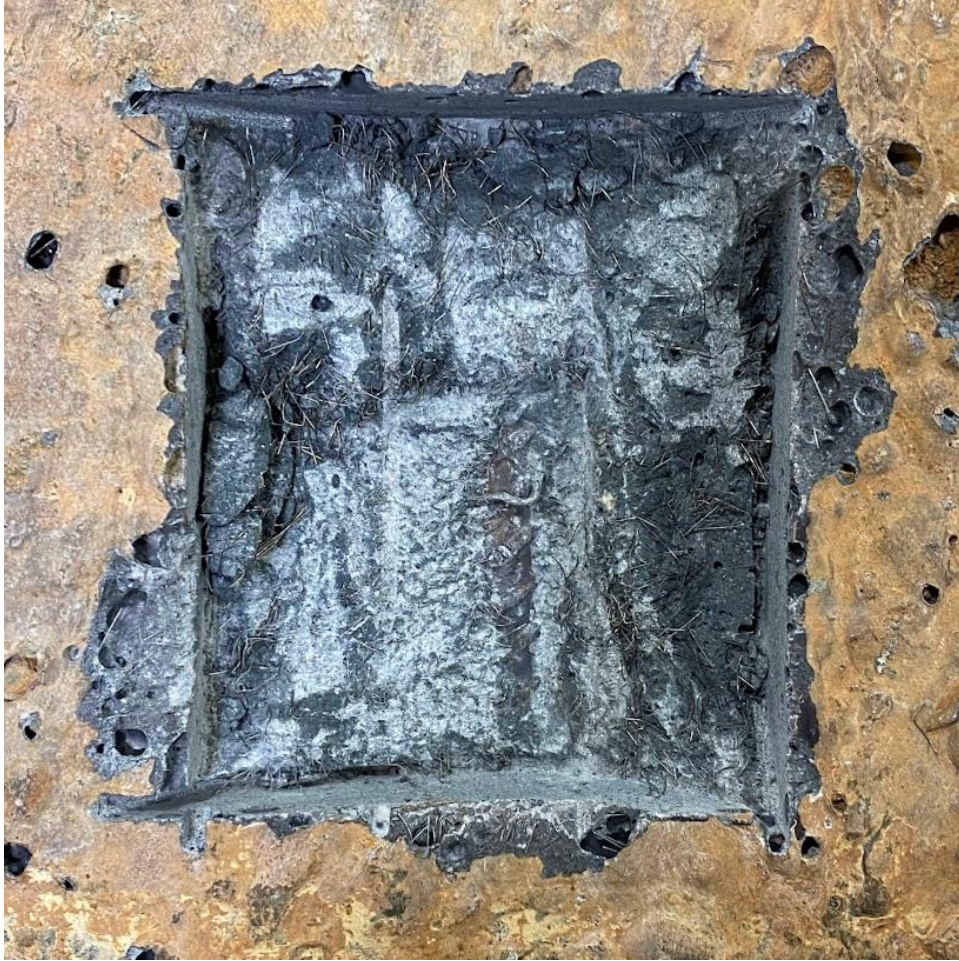
*Figure 5-30: CU-L observed rebar D, 65 days tested*

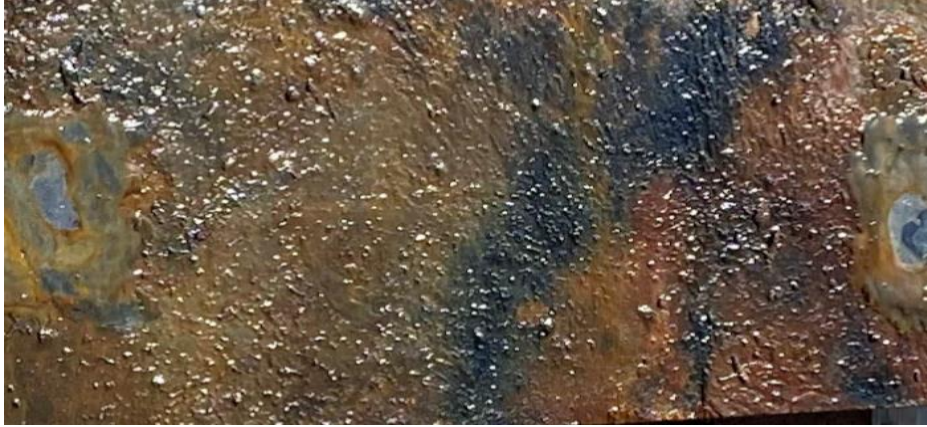
*Figure 5-31: Surface of specimen CU-N after 65 days of corrosion testing*

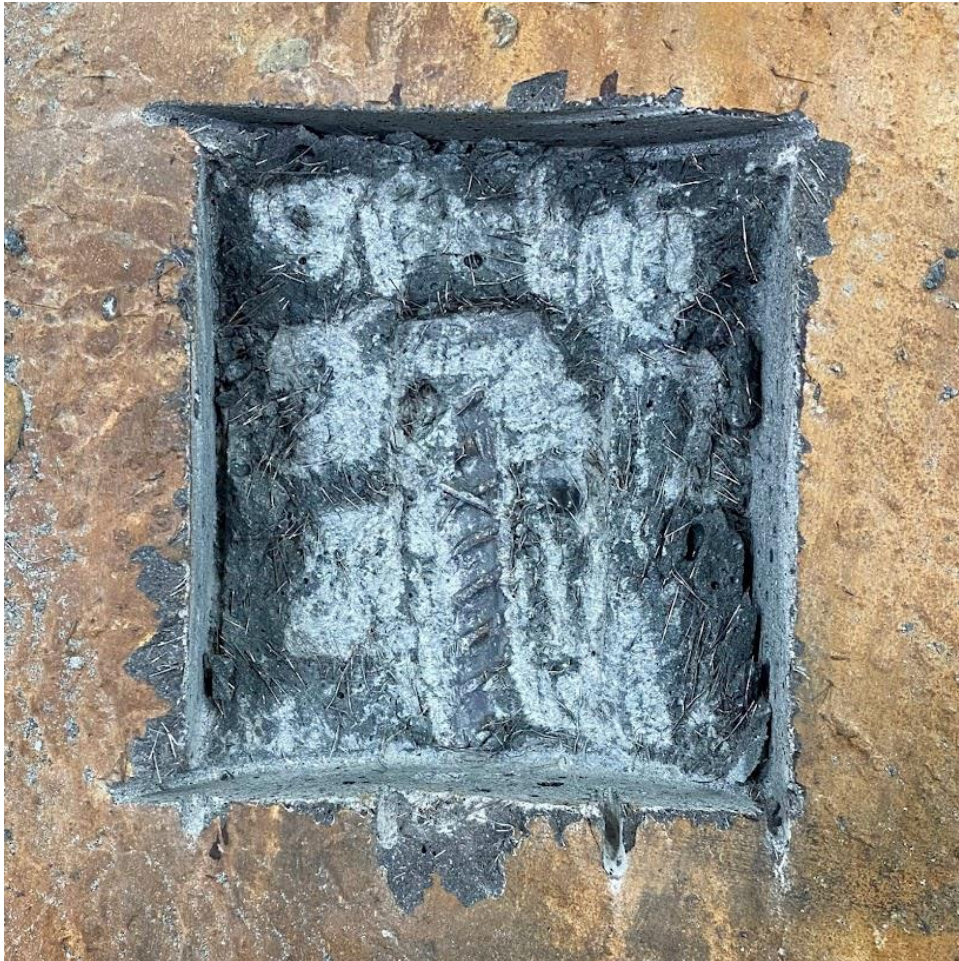
*Figure 5-32: CU-N observed rebar C, 65 days tested*

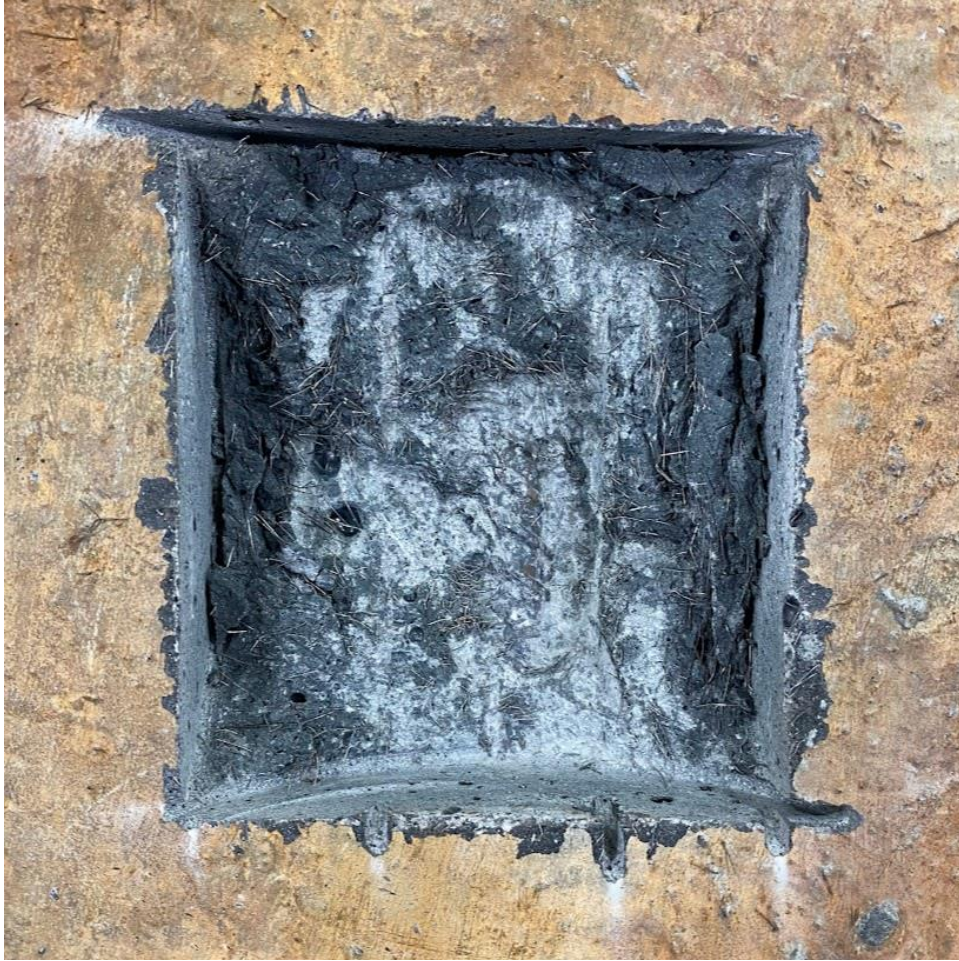
*Figure 5-33: CU-N observed rebar D, 65 days tested*
